The Road Inventory
of
Oregon Caves National Monument
ORCA - 9340

Road Inventory Program

Prepared By:
Federal Highway Administration
Eastern Federal Lands Highway Division
Cycle 3

Oregon Caves National Monument
in
Oregon

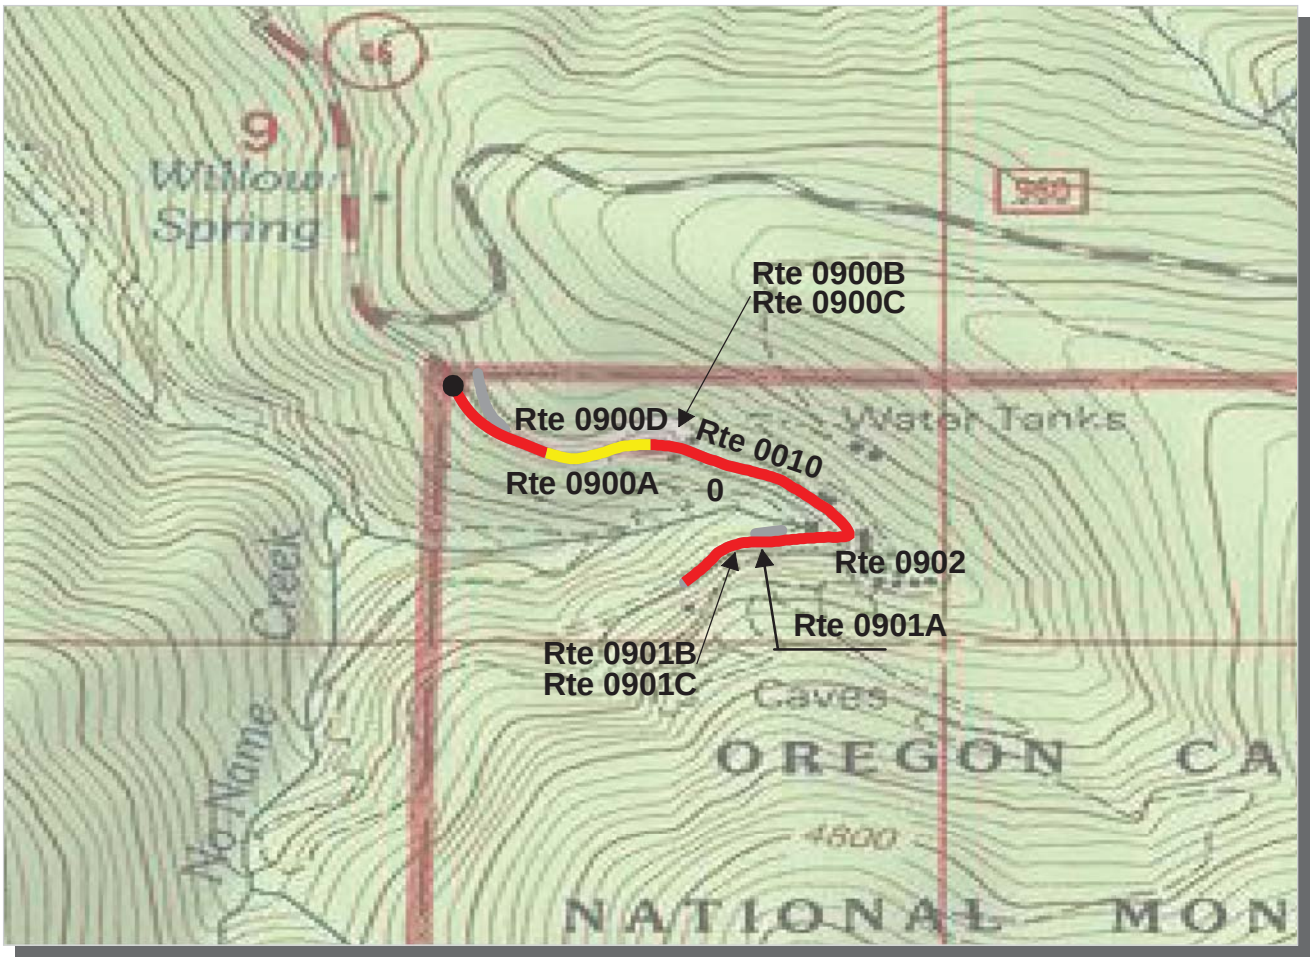
Section Number	0				
Section Length (mi)	0.51				
AADT	**				
SADT	**				
ADT Date	**				
Cross Section Information					
Number of Lanes	2				
Paved Width (ft)	20				
Lane Width (ft)	9				
Shoulder Width (ft)	0				
Roadway Condition Information					
PCR (Pavement Condition Rating)	48				
RCI (Roughness Condition Index)	61				
SCR (Surface Condition Rating)	49				
Alligator Cracking Index	96				
Rutting Index	53				
Patching Index	99				
Tranverse Cracking Index	99				
Longitudinal Cracking Index	99				
Shoulder Condition Rating	N/A				
Drainage Condition Rating	GOOD

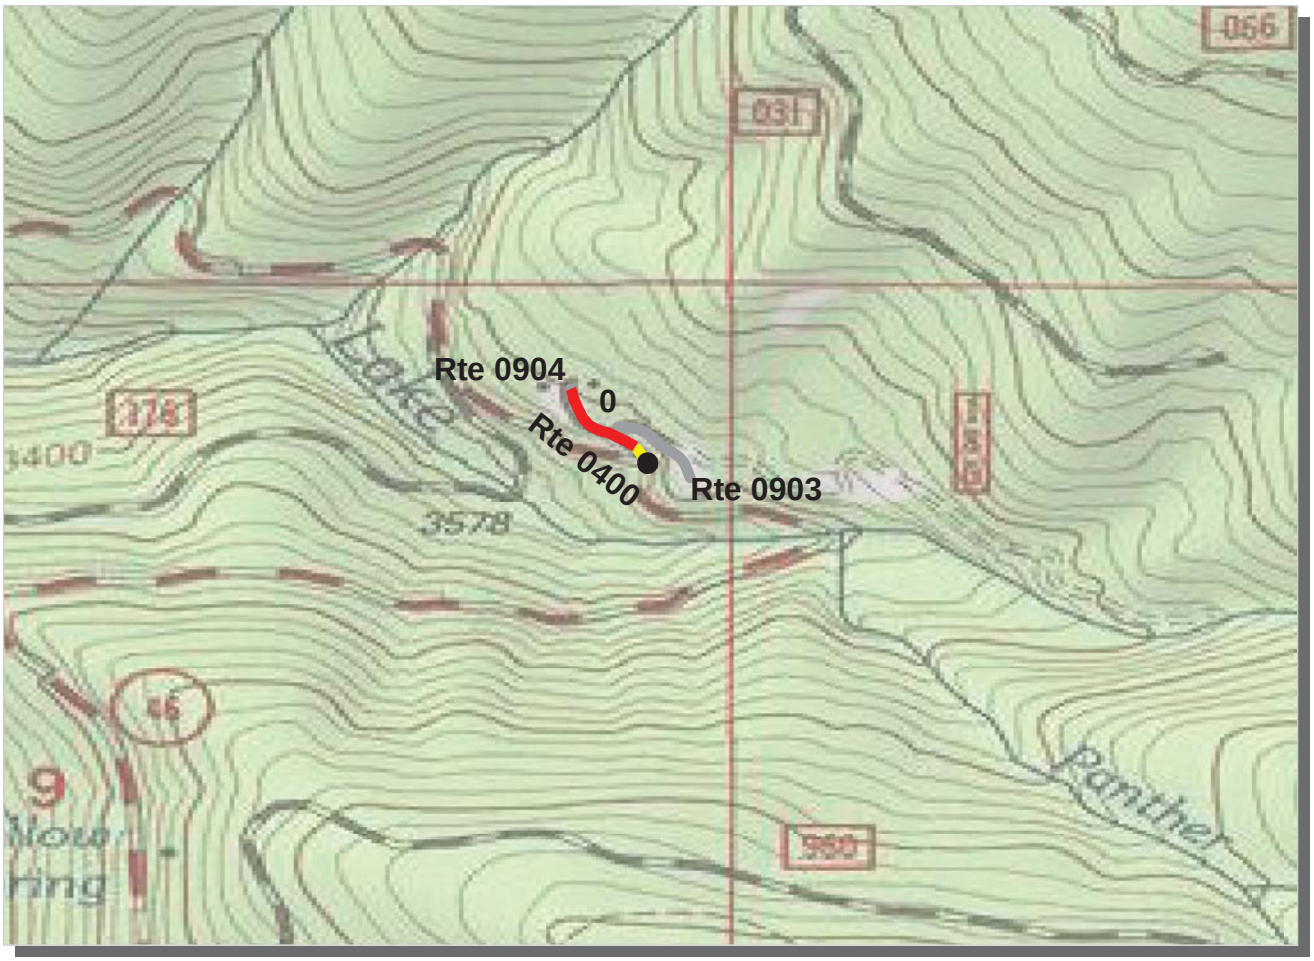
Section Number	0				
Section Length (mi)	0.11				
AADT	**				
SADT	**				
ADT Date	**				
Cross Section Information					
Number of Lanes	2				
Paved Width (ft)	18				
Lane Width (ft)	9				
Shoulder Width (ft)	0				
Roadway Condition Information					
PCR (Pavement Condition Rating)	39				
RCI (Roughness Condition Index)	33				
SCR (Surface Condition Rating)	43				
Alligator Cracking Index	89				
Rutting Index	57				
Patching Index	96				
Tranverse Cracking Index	97				
Longitudinal Cracking Index	97				
Shoulder Condition Rating	N/A				
Drainage Condition Rating	GOOD

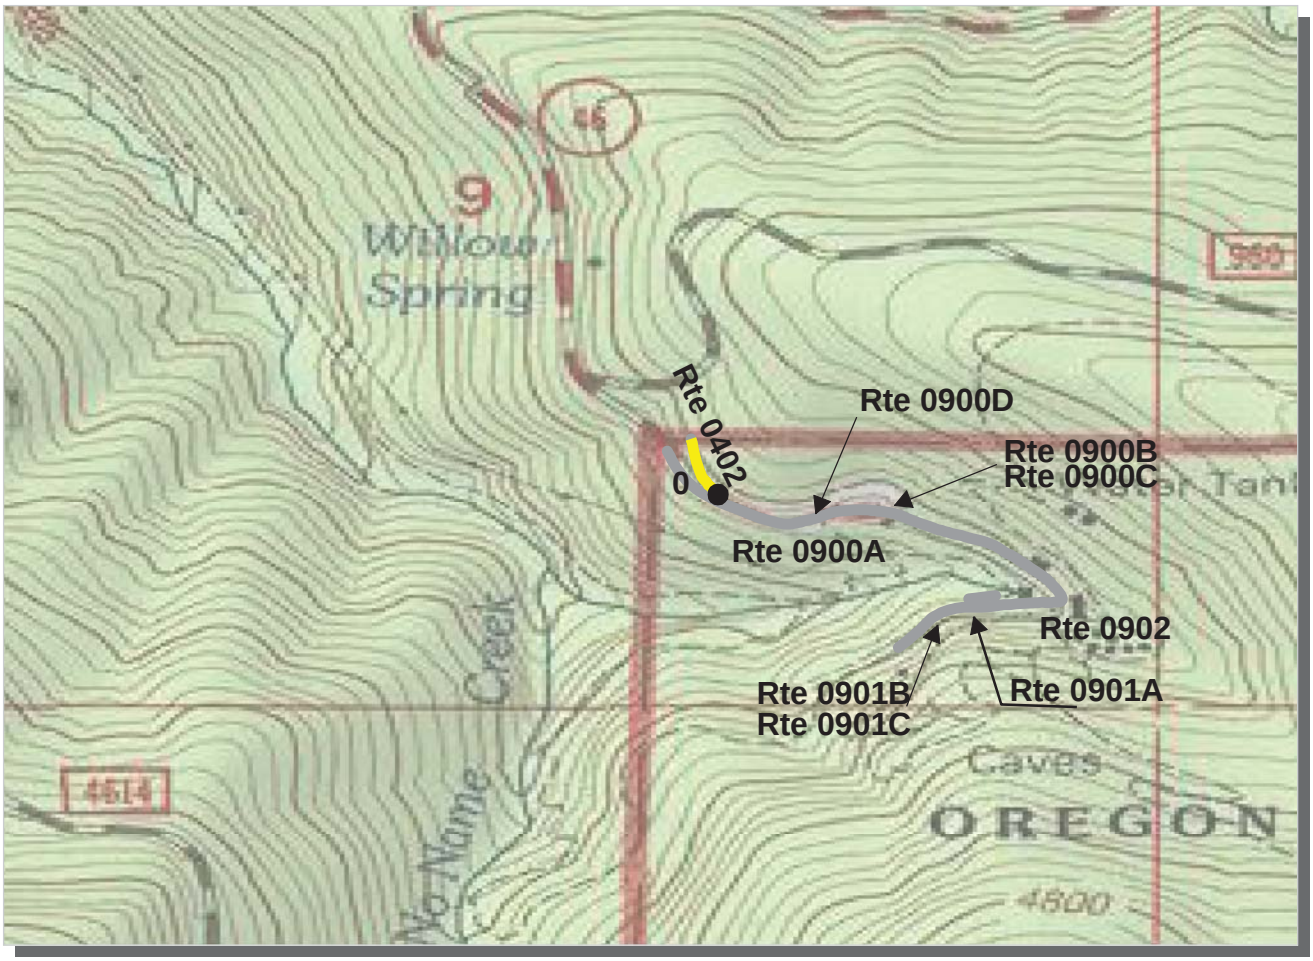
Section Number	0				
Section Length (mi)	0.07				
AADT	**				
SADT	**				
ADT Date	**				
Cross Section Information					
Number of Lanes	1				
Paved Width (ft)	13				
Lane Width (ft)	13				
Shoulder Width (ft)	0				
Roadway Condition Information					
PCR (Pavement Condition Rating)	58				
RCI (Roughness Condition Index)	NC				
SCR (Surface Condition Rating)	58				
Alligator Cracking Index	98				
Rutting Index	62				
Patching Index	100				
Tranverse Cracking Index	99				
Longitudinal Cracking Index	98				
Shoulder Condition Rating	N/A				
Drainage Condition Rating	GOOD

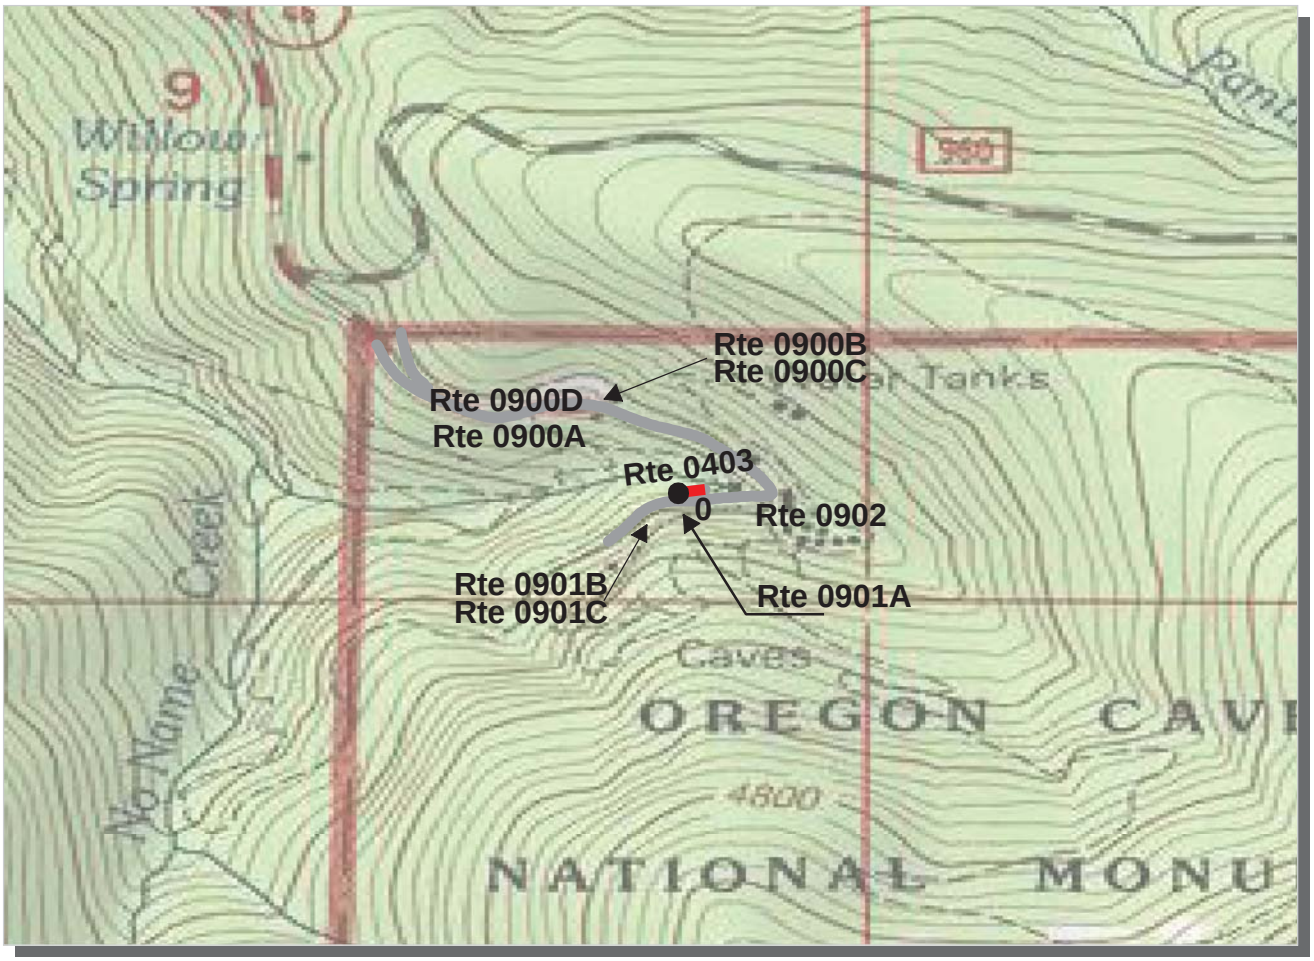
Section Number	0				
Section Length (mi)	0.04				
AADT	**				
SADT	**				
ADT Date	**				
Cross Section Information					
Number of Lanes	1				
Paved Width (ft)	9				
Lane Width (ft)	9				
Shoulder Width (ft)	0				
Roadway Condition Information					
PCR (Pavement Condition Rating)	13				
RCI (Roughness Condition Index)	NC				
SCR (Surface Condition Rating)	13				
Alligator Cracking Index	90				
Rutting Index	27				
Patching Index	100				
Tranverse Cracking Index	99				
Longitudinal Cracking Index	96				
Shoulder Condition Rating	N/A				
Drainage Condition Rating	GOOD

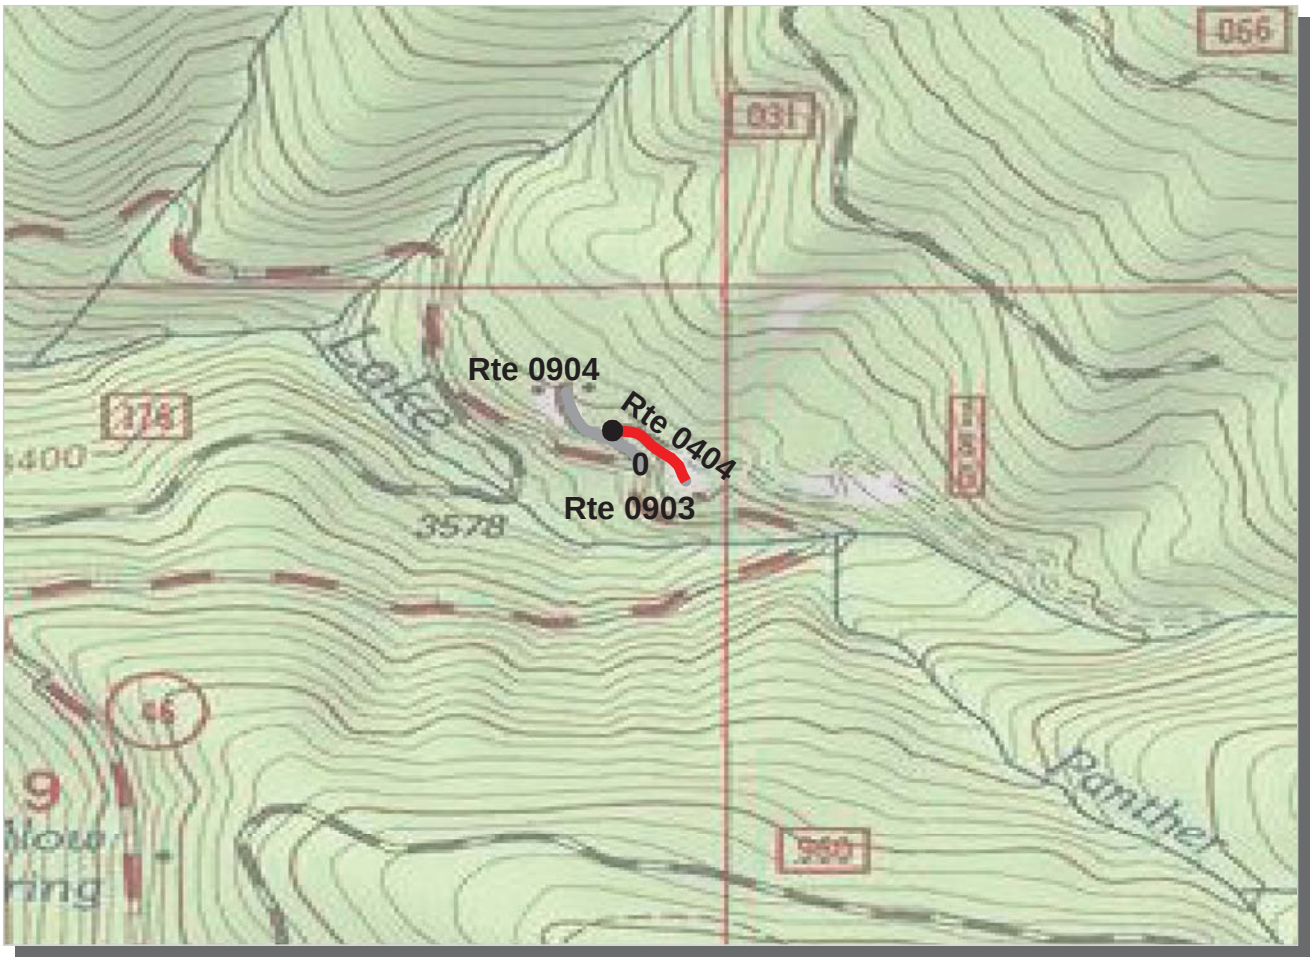
Section Number	0				
Section Length (mi)	0.10				
AADT	**				
SADT	**				
ADT Date	**				
Cross Section Information					
Number of Lanes	2				
Paved Width (ft)	17				
Lane Width (ft)	8				
Shoulder Width (ft)	0				
Roadway Condition Information					
PCR (Pavement Condition Rating)	42				
RCI (Roughness Condition Index)	NC				
SCR (Surface Condition Rating)	42				
Alligator Cracking Index	96				
Rutting Index	52				
Patching Index	95				
Tranverse Cracking Index	98				
Longitudinal Cracking Index	99				
Shoulder Condition Rating	N/A				
Drainage Condition Rating	GOOD

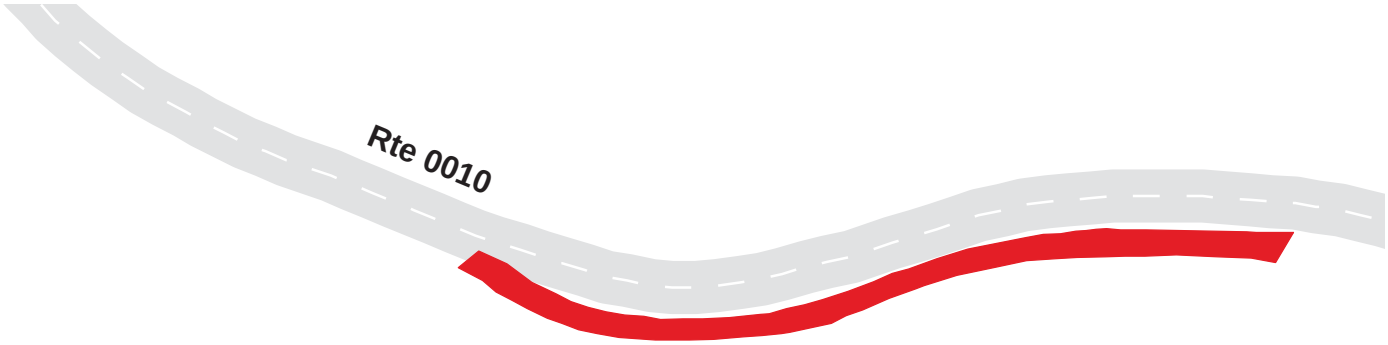
Route	Public / NonPublic	Date Visited	Area (sq ft)	Lane Miles *	Surface Type	Condition / PCR
0900A	Public	6/6/2003	9797	0.17	AS	GOOD / 90

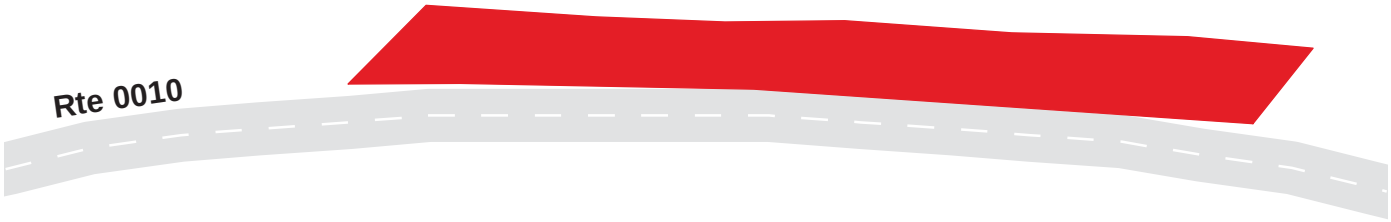
Oregon Caves National Monument
Route 0900D
Visitor Center Parking
FROM ROUTE 0010

Route	Public / NonPublic	Date Visited	Area (sq ft)	Lane Miles *	Surface Type	Condition / PCR
0900D	Public	6/6/2003	6784	0.12	AS	GOOD / 90

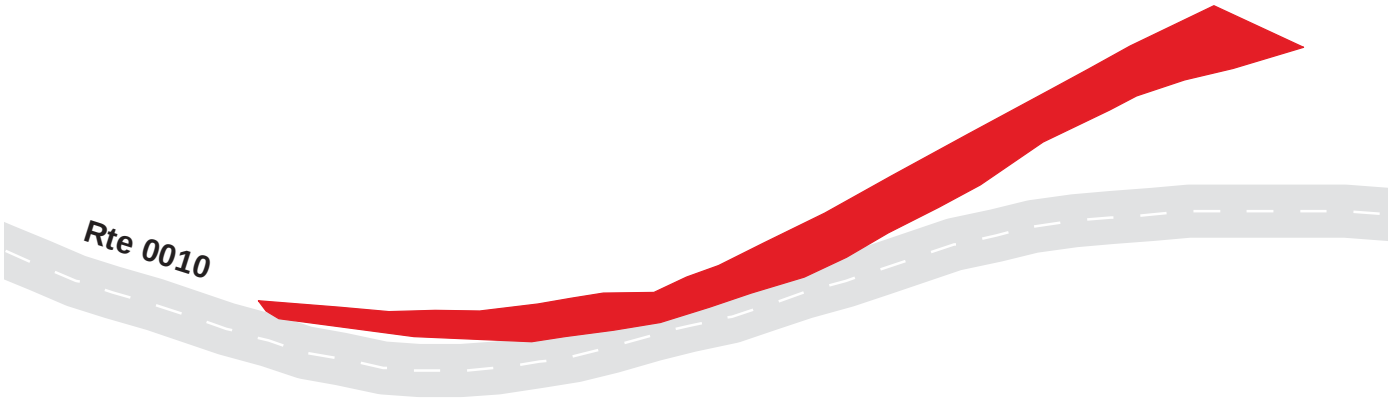
Oregon Caves National Monument
Route 0901A
Chateau Parking
FROM ROUTE 0010

Route	Public / NonPublic	Date Visited	Area (sq ft)	Lane Miles *	Surface Type	Condition / PCR
0901A	Public	6/6/2003	5055	0.09	AS	GOOD / 90

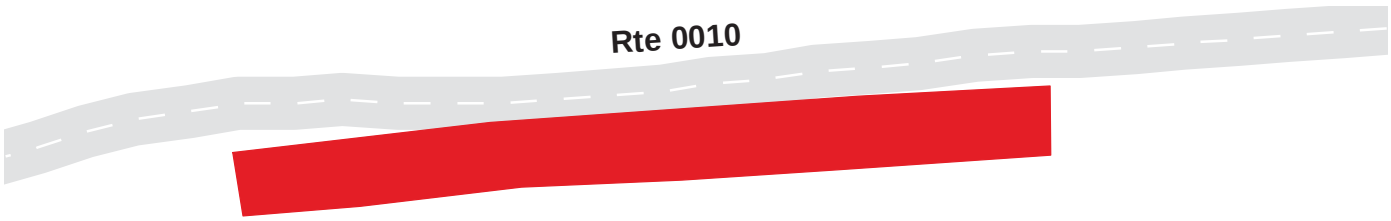
Oregon Caves National Monument
Route 0901B
Chateau Parking
FROM ROUTE 0010

Route	Public / NonPublic	Date Visited	Area (sq ft)	Lane Miles *	Surface Type	Condition / PCR
0901B	Public	6/6/2003	1776	0.03	AS	GOOD / 90

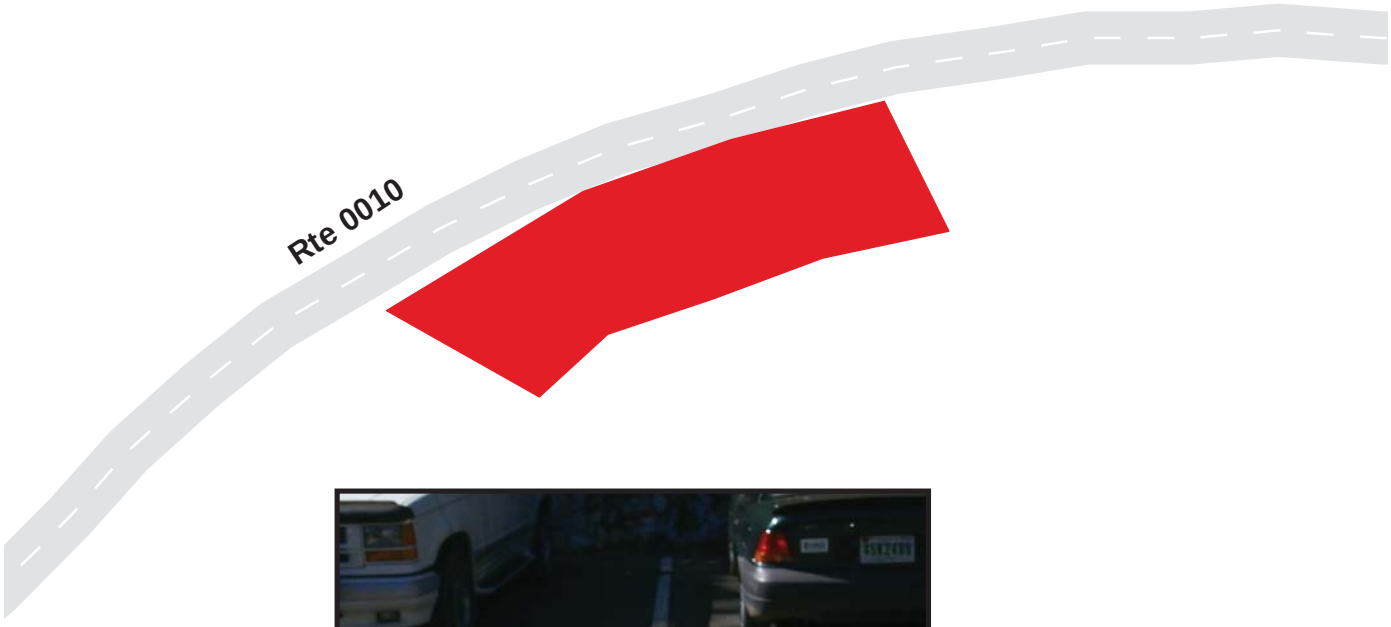
Oregon Caves National Monument
Route 0902
Handicap Parking
FROM ROUTE 0010

Route	Public / NonPublic	Date Visited	Area (sq ft)	Lane Miles *	Surface Type	Condition / PCR
0902	Public	6/6/2003	1636	0.03	AS	GOOD / 90

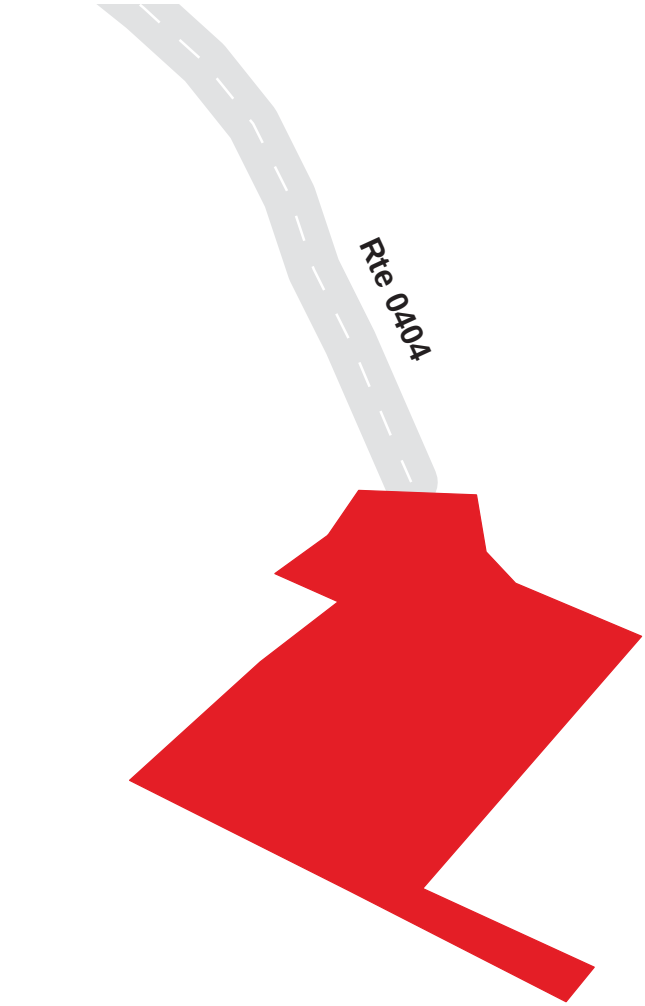
Route	Public / NonPublic	Date Visited	Area (sq ft)	Lane Miles *	Surface Type	Condition / PCR
0903	NonPublic	6/6/2003	4512	0.08	AS	FAIR / 73

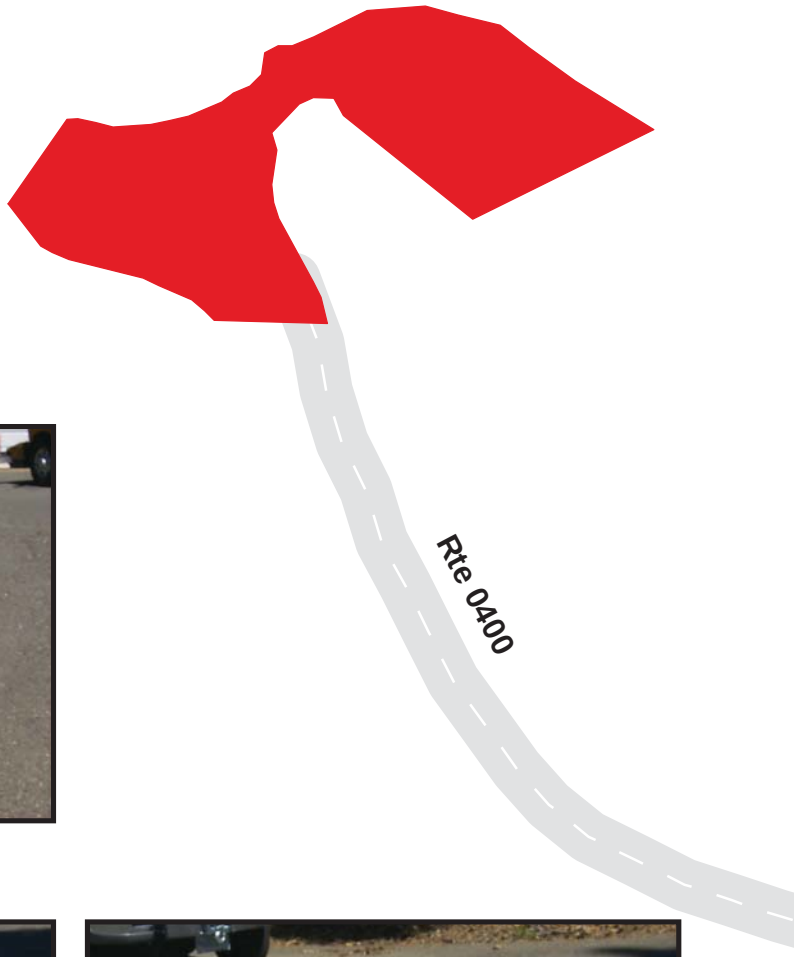
Route	Public / NonPublic	Date Visited	Area (sq ft)	Lane Miles *	Surface Type	Condition / PCR
0904	NonPublic	6/6/2003	8110	0.14	AS	FAIR / 73

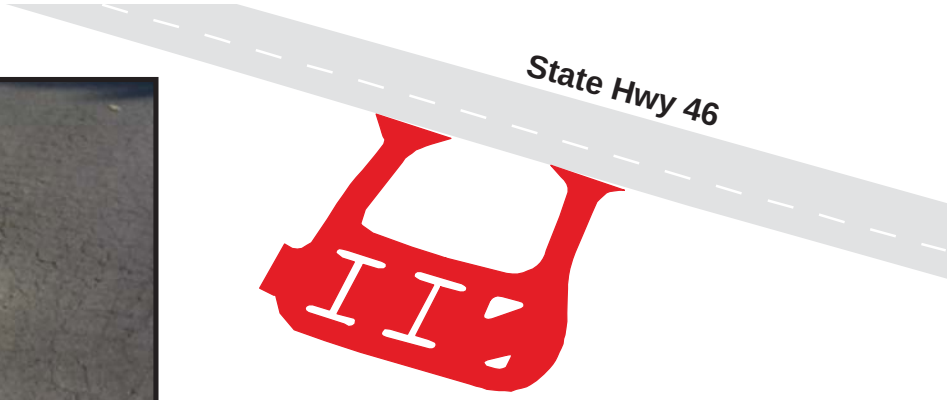
Route	Public / NonPublic	Date Visited	Area (sq ft)	Lane Miles *	Surface Type	Condition / PCR
0905	Public	6/6/2003	34937	0.60	AS	FAIR / 73
