Road Inventory and Condition Assessment

Amistad National Recreation Area

AMIS - 7100

Cycle 5 Report

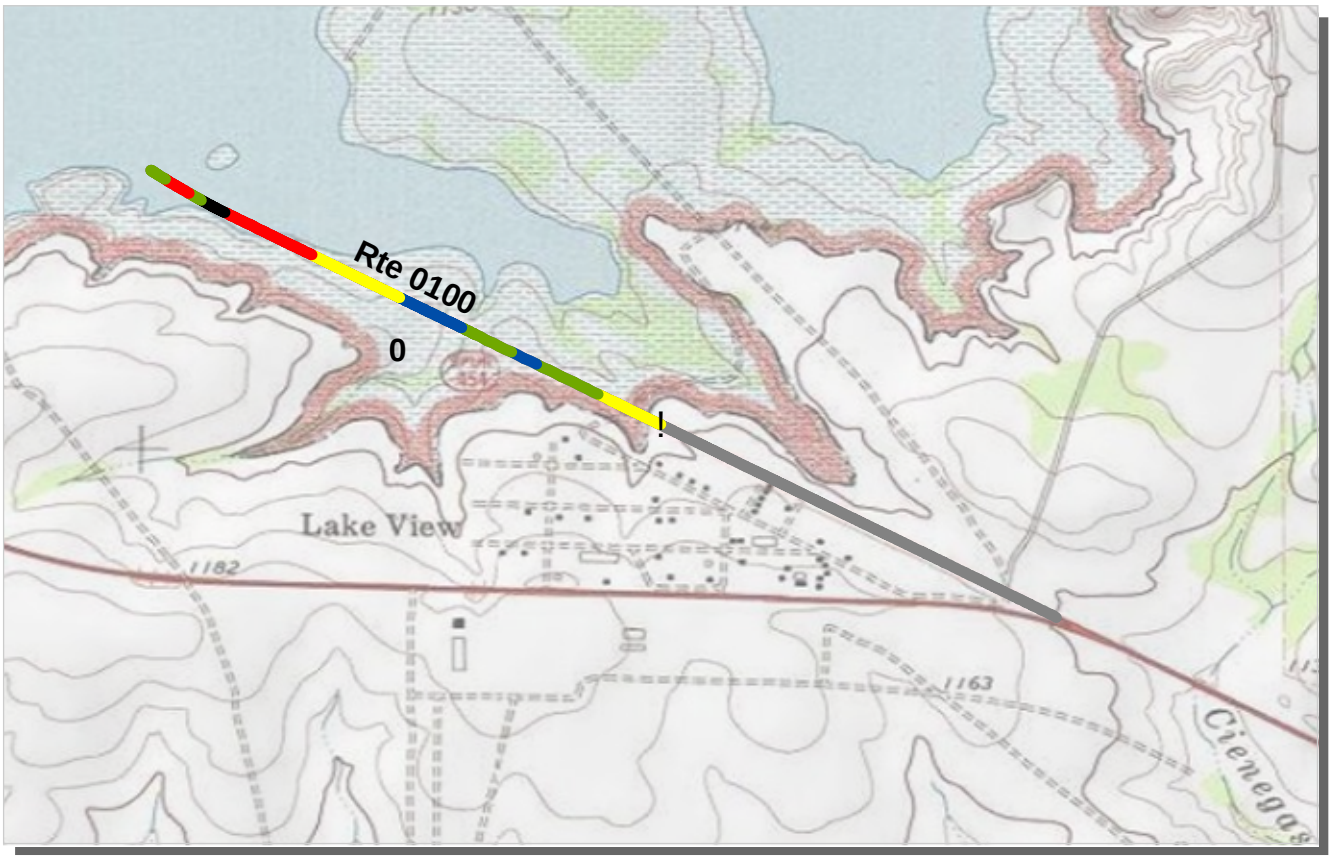
Section Number	0				
Section Length (mi)	0.83				
Cross Section Information					
Number of Lanes	2				
Paved Width (ft)	28				
Lane Width (ft)	14				
Roadway Condition Information					
SCR (Surface Condition Rating)	33				
PCR (Pavement Condition Rating)	51				
Distress Index Values					
Structural Crack Index	33				
Transverse Cracking Index	93				
Patching Index	100				
Rutting Index	93				
Roughness Condition Index (RCI)	77

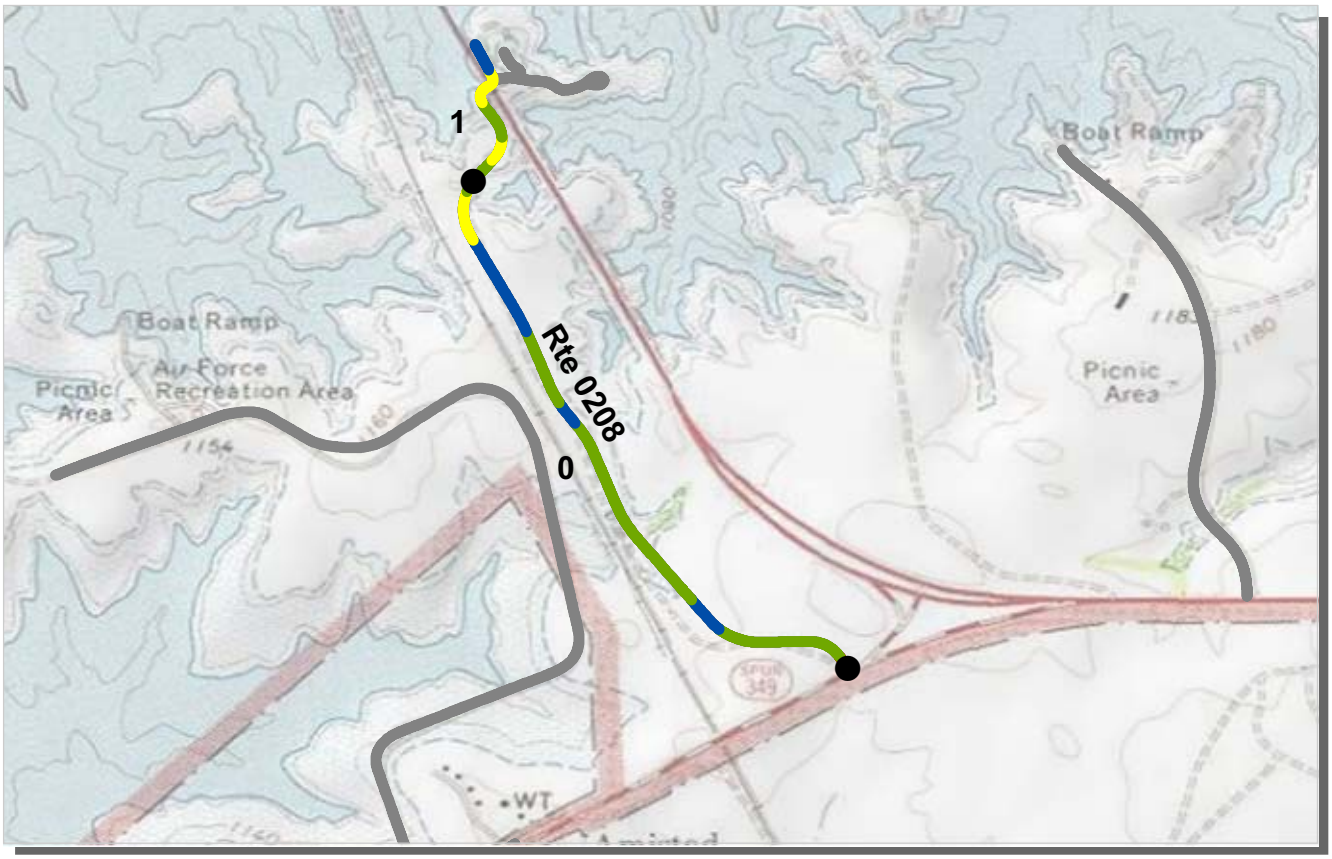
Section Number	0	1			
Section Length (mi)	1.00	0.24			
Cross Section Information					
Number of Lanes	2	2			
Paved Width (ft)	28	27			
Lane Width (ft)	11	12			
Roadway Condition Information					
SCR (Surface Condition Rating)	84	64			
PCR (Pavement Condition Rating)	90	78			
Distress Index Values					
Structural Crack Index	84	64			
Transverse Cracking Index	91	90			
Patching Index	100	100			
Rutting Index	100	100			
Roughness Condition Index (RCI)	100	100

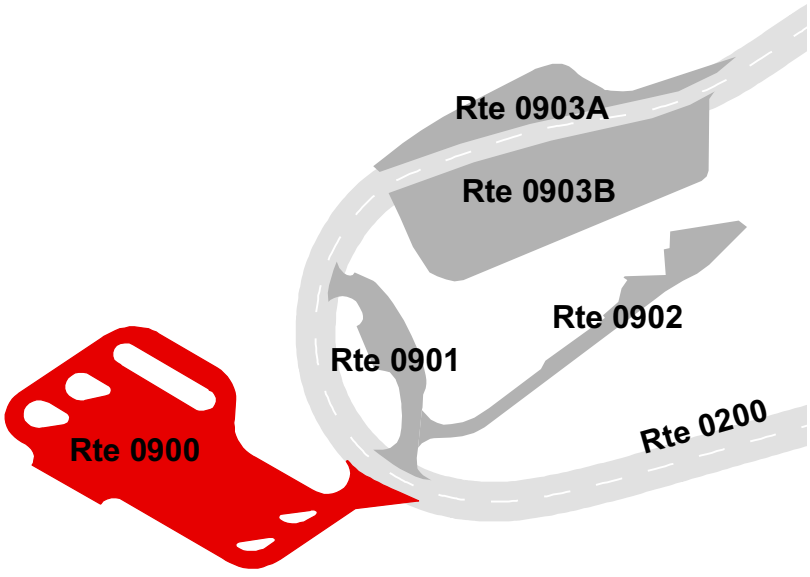
Route Number	Public / NonPublic	Date Visited	Area (sq ft)	Lane Miles *	Surface Type
0900	PUBLIC	2/12/2011	59,819	1.03	AS
Culverts	**Drop Inlets**	**Gates**	**Curb & Gutter**	**Curb**	**PCR**
0	2	0	CONCRETE CURB AND GUTTER	NO CURB	FAIR/73

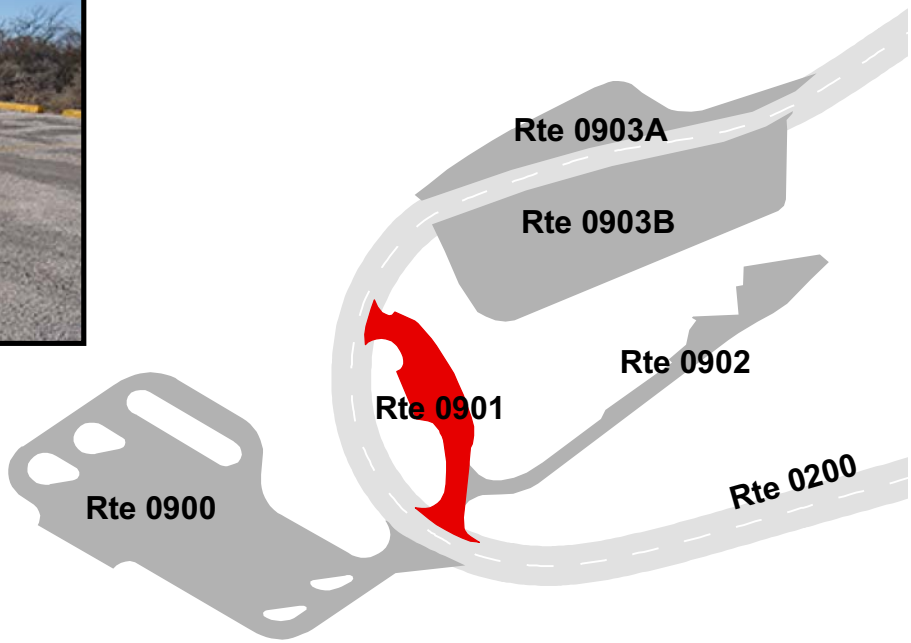
Route Number	Public / NonPublic	Date Visited	Area (sq ft)	Lane Miles *	Surface Type
0901	PUBLIC	2/12/2011	11,072	0.19	AS
Culverts	**Drop Inlets**	**Gates**	**Curb & Gutter**	**Curb**	**PCR**
2	0	0	CONCRETE CURB AND GUTTER	NO CURB	FAIR/73

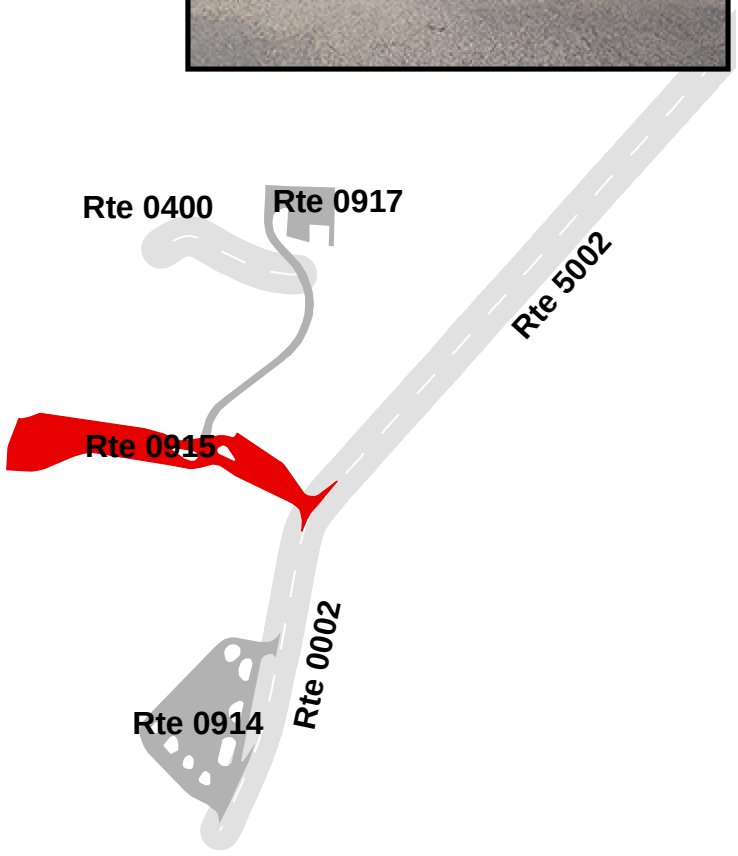
AMISTAD NATIONAL RECREATION AREA
Route 0917
ROUGH CANYON MAINTENANCE AREA
FROM ROUTE 0915 (ROUGH CANYON AREA PARKING)
TO MAINTENANCE AREA

Route Number	Public / NonPublic	Date Visited	Area (sq ft)	Lane Miles *	Surface Type
0917	NONPUBLIC	2/11/2011	37,339	0.64	AS
Culverts	**Drop Inlets**	**Gates**	**Curb & Gutter**	**Curb**	**PCR**
0	0	1	NO CURB AND GUTTER	CONCRETE CURB	FAIR/73
