Federal Lands Highway
Road Inventory Program

Road Inventory and Condition Assessment

Kaloko-Honokohau National Historical Park
KAHO

Updated Cycle 5 Report

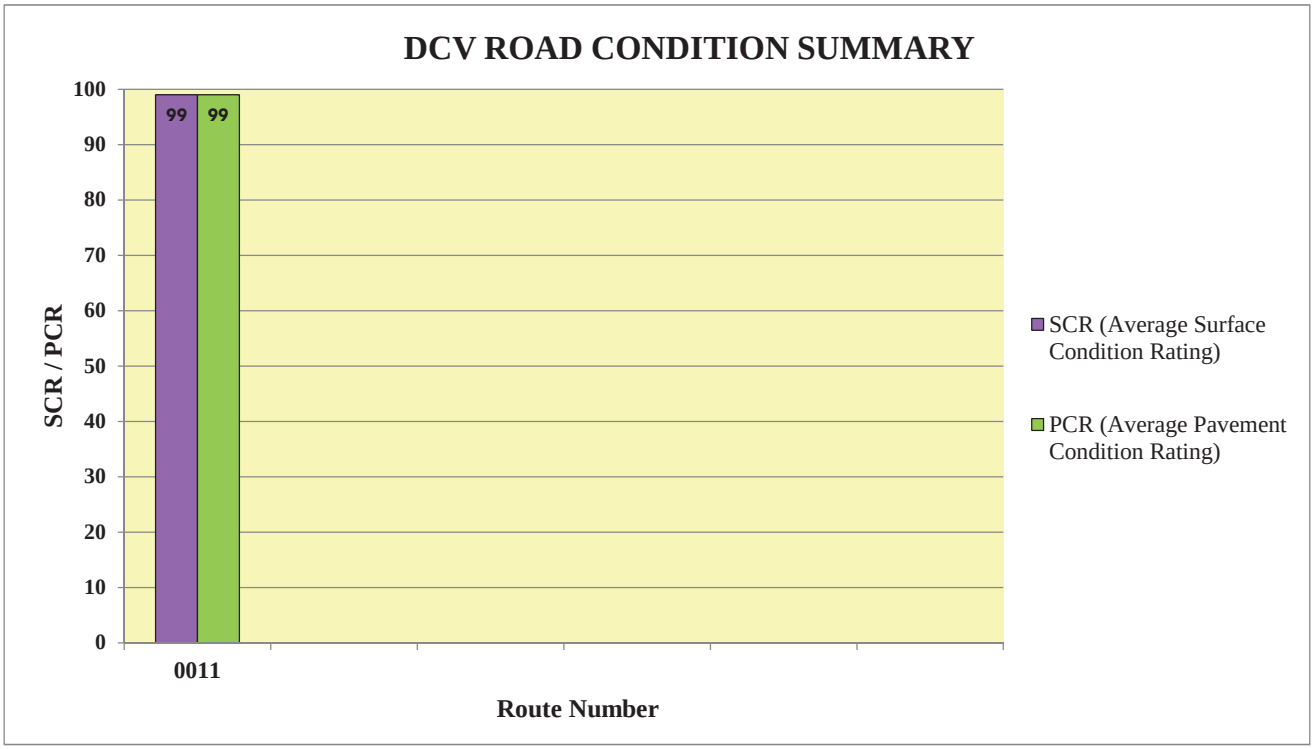
KAHO: DCV ROAD CONDITION SUMMARY

ROUTE NUMBER	ROUTE NAME	FUNCTIONAL CLASS	PAVED LENGTH	SURFACE TYPE	AVERAGE SURFACE CONDITION RATING (SCR)	AVERAGE PAVEMENT CONDITION RATING (PCR)
0011	VISITOR CENTER ENTRANCE ROAD	1	0.06	ASPHALT	99	99

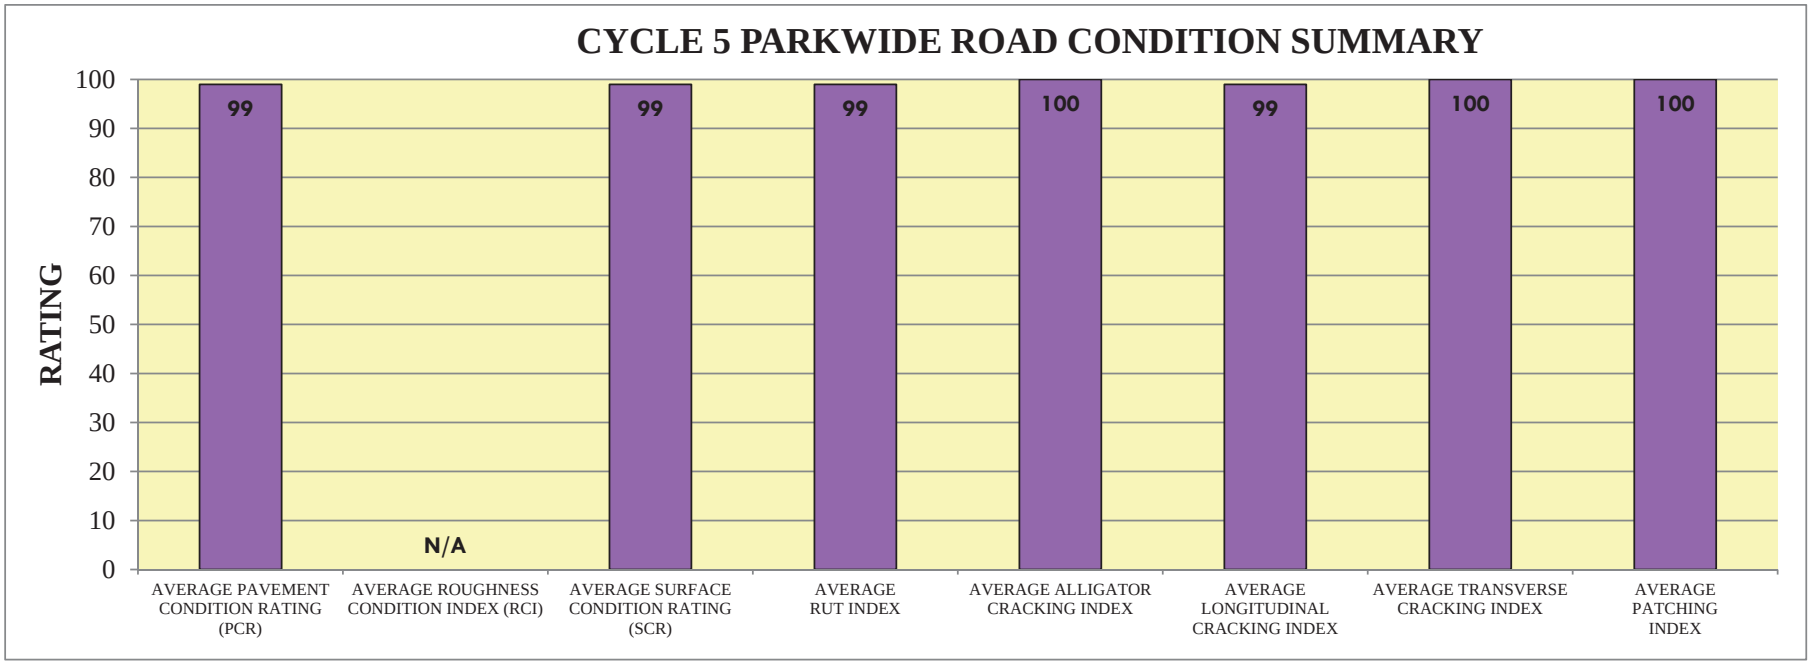
KAHO: PARKWIDE DCV CONDITION SUMMARY

AVERAGE PAVEMENT CONDITION RATING (PCR)	AVERAGE ROUGHNESS CONDITION INDEX (RCI)	AVERAGE SURFACE CONDITION RATING (SCR)	AVERAGE RUT INDEX	AVERAGE ALLIGATOR CRACKING INDEX	AVERAGE LONGITUDINAL CRACKING INDEX	AVERAGE TRANSVERSE CRACKING INDEX	AVERAGE PATCHING INDEX
99	N/A	99	99	100	99	100	100

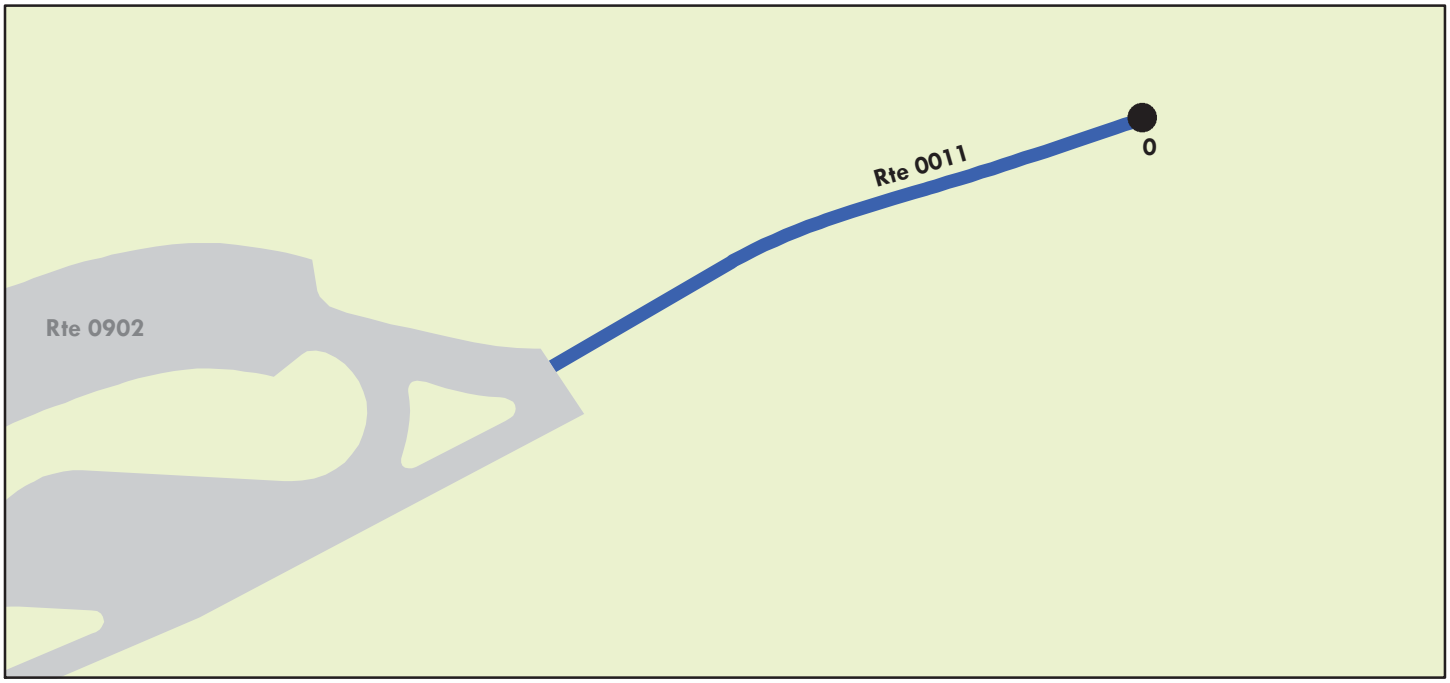
ROUTE 0011: VISITOR CENTER ENTRANCE ROAD

Inspection Date: 4/18/2014	**Section Number**	0				
Paved Length (Miles): 0.06	**Section Length (MI)**	0.06				
Surface Type: ASPHALT	**Route Summary**					
Roadway Condition Information						
Pavement Condition Rating (PCR)	99	99				
Surface Condition Rating (SCR)	99	99				
Roughness Condition Index (RCI)	N/A	N/A				
Distress Index Values						
Structural Crack Index	99	99				
Transverse Cracking Index	100	100				
Patching Index	100	100				
Rutting Index	99	99				
International Roughness Index (IRI)	N/A	N/A				
Lane &Width Information						
Number of Lanes	2	2				
Paved Width (ft)	28	28				
Lane Width (ft)	12	12

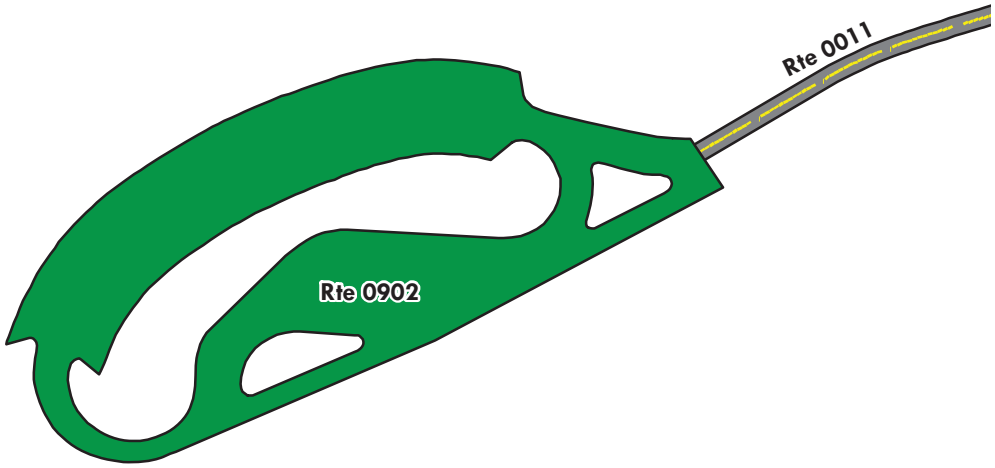
Inspection Date	FMSS Number	User Access	Surface Type
4/7/2014	94778	PUBLIC	ASPHALT
Area (Sq. Ft.)	**Lane Miles (11' Widths)**	**Curb Reveal (Inches)**	**Curb Recommendation**
48,454	0.834	5	DO NOTHING
Curb Type		**Curb & Gutter Type**	
CONCRETE CURB		CONCRETE CURB AND GUTTER	
Culverts	**Drop Inlets**	**Gates**	
0	2	0	
Pavement Recommendation		**Condition Rating / PCR**	
PREVENTIVE MAINTENANCE		GOOD / 90
