Federal Lands Highway

Road Inventory and Condition Assessment

Pipe Spring National Monument
PISP

Cycle 5 Report

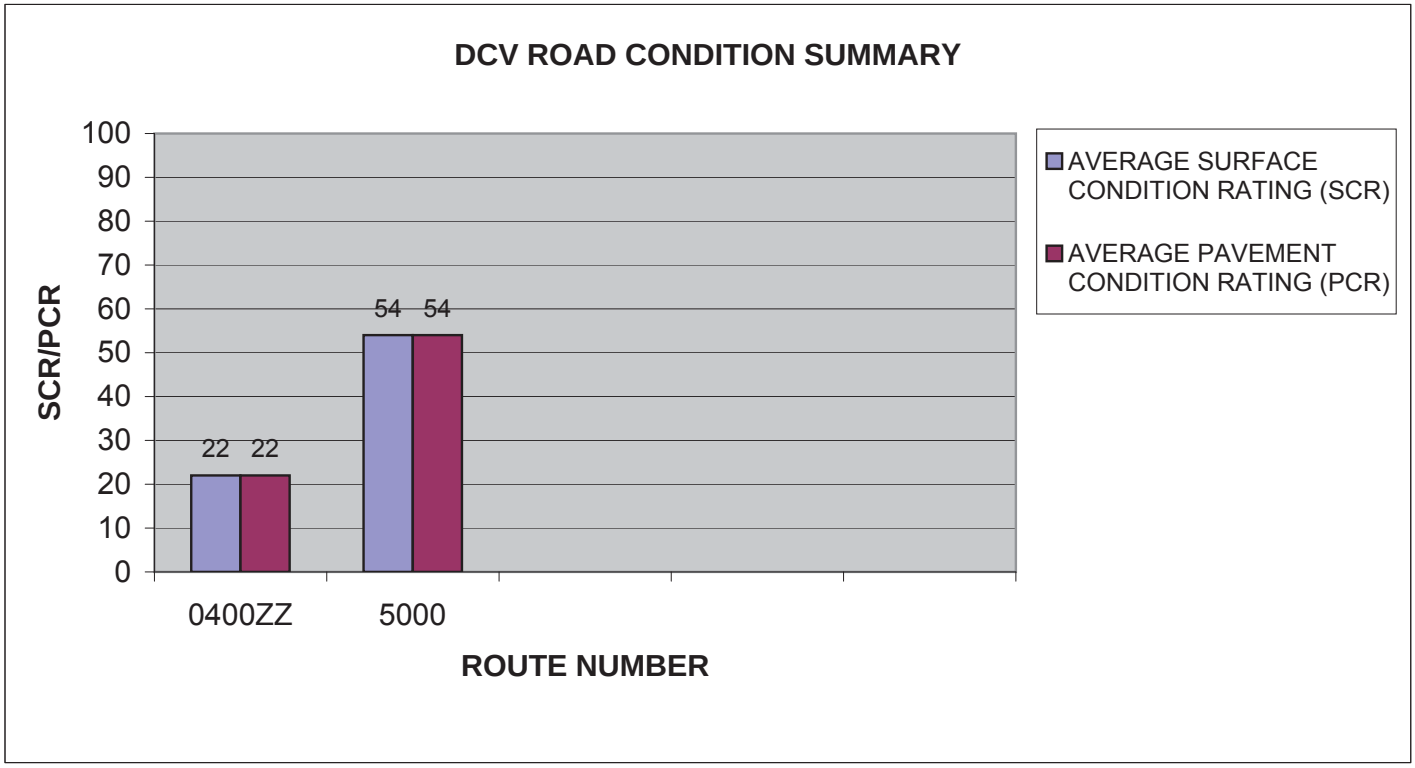
PISP: DCV ROAD CONDITION SUMMARY

ROUTE NUMBER	ROUTE NAME	FUNCT CLASS	PAVED LENGTH	SURFACE TYPE	AVERAGE SURFACE CONDITION RATING (SCR)	AVERAGE PAVEMENT CONDITION RATING (PCR)
0400ZZ	RESIDENCE ROADS	5	0.25	ASPHALT	22	22
5000	RV PARK ROAD	NA	0.14	ASPHALT	54	54

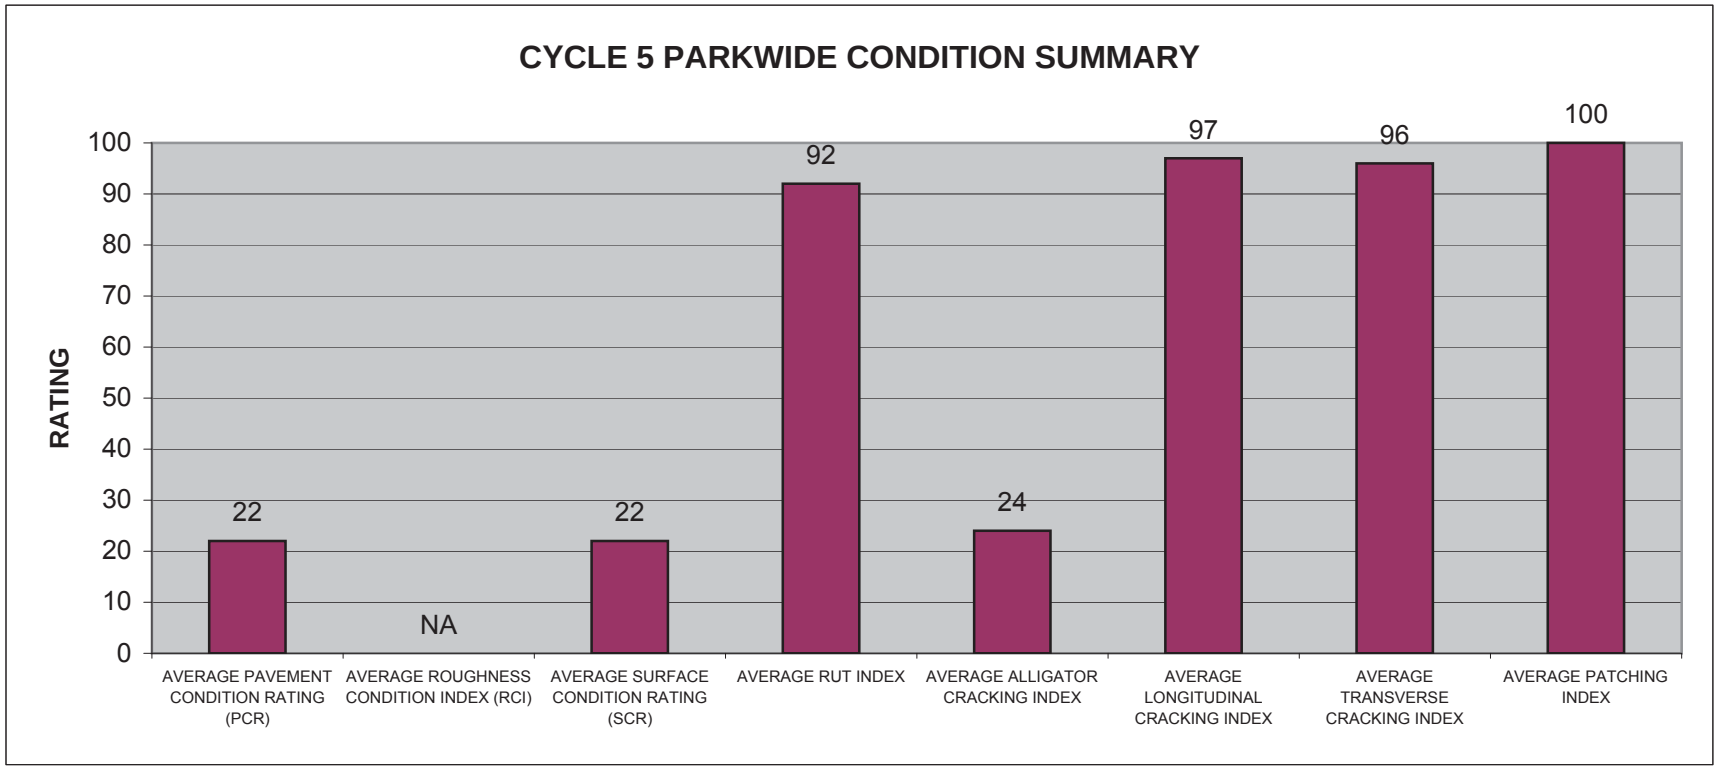
PISP: PARKWIDE DCV CONDITION SUMMARY

AVERAGE PAVEMENT CONDITION RATING (PCR)	AVERAGE ROUGHNESS CONDITION INDEX (RCI)	AVERAGE SURFACE CONDITION RATING (SCR)	AVERAGE RUT INDEX	AVERAGE ALLIGATOR CRACKING INDEX	AVERAGE LONGITUDINAL CRACKING INDEX	AVERAGE TRANSVERSE CRACKING INDEX	AVERAGE PATCHING INDEX
22	NA	22	92	24	97	96	100

All Index values are based on Data Collection Vehicle (DCV) driven roads that were collected in Cycle-5.
Roughness data is only collected on routes with lengths greater than 0.5 miles and a posted speed limit of 25 MPH or greater.

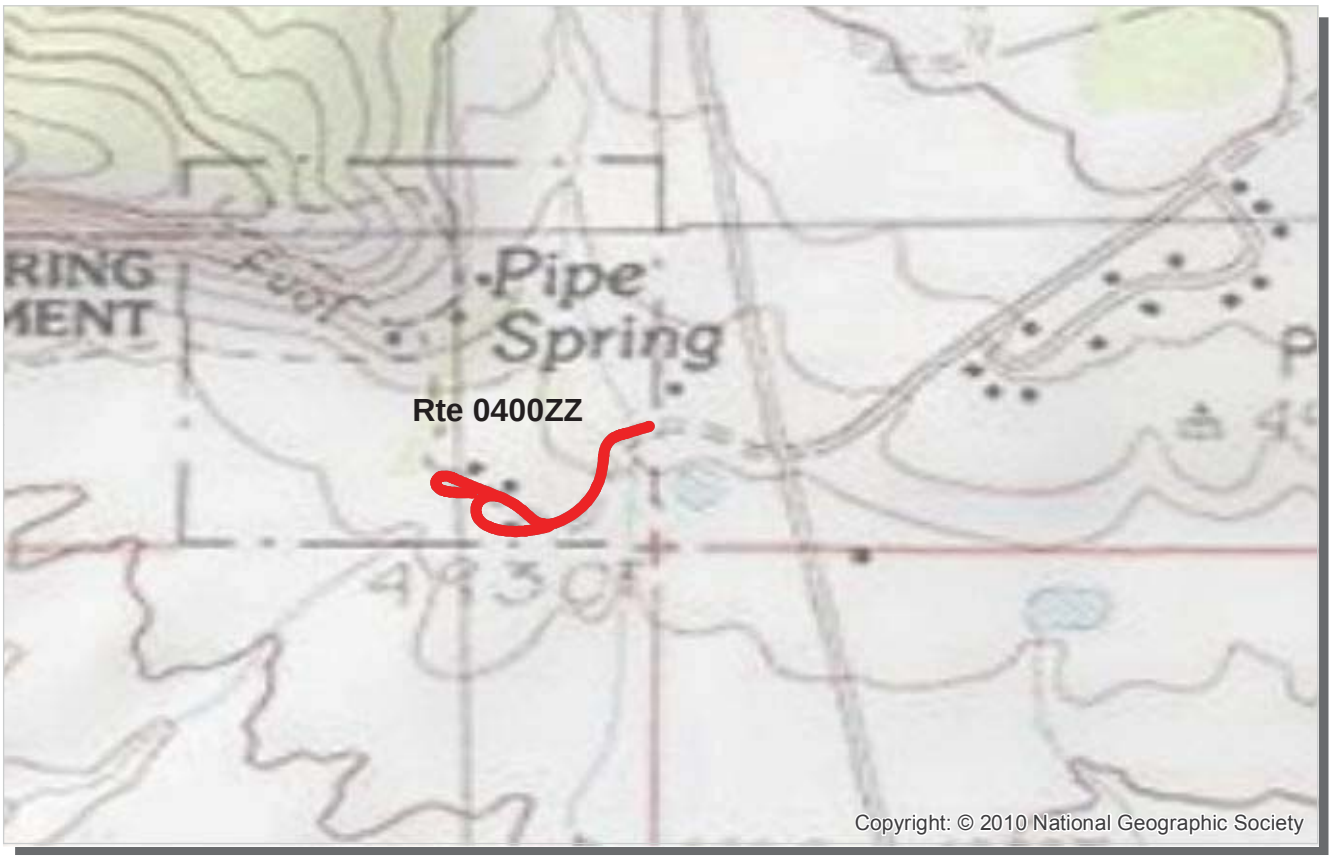
Section Number					
Section Length (mi)					
Cross Section Information					
Number of Lanes	N/A				
Paved Width (ft)	N/A				
Lane Width (ft)	N/A				
Roadway Condition Information					
SCR (Surface Condition Rating)	22				
PCR (Pavement Condition Rating)	22				
Distress Index Values					
Structural Crack Index	N/A				
Transverse Cracking Index	N/A				
Patching Index	N/A				
Rutting Index	N/A				
Roughness Condition Index (RCI)	N/A

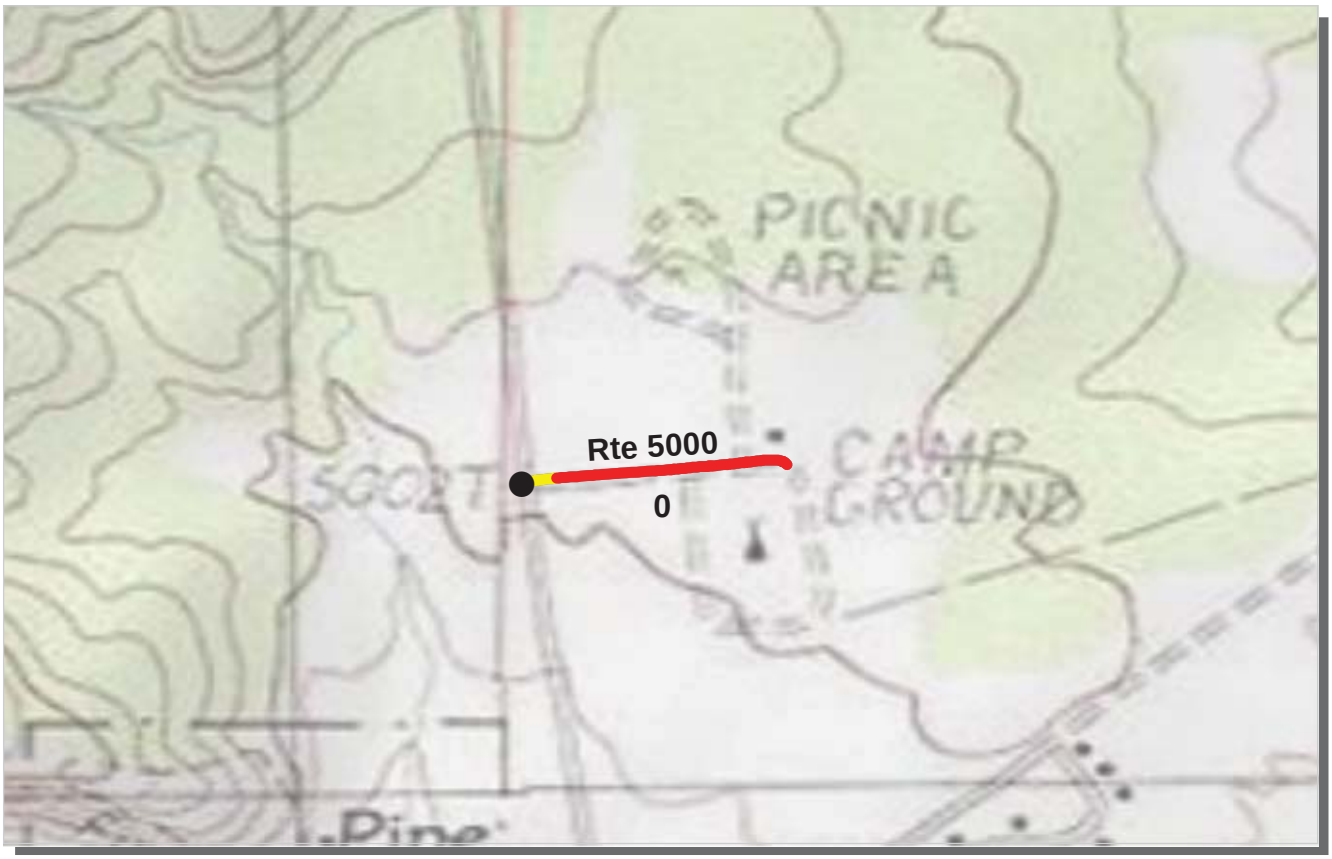
Section Number	0				
Section Length (mi)	0.14				
Cross Section Information					
Number of Lanes	2				
Paved Width (ft)	25				
Lane Width (ft)	12				
Roadway Condition Information					
SCR (Surface Condition Rating)	54				
PCR (Pavement Condition Rating)	54				
Distress Index Values					
Structural Crack Index	54				
Transverse Cracking Index	93				
Patching Index	100				
Rutting Index	98				
Roughness Condition Index (RCI)	NC

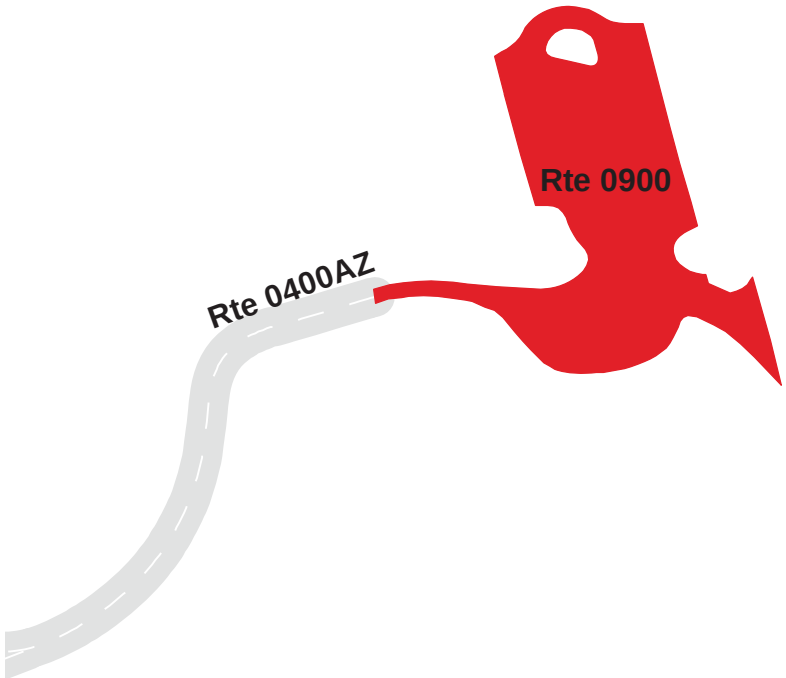
Route Number	Public / NonPublic	Date Visited	Area (sq ft)	Lane Miles *	Surface Type
0900	PUBLIC	8/14/2011	40,747	0.70	AS
Culverts	**Drop Inlets**	**Gates**	**Curb & Gutter**	**Curb**	**PCR**
1	1	2	CONCRETE CURB AND GUTTER	NO CURB	FAIR/73
