Road Inventory and Condition Assessment

Whitman Mission National Historic Site

WHMI - 9550

Cycle 5 Report

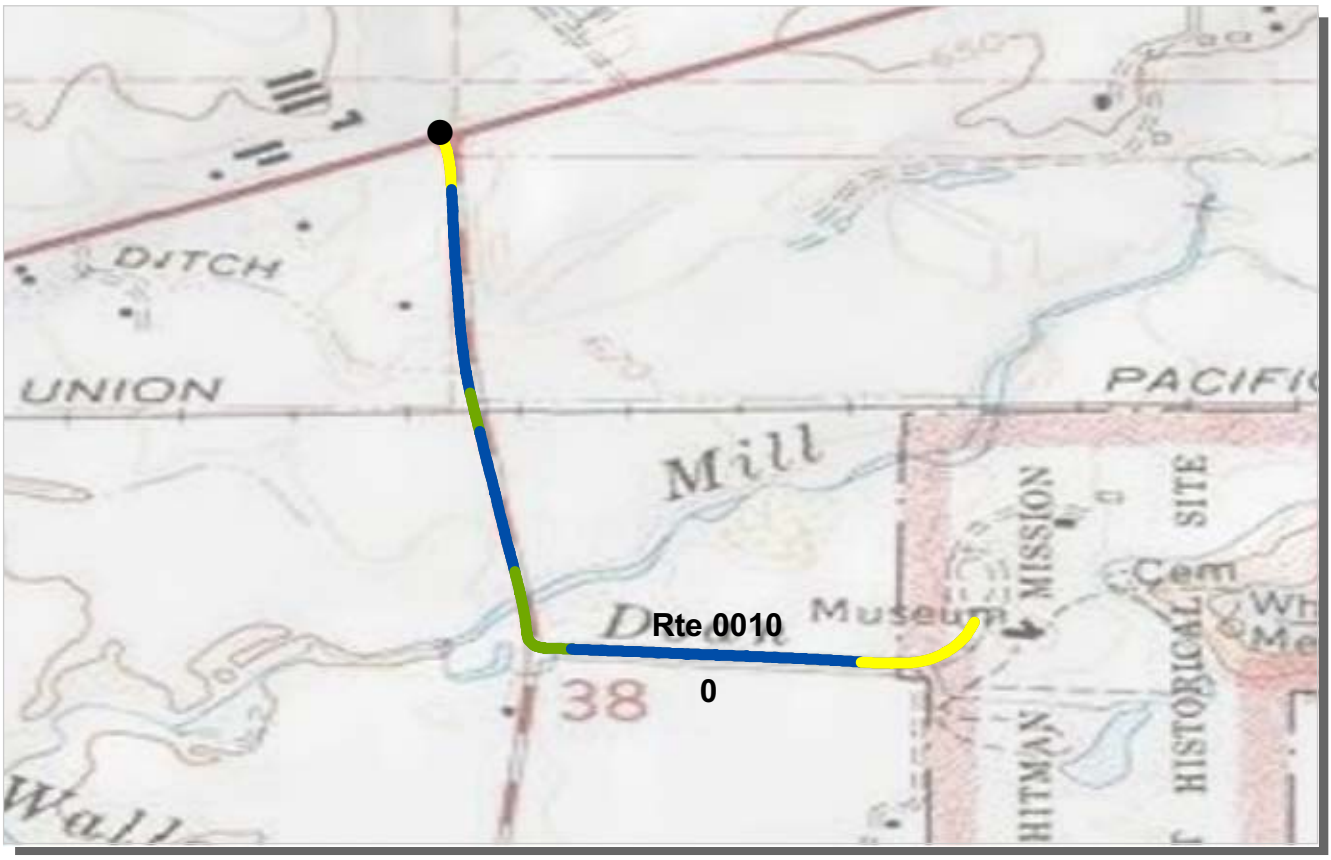
Section Number	0				
Section Length (mi)	0.84				
Cross Section Information					
Number of Lanes	2				
Paved Width (ft)	26				
Lane Width (ft)	12				
Roadway Condition Information					
SCR (Surface Condition Rating)	96				
PCR (Pavement Condition Rating)	93				
Distress Index Values					
Structural Crack Index	97				
Transverse Cracking Index	96				
Patching Index	100				
Rutting Index	99				
Roughness Condition Index (RCI)	89
