ARCH
Cycle 6

Final Report

Road Inventory and Condition Assessment of Paved Routes
Arches National Park

Federal Lands Highway
Road Inventory Program

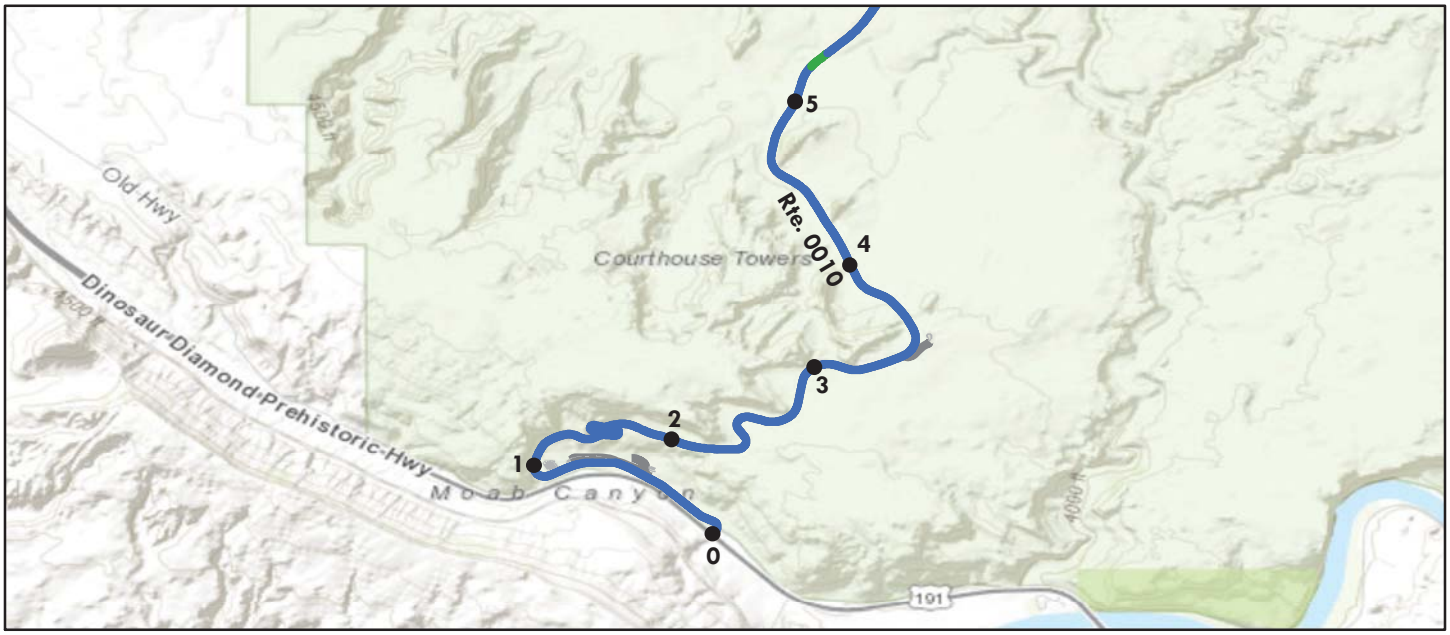
Inspection Date: 11/29/2017	**Beginning Section MP**	0	1	2	3	4
Paved Length (Miles): 18.73	**Section Length (MI)**	1	1	1	1	1
Surface Type: ASPHALT	**Route Summary**					
Roadway Condition Information						
Pavement Condition Rating (PCR)	100	99	100	100	100	100
Surface Condition Rating (SCR)	100	99	100	100	100	100
Roughness Condition Index (RCI)	100	100	100	100	100	100
Distress Index Values						
Structural Crack Index	100	100	100	100	100	100
Alligator Crack Index	100	100	100	100	100	100
Longitudinal Crack Index	100	100	100	100	100	100
Transverse Cracking Index	100	100	100	100	100	100
Patching Index	100	100	100	100	100	100
Rutting Index	100	99	100	100	100	100
International Roughness Index (IRI)	53	74	56	46	39	44
Lane & Width Information						
Number of Lanes	2	3	2	2	2	2
Paved Width (ft)	21.8	27.2	21.6	21.8	22	21.6
Lane Width (ft)	9.1	9.8	9.3	8.8	8.8	9.1

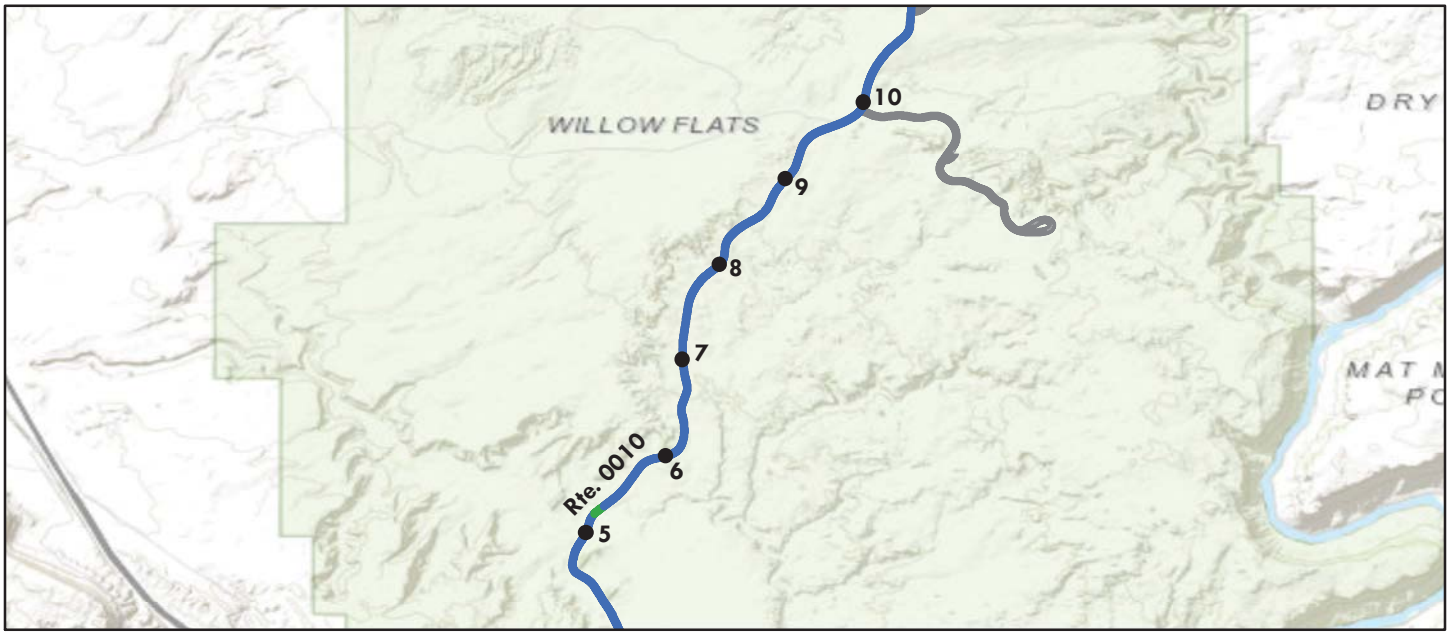
Inspection Date: 11/29/2017	**Beginning Section MP**	5	6	7	8	9
Paved Length (Miles): 18.73	**Section Length (MI)**	1	1	1	1	1
Surface Type: ASPHALT	**Route Summary**					
Roadway Condition Information						
Pavement Condition Rating (PCR)	100	100	100	100	100	100
Surface Condition Rating (SCR)	100	100	100	100	100	100
Roughness Condition Index (RCI)	100	100	100	100	100	100
Distress Index Values						
Structural Crack Index	100	100	100	100	100	100
Alligator Crack Index	100	100	100	100	100	100
Longitudinal Crack Index	100	100	100	100	100	100
Transverse Cracking Index	100	100	100	100	100	100
Patching Index	100	100	100	100	100	100
Rutting Index	100	100	100	100	100	100
International Roughness Index (IRI)	53	61	42	42	46	45
Lane & Width Information						
Number of Lanes	2	2	2	2	2	2
Paved Width (ft)	21.8	21.6	21.6	21.5	21.5	21
Lane Width (ft)	9.1	8.8	8.8	8.8	8.8	8.7

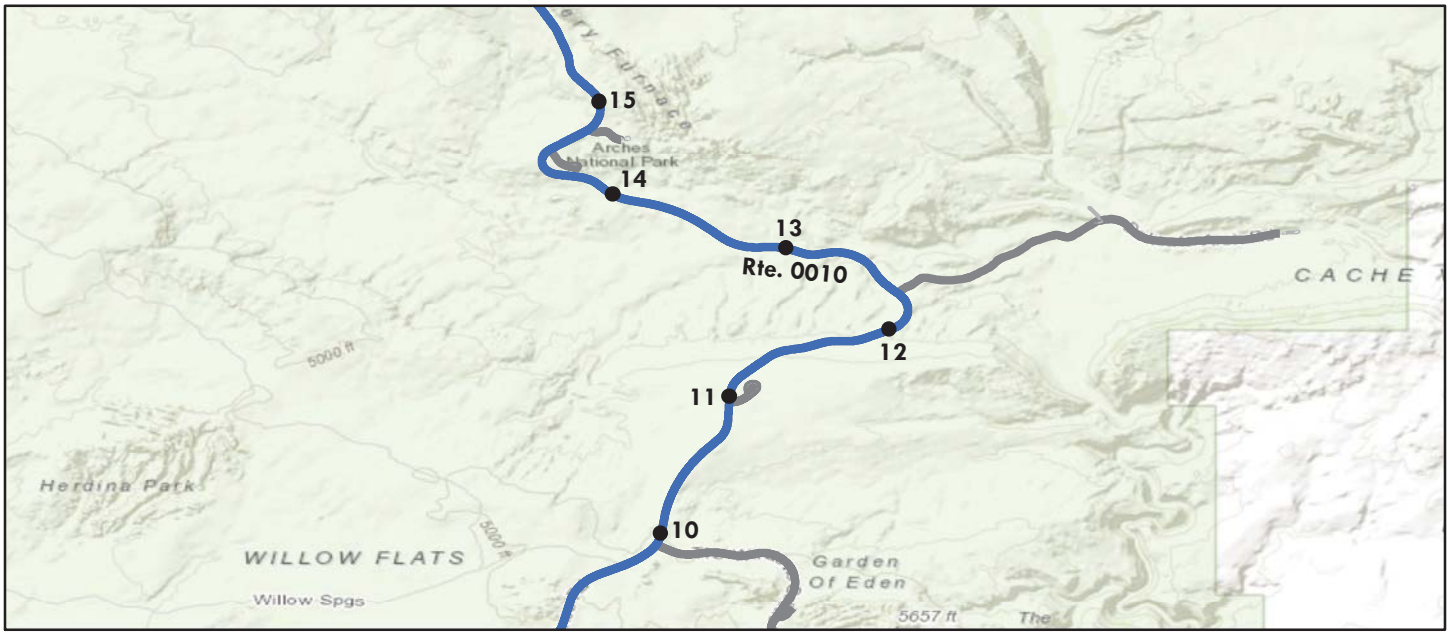
Inspection Date: 11/29/2017	**Beginning Section MP**	10	11	12	13	14
Paved Length (Miles): 18.73	**Section Length (MI)**	1	1	1	1	1
Surface Type: ASPHALT	**Route Summary**					
Roadway Condition Information						
Pavement Condition Rating (PCR)	100	100	100	100	100	100
Surface Condition Rating (SCR)	100	100	100	100	100	100
Roughness Condition Index (RCI)	100	100	100	100	100	100
Distress Index Values						
Structural Crack Index	100	100	100	100	100	100
Alligator Crack Index	100	100	100	100	100	100
Longitudinal Crack Index	100	100	100	100	100	100
Transverse Cracking Index	100	100	100	100	100	100
Patching Index	100	100	100	100	100	100
Rutting Index	100	100	100	100	100	100
International Roughness Index (IRI)	53	48	52	63	58	55
Lane & Width Information						
Number of Lanes	2	2	2	2	2	2
Paved Width (ft)	21.8	21.7	22.4	22.6	21.1	22
Lane Width (ft)	9.1	8.8	9	9	8.8	8.9

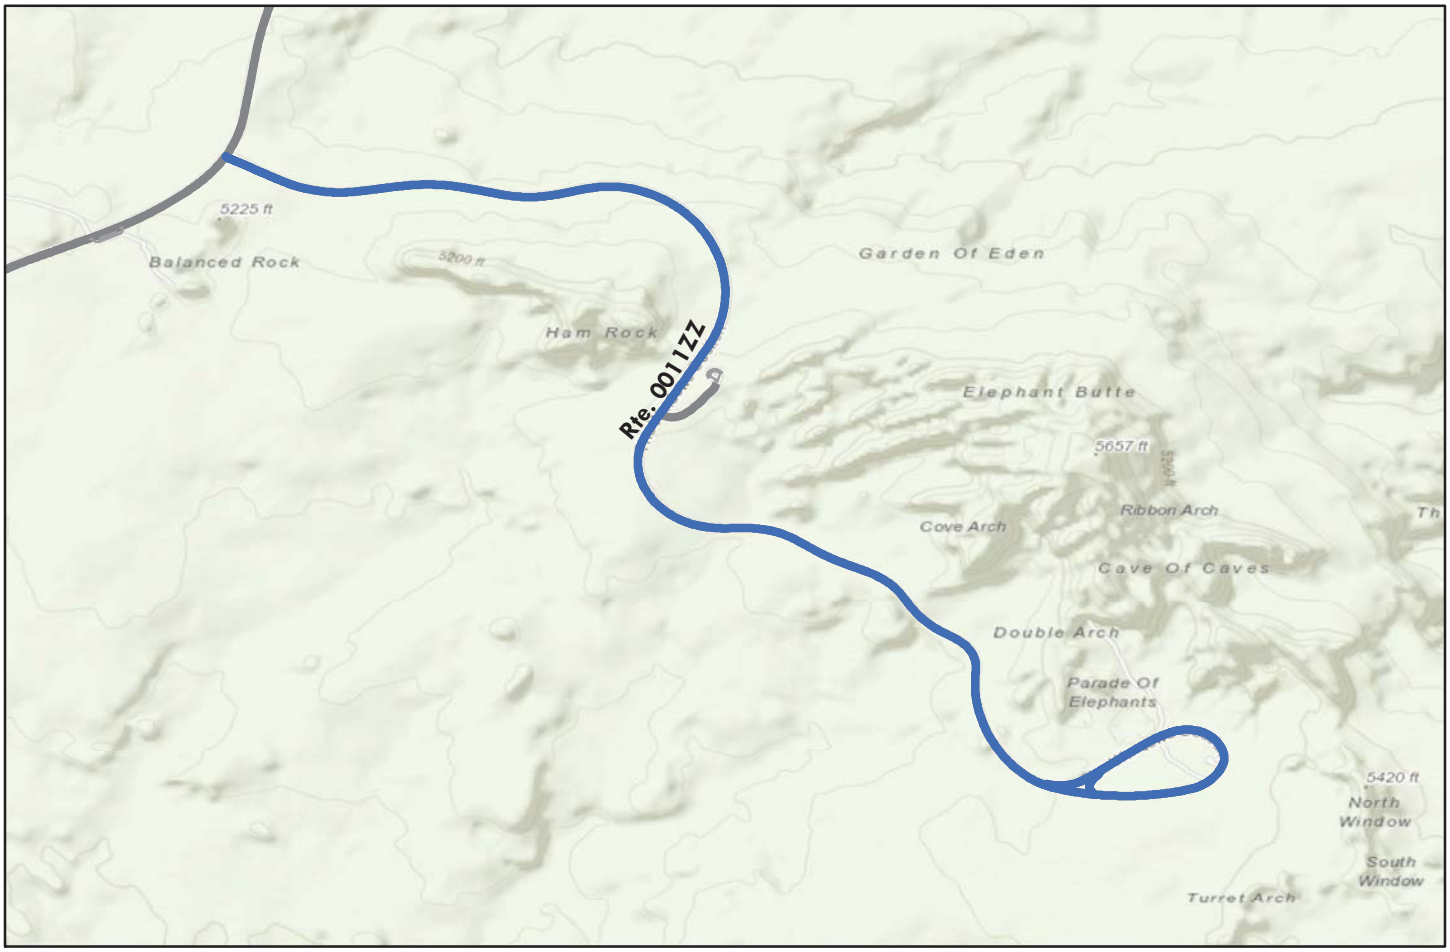
ROUTE 0011ZZ: WINDOWS ROAD

Inspection Date:	11/29/2017
Paved Length (Miles):	2.77
Surface Type:	ASPHALT
Roadway Condition Information	
Pavement Condition Rating (PCR)	100
Lane & Width Information	
Number of Lanes	1
Paved Width (ft)	19.4
Lane Width (ft)	9.1

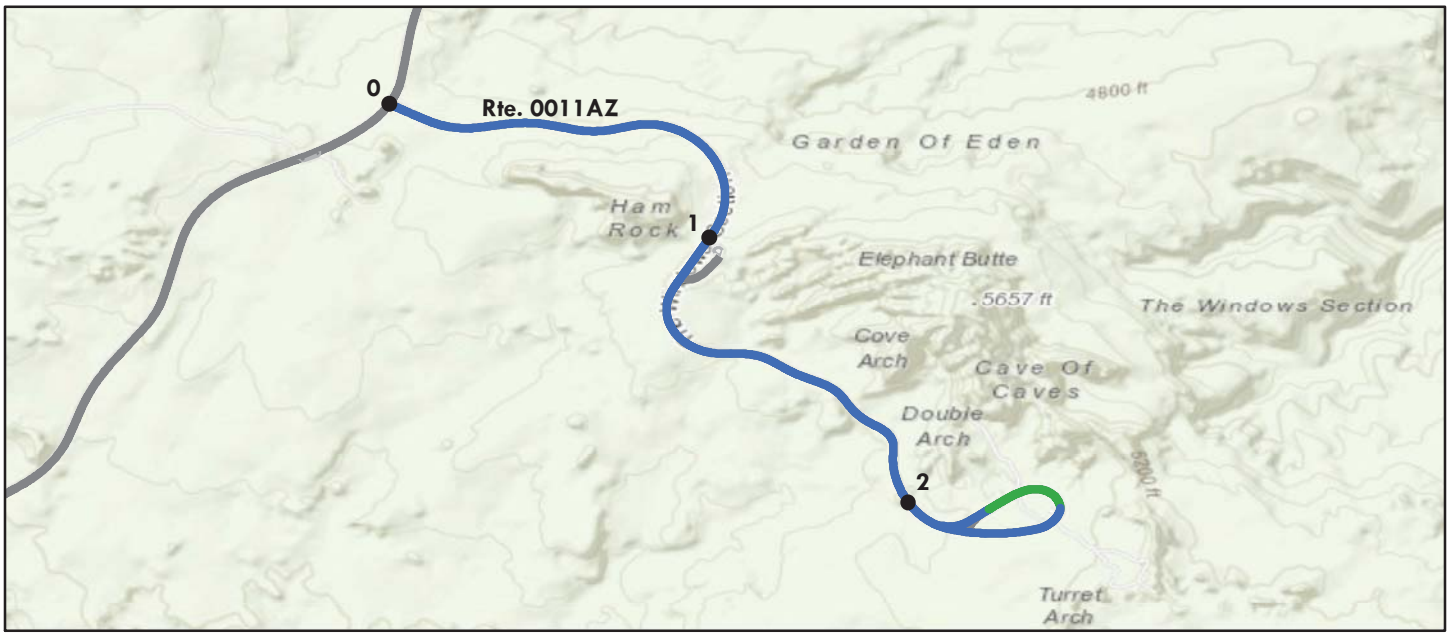
Inspection Date: 11/29/2017	**Beginning Section MP**	0	1	2		
Paved Length (Miles): 2.73	**Section Length (MI)**	1	1	0.73		
Surface Type: ASPHALT	**Route Summary**					
Roadway Condition Information						
Pavement Condition Rating (PCR)	100	100	100	100		
Surface Condition Rating (SCR)	100	100	100	100		
Roughness Condition Index (RCI)	100	100	100	99		
Distress Index Values						
Structural Crack Index	100	100	100	100		
Alligator Crack Index	100	100	100	100		
Longitudinal Crack Index	100	100	100	100		
Transverse Cracking Index	100	100	100	100		
Patching Index	100	100	100	100		
Rutting Index	100	100	100	100		
International Roughness Index (IRI)	63	43	50	116		
Lane & Width Information						
Number of Lanes	2	2	2	1		
Paved Width (ft)	19.5	21.3	20.6	9.5		
Lane Width (ft)	9	8.9	8.7	9.5

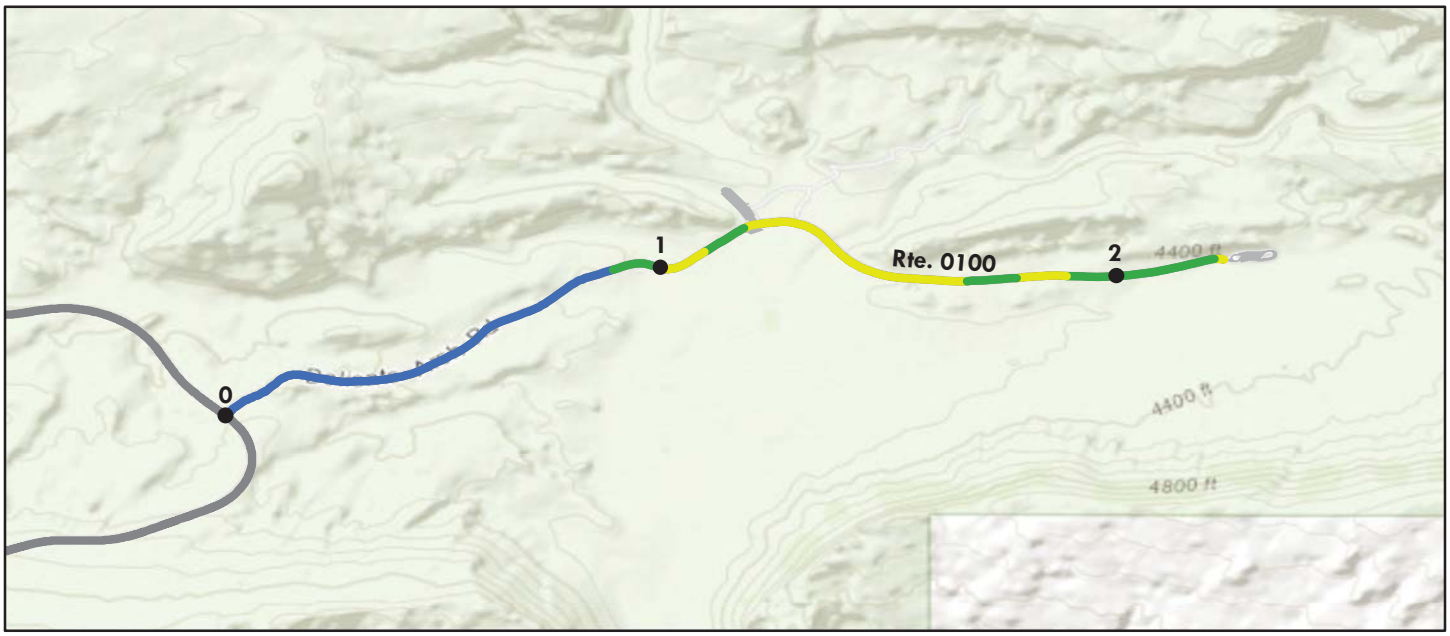
ROUTE 0100: DELICATE ARCH ROAD

Inspection Date: 11/29/2017	**Beginning Section MP**	0	1	2		
Paved Length (Miles): 2.22	**Section Length (MI)**	1	1	0.22		
Surface Type: ASPHALT	**Route Summary**					
Roadway Condition Information						
Pavement Condition Rating (PCR)	93	99	82	86		
Surface Condition Rating (SCR)	90	99	80	92		
Roughness Condition Index (RCI)	97	100	85	78		
Distress Index Values						
Structural Crack Index	97	99	94	97		
Alligator Crack Index	100	100	100	100		
Longitudinal Crack Index	97	99	94	97		
Transverse Cracking Index	90	99	80	92		
Patching Index	100	100	100	100		
Rutting Index	98	100	96	95		
International Roughness Index (IRI)	123	79	154	176		
Lane & Width Information						
Number of Lanes	2	2	2	2		
Paved Width (ft)	22.9	22.3	23	25.3		
Lane Width (ft)	9	8.9	8.9	9.4

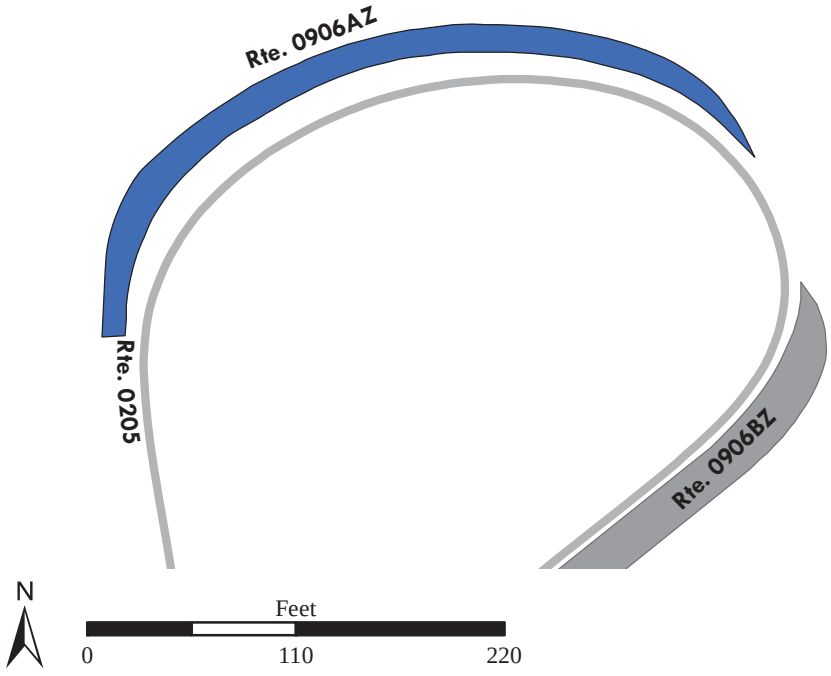
ROUTE 0906AZ: PANORAMA POINT PARKING A

Note: Parking area square footage contains a 730 square foot concrete ADA pad.

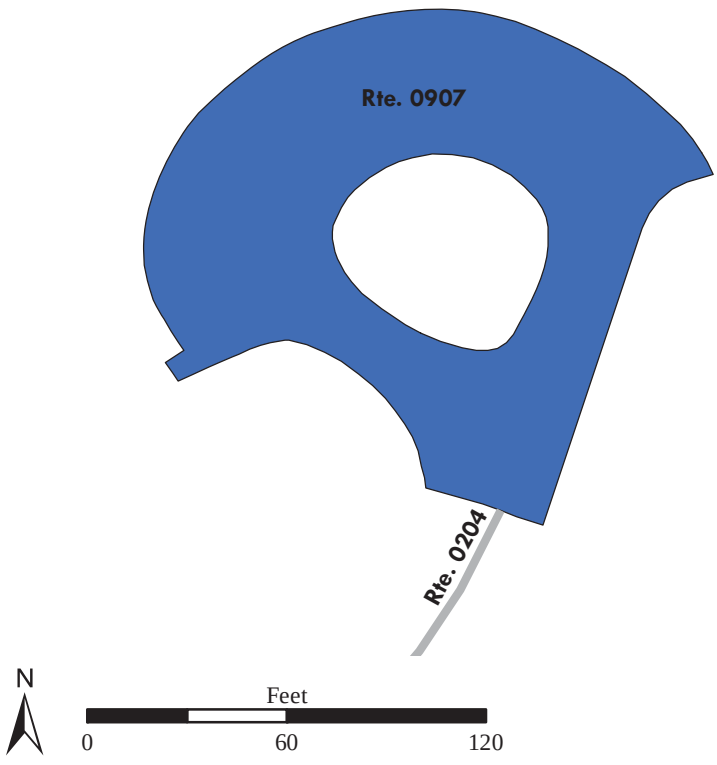
ROUTE 0907: GARDEN OF EDEN PARKING

Note: Parking area square footage contains a 442 square foot concrete ADA pad.

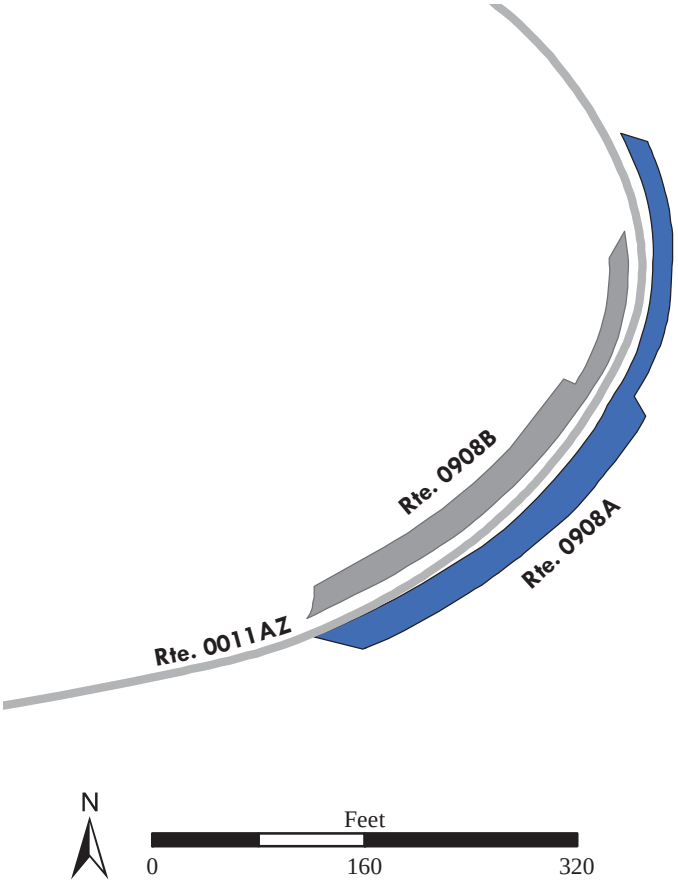
ROUTE 0908A: WINDOWS PARKING A

Note: Parking area square footage contains a 645 square foot concrete ADA pad.

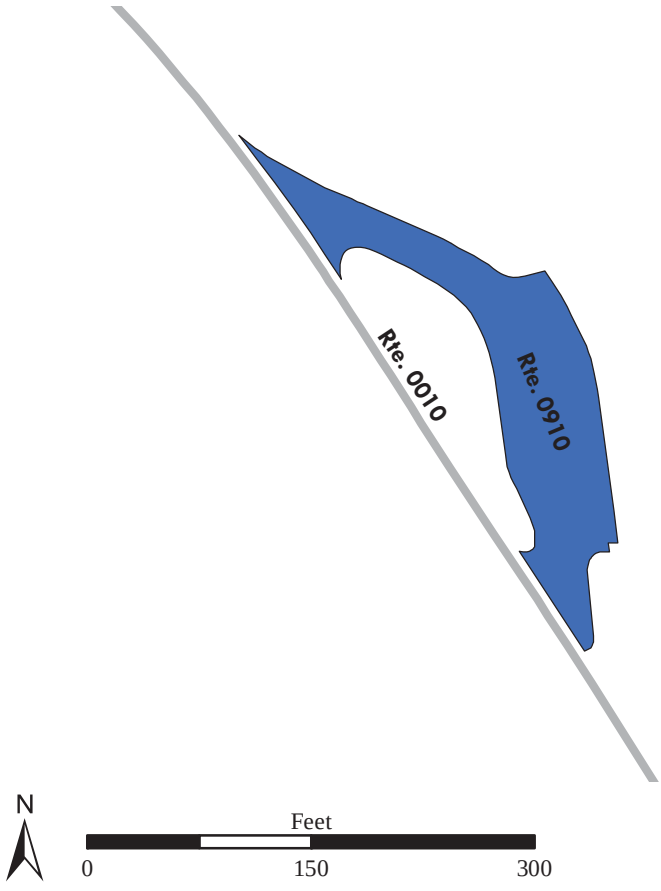
ROUTE 0910: COURTHOUSE TOWERS PARKING

Note: Parking area square footage contains a 390 square foot concrete ADA pad.

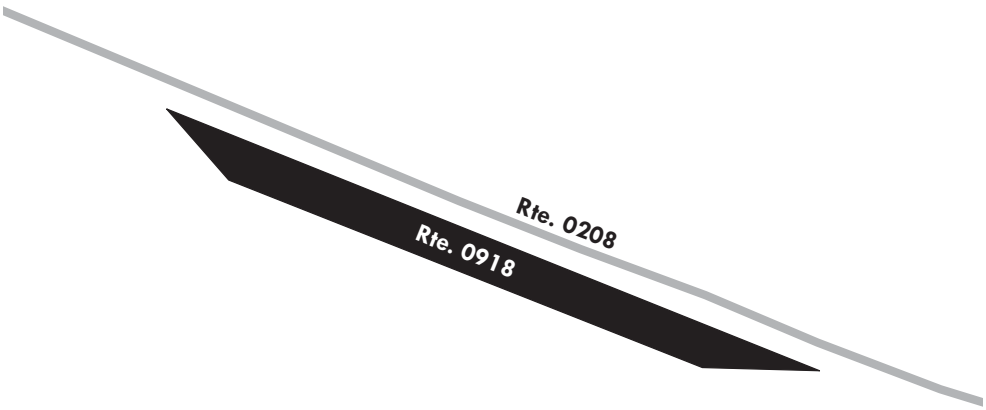
ROUTE 0918: CAMPGROUND REGISTRATION PARKING

Note: Parking area was not rated because it was under construction.

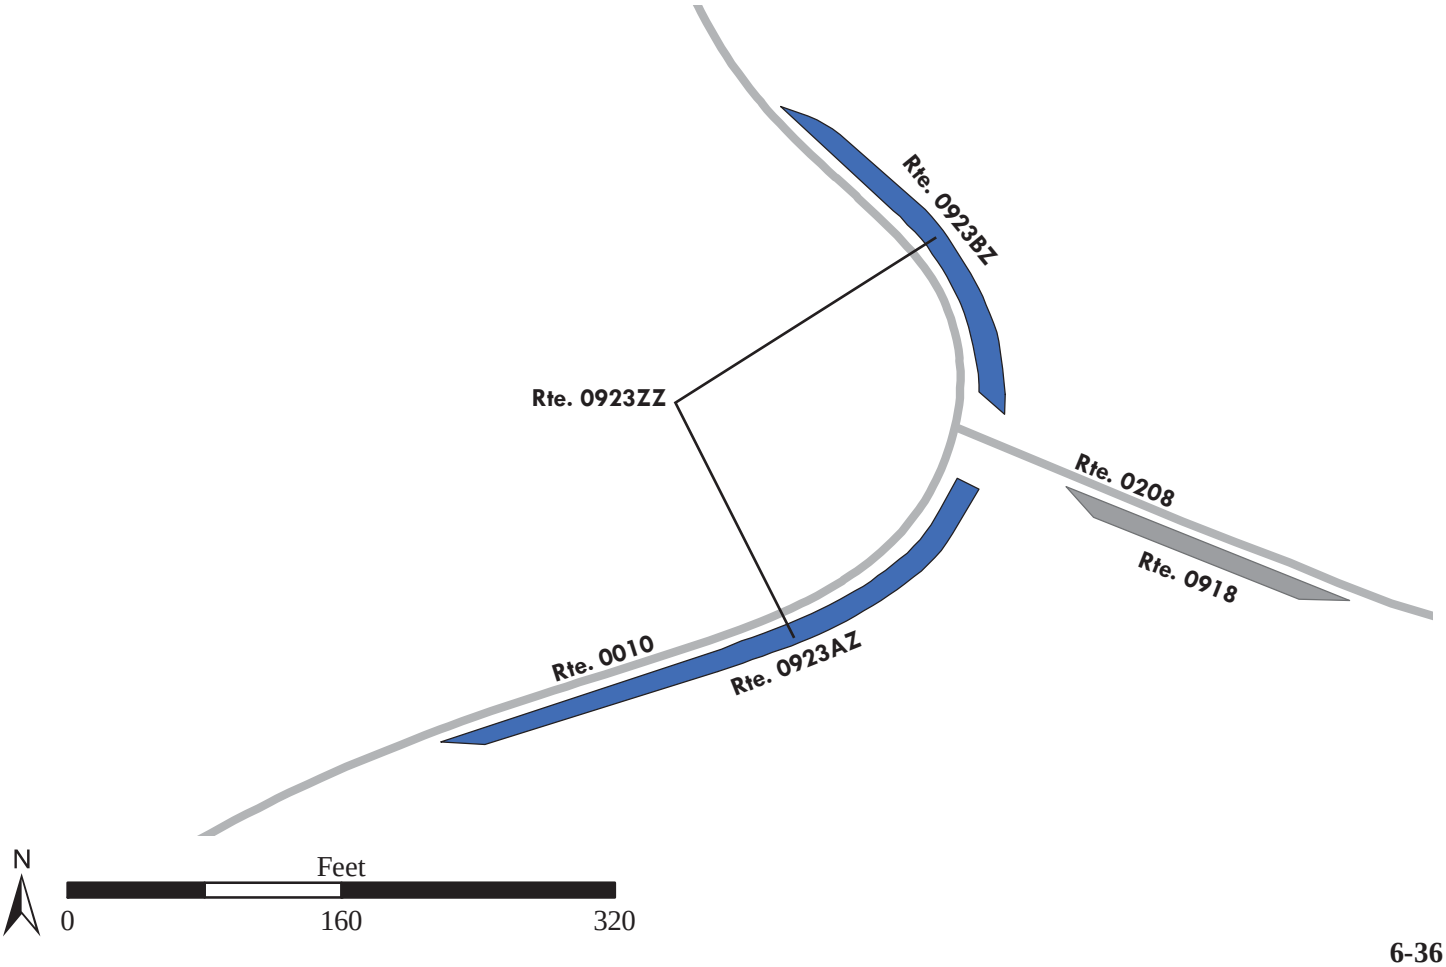
ROUTE 0923AZ: CAMPGROUND PARKING A

Inspection Date	FMSS Number	User Access	Surface Type
11/29/2017	100092	PUBLIC	ASPHALT
Area (Sq. Ft.)	**Lane Miles (11' Widths)**	**Curb Reveal (Inches)**	**Curb Recommendation**
3,175	0.055	5	DO NOTHING
Curb Type		**Curb & Gutter Type**	
CONCRETE		NO CURB AND GUTTER	
Pavement Recommendation		**Condition Rating / PCR**	
DO NOTHING		EXCELLENT / 97

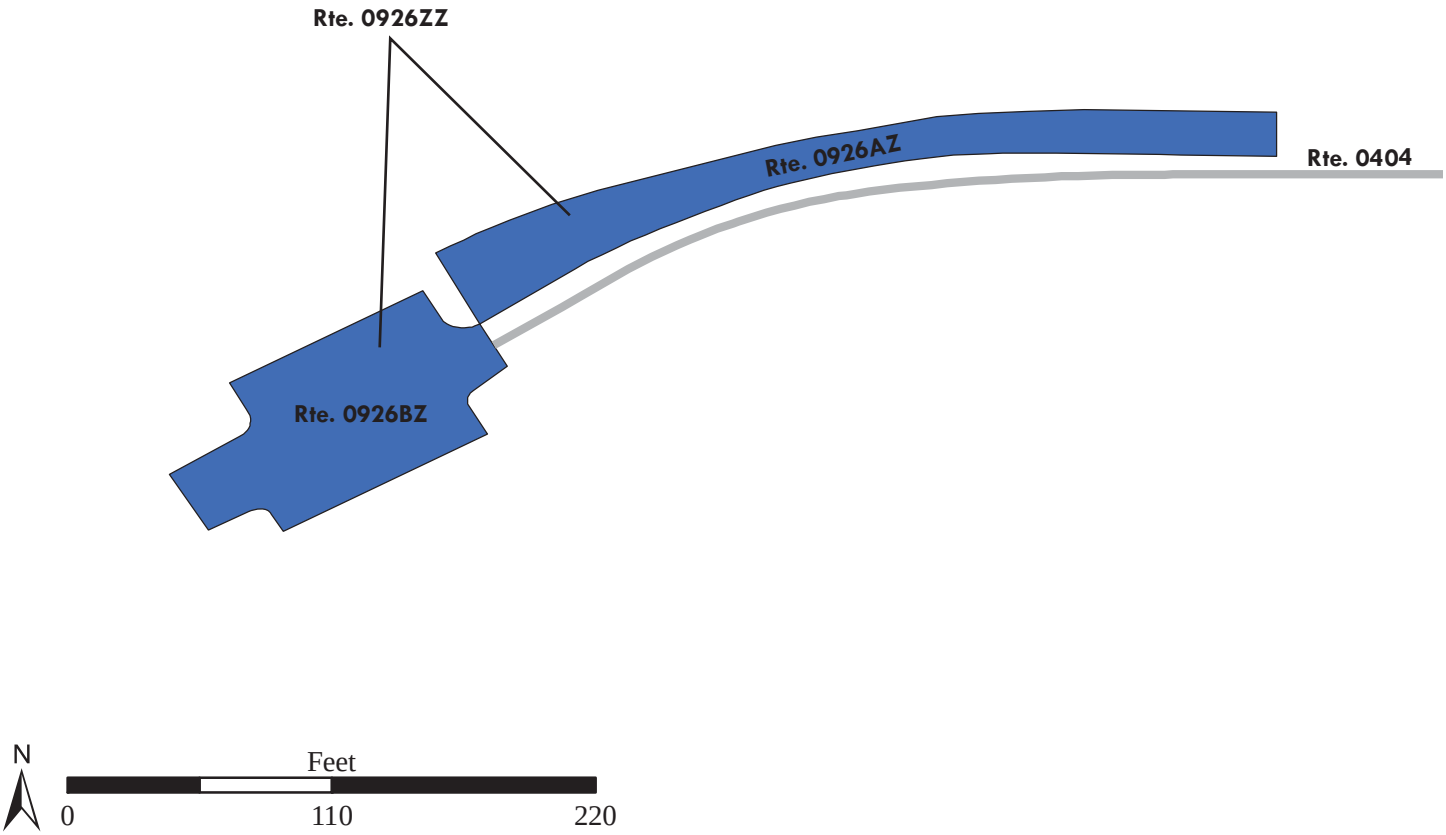
ROUTE 0926AZ: VISITOR CENTER STAFF PARKING A

Inspection Date	FMSS Number	User Access	Surface Type
11/28/2017	100105	NONPUBLIC	ASPHALT
Area (Sq. Ft.)	**Lane Miles (11' Widths)**	**Curb Reveal (Inches)**	**Curb Recommendation**
5,629	0.097	NOT APPLICABLE	NOT APPLICABLE
Curb Type		**Curb & Gutter Type**	
NO CURB		NO CURB AND GUTTER	
Pavement Recommendation		**Condition Rating / PCR**	
DO NOTHING		EXCELLENT / 97

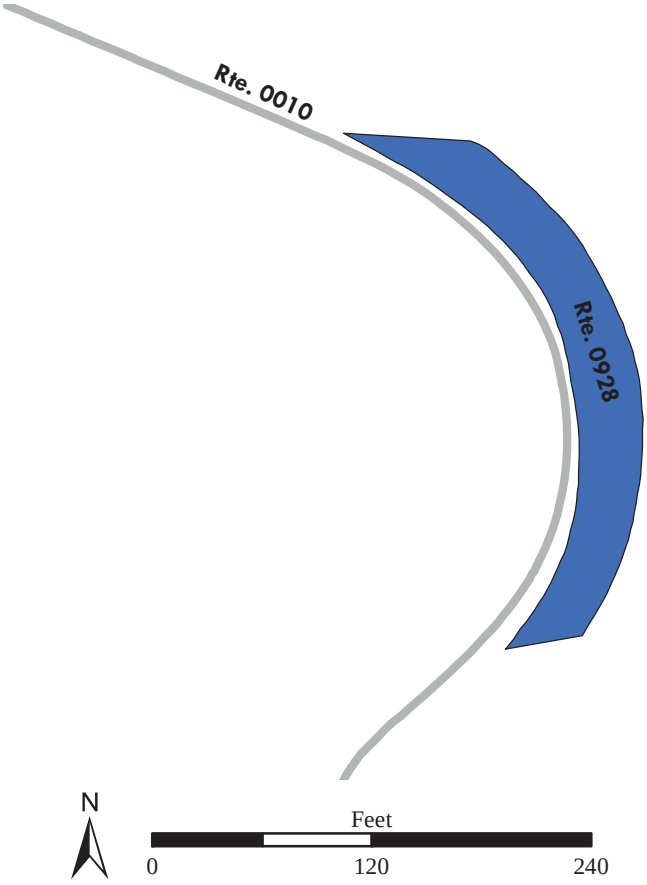
ROUTE 0928: ENTRANCE SIGN PARKING

Inspection Date	FMSS Number	User Access	Surface Type
11/28/2017	227329	PUBLIC	ASPHALT
Area (Sq. Ft.)	**Lane Miles (11' Widths)**	**Curb Reveal (Inches)**	**Curb Recommendation**
8,351	0.144	NOT APPLICABLE	DO NOTHING
Curb Type		**Curb & Gutter Type**	
NO CURB		CONCRETE	
Pavement Recommendation		**Condition Rating / PCR**	
DO NOTHING		EXCELLENT / 97
