**NPS Guardwall/Rail Inventory Program
Bighorn Canyon National Recreation Area**

**Federal Lands Highway
Road Inventory Program**

**Federal Highway Administration
Eastern Federal Lands Highway Division
Road Inventory Program (RIP)**

**Data Collection Date: August 2010
Report Date: December 2015**

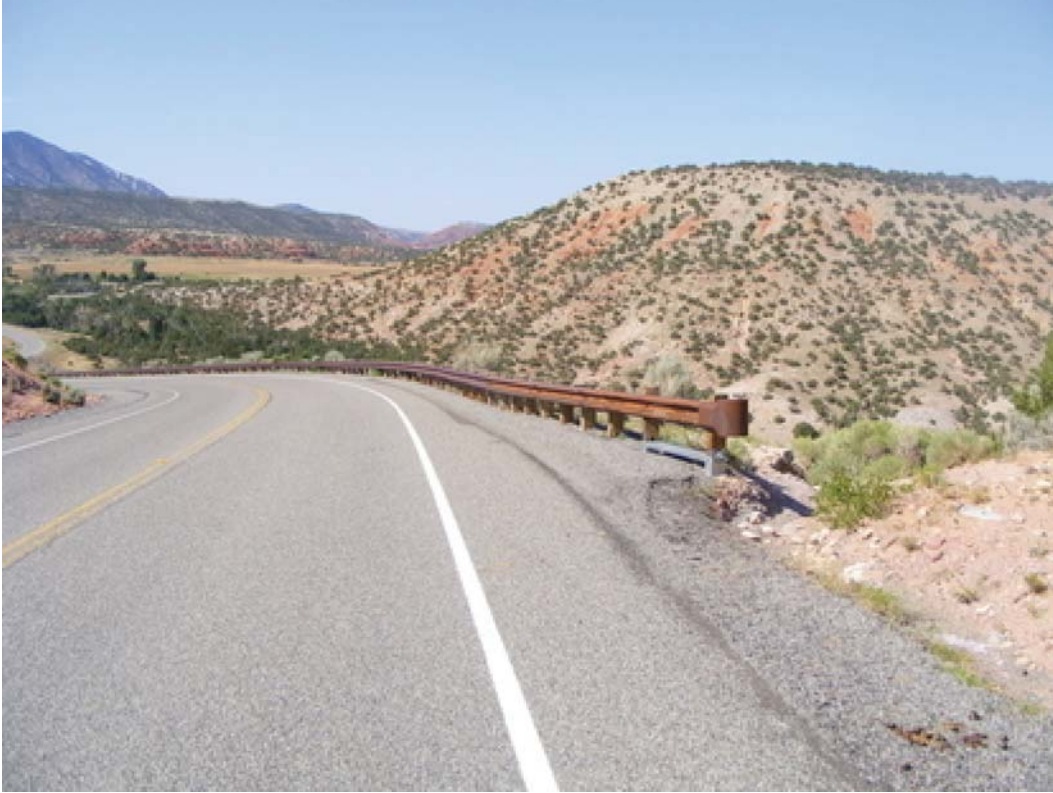
BICA_0013_10.409_R_1.JPG

Barrier ID:	BICA-0013-10.409-R				
Route Name:	BAD PASS ROAD				
Inspection Date:	05/08/2010	Barrier Rating:	35.50		
Barrier Description					
Type:	W-BEAM STRONG POST	Barrier Function:	TRAFFIC		
Barrier Material:	WEATHERING STEEL/CORTEN	Post Material:	WOOD		
Blockout Type:	WOOD	Length (ft.):	715		
Speed Limit (MPH):	40	Placement with Respect to Road:	OUTSIDE OF CURVE		
Hazard Behind Barrier:	HIGH				
Barrier Crashworthiness					
Appropriate Test Level:	TL-2	Barrier Test Level:	TL-3	Is Barrier Crashworthy?:	YES
Beg. End Trtmt Type:	W-BEAM FLARED 350 COMPLIANT	Is Beg. End Trtmt Crashworthy?:	YES	Approach Transition Type:	NONE
Ending End Trtmt Type:	W-BEAM FLARED 350 COMPLIANT	Ending End Trtmt Crashworthy?:	YES		
Average Measurements					
Design Height (In.):	27	Width (In.):	0.0	Post Spacing (In.):	76.0
Height (In.):	29.0	Lateral Offset (In.):	73.0	Road Grade (%):	7.80
Physical Condition					
Barrier	Alignment and Height:	The alignment had no deflection and the height was 1 to 3 in above the 27 in design height.

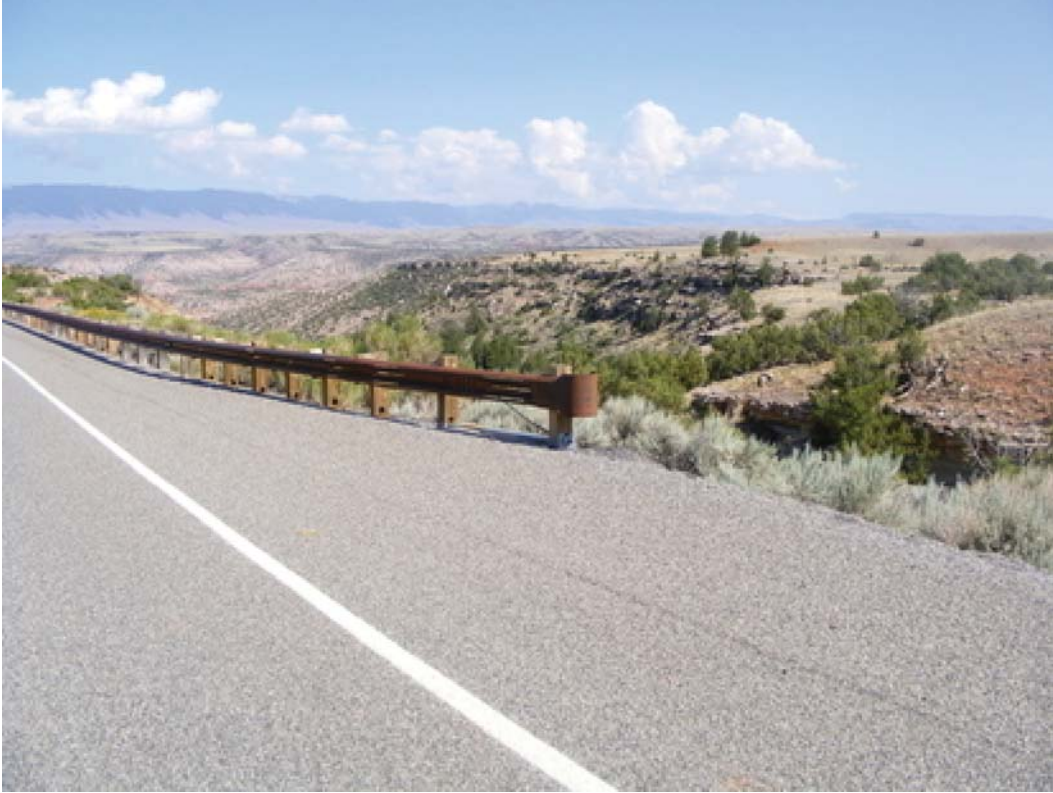
BICA_0013_12.829_R_1.JPG

Barrier ID:	BICA-0013-12.829-R				
Route Name:	BAD PASS ROAD				
Inspection Date:	05/08/2010	Barrier Rating:	28.60		
Barrier Description					
Type:	W-BEAM STRONG POST	Barrier Function:	TRAFFIC		
Barrier Material:	WEATHERING STEEL/CORTEN	Post Material:	WOOD		
Blockout Type:	WOOD	Length (ft.):	358		
Speed Limit (MPH):	40	Placement with Respect to Road:	OUTSIDE OF CURVE		
Hazard Behind Barrier:	EXTREME				
Barrier Crashworthiness					
Appropriate Test Level:	TL-2	Barrier Test Level:	TL-3	Is Barrier Crashworthy?:	YES
Beg. End Trtmt Type:	W-BEAM FLARED 350 COMPLIANT	Is Beg. End Trtmt Crashworthy?:	YES	Approach Transition Type:	NONE
Ending End Trtmt Type:	W-BEAM FLARED 350 COMPLIANT	Ending End Trtmt Crashworthy?:	YES		
Average Measurements					
Design Height (In.):	27	Width (In.):	0.0	Post Spacing (In.):	74.6
Height (In.):	29.7	Lateral Offset (In.):	95.0	Road Grade (%):	1.30
Physical Condition					
Barrier	Alignment and Height:	The alignment had no deflection and the height was 2 to 3 in above the 27 in design height.

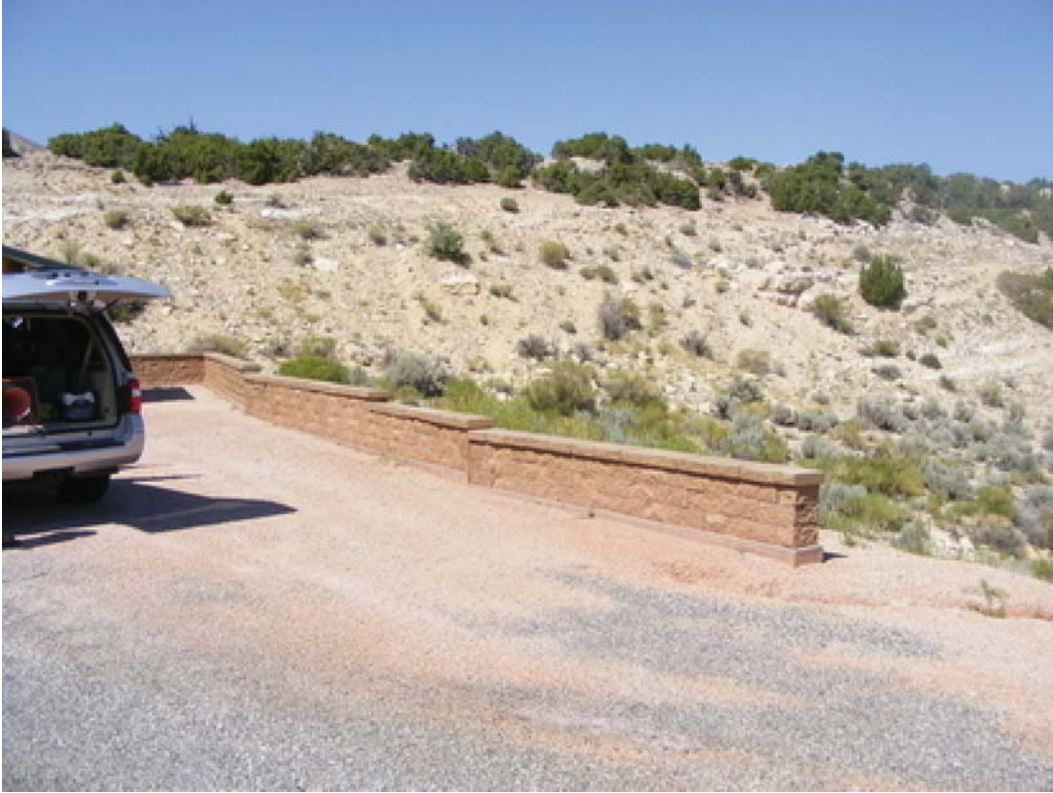
BICA_0204_0.050_L_1.JPG

Barrier ID:	BICA-0204-0.050-L				
Route Name:	DEVIL'S CANYON OVERLOOK ROAD				
Inspection Date:	05/08/2010	Barrier Rating:	4.30		
Barrier Description					
Type:	OTHER: CMU/SPLIT FACE CINDER BLOCK	Barrier Function:	NON-TRAFFIC		
Barrier Material:	CONCRETE	Post Material:	N/A		
Blockout Type:	N/A	Length (ft.):	135		
Speed Limit (MPH):	35	Placement with Respect to Road:	NON-TRAFFIC BARRIER		
Hazard Behind Barrier:	N/A				
Barrier Crashworthiness					
Appropriate Test Level:	TL-2	Barrier Test Level:	N/A	Is Barrier Crashworthy?:	N/A
Beg. End Trtmt Type:	NONE	Is Beg. End Trtmt Crashworthy?:	N/A	Approach Transition Type:	NONE
Ending End Trtmt Type:	NONE	Ending End Trtmt Crashworthy?:	N/A		
Average Measurements					
Design Height (In.):	24	Width (In.):	12.0	Post Spacing (In.):	0.0
Height (In.):	29.0	Lateral Offset (In.):	0.0	Road Grade (%):	0.00
Physical Condition					
Barrier	Alignment and Height:	The alignment had no deflection; barrier is stepped in design. The height ranged from 1 to 7 in above the 24 in design height.

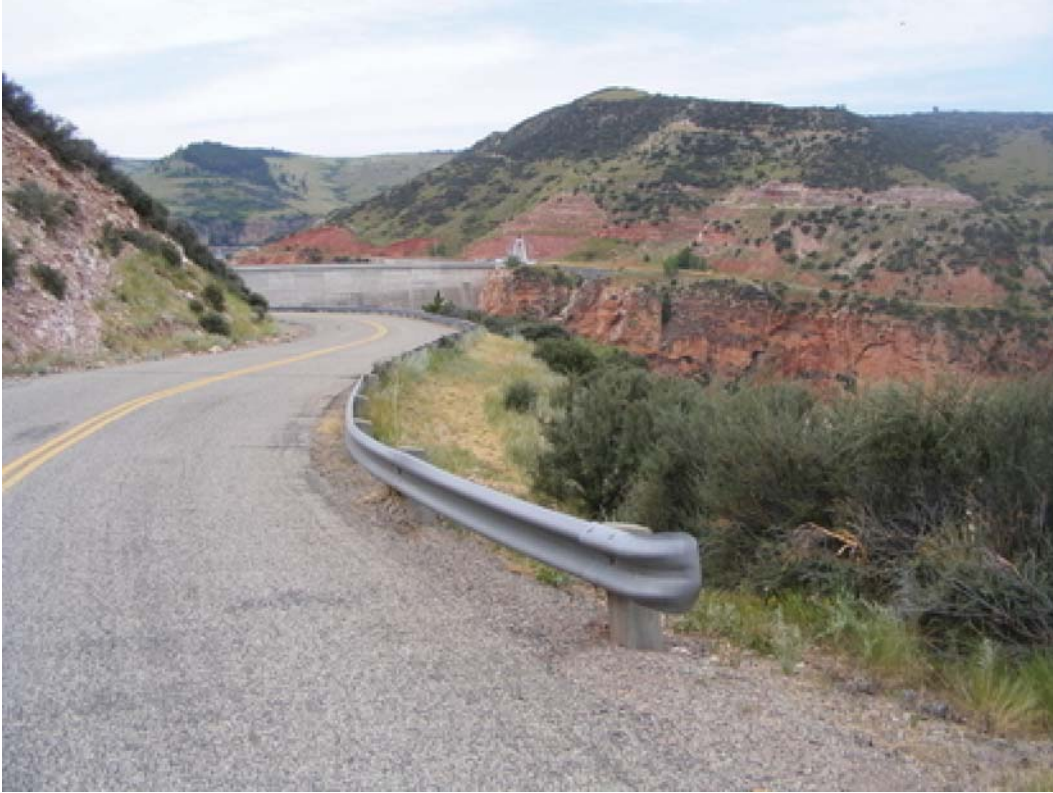
BICA_0210_0.087_L_1.JPG

Barrier ID:	BICA-0210-0.087-L				
Route Name:	WAPPA UPPER SWITCHYARD ROAD				
Inspection Date:	03/08/2010	Barrier Rating:	62.40		
Barrier Description					
Type:	W-BEAM WEAK POST	Barrier Function:	TRAFFIC		
Barrier Material:	GALVANIZED STEEL	Post Material:	OTHER: CONCRETE		
Blockout Type:	N/A	Length (ft.):	440		
Speed Limit (MPH):	25	Placement with Respect to Road:	BOTH INSIDE AND OUTSIDE		
Hazard Behind Barrier:	EXTREME				
Barrier Crashworthiness					
Appropriate Test Level:	TL-1	Barrier Test Level:	TL-2	Is Barrier Crashworthy?:	YES
Beg. End Trtmt Type:	NONE	Is Beg. End Trtmt Crashworthy?:	N/A	Approach Transition Type:	NONE
Ending End Trtmt Type:	NONE	Ending End Trtmt Crashworthy?:	N/A		
Average Measurements					
Design Height (In.):	27	Width (In.):	0.0	Post Spacing (In.):	150.6
Height (In.):	17.2	Lateral Offset (In.):	23.2	Road Grade (%):	3.40
Physical Condition					
Barrier	Alignment and Height:	The alignment had no deflection and the height was 9 to 11 in below the 27 in design height.

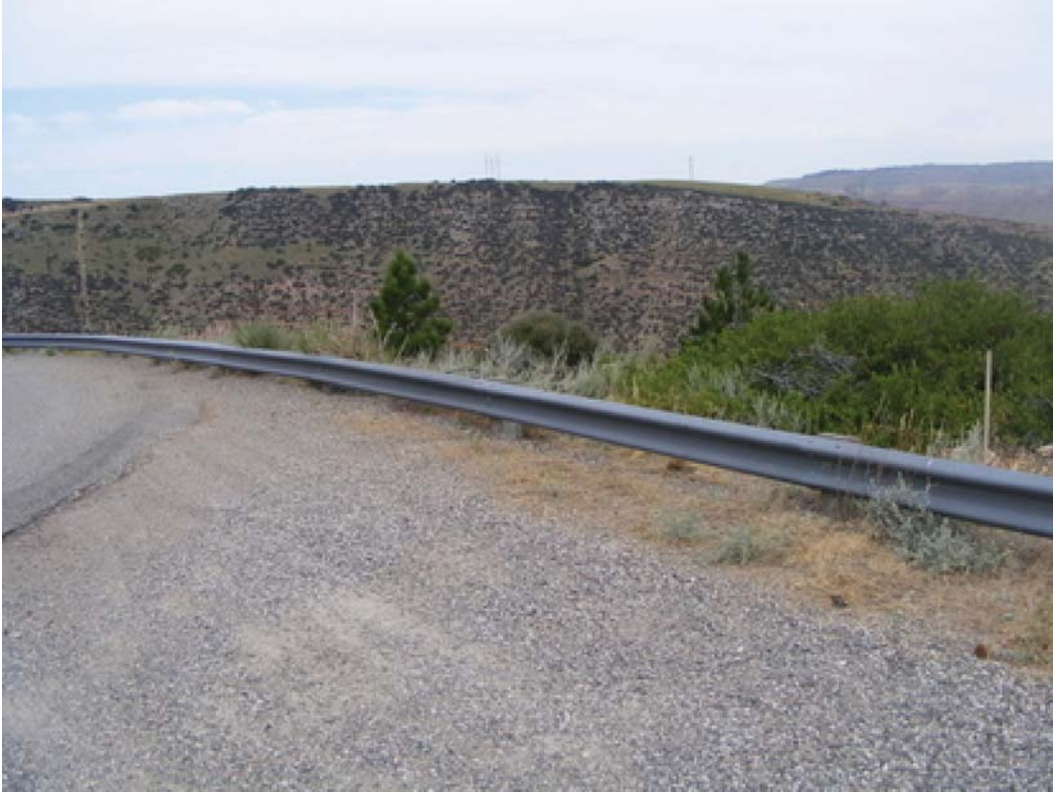
BICA_0210_0.199_L_1.JPG

Barrier ID:	BICA-0210-0.199-L				
Route Name:	WAPPA UPPER SWITCHYARD ROAD				
Inspection Date:	03/08/2010	Barrier Rating:	55.90		
Barrier Description					
Type:	W-BEAM STRONG POST	Barrier Function:	TRAFFIC		
Barrier Material:	GALVANIZED STEEL	Post Material:	OTHER: CONCRETE		
Blockout Type:	WOOD	Length (ft.):	536		
Speed Limit (MPH):	25	Placement with Respect to Road:	BOTH INSIDE AND OUTSIDE		
Hazard Behind Barrier:	EXTREME				
Barrier Crashworthiness					
Appropriate Test Level:	TL-1	Barrier Test Level:	TL-2	Is Barrier Crashworthy?:	YES
Beg. End Trtmt Type:	NONE	Is Beg. End Trtmt Crashworthy?:	N/A	Approach Transition Type:	NONE
Ending End Trtmt Type:	NONE	Ending End Trtmt Crashworthy?:	N/A		
Average Measurements					
Design Height (In.):	27	Width (In.):	0.0	Post Spacing (In.):	150.6
Height (In.):	22.2	Lateral Offset (In.):	23.2	Road Grade (%):	3.40
Physical Condition					
Barrier	Alignment and Height:	The alignment had no deflection except for 1 impacted rail pushed off alignment by 6 in or less. The height was 3 in below 27 in design height for 165 ft and was 4 to 7 in below for 371 ft.

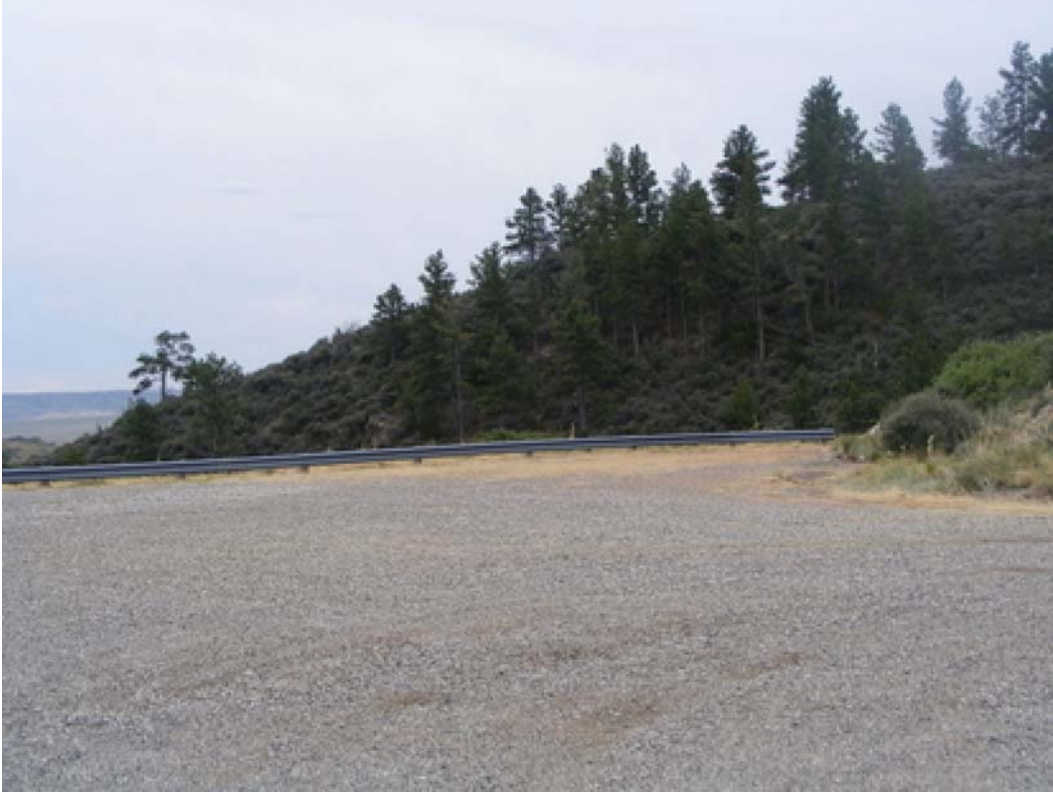
BICA_0210_0.301_L_1.JPG

Barrier ID:	BICA-0210-0.301-L				
Route Name:	WAPPA UPPER SWITCHYARD ROAD				
Inspection Date:	03/08/2010	Barrier Rating:	24.30		
Barrier Description					
Type:	W-BEAM WEAK POST	Barrier Function:	NON-TRAFFIC		
Barrier Material:	GALVANIZED STEEL	Post Material:	OTHER: CONCRETE		
Blockout Type:	N/A	Length (ft.):	370		
Speed Limit (MPH):	25	Placement with Respect to Road:	NON-TRAFFIC BARRIER		
Hazard Behind Barrier:	N/A				
Barrier Crashworthiness					
Appropriate Test Level:	TL-1	Barrier Test Level:	N/A	Is Barrier Crashworthy?:	N/A
Beg. End Trtmt Type:	NONE	Is Beg. End Trtmt Crashworthy?:	N/A	Approach Transition Type:	NONE
Ending End Trtmt Type:	NONE	Ending End Trtmt Crashworthy?:	N/A		
Average Measurements					
Design Height (In.):	27	Width (In.):	0.0	Post Spacing (In.):	0.0
Height (In.):	20.5	Lateral Offset (In.):	0.0	Road Grade (%):	0.00
Physical Condition					
Barrier	Alignment and Height:	The alignment had no deflection and the height was 5 to 9 in below the 27 in design height throughout.

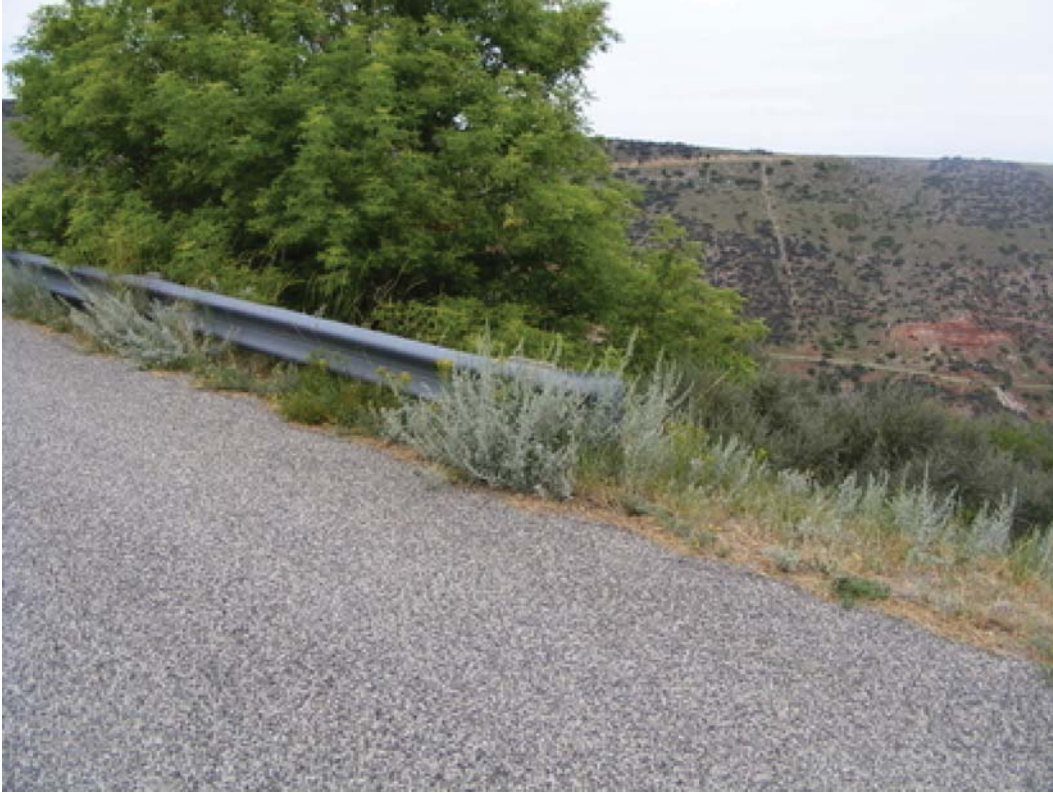
BICA_0210_0.413_R_1.JPG

Barrier ID:	BICA-0210-0.413-R				
Route Name:	WAPPA UPPER SWITCHYARD ROAD				
Inspection Date:	03/08/2010	Barrier Rating:	47.20		
Barrier Description					
Type:	W-BEAM WEAK POST	Barrier Function:	TRAFFIC		
Barrier Material:	GALVANIZED STEEL	Post Material:	OTHER: CONCRETE		
Blockout Type:	N/A	Length (ft.):	325		
Speed Limit (MPH):	25	Placement with Respect to Road:	OUTSIDE OF CURVE		
Hazard Behind Barrier:	EXTREME				
Barrier Crashworthiness					
Appropriate Test Level:	TL-1	Barrier Test Level:	TL-2	Is Barrier Crashworthy?:	YES
Beg. End Trtmt Type:	NONE	Is Beg. End Trtmt Crashworthy?:	N/A	Approach Transition Type:	NONE
Ending End Trtmt Type:	NONE	Ending End Trtmt Crashworthy?:	N/A		
Average Measurements					
Design Height (In.):	27	Width (In.):	0.0	Post Spacing (In.):	150.0
Height (In.):	21.0	Lateral Offset (In.):	13.6	Road Grade (%):	3.20
Physical Condition					
Barrier	Alignment and Height:	Minor impact to w-beam (snow plow). The overall alignment had no significant deflection and the height was 6 in below the 27 in design height throughout.

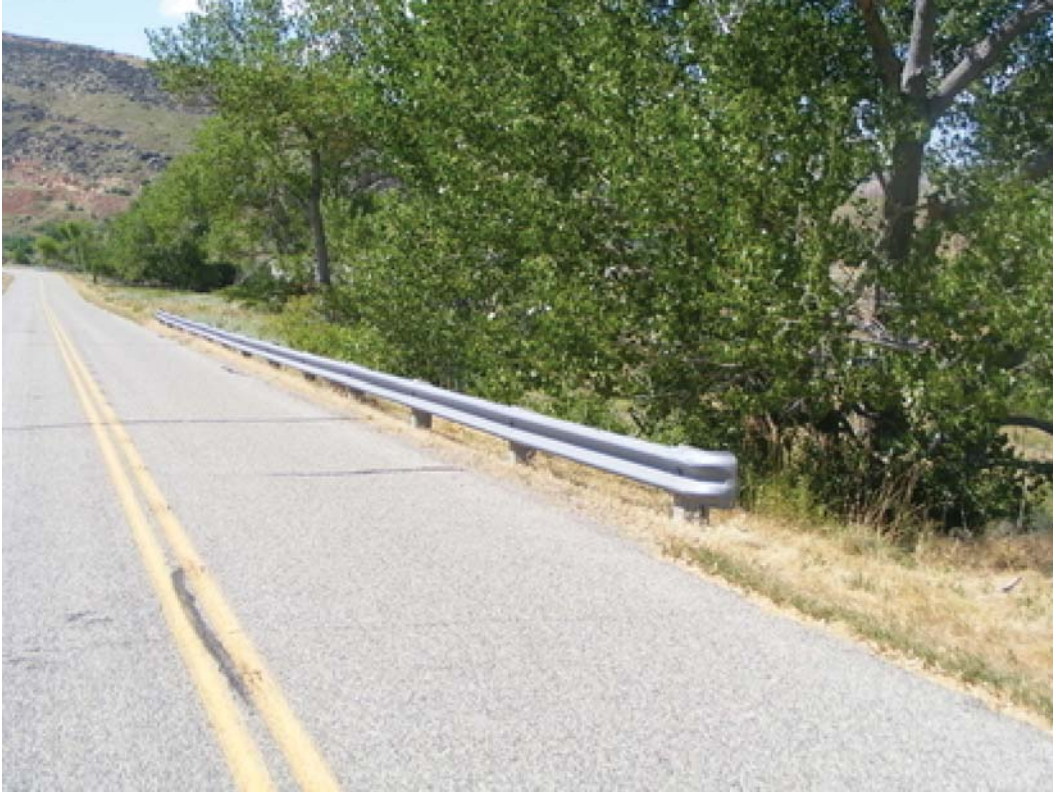
BICA_0211_0.116_R_1.JPG

Barrier ID:	BICA-0211-0.116-R				
Route Name:	YELLOWTAIL POWER PLANT ROAD				
Inspection Date:	02/08/2010	Barrier Rating:	29.60		
Barrier Description					
Type:	W-BEAM WEAK POST	Barrier Function:	TRAFFIC		
Barrier Material:	GALVANIZED STEEL	Post Material:	OTHER: CONCRETE		
Blockout Type:	N/A	Length (ft.):	156		
Speed Limit (MPH):	35	Placement with Respect to Road:	TANGENT		
Hazard Behind Barrier:	MEDIUM				
Barrier Crashworthiness					
Appropriate Test Level:	TL-2	Barrier Test Level:	TL-2	Is Barrier Crashworthy?:	YES
Beg. End Trtmt Type:	NONE	Is Beg. End Trtmt Crashworthy?:	N/A	Approach Transition Type:	NONE
Ending End Trtmt Type:	NONE	Ending End Trtmt Crashworthy?:	N/A		
Average Measurements					
Design Height (In.):	27	Width (In.):	0.0	Post Spacing (In.):	150.0
Height (In.):	21.0	Lateral Offset (In.):	24.0	Road Grade (%):	2.80
Physical Condition					
Barrier	Alignment and Height:	The alignment had no deflection and the height was 5 to 7 in below the 27 in design height.

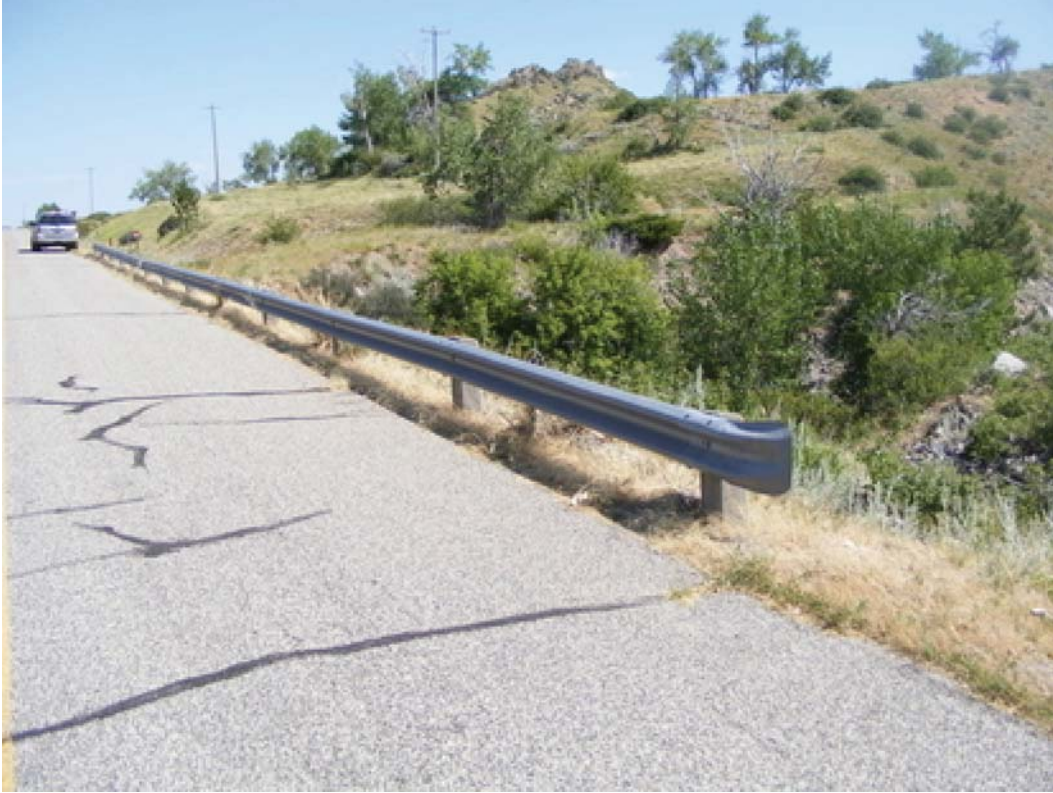
BICA_0211_0.117_L_1.JPG

Barrier ID:	BICA-0211-0.117-L				
Route Name:	YELLOWTAIL POWER PLANT ROAD				
Inspection Date:	02/08/2010	Barrier Rating:	32.40		
Barrier Description					
Type:	W-BEAM WEAK POST	Barrier Function:	TRAFFIC		
Barrier Material:	GALVANIZED STEEL	Post Material:	OTHER: CONCRETE		
Blockout Type:	N/A	Length (ft.):	154		
Speed Limit (MPH):	35	Placement with Respect to Road:	TANGENT		
Hazard Behind Barrier:	MEDIUM				
Barrier Crashworthiness					
Appropriate Test Level:	TL-2	Barrier Test Level:	TL-2	Is Barrier Crashworthy?:	YES
Beg. End Trtmt Type:	NONE	Is Beg. End Trtmt Crashworthy?:	N/A	Approach Transition Type:	NONE
Ending End Trtmt Type:	NONE	Ending End Trtmt Crashworthy?:	N/A		
Average Measurements					
Design Height (In.):	27	Width (In.):	0.0	Post Spacing (In.):	150.6
Height (In.):	22.6	Lateral Offset (In.):	16.0	Road Grade (%):	2.40
Physical Condition					
Barrier	Alignment and Height:	The alignment had no deflection and the height was 4 to 5 in below the 27 in design height.

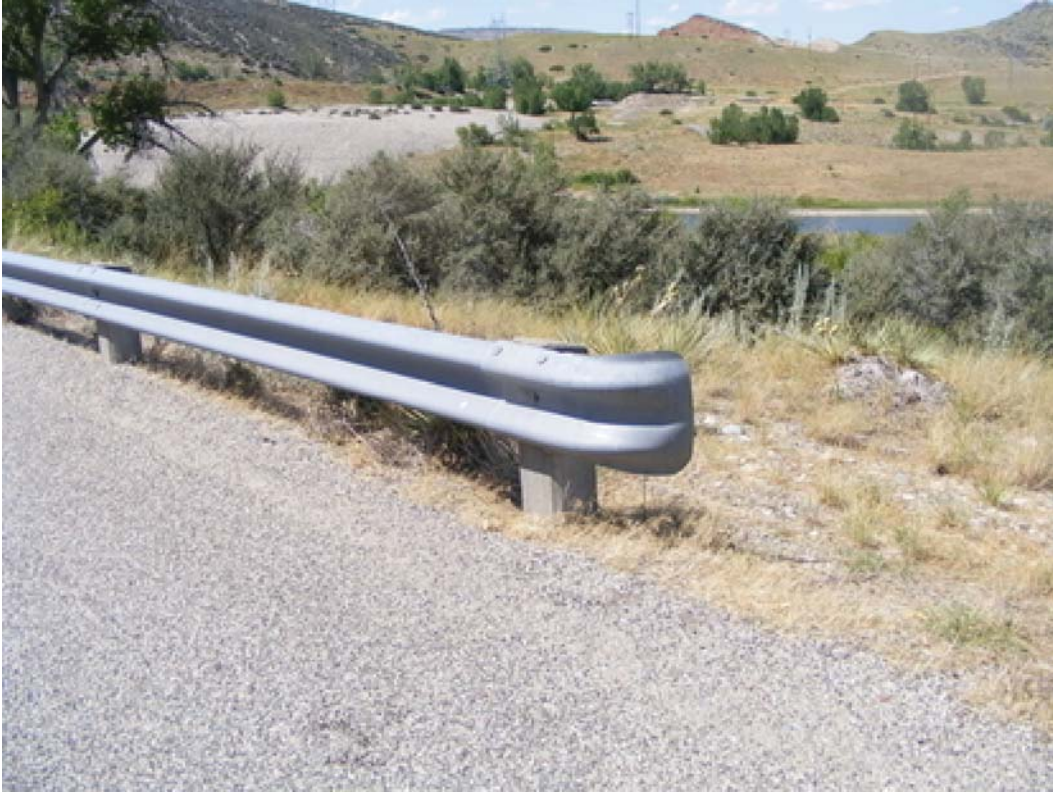
BICA_0211_0.278_R_1.JPG

Barrier ID:	BICA-0211-0.278-R				
Route Name:	YELLOWTAIL POWER PLANT ROAD				
Inspection Date:	02/08/2010	Barrier Rating:	34.20		
Barrier Description					
Type:	W-BEAM WEAK POST	Barrier Function:	TRAFFIC		
Barrier Material:	GALVANIZED STEEL	Post Material:	OTHER: CONCRETE		
Blockout Type:	N/A	Length (ft.):	204		
Speed Limit (MPH):	35	Placement with Respect to Road:	OUTSIDE OF CURVE		
Hazard Behind Barrier:	HIGH				
Barrier Crashworthiness					
Appropriate Test Level:	TL-2	Barrier Test Level:	TL-2	Is Barrier Crashworthy?:	YES
Beg. End Trtmt Type:	NONE	Is Beg. End Trtmt Crashworthy?:	N/A	Approach Transition Type:	NONE
Ending End Trtmt Type:	NONE	Ending End Trtmt Crashworthy?:	N/A		
Average Measurements					
Design Height (In.):	27	Width (In.):	0.0	Post Spacing (In.):	150.0
Height (In.):	25.0	Lateral Offset (In.):	13.6	Road Grade (%):	1.50
Physical Condition					
Barrier	Alignment and Height:	The alignment had no deflection and the height was at or within 1 in of the 27 in design height for 77 ft between 1 and 3 in below for 100 ft and greater than 3 in below for 27 ft.

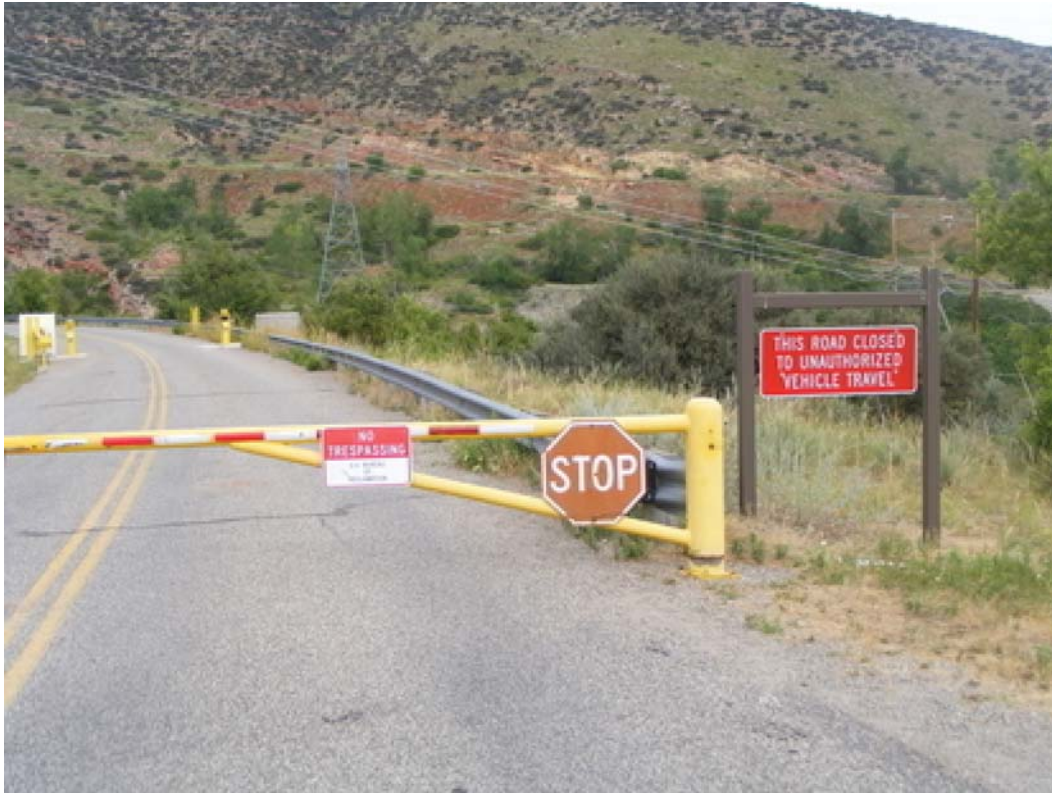
BICA_0211_0.349_R_1.JPG

Barrier ID:	BICA-0211-0.349-R				
Route Name:	YELLOWTAIL POWER PLANT ROAD				
Inspection Date:	03/08/2010	Barrier Rating:	61.20		
Barrier Description					
Type:	W-BEAM WEAK POST	Barrier Function:	TRAFFIC		
Barrier Material:	GALVANIZED STEEL	Post Material:	OTHER: CONCRETE		
Blockout Type:	N/A	Length (ft.):	791		
Speed Limit (MPH):	35	Placement with Respect to Road:	OUTSIDE OF CURVE		
Hazard Behind Barrier:	HIGH				
Barrier Crashworthiness					
Appropriate Test Level:	TL-2	Barrier Test Level:	TL-2	Is Barrier Crashworthy?:	YES
Beg. End Trtmt Type:	NONE	Is Beg. End Trtmt Crashworthy?:	N/A	Approach Transition Type:	NONE
Ending End Trtmt Type:	NONE	Ending End Trtmt Crashworthy?:	N/A		
Average Measurements					
Design Height (In.):	27	Width (In.):	0.0	Post Spacing (In.):	150.6
Height (In.):	21.6	Lateral Offset (In.):	17.0	Road Grade (%):	1.20
Physical Condition					
Barrier	Alignment and Height:	The alignment had no deflection and the height was 2 to 3 in below the 27 in design height for 150 ft and was between 3 to 9 in below for 641 ft.

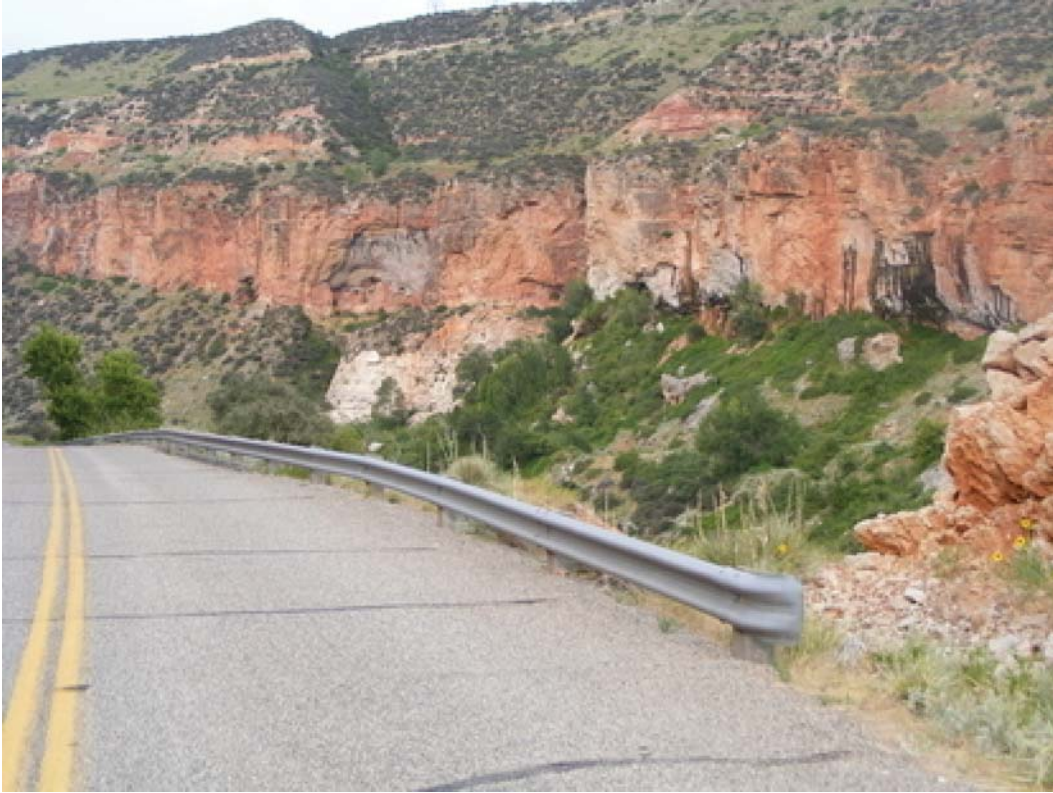
BICA_0211_0.544_R_1.JPG

Barrier ID:	BICA-0211-0.544-R				
Route Name:	YELLOWTAIL POWER PLANT ROAD				
Inspection Date:	03/08/2010	Barrier Rating:	60.20		
Barrier Description					
Type:	W-BEAM WEAK POST	Barrier Function:	TRAFFIC		
Barrier Material:	GALVANIZED STEEL	Post Material:	OTHER: CONCRETE		
Blockout Type:	N/A	Length (ft.):	418		
Speed Limit (MPH):	35	Placement with Respect to Road:	OUTSIDE OF CURVE		
Hazard Behind Barrier:	EXTREME				
Barrier Crashworthiness					
Appropriate Test Level:	TL-2	Barrier Test Level:	TL-2	Is Barrier Crashworthy?:	YES
Beg. End Trtmt Type:	NONE	Is Beg. End Trtmt Crashworthy?:	N/A	Approach Transition Type:	NONE
Ending End Trtmt Type:	NONE	Ending End Trtmt Crashworthy?:	N/A		
Average Measurements					
Design Height (In.):	27	Width (In.):	0.0	Post Spacing (In.):	150.0
Height (In.):	20.6	Lateral Offset (In.):	16.6	Road Grade (%):	4.30
Physical Condition					
Barrier	Alignment and Height:	The alignment had no deflection and the height was 5 to 8 in below the 27 in design height throughout.

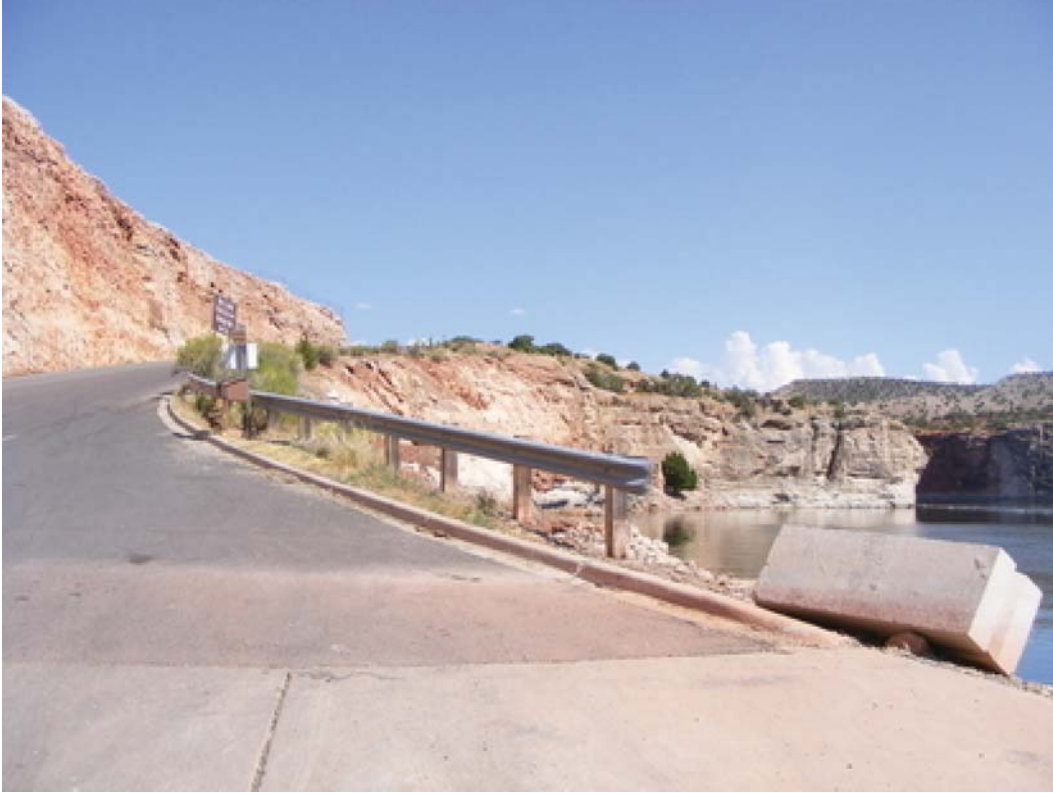
BICA_0219_2.011_L_1.JPG

Barrier ID:	BICA-0219-2.011-L				
Route Name:	BARRY'S LANDING BOAT RAMP ROAD				
Inspection Date:	05/08/2010	Barrier Rating:	40.20		
Barrier Description					
Type:	W-BEAM WEAK POST	Barrier Function:	TRAFFIC		
Barrier Material:	GALVANIZED STEEL	Post Material:	WOOD		
Blockout Type:	N/A	Length (ft.):	438		
Speed Limit (MPH):	30	Placement with Respect to Road:	BOTH INSIDE AND OUTSIDE		
Hazard Behind Barrier:	EXTREME				
Barrier Crashworthiness					
Appropriate Test Level:	TL-1	Barrier Test Level:	TL-2	Is Barrier Crashworthy?:	YES
Beg. End Trtmt Type:	NONE	Is Beg. End Trtmt Crashworthy?:	N/A	Approach Transition Type:	NONE
Ending End Trtmt Type:	NONE	Ending End Trtmt Crashworthy?:	N/A		
Average Measurements					
Design Height (In.):	27	Width (In.):	0.0	Post Spacing (In.):	75.3
Height (In.):	25.7	Lateral Offset (In.):	41.2	Road Grade (%):	11.90
Physical Condition					
Barrier	Alignment and Height:	The alignment had no deflection and the height was above the 27 in design height up to 32 in when barrier was behind the concrete curb for 191 ft and was 4 to 5 in below when there was no curb which was for 247 ft.

Breaking and Cracking:	There were 5 damaged rails from impact 4 being more minor. There was 1 cracked post and a couple of loose bolts.			
	Missing Elements:	2 missing bolts. No other missing barrier elements.			
	Corrosion and Weathering:	No corrosion of galvanized rails. Moderate weathering of wood barrier posts. 4 rotten posts down by water's edge.			
End Treatments	Alignment and Height:				
	Breaking and Cracking:				
	Missing Elements:				
	Corrosion and Weathering:

Repair Action:	REPAIR	FMSS Work Type:	DEFERRED MAINTENANCE	Repair Cost:	\$8448
Brief Workorder:	Raise 247-ft of barrier up to the 27-in design height replace 68 feet of rail 5 posts and tighten loose hardware.				
Workorder:	Replace Rail at \$25- per -Lin. Ft. for 68-ft = \$1700. Replace 5 impacted rails. Replace Post at \$100- per -Each for 5 Post(s) = \$500. Replace 5 wooden posts. Adjust Guardrail at \$10- per -Lin. Ft. for 247-ft = \$2470. Raise 247-ft of guardrail to 27 inch design height. Labor at \$60- per -Hour for 1 Hrs = \$60. 1 hour of labor to tighten/replace bolts. Low Speed Traffic Control at \$1475- per -Day for 2 Day(s) = \$2950.
