**GIP Report**

**NPS Guardwall/Rail Inventory Program  
Big South Fork National River and Recreation Area**

**Federal Highway Administration  
Eastern Federal Lands Highway Division  
Road Inventory Program (RIP)**

**Data Collection Date: October 2010  
Report Date: November 2015**

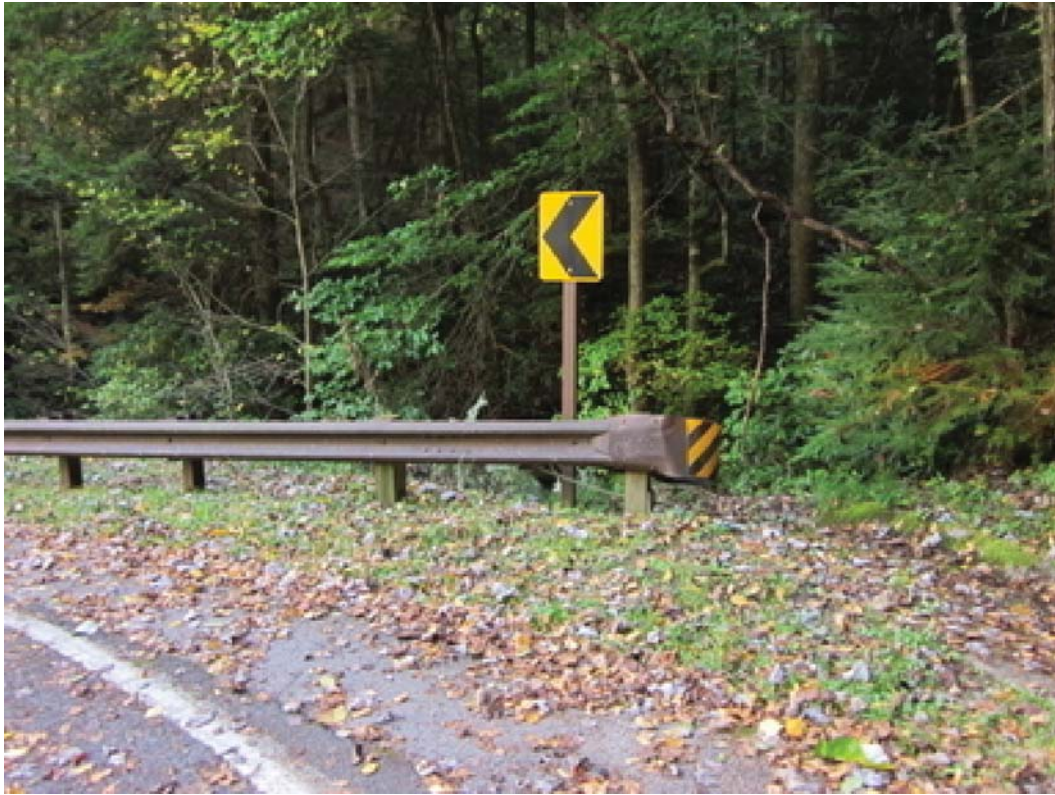
BISO\_0010\_2.378\_L\_1.JPG

| | <b>Breaking and Cracking:</b> | No breaking or cracking observed. | | | |
| | <b>Missing Elements:</b> | No missing elements observed. | | | |
| | <b>Corrosion and Weathering:</b> | No corrosion or weathering observed. | | | |

| <b>Repair Action:</b> | NO ACTION | <b>FMSS Work Type:</b> | N/A | <b>Repair Cost:</b> | \$0 |

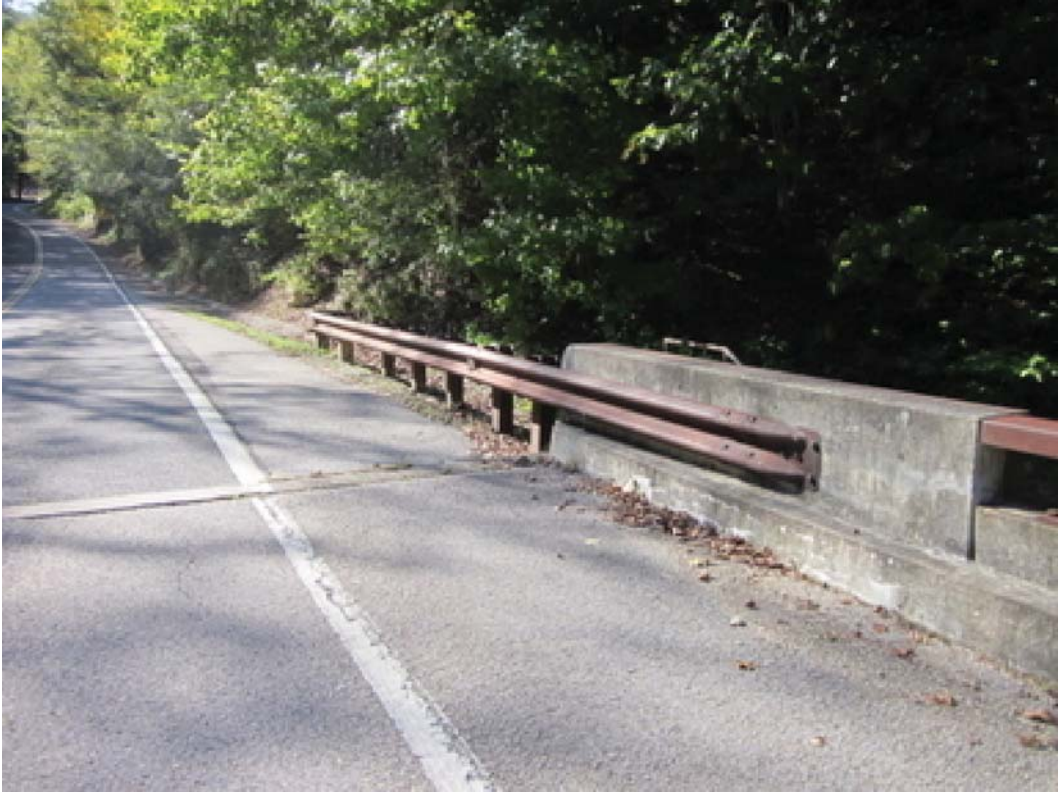
BISO\_0010\_2.380\_R\_1.JPG

| | <b>Breaking and Cracking:</b> | No breaking or cracking observed. | | | |
| | <b>Missing Elements:</b> | No missing elements observed. | | | |
| | <b>Corrosion and Weathering:</b> | No corrosion or weathering observed. | | | |

| <b>Repair Action:</b> | NO ACTION | <b>FMSS Work Type:</b> | N/A | <b>Repair Cost:</b> | \$0 |

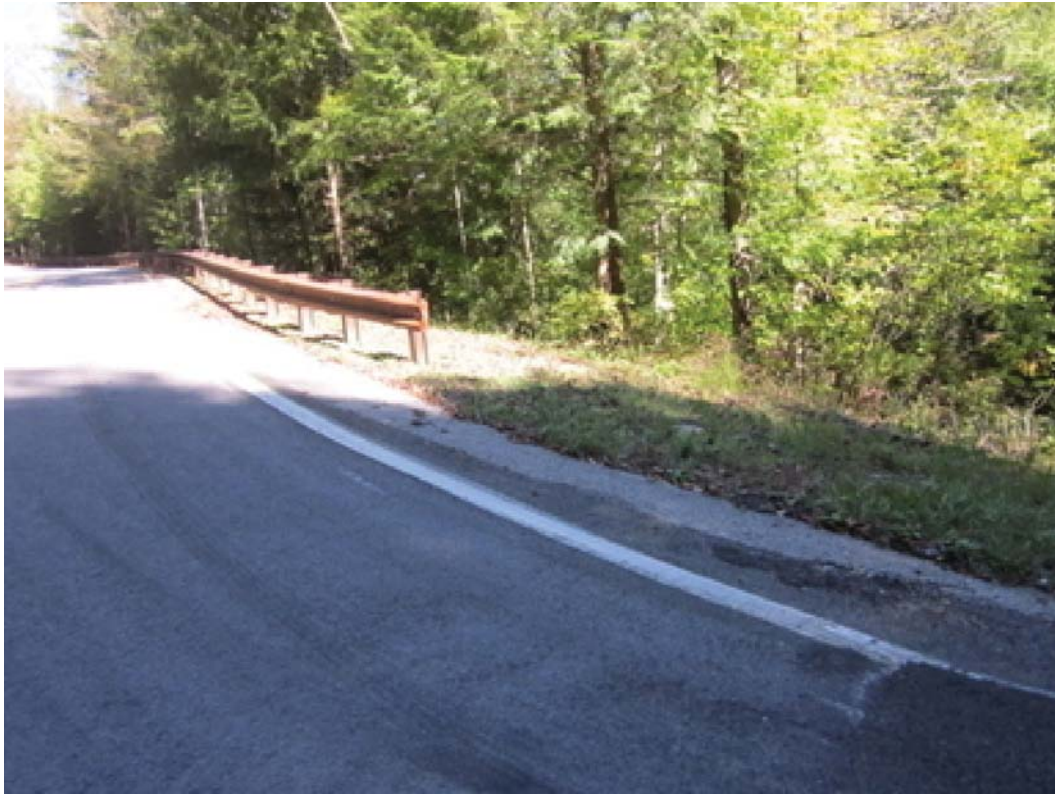
**BISO\_0010\_2.563\_R\_1.JPG**

| | <b>Breaking and Cracking:</b> | No breaking or cracking observed. | | | |
| | <b>Missing Elements:</b> | No missing elements observed. | | | |
| | <b>Corrosion and Weathering:</b> | No corrosion or weathering observed. | | | |

| <b>Repair Action:</b> | NO ACTION | <b>FMSS Work Type:</b> | N/A | <b>Repair Cost:</b> | \$0 |

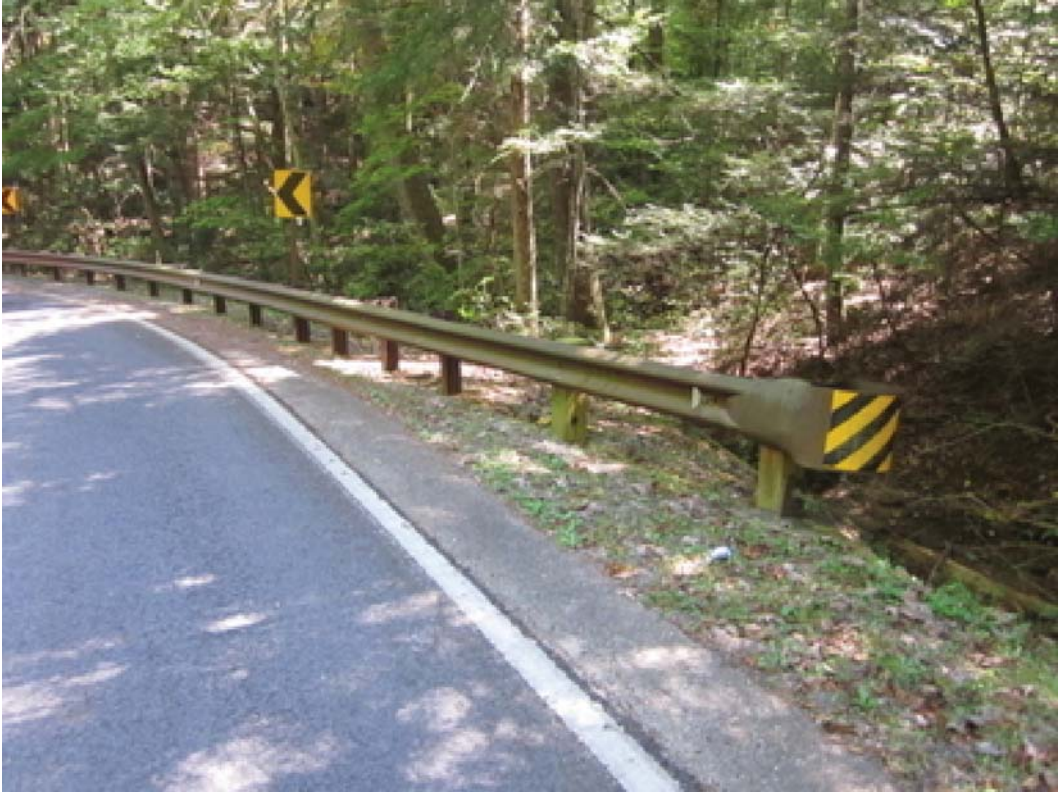
BISO\_0010\_2.742\_L\_1.JPG

| | <b>Breaking and Cracking:</b> | No breaking or cracking observed. | | | |
| | <b>Missing Elements:</b> | No missing elements observed. | | | |
| | <b>Corrosion and Weathering:</b> | No corrosion or weathering observed. | | | |

| <b>Repair Action:</b> | NO ACTION | <b>FMSS Work Type:</b> | N/A | <b>Repair Cost:</b> | \$0 |

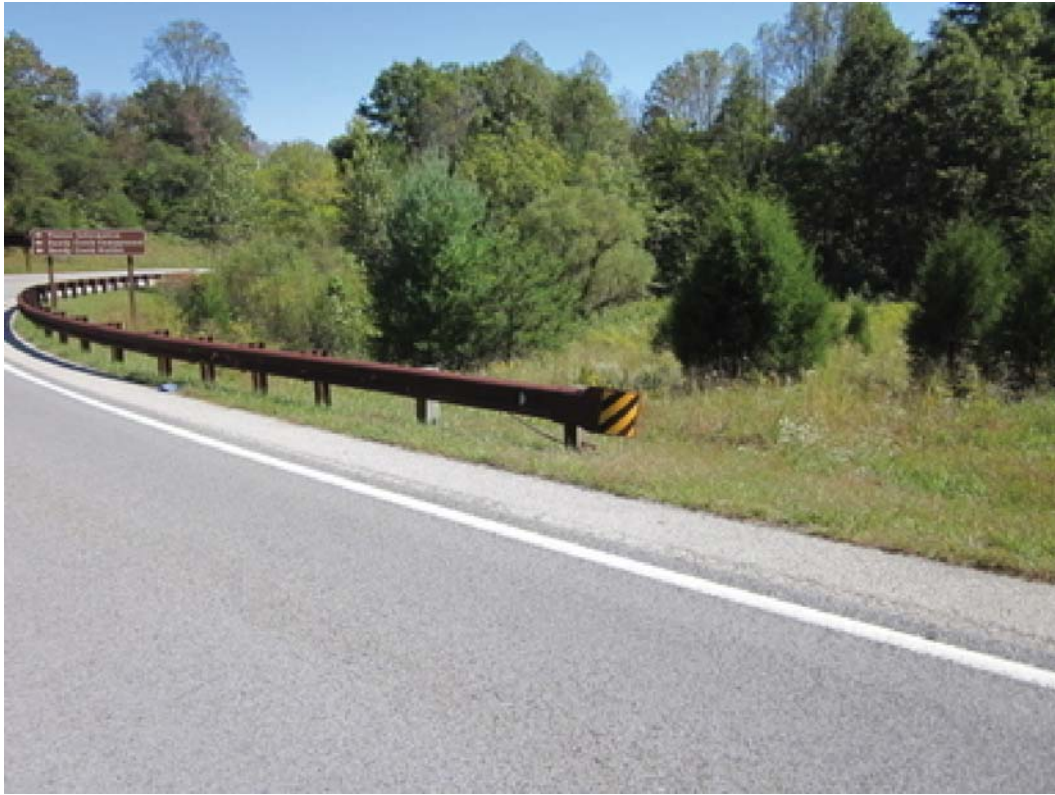
BISO\_0010\_3.298\_L\_1.JPG

| | <b>Breaking and Cracking:</b> | There was 1 rail section that was impacted and bent in. | | | |
| | <b>Missing Elements:</b> | No missing elements observed. | | | |
| | <b>Corrosion and Weathering:</b> | No corrosion or weathering observed. | | | |

| <b>Repair Action:</b> | REPAIR | <b>FMSS Work Type:</b> | DEFERRED MAINTENANCE | <b>Repair Cost:</b> | \$1953 |
| <b>Brief Workorder:</b> | Replace 12 feet of guardrail. | | | | |
| <b>Workorder:</b> | Replace Rail at \$25- per -Lin. Ft. for 12 LF = \$300.<br>Low Speed Traffic Control at \$1475- per -Day for 1 Day(s) = \$1475. | | | | |

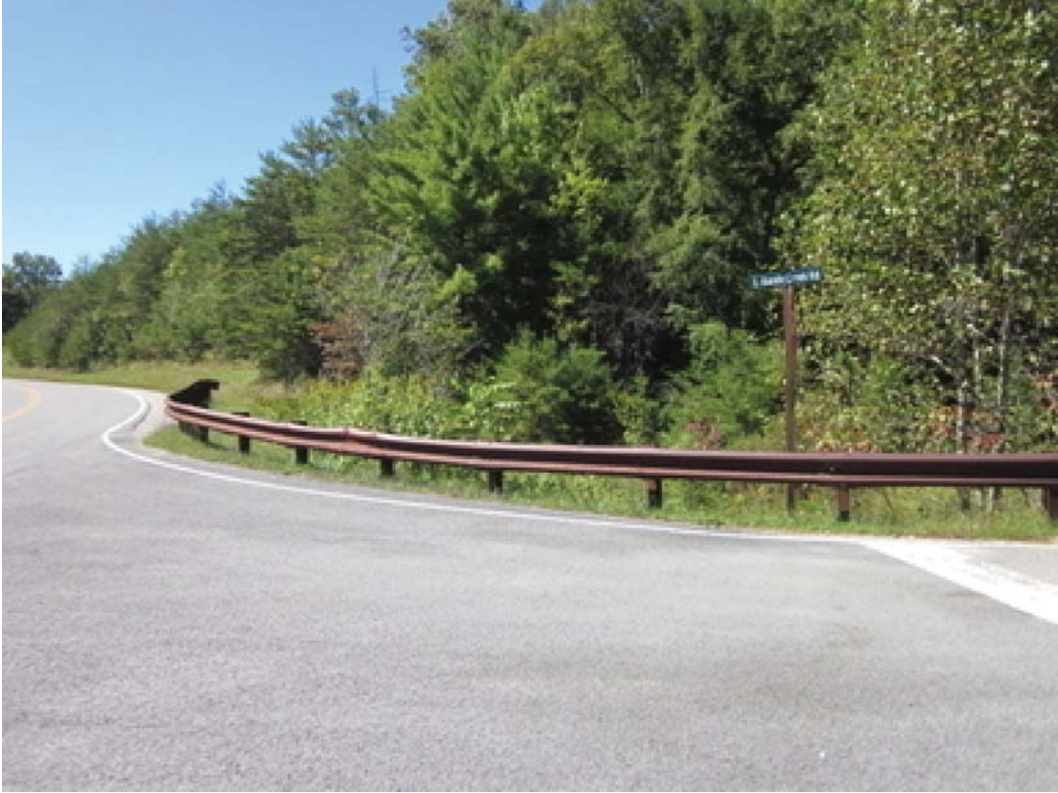
BISO\_0010\_3.321\_R\_1.JPG

| | <b>Breaking and Cracking:</b> | No breaking or cracking observed. | | | |
| | <b>Missing Elements:</b> | No missing elements observed. | | | |
| | <b>Corrosion and Weathering:</b> | No corrosion or weathering observed. | | | |

| <b>Repair Action:</b> | NO ACTION | <b>FMSS Work Type:</b> | N/A | <b>Repair Cost:</b> | \$0 |

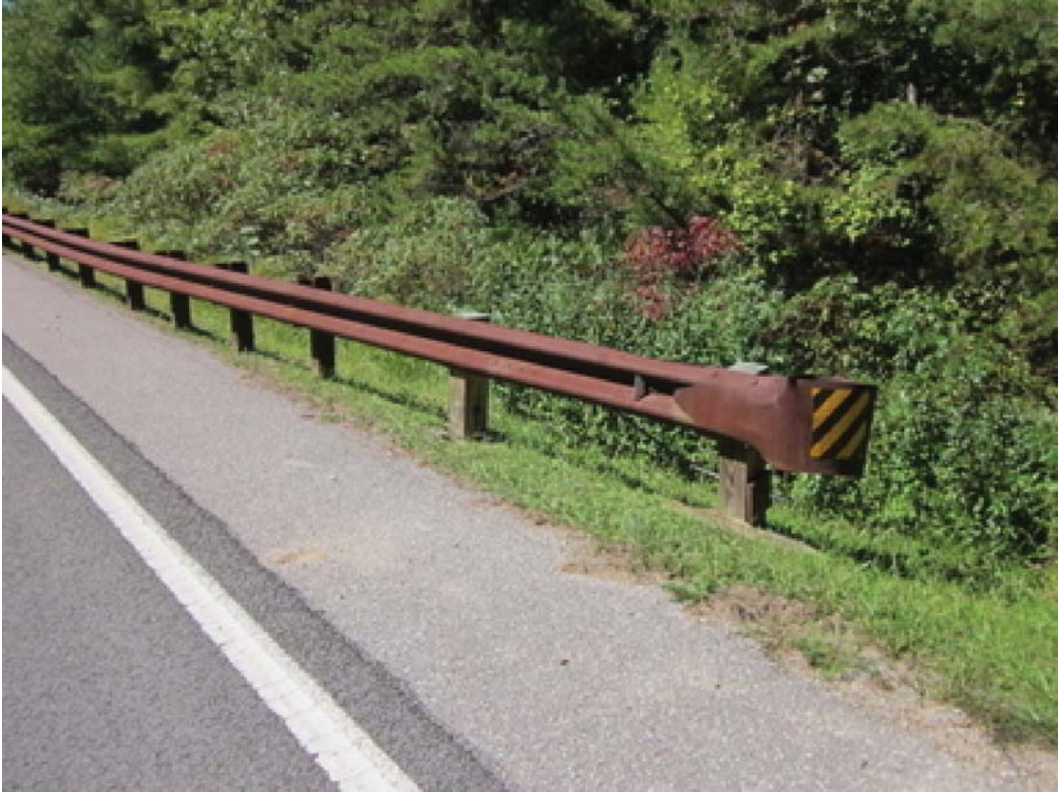
BISO\_0010\_3.798\_R\_1.JPG

| | <b>Breaking and Cracking:</b> | No breaking or cracking observed. | | | |
| | <b>Missing Elements:</b> | No missing elements observed. | | | |
| | <b>Corrosion and Weathering:</b> | No corrosion or weathering observed. | | | |

| <b>Repair Action:</b> | NO ACTION | <b>FMSS Work Type:</b> | N/A | <b>Repair Cost:</b> | \$0 |

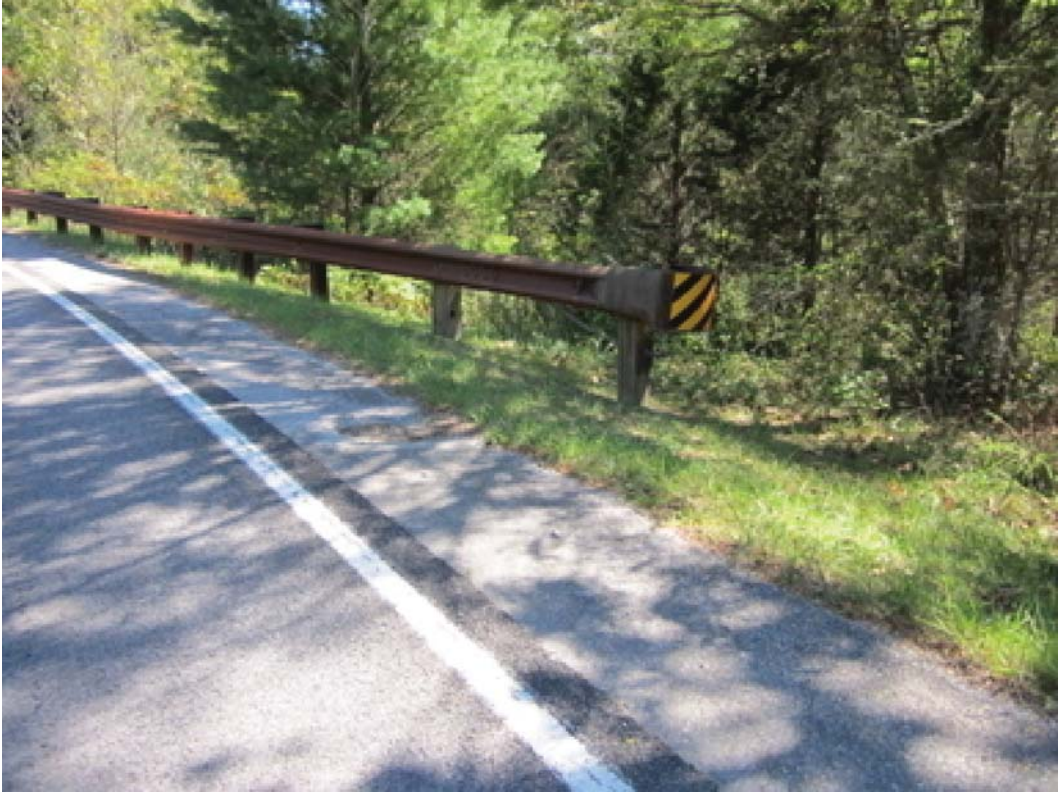
BISO\_0010\_3.825\_L\_1.JPG

| | <b>Breaking and Cracking:</b> | No breaking or cracking observed. | | | |
| | <b>Missing Elements:</b> | No missing elements observed. | | | |
| | <b>Corrosion and Weathering:</b> | No corrosion or weathering observed. | | | |

| <b>Repair Action:</b> | NO ACTION | <b>FMSS Work Type:</b> | N/A | <b>Repair Cost:</b> | \$0 |
