CANY GIP Report

NPS Guardwall/Rail Inventory Program Canyonlands National Park

**Federal Lands Highway
Road Inventory Program**

**Data Collection Date: April 2010
Report Date: November 2015**

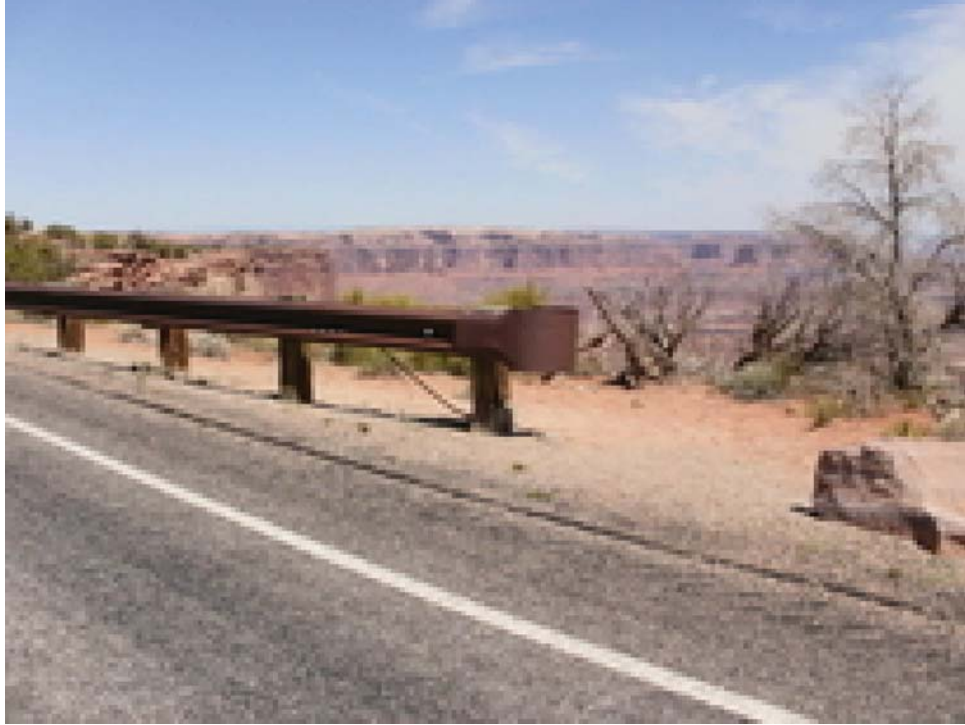
CANY_0011_16.841_L_1.JPG

Barrier ID:	CANY-0011-16.841-L				
Route Name:	ISLAND IN THE SKY ROAD				
Inspection Date:	04/14/2010	Barrier Rating:	24.30		
Barrier Description					
Type:	W-BEAM STRONG POST	Barrier Function:	TRAFFIC		
Barrier Material:	WEATHERING STEEL/CORTEN	Post Material:	WOOD		
Blockout Type:	WOOD	Length (ft.):	165		
Speed Limit (MPH):	35	Placement with Respect to Road:	OUTSIDE OF CURVE		
Hazard Behind Barrier:	EXTREME				
Barrier Crashworthiness					
Appropriate Test Level:	TL-2	Barrier Test Level:	TL-3	Is Barrier Crashworthy?:	YES
Beg. End Trtmt Type:	W-BEAM BCT	Is Beg. End Trtmt Crashworthy?:	NO	Approach Transition Type:	NONE
Ending End Trtmt Type:	W-BEAM BCT	Ending End Trtmt Crashworthy?:	NO		
Average Measurements					
Design Height (In.):	27	Width (In.):	0.0	Post Spacing (In.):	75.0
Height (In.):	29.7	Lateral Offset (In.):	36.0	Road Grade (%):	1.60
Physical Condition					
Barrier	Alignment and Height:	Alignment of guardrail is acceptable. Height is 0-3 in above 27-in. design height. No evidence of impact.

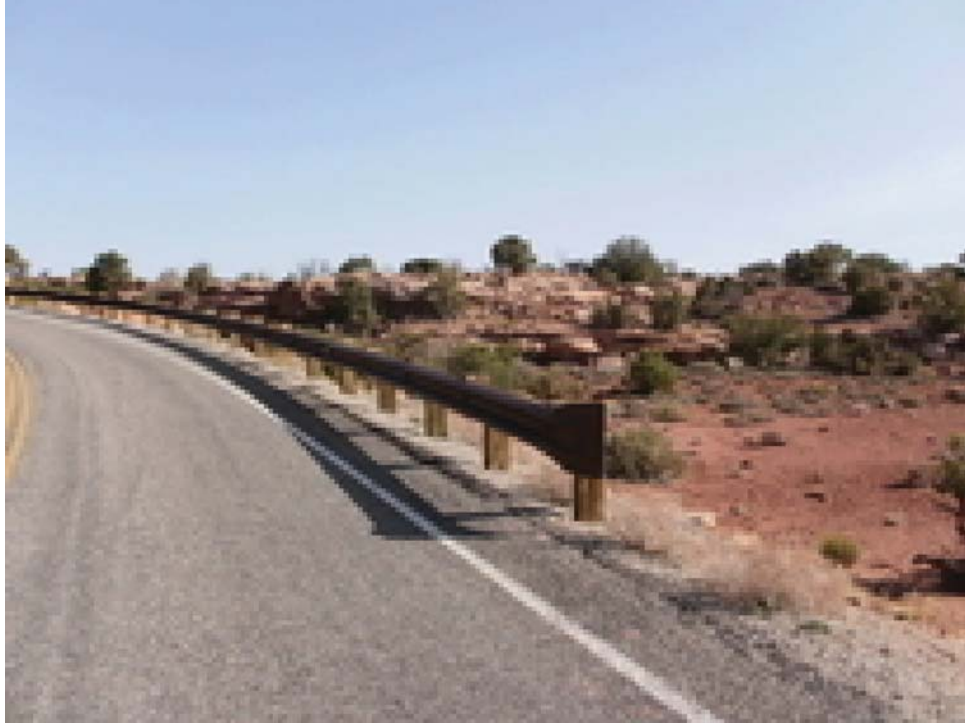
CANY_0113_1.207_L_1.JPG

Barrier ID:	CANY-0113-1.207-L				
Route Name:	GREEN RIVER OVERLOOK ROAD				
Inspection Date:	04/15/2010	Barrier Rating:	16.60		
Barrier Description					
Type:	W-BEAM STRONG POST	Barrier Function:	TRAFFIC		
Barrier Material:	WEATHERING STEEL/CORTEN	Post Material:	WOOD		
Blockout Type:	WOOD	Length (ft.):	201		
Speed Limit (MPH):	15	Placement with Respect to Road:	OUTSIDE OF CURVE		
Hazard Behind Barrier:	MEDIUM				
Barrier Crashworthiness					
Appropriate Test Level:	TL-1	Barrier Test Level:	TL-3	Is Barrier Crashworthy?:	YES
Beg. End Trtmt Type:	NONE	Is Beg. End Trtmt Crashworthy?:	N/A	Approach Transition Type:	NONE
Ending End Trtmt Type:	NONE	Ending End Trtmt Crashworthy?:	N/A		
Average Measurements					
Design Height (In.):	27	Width (In.):	0.0	Post Spacing (In.):	76.3
Height (In.):	27.7	Lateral Offset (In.):	47.2	Road Grade (%):	11.20
Physical Condition					
Barrier	Alignment and Height:	Alignment of barrier is acceptable and height is 0-2 in above 27-in. design height except for a 74 ft. length where gravel is in front of barrier.

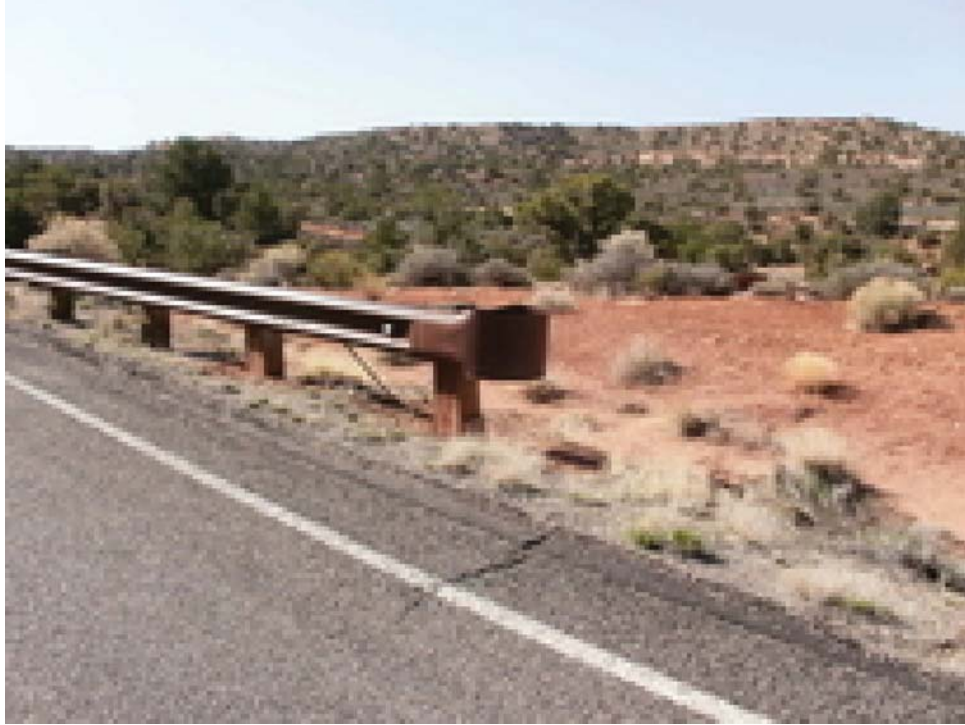
CANY_0114_2.235_L_1.JPG

Barrier ID:	CANY-0114-2.235-L				
Route Name:	UPHEAVAL DOME ROAD				
Inspection Date:	04/15/2010	Barrier Rating:	12.10		
Barrier Description					
Type:	W-BEAM STRONG POST	Barrier Function:	TRAFFIC		
Barrier Material:	WEATHERING STEEL/CORTEN	Post Material:	WOOD		
Blockout Type:	WOOD	Length (ft.):	205		
Speed Limit (MPH):	25	Placement with Respect to Road:	TANGENT		
Hazard Behind Barrier:	MEDIUM				
Barrier Crashworthiness					
Appropriate Test Level:	TL-1	Barrier Test Level:	TL-3	Is Barrier Crashworthy?:	YES
Beg. End Trtmt Type:	W-BEAM BCT	Is Beg. End Trtmt Crashworthy?:	NO	Approach Transition Type:	NONE
Ending End Trtmt Type:	W-BEAM BCT	Ending End Trtmt Crashworthy?:	NO		
Average Measurements					
Design Height (In.):	27	Width (In.):	0.0	Post Spacing (In.):	74.6
Height (In.):	26.7	Lateral Offset (In.):	36.2	Road Grade (%):	2.80
Physical Condition					
Barrier	Alignment and Height:	Alignment acceptable. Height within 1-in of 27-in design height. No evidence of impact.

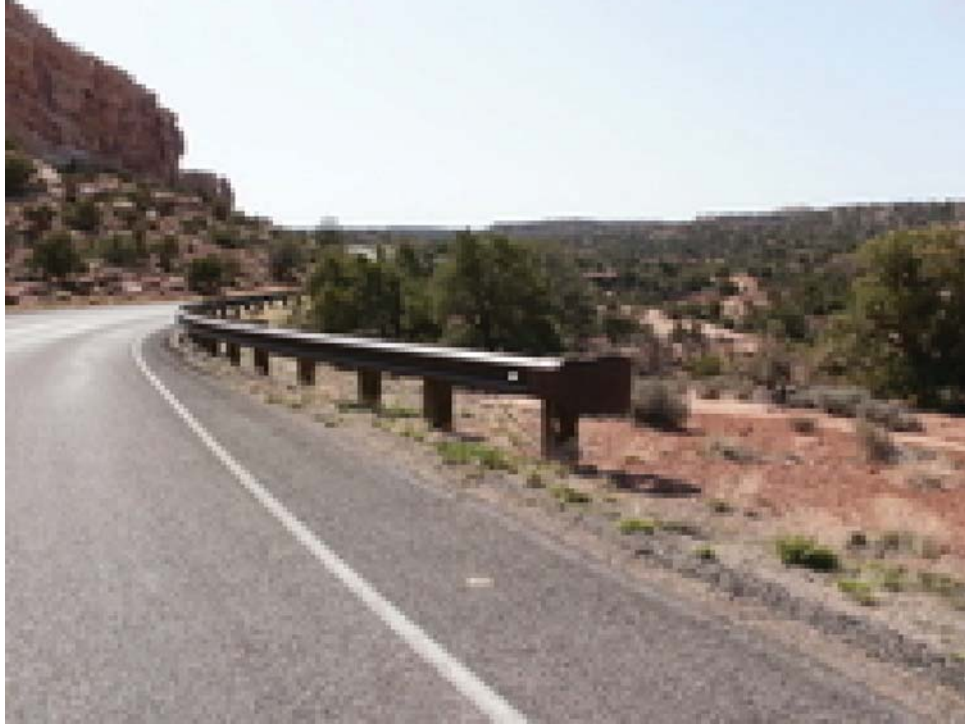
CANY_0114_2.324_L_1.JPG

Barrier ID:	CANY-0114-2.324-L				
Route Name:	UPHEAVAL DOME ROAD				
Inspection Date:	04/15/2010	Barrier Rating:	28.20		
Barrier Description					
Type:	W-BEAM STRONG POST	Barrier Function:	TRAFFIC		
Barrier Material:	WEATHERING STEEL/CORTEN	Post Material:	WOOD		
Blockout Type:	WOOD	Length (ft.):	781		
Speed Limit (MPH):	25	Placement with Respect to Road:	BOTH INSIDE AND OUTSIDE		
Hazard Behind Barrier:	HIGH				
Barrier Crashworthiness					
Appropriate Test Level:	TL-1	Barrier Test Level:	TL-3	Is Barrier Crashworthy?:	YES
Beg. End Trtmt Type:	W-BEAM BCT	Is Beg. End Trtmt Crashworthy?:	NO	Approach Transition Type:	NONE
Ending End Trtmt Type:	W-BEAM BCT	Ending End Trtmt Crashworthy?:	NO		
Average Measurements					
Design Height (In.):	27	Width (In.):	0.0	Post Spacing (In.):	74.5
Height (In.):	27.5	Lateral Offset (In.):	43.2	Road Grade (%):	2.10
Physical Condition					
Barrier	Alignment and Height:	Alignment of barrier is acceptable. 70 ft is more than 1 in to 3 in below 27-in. design height.

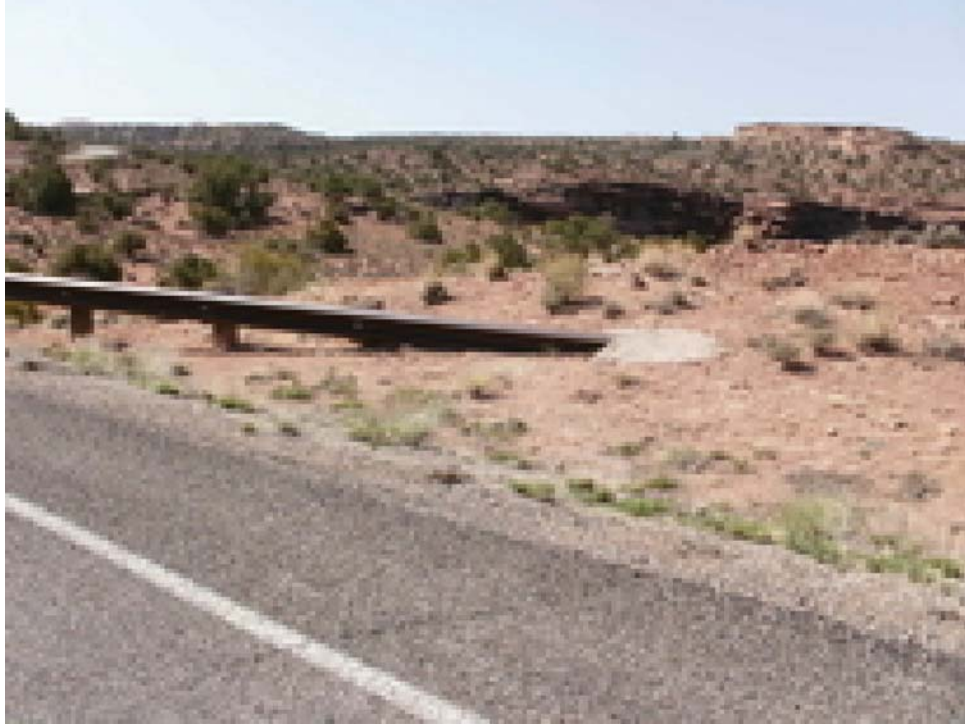
CANY_0114_2.618_L_1.JPG

Barrier ID:	CANY-0114-2.618-L				
Route Name:	UPHEAVAL DOME ROAD				
Inspection Date:	04/15/2010	Barrier Rating:	15.10		
Barrier Description					
Type:	W-BEAM STRONG POST	Barrier Function:	TRAFFIC		
Barrier Material:	WEATHERING STEEL/CORTEN	Post Material:	WOOD		
Blockout Type:	WOOD	Length (ft.):	368		
Speed Limit (MPH):	25	Placement with Respect to Road:	INSIDE OF CURVE		
Hazard Behind Barrier:	MEDIUM				
Barrier Crashworthiness					
Appropriate Test Level:	TL-1	Barrier Test Level:	TL-3	Is Barrier Crashworthy?:	YES
Beg. End Trtmt Type:	W-BEAM BURIED END	Is Beg. End Trtmt Crashworthy?:	YES	Approach Transition Type:	NONE
Ending End Trtmt Type:	W-BEAM BCT	Ending End Trtmt Crashworthy?:	NO		
Average Measurements					
Design Height (In.):	27	Width (In.):	0.0	Post Spacing (In.):	75.0
Height (In.):	29.2	Lateral Offset (In.):	61.0	Road Grade (%):	2.00
Physical Condition					
Barrier	Alignment and Height:	Alignment of barrier is acceptable. Height is 0-3 in above 27-in. design height. No evidence of impact.

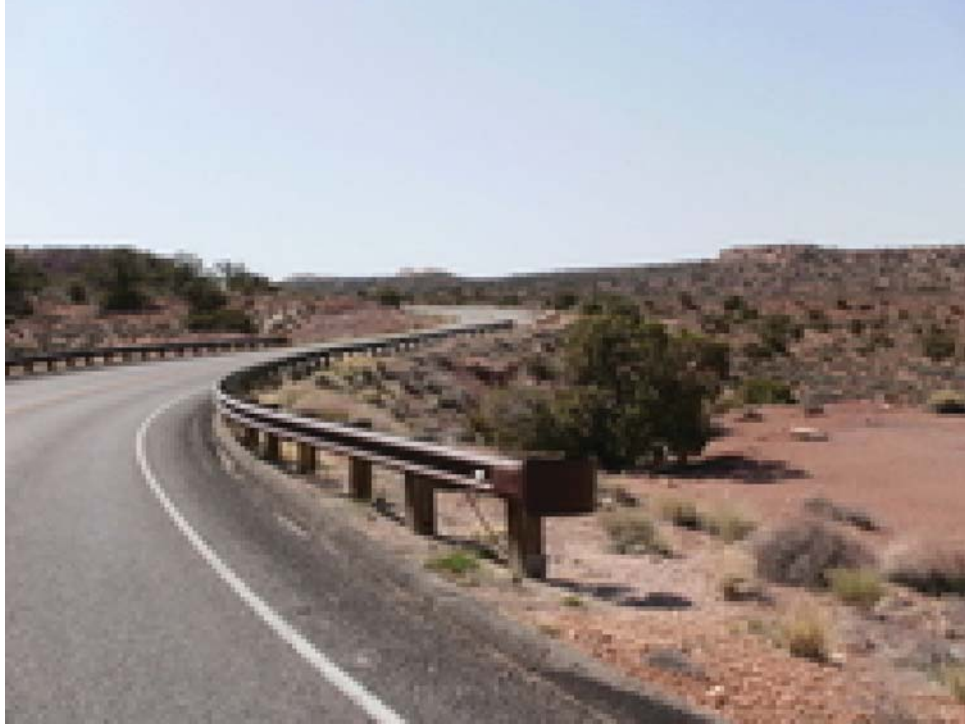
CANY_0114_2.950_L_1.JPG

Barrier ID:	CANY-0114-2.950-L				
Route Name:	UPHEAVAL DOME ROAD				
Inspection Date:	04/15/2010	Barrier Rating:	16.60		
Barrier Description					
Type:	W-BEAM STRONG POST	Barrier Function:	TRAFFIC		
Barrier Material:	WEATHERING STEEL/CORTEN	Post Material:	WOOD		
Blockout Type:	WOOD	Length (ft.):	244		
Speed Limit (MPH):	25	Placement with Respect to Road:	INSIDE OF CURVE		
Hazard Behind Barrier:	MEDIUM				
Barrier Crashworthiness					
Appropriate Test Level:	TL-1	Barrier Test Level:	TL-3	Is Barrier Crashworthy?:	YES
Beg. End Trtmt Type:	W-BEAM BCT	Is Beg. End Trtmt Crashworthy?:	NO	Approach Transition Type:	NONE
Ending End Trtmt Type:	W-BEAM BCT	Ending End Trtmt Crashworthy?:	NO		
Average Measurements					
Design Height (In.):	27	Width (In.):	0.0	Post Spacing (In.):	74.6
Height (In.):	28.0	Lateral Offset (In.):	50.0	Road Grade (%):	0.80
Physical Condition					
Barrier	Alignment and Height:	Alignment of barrier is acceptable. Barrier is more than 1-in to 3-in above 27-in design height for more than 16 ft and more than 3-in above for 27 ft.

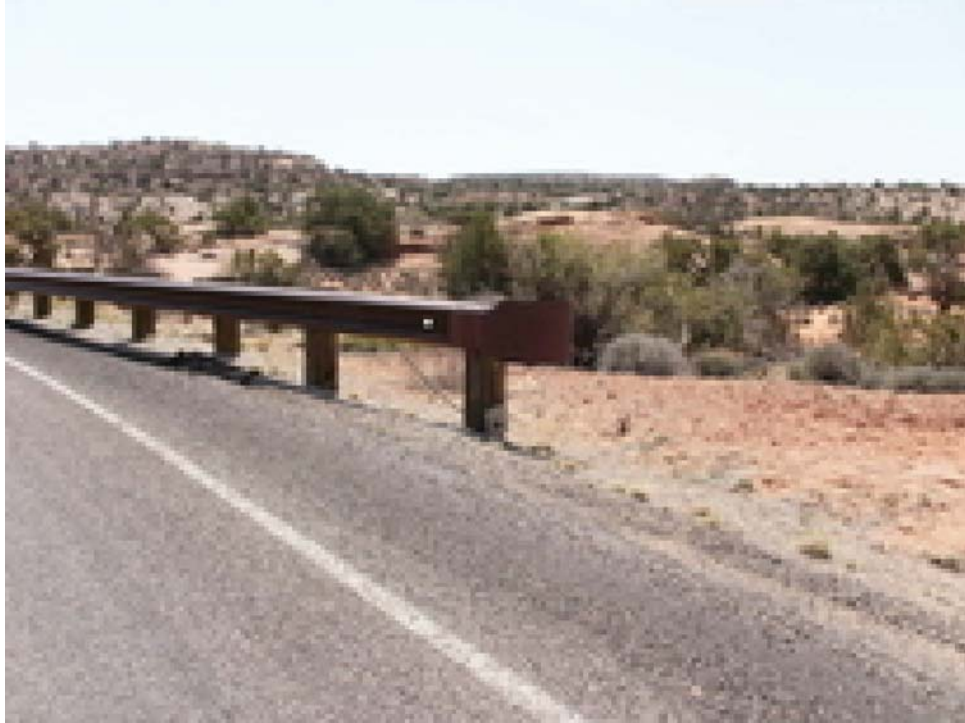
CANY_0114_3.721_L_1.JPG

Barrier ID:	CANY-0114-3.721-L				
Route Name:	UPHEAVAL DOME ROAD				
Inspection Date:	04/15/2010	Barrier Rating:	23.70		
Barrier Description					
Type:	W-BEAM STRONG POST	Barrier Function:	TRAFFIC		
Barrier Material:	WEATHERING STEEL/CORTEN	Post Material:	WOOD		
Blockout Type:	WOOD	Length (ft.):	255		
Speed Limit (MPH):	25	Placement with Respect to Road:	BOTH INSIDE AND OUTSIDE		
Hazard Behind Barrier:	MEDIUM				
Barrier Crashworthiness					
Appropriate Test Level:	TL-1	Barrier Test Level:	TL-3	Is Barrier Crashworthy?:	YES
Beg. End Trtmt Type:	W-BEAM BCT	Is Beg. End Trtmt Crashworthy?:	NO	Approach Transition Type:	NONE
Ending End Trtmt Type:	W-BEAM BCT	Ending End Trtmt Crashworthy?:	NO		
Average Measurements					
Design Height (In.):	27	Width (In.):	0.0	Post Spacing (In.):	74.6
Height (In.):	28.0	Lateral Offset (In.):	43.2	Road Grade (%):	0.50
Physical Condition					
Barrier	Alignment and Height:	Alignment of barrier is acceptable. Height of barrier is 0-2 in above 27-in. design height.

Breaking and Cracking:	No broken or cracked barrier elements.			
	Missing Elements:	No missing barrier elements.			
	Corrosion and Weathering:	No corrosion of guardrail. Moderate weathering of blocks and posts. Erosion does not compromise stability of posts.			
End Treatments	Alignment and Height:	Alignment is acceptable. 15 lf of approach end treatment is more than 8 in above 27-in. design height.			
	Breaking and Cracking:	No broken or cracked end treatment elements.			
	Missing Elements:	No missing end treatment elements.			
	Corrosion and Weathering:	No corrosion of end treatments. Moderate weathering of posts and blocks.

Repair Action:	REPAIR	FMSS Work Type:	DEFERRED MAINTENANCE	Repair Cost:	\$1788
Brief Workorder:	Lower 15 W-beam guardrail (approach end treatment) to 27-in. design height.				
Workorder:	Adjust Guardrail at \$10- per -Lin. Ft. for 15 LF = \$150. Lower 15ft. of barrier to 27-in. design height. Low Speed Traffic Control at \$1475- per -Day for 1 Day(s) = \$1475.

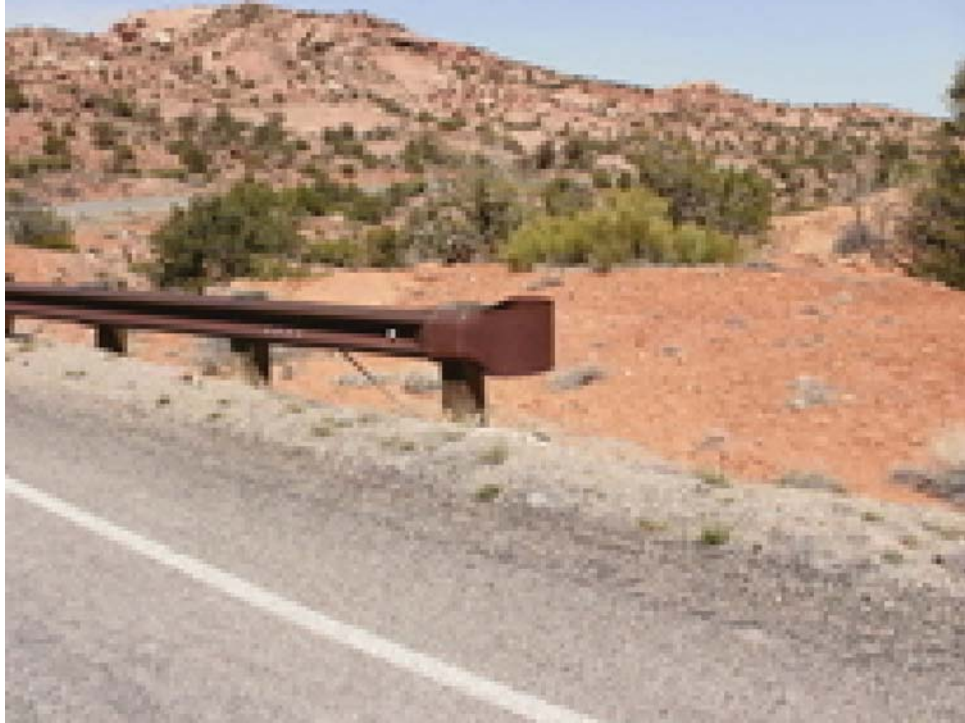
CANY_0114_4.442_R_1.JPG

Barrier ID:	CANY-0114-4.442-R				
Route Name:	UPHEAVAL DOME ROAD				
Inspection Date:	04/15/2010	Barrier Rating:	16.70		
Barrier Description					
Type:	W-BEAM STRONG POST	Barrier Function:	TRAFFIC		
Barrier Material:	WEATHERING STEEL/CORTEN	Post Material:	WOOD		
Blockout Type:	WOOD	Length (ft.):	248		
Speed Limit (MPH):	25	Placement with Respect to Road:	INSIDE OF CURVE		
Hazard Behind Barrier:	MEDIUM				
Barrier Crashworthiness					
Appropriate Test Level:	TL-1	Barrier Test Level:	TL-3	Is Barrier Crashworthy?:	YES
Beg. End Trtmt Type:	W-BEAM BCT	Is Beg. End Trtmt Crashworthy?:	NO	Approach Transition Type:	NONE
Ending End Trtmt Type:	W-BEAM BCT	Ending End Trtmt Crashworthy?:	NO		
Average Measurements					
Design Height (In.):	27	Width (In.):	0.0	Post Spacing (In.):	74.3
Height (In.):	28.0	Lateral Offset (In.):	59.0	Road Grade (%):	4.80
Physical Condition					
Barrier	Alignment and Height:	Alignment acceptable. Height within 1-in of 27-in design height. No evidence of impact.

Breaking and Cracking:	One cracked post and one cracked block. One loose bolt. No cracked or broken rails.			
	Missing Elements:	No missing barrier elements.			
	Corrosion and Weathering:	No corrosion of guardrail. Moderate weathering of blocks and posts. Erosion does not compromise stability of posts.			
End Treatments	Alignment and Height:	Alignment is acceptable. 26 ft of approach end is 6 in below the 27-in. design height due to gravel build-up.			
	Breaking and Cracking:	No cracked or broken end treatment elements.			
	Missing Elements:	No missing end treatment elements.			
	Corrosion and Weathering:	No corrosion of end treatments. Moderate weathering of posts and blocks.

Repair Action:	REPAIR	FMSS Work Type:	DEFERRED MAINTENANCE	Repair Cost:	\$2030
Brief Workorder:	Remove gravel build-up from front of approach end treatment. Replace one cracked block and one cracked post. Tighten loose bolts.				
Workorder:	Labor at \$60- per -Hour for 4 Hrs = \$240. Remove gravel from approach end treatment and tighten bolts. Replace Post at \$100- per -Each for 1 Post(s) = \$100. Replace one cracked post. Replace Block at \$30- per -Each for 1 Block(s) = \$30. Replace one cracked block. Low Speed Traffic Control at \$1475- per -Day for 1 Day(s) = \$1475.

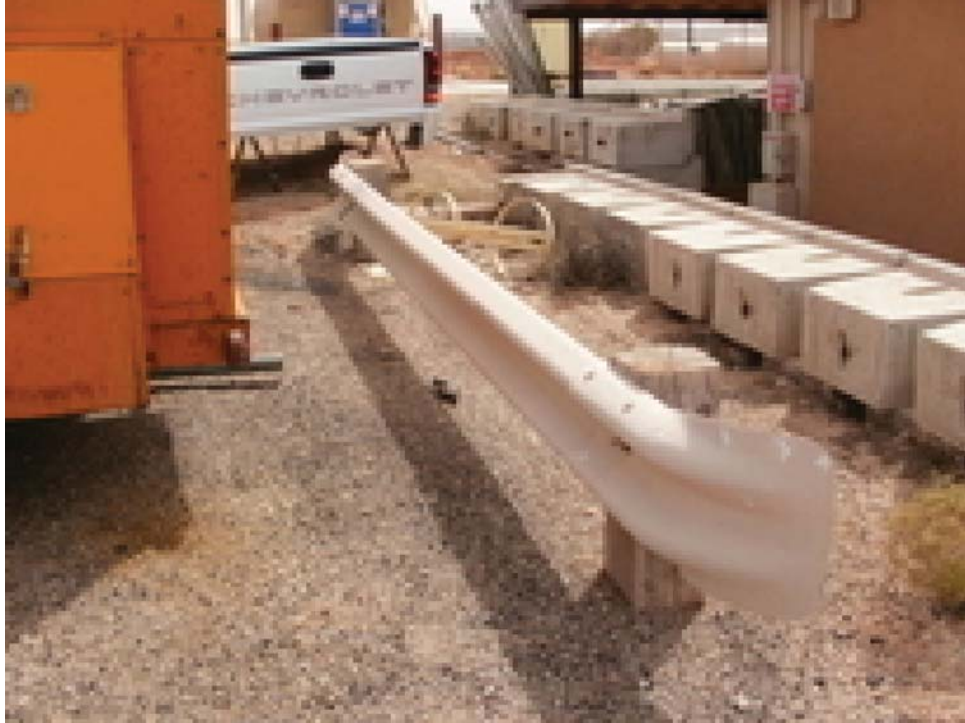
CANY_0407_0.100_L_1.JPG

Barrier ID:	CANY-0407-0.100-L				
Route Name:	I-SKY MAINTENANCE ROAD				
Inspection Date:	04/12/2010	Barrier Rating:	12.80		
Barrier Description					
Type:	W-BEAM WEAK POST	Barrier Function:	NON-TRAFFIC		
Barrier Material:	GALVANIZED STEEL	Post Material:	WOOD		
Blockout Type:	N/A	Length (ft.):	17		
Speed Limit (MPH):	15	Placement with Respect to Road:	NON-TRAFFIC BARRIER		
Hazard Behind Barrier:	N/A				
Barrier Crashworthiness					
Appropriate Test Level:	TL-1	Barrier Test Level:	N/A	Is Barrier Crashworthy?:	N/A
Beg. End Trtmt Type:	NONE	Is Beg. End Trtmt Crashworthy?:	N/A	Approach Transition Type:	NONE
Ending End Trtmt Type:	NONE	Ending End Trtmt Crashworthy?:	N/A		
Average Measurements					
Design Height (In.):	27	Width (In.):	0.0	Post Spacing (In.):	148.0
Height (In.):	21.0	Lateral Offset (In.):	0.0	Road Grade (%):	0.00
Physical Condition					
Barrier	Alignment and Height:	Alignment and height are at design specifications for non-traffic barrier.

Breaking and Cracking:	One minor bend in w-beam of barrier.			
	Missing Elements:	No missing elements in barrier.			
	Corrosion and Weathering:	No corrosion or weathering in barrier.			
End Treatments	Alignment and Height:				
	Breaking and Cracking:				
	Missing Elements:				
	Corrosion and Weathering:

Repair Action:	NO ACTION	FMSS Work Type:	N/A	Repair Cost:	\$0
Brief Workorder:	N/A				
Workorder:
