COLM GIP Report

NPS Guardwall/Rail Inventory Program Colorado National Monument

**Federal Lands Highway
Road Inventory Program**

Data Collection Date: March 2011
Report Date: November 2015

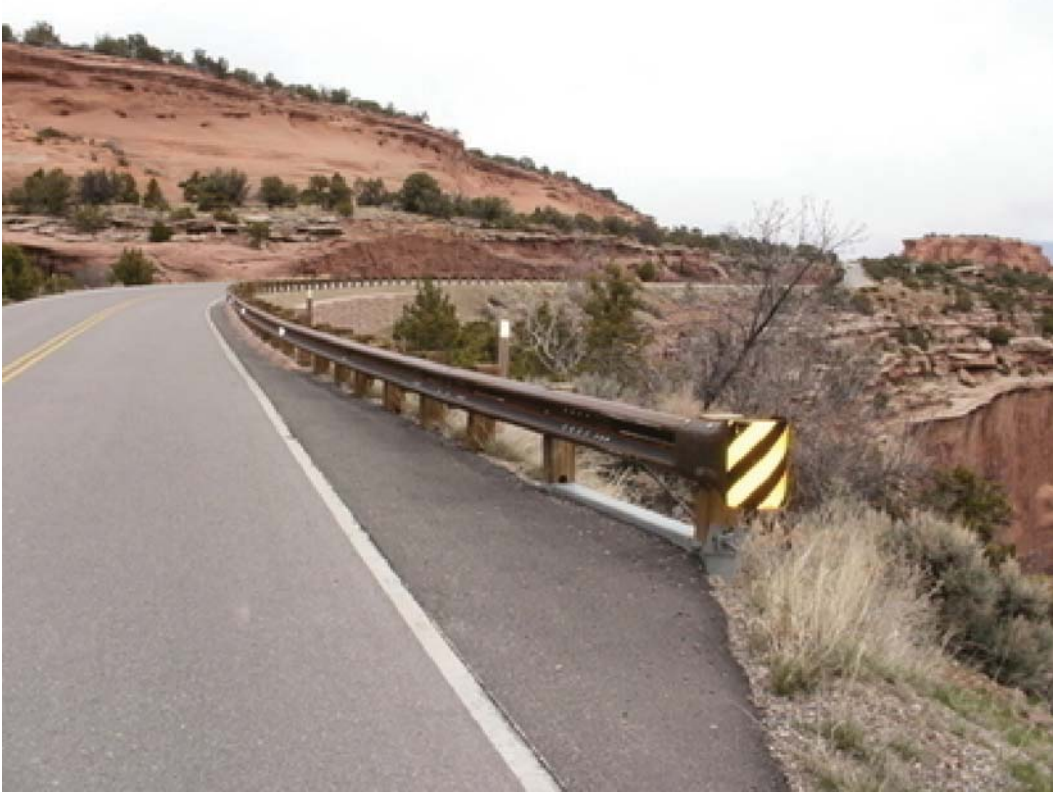
COLM_0010_4.649_L_1.JPG

Barrier ID:	COLM-0010-4.649-L				
Route Name:	RIMROCK DRIVE				
Inspection Date:	06/04/2010	Barrier Rating:	31.50		
Barrier Description					
Type:	W-BEAM STRONG POST	Barrier Function:	TRAFFIC		
Barrier Material:	WEATHERING STEEL/CORTEN	Post Material:	WOOD		
Blockout Type:	WOOD	Length (ft.):	456		
Speed Limit (MPH):	35	Placement with Respect to Road:	INSIDE OF CURVE		
Hazard Behind Barrier:	EXTREME				
Barrier Crashworthiness					
Appropriate Test Level:	TL-2	Barrier Test Level:	TL-3	Is Barrier Crashworthy?:	YES
Beg. End Trtmt Type:	W-BEAM TANGENT 350	Is Beg. End Trtmt Crashworthy?:	YES	Approach Transition Type:	NONE
Ending End Trtmt Type:	W-BEAM TANGENT 350	Ending End Trtmt Crashworthy?:	YES		
Average Measurements					
Design Height (In.):	27	Width (In.):	0.0	Post Spacing (In.):	75.6
Height (In.):	27.7	Lateral Offset (In.):	18.2	Road Grade (%):	2.50
Physical Condition					
Barrier	Alignment and Height:	Alignment acceptable. Height within 1-in of 27-in design height.

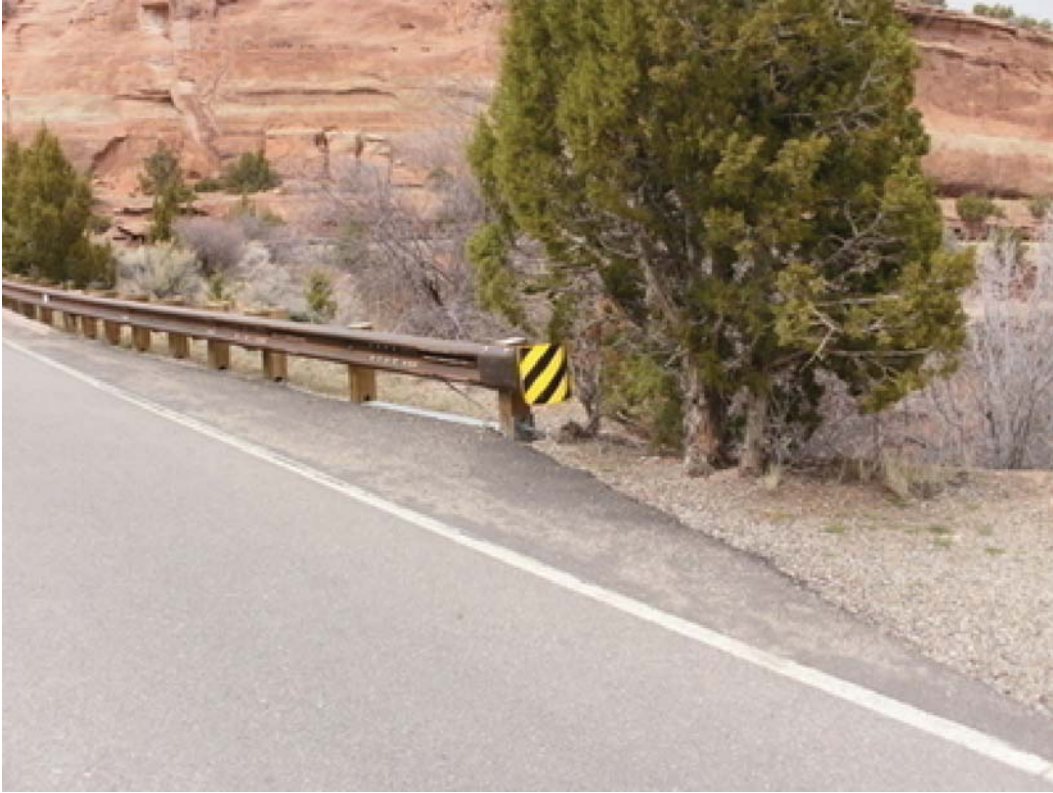
COLM_0010_4.794_L_1.JPG

Barrier ID:	COLM-0010-4.794-L				
Route Name:	RIMROCK DRIVE				
Inspection Date:	06/04/2010	Barrier Rating:	28.70		
Barrier Description					
Type:	W-BEAM STRONG POST	Barrier Function:	TRAFFIC		
Barrier Material:	WEATHERING STEEL/CORTEN	Post Material:	WOOD		
Blockout Type:	WOOD	Length (ft.):	697		
Speed Limit (MPH):	35	Placement with Respect to Road:	INSIDE OF CURVE		
Hazard Behind Barrier:	EXTREME				
Barrier Crashworthiness					
Appropriate Test Level:	TL-2	Barrier Test Level:	TL-3	Is Barrier Crashworthy?:	YES
Beg. End Trtmt Type:	W-BEAM TANGENT 350	Is Beg. End Trtmt Crashworthy?:	YES	Approach Transition Type:	NONE
Ending End Trtmt Type:	W-BEAM TANGENT 350	Ending End Trtmt Crashworthy?:	YES		
Average Measurements					
Design Height (In.):	27	Width (In.):	0.0	Post Spacing (In.):	75.0
Height (In.):	29.0	Lateral Offset (In.):	25.5	Road Grade (%):	2.30
Physical Condition					
Barrier	Alignment and Height:	Alignment acceptable. Height was 1 to 4-in above the 27-in design height.

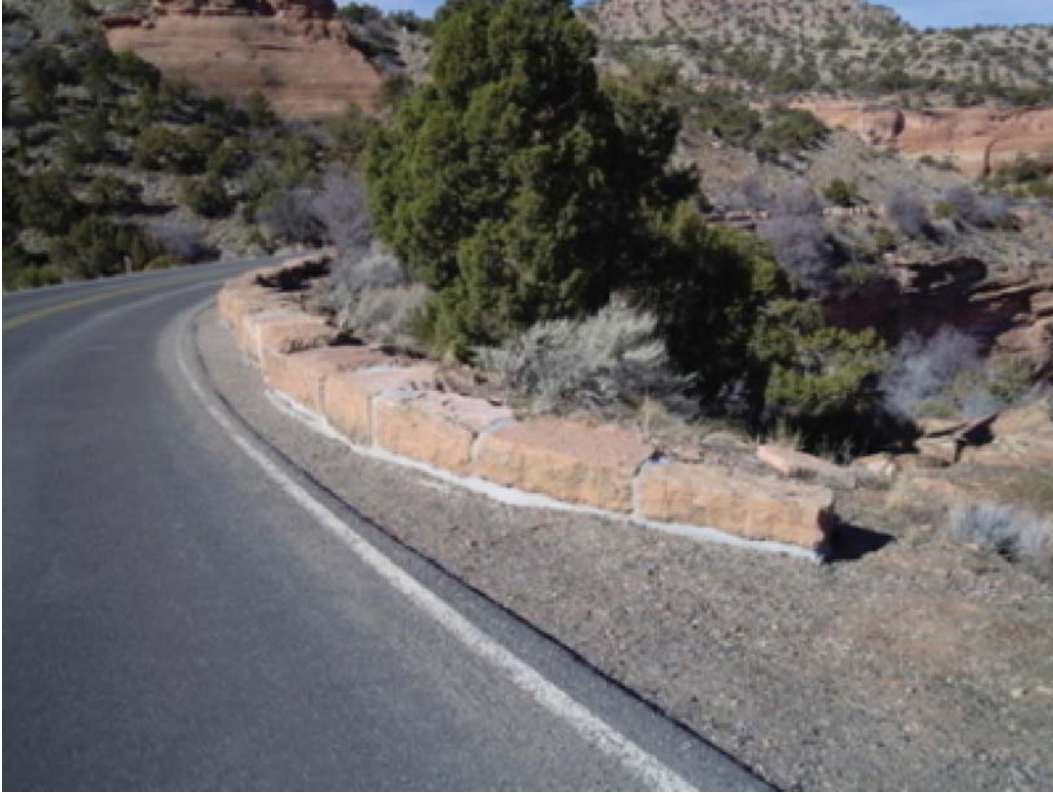
COLM_0010_4.931_L_1.jpg

Barrier ID:	COLM-0010-4.931-L				
Route Name:	RIMROCK DRIVE				
Inspection Date:	06/04/2010	Barrier Rating:	63.70		
Barrier Description					
Type:	STONE MASONRY WITHOUT CONCRETE CORE WALL	Barrier Function:	TRAFFIC		
Barrier Material:	STONE	Post Material:	N/A		
Blockout Type:	N/A	Length (ft.):	540		
Speed Limit (MPH):	35	Placement with Respect to Road:	INSIDE OF CURVE		
Hazard Behind Barrier:	EXTREME				
Barrier Crashworthiness					
Appropriate Test Level:	TL-2	Barrier Test Level:	NCW	Is Barrier Crashworthy?:	NO
Beg. End Trtmt Type:	NONE	Is Beg. End Trtmt Crashworthy?:	N/A	Approach Transition Type:	NONE
Ending End Trtmt Type:	NONE	Ending End Trtmt Crashworthy?:	N/A		
Average Measurements					
Design Height (In.):	24	Width (In.):	22.0	Post Spacing (In.):	0.0
Height (In.):	16.5	Lateral Offset (In.):	48.0	Road Grade (%):	1.50
Physical Condition					
Barrier	Alignment and Height:	Alignment acceptable. 95-ft was 3 to 6-in below the 24-in design height and 445-ft was 6 to 9-in below.

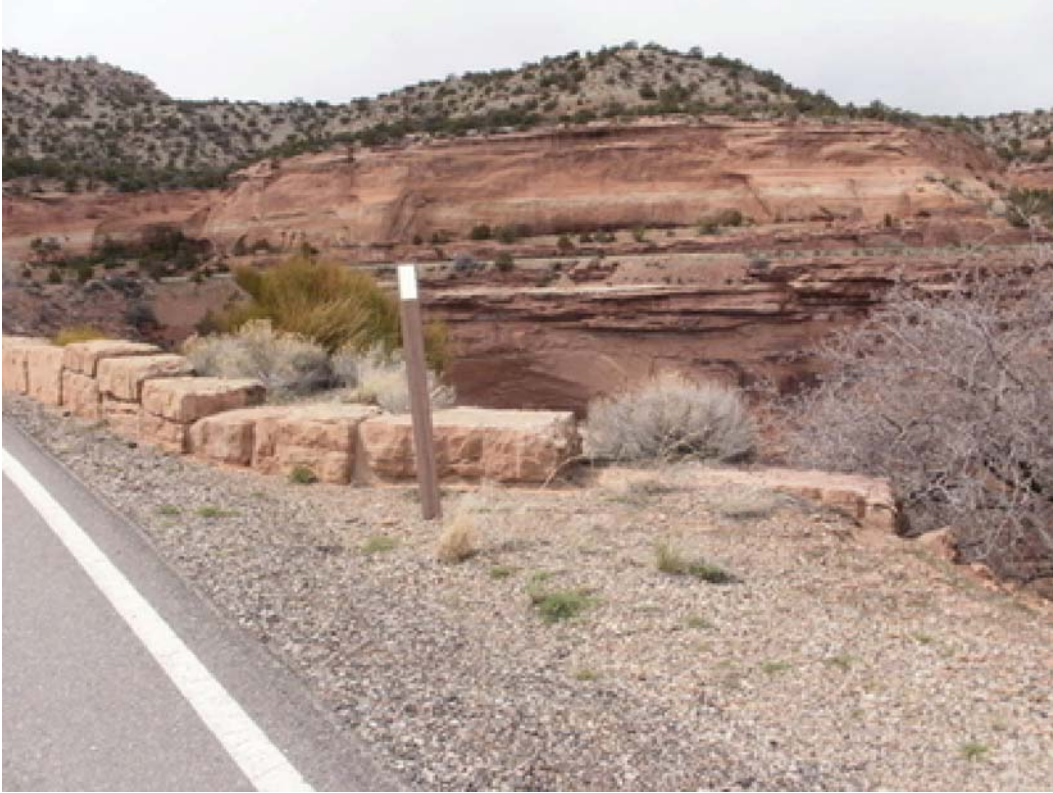
COLM_0010_5.054_L_1.JPG

Barrier ID:	COLM-0010-5.054-L				
Route Name:	RIMROCK DRIVE				
Inspection Date:	06/04/2010	Barrier Rating:	54.50		
Barrier Description					
Type:	STONE MASONRY WITHOUT CONCRETE CORE WALL	Barrier Function:	TRAFFIC		
Barrier Material:	STONE	Post Material:	N/A		
Blockout Type:	N/A	Length (ft.):	281		
Speed Limit (MPH):	35	Placement with Respect to Road:	OUTSIDE OF CURVE		
Hazard Behind Barrier:	EXTREME				
Barrier Crashworthiness					
Appropriate Test Level:	TL-2	Barrier Test Level:	NCW	Is Barrier Crashworthy?:	NO
Beg. End Trtmt Type:	NONE	Is Beg. End Trtmt Crashworthy?:	N/A	Approach Transition Type:	NONE
Ending End Trtmt Type:	NONE	Ending End Trtmt Crashworthy?:	N/A		
Average Measurements					
Design Height (In.):	24	Width (In.):	22.7	Post Spacing (In.):	0.0
Height (In.):	17.7	Lateral Offset (In.):	38.2	Road Grade (%):	1.40
Physical Condition					
Barrier	Alignment and Height:	Alignment acceptable. 40-ft was within 3-in of the 24-in design height 109-ft was 3 to 6-in below and 132-ft was 6 to 9-in below.

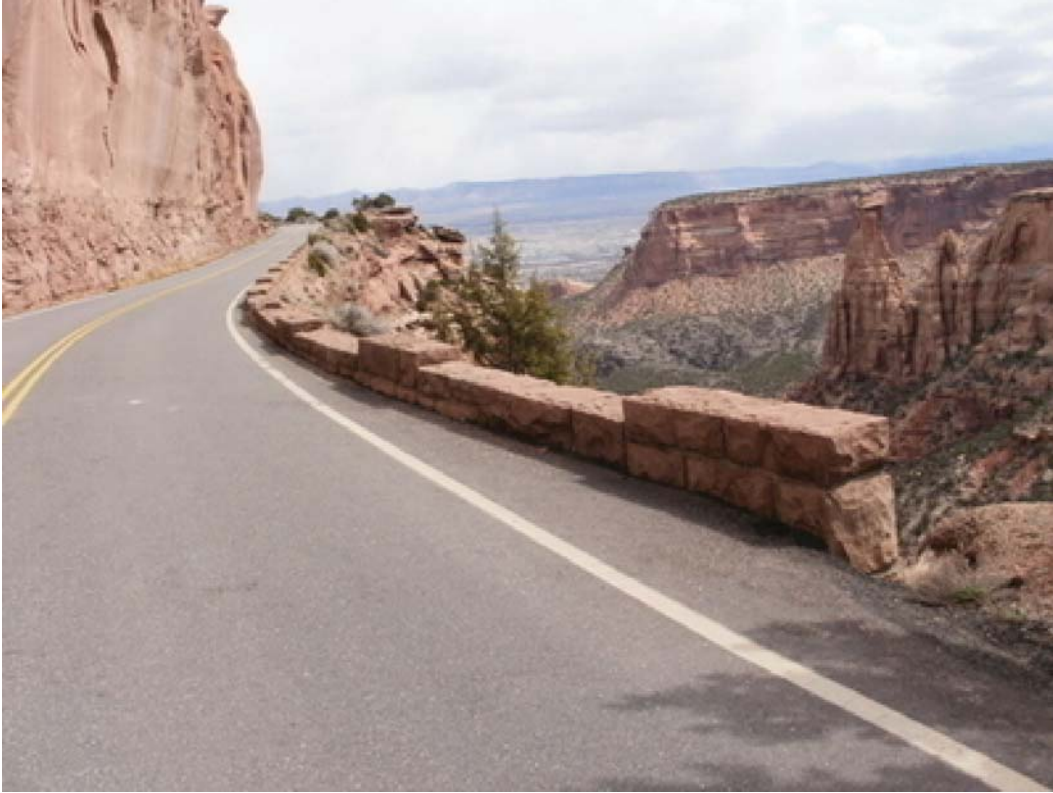
COLM_0010_6.146_L_1.JPG

Barrier ID:	COLM-0010-6.146-L				
Route Name:	RIMROCK DRIVE				
Inspection Date:	06/04/2010	Barrier Rating:	60.00		
Barrier Description					
Type:	STONE MASONRY CRENELLATED WITHOUT	Barrier Function:	TRAFFIC		
Barrier Material:	STONE	Post Material:	N/A		
Blockout Type:	N/A	Length (ft.):	656		
Speed Limit (MPH):	35	Placement with Respect to Road:	INSIDE OF CURVE		
Hazard Behind Barrier:	EXTREME				
Barrier Crashworthiness					
Appropriate Test Level:	TL-2	Barrier Test Level:	NCW	Is Barrier Crashworthy?:	NO
Beg. End Trtmt Type:	NONE	Is Beg. End Trtmt Crashworthy?:	N/A	Approach Transition Type:	NONE
Ending End Trtmt Type:	NONE	Ending End Trtmt Crashworthy?:	N/A		
Average Measurements					
Design Height (In.):	18	Width (In.):	18.0	Post Spacing (In.):	0.0
Height (In.):	13.0	Lateral Offset (In.):	16.7	Road Grade (%):	0.40
Physical Condition					
Barrier	Alignment and Height:	Alignment acceptable. 164-ft was within 3-in of the 18-in/24-in crenellated design height and 492-ft was 3 to 6-in below.

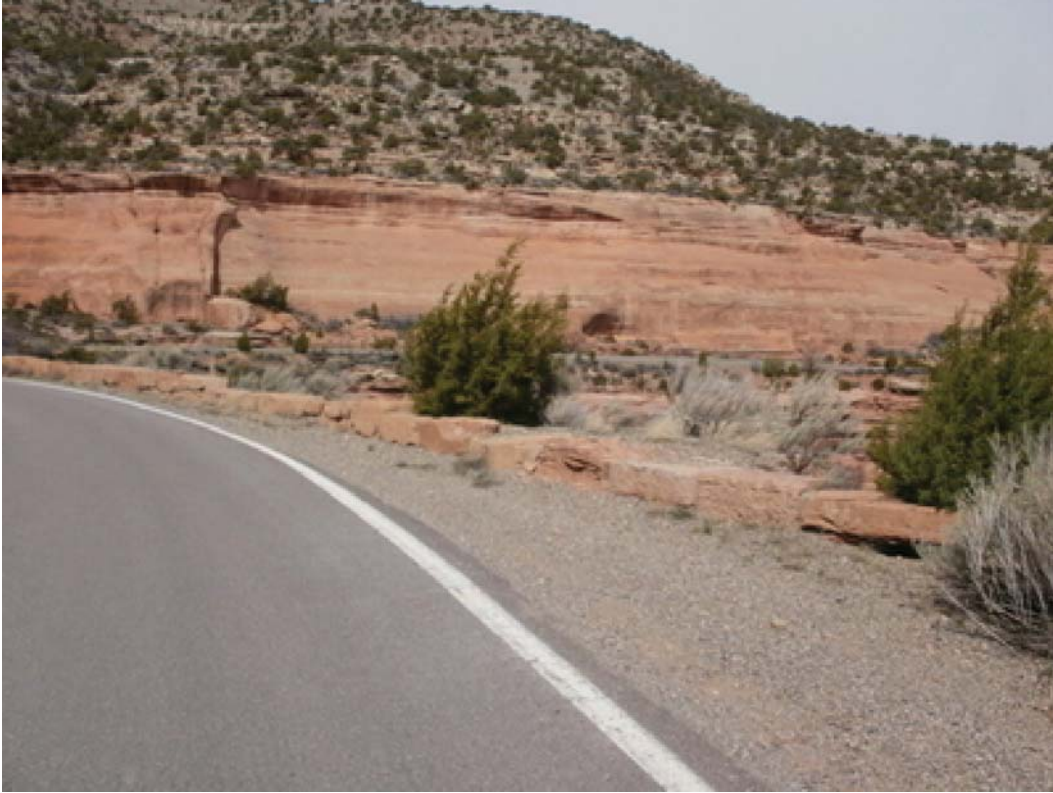
COLM_0010_6.504_L_1.JPG

Barrier ID:	COLM-0010-6.504-L				
Route Name:	RIMROCK DRIVE				
Inspection Date:	06/04/2010	Barrier Rating:	49.50		
Barrier Description					
Type:	STONE MASONRY WITHOUT CONCRETE CORE WALL	Barrier Function:	TRAFFIC		
Barrier Material:	STONE	Post Material:	N/A		
Blockout Type:	N/A	Length (ft.):	242		
Speed Limit (MPH):	35	Placement with Respect to Road:	TANGENT		
Hazard Behind Barrier:	EXTREME				
Barrier Crashworthiness					
Appropriate Test Level:	TL-2	Barrier Test Level:	NCW	Is Barrier Crashworthy?:	NO
Beg. End Trtmt Type:	NONE	Is Beg. End Trtmt Crashworthy?:	N/A	Approach Transition Type:	NONE
Ending End Trtmt Type:	NONE	Ending End Trtmt Crashworthy?:	N/A		
Average Measurements					
Design Height (In.):	24	Width (In.):	28.0	Post Spacing (In.):	0.0
Height (In.):	15.0	Lateral Offset (In.):	44.7	Road Grade (%):	1.70
Physical Condition					
Barrier	Alignment and Height:	Alignment acceptable. 81-ft was 3 to 6-in below the 24-in design height and 161-ft was 6 to 12-in below.

Breaking and Cracking:	Rock spalling in barrier for 10 linear ft has deteriorated approximately 1/2 of rock.			
	Missing Elements:	No missing elements in barrier.			
	Corrosion and Weathering:	Erosional hole under approach end of barrier where water drains off roadway undermining end of wall.			
End Treatments	Alignment and Height:				
	Breaking and Cracking:				
	Missing Elements:				
	Corrosion and Weathering:

Repair Action:	REPAIR	FMSS Work Type:	DEFERRED MAINTENANCE	Repair Cost:	\$229515
Brief Workorder:	Raise guardwall 4-in. Remove and reset 161-ft of stone masonry guardwall on concrete footer to 24-in design height. Add 1CY backfill to repair erosion. Add 1 CY riprap for erosion control on approach end.				
Workorder:	<p>Remove & Reset Stone Masonry Guardwall at \$250- per -Cu. Ft. for 741 CF = \$185250. (2st)(2.3ft)(161ft) = 740.6 CF</p> <p>Structural Concrete at \$1000- per -Cu. Yd. for 7 CY = \$7000. [(2.3ft)(0.5ft)(161ft)]/27 = 6.9 CY</p> <p>Structural Backfill at \$50- per -Cu. Yd. for 1 CY = \$50. Backfill to repair erosion</p> <p>Riprap at \$100- per -Cu. Yd. for 1 CY = \$100. Add riprap for erosion control</p> <p>New Boulders at \$250- per -Each for 6 Day(s) = \$1500.</p> <p>Low Speed Traffic Control at \$1475- per -Day for 10 Day(s) = \$14750. 2 days removal 7 days installation 1 day erosion control</p>

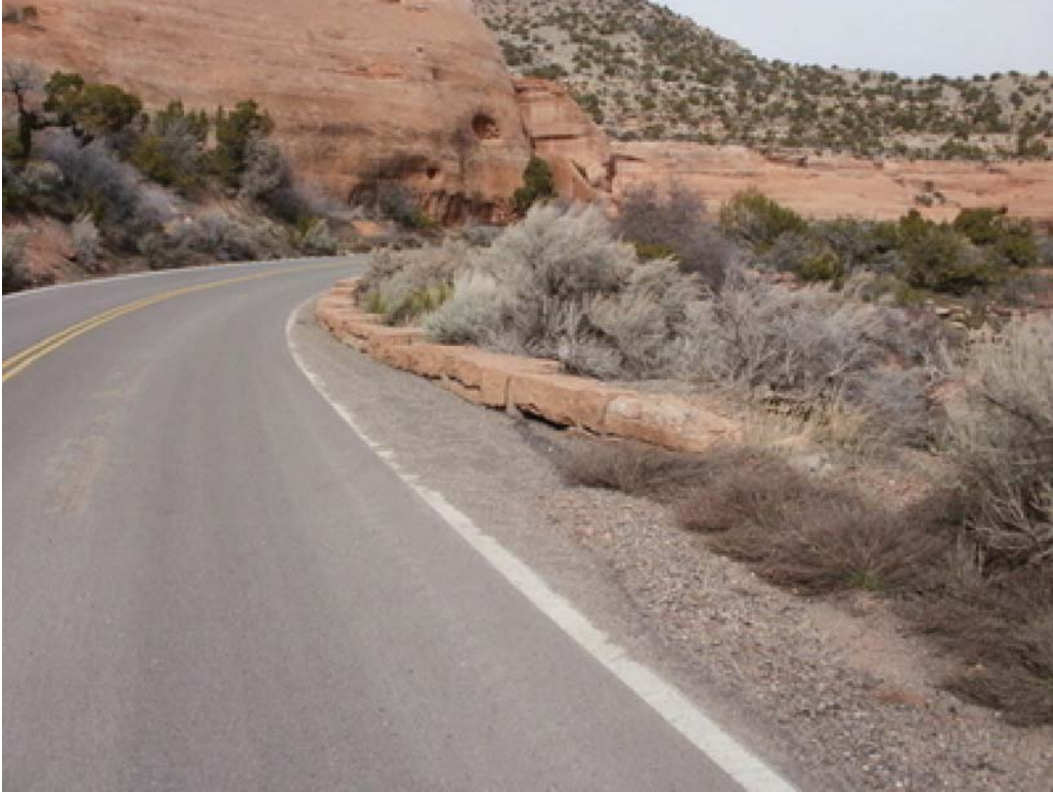
COLM_0010_6.596_L_1.JPG

Barrier ID:	COLM-0010-6.596-L				
Route Name:	RIMROCK DRIVE				
Inspection Date:	06/04/2010	Barrier Rating:	57.20		
Barrier Description					
Type:	STONE MASONRY WITHOUT CONCRETE CORE WALL	Barrier Function:	TRAFFIC		
Barrier Material:	STONE	Post Material:	N/A		
Blockout Type:	N/A	Length (ft.):	151		
Speed Limit (MPH):	35	Placement with Respect to Road:	INSIDE OF CURVE		
Hazard Behind Barrier:	EXTREME				
Barrier Crashworthiness					
Appropriate Test Level:	TL-2	Barrier Test Level:	NCW	Is Barrier Crashworthy?:	NO
Beg. End Trtmt Type:	NONE	Is Beg. End Trtmt Crashworthy?:	N/A	Approach Transition Type:	NONE
Ending End Trtmt Type:	NONE	Ending End Trtmt Crashworthy?:	N/A		
Average Measurements					
Design Height (In.):	24	Width (In.):	20.7	Post Spacing (In.):	0.0
Height (In.):	11.3	Lateral Offset (In.):	19.0	Road Grade (%):	0.30
Physical Condition					
Barrier	Alignment and Height:	Alignment acceptable. Height was 11 to 14-in below the 24-in design height.

Breaking and Cracking:	1-in crack spalling rock face for 10 linear ft total in barrier.			
	Missing Elements:	No missing elements in barrier.			
	Corrosion and Weathering:	Erosion on backside of barrier directly across the roadway from inlet is undermining wall for 10 linear ft.			
End Treatments	Alignment and Height:				
	Breaking and Cracking:				
	Missing Elements:				
	Corrosion and Weathering:

Repair Action:	REPAIR	FMSS Work Type:	DEFERRED MAINTENANCE	Repair Cost:	\$165385
Brief Workorder:	Raise guardwall 12-in. Remove and reset 151-ft of stone masonry guardwall on concrete footer to 24-in design height. Add 1 CY structural backfill for erosion control.				
Workorder:	Remove & Reset Stone Masonry Guardwall at \$250- per -Cu. Ft. for 514 CF = \$128500. (2ft)(1.7ft)(151ft) = 513.4 CF Structural Concrete at \$1000- per -Cu. Yd. for 10 CY = \$10000. [(1.7ft)(1ft)(151ft)]/27 = 9.5 CY Low Speed Traffic Control at \$1475- per -Day for 8 Day(s) = \$11800. 2 days removal and 6 days installation. Structural Backfill at \$50- per -Cu. Yd. for 1 CY = \$50.

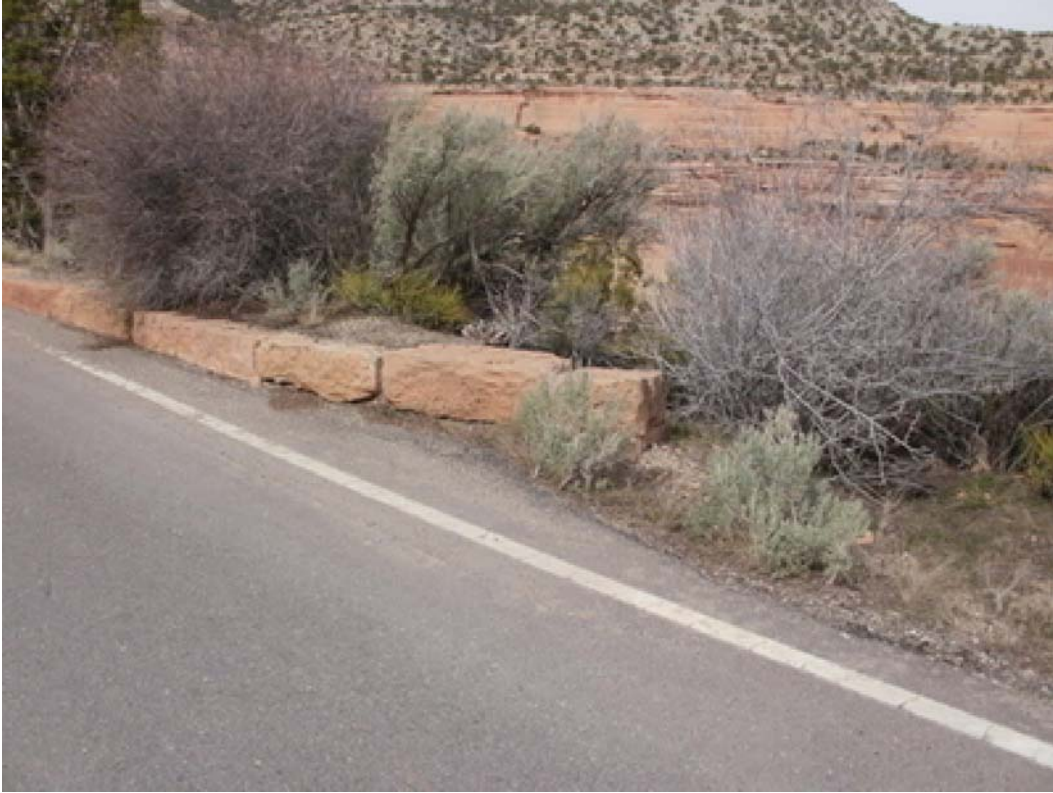
COLM_0010_6.654_L_1.JPG

Barrier ID:	COLM-0010-6.654-L				
Route Name:	RIMROCK DRIVE				
Inspection Date:	06/04/2010	Barrier Rating:	80.00		
Barrier Description					
Type:	STONE MASONRY WITHOUT CONCRETE CORE WALL	Barrier Function:	TRAFFIC		
Barrier Material:	STONE	Post Material:	N/A		
Blockout Type:	N/A	Length (ft.):	880		
Speed Limit (MPH):	35	Placement with Respect to Road:	INSIDE OF CURVE		
Hazard Behind Barrier:	EXTREME				
Barrier Crashworthiness					
Appropriate Test Level:	TL-2	Barrier Test Level:	NCW	Is Barrier Crashworthy?:	NO
Beg. End Trtmt Type:	NONE	Is Beg. End Trtmt Crashworthy?:	N/A	Approach Transition Type:	NONE
Ending End Trtmt Type:	NONE	Ending End Trtmt Crashworthy?:	N/A		
Average Measurements					
Design Height (In.):	24	Width (In.):	24.3	Post Spacing (In.):	0.0
Height (In.):	10.8	Lateral Offset (In.):	19.2	Road Grade (%):	1.10
Physical Condition					
Barrier	Alignment and Height:	80 to 100-ft of barrier leaning outward; misalignment greater than 6-in. Height was 11 to 14-in below the 24-in design height.

Breaking and Cracking:	7 stones (about 24 linear ft) are highly weathered and broken. Mostly minor cracking less than 1/4 in wide of mortar.			
	Missing Elements:	5 sq ft of mortar is missing from joints.			
	Corrosion and Weathering:	Two of three drain openings through guardwall have severe erosion along back side of barrier compromising stability. Some of the stones are weathered - mostly those placed with bedding plane vertical.			
End Treatments	Alignment and Height:				
	Breaking and Cracking:				
	Missing Elements:				
	Corrosion and Weathering:

Repair Action:	REPAIR	FMSS Work Type:	DEFERRED MAINTENANCE	Repair Cost:	\$1126125
Brief Workorder:	Raise guardwall 13-in. Remove and reset 880-ft of stone masonry guardwall on concrete footer to 24-in design height. Replace 14 boulders and repair 6CY of erosion at 2 drain openings through guardwall.				
Workorder:	<p>Remove & Reset Stone Masonry Guardwall at \$250- per -Cu. Ft. for 3520 CF = \$880000. $(2\text{ft})(2\text{ft})(880\text{ft}) = 3520\text{ CF}$</p> <p>Structural Concrete at \$1000- per -Cu. Yd. for 72 CY = \$72000. $[(2\text{ft})(1.1\text{ft})(880\text{ft})]/27 = 71.7\text{ CY}$</p> <p>Structural Backfill at \$50- per -Cu. Yd. for 4 CY = \$200. Backfill to repair erosion at drain openings.</p> <p>Riprap at \$100- per -Cu. Yd. for 2 CY = \$200. Erosion repair at drain openings.</p> <p>Low Speed Traffic Control at \$1475- per -Day for 46 Day(s) = \$67850. 9 days removal 36 days installation and 1 day erosion control</p> <p>New Boulders at \$250- per -Each for 14 = \$3500.</p>

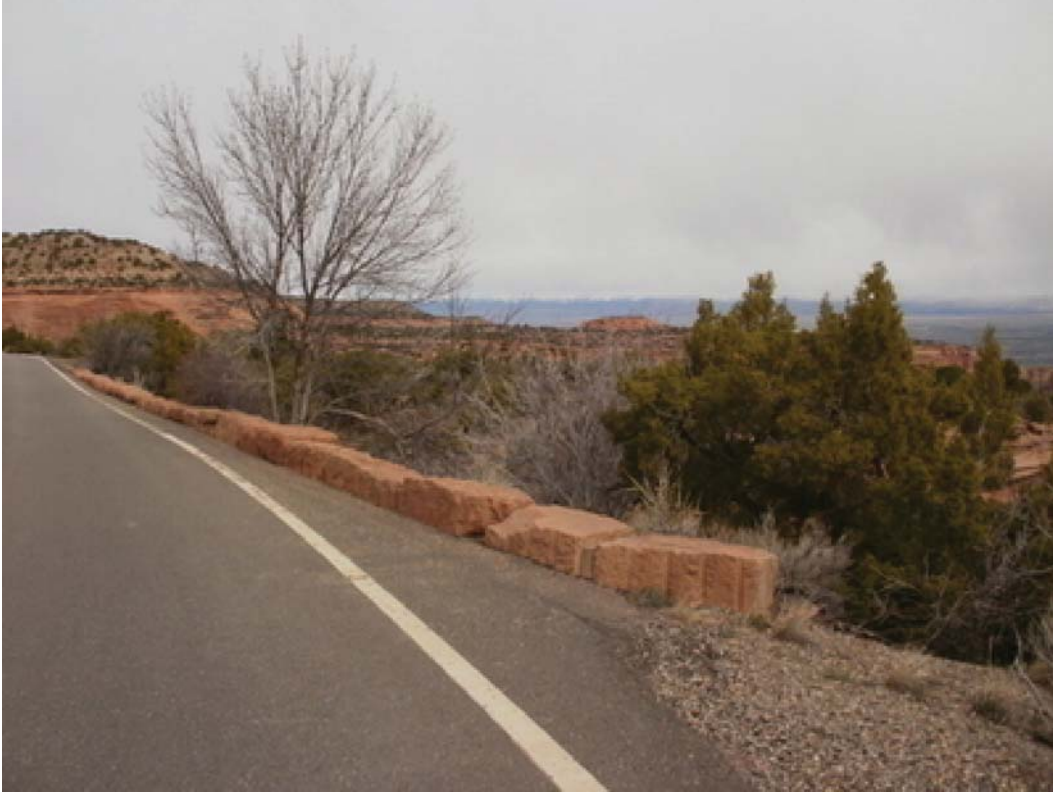
COLM_0010_6.929_L_1.JPG

Barrier ID:	COLM-0010-6.929-L				
Route Name:	RIMROCK DRIVE				
Inspection Date:	06/04/2010	Barrier Rating:	54.40		
Barrier Description					
Type:	STONE MASONRY WITHOUT CONCRETE CORE WALL	Barrier Function:	TRAFFIC		
Barrier Material:	STONE	Post Material:	N/A		
Blockout Type:	N/A	Length (ft.):	164		
Speed Limit (MPH):	35	Placement with Respect to Road:	TANGENT		
Hazard Behind Barrier:	EXTREME				
Barrier Crashworthiness					
Appropriate Test Level:	TL-2	Barrier Test Level:	NCW	Is Barrier Crashworthy?:	NO
Beg. End Trtmt Type:	NONE	Is Beg. End Trtmt Crashworthy?:	N/A	Approach Transition Type:	NONE
Ending End Trtmt Type:	NONE	Ending End Trtmt Crashworthy?:	N/A		
Average Measurements					
Design Height (In.):	24	Width (In.):	25.0	Post Spacing (In.):	0.0
Height (In.):	11.0	Lateral Offset (In.):	16.0	Road Grade (%):	2.70
Physical Condition					
Barrier	Alignment and Height:	Alignment acceptable. Height was 11 to 15-in below the 24-in design height.

Breaking and Cracking:	1/2-in spalling cracks on back of wall rock for 7 linear ft total in barrier.			
	Missing Elements:	No missing elements in barrier.			
	Corrosion and Weathering:	Minor spalling on back of rocks for 4 linear ft total.			
End Treatments	Alignment and Height:				
	Breaking and Cracking:				
	Missing Elements:				
	Corrosion and Weathering:

Repair Action:	REPAIR	FMSS Work Type:	DEFERRED MAINTENANCE	Repair Cost:	\$218378
Brief Workorder:	Raise guardwall 12-in. Remove and reset 164-ft of stone masonry guardwall on concrete footer to 24-in design height.				
Workorder:	Remove & Reset Stone Masonry Guardwall at \$250- per -Cu. Ft. for 689 CF = \$172250. (2ft)(2.1ft)(164ft) = 689 CF Structural Concrete at \$1000- per -Cu. Yd. for 13 CY = \$13000. [(2.1ft)(1ft)(164ft)]/27 = 12.8 CY Low Speed Traffic Control at \$1475- per -Day for 9 Day(s) = \$13275. 2 days removal and 7 days installation.

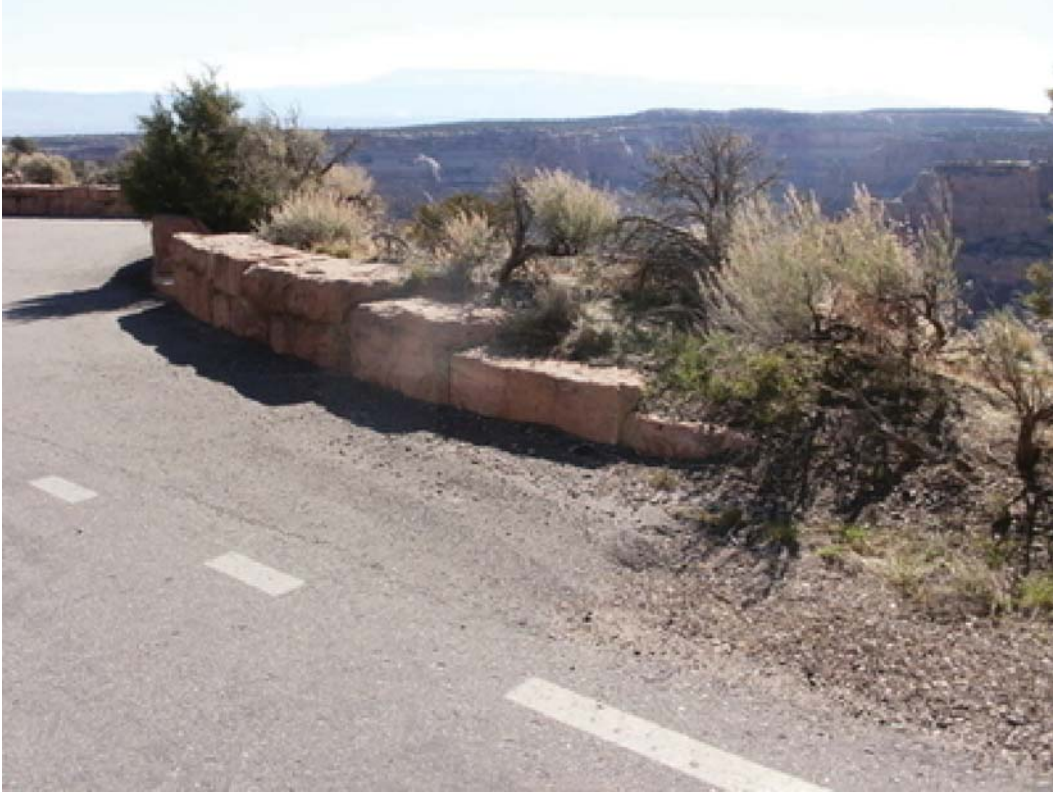
COLM_0010_7.970_L_1.JPG

Barrier ID:	COLM-0010-7.970-L				
Route Name:	RIMROCK DRIVE				
Inspection Date:	08/04/2010	Barrier Rating:	28.60		
Barrier Description					
Type:	STONE MASONRY WITHOUT CONCRETE CORE WALL	Barrier Function:	NON-TRAFFIC		
Barrier Material:	STONE	Post Material:	N/A		
Blockout Type:	N/A	Length (ft.):	230		
Speed Limit (MPH):	25	Placement with Respect to Road:	OUTSIDE OF CURVE		
Hazard Behind Barrier:	N/A				
Barrier Crashworthiness					
Appropriate Test Level:	TL-1	Barrier Test Level:	N/A	Is Barrier Crashworthy?:	N/A
Beg. End Trtmt Type:	NONE	Is Beg. End Trtmt Crashworthy?:	N/A	Approach Transition Type:	NONE
Ending End Trtmt Type:	NONE	Ending End Trtmt Crashworthy?:	N/A		
Average Measurements					
Design Height (In.):	24	Width (In.):	27.0	Post Spacing (In.):	0.0
Height (In.):	18.7	Lateral Offset (In.):	0.0	Road Grade (%):	0.00
Physical Condition					
Barrier	Alignment and Height:	Alignment acceptable. 80-ft was within 3-in of the 24-in design height 80-ft was 3 to 6-in below and 70- ft was 6 to 10-in below.

Breaking and Cracking:	No breaking or cracking of barrier elements. Barrier recently repointed. Mortar in excellent condition.			
	Missing Elements:	No missing stones or mortar in barrier.			
	Corrosion and Weathering:	Minimal weathering of barrier. No erosion to compromise stability.			
End Treatments	Alignment and Height:				
	Breaking and Cracking:				
	Missing Elements:				
	Corrosion and Weathering:

Repair Action:	REPAIR	FMSS Work Type:	DEFERRED MAINTENANCE	Repair Cost:	\$98340
Brief Workorder:	Raise guardwall 2-in. Remove and reset 70-ft of stone masonry guardwall on concrete footer to adjacent 18-in height.				
Workorder:	Remove & Reset Stone Masonry Guardwall at \$250- per -Cu. Ft. for 322 CF = \$80500. (2ft)(2.3ft)(70ft) = 322 CF Structural Concrete at \$1000- per -Cu. Yd. for 3 CY = \$3000. [(2.3ft)(0.5ft)(70ft)]/27 = 2.9 CY Low Speed Traffic Control at \$1475- per -Day for 4 Day(s) = \$5900. 1 day removal and 3 days installation.

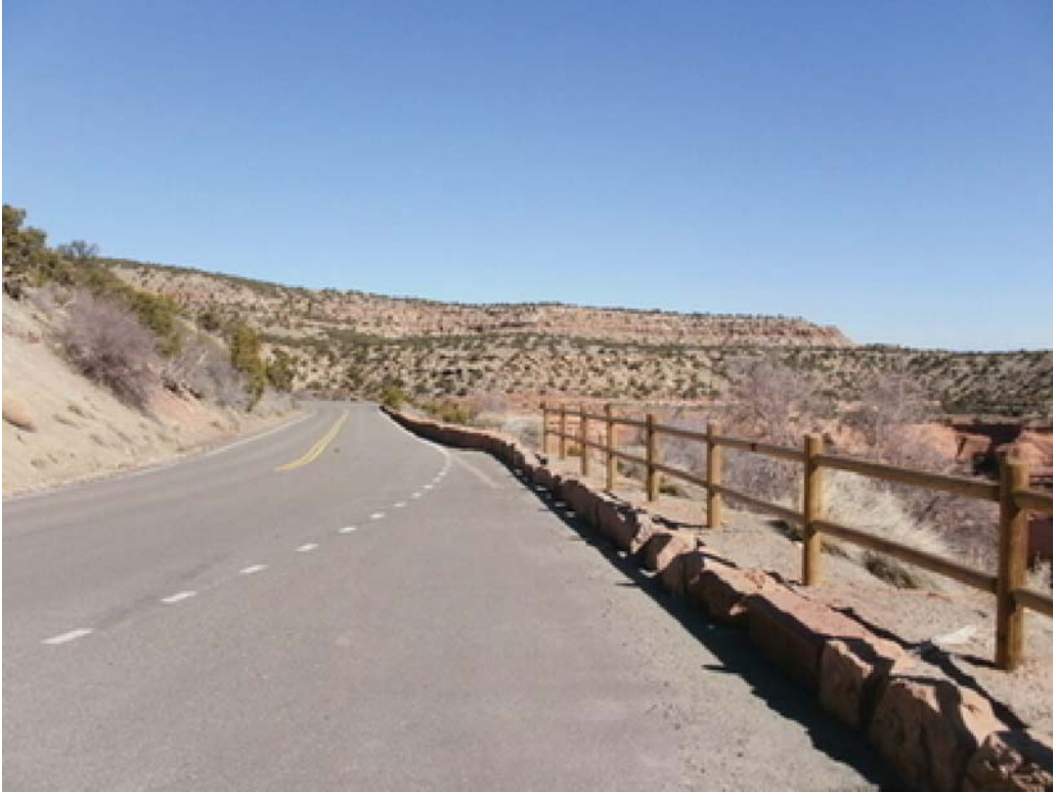
COLM_0010_8.626_L_1.JPG

Barrier ID:	COLM-0010-8.626-L				
Route Name:	RIMROCK DRIVE				
Inspection Date:	08/04/2010	Barrier Rating:	69.50		
Barrier Description					
Type:	STONE MASONRY WITHOUT CONCRETE CORE WALL	Barrier Function:	TRAFFIC		
Barrier Material:	STONE	Post Material:	N/A		
Blockout Type:	N/A	Length (ft.):	409		
Speed Limit (MPH):	35	Placement with Respect to Road:	OUTSIDE OF CURVE		
Hazard Behind Barrier:	EXTREME				
Barrier Crashworthiness					
Appropriate Test Level:	TL-2	Barrier Test Level:	NCW	Is Barrier Crashworthy?:	NO
Beg. End Trtmt Type:	NONE	Is Beg. End Trtmt Crashworthy?:	N/A	Approach Transition Type:	NONE
Ending End Trtmt Type:	NONE	Ending End Trtmt Crashworthy?:	N/A		
Average Measurements					
Design Height (In.):	24	Width (In.):	17.0	Post Spacing (In.):	0.0
Height (In.):	14.0	Lateral Offset (In.):	26.7	Road Grade (%):	1.80
Physical Condition					
Barrier	Alignment and Height:	Alignment acceptable. Height was 7 to 13-in below the 24-in design height.

Breaking and Cracking:	No breaking or cracking in barrier.			
	Missing Elements:	15 square feet of missing grout.			
	Corrosion and Weathering:	No weathering in barrier.			
End Treatments	Alignment and Height:				
	Breaking and Cracking:				
	Missing Elements:				
	Corrosion and Weathering:

Repair Action:	REPAIR	FMSS Work Type:	DEFERRED MAINTENANCE	Repair Cost:	\$366025
Brief Workorder:	Raise guardwall 10-in. Remove and reset 409-ft of stone masonry guardwall on concrete footer to 24-in design height.				
Workorder:	Remove & Reset Stone Masonry Guardwall at \$250- per -Cu. Ft. for 1145 CF = \$286250. (2ft)(1.4ft)(409ft) = 1145.2 CF Structural Concrete at \$1000- per -Cu. Yd. for 17 CY = \$17000. [(1.4ft)(0.8ft)(409ft)]/27 = 16.9 CY Low Speed Traffic Control at \$1475- per -Day for 22 Day(s) = \$32450. 5 days removal and 17 days installation.

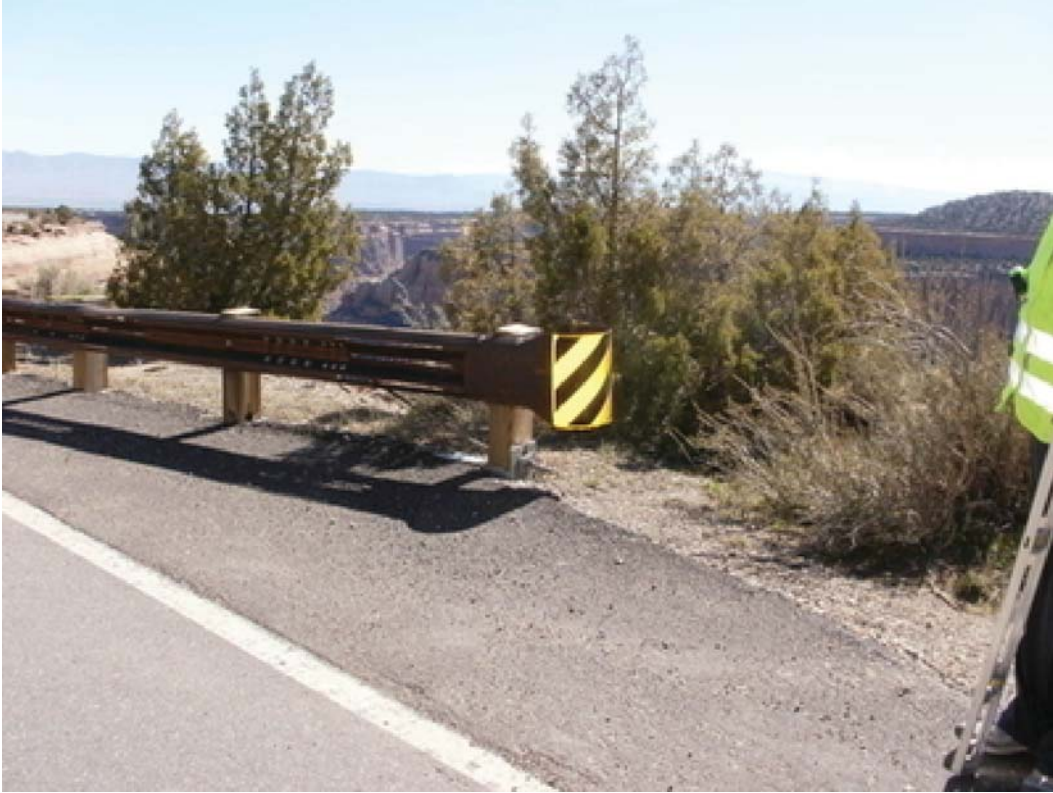
COLM_0010_8.886_L_1.JPG

Barrier ID:	COLM-0010-8.886-L				
Route Name:	RIMROCK DRIVE				
Inspection Date:	08/04/2010	Barrier Rating:	25.70		
Barrier Description					
Type:	W-BEAM STRONG POST	Barrier Function:	TRAFFIC		
Barrier Material:	WEATHERING STEEL/CORTEN	Post Material:	WOOD		
Blockout Type:	WOOD	Length (ft.):	242		
Speed Limit (MPH):	25	Placement with Respect to Road:	INSIDE OF CURVE		
Hazard Behind Barrier:	EXTREME				
Barrier Crashworthiness					
Appropriate Test Level:	TL-1	Barrier Test Level:	TL-3	Is Barrier Crashworthy?:	YES
Beg. End Trtmt Type:	W-BEAM TANGENT 350	Is Beg. End Trtmt Crashworthy?:	YES	Approach Transition Type:	NONE
Ending End Trtmt Type:	W-BEAM TANGENT 350	Ending End Trtmt Crashworthy?:	YES		
Average Measurements					
Design Height (In.):	27	Width (In.):	0.0	Post Spacing (In.):	75.0
Height (In.):	29.0	Lateral Offset (In.):	30.2	Road Grade (%):	5.30
Physical Condition					
Barrier	Alignment and Height:	Alignment acceptable. Height was 1 to 3-in above the 27-in design height.

Breaking and Cracking:	No breaking or cracking of barrier elements.			
	Missing Elements:	No missing barrier elements.			
	Corrosion and Weathering:	No corrosion or weathering of barrier elements. No erosion compromising barrier posts.			
End Treatments	Alignment and Height:	Alignment acceptable. Height within 1-in of 27-in design height.			
	Breaking and Cracking:	No breaking or cracking of end treatment elements.			
	Missing Elements:	No missing end treatment elements.			
	Corrosion and Weathering:	No corrosion or weathering of end treatment elements.

Repair Action:	NO ACTION	FMSS Work Type:	N/A	Repair Cost:	\$0
Brief Workorder:	N/A				
Workorder:

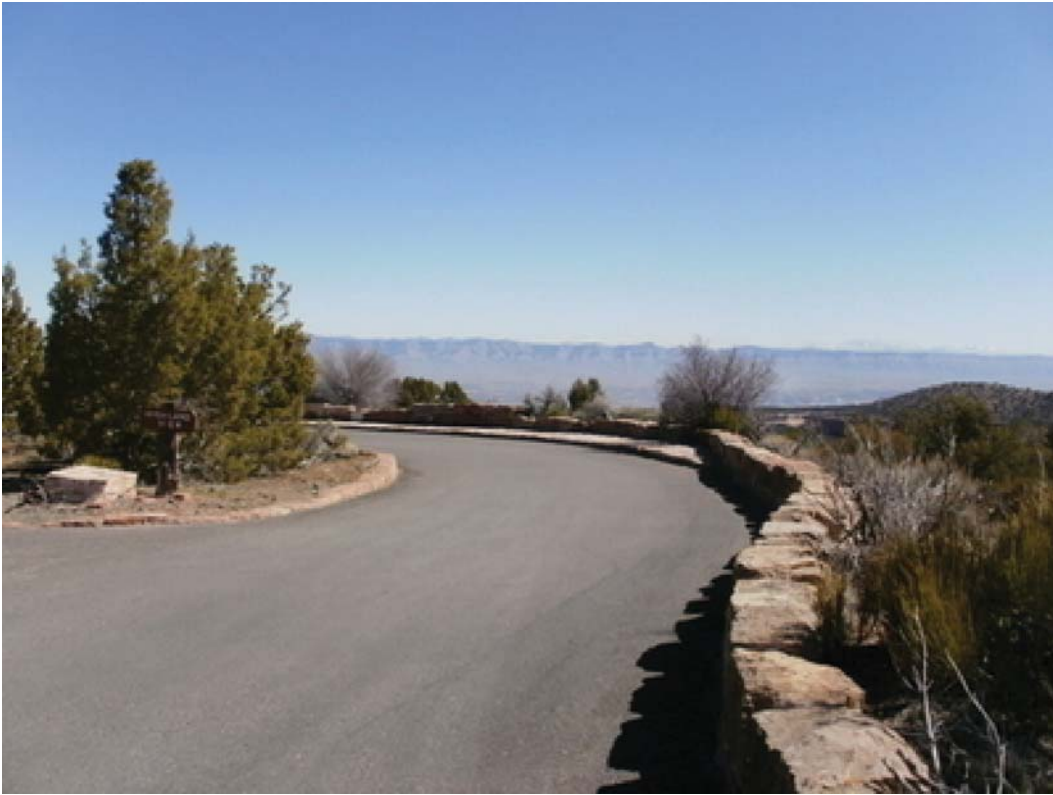
COLM_0010_9.938_L_1.JPG

Barrier ID:	COLM-0010-9.938-L				
Route Name:	RIMROCK DRIVE				
Inspection Date:	08/04/2010	Barrier Rating:	15.80		
Barrier Description					
Type:	STONE MASONRY WITHOUT CONCRETE CORE WALL	Barrier Function:	NON-TRAFFIC		
Barrier Material:	STONE	Post Material:	N/A		
Blockout Type:	N/A	Length (ft.):	250		
Speed Limit (MPH):	35	Placement with Respect to Road:	NON-TRAFFIC BARRIER		
Hazard Behind Barrier:	N/A				
Barrier Crashworthiness					
Appropriate Test Level:	TL-2	Barrier Test Level:	N/A	Is Barrier Crashworthy?:	N/A
Beg. End Trtmt Type:	NONE	Is Beg. End Trtmt Crashworthy?:	N/A	Approach Transition Type:	NONE
Ending End Trtmt Type:	NONE	Ending End Trtmt Crashworthy?:	N/A		
Average Measurements					
Design Height (In.):	24	Width (In.):	18.0	Post Spacing (In.):	0.0
Height (In.):	21.2	Lateral Offset (In.):	0.0	Road Grade (%):	0.00
Physical Condition					
Barrier	Alignment and Height:	Alignment acceptable. 80-ft was 3 to 5-in above the 24-in design height 100-ft was within 3-in 50-ft was 3 to 6-in below and 20-ft was 6 to 11-in below.

Breaking and Cracking:	No breaking or cracking in barrier.			
	Missing Elements:	No missing elements in barrier.			
	Corrosion and Weathering:	No weathering in barrier.			
End Treatments	Alignment and Height:				
	Breaking and Cracking:				
	Missing Elements:				
	Corrosion and Weathering:

Repair Action:	REPAIR	FMSS Work Type:	DEFERRED MAINTENANCE	Repair Cost:	\$20845
Brief Workorder:	Raise guardwall 5 inches. Remove and reset 20-ft stone masonry guardwall on concrete footer to adjacent 18-in height.				
Workorder:	Remove & Reset Stone Masonry Guardwall at \$250- per -Cu. Ft. for 60 CF = \$15000. (2ft)(1.5ft)(20ft) = 60 CF Structural Concrete at \$1000- per -Cu. Yd. for 1 CY = \$1000. [(1.5ft)(0.5ft)(20ft)]/27 = 0.6 CY Low Speed Traffic Control at \$1475- per -Day for 2 Day(s) = \$2950. 1 day removal and 1 day installation.

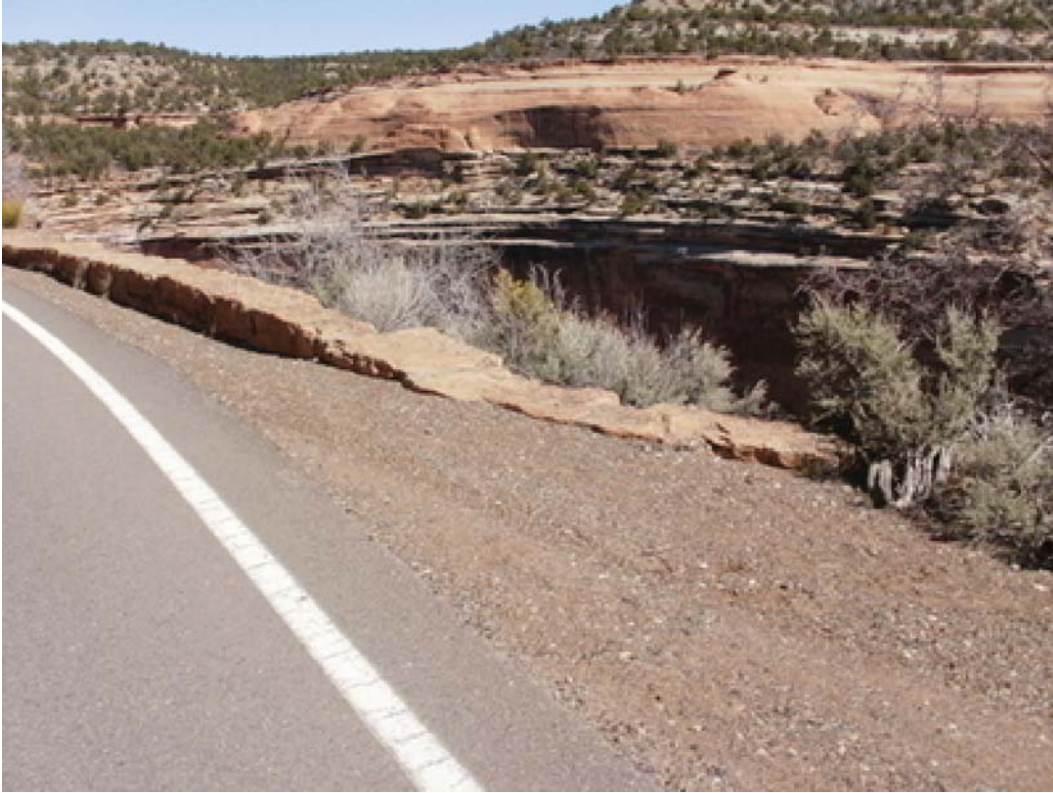
COLM_0010_12.560_L_1.JPG

Barrier ID:	COLM-0010-12.560-L				
Route Name:	RIMROCK DRIVE				
Inspection Date:	08/04/2010	Barrier Rating:	58.00		
Barrier Description					
Type:	STONE MASONRY WITHOUT CONCRETE CORE WALL	Barrier Function:	TRAFFIC		
Barrier Material:	STONE	Post Material:	N/A		
Blockout Type:	N/A	Length (ft.):	165		
Speed Limit (MPH):	35	Placement with Respect to Road:	OUTSIDE OF CURVE		
Hazard Behind Barrier:	EXTREME				
Barrier Crashworthiness					
Appropriate Test Level:	TL-2	Barrier Test Level:	NCW	Is Barrier Crashworthy?:	NO
Beg. End Trtmt Type:	NONE	Is Beg. End Trtmt Crashworthy?:	N/A	Approach Transition Type:	NONE
Ending End Trtmt Type:	NONE	Ending End Trtmt Crashworthy?:	N/A		
Average Measurements					
Design Height (In.):	24	Width (In.):	21.7	Post Spacing (In.):	0.0
Height (In.):	14.0	Lateral Offset (In.):	45.0	Road Grade (%):	2.20
Physical Condition					
Barrier	Alignment and Height:	Alignment acceptable. 45-ft was 3 to 6-in below the 24-in design height and 120-ft was 6 to 14-in below. Gravel built up in front of barrier.

Breaking and Cracking:	Mostly minor cracking of mortar with some missing. No cracked or broken stones.			
	Missing Elements:	15 SF of mortar missing. (5 SF from area where height is 18 to 21-in and 10 SF from areas where height is lower than 18-in.)			
	Corrosion and Weathering:	Barrier is older construction and therefore highly weathered.			
End Treatments	Alignment and Height:				
	Breaking and Cracking:				
	Missing Elements:				
	Corrosion and Weathering:

Repair Action:	REPAIR	FMSS Work Type:	DEFERRED MAINTENANCE	Repair Cost:	\$136890
Brief Workorder:	Raise guardwall 9-in. Remove and reset 120-ft of stone masonry guardwall on concrete footer to adjacent 18-in height. Remove gravel build up from 45 linear feet of barrier.				
Workorder:	Remove & Reset Stone Masonry Guardwall at \$250- per -Cu. Ft. for 432 CF = \$108000. (2ft)(1.8ft)(120ft) = 432 CF Structural Concrete at \$1000- per -Cu. Yd. for 6 CY = \$6000. [(1.8ft)(0.75ft)(120ft)]/27 = 6 CY Labor at \$60- per -Hour for 2 Hrs = \$120. Remove gravel from front of barrier. Low Speed Traffic Control at \$1475- per -Day for 7 Day(s) = \$10325. 2 days removal and 5 days installation.

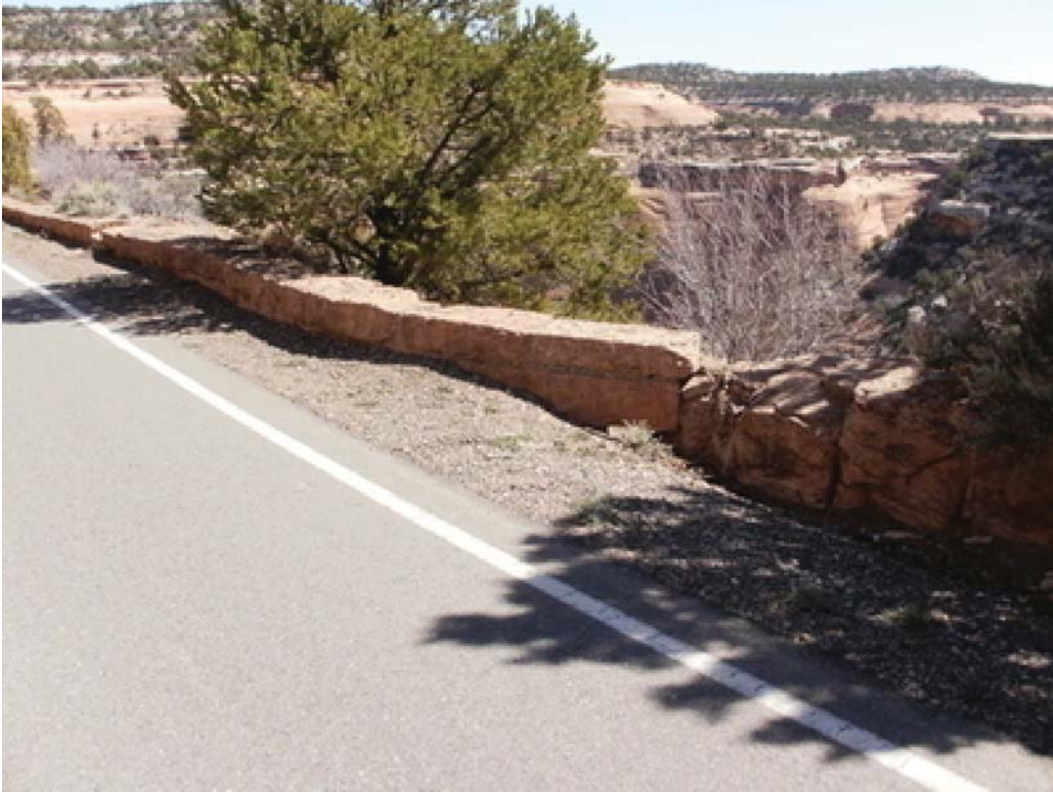
COLM_0010_12.610_L_1.JPG

Barrier ID:	COLM-0010-12.610-L				
Route Name:	RIMROCK DRIVE				
Inspection Date:	08/04/2010	Barrier Rating:	55.20		
Barrier Description					
Type:	STONE MASONRY WITHOUT CONCRETE CORE WALL	Barrier Function:	TRAFFIC		
Barrier Material:	STONE	Post Material:	N/A		
Blockout Type:	N/A	Length (ft.):	108		
Speed Limit (MPH):	35	Placement with Respect to Road:	OUTSIDE OF CURVE		
Hazard Behind Barrier:	EXTREME				
Barrier Crashworthiness					
Appropriate Test Level:	TL-2	Barrier Test Level:	NCW	Is Barrier Crashworthy?:	NO
Beg. End Trtmt Type:	NONE	Is Beg. End Trtmt Crashworthy?:	N/A	Approach Transition Type:	NONE
Ending End Trtmt Type:	NONE	Ending End Trtmt Crashworthy?:	N/A		
Average Measurements					
Design Height (In.):	24	Width (In.):	20.2	Post Spacing (In.):	0.0
Height (In.):	13.0	Lateral Offset (In.):	61.7	Road Grade (%):	1.90
Physical Condition					
Barrier	Alignment and Height:	Alignment acceptable. Height was 9 to 12-in below the 24 in design height.

Breaking and Cracking:	2 broken stones. Mortar is cracked and missing in many locations along barrier.			
	Missing Elements:	9 SF of missing mortar. No stones missing from barrier.			
	Corrosion and Weathering:	Moderate weathering of barrier. Erosion does not compromise stability.			
End Treatments	Alignment and Height:				
	Breaking and Cracking:				
	Missing Elements:				
	Corrosion and Weathering:

Repair Action:	REPAIR	FMSS Work Type:	DEFERRED MAINTENANCE	Repair Cost:	\$119185
Brief Workorder:	Raise guardwall 11-in. Remove and reset 108-ft of stone masonry guardwall on concrete footer to 24-in design height. Replace 2 boulders.				
Workorder:	Remove & Reset Stone Masonry Guardwall at \$250- per -Cu. Ft. for 368 CF = \$92000. (2ft)(1.7ft)(108ft) = 368 CF Structural Concrete at \$1000- per -Cu. Yd. for 7 CY = \$7000. [(1.7ft)(0.9ft)(108ft)]/27 = 6.2 CY New Boulders at \$250- per -Each for 2 = \$500. Low Speed Traffic Control at \$1475- per -Day for 6 Day(s) = \$8850. 2 days removal and 4 days installation.

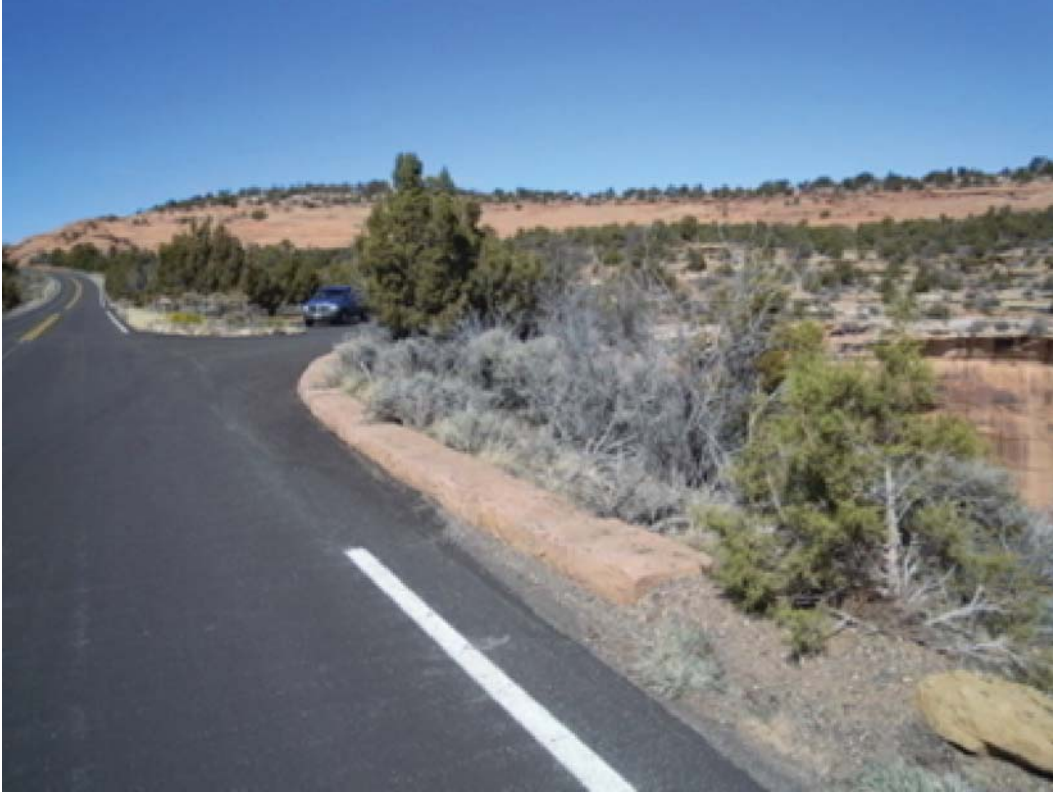
COLM_0010_16.138_L_1.jpg

Barrier ID:	COLM-0010-16.138-L				
Route Name:	RIMROCK DRIVE				
Inspection Date:	08/04/2010	Barrier Rating:	24.20		
Barrier Description					
Type:	STONE MASONRY WITHOUT CONCRETE CORE WALL	Barrier Function:	NON-TRAFFIC		
Barrier Material:	STONE	Post Material:	N/A		
Blockout Type:	N/A	Length (ft.):	223		
Speed Limit (MPH):	35	Placement with Respect to Road:	NON-TRAFFIC BARRIER		
Hazard Behind Barrier:	N/A				
Barrier Crashworthiness					
Appropriate Test Level:	TL-2	Barrier Test Level:	N/A	Is Barrier Crashworthy?:	N/A
Beg. End Trtmt Type:	NONE	Is Beg. End Trtmt Crashworthy?:	N/A	Approach Transition Type:	NONE
Ending End Trtmt Type:	NONE	Ending End Trtmt Crashworthy?:	N/A		
Average Measurements					
Design Height (In.):	24	Width (In.):	18.7	Post Spacing (In.):	0.0
Height (In.):	19.2	Lateral Offset (In.):	0.0	Road Grade (%):	0.00
Physical Condition					
Barrier	Alignment and Height:	Alignment acceptable. 75-ft was within 3-in of the 24-in design height 75-ft was 3 to 6-in below and 73-ft was 6 to 11-in below.

Breaking and Cracking:	No breaking or cracking in barrier.			
	Missing Elements:	No missing elements in barrier.			
	Corrosion and Weathering:	No weathering in barrier.			
End Treatments	Alignment and Height:				
	Breaking and Cracking:				
	Missing Elements:				
	Corrosion and Weathering:

Repair Action:	REPAIR	FMSS Work Type:	DEFERRED MAINTENANCE	Repair Cost:	\$74140
Brief Workorder:	Raise guardwall 4 inches. Remove and reset 73-ft of stone masonry guardwall on concrete footer to adjacent 18-in height.				
Workorder:	Remove & Reset Stone Masonry Guardwall at \$250- per -Cu. Ft. for 234 CF = \$58500. $(2ft)(1.6ft)(73ft) = 233.6 CY$ Structural Concrete at \$1000- per -Cu. Yd. for 3 CY = \$3000. $[(1.6ft)(0.5ft)(73ft)]/27 = 2.2 CY$ Low Speed Traffic Control at \$1475- per -Day for 4 Day(s) = \$5900. 1 day removal and 3 days installation.
