COLM GIP Report

NPS Guardwall/Rail Inventory Program Colorado National Monument

**Federal Lands Highway
Road Inventory Program**

Data Collection Date: March 2011
Report Date: November 2015

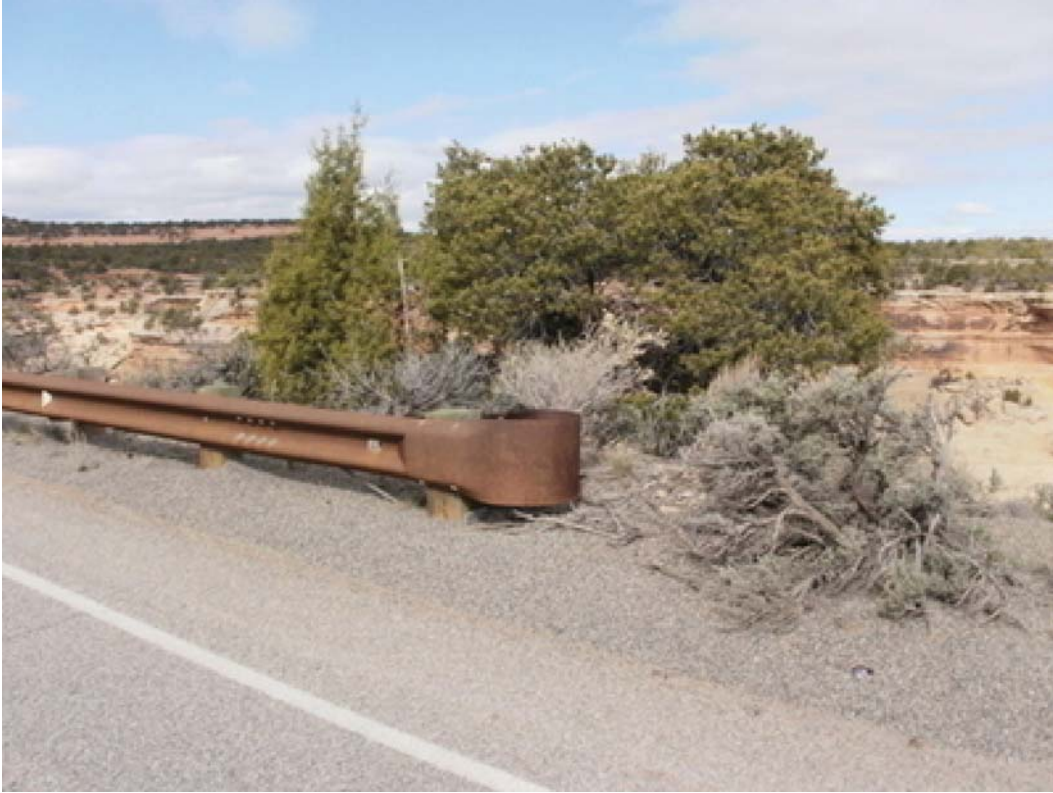
COLM_0010_18.620_L_1.JPG

Barrier ID:	COLM-0010-18.620-L				
Route Name:	RIMROCK DRIVE				
Inspection Date:	07/04/2010	Barrier Rating:	48.70		
Barrier Description					
Type:	W-BEAM STRONG POST	Barrier Function:	TRAFFIC		
Barrier Material:	WEATHERING STEEL/CORTEN	Post Material:	WOOD		
Blockout Type:	WOOD	Length (ft.):	404		
Speed Limit (MPH):	35	Placement with Respect to Road:	TANGENT		
Hazard Behind Barrier:	EXTREME				
Barrier Crashworthiness					
Appropriate Test Level:	TL-2	Barrier Test Level:	TL-3	Is Barrier Crashworthy?:	YES
Beg. End Trtmt Type:	W-BEAM BCT	Is Beg. End Trtmt Crashworthy?:	NO	Approach Transition Type:	NONE
Ending End Trtmt Type:	W-BEAM BCT	Ending End Trtmt Crashworthy?:	NO		
Average Measurements					
Design Height (In.):	27	Width (In.):	0.0	Post Spacing (In.):	74.6
Height (In.):	22.7	Lateral Offset (In.):	30.2	Road Grade (%):	2.70
Physical Condition					
Barrier	Alignment and Height:	Alignment acceptable. Height was 4 to 5-in below the 27-in design height. Two areas of minor impact. Gravel is piled up in front of rail.

Breaking and Cracking:	25-ft of damaged rail. Four damaged/bent reflectors.			
	Missing Elements:	No missing rail elements.			
	Corrosion and Weathering:	Minimal corrosion or rail and weathering of blocks and posts.			
End Treatments	Alignment and Height:	Alignment acceptable. Height was 4-in below the 27-in design height.			
	Breaking and Cracking:	Minor impact on ending end BCT. No cracking.			
	Missing Elements:	No missing end treatment elements.			
	Corrosion and Weathering:	Minimal corrosion/weathering of end treatments.

Repair Action:	REPAIR	FMSS Work Type:	DEFERRED MAINTENANCE	Repair Cost:	\$8580
Brief Workorder:	Raise 404-ft of barrier up to 27-in design height replace 25-ft of bent rail bend reflectors back into place and remove gravel from in front of barrier.				
Workorder:	Adjust Guardrail at \$10- per -Lin. Ft. for 404 LF = \$4040. Raise 404-ft of barrier up to 27-in design height. Replace Rail at \$25- per -Lin. Ft. for 25 LF = \$625. Replace 25-ft of rail. Labor at \$60- per -Hour for 1 Hrs = \$60. Bend reflectors back into place. Grader at \$125- per -Hour for 1 Hrs = \$125. Remove gravel from in front of barrier. Low Speed Traffic Control at \$1475- per -Day for 2 Day(s) = \$2950.

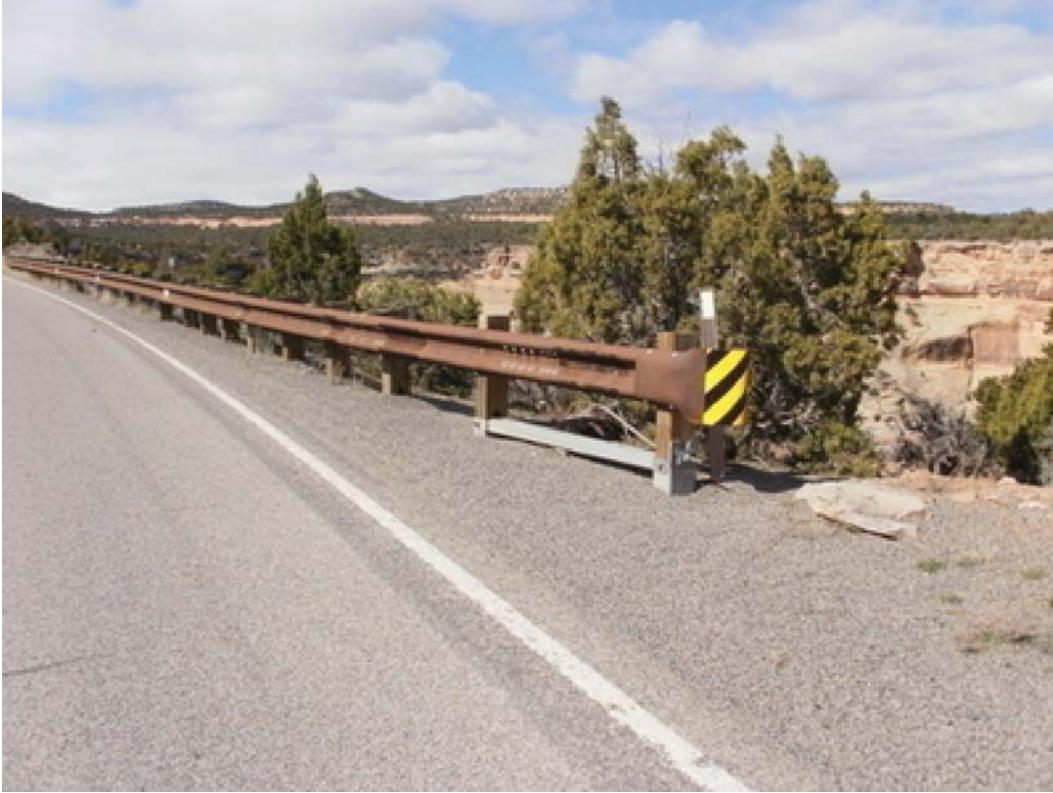
COLM_0010_18.917_L_1.JPG

Barrier ID:	COLM-0010-18.917-L				
Route Name:	RIMROCK DRIVE				
Inspection Date:	07/04/2010	Barrier Rating:	25.70		
Barrier Description					
Type:	W-BEAM STRONG POST	Barrier Function:	TRAFFIC		
Barrier Material:	WEATHERING STEEL/CORTEN	Post Material:	WOOD		
Blockout Type:	WOOD	Length (ft.):	178		
Speed Limit (MPH):	35	Placement with Respect to Road:	TANGENT		
Hazard Behind Barrier:	EXTREME				
Barrier Crashworthiness					
Appropriate Test Level:	TL-2	Barrier Test Level:	TL-3	Is Barrier Crashworthy?:	YES
Beg. End Trtmt Type:	W-BEAM TANGENT 350	Is Beg. End Trtmt Crashworthy?:	YES	Approach Transition Type:	NONE
Ending End Trtmt Type:	W-BEAM TANGENT 350	Ending End Trtmt Crashworthy?:	YES		
Average Measurements					
Design Height (In.):	27	Width (In.):	0.0	Post Spacing (In.):	74.3
Height (In.):	28.0	Lateral Offset (In.):	14.3	Road Grade (%):	3.90
Physical Condition					
Barrier	Alignment and Height:	Alignment acceptable. Height within 1-in of 27-in design height.

Breaking and Cracking:	No breaking or cracking in barrier			
	Missing Elements:	No missing elements in barrier.			
	Corrosion and Weathering:	No corrosion or weathering in barrier.			
End Treatments	Alignment and Height:	Alignment acceptable. Height within 1-in of 27-in design height.			
	Breaking and Cracking:	No breaking or cracking in end treatments.			
	Missing Elements:	No missing elements in end treatments			
	Corrosion and Weathering:	No corrosion or weathering in end treatments.

Repair Action:	NO ACTION	FMSS Work Type:	N/A	Repair Cost:	\$0
Brief Workorder:	N/A				
Workorder:

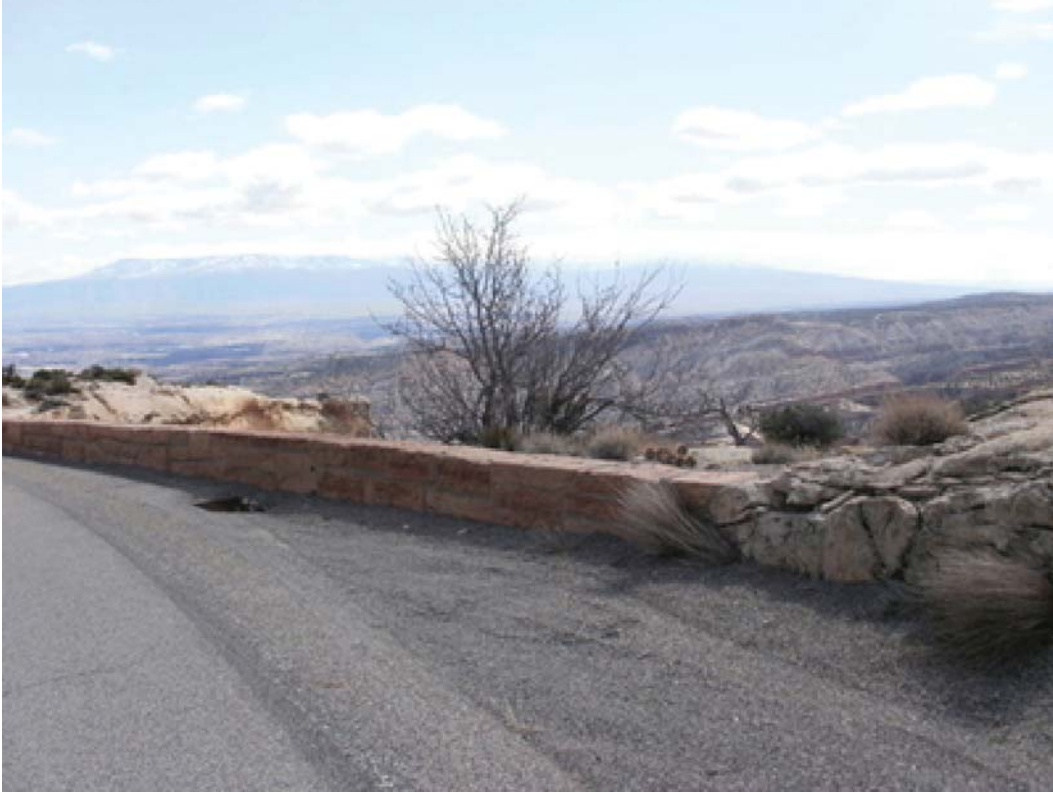
COLM_0010_19.404_R_1.JPG

Barrier ID:	COLM-0010-19.404-R				
Route Name:	RIMROCK DRIVE				
Inspection Date:	07/04/2010	Barrier Rating:	50.20		
Barrier Description					
Type:	STONE MASONRY WITHOUT CONCRETE CORE WALL	Barrier Function:	TRAFFIC		
Barrier Material:	STONE	Post Material:	N/A		
Blockout Type:	N/A	Length (ft.):	497		
Speed Limit (MPH):	25	Placement with Respect to Road:	BOTH INSIDE AND OUTSIDE		
Hazard Behind Barrier:	EXTREME				
Barrier Crashworthiness					
Appropriate Test Level:	TL-1	Barrier Test Level:	NCW	Is Barrier Crashworthy?:	NO
Beg. End Trtmt Type:	NONE	Is Beg. End Trtmt Crashworthy?:	N/A	Approach Transition Type:	NONE
Ending End Trtmt Type:	NONE	Ending End Trtmt Crashworthy?:	N/A		
Average Measurements					
Design Height (In.):	24	Width (In.):	18.2	Post Spacing (In.):	0.0
Height (In.):	21.7	Lateral Offset (In.):	32.0	Road Grade (%):	6.30
Physical Condition					
Barrier	Alignment and Height:	Alignment acceptable. 227-ft was within 3-in of the 24-in design height 185-ft was 3 to 6-in below and 85-ft was 6 to 7-in below.

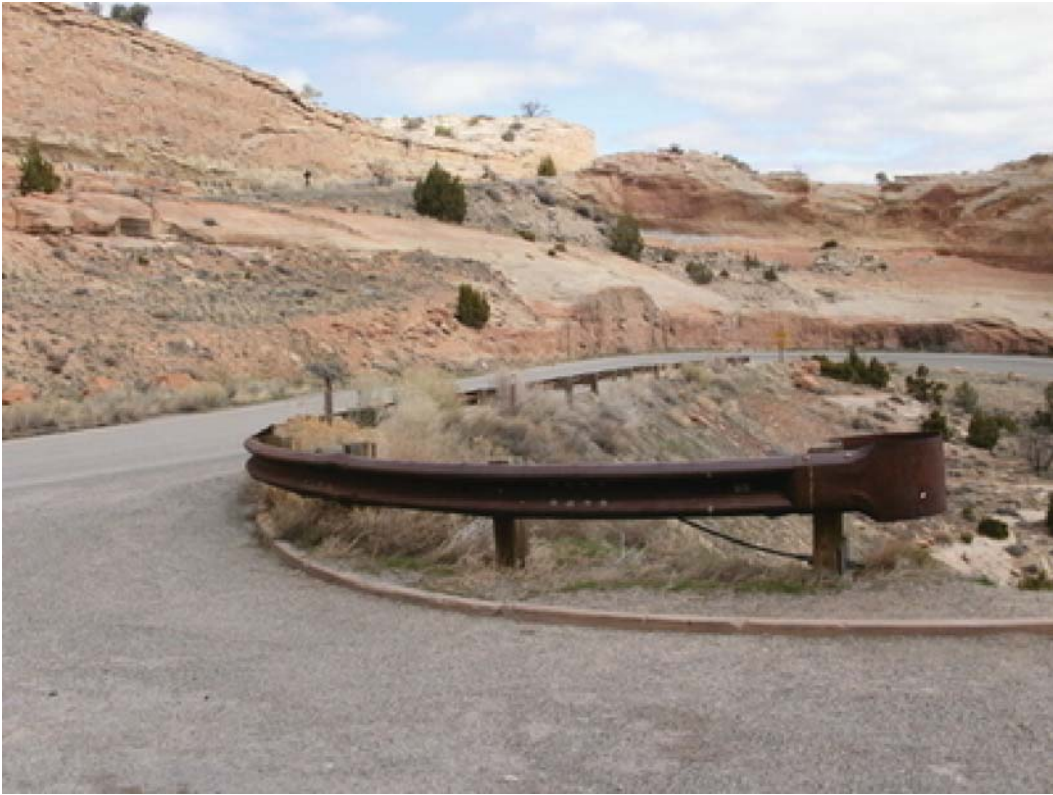
COLM_0010_19.858_R_1.JPG

Barrier ID:	COLM-0010-19.858-R				
Route Name:	RIMROCK DRIVE				
Inspection Date:	07/04/2010	Barrier Rating:	34.00		
Barrier Description					
Type:	W-BEAM STRONG POST	Barrier Function:	TRAFFIC		
Barrier Material:	WEATHERING STEEL/CORTEN	Post Material:	WOOD		
Blockout Type:	WOOD	Length (ft.):	247		
Speed Limit (MPH):	25	Placement with Respect to Road:	INSIDE OF CURVE		
Hazard Behind Barrier:	HIGH				
Barrier Crashworthiness					
Appropriate Test Level:	TL-1	Barrier Test Level:	TL-3	Is Barrier Crashworthy?:	YES
Beg. End Trtmt Type:	W-BEAM BCT	Is Beg. End Trtmt Crashworthy?:	NO	Approach Transition Type:	NONE
Ending End Trtmt Type:	W-BEAM BCT	Ending End Trtmt Crashworthy?:	NO		
Average Measurements					
Design Height (In.):	27	Width (In.):	0.0	Post Spacing (In.):	150.6
Height (In.):	26.7	Lateral Offset (In.):	30.7	Road Grade (%):	6.60
Physical Condition					
Barrier	Alignment and Height:	Alignment acceptable. Height within 1-in of 27-in design height.

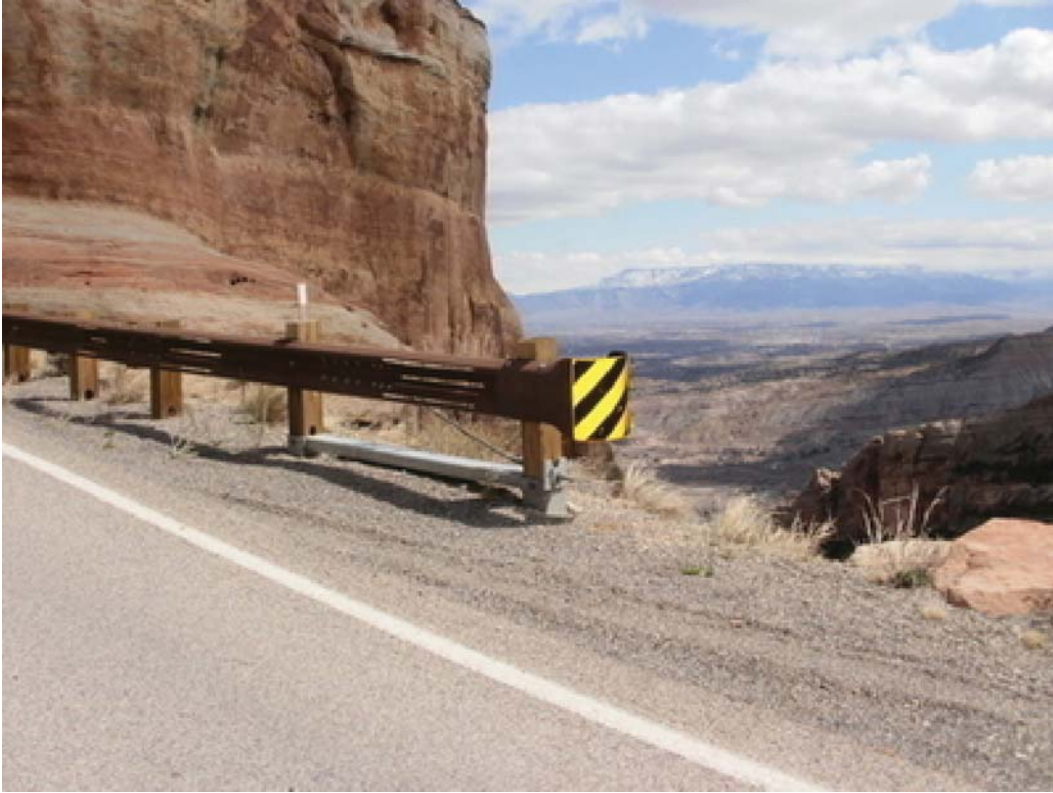
COLM_0010_19.940_L_1.JPG

Barrier ID:	COLM-0010-19.940-L				
Route Name:	RIMROCK DRIVE				
Inspection Date:	07/04/2010	Barrier Rating:	30.00		
Barrier Description					
Type:	W-BEAM STRONG POST	Barrier Function:	TRAFFIC		
Barrier Material:	WEATHERING STEEL/CORTEN	Post Material:	WOOD		
Blockout Type:	WOOD	Length (ft.):	226		
Speed Limit (MPH):	25	Placement with Respect to Road:	OUTSIDE OF CURVE		
Hazard Behind Barrier:	EXTREME				
Barrier Crashworthiness					
Appropriate Test Level:	TL-1	Barrier Test Level:	TL-3	Is Barrier Crashworthy?:	YES
Beg. End Trtmt Type:	W-BEAM TANGENT 350	Is Beg. End Trtmt Crashworthy?:	YES	Approach Transition Type:	NONE
Ending End Trtmt Type:	W-BEAM TANGENT 350	Ending End Trtmt Crashworthy?:	YES		
Average Measurements					
Design Height (In.):	27	Width (In.):	0.0	Post Spacing (In.):	76.0
Height (In.):	29.0	Lateral Offset (In.):	22.0	Road Grade (%):	7.00
Physical Condition					
Barrier	Alignment and Height:	Alignment acceptable. Height was 1 to 3-in above the 27-in design height.

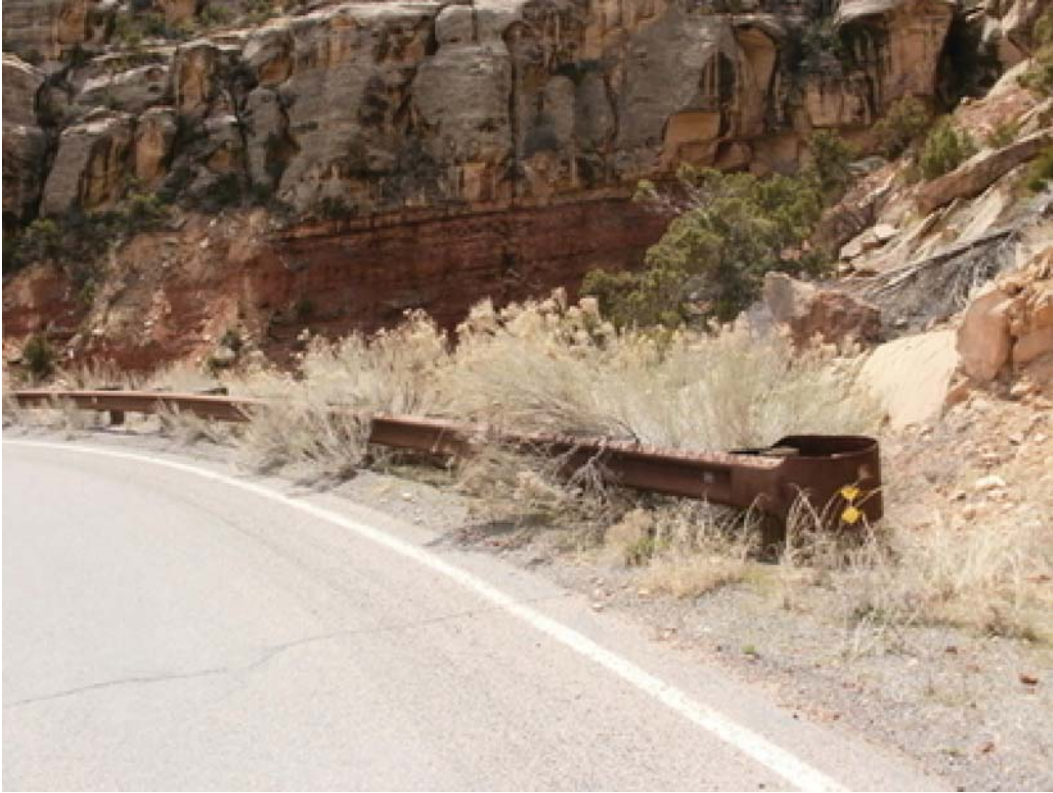
COLM_0010_20.296_R_1.JPG

Barrier ID:	COLM-0010-20.296-R				
Route Name:	RIMROCK DRIVE				
Inspection Date:	07/04/2010	Barrier Rating:	40.20		
Barrier Description					
Type:	W-BEAM STRONG POST	Barrier Function:	TRAFFIC		
Barrier Material:	WEATHERING STEEL/CORTEN	Post Material:	WOOD		
Blockout Type:	WOOD	Length (ft.):	421		
Speed Limit (MPH):	25	Placement with Respect to Road:	OUTSIDE OF CURVE		
Hazard Behind Barrier:	EXTREME				
Barrier Crashworthiness					
Appropriate Test Level:	TL-1	Barrier Test Level:	TL-3	Is Barrier Crashworthy?:	YES
Beg. End Trtmt Type:	W-BEAM BCT	Is Beg. End Trtmt Crashworthy?:	NO	Approach Transition Type:	NONE
Ending End Trtmt Type:	W-BEAM BCT	Ending End Trtmt Crashworthy?:	NO		
Average Measurements					
Design Height (In.):	27	Width (In.):	0.0	Post Spacing (In.):	100.3
Height (In.):	26.7	Lateral Offset (In.):	40.2	Road Grade (%):	8.70
Physical Condition					
Barrier	Alignment and Height:	Alignment acceptable. Height within 1-in of 27-in design height.

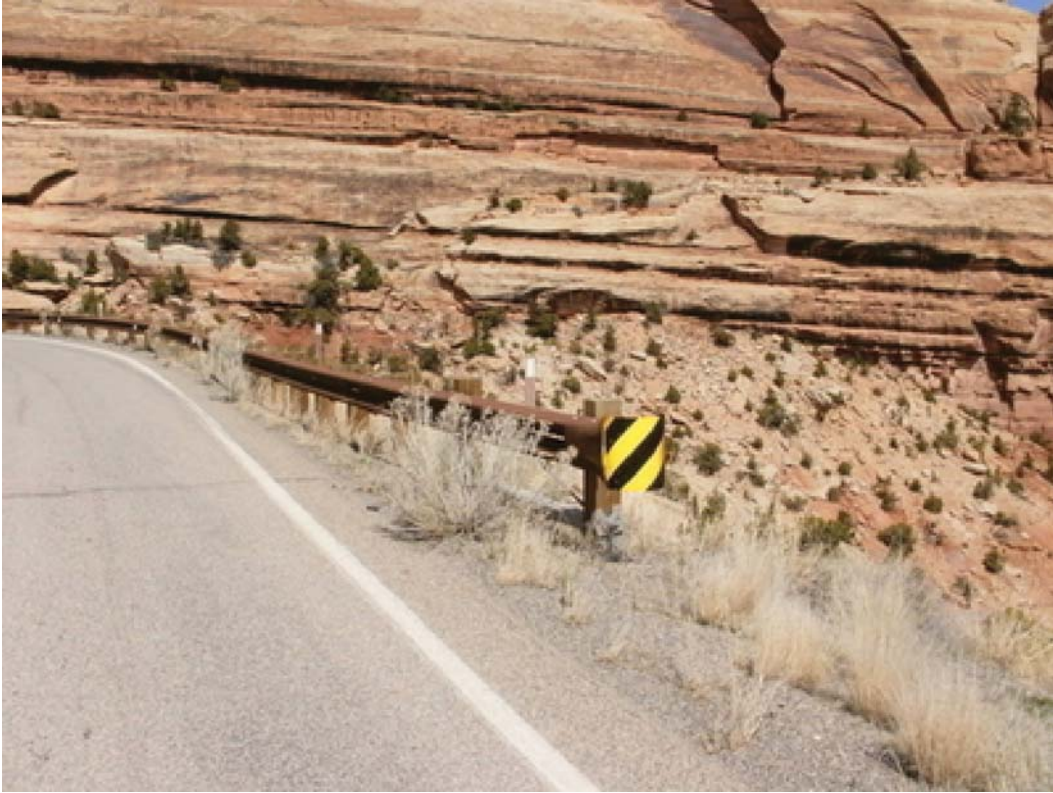
COLM_0010_20.412_L_1.JPG

Barrier ID:	COLM-0010-20.412-L				
Route Name:	RIMROCK DRIVE				
Inspection Date:	07/04/2010	Barrier Rating:	28.30		
Barrier Description					
Type:	W-BEAM STRONG POST	Barrier Function:	TRAFFIC		
Barrier Material:	WEATHERING STEEL/CORTEN	Post Material:	WOOD		
Blockout Type:	WOOD	Length (ft.):	325		
Speed Limit (MPH):	25	Placement with Respect to Road:	OUTSIDE OF CURVE		
Hazard Behind Barrier:	HIGH				
Barrier Crashworthiness					
Appropriate Test Level:	TL-1	Barrier Test Level:	TL-3	Is Barrier Crashworthy?:	YES
Beg. End Trtmt Type:	W-BEAM TANGENT 350	Is Beg. End Trtmt Crashworthy?:	YES	Approach Transition Type:	NONE
Ending End Trtmt Type:	W-BEAM TANGENT 350	Ending End Trtmt Crashworthy?:	YES		
Average Measurements					
Design Height (In.):	27	Width (In.):	0.0	Post Spacing (In.):	75.3
Height (In.):	28.7	Lateral Offset (In.):	26.0	Road Grade (%):	6.80
Physical Condition					
Barrier	Alignment and Height:	Alignment acceptable. Height was 1 to 2-in above the 27-in design height.

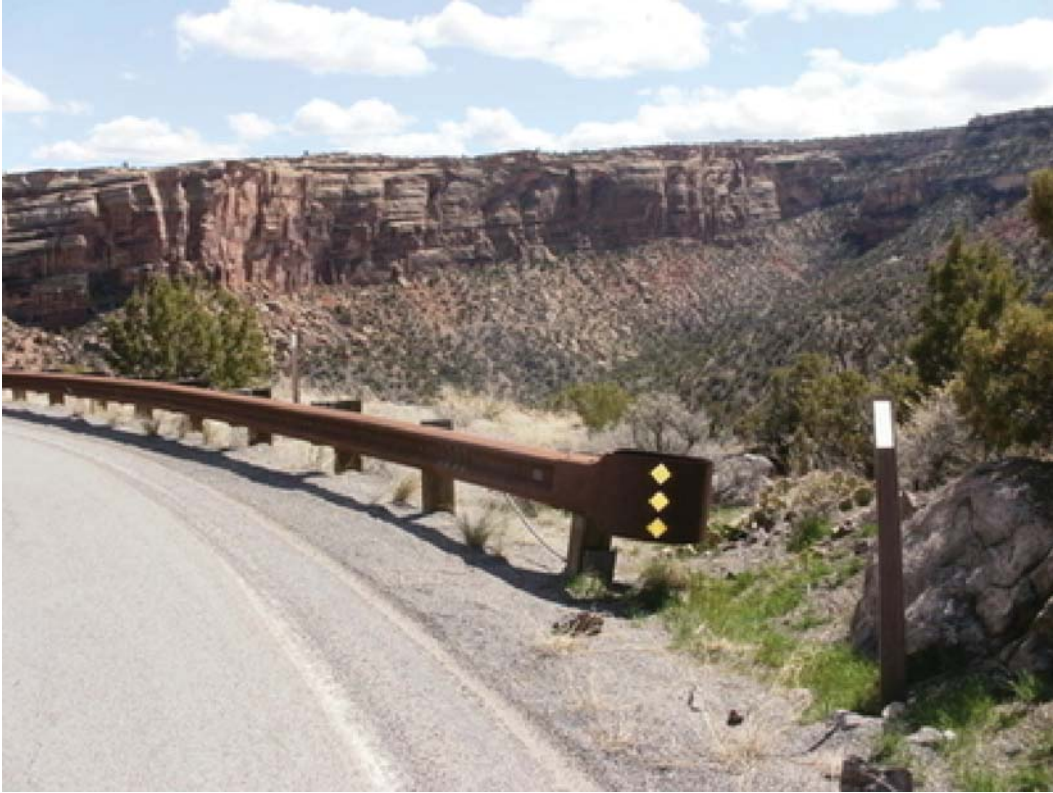
COLM_0010_20.936_R_1.JPG

Barrier ID:	COLM-0010-20.936-R				
Route Name:	RIMROCK DRIVE				
Inspection Date:	07/04/2010	Barrier Rating:	35.90		
Barrier Description					
Type:	W-BEAM STRONG POST	Barrier Function:	TRAFFIC		
Barrier Material:	WEATHERING STEEL/CORTEN	Post Material:	WOOD		
Blockout Type:	WOOD	Length (ft.):	287		
Speed Limit (MPH):	25	Placement with Respect to Road:	OUTSIDE OF CURVE		
Hazard Behind Barrier:	EXTREME				
Barrier Crashworthiness					
Appropriate Test Level:	TL-1	Barrier Test Level:	TL-3	Is Barrier Crashworthy?:	YES
Beg. End Trtmt Type:	W-BEAM BCT	Is Beg. End Trtmt Crashworthy?:	NO	Approach Transition Type:	NONE
Ending End Trtmt Type:	W-BEAM BCT	Ending End Trtmt Crashworthy?:	NO		
Average Measurements					
Design Height (In.):	27	Width (In.):	0.0	Post Spacing (In.):	125.0
Height (In.):	27.2	Lateral Offset (In.):	30.2	Road Grade (%):	5.60
Physical Condition					
Barrier	Alignment and Height:	Alignment acceptable. Height within 1-in of 27-in design height.

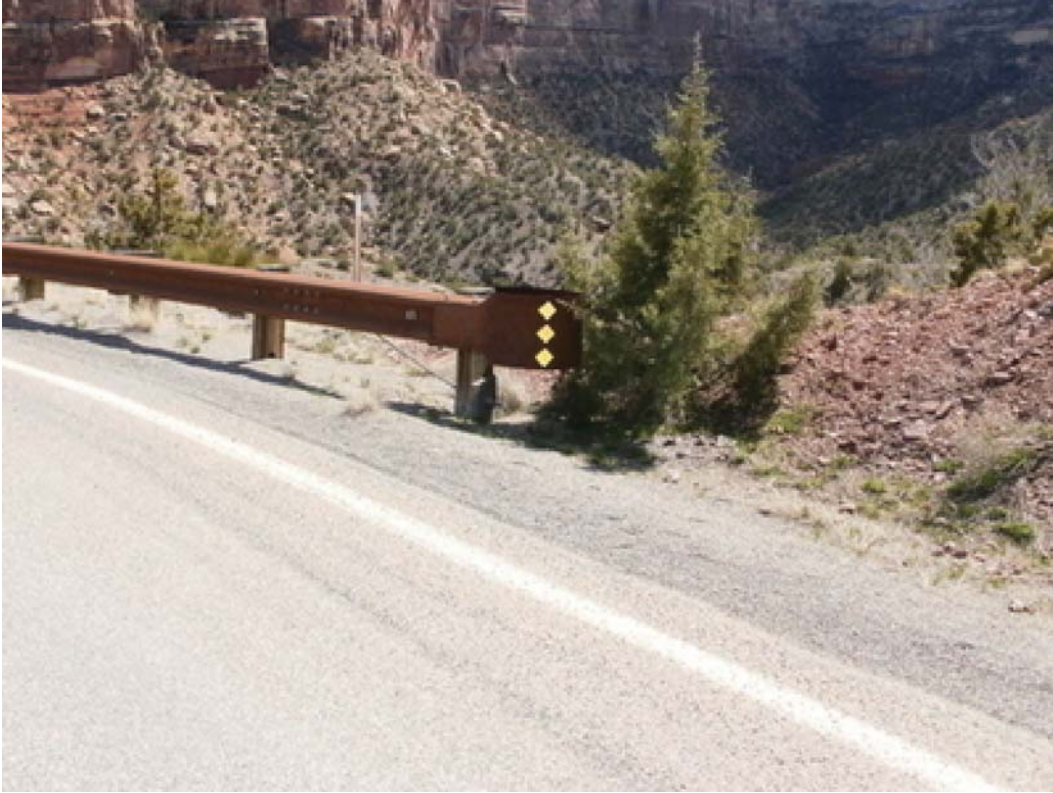
COLM_0010_21.346_R_1.JPG

Barrier ID:	COLM-0010-21.346-R				
Route Name:	RIMROCK DRIVE				
Inspection Date:	07/04/2010	Barrier Rating:	40.20		
Barrier Description					
Type:	W-BEAM STRONG POST	Barrier Function:	TRAFFIC		
Barrier Material:	WEATHERING STEEL/CORTEN	Post Material:	WOOD		
Blockout Type:	WOOD	Length (ft.):	363		
Speed Limit (MPH):	25	Placement with Respect to Road:	OUTSIDE OF CURVE		
Hazard Behind Barrier:	EXTREME				
Barrier Crashworthiness					
Appropriate Test Level:	TL-1	Barrier Test Level:	TL-3	Is Barrier Crashworthy?:	YES
Beg. End Trtmt Type:	W-BEAM BCT	Is Beg. End Trtmt Crashworthy?:	NO	Approach Transition Type:	NONE
Ending End Trtmt Type:	W-BEAM BCT	Ending End Trtmt Crashworthy?:	NO		
Average Measurements					
Design Height (In.):	27	Width (In.):	0.0	Post Spacing (In.):	124.6
Height (In.):	27.2	Lateral Offset (In.):	33.7	Road Grade (%):	6.40
Physical Condition					
Barrier	Alignment and Height:	Alignment acceptable. Height within 1-in of 27-in design height.

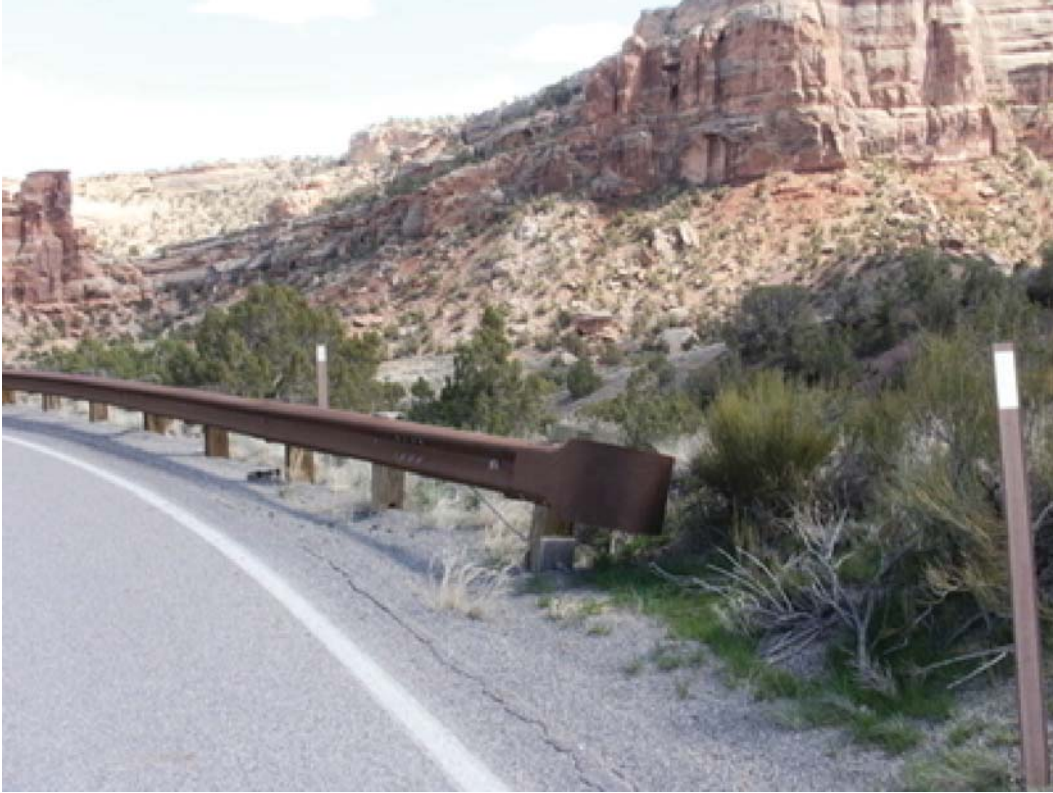
COLM_0010_21.602_R_1.JPG

Barrier ID:	COLM-0010-21.602-R				
Route Name:	RIMROCK DRIVE				
Inspection Date:	07/04/2010	Barrier Rating:	40.20		
Barrier Description					
Type:	W-BEAM STRONG POST	Barrier Function:	TRAFFIC		
Barrier Material:	WEATHERING STEEL/CORTEN	Post Material:	WOOD		
Blockout Type:	WOOD	Length (ft.):	411		
Speed Limit (MPH):	25	Placement with Respect to Road:	OUTSIDE OF CURVE		
Hazard Behind Barrier:	EXTREME				
Barrier Crashworthiness					
Appropriate Test Level:	TL-1	Barrier Test Level:	TL-3	Is Barrier Crashworthy?:	YES
Beg. End Trtmt Type:	W-BEAM BCT	Is Beg. End Trtmt Crashworthy?:	NO	Approach Transition Type:	NONE
Ending End Trtmt Type:	W-BEAM BCT	Ending End Trtmt Crashworthy?:	NO		
Average Measurements					
Design Height (In.):	27	Width (In.):	0.0	Post Spacing (In.):	99.6
Height (In.):	27.7	Lateral Offset (In.):	29.0	Road Grade (%):	6.30
Physical Condition					
Barrier	Alignment and Height:	Alignment acceptable. 217-ft was 1 to 3-in above the 27-in design height and 194-ft was within 1-in.

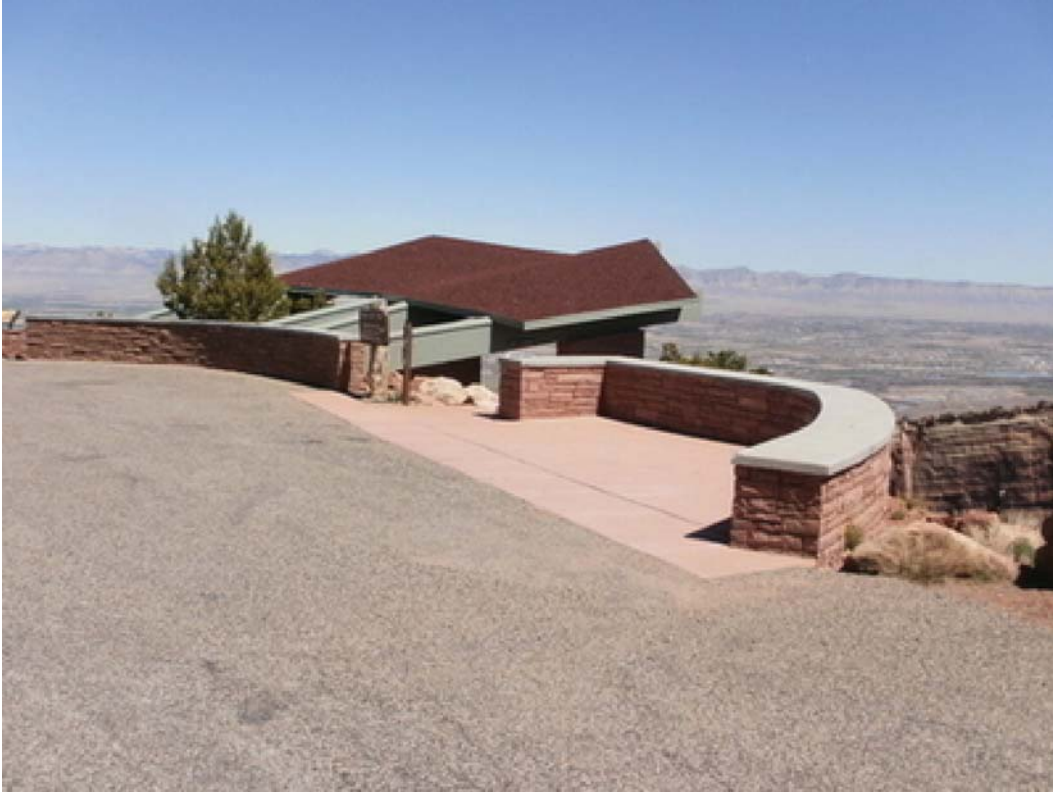
COLM_0200_0.546_L_1.JPG

Barrier ID:	COLM-0200-0.546-L				
Route Name:	SADDLEHORN LOOP ROAD				
Inspection Date:	08/04/2010	Barrier Rating:	0.00		
Barrier Description					
Type:	STONE MASONRY WITHOUT CONCRETE CORE WALL	Barrier Function:	NON-TRAFFIC		
Barrier Material:	STONE	Post Material:	N/A		
Blockout Type:	N/A	Length (ft.):	72		
Speed Limit (MPH):	15	Placement with Respect to Road:	NON-TRAFFIC BARRIER		
Hazard Behind Barrier:	N/A				
Barrier Crashworthiness					
Appropriate Test Level:	TL-1	Barrier Test Level:	N/A	Is Barrier Crashworthy?:	N/A
Beg. End Trtmt Type:	NONE	Is Beg. End Trtmt Crashworthy?:	N/A	Approach Transition Type:	NONE
Ending End Trtmt Type:	NONE	Ending End Trtmt Crashworthy?:	N/A		
Average Measurements					
Design Height (In.):	24	Width (In.):	23.0	Post Spacing (In.):	0.0
Height (In.):	34.5	Lateral Offset (In.):	0.0	Road Grade (%):	0.00
Physical Condition					
Barrier	Alignment and Height:	Alignment acceptable. Height was 2 to 19-in above the 24-in design height.
