GIP Report

NPS Guardwall/Rail Inventory Program Colonial National Historical Park

**Federal Highway Administration
Eastern Federal Lands Highway Division
Road Inventory Program (RIP)**

**Data Collection Date: November 2010
Report Date: December 2015**

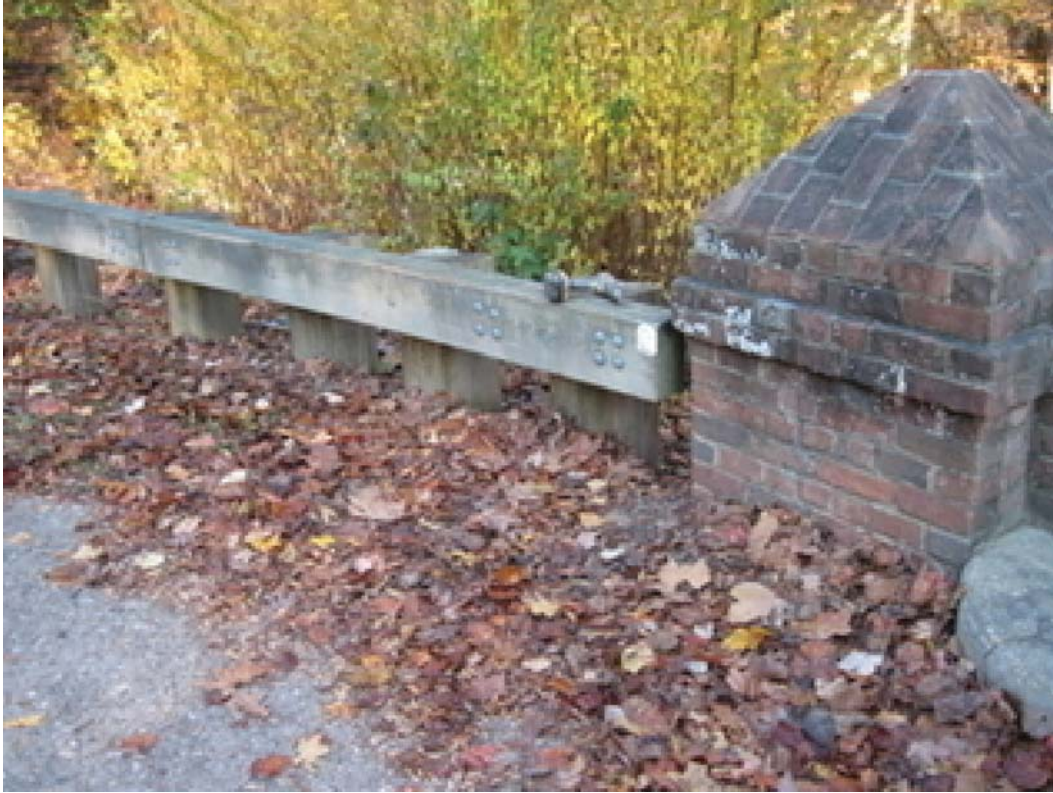
COLO_0001_0.501_R_1.jpg

Barrier ID:	COLO-0001-0.501-R				
Route Name:	COLONIAL PARKWAY				
Inspection Date:	11/18/2010	Barrier Rating:	19.20		
Barrier Description					
Type:	STEEL-BACKED TIMBER WITHOUT BLOCKOUT	Barrier Function:	TRAFFIC		
Barrier Material:	STEEL-BACKED TIMBER/LOG	Post Material:	WOOD		
Blockout Type:	N/A	Length (ft.):	56		
Speed Limit (MPH):	35	Placement with Respect to Road:	TANGENT		
Hazard Behind Barrier:	MEDIUM				
Barrier Crashworthiness					
Appropriate Test Level:	TL-2	Barrier Test Level:	TL-2	Is Barrier Crashworthy?:	YES
Beg. End Trtmt Type:	NONE	Is Beg. End Trtmt Crashworthy?:	N/A	Approach Transition Type:	RIGID SBT WALL - SBT
Ending End Trtmt Type:	SBT/LOG FLARED	Ending End Trtmt Crashworthy?:	NO		
Average Measurements					
Design Height (In.):	27	Width (In.):	0.0	Post Spacing (In.):	99.6
Height (In.):	27.5	Lateral Offset (In.):	118.6	Road Grade (%):	3.40
Physical Condition					
Barrier	Alignment and Height:	No alignment deflection observed. Height ranges from 0 in to 1 in above 27 in design height.

Breaking and Cracking:	No breaking or cracking observed.			
	Missing Elements:	No missing elements observed.			
	Corrosion and Weathering:	No corrosion or weathering observed.			
End Treatments	Alignment and Height:	Alignment acceptable. Height within 1-in of 27-in design height.			
	Breaking and Cracking:	No breaking or cracking observed.			
	Missing Elements:	No missing elements observed.			
	Corrosion and Weathering:	No corrosion or weathering observed.

Barrier ID:	COLO-0001-0.501-R				
Route Name:	COLONIAL PARKWAY				
Inspection Date:	11/18/2010	Barrier Rating:		19.20	
Repair Recommendations					
Repair Action:	NO ACTION	FMSS Work Type:	N/A	Repair Cost:	\$0
Brief Workorder:	N/A				
Workorder:	No action.

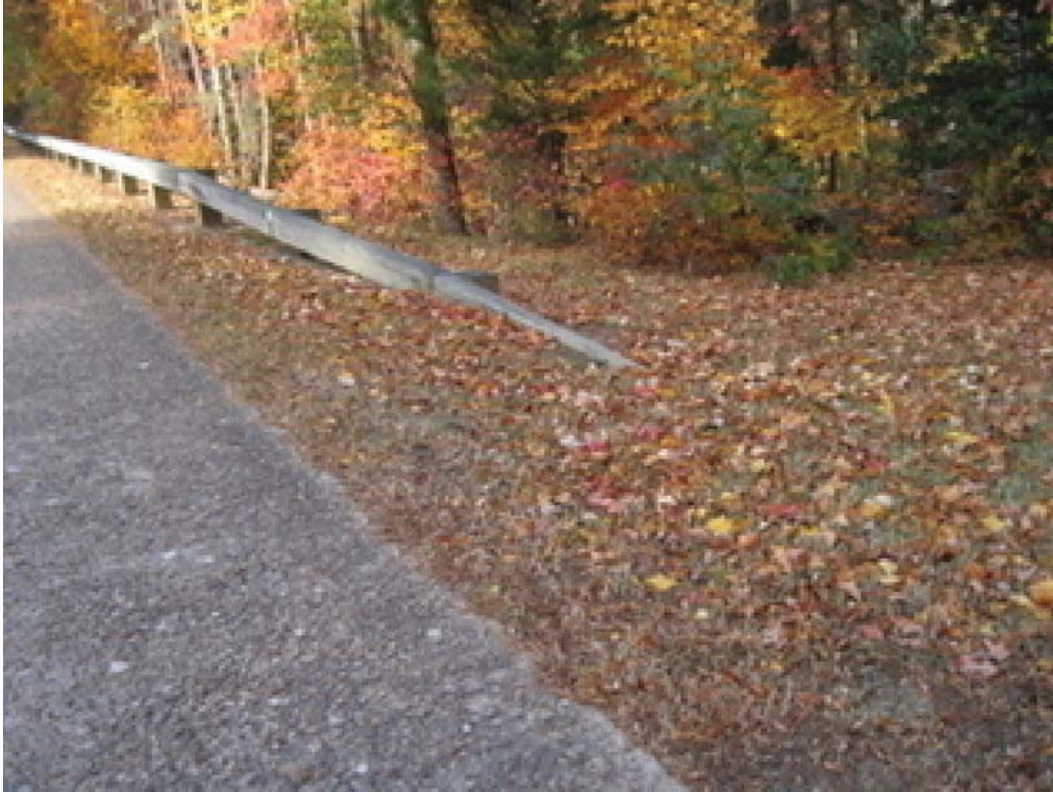
COLO_0001_0.540_R_1.jpg

Barrier ID:	COLO-0001-0.540-R				
Route Name:	COLONIAL PARKWAY				
Inspection Date:	11/18/2010	Barrier Rating:	25.10		
Barrier Description					
Type:	STEEL-BACKED TIMBER WITHOUT BLOCKOUT	Barrier Function:	TRAFFIC		
Barrier Material:	STEEL-BACKED TIMBER/LOG	Post Material:	WOOD		
Blockout Type:	N/A	Length (ft.):	306		
Speed Limit (MPH):	35	Placement with Respect to Road:	INSIDE OF CURVE		
Hazard Behind Barrier:	MEDIUM				
Barrier Crashworthiness					
Appropriate Test Level:	TL-2	Barrier Test Level:	TL-2	Is Barrier Crashworthy?:	YES
Beg. End Trtmt Type:	SBT/LOG FLARED	Is Beg. End Trtmt Crashworthy?:	N/A	Approach Transition Type:	RIGID SBT WALL - SBT
Ending End Trtmt Type:	NONE	Ending End Trtmt Crashworthy?:	NO		
Average Measurements					
Design Height (In.):	27	Width (In.):	0.0	Post Spacing (In.):	120.6
Height (In.):	26.5	Lateral Offset (In.):	52.7	Road Grade (%):	4.60
Physical Condition					
Barrier	Alignment and Height:	No alignment deflection observed. Height is 0-1 in below the 27-in design height along entire length.

Breaking and Cracking:	No breaking or cracking observed.			
	Missing Elements:	No missing elements observed.			
	Corrosion and Weathering:	No corrosion or weathering observed.			
End Treatments	Alignment and Height:	Alignment acceptable. Height within 1-in of 27-in design height.			
	Breaking and Cracking:	No breaking or cracking observed.			
	Missing Elements:	No missing elements observed.			
	Corrosion and Weathering:	No corrosion or weathering observed.

Barrier ID:	COLO-0001-0.540-R				
Route Name:	COLONIAL PARKWAY				
Inspection Date:	11/18/2010	Barrier Rating:		25.10	
Repair Recommendations					
Repair Action:	NO ACTION	FMSS Work Type:	N/A	Repair Cost:	\$0
Brief Workorder:	N/A				
Workorder:

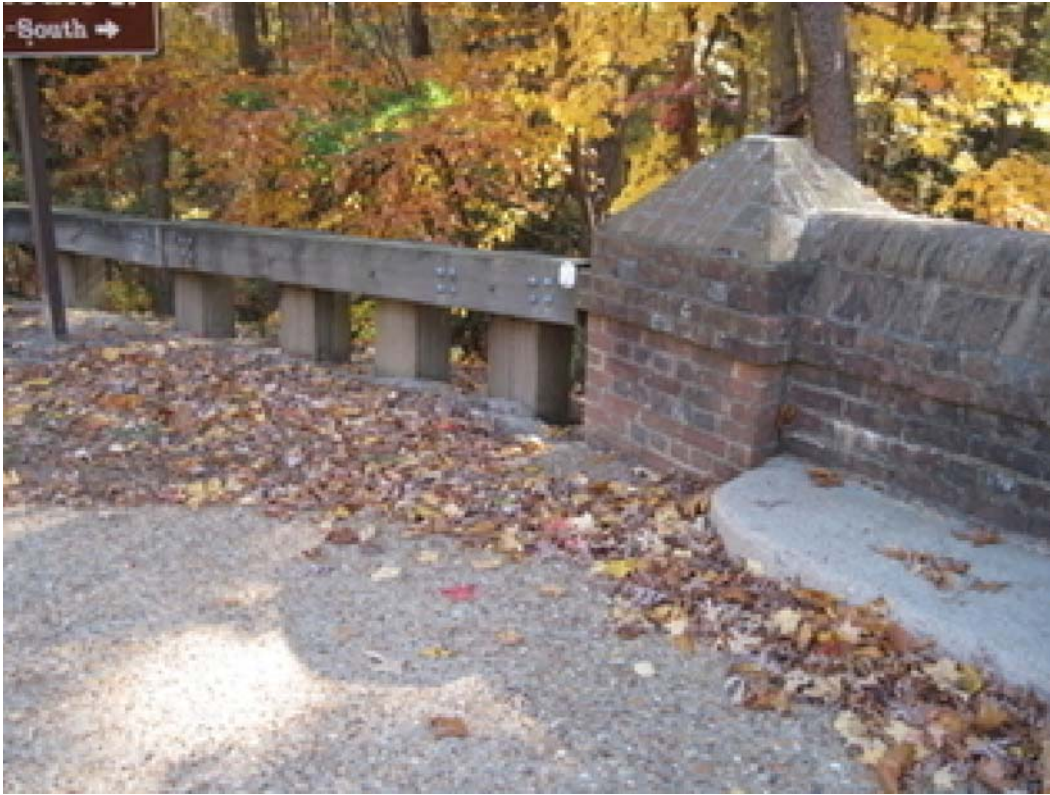
COLO_0001_0.567_L_1.jpg

Barrier ID:	COLO-0001-0.567-L				
Route Name:	COLONIAL PARKWAY				
Inspection Date:	11/18/2010	Barrier Rating:	34.00		
Barrier Description					
Type:	STEEL-BACKED TIMBER WITHOUT BLOCKOUT	Barrier Function:	TRAFFIC		
Barrier Material:	STEEL-BACKED TIMBER/LOG	Post Material:	WOOD		
Blockout Type:	N/A	Length (ft.):	220		
Speed Limit (MPH):	35	Placement with Respect to Road:	OUTSIDE OF CURVE		
Hazard Behind Barrier:	HIGH				
Barrier Crashworthiness					
Appropriate Test Level:	TL-2	Barrier Test Level:	TL-2	Is Barrier Crashworthy?:	YES
Beg. End Trtmt Type:	NONE	Is Beg. End Trtmt Crashworthy?:	NO	Approach Transition Type:	RIGID SBT WALL - SBT
Ending End Trtmt Type:	NONE	Ending End Trtmt Crashworthy?:	N/A		
Average Measurements					
Design Height (In.):	27	Width (In.):	0.0	Post Spacing (In.):	120.0
Height (In.):	26.7	Lateral Offset (In.):	57.2	Road Grade (%):	4.20
Physical Condition					
Barrier	Alignment and Height:	No alignment deflection was observed. Height is within 1 in of 27-in design height.

Breaking and Cracking:	No breaking or cracking was observed.			
	Missing Elements:	No missing elements were observed.			
	Corrosion and Weathering:	No corrosion or weathering was observed.			
End Treatments	Alignment and Height:				
	Breaking and Cracking:				
	Missing Elements:				
	Corrosion and Weathering:

Barrier ID:	COLO-0001-0.567-L				
Route Name:	COLONIAL PARKWAY				
Inspection Date:	11/18/2010	Barrier Rating:		34.00	
Repair Recommendations					
Repair Action:	NO ACTION	FMSS Work Type:	N/A	Repair Cost:	\$0
Brief Workorder:	N/A				
Workorder:

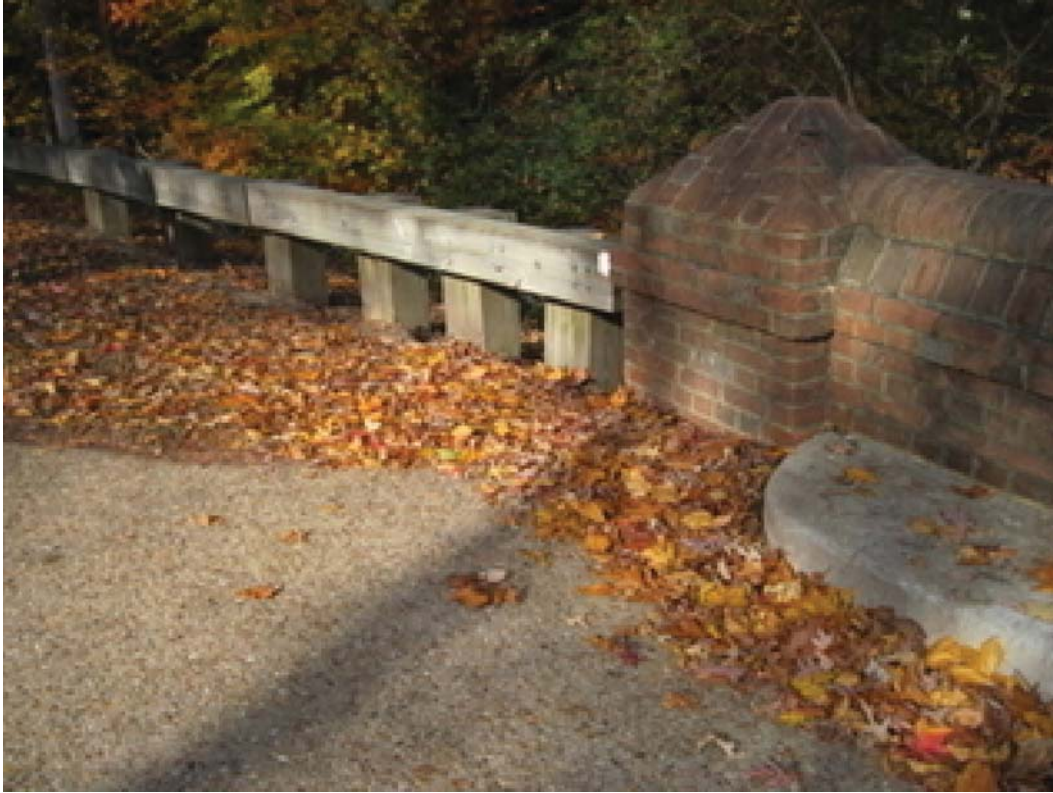
COLO_0001_0.637_R_1.jpg

Barrier ID:	COLO-0001-0.637-R				
Route Name:	COLONIAL PARKWAY				
Inspection Date:	11/18/2010	Barrier Rating:	38.00		
Barrier Description					
Type:	STEEL-BACKED TIMBER WITHOUT BLOCKOUT	Barrier Function:	TRAFFIC		
Barrier Material:	STEEL-BACKED TIMBER/LOG	Post Material:	WOOD		
Blockout Type:	N/A	Length (ft.):	579		
Speed Limit (MPH):	35	Placement with Respect to Road:	INSIDE OF CURVE		
Hazard Behind Barrier:	MEDIUM				
Barrier Crashworthiness					
Appropriate Test Level:	TL-2	Barrier Test Level:	TL-2	Is Barrier Crashworthy?:	YES
Beg. End Trtmt Type:	NONE	Is Beg. End Trtmt Crashworthy?:	N/A	Approach Transition Type:	RIGID SBT WALL - SBT
Ending End Trtmt Type:	NONE	Ending End Trtmt Crashworthy?:	N/A		
Average Measurements					
Design Height (In.):	27	Width (In.):	0.0	Post Spacing (In.):	120.0
Height (In.):	25.0	Lateral Offset (In.):	57.0	Road Grade (%):	0.30
Physical Condition					
Barrier	Alignment and Height:	No alignment deflection observed. Height is 1-3 in below 27-in design height along 80 ft and 3 - 4 in below along 260 ft.

Breaking and Cracking:	One 10-ft. rail has been struck by a tree and metal plate connectors are bent.			
	Missing Elements:	No missing elements observed.			
	Corrosion and Weathering:	No corrosion or weathering observed.			
End Treatments	Alignment and Height:				
	Breaking and Cracking:				
	Missing Elements:				
	Corrosion and Weathering:

Repair Action:	REPAIR	FMSS Work Type:	DEFERRED MAINTENANCE	Repair Cost:	\$7260
Brief Workorder:	Raise 340 feet to 27-inch design height and replace 10 feet of rail.				
Workorder:	Adjust Guardrail at \$10- per -Lin. Ft. for 340 LF = \$3400. Raise 340 feet of barrier to 27-inch design height. Replace Rail at \$25- per -Lin. Ft. for 10 LF = \$250. Replace 1 rail struck by tree. Low Speed Traffic Control at \$1475- per -Day for 2 Day(s) = \$2950.

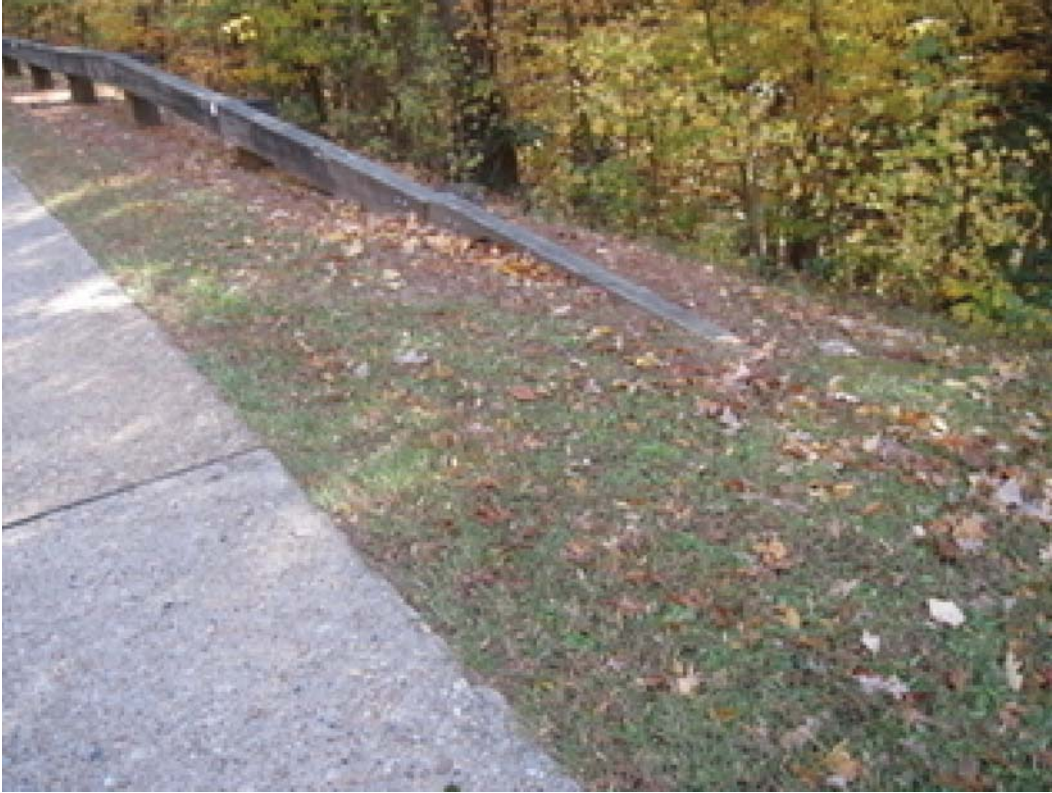
COLO_0001_0.640_L_1.jpg

Barrier ID:	COLO-0001-0.640-L				
Route Name:	COLONIAL PARKWAY				
Inspection Date:	11/18/2010	Barrier Rating:	30.70		
Barrier Description					
Type:	STEEL-BACKED TIMBER WITHOUT BLOCKOUT	Barrier Function:	TRAFFIC		
Barrier Material:	STEEL-BACKED TIMBER/LOG	Post Material:	WOOD		
Blockout Type:	N/A	Length (ft.):	466		
Speed Limit (MPH):	35	Placement with Respect to Road:	OUTSIDE OF CURVE		
Hazard Behind Barrier:	MEDIUM				
Barrier Crashworthiness					
Appropriate Test Level:	TL-2	Barrier Test Level:	TL-2	Is Barrier Crashworthy?:	YES
Beg. End Trtmt Type:	NONE	Is Beg. End Trtmt Crashworthy?:	N/A	Approach Transition Type:	RIGID SBT WALL - SBT
Ending End Trtmt Type:	SBT/LOG FLARED	Ending End Trtmt Crashworthy?:	NO		
Average Measurements					
Design Height (In.):	27	Width (In.):	0.0	Post Spacing (In.):	120.0
Height (In.):	26.0	Lateral Offset (In.):	56.2	Road Grade (%):	0.30
Physical Condition					
Barrier	Alignment and Height:	1 rail has been hit by a tree and is out of alignment by 6 - 12 in. Height is within 1 in of 27-in design height.

Breaking and Cracking:	Metal plate connectors on rail that has been hit are bent.			
	Missing Elements:	No missing elements were observed.			
	Corrosion and Weathering:	No corrosion or weathering was observed.			
End Treatments	Alignment and Height:	Alignment acceptable. Height within 1-in of 27-in design height.			
	Breaking and Cracking:	One post is broken such that a bolt is exposed.			
	Missing Elements:	No missing elements were observed.			
	Corrosion and Weathering:	No corrosion or weathering was observed.

Repair Action:	REPAIR	FMSS Work Type:	DEFERRED MAINTENANCE	Repair Cost:	\$2008
Brief Workorder:	Replace 1 broken post and 10 feet of rail.				
Workorder:	Replace Post at \$100- per -Each for 1 Post(s) = \$100. Replace broken post on end treatment Replace Rail at \$25- per -Lin. Ft. for 10 LF = \$250. Replace rail that has been hit by a tree Low Speed Traffic Control at \$1475- per -Day for 1 Day(s) = \$1475.

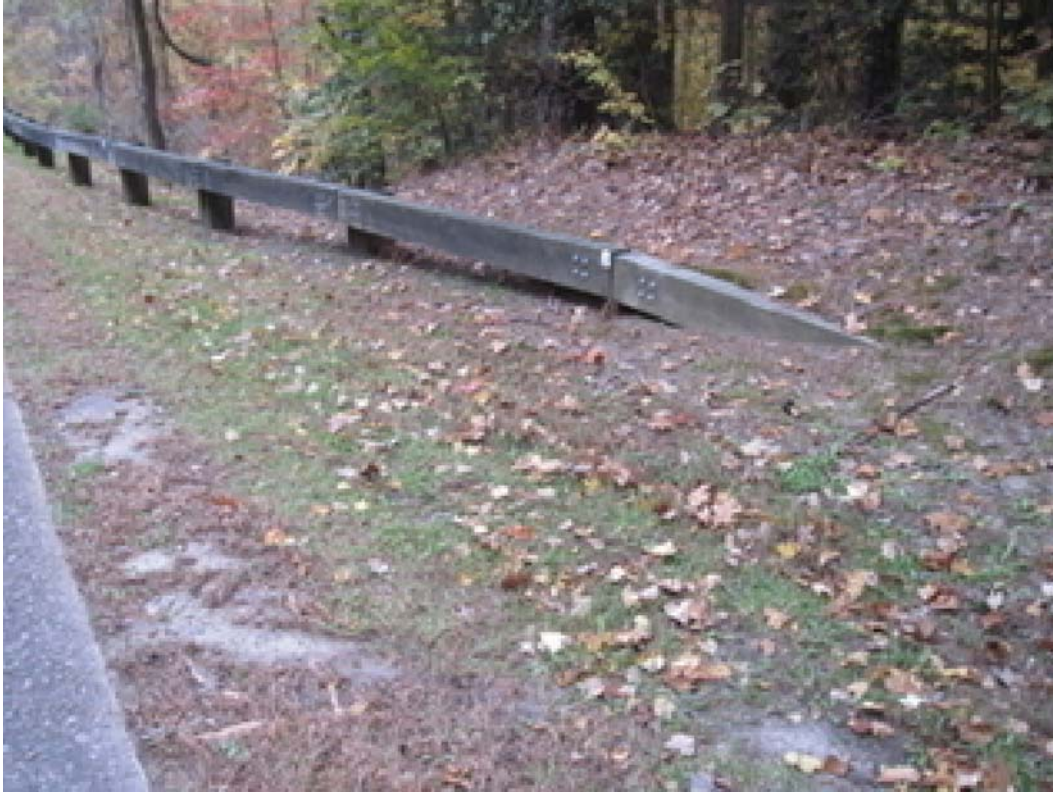
COLO_0001_1.450_L_1.jpg

Barrier ID:	COLO-0001-1.450-L				
Route Name:	COLONIAL PARKWAY				
Inspection Date:	11/15/2010	Barrier Rating:	24.00		
Barrier Description					
Type:	STEEL-BACKED TIMBER WITHOUT BLOCKOUT	Barrier Function:	TRAFFIC		
Barrier Material:	STEEL-BACKED TIMBER/LOG	Post Material:	WOOD		
Blockout Type:	N/A	Length (ft.):	453		
Speed Limit (MPH):	45	Placement with Respect to Road:	TANGENT		
Hazard Behind Barrier:	LOW				
Barrier Crashworthiness					
Appropriate Test Level:	TL-2	Barrier Test Level:	TL-2	Is Barrier Crashworthy?:	YES
Beg. End Trtmt Type:	SBT/LOG FLARED	Is Beg. End Trtmt Crashworthy?:	NO	Approach Transition Type:	NONE
Ending End Trtmt Type:	SBT/LOG BURIED	Ending End Trtmt Crashworthy?:	YES		
Average Measurements					
Design Height (In.):	27	Width (In.):	0.0	Post Spacing (In.):	120.0
Height (In.):	26.7	Lateral Offset (In.):	53.0	Road Grade (%):	2.10
Physical Condition					
Barrier	Alignment and Height:	No alignment deflection observed. Height ranges from 1-in below to 1-in above the 27-in design height.

Breaking and Cracking:	No breaking or cracking observed.			
	Missing Elements:	No missing elements observed.			
	Corrosion and Weathering:	No corrosion or weathering observed.			
End Treatments	Alignment and Height:	Alignment acceptable. Height within 1-in of 27-in design height.			
	Breaking and Cracking:	No breaking or cracking observed.			
	Missing Elements:	No missing elements observed.			
	Corrosion and Weathering:	No corrosion or weathering observed.

Barrier ID:	COLO-0001-1.450-L				
Route Name:	COLONIAL PARKWAY				
Inspection Date:	11/15/2010	Barrier Rating:		24.00	
Repair Recommendations					
Repair Action:	NO ACTION	FMSS Work Type:	N/A	Repair Cost:	\$0
Brief Workorder:	N/A				
Workorder:

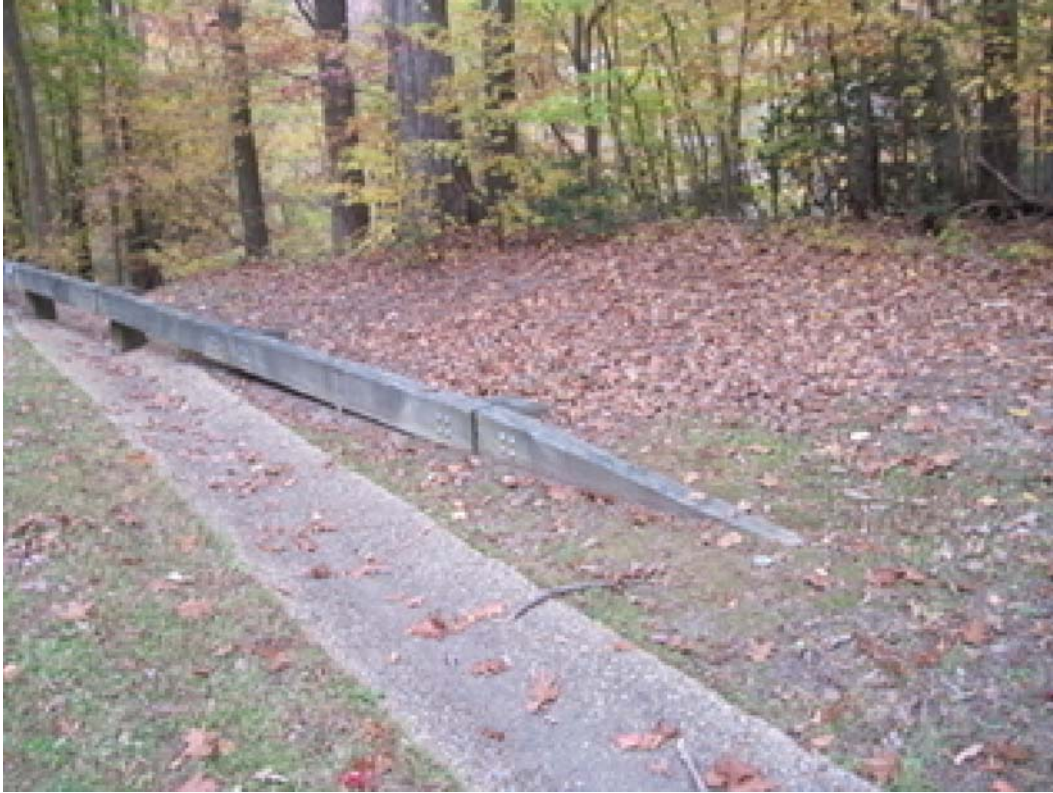
COLO_0001_1.464_R_1.jpg

Barrier ID:	COLO-0001-1.464-R				
Route Name:	COLONIAL PARKWAY				
Inspection Date:	11/15/2010	Barrier Rating:	30.80		
Barrier Description					
Type:	STEEL-BACKED TIMBER WITHOUT BLOCKOUT	Barrier Function:	TRAFFIC		
Barrier Material:	STEEL-BACKED TIMBER/LOG	Post Material:	WOOD		
Blockout Type:	N/A	Length (ft.):	407		
Speed Limit (MPH):	45	Placement with Respect to Road:	TANGENT		
Hazard Behind Barrier:	MEDIUM				
Barrier Crashworthiness					
Appropriate Test Level:	TL-2	Barrier Test Level:	TL-2	Is Barrier Crashworthy?:	YES
Beg. End Trtmt Type:	SBT/LOG FLARED	Is Beg. End Trtmt Crashworthy?:	NO	Approach Transition Type:	NONE
Ending End Trtmt Type:	SBT/LOG BURIED	Ending End Trtmt Crashworthy?:	YES		
Average Measurements					
Design Height (In.):	27	Width (In.):	0.0	Post Spacing (In.):	119.6
Height (In.):	26.0	Lateral Offset (In.):	74.6	Road Grade (%):	2.70
Physical Condition					
Barrier	Alignment and Height:	One rail is leaning toward road out of alignment by 6 - 12 in. 120 ft of barrier is 1 - 2 in below 27-in design height.

Breaking and Cracking:	Rail that is out of alignment has bent metal plate connectors due to impact from falling tree.			
	Missing Elements:	No missing elements were observed.			
	Corrosion and Weathering:	No corrosion or weathering was observed.			
End Treatments	Alignment and Height:	Alignment acceptable. Height within 1-in of 27-in design height.			
	Breaking and Cracking:	No breaking or cracking was observed.			
	Missing Elements:	No missing elements were observed.			
	Corrosion and Weathering:	No corrosion or weathering was observed.

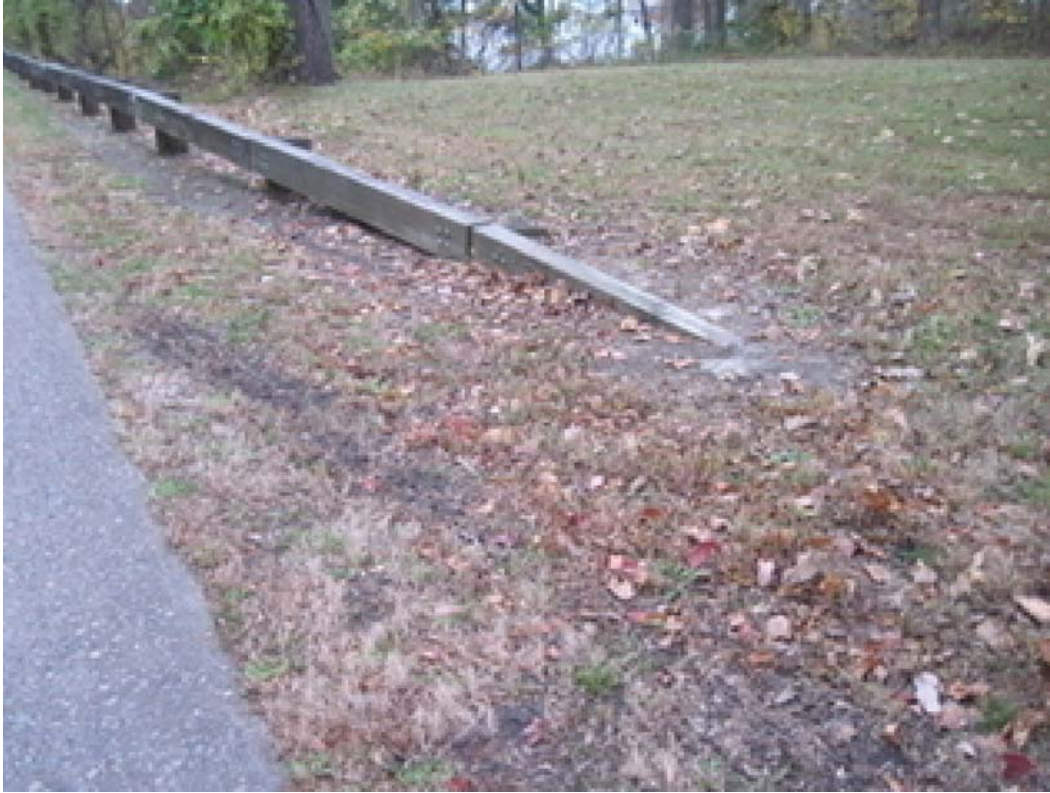
COLO_0001_2.225_R_1.jpg

Barrier ID:	COLO-0001-2.225-R				
Route Name:	COLONIAL PARKWAY				
Inspection Date:	11/15/2010	Barrier Rating:	55.20		
Barrier Description					
Type:	STEEL-BACKED TIMBER WITHOUT BLOCKOUT	Barrier Function:	TRAFFIC		
Barrier Material:	STEEL-BACKED TIMBER/LOG	Post Material:	WOOD		
Blockout Type:	N/A	Length (ft.):	745		
Speed Limit (MPH):	45	Placement with Respect to Road:	OUTSIDE OF CURVE		
Hazard Behind Barrier:	MEDIUM				
Barrier Crashworthiness					
Appropriate Test Level:	TL-2	Barrier Test Level:	TL-2	Is Barrier Crashworthy?:	YES
Beg. End Trtmt Type:	SBT/LOG FLARED	Is Beg. End Trtmt Crashworthy?:	NO	Approach Transition Type:	NONE
Ending End Trtmt Type:	SBT/LOG FLARED	Ending End Trtmt Crashworthy?:	NO		
Average Measurements					
Design Height (In.):	27	Width (In.):	0.0	Post Spacing (In.):	120.0
Height (In.):	25.7	Lateral Offset (In.):	47.0	Road Grade (%):	0.60
Physical Condition					
Barrier	Alignment and Height:	No alignment deflection observed. Height ranges from 3 in to 4 in below 27 in design height for 395 ft 1 in to 3 in below for 100 ft and from 1 in below to 4 in above design height for 190 ft.

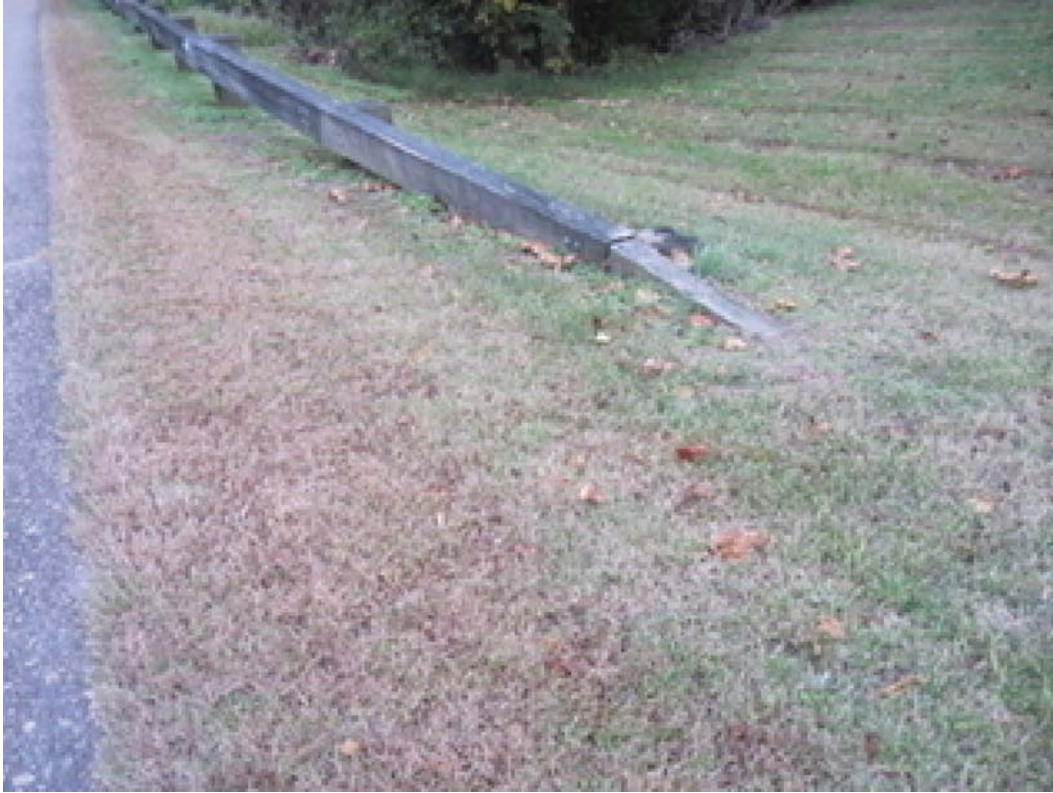
COLO_0001_2.288_L_1.jpg

Barrier ID:	COLO-0001-2.288-L				
Route Name:	COLONIAL PARKWAY				
Inspection Date:	11/15/2010	Barrier Rating:	26.50		
Barrier Description					
Type:	STEEL-BACKED TIMBER WITHOUT BLOCKOUT	Barrier Function:	TRAFFIC		
Barrier Material:	STEEL-BACKED TIMBER/LOG	Post Material:	WOOD		
Blockout Type:	N/A	Length (ft.):	288		
Speed Limit (MPH):	45	Placement with Respect to Road:	TANGENT		
Hazard Behind Barrier:	MEDIUM				
Barrier Crashworthiness					
Appropriate Test Level:	TL-2	Barrier Test Level:	TL-2	Is Barrier Crashworthy?:	YES
Beg. End Trtmt Type:	SBT/LOG FLARED	Is Beg. End Trtmt Crashworthy?:	NO	Approach Transition Type:	NONE
Ending End Trtmt Type:	SBT/LOG FLARED	Ending End Trtmt Crashworthy?:	NO		
Average Measurements					
Design Height (In.):	27	Width (In.):	0.0	Post Spacing (In.):	120.0
Height (In.):	26.0	Lateral Offset (In.):	51.2	Road Grade (%):	1.00
Physical Condition					
Barrier	Alignment and Height:	No alignment deflection was observed. Height is 1 - 3 in below 27-in design height along 70 ft.

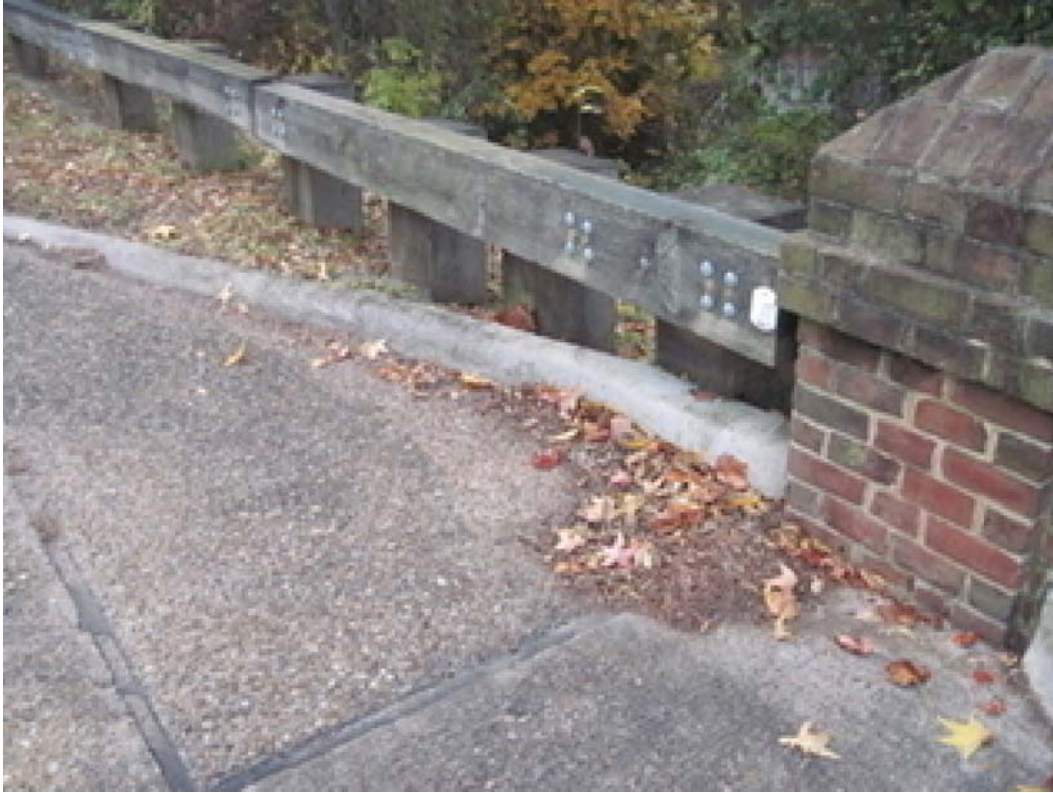
COLO_0001_2.422_L_1.jpg

Barrier ID:	COLO-0001-2.422-L				
Route Name:	COLONIAL PARKWAY				
Inspection Date:	11/16/2010	Barrier Rating:	26.50		
Barrier Description					
Type:	STEEL-BACKED TIMBER WITHOUT BLOCKOUT	Barrier Function:	TRAFFIC		
Barrier Material:	STEEL-BACKED TIMBER/LOG	Post Material:	WOOD		
Blockout Type:	N/A	Length (ft.):	155		
Speed Limit (MPH):	45	Placement with Respect to Road:	INSIDE OF CURVE		
Hazard Behind Barrier:	MEDIUM				
Barrier Crashworthiness					
Appropriate Test Level:	TL-2	Barrier Test Level:	TL-2	Is Barrier Crashworthy?:	YES
Beg. End Trtmt Type:	NONE	Is Beg. End Trtmt Crashworthy?:	N/A	Approach Transition Type:	RIGID SBT WALL - SBT
Ending End Trtmt Type:	SBT/LOG FLARED	Ending End Trtmt Crashworthy?:	NO		
Average Measurements					
Design Height (In.):	27	Width (In.):	0.0	Post Spacing (In.):	119.6
Height (In.):	26.2	Lateral Offset (In.):	49.7	Road Grade (%):	2.70
Physical Condition					
Barrier	Alignment and Height:	No alignment deflection observed. Height ranges from 0 in to 1 in below 27 in design height.

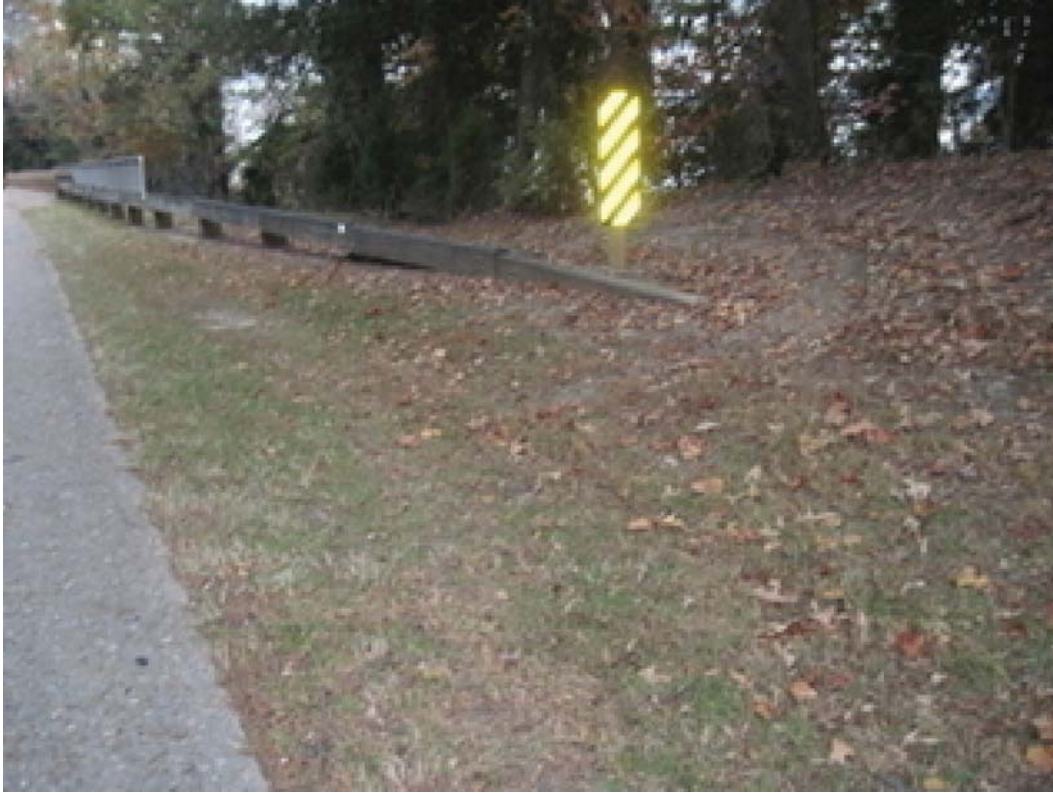
COLO_0001_2.422_R_1.jpg

Barrier ID:	COLO-0001-2.422-R				
Route Name:	COLONIAL PARKWAY				
Inspection Date:	11/15/2010	Barrier Rating:	27.80		
Barrier Description					
Type:	STEEL-BACKED TIMBER WITHOUT BLOCKOUT	Barrier Function:	TRAFFIC		
Barrier Material:	STEEL-BACKED TIMBER/LOG	Post Material:	WOOD		
Blockout Type:	N/A	Length (ft.):	120		
Speed Limit (MPH):	45	Placement with Respect to Road:	TANGENT		
Hazard Behind Barrier:	MEDIUM				
Barrier Crashworthiness					
Appropriate Test Level:	TL-2	Barrier Test Level:	TL-2	Is Barrier Crashworthy?:	YES
Beg. End Trtmt Type:	SBT/LOG FLARED	Is Beg. End Trtmt Crashworthy?:	NO	Approach Transition Type:	RIGID SBT WALL - SBT
Ending End Trtmt Type:	NONE	Ending End Trtmt Crashworthy?:	N/A		
Average Measurements					
Design Height (In.):	27	Width (In.):	0.0	Post Spacing (In.):	119.6
Height (In.):	26.2	Lateral Offset (In.):	67.6	Road Grade (%):	3.20
Physical Condition					
Barrier	Alignment and Height:	No alignment deflection observed. Height is 0-1 in below the 27-in design height.

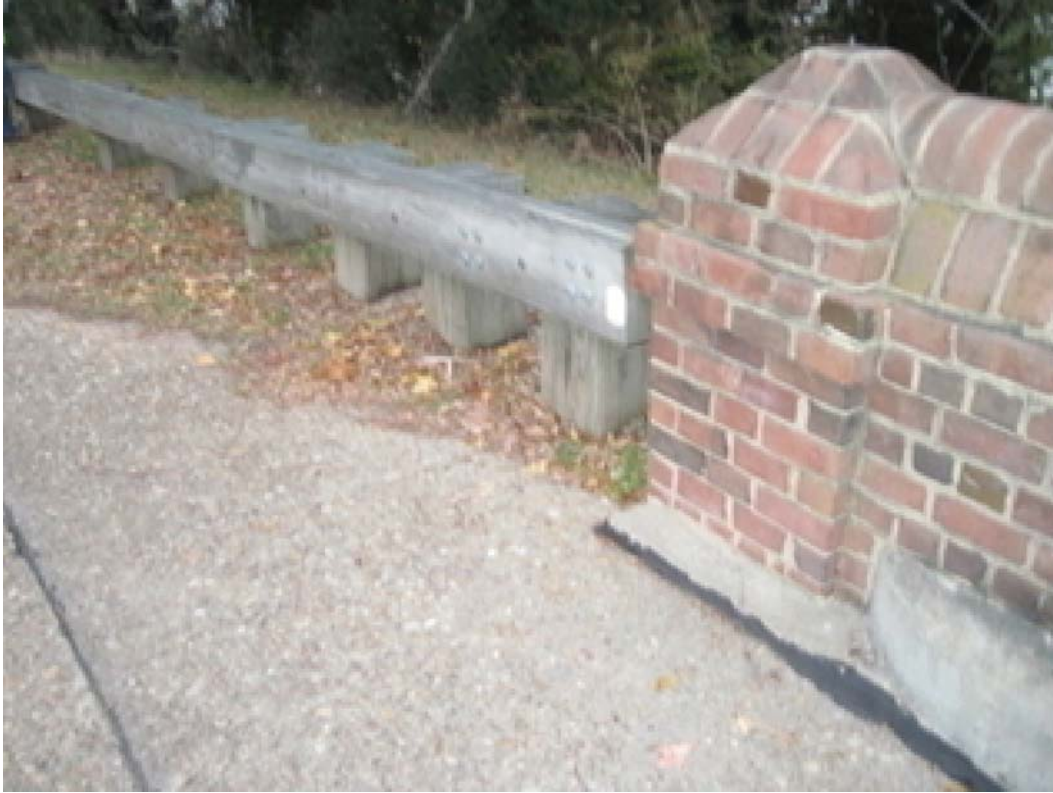
COLO_0001_2.467_R_1.jpg

Barrier ID:	COLO-0001-2.467-R				
Route Name:	COLONIAL PARKWAY				
Inspection Date:	11/15/2010	Barrier Rating:	32.20		
Barrier Description					
Type:	STEEL-BACKED TIMBER WITHOUT BLOCKOUT	Barrier Function:	TRAFFIC		
Barrier Material:	STEEL-BACKED TIMBER/LOG	Post Material:	WOOD		
Blockout Type:	N/A	Length (ft.):	103		
Speed Limit (MPH):	45	Placement with Respect to Road:	TANGENT		
Hazard Behind Barrier:	MEDIUM				
Barrier Crashworthiness					
Appropriate Test Level:	TL-2	Barrier Test Level:	TL-2	Is Barrier Crashworthy?:	YES
Beg. End Trtmt Type:	NONE	Is Beg. End Trtmt Crashworthy?:	N/A	Approach Transition Type:	RIGID SBT WALL - SBT
Ending End Trtmt Type:	SBT/LOG FLARED	Ending End Trtmt Crashworthy?:	NO		
Average Measurements					
Design Height (In.):	27	Width (In.):	0.0	Post Spacing (In.):	120.3
Height (In.):	24.7	Lateral Offset (In.):	59.2	Road Grade (%):	5.10
Physical Condition					
Barrier	Alignment and Height:	No alignment deflection observed. Height is up to 1-3 in below the 27-in design height along 50 ft of barrier.

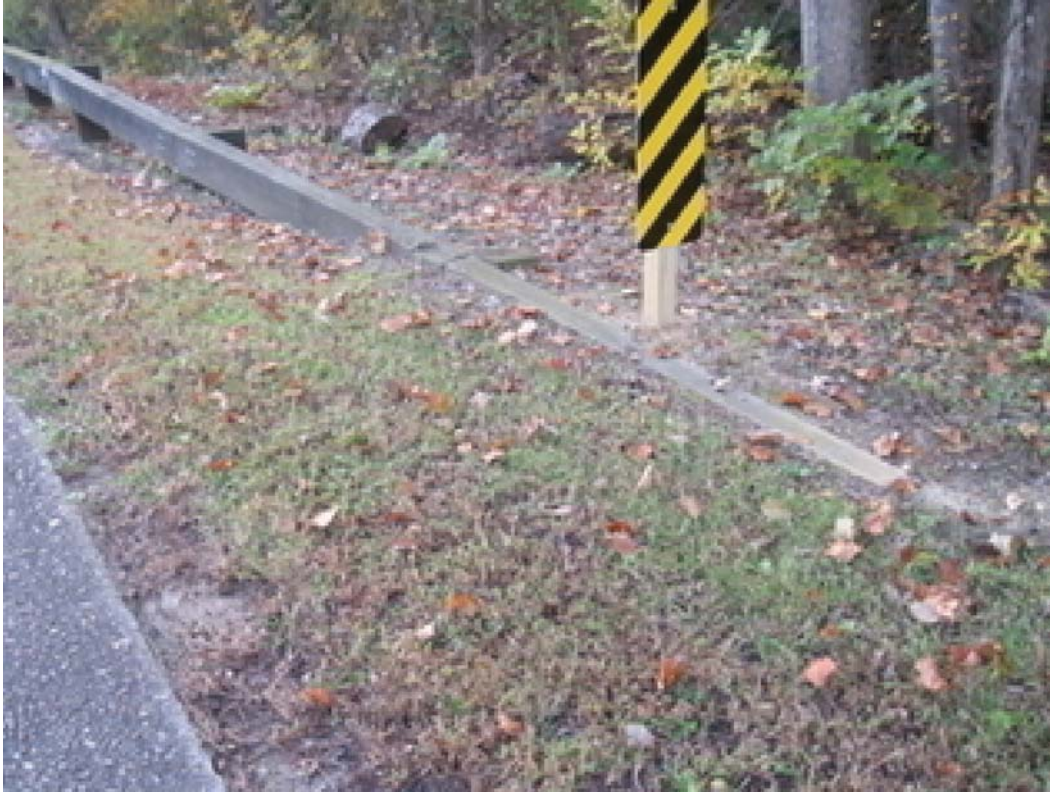
COLO_0001_2.470_L_1.jpg

Barrier ID:	COLO-0001-2.470-L				
Route Name:	COLONIAL PARKWAY				
Inspection Date:	11/16/2010	Barrier Rating:	32.20		
Barrier Description					
Type:	STEEL-BACKED TIMBER WITHOUT BLOCKOUT	Barrier Function:	TRAFFIC		
Barrier Material:	STEEL-BACKED TIMBER/LOG	Post Material:	WOOD		
Blockout Type:	N/A	Length (ft.):	306		
Speed Limit (MPH):	45	Placement with Respect to Road:	INSIDE OF CURVE		
Hazard Behind Barrier:	MEDIUM				
Barrier Crashworthiness					
Appropriate Test Level:	TL-2	Barrier Test Level:	TL-2	Is Barrier Crashworthy?:	YES
Beg. End Trtmt Type:	NONE	Is Beg. End Trtmt Crashworthy?:	N/A	Approach Transition Type:	RIGID SBT WALL - SBT
Ending End Trtmt Type:	SBT/LOG FLARED	Ending End Trtmt Crashworthy?:	NO		
Average Measurements					
Design Height (In.):	27	Width (In.):	0.0	Post Spacing (In.):	120.0
Height (In.):	26.7	Lateral Offset (In.):	47.2	Road Grade (%):	4.00
Physical Condition					
Barrier	Alignment and Height:	No alignment deflection observed. Height ranges from 0 in to 1 in below 27 in design height.

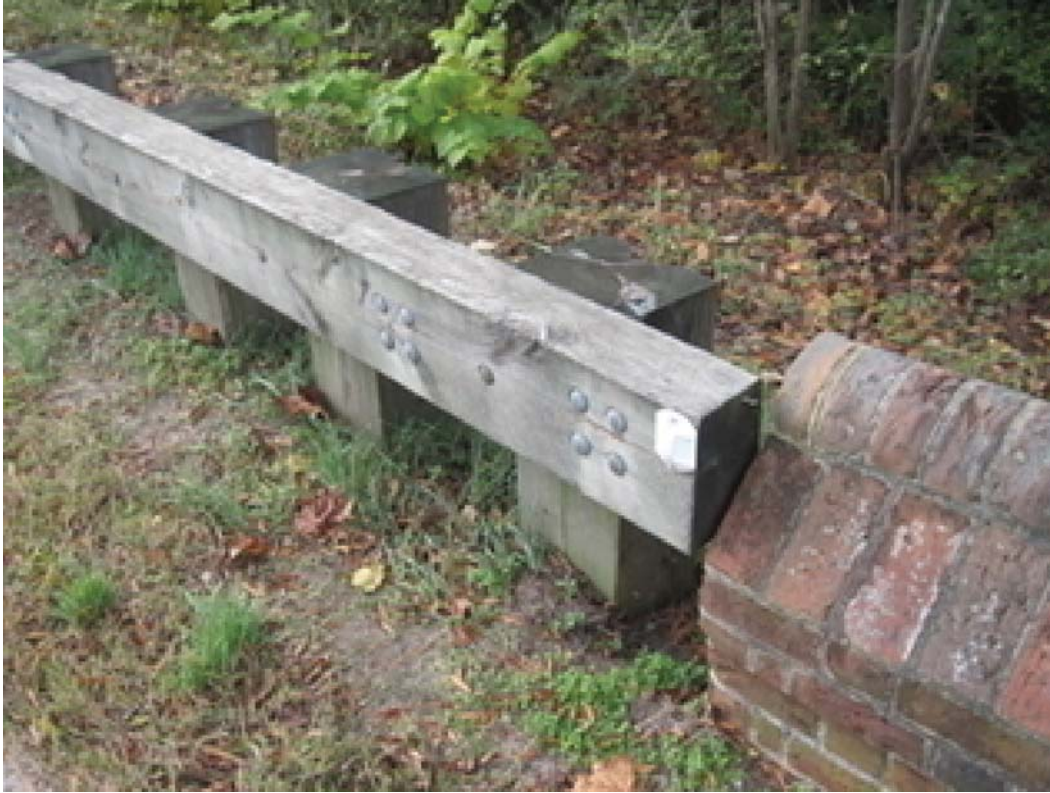
COLO_0001_2.881_L_1.jpg

Barrier ID:	COLO-0001-2.881-L				
Route Name:	COLONIAL PARKWAY				
Inspection Date:	11/16/2010	Barrier Rating:	32.20		
Barrier Description					
Type:	STEEL-BACKED TIMBER WITHOUT BLOCKOUT	Barrier Function:	TRAFFIC		
Barrier Material:	STEEL-BACKED TIMBER/LOG	Post Material:	WOOD		
Blockout Type:	N/A	Length (ft.):	215		
Speed Limit (MPH):	45	Placement with Respect to Road:	OUTSIDE OF CURVE		
Hazard Behind Barrier:	MEDIUM				
Barrier Crashworthiness					
Appropriate Test Level:	TL-2	Barrier Test Level:	TL-2	Is Barrier Crashworthy?:	YES
Beg. End Trtmt Type:	SBT/LOG FLARED	Is Beg. End Trtmt Crashworthy?:	NO	Approach Transition Type:	RIGID SBT WALL - SBT
Ending End Trtmt Type:	NONE	Ending End Trtmt Crashworthy?:	N/A		
Average Measurements					
Design Height (In.):	27	Width (In.):	0.0	Post Spacing (In.):	120.3
Height (In.):	26.2	Lateral Offset (In.):	49.0	Road Grade (%):	1.80
Physical Condition					
Barrier	Alignment and Height:	No alignment deflection observed. Height is 0-1 in below the 27-in design height.

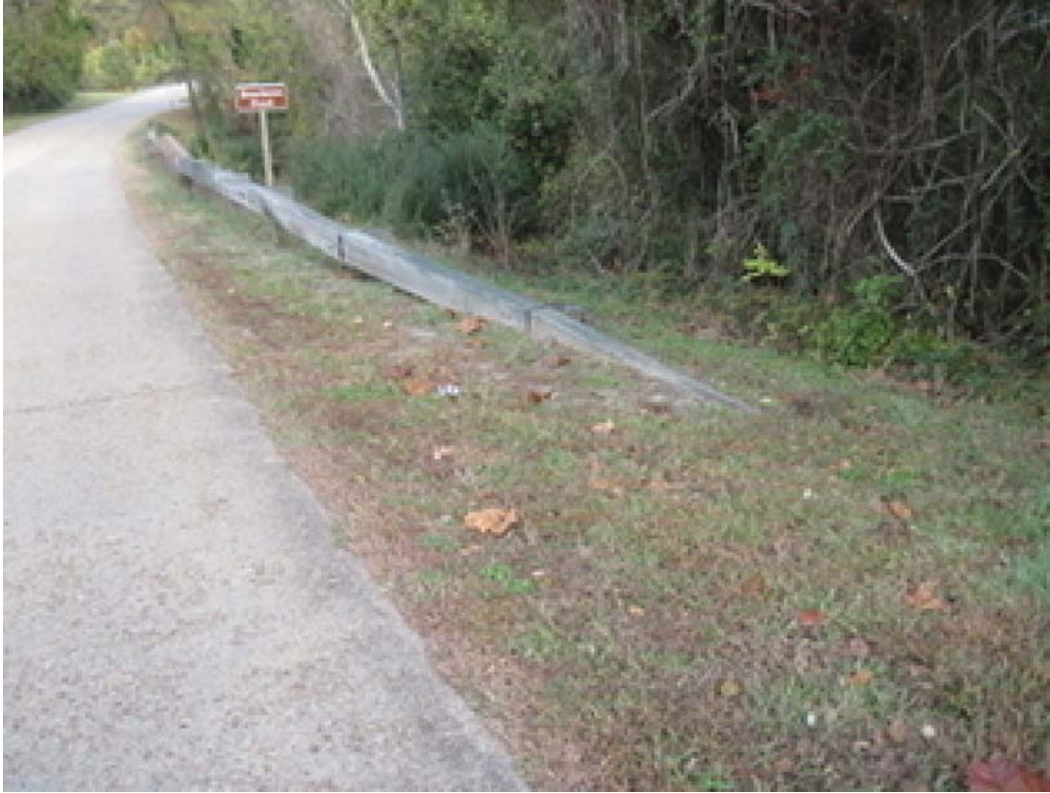
COLO_0001_2.908_R_1.jpg

Barrier ID:	COLO-0001-2.908-R				
Route Name:	COLONIAL PARKWAY				
Inspection Date:	11/16/2010	Barrier Rating:	31.20		
Barrier Description					
Type:	STEEL-BACKED TIMBER WITHOUT BLOCKOUT	Barrier Function:	TRAFFIC		
Barrier Material:	STEEL-BACKED TIMBER/LOG	Post Material:	WOOD		
Blockout Type:	N/A	Length (ft.):	58		
Speed Limit (MPH):	45	Placement with Respect to Road:	INSIDE OF CURVE		
Hazard Behind Barrier:	LOW				
Barrier Crashworthiness					
Appropriate Test Level:	TL-2	Barrier Test Level:	TL-2	Is Barrier Crashworthy?:	YES
Beg. End Trtmt Type:	SBT/LOG FLARED	Is Beg. End Trtmt Crashworthy?:	NO	Approach Transition Type:	RIGID SBT WALL - SBT
Ending End Trtmt Type:	NONE	Ending End Trtmt Crashworthy?:	N/A		
Average Measurements					
Design Height (In.):	27	Width (In.):	0.0	Post Spacing (In.):	80.3
Height (In.):	24.7	Lateral Offset (In.):	46.2	Road Grade (%):	0.60
Physical Condition					
Barrier	Alignment and Height:	No alignment deflection was observed. Height is 2 - 3 in below 27-in design height.

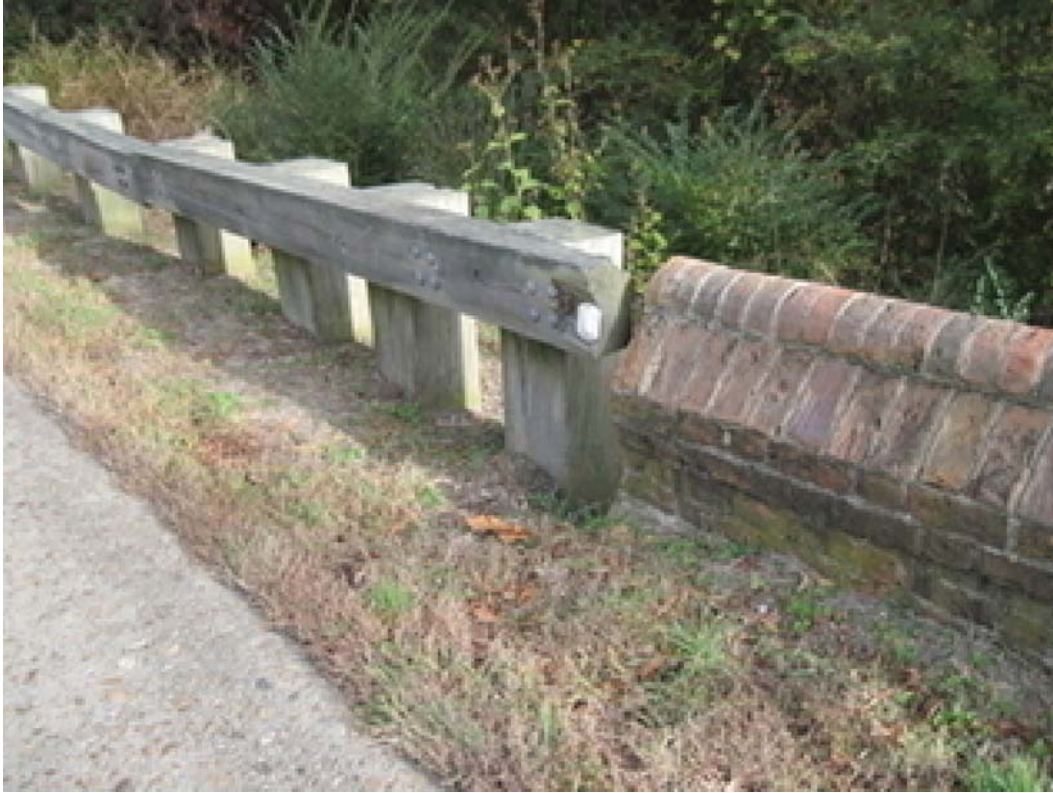
COLO_0001_2.926_R_1.jpg

Barrier ID:	COLO-0001-2.926-R				
Route Name:	COLONIAL PARKWAY				
Inspection Date:	11/16/2010	Barrier Rating:	33.70		
Barrier Description					
Type:	STEEL-BACKED TIMBER WITHOUT BLOCKOUT	Barrier Function:	TRAFFIC		
Barrier Material:	STEEL-BACKED TIMBER/LOG	Post Material:	WOOD		
Blockout Type:	N/A	Length (ft.):	151		
Speed Limit (MPH):	45	Placement with Respect to Road:	INSIDE OF CURVE		
Hazard Behind Barrier:	MEDIUM				
Barrier Crashworthiness					
Appropriate Test Level:	TL-2	Barrier Test Level:	TL-2	Is Barrier Crashworthy?:	YES
Beg. End Trtmt Type:	NONE	Is Beg. End Trtmt Crashworthy?:	N/A	Approach Transition Type:	RIGID SBT WALL - SBT
Ending End Trtmt Type:	SBT/LOG FLARED	Ending End Trtmt Crashworthy?:	NO		
Average Measurements					
Design Height (In.):	27	Width (In.):	0.0	Post Spacing (In.):	120.0
Height (In.):	24.0	Lateral Offset (In.):	47.0	Road Grade (%):	0.40
Physical Condition					
Barrier	Alignment and Height:	No alignment deflection was observed. Height is 1-3 in below 27-in design height for 101 ft.

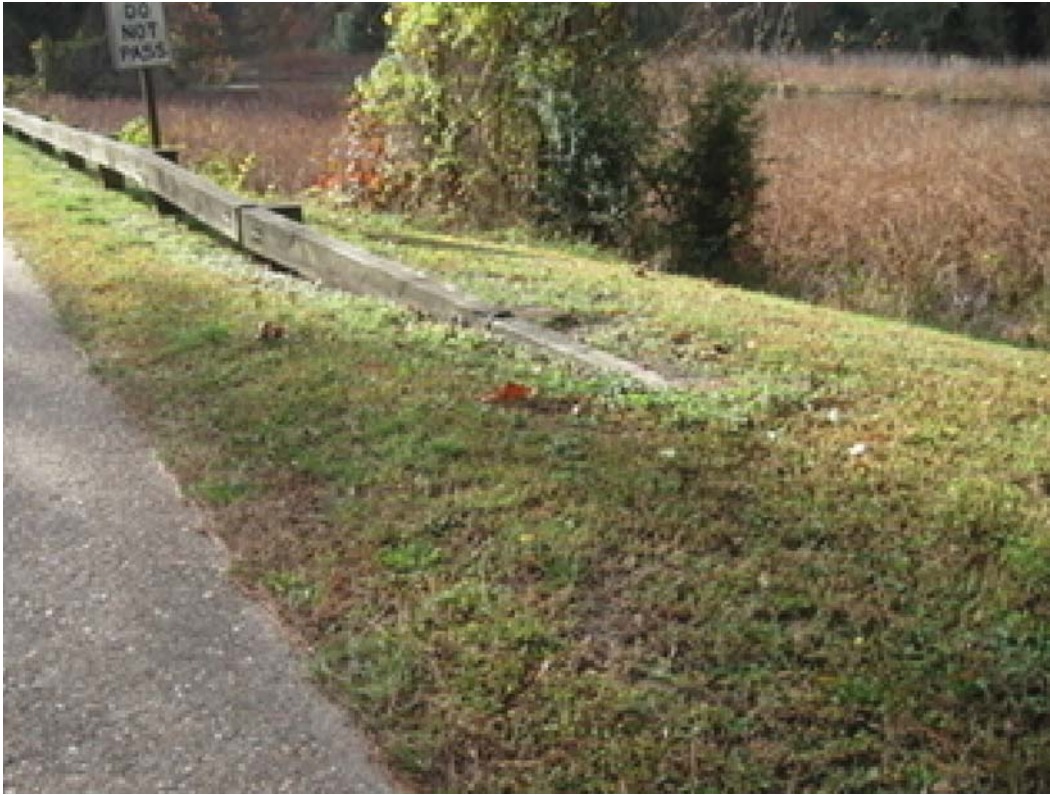
COLO_0001_2.928_L_1.jpg

Barrier ID:	COLO-0001-2.928-L				
Route Name:	COLONIAL PARKWAY				
Inspection Date:	11/16/2010	Barrier Rating:	35.00		
Barrier Description					
Type:	STEEL-BACKED TIMBER WITHOUT BLOCKOUT	Barrier Function:	TRAFFIC		
Barrier Material:	STEEL-BACKED TIMBER/LOG	Post Material:	WOOD		
Blockout Type:	N/A	Length (ft.):	175		
Speed Limit (MPH):	45	Placement with Respect to Road:	OUTSIDE OF CURVE		
Hazard Behind Barrier:	MEDIUM				
Barrier Crashworthiness					
Appropriate Test Level:	TL-2	Barrier Test Level:	TL-2	Is Barrier Crashworthy?:	YES
Beg. End Trtmt Type:	NONE	Is Beg. End Trtmt Crashworthy?:	N/A	Approach Transition Type:	RIGID SBT WALL - SBT
Ending End Trtmt Type:	SBT/LOG FLARED	Ending End Trtmt Crashworthy?:	NO		
Average Measurements					
Design Height (In.):	27	Width (In.):	0.0	Post Spacing (In.):	120.6
Height (In.):	26.2	Lateral Offset (In.):	45.2	Road Grade (%):	0.70
Physical Condition					
Barrier	Alignment and Height:	No alignment deflection observed. Height is 1-3 in below the 27-in design height along 50 ft of barrier.

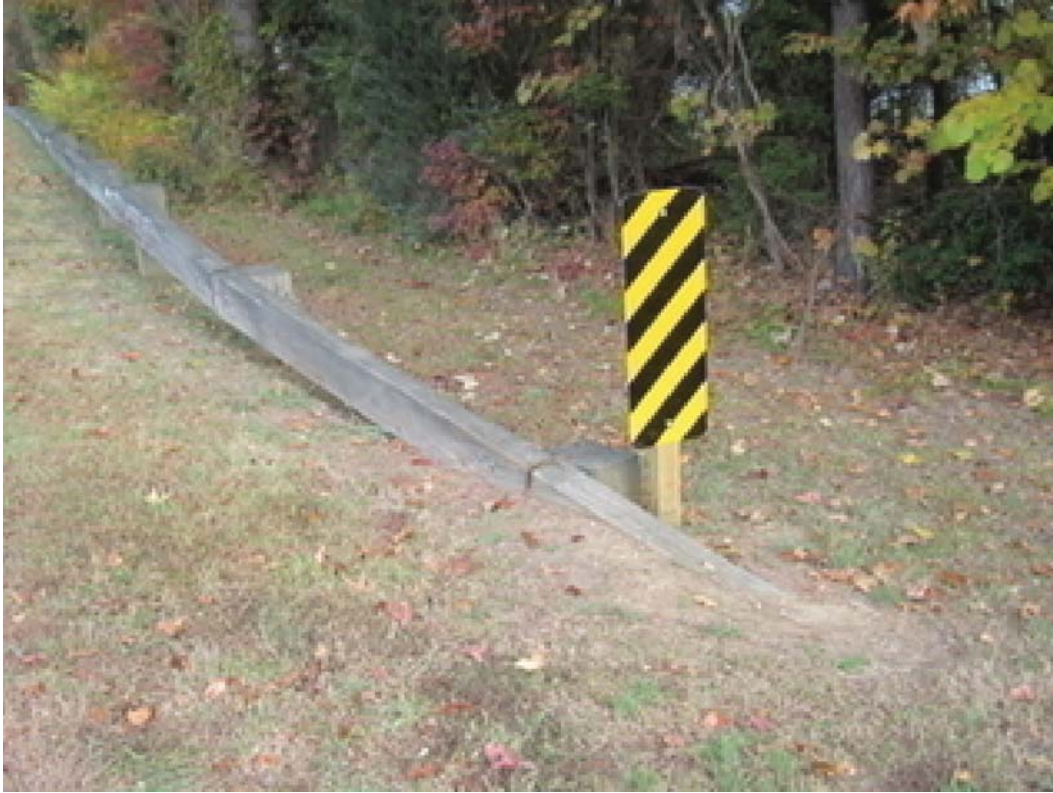
COLO_0001_3.024_R_1.jpg

Barrier ID:	COLO-0001-3.024-R				
Route Name:	COLONIAL PARKWAY				
Inspection Date:	11/16/2010	Barrier Rating:	35.20		
Barrier Description					
Type:	STEEL-BACKED TIMBER WITHOUT BLOCKOUT	Barrier Function:	TRAFFIC		
Barrier Material:	STEEL-BACKED TIMBER/LOG	Post Material:	WOOD		
Blockout Type:	N/A	Length (ft.):	254		
Speed Limit (MPH):	45	Placement with Respect to Road:	TANGENT		
Hazard Behind Barrier:	MEDIUM				
Barrier Crashworthiness					
Appropriate Test Level:	TL-2	Barrier Test Level:	TL-2	Is Barrier Crashworthy?:	YES
Beg. End Trtmt Type:	SBT/LOG FLARED	Is Beg. End Trtmt Crashworthy?:	NO	Approach Transition Type:	RIGID SBT WALL - SBT
Ending End Trtmt Type:	NONE	Ending End Trtmt Crashworthy?:	N/A		
Average Measurements					
Design Height (In.):	27	Width (In.):	0.0	Post Spacing (In.):	120.3
Height (In.):	25.2	Lateral Offset (In.):	72.6	Road Grade (%):	1.80
Physical Condition					
Barrier	Alignment and Height:	No alignment deflection was observed. Height is 1 - 3 in below 27-in design height along 150 ft.

Breaking and Cracking:	No breaking or cracking was observed.			
	Missing Elements:	No missing elements were observed.			
	Corrosion and Weathering:	No corrosion or weathering was observed.			
End Treatments	Alignment and Height:	Alignment acceptable. Height within 1-in of 27-in design height.			
	Breaking and Cracking:	No breaking or cracking was observed.			
	Missing Elements:	No missing elements were observed.			
	Corrosion and Weathering:	No corrosion or weathering was observed.

Repair Action:	REPAIR	FMSS Work Type:	DEFERRED MAINTENANCE	Repair Cost:	\$3273
Brief Workorder:	Raise 150 feet of guardrail to 27-inch design height.				
Workorder:	Adjust Guardrail at \$10- per -Lin. Ft. for 150 LF = \$1500. Raise 150 feet of guardrail to 27-inch design height. Low Speed Traffic Control at \$1475- per -Day for 1 Day(s) = \$1475.
