GIP Report

NPS Guardwall/Rail Inventory Program Colonial National Historical Park

**Federal Highway Administration
Eastern Federal Lands Highway Division
Road Inventory Program (RIP)**

**Data Collection Date: November 2010
Report Date: December 2015**

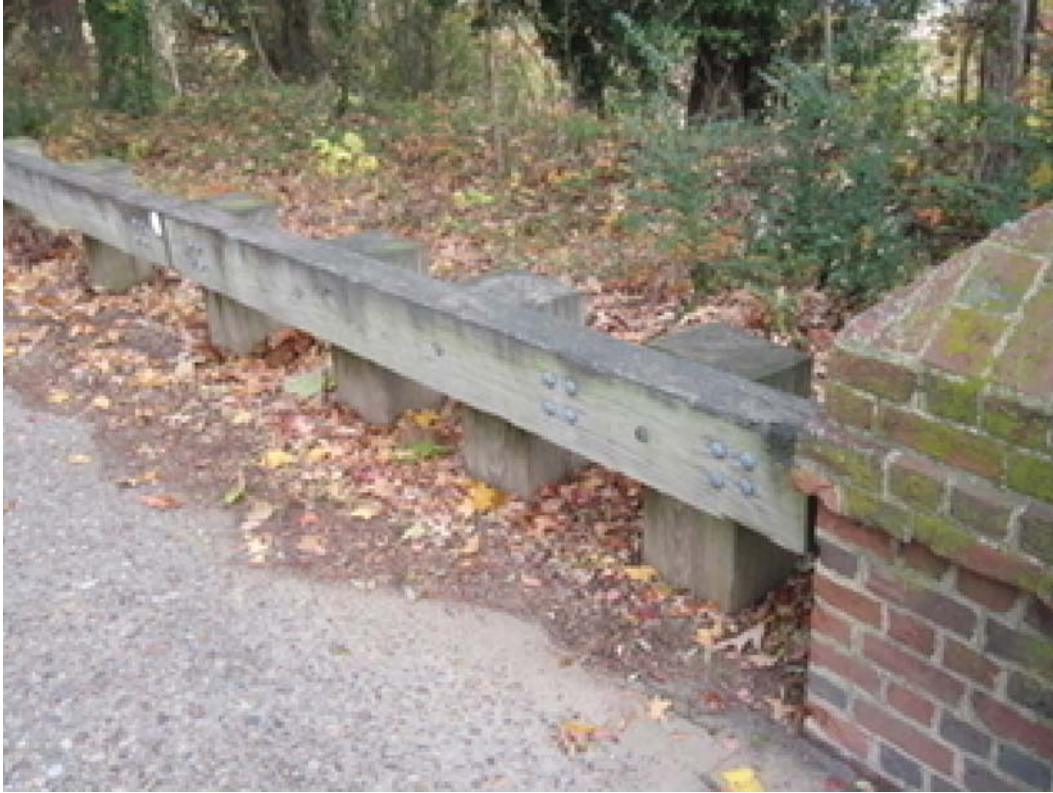
COLO_0001_3.098_R_1.jpg

Barrier ID:	COLO-0001-3.098-R				
Route Name:	COLONIAL PARKWAY				
Inspection Date:	11/16/2010	Barrier Rating:	28.00		
Barrier Description					
Type:	STEEL-BACKED TIMBER WITHOUT BLOCKOUT	Barrier Function:	TRAFFIC		
Barrier Material:	STEEL-BACKED TIMBER/LOG	Post Material:	WOOD		
Blockout Type:	N/A	Length (ft.):	157		
Speed Limit (MPH):	45	Placement with Respect to Road:	TANGENT		
Hazard Behind Barrier:	MEDIUM				
Barrier Crashworthiness					
Appropriate Test Level:	TL-2	Barrier Test Level:	TL-2	Is Barrier Crashworthy?:	YES
Beg. End Trtmt Type:	NONE	Is Beg. End Trtmt Crashworthy?:	N/A	Approach Transition Type:	RIGID SBT WALL - SBT
Ending End Trtmt Type:	SBT/LOG BURIED	Ending End Trtmt Crashworthy?:	YES		
Average Measurements					
Design Height (In.):	27	Width (In.):	0.0	Post Spacing (In.):	120.0
Height (In.):	25.7	Lateral Offset (In.):	83.6	Road Grade (%):	2.00
Physical Condition					
Barrier	Alignment and Height:	No alignment deflection was observed. Height is 1 - 3 in below 27-in design height along 60 ft.

Breaking and Cracking:	No breaking or cracking was observed.			
	Missing Elements:	No missing elements were observed.			
	Corrosion and Weathering:	No corrosion or weathering was observed.			
End Treatments	Alignment and Height:	Alignment acceptable. Height within 1-in of 27-in design height.			
	Breaking and Cracking:	No breaking or cracking was observed.			
	Missing Elements:	No missing elements were observed.			
	Corrosion and Weathering:	No corrosion or weathering was observed.

Repair Action:	REPAIR	FMSS Work Type:	DEFERRED MAINTENANCE	Repair Cost:	\$2283
Brief Workorder:	Raise 60 feet of guardrail to 27-inch design height.				
Workorder:	Adjust Guardrail at \$10- per -Lin. Ft. for 60 LF = \$600. Raise 60 feet of guardrail to 27-inch design height. Low Speed Traffic Control at \$1475- per -Day for 1 Day(s) = \$1475.

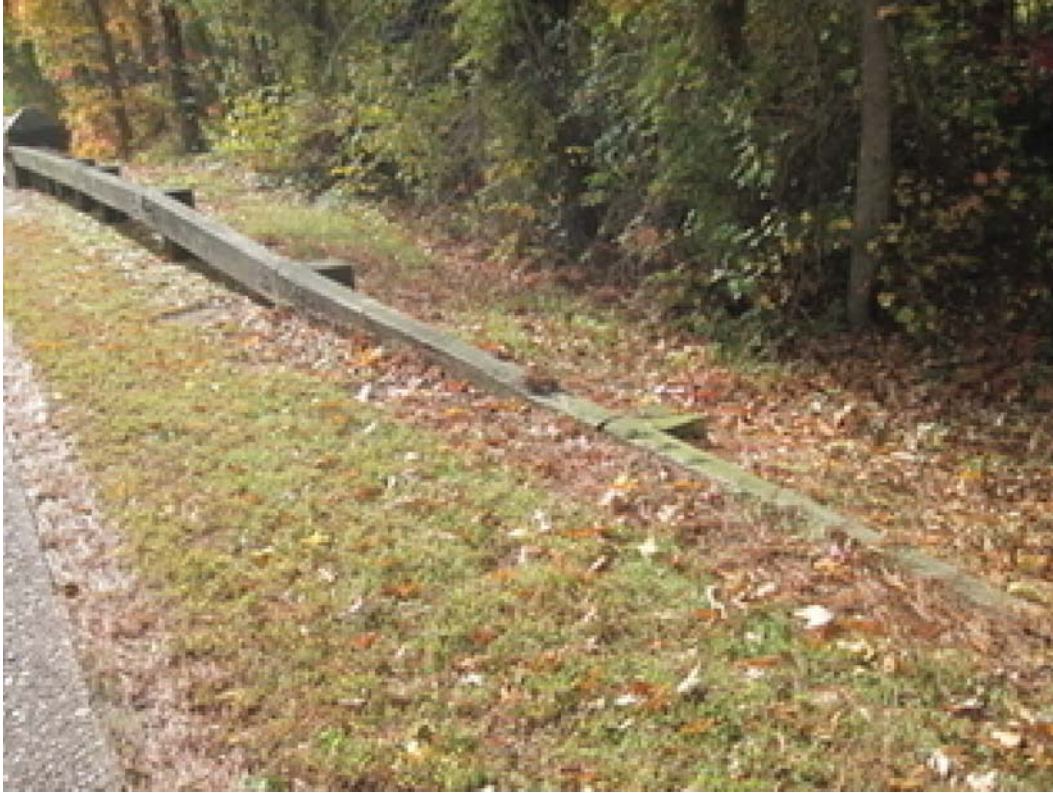
COLO_0001_3.099_L_1.jpg

Barrier ID:	COLO-0001-3.099-L				
Route Name:	COLONIAL PARKWAY				
Inspection Date:	11/16/2010	Barrier Rating:	28.00		
Barrier Description					
Type:	STEEL-BACKED TIMBER WITHOUT BLOCKOUT	Barrier Function:	TRAFFIC		
Barrier Material:	STEEL-BACKED TIMBER/LOG	Post Material:	WOOD		
Blockout Type:	N/A	Length (ft.):	58		
Speed Limit (MPH):	45	Placement with Respect to Road:	TANGENT		
Hazard Behind Barrier:	MEDIUM				
Barrier Crashworthiness					
Appropriate Test Level:	TL-2	Barrier Test Level:	TL-2	Is Barrier Crashworthy?:	YES
Beg. End Trtmt Type:	NONE	Is Beg. End Trtmt Crashworthy?:	N/A	Approach Transition Type:	RIGID SBT WALL - SBT
Ending End Trtmt Type:	SBT/LOG FLARED	Ending End Trtmt Crashworthy?:	NO		
Average Measurements					
Design Height (In.):	27	Width (In.):	0.0	Post Spacing (In.):	48.2
Height (In.):	25.7	Lateral Offset (In.):	53.0	Road Grade (%):	1.30
Physical Condition					
Barrier	Alignment and Height:	No alignment deflection observed. Height ranges from 0 in to 1 in below 27 in design height for 10ft and from 1 in to 2 in below for 30ft.

Breaking and Cracking:	No breaking or cracking observed.			
	Missing Elements:	No missing elements observed.			
	Corrosion and Weathering:	No corrosion or weathering observed.			
End Treatments	Alignment and Height:	Alignment acceptable. Height within 1-in of 27-in design height.			
	Breaking and Cracking:	No breaking or cracking observed.			
	Missing Elements:	No missing elements observed.			
	Corrosion and Weathering:	No corrosion or weathering observed.

Repair Action:	REPAIR	FMSS Work Type:	DEFERRED MAINTENANCE	Repair Cost:	\$1953
Brief Workorder:	Raise 30 feet of guardrail to 27 inch design height.				
Workorder:	Adjust Guardrail at \$10- per -Lin. Ft. for 30 LF = \$300. Raise 30 feet of guardrail to 27-inch design height. Low Speed Traffic Control at \$1475- per -Day for 1 Day(s) = \$1475.

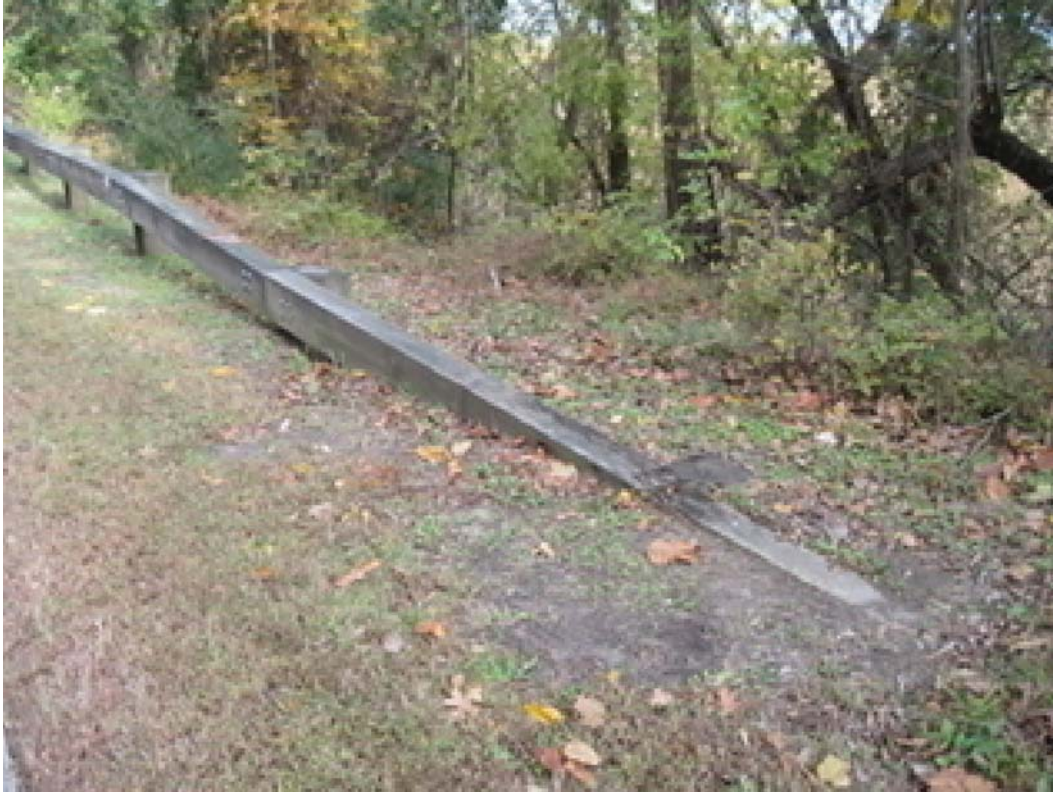
COLO_0001_3.171_R_1.jpg

Barrier ID:	COLO-0001-3.171-R				
Route Name:	COLONIAL PARKWAY				
Inspection Date:	11/16/2010	Barrier Rating:	59.40		
Barrier Description					
Type:	STEEL-BACKED TIMBER WITHOUT BLOCKOUT	Barrier Function:	TRAFFIC		
Barrier Material:	STEEL-BACKED TIMBER/LOG	Post Material:	WOOD		
Blockout Type:	N/A	Length (ft.):	908		
Speed Limit (MPH):	45	Placement with Respect to Road:	OUTSIDE OF CURVE		
Hazard Behind Barrier:	MEDIUM				
Barrier Crashworthiness					
Appropriate Test Level:	TL-2	Barrier Test Level:	TL-2	Is Barrier Crashworthy?:	YES
Beg. End Trtmt Type:	SBT/LOG FLARED	Is Beg. End Trtmt Crashworthy?:	NO	Approach Transition Type:	NONE
Ending End Trtmt Type:	SBT/LOG FLARED	Ending End Trtmt Crashworthy?:	NO		
Average Measurements					
Design Height (In.):	27	Width (In.):	0.0	Post Spacing (In.):	119.5
Height (In.):	23.0	Lateral Offset (In.):	62.7	Road Grade (%):	1.10
Physical Condition					
Barrier	Alignment and Height:	No alignment deflection observed. Height is 1-3 in below the 27-in design height along 200 ft. Height is 3 - 6 in below the 27-in design height along 608 ft of barrier.

Breaking and Cracking:	No breaking or cracking observed.			
	Missing Elements:	No missing elements observed.			
	Corrosion and Weathering:	No corrosion or weathering observed.			
End Treatments	Alignment and Height:	Alignment acceptable. Height within 1-in of 27-in design height.			
	Breaking and Cracking:	No breaking or cracking observed.			
	Missing Elements:	No missing elements observed.			
	Corrosion and Weathering:	No corrosion or weathering observed.

Repair Action:	REPAIR	FMSS Work Type:	DEFERRED MAINTENANCE	Repair Cost:	\$15378
Brief Workorder:	Raise 808 feet of barrier to 27-inch design height.				
Workorder:	Adjust Guardrail at \$10- per -Lin. Ft. for 808 LF = \$8080. Raise 808 feet of barrier to 27 inch design height. Low Speed Traffic Control at \$1475- per -Day for 4 Day(s) = \$5900.

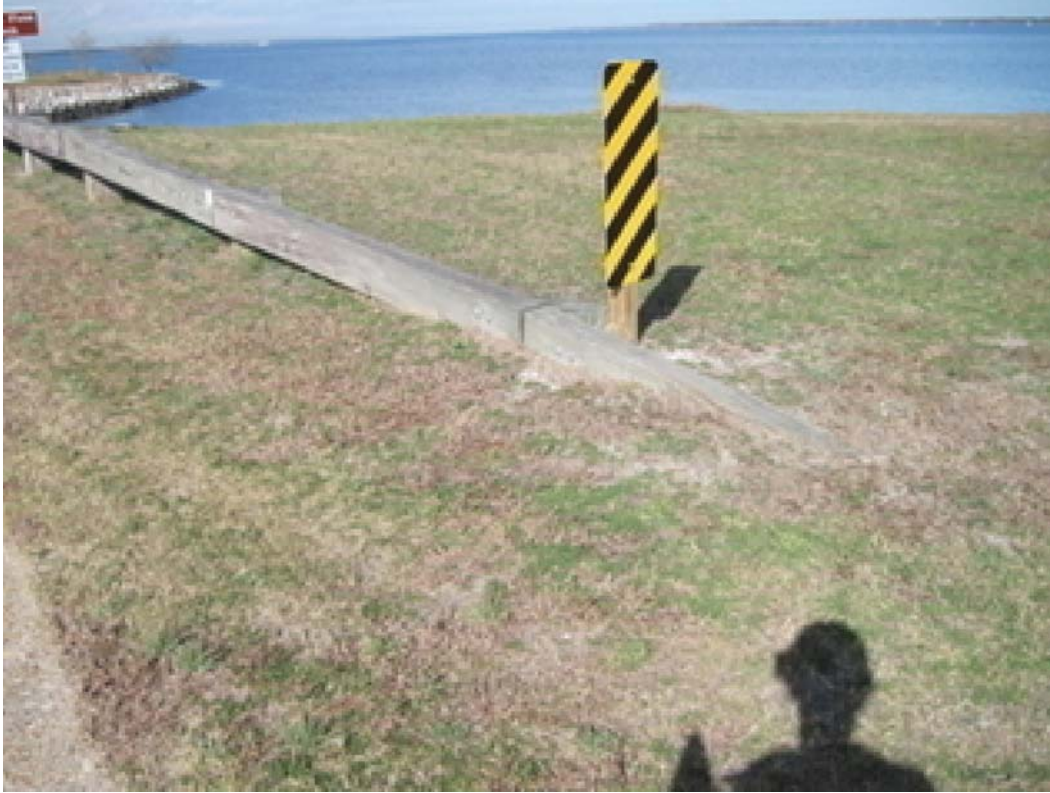
COLO_0001_4.384_R_1.jpg

Barrier ID:	COLO-0001-4.384-R				
Route Name:	COLONIAL PARKWAY				
Inspection Date:	11/16/2010	Barrier Rating:	28.00		
Barrier Description					
Type:	STEEL-BACKED TIMBER WITHOUT BLOCKOUT	Barrier Function:	TRAFFIC		
Barrier Material:	STEEL-BACKED TIMBER/LOG	Post Material:	WOOD		
Blockout Type:	N/A	Length (ft.):	75		
Speed Limit (MPH):	45	Placement with Respect to Road:	TANGENT		
Hazard Behind Barrier:	MEDIUM				
Barrier Crashworthiness					
Appropriate Test Level:	TL-2	Barrier Test Level:	TL-2	Is Barrier Crashworthy?:	YES
Beg. End Trtmt Type:	SBT/LOG FLARED	Is Beg. End Trtmt Crashworthy?:	NO	Approach Transition Type:	RIGID SBT WALL - SBT
Ending End Trtmt Type:	NONE	Ending End Trtmt Crashworthy?:	N/A		
Average Measurements					
Design Height (In.):	27	Width (In.):	0.0	Post Spacing (In.):	119.6
Height (In.):	25.5	Lateral Offset (In.):	62.7	Road Grade (%):	0.50
Physical Condition					
Barrier	Alignment and Height:	No alignment deflection was observed. Height is 1 - 3 in below 27-in design height along 20 ft where barrier tapers down to meet bridge.

Breaking and Cracking:	No breaking or cracking was observed.			
	Missing Elements:	No missing elements were observed.			
	Corrosion and Weathering:	No corrosion or weathering was observed.			
End Treatments	Alignment and Height:	Alignment acceptable. Height within 1-in of 27-in design height.			
	Breaking and Cracking:	No breaking or cracking was observed.			
	Missing Elements:	No missing elements were observed.			
	Corrosion and Weathering:	No corrosion or weathering was observed.

Barrier ID:	COLO-0001-4.384-R				
Route Name:	COLONIAL PARKWAY				
Inspection Date:	11/16/2010	Barrier Rating:		28.00	
Repair Recommendations					
Repair Action:	NO ACTION	FMSS Work Type:	N/A	Repair Cost:	\$0
Brief Workorder:	N/A				
Workorder:

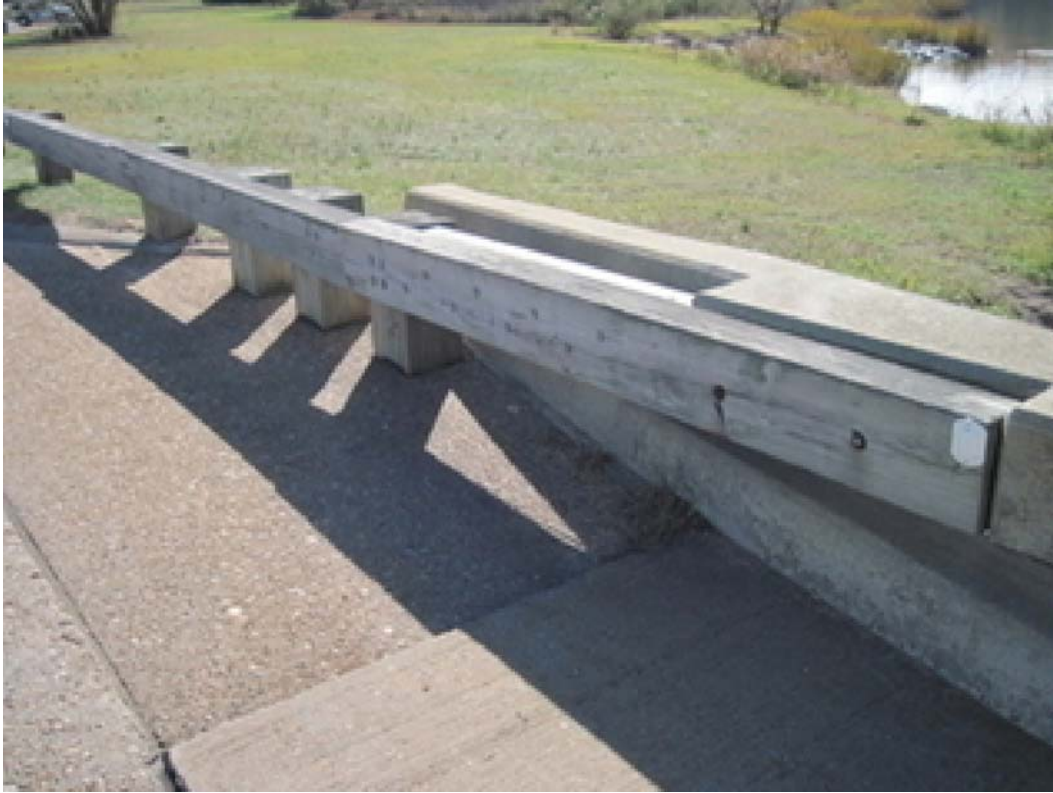
COLO_0001_4.385_L_1.jpg

Barrier ID:	COLO-0001-4.385-L				
Route Name:	COLONIAL PARKWAY				
Inspection Date:	11/16/2010	Barrier Rating:	24.00		
Barrier Description					
Type:	STEEL-BACKED TIMBER WITHOUT BLOCKOUT	Barrier Function:	TRAFFIC		
Barrier Material:	STEEL-BACKED TIMBER/LOG	Post Material:	WOOD		
Blockout Type:	N/A	Length (ft.):	73		
Speed Limit (MPH):	45	Placement with Respect to Road:	INSIDE OF CURVE		
Hazard Behind Barrier:	LOW				
Barrier Crashworthiness					
Appropriate Test Level:	TL-2	Barrier Test Level:	TL-2	Is Barrier Crashworthy?:	YES
Beg. End Trtmt Type:	SBT/LOG FLARED	Is Beg. End Trtmt Crashworthy?:	NO	Approach Transition Type:	RIGID SBT WALL - SBT
Ending End Trtmt Type:	NONE	Ending End Trtmt Crashworthy?:	N/A		
Average Measurements					
Design Height (In.):	27	Width (In.):	0.0	Post Spacing (In.):	100.0
Height (In.):	26.2	Lateral Offset (In.):	56.7	Road Grade (%):	0.90
Physical Condition					
Barrier	Alignment and Height:	No alignment deflection observed. Height ranges from 0 in to 1 in below 27 in design height.

Breaking and Cracking:	No breaking or cracking observed.			
	Missing Elements:	No missing elements observed.			
	Corrosion and Weathering:	No corrosion or weathering observed.			
End Treatments	Alignment and Height:	Alignment acceptable. Height within 1-in of 27-in design height.			
	Breaking and Cracking:	No breaking or cracking observed.			
	Missing Elements:	No missing elements observed.			
	Corrosion and Weathering:	No corrosion or weathering observed.

Repair Action:	NO ACTION	FMSS Work Type:	N/A	Repair Cost:	\$0
Brief Workorder:	N/A				
Workorder:	No action.

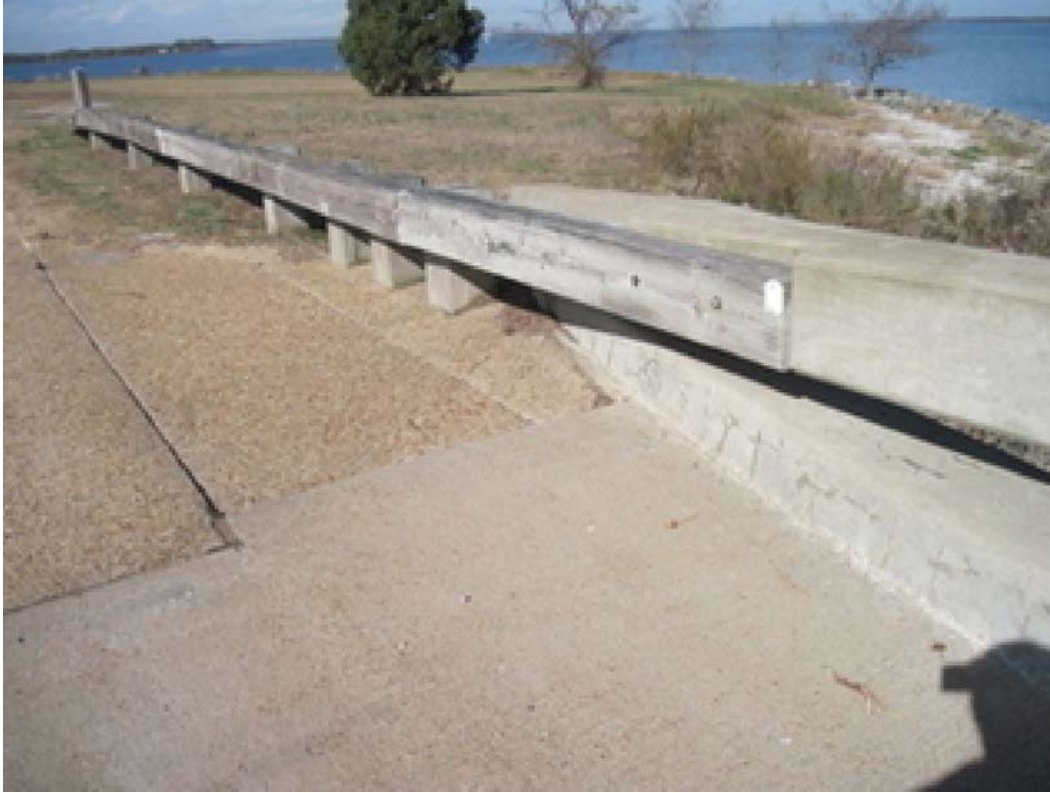
COLO_0001_4.432_R_1.jpg

Barrier ID:	COLO-0001-4.432-R				
Route Name:	COLONIAL PARKWAY				
Inspection Date:	11/16/2010	Barrier Rating:	21.10		
Barrier Description					
Type:	STEEL-BACKED TIMBER WITHOUT BLOCKOUT	Barrier Function:	TRAFFIC		
Barrier Material:	STEEL-BACKED TIMBER/LOG	Post Material:	WOOD		
Blockout Type:	N/A	Length (ft.):	74		
Speed Limit (MPH):	45	Placement with Respect to Road:	TANGENT		
Hazard Behind Barrier:	LOW				
Barrier Crashworthiness					
Appropriate Test Level:	TL-2	Barrier Test Level:	TL-2	Is Barrier Crashworthy?:	YES
Beg. End Trtmt Type:	NONE	Is Beg. End Trtmt Crashworthy?:	N/A	Approach Transition Type:	RIGID SBT WALL - SBT
Ending End Trtmt Type:	SBT/LOG FLARED	Ending End Trtmt Crashworthy?:	NO		
Average Measurements					
Design Height (In.):	27	Width (In.):	0.0	Post Spacing (In.):	120.0
Height (In.):	26.2	Lateral Offset (In.):	63.7	Road Grade (%):	0.80
Physical Condition					
Barrier	Alignment and Height:	No alignment deflection was observed. Height is 0 - 1 in below 27-in design height.

Breaking and Cracking:	No breaking or cracking was observed.			
	Missing Elements:	No missing elements were observed.			
	Corrosion and Weathering:	Wood splintering resulting in less than 5 percent loss of cross section was observed.			
End Treatments	Alignment and Height:	Alignment acceptable. Height within 1-in of 27-in design height.			
	Breaking and Cracking:	No breaking or cracking was observed.			
	Missing Elements:	No missing elements were observed.			
	Corrosion and Weathering:	Wood splintering resulting in less than 5 percent loss of cross section was observed.

Barrier ID:	COLO-0001-4.432-R				
Route Name:	COLONIAL PARKWAY				
Inspection Date:	11/16/2010	Barrier Rating:		21.10	
Repair Recommendations					
Repair Action:	NO ACTION	FMSS Work Type:	N/A	Repair Cost:	\$0
Brief Workorder:	N/A				
Workorder:

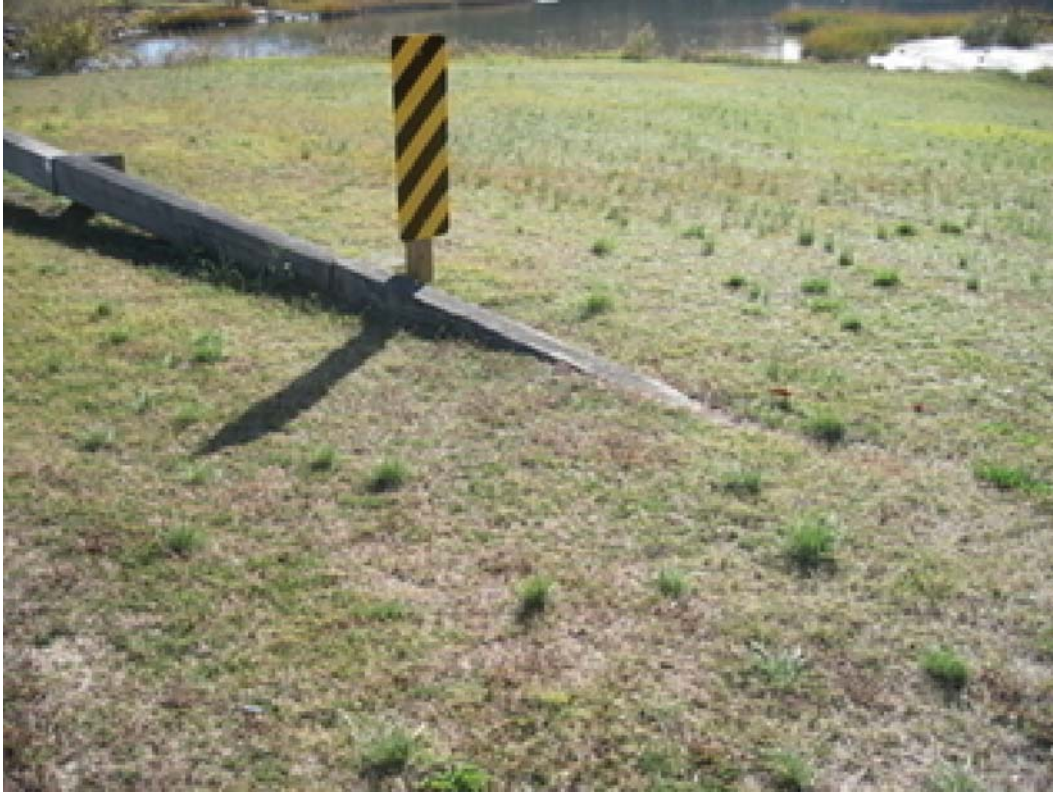
COLO_0001_4.433_L_1.jpg

Barrier ID:	COLO-0001-4.433-L				
Route Name:	COLONIAL PARKWAY				
Inspection Date:	11/16/2010	Barrier Rating:	28.30		
Barrier Description					
Type:	STEEL-BACKED TIMBER WITHOUT BLOCKOUT	Barrier Function:	TRAFFIC		
Barrier Material:	STEEL-BACKED TIMBER/LOG	Post Material:	WOOD		
Blockout Type:	N/A	Length (ft.):	77		
Speed Limit (MPH):	45	Placement with Respect to Road:	INSIDE OF CURVE		
Hazard Behind Barrier:	LOW				
Barrier Crashworthiness					
Appropriate Test Level:	TL-2	Barrier Test Level:	TL-2	Is Barrier Crashworthy?:	YES
Beg. End Trtmt Type:	NONE	Is Beg. End Trtmt Crashworthy?:	N/A	Approach Transition Type:	RIGID SBT WALL - SBT
Ending End Trtmt Type:	SBT/LOG FLARED	Ending End Trtmt Crashworthy?:	NO		
Average Measurements					
Design Height (In.):	27	Width (In.):	0.0	Post Spacing (In.):	100.0
Height (In.):	25.0	Lateral Offset (In.):	51.7	Road Grade (%):	0.20
Physical Condition					
Barrier	Alignment and Height:	No alignment deflection observed. Height ranges from 1 in to 3 in below 27 in design height for 47 ft.

Breaking and Cracking:	No breaking or cracking observed.			
	Missing Elements:	No missing elements observed.			
	Corrosion and Weathering:	No corrosion or weathering observed.			
End Treatments	Alignment and Height:	Alignment acceptable. Height within 1-in of 27-in design height.			
	Breaking and Cracking:	No breaking or cracking observed.			
	Missing Elements:	No missing elements observed.			
	Corrosion and Weathering:	No corrosion or weathering observed.

Repair Action:	REPAIR	FMSS Work Type:	DEFERRED MAINTENANCE	Repair Cost:	\$2140
Brief Workorder:	Raise 47 feet of guardrail to 27-inch design height.				
Workorder:	Adjust Guardrail at \$10- per -Lin. Ft. for 47 LF = \$470. Raise 47 feet of guardrail to 27-inch design height. Low Speed Traffic Control at \$1475- per -Day for 1 Day(s) = \$1475.

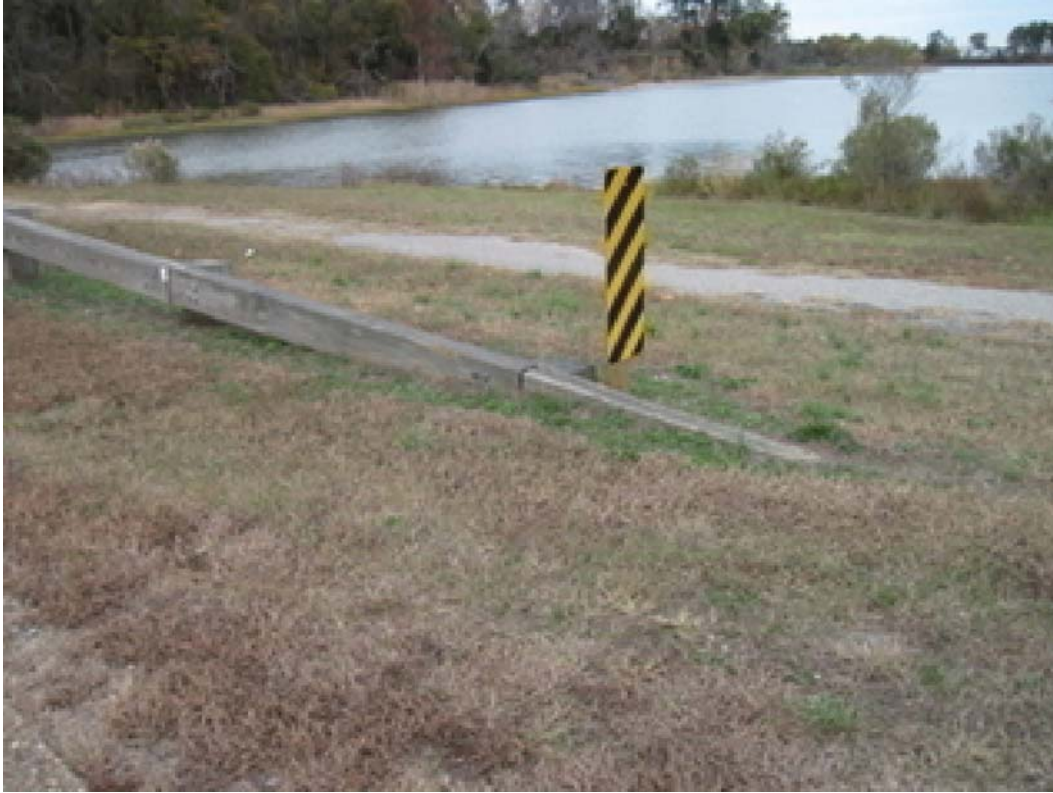
COLO_0001_6.018_R_1.jpg

Barrier ID:	COLO-0001-6.018-R				
Route Name:	COLONIAL PARKWAY				
Inspection Date:	11/16/2010	Barrier Rating:	25.50		
Barrier Description					
Type:	STEEL-BACKED TIMBER WITHOUT BLOCKOUT	Barrier Function:	TRAFFIC		
Barrier Material:	STEEL-BACKED TIMBER/LOG	Post Material:	WOOD		
Blockout Type:	N/A	Length (ft.):	78		
Speed Limit (MPH):	45	Placement with Respect to Road:	TANGENT		
Hazard Behind Barrier:	LOW				
Barrier Crashworthiness					
Appropriate Test Level:	TL-2	Barrier Test Level:	TL-2	Is Barrier Crashworthy?:	YES
Beg. End Trtmt Type:	SBT/LOG FLARED	Is Beg. End Trtmt Crashworthy?:	NO	Approach Transition Type:	RIGID SBT WALL - SBT
Ending End Trtmt Type:	NONE	Ending End Trtmt Crashworthy?:	N/A		
Average Measurements					
Design Height (In.):	27	Width (In.):	0.0	Post Spacing (In.):	120.0
Height (In.):	24.2	Lateral Offset (In.):	88.3	Road Grade (%):	1.00
Physical Condition					
Barrier	Alignment and Height:	No alignment deflection observed. Height ranges from 2 in to 3 in below 27 in design height.

Breaking and Cracking:	No breaking or cracking observed.			
	Missing Elements:	No missing elements observed.			
	Corrosion and Weathering:	No corrosion or weathering observed.			
End Treatments	Alignment and Height:	Alignment acceptable. Height within 1-in of 27-in design height.			
	Breaking and Cracking:	No breaking or cracking observed.			
	Missing Elements:	No missing elements observed.			
	Corrosion and Weathering:	No corrosion or weathering observed.

Repair Action:	REPAIR	FMSS Work Type:	DEFERRED MAINTENANCE	Repair Cost:	\$2481
Brief Workorder:	Raise 78 feet of guardrail to 27-inch design height.				
Workorder:	Adjust Guardrail at \$10- per -Lin. Ft. for 78 LF = \$780. Raise 78 feet of guardrail to 27-inch design height. Low Speed Traffic Control at \$1475- per -Day for 1 Day(s) = \$1475.

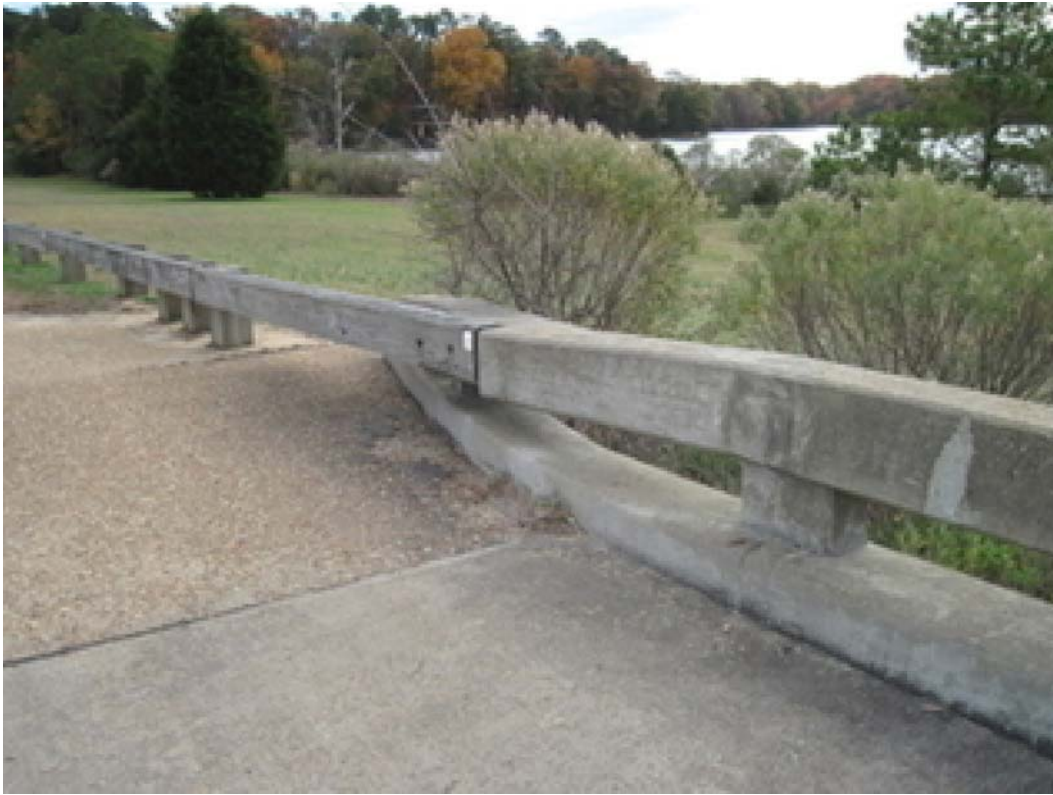
COLO_0001_6.021_L_1.jpg

Barrier ID:	COLO-0001-6.021-L				
Route Name:	COLONIAL PARKWAY				
Inspection Date:	11/16/2010	Barrier Rating:	21.10		
Barrier Description					
Type:	STEEL-BACKED TIMBER WITHOUT BLOCKOUT	Barrier Function:	TRAFFIC		
Barrier Material:	STEEL-BACKED TIMBER/LOG	Post Material:	WOOD		
Blockout Type:	N/A	Length (ft.):	80		
Speed Limit (MPH):	45	Placement with Respect to Road:	TANGENT		
Hazard Behind Barrier:	LOW				
Barrier Crashworthiness					
Appropriate Test Level:	TL-2	Barrier Test Level:	TL-2	Is Barrier Crashworthy?:	YES
Beg. End Trtmt Type:	SBT/LOG FLARED	Is Beg. End Trtmt Crashworthy?:	NO	Approach Transition Type:	RIGID SBT WALL - SBT
Ending End Trtmt Type:	NONE	Ending End Trtmt Crashworthy?:	N/A		
Average Measurements					
Design Height (In.):	27	Width (In.):	0.0	Post Spacing (In.):	120.0
Height (In.):	26.2	Lateral Offset (In.):	85.3	Road Grade (%):	1.50
Physical Condition					
Barrier	Alignment and Height:	No alignment deflection observed. Height is 0-1 in below the 27-in design height.

Breaking and Cracking:	No breaking or cracking observed.			
	Missing Elements:	No missing elements observed.			
	Corrosion and Weathering:	No corrosion or weathering observed.			
End Treatments	Alignment and Height:	Alignment acceptable. Height within 1-in of 27-in design height.			
	Breaking and Cracking:	No breaking or cracking observed.			
	Missing Elements:	No missing elements observed.			
	Corrosion and Weathering:	No corrosion or weathering observed.

Barrier ID:	COLO-0001-6.021-L				
Route Name:	COLONIAL PARKWAY				
Inspection Date:	11/16/2010	Barrier Rating:		21.10	
Repair Recommendations					
Repair Action:	NO ACTION	FMSS Work Type:	N/A	Repair Cost:	\$0
Brief Workorder:	N/A				
Workorder:

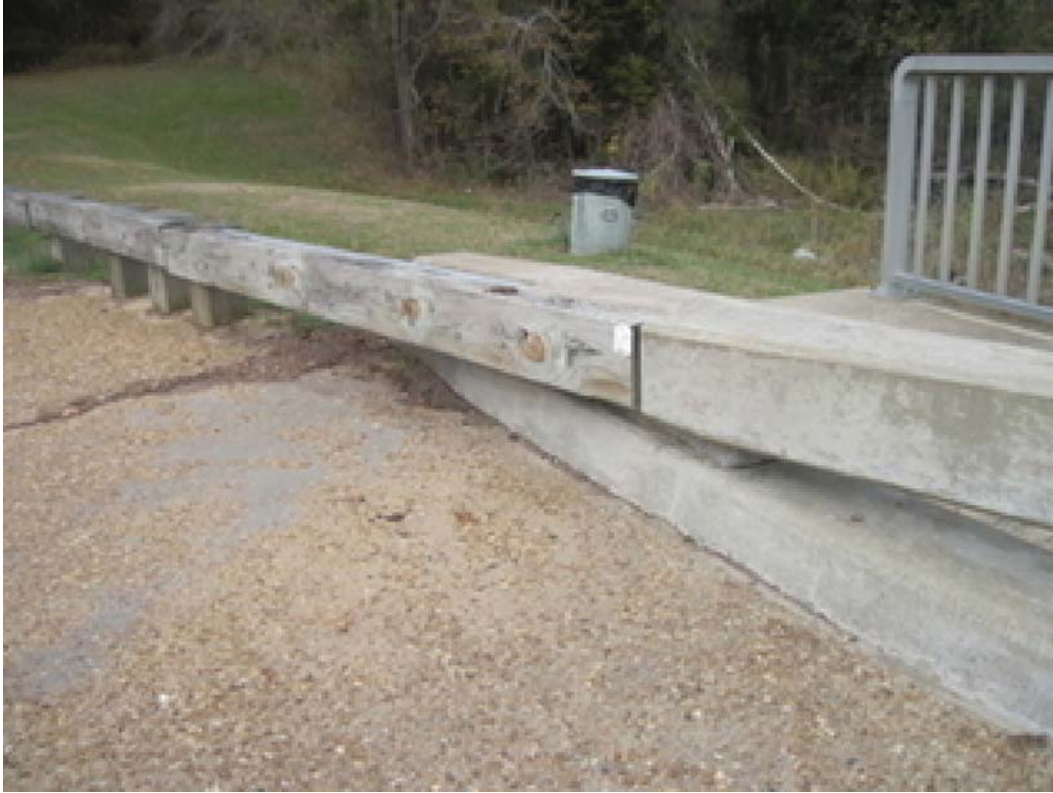
COLO_0001_6.090_R_1.jpg

Barrier ID:	COLO-0001-6.090-R				
Route Name:	COLONIAL PARKWAY				
Inspection Date:	11/16/2010	Barrier Rating:	21.10		
Barrier Description					
Type:	STEEL-BACKED TIMBER WITHOUT BLOCKOUT	Barrier Function:	TRAFFIC		
Barrier Material:	STEEL-BACKED TIMBER/LOG	Post Material:	WOOD		
Blockout Type:	N/A	Length (ft.):	78		
Speed Limit (MPH):	45	Placement with Respect to Road:	TANGENT		
Hazard Behind Barrier:	LOW				
Barrier Crashworthiness					
Appropriate Test Level:	TL-2	Barrier Test Level:	TL-2	Is Barrier Crashworthy?:	YES
Beg. End Trtmt Type:	NONE	Is Beg. End Trtmt Crashworthy?:	N/A	Approach Transition Type:	RIGID SBT WALL - SBT
Ending End Trtmt Type:	SBT/LOG FLARED	Ending End Trtmt Crashworthy?:	NO		
Average Measurements					
Design Height (In.):	27	Width (In.):	0.0	Post Spacing (In.):	119.6
Height (In.):	23.7	Lateral Offset (In.):	78.6	Road Grade (%):	2.00
Physical Condition					
Barrier	Alignment and Height:	No alignment deflection observed. Height ranges from 0 in to 1 in above 27 in design height.

Breaking and Cracking:	No breaking or cracking observed.			
	Missing Elements:	No missing elements observed.			
	Corrosion and Weathering:	No corrosion or weathering observed.			
End Treatments	Alignment and Height:	Alignment acceptable. Height within 1-in of 27-in design height.			
	Breaking and Cracking:	No breaking or cracking observed.			
	Missing Elements:	No missing elements observed.			
	Corrosion and Weathering:	No corrosion or weathering observed.

Barrier ID:	COLO-0001-6.090-R				
Route Name:	COLONIAL PARKWAY				
Inspection Date:	11/16/2010	Barrier Rating:		21.10	
Repair Recommendations					
Repair Action:	NO ACTION	FMSS Work Type:	N/A	Repair Cost:	\$0
Brief Workorder:	N/A				
Workorder:	No action.

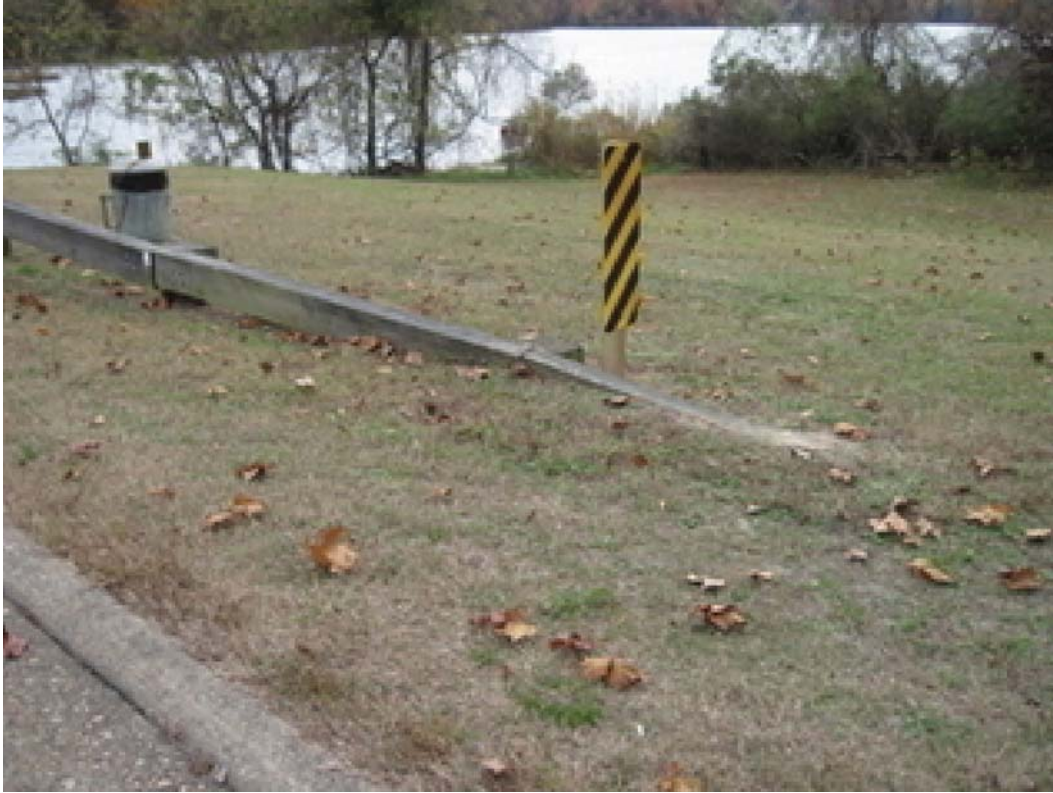
COLO_0001_6.091_L_1.jpg

Barrier ID:	COLO-0001-6.091-L				
Route Name:	COLONIAL PARKWAY				
Inspection Date:	11/16/2010	Barrier Rating:	29.80		
Barrier Description					
Type:	STEEL-BACKED TIMBER WITHOUT BLOCKOUT	Barrier Function:	TRAFFIC		
Barrier Material:	STEEL-BACKED TIMBER/LOG	Post Material:	WOOD		
Blockout Type:	N/A	Length (ft.):	77		
Speed Limit (MPH):	45	Placement with Respect to Road:	TANGENT		
Hazard Behind Barrier:	LOW				
Barrier Crashworthiness					
Appropriate Test Level:	TL-2	Barrier Test Level:	TL-2	Is Barrier Crashworthy?:	YES
Beg. End Trtmt Type:	NONE	Is Beg. End Trtmt Crashworthy?:	N/A	Approach Transition Type:	RIGID SBT WALL - SBT
Ending End Trtmt Type:	SBT/LOG FLARED	Ending End Trtmt Crashworthy?:	NO		
Average Measurements					
Design Height (In.):	27	Width (In.):	0.0	Post Spacing (In.):	120.3
Height (In.):	27.2	Lateral Offset (In.):	116.6	Road Grade (%):	2.40
Physical Condition					
Barrier	Alignment and Height:	No alignment deflection observed. Height is 3 to 4 in below the 27-in design height along 40 ft of barrier.

Breaking and Cracking:	No breaking or cracking observed.			
	Missing Elements:	No missing elements observed.			
	Corrosion and Weathering:	No corrosion or weathering observed.			
End Treatments	Alignment and Height:	Alignment acceptable. Height within 1-in of 27-in design height.			
	Breaking and Cracking:	No breaking or cracking observed.			
	Missing Elements:	No missing elements observed.			
	Corrosion and Weathering:	No corrosion or weathering observed.

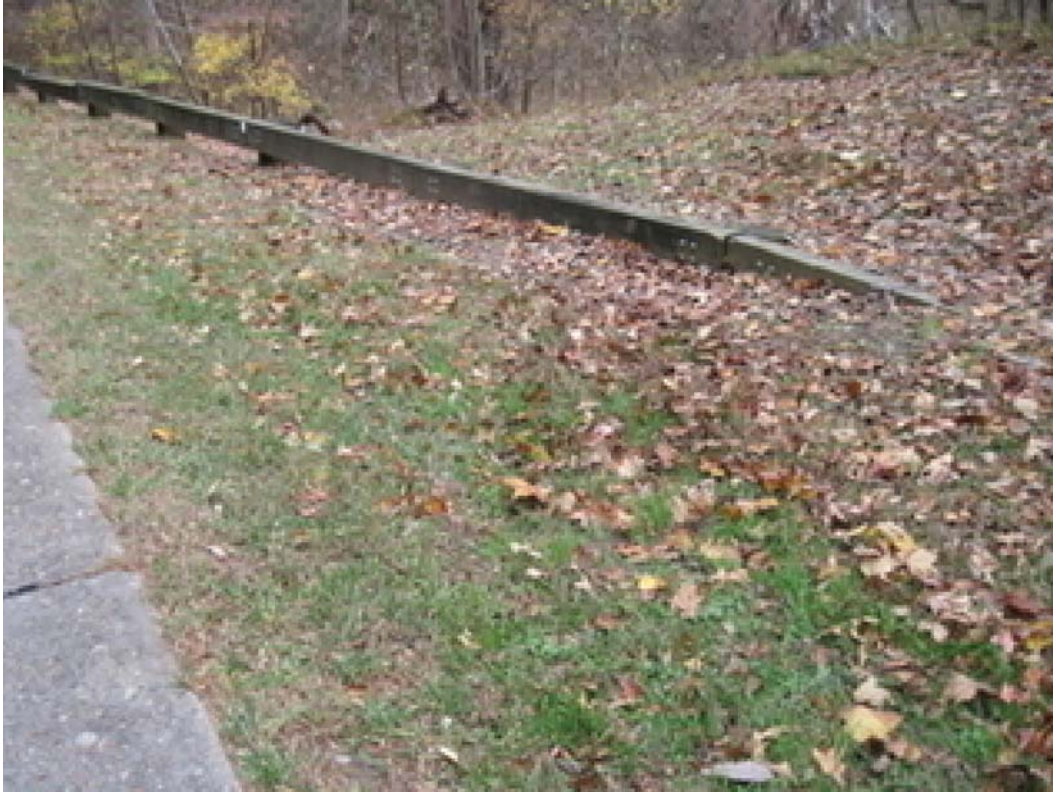
COLO_0001_6.651_L_1.jpg

Barrier ID:	COLO-0001-6.651-L				
Route Name:	COLONIAL PARKWAY				
Inspection Date:	11/16/2010	Barrier Rating:	28.00		
Barrier Description					
Type:	STEEL-BACKED TIMBER WITHOUT BLOCKOUT	Barrier Function:	TRAFFIC		
Barrier Material:	STEEL-BACKED TIMBER/LOG	Post Material:	WOOD		
Blockout Type:	N/A	Length (ft.):	141		
Speed Limit (MPH):	45	Placement with Respect to Road:	TANGENT		
Hazard Behind Barrier:	MEDIUM				
Barrier Crashworthiness					
Appropriate Test Level:	TL-2	Barrier Test Level:	TL-2	Is Barrier Crashworthy?:	YES
Beg. End Trtmt Type:	SBT/LOG BURIED	Is Beg. End Trtmt Crashworthy?:	YES	Approach Transition Type:	NONE
Ending End Trtmt Type:	SBT/LOG FLARED	Ending End Trtmt Crashworthy?:	NO		
Average Measurements					
Design Height (In.):	27	Width (In.):	0.0	Post Spacing (In.):	120.0
Height (In.):	25.0	Lateral Offset (In.):	55.2	Road Grade (%):	0.80
Physical Condition					
Barrier	Alignment and Height:	One rail has been hit by a tree and is out of alignment by 6 - 12 in. 50 ft of barrier (including rail that has been hit) is 1 - 3 in below 27-in design height.

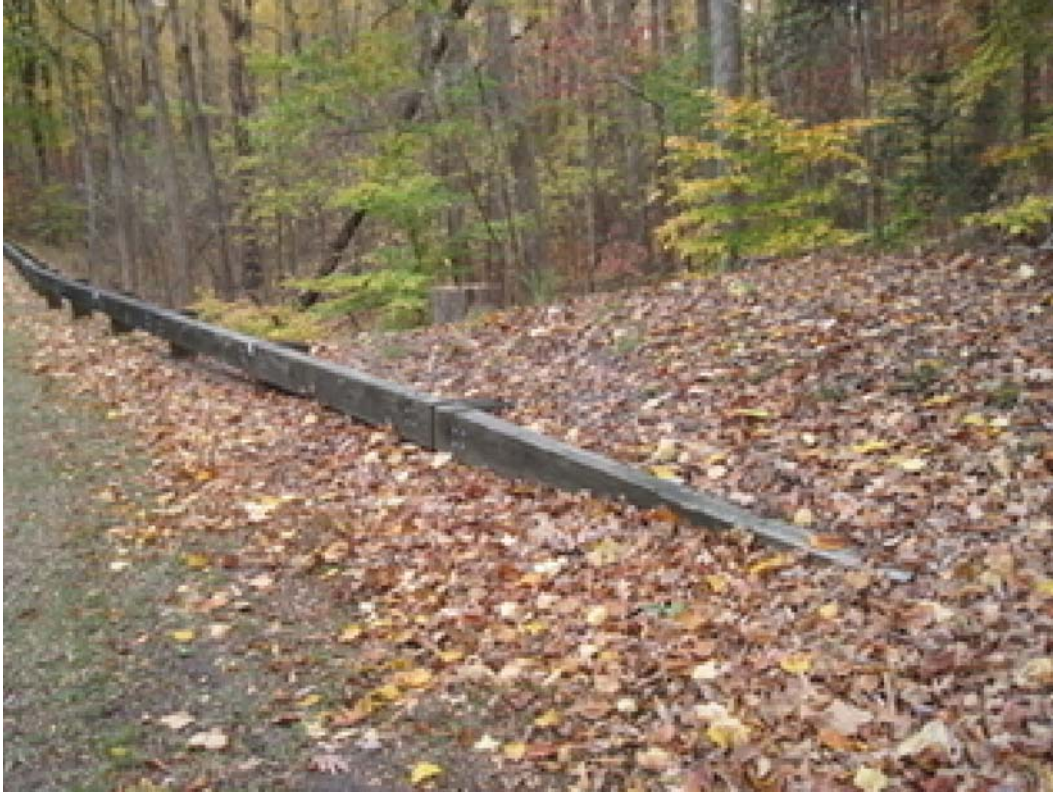
COLO_0001_7.032_L_1.jpg

Barrier ID:	COLO-0001-7.032-L				
Route Name:	COLONIAL PARKWAY				
Inspection Date:	11/16/2010	Barrier Rating:	21.10		
Barrier Description					
Type:	STEEL-BACKED TIMBER WITHOUT BLOCKOUT	Barrier Function:	TRAFFIC		
Barrier Material:	STEEL-BACKED TIMBER/LOG	Post Material:	WOOD		
Blockout Type:	N/A	Length (ft.):	203		
Speed Limit (MPH):	45	Placement with Respect to Road:	TANGENT		
Hazard Behind Barrier:	LOW				
Barrier Crashworthiness					
Appropriate Test Level:	TL-2	Barrier Test Level:	TL-2	Is Barrier Crashworthy?:	YES
Beg. End Trtmt Type:	SBT/LOG FLARED	Is Beg. End Trtmt Crashworthy?:	NO	Approach Transition Type:	NONE
Ending End Trtmt Type:	SBT/LOG FLARED	Ending End Trtmt Crashworthy?:	NO		
Average Measurements					
Design Height (In.):	27	Width (In.):	0.0	Post Spacing (In.):	119.6
Height (In.):	26.2	Lateral Offset (In.):	51.2	Road Grade (%):	1.70
Physical Condition					
Barrier	Alignment and Height:	No alignment deflection observed. Height is 0-1 in below the 27-in design height.

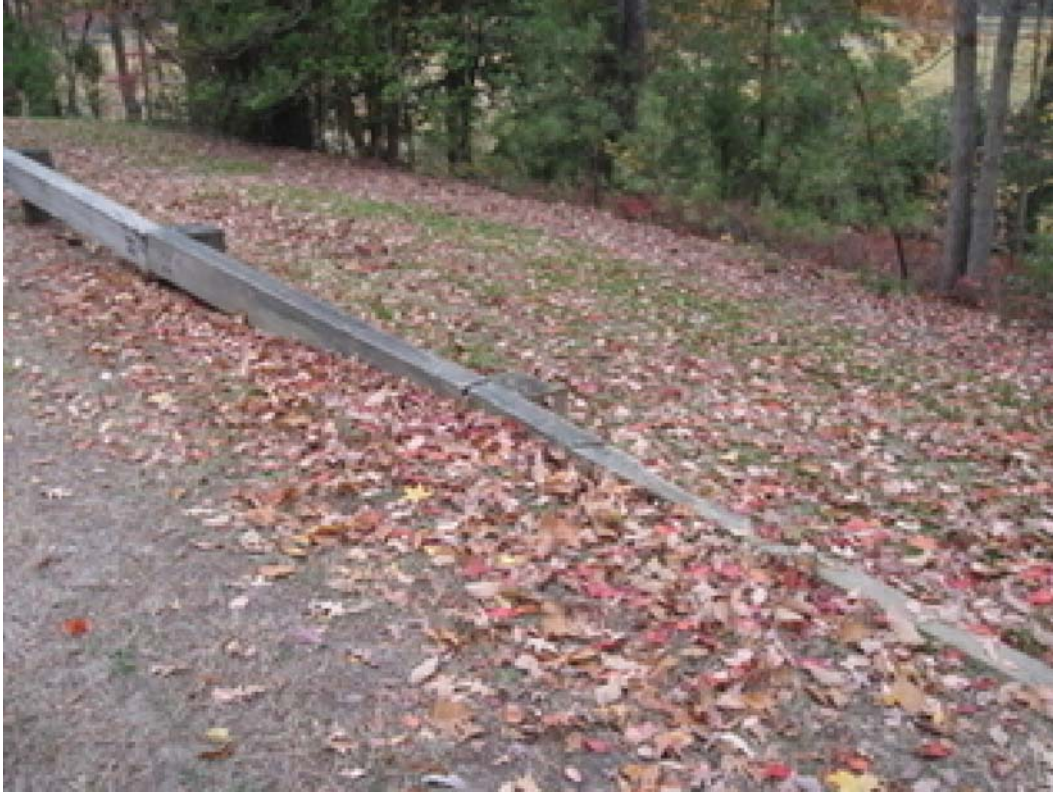
COLO_0001_7.147_R_1.jpg

Barrier ID:	COLO-0001-7.147-R				
Route Name:	COLONIAL PARKWAY				
Inspection Date:	11/16/2010	Barrier Rating:	28.00		
Barrier Description					
Type:	STEEL-BACKED TIMBER WITHOUT BLOCKOUT	Barrier Function:	TRAFFIC		
Barrier Material:	STEEL-BACKED TIMBER/LOG	Post Material:	WOOD		
Blockout Type:	N/A	Length (ft.):	89		
Speed Limit (MPH):	45	Placement with Respect to Road:	TANGENT		
Hazard Behind Barrier:	MEDIUM				
Barrier Crashworthiness					
Appropriate Test Level:	TL-2	Barrier Test Level:	TL-2	Is Barrier Crashworthy?:	YES
Beg. End Trtmt Type:	SBT/LOG FLARED	Is Beg. End Trtmt Crashworthy?:	NO	Approach Transition Type:	RIGID SBT WALL - SBT
Ending End Trtmt Type:	NONE	Ending End Trtmt Crashworthy?:	N/A		
Average Measurements					
Design Height (In.):	27	Width (In.):	0.0	Post Spacing (In.):	120.3
Height (In.):	25.2	Lateral Offset (In.):	50.2	Road Grade (%):	1.30
Physical Condition					
Barrier	Alignment and Height:	No alignment deflection observed. Height ranges from 0-1 in below 27 in design height for 40ft and 1 in to 3 in below for 29ft.

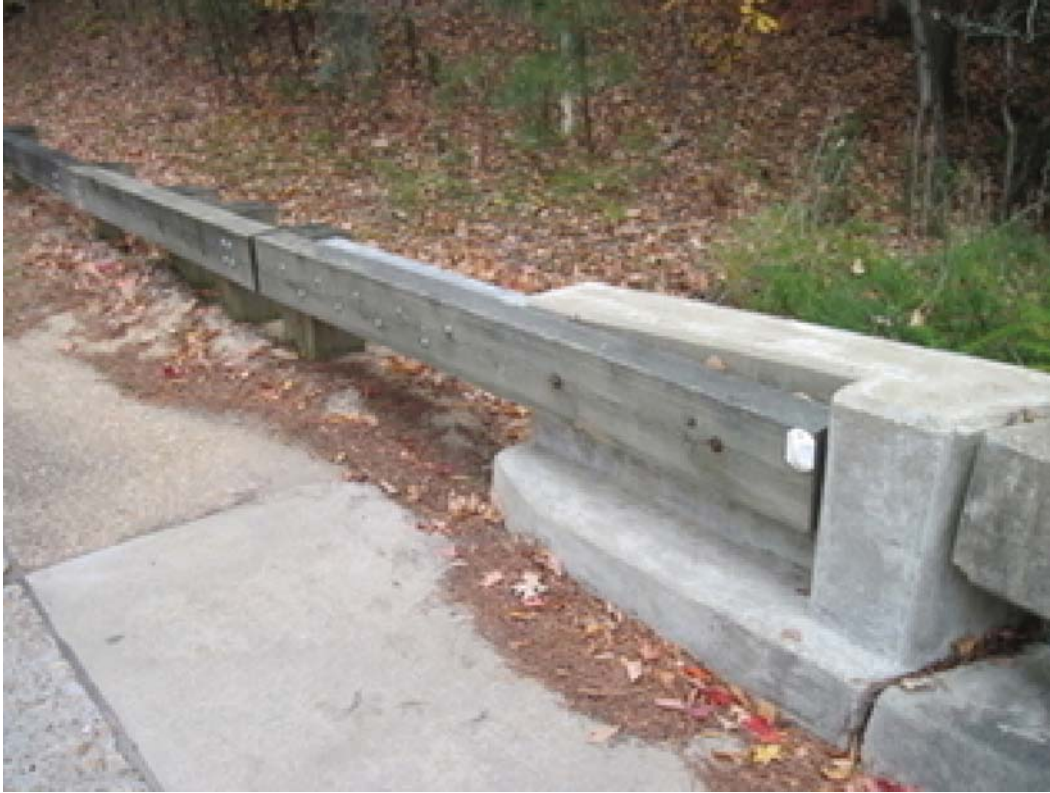
COLO_0001_7.152_L_1.jpg

Barrier ID:	COLO-0001-7.152-L				
Route Name:	COLONIAL PARKWAY				
Inspection Date:	11/16/2010	Barrier Rating:	32.40		
Barrier Description					
Type:	STEEL-BACKED TIMBER WITHOUT BLOCKOUT	Barrier Function:	TRAFFIC		
Barrier Material:	STEEL-BACKED TIMBER/LOG	Post Material:	WOOD		
Blockout Type:	N/A	Length (ft.):	70		
Speed Limit (MPH):	45	Placement with Respect to Road:	TANGENT		
Hazard Behind Barrier:	MEDIUM				
Barrier Crashworthiness					
Appropriate Test Level:	TL-2	Barrier Test Level:	TL-2	Is Barrier Crashworthy?:	YES
Beg. End Trtmt Type:	SBT/LOG FLARED	Is Beg. End Trtmt Crashworthy?:	NO	Approach Transition Type:	RIGID SBT WALL - SBT
Ending End Trtmt Type:	NONE	Ending End Trtmt Crashworthy?:	N/A		
Average Measurements					
Design Height (In.):	27	Width (In.):	0.0	Post Spacing (In.):	100.0
Height (In.):	23.0	Lateral Offset (In.):	55.0	Road Grade (%):	1.60
Physical Condition					
Barrier	Alignment and Height:	No alignment deflection observed. Height is 1-3 in below 27 in design height for 20ft and ranges from 3 in to 5 in below for 25ft.

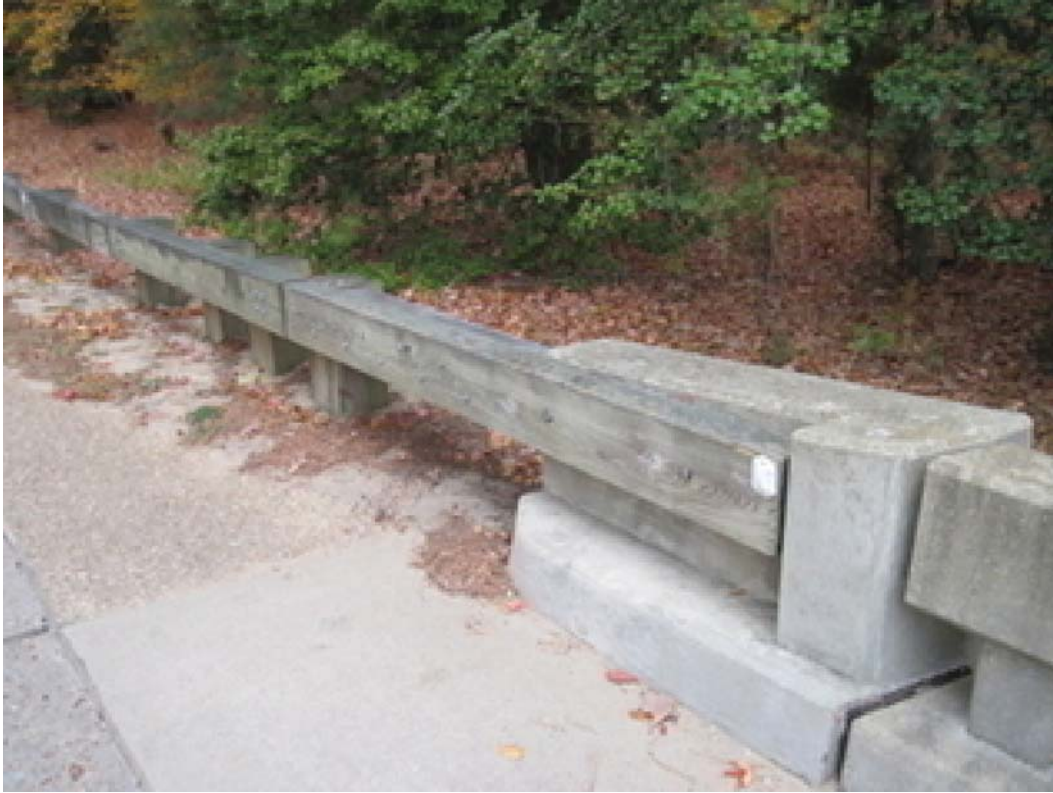
COLO_0001_7.290_R_1.jpg

Barrier ID:	COLO-0001-7.290-R				
Route Name:	COLONIAL PARKWAY				
Inspection Date:	11/16/2010	Barrier Rating:	29.80		
Barrier Description					
Type:	STEEL-BACKED TIMBER WITHOUT BLOCKOUT	Barrier Function:	TRAFFIC		
Barrier Material:	STEEL-BACKED TIMBER/LOG	Post Material:	WOOD		
Blockout Type:	N/A	Length (ft.):	98		
Speed Limit (MPH):	45	Placement with Respect to Road:	TANGENT		
Hazard Behind Barrier:	LOW				
Barrier Crashworthiness					
Appropriate Test Level:	TL-2	Barrier Test Level:	TL-2	Is Barrier Crashworthy?:	YES
Beg. End Trtmt Type:	NONE	Is Beg. End Trtmt Crashworthy?:	N/A	Approach Transition Type:	RIGID SBT WALL - SBT
Ending End Trtmt Type:	SBT/LOG FLARED	Ending End Trtmt Crashworthy?:	NO		
Average Measurements					
Design Height (In.):	27	Width (In.):	0.0	Post Spacing (In.):	120.0
Height (In.):	26.2	Lateral Offset (In.):	57.7	Road Grade (%):	1.90
Physical Condition					
Barrier	Alignment and Height:	No alignment deflection was observed. Height is 3 - 4 in below 27-in design height.

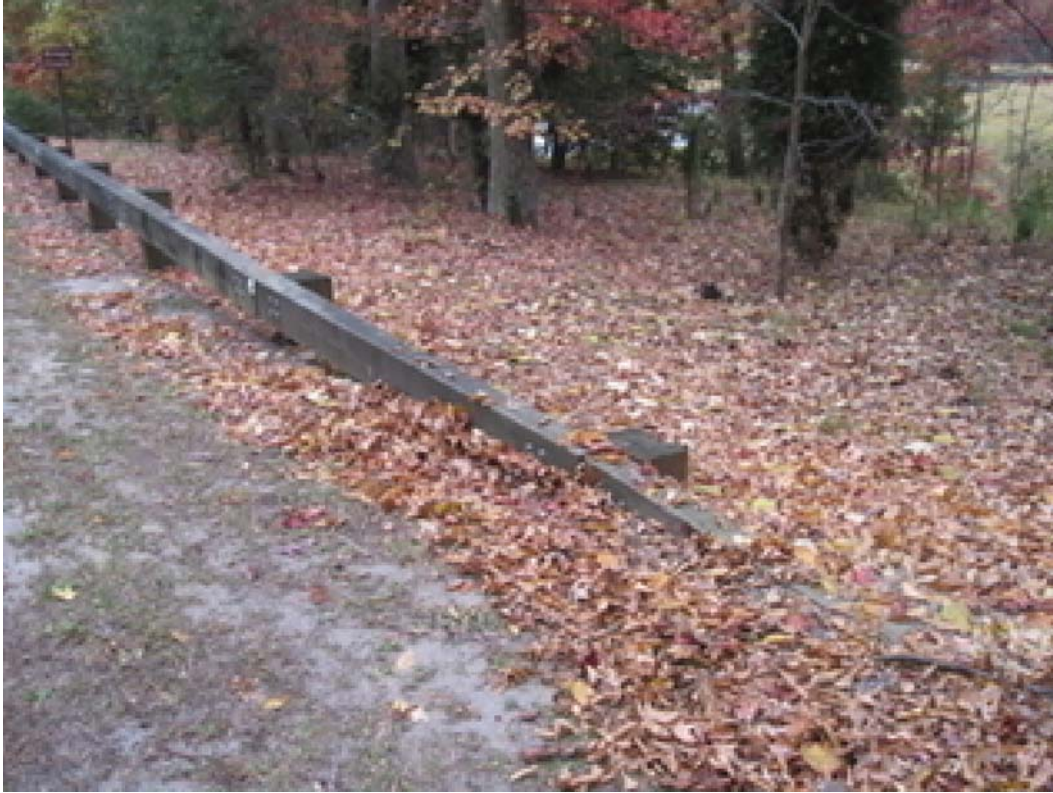
COLO_0001_7.291_L_1.jpg

Barrier ID:	COLO-0001-7.291-L				
Route Name:	COLONIAL PARKWAY				
Inspection Date:	11/16/2010	Barrier Rating:	21.10		
Barrier Description					
Type:	STEEL-BACKED TIMBER WITHOUT BLOCKOUT	Barrier Function:	TRAFFIC		
Barrier Material:	STEEL-BACKED TIMBER/LOG	Post Material:	WOOD		
Blockout Type:	N/A	Length (ft.):	96		
Speed Limit (MPH):	45	Placement with Respect to Road:	TANGENT		
Hazard Behind Barrier:	LOW				
Barrier Crashworthiness					
Appropriate Test Level:	TL-2	Barrier Test Level:	TL-2	Is Barrier Crashworthy?:	YES
Beg. End Trtmt Type:	NONE	Is Beg. End Trtmt Crashworthy?:	N/A	Approach Transition Type:	RIGID SBT WALL - SBT
Ending End Trtmt Type:	SBT/LOG FLARED	Ending End Trtmt Crashworthy?:	NO		
Average Measurements					
Design Height (In.):	27	Width (In.):	0.0	Post Spacing (In.):	120.0
Height (In.):	23.2	Lateral Offset (In.):	54.7	Road Grade (%):	1.70
Physical Condition					
Barrier	Alignment and Height:	No alignment deflection was observed. Height is 0 - 1 in below 27-in design height.
