GIP Report

NPS Guardwall/Rail Inventory Program Colonial National Historical Park

**Federal Highway Administration
Eastern Federal Lands Highway Division
Road Inventory Program (RIP)**

**Data Collection Date: November 2010
Report Date: December 2015**

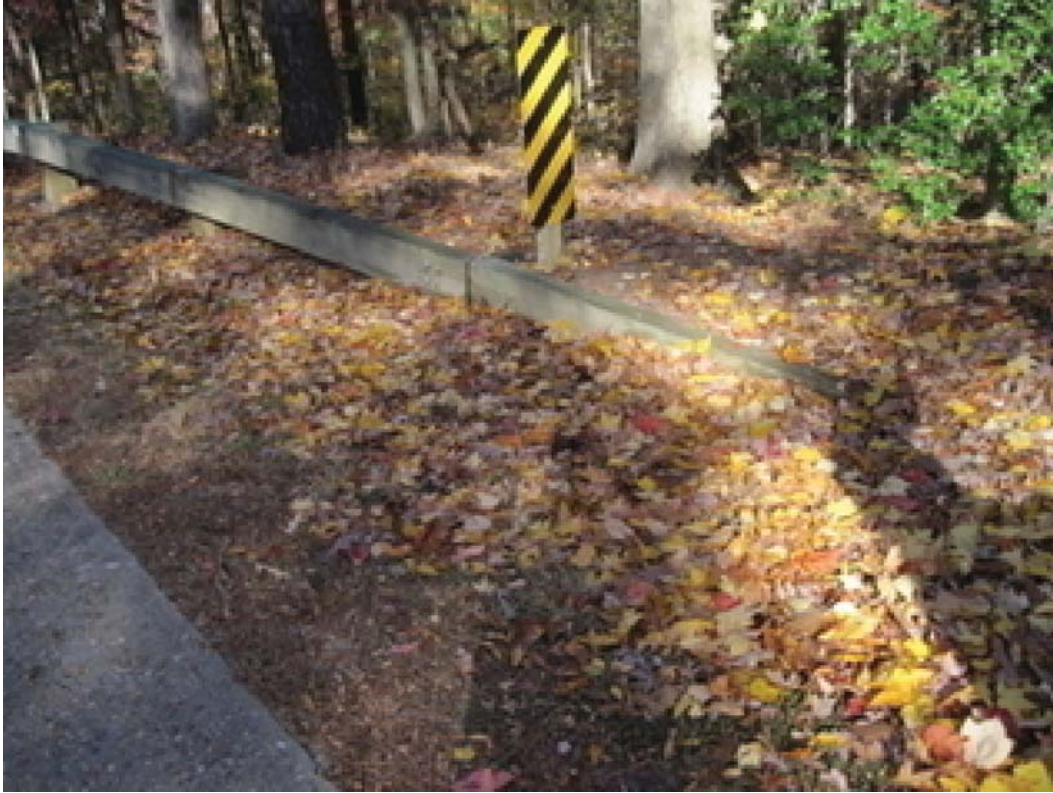
COLO_0001_8.554_R_1.jpg

Barrier ID:	COLO-0001-8.554-R				
Route Name:	COLONIAL PARKWAY				
Inspection Date:	11/17/2010	Barrier Rating:	29.30		
Barrier Description					
Type:	STEEL-BACKED TIMBER WITHOUT BLOCKOUT	Barrier Function:	TRAFFIC		
Barrier Material:	STEEL-BACKED TIMBER/LOG	Post Material:	WOOD		
Blockout Type:	N/A	Length (ft.):	57		
Speed Limit (MPH):	45	Placement with Respect to Road:	OUTSIDE OF CURVE		
Hazard Behind Barrier:	MEDIUM				
Barrier Crashworthiness					
Appropriate Test Level:	TL-2	Barrier Test Level:	TL-2	Is Barrier Crashworthy?:	YES
Beg. End Trtmt Type:	SBT/LOG FLARED	Is Beg. End Trtmt Crashworthy?:	NO	Approach Transition Type:	RIGID SBT WALL - SBT
Ending End Trtmt Type:	NONE	Ending End Trtmt Crashworthy?:	N/A		
Average Measurements					
Design Height (In.):	27	Width (In.):	0.0	Post Spacing (In.):	80.0
Height (In.):	29.7	Lateral Offset (In.):	55.2	Road Grade (%):	1.00
Physical Condition					
Barrier	Alignment and Height:	No alignment deflection observed. Height ranges from 2-3 in above the 27-in design height.

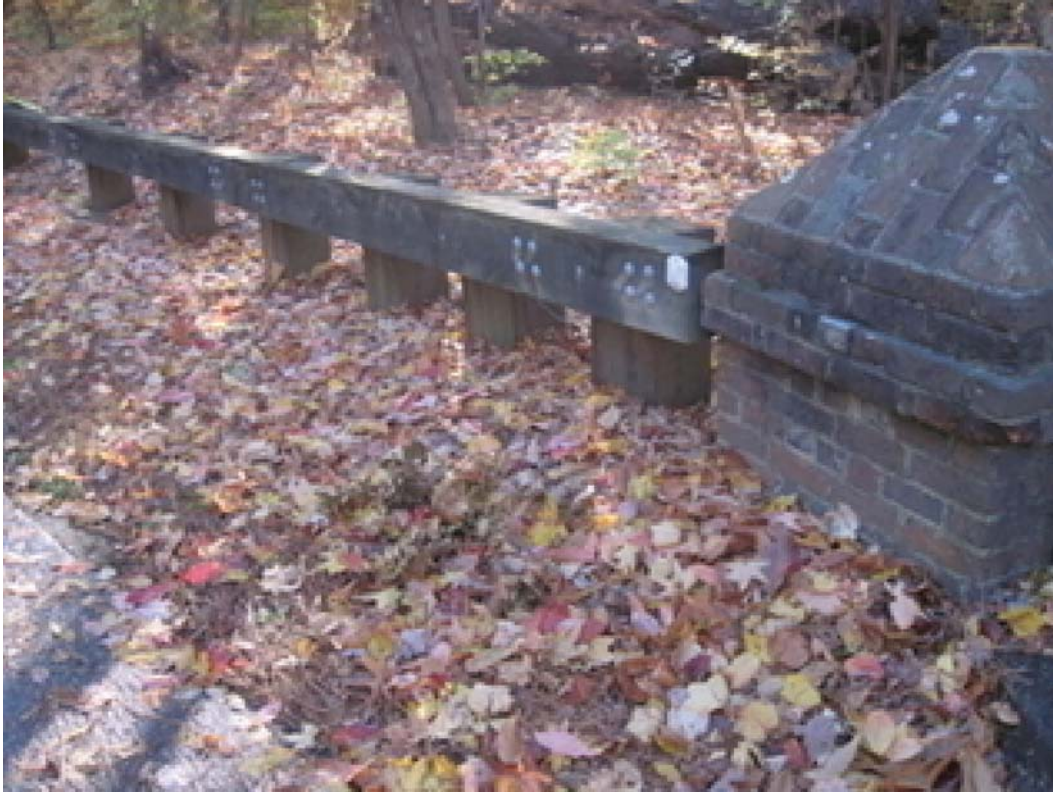
COLO_0001_8.558_L_1.jpg

Barrier ID:	COLO-0001-8.558-L				
Route Name:	COLONIAL PARKWAY				
Inspection Date:	11/17/2010	Barrier Rating:	18.20		
Barrier Description					
Type:	STEEL-BACKED TIMBER WITHOUT BLOCKOUT	Barrier Function:	TRAFFIC		
Barrier Material:	STEEL-BACKED TIMBER/LOG	Post Material:	WOOD		
Blockout Type:	N/A	Length (ft.):	58		
Speed Limit (MPH):	45	Placement with Respect to Road:	TANGENT		
Hazard Behind Barrier:	LOW				
Barrier Crashworthiness					
Appropriate Test Level:	TL-2	Barrier Test Level:	TL-2	Is Barrier Crashworthy?:	YES
Beg. End Trtmt Type:	SBT/LOG FLARED	Is Beg. End Trtmt Crashworthy?:	NO	Approach Transition Type:	RIGID SBT WALL - SBT
Ending End Trtmt Type:	NONE	Ending End Trtmt Crashworthy?:	N/A		
Average Measurements					
Design Height (In.):	27	Width (In.):	0.0	Post Spacing (In.):	99.6
Height (In.):	26.7	Lateral Offset (In.):	63.2	Road Grade (%):	1.20
Physical Condition					
Barrier	Alignment and Height:	No alignment deflection observed. Height is within 1-in of 27-in design height.

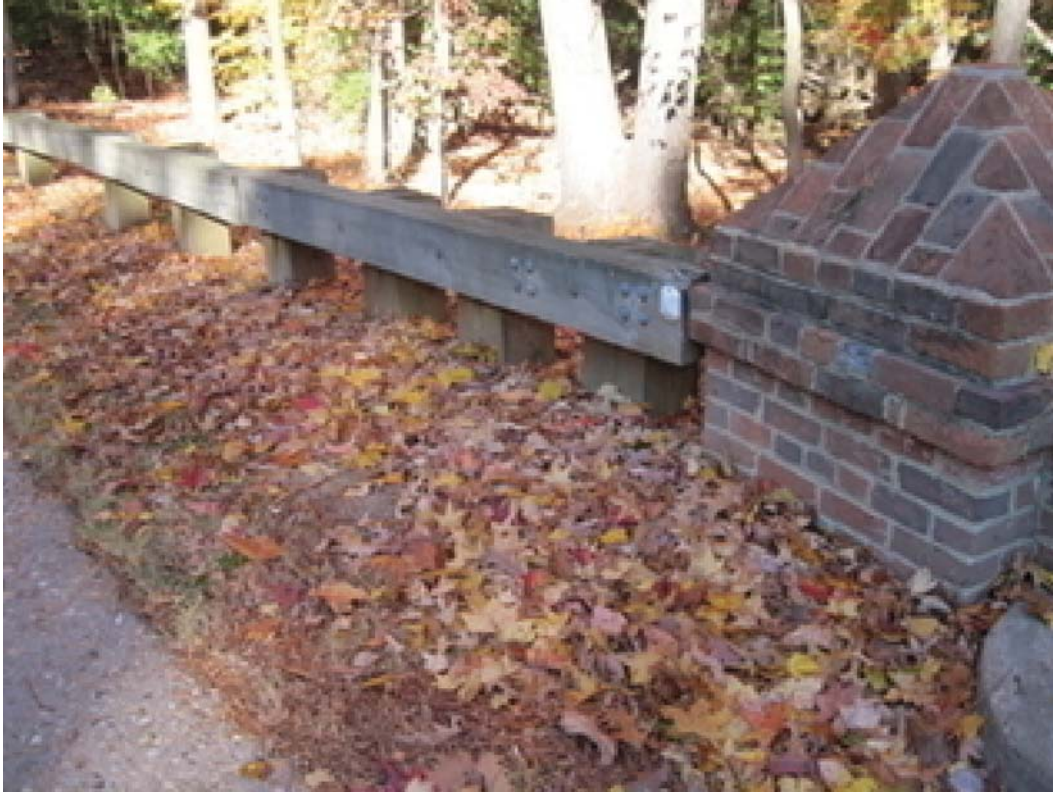
COLO_0001_8.603_R_1.jpg

Barrier ID:	COLO-0001-8.603-R				
Route Name:	COLONIAL PARKWAY				
Inspection Date:	11/17/2010	Barrier Rating:	26.80		
Barrier Description					
Type:	STEEL-BACKED TIMBER WITHOUT BLOCKOUT	Barrier Function:	TRAFFIC		
Barrier Material:	STEEL-BACKED TIMBER/LOG	Post Material:	WOOD		
Blockout Type:	N/A	Length (ft.):	54		
Speed Limit (MPH):	45	Placement with Respect to Road:	OUTSIDE OF CURVE		
Hazard Behind Barrier:	LOW				
Barrier Crashworthiness					
Appropriate Test Level:	TL-2	Barrier Test Level:	TL-2	Is Barrier Crashworthy?:	YES
Beg. End Trtmt Type:	NONE	Is Beg. End Trtmt Crashworthy?:	N/A	Approach Transition Type:	RIGID SBT WALL - SBT
Ending End Trtmt Type:	SBT/LOG FLARED	Ending End Trtmt Crashworthy?:	NO		
Average Measurements					
Design Height (In.):	27	Width (In.):	0.0	Post Spacing (In.):	80.0
Height (In.):	28.2	Lateral Offset (In.):	57.0	Road Grade (%):	0.30
Physical Condition					
Barrier	Alignment and Height:	No alignment deflection observed. Height ranges from 0 in to 2 in above 27 in design height.

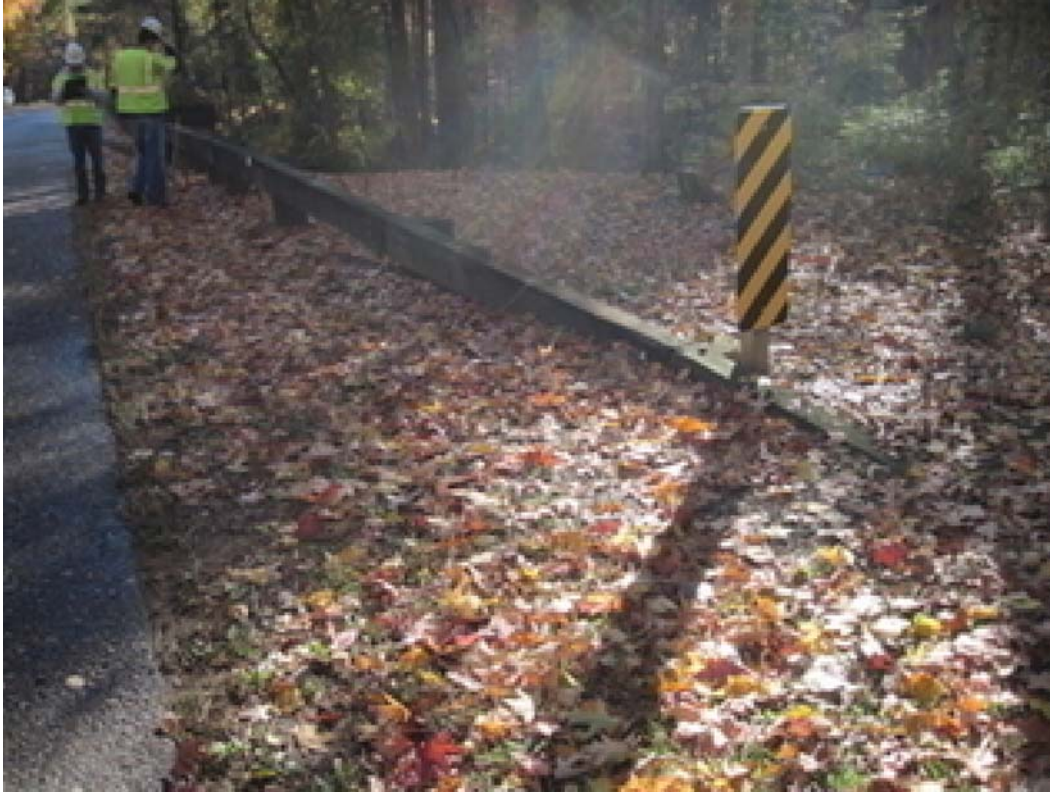
COLO_0001_8.608_L_1.jpg

Barrier ID:	COLO-0001-8.608-L				
Route Name:	COLONIAL PARKWAY				
Inspection Date:	11/17/2010	Barrier Rating:	18.20		
Barrier Description					
Type:	STEEL-BACKED TIMBER WITHOUT BLOCKOUT	Barrier Function:	TRAFFIC		
Barrier Material:	STEEL-BACKED TIMBER/LOG	Post Material:	WOOD		
Blockout Type:	N/A	Length (ft.):	55		
Speed Limit (MPH):	45	Placement with Respect to Road:	TANGENT		
Hazard Behind Barrier:	LOW				
Barrier Crashworthiness					
Appropriate Test Level:	TL-2	Barrier Test Level:	TL-2	Is Barrier Crashworthy?:	YES
Beg. End Trtmt Type:	NONE	Is Beg. End Trtmt Crashworthy?:	N/A	Approach Transition Type:	RIGID SBT WALL - SBT
Ending End Trtmt Type:	SBT/LOG FLARED	Ending End Trtmt Crashworthy?:	NO		
Average Measurements					
Design Height (In.):	27	Width (In.):	0.0	Post Spacing (In.):	80.6
Height (In.):	26.7	Lateral Offset (In.):	62.2	Road Grade (%):	1.10
Physical Condition					
Barrier	Alignment and Height:	No alignment deflection observed. Height is within 1-in of 27-in design height.

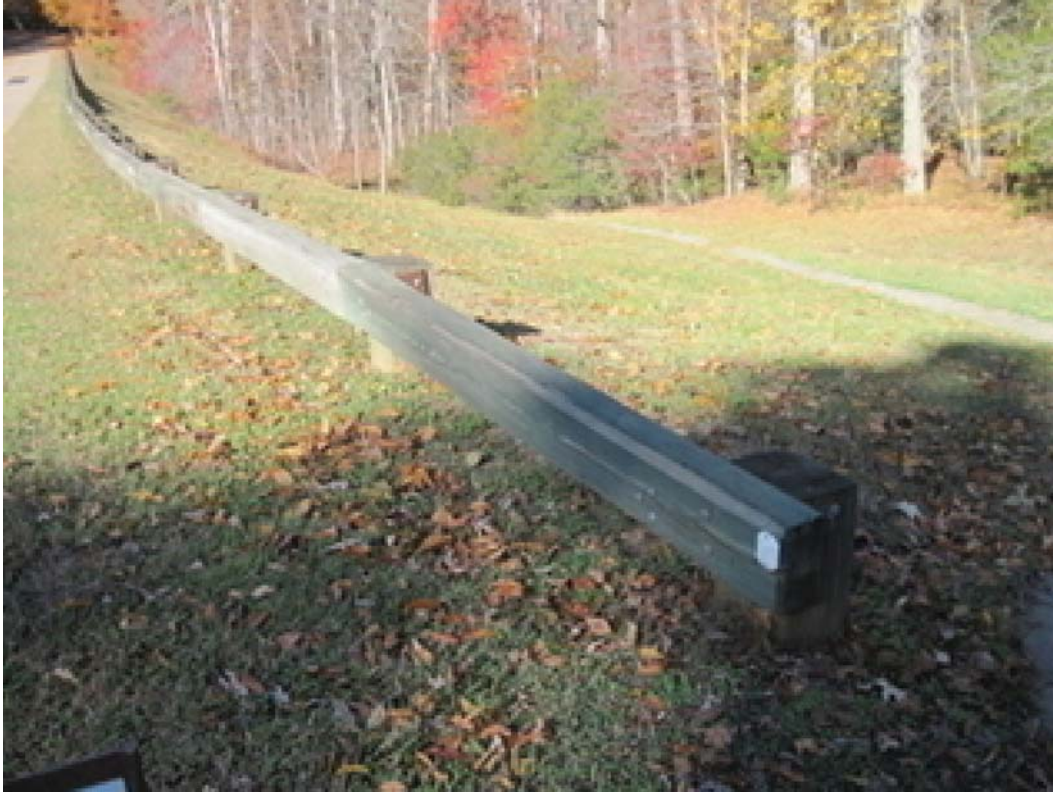
COLO_0001_9.370_R_1.jpg

Barrier ID:	COLO-0001-9.370-R				
Route Name:	COLONIAL PARKWAY				
Inspection Date:	11/17/2010	Barrier Rating:	32.50		
Barrier Description					
Type:	STEEL-BACKED TIMBER WITHOUT BLOCKOUT	Barrier Function:	TRAFFIC		
Barrier Material:	STEEL-BACKED TIMBER/LOG	Post Material:	WOOD		
Blockout Type:	N/A	Length (ft.):	562		
Speed Limit (MPH):	45	Placement with Respect to Road:	TANGENT		
Hazard Behind Barrier:	MEDIUM				
Barrier Crashworthiness					
Appropriate Test Level:	TL-2	Barrier Test Level:	TL-2	Is Barrier Crashworthy?:	YES
Beg. End Trtmt Type:	NONE	Is Beg. End Trtmt Crashworthy?:	N/A	Approach Transition Type:	NONE
Ending End Trtmt Type:	NONE	Ending End Trtmt Crashworthy?:	N/A		
Average Measurements					
Design Height (In.):	27	Width (In.):	0.0	Post Spacing (In.):	120.0
Height (In.):	24.0	Lateral Offset (In.):	57.2	Road Grade (%):	1.70
Physical Condition					
Barrier	Alignment and Height:	No alignment deflection observed. Height is 1-3 in below the 27-in design height along entire length.

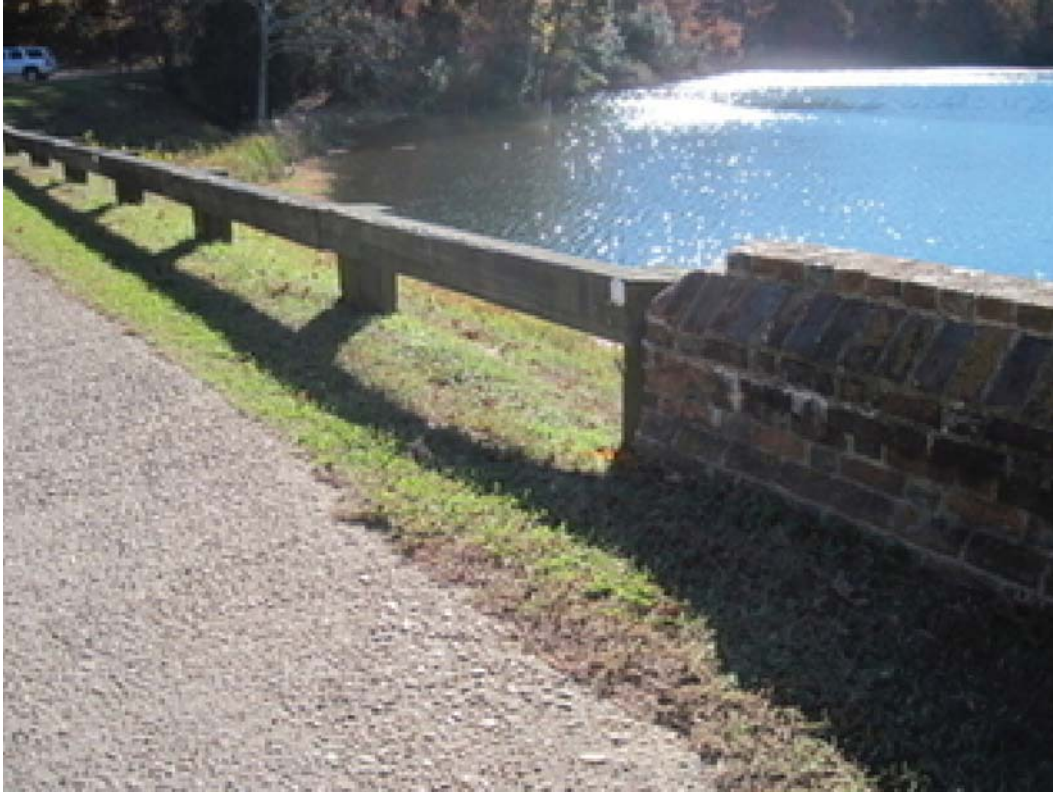
COLO_0001_9.379_L_1.jpg

Barrier ID:	COLO-0001-9.379-L				
Route Name:	COLONIAL PARKWAY				
Inspection Date:	11/17/2010	Barrier Rating:	31.30		
Barrier Description					
Type:	STEEL-BACKED TIMBER WITHOUT BLOCKOUT	Barrier Function:	TRAFFIC		
Barrier Material:	STEEL-BACKED TIMBER/LOG	Post Material:	WOOD		
Blockout Type:	N/A	Length (ft.):	161		
Speed Limit (MPH):	45	Placement with Respect to Road:	TANGENT		
Hazard Behind Barrier:	HIGH				
Barrier Crashworthiness					
Appropriate Test Level:	TL-2	Barrier Test Level:	TL-2	Is Barrier Crashworthy?:	YES
Beg. End Trtmt Type:	NONE	Is Beg. End Trtmt Crashworthy?:	N/A	Approach Transition Type:	NONE
Ending End Trtmt Type:	NONE	Ending End Trtmt Crashworthy?:	N/A		
Average Measurements					
Design Height (In.):	27	Width (In.):	0.0	Post Spacing (In.):	120.3
Height (In.):	25.0	Lateral Offset (In.):	63.2	Road Grade (%):	2.20
Physical Condition					
Barrier	Alignment and Height:	Alignment deflection of 0 - 6 in was observed. Height is 2-3 in below 27-in design height along entire length.

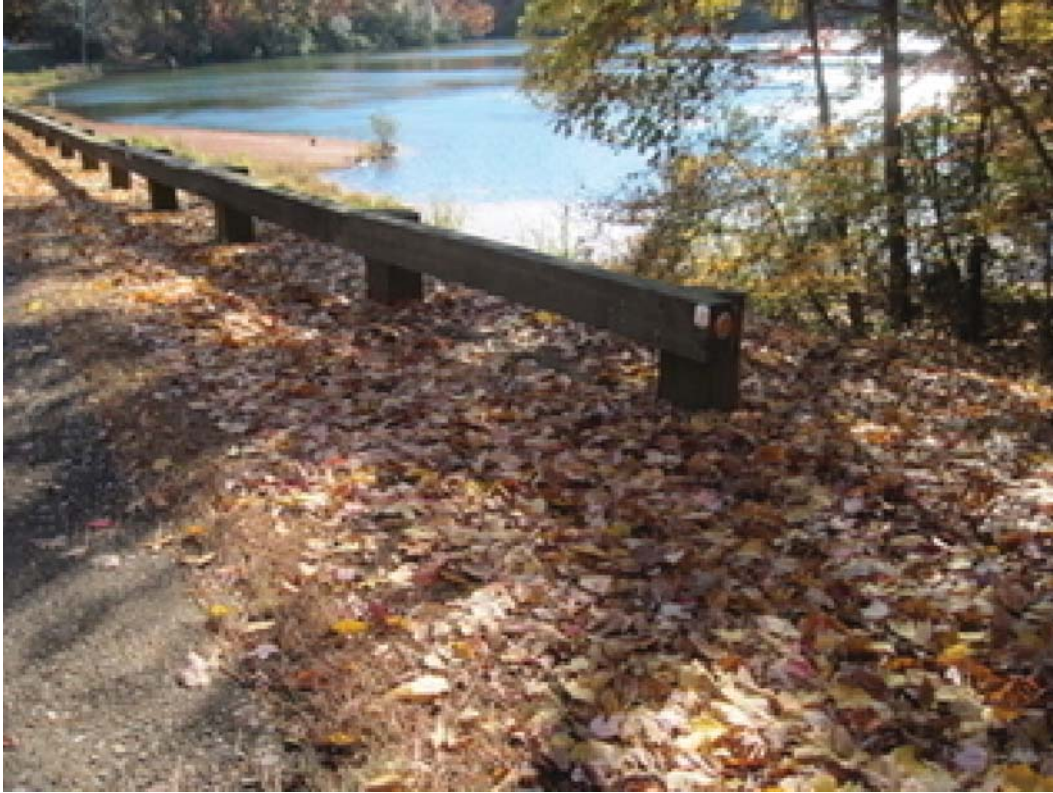
COLO_0001_9.419_L_1.jpg

Barrier ID:	COLO-0001-9.419-L				
Route Name:	COLONIAL PARKWAY				
Inspection Date:	11/17/2010	Barrier Rating:	34.20		
Barrier Description					
Type:	STEEL-BACKED TIMBER WITHOUT BLOCKOUT	Barrier Function:	TRAFFIC		
Barrier Material:	STEEL-BACKED TIMBER/LOG	Post Material:	WOOD		
Blockout Type:	N/A	Length (ft.):	321		
Speed Limit (MPH):	45	Placement with Respect to Road:	TANGENT		
Hazard Behind Barrier:	HIGH				
Barrier Crashworthiness					
Appropriate Test Level:	TL-2	Barrier Test Level:	TL-2	Is Barrier Crashworthy?:	YES
Beg. End Trtmt Type:	NONE	Is Beg. End Trtmt Crashworthy?:	N/A	Approach Transition Type:	NONE
Ending End Trtmt Type:	NONE	Ending End Trtmt Crashworthy?:	N/A		
Average Measurements					
Design Height (In.):	27	Width (In.):	0.0	Post Spacing (In.):	120.0
Height (In.):	24.2	Lateral Offset (In.):	68.0	Road Grade (%):	1.20
Physical Condition					
Barrier	Alignment and Height:	Alignment deflection of 0 - 6 in was observed. Height is 2-3 in below 27-in design height along entire length.

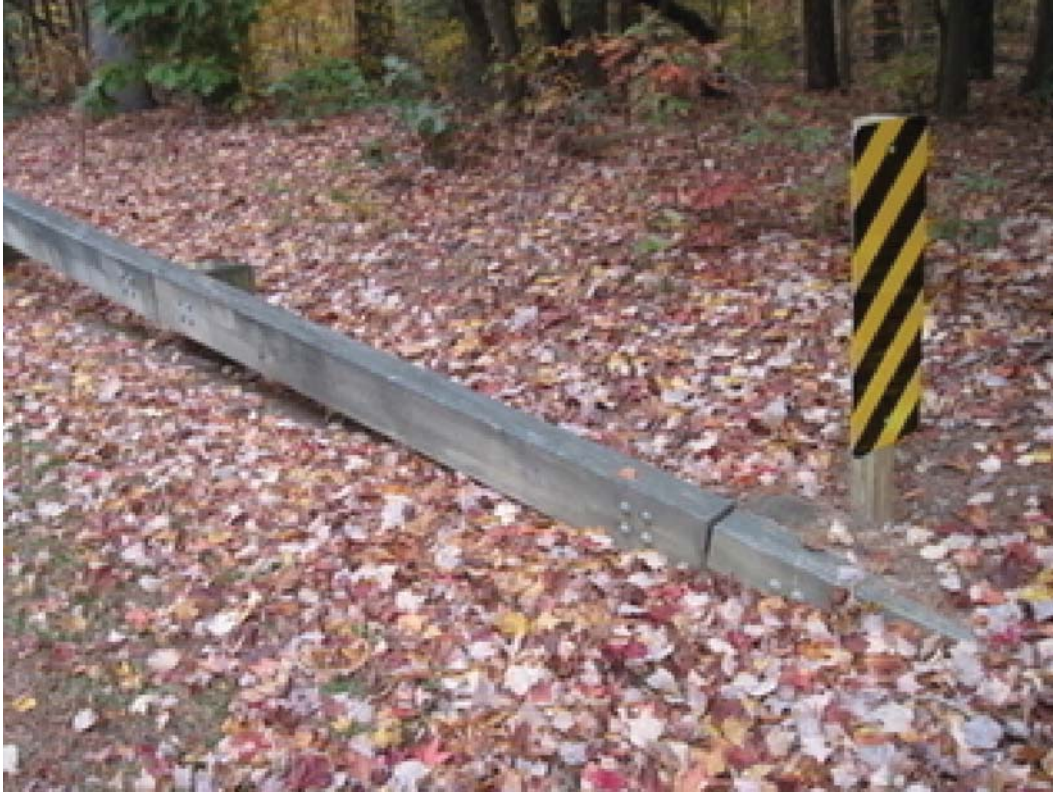
COLO_0001_11.238_R_1.jpg

Barrier ID:	COLO-0001-11.238-R				
Route Name:	COLONIAL PARKWAY				
Inspection Date:	11/18/2010	Barrier Rating:	21.10		
Barrier Description					
Type:	STEEL-BACKED TIMBER WITHOUT BLOCKOUT	Barrier Function:	TRAFFIC		
Barrier Material:	STEEL-BACKED TIMBER/LOG	Post Material:	WOOD		
Blockout Type:	N/A	Length (ft.):	52		
Speed Limit (MPH):	45	Placement with Respect to Road:	TANGENT		
Hazard Behind Barrier:	LOW				
Barrier Crashworthiness					
Appropriate Test Level:	TL-2	Barrier Test Level:	TL-2	Is Barrier Crashworthy?:	YES
Beg. End Trtmt Type:	SBT/LOG FLARED	Is Beg. End Trtmt Crashworthy?:	NO	Approach Transition Type:	RIGID SBT WALL - SBT
Ending End Trtmt Type:	NONE	Ending End Trtmt Crashworthy?:	N/A		
Average Measurements					
Design Height (In.):	27	Width (In.):	0.0	Post Spacing (In.):	100.6
Height (In.):	27.2	Lateral Offset (In.):	52.2	Road Grade (%):	2.00
Physical Condition					
Barrier	Alignment and Height:	No alignment deflection observed. Height is 0-1 in above the 27-in design height.

Breaking and Cracking:	No breaking or cracking observed.			
	Missing Elements:	No missing elements observed.			
	Corrosion and Weathering:	No corrosion or weathering observed.			
End Treatments	Alignment and Height:	Alignment acceptable. Height within 1-in of 27-in design height.			
	Breaking and Cracking:	No breaking or cracking observed.			
	Missing Elements:	No missing elements observed.			
	Corrosion and Weathering:	No corrosion or weathering observed.

Repair Action:	NO ACTION	FMSS Work Type:	N/A	Repair Cost:	\$0
Brief Workorder:	N/A				
Workorder:

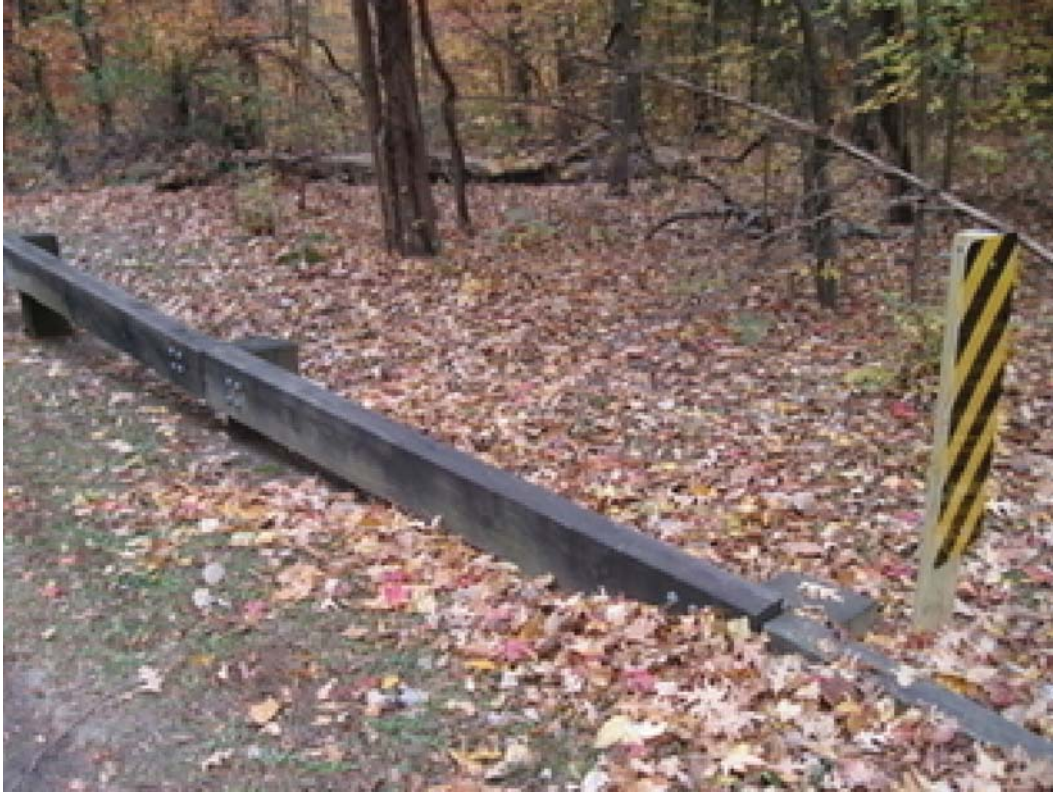
COLO_0001_11.271_L_1.jpg

Barrier ID:	COLO-0001-11.271-L				
Route Name:	COLONIAL PARKWAY				
Inspection Date:	11/18/2010	Barrier Rating:	23.60		
Barrier Description					
Type:	STEEL-BACKED TIMBER WITHOUT BLOCKOUT	Barrier Function:	TRAFFIC		
Barrier Material:	STEEL-BACKED TIMBER/LOG	Post Material:	WOOD		
Blockout Type:	N/A	Length (ft.):	54		
Speed Limit (MPH):	45	Placement with Respect to Road:	TANGENT		
Hazard Behind Barrier:	MEDIUM				
Barrier Crashworthiness					
Appropriate Test Level:	TL-2	Barrier Test Level:	TL-2	Is Barrier Crashworthy?:	YES
Beg. End Trtmt Type:	NONE	Is Beg. End Trtmt Crashworthy?:	N/A	Approach Transition Type:	RIGID SBT WALL - SBT
Ending End Trtmt Type:	SBT/LOG FLARED	Ending End Trtmt Crashworthy?:	NO		
Average Measurements					
Design Height (In.):	27	Width (In.):	0.0	Post Spacing (In.):	80.0
Height (In.):	26.7	Lateral Offset (In.):	54.7	Road Grade (%):	1.20
Physical Condition					
Barrier	Alignment and Height:	No alignment deflection observed. Height ranges from 0 in to 1 in below 27 in design height.

Breaking and Cracking:	No breaking or cracking observed.			
	Missing Elements:	No missing elements observed.			
	Corrosion and Weathering:	No corrosion or weathering observed.			
End Treatments	Alignment and Height:	Alignment acceptable. Height within 1-in of 27-in design height.			
	Breaking and Cracking:	No breaking or cracking observed.			
	Missing Elements:	No missing elements observed.			
	Corrosion and Weathering:	No corrosion or weathering observed.

Repair Action:	NO ACTION	FMSS Work Type:	N/A	Repair Cost:	\$0
Brief Workorder:	N/A				
Workorder:	No action.

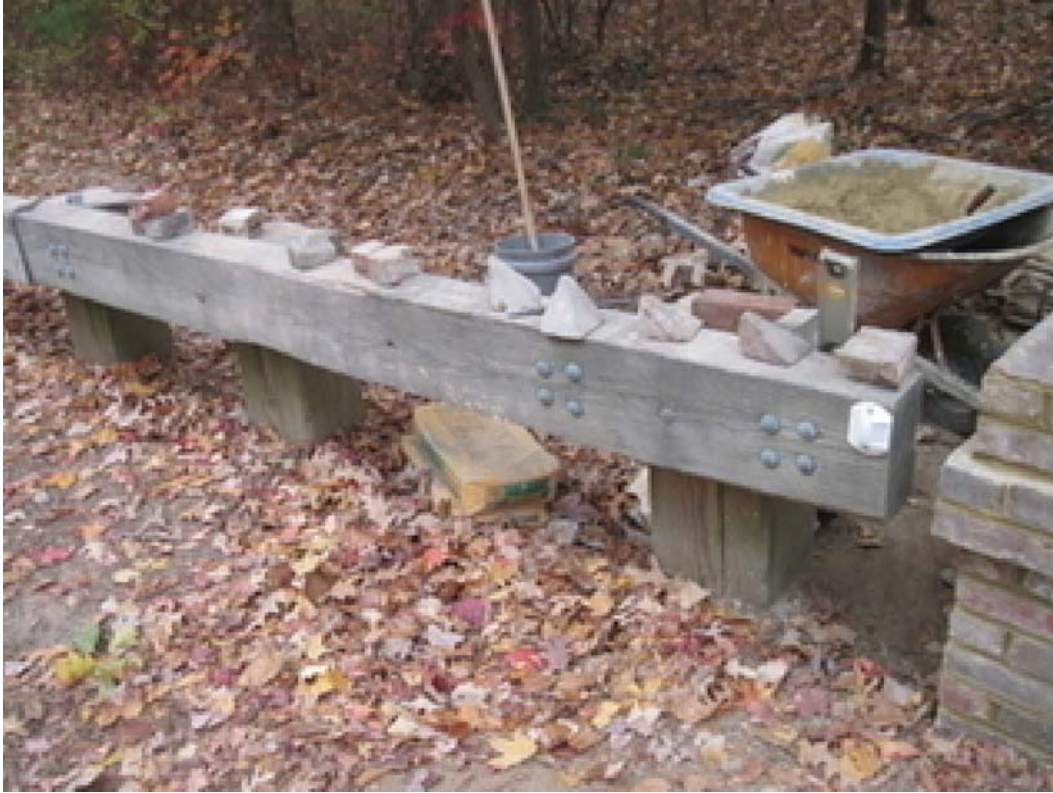
COLO_0001_11.272_R_1.jpg

Barrier ID:	COLO-0001-11.272-R				
Route Name:	COLONIAL PARKWAY				
Inspection Date:	11/18/2010	Barrier Rating:	21.10		
Barrier Description					
Type:	STEEL-BACKED TIMBER WITHOUT BLOCKOUT	Barrier Function:	TRAFFIC		
Barrier Material:	STEEL-BACKED TIMBER/LOG	Post Material:	WOOD		
Blockout Type:	N/A	Length (ft.):	54		
Speed Limit (MPH):	45	Placement with Respect to Road:	TANGENT		
Hazard Behind Barrier:	LOW				
Barrier Crashworthiness					
Appropriate Test Level:	TL-2	Barrier Test Level:	TL-2	Is Barrier Crashworthy?:	YES
Beg. End Trtmt Type:	NONE	Is Beg. End Trtmt Crashworthy?:	N/A	Approach Transition Type:	RIGID SBT WALL - SBT
Ending End Trtmt Type:	SBT/LOG FLARED	Ending End Trtmt Crashworthy?:	NO		
Average Measurements					
Design Height (In.):	27	Width (In.):	0.0	Post Spacing (In.):	60.0
Height (In.):	26.0	Lateral Offset (In.):	51.7	Road Grade (%):	0.20
Physical Condition					
Barrier	Alignment and Height:	No alignment deflection observed. Height is 1 in below the 27-in design height.

Breaking and Cracking:	No breaking or cracking observed.			
	Missing Elements:	No missing elements observed.			
	Corrosion and Weathering:	No corrosion or weathering observed.			
End Treatments	Alignment and Height:	Alignment acceptable. Height within 1-in of 27-in design height.			
	Breaking and Cracking:	No breaking or cracking observed.			
	Missing Elements:	No missing elements observed.			
	Corrosion and Weathering:	No corrosion or weathering observed.

Barrier ID:	COLO-0001-11.272-R				
Route Name:	COLONIAL PARKWAY				
Inspection Date:	11/18/2010	Barrier Rating:		21.10	
Repair Recommendations					
Repair Action:	NO ACTION	FMSS Work Type:	N/A	Repair Cost:	\$0
Brief Workorder:	N/A				
Workorder:

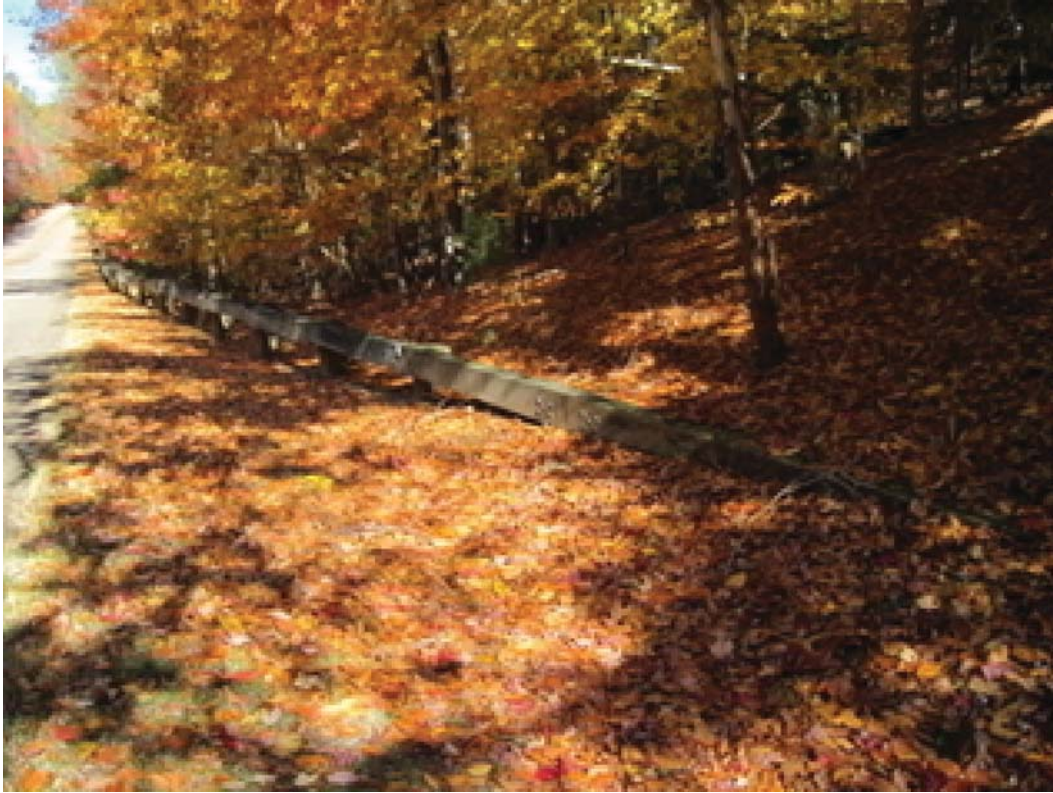
COLO_0001_15.290_L_1.jpg

Barrier ID:	COLO-0001-15.290-L				
Route Name:	COLONIAL PARKWAY				
Inspection Date:	11/17/2010	Barrier Rating:	28.10		
Barrier Description					
Type:	STEEL-BACKED TIMBER WITHOUT BLOCKOUT	Barrier Function:	TRAFFIC		
Barrier Material:	STEEL-BACKED TIMBER/LOG	Post Material:	WOOD		
Blockout Type:	N/A	Length (ft.):	634		
Speed Limit (MPH):	45	Placement with Respect to Road:	TANGENT		
Hazard Behind Barrier:	MEDIUM				
Barrier Crashworthiness					
Appropriate Test Level:	TL-2	Barrier Test Level:	TL-2	Is Barrier Crashworthy?:	YES
Beg. End Trtmt Type:	SBT/LOG BURIED	Is Beg. End Trtmt Crashworthy?:	YES	Approach Transition Type:	NONE
Ending End Trtmt Type:	SBT/LOG BURIED	Ending End Trtmt Crashworthy?:	YES		
Average Measurements					
Design Height (In.):	27	Width (In.):	0.0	Post Spacing (In.):	120.0
Height (In.):	26.0	Lateral Offset (In.):	67.6	Road Grade (%):	0.40
Physical Condition					
Barrier	Alignment and Height:	No alignment deflection was observed. Height is 1 - 3 in below 27-in design height along 140 ft.

Breaking and Cracking:	No breaking or cracking was observed.			
	Missing Elements:	No missing elements were observed.			
	Corrosion and Weathering:	No corrosion or weathering was observed.			
End Treatments	Alignment and Height:	Alignment acceptable. Height within 1-in of 27-in design height.			
	Breaking and Cracking:	No breaking or cracking was observed.			
	Missing Elements:	No missing elements were observed.			
	Corrosion and Weathering:	No corrosion or weathering was observed.

Repair Action:	REPAIR	FMSS Work Type:	DEFERRED MAINTENANCE	Repair Cost:	\$3163
Brief Workorder:	Raise 140 feet of guardrail to 27-inch design height.				
Workorder:	Adjust Guardrail at \$10- per -Lin. Ft. for 140 LF = \$1400. Raise 140 feet of guardrail to 27-inch design height. Low Speed Traffic Control at \$1475- per -Day for 1 Day(s) = \$1475.

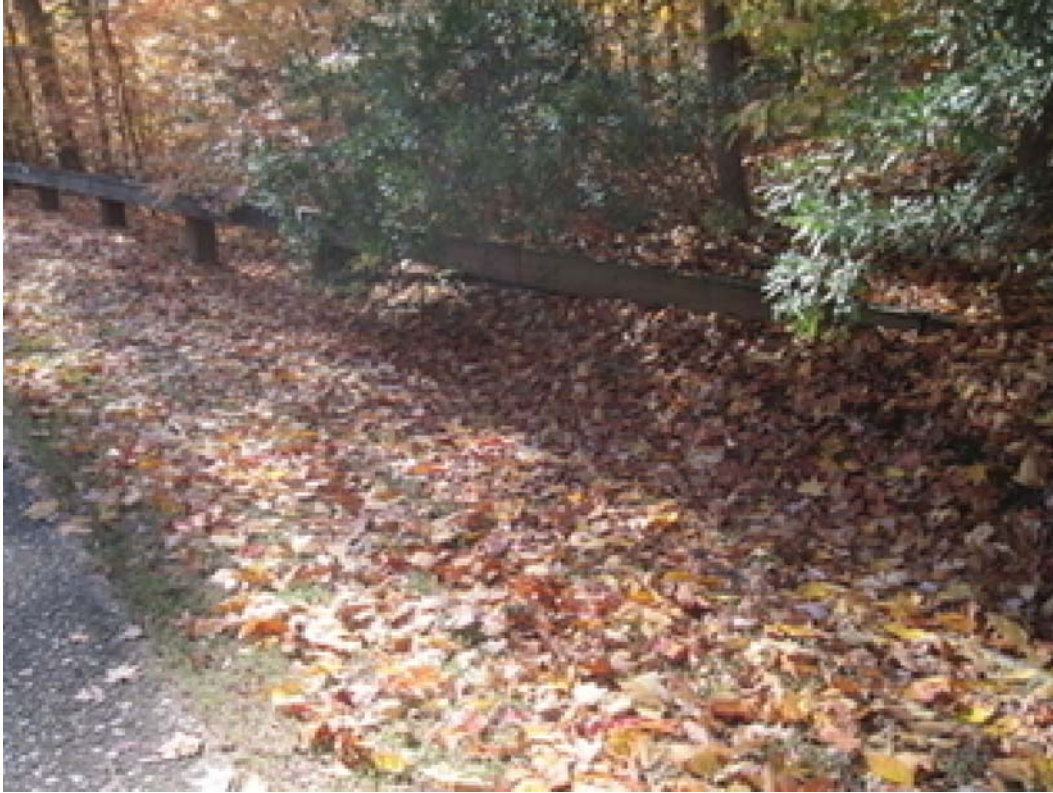
COLO_0001_15.297_R_1.jpg

Barrier ID:	COLO-0001-15.297-R				
Route Name:	COLONIAL PARKWAY				
Inspection Date:	11/17/2010	Barrier Rating:	39.70		
Barrier Description					
Type:	STEEL-BACKED TIMBER WITHOUT BLOCKOUT	Barrier Function:	TRAFFIC		
Barrier Material:	STEEL-BACKED TIMBER/LOG	Post Material:	WOOD		
Blockout Type:	N/A	Length (ft.):	1212		
Speed Limit (MPH):	45	Placement with Respect to Road:	BOTH INSIDE AND OUTSIDE		
Hazard Behind Barrier:	HIGH				
Barrier Crashworthiness					
Appropriate Test Level:	TL-2	Barrier Test Level:	TL-2	Is Barrier Crashworthy?:	YES
Beg. End Trtmt Type:	SBT/LOG BURIED	Is Beg. End Trtmt Crashworthy?:	YES	Approach Transition Type:	NONE
Ending End Trtmt Type:	SBT/LOG FLARED	Ending End Trtmt Crashworthy?:	YES		
Average Measurements					
Design Height (In.):	27	Width (In.):	0.0	Post Spacing (In.):	120.0
Height (In.):	27.0	Lateral Offset (In.):	25.7	Road Grade (%):	0.70
Physical Condition					
Barrier	Alignment and Height:	No alignment deflection observed. Height ranges from 1 in below 27 in design height to 1 in over.

Breaking and Cracking:	Steel backing on one 10 ft rail is bent due to a fallen tree.			
	Missing Elements:	No missing elements observed.			
	Corrosion and Weathering:	No corrosion or weathering observed.			
End Treatments	Alignment and Height:	Alignment acceptable. Height within 1-in of 27-in design height.			
	Breaking and Cracking:	No breaking or cracking observed.			
	Missing Elements:	No missing elements observed.			
	Corrosion and Weathering:	No corrosion or weathering observed.

Repair Action:	REPAIR	FMSS Work Type:	DEFERRED MAINTENANCE	Repair Cost:	\$1898
Brief Workorder:	Replace 10 feet of rail.				
Workorder:	Replace Rail at \$25- per -Lin. Ft. for 10 LF = \$250. Low Speed Traffic Control at \$1475- per -Day for 1 Day(s) = \$1475.

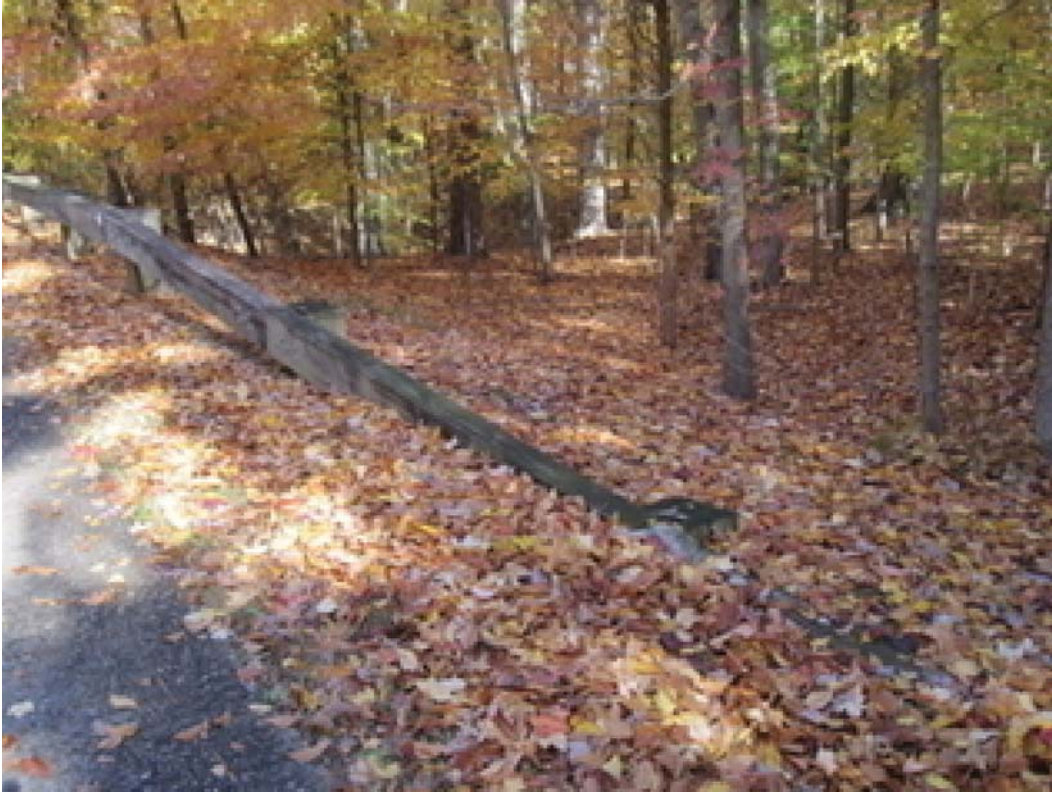
COLO_0001_15.464_L_1.jpg

Barrier ID:	COLO-0001-15.464-L				
Route Name:	COLONIAL PARKWAY				
Inspection Date:	11/17/2010	Barrier Rating:	35.40		
Barrier Description					
Type:	STEEL-BACKED TIMBER WITHOUT BLOCKOUT	Barrier Function:	TRAFFIC		
Barrier Material:	STEEL-BACKED TIMBER/LOG	Post Material:	WOOD		
Blockout Type:	N/A	Length (ft.):	302		
Speed Limit (MPH):	45	Placement with Respect to Road:	TANGENT		
Hazard Behind Barrier:	MEDIUM				
Barrier Crashworthiness					
Appropriate Test Level:	TL-2	Barrier Test Level:	TL-2	Is Barrier Crashworthy?:	YES
Beg. End Trtmt Type:	SBT/LOG FLARED	Is Beg. End Trtmt Crashworthy?:	NO	Approach Transition Type:	NONE
Ending End Trtmt Type:	SBT/LOG FLARED	Ending End Trtmt Crashworthy?:	NO		
Average Measurements					
Design Height (In.):	27	Width (In.):	0.0	Post Spacing (In.):	120.6
Height (In.):	25.2	Lateral Offset (In.):	36.2	Road Grade (%):	0.90
Physical Condition					
Barrier	Alignment and Height:	No alignment deflection observed. Height is 1-3 in below the 27-in design height along 60 ft. Height is 3 - 4 in below the 27-in design height along 100 ft.

Breaking and Cracking:	No breaking or cracking observed.			
	Missing Elements:	No missing elements observed.			
	Corrosion and Weathering:	No corrosion or weathering observed.			
End Treatments	Alignment and Height:	Alignment acceptable. Height within 1-in of 27-in design height.			
	Breaking and Cracking:	No breaking or cracking observed.			
	Missing Elements:	No missing elements observed.			
	Corrosion and Weathering:	No corrosion or weathering observed.

Repair Action:	REPAIR	FMSS Work Type:	DEFERRED MAINTENANCE	Repair Cost:	\$3383
Brief Workorder:	Raise 160 feet of barrier to 27-inch design height.				
Workorder:	Adjust Guardrail at \$10- per -Lin. Ft. for 160 LF = \$1600. Raise 160 feet of barrier to 27-inch design height. Low Speed Traffic Control at \$1475- per -Day for 1 Day(s) = \$1475.

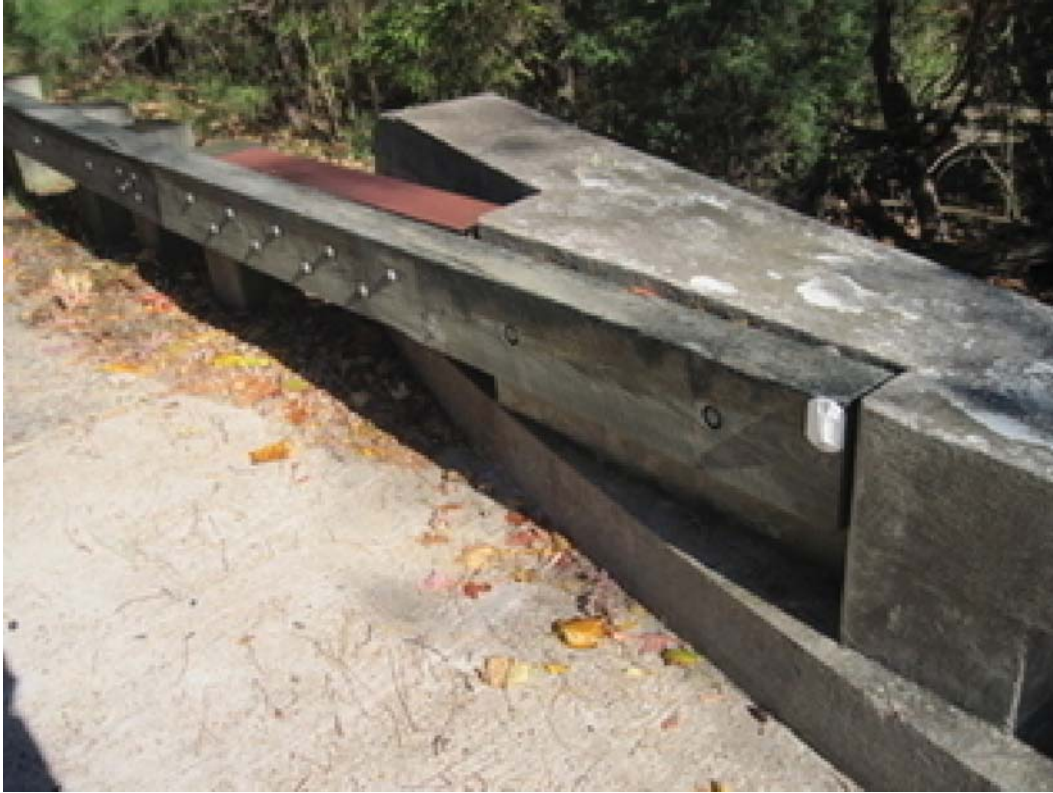
COLO_0001_15.713_L_1.jpg

Barrier ID:	COLO-0001-15.713-L				
Route Name:	COLONIAL PARKWAY				
Inspection Date:	11/17/2010	Barrier Rating:	26.50		
Barrier Description					
Type:	STEEL-BACKED TIMBER WITHOUT BLOCKOUT	Barrier Function:	TRAFFIC		
Barrier Material:	STEEL-BACKED TIMBER/LOG	Post Material:	WOOD		
Blockout Type:	N/A	Length (ft.):	113		
Speed Limit (MPH):	45	Placement with Respect to Road:	TANGENT		
Hazard Behind Barrier:	MEDIUM				
Barrier Crashworthiness					
Appropriate Test Level:	TL-2	Barrier Test Level:	TL-2	Is Barrier Crashworthy?:	YES
Beg. End Trtmt Type:	SBT/LOG FLARED	Is Beg. End Trtmt Crashworthy?:	NO	Approach Transition Type:	RIGID SBT WALL - SBT
Ending End Trtmt Type:	NONE	Ending End Trtmt Crashworthy?:	N/A		
Average Measurements					
Design Height (In.):	27	Width (In.):	0.0	Post Spacing (In.):	120.0
Height (In.):	26.2	Lateral Offset (In.):	21.0	Road Grade (%):	3.50
Physical Condition					
Barrier	Alignment and Height:	No alignment deflection observed. Height ranges from 0-1 in below 27 in design height.

Breaking and Cracking:	No breaking or cracking observed.			
	Missing Elements:	No missing elements observed.			
	Corrosion and Weathering:	No corrosion or weathering observed.			
End Treatments	Alignment and Height:	Alignment acceptable. Height within 1-in of 27-in design height.			
	Breaking and Cracking:	No breaking or cracking observed.			
	Missing Elements:	No missing elements observed.			
	Corrosion and Weathering:	No corrosion or weathering observed.

Barrier ID:	COLO-0001-15.713-L				
Route Name:	COLONIAL PARKWAY				
Inspection Date:	11/17/2010	Barrier Rating:		26.50	
Repair Recommendations					
Repair Action:	NO ACTION	FMSS Work Type:	N/A	Repair Cost:	\$0
Brief Workorder:	N/A				
Workorder:	No action.

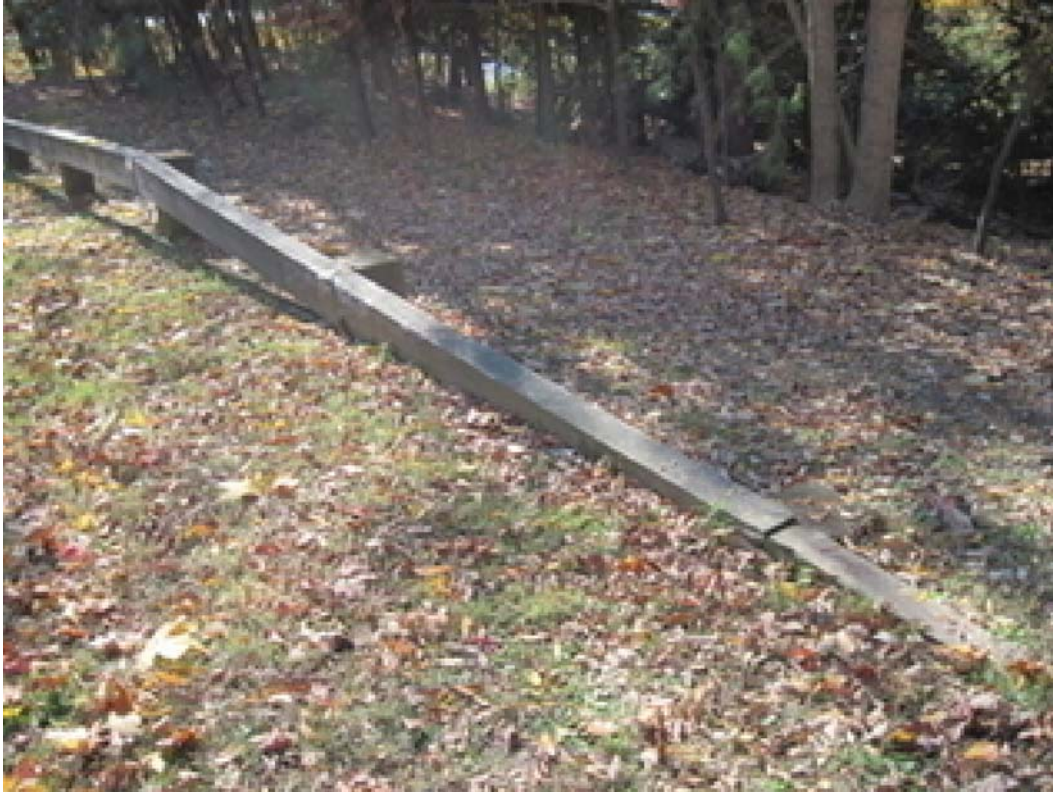
COLO_0001_15.714_R_1.jpg

Barrier ID:	COLO-0001-15.714-R				
Route Name:	COLONIAL PARKWAY				
Inspection Date:	11/17/2010	Barrier Rating:	25.10		
Barrier Description					
Type:	STEEL-BACKED TIMBER WITHOUT BLOCKOUT	Barrier Function:	TRAFFIC		
Barrier Material:	STEEL-BACKED TIMBER/LOG	Post Material:	WOOD		
Blockout Type:	N/A	Length (ft.):	103		
Speed Limit (MPH):	45	Placement with Respect to Road:	TANGENT		
Hazard Behind Barrier:	MEDIUM				
Barrier Crashworthiness					
Appropriate Test Level:	TL-2	Barrier Test Level:	TL-2	Is Barrier Crashworthy?:	YES
Beg. End Trtmt Type:	SBT/LOG FLARED	Is Beg. End Trtmt Crashworthy?:	NO	Approach Transition Type:	RIGID SBT WALL - SBT
Ending End Trtmt Type:	NONE	Ending End Trtmt Crashworthy?:	N/A		
Average Measurements					
Design Height (In.):	27	Width (In.):	0.0	Post Spacing (In.):	120.0
Height (In.):	26.0	Lateral Offset (In.):	66.3	Road Grade (%):	3.00
Physical Condition					
Barrier	Alignment and Height:	No alignment deflection observed. Height is 1 in below 27 in design height.

Breaking and Cracking:	No breaking or cracking observed.			
	Missing Elements:	No missing elements observed.			
	Corrosion and Weathering:	No corrosion or weathering observed.			
End Treatments	Alignment and Height:	Alignment acceptable. Height within 1-in of 27-in design height.			
	Breaking and Cracking:	No breaking or cracking observed.			
	Missing Elements:	No missing elements observed.			
	Corrosion and Weathering:	No corrosion or weathering observed.

Barrier ID:	COLO-0001-15.714-R				
Route Name:	COLONIAL PARKWAY				
Inspection Date:	11/17/2010	Barrier Rating:		25.10	
Repair Recommendations					
Repair Action:	NO ACTION	FMSS Work Type:	N/A	Repair Cost:	\$0
Brief Workorder:	N/A				
Workorder:	No action.

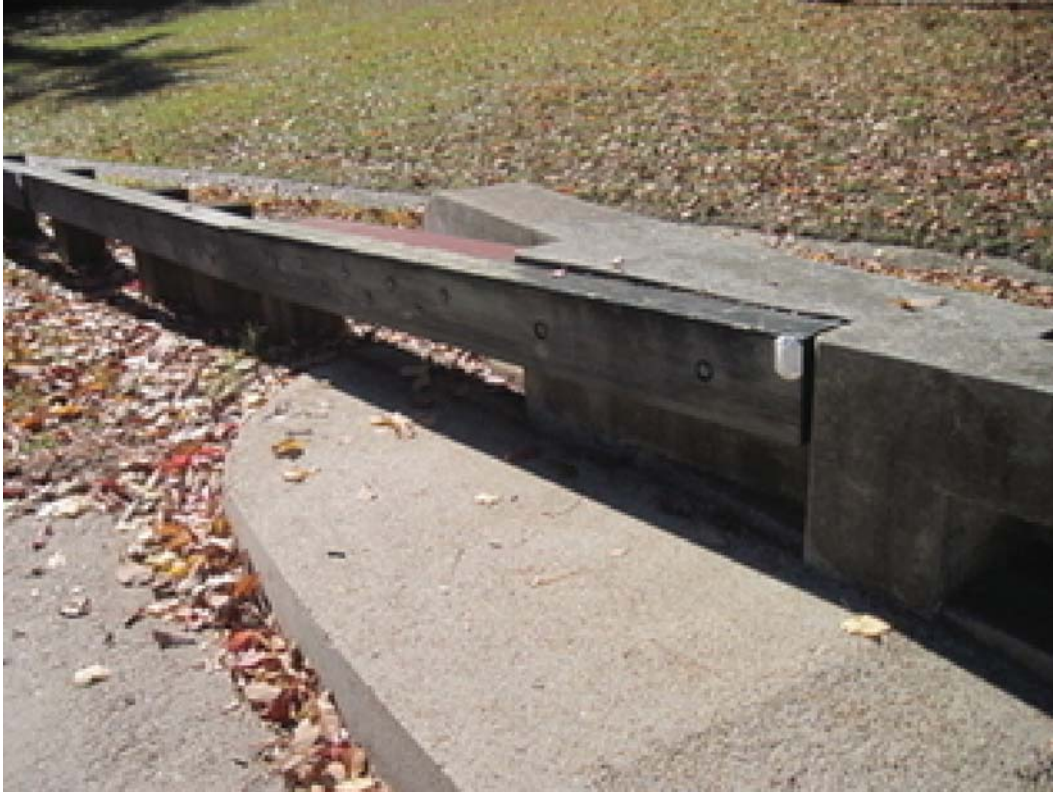
COLO_0001_15.892_R_1.jpg

Barrier ID:	COLO-0001-15.892-R				
Route Name:	COLONIAL PARKWAY				
Inspection Date:	11/17/2010	Barrier Rating:	27.10		
Barrier Description					
Type:	STEEL-BACKED TIMBER WITHOUT BLOCKOUT	Barrier Function:	TRAFFIC		
Barrier Material:	STEEL-BACKED TIMBER/LOG	Post Material:	WOOD		
Blockout Type:	N/A	Length (ft.):	161		
Speed Limit (MPH):	45	Placement with Respect to Road:	TANGENT		
Hazard Behind Barrier:	LOW				
Barrier Crashworthiness					
Appropriate Test Level:	TL-2	Barrier Test Level:	TL-2	Is Barrier Crashworthy?:	YES
Beg. End Trtmt Type:	NONE	Is Beg. End Trtmt Crashworthy?:	N/A	Approach Transition Type:	RIGID SBT WALL - SBT
Ending End Trtmt Type:	SBT/LOG FLARED	Ending End Trtmt Crashworthy?:	NO		
Average Measurements					
Design Height (In.):	27	Width (In.):	0.0	Post Spacing (In.):	119.3
Height (In.):	25.7	Lateral Offset (In.):	82.0	Road Grade (%):	3.50
Physical Condition					
Barrier	Alignment and Height:	No alignment deflection was observed. Height is 1 - 3 in below 27-in design height along 60 ft and 3 - 4 in below along 30 ft.

Breaking and Cracking:	No breaking or cracking was observed.			
	Missing Elements:	No missing elements were observed.			
	Corrosion and Weathering:	No corrosion or weathering was observed.			
End Treatments	Alignment and Height:	Alignment acceptable. Height within 1-in of 27-in design height.			
	Breaking and Cracking:	No breaking or cracking was observed.			
	Missing Elements:	No missing elements were observed.			
	Corrosion and Weathering:	No corrosion or weathering was observed.

Repair Action:	REPAIR	FMSS Work Type:	DEFERRED MAINTENANCE	Repair Cost:	\$2613
Brief Workorder:	Raise 90 feet of guardrail to 27-inch design height.				
Workorder:	Adjust Guardrail at \$10- per -Lin. Ft. for 90 LF = \$900. Raise 90 feet of guardrail to 27-inch design height. Low Speed Traffic Control at \$1475- per -Day for 1 Day(s) = \$1475.

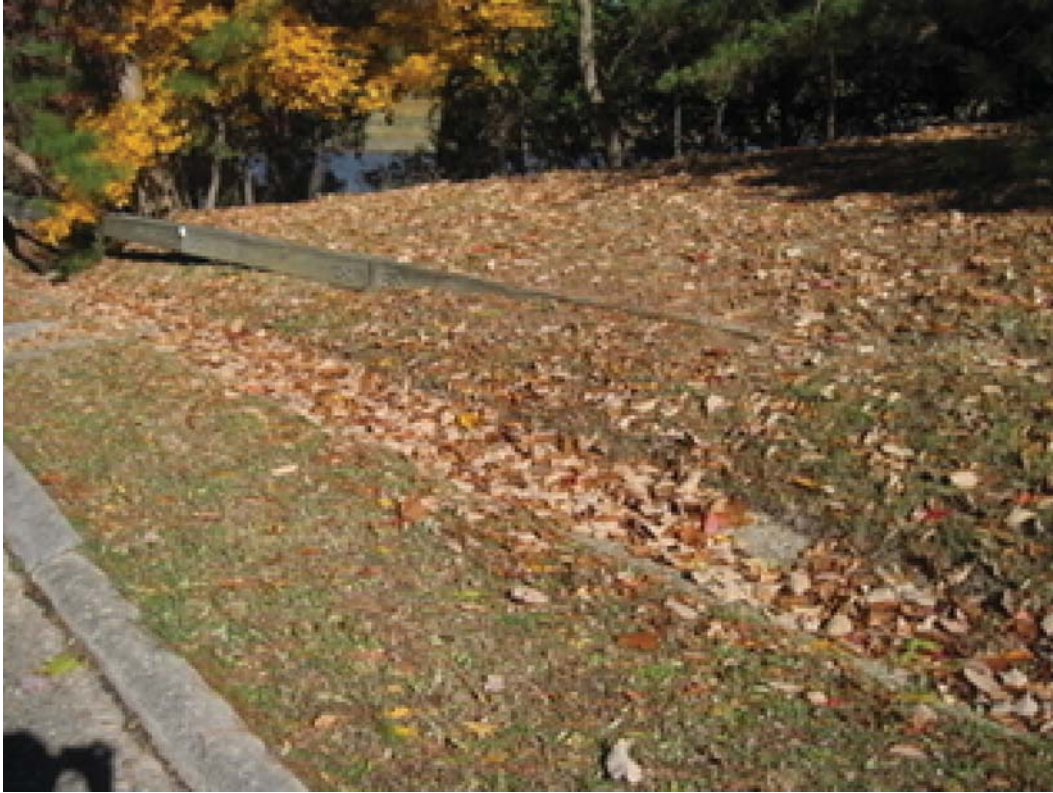
COLO_0001_15.893_L_1.jpg

Barrier ID:	COLO-0001-15.893-L				
Route Name:	COLONIAL PARKWAY				
Inspection Date:	11/17/2010	Barrier Rating:	25.10		
Barrier Description					
Type:	STEEL-BACKED TIMBER WITHOUT BLOCKOUT	Barrier Function:	TRAFFIC		
Barrier Material:	STEEL-BACKED TIMBER/LOG	Post Material:	WOOD		
Blockout Type:	N/A	Length (ft.):	144		
Speed Limit (MPH):	45	Placement with Respect to Road:	TANGENT		
Hazard Behind Barrier:	MEDIUM				
Barrier Crashworthiness					
Appropriate Test Level:	TL-2	Barrier Test Level:	TL-2	Is Barrier Crashworthy?:	YES
Beg. End Trtmt Type:	NONE	Is Beg. End Trtmt Crashworthy?:	N/A	Approach Transition Type:	RIGID SBT WALL - SBT
Ending End Trtmt Type:	SBT/LOG BURIED	Ending End Trtmt Crashworthy?:	YES		
Average Measurements					
Design Height (In.):	27	Width (In.):	0.0	Post Spacing (In.):	119.6
Height (In.):	26.2	Lateral Offset (In.):	52.0	Road Grade (%):	3.20
Physical Condition					
Barrier	Alignment and Height:	No alignment deflection was observed. Height is 0 - 1 in below 27-in design height.

Breaking and Cracking:	No breaking or cracking was observed.			
	Missing Elements:	No missing elements were observed.			
	Corrosion and Weathering:	No corrosion or weathering was observed.			
End Treatments	Alignment and Height:	Alignment acceptable. Height within 1-in of 27-in design height.			
	Breaking and Cracking:	No breaking or cracking was observed.			
	Missing Elements:	No missing elements were observed.			
	Corrosion and Weathering:	No corrosion or weathering was observed.

Barrier ID:	COLO-0001-15.893-L				
Route Name:	COLONIAL PARKWAY				
Inspection Date:	11/17/2010		Barrier Rating:	25.10	
Repair Recommendations					
Repair Action:	NO ACTION	FMSS Work Type:	N/A	Repair Cost:	\$0
Brief Workorder:	N/A				
Workorder:

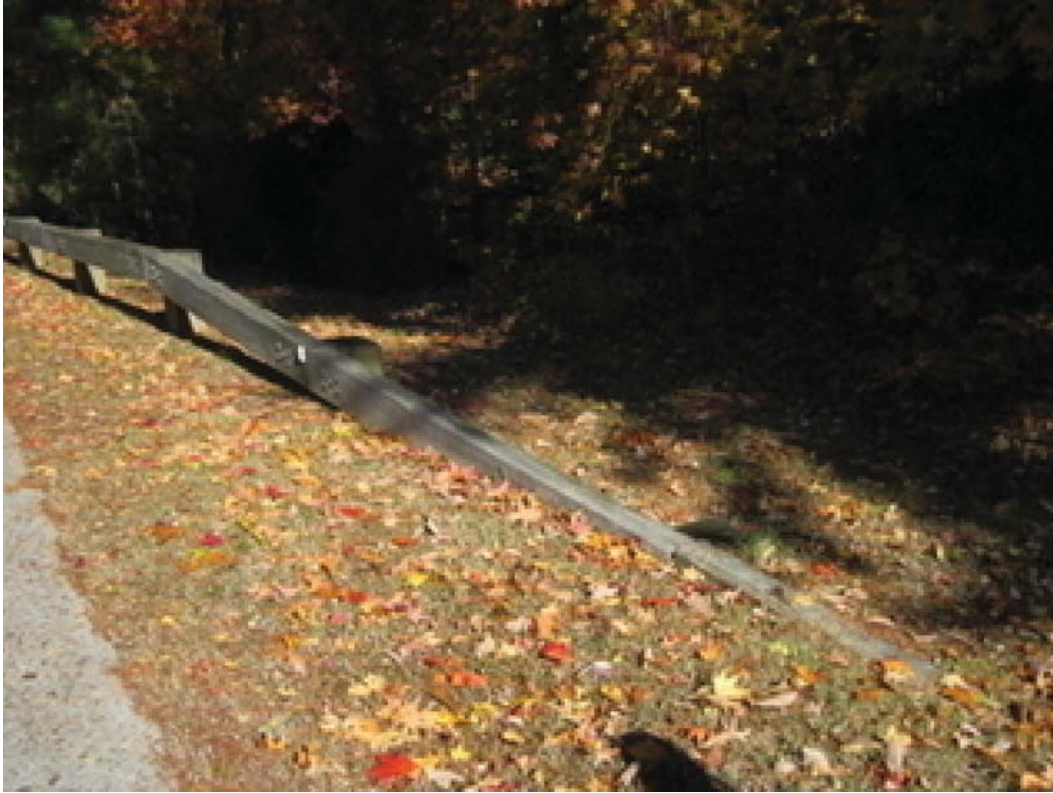
COLO_0001_16.225_L_1.jpg

Barrier ID:	COLO-0001-16.225-L				
Route Name:	COLONIAL PARKWAY				
Inspection Date:	11/17/2010	Barrier Rating:	32.70		
Barrier Description					
Type:	STEEL-BACKED TIMBER WITHOUT BLOCKOUT	Barrier Function:	TRAFFIC		
Barrier Material:	STEEL-BACKED TIMBER/LOG	Post Material:	WOOD		
Blockout Type:	N/A	Length (ft.):	718		
Speed Limit (MPH):	45	Placement with Respect to Road:	OUTSIDE OF CURVE		
Hazard Behind Barrier:	LOW				
Barrier Crashworthiness					
Appropriate Test Level:	TL-2	Barrier Test Level:	TL-2	Is Barrier Crashworthy?:	YES
Beg. End Trtmt Type:	SBT/LOG FLARED	Is Beg. End Trtmt Crashworthy?:	NO	Approach Transition Type:	NONE
Ending End Trtmt Type:	SBT/LOG FLARED	Ending End Trtmt Crashworthy?:	NO		
Average Measurements					
Design Height (In.):	27	Width (In.):	0.0	Post Spacing (In.):	120.0
Height (In.):	26.7	Lateral Offset (In.):	28.5	Road Grade (%):	0.50
Physical Condition					
Barrier	Alignment and Height:	No alignment deflection observed. Height is within 1-in of 27-in design height along entire length.

Breaking and Cracking:	No breaking or cracking observed.			
	Missing Elements:	No missing elements observed.			
	Corrosion and Weathering:	No corrosion or weathering observed.			
End Treatments	Alignment and Height:	Alignment acceptable. Height within 1-in of 27-in design height.			
	Breaking and Cracking:	No breaking or cracking observed.			
	Missing Elements:	No missing elements observed.			
	Corrosion and Weathering:	No corrosion or weathering observed.

Repair Action:	NO ACTION	FMSS Work Type:	N/A	Repair Cost:	\$0
Brief Workorder:	N/A				
Workorder:
