GIP Report

NPS Guardwall/Rail Inventory Program Colonial National Historical Park

**Federal Highway Administration
Eastern Federal Lands Highway Division
Road Inventory Program (RIP)**

**Data Collection Date: November 2010
Report Date: December 2015**

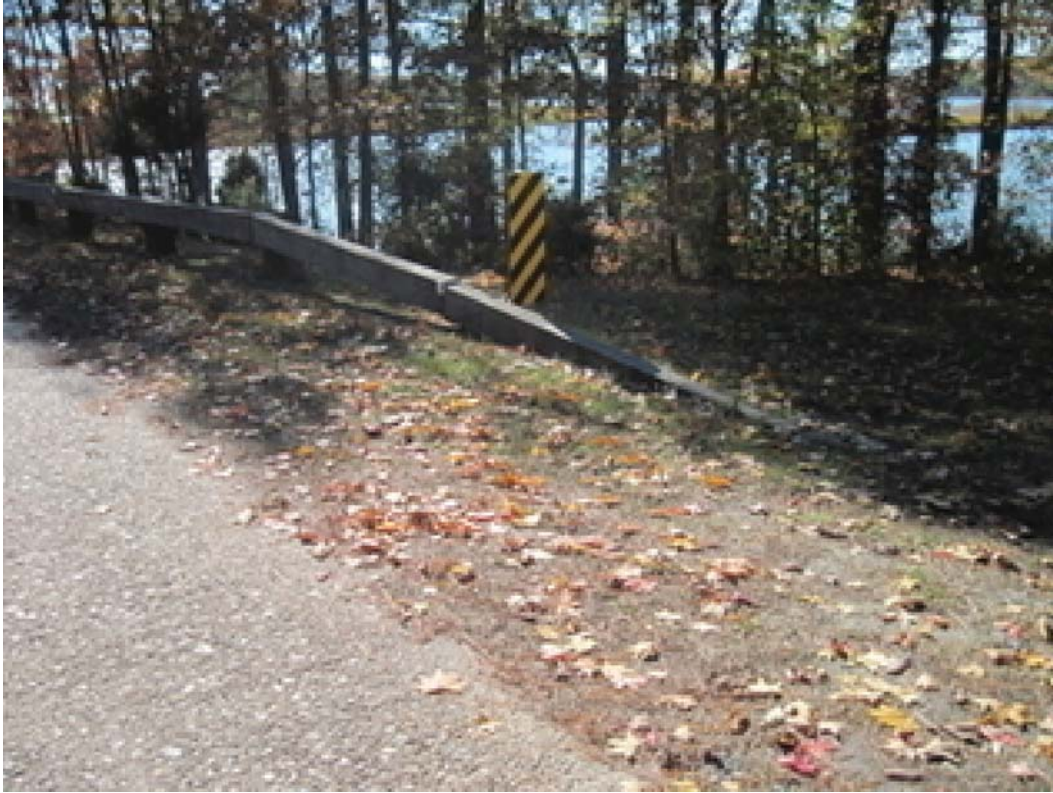
COLO_0001_16.383_R_1.jpg

Barrier ID:	COLO-0001-16.383-R				
Route Name:	COLONIAL PARKWAY				
Inspection Date:	11/17/2010	Barrier Rating:	19.30		
Barrier Description					
Type:	STEEL-BACKED TIMBER WITHOUT BLOCKOUT	Barrier Function:	TRAFFIC		
Barrier Material:	STEEL-BACKED TIMBER/LOG	Post Material:	WOOD		
Blockout Type:	N/A	Length (ft.):	221		
Speed Limit (MPH):	35	Placement with Respect to Road:	INSIDE OF CURVE		
Hazard Behind Barrier:	MEDIUM				
Barrier Crashworthiness					
Appropriate Test Level:	TL-2	Barrier Test Level:	TL-2	Is Barrier Crashworthy?:	YES
Beg. End Trtmt Type:	SBT/LOG FLARED	Is Beg. End Trtmt Crashworthy?:	NO	Approach Transition Type:	RIGID SBT WALL - SBT
Ending End Trtmt Type:	NONE	Ending End Trtmt Crashworthy?:	N/A		
Average Measurements					
Design Height (In.):	27	Width (In.):	0.0	Post Spacing (In.):	120.0
Height (In.):	26.2	Lateral Offset (In.):	59.2	Road Grade (%):	0.40
Physical Condition					
Barrier	Alignment and Height:	No alignment deflection was observed. Height is 0 - 1 in below 27-in design height.

Breaking and Cracking:	No breaking or cracking was observed.			
	Missing Elements:	No missing elements were observed.			
	Corrosion and Weathering:	No corrosion or weathering was observed.			
End Treatments	Alignment and Height:	Alignment acceptable. Height within 1-in of 27-in design height.			
	Breaking and Cracking:	No breaking or cracking was observed.			
	Missing Elements:	No missing elements were observed.			
	Corrosion and Weathering:	No corrosion or weathering was observed.

Barrier ID:	COLO-0001-16.383-R				
Route Name:	COLONIAL PARKWAY				
Inspection Date:	11/17/2010	Barrier Rating:		19.30	
Repair Recommendations					
Repair Action:	NO ACTION	FMSS Work Type:	N/A	Repair Cost:	\$0
Brief Workorder:	N/A				
Workorder:

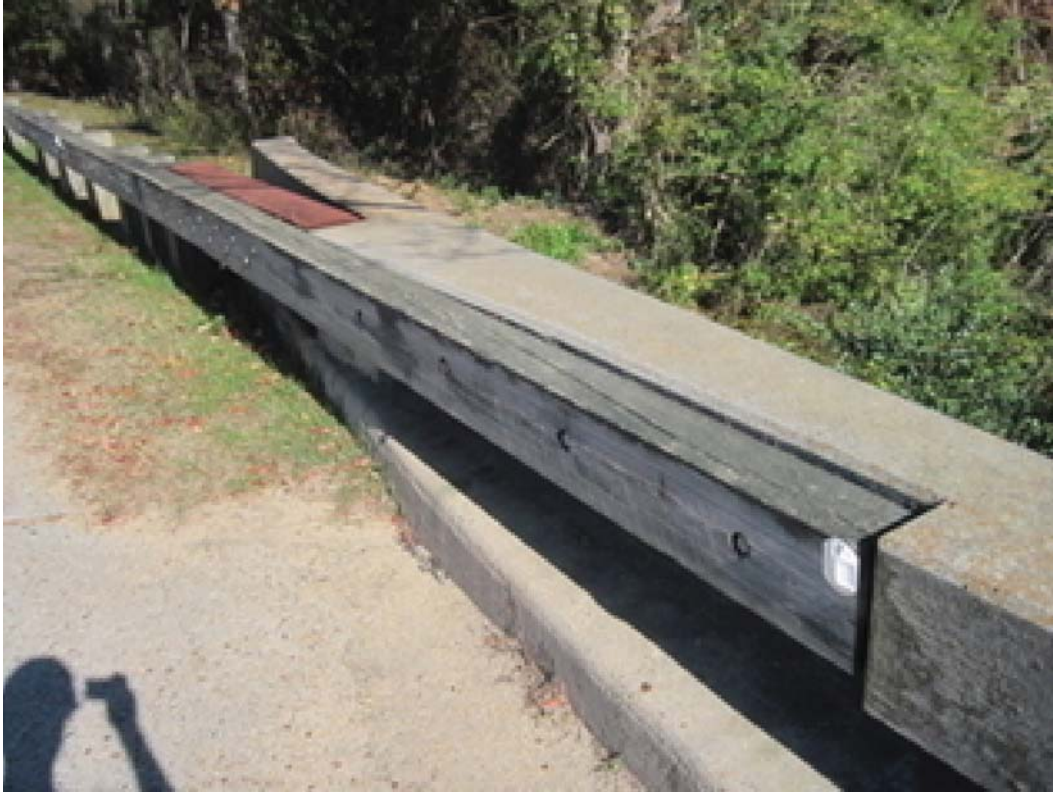
COLO_0001_16.389_L_1.jpg

Barrier ID:	COLO-0001-16.389-L				
Route Name:	COLONIAL PARKWAY				
Inspection Date:	11/17/2010	Barrier Rating:	25.10		
Barrier Description					
Type:	STEEL-BACKED TIMBER WITHOUT BLOCKOUT	Barrier Function:	TRAFFIC		
Barrier Material:	STEEL-BACKED TIMBER/LOG	Post Material:	WOOD		
Blockout Type:	N/A	Length (ft.):	220		
Speed Limit (MPH):	35	Placement with Respect to Road:	OUTSIDE OF CURVE		
Hazard Behind Barrier:	MEDIUM				
Barrier Crashworthiness					
Appropriate Test Level:	TL-2	Barrier Test Level:	TL-2	Is Barrier Crashworthy?:	YES
Beg. End Trtmt Type:	SBT/LOG FLARED	Is Beg. End Trtmt Crashworthy?:	NO	Approach Transition Type:	RIGID SBT WALL - SBT
Ending End Trtmt Type:	NONE	Ending End Trtmt Crashworthy?:	N/A		
Average Measurements					
Design Height (In.):	27	Width (In.):	0.0	Post Spacing (In.):	120.3
Height (In.):	26.7	Lateral Offset (In.):	51.2	Road Grade (%):	0.20
Physical Condition					
Barrier	Alignment and Height:	No alignment deflection observed. Height ranges from 1 in below 27 in design height to 1 in over.

Repair Action:	NO ACTION	FMSS Work Type:	N/A	Repair Cost:	\$0
Brief Workorder:	N/A				
Workorder:	No action.

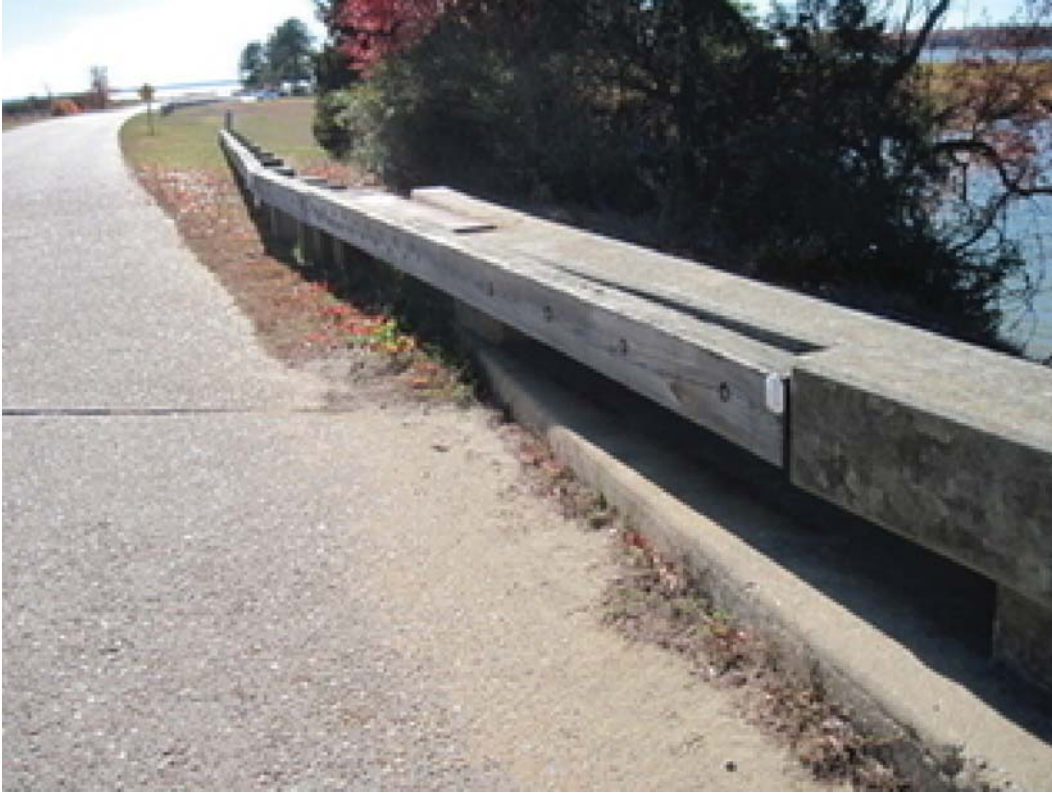
COLO_0001_16.451_R_1.jpg

Barrier ID:	COLO-0001-16.451-R				
Route Name:	COLONIAL PARKWAY				
Inspection Date:	11/17/2010	Barrier Rating:	16.80		
Barrier Description					
Type:	STEEL-BACKED TIMBER WITHOUT BLOCKOUT	Barrier Function:	TRAFFIC		
Barrier Material:	STEEL-BACKED TIMBER/LOG	Post Material:	WOOD		
Blockout Type:	N/A	Length (ft.):	121		
Speed Limit (MPH):	35	Placement with Respect to Road:	INSIDE OF CURVE		
Hazard Behind Barrier:	LOW				
Barrier Crashworthiness					
Appropriate Test Level:	TL-2	Barrier Test Level:	TL-2	Is Barrier Crashworthy?:	YES
Beg. End Trtmt Type:	NONE	Is Beg. End Trtmt Crashworthy?:	N/A	Approach Transition Type:	RIGID SBT WALL - SBT
Ending End Trtmt Type:	SBT/LOG FLARED	Ending End Trtmt Crashworthy?:	NO		
Average Measurements					
Design Height (In.):	27	Width (In.):	0.0	Post Spacing (In.):	120.0
Height (In.):	26.7	Lateral Offset (In.):	78.0	Road Grade (%):	0.70
Physical Condition					
Barrier	Alignment and Height:	No alignment deflection was observed. Height is 1 - 3 in below 27-in design height along 30 ft.

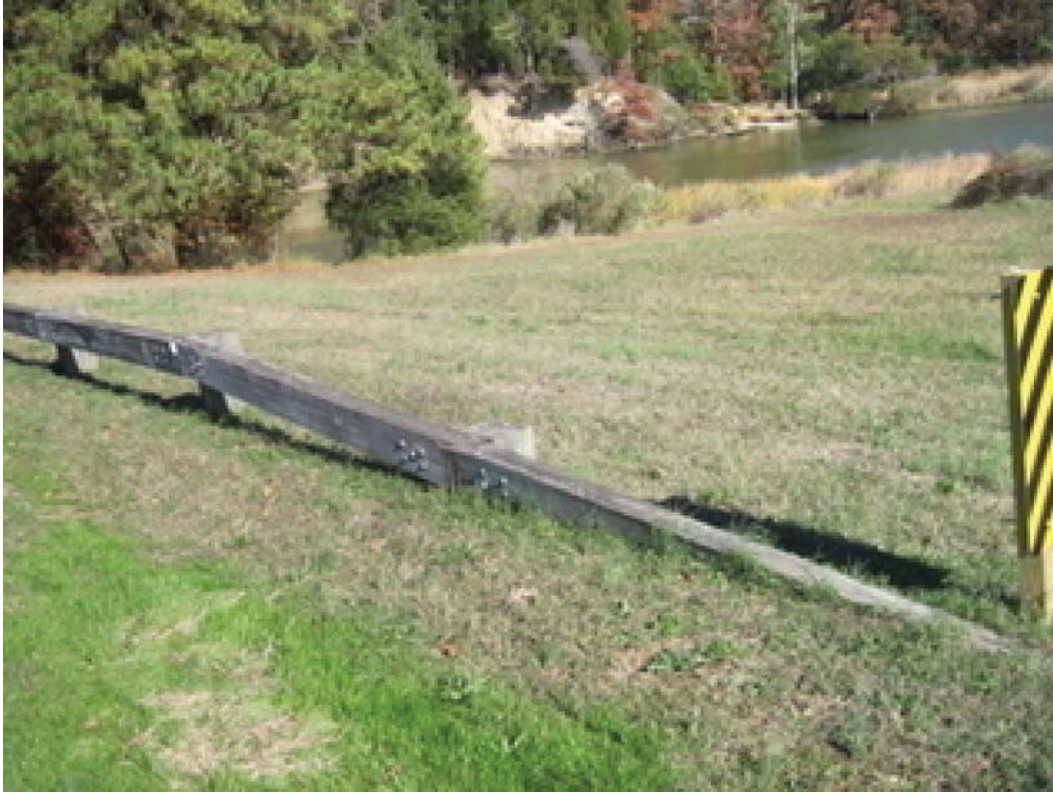
COLO_0001_16.454_L_1.jpg

Barrier ID:	COLO-0001-16.454-L				
Route Name:	COLONIAL PARKWAY				
Inspection Date:	11/17/2010	Barrier Rating:	25.10		
Barrier Description					
Type:	STEEL-BACKED TIMBER WITHOUT BLOCKOUT	Barrier Function:	TRAFFIC		
Barrier Material:	STEEL-BACKED TIMBER/LOG	Post Material:	WOOD		
Blockout Type:	N/A	Length (ft.):	250		
Speed Limit (MPH):	35	Placement with Respect to Road:	OUTSIDE OF CURVE		
Hazard Behind Barrier:	MEDIUM				
Barrier Crashworthiness					
Appropriate Test Level:	TL-2	Barrier Test Level:	TL-2	Is Barrier Crashworthy?:	YES
Beg. End Trtmt Type:	NONE	Is Beg. End Trtmt Crashworthy?:	N/A	Approach Transition Type:	RIGID SBT WALL - SBT
Ending End Trtmt Type:	SBT/LOG FLARED	Ending End Trtmt Crashworthy?:	NO		
Average Measurements					
Design Height (In.):	27	Width (In.):	0.0	Post Spacing (In.):	119.6
Height (In.):	27.0	Lateral Offset (In.):	119.0	Road Grade (%):	0.60
Physical Condition					
Barrier	Alignment and Height:	No alignment deflection observed. Height ranges from 0.5 in below 27 in design height to 1.0 in above.

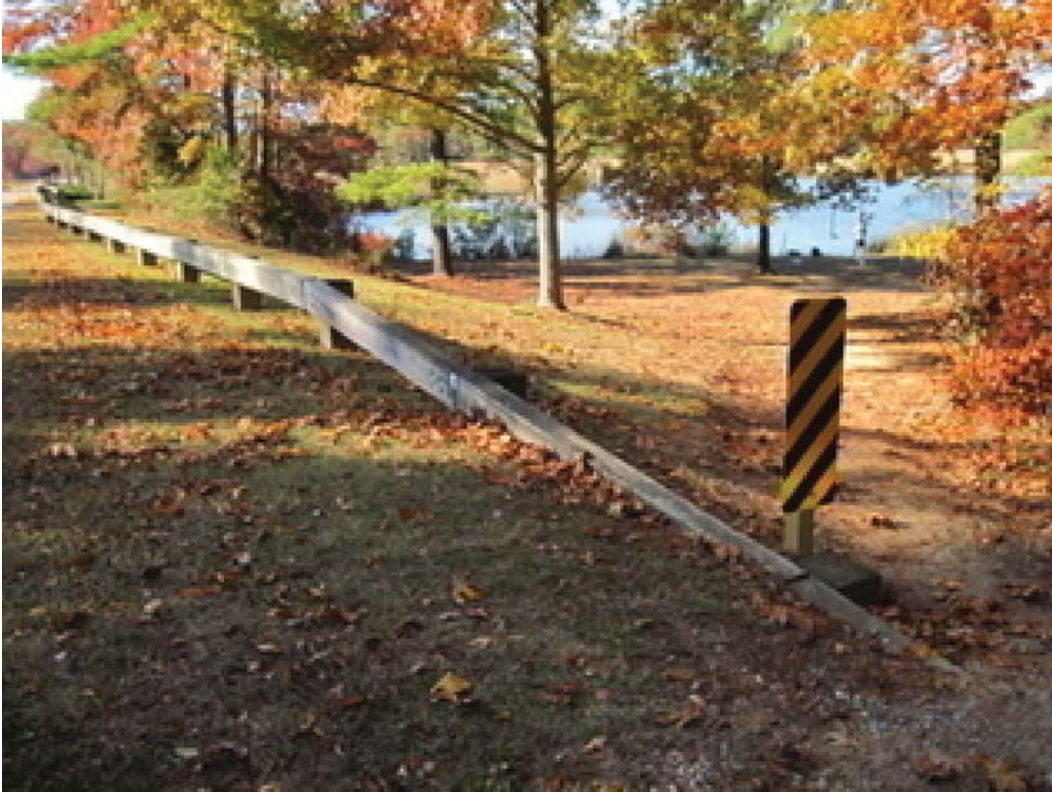
COLO_0001_19.466_R_1.jpg

Barrier ID:	COLO-0001-19.466-R				
Route Name:	COLONIAL PARKWAY				
Inspection Date:	11/17/2010	Barrier Rating:	27.10		
Barrier Description					
Type:	STEEL-BACKED TIMBER WITHOUT BLOCKOUT	Barrier Function:	TRAFFIC		
Barrier Material:	STEEL-BACKED TIMBER/LOG	Post Material:	WOOD		
Blockout Type:	N/A	Length (ft.):	220		
Speed Limit (MPH):	45	Placement with Respect to Road:	TANGENT		
Hazard Behind Barrier:	LOW				
Barrier Crashworthiness					
Appropriate Test Level:	TL-2	Barrier Test Level:	TL-2	Is Barrier Crashworthy?:	YES
Beg. End Trtmt Type:	SBT/LOG FLARED	Is Beg. End Trtmt Crashworthy?:	NO	Approach Transition Type:	RIGID SBT WALL - SBT
Ending End Trtmt Type:	NONE	Ending End Trtmt Crashworthy?:	N/A		
Average Measurements					
Design Height (In.):	27	Width (In.):	0.0	Post Spacing (In.):	120.3
Height (In.):	24.2	Lateral Offset (In.):	62.0	Road Grade (%):	0.20
Physical Condition					
Barrier	Alignment and Height:	No alignment deflection observed. Height is more than 3 in below the 27-in design height along 70 ft. Height is 1 to 3 in below the 27-in design height along 20 ft.

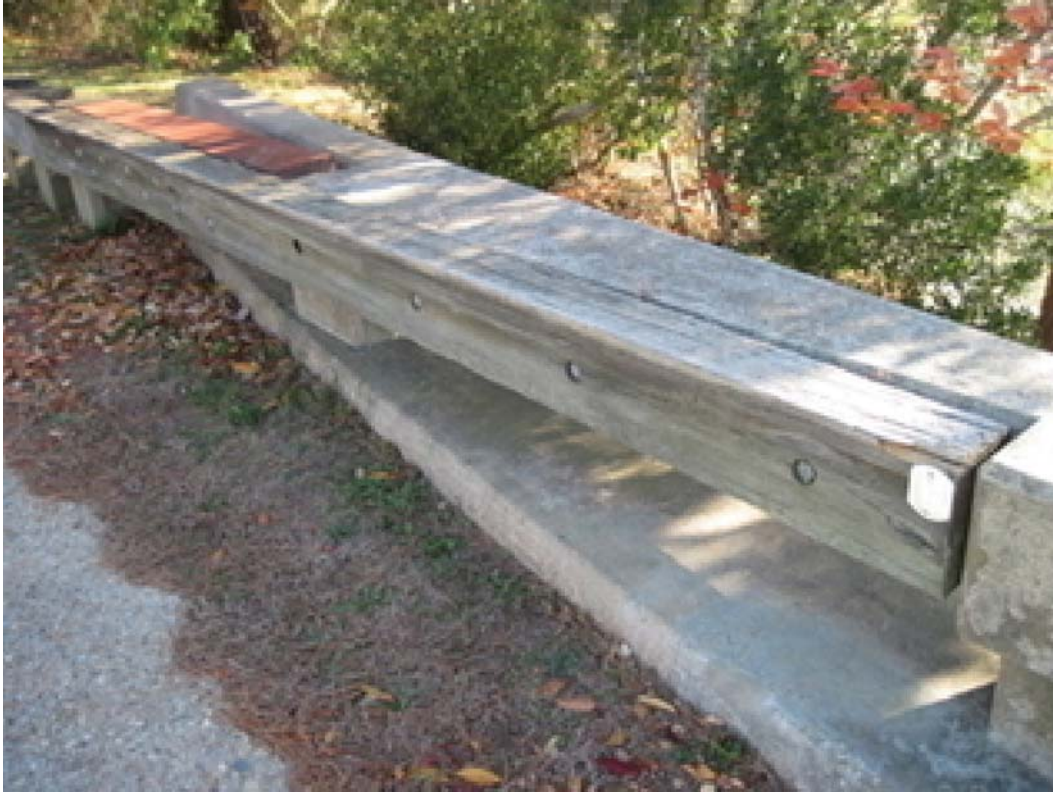
COLO_0001_19.485_L_1.jpg

Barrier ID:	COLO-0001-19.485-L				
Route Name:	COLONIAL PARKWAY				
Inspection Date:	11/17/2010	Barrier Rating:	20.70		
Barrier Description					
Type:	STEEL-BACKED TIMBER WITHOUT BLOCKOUT	Barrier Function:	TRAFFIC		
Barrier Material:	STEEL-BACKED TIMBER/LOG	Post Material:	WOOD		
Blockout Type:	N/A	Length (ft.):	126		
Speed Limit (MPH):	45	Placement with Respect to Road:	TANGENT		
Hazard Behind Barrier:	MEDIUM				
Barrier Crashworthiness					
Appropriate Test Level:	TL-2	Barrier Test Level:	TL-2	Is Barrier Crashworthy?:	YES
Beg. End Trtmt Type:	SBT/LOG FLARED	Is Beg. End Trtmt Crashworthy?:	NO	Approach Transition Type:	RIGID SBT WALL - SBT
Ending End Trtmt Type:	NONE	Ending End Trtmt Crashworthy?:	N/A		
Average Measurements					
Design Height (In.):	27	Width (In.):	0.0	Post Spacing (In.):	120.3
Height (In.):	27.0	Lateral Offset (In.):	52.0	Road Grade (%):	0.10
Physical Condition					
Barrier	Alignment and Height:	No alignment deflection observed. Height ranges from 1 in below 27 in design height to 1 in over.

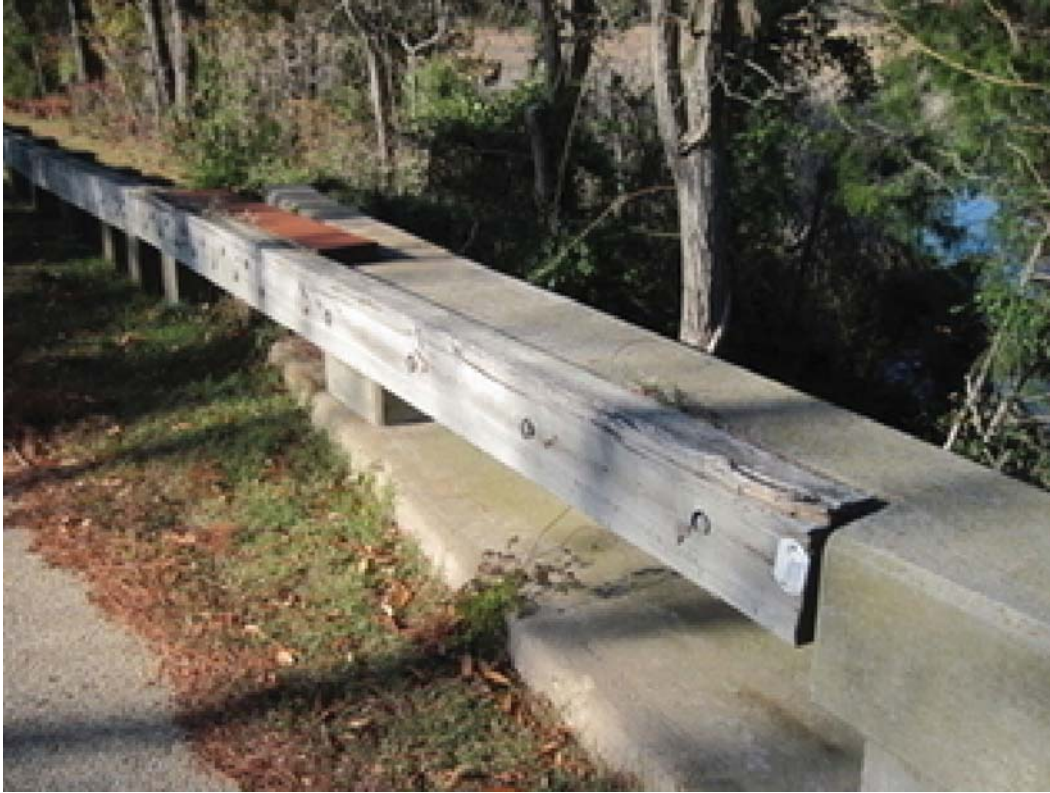
COLO_0001_19.526_R_1.jpg

Barrier ID:	COLO-0001-19.526-R				
Route Name:	COLONIAL PARKWAY				
Inspection Date:	11/17/2010	Barrier Rating:	26.60		
Barrier Description					
Type:	STEEL-BACKED TIMBER WITHOUT BLOCKOUT	Barrier Function:	TRAFFIC		
Barrier Material:	STEEL-BACKED TIMBER/LOG	Post Material:	WOOD		
Blockout Type:	N/A	Length (ft.):	268		
Speed Limit (MPH):	45	Placement with Respect to Road:	TANGENT		
Hazard Behind Barrier:	MEDIUM				
Barrier Crashworthiness					
Appropriate Test Level:	TL-2	Barrier Test Level:	TL-2	Is Barrier Crashworthy?:	YES
Beg. End Trtmt Type:	NONE	Is Beg. End Trtmt Crashworthy?:	N/A	Approach Transition Type:	RIGID SBT WALL - SBT
Ending End Trtmt Type:	SBT/LOG FLARED	Ending End Trtmt Crashworthy?:	NO		
Average Measurements					
Design Height (In.):	27	Width (In.):	0.0	Post Spacing (In.):	120.0
Height (In.):	28.0	Lateral Offset (In.):	33.0	Road Grade (%):	1.60
Physical Condition					
Barrier	Alignment and Height:	No alignment deflection observed. Height is 0 to 3 in above the 27-in design height.

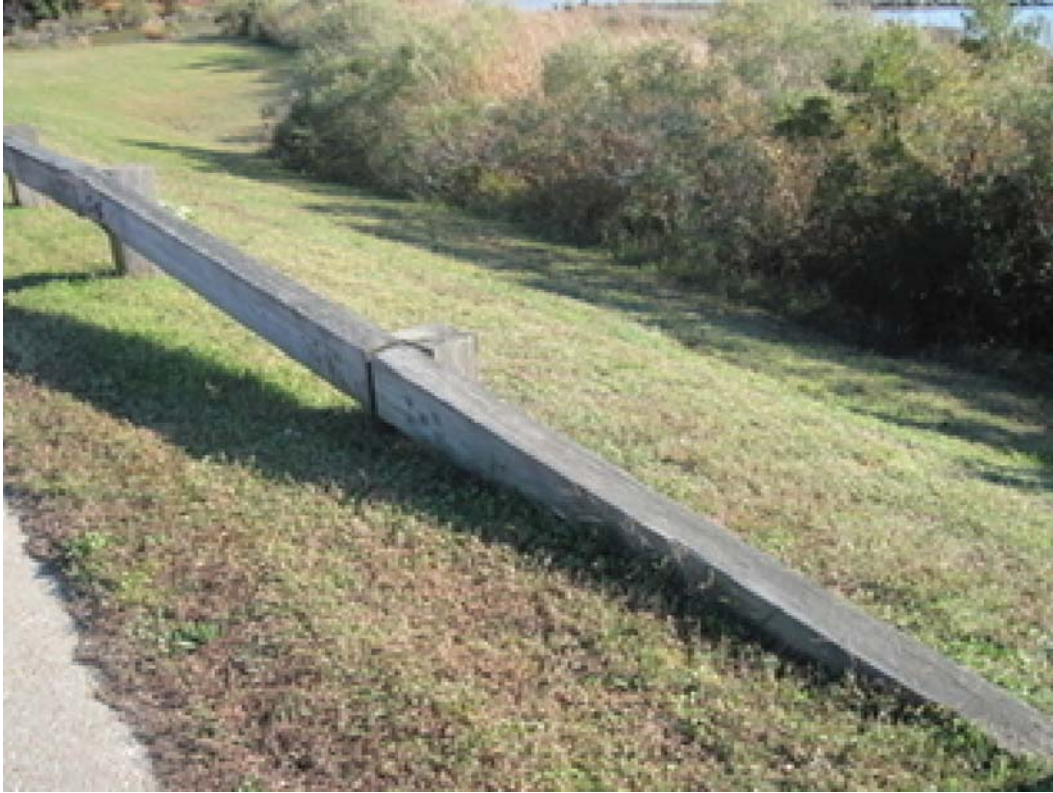
COLO_0001_19.527_L_1.jpg

Barrier ID:	COLO-0001-19.527-L				
Route Name:	COLONIAL PARKWAY				
Inspection Date:	11/17/2010	Barrier Rating:	26.60		
Barrier Description					
Type:	STEEL-BACKED TIMBER WITHOUT BLOCKOUT	Barrier Function:	TRAFFIC		
Barrier Material:	STEEL-BACKED TIMBER/LOG	Post Material:	WOOD		
Blockout Type:	N/A	Length (ft.):	368		
Speed Limit (MPH):	45	Placement with Respect to Road:	TANGENT		
Hazard Behind Barrier:	MEDIUM				
Barrier Crashworthiness					
Appropriate Test Level:	TL-2	Barrier Test Level:	TL-2	Is Barrier Crashworthy?:	YES
Beg. End Trtmt Type:	NONE	Is Beg. End Trtmt Crashworthy?:	N/A	Approach Transition Type:	RIGID SBT WALL - SBT
Ending End Trtmt Type:	SBT/LOG FLARED	Ending End Trtmt Crashworthy?:	NO		
Average Measurements					
Design Height (In.):	27	Width (In.):	0.0	Post Spacing (In.):	120.0
Height (In.):	27.0	Lateral Offset (In.):	37.7	Road Grade (%):	1.60
Physical Condition					
Barrier	Alignment and Height:	No alignment deflection observed. Height ranges from 1 in below 27 in design height to 1 in over.

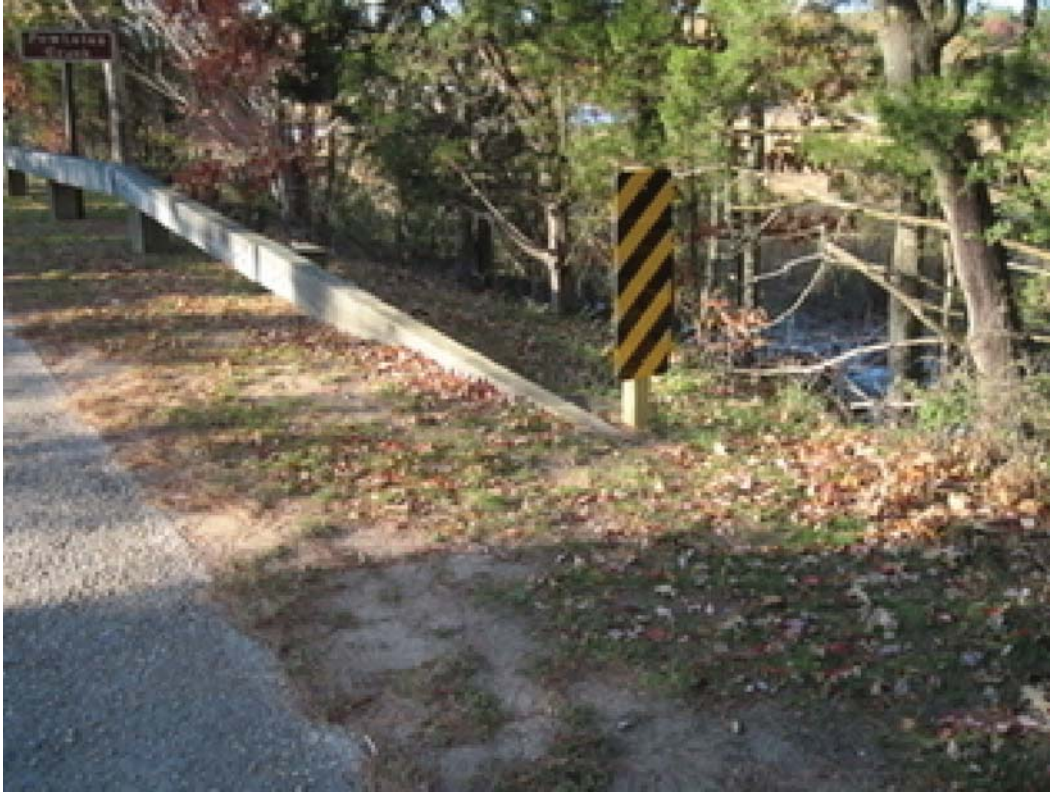
COLO_0001_21.442_R_1.jpg

Barrier ID:	COLO-0001-21.442-R				
Route Name:	COLONIAL PARKWAY				
Inspection Date:	11/17/2010	Barrier Rating:	28.00		
Barrier Description					
Type:	STEEL-BACKED TIMBER WITHOUT BLOCKOUT	Barrier Function:	TRAFFIC		
Barrier Material:	STEEL-BACKED TIMBER/LOG	Post Material:	WOOD		
Blockout Type:	N/A	Length (ft.):	95		
Speed Limit (MPH):	35	Placement with Respect to Road:	OUTSIDE OF CURVE		
Hazard Behind Barrier:	MEDIUM				
Barrier Crashworthiness					
Appropriate Test Level:	TL-2	Barrier Test Level:	TL-2	Is Barrier Crashworthy?:	YES
Beg. End Trtmt Type:	SBT/LOG FLARED	Is Beg. End Trtmt Crashworthy?:	NO	Approach Transition Type:	RIGID SBT WALL - SBT
Ending End Trtmt Type:	NONE	Ending End Trtmt Crashworthy?:	N/A		
Average Measurements					
Design Height (In.):	27	Width (In.):	0.0	Post Spacing (In.):	119.6
Height (In.):	29.2	Lateral Offset (In.):	40.0	Road Grade (%):	0.60
Physical Condition					
Barrier	Alignment and Height:	No alignment deflection was observed. Height is 2-3 in above 27-in design height.

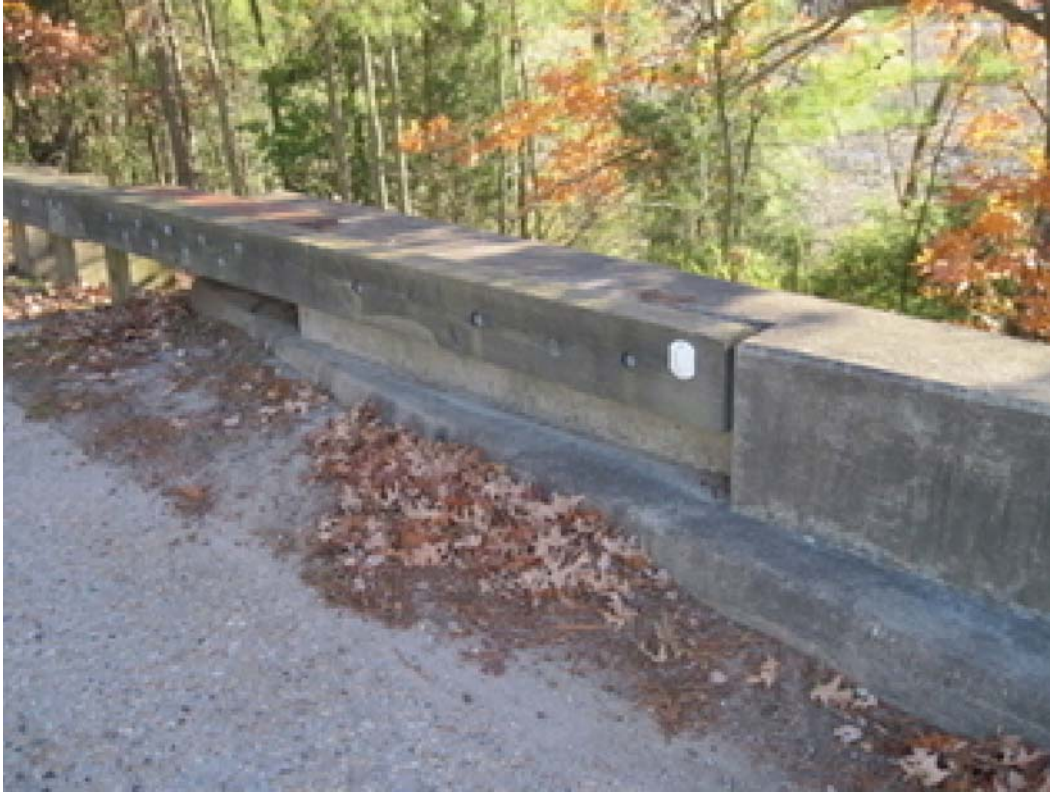
COLO_0001_21.451_L_1.jpg

Barrier ID:	COLO-0001-21.451-L				
Route Name:	COLONIAL PARKWAY				
Inspection Date:	11/17/2010	Barrier Rating:	22.20		
Barrier Description					
Type:	STEEL-BACKED TIMBER WITHOUT BLOCKOUT	Barrier Function:	TRAFFIC		
Barrier Material:	STEEL-BACKED TIMBER/LOG	Post Material:	WOOD		
Blockout Type:	N/A	Length (ft.):	55		
Speed Limit (MPH):	35	Placement with Respect to Road:	INSIDE OF CURVE		
Hazard Behind Barrier:	MEDIUM				
Barrier Crashworthiness					
Appropriate Test Level:	TL-2	Barrier Test Level:	TL-2	Is Barrier Crashworthy?:	YES
Beg. End Trtmt Type:	SBT/LOG FLARED	Is Beg. End Trtmt Crashworthy?:	NO	Approach Transition Type:	RIGID SBT WALL - SBT
Ending End Trtmt Type:	NONE	Ending End Trtmt Crashworthy?:	N/A		
Average Measurements					
Design Height (In.):	27	Width (In.):	0.0	Post Spacing (In.):	60.2
Height (In.):	26.2	Lateral Offset (In.):	40.7	Road Grade (%):	0.50
Physical Condition					
Barrier	Alignment and Height:	No alignment deflection was observed. Height is 0-1 in below 27-in design height.

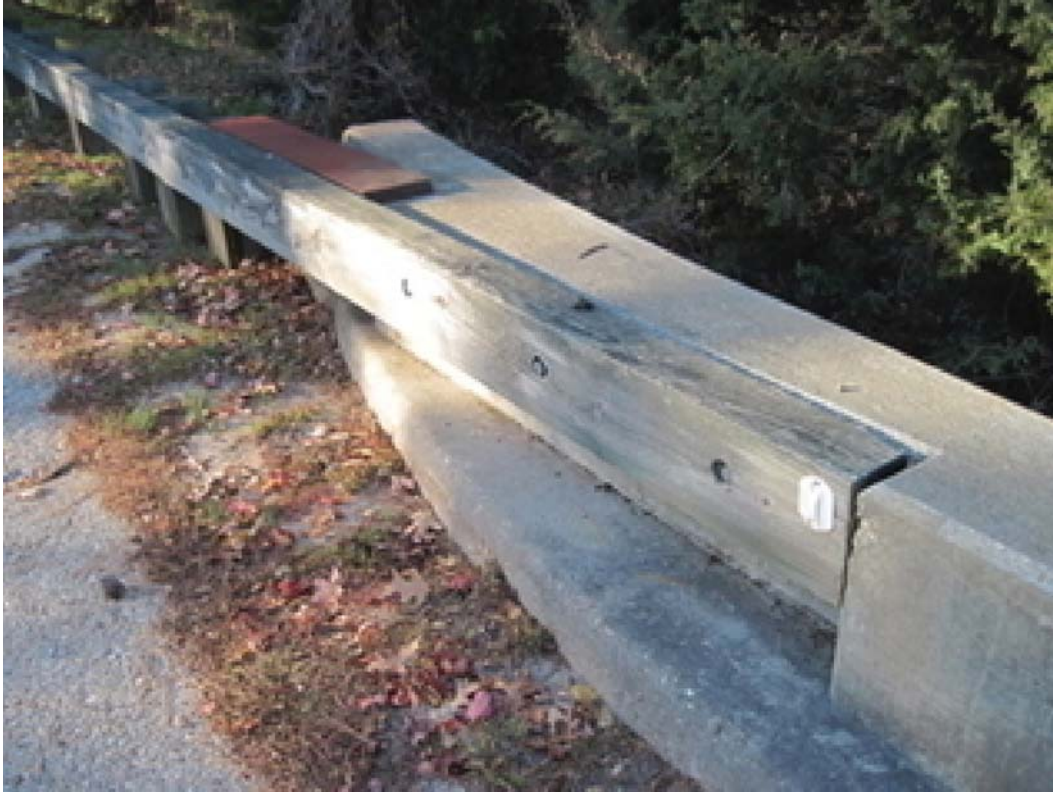
COLO_0001_21.607_R_1.jpg

Barrier ID:	COLO-0001-21.607-R				
Route Name:	COLONIAL PARKWAY				
Inspection Date:	11/17/2010	Barrier Rating:	16.80		
Barrier Description					
Type:	STEEL-BACKED TIMBER WITHOUT BLOCKOUT	Barrier Function:	TRAFFIC		
Barrier Material:	STEEL-BACKED TIMBER/LOG	Post Material:	WOOD		
Blockout Type:	N/A	Length (ft.):	144		
Speed Limit (MPH):	35	Placement with Respect to Road:	TANGENT		
Hazard Behind Barrier:	LOW				
Barrier Crashworthiness					
Appropriate Test Level:	TL-2	Barrier Test Level:	TL-2	Is Barrier Crashworthy?:	YES
Beg. End Trtmt Type:	NONE	Is Beg. End Trtmt Crashworthy?:	N/A	Approach Transition Type:	RIGID SBT WALL - SBT
Ending End Trtmt Type:	SBT/LOG FLARED	Ending End Trtmt Crashworthy?:	NO		
Average Measurements					
Design Height (In.):	27	Width (In.):	0.0	Post Spacing (In.):	120.0
Height (In.):	28.0	Lateral Offset (In.):	32.2	Road Grade (%):	0.30
Physical Condition					
Barrier	Alignment and Height:	No alignment deflection observed. Height is 1 in above the 27-in design height.

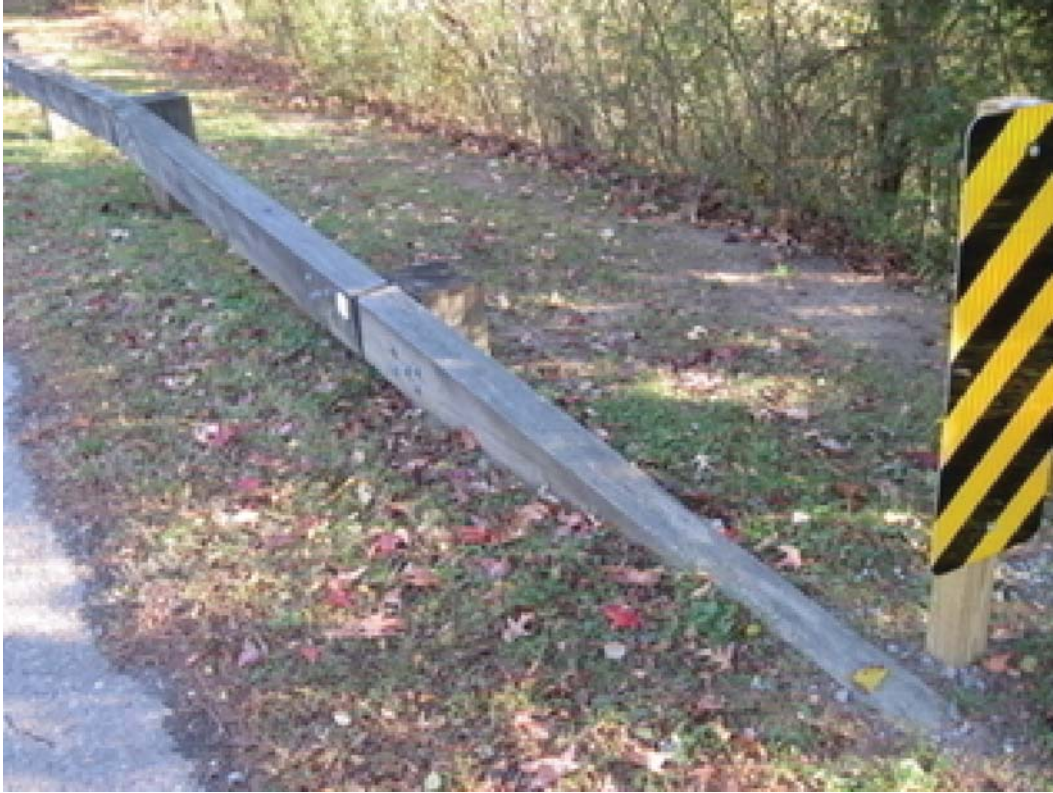
COLO_0001_21.608_L_1.jpg

Barrier ID:	COLO-0001-21.608-L				
Route Name:	COLONIAL PARKWAY				
Inspection Date:	11/17/2010	Barrier Rating:	19.30		
Barrier Description					
Type:	STEEL-BACKED TIMBER WITHOUT BLOCKOUT	Barrier Function:	TRAFFIC		
Barrier Material:	STEEL-BACKED TIMBER/LOG	Post Material:	WOOD		
Blockout Type:	N/A	Length (ft.):	140		
Speed Limit (MPH):	35	Placement with Respect to Road:	TANGENT		
Hazard Behind Barrier:	MEDIUM				
Barrier Crashworthiness					
Appropriate Test Level:	TL-2	Barrier Test Level:	TL-2	Is Barrier Crashworthy?:	YES
Beg. End Trtmt Type:	NONE	Is Beg. End Trtmt Crashworthy?:	N/A	Approach Transition Type:	RIGID SBT WALL - SBT
Ending End Trtmt Type:	SBT/LOG FLARED	Ending End Trtmt Crashworthy?:	NO		
Average Measurements					
Design Height (In.):	27	Width (In.):	0.0	Post Spacing (In.):	120.0
Height (In.):	26.7	Lateral Offset (In.):	28.7	Road Grade (%):	0.30
Physical Condition					
Barrier	Alignment and Height:	No alignment deflection observed. Height is 0-1 in below the 27-in design height.

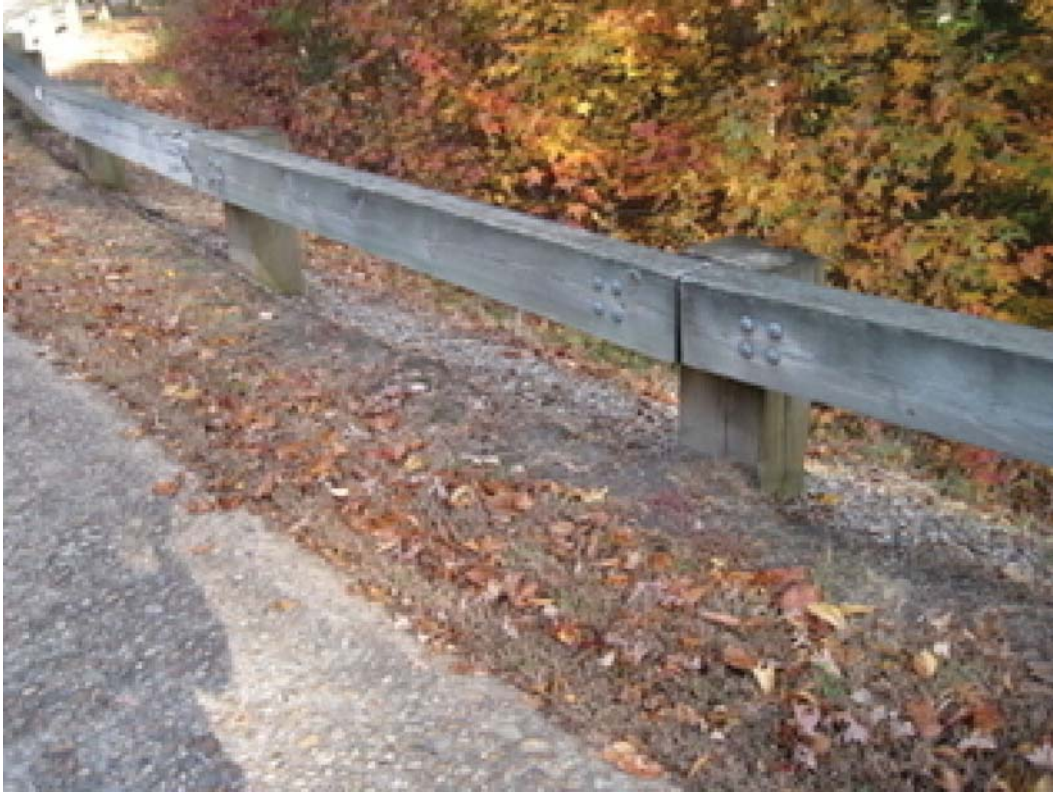
COLO_0105A_0.004_R_1.jpg

Barrier ID:	COLO-0105A-0.004-R				
Route Name:	US ROUTE 17 ACCESS ROAD A				
Inspection Date:	11/18/2010	Barrier Rating:	28.20		
Barrier Description					
Type:	STEEL-BACKED TIMBER WITHOUT BLOCKOUT	Barrier Function:	TRAFFIC		
Barrier Material:	STEEL-BACKED TIMBER/LOG	Post Material:	WOOD		
Blockout Type:	N/A	Length (ft.):	227		
Speed Limit (MPH):	35	Placement with Respect to Road:	INSIDE OF CURVE		
Hazard Behind Barrier:	MEDIUM				
Barrier Crashworthiness					
Appropriate Test Level:	TL-2	Barrier Test Level:	TL-2	Is Barrier Crashworthy?:	YES
Beg. End Trtmt Type:	NONE	Is Beg. End Trtmt Crashworthy?:	N/A	Approach Transition Type:	NONE
Ending End Trtmt Type:	SBT/LOG FLARED	Ending End Trtmt Crashworthy?:	NO		
Average Measurements					
Design Height (In.):	27	Width (In.):	0.0	Post Spacing (In.):	119.3
Height (In.):	25.0	Lateral Offset (In.):	42.0	Road Grade (%):	2.60
Physical Condition					
Barrier	Alignment and Height:	No alignment deflection observed. Height is 2 in below 27 in design height.

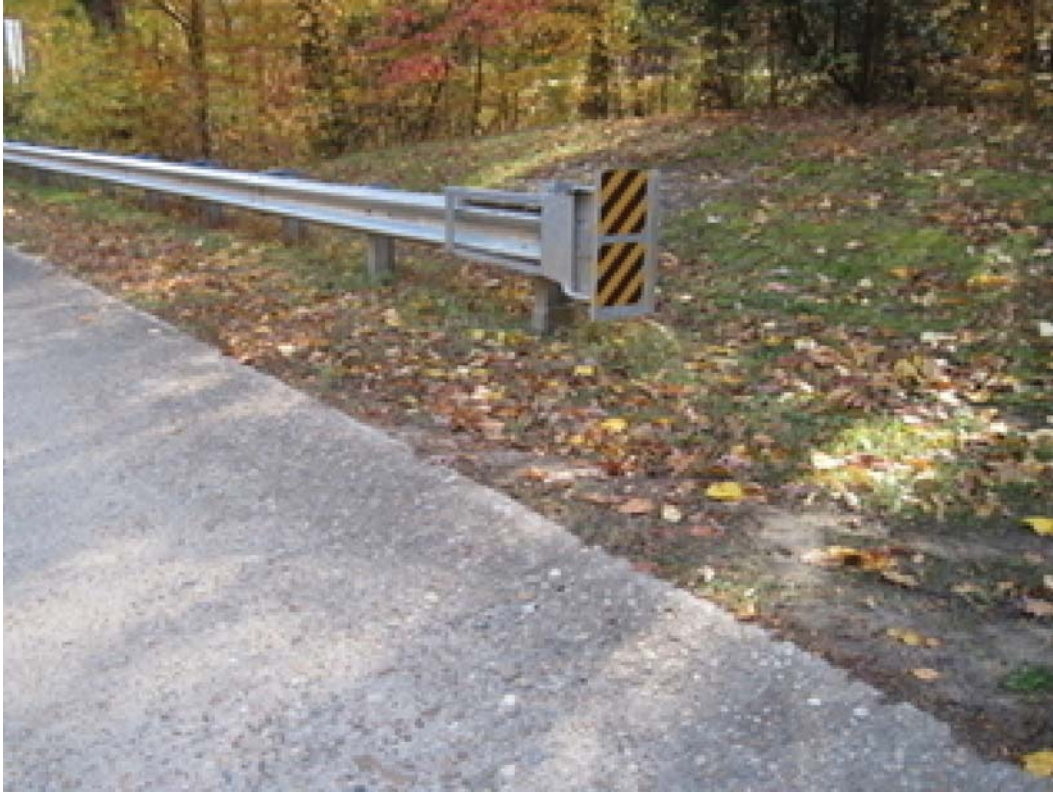
COLO_0105A_0.141_R_1.jpg

Barrier ID:	COLO-0105A-0.141-R				
Route Name:	US ROUTE 17 ACCESS ROAD A				
Inspection Date:	11/18/2010	Barrier Rating:	17.80		
Barrier Description					
Type:	W-BEAM STRONG POST	Barrier Function:	TRAFFIC		
Barrier Material:	GALVANIZED STEEL	Post Material:	GALVANIZED STEEL		
Blockout Type:	PLASTIC	Length (ft.):	128		
Speed Limit (MPH):	35	Placement with Respect to Road:	TANGENT		
Hazard Behind Barrier:	MEDIUM				
Barrier Crashworthiness					
Appropriate Test Level:	TL-2	Barrier Test Level:	TL-3	Is Barrier Crashworthy?:	YES
Beg. End Trtmt Type:	W-BEAM TANGENT 350	Is Beg. End Trtmt Crashworthy?:	YES	Approach Transition Type:	NONE
Ending End Trtmt Type:	NONE	Ending End Trtmt Crashworthy?:	N/A		
Average Measurements					
Design Height (In.):	27	Width (In.):	0.0	Post Spacing (In.):	75.3
Height (In.):	26.7	Lateral Offset (In.):	86.6	Road Grade (%):	4.20
Physical Condition					
Barrier	Alignment and Height:	No alignment deflection observed. Height ranges from 1 in to 2 in below 27 in design height for 75ft and from 1 in below to 2 in above design height for 23ft.

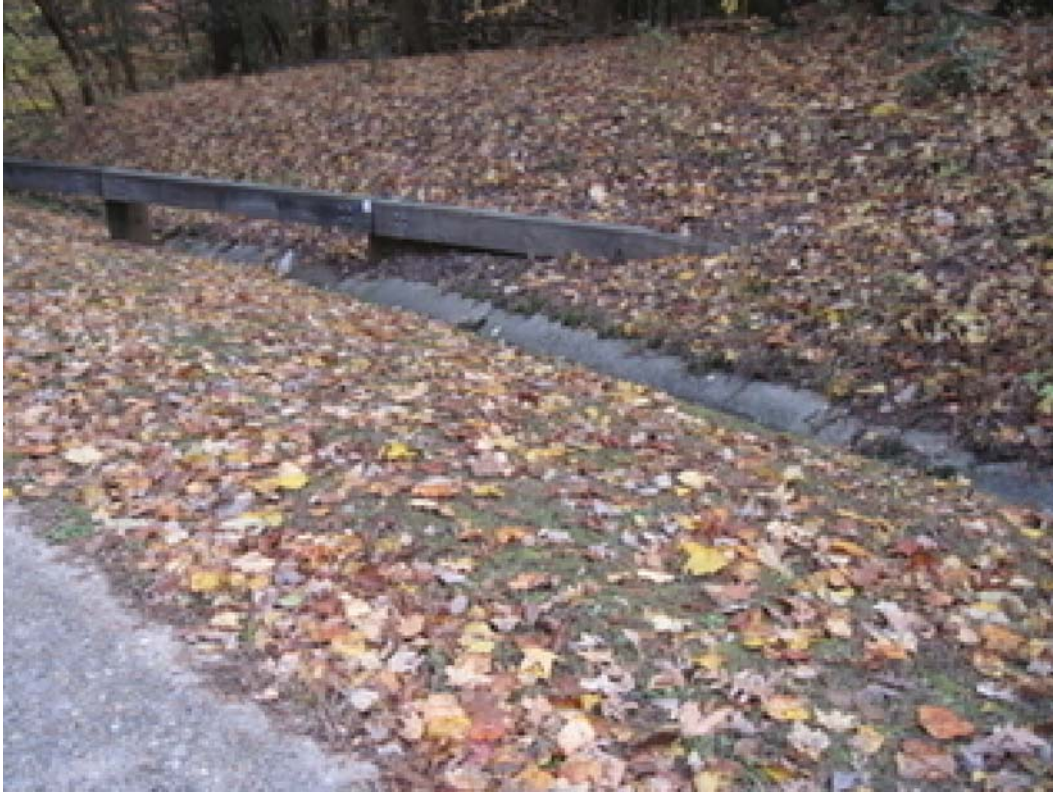
COLO_0105B_0.050_R_1.jpg

Barrier ID:	COLO-0105B-0.050-R				
Route Name:	US ROUTE 17 ACCESS ROAD B				
Inspection Date:	11/18/2010	Barrier Rating:	22.20		
Barrier Description					
Type:	STEEL-BACKED TIMBER WITHOUT BLOCKOUT	Barrier Function:	TRAFFIC		
Barrier Material:	STEEL-BACKED TIMBER/LOG	Post Material:	WOOD		
Blockout Type:	N/A	Length (ft.):	231		
Speed Limit (MPH):	35	Placement with Respect to Road:	OUTSIDE OF CURVE		
Hazard Behind Barrier:	MEDIUM				
Barrier Crashworthiness					
Appropriate Test Level:	TL-2	Barrier Test Level:	TL-2	Is Barrier Crashworthy?:	YES
Beg. End Trtmt Type:	SBT/LOG BURIED	Is Beg. End Trtmt Crashworthy?:	YES	Approach Transition Type:	NONE
Ending End Trtmt Type:	SBT/LOG FLARED	Ending End Trtmt Crashworthy?:	NO		
Average Measurements					
Design Height (In.):	27	Width (In.):	0.0	Post Spacing (In.):	120.3
Height (In.):	26.5	Lateral Offset (In.):	55.7	Road Grade (%):	1.10
Physical Condition					
Barrier	Alignment and Height:	No alignment deflection observed. Height ranges from 0-1 in below 27 in design height.

Breaking and Cracking:	No breaking or cracking observed.			
	Missing Elements:	No missing elements observed.			
	Corrosion and Weathering:	No corrosion or weathering observed.			
End Treatments	Alignment and Height:	Alignment acceptable. Height within 1-in of 27-in design height.			
	Breaking and Cracking:	No breaking or cracking observed.			
	Missing Elements:	No missing elements observed.			
	Corrosion and Weathering:	No corrosion or weathering observed.

Barrier ID:	COLO-0105B-0.050-R				
Route Name:	US ROUTE 17 ACCESS ROAD B				
Inspection Date:	11/18/2010		Barrier Rating:	22.20	
Repair Recommendations					
Repair Action:	NO ACTION	FMSS Work Type:	N/A	Repair Cost:	\$0
Brief Workorder:	N/A				
Workorder:	No action.

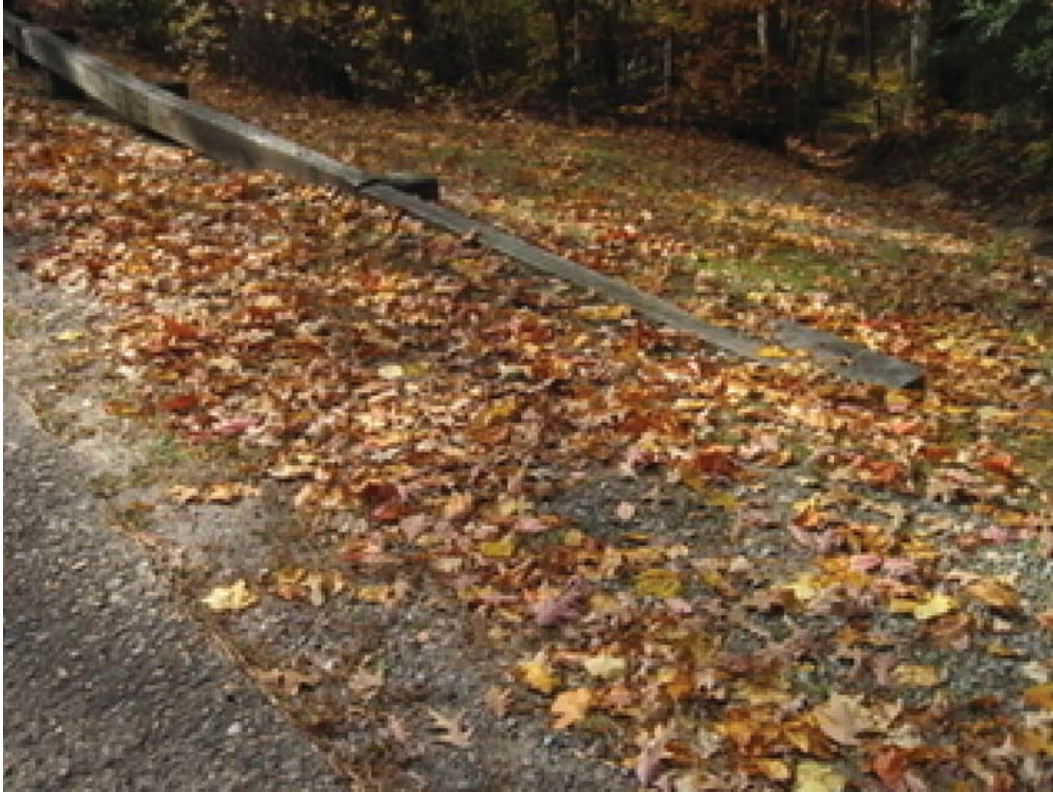
COLO_0105B_0.067_L_1.jpg

Barrier ID:	COLO-0105B-0.067-L				
Route Name:	US ROUTE 17 ACCESS ROAD B				
Inspection Date:	11/18/2010	Barrier Rating:	16.50		
Barrier Description					
Type:	STEEL-BACKED TIMBER WITHOUT BLOCKOUT	Barrier Function:	TRAFFIC		
Barrier Material:	STEEL-BACKED TIMBER/LOG	Post Material:	WOOD		
Blockout Type:	N/A	Length (ft.):	210		
Speed Limit (MPH):	35	Placement with Respect to Road:	INSIDE OF CURVE		
Hazard Behind Barrier:	MEDIUM				
Barrier Crashworthiness					
Appropriate Test Level:	TL-2	Barrier Test Level:	TL-2	Is Barrier Crashworthy?:	YES
Beg. End Trtmt Type:	SBT/LOG FLARED	Is Beg. End Trtmt Crashworthy?:	NO	Approach Transition Type:	NONE
Ending End Trtmt Type:	SBT/LOG FLARED	Ending End Trtmt Crashworthy?:	NO		
Average Measurements					
Design Height (In.):	27	Width (In.):	0.0	Post Spacing (In.):	119.6
Height (In.):	27.0	Lateral Offset (In.):	60.2	Road Grade (%):	0.70
Physical Condition					
Barrier	Alignment and Height:	No alignment deflection observed. Height is at the 27-in design height along entire length.

Breaking and Cracking:	No breaking or cracking observed.			
	Missing Elements:	No missing elements observed.			
	Corrosion and Weathering:	No corrosion or weathering observed.			
End Treatments	Alignment and Height:	Alignment acceptable. Height within 1-in of 27-in design height.			
	Breaking and Cracking:	No breaking or cracking observed.			
	Missing Elements:	No missing elements observed.			
	Corrosion and Weathering:	No corrosion or weathering observed.

Repair Action:	NO ACTION	FMSS Work Type:	N/A	Repair Cost:	\$0
Brief Workorder:	N/A				
Workorder:

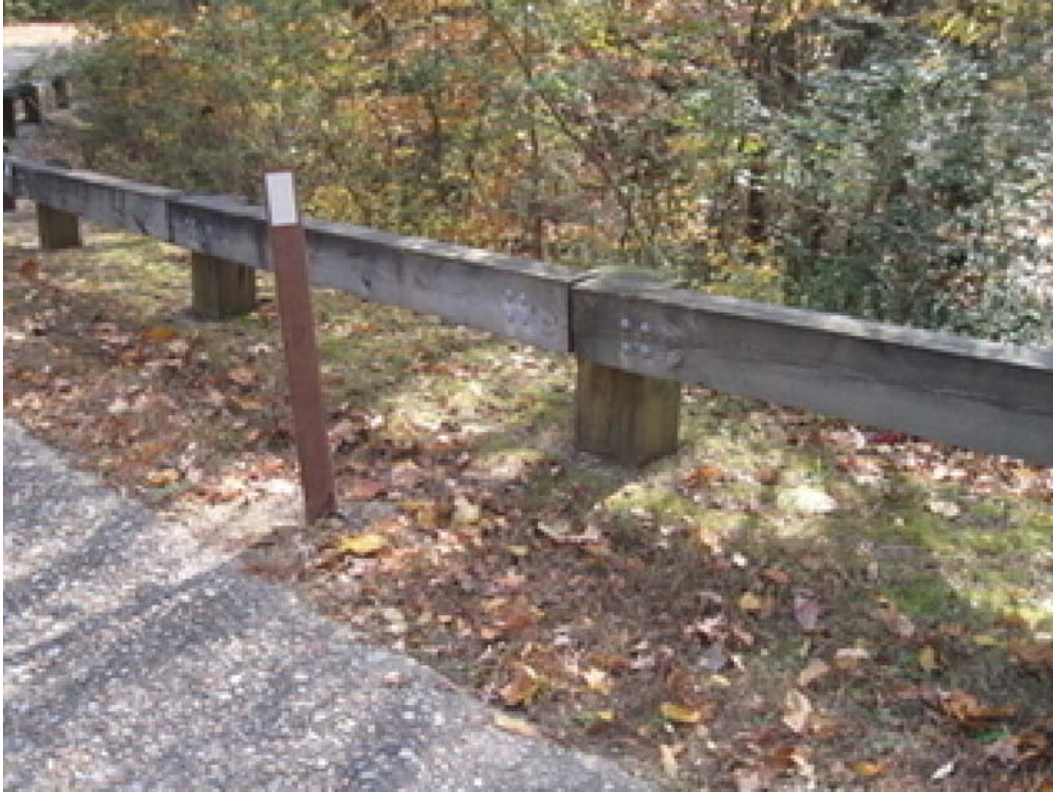
COLO_0105B_0.155_L_1.jpg

Barrier ID:	COLO-0105B-0.155-L				
Route Name:	US ROUTE 17 ACCESS ROAD B				
Inspection Date:	11/18/2010	Barrier Rating:	18.20		
Barrier Description					
Type:	STEEL-BACKED TIMBER WITHOUT BLOCKOUT	Barrier Function:	TRAFFIC		
Barrier Material:	STEEL-BACKED TIMBER/LOG	Post Material:	WOOD		
Blockout Type:	N/A	Length (ft.):	148		
Speed Limit (MPH):	35	Placement with Respect to Road:	INSIDE OF CURVE		
Hazard Behind Barrier:	HIGH				
Barrier Crashworthiness					
Appropriate Test Level:	TL-2	Barrier Test Level:	TL-2	Is Barrier Crashworthy?:	YES
Beg. End Trtmt Type:	SBT/LOG FLARED	Is Beg. End Trtmt Crashworthy?:	NO	Approach Transition Type:	NONE
Ending End Trtmt Type:	NONE	Ending End Trtmt Crashworthy?:	N/A		
Average Measurements					
Design Height (In.):	27	Width (In.):	0.0	Post Spacing (In.):	118.3
Height (In.):	27.7	Lateral Offset (In.):	51.0	Road Grade (%):	1.90
Physical Condition					
Barrier	Alignment and Height:	No alignment deflection observed. Height is 0 - 1 in above the 27-in design height.

Breaking and Cracking:	No breaking or cracking observed.			
	Missing Elements:	No missing elements observed.			
	Corrosion and Weathering:	No corrosion or weathering observed.			
End Treatments	Alignment and Height:	Alignment acceptable. Height within 1-in of 27-in design height.			
	Breaking and Cracking:	No breaking or cracking observed.			
	Missing Elements:	No missing elements observed.			
	Corrosion and Weathering:	No corrosion or weathering observed.

Repair Action:	NO ACTION	FMSS Work Type:	N/A	Repair Cost:	\$0
Brief Workorder:	N/A				
Workorder:

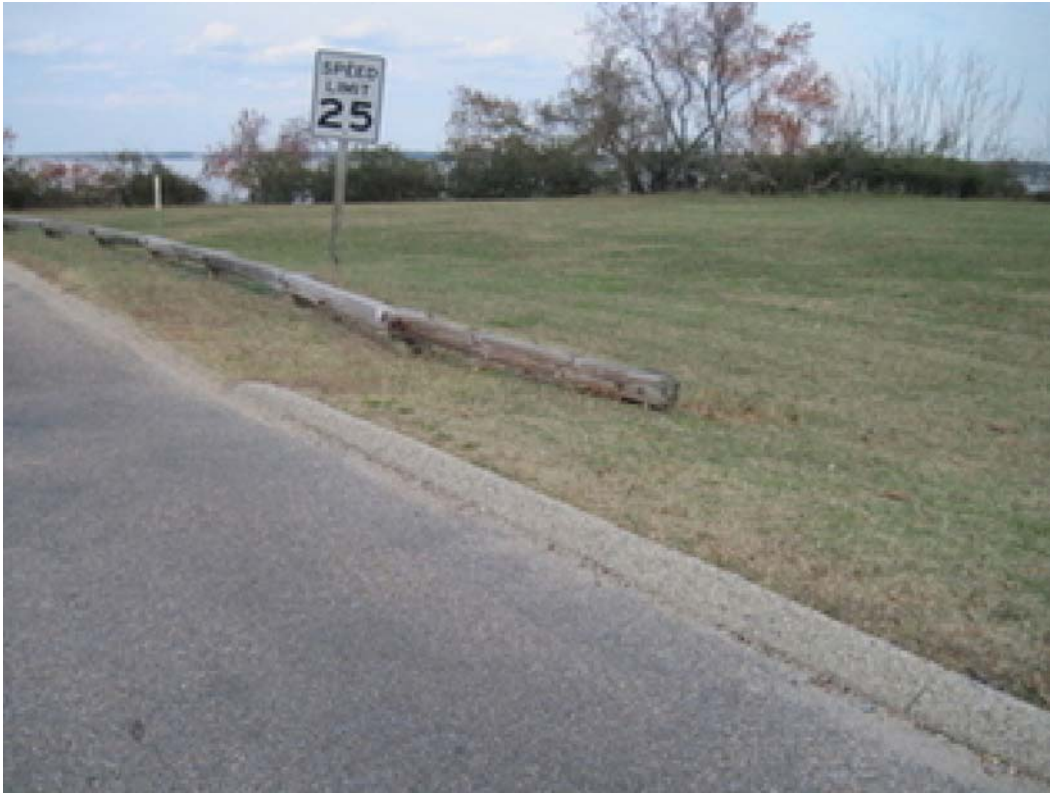
COLO_0106_0.297_L_1.jpg

Barrier ID:	COLO-0106-0.297-L				
Route Name:	FUSILIER'S ROAD				
Inspection Date:	11/18/2010	Barrier Rating:	29.80		
Barrier Description					
Type:	OTHER: TIMBER RAIL ON TIMBER POSTS	Barrier Function:	TRAFFIC		
Barrier Material:	LOG/TIMBER/WOOD	Post Material:	WOOD		
Blockout Type:	N/A	Length (ft.):	207		
Speed Limit (MPH):	25	Placement with Respect to Road:	OUTSIDE OF CURVE		
Hazard Behind Barrier:	HIGH				
Barrier Crashworthiness					
Appropriate Test Level:	TL-1	Barrier Test Level:	NCW	Is Barrier Crashworthy?:	NO
Beg. End Trtmt Type:	NONE	Is Beg. End Trtmt Crashworthy?:	N/A	Approach Transition Type:	NONE
Ending End Trtmt Type:	OTHER: TIMBER FLARED	Ending End Trtmt Crashworthy?:	NO		
Average Measurements					
Design Height (In.):	12	Width (In.):	0.0	Post Spacing (In.):	96.3
Height (In.):	12.0	Lateral Offset (In.):	68.6	Road Grade (%):	0.20
Physical Condition					
Barrier	Alignment and Height:	No alignment deflection was observed. Height is 12 in along entire length which appears to be the intended design height based on field observation and from direction from the park.

Breaking and Cracking:	One rail is broken possibly from impact such that the cross section is not maintained.			
	Missing Elements:	No missing elements were observed.			
	Corrosion and Weathering:	Rails and posts are damaged due to weathering. 1 rail is rotting from the inside such that at least 10 percent of the cross section is gone. All other rails and posts are weathered such that 5 percent or less of cross section is deteriorated.			
End Treatments	Alignment and Height:	Alignment and height are as designed.			
	Breaking and Cracking:	No breaking or cracking was observed.			
	Missing Elements:	No missing elements were observed.			
	Corrosion and Weathering:	Weathering resulting in less than five percent loss in cross section was observed.

Repair Action:	REPAIR	FMSS Work Type:	DEFERRED MAINTENANCE	Repair Cost:	\$2063
Brief Workorder:	Replace 16 feet of rail.				
Workorder:	Replace Rail at \$25- per -Lin. Ft. for 16 LF = \$400. Low Speed Traffic Control at \$1475- per -Day for 1 Day(s) = \$1475.
