GIP Report

NPS Guardwall/Rail Inventory Program Colonial National Historical Park

**Federal Highway Administration
Eastern Federal Lands Highway Division
Road Inventory Program (RIP)**

**Data Collection Date: November 2010
Report Date: December 2015**

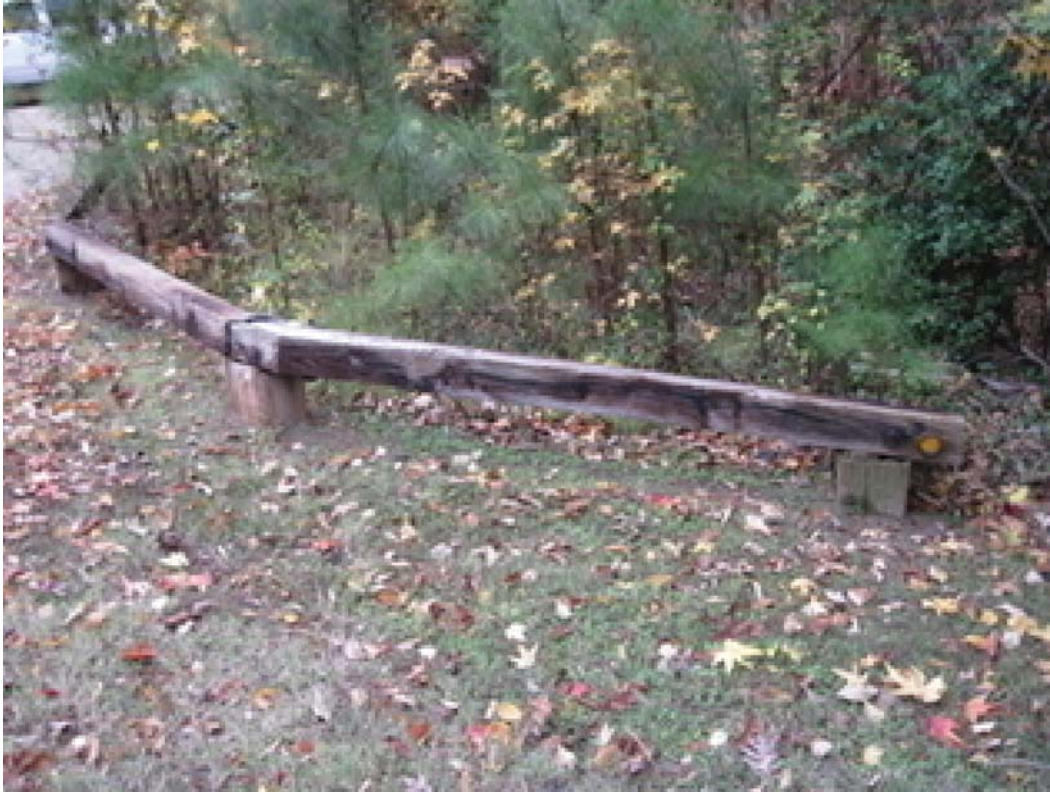
COLO_0111A_0.038_R_1.jpg

Barrier ID:	COLO-0111A-0.038-R				
Route Name:	STATE ROUTE 199 KINGS POINT A				
Inspection Date:	11/18/2010	Barrier Rating:	23.60		
Barrier Description					
Type:	OTHER: TIMBER RAIL ON TIMBER POSTS	Barrier Function:	TRAFFIC		
Barrier Material:	LOG/TIMBER/WOOD	Post Material:	WOOD		
Blockout Type:	N/A	Length (ft.):	35		
Speed Limit (MPH):	35	Placement with Respect to Road:	TANGENT		
Hazard Behind Barrier:	MEDIUM				
Barrier Crashworthiness					
Appropriate Test Level:	TL-2	Barrier Test Level:	NCW	Is Barrier Crashworthy?:	NO
Beg. End Trtmt Type:	NONE	Is Beg. End Trtmt Crashworthy?:	N/A	Approach Transition Type:	NONE
Ending End Trtmt Type:	NONE	Ending End Trtmt Crashworthy?:	N/A		
Average Measurements					
Design Height (In.):	18	Width (In.):	0.0	Post Spacing (In.):	104.3
Height (In.):	20.2	Lateral Offset (In.):	60.0	Road Grade (%):	3.20
Physical Condition					
Barrier	Alignment and Height:	No alignment deflection was observed. Height is 0-3 in above the 18-in design height which was field-observed. Park confirmed design height.

Breaking and Cracking:	No breaking or cracking was observed.			
	Missing Elements:	No missing elements were observed.			
	Corrosion and Weathering:	Posts and rails are weathered with deterioration of 5 percent or less of cross section.			
End Treatments	Alignment and Height:				
	Breaking and Cracking:				
	Missing Elements:				
	Corrosion and Weathering:

Repair Action:	NO ACTION	FMSS Work Type:	N/A	Repair Cost:	\$0
Brief Workorder:	N/A				
Workorder:

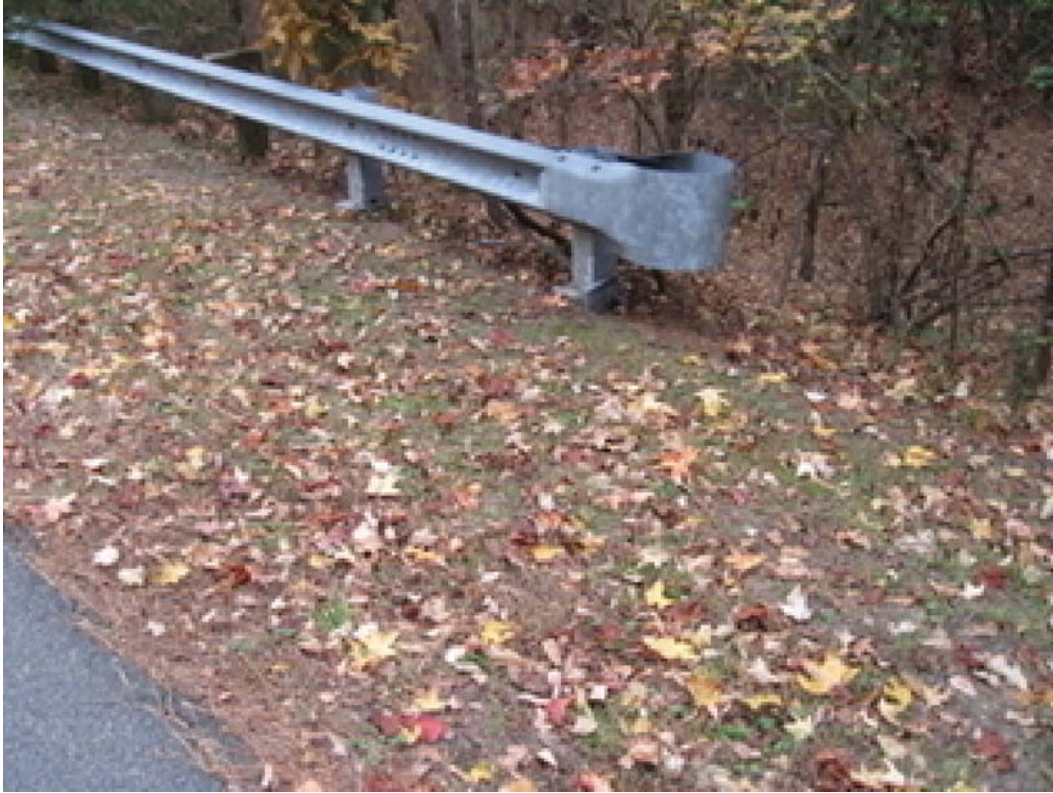
COLO_0111C_0.016_L_1.jpg

Barrier ID:	COLO-0111C-0.016-L				
Route Name:	STATE ROUTE 199 KINGS POINT C				
Inspection Date:	11/18/2010	Barrier Rating:	16.50		
Barrier Description					
Type:	W-BEAM STRONG POST	Barrier Function:	TRAFFIC		
Barrier Material:	GALVANIZED STEEL	Post Material:	WOOD		
Blockout Type:	WOOD	Length (ft.):	89		
Speed Limit (MPH):	35	Placement with Respect to Road:	INSIDE OF CURVE		
Hazard Behind Barrier:	MEDIUM				
Barrier Crashworthiness					
Appropriate Test Level:	TL-2	Barrier Test Level:	TL-3	Is Barrier Crashworthy?:	YES
Beg. End Trtmt Type:	NONE	Is Beg. End Trtmt Crashworthy?:	N/A	Approach Transition Type:	NONE
Ending End Trtmt Type:	W-BEAM BCT	Ending End Trtmt Crashworthy?:	NO		
Average Measurements					
Design Height (In.):	27	Width (In.):	0.0	Post Spacing (In.):	74.3
Height (In.):	26.7	Lateral Offset (In.):	116.6	Road Grade (%):	2.00
Physical Condition					
Barrier	Alignment and Height:	No alignment deflection was observed. Height is within 1 in of 27-in design height.

Breaking and Cracking:	No breaking or cracking was observed.			
	Missing Elements:	No missing elements were observed. 4 wooden blocks are twisted.			
	Corrosion and Weathering:	No corrosion or weathering was observed.			
End Treatments	Alignment and Height:				
	Breaking and Cracking:				
	Missing Elements:				
	Corrosion and Weathering:

Repair Action:	REPAIR	FMSS Work Type:	DEFERRED MAINTENANCE	Repair Cost:	\$1689
Brief Workorder:	Adjust 4 twisted wooden blocks.				
Workorder:	Labor at \$60- per -Hour for 1 Hrs = \$60. Adjust 4 twisted wooden blocks Low Speed Traffic Control at \$1475- per -Day for 1 Day(s) = \$1475.
