**GIP Report**

**NPS Guardwall/Rail Inventory Program  
Crater Lake National Park**

**Federal Highway Administration  
Eastern Federal Lands Highway Division  
Road Inventory Program (RIP)**

**Data Collection Date: July 2010  
Report Date: December 2015**

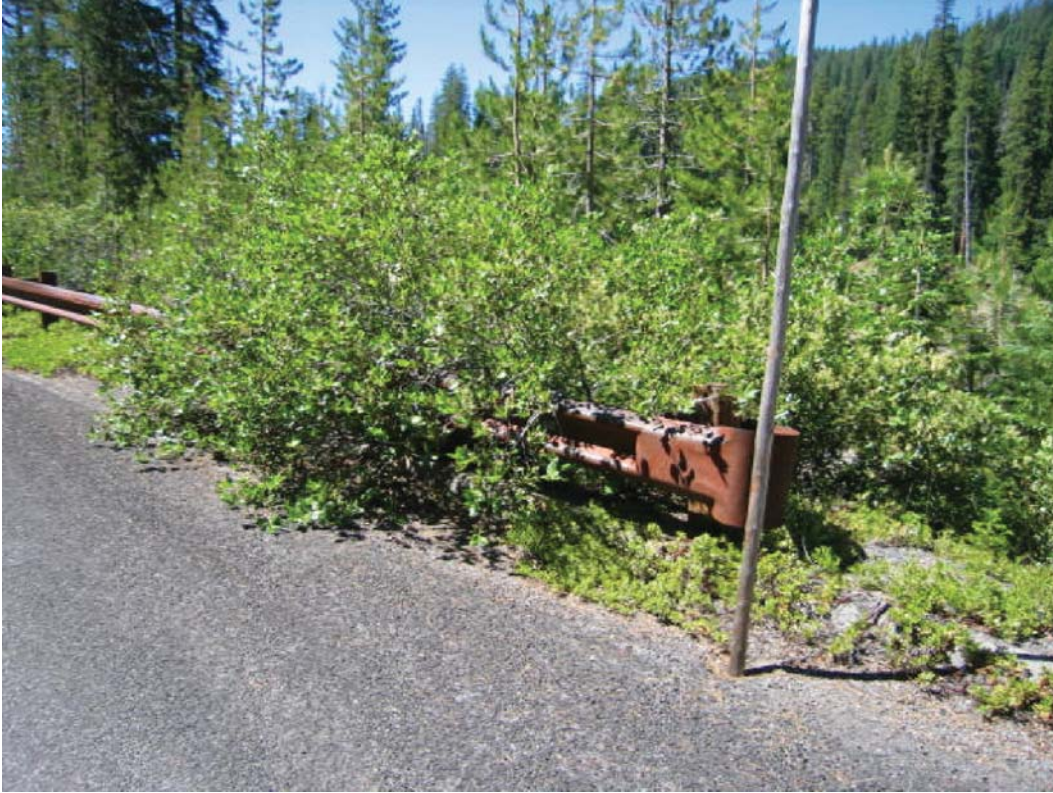
CRLA\_0011\_13.680\_L\_1.jpg

<b>Barrier ID:</b>	CRLA-0011-13.680-L				
<b>Route Name:</b>	CRATER LAKE HIGHWAY				
<b>Inspection Date:</b>	07/18/2010	<b>Barrier Rating:</b>	30.80		
<b>Barrier Description</b>					
<b>Type:</b>	W-BEAM STRONG POST	<b>Barrier Function:</b>	TRAFFIC		
<b>Barrier Material:</b>	WEATHERING STEEL/CORTEN	<b>Post Material:</b>	WOOD		
<b>Blockout Type:</b>	WOOD	<b>Length (ft.):</b>	185		
<b>Speed Limit (MPH):</b>	45	<b>Placement with Respect to Road:</b>	OUTSIDE OF CURVE		
<b>Hazard Behind Barrier:</b>	MEDIUM				
<b>Barrier Crashworthiness</b>					
<b>Appropriate Test Level:</b>	TL-2	<b>Barrier Test Level:</b>	TL-3	<b>Is Barrier Crashworthy?:</b>	YES
<b>Beg. End Trtmt Type:</b>	NONE	<b>Is Beg. End Trtmt Crashworthy?:</b>	N/A	<b>Approach Transition Type:</b>	NONE
<b>Ending End Trtmt Type:</b>	W-BEAM BURIED END	<b>Ending End Trtmt Crashworthy?:</b>	YES		
<b>Average Measurements</b>					
<b>Design Height (In.):</b>	27	<b>Width (In.):</b>	0.0	<b>Post Spacing (In.):</b>	75.0

<b>Height (In.):</b>	26.7	<b>Lateral Offset (In.):</b>	50.0	<b>Road Grade (%):</b>	3.90
<b>Physical Condition</b>					
<b>Barrier</b>	<b>Alignment and Height:</b>	Posts are plumb. The rail is flattened. Rail not tight to blocks.			
	<b>Breaking and Cracking:</b>	Some minor cracking on posts and blocks.			
	<b>Missing Elements:</b>	None observed. All hardware blocks and posts in place.			
	<b>Corrosion and Weathering:</b>	The rail does show signs of corrosion.			
<b>End Treatments</b>	<b>Alignment and Height:</b>	The buried end is at design height (27-in).			
	<b>Breaking and Cracking:</b>	No cracking or breaking.			
	<b>Missing Elements:</b>	No missing elements observed.			
	<b>Corrosion and Weathering:</b>	Rail corroded.

<b>Repair Action:</b>	REPAIR	<b>FMSS Work Type:</b>	DEFERRED MAINTENANCE	<b>Repair Cost:</b>	\$5164
<b>Brief Workorder:</b>	Replace 100 l.f. of corroded W-beam tighten bolts and reshape 40 l.f. of W-beam.				
<b>Workorder:</b>	Replace Rail at \$25- per -Lin. Ft. for 100 LF = \$2500. Remove 100-ft of corroded rail and replace with new rail. Labor at \$60- per -Hour for 4 Hrs = \$240. 4-hrs labor to tighten bolts. Labor at \$60- per -Hour for 8 Hrs = \$480. 8-hrs labor to reshape 40-ft of flattened rail. Low Speed Traffic Control at \$1475- per -Day for 1 Day(s) = \$1475. One day to complete all work.

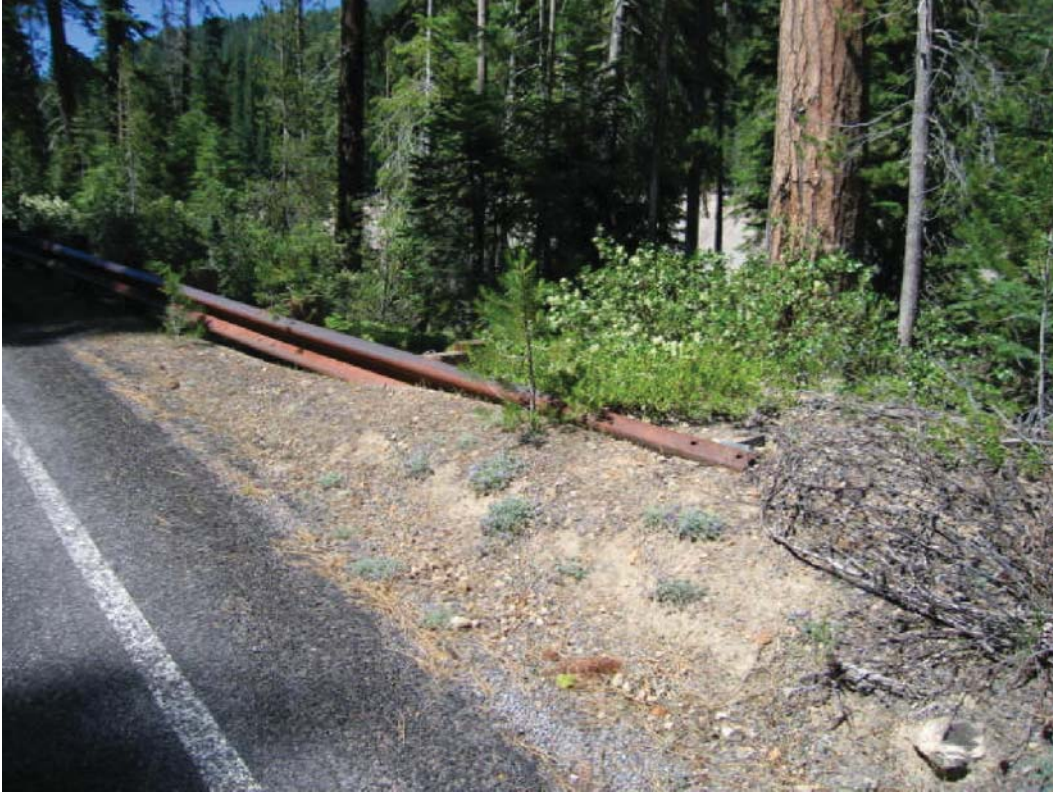
CRLA\_0011\_13.798\_L\_1.jpg

<b>Barrier ID:</b>	CRLA-0011-13.798-L				
<b>Route Name:</b>	CRATER LAKE HIGHWAY				
<b>Inspection Date:</b>	07/18/2010	<b>Barrier Rating:</b>	36.70		
<b>Barrier Description</b>					
<b>Type:</b>	W-BEAM STRONG POST	<b>Barrier Function:</b>	TRAFFIC		
<b>Barrier Material:</b>	WEATHERING STEEL/CORTEN	<b>Post Material:</b>	WOOD		
<b>Blockout Type:</b>	WOOD	<b>Length (ft.):</b>	266		
<b>Speed Limit (MPH):</b>	45	<b>Placement with Respect to Road:</b>	OUTSIDE OF CURVE		
<b>Hazard Behind Barrier:</b>	MEDIUM				
<b>Barrier Crashworthiness</b>					
<b>Appropriate Test Level:</b>	TL-2	<b>Barrier Test Level:</b>	TL-3	<b>Is Barrier Crashworthy?:</b>	YES
<b>Beg. End Trtmt Type:</b>	NONE	<b>Is Beg. End Trtmt Crashworthy?:</b>	N/A	<b>Approach Transition Type:</b>	NONE
<b>Ending End Trtmt Type:</b>	W-BEAM BURIED END	<b>Ending End Trtmt Crashworthy?:</b>	YES		
<b>Average Measurements</b>					
<b>Design Height (In.):</b>	27	<b>Width (In.):</b>	0.0	<b>Post Spacing (In.):</b>	75.0

<b>Height (In.):</b>	27.0	<b>Lateral Offset (In.):</b>	44.0	<b>Road Grade (%):</b>	3.90
<b>Physical Condition</b>					
<b>Barrier</b>	<b>Alignment and Height:</b>	50-ft of rail is flattened. Posts and blocks are plumb. 75-ft of rail is flattened slightly.			
	<b>Breaking and Cracking:</b>	Minor cracking in posts and blocks.			
	<b>Missing Elements:</b>	Two missing blockouts. No missing hardware or posts.			
	<b>Corrosion and Weathering:</b>	Rail looks corroded.			
<b>End Treatments</b>	<b>Alignment and Height:</b>	No deviation in end terminal height or alignment.			
	<b>Breaking and Cracking:</b>	No breaking or cracking observed.			
	<b>Missing Elements:</b>	None observed.			
	<b>Corrosion and Weathering:</b>	The rail looks corroded.

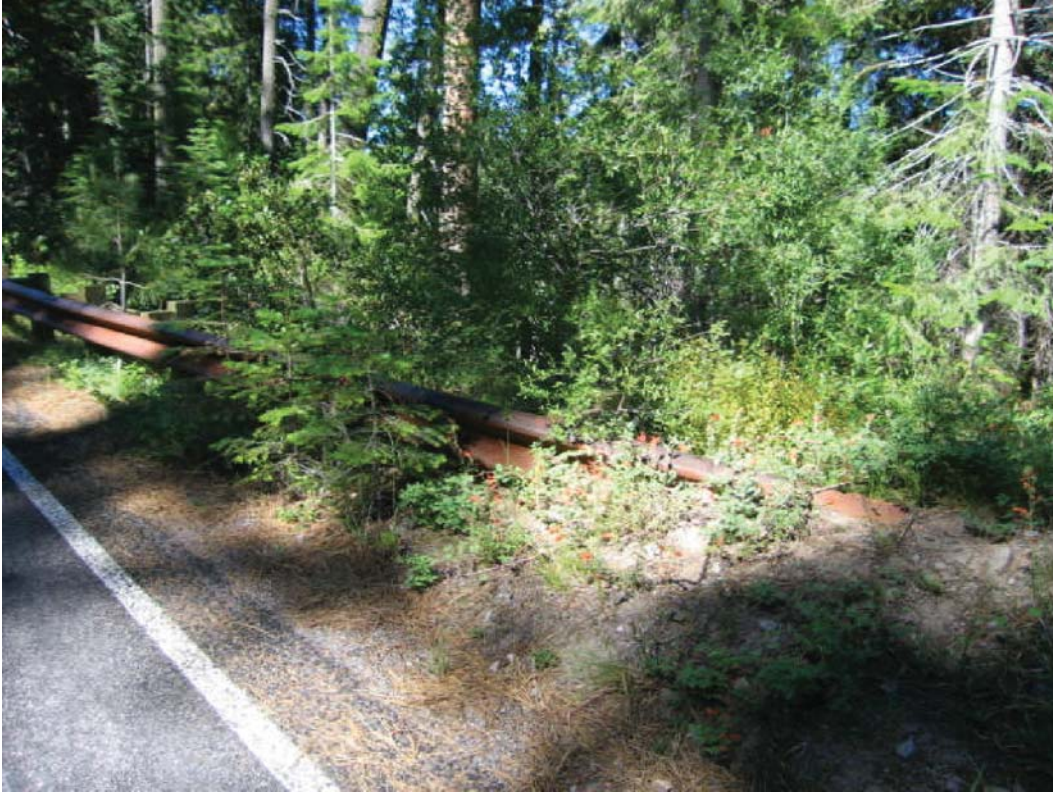
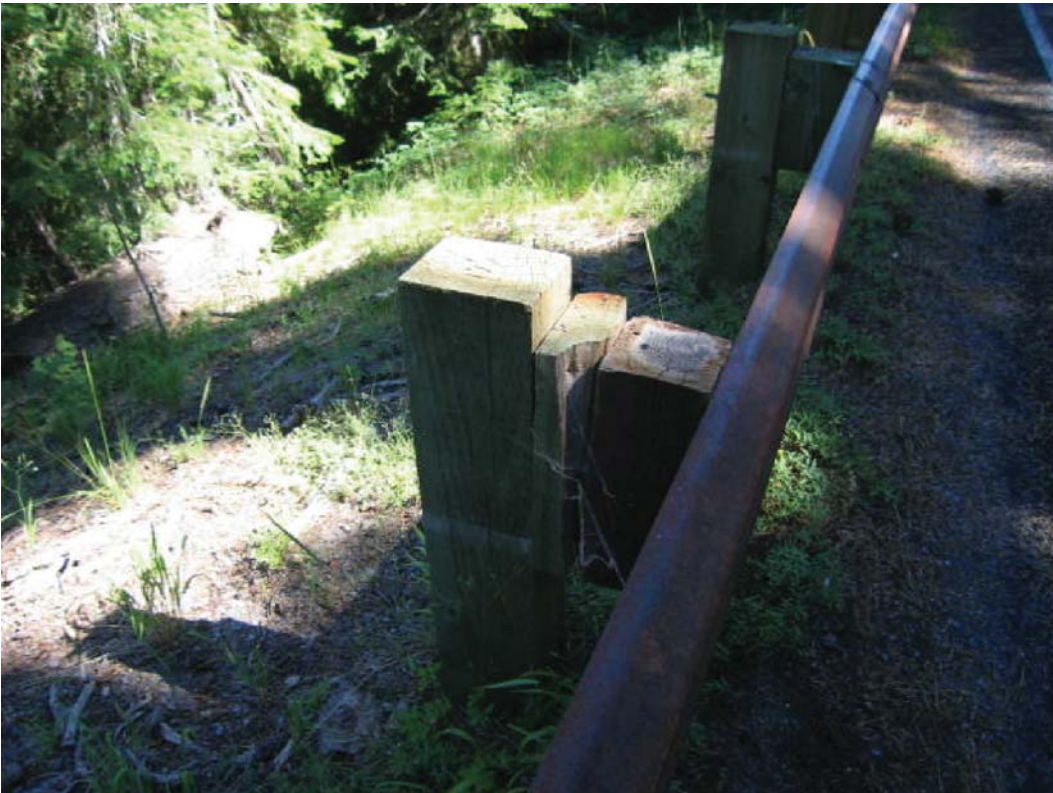
CRLA\_0011\_15.395\_L\_1.jpg

<b>Barrier ID:</b>	CRLA-0011-15.395-L				
<b>Route Name:</b>	CRATER LAKE HIGHWAY				
<b>Inspection Date:</b>	07/18/2010	<b>Barrier Rating:</b>	29.30		
<b>Barrier Description</b>					
<b>Type:</b>	W-BEAM STRONG POST	<b>Barrier Function:</b>	TRAFFIC		
<b>Barrier Material:</b>	WEATHERING STEEL/CORTEN	<b>Post Material:</b>	WOOD		
<b>Blockout Type:</b>	WOOD	<b>Length (ft.):</b>	190		
<b>Speed Limit (MPH):</b>	45	<b>Placement with Respect to Road:</b>	OUTSIDE OF CURVE		
<b>Hazard Behind Barrier:</b>	MEDIUM				
<b>Barrier Crashworthiness</b>					
<b>Appropriate Test Level:</b>	TL-2	<b>Barrier Test Level:</b>	TL-3	<b>Is Barrier Crashworthy?:</b>	YES
<b>Beg. End Trtmt Type:</b>	W-BEAM BURIED END	<b>Is Beg. End Trtmt Crashworthy?:</b>	YES	<b>Approach Transition Type:</b>	NONE
<b>Ending End Trtmt Type:</b>	W-BEAM BURIED END	<b>Ending End Trtmt Crashworthy?:</b>	YES		
<b>Average Measurements</b>					
<b>Design Height (In.):</b>	27	<b>Width (In.):</b>	0.0	<b>Post Spacing (In.):</b>	75.0

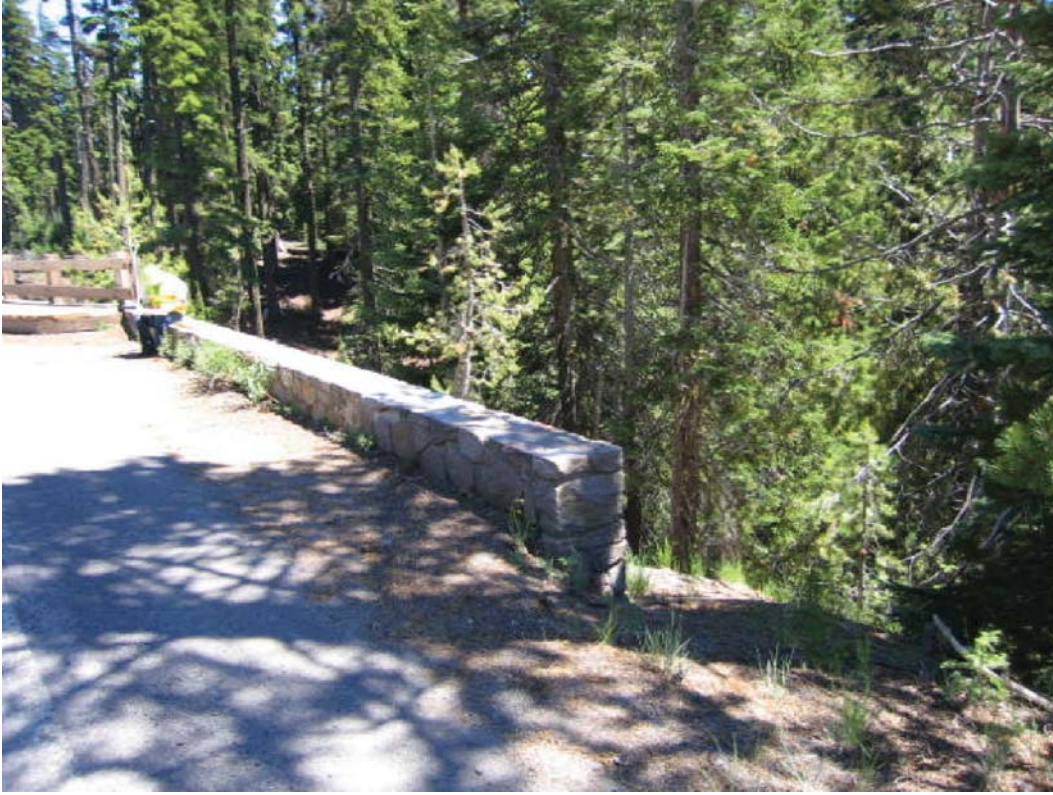
CRLA\_0012\_1.298\_R\_1.jpg

<b>Barrier ID:</b>	CRLA-0012-1.298-R				
<b>Route Name:</b>	MUNSON VALLEY ROAD				
<b>Inspection Date:</b>	07/16/2010	<b>Barrier Rating:</b>	44.90		
<b>Barrier Description</b>					
<b>Type:</b>	STONE MASONRY WITHOUT CONCRETE CORE WALL	<b>Barrier Function:</b>	TRAFFIC		
<b>Barrier Material:</b>	STONE	<b>Post Material:</b>	N/A		
<b>Blockout Type:</b>	N/A	<b>Length (ft.):</b>	30		
<b>Speed Limit (MPH):</b>	35	<b>Placement with Respect to Road:</b>	TANGENT		
<b>Hazard Behind Barrier:</b>	HIGH				
<b>Barrier Crashworthiness</b>					
<b>Appropriate Test Level:</b>	TL-2	<b>Barrier Test Level:</b>	NCW	<b>Is Barrier Crashworthy?:</b>	NO
<b>Beg. End Trtmt Type:</b>	NONE	<b>Is Beg. End Trtmt Crashworthy?:</b>	N/A	<b>Approach Transition Type:</b>	NONE
<b>Ending End Trtmt Type:</b>	NONE	<b>Ending End Trtmt Crashworthy?:</b>	N/A		
<b>Average Measurements</b>					
<b>Design Height (In.):</b>	24	<b>Width (In.):</b>	18.0	<b>Post Spacing (In.):</b>	0.0

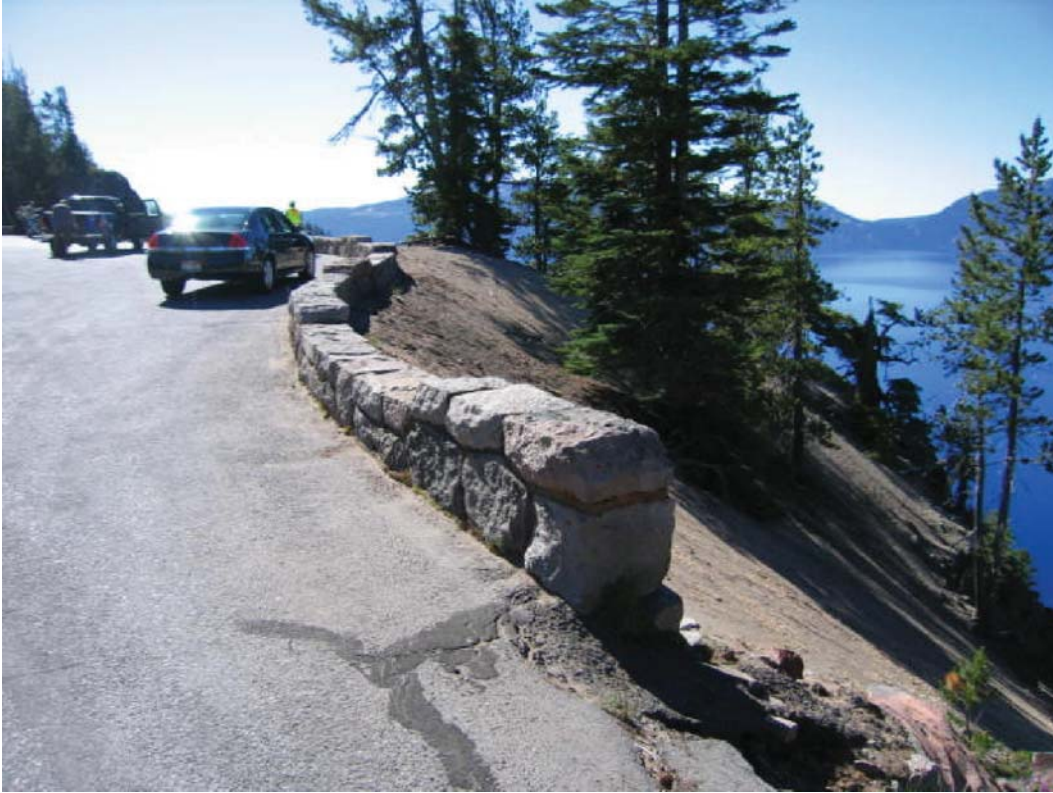
CRLA\_0013\_2.646\_R\_1.jpg

<b>Barrier ID:</b>	CRLA-0013-2.646-R				
<b>Route Name:</b>	EAST RIM DRIVE				
<b>Inspection Date:</b>	07/17/2010	<b>Barrier Rating:</b>	21.30		
<b>Barrier Description</b>					
<b>Type:</b>	STONE MASONRY CRENELLATED WITHOUT	<b>Barrier Function:</b>	NON-TRAFFIC		
<b>Barrier Material:</b>	STONE	<b>Post Material:</b>	N/A		
<b>Blockout Type:</b>	N/A	<b>Length (ft.):</b>	231		
<b>Speed Limit (MPH):</b>	35	<b>Placement with Respect to Road:</b>	NON-TRAFFIC BARRIER		
<b>Hazard Behind Barrier:</b>	N/A				
<b>Barrier Crashworthiness</b>					
<b>Appropriate Test Level:</b>	TL-2	<b>Barrier Test Level:</b>	N/A	<b>Is Barrier Crashworthy?:</b>	N/A
<b>Beg. End Trtmt Type:</b>	NONE	<b>Is Beg. End Trtmt Crashworthy?:</b>	N/A	<b>Approach Transition Type:</b>	NONE
<b>Ending End Trtmt Type:</b>	NONE	<b>Ending End Trtmt Crashworthy?:</b>	N/A		
<b>Average Measurements</b>					
<b>Design Height (In.):</b>	18	<b>Width (In.):</b>	19.0	<b>Post Spacing (In.):</b>	0.0

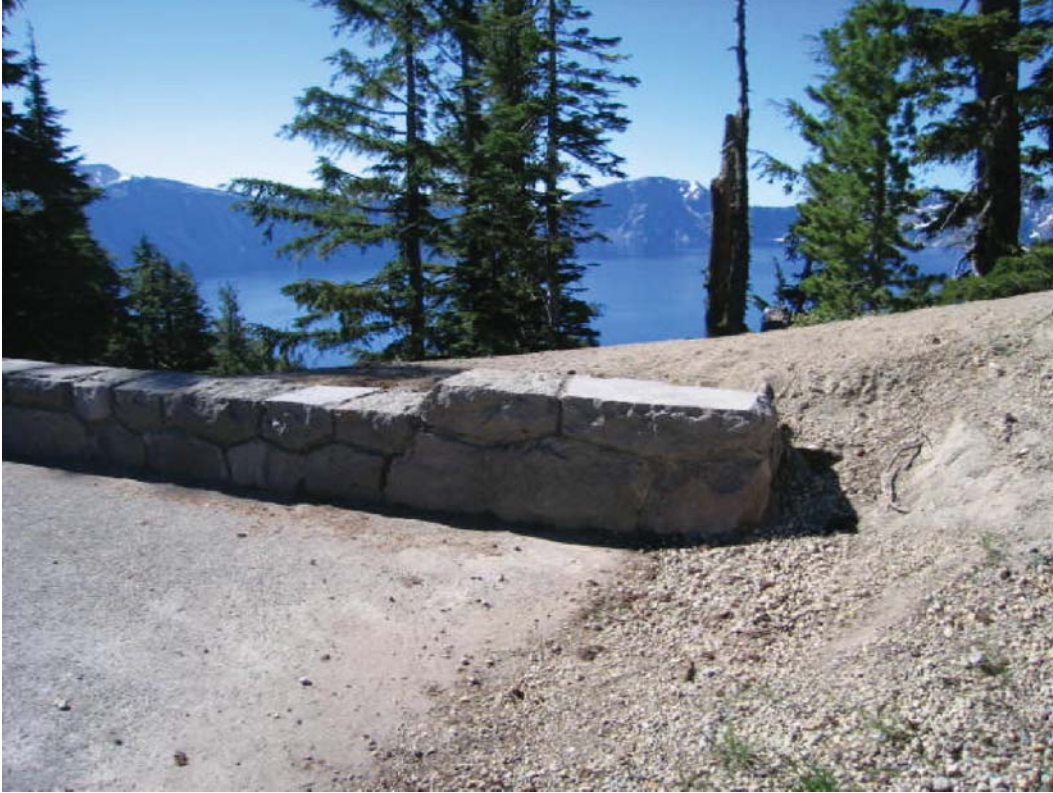
CRLA\_0013\_2.780\_R\_1.jpg

<b>Barrier ID:</b>	CRLA-0013-2.780-R				
<b>Route Name:</b>	EAST RIM DRIVE				
<b>Inspection Date:</b>	07/17/2010	<b>Barrier Rating:</b>	12.80		
<b>Barrier Description</b>					
<b>Type:</b>	STONE MASONRY CRENELLATED WITHOUT	<b>Barrier Function:</b>	NON-TRAFFIC		
<b>Barrier Material:</b>	STONE	<b>Post Material:</b>	N/A		
<b>Blockout Type:</b>	N/A	<b>Length (ft.):</b>	112		
<b>Speed Limit (MPH):</b>	35	<b>Placement with Respect to Road:</b>	NON-TRAFFIC BARRIER		
<b>Hazard Behind Barrier:</b>	N/A				
<b>Barrier Crashworthiness</b>					
<b>Appropriate Test Level:</b>	TL-2	<b>Barrier Test Level:</b>	N/A	<b>Is Barrier Crashworthy?:</b>	N/A
<b>Beg. End Trtmt Type:</b>	NONE	<b>Is Beg. End Trtmt Crashworthy?:</b>	N/A	<b>Approach Transition Type:</b>	NONE
<b>Ending End Trtmt Type:</b>	NONE	<b>Ending End Trtmt Crashworthy?:</b>	N/A		
<b>Average Measurements</b>					
<b>Design Height (In.):</b>	18	<b>Width (In.):</b>	19.0	<b>Post Spacing (In.):</b>	0.0

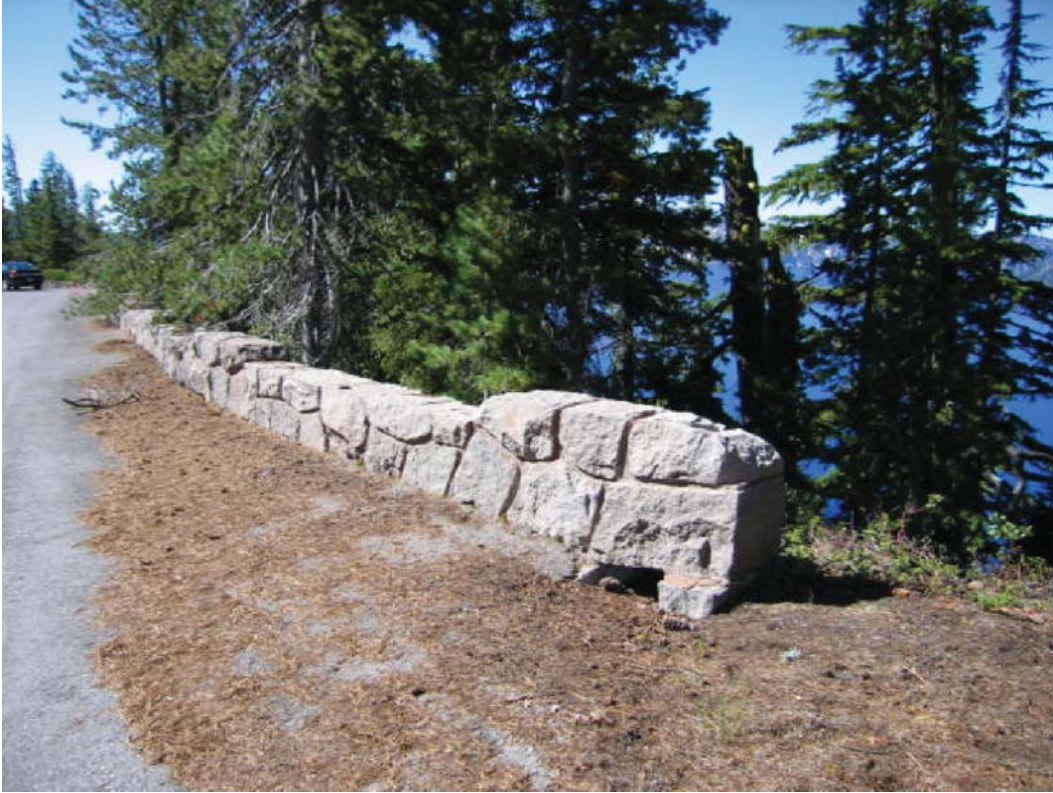
CRLA\_0013\_3.284\_R\_1.jpg

<b>Barrier ID:</b>	CRLA-0013-3.284-R				
<b>Route Name:</b>	EAST RIM DRIVE				
<b>Inspection Date:</b>	07/17/2010	<b>Barrier Rating:</b>	24.20		
<b>Barrier Description</b>					
<b>Type:</b>	STONE MASONRY CRENELLATED WITHOUT	<b>Barrier Function:</b>	NON-TRAFFIC		
<b>Barrier Material:</b>	STONE	<b>Post Material:</b>	N/A		
<b>Blockout Type:</b>	N/A	<b>Length (ft.):</b>	440		
<b>Speed Limit (MPH):</b>	35	<b>Placement with Respect to Road:</b>	NON-TRAFFIC BARRIER		
<b>Hazard Behind Barrier:</b>	N/A				
<b>Barrier Crashworthiness</b>					
<b>Appropriate Test Level:</b>	TL-2	<b>Barrier Test Level:</b>	N/A	<b>Is Barrier Crashworthy?:</b>	N/A
<b>Beg. End Trtmt Type:</b>	NONE	<b>Is Beg. End Trtmt Crashworthy?:</b>	N/A	<b>Approach Transition Type:</b>	NONE
<b>Ending End Trtmt Type:</b>	NONE	<b>Ending End Trtmt Crashworthy?:</b>	N/A		
<b>Average Measurements</b>					
<b>Design Height (In.):</b>	18	<b>Width (In.):</b>	19.0	<b>Post Spacing (In.):</b>	0.0

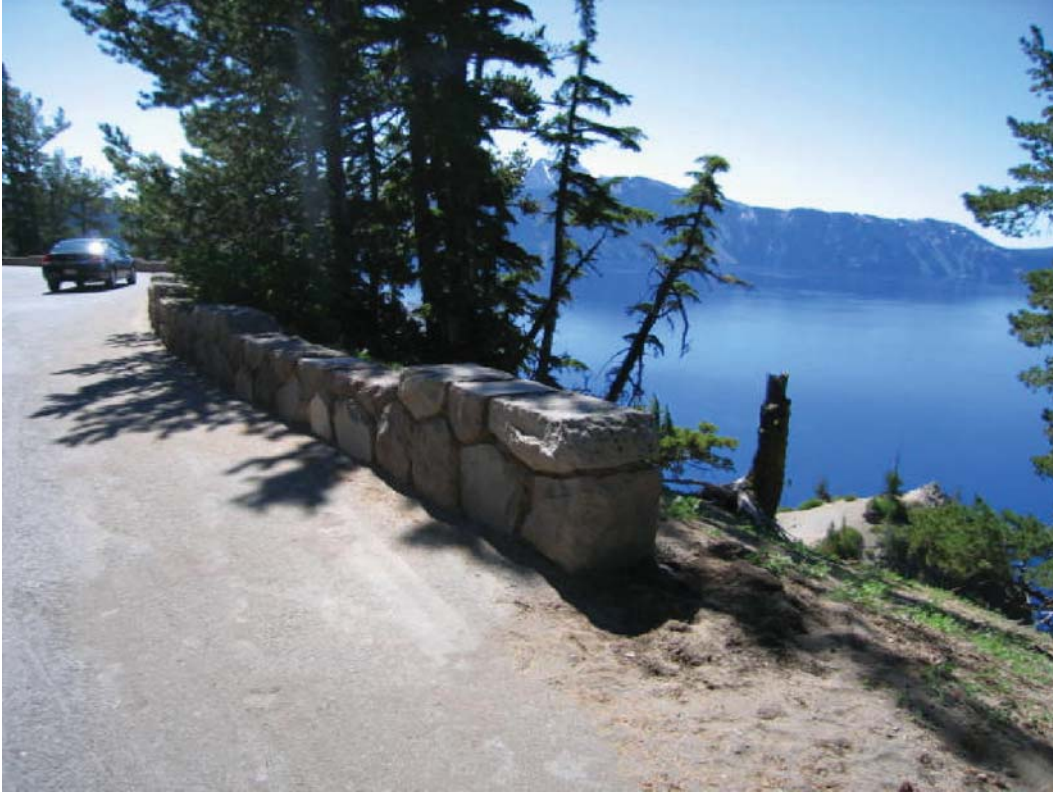
CRLA\_0013\_3.674\_R\_1.jpg

<b>Barrier ID:</b>	CRLA-0013-3.674-R				
<b>Route Name:</b>	EAST RIM DRIVE				
<b>Inspection Date:</b>	07/17/2010	<b>Barrier Rating:</b>	24.20		
<b>Barrier Description</b>					
<b>Type:</b>	STONE MASONRY CRENELLATED WITHOUT	<b>Barrier Function:</b>	NON-TRAFFIC		
<b>Barrier Material:</b>	STONE	<b>Post Material:</b>	N/A		
<b>Blockout Type:</b>	N/A	<b>Length (ft.):</b>	285		
<b>Speed Limit (MPH):</b>	35	<b>Placement with Respect to Road:</b>	NON-TRAFFIC BARRIER		
<b>Hazard Behind Barrier:</b>	N/A				
<b>Barrier Crashworthiness</b>					
<b>Appropriate Test Level:</b>	TL-2	<b>Barrier Test Level:</b>	N/A	<b>Is Barrier Crashworthy?:</b>	N/A
<b>Beg. End Trtmt Type:</b>	NONE	<b>Is Beg. End Trtmt Crashworthy?:</b>	N/A	<b>Approach Transition Type:</b>	NONE
<b>Ending End Trtmt Type:</b>	NONE	<b>Ending End Trtmt Crashworthy?:</b>	N/A		
<b>Average Measurements</b>					
<b>Design Height (In.):</b>	18	<b>Width (In.):</b>	18.2	<b>Post Spacing (In.):</b>	0.0

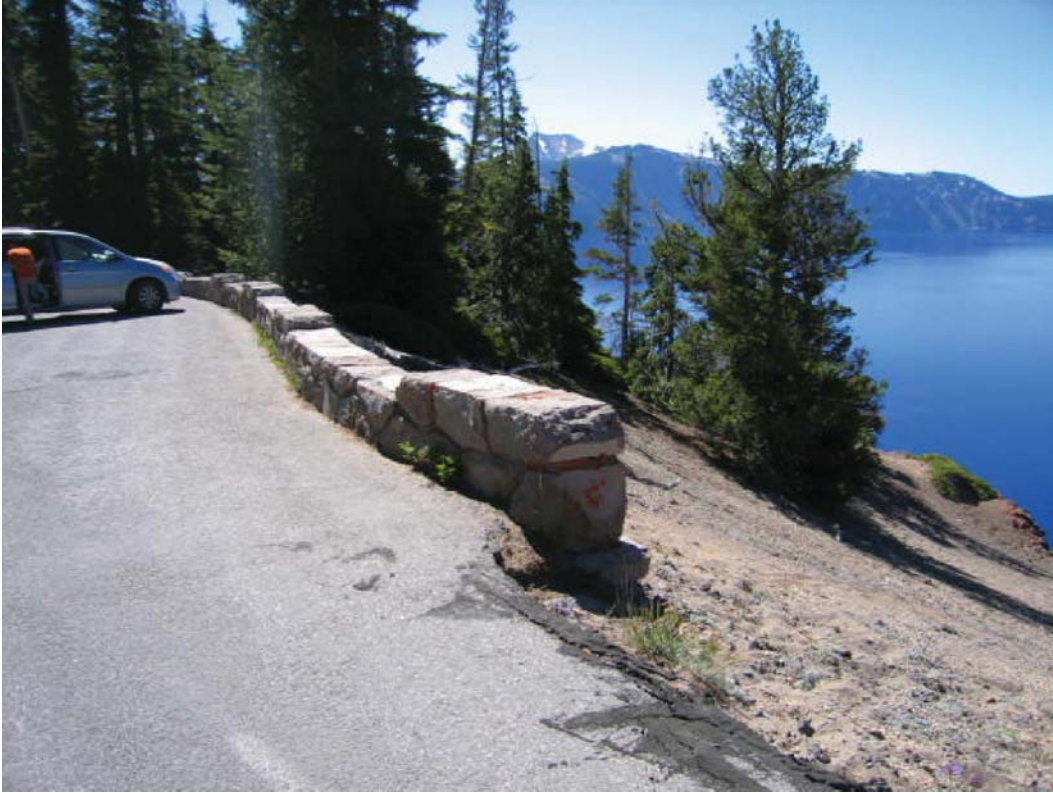
CRLA\_0013\_3.773\_R\_1.jpg

<b>Barrier ID:</b>	CRLA-0013-3.773-R				
<b>Route Name:</b>	EAST RIM DRIVE				
<b>Inspection Date:</b>	07/17/2010	<b>Barrier Rating:</b>	21.30		
<b>Barrier Description</b>					
<b>Type:</b>	STONE MASONRY CRENELLATED WITHOUT	<b>Barrier Function:</b>	NON-TRAFFIC		
<b>Barrier Material:</b>	STONE	<b>Post Material:</b>	N/A		
<b>Blockout Type:</b>	N/A	<b>Length (ft.):</b>	143		
<b>Speed Limit (MPH):</b>	35	<b>Placement with Respect to Road:</b>	NON-TRAFFIC BARRIER		
<b>Hazard Behind Barrier:</b>	N/A				
<b>Barrier Crashworthiness</b>					
<b>Appropriate Test Level:</b>	TL-2	<b>Barrier Test Level:</b>	N/A	<b>Is Barrier Crashworthy?:</b>	N/A
<b>Beg. End Trtmt Type:</b>	NONE	<b>Is Beg. End Trtmt Crashworthy?:</b>	N/A	<b>Approach Transition Type:</b>	NONE
<b>Ending End Trtmt Type:</b>	NONE	<b>Ending End Trtmt Crashworthy?:</b>	N/A		
<b>Average Measurements</b>					
<b>Design Height (In.):</b>	18	<b>Width (In.):</b>	18.7	<b>Post Spacing (In.):</b>	0.0

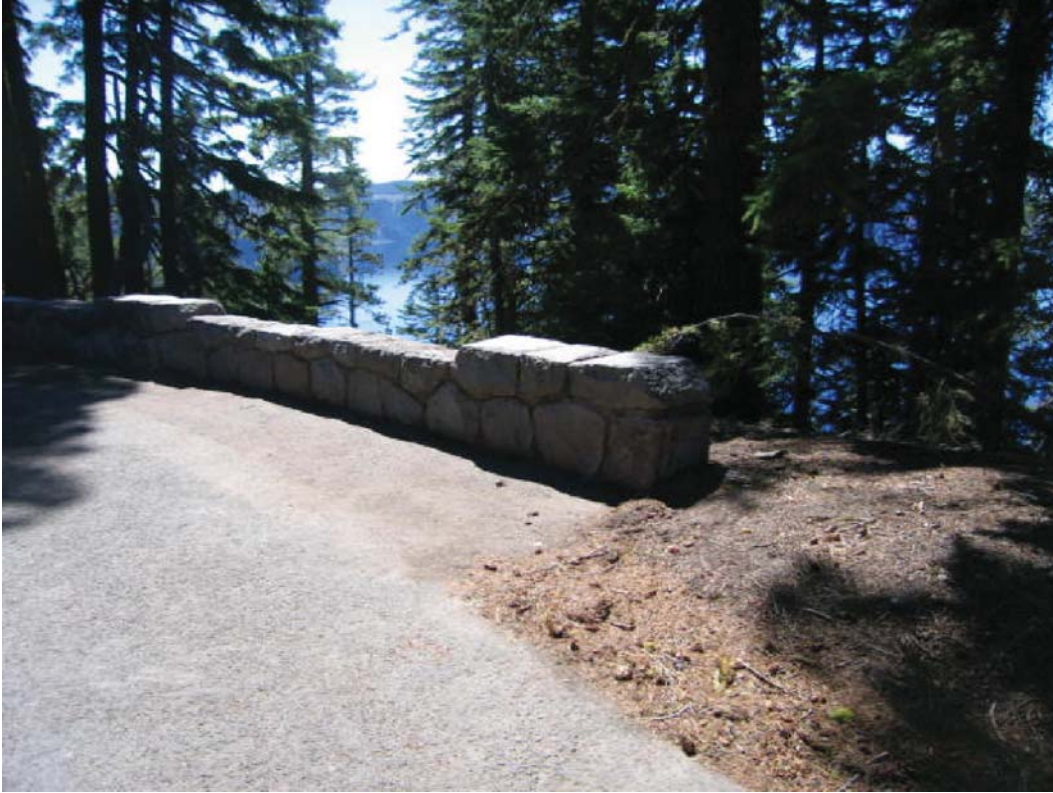
CRLA\_0013\_3.933\_R\_1.jpg

<b>Barrier ID:</b>	CRLA-0013-3.933-R				
<b>Route Name:</b>	EAST RIM DRIVE				
<b>Inspection Date:</b>	07/17/2010	<b>Barrier Rating:</b>	21.30		
<b>Barrier Description</b>					
<b>Type:</b>	STONE MASONRY CRENELLATED WITHOUT	<b>Barrier Function:</b>	NON-TRAFFIC		
<b>Barrier Material:</b>	STONE	<b>Post Material:</b>	N/A		
<b>Blockout Type:</b>	N/A	<b>Length (ft.):</b>	145		
<b>Speed Limit (MPH):</b>	35	<b>Placement with Respect to Road:</b>	NON-TRAFFIC BARRIER		
<b>Hazard Behind Barrier:</b>	N/A				
<b>Barrier Crashworthiness</b>					
<b>Appropriate Test Level:</b>	TL-2	<b>Barrier Test Level:</b>	N/A	<b>Is Barrier Crashworthy?:</b>	N/A
<b>Beg. End Trtmt Type:</b>	NONE	<b>Is Beg. End Trtmt Crashworthy?:</b>	N/A	<b>Approach Transition Type:</b>	NONE
<b>Ending End Trtmt Type:</b>	NONE	<b>Ending End Trtmt Crashworthy?:</b>	N/A		
<b>Average Measurements</b>					
<b>Design Height (In.):</b>	18	<b>Width (In.):</b>	20.2	<b>Post Spacing (In.):</b>	0.0

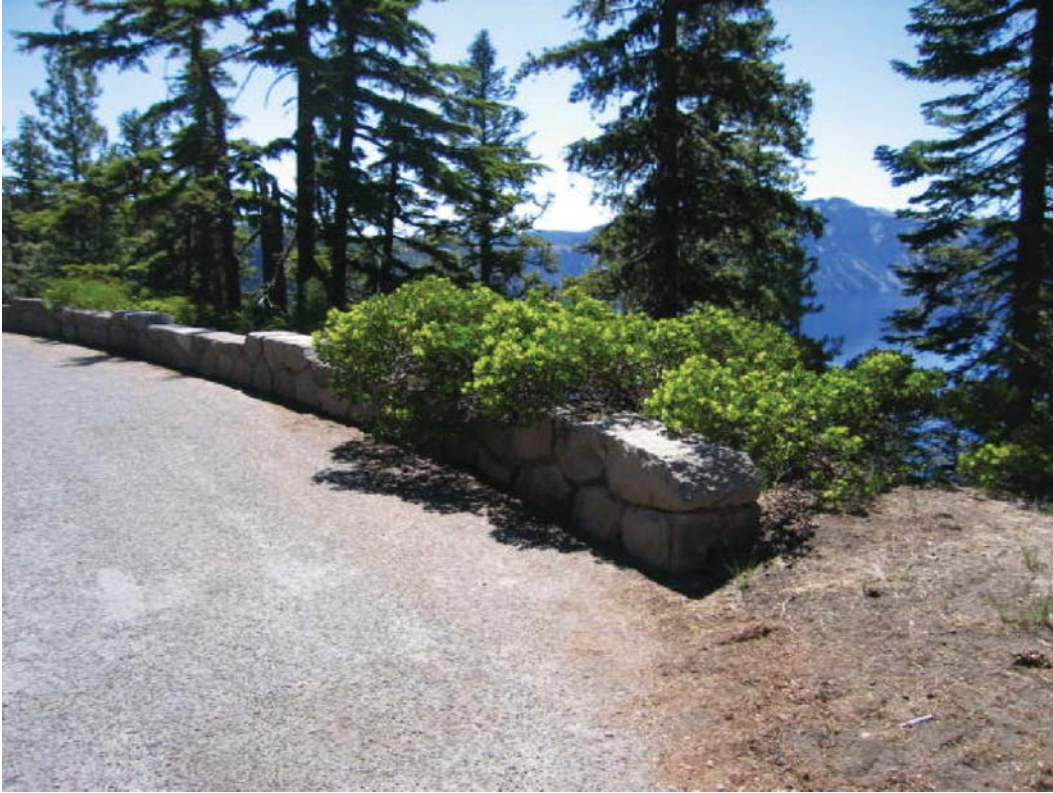
CRLA\_0013\_4.211\_R\_1.jpg

<b>Barrier ID:</b>	CRLA-0013-4.211-R				
<b>Route Name:</b>	EAST RIM DRIVE				
<b>Inspection Date:</b>	07/17/2010	<b>Barrier Rating:</b>	24.20		
<b>Barrier Description</b>					
<b>Type:</b>	STONE MASONRY CRENELLATED WITHOUT	<b>Barrier Function:</b>	NON-TRAFFIC		
<b>Barrier Material:</b>	STONE	<b>Post Material:</b>	N/A		
<b>Blockout Type:</b>	N/A	<b>Length (ft.):</b>	251		
<b>Speed Limit (MPH):</b>	35	<b>Placement with Respect to Road:</b>	NON-TRAFFIC BARRIER		
<b>Hazard Behind Barrier:</b>	N/A				
<b>Barrier Crashworthiness</b>					
<b>Appropriate Test Level:</b>	TL-2	<b>Barrier Test Level:</b>	N/A	<b>Is Barrier Crashworthy?:</b>	N/A
<b>Beg. End Trtmt Type:</b>	NONE	<b>Is Beg. End Trtmt Crashworthy?:</b>	N/A	<b>Approach Transition Type:</b>	NONE
<b>Ending End Trtmt Type:</b>	NONE	<b>Ending End Trtmt Crashworthy?:</b>	N/A		
<b>Average Measurements</b>					
<b>Design Height (In.):</b>	18	<b>Width (In.):</b>	19.0	<b>Post Spacing (In.):</b>	0.0

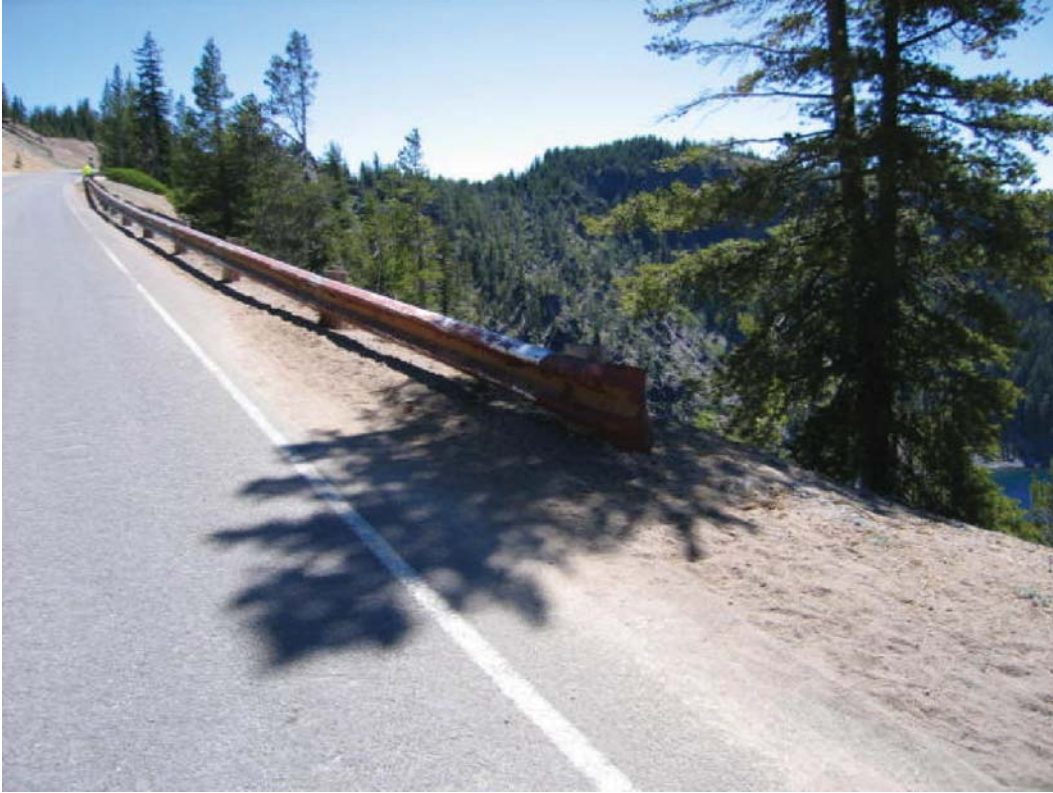
CRLA\_0013\_4.567\_R\_1.jpg

<b>Barrier ID:</b>	CRLA-0013-4.567-R				
<b>Route Name:</b>	EAST RIM DRIVE				
<b>Inspection Date:</b>	07/17/2010	<b>Barrier Rating:</b>	40.00		
<b>Barrier Description</b>					
<b>Type:</b>	W-BEAM WEAK POST	<b>Barrier Function:</b>	TRAFFIC		
<b>Barrier Material:</b>	OTHER: STEEL	<b>Post Material:</b>	WOOD		
<b>Blockout Type:</b>	N/A	<b>Length (ft.):</b>	204		
<b>Speed Limit (MPH):</b>	20	<b>Placement with Respect to Road:</b>	INSIDE OF CURVE		
<b>Hazard Behind Barrier:</b>	EXTREME				
<b>Barrier Crashworthiness</b>					
<b>Appropriate Test Level:</b>	TL-1	<b>Barrier Test Level:</b>	TL-2	<b>Is Barrier Crashworthy?:</b>	YES
<b>Beg. End Trtmt Type:</b>	NONE	<b>Is Beg. End Trtmt Crashworthy?:</b>	N/A	<b>Approach Transition Type:</b>	NONE
<b>Ending End Trtmt Type:</b>	NONE	<b>Ending End Trtmt Crashworthy?:</b>	N/A		
<b>Average Measurements</b>					
<b>Design Height (In.):</b>	27	<b>Width (In.):</b>	0.0	<b>Post Spacing (In.):</b>	150.0

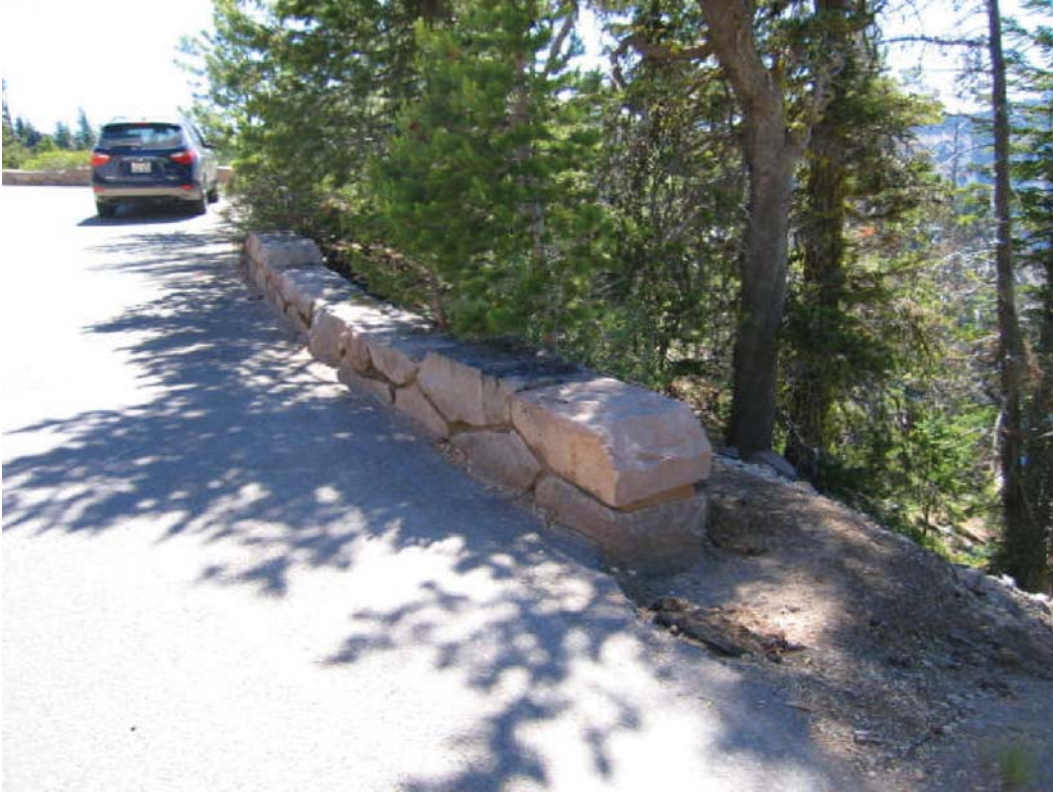
CRLA\_0013\_4.731\_R\_1.jpg

<b>Barrier ID:</b>	CRLA-0013-4.731-R				
<b>Route Name:</b>	EAST RIM DRIVE				
<b>Inspection Date:</b>	07/17/2010	<b>Barrier Rating:</b>	41.50		
<b>Barrier Description</b>					
<b>Type:</b>	STONE MASONRY CRENELLATED WITHOUT	<b>Barrier Function:</b>	TRAFFIC		
<b>Barrier Material:</b>	STONE	<b>Post Material:</b>	N/A		
<b>Blockout Type:</b>	N/A	<b>Length (ft.):</b>	340		
<b>Speed Limit (MPH):</b>	35	<b>Placement with Respect to Road:</b>	INSIDE OF CURVE		
<b>Hazard Behind Barrier:</b>	EXTREME				
<b>Barrier Crashworthiness</b>					
<b>Appropriate Test Level:</b>	TL-2	<b>Barrier Test Level:</b>	NCW	<b>Is Barrier Crashworthy?:</b>	NO
<b>Beg. End Trtmt Type:</b>	NONE	<b>Is Beg. End Trtmt Crashworthy?:</b>	N/A	<b>Approach Transition Type:</b>	NONE
<b>Ending End Trtmt Type:</b>	NONE	<b>Ending End Trtmt Crashworthy?:</b>	N/A		
<b>Average Measurements</b>					
<b>Design Height (In.):</b>	18	<b>Width (In.):</b>	19.7	<b>Post Spacing (In.):</b>	0.0

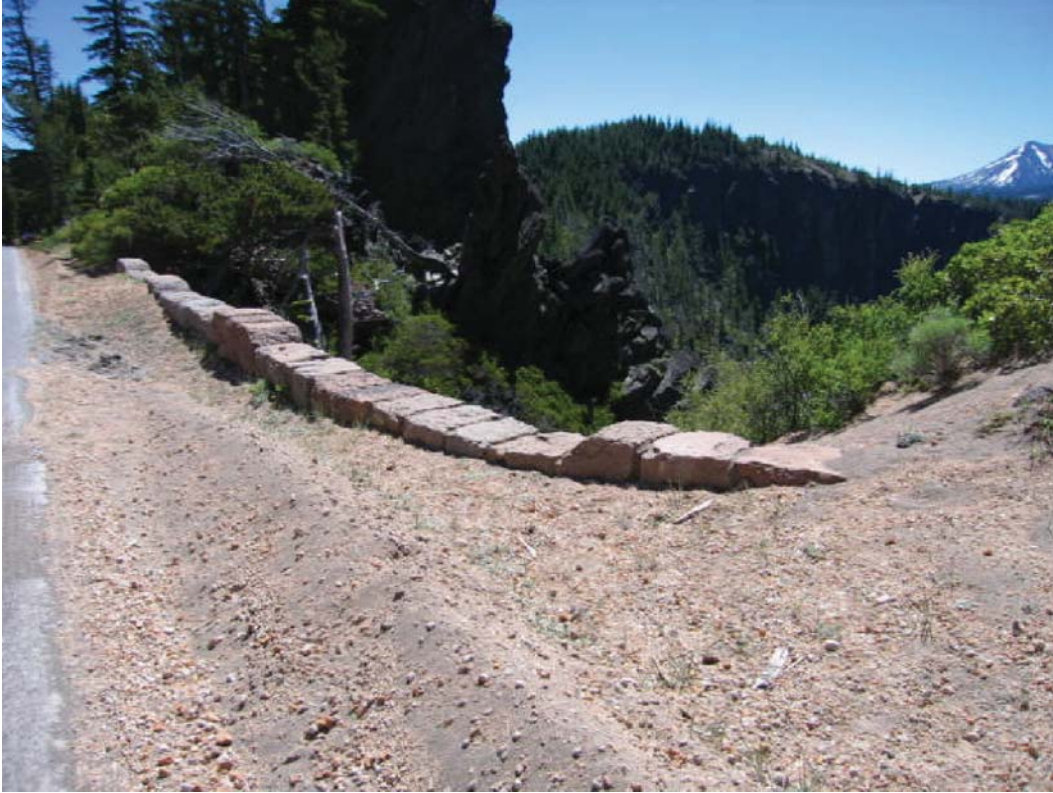
CRLA\_0013\_4.803\_R\_1.jpg

<b>Barrier ID:</b>	CRLA-0013-4.803-R				
<b>Route Name:</b>	EAST RIM DRIVE				
<b>Inspection Date:</b>	07/17/2010	<b>Barrier Rating:</b>	27.20		
<b>Barrier Description</b>					
<b>Type:</b>	STONE MASONRY CRENELLATED WITHOUT	<b>Barrier Function:</b>	TRAFFIC		
<b>Barrier Material:</b>	STONE	<b>Post Material:</b>	N/A		
<b>Blockout Type:</b>	N/A	<b>Length (ft.):</b>	65		
<b>Speed Limit (MPH):</b>	35	<b>Placement with Respect to Road:</b>	TANGENT		
<b>Hazard Behind Barrier:</b>	EXTREME				
<b>Barrier Crashworthiness</b>					
<b>Appropriate Test Level:</b>	TL-2	<b>Barrier Test Level:</b>	NCW	<b>Is Barrier Crashworthy?:</b>	NO
<b>Beg. End Trtmt Type:</b>	NONE	<b>Is Beg. End Trtmt Crashworthy?:</b>	N/A	<b>Approach Transition Type:</b>	NONE
<b>Ending End Trtmt Type:</b>	NONE	<b>Ending End Trtmt Crashworthy?:</b>	N/A		
<b>Average Measurements</b>					
<b>Design Height (In.):</b>	18	<b>Width (In.):</b>	20.0	<b>Post Spacing (In.):</b>	0.0

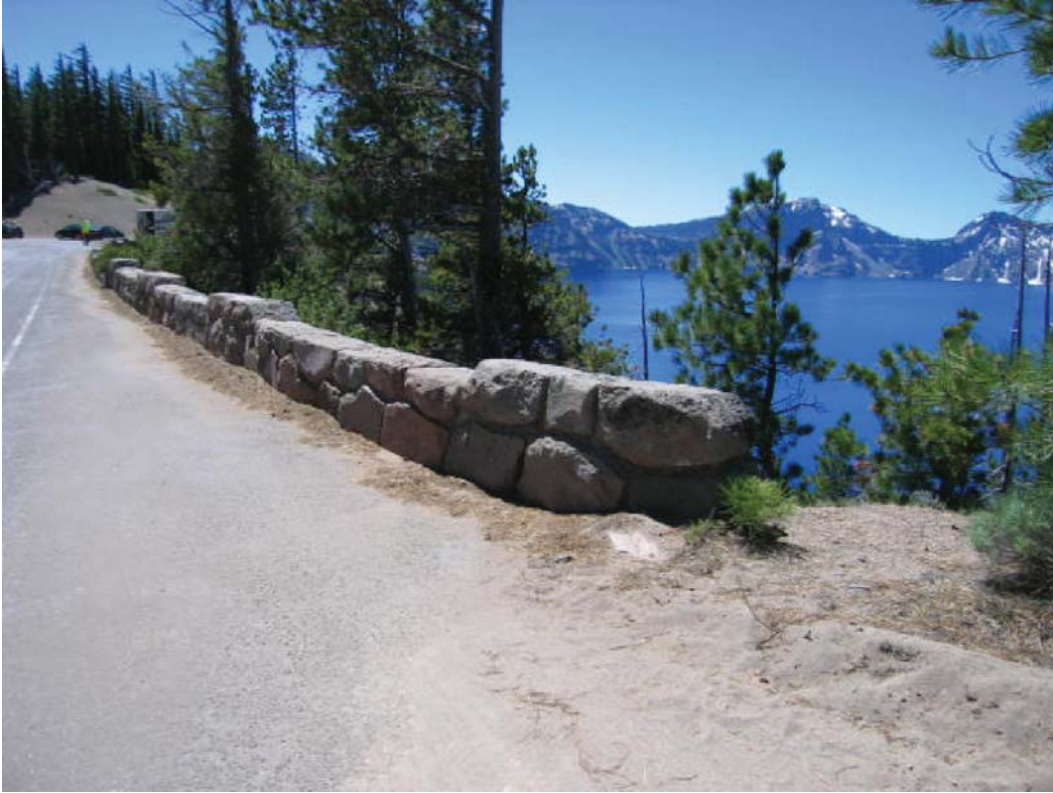
CRLA\_0013\_5.915\_R\_1.jpg

<b>Barrier ID:</b>	CRLA-0013-5.915-R				
<b>Route Name:</b>	EAST RIM DRIVE				
<b>Inspection Date:</b>	07/17/2010	<b>Barrier Rating:</b>	44.20		
<b>Barrier Description</b>					
<b>Type:</b>	STONE MASONRY CRENELLATED WITHOUT	<b>Barrier Function:</b>	TRAFFIC		
<b>Barrier Material:</b>	STONE	<b>Post Material:</b>	N/A		
<b>Blockout Type:</b>	N/A	<b>Length (ft.):</b>	184		
<b>Speed Limit (MPH):</b>	35	<b>Placement with Respect to Road:</b>	OUTSIDE OF CURVE		
<b>Hazard Behind Barrier:</b>	EXTREME				
<b>Barrier Crashworthiness</b>					
<b>Appropriate Test Level:</b>	TL-2	<b>Barrier Test Level:</b>	NCW	<b>Is Barrier Crashworthy?:</b>	NO
<b>Beg. End Trtmt Type:</b>	NONE	<b>Is Beg. End Trtmt Crashworthy?:</b>	N/A	<b>Approach Transition Type:</b>	NONE
<b>Ending End Trtmt Type:</b>	NONE	<b>Ending End Trtmt Crashworthy?:</b>	N/A		
<b>Average Measurements</b>					
<b>Design Height (In.):</b>	18	<b>Width (In.):</b>	18.7	<b>Post Spacing (In.):</b>	0.0

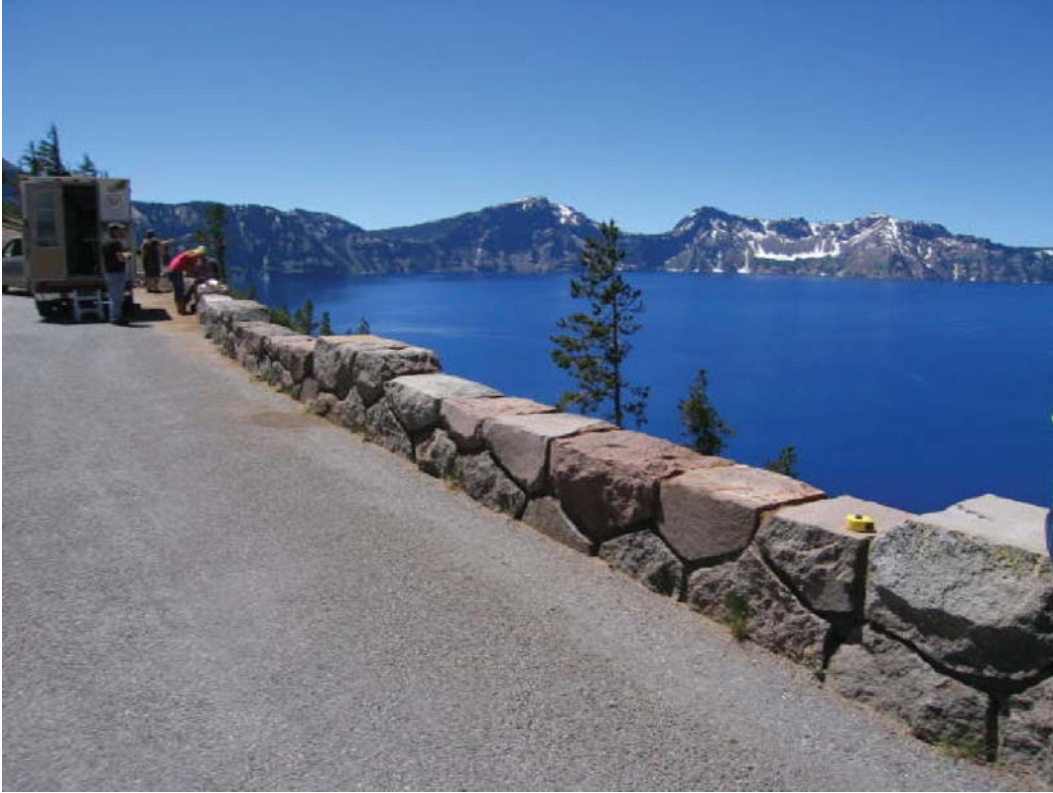
CRLA\_0013\_5.944\_R\_1.jpg

<b>Barrier ID:</b>	CRLA-0013-5.944-R				
<b>Route Name:</b>	EAST RIM DRIVE				
<b>Inspection Date:</b>	07/17/2010	<b>Barrier Rating:</b>	21.30		
<b>Barrier Description</b>					
<b>Type:</b>	STONE MASONRY CRENELLATED WITHOUT	<b>Barrier Function:</b>	NON-TRAFFIC		
<b>Barrier Material:</b>	STONE	<b>Post Material:</b>	N/A		
<b>Blockout Type:</b>	N/A	<b>Length (ft.):</b>	102		
<b>Speed Limit (MPH):</b>	35	<b>Placement with Respect to Road:</b>	NON-TRAFFIC BARRIER		
<b>Hazard Behind Barrier:</b>	N/A				
<b>Barrier Crashworthiness</b>					
<b>Appropriate Test Level:</b>	TL-2	<b>Barrier Test Level:</b>	N/A	<b>Is Barrier Crashworthy?:</b>	N/A
<b>Beg. End Trtmt Type:</b>	NONE	<b>Is Beg. End Trtmt Crashworthy?:</b>	N/A	<b>Approach Transition Type:</b>	NONE
<b>Ending End Trtmt Type:</b>	NONE	<b>Ending End Trtmt Crashworthy?:</b>	N/A		
<b>Average Measurements</b>					
<b>Design Height (In.):</b>	18	<b>Width (In.):</b>	18.7	<b>Post Spacing (In.):</b>	0.0

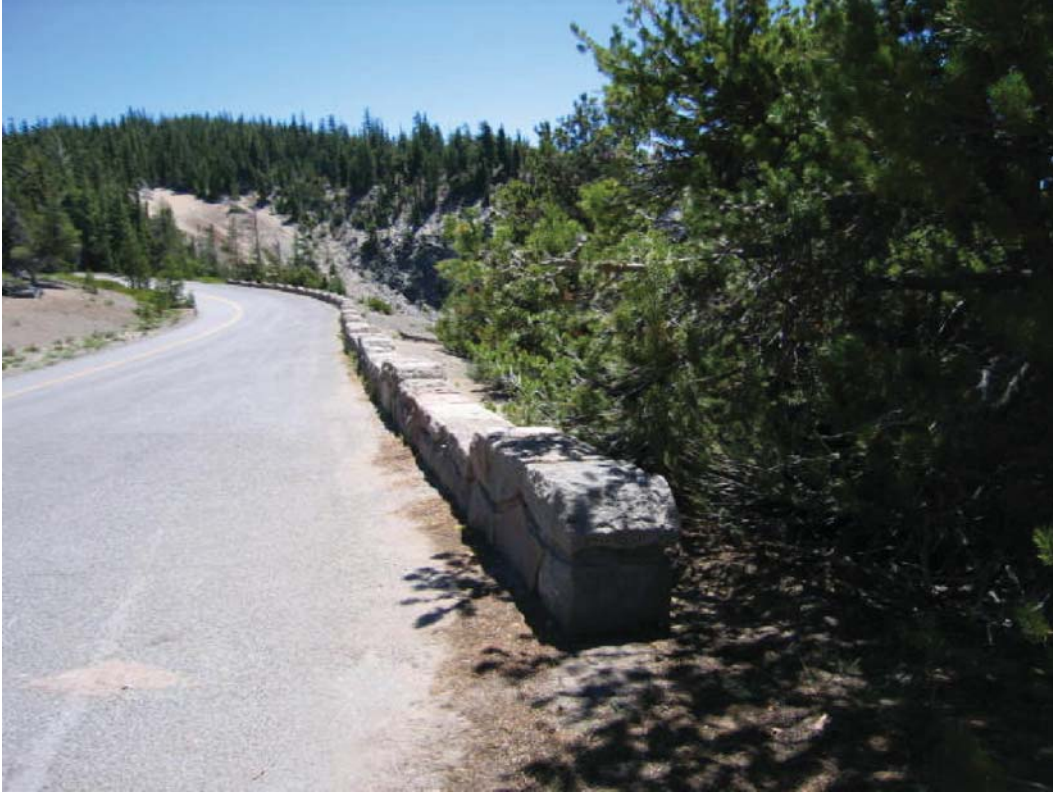
CRLA\_0013\_6.340\_R\_1.jpg

<b>Barrier ID:</b>	CRLA-0013-6.340-R				
<b>Route Name:</b>	EAST RIM DRIVE				
<b>Inspection Date:</b>	07/17/2010	<b>Barrier Rating:</b>	47.20		
<b>Barrier Description</b>					
<b>Type:</b>	STONE MASONRY CRENELLATED WITHOUT	<b>Barrier Function:</b>	TRAFFIC		
<b>Barrier Material:</b>	STONE	<b>Post Material:</b>	N/A		
<b>Blockout Type:</b>	N/A	<b>Length (ft.):</b>	358		
<b>Speed Limit (MPH):</b>	35	<b>Placement with Respect to Road:</b>	OUTSIDE OF CURVE		
<b>Hazard Behind Barrier:</b>	EXTREME				
<b>Barrier Crashworthiness</b>					
<b>Appropriate Test Level:</b>	TL-2	<b>Barrier Test Level:</b>	NCW	<b>Is Barrier Crashworthy?:</b>	NO
<b>Beg. End Trtmt Type:</b>	NONE	<b>Is Beg. End Trtmt Crashworthy?:</b>	N/A	<b>Approach Transition Type:</b>	NONE
<b>Ending End Trtmt Type:</b>	NONE	<b>Ending End Trtmt Crashworthy?:</b>	N/A		
<b>Average Measurements</b>					
<b>Design Height (In.):</b>	18	<b>Width (In.):</b>	18.7	<b>Post Spacing (In.):</b>	0.0

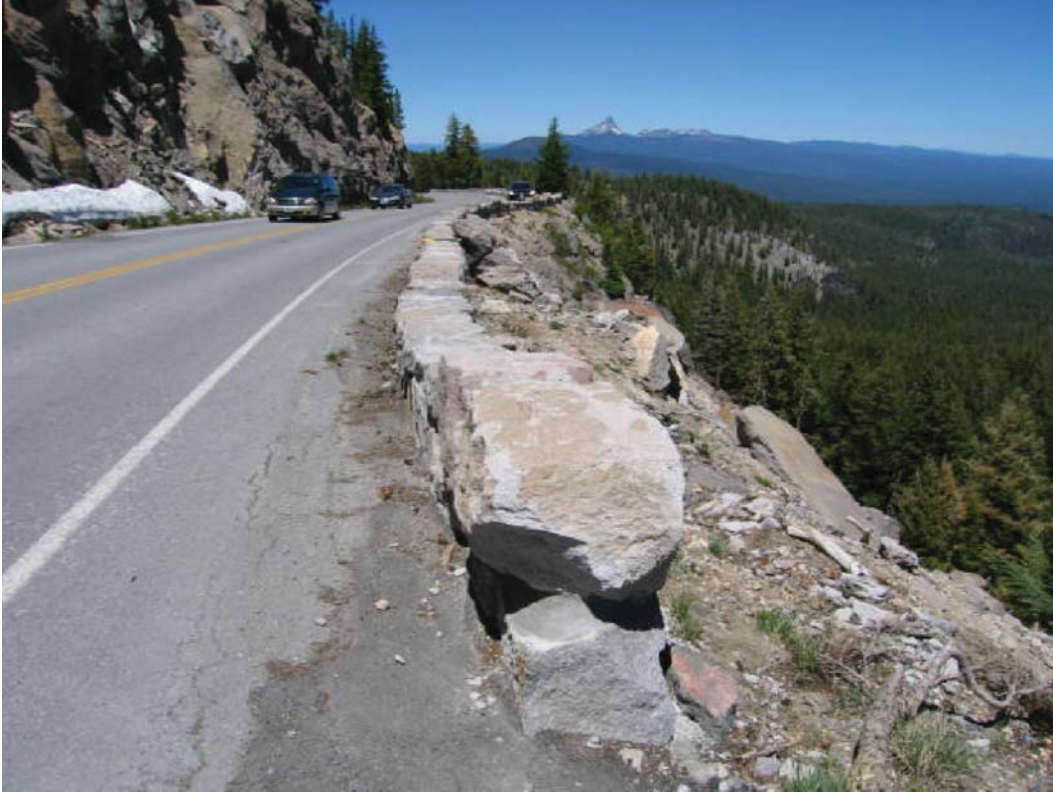
CRLA\_0013\_10.087\_L\_1.jpg

<b>Barrier ID:</b>	CRLA-0013-10.087-L				
<b>Route Name:</b>	EAST RIM DRIVE				
<b>Inspection Date:</b>	07/17/2010	<b>Barrier Rating:</b>	50.00		
<b>Barrier Description</b>					
<b>Type:</b>	STONE MASONRY CRENELLATED WITHOUT	<b>Barrier Function:</b>	TRAFFIC		
<b>Barrier Material:</b>	STONE	<b>Post Material:</b>	N/A		
<b>Blockout Type:</b>	N/A	<b>Length (ft.):</b>	420		
<b>Speed Limit (MPH):</b>	35	<b>Placement with Respect to Road:</b>	INSIDE OF CURVE		
<b>Hazard Behind Barrier:</b>	EXTREME				
<b>Barrier Crashworthiness</b>					
<b>Appropriate Test Level:</b>	TL-2	<b>Barrier Test Level:</b>	NCW	<b>Is Barrier Crashworthy?:</b>	NO
<b>Beg. End Trtmt Type:</b>	NONE	<b>Is Beg. End Trtmt Crashworthy?:</b>	N/A	<b>Approach Transition Type:</b>	NONE
<b>Ending End Trtmt Type:</b>	NONE	<b>Ending End Trtmt Crashworthy?:</b>	N/A		
<b>Average Measurements</b>					
<b>Design Height (In.):</b>	18	<b>Width (In.):</b>	19.7	<b>Post Spacing (In.):</b>	0.0

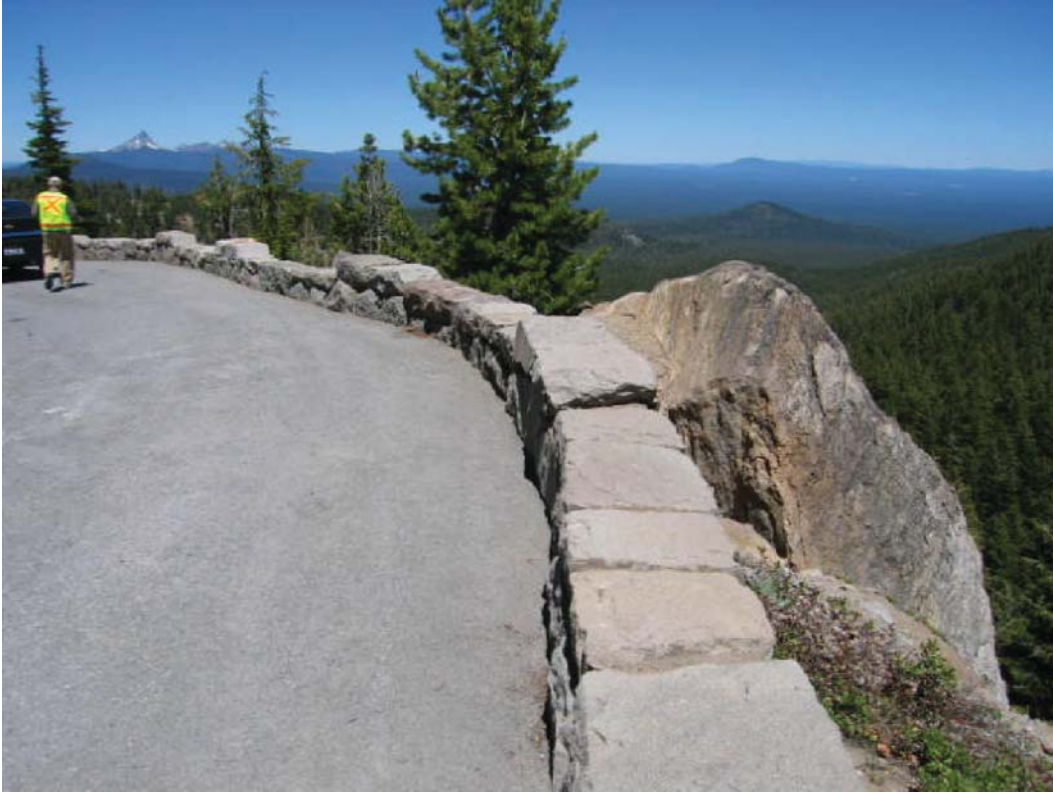
CRLA\_0013\_10.110\_L\_1.jpg

<b>Barrier ID:</b>	CRLA-0013-10.110-L				
<b>Route Name:</b>	EAST RIM DRIVE				
<b>Inspection Date:</b>	07/17/2010	<b>Barrier Rating:</b>	21.30		
<b>Barrier Description</b>					
<b>Type:</b>	STONE MASONRY CRENELLATED WITHOUT	<b>Barrier Function:</b>	NON-TRAFFIC		
<b>Barrier Material:</b>	STONE	<b>Post Material:</b>	N/A		
<b>Blockout Type:</b>	N/A	<b>Length (ft.):</b>	140		
<b>Speed Limit (MPH):</b>	35	<b>Placement with Respect to Road:</b>	NON-TRAFFIC BARRIER		
<b>Hazard Behind Barrier:</b>	N/A				
<b>Barrier Crashworthiness</b>					
<b>Appropriate Test Level:</b>	TL-2	<b>Barrier Test Level:</b>	N/A	<b>Is Barrier Crashworthy?:</b>	N/A
<b>Beg. End Trtmt Type:</b>	NONE	<b>Is Beg. End Trtmt Crashworthy?:</b>	N/A	<b>Approach Transition Type:</b>	NONE
<b>Ending End Trtmt Type:</b>	NONE	<b>Ending End Trtmt Crashworthy?:</b>	N/A		
<b>Average Measurements</b>					
<b>Design Height (In.):</b>	18	<b>Width (In.):</b>	19.7	<b>Post Spacing (In.):</b>	0.0
