**GIP Report**

**NPS Guardwall/Rail Inventory Program  
Crater Lake National Park**

**Federal Highway Administration  
Eastern Federal Lands Highway Division  
Road Inventory Program (RIP)**

**Data Collection Date: July 2010  
Report Date: December 2015**

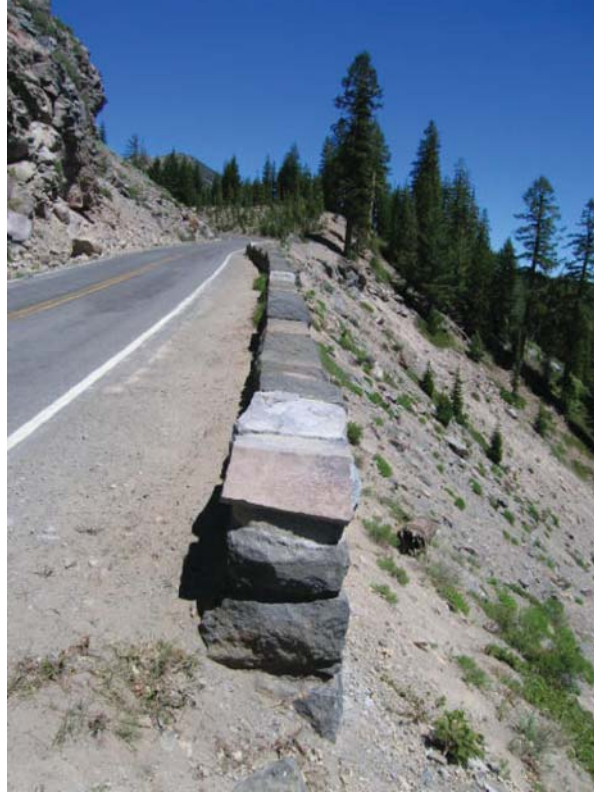
CRLA\_0013\_13.931\_L\_1.jpg

<b>Barrier ID:</b>	CRLA-0013-13.931-L				
<b>Route Name:</b>	EAST RIM DRIVE				
<b>Inspection Date:</b>	07/17/2010	<b>Barrier Rating:</b>	25.70		
<b>Barrier Description</b>					
<b>Type:</b>	STONE MASONRY CRENELLATED WITHOUT	<b>Barrier Function:</b>	TRAFFIC		
<b>Barrier Material:</b>	STONE	<b>Post Material:</b>	N/A		
<b>Blockout Type:</b>	N/A	<b>Length (ft.):</b>	216		
<b>Speed Limit (MPH):</b>	35	<b>Placement with Respect to Road:</b>	INSIDE OF CURVE		
<b>Hazard Behind Barrier:</b>	EXTREME				
<b>Barrier Crashworthiness</b>					
<b>Appropriate Test Level:</b>	TL-2	<b>Barrier Test Level:</b>	NCW	<b>Is Barrier Crashworthy?:</b>	NO
<b>Beg. End Trtmt Type:</b>	NONE	<b>Is Beg. End Trtmt Crashworthy?:</b>	N/A	<b>Approach Transition Type:</b>	NONE
<b>Ending End Trtmt Type:</b>	NONE	<b>Ending End Trtmt Crashworthy?:</b>	N/A		
<b>Average Measurements</b>					
<b>Design Height (In.):</b>	18	<b>Width (In.):</b>	19.7	<b>Post Spacing (In.):</b>	0.0

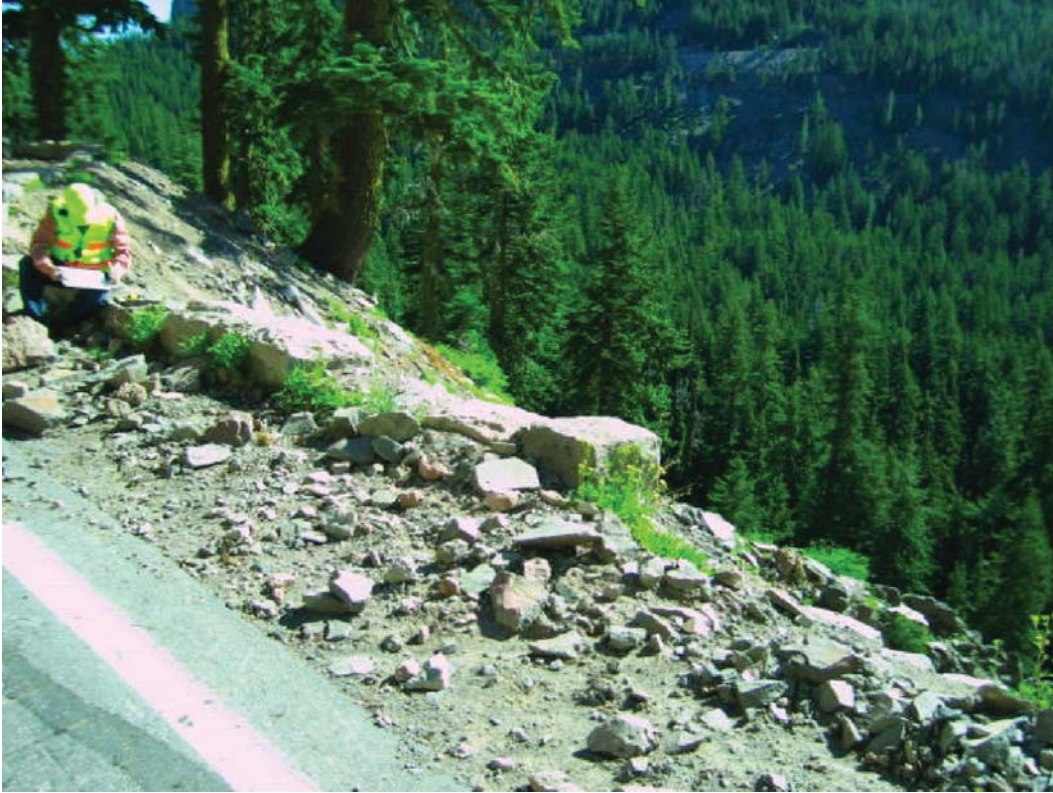
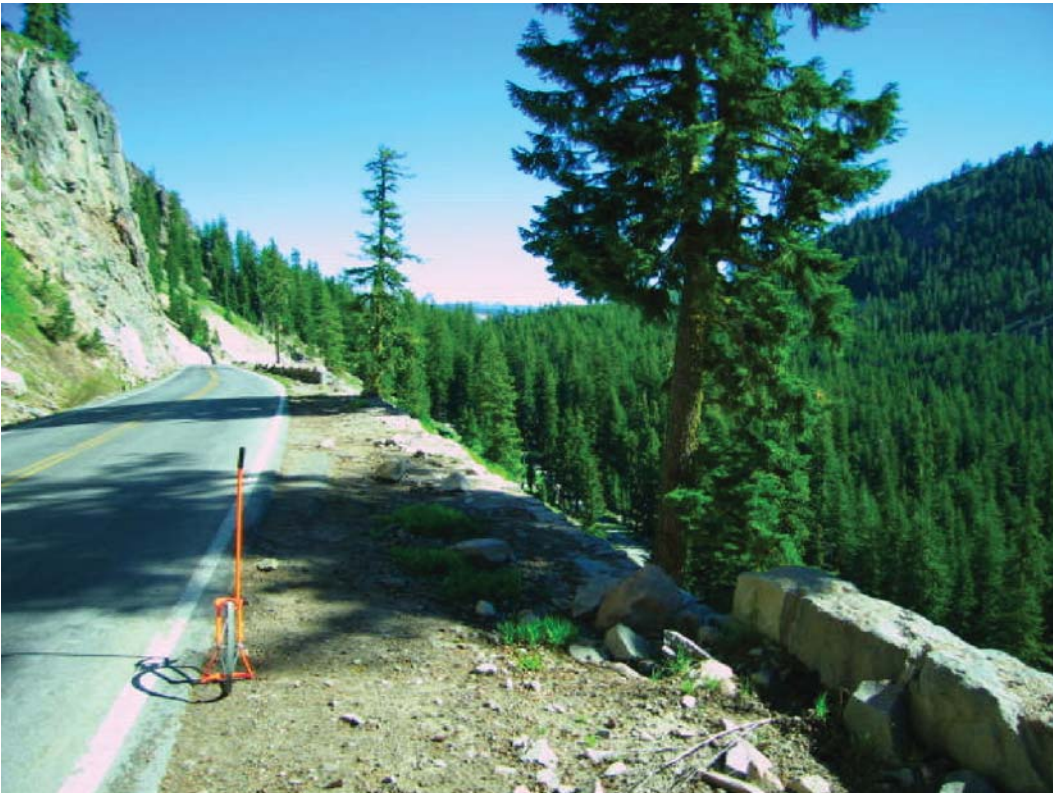
CRLA\_0013\_15.273\_L\_1.jpg

<b>Barrier ID:</b>	CRLA-0013-15.273-L				
<b>Route Name:</b>	EAST RIM DRIVE				
<b>Inspection Date:</b>	07/18/2010	<b>Barrier Rating:</b>	57.20		
<b>Barrier Description</b>					
<b>Type:</b>	STONE MASONRY CRENELLATED WITHOUT	<b>Barrier Function:</b>	TRAFFIC		
<b>Barrier Material:</b>	STONE	<b>Post Material:</b>	N/A		
<b>Blockout Type:</b>	N/A	<b>Length (ft.):</b>	820		
<b>Speed Limit (MPH):</b>	35	<b>Placement with Respect to Road:</b>	INSIDE OF CURVE		
<b>Hazard Behind Barrier:</b>	EXTREME				
<b>Barrier Crashworthiness</b>					
<b>Appropriate Test Level:</b>	TL-2	<b>Barrier Test Level:</b>	NCW	<b>Is Barrier Crashworthy?:</b>	NO
<b>Beg. End Trtmt Type:</b>	NONE	<b>Is Beg. End Trtmt Crashworthy?:</b>	N/A	<b>Approach Transition Type:</b>	NONE
<b>Ending End Trtmt Type:</b>	NONE	<b>Ending End Trtmt Crashworthy?:</b>	N/A		
<b>Average Measurements</b>					
<b>Design Height (In.):</b>	18	<b>Width (In.):</b>	19.8	<b>Post Spacing (In.):</b>	0.0

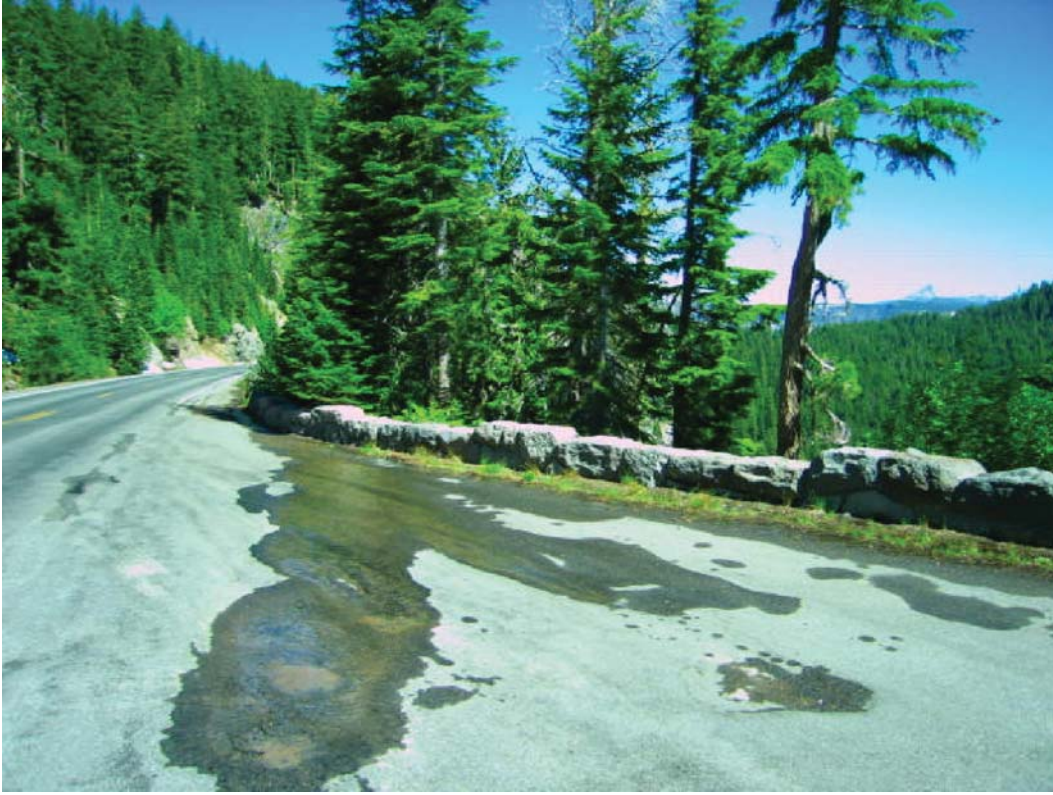
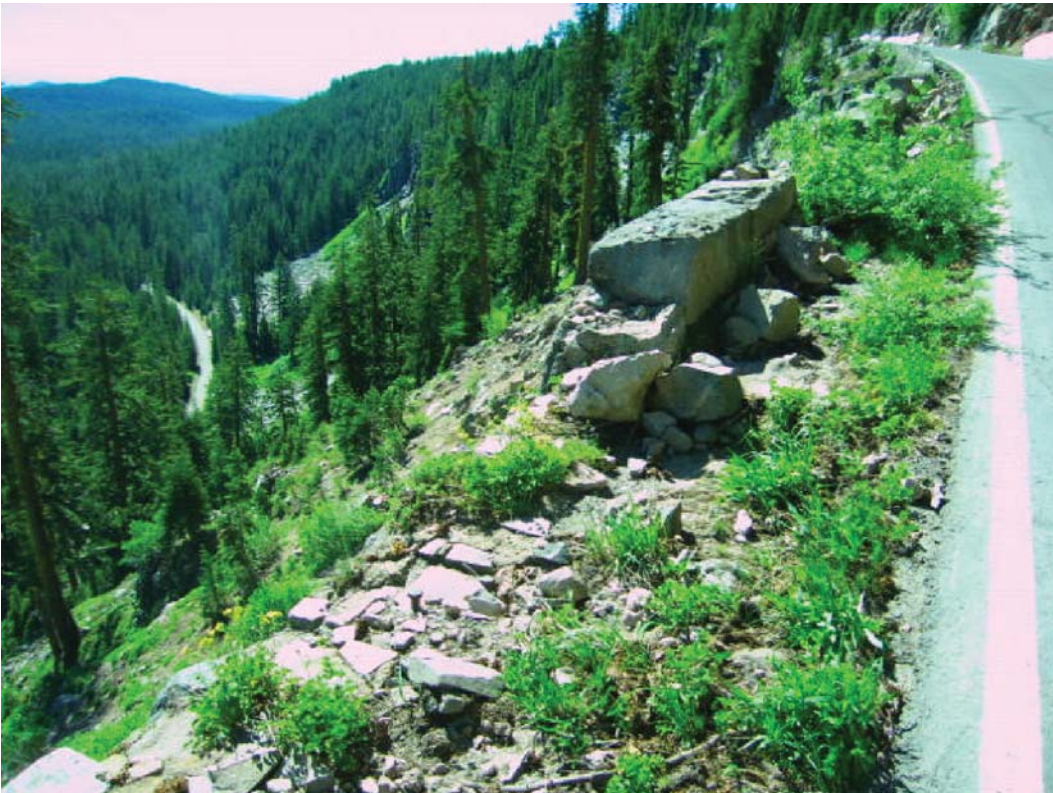
CRLA\_0013\_15.504\_L\_1.jpg

<b>Barrier ID:</b>	CRLA-0013-15.504-L				
<b>Route Name:</b>	EAST RIM DRIVE				
<b>Inspection Date:</b>	07/18/2010	<b>Barrier Rating:</b>	58.50		
<b>Barrier Description</b>					
<b>Type:</b>	STONE MASONRY CRENELLATED WITHOUT	<b>Barrier Function:</b>	TRAFFIC		
<b>Barrier Material:</b>	STONE	<b>Post Material:</b>	N/A		
<b>Blockout Type:</b>	N/A	<b>Length (ft.):</b>	1490		
<b>Speed Limit (MPH):</b>	35	<b>Placement with Respect to Road:</b>	BOTH INSIDE AND OUTSIDE		
<b>Hazard Behind Barrier:</b>	EXTREME				
<b>Barrier Crashworthiness</b>					
<b>Appropriate Test Level:</b>	TL-2	<b>Barrier Test Level:</b>	NCW	<b>Is Barrier Crashworthy?:</b>	NO
<b>Beg. End Trtmt Type:</b>	NONE	<b>Is Beg. End Trtmt Crashworthy?:</b>	N/A	<b>Approach Transition Type:</b>	NONE
<b>Ending End Trtmt Type:</b>	NONE	<b>Ending End Trtmt Crashworthy?:</b>	N/A		
<b>Average Measurements</b>					
<b>Design Height (In.):</b>	18	<b>Width (In.):</b>	20.0	<b>Post Spacing (In.):</b>	0.0

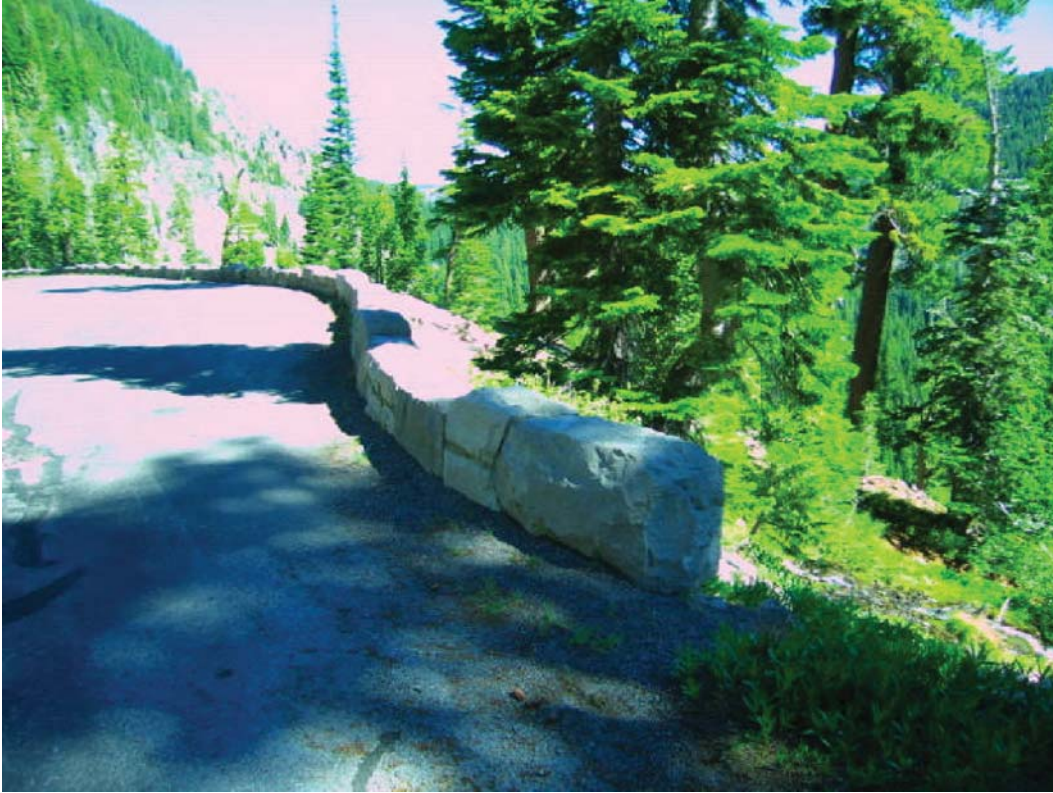
CRLA\_0013\_15.774\_L\_1.jpg

<b>Barrier ID:</b>	CRLA-0013-15.774-L				
<b>Route Name:</b>	EAST RIM DRIVE				
<b>Inspection Date:</b>	07/18/2010	<b>Barrier Rating:</b>	12.80		
<b>Barrier Description</b>					
<b>Type:</b>	STONE MASONRY CRENELLATED WITHOUT	<b>Barrier Function:</b>	NON-TRAFFIC		
<b>Barrier Material:</b>	STONE	<b>Post Material:</b>	N/A		
<b>Blockout Type:</b>	N/A	<b>Length (ft.):</b>	240		
<b>Speed Limit (MPH):</b>	35	<b>Placement with Respect to Road:</b>	NON-TRAFFIC BARRIER		
<b>Hazard Behind Barrier:</b>	N/A				
<b>Barrier Crashworthiness</b>					
<b>Appropriate Test Level:</b>	TL-2	<b>Barrier Test Level:</b>	N/A	<b>Is Barrier Crashworthy?:</b>	N/A
<b>Beg. End Trtmt Type:</b>	NONE	<b>Is Beg. End Trtmt Crashworthy?:</b>	N/A	<b>Approach Transition Type:</b>	NONE
<b>Ending End Trtmt Type:</b>	NONE	<b>Ending End Trtmt Crashworthy?:</b>	N/A		
<b>Average Measurements</b>					
<b>Design Height (In.):</b>	18	<b>Width (In.):</b>	20.0	<b>Post Spacing (In.):</b>	0.0

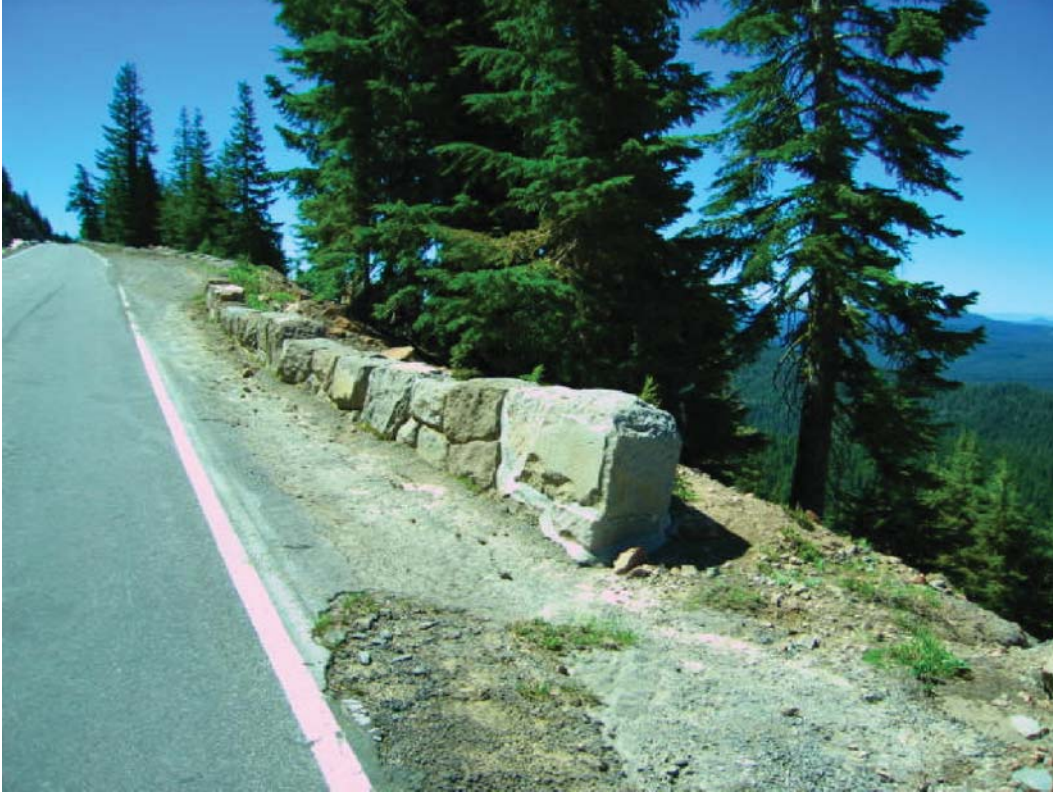
CRLA\_0013\_17.778\_L\_1.jpg

<b>Barrier ID:</b>	CRLA-0013-17.778-L				
<b>Route Name:</b>	EAST RIM DRIVE				
<b>Inspection Date:</b>	07/18/2010	<b>Barrier Rating:</b>	50.00		
<b>Barrier Description</b>					
<b>Type:</b>	STONE MASONRY CRENELLATED WITHOUT	<b>Barrier Function:</b>	TRAFFIC		
<b>Barrier Material:</b>	STONE	<b>Post Material:</b>	N/A		
<b>Blockout Type:</b>	N/A	<b>Length (ft.):</b>	1018		
<b>Speed Limit (MPH):</b>	35	<b>Placement with Respect to Road:</b>	BOTH INSIDE AND OUTSIDE		
<b>Hazard Behind Barrier:</b>	EXTREME				
<b>Barrier Crashworthiness</b>					
<b>Appropriate Test Level:</b>	TL-2	<b>Barrier Test Level:</b>	NCW	<b>Is Barrier Crashworthy?:</b>	NO
<b>Beg. End Trtmt Type:</b>	NONE	<b>Is Beg. End Trtmt Crashworthy?:</b>	N/A	<b>Approach Transition Type:</b>	NONE
<b>Ending End Trtmt Type:</b>	NONE	<b>Ending End Trtmt Crashworthy?:</b>	N/A		
<b>Average Measurements</b>					
<b>Design Height (In.):</b>	18	<b>Width (In.):</b>	19.0	<b>Post Spacing (In.):</b>	0.0

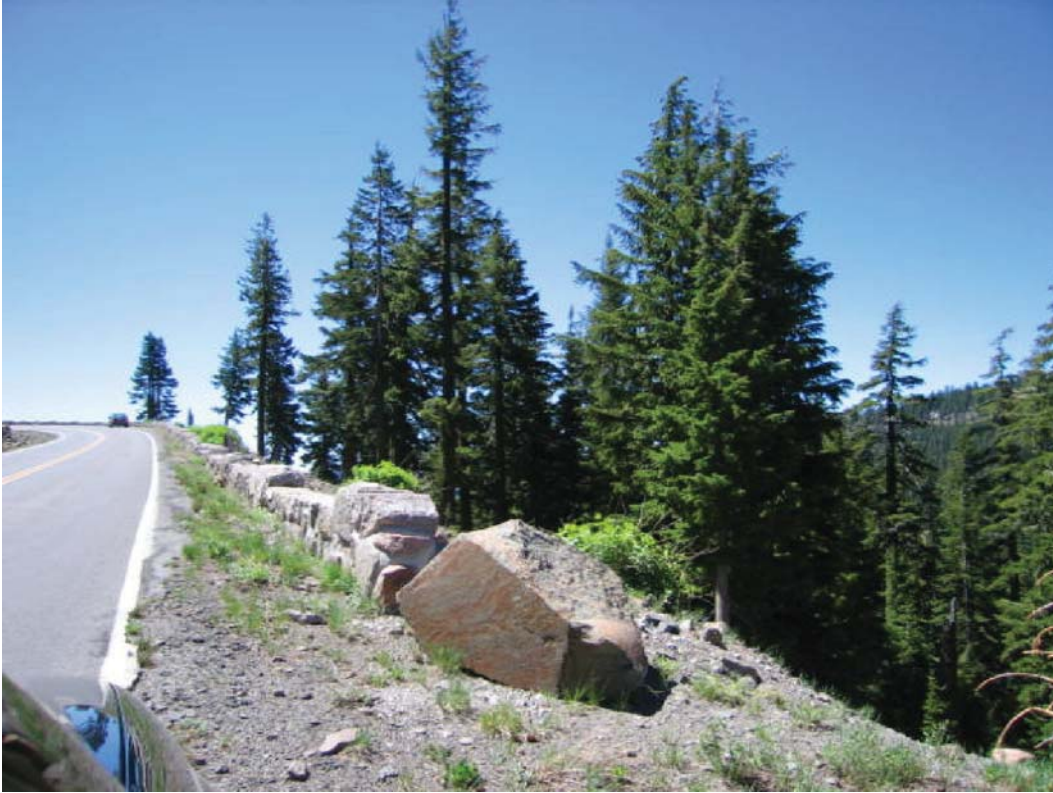
CRLA\_0013\_18.306\_L\_1.jpg

<b>Barrier ID:</b>	CRLA-0013-18.306-L				
<b>Route Name:</b>	EAST RIM DRIVE				
<b>Inspection Date:</b>	07/18/2010	<b>Barrier Rating:</b>	37.00		
<b>Barrier Description</b>					
<b>Type:</b>	STONE MASONRY CRENELLATED WITHOUT	<b>Barrier Function:</b>	TRAFFIC		
<b>Barrier Material:</b>	STONE	<b>Post Material:</b>	N/A		
<b>Blockout Type:</b>	N/A	<b>Length (ft.):</b>	2060		
<b>Speed Limit (MPH):</b>	35	<b>Placement with Respect to Road:</b>	BOTH INSIDE AND OUTSIDE		
<b>Hazard Behind Barrier:</b>	EXTREME				
<b>Barrier Crashworthiness</b>					
<b>Appropriate Test Level:</b>	TL-2	<b>Barrier Test Level:</b>	NCW	<b>Is Barrier Crashworthy?:</b>	NO
<b>Beg. End Trtmt Type:</b>	NONE	<b>Is Beg. End Trtmt Crashworthy?:</b>	N/A	<b>Approach Transition Type:</b>	NONE
<b>Ending End Trtmt Type:</b>	NONE	<b>Ending End Trtmt Crashworthy?:</b>	N/A		
<b>Average Measurements</b>					
<b>Design Height (In.):</b>	18	<b>Width (In.):</b>	20.0	<b>Post Spacing (In.):</b>	0.0

<b>Height (In.):</b>	20.1	<b>Lateral Offset (In.):</b>	68.9	<b>Road Grade (%):</b>	5.70
<b>Physical Condition</b>					
<b>Barrier</b>	<b>Alignment and Height:</b>	The horizontal and vertical alignments showed no deviations. Barrier height was consistently at or above design height (18-in) with the exception of a 10-ft run that was 14-in high.			
	<b>Breaking and Cracking:</b>	Observed several areas of cracking grout; in same area as missing grout. 60-linear-ft showed cracks ranging from 1/4 to 1/2-in wide.			
	<b>Missing Elements:</b>	Observed several areas of missing grout. Total length of 60-linear-ft. Grout missing on tope and front of barrier.			
	<b>Corrosion and Weathering:</b>	A few of the stones were spalling on top. Observed six stones total; approximately 25-linear-ft.			
<b>End Treatments</b>	<b>Alignment and Height:</b>				
	<b>Breaking and Cracking:</b>				
	<b>Missing Elements:</b>

<b>Repair Action:</b>	REPAIR	<b>FMSS Work Type:</b>	DEFERRED MAINTENANCE	<b>Repair Cost:</b>	\$6110
<b>Brief Workorder:</b>	Repoint stone masonry barrier and use grader to remove debris and gravel from in-front of barrier.				
<b>Workorder:</b>	<p>Re-Point Masonry Barrier at \$140- per -Sq. Yd. for 22 SY = \$3080. [(60-ft) x (20-in/12-in + 20-in/12-in)] /9 = 22.2 SY.  20-in for front face of barrier and 20-in for top side of barrier.  Grader at \$125- per -Hour for 8 Hrs = \$1000. 8 hrs of grader to remove stones and debris in front of barrier.  Low Speed Traffic Control at \$1475- per -Day for 1 Day(s) = \$1475. 1 day to complete all work.</p>

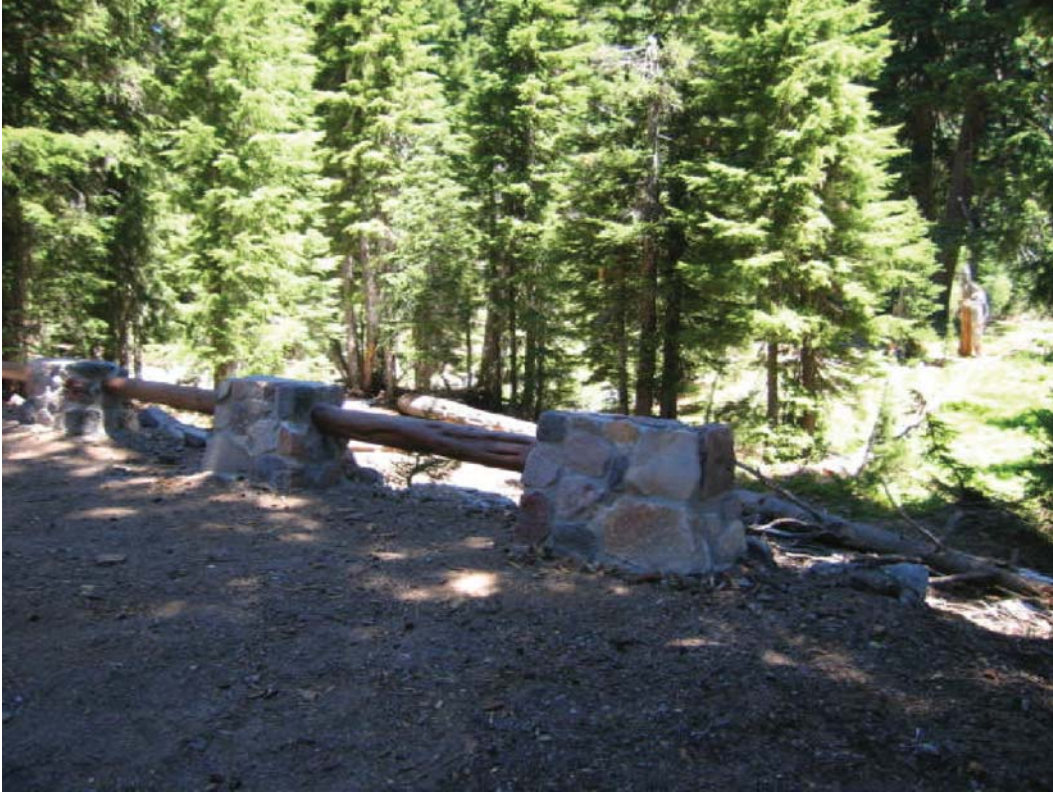
CRLA\_0013\_22.842\_R\_1.jpg

<b>Barrier ID:</b>	CRLA-0013-22.842-R				
<b>Route Name:</b>	EAST RIM DRIVE				
<b>Inspection Date:</b>	07/18/2010	<b>Barrier Rating:</b>	8.50		
<b>Barrier Description</b>					
<b>Type:</b>	OTHER: LOG RAIL ON STONE POSTS	<b>Barrier Function:</b>	NON-TRAFFIC		
<b>Barrier Material:</b>	LOG/TIMBER/WOOD	<b>Post Material:</b>	OTHER: STONE		
<b>Blockout Type:</b>	N/A	<b>Length (ft.):</b>	112		
<b>Speed Limit (MPH):</b>	35	<b>Placement with Respect to Road:</b>	NON-TRAFFIC BARRIER		
<b>Hazard Behind Barrier:</b>	N/A				
<b>Barrier Crashworthiness</b>					
<b>Appropriate Test Level:</b>	TL-2	<b>Barrier Test Level:</b>	N/A	<b>Is Barrier Crashworthy?:</b>	N/A
<b>Beg. End Trtmt Type:</b>	NONE	<b>Is Beg. End Trtmt Crashworthy?:</b>	N/A	<b>Approach Transition Type:</b>	NONE
<b>Ending End Trtmt Type:</b>	NONE	<b>Ending End Trtmt Crashworthy?:</b>	N/A		
<b>Average Measurements</b>					
<b>Design Height (In.):</b>	27	<b>Width (In.):</b>	24.0	<b>Post Spacing (In.):</b>	144.0

<b>Height (In.):</b>	27.0	<b>Lateral Offset (In.):</b>	0.0	<b>Road Grade (%):</b>	0.00
<b>Physical Condition</b>					
<b>Barrier</b>	<b>Alignment and Height:</b>	Newly installed barrier. No deviation in horizontal or vertical alignments. Height is consistent at 27-in to the top of the log rail (assumed design height is 27-in).			
	<b>Breaking and Cracking:</b>	There is some cracking of the grout. Cracks up to 1/8-in were recorded. Recommend monitoring the cracks.			
	<b>Missing Elements:</b>	None observed.			
	<b>Corrosion and Weathering:</b>	No weathering of logs or stone.			
<b>End Treatments</b>	<b>Alignment and Height:</b>				
	<b>Breaking and Cracking:</b>				
	<b>Missing Elements:</b>				
	<b>Corrosion and Weathering:</b>

<b>Repair Action:</b>	MONITOR	<b>FMSS Work Type:</b>	N/A	<b>Repair Cost:</b>	\$0
<b>Brief Workorder:</b>	Monitor cracks in grout.				
<b>Workorder:</b>

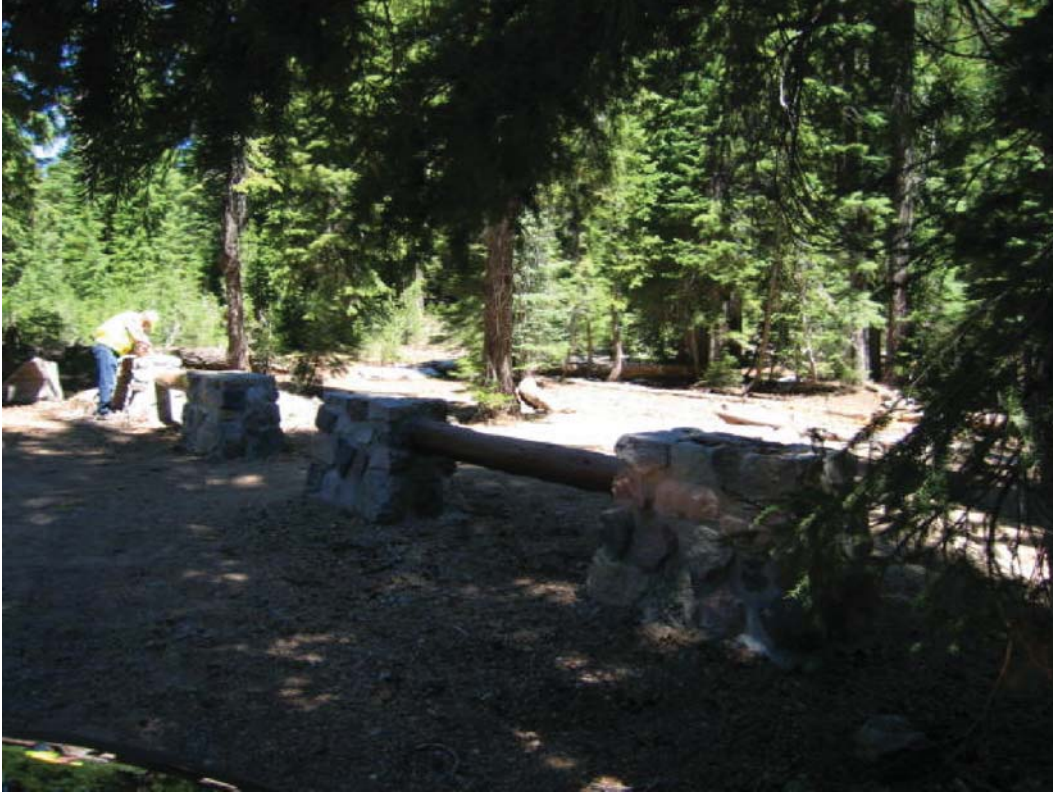
CRLA\_0013\_22.860\_R\_1.jpg

<b>Barrier ID:</b>	CRLA-0013-22.860-R				
<b>Route Name:</b>	EAST RIM DRIVE				
<b>Inspection Date:</b>	07/18/2010	<b>Barrier Rating:</b>	8.50		
<b>Barrier Description</b>					
<b>Type:</b>	OTHER: LOG RAIL ON STONE POSTS	<b>Barrier Function:</b>	NON-TRAFFIC		
<b>Barrier Material:</b>	LOG/TIMBER/WOOD	<b>Post Material:</b>	OTHER: STONE		
<b>Blockout Type:</b>	N/A	<b>Length (ft.):</b>	36		
<b>Speed Limit (MPH):</b>	35	<b>Placement with Respect to Road:</b>	NON-TRAFFIC BARRIER		
<b>Hazard Behind Barrier:</b>	N/A				
<b>Barrier Crashworthiness</b>					
<b>Appropriate Test Level:</b>	TL-2	<b>Barrier Test Level:</b>	N/A	<b>Is Barrier Crashworthy?:</b>	N/A
<b>Beg. End Trtmt Type:</b>	NONE	<b>Is Beg. End Trtmt Crashworthy?:</b>	N/A	<b>Approach Transition Type:</b>	NONE
<b>Ending End Trtmt Type:</b>	NONE	<b>Ending End Trtmt Crashworthy?:</b>	N/A		
<b>Average Measurements</b>					
<b>Design Height (In.):</b>	27	<b>Width (In.):</b>	24.0	<b>Post Spacing (In.):</b>	84.0

<b>Height (In.):</b>	27.7	<b>Lateral Offset (In.):</b>	0.0	<b>Road Grade (%):</b>	0.00
<b>Physical Condition</b>					
<b>Barrier</b>	<b>Alignment and Height:</b>	Newly installed barrier. No deviation in horizontal or vertical alignments. Height is consistent no more than 1-in above assumed design height (27-in).			
	<b>Breaking and Cracking:</b>	Observed one shrinkage crack in the grout. Crack measured 1/8-in wide and 4-in long. No other cracking observed.			
	<b>Missing Elements:</b>	No missing elements.			
	<b>Corrosion and Weathering:</b>	No weathering observed.			
<b>End Treatments</b>	<b>Alignment and Height:</b>				
	<b>Breaking and Cracking:</b>				
	<b>Missing Elements:</b>				
	<b>Corrosion and Weathering:</b>

<b>Repair Action:</b>	MONITOR	<b>FMSS Work Type:</b>	N/A	<b>Repair Cost:</b>	\$0
<b>Brief Workorder:</b>	Monitor grout for further cracking.				
<b>Workorder:</b>

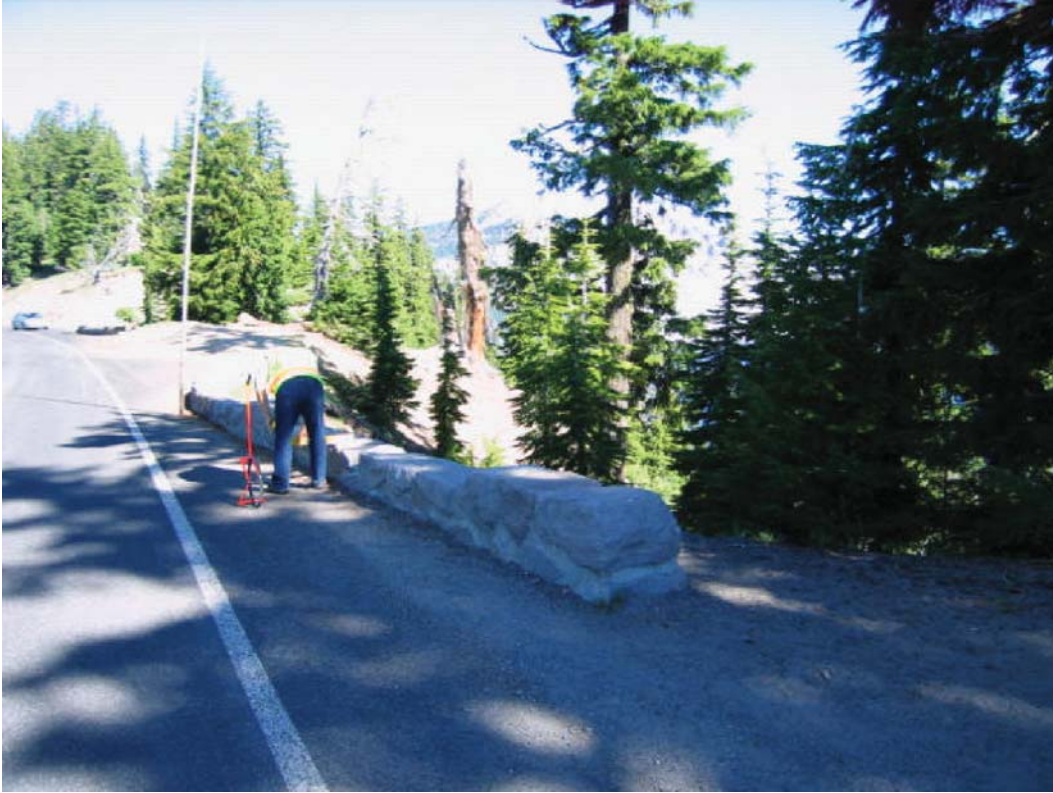
CRLA\_0014\_0.171\_R\_1.jpg

<b>Barrier ID:</b>	CRLA-0014-0.171-R				
<b>Route Name:</b>	WEST RIM DRIVE				
<b>Inspection Date:</b>	07/16/2010	<b>Barrier Rating:</b>	44.20		
<b>Barrier Description</b>					
<b>Type:</b>	STONE MASONRY CRENELLATED WITHOUT	<b>Barrier Function:</b>	TRAFFIC		
<b>Barrier Material:</b>	STONE	<b>Post Material:</b>	N/A		
<b>Blockout Type:</b>	N/A	<b>Length (ft.):</b>	82		
<b>Speed Limit (MPH):</b>	35	<b>Placement with Respect to Road:</b>	OUTSIDE OF CURVE		
<b>Hazard Behind Barrier:</b>	EXTREME				
<b>Barrier Crashworthiness</b>					
<b>Appropriate Test Level:</b>	TL-2	<b>Barrier Test Level:</b>	NCW	<b>Is Barrier Crashworthy?:</b>	NO
<b>Beg. End Trtmt Type:</b>	NONE	<b>Is Beg. End Trtmt Crashworthy?:</b>	N/A	<b>Approach Transition Type:</b>	NONE
<b>Ending End Trtmt Type:</b>	NONE	<b>Ending End Trtmt Crashworthy?:</b>	N/A		
<b>Average Measurements</b>					
<b>Design Height (In.):</b>	18	<b>Width (In.):</b>	18.2	<b>Post Spacing (In.):</b>	0.0

<b>Height (In.):</b>	13.6	<b>Lateral Offset (In.):</b>	70.0	<b>Road Grade (%):</b>	2.70
<b>Physical Condition</b>					
<b>Barrier</b>	<b>Alignment and Height:</b>	All height is below 18-in. Entire run of barrier is lower than 15-in (3-in lower than 18-in design height). Alignment is good.			
	<b>Breaking and Cracking:</b>	1/4 to 1/2-in cracks in mortar observed over 30-ft of barrier only on the front side. 5-ft of downstream end is cracked and needs to be reset.			
	<b>Missing Elements:</b>	None. All elements present.			
	<b>Corrosion and Weathering:</b>	None. No weathering noted.			
<b>End Treatments</b>	<b>Alignment and Height:</b>				
	<b>Breaking and Cracking:</b>				
	<b>Missing Elements:</b>				
	<b>Corrosion and Weathering:</b>

<b>Repair Action:</b>	REPAIR	<b>FMSS Work Type:</b>	DEFERRED MAINTENANCE	<b>Repair Cost:</b>	\$2513
<b>Brief Workorder:</b>	Repoint 30 l.f. and reset 5 l.f. of stone masonry barrier				
<b>Workorder:</b>	<p>Re-Point Masonry Barrier at \$140- per -Sq. Yd. for 4 SY = \$560. [(30-ft) x (14-in/12-in)]/9 = 3.8 SY. Round to 4 S.Y.</p> <p>Low Speed Traffic Control at \$1475- per -Day for 1 Day(s) = \$1475. 1 day to complete work.</p> <p>Remove &amp; Reset Stone Masonry Guardwall at \$250- per -Cu. Ft. for 1 CF = \$250. [(5-ft) x (14-in/12-in) x (18-in/12-in)] / 9 = 0.97 CF.</p>

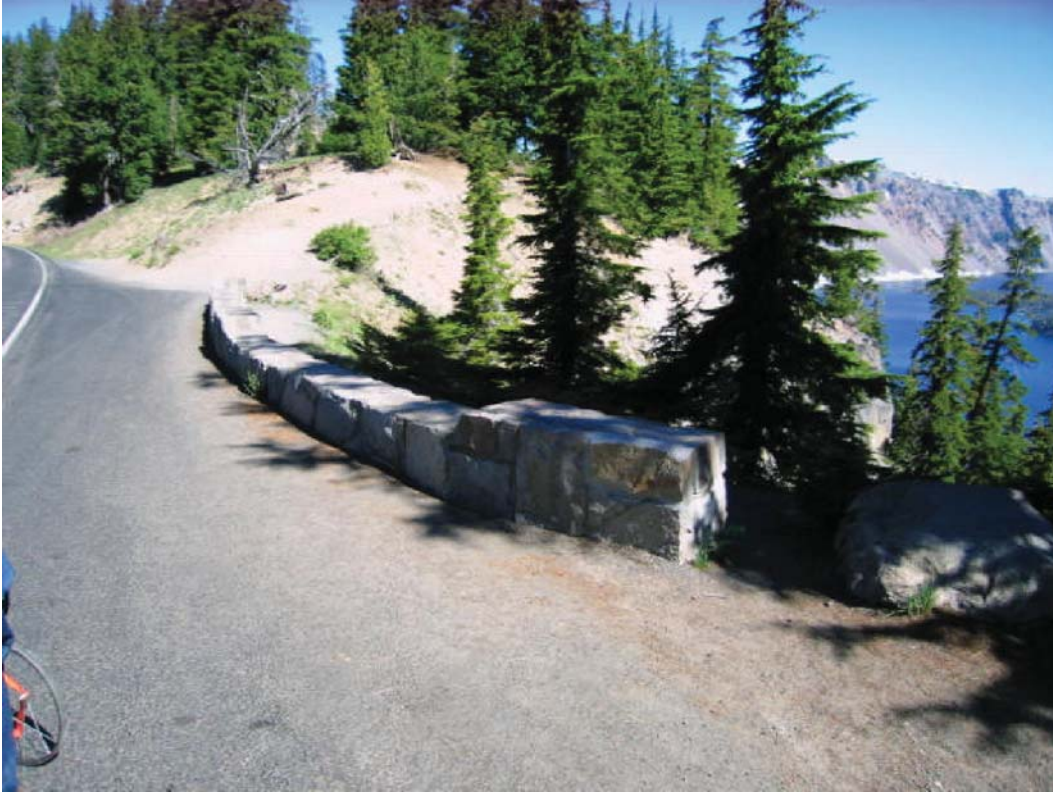
CRLA\_0014\_0.204\_R\_1.jpg

<b>Barrier ID:</b>	CRLA-0014-0.204-R				
<b>Route Name:</b>	WEST RIM DRIVE				
<b>Inspection Date:</b>	07/16/2010	<b>Barrier Rating:</b>	35.70		
<b>Barrier Description</b>					
<b>Type:</b>	STONE MASONRY CRENELLATED WITHOUT	<b>Barrier Function:</b>	TRAFFIC		
<b>Barrier Material:</b>	STONE	<b>Post Material:</b>	N/A		
<b>Blockout Type:</b>	N/A	<b>Length (ft.):</b>	57		
<b>Speed Limit (MPH):</b>	35	<b>Placement with Respect to Road:</b>	OUTSIDE OF CURVE		
<b>Hazard Behind Barrier:</b>	EXTREME				
<b>Barrier Crashworthiness</b>					
<b>Appropriate Test Level:</b>	TL-2	<b>Barrier Test Level:</b>	NCW	<b>Is Barrier Crashworthy?:</b>	NO
<b>Beg. End Trtmt Type:</b>	NONE	<b>Is Beg. End Trtmt Crashworthy?:</b>	N/A	<b>Approach Transition Type:</b>	NONE
<b>Ending End Trtmt Type:</b>	NONE	<b>Ending End Trtmt Crashworthy?:</b>	N/A		
<b>Average Measurements</b>					
<b>Design Height (In.):</b>	18	<b>Width (In.):</b>	18.0	<b>Post Spacing (In.):</b>	0.0

<b>Height (In.):</b>	15.3	<b>Lateral Offset (In.):</b>	113.5	<b>Road Grade (%):</b>	2.10
<b>Physical Condition</b>					
<b>Barrier</b>	<b>Alignment and Height:</b>	Minimum height of barrier was measured at 15-in which is 3-in lower than the design height of 18-in.			
	<b>Breaking and Cracking:</b>	None. All barrier is in excellent condition.			
	<b>Missing Elements:</b>	None. All barrier is in excellent condition.			
	<b>Corrosion and Weathering:</b>	None. All barrier is in excellent condition.			
<b>End Treatments</b>	<b>Alignment and Height:</b>				
	<b>Breaking and Cracking:</b>				
	<b>Missing Elements:</b>				
	<b>Corrosion and Weathering:</b>

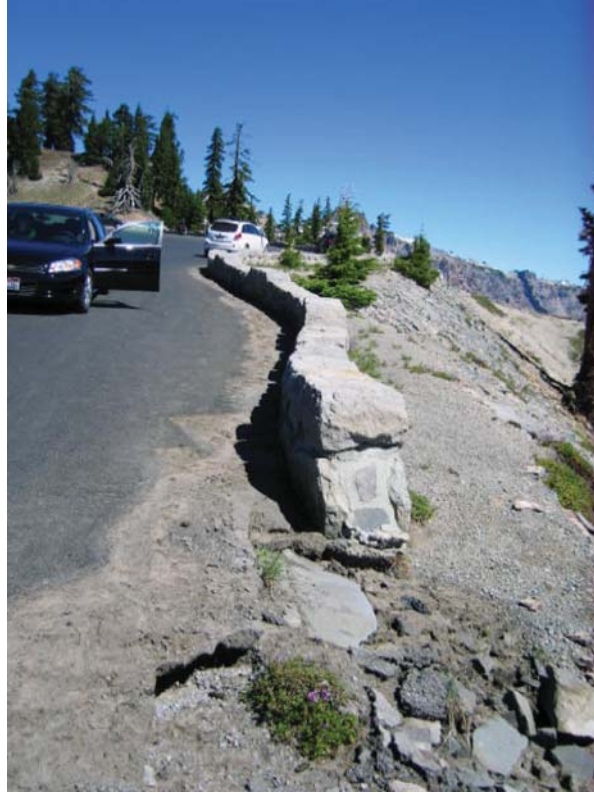
CRLA\_0014\_1.040\_R\_1.jpg

<b>Barrier ID:</b>	CRLA-0014-1.040-R				
<b>Route Name:</b>	WEST RIM DRIVE				
<b>Inspection Date:</b>	07/16/2010	<b>Barrier Rating:</b>	24.20		
<b>Barrier Description</b>					
<b>Type:</b>	STONE MASONRY CRENELLATED WITHOUT	<b>Barrier Function:</b>	NON-TRAFFIC		
<b>Barrier Material:</b>	STONE	<b>Post Material:</b>	N/A		
<b>Blockout Type:</b>	N/A	<b>Length (ft.):</b>	420		
<b>Speed Limit (MPH):</b>	35	<b>Placement with Respect to Road:</b>	NON-TRAFFIC BARRIER		
<b>Hazard Behind Barrier:</b>	N/A				
<b>Barrier Crashworthiness</b>					
<b>Appropriate Test Level:</b>	TL-2	<b>Barrier Test Level:</b>	N/A	<b>Is Barrier Crashworthy?:</b>	N/A
<b>Beg. End Trtmt Type:</b>	NONE	<b>Is Beg. End Trtmt Crashworthy?:</b>	N/A	<b>Approach Transition Type:</b>	NONE
<b>Ending End Trtmt Type:</b>	NONE	<b>Ending End Trtmt Crashworthy?:</b>	N/A		
<b>Average Measurements</b>					
<b>Design Height (In.):</b>	18	<b>Width (In.):</b>	19.0	<b>Post Spacing (In.):</b>	0.0

<b>Height (In.):</b>	17.7	<b>Lateral Offset (In.):</b>	0.0	<b>Road Grade (%):</b>	0.00
<b>Physical Condition</b>					
<b>Barrier</b>	<b>Alignment and Height:</b>	Alignment acceptable. Height was within 3-in of the 18-in design height.			
	<b>Breaking and Cracking:</b>	Very minor cracking in mortar but still good.			
	<b>Missing Elements:</b>	No missing elements.			
	<b>Corrosion and Weathering:</b>	No weathering noted.			
<b>End Treatments</b>	<b>Alignment and Height:</b>				
	<b>Breaking and Cracking:</b>				
	<b>Missing Elements:</b>				
	<b>Corrosion and Weathering:</b>

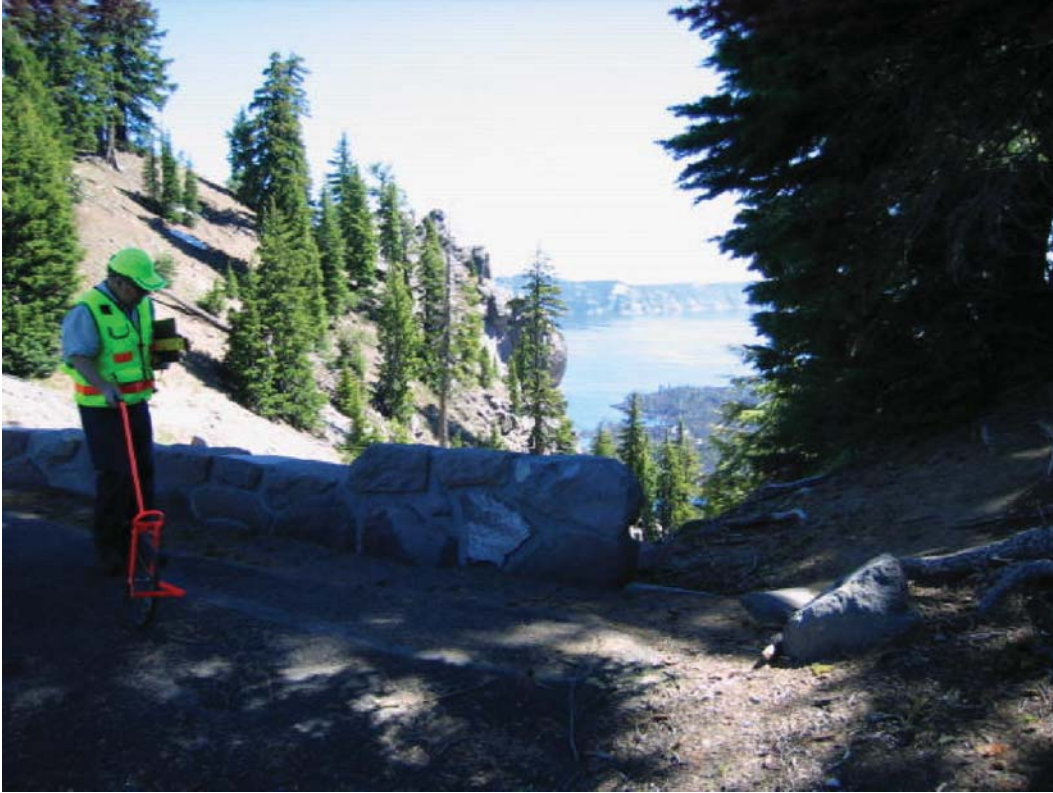
CRLA\_0014\_2.187\_R\_1.jpg

<b>Barrier ID:</b>	CRLA-0014-2.187-R				
<b>Route Name:</b>	WEST RIM DRIVE				
<b>Inspection Date:</b>	07/16/2010	<b>Barrier Rating:</b>	27.80		
<b>Barrier Description</b>					
<b>Type:</b>	STONE MASONRY CRENELLATED WITHOUT	<b>Barrier Function:</b>	NON-TRAFFIC		
<b>Barrier Material:</b>	STONE	<b>Post Material:</b>	N/A		
<b>Blockout Type:</b>	N/A	<b>Length (ft.):</b>	234		
<b>Speed Limit (MPH):</b>	35	<b>Placement with Respect to Road:</b>	NON-TRAFFIC BARRIER		
<b>Hazard Behind Barrier:</b>	N/A				
<b>Barrier Crashworthiness</b>					
<b>Appropriate Test Level:</b>	TL-2	<b>Barrier Test Level:</b>	N/A	<b>Is Barrier Crashworthy?:</b>	N/A
<b>Beg. End Trtmt Type:</b>	NONE	<b>Is Beg. End Trtmt Crashworthy?:</b>	N/A	<b>Approach Transition Type:</b>	NONE
<b>Ending End Trtmt Type:</b>	NONE	<b>Ending End Trtmt Crashworthy?:</b>	N/A		
<b>Average Measurements</b>					
<b>Design Height (In.):</b>	18	<b>Width (In.):</b>	18.7	<b>Post Spacing (In.):</b>	0.0

<b>Height (In.):</b>	16.0	<b>Lateral Offset (In.):</b>	0.0	<b>Road Grade (%):</b>	0.00
<b>Physical Condition</b>					
<b>Barrier</b>	<b>Alignment and Height:</b>	The height of the barrier was within 3-in of the 18-in design height. Horizontal alignment shows no deviation. Barrier all vertical.			
	<b>Breaking and Cracking:</b>	There is some minor cracking in the mortar for less than 1/4-in wide along 60-ft of the roadside face of the barrier.			
	<b>Missing Elements:</b>	None observed.			
	<b>Corrosion and Weathering:</b>	Mortar is in new condition.			
<b>End Treatments</b>	<b>Alignment and Height:</b>				
	<b>Breaking and Cracking:</b>				
	<b>Missing Elements:</b>				
	<b>Corrosion and Weathering:</b>

<b>Repair Action:</b>	REPAIR	<b>FMSS Work Type:</b>	DEFERRED MAINTENANCE	<b>Repair Cost:</b>	\$3008
<b>Brief Workorder:</b>	Repoint stone masonry barrier.				
<b>Workorder:</b>	Re-Point Masonry Barrier at \$140- per -Sq. Yd. for 9 SY = \$1260. $[(60\text{-ft}) \times (16\text{-in}/12\text{-in})]/9 = 8.9 \text{ SY}$ . Round to 9 S.Y. Low Speed Traffic Control at \$1475- per -Day for 1 Day(s) = \$1475. One day to complete work.

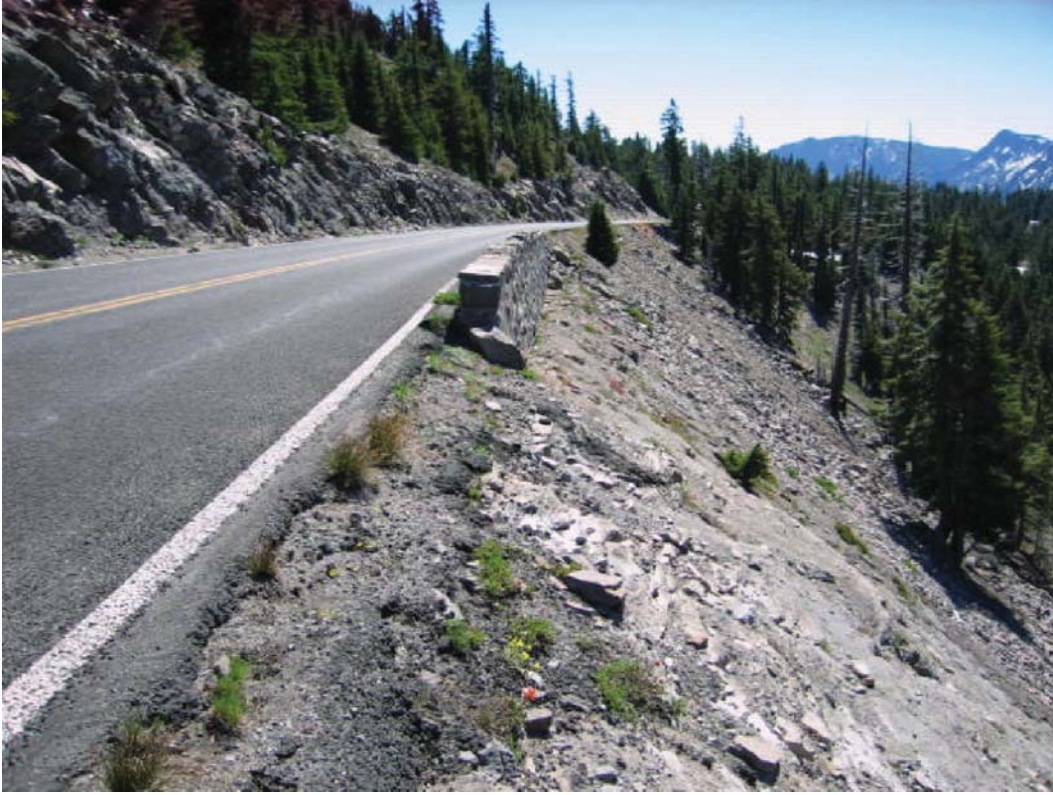
CRLA\_0014\_2.862\_L\_1.jpg

<b>Barrier ID:</b>	CRLA-0014-2.862-L				
<b>Route Name:</b>	WEST RIM DRIVE				
<b>Inspection Date:</b>	07/16/2010	<b>Barrier Rating:</b>	48.50		
<b>Barrier Description</b>					
<b>Type:</b>	STONE MASONRY CRENELLATED WITHOUT	<b>Barrier Function:</b>	TRAFFIC		
<b>Barrier Material:</b>	STONE	<b>Post Material:</b>	N/A		
<b>Blockout Type:</b>	N/A	<b>Length (ft.):</b>	125		
<b>Speed Limit (MPH):</b>	35	<b>Placement with Respect to Road:</b>	INSIDE OF CURVE		
<b>Hazard Behind Barrier:</b>	EXTREME				
<b>Barrier Crashworthiness</b>					
<b>Appropriate Test Level:</b>	TL-2	<b>Barrier Test Level:</b>	NCW	<b>Is Barrier Crashworthy?:</b>	NO
<b>Beg. End Trtmt Type:</b>	NONE	<b>Is Beg. End Trtmt Crashworthy?:</b>	N/A	<b>Approach Transition Type:</b>	NONE
<b>Ending End Trtmt Type:</b>	NONE	<b>Ending End Trtmt Crashworthy?:</b>	N/A		
<b>Average Measurements</b>					
<b>Design Height (In.):</b>	18	<b>Width (In.):</b>	19.0	<b>Post Spacing (In.):</b>	0.0

<b>Height (In.):</b>	17.6	<b>Lateral Offset (In.):</b>	23.2	<b>Road Grade (%):</b>	3.50
<b>Physical Condition</b>					
<b>Barrier</b>	<b>Alignment and Height:</b>	Alignment acceptable. Height was within 3-in of the 18-in design height.			
	<b>Breaking and Cracking:</b>	None observed			
	<b>Missing Elements:</b>	10-ft of the barrier is missing. Replace.			
	<b>Corrosion and Weathering:</b>	None observed			
<b>End Treatments</b>	<b>Alignment and Height:</b>				
	<b>Breaking and Cracking:</b>				
	<b>Missing Elements:</b>				
	<b>Corrosion and Weathering:</b>

<b>Repair Action:</b>	REPAIR	<b>FMSS Work Type:</b>	DEFERRED MAINTENANCE	<b>Repair Cost:</b>	\$7122
<b>Brief Workorder:</b>	Replace 10 l.f. section of stone masonry barrier.				
<b>Workorder:</b>	Stone Masonry Crenellated w/o Concrete Core at \$500- per -Lin. Ft. for 10 LF = \$5000. Replace missing section of barrier to match existing height of adjacent barrier. Low Speed Traffic Control at \$1475- per -Day for 1 Day(s) = \$1475. One day to install new section of barrier.

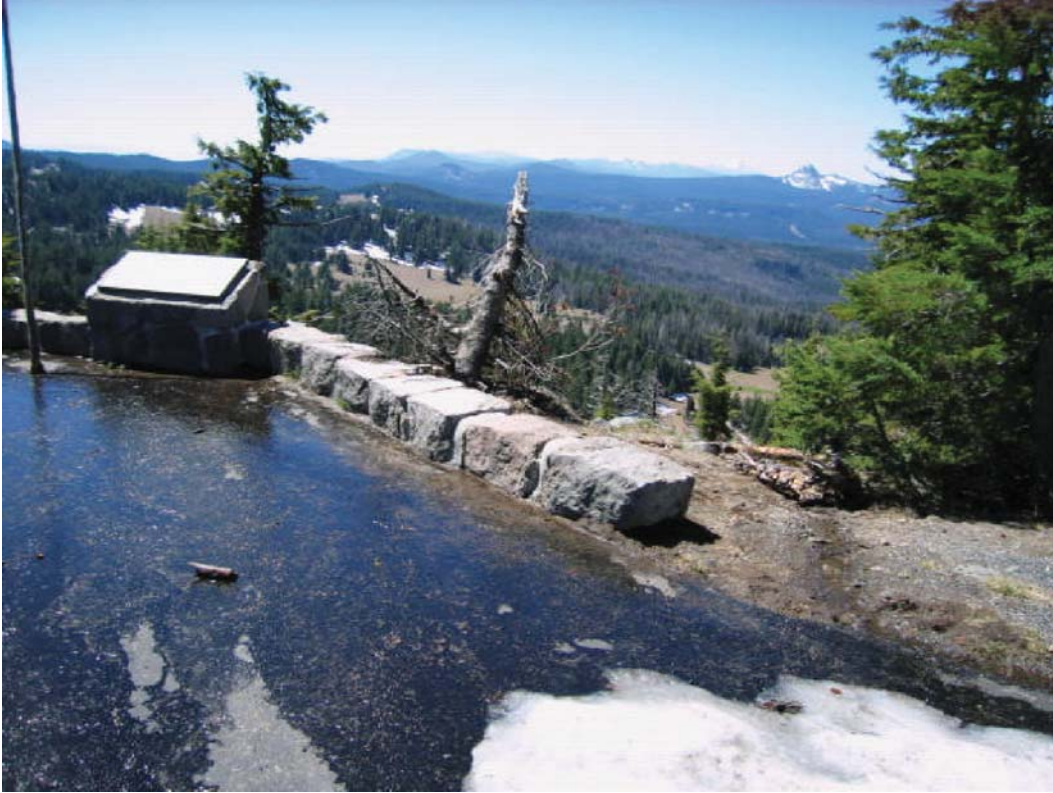
CRLA\_0014\_2.903\_L\_1.jpg

<b>Barrier ID:</b>	CRLA-0014-2.903-L				
<b>Route Name:</b>	WEST RIM DRIVE				
<b>Inspection Date:</b>	07/16/2010	<b>Barrier Rating:</b>	54.40		
<b>Barrier Description</b>					
<b>Type:</b>	STONE MASONRY CRENELLATED WITHOUT	<b>Barrier Function:</b>	TRAFFIC		
<b>Barrier Material:</b>	STONE	<b>Post Material:</b>	N/A		
<b>Blockout Type:</b>	N/A	<b>Length (ft.):</b>	535		
<b>Speed Limit (MPH):</b>	35	<b>Placement with Respect to Road:</b>	OUTSIDE OF CURVE		
<b>Hazard Behind Barrier:</b>	EXTREME				
<b>Barrier Crashworthiness</b>					
<b>Appropriate Test Level:</b>	TL-2	<b>Barrier Test Level:</b>	NCW	<b>Is Barrier Crashworthy?:</b>	NO
<b>Beg. End Trtmt Type:</b>	NONE	<b>Is Beg. End Trtmt Crashworthy?:</b>	N/A	<b>Approach Transition Type:</b>	NONE
<b>Ending End Trtmt Type:</b>	NONE	<b>Ending End Trtmt Crashworthy?:</b>	N/A		
<b>Average Measurements</b>					
<b>Design Height (In.):</b>	18	<b>Width (In.):</b>	19.2	<b>Post Spacing (In.):</b>	0.0

<b>Height (In.):</b>	18.0	<b>Lateral Offset (In.):</b>	34.5	<b>Road Grade (%):</b>	3.90
<b>Physical Condition</b>					
<b>Barrier</b>	<b>Alignment and Height:</b>	Height of barrier is no more than 3-in from design height of 18-in. 40-ft of barrier leaning but stable. Rest of barrier is ok with/ regards to alignment.			
	<b>Breaking and Cracking:</b>	Nothing observed			
	<b>Missing Elements:</b>	No missing elements			
	<b>Corrosion and Weathering:</b>	Stone is stable. No corrosion or weathering noted.			
<b>End Treatments</b>	<b>Alignment and Height:</b>				
	<b>Breaking and Cracking:</b>				
	<b>Missing Elements:</b>				
	<b>Corrosion and Weathering:</b>

<b>Repair Action:</b>	MONITOR	<b>FMSS Work Type:</b>	N/A	<b>Repair Cost:</b>	\$0
<b>Brief Workorder:</b>	Monitor 40 l.f. section of barrier that is leaning and investigate water runoff.				
<b>Workorder:</b>

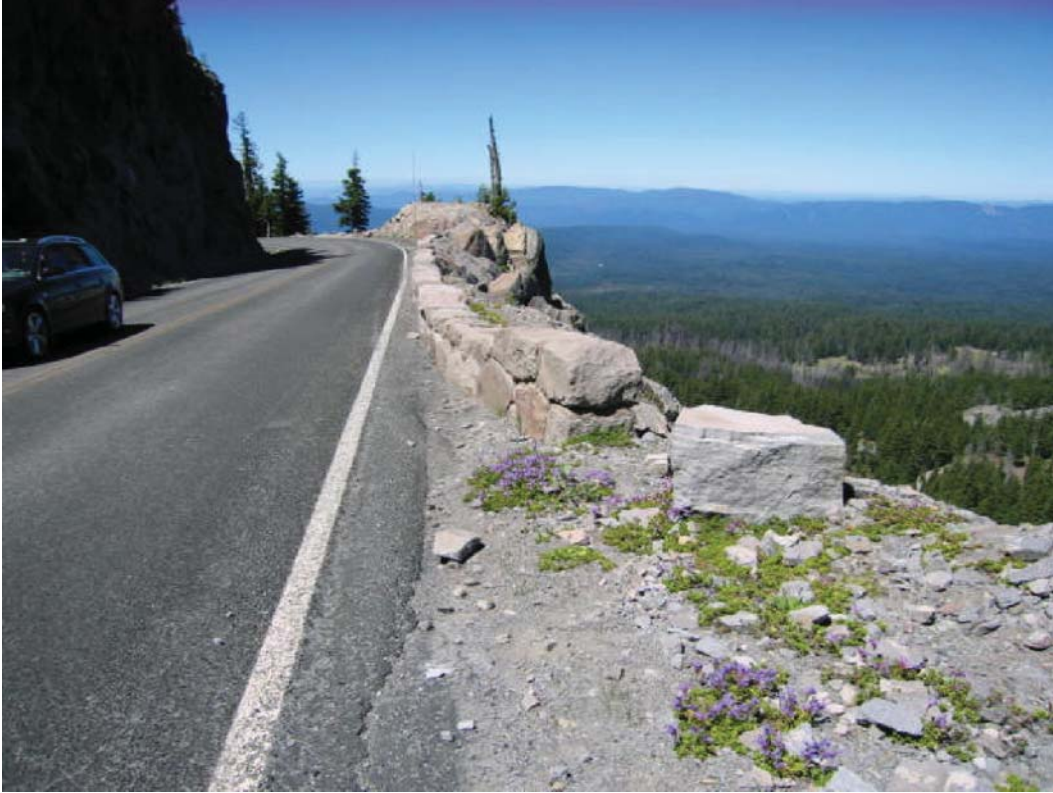
CRLA\_0014\_3.320\_L\_1.jpg

<b>Barrier ID:</b>	CRLA-0014-3.320-L				
<b>Route Name:</b>	WEST RIM DRIVE				
<b>Inspection Date:</b>	07/16/2010	<b>Barrier Rating:</b>	45.70		
<b>Barrier Description</b>					
<b>Type:</b>	STONE MASONRY CRENELLATED WITHOUT	<b>Barrier Function:</b>	TRAFFIC		
<b>Barrier Material:</b>	STONE	<b>Post Material:</b>	N/A		
<b>Blockout Type:</b>	N/A	<b>Length (ft.):</b>	160		
<b>Speed Limit (MPH):</b>	35	<b>Placement with Respect to Road:</b>	TANGENT		
<b>Hazard Behind Barrier:</b>	EXTREME				
<b>Barrier Crashworthiness</b>					
<b>Appropriate Test Level:</b>	TL-2	<b>Barrier Test Level:</b>	NCW	<b>Is Barrier Crashworthy?:</b>	NO
<b>Beg. End Trtmt Type:</b>	NONE	<b>Is Beg. End Trtmt Crashworthy?:</b>	N/A	<b>Approach Transition Type:</b>	NONE
<b>Ending End Trtmt Type:</b>	NONE	<b>Ending End Trtmt Crashworthy?:</b>	N/A		
<b>Average Measurements</b>					
<b>Design Height (In.):</b>	18	<b>Width (In.):</b>	20.0	<b>Post Spacing (In.):</b>	0.0

<b>Height (In.):</b>	18.7	<b>Lateral Offset (In.):</b>	17.6	<b>Road Grade (%):</b>	3.70
<b>Physical Condition</b>					
<b>Barrier</b>	<b>Alignment and Height:</b>	Alignment acceptable. Height was within 3-in of the 18-in design height.			
	<b>Breaking and Cracking:</b>	20-ft section of very minor grout cracking.			
	<b>Missing Elements:</b>	None observed.			
	<b>Corrosion and Weathering:</b>	None observed.			
<b>End Treatments</b>	<b>Alignment and Height:</b>				
	<b>Breaking and Cracking:</b>				
	<b>Missing Elements:</b>				
	<b>Corrosion and Weathering:</b>

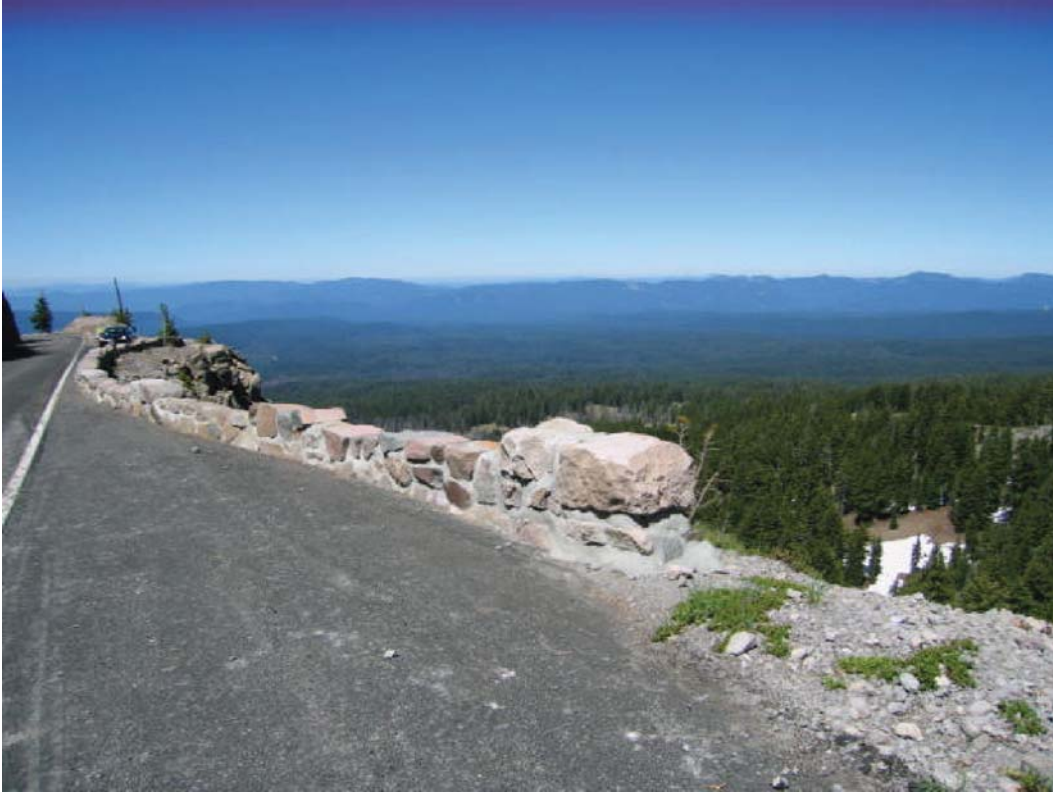
CRLA\_0014\_3.359\_L\_1.jpg

<b>Barrier ID:</b>	CRLA-0014-3.359-L				
<b>Route Name:</b>	WEST RIM DRIVE				
<b>Inspection Date:</b>	07/16/2010	<b>Barrier Rating:</b>	42.90		
<b>Barrier Description</b>					
<b>Type:</b>	STONE MASONRY CRENELLATED WITHOUT	<b>Barrier Function:</b>	TRAFFIC		
<b>Barrier Material:</b>	STONE	<b>Post Material:</b>	N/A		
<b>Blockout Type:</b>	N/A	<b>Length (ft.):</b>	320		
<b>Speed Limit (MPH):</b>	35	<b>Placement with Respect to Road:</b>	TANGENT		
<b>Hazard Behind Barrier:</b>	EXTREME				
<b>Barrier Crashworthiness</b>					
<b>Appropriate Test Level:</b>	TL-2	<b>Barrier Test Level:</b>	NCW	<b>Is Barrier Crashworthy?:</b>	NO
<b>Beg. End Trtmt Type:</b>	NONE	<b>Is Beg. End Trtmt Crashworthy?:</b>	N/A	<b>Approach Transition Type:</b>	NONE
<b>Ending End Trtmt Type:</b>	NONE	<b>Ending End Trtmt Crashworthy?:</b>	N/A		
<b>Average Measurements</b>					
<b>Design Height (In.):</b>	18	<b>Width (In.):</b>	18.0	<b>Post Spacing (In.):</b>	0.0

<b>Height (In.):</b>	17.2	<b>Lateral Offset (In.):</b>	50.7	<b>Road Grade (%):</b>	3.40
<b>Physical Condition</b>					
<b>Barrier</b>	<b>Alignment and Height:</b>	Alignment acceptable. Height was within 3-in of the 18-in design height.			
	<b>Breaking and Cracking:</b>	5-ft section of rocks is loose and needs to be repointed			
	<b>Missing Elements:</b>	None observed			
	<b>Corrosion and Weathering:</b>	None observed			
<b>End Treatments</b>	<b>Alignment and Height:</b>				
	<b>Breaking and Cracking:</b>				
	<b>Missing Elements:</b>				
	<b>Corrosion and Weathering:</b>

<b>Repair Action:</b>	REPAIR	<b>FMSS Work Type:</b>	DEFERRED MAINTENANCE	<b>Repair Cost:</b>	\$2393
<b>Brief Workorder:</b>	Repoint 30 l.f. section of stone masonry barrier.				
<b>Workorder:</b>	Re-Point Masonry Barrier at \$140- per -Sq. Yd. for 5 SY = \$700. $[(30) \times (16/12)]/9 = 4.4$ SY. Round to 5 S.Y. Low Speed Traffic Control at \$1475- per -Day for 1 Day(s) = \$1475. One day to complete work.
