**GIP Report**

**NPS Guardwall/Rail Inventory Program  
Crater Lake National Park**

**Federal Highway Administration  
Eastern Federal Lands Highway Division  
Road Inventory Program (RIP)**

**Data Collection Date: July 2010  
Report Date: December 2015**

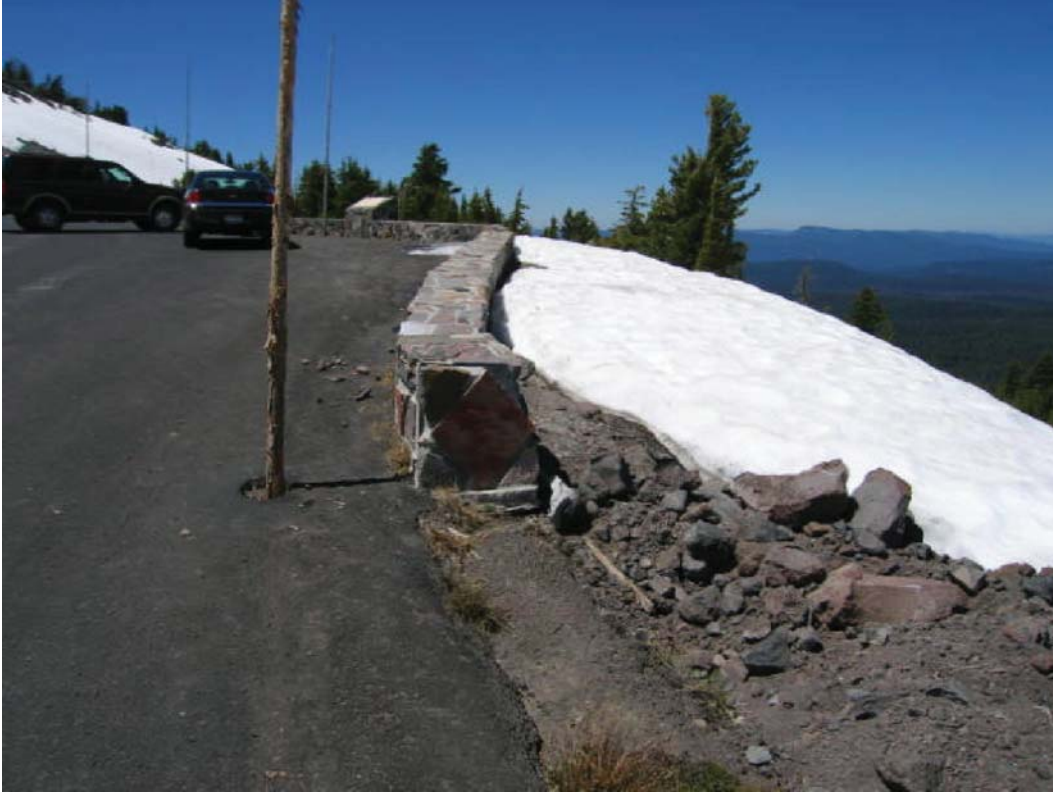
CRLA\_0014\_4.449\_L\_1.jpg

<b>Barrier ID:</b>	CRLA-0014-4.449-L				
<b>Route Name:</b>	WEST RIM DRIVE				
<b>Inspection Date:</b>	07/16/2010	<b>Barrier Rating:</b>	21.30		
<b>Barrier Description</b>					
<b>Type:</b>	STONE MASONRY WITHOUT CONCRETE CORE WALL	<b>Barrier Function:</b>	NON-TRAFFIC		
<b>Barrier Material:</b>	STONE	<b>Post Material:</b>	N/A		
<b>Blockout Type:</b>	N/A	<b>Length (ft.):</b>	168		
<b>Speed Limit (MPH):</b>	35	<b>Placement with Respect to Road:</b>	NON-TRAFFIC BARRIER		
<b>Hazard Behind Barrier:</b>	MEDIUM				
<b>Barrier Crashworthiness</b>					
<b>Appropriate Test Level:</b>	TL-2	<b>Barrier Test Level:</b>	N/A	<b>Is Barrier Crashworthy?:</b>	N/A
<b>Beg. End Trtmt Type:</b>	NONE	<b>Is Beg. End Trtmt Crashworthy?:</b>	N/A	<b>Approach Transition Type:</b>	NONE
<b>Ending End Trtmt Type:</b>	NONE	<b>Ending End Trtmt Crashworthy?:</b>	N/A		
<b>Average Measurements</b>					
<b>Design Height (In.):</b>	24	<b>Width (In.):</b>	19.0	<b>Post Spacing (In.):</b>	0.0

<b>Height (In.):</b>	16.7	<b>Lateral Offset (In.):</b>	0.0	<b>Road Grade (%):</b>	0.00
<b>Physical Condition</b>					
<b>Barrier</b>	<b>Alignment and Height:</b>	No deviations in horizontal or vertical alignment. Height is consistent but typically 6 in under 24 in design height.			
	<b>Breaking and Cracking:</b>	None observed			
	<b>Missing Elements:</b>	None observed			
	<b>Corrosion and Weathering:</b>	None observed			
<b>End Treatments</b>	<b>Alignment and Height:</b>				
	<b>Breaking and Cracking:</b>				
	<b>Missing Elements:</b>				
	<b>Corrosion and Weathering:</b>

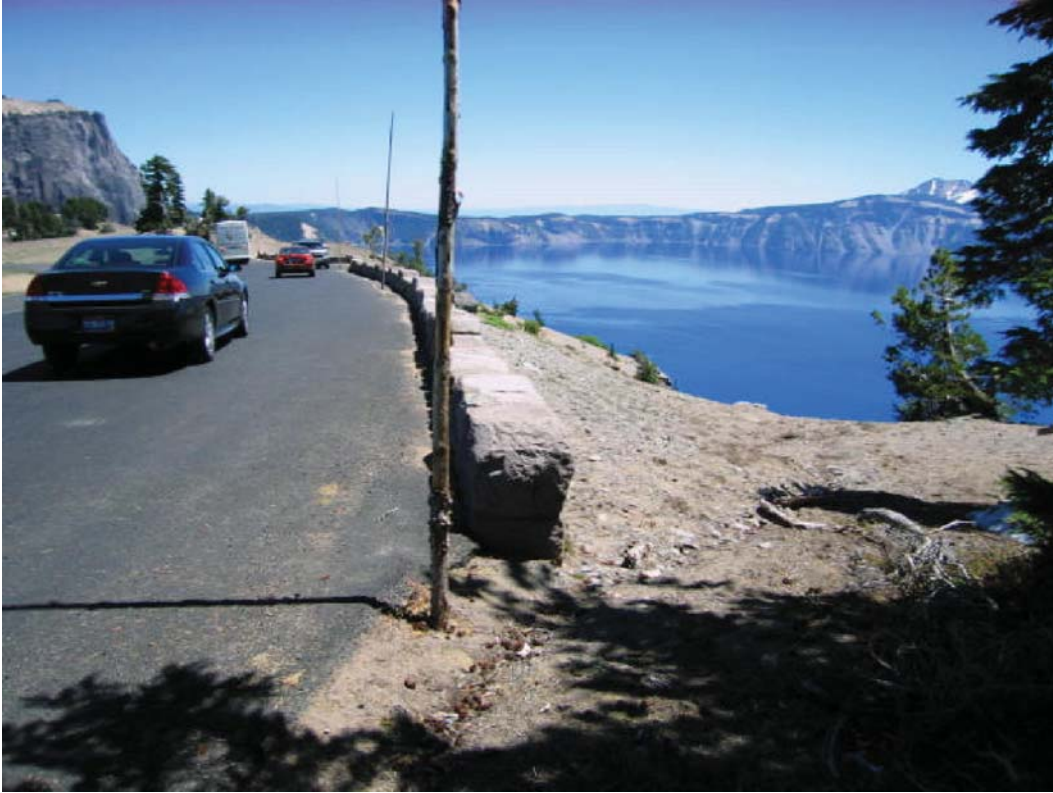
CRLA\_0014\_5.485\_R\_1.jpg

<b>Barrier ID:</b>	CRLA-0014-5.485-R				
<b>Route Name:</b>	WEST RIM DRIVE				
<b>Inspection Date:</b>	07/16/2010	<b>Barrier Rating:</b>	24.20		
<b>Barrier Description</b>					
<b>Type:</b>	STONE MASONRY CRENELLATED WITHOUT	<b>Barrier Function:</b>	NON-TRAFFIC		
<b>Barrier Material:</b>	STONE	<b>Post Material:</b>	N/A		
<b>Blockout Type:</b>	N/A	<b>Length (ft.):</b>	320		
<b>Speed Limit (MPH):</b>	35	<b>Placement with Respect to Road:</b>	NON-TRAFFIC BARRIER		
<b>Hazard Behind Barrier:</b>	N/A				
<b>Barrier Crashworthiness</b>					
<b>Appropriate Test Level:</b>	TL-2	<b>Barrier Test Level:</b>	N/A	<b>Is Barrier Crashworthy?:</b>	N/A
<b>Beg. End Trtmt Type:</b>	NONE	<b>Is Beg. End Trtmt Crashworthy?:</b>	N/A	<b>Approach Transition Type:</b>	NONE
<b>Ending End Trtmt Type:</b>	NONE	<b>Ending End Trtmt Crashworthy?:</b>	N/A		
<b>Average Measurements</b>					
<b>Design Height (In.):</b>	18	<b>Width (In.):</b>	19.7	<b>Post Spacing (In.):</b>	0.0

<b>Height (In.):</b>	18.2	<b>Lateral Offset (In.):</b>	0.0	<b>Road Grade (%):</b>	0.00
<b>Physical Condition</b>					
<b>Barrier</b>	<b>Alignment and Height:</b>	Alignment acceptable. Height was within 3-in of the 18-in design height.			
	<b>Breaking and Cracking:</b>	None observed.			
	<b>Missing Elements:</b>	None observed.			
	<b>Corrosion and Weathering:</b>	None observed.			
<b>End Treatments</b>	<b>Alignment and Height:</b>				
	<b>Breaking and Cracking:</b>				
	<b>Missing Elements:</b>				
	<b>Corrosion and Weathering:</b>
