# GLCA GIP Report

## NPS Guardwall/Rail Inventory Program Glen Canyon National Recreation Area

Federal Highway Administration  
Eastern Federal Lands Highway Division  
Road Inventory Program (RIP)

Data Collection Date: April 2010  
Report Date: November 2015

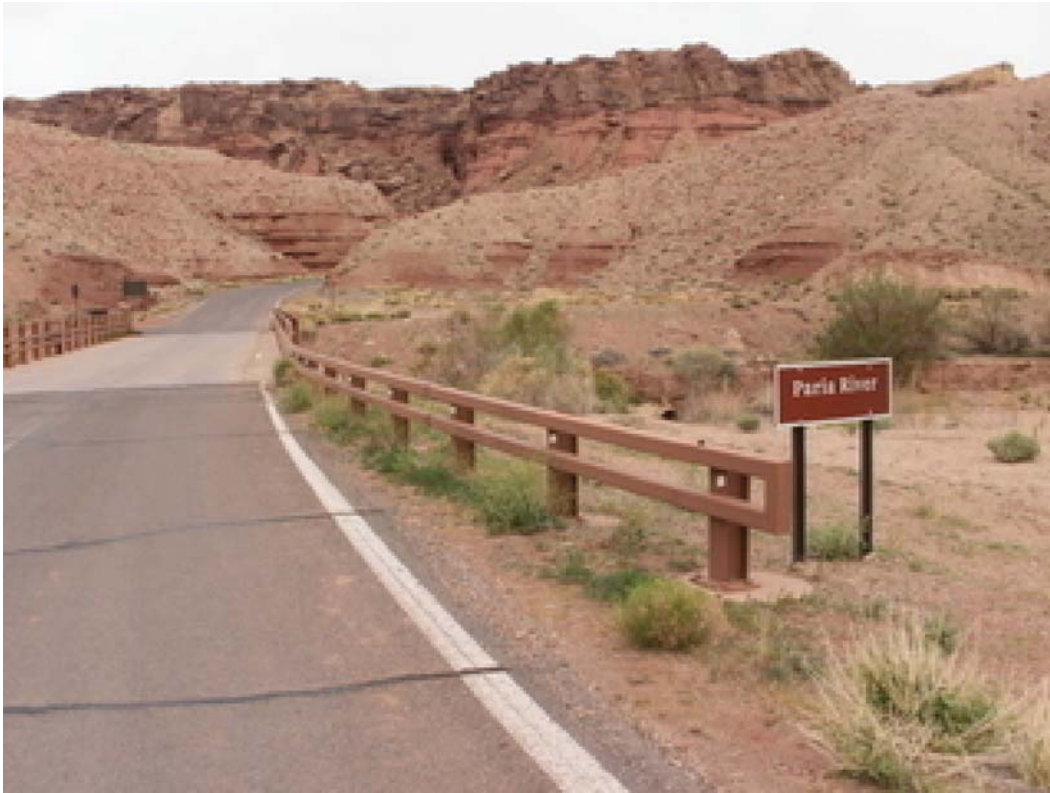
GLCA\_0005\_5.174\_L\_1.JPG

<b>Barrier ID:</b>	GLCA-0005-5.174-L				
<b>Route Name:</b>	LEES FERRY ACCESS ROAD				
<b>Inspection Date:</b>	04/22/2010	<b>Barrier Rating:</b>	8.00		
<b>Barrier Description</b>					
<b>Type:</b>	BOX BEAM	<b>Barrier Function:</b>	TRAFFIC		
<b>Barrier Material:</b>	OTHER: STEEL	<b>Post Material:</b>	OTHER: STEEL		
<b>Blockout Type:</b>	N/A	<b>Length (ft.):</b>	55		
<b>Speed Limit (MPH):</b>	25	<b>Placement with Respect to Road:</b>	TANGENT		
<b>Hazard Behind Barrier:</b>	MEDIUM				
<b>Barrier Crashworthiness</b>					
<b>Appropriate Test Level:</b>	TL-1	<b>Barrier Test Level:</b>	TL-3	<b>Is Barrier Crashworthy?:</b>	YES
<b>Beg. End Trtmt Type:</b>	NONE	<b>Is Beg. End Trtmt Crashworthy?:</b>	N/A	<b>Approach Transition Type:</b>	NONE
<b>Ending End Trtmt Type:</b>	NONE	<b>Ending End Trtmt Crashworthy?:</b>	N/A		
<b>Average Measurements</b>					
<b>Design Height (In.):</b>	27	<b>Width (In.):</b>	4.0	<b>Post Spacing (In.):</b>	75.0

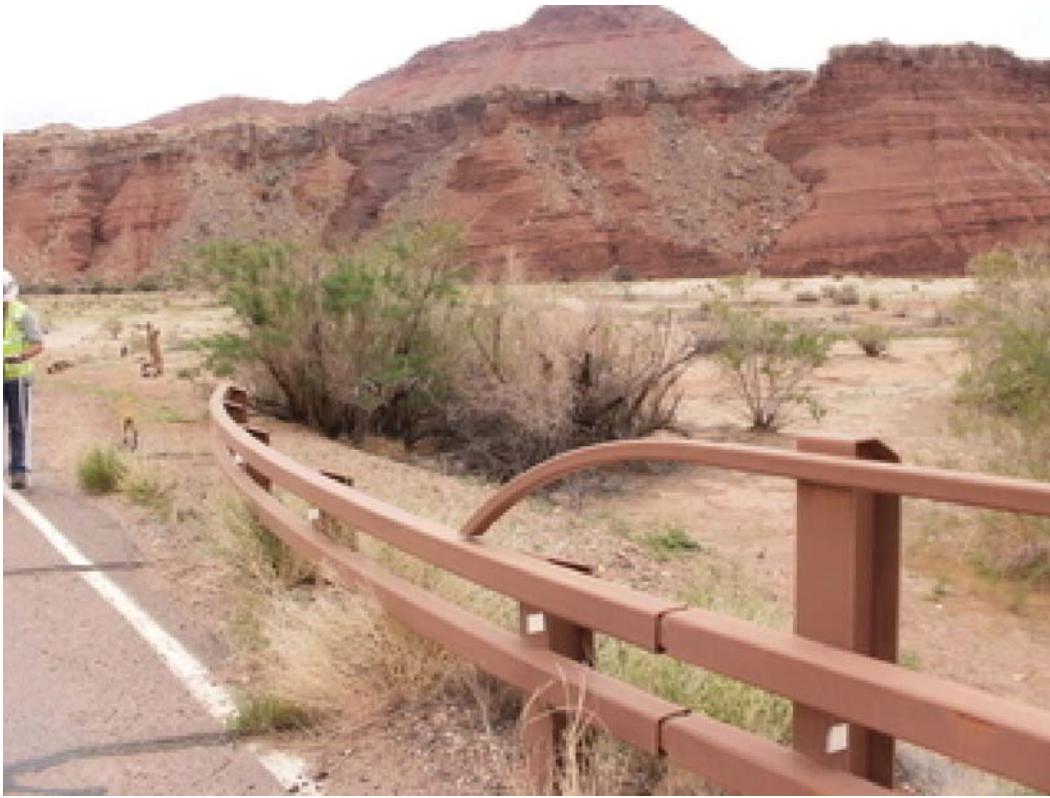
GLCA\_0005\_5.174\_R\_1.JPG

<b>Barrier ID:</b>	GLCA-0005-5.174-R				
<b>Route Name:</b>	LEES FERRY ACCESS ROAD				
<b>Inspection Date:</b>	04/22/2010	<b>Barrier Rating:</b>	8.00		
<b>Barrier Description</b>					
<b>Type:</b>	BOX BEAM	<b>Barrier Function:</b>	TRAFFIC		
<b>Barrier Material:</b>	OTHER: STEEL	<b>Post Material:</b>	OTHER: STEEL		
<b>Blockout Type:</b>	N/A	<b>Length (ft.):</b>	29		
<b>Speed Limit (MPH):</b>	25	<b>Placement with Respect to Road:</b>	TANGENT		
<b>Hazard Behind Barrier:</b>	MEDIUM				
<b>Barrier Crashworthiness</b>					
<b>Appropriate Test Level:</b>	TL-1	<b>Barrier Test Level:</b>	TL-3	<b>Is Barrier Crashworthy?:</b>	YES
<b>Beg. End Trtmt Type:</b>	NONE	<b>Is Beg. End Trtmt Crashworthy?:</b>	N/A	<b>Approach Transition Type:</b>	NONE
<b>Ending End Trtmt Type:</b>	NONE	<b>Ending End Trtmt Crashworthy?:</b>	N/A		
<b>Average Measurements</b>					
<b>Design Height (In.):</b>	27	<b>Width (In.):</b>	4.0	<b>Post Spacing (In.):</b>	75.0

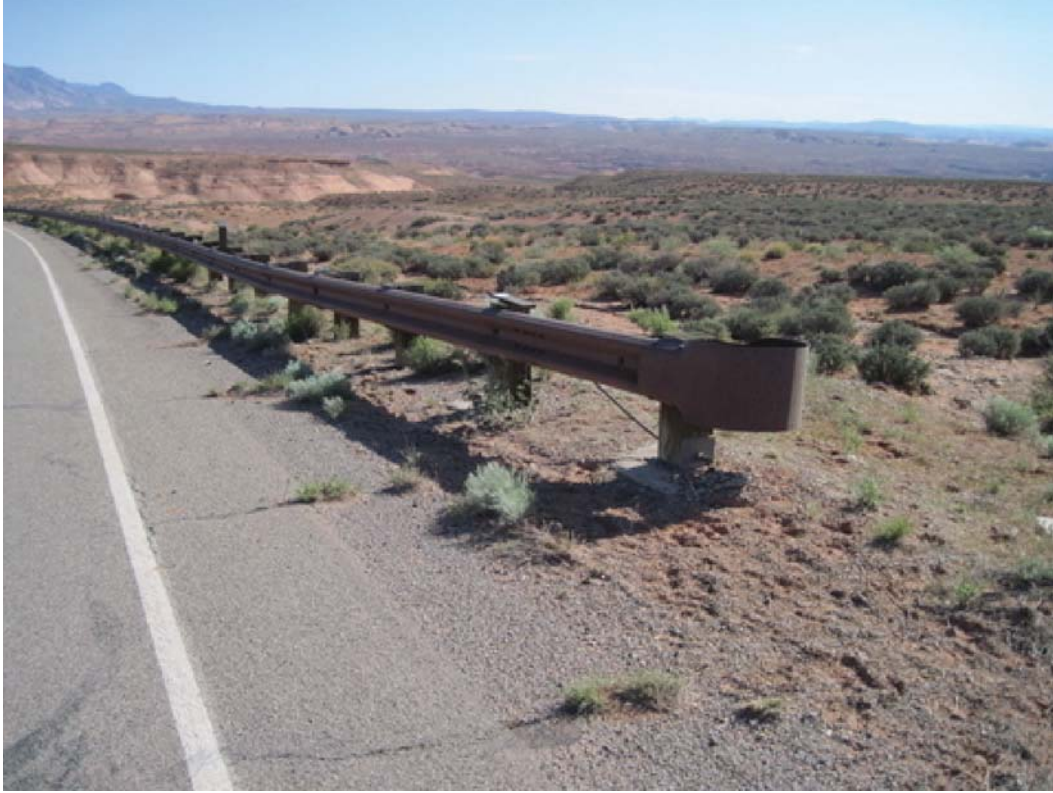
GLCA\_0006\_1.224\_L\_1.jpg

<b>Barrier ID:</b>	GLCA-0006-1.224-L				
<b>Route Name:</b>	BULLFROG BASIN ACCESS ROAD				
<b>Inspection Date:</b>	04/24/2010	<b>Barrier Rating:</b>	36.50		
<b>Barrier Description</b>					
<b>Type:</b>	W-BEAM STRONG POST	<b>Barrier Function:</b>	TRAFFIC		
<b>Barrier Material:</b>	WEATHERING STEEL/CORTEN	<b>Post Material:</b>	WOOD		
<b>Blockout Type:</b>	WOOD	<b>Length (ft.):</b>	882		
<b>Speed Limit (MPH):</b>	45	<b>Placement with Respect to Road:</b>	OUTSIDE OF CURVE		
<b>Hazard Behind Barrier:</b>	MEDIUM				
<b>Barrier Crashworthiness</b>					
<b>Appropriate Test Level:</b>	TL-2	<b>Barrier Test Level:</b>	TL-3	<b>Is Barrier Crashworthy?:</b>	YES
<b>Beg. End Trtmt Type:</b>	W-BEAM BCT	<b>Is Beg. End Trtmt Crashworthy?:</b>	NO	<b>Approach Transition Type:</b>	NONE
<b>Ending End Trtmt Type:</b>	W-BEAM TRAILING END	<b>Ending End Trtmt Crashworthy?:</b>	YES		
<b>Average Measurements</b>					
<b>Design Height (In.):</b>	27	<b>Width (In.):</b>	0.0	<b>Post Spacing (In.):</b>	75.0

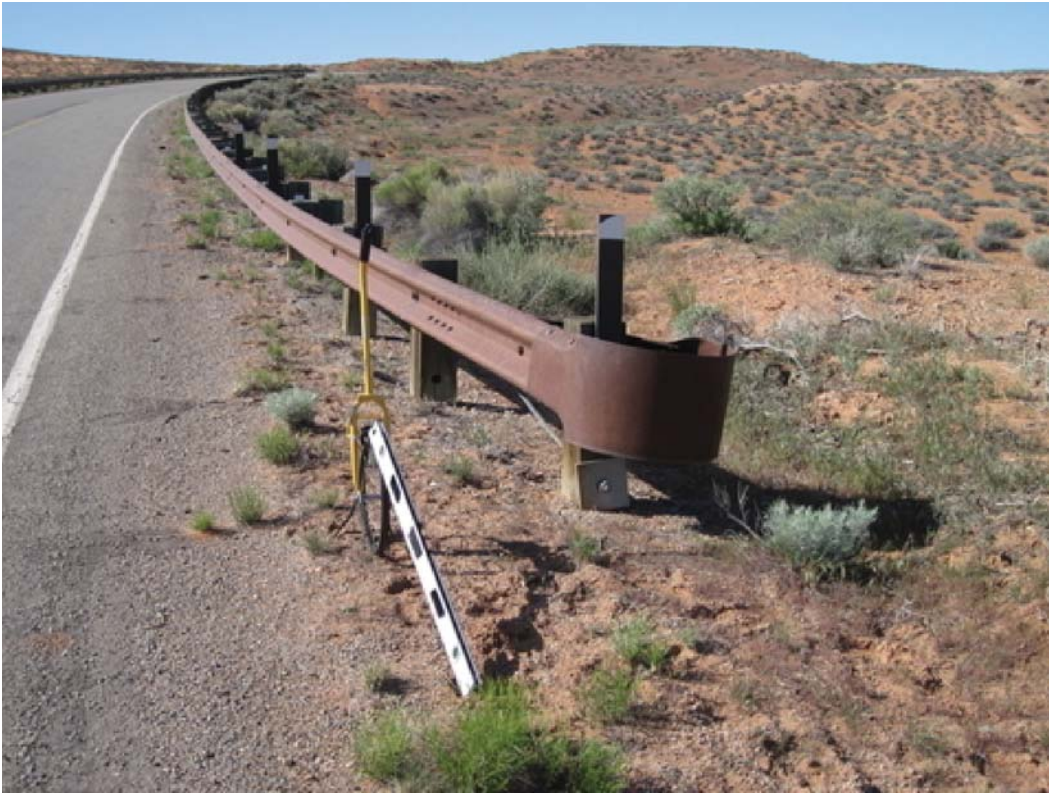
GLCA\_0006\_1.236\_R\_1.jpg

<b>Barrier ID:</b>	GLCA-0006-1.236-R				
<b>Route Name:</b>	BULLFROG BASIN ACCESS ROAD				
<b>Inspection Date:</b>	04/24/2010	<b>Barrier Rating:</b>	32.50		
<b>Barrier Description</b>					
<b>Type:</b>	W-BEAM STRONG POST	<b>Barrier Function:</b>	TRAFFIC		
<b>Barrier Material:</b>	WEATHERING STEEL/CORTEN	<b>Post Material:</b>	WOOD		
<b>Blockout Type:</b>	WOOD	<b>Length (ft.):</b>	548		
<b>Speed Limit (MPH):</b>	45	<b>Placement with Respect to Road:</b>	INSIDE OF CURVE		
<b>Hazard Behind Barrier:</b>	MEDIUM				
<b>Barrier Crashworthiness</b>					
<b>Appropriate Test Level:</b>	TL-2	<b>Barrier Test Level:</b>	TL-3	<b>Is Barrier Crashworthy?:</b>	YES
<b>Beg. End Trtmt Type:</b>	W-BEAM BCT	<b>Is Beg. End Trtmt Crashworthy?:</b>	NO	<b>Approach Transition Type:</b>	NONE
<b>Ending End Trtmt Type:</b>	W-BEAM TRAILING END	<b>Ending End Trtmt Crashworthy?:</b>	YES		
<b>Average Measurements</b>					
<b>Design Height (In.):</b>	27	<b>Width (In.):</b>	0.0	<b>Post Spacing (In.):</b>	75.3

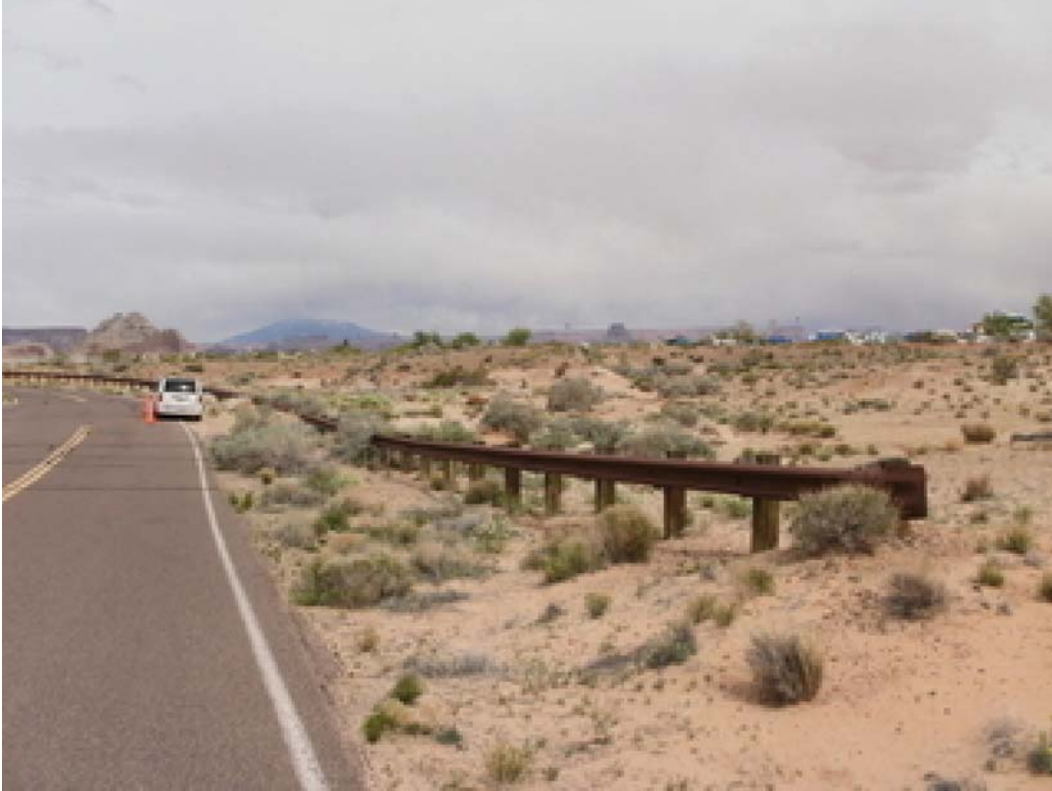
GLCA\_0204\_0.009\_L\_1.JPG

<b>Barrier ID:</b>	GLCA-0204-0.009-L				
<b>Route Name:</b>	COVES ROAD				
<b>Inspection Date:</b>	04/24/2010	<b>Barrier Rating:</b>	31.20		
<b>Barrier Description</b>					
<b>Type:</b>	W-BEAM STRONG POST	<b>Barrier Function:</b>	TRAFFIC		
<b>Barrier Material:</b>	WEATHERING STEEL/CORTEN	<b>Post Material:</b>	WOOD		
<b>Blockout Type:</b>	WOOD	<b>Length (ft.):</b>	515		
<b>Speed Limit (MPH):</b>	35	<b>Placement with Respect to Road:</b>	BOTH INSIDE AND OUTSIDE		
<b>Hazard Behind Barrier:</b>	LOW				
<b>Barrier Crashworthiness</b>					
<b>Appropriate Test Level:</b>	TL-2	<b>Barrier Test Level:</b>	TL-3	<b>Is Barrier Crashworthy?:</b>	YES
<b>Beg. End Trtmt Type:</b>	NONE	<b>Is Beg. End Trtmt Crashworthy?:</b>	N/A	<b>Approach Transition Type:</b>	NONE
<b>Ending End Trtmt Type:</b>	NONE	<b>Ending End Trtmt Crashworthy?:</b>	N/A		
<b>Average Measurements</b>					
<b>Design Height (In.):</b>	27	<b>Width (In.):</b>	0.0	<b>Post Spacing (In.):</b>	74.6

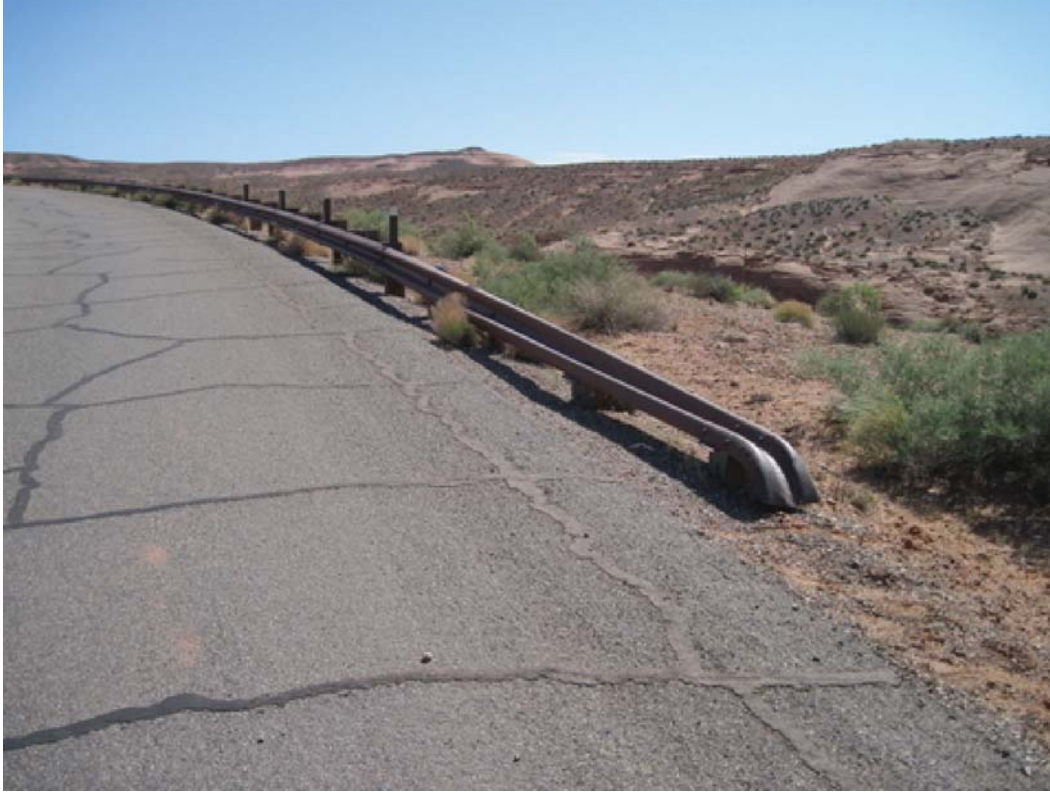
**GLCA\_0205\_1.437\_L\_1.jpg**

<b>Barrier ID:</b>	GLCA-0205-1.437-L				
<b>Route Name:</b>	BULLFROG BASIN FERRY BOAT RAMP ROAD				
<b>Inspection Date:</b>	04/24/2010	<b>Barrier Rating:</b>	44.20		
<b>Barrier Description</b>					
<b>Type:</b>	W-BEAM STRONG POST	<b>Barrier Function:</b>	TRAFFIC		
<b>Barrier Material:</b>	WEATHERING STEEL/CORTEN	<b>Post Material:</b>	WOOD		
<b>Blockout Type:</b>	WOOD	<b>Length (ft.):</b>	427		
<b>Speed Limit (MPH):</b>	15	<b>Placement with Respect to Road:</b>	OUTSIDE OF CURVE		
<b>Hazard Behind Barrier:</b>	HIGH				
<b>Barrier Crashworthiness</b>					
<b>Appropriate Test Level:</b>	TL-1	<b>Barrier Test Level:</b>	TL-3	<b>Is Barrier Crashworthy?:</b>	YES
<b>Beg. End Trtmt Type:</b>	W-BEAM TURN DOWN	<b>Is Beg. End Trtmt Crashworthy?:</b>	NO	<b>Approach Transition Type:</b>	NONE
<b>Ending End Trtmt Type:</b>	W-BEAM TURN DOWN	<b>Ending End Trtmt Crashworthy?:</b>	NO		
<b>Average Measurements</b>					
<b>Design Height (In.):</b>	27	<b>Width (In.):</b>	0.0	<b>Post Spacing (In.):</b>	75.0

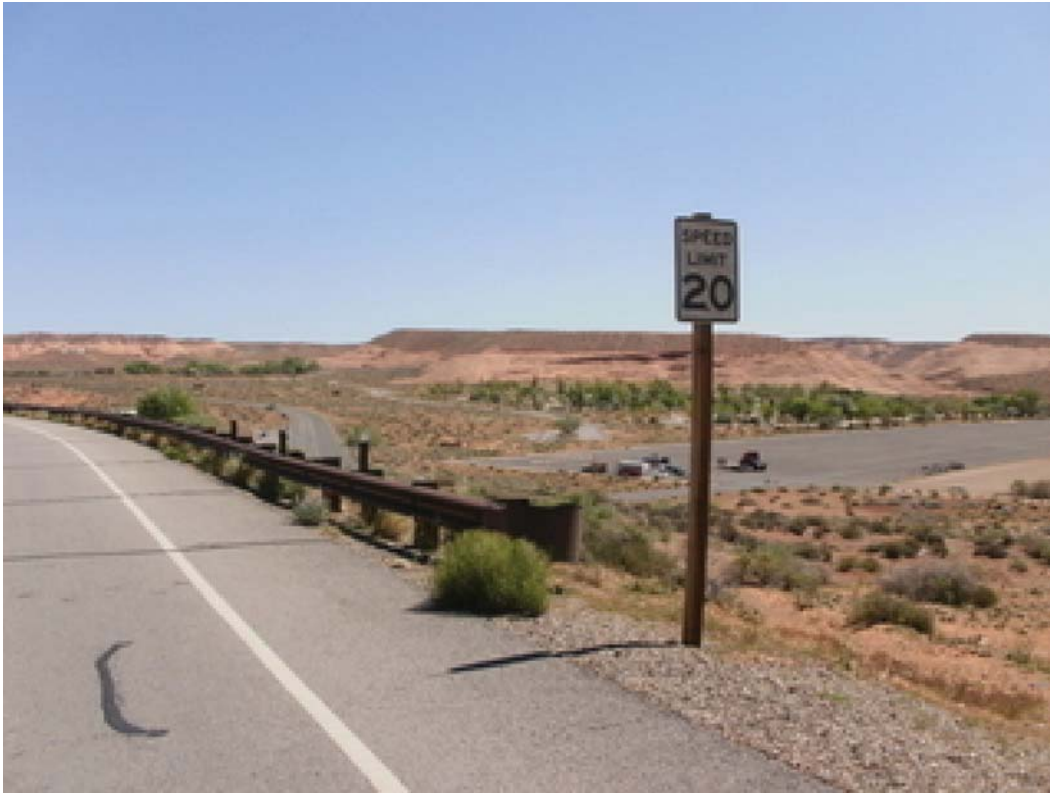
GLCA\_0416\_0.136\_L\_1.JPG

<b>Barrier ID:</b>	GLCA-0416-0.136-L				
<b>Route Name:</b>	BULLFROG BASIN LODGE ROAD				
<b>Inspection Date:</b>	04/24/2010	<b>Barrier Rating:</b>	51.20		
<b>Barrier Description</b>					
<b>Type:</b>	W-BEAM STRONG POST	<b>Barrier Function:</b>	TRAFFIC		
<b>Barrier Material:</b>	WEATHERING STEEL/CORTEN	<b>Post Material:</b>	WOOD		
<b>Blockout Type:</b>	WOOD	<b>Length (ft.):</b>	875		
<b>Speed Limit (MPH):</b>	20	<b>Placement with Respect to Road:</b>	OUTSIDE OF CURVE		
<b>Hazard Behind Barrier:</b>	HIGH				
<b>Barrier Crashworthiness</b>					
<b>Appropriate Test Level:</b>	TL-1	<b>Barrier Test Level:</b>	TL-3	<b>Is Barrier Crashworthy?:</b>	YES
<b>Beg. End Trtmt Type:</b>	W-BEAM TRAILING END	<b>Is Beg. End Trtmt Crashworthy?:</b>	YES	<b>Approach Transition Type:</b>	NONE
<b>Ending End Trtmt Type:</b>	W-BEAM BCT	<b>Ending End Trtmt Crashworthy?:</b>	NO		
<b>Average Measurements</b>					
<b>Design Height (In.):</b>	27	<b>Width (In.):</b>	0.0	<b>Post Spacing (In.):</b>	75.4

<b>Height (In.):</b>	23.5	<b>Lateral Offset (In.):</b>	84.1	<b>Road Grade (%):</b>	0.70
<b>Physical Condition</b>					
<b>Barrier</b>	<b>Alignment and Height:</b>	Alignment acceptable. Barrier height is 3 to 4 in below 27-in design height for entire barrier.			
	<b>Breaking and Cracking:</b>	Most posts and blocks in barrier are 5% to 50% cracked but retain original cross section.			
	<b>Missing Elements:</b>	No missing elements in barrier.			
	<b>Corrosion and Weathering:</b>	No corrosion in w-beam. Posts and blocks are moderately weathered.			
<b>End Treatments</b>	<b>Alignment and Height:</b>	Trailing end treatment is more than 6-in out of alignment. Both end treatments are 5 to 6 in below 27-inch design height.			
	<b>Breaking and Cracking:</b>	Approach end treatment has 1 broken block; trailing end treatment has 3 broken turned blocks.			
	<b>Missing Elements:</b>	No missing elements in end treatments observed.

<b>Corrosion and Weathering:</b>	No corrosion in end treatments; moderate weathering in posts and blocks.

<b>Repair Action:</b>	REPAIR	<b>FMSS Work Type:</b>	DEFERRED MAINTENANCE	<b>Repair Cost:</b>	\$16247
<b>Brief Workorder:</b>	Raise 875ft. of barrier up to 27-inch design height. Replace 4 broken blocks in end treatments. Monitor cracking in posts and blocks and monitor vegetation build up.				
<b>Workorder:</b>	Adjust Guardrail at \$10- per -Lin. Ft. for 875 LF = \$8750. Raise 875 ft. of barrier up to 27-in. design height. Replace Block at \$30- per -Each for 4 Block(s) = \$120. Replace broken blocks in end treatments. Low Speed Traffic Control at \$1475- per -Day for 4 Day(s) = \$5900.

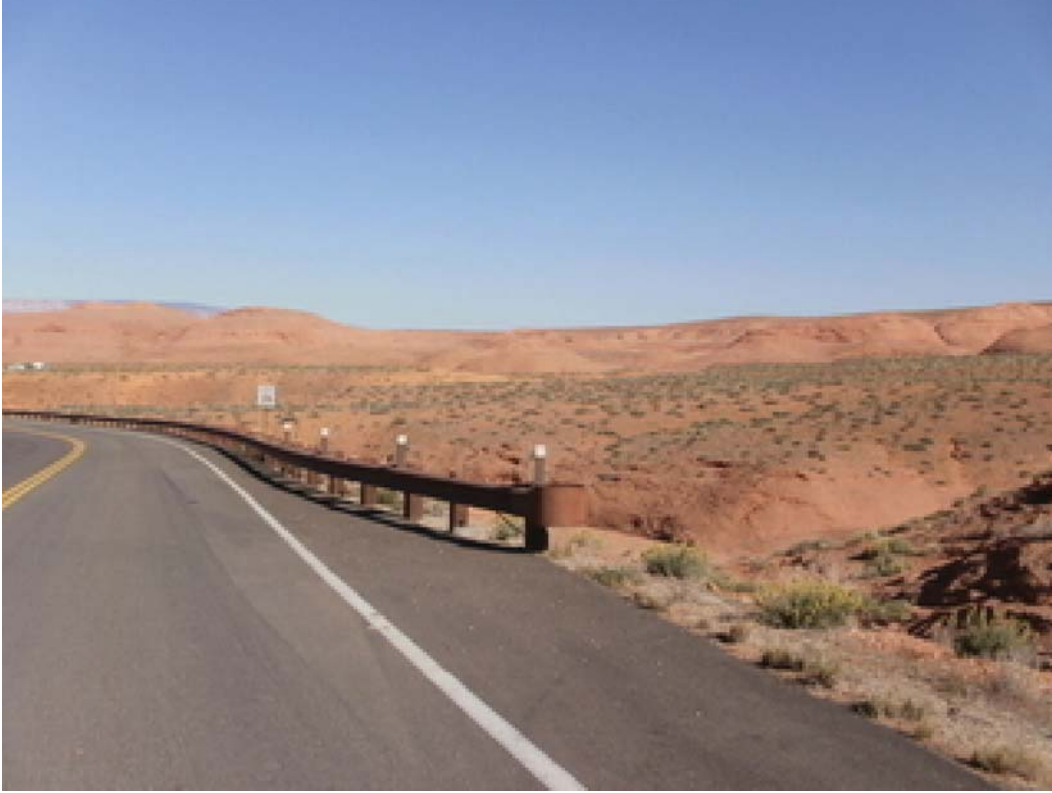
**GLCA\_0417\_0.073\_R\_1.JPG**

<b>Barrier ID:</b>	GLCA-0417-0.073-R				
<b>Route Name:</b>	BULLFROG BASIN VISITOR CENTER ROAD				
<b>Inspection Date:</b>	04/24/2010	<b>Barrier Rating:</b>	40.20		
<b>Barrier Description</b>					
<b>Type:</b>	W-BEAM STRONG POST	<b>Barrier Function:</b>	TRAFFIC		
<b>Barrier Material:</b>	WEATHERING STEEL/CORTEN	<b>Post Material:</b>	WOOD		
<b>Blockout Type:</b>	WOOD	<b>Length (ft.):</b>	717		
<b>Speed Limit (MPH):</b>	35	<b>Placement with Respect to Road:</b>	OUTSIDE OF CURVE		
<b>Hazard Behind Barrier:</b>	EXTREME				
<b>Barrier Crashworthiness</b>					
<b>Appropriate Test Level:</b>	TL-2	<b>Barrier Test Level:</b>	TL-3	<b>Is Barrier Crashworthy?:</b>	YES
<b>Beg. End Trtmt Type:</b>	W-BEAM BCT	<b>Is Beg. End Trtmt Crashworthy?:</b>	NO	<b>Approach Transition Type:</b>	NONE
<b>Ending End Trtmt Type:</b>	W-BEAM BCT	<b>Ending End Trtmt Crashworthy?:</b>	NO		
<b>Average Measurements</b>					
<b>Design Height (In.):</b>	27	<b>Width (In.):</b>	0.0	<b>Post Spacing (In.):</b>	74.5

<b>Height (In.):</b>	26.6	<b>Lateral Offset (In.):</b>	47.5	<b>Road Grade (%):</b>	4.50
<b>Physical Condition</b>					
<b>Barrier</b>	<b>Alignment and Height:</b>	Alignment is acceptable. Height is within 1-in of 27-in design height.			
	<b>Breaking and Cracking:</b>	All posts and blocks are cracked over 5% to 50% but retain original cross section. 6 blocks and 1 post are broken.			
	<b>Missing Elements:</b>	No missing elements in barrier.			
	<b>Corrosion and Weathering:</b>	No corrosion in w-beam. Moderately weathered posts and blocks.			
<b>End Treatments</b>	<b>Alignment and Height:</b>	Alignment is acceptable. Height is within 1-in of 27-in design height.			
	<b>Breaking and Cracking:</b>	There was no breaking or cracking observed in the end treatments.			
	<b>Missing Elements:</b>	No missing elements in end treatments observed.			
	<b>Corrosion and Weathering:</b>	No corrosion in end treatments but moderate weathering in posts and blocks.

<b>Repair Action:</b>	REPAIR	<b>FMSS Work Type:</b>	DEFERRED MAINTENANCE	<b>Repair Cost:</b>	\$1997
<b>Brief Workorder:</b>	Replace 6 blocks and 1 post. Adjust 1 turned block. Monitor all posts and blocks for cracking.				
<b>Workorder:</b>	Replace Block at \$30- per -Each for 6 Block(s) = \$180. Replace broken blocks. Replace Post at \$100- per -Each for 1 Post(s) = \$100. Replace broken post. Labor at \$60- per -Hour for 1 Hrs = \$60. Adjust turned block. Low Speed Traffic Control at \$1475- per -Day for 1 Day(s) = \$1475.

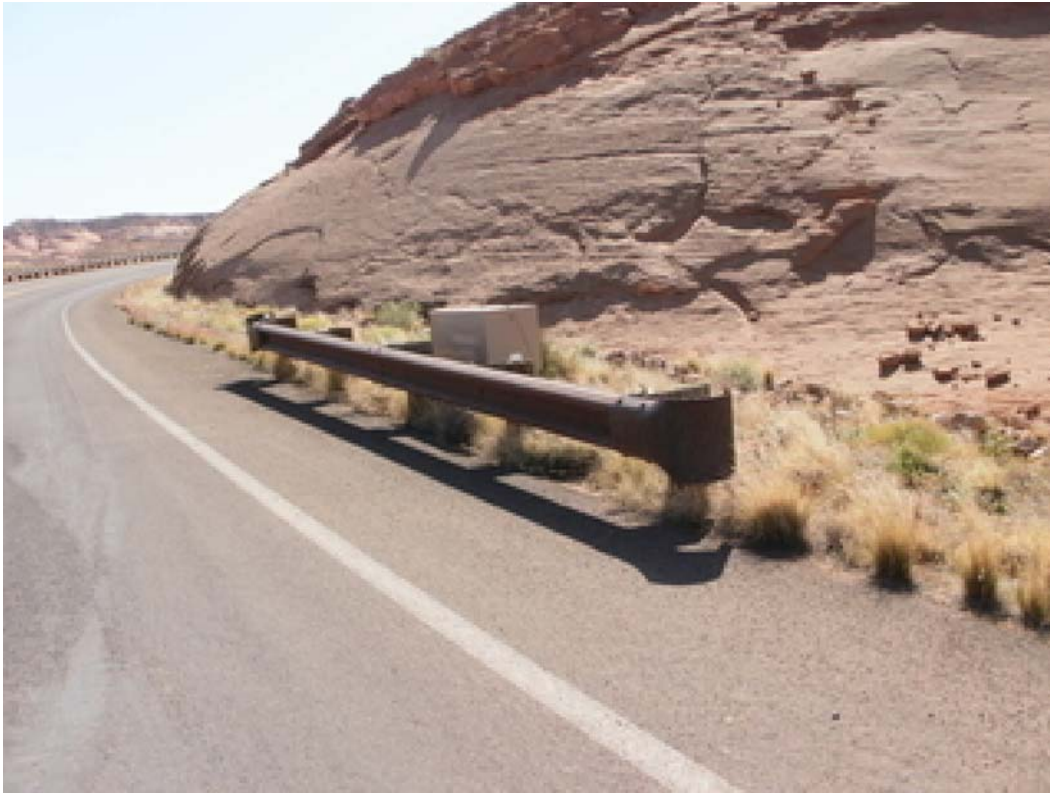
**GLCA\_0417\_0.199\_L\_1.JPG**

<b>Barrier ID:</b>	GLCA-0417-0.199-L				
<b>Route Name:</b>	BULLFROG BASIN VISITOR CENTER ROAD				
<b>Inspection Date:</b>	04/24/2010	<b>Barrier Rating:</b>	15.50		
<b>Barrier Description</b>					
<b>Type:</b>	W-BEAM STRONG POST	<b>Barrier Function:</b>	TRAFFIC		
<b>Barrier Material:</b>	WEATHERING STEEL/CORTEN	<b>Post Material:</b>	WOOD		
<b>Blockout Type:</b>	WOOD	<b>Length (ft.):</b>	29		
<b>Speed Limit (MPH):</b>	35	<b>Placement with Respect to Road:</b>	TANGENT		
<b>Hazard Behind Barrier:</b>	LOW				
<b>Barrier Crashworthiness</b>					
<b>Appropriate Test Level:</b>	TL-2	<b>Barrier Test Level:</b>	TL-3	<b>Is Barrier Crashworthy?:</b>	YES
<b>Beg. End Trtmt Type:</b>	NONE	<b>Is Beg. End Trtmt Crashworthy?:</b>	N/A	<b>Approach Transition Type:</b>	NONE
<b>Ending End Trtmt Type:</b>	NONE	<b>Ending End Trtmt Crashworthy?:</b>	N/A		
<b>Average Measurements</b>					
<b>Design Height (In.):</b>	27	<b>Width (In.):</b>	0.0	<b>Post Spacing (In.):</b>	74.3

<b>Height (In.):</b>	24.6	<b>Lateral Offset (In.):</b>	54.2	<b>Road Grade (%):</b>	4.40
<b>Physical Condition</b>					
<b>Barrier</b>	<b>Alignment and Height:</b>	Alignment acceptable. 29-ft was between 1 and 3-in below the 27-in design height.			
	<b>Breaking and Cracking:</b>	Minor cracking 1/4 to 1/2 in wide cracks on barrier posts and blocks.			
	<b>Missing Elements:</b>	No missing elements in barrier.			
	<b>Corrosion and Weathering:</b>	No major weathering of barrier.			
<b>End Treatments</b>	<b>Alignment and Height:</b>				
	<b>Breaking and Cracking:</b>				
	<b>Missing Elements:</b>				
	<b>Corrosion and Weathering:</b>

<b>Repair Action:</b>	REPAIR	<b>FMSS Work Type:</b>	DEFERRED MAINTENANCE	<b>Repair Cost:</b>	\$1942
<b>Brief Workorder:</b>	Raise 29ft. of barrier up to 27in. design height.				
<b>Workorder:</b>	Adjust Guardrail at \$10- per -Lin. Ft. for 29 LF = \$290. Raise 29ft. of barrier up to 27in. design height. Low Speed Traffic Control at \$1475- per -Day for 1 Day(s) = \$1475.

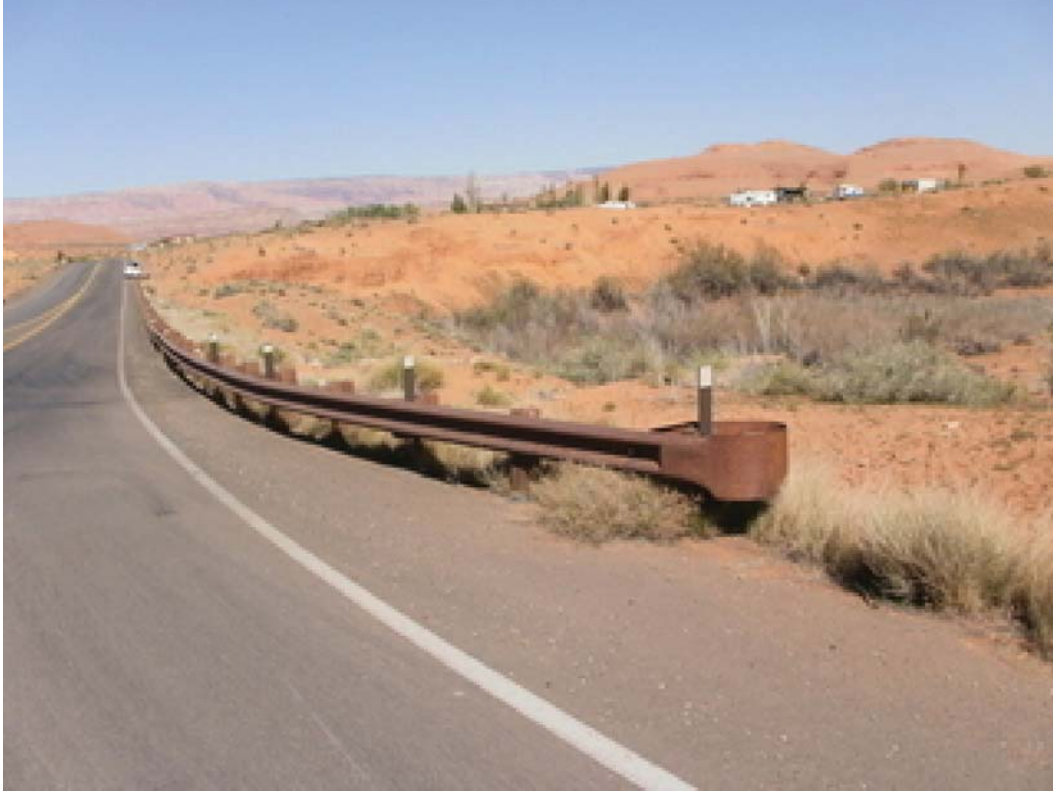
**GLCA\_0417\_0.317\_R\_1.JPG**

<b>Barrier ID:</b>	GLCA-0417-0.317-R				
<b>Route Name:</b>	BULLFROG BASIN VISITOR CENTER ROAD				
<b>Inspection Date:</b>	04/24/2010	<b>Barrier Rating:</b>	23.70		
<b>Barrier Description</b>					
<b>Type:</b>	W-BEAM STRONG POST	<b>Barrier Function:</b>	TRAFFIC		
<b>Barrier Material:</b>	WEATHERING STEEL/CORTEN	<b>Post Material:</b>	WOOD		
<b>Blockout Type:</b>	WOOD	<b>Length (ft.):</b>	382		
<b>Speed Limit (MPH):</b>	35	<b>Placement with Respect to Road:</b>	TANGENT		
<b>Hazard Behind Barrier:</b>	MEDIUM				
<b>Barrier Crashworthiness</b>					
<b>Appropriate Test Level:</b>	TL-2	<b>Barrier Test Level:</b>	TL-3	<b>Is Barrier Crashworthy?:</b>	YES
<b>Beg. End Trtmt Type:</b>	W-BEAM BCT	<b>Is Beg. End Trtmt Crashworthy?:</b>	NO	<b>Approach Transition Type:</b>	NONE
<b>Ending End Trtmt Type:</b>	W-BEAM BCT	<b>Ending End Trtmt Crashworthy?:</b>	NO		
<b>Average Measurements</b>					
<b>Design Height (In.):</b>	27	<b>Width (In.):</b>	0.0	<b>Post Spacing (In.):</b>	74.5

<b>Height (In.):</b>	25.2	<b>Lateral Offset (In.):</b>	37.2	<b>Road Grade (%):</b>	2.60
<b>Physical Condition</b>					
<b>Barrier</b>	<b>Alignment and Height:</b>	Alignment acceptable. 113-ft was between 1 and 3-in below the 27-in design height.			
	<b>Breaking and Cracking:</b>	Minor cracking 1/4 to 1/2 in wide cracks on posts and blocks in barrier.			
	<b>Missing Elements:</b>	1 broken block.			
	<b>Corrosion and Weathering:</b>	No major weathering of barrier elements.			
<b>End Treatments</b>	<b>Alignment and Height:</b>	Alignment acceptable. Height of end treatment at approach end is 3 in below design height of 27 ins.			
	<b>Breaking and Cracking:</b>	There was no breaking or cracking observed in the end treatments.			
	<b>Missing Elements:</b>	No missing elements in end treatments observed.			
	<b>Corrosion and Weathering:</b>	No major weathering of end treatments was observed.

<b>Repair Action:</b>	REPAIR	<b>FMSS Work Type:</b>	DEFERRED MAINTENANCE	<b>Repair Cost:</b>	\$2897
<b>Brief Workorder:</b>	Raise 113ft. of barrier up to 27in. design height and replace 1 block.				
<b>Workorder:</b>	Adjust Guardrail at \$10- per -Lin. Ft. for 113 LF = \$1130. Raise 113 ft. of barrier up to 27-in. design height. Replace Block at \$30- per -Each for 1 Block(s) = \$30. Low Speed Traffic Control at \$1475- per -Day for 1 Day(s) = \$1475.

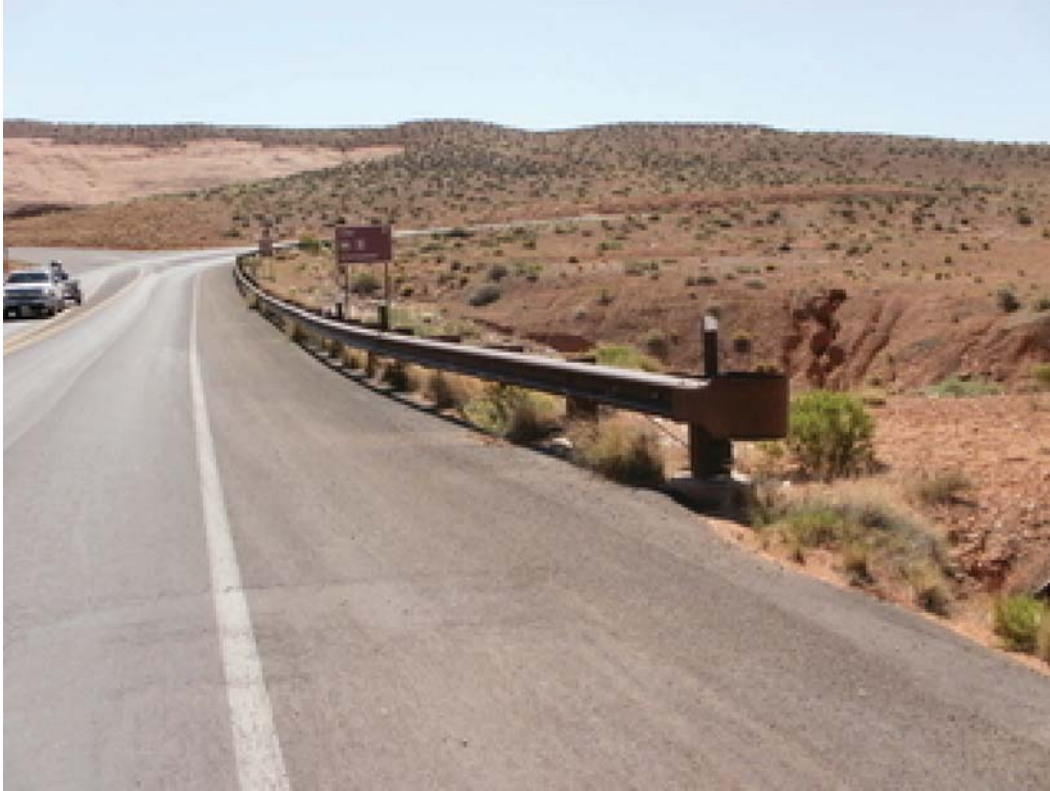
**GLCA\_0417\_0.321\_L\_1.JPG**

<b>Barrier ID:</b>	GLCA-0417-0.321-L				
<b>Route Name:</b>	BULLFROG BASIN VISITOR CENTER ROAD				
<b>Inspection Date:</b>	04/24/2010	<b>Barrier Rating:</b>	25.60		
<b>Barrier Description</b>					
<b>Type:</b>	W-BEAM STRONG POST	<b>Barrier Function:</b>	TRAFFIC		
<b>Barrier Material:</b>	WEATHERING STEEL/CORTEN	<b>Post Material:</b>	WOOD		
<b>Blockout Type:</b>	WOOD	<b>Length (ft.):</b>	359		
<b>Speed Limit (MPH):</b>	35	<b>Placement with Respect to Road:</b>	INSIDE OF CURVE		
<b>Hazard Behind Barrier:</b>	HIGH				
<b>Barrier Crashworthiness</b>					
<b>Appropriate Test Level:</b>	TL-2	<b>Barrier Test Level:</b>	TL-3	<b>Is Barrier Crashworthy?:</b>	YES
<b>Beg. End Trtmt Type:</b>	W-BEAM BCT	<b>Is Beg. End Trtmt Crashworthy?:</b>	NO	<b>Approach Transition Type:</b>	NONE
<b>Ending End Trtmt Type:</b>	W-BEAM BCT	<b>Ending End Trtmt Crashworthy?:</b>	NO		
<b>Average Measurements</b>					
<b>Design Height (In.):</b>	27	<b>Width (In.):</b>	0.0	<b>Post Spacing (In.):</b>	74.3

<b>Height (In.):</b>	26.7	<b>Lateral Offset (In.):</b>	88.3	<b>Road Grade (%):</b>	3.80
<b>Physical Condition</b>					
<b>Barrier</b>	<b>Alignment and Height:</b>	Alignment acceptable. 12-ft was between 1 and 3-in below the 27-in design height.			
	<b>Breaking and Cracking:</b>	3 blocks and 2 post mounted delineators are broken. 3 blocks are turned and 1 post is broken. 120 ft of barrier has blocks and posts that are 5% to 50% cracked but retain original cross section.			
	<b>Missing Elements:</b>	2 post mounted delineators are broken off of barrier post; no other missing elements in barrier			
	<b>Corrosion and Weathering:</b>	No corrosion in w-beam. Moderate weathering of posts and blocks with one rotted post in barrier.			
<b>End Treatments</b>	<b>Alignment and Height:</b>	Alignment is acceptable. Height is within 1-in of 27-in design height.			
	<b>Breaking and Cracking:</b>	There was no breaking or cracking observed in the end treatments.

<b>Missing Elements:</b>	No missing elements in end treatments observed.			
	<b>Corrosion and Weathering:</b>	No corrosion in end treatment; moderate weathering of posts and blocks in end treatments.

<b>Repair Action:</b>	REPAIR	<b>FMSS Work Type:</b>	DEFERRED MAINTENANCE	<b>Repair Cost:</b>	\$2316
<b>Brief Workorder:</b>	Raise 12 feet of barrier up to 27-in. design height and replace 3 broken blocks 1 rotted post and 2 broken delineators. Adjust 3 turned blocks. Monitor cracking in posts and blocks.				
<b>Workorder:</b>	Adjust Guardrail at \$10- per -Lin. Ft. for 12 LF = \$120. Raise 12ft. of barrier to 27in. design height. Replace Block at \$30- per -Each for 3 Block(s) = \$90. Replace broken blocks. Replace Post at \$100- per -Each for 1 Post(s) = \$100. Replace rotted post. Delineators on Curve and Tangent at \$100- per -Each for 2 Unit(s) = \$200. Replace 2 post mounted delineators. Labor at \$60- per -Hour for 2 Hrs = \$120. Adjust 3 turned blocks. Low Speed Traffic Control at \$1475- per -Day for 1 Day(s) = \$1475.
