GOGA GIP Report

NPS Guardwall/Rail Inventory Program Golden Gate National Recreation Area

**Federal Highway Administration
Eastern Federal Lands Highway Division
Road Inventory Program (RIP)**

**Data Collection Date: November 2009
Report Date: November 2015**

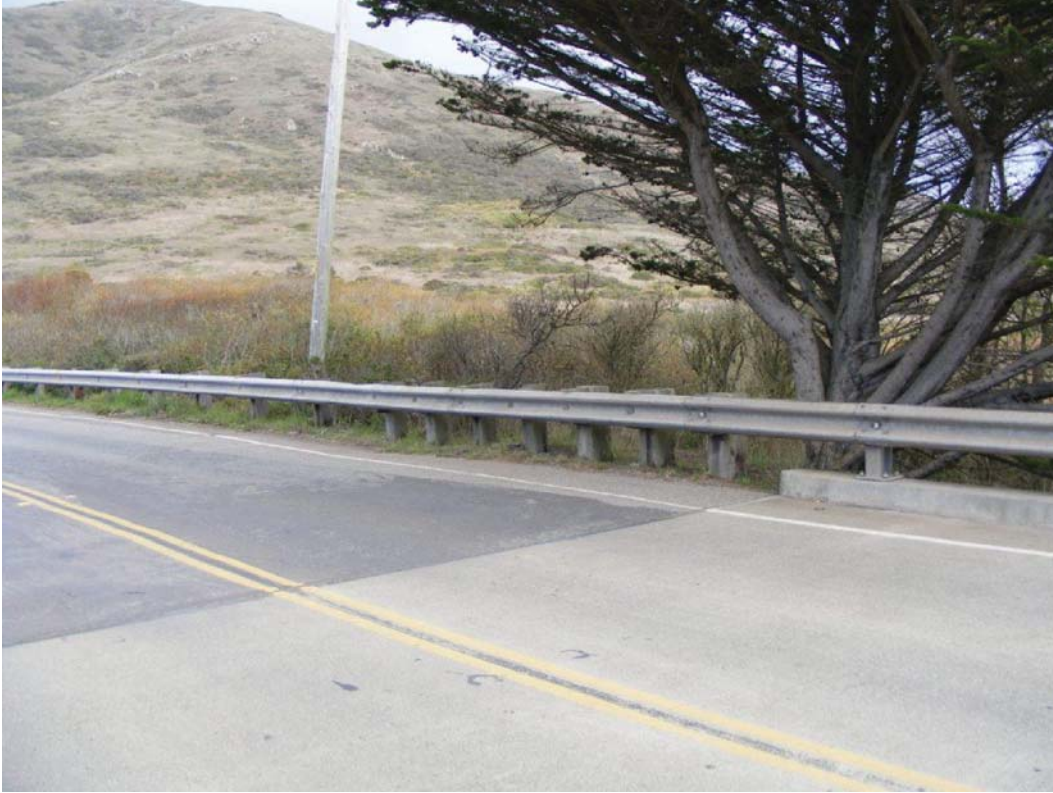
GOGA_0105_3.287_R_1.jpg

Barrier ID:	GOGA-0105-3.287-R				
Route Name:	BUNKER ROAD				
Inspection Date:	04/11/2009	Barrier Rating:	16.60		
Barrier Description					
Type:	W-BEAM STRONG POST	Barrier Function:	TRAFFIC		
Barrier Material:	GALVANIZED STEEL	Post Material:	WOOD		
Blockout Type:	WOOD	Length (ft.):	118		
Speed Limit (MPH):	25	Placement with Respect to Road:	OUTSIDE OF CURVE		
Hazard Behind Barrier:	MEDIUM				
Barrier Crashworthiness					
Appropriate Test Level:	TL-1	Barrier Test Level:	TL-3	Is Barrier Crashworthy?:	YES
Beg. End Trtmt Type:	NONE	Is Beg. End Trtmt Crashworthy?:	N/A	Approach Transition Type:	BRIDGE RAIL W-BEAM
Ending End Trtmt Type:	W-BEAM BCT	Ending End Trtmt Crashworthy?:	NO		
Average Measurements					
Design Height (In.):	27	Width (In.):	0.0	Post Spacing (In.):	74.5
Height (In.):	28.6	Lateral Offset (In.):	35.5	Road Grade (%):	1.20
Physical Condition					
Barrier	Alignment and Height:	Alignment acceptable. Height was 0-3in above the 27-in design height.

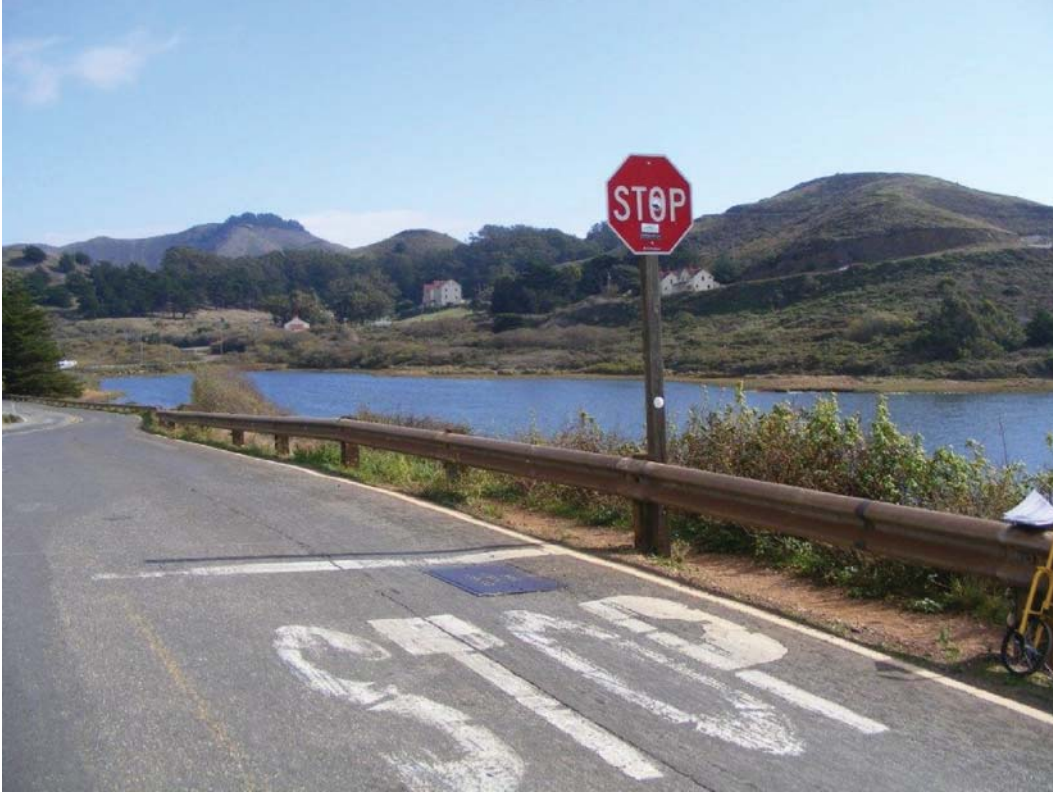
GOGA_0105_3.420_L_1.jpg

Barrier ID:	GOGA-0105-3.420-L				
Route Name:	BUNKER ROAD				
Inspection Date:	04/11/2009	Barrier Rating:	46.70		
Barrier Description					
Type:	W-BEAM WEAK POST	Barrier Function:	TRAFFIC		
Barrier Material:	GALVANIZED STEEL	Post Material:	WOOD		
Blockout Type:	N/A	Length (ft.):	877		
Speed Limit (MPH):	35	Placement with Respect to Road:	BOTH INSIDE AND OUTSIDE		
Hazard Behind Barrier:	MEDIUM				
Barrier Crashworthiness					
Appropriate Test Level:	TL-2	Barrier Test Level:	TL-2	Is Barrier Crashworthy?:	YES
Beg. End Trtmt Type:	NONE	Is Beg. End Trtmt Crashworthy?:	N/A	Approach Transition Type:	NONE
Ending End Trtmt Type:	NONE	Ending End Trtmt Crashworthy?:	N/A		
Average Measurements					
Design Height (In.):	27	Width (In.):	0.0	Post Spacing (In.):	150.1
Height (In.):	25.0	Lateral Offset (In.):	26.7	Road Grade (%):	3.20
Physical Condition					
Barrier	Alignment and Height:	Alignment acceptable. 600-ft was between 1 and 3-in below the 27-in design height.

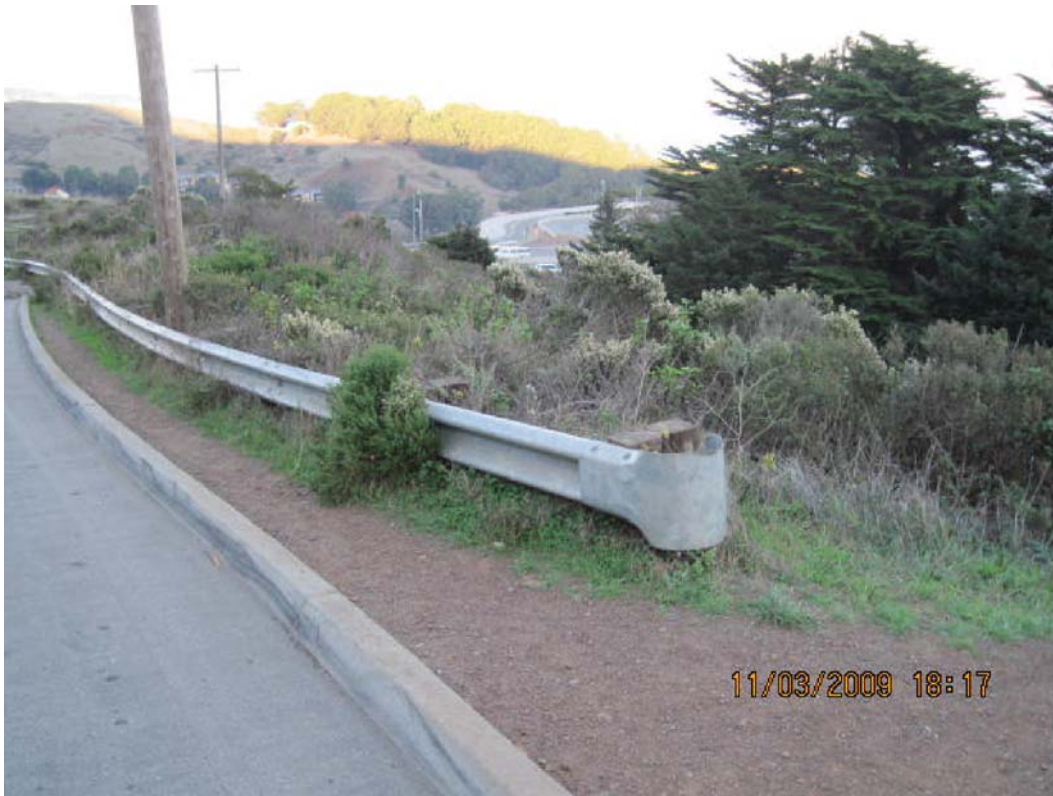
GOGA_0109ZZ_0.035_L_1.jpg

Barrier ID:	GOGA-0109ZZ-0.035-L				
Route Name:	CONZELMAN ROAD				
Inspection Date:	03/11/2009	Barrier Rating:	51.20		
Barrier Description					
Type:	W-BEAM STRONG POST	Barrier Function:	TRAFFIC		
Barrier Material:	GALVANIZED STEEL	Post Material:	WOOD		
Blockout Type:	WOOD	Length (ft.):	153		
Speed Limit (MPH):	25	Placement with Respect to Road:	OUTSIDE OF CURVE		
Hazard Behind Barrier:	MEDIUM				
Barrier Crashworthiness					
Appropriate Test Level:	TL-1	Barrier Test Level:	TL-3	Is Barrier Crashworthy?:	YES
Beg. End Trtmt Type:	NONE	Is Beg. End Trtmt Crashworthy?:	N/A	Approach Transition Type:	NONE
Ending End Trtmt Type:	NONE	Ending End Trtmt Crashworthy?:	N/A		
Average Measurements					
Design Height (In.):	27	Width (In.):	0.0	Post Spacing (In.):	75.3
Height (In.):	20.7	Lateral Offset (In.):	126.0	Road Grade (%):	10.80
Physical Condition					
Barrier	Alignment and Height:	Alignment acceptable. Entire barrier is between 6-7in below the 27-in design height.

Breaking and Cracking:	60 ft of rail is cracked or dented.			
	Missing Elements:	No missing elements.			
	Corrosion and Weathering:	No corrosion or weathering observed.			
End Treatments	Alignment and Height:				
	Breaking and Cracking:				
	Missing Elements:				
	Corrosion and Weathering:

Repair Action:	REPAIR	FMSS Work Type:	DEFERRED MAINTENANCE	Repair Cost:	\$4956
Brief Workorder:	Raise 153ft. of barrier up to 27-in design height and replace 60 L.F. of rail.				
Workorder:	Adjust Guardrail at \$10- per -Lin. Ft. for 153 LF = \$1530. Raise 153ft. of barrier up to 27-in design height. Replace rail at \$25- per -Lin. Ft. for 60 LF = \$1500. Low Speed Traffic Control at \$1475- per -Day for 1 Day(s) = \$1475.

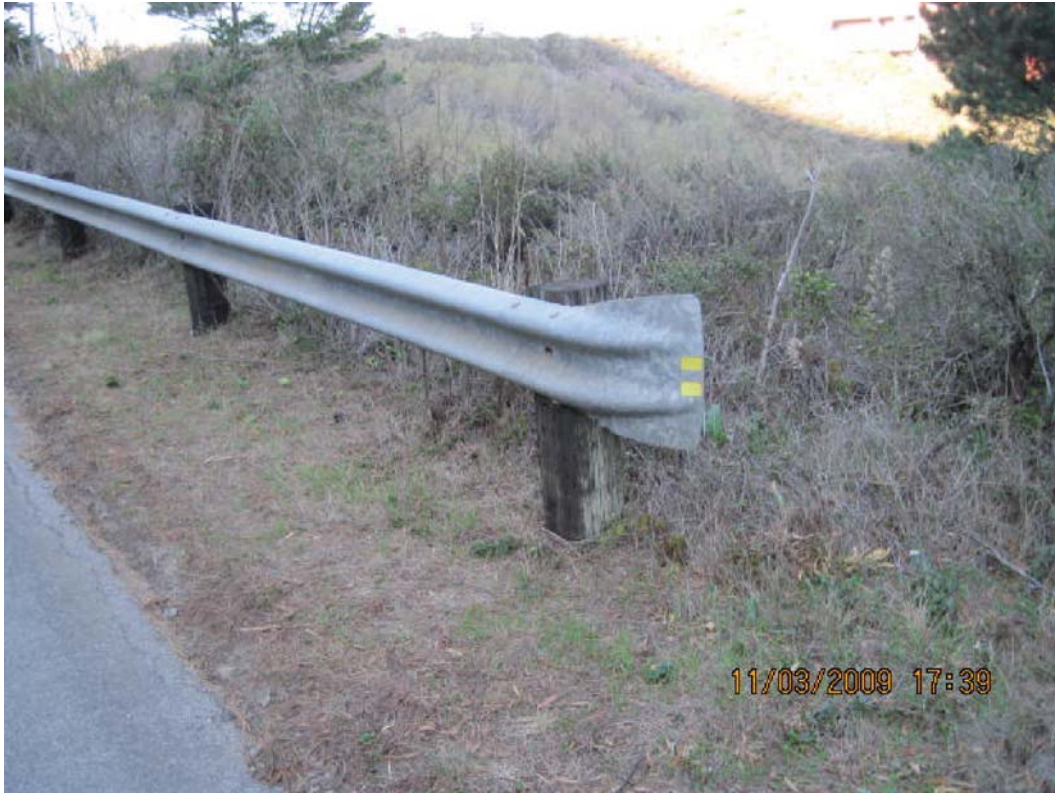
GOGA_0109ZZ_0.153_R_1.jpg

Barrier ID:	GOGA-0109ZZ-0.153-R				
Route Name:	CONZELMAN ROAD				
Inspection Date:	03/11/2009	Barrier Rating:	27.20		
Barrier Description					
Type:	W-BEAM WEAK POST	Barrier Function:	TRAFFIC		
Barrier Material:	GALVANIZED STEEL	Post Material:	WOOD		
Blockout Type:	N/A	Length (ft.):	445		
Speed Limit (MPH):	15	Placement with Respect to Road:	INSIDE OF CURVE		
Hazard Behind Barrier:	LOW				
Barrier Crashworthiness					
Appropriate Test Level:	TL-1	Barrier Test Level:	TL-2	Is Barrier Crashworthy?:	YES
Beg. End Trtmt Type:	NONE	Is Beg. End Trtmt Crashworthy?:	N/A	Approach Transition Type:	NONE
Ending End Trtmt Type:	NONE	Ending End Trtmt Crashworthy?:	N/A		
Average Measurements					
Design Height (In.):	27	Width (In.):	0.0	Post Spacing (In.):	149.3
Height (In.):	33.0	Lateral Offset (In.):	40.0	Road Grade (%):	7.70
Physical Condition					
Barrier	Alignment and Height:	Alignment acceptable. Height was 5-7in. above the 27-in design height.

Breaking and Cracking:	7 rails were bent. 1 cracked post (1in wide and goes entire vertical length of post)			
	Missing Elements:	No missing elements.			
	Corrosion and Weathering:	Some moss growing on posts.			
End Treatments	Alignment and Height:				
	Breaking and Cracking:				
	Missing Elements:				
	Corrosion and Weathering:

Repair Action:	REPAIR	FMSS Work Type:	DEFERRED MAINTENANCE	Repair Cost:	\$5418
Brief Workorder:	Lower 125ft. of barrier down to 27-in design height and replace 7 bent rails and 1 cracked post.				
Workorder:	Adjust Guardrail at \$10- per -Lin. Ft. for 125 LF = \$1250. Lower 125ft. of barrier down to 27-in design height. Replace rail at \$25- per -Lin. Ft. for 84 LF = \$2100. Replace post at \$100- per -Each for 1 Post(s) = \$100. Low Speed Traffic Control at \$1475- per -Day for 1 Day(s) = \$1475.

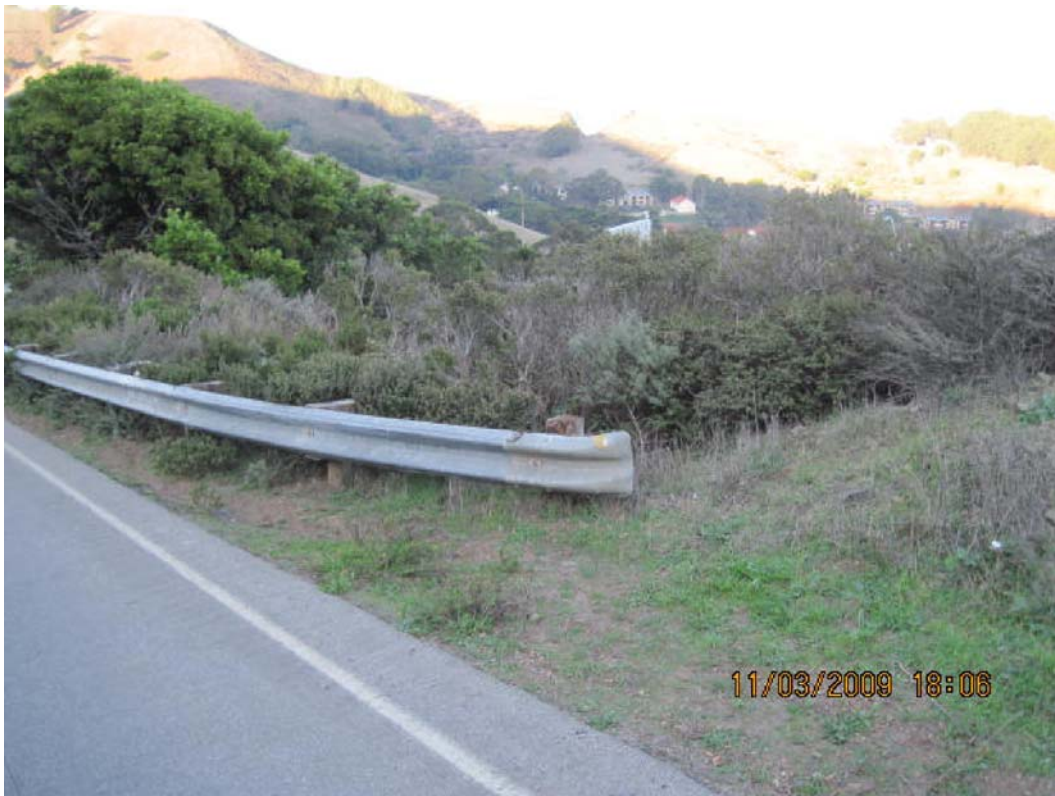
GOGA_0109ZZ_0.191_L_1.jpg

Barrier ID:	GOGA-0109ZZ-0.191-L				
Route Name:	CONZELMAN ROAD				
Inspection Date:	03/11/2009	Barrier Rating:	34.50		
Barrier Description					
Type:	W-BEAM STRONG POST	Barrier Function:	TRAFFIC		
Barrier Material:	GALVANIZED STEEL	Post Material:	WOOD		
Blockout Type:	WOOD	Length (ft.):	133		
Speed Limit (MPH):	25	Placement with Respect to Road:	TANGENT		
Hazard Behind Barrier:	LOW				
Barrier Crashworthiness					
Appropriate Test Level:	TL-1	Barrier Test Level:	TL-3	Is Barrier Crashworthy?:	YES
Beg. End Trtmt Type:	NONE	Is Beg. End Trtmt Crashworthy?:	N/A	Approach Transition Type:	NONE
Ending End Trtmt Type:	NONE	Ending End Trtmt Crashworthy?:	N/A		
Average Measurements					
Design Height (In.):	27	Width (In.):	0.0	Post Spacing (In.):	75.0
Height (In.):	23.7	Lateral Offset (In.):	42.0	Road Grade (%):	11.40
Physical Condition					
Barrier	Alignment and Height:	Alignment acceptable. 63-ft was between 1 and 3-in below the 27-in design height and 70-ft was more than 3-in below the design height.

Breaking and Cracking:	7 cracked posts 1 cracked blockout.			
	Missing Elements:	No missing elements.			
	Corrosion and Weathering:	No corrosion or weathering observed. Vegetation growing in front of barrier.			
End Treatments	Alignment and Height:				
	Breaking and Cracking:				
	Missing Elements:				
	Corrosion and Weathering:

Repair Action:	REPAIR	FMSS Work Type:	DEFERRED MAINTENANCE	Repair Cost:	\$4087
Brief Workorder:	Raise 133L.F. of guardrail up to 27-in design height. Replace 7 posts 1 block and remove vegetation from in front of barrier.				
Workorder:	Adjust Guardrail at \$10- per -Lin. Ft. for 133 LF = \$1330. Raise 133ft. of barrier up to 27-in design height. Replace post at \$100- per -Each for 7 Post(s) = \$700. Replace block at \$30- per -Each for 1 Block(s) = \$30. Labor at \$60- per -Hour for 3 Hrs = \$180. Remove vegetation in front of barrier. Low Speed Traffic Control at \$1475- per -Day for 1 Day(s) = \$1475.

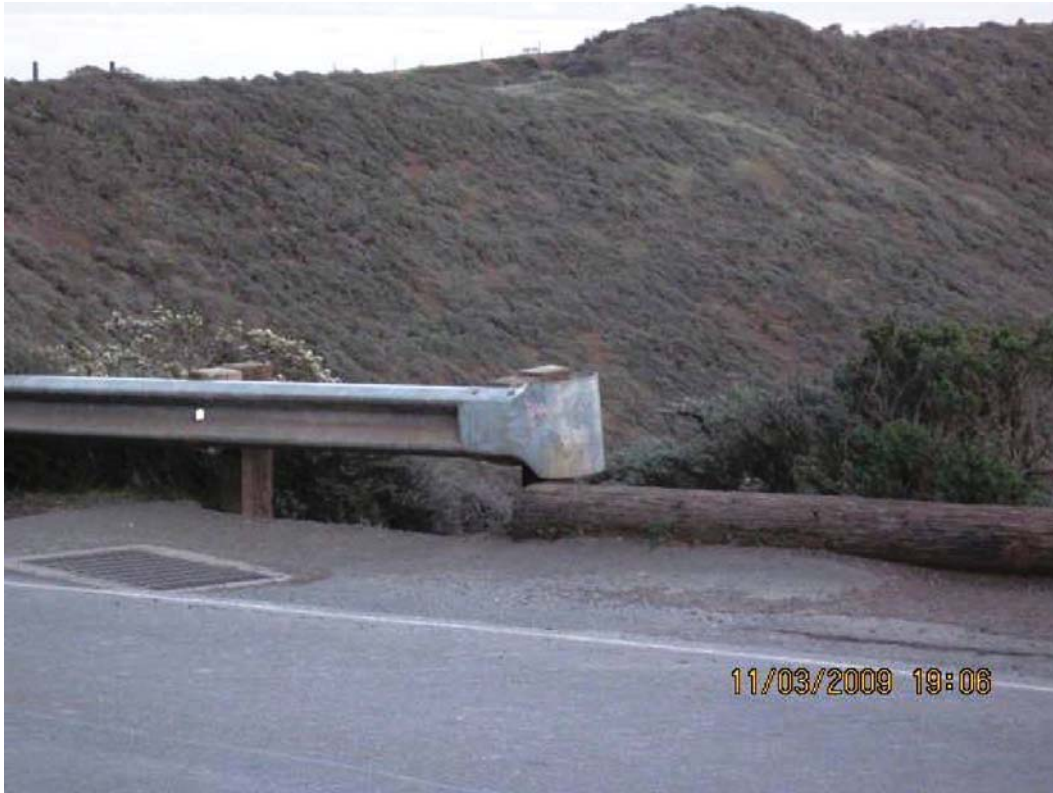
GOGA_0109ZZ_0.273_L_1.jpg

Barrier ID:	GOGA-0109ZZ-0.273-L				
Route Name:	CONZELMAN ROAD				
Inspection Date:	03/11/2009	Barrier Rating:	46.00		
Barrier Description					
Type:	W-BEAM STRONG POST	Barrier Function:	TRAFFIC		
Barrier Material:	GALVANIZED STEEL	Post Material:	WOOD		
Blockout Type:	WOOD	Length (ft.):	595		
Speed Limit (MPH):	25	Placement with Respect to Road:	BOTH INSIDE AND OUTSIDE		
Hazard Behind Barrier:	HIGH				
Barrier Crashworthiness					
Appropriate Test Level:	TL-1	Barrier Test Level:	TL-3	Is Barrier Crashworthy?:	YES
Beg. End Trtmt Type:	NONE	Is Beg. End Trtmt Crashworthy?:	N/A	Approach Transition Type:	NONE
Ending End Trtmt Type:	NONE	Ending End Trtmt Crashworthy?:	N/A		
Average Measurements					
Design Height (In.):	27	Width (In.):	0.0	Post Spacing (In.):	74.8
Height (In.):	25.7	Lateral Offset (In.):	41.7	Road Grade (%):	3.60
Physical Condition					
Barrier	Alignment and Height:	Alignment acceptable. 75-ft was within 1-in of the 27-in design height and 520-ft was between 1 and 3-in below the design height.

Breaking and Cracking:	No breaking or cracking observed.			
	Missing Elements:	No missing elements.			
	Corrosion and Weathering:	No corrosion or weathering observed.			
End Treatments	Alignment and Height:				
	Breaking and Cracking:				
	Missing Elements:				
	Corrosion and Weathering:

Repair Action:	REPAIR	FMSS Work Type:	DEFERRED MAINTENANCE	Repair Cost:	\$10588
Brief Workorder:	Raise 520 L.F. of W-Beam to 27-in design height.				
Workorder:	Adjust Guardrail at \$10- per -Lin. Ft. for 520 LF = \$5200. Raise 520-ft of barrier up to 27-in design height. Low Speed Traffic Control at \$1475- per -Day for 3 Day(s) = \$4425.

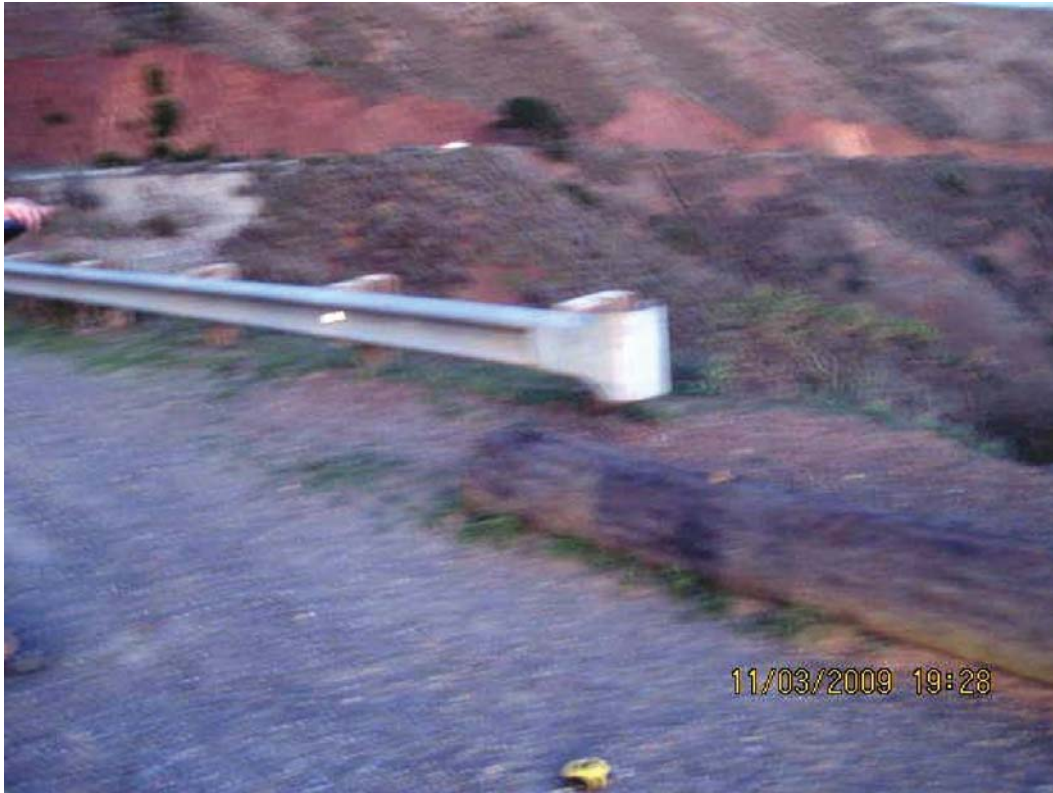
GOGA_0109ZZ_0.417_L_1.jpg

Barrier ID:	GOGA-0109ZZ-0.417-L				
Route Name:	CONZELMAN ROAD				
Inspection Date:	03/11/2009	Barrier Rating:	54.40		
Barrier Description					
Type:	W-BEAM STRONG POST	Barrier Function:	TRAFFIC		
Barrier Material:	GALVANIZED STEEL	Post Material:	WOOD		
Blockout Type:	WOOD	Length (ft.):	2436		
Speed Limit (MPH):	25	Placement with Respect to Road:	BOTH INSIDE AND OUTSIDE		
Hazard Behind Barrier:	HIGH				
Barrier Crashworthiness					
Appropriate Test Level:	TL-1	Barrier Test Level:	TL-3	Is Barrier Crashworthy?:	YES
Beg. End Trtmt Type:	NONE	Is Beg. End Trtmt Crashworthy?:	N/A	Approach Transition Type:	NONE
Ending End Trtmt Type:	NONE	Ending End Trtmt Crashworthy?:	N/A		
Average Measurements					
Design Height (In.):	27	Width (In.):	0.0	Post Spacing (In.):	75.1
Height (In.):	24.7	Lateral Offset (In.):	112.1	Road Grade (%):	3.30
Physical Condition					
Barrier	Alignment and Height:	Alignment acceptable. 100-ft was within 1-in of the 27-in design height and 2336-ft was between 1 and 3-in below the design height.

Breaking and Cracking:	No breaking or cracking observed.			
	Missing Elements:	No missing elements.			
	Corrosion and Weathering:	No corrosion or weathering observed.			
End Treatments	Alignment and Height:				
	Breaking and Cracking:				
	Missing Elements:				
	Corrosion and Weathering:

Repair Action:	REPAIR	FMSS Work Type:	DEFERRED MAINTENANCE	Repair Cost:	\$43021
Brief Workorder:	Raise 2436 L.F. of W-Beam to 27-in design height.				
Workorder:	Adjust Guardrail at \$10- per -Lin. Ft. for 2436 LF = \$24360. Raise 2436-ft of barrier up to 27-in design height. Low Speed Traffic Control at \$1475- per -Day for 10 Day(s) = \$14750.

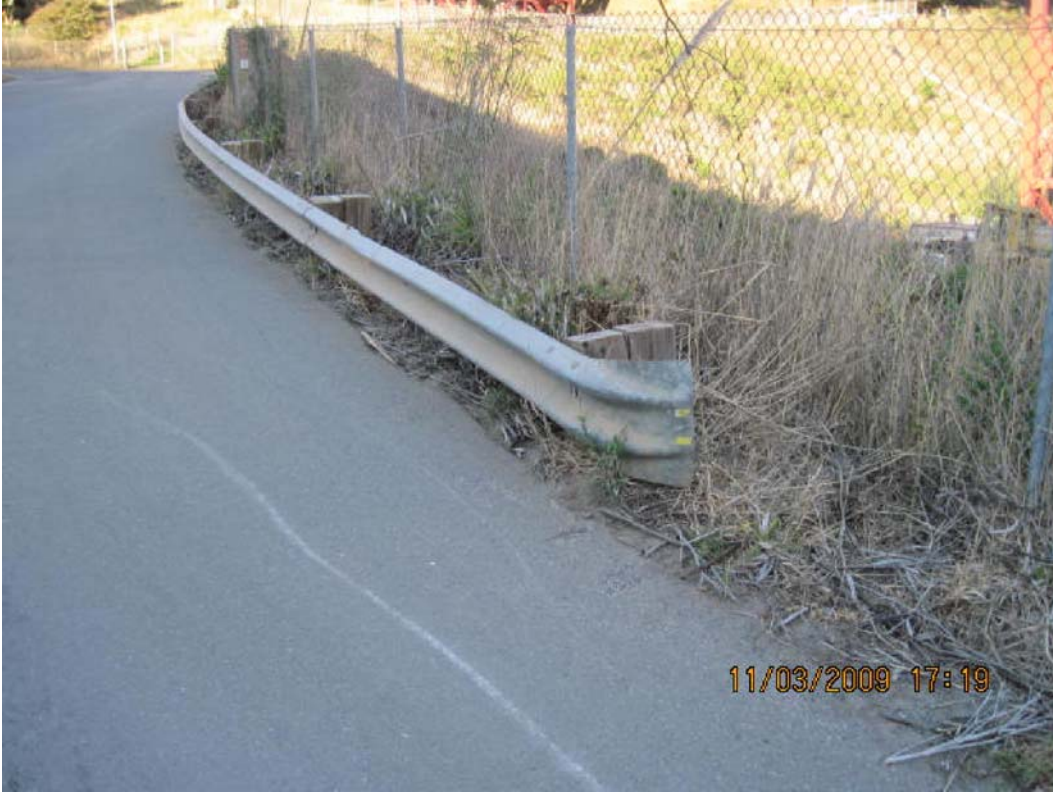
GOGA_0109ZZ_0.420_R_1.jpg

Barrier ID:	GOGA-0109ZZ-0.420-R				
Route Name:	CONZELMAN ROAD				
Inspection Date:	03/11/2009	Barrier Rating:	41.50		
Barrier Description					
Type:	W-BEAM STRONG POST	Barrier Function:	TRAFFIC		
Barrier Material:	GALVANIZED STEEL	Post Material:	WOOD		
Blockout Type:	WOOD	Length (ft.):	205		
Speed Limit (MPH):	15	Placement with Respect to Road:	INSIDE OF CURVE		
Hazard Behind Barrier:	LOW				
Barrier Crashworthiness					
Appropriate Test Level:	TL-1	Barrier Test Level:	TL-3	Is Barrier Crashworthy?:	YES
Beg. End Trtmt Type:	NONE	Is Beg. End Trtmt Crashworthy?:	N/A	Approach Transition Type:	NONE
Ending End Trtmt Type:	NONE	Ending End Trtmt Crashworthy?:	N/A		
Average Measurements					
Design Height (In.):	27	Width (In.):	0.0	Post Spacing (In.):	149.3
Height (In.):	21.2	Lateral Offset (In.):	46.0	Road Grade (%):	9.50
Physical Condition					
Barrier	Alignment and Height:	Entire barrier is between 5-6in. below the 27-in design height.

Breaking and Cracking:	8 rails are bent.			
	Missing Elements:	No missing elements. Several blocks are tilted.			
	Corrosion and Weathering:	No corrosion or weathering observed.			
End Treatments	Alignment and Height:				
	Breaking and Cracking:				
	Missing Elements:				
	Corrosion and Weathering:

Repair Action:	REPAIR	FMSS Work Type:	DEFERRED MAINTENANCE	Repair Cost:	\$8498
Brief Workorder:	Raise 205-ft of barrier up to 27-in design height.				
Workorder:	Adjust Guardrail at \$10- per -Lin. Ft. for 205 LF = \$2050. Raise 205-ft of barrier up to 27-in design height. Replace rail at \$25- per -Lin. Ft. for 96 LF = \$2400. Remove asphalt at \$10- per -Sq. Yd. for 1 = \$10. Low Speed Traffic Control at \$1475- per -Day for 2 Day(s) = \$2950. Base Course at \$75- per -Cu. Yd. for 1 CY = \$75. Labor at \$60- per -Hour for 4 Hrs = \$240. Labor to right the tilted blocks.

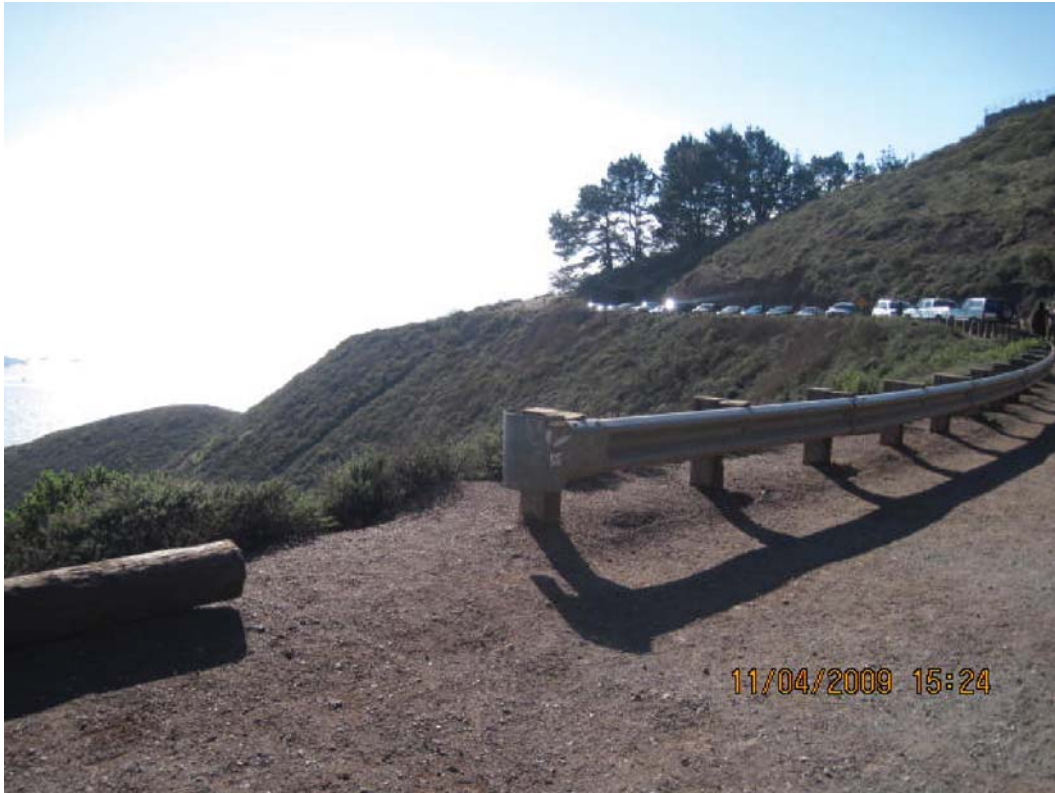
GOGA_0109ZZ_0.454_L_1.jpg

Barrier ID:	GOGA-0109ZZ-0.454-L				
Route Name:	CONZELMAN ROAD				
Inspection Date:	04/11/2009	Barrier Rating:	54.50		
Barrier Description					
Type:	W-BEAM STRONG POST	Barrier Function:	TRAFFIC		
Barrier Material:	GALVANIZED STEEL	Post Material:	WOOD		
Blockout Type:	WOOD	Length (ft.):	4690		
Speed Limit (MPH):	15	Placement with Respect to Road:	BOTH INSIDE AND OUTSIDE		
Hazard Behind Barrier:	EXTREME				
Barrier Crashworthiness					
Appropriate Test Level:	TL-1	Barrier Test Level:	TL-3	Is Barrier Crashworthy?:	YES
Beg. End Trtmt Type:	NONE	Is Beg. End Trtmt Crashworthy?:	N/A	Approach Transition Type:	NONE
Ending End Trtmt Type:	NONE	Ending End Trtmt Crashworthy?:	N/A		
Average Measurements					
Design Height (In.):	27	Width (In.):	0.0	Post Spacing (In.):	74.8
Height (In.):	26.2	Lateral Offset (In.):	36.7	Road Grade (%):	10.50
Physical Condition					
Barrier	Alignment and Height:	Alignment acceptable. 3190-ft was within 1-in of the 27-in design height and 1500-ft was between 1 and 3-in below the design height.

Breaking and Cracking:	A 12 ft long section of guardrail is bent.			
	Missing Elements:	No missing elements.			
	Corrosion and Weathering:	No corrosion or weathering.			
End Treatments	Alignment and Height:				
	Breaking and Cracking:				
	Missing Elements:				
	Corrosion and Weathering:

Repair Action:	REPAIR	FMSS Work Type:	DEFERRED MAINTENANCE	Repair Cost:	\$26566
Brief Workorder:	Raise 1500-ft of barrier up to 27-in design height. Replace 12 feet of rail. Remove and cut vegetation from front and back of barrier.				
Workorder:	Adjust Guardrail at \$10- per -Lin. Ft. for 1500 LF = \$15000. Raise 1500-ft of barrier up to 27-in design height. Replace rail at \$25- per -Lin. Ft. for 12 LF = \$300. Low Speed Traffic Control at \$1475- per -Day for 6 Day(s) = \$8850.

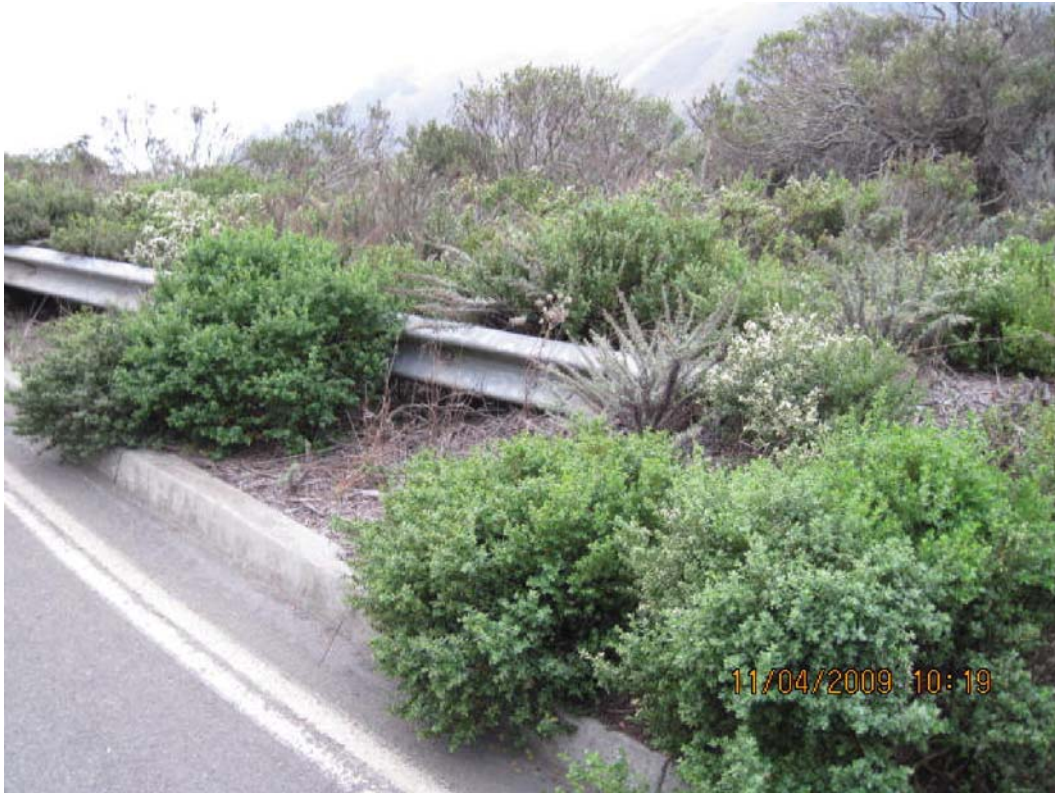
GOGA_0109ZZ_0.908_L_1.jpg

Barrier ID:	GOGA-0109ZZ-0.908-L				
Route Name:	CONZELMAN ROAD				
Inspection Date:	04/11/2009	Barrier Rating:	41.20		
Barrier Description					
Type:	W-BEAM STRONG POST	Barrier Function:	TRAFFIC		
Barrier Material:	GALVANIZED STEEL	Post Material:	WOOD		
Blockout Type:	WOOD	Length (ft.):	333		
Speed Limit (MPH):	25	Placement with Respect to Road:	BOTH INSIDE AND OUTSIDE		
Hazard Behind Barrier:	MEDIUM				
Barrier Crashworthiness					
Appropriate Test Level:	TL-1	Barrier Test Level:	TL-3	Is Barrier Crashworthy?:	YES
Beg. End Trtmt Type:	W-BEAM BURIED END	Is Beg. End Trtmt Crashworthy?:	YES	Approach Transition Type:	NONE
Ending End Trtmt Type:	NONE	Ending End Trtmt Crashworthy?:	N/A		
Average Measurements					
Design Height (In.):	27	Width (In.):	0.0	Post Spacing (In.):	75.0
Height (In.):	25.0	Lateral Offset (In.):	56.2	Road Grade (%):	3.90
Physical Condition					
Barrier	Alignment and Height:	Alignment acceptable. Entire barrier is between 1-4in below the 27-in design height.

Breaking and Cracking:	3 cracked blocks and 1 cracked post each crack was approx. half an in wide.			
	Missing Elements:	No missing elements. Vegetation growing in front of barrier.			
	Corrosion and Weathering:	No corrosion or weathering observed.			
End Treatments	Alignment and Height:	Alignment acceptable. Height within 1-in of 27-in design height.			
	Breaking and Cracking:	No breaking or cracking observed.			
	Missing Elements:	No missing elements.			
	Corrosion and Weathering:	No corrosion or weathering observed.

Repair Action:	REPAIR	FMSS Work Type:	DEFERRED MAINTENANCE	Repair Cost:	\$7315
Brief Workorder:	Raise 333 L.F. of W-Beam up to 27-in design height. Replace 3 blocks and 1 post and remove vegetation from face of barrier.				
Workorder:	Adjust Guardrail at \$10- per -Lin. Ft. for 333 LF = \$3330. Raise 333-ft of barrier up to 27-in design height. Replace post at \$100- per -Each for 1 Post(s) = \$100. Replace block at \$30- per -Each for 3 Block(s) = \$90. Labor at \$60- per -Hour for 3 Hrs = \$180. Remove vegetation from face of barrier. Low Speed Traffic Control at \$1475- per -Day for 2 Day(s) = \$2950.

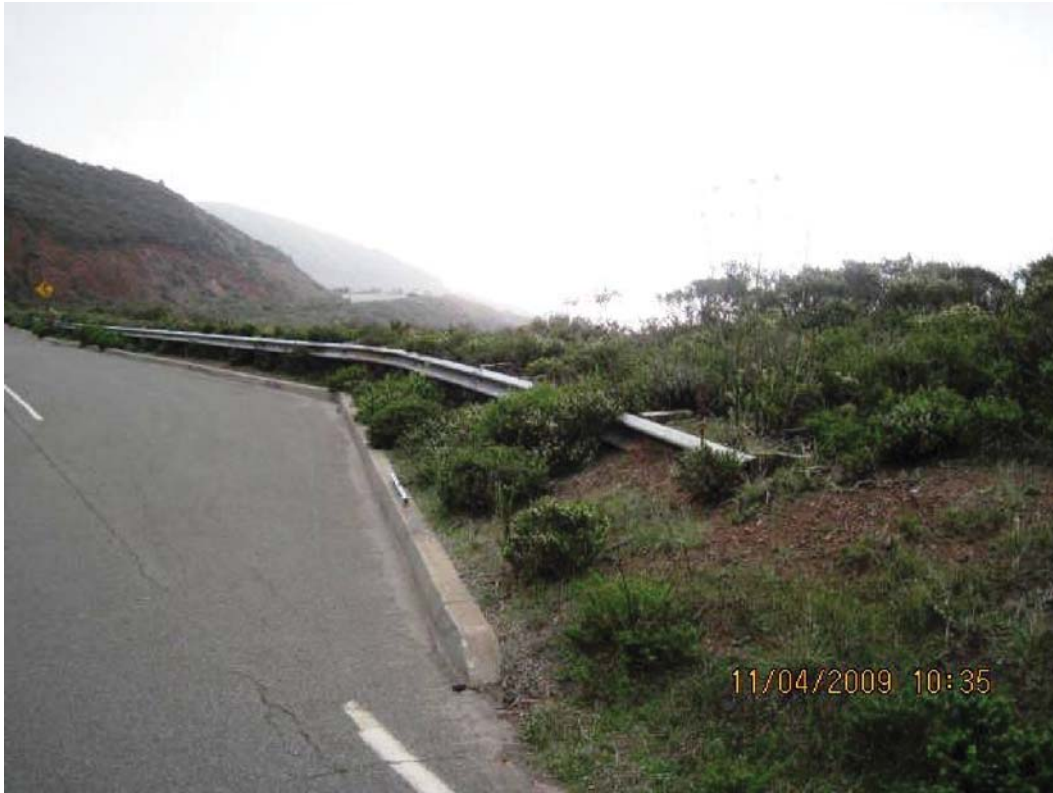
GOGA_0109ZZ_0.995_L_1.jpg

Barrier ID:	GOGA-0109ZZ-0.995-L				
Route Name:	CONZELMAN ROAD				
Inspection Date:	04/11/2009	Barrier Rating:	30.10		
Barrier Description					
Type:	W-BEAM STRONG POST	Barrier Function:	TRAFFIC		
Barrier Material:	GALVANIZED STEEL	Post Material:	WOOD		
Blockout Type:	WOOD	Length (ft.):	299		
Speed Limit (MPH):	25	Placement with Respect to Road:	TANGENT		
Hazard Behind Barrier:	N/A				
Barrier Crashworthiness					
Appropriate Test Level:	TL-1	Barrier Test Level:	TL-3	Is Barrier Crashworthy?:	YES
Beg. End Trtmt Type:	W-BEAM BURIED END	Is Beg. End Trtmt Crashworthy?:	YES	Approach Transition Type:	NONE
Ending End Trtmt Type:	W-BEAM BURIED END	Ending End Trtmt Crashworthy?:	YES		
Average Measurements					
Design Height (In.):	27	Width (In.):	0.0	Post Spacing (In.):	75.6
Height (In.):	26.2	Lateral Offset (In.):	208.0	Road Grade (%):	4.90
Physical Condition					
Barrier	Alignment and Height:	Alignment acceptable. 18-ft was within 1-in of the 27-in design height 69-ft was between 1 and 3-in below and 50-ft was more than 3-in below the design height.

Breaking and Cracking:	4 rails were bent.			
	Missing Elements:	No missing elements.			
	Corrosion and Weathering:	No corrosion or weathering observed.			
End Treatments	Alignment and Height:	Alignment acceptable. Height within 1-in of 27-in design height.			
	Breaking and Cracking:	No breaking or cracking observed.			
	Missing Elements:	No missing elements.			
	Corrosion and Weathering:	No corrosion or weathering observed.

Repair Action:	REPAIR	FMSS Work Type:	DEFERRED MAINTENANCE	Repair Cost:	\$5874
Brief Workorder:	Raise 119 L.F. of the W-Beam to 27-in design height. Replace 48 feet of rail.				
Workorder:	Adjust Guardrail at \$10- per -Lin. Ft. for 119 LF = \$1190. Raise 119-ft of barrier up to 27-in design height. Replace rail at \$25- per -Lin. Ft. for 48 LF = \$1200. Low Speed Traffic Control at \$1475- per -Day for 2 Day(s) = \$2950.

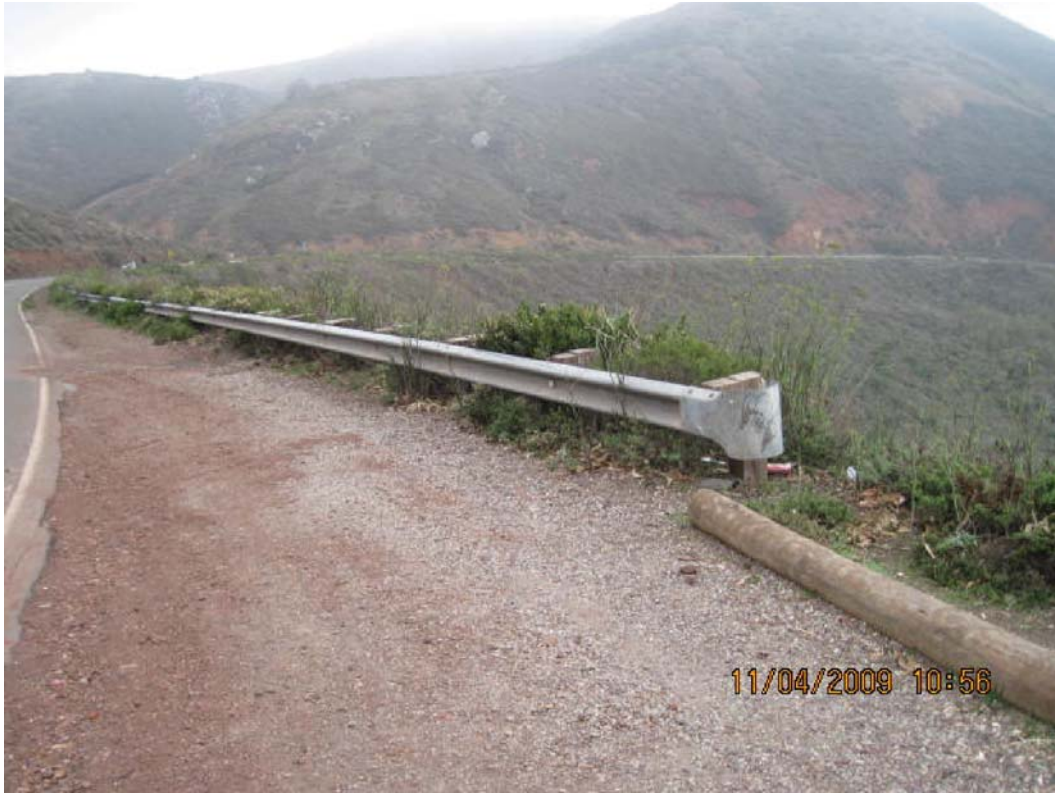
GOGA_0109ZZ_1.100_L_1.jpg

Barrier ID:	GOGA-0109ZZ-1.100-L				
Route Name:	CONZELMAN ROAD				
Inspection Date:	04/11/2009	Barrier Rating:	45.50		
Barrier Description					
Type:	W-BEAM STRONG POST	Barrier Function:	TRAFFIC		
Barrier Material:	GALVANIZED STEEL	Post Material:	WOOD		
Blockout Type:	WOOD	Length (ft.):	554		
Speed Limit (MPH):	25	Placement with Respect to Road:	BOTH INSIDE AND OUTSIDE		
Hazard Behind Barrier:	MEDIUM				
Barrier Crashworthiness					
Appropriate Test Level:	TL-1	Barrier Test Level:	TL-3	Is Barrier Crashworthy?:	YES
Beg. End Trtmt Type:	NONE	Is Beg. End Trtmt Crashworthy?:	N/A	Approach Transition Type:	NONE
Ending End Trtmt Type:	W-BEAM BURIED END	Ending End Trtmt Crashworthy?:	YES		
Average Measurements					
Design Height (In.):	27	Width (In.):	0.0	Post Spacing (In.):	74.3
Height (In.):	25.0	Lateral Offset (In.):	74.3	Road Grade (%):	8.30
Physical Condition					
Barrier	Alignment and Height:	Alignment acceptable. 554-ft was within 1-in of the 27-in design height.

Breaking and Cracking:	3 blockouts were broken.			
	Missing Elements:	No missing elements.			
	Corrosion and Weathering:	No corrosion or weathering observed.			
End Treatments	Alignment and Height:	Alignment acceptable. Height within 1-in of 27-in design height.			
	Breaking and Cracking:	No breaking or cracking observed.			
	Missing Elements:	No missing elements.			
	Corrosion and Weathering:	No corrosion or weathering observed.

Repair Action:	REPAIR	FMSS Work Type:	DEFERRED MAINTENANCE	Repair Cost:	\$11061
Brief Workorder:	Raise 554 L.F. of W-Beam to 27-in design height; replace 3 broken blockouts.				
Workorder:	Adjust Guardrail at \$10- per -Lin. Ft. for 554 LF = \$5540. Raise 554-ft of barrier up to 27-in design height. Replace block at \$30- per -Each for 3 Block(s) = \$90. Low Speed Traffic Control at \$1475- per -Day for 3 Day(s) = \$4425.

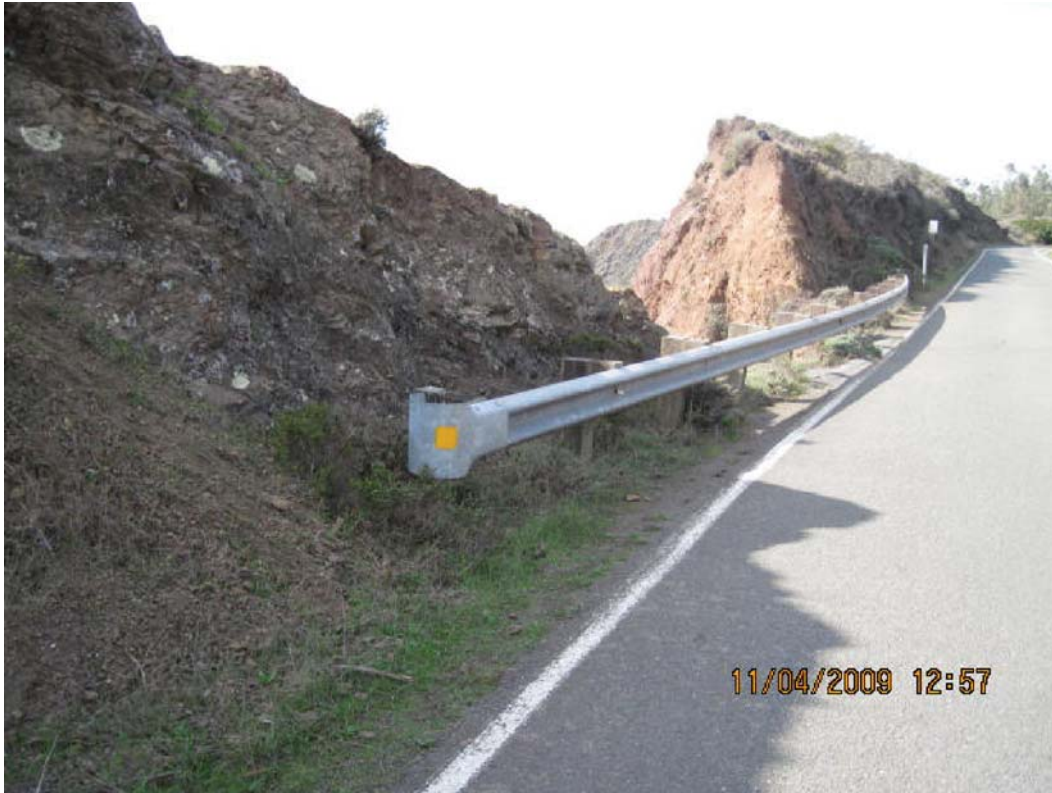
GOGA_0109ZZ_1.601_L_1.jpg

Barrier ID:	GOGA-0109ZZ-1.601-L				
Route Name:	CONZELMAN ROAD				
Inspection Date:	04/11/2009	Barrier Rating:	24.20		
Barrier Description					
Type:	W-BEAM STRONG POST	Barrier Function:	TRAFFIC		
Barrier Material:	GALVANIZED STEEL	Post Material:	WOOD		
Blockout Type:	WOOD	Length (ft.):	92		
Speed Limit (MPH):	15	Placement with Respect to Road:	TANGENT		
Hazard Behind Barrier:	HIGH				
Barrier Crashworthiness					
Appropriate Test Level:	TL-1	Barrier Test Level:	TL-3	Is Barrier Crashworthy?:	YES
Beg. End Trtmt Type:	NONE	Is Beg. End Trtmt Crashworthy?:	N/A	Approach Transition Type:	NONE
Ending End Trtmt Type:	NONE	Ending End Trtmt Crashworthy?:	N/A		
Average Measurements					
Design Height (In.):	27	Width (In.):	0.0	Post Spacing (In.):	74.6
Height (In.):	26.7	Lateral Offset (In.):	19.0	Road Grade (%):	0.20
Physical Condition					
Barrier	Alignment and Height:	Alignment acceptable. Height within 1-in of 27-in design height.

Breaking and Cracking:	No breaking or cracking observed.			
	Missing Elements:	No missing elements.			
	Corrosion and Weathering:	Some rusting on rail.			
End Treatments	Alignment and Height:				
	Breaking and Cracking:				
	Missing Elements:				
	Corrosion and Weathering:

Barrier ID:	GOGA-0109ZZ-1.601-L				
Route Name:	CONZELMAN ROAD				
Inspection Date:	04/11/2009	Barrier Rating:		24.20	
Repair Recommendations					
Repair Action:	NO ACTION	FMSS Work Type:	N/A	Repair Cost:	\$0
Brief Workorder:	N/A				
Workorder:

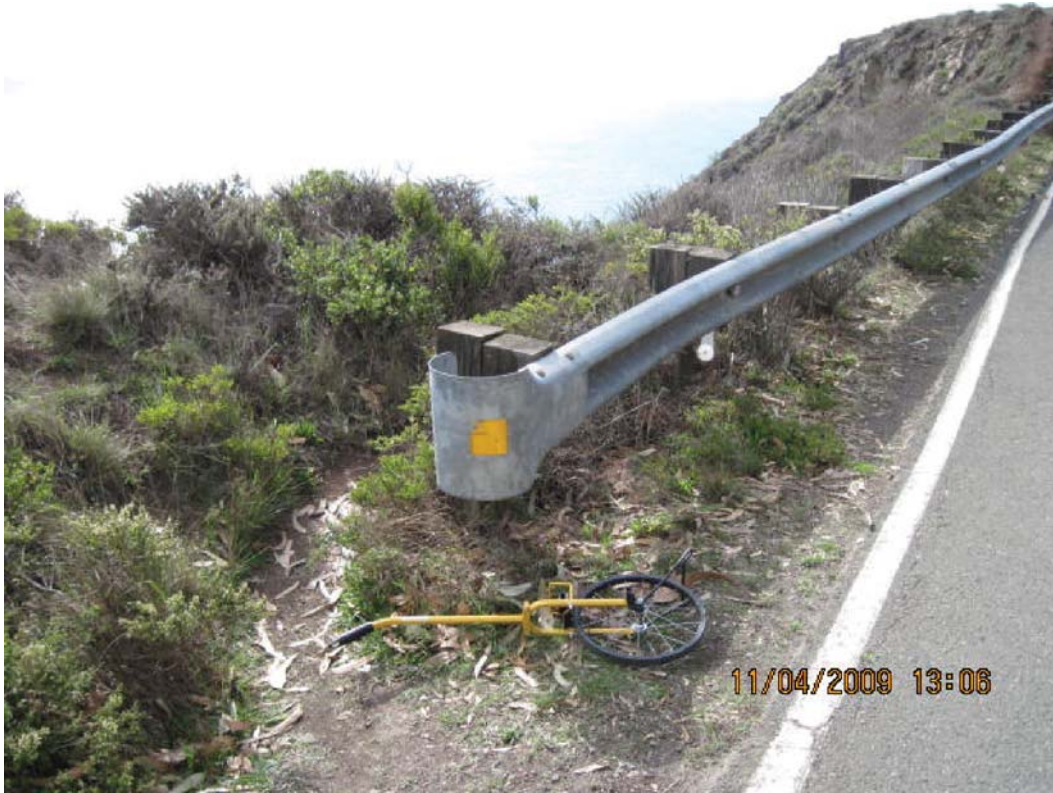
GOGA_0109ZZ_1.735_L_1.jpg

Barrier ID:	GOGA-0109ZZ-1.735-L				
Route Name:	CONZELMAN ROAD				
Inspection Date:	04/11/2009	Barrier Rating:	34.40		
Barrier Description					
Type:	W-BEAM STRONG POST	Barrier Function:	TRAFFIC		
Barrier Material:	GALVANIZED STEEL	Post Material:	WOOD		
Blockout Type:	WOOD	Length (ft.):	102		
Speed Limit (MPH):	15	Placement with Respect to Road:	OUTSIDE OF CURVE		
Hazard Behind Barrier:	HIGH				
Barrier Crashworthiness					
Appropriate Test Level:	TL-1	Barrier Test Level:	TL-3	Is Barrier Crashworthy?:	YES
Beg. End Trtmt Type:	NONE	Is Beg. End Trtmt Crashworthy?:	N/A	Approach Transition Type:	NONE
Ending End Trtmt Type:	NONE	Ending End Trtmt Crashworthy?:	N/A		
Average Measurements					
Design Height (In.):	27	Width (In.):	0.0	Post Spacing (In.):	74.6
Height (In.):	27.0	Lateral Offset (In.):	31.0	Road Grade (%):	1.60
Physical Condition					
Barrier	Alignment and Height:	Alignment acceptable. Height within 1-in of 27-in design height.

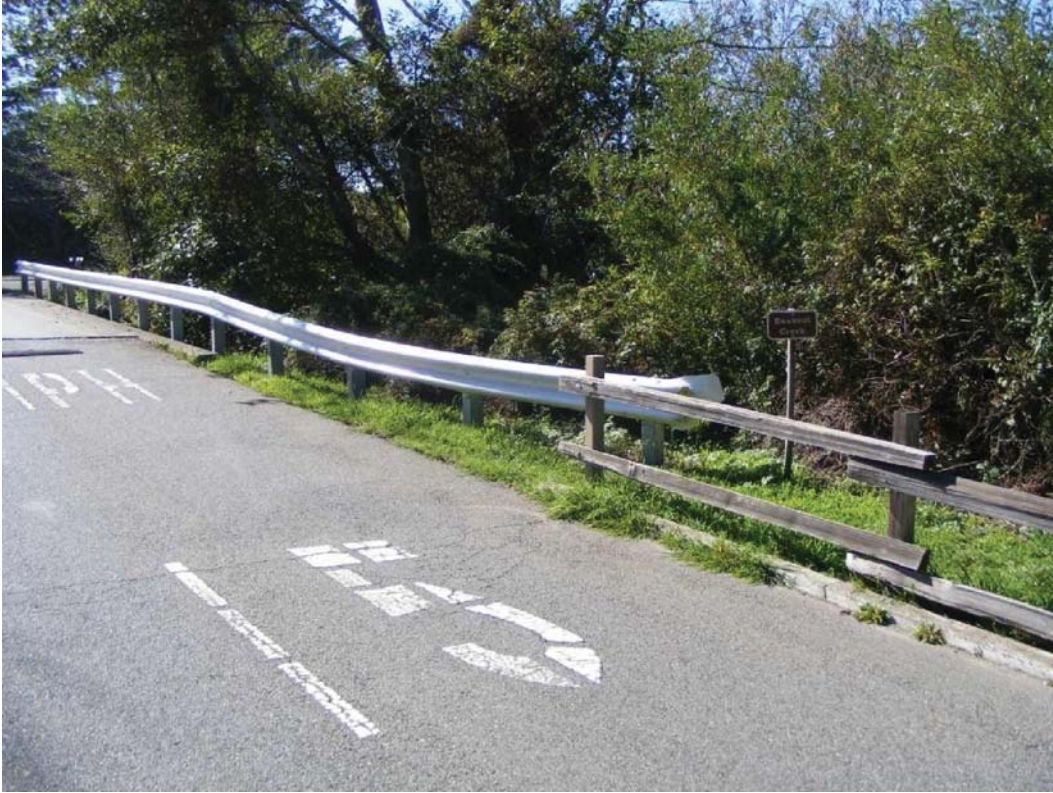
GOGA_0205ZZ_0.028_R_1.jpg

Barrier ID:	GOGA-0205ZZ-0.028-R				
Route Name:	STINSON BEACH ACCESS ROADS				
Inspection Date:	03/11/2009	Barrier Rating:	8.30		
Barrier Description					
Type:	W-BEAM WEAK POST	Barrier Function:	TRAFFIC		
Barrier Material:	GALVANIZED STEEL	Post Material:	GALVANIZED STEEL		
Blockout Type:	N/A	Length (ft.):	35		
Speed Limit (MPH):	15	Placement with Respect to Road:	TANGENT		
Hazard Behind Barrier:	LOW				
Barrier Crashworthiness					
Appropriate Test Level:	TL-1	Barrier Test Level:	TL-2	Is Barrier Crashworthy?:	YES
Beg. End Trtmt Type:	NONE	Is Beg. End Trtmt Crashworthy?:	N/A	Approach Transition Type:	NONE
Ending End Trtmt Type:	NONE	Ending End Trtmt Crashworthy?:	N/A		
Average Measurements					
Design Height (In.):	27	Width (In.):	0.0	Post Spacing (In.):	75.0
Height (In.):	28.0	Lateral Offset (In.):	15.0	Road Grade (%):	1.30
Physical Condition					
Barrier	Alignment and Height:	Entire barrier is between 1-in below to 4-in above the 27-in design height.

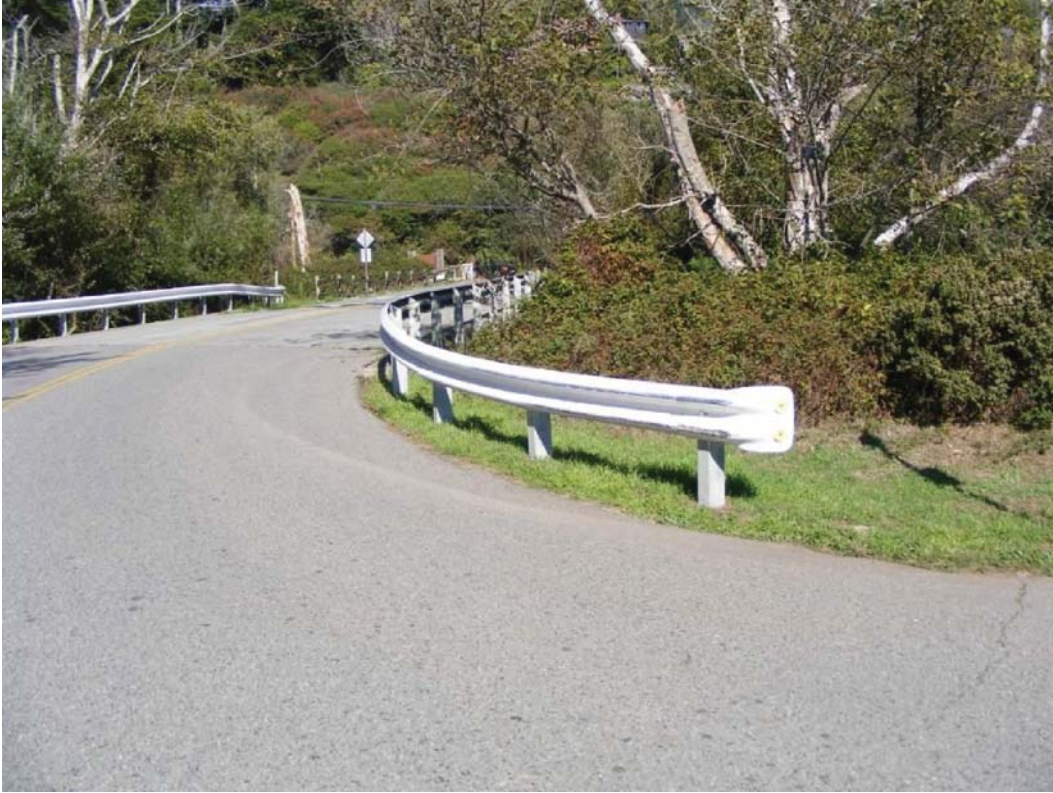
GOGA_0205ZZ_0.033_L_1.jpg

Barrier ID:	GOGA-0205ZZ-0.033-L				
Route Name:	STINSON BEACH ACCESS ROADS				
Inspection Date:	03/11/2009	Barrier Rating:	11.10		
Barrier Description					
Type:	W-BEAM WEAK POST	Barrier Function:	TRAFFIC		
Barrier Material:	GALVANIZED STEEL	Post Material:	GALVANIZED STEEL		
Blockout Type:	N/A	Length (ft.):	38		
Speed Limit (MPH):	15	Placement with Respect to Road:	INSIDE OF CURVE		
Hazard Behind Barrier:	LOW				
Barrier Crashworthiness					
Appropriate Test Level:	TL-1	Barrier Test Level:	TL-2	Is Barrier Crashworthy?:	YES
Beg. End Trtmt Type:	NONE	Is Beg. End Trtmt Crashworthy?:	N/A	Approach Transition Type:	NONE
Ending End Trtmt Type:	NONE	Ending End Trtmt Crashworthy?:	N/A		
Average Measurements					
Design Height (In.):	27	Width (In.):	0.0	Post Spacing (In.):	74.3
Height (In.):	30.2	Lateral Offset (In.):	9.0	Road Grade (%):	3.10
Physical Condition					
Barrier	Alignment and Height:	Alignment acceptable. Height was 1-6in above the 27-in design height.

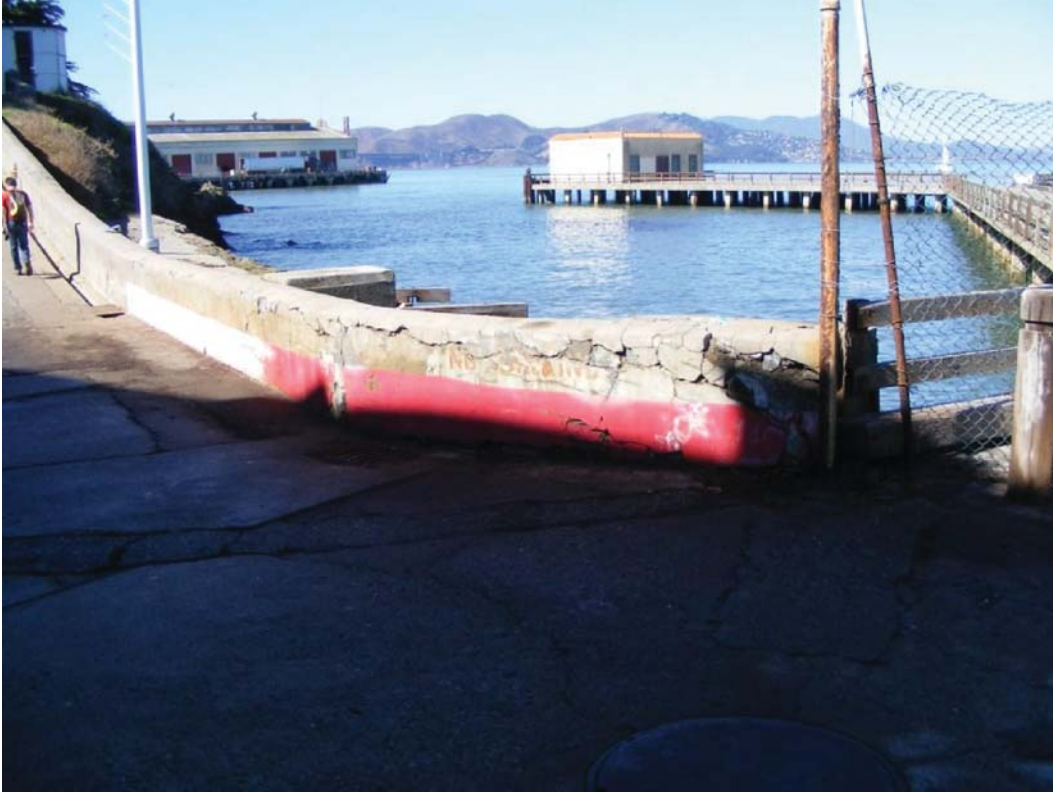
GOGA_0405_0.019_R_1.jpg

Barrier ID:	GOGA-0405-0.019-R				
Route Name:	MCDOWELL AVENUE				
Inspection Date:	02/11/2009	Barrier Rating:	17.00		
Barrier Description					
Type:	STONE MASONRY WITHOUT CONCRETE CORE WALL	Barrier Function:	TRAFFIC		
Barrier Material:	STONE	Post Material:	N/A		
Blockout Type:	N/A	Length (ft.):	197		
Speed Limit (MPH):	15	Placement with Respect to Road:	TANGENT		
Hazard Behind Barrier:	HIGH				
Barrier Crashworthiness					
Appropriate Test Level:	TL-1	Barrier Test Level:	NCW	Is Barrier Crashworthy?:	NO
Beg. End Trtmt Type:	NONE	Is Beg. End Trtmt Crashworthy?:	N/A	Approach Transition Type:	NONE
Ending End Trtmt Type:	NONE	Ending End Trtmt Crashworthy?:	N/A		
Average Measurements					
Design Height (In.):	24	Width (In.):	20.0	Post Spacing (In.):	0.0
Height (In.):	33.5	Lateral Offset (In.):	85.3	Road Grade (%):	11.60
Physical Condition					
Barrier	Alignment and Height:	Alignment acceptable. Height was 6-7in above the 27-in design height.
