GOGA GIP Report

NPS Guardwall/Rail Inventory Program Golden Gate National Recreation Area

**Federal Highway Administration
Eastern Federal Lands Highway Division
Road Inventory Program (RIP)**

**Data Collection Date: November 2009
Report Date: November 2015**

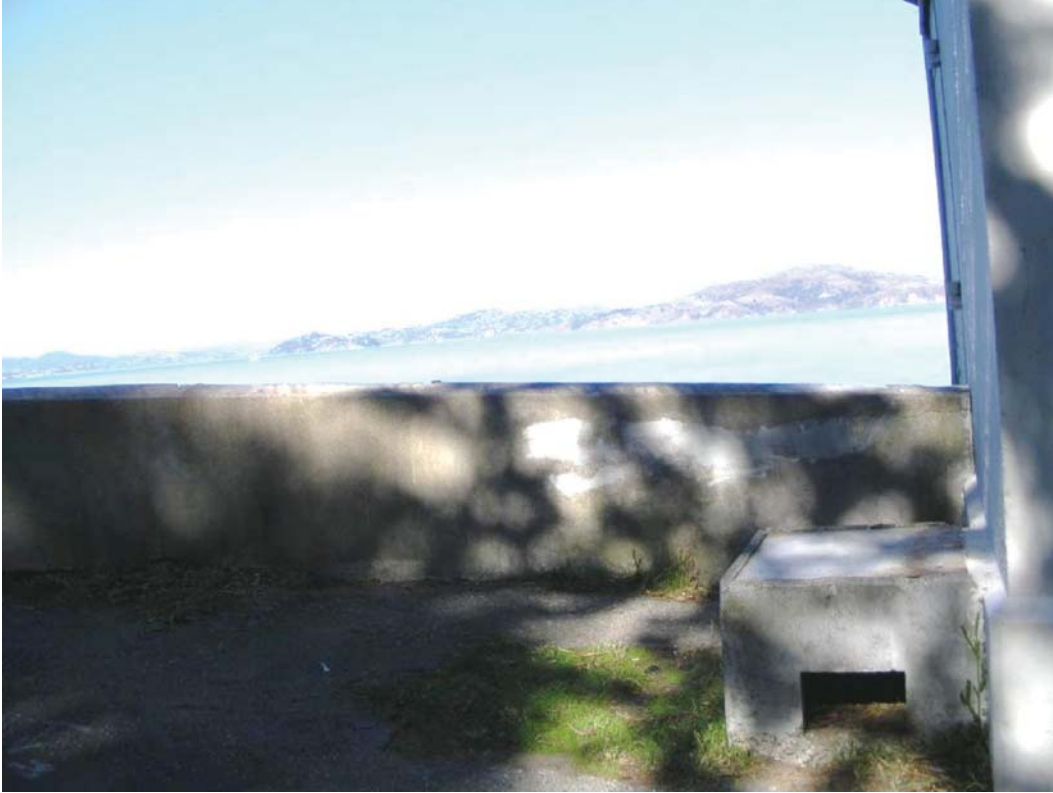
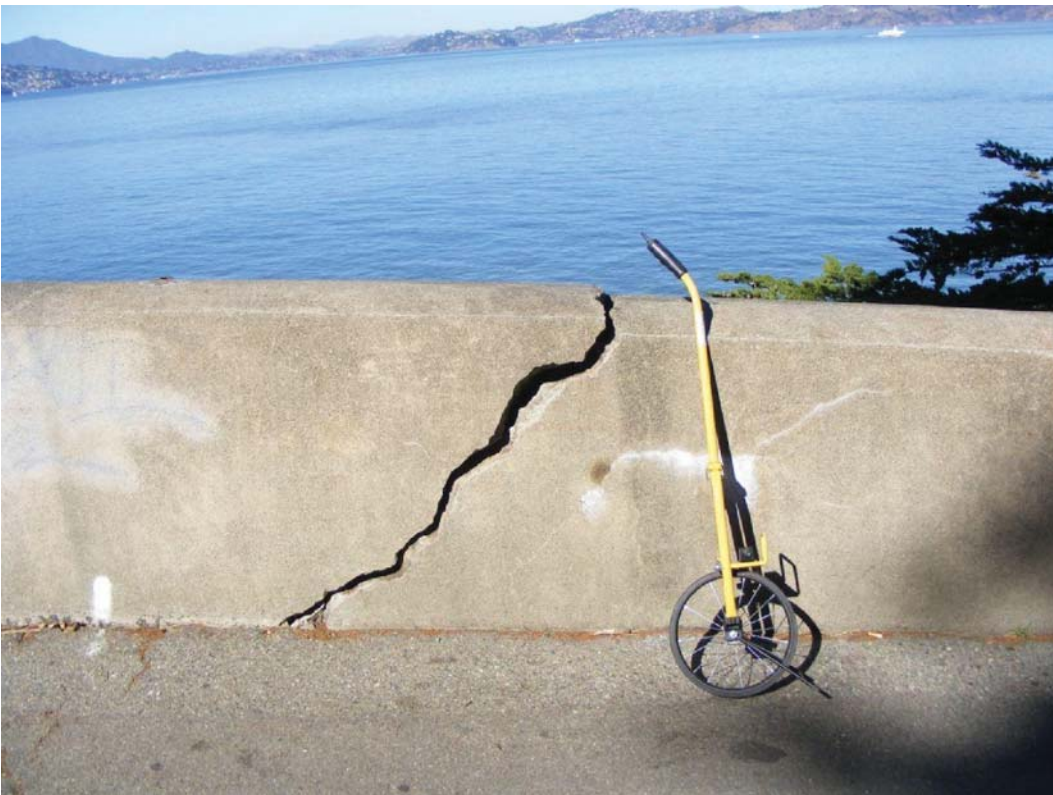
GOGA_0405_0.060_R_1.jpg

Barrier ID:	GOGA-0405-0.060-R				
Route Name:	MCDOWELL AVENUE				
Inspection Date:	02/11/2009	Barrier Rating:	22.70		
Barrier Description					
Type:	CONCRETE BARRIER	Barrier Function:	TRAFFIC		
Barrier Material:	CONCRETE	Post Material:	N/A		
Blockout Type:	N/A	Length (ft.):	483		
Speed Limit (MPH):	15	Placement with Respect to Road:	OUTSIDE OF CURVE		
Hazard Behind Barrier:	HIGH				
Barrier Crashworthiness					
Appropriate Test Level:	TL-1	Barrier Test Level:	TL-3	Is Barrier Crashworthy?:	YES
Beg. End Trtmt Type:	NONE	Is Beg. End Trtmt Crashworthy?:	N/A	Approach Transition Type:	NONE
Ending End Trtmt Type:	NONE	Ending End Trtmt Crashworthy?:	N/A		
Average Measurements					
Design Height (In.):	32	Width (In.):	20.0	Post Spacing (In.):	0.0
Height (In.):	33.7	Lateral Offset (In.):	100.0	Road Grade (%):	8.10
Physical Condition					
Barrier	Alignment and Height:	Alignment acceptable. Height was 0-5in above assumed 32-in design height.

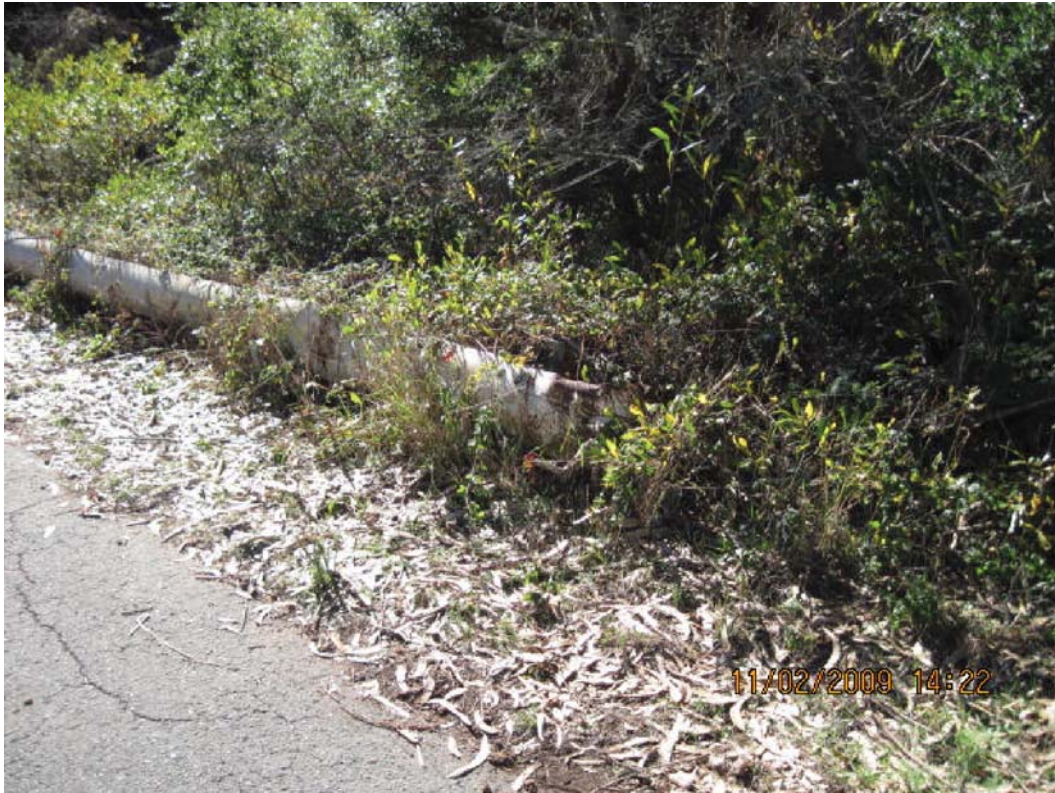
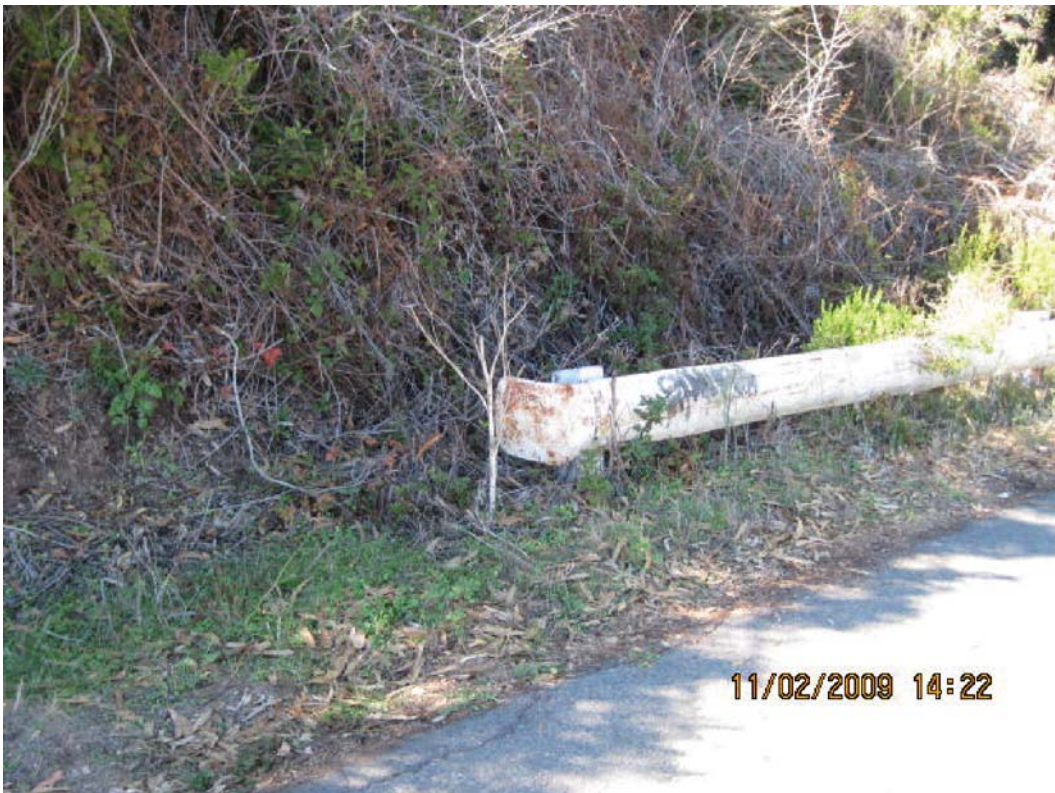
GOGA_0406_0.232_R_1.jpg

Barrier ID:	GOGA-0406-0.232-R				
Route Name:	SWEENEY RIDGE ROAD				
Inspection Date:	02/11/2009	Barrier Rating:	24.20		
Barrier Description					
Type:	OTHER: NON-STANDARD STEEL BARRIER	Barrier Function:	TRAFFIC		
Barrier Material:	WEATHERING STEEL/CORTEN	Post Material:	WOOD		
Blockout Type:	N/A	Length (ft.):	102		
Speed Limit (MPH):	15	Placement with Respect to Road:	OUTSIDE OF CURVE		
Hazard Behind Barrier:	LOW				
Barrier Crashworthiness					
Appropriate Test Level:	TL-1	Barrier Test Level:	NCW	Is Barrier Crashworthy?:	NO
Beg. End Trtmt Type:	NONE	Is Beg. End Trtmt Crashworthy?:	N/A	Approach Transition Type:	NONE
Ending End Trtmt Type:	NONE	Ending End Trtmt Crashworthy?:	N/A		
Average Measurements					
Design Height (In.):	27	Width (In.):	0.0	Post Spacing (In.):	150.0
Height (In.):	20.0	Lateral Offset (In.):	43.0	Road Grade (%):	8.20
Physical Condition					
Barrier	Alignment and Height:	Alignment acceptable. Entire barrier is 7-in below the 27-in design height.

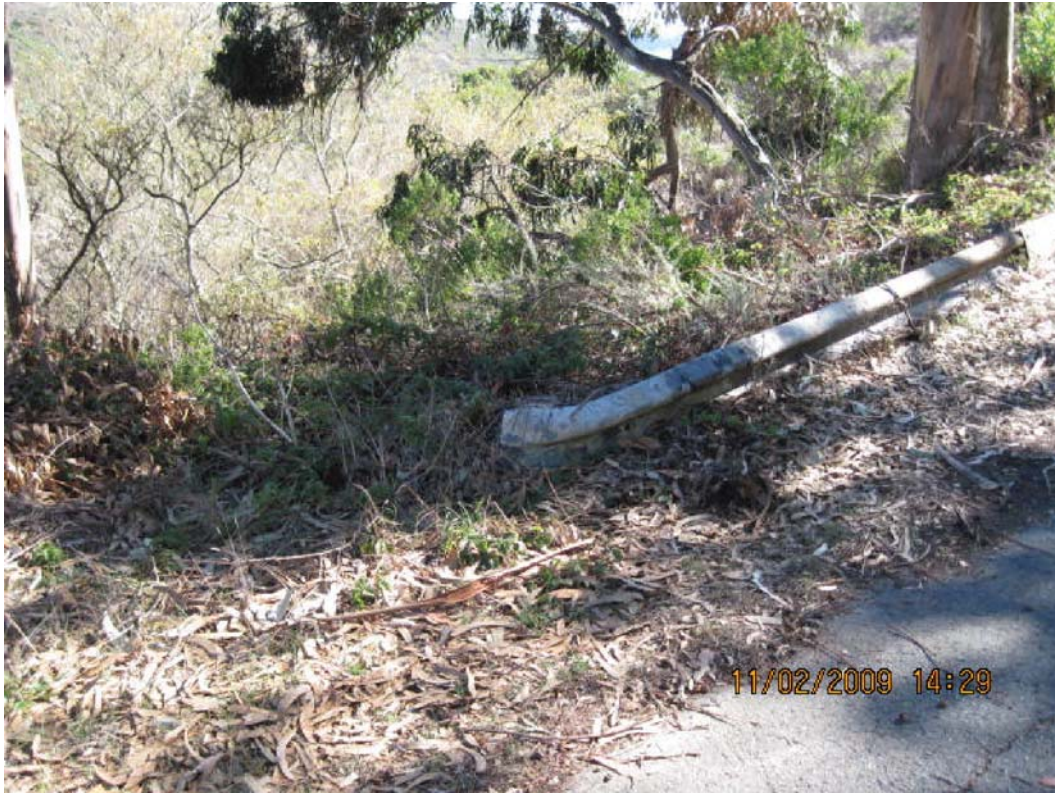
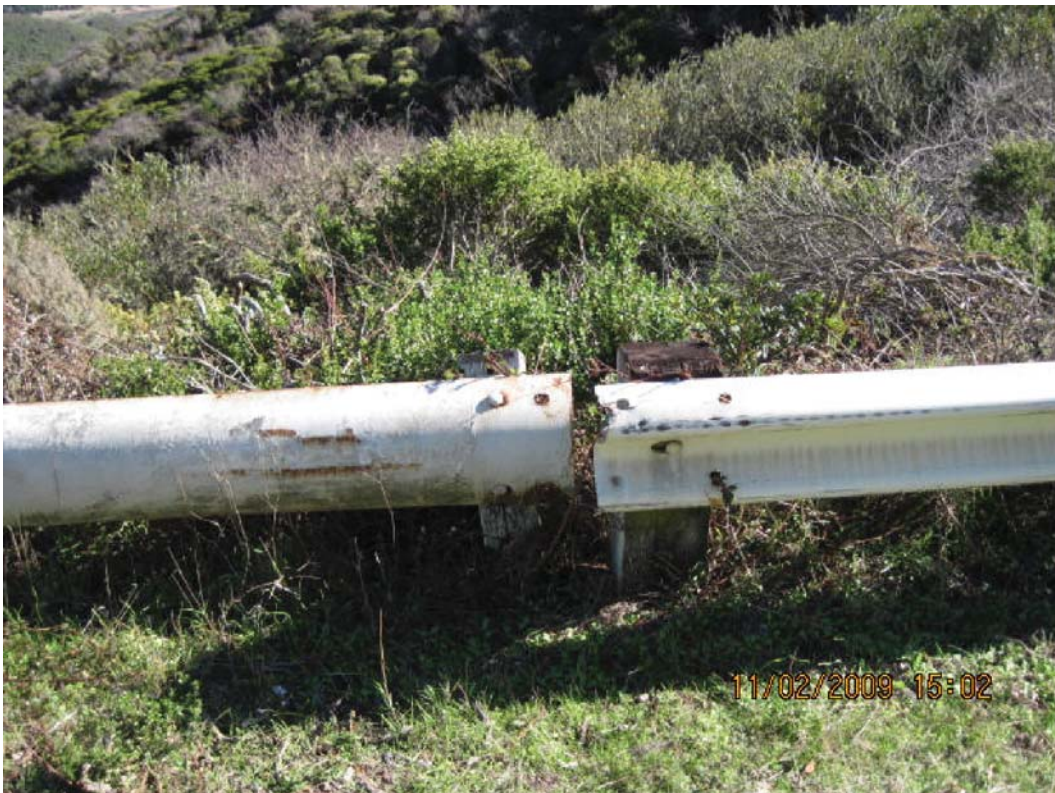
GOGA_0406_0.234_L_1.jpg

Barrier ID:	GOGA-0406-0.234-L				
Route Name:	SWEENEY RIDGE ROAD				
Inspection Date:	02/11/2009	Barrier Rating:	55.50		
Barrier Description					
Type:	OTHER: NON-STANDARD STEEL BARRIER	Barrier Function:	TRAFFIC		
Barrier Material:	WEATHERING STEEL/CORTEN	Post Material:	WOOD		
Blockout Type:	N/A	Length (ft.):	2940		
Speed Limit (MPH):	15	Placement with Respect to Road:	BOTH INSIDE AND OUTSIDE		
Hazard Behind Barrier:	LOW				
Barrier Crashworthiness					
Appropriate Test Level:	TL-1	Barrier Test Level:	NCW	Is Barrier Crashworthy?:	NO
Beg. End Trtmt Type:	NONE	Is Beg. End Trtmt Crashworthy?:	N/A	Approach Transition Type:	NONE
Ending End Trtmt Type:	NONE	Ending End Trtmt Crashworthy?:	N/A		
Average Measurements					
Design Height (In.):	27	Width (In.):	0.0	Post Spacing (In.):	149.8
Height (In.):	19.7	Lateral Offset (In.):	39.2	Road Grade (%):	6.50
Physical Condition					
Barrier	Alignment and Height:	Alignment acceptable. Entire barrier is between 7-11 in below the 27-in design height.

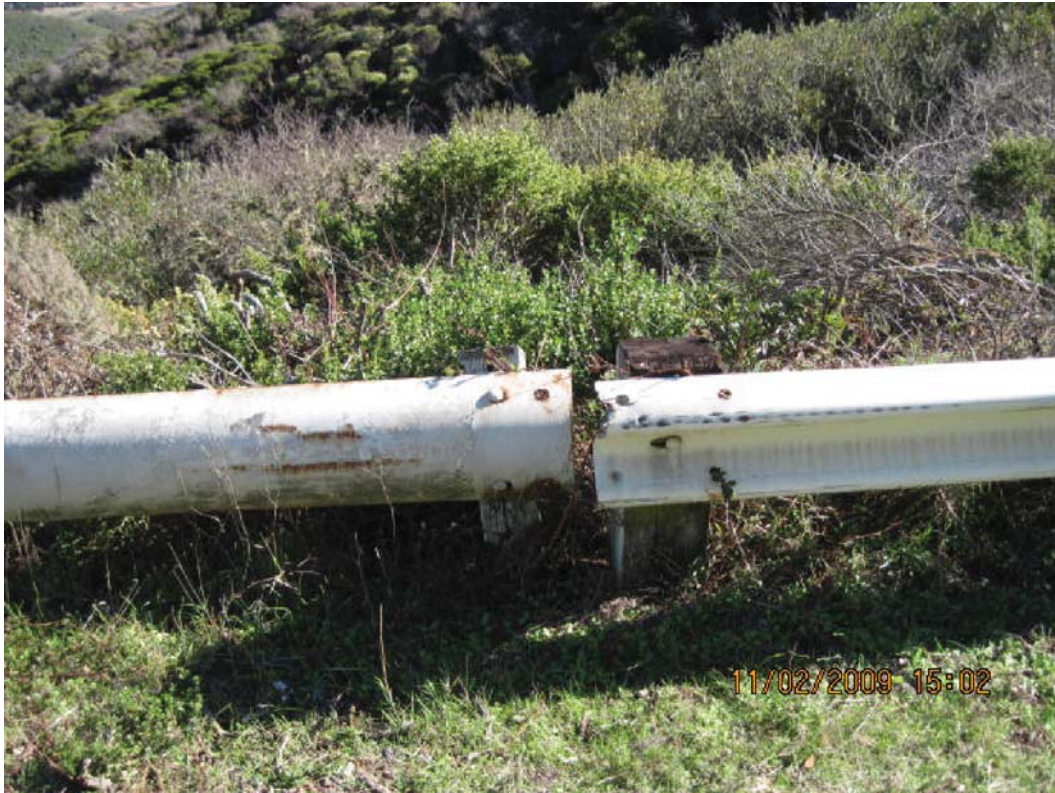
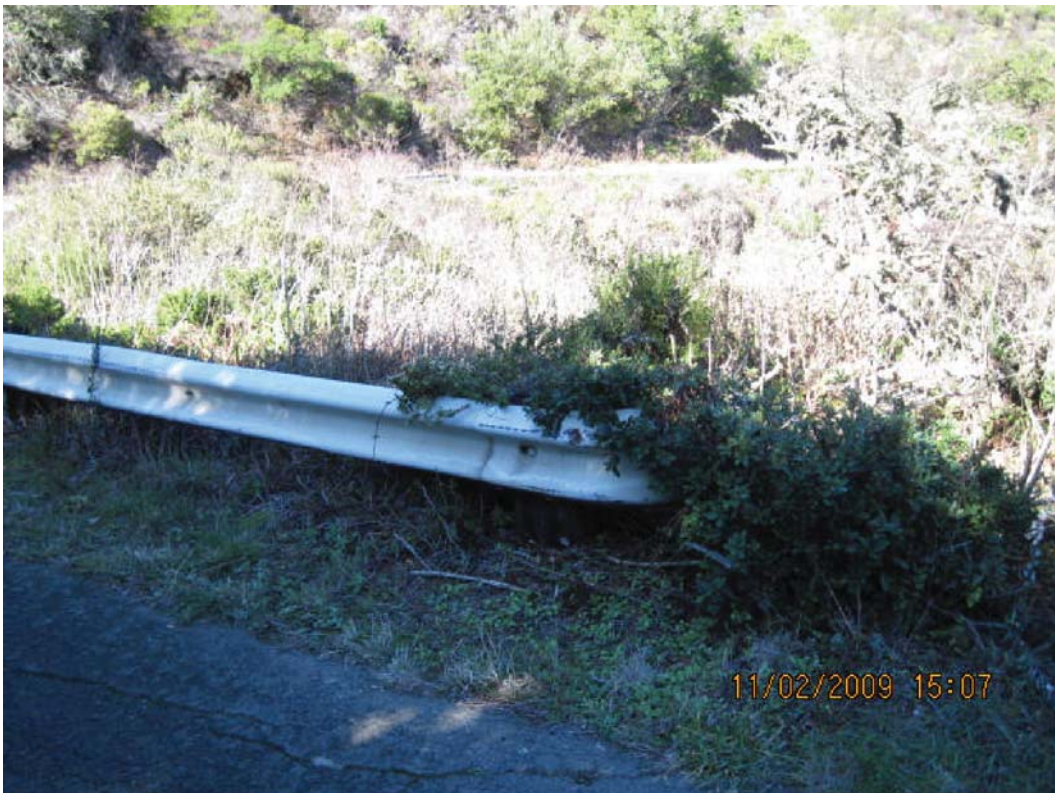
GOGA_0406_0.791_L_1.jpg

Barrier ID:	GOGA-0406-0.791-L				
Route Name:	SWEENEY RIDGE ROAD				
Inspection Date:	02/11/2009	Barrier Rating:	34.20		
Barrier Description					
Type:	W-BEAM WEAK POST	Barrier Function:	TRAFFIC		
Barrier Material:	WEATHERING STEEL/CORTEN	Post Material:	WOOD		
Blockout Type:	N/A	Length (ft.):	134		
Speed Limit (MPH):	15	Placement with Respect to Road:	INSIDE OF CURVE		
Hazard Behind Barrier:	LOW				
Barrier Crashworthiness					
Appropriate Test Level:	TL-1	Barrier Test Level:	TL-2	Is Barrier Crashworthy?:	YES
Beg. End Trtmt Type:	NONE	Is Beg. End Trtmt Crashworthy?:	N/A	Approach Transition Type:	NONE
Ending End Trtmt Type:	NONE	Ending End Trtmt Crashworthy?:	N/A		
Average Measurements					
Design Height (In.):	27	Width (In.):	0.0	Post Spacing (In.):	149.6
Height (In.):	22.0	Lateral Offset (In.):	47.0	Road Grade (%):	7.70
Physical Condition					
Barrier	Alignment and Height:	Alignment acceptable. Entire barrier is between 4-7in below the 27-in design height.

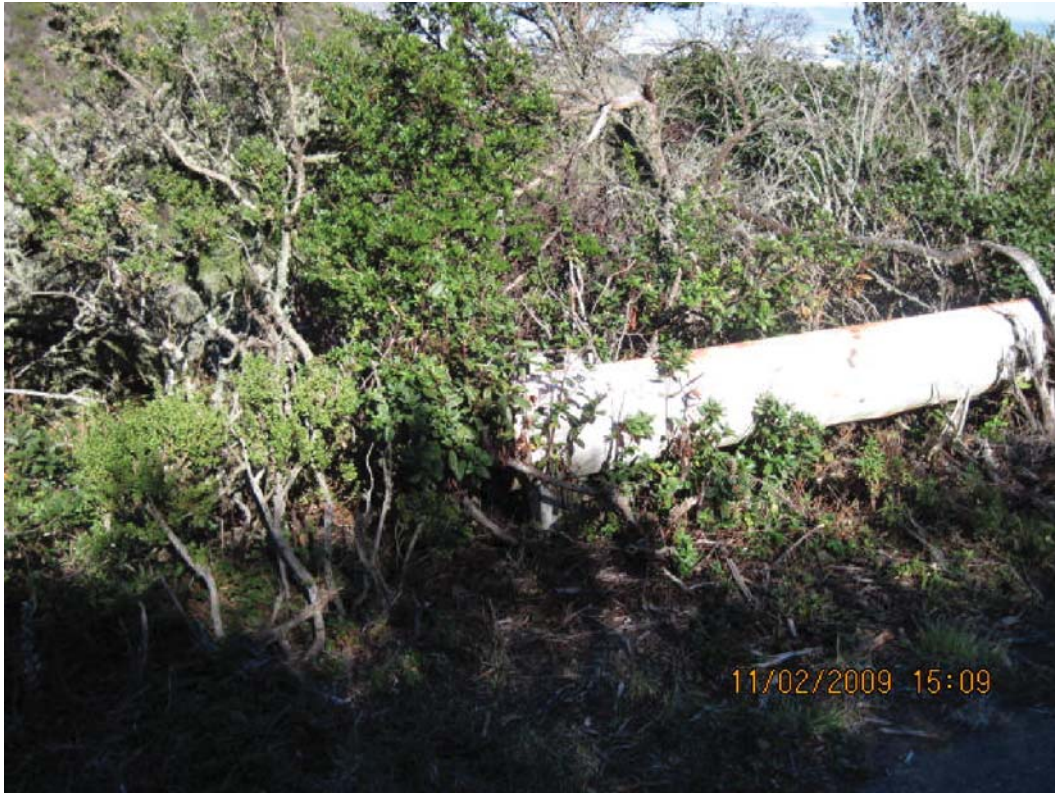
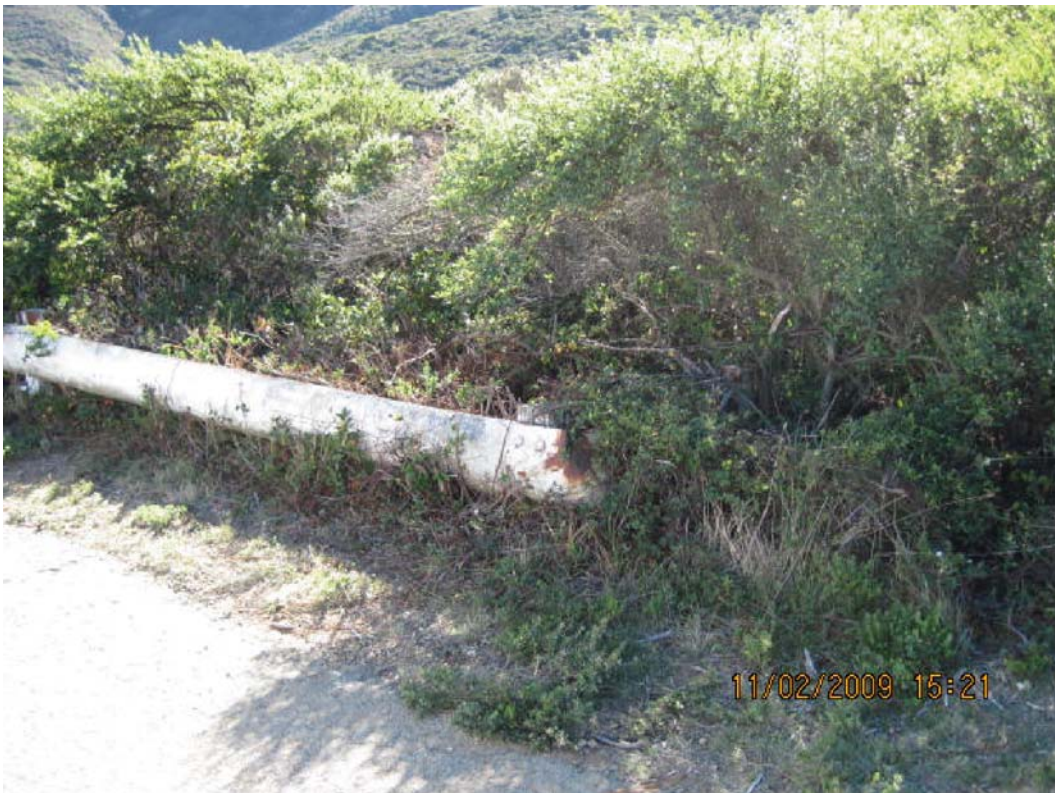
GOGA_0406_0.824_L_1.jpg

Barrier ID:	GOGA-0406-0.824-L				
Route Name:	SWEENEY RIDGE ROAD				
Inspection Date:	02/11/2009	Barrier Rating:	58.00		
Barrier Description					
Type:	OTHER: NON-STANDARD STEEL BARRIER	Barrier Function:	TRAFFIC		
Barrier Material:	WEATHERING STEEL/CORTEN	Post Material:	WOOD		
Blockout Type:	N/A	Length (ft.):	1169		
Speed Limit (MPH):	15	Placement with Respect to Road:	BOTH INSIDE AND OUTSIDE		
Hazard Behind Barrier:	MEDIUM				
Barrier Crashworthiness					
Appropriate Test Level:	TL-1	Barrier Test Level:	NCW	Is Barrier Crashworthy?:	NO
Beg. End Trtmt Type:	NONE	Is Beg. End Trtmt Crashworthy?:	N/A	Approach Transition Type:	NONE
Ending End Trtmt Type:	NONE	Ending End Trtmt Crashworthy?:	N/A		
Average Measurements					
Design Height (In.):	27	Width (In.):	0.0	Post Spacing (In.):	150.3
Height (In.):	22.0	Lateral Offset (In.):	36.7	Road Grade (%):	11.10
Physical Condition					
Barrier	Alignment and Height:	Alignment acceptable. Entire barrier is between 4-6in below the 27-in design height.

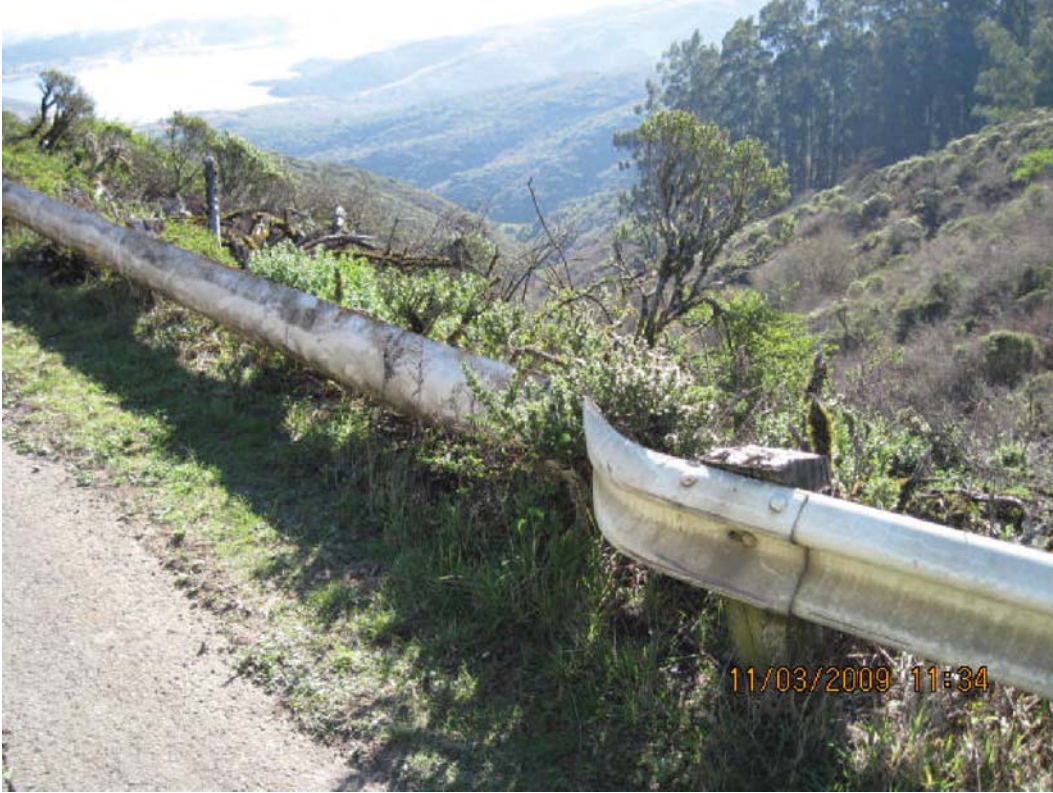
GOGA_0406_1.216_L_1.jpg

Barrier ID:	GOGA-0406-1.216-L				
Route Name:	SWEENEY RIDGE ROAD				
Inspection Date:	03/11/2009	Barrier Rating:	50.90		
Barrier Description					
Type:	OTHER: NON-STANDARD STEEL BARRIER	Barrier Function:	TRAFFIC		
Barrier Material:	WEATHERING STEEL/CORTEN	Post Material:	WOOD		
Blockout Type:	N/A	Length (ft.):	608		
Speed Limit (MPH):	15	Placement with Respect to Road:	BOTH INSIDE AND OUTSIDE		
Hazard Behind Barrier:	MEDIUM				
Barrier Crashworthiness					
Appropriate Test Level:	TL-1	Barrier Test Level:	NCW	Is Barrier Crashworthy?:	NO
Beg. End Trtmt Type:	NONE	Is Beg. End Trtmt Crashworthy?:	N/A	Approach Transition Type:	NONE
Ending End Trtmt Type:	NONE	Ending End Trtmt Crashworthy?:	N/A		
Average Measurements					
Design Height (In.):	27	Width (In.):	0.0	Post Spacing (In.):	150.0
Height (In.):	21.2	Lateral Offset (In.):	38.7	Road Grade (%):	7.00
Physical Condition					
Barrier	Alignment and Height:	Alignment off by 6-12in. Entire barrier is between 3-6in. below the 27-in design height.

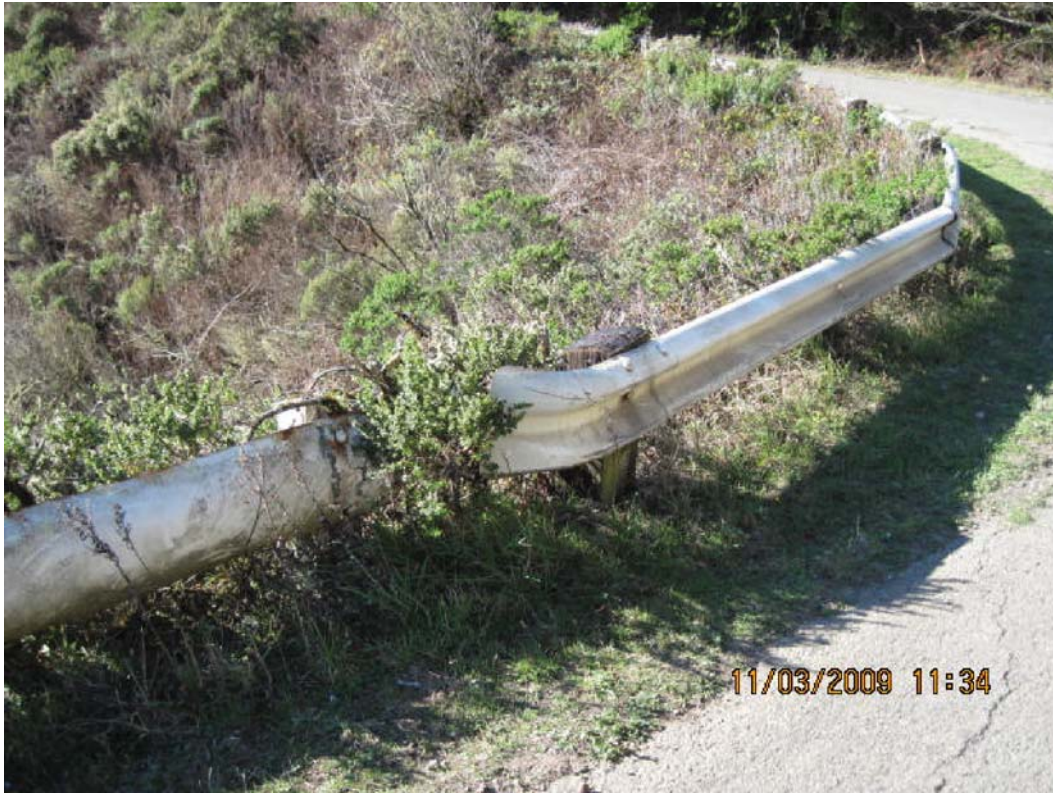
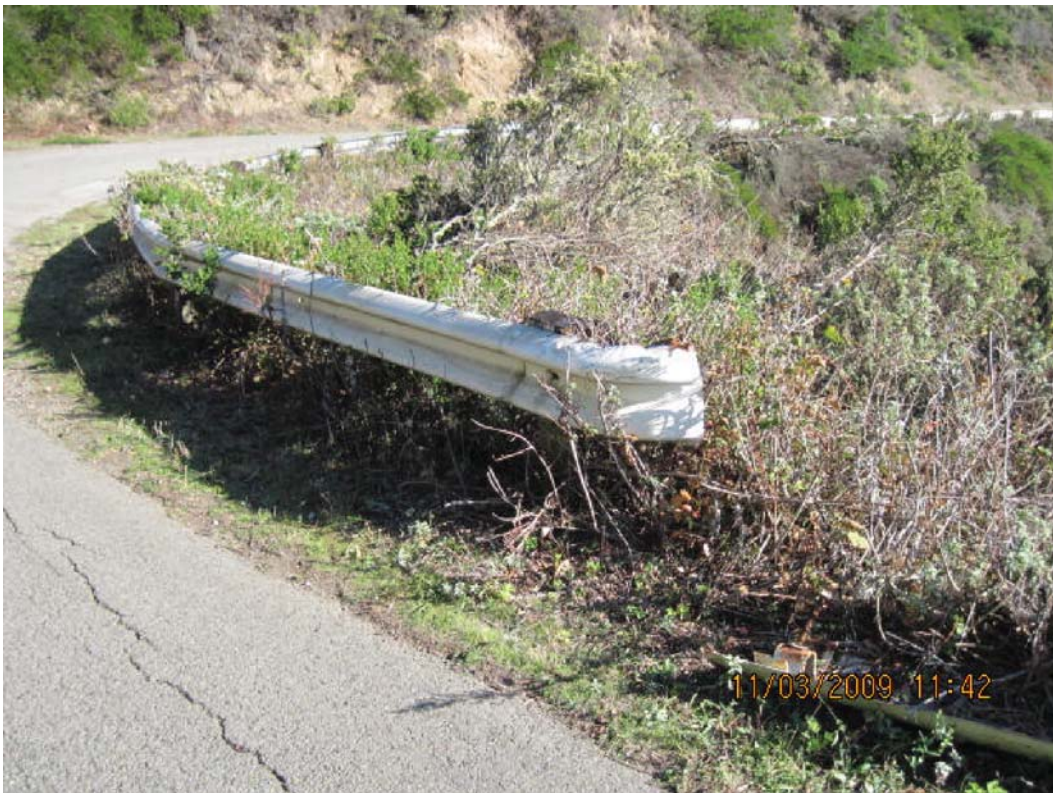
GOGA_0406_1.331_L_1.jpg

Barrier ID:	GOGA-0406-1.331-L				
Route Name:	SWEENEY RIDGE ROAD				
Inspection Date:	03/11/2009	Barrier Rating:	33.90		
Barrier Description					
Type:	W-BEAM WEAK POST	Barrier Function:	TRAFFIC		
Barrier Material:	WEATHERING STEEL/CORTEN	Post Material:	WOOD		
Blockout Type:	N/A	Length (ft.):	98		
Speed Limit (MPH):	15	Placement with Respect to Road:	INSIDE OF CURVE		
Hazard Behind Barrier:	MEDIUM				
Barrier Crashworthiness					
Appropriate Test Level:	TL-1	Barrier Test Level:	TL-2	Is Barrier Crashworthy?:	YES
Beg. End Trtmt Type:	NONE	Is Beg. End Trtmt Crashworthy?:	N/A	Approach Transition Type:	NONE
Ending End Trtmt Type:	NONE	Ending End Trtmt Crashworthy?:	N/A		
Average Measurements					
Design Height (In.):	27	Width (In.):	0.0	Post Spacing (In.):	148.3
Height (In.):	22.7	Lateral Offset (In.):	82.0	Road Grade (%):	7.30
Physical Condition					
Barrier	Alignment and Height:	Alignment off by 6-12in. Entire barrier is between 3-6in. below the 27-in design height.

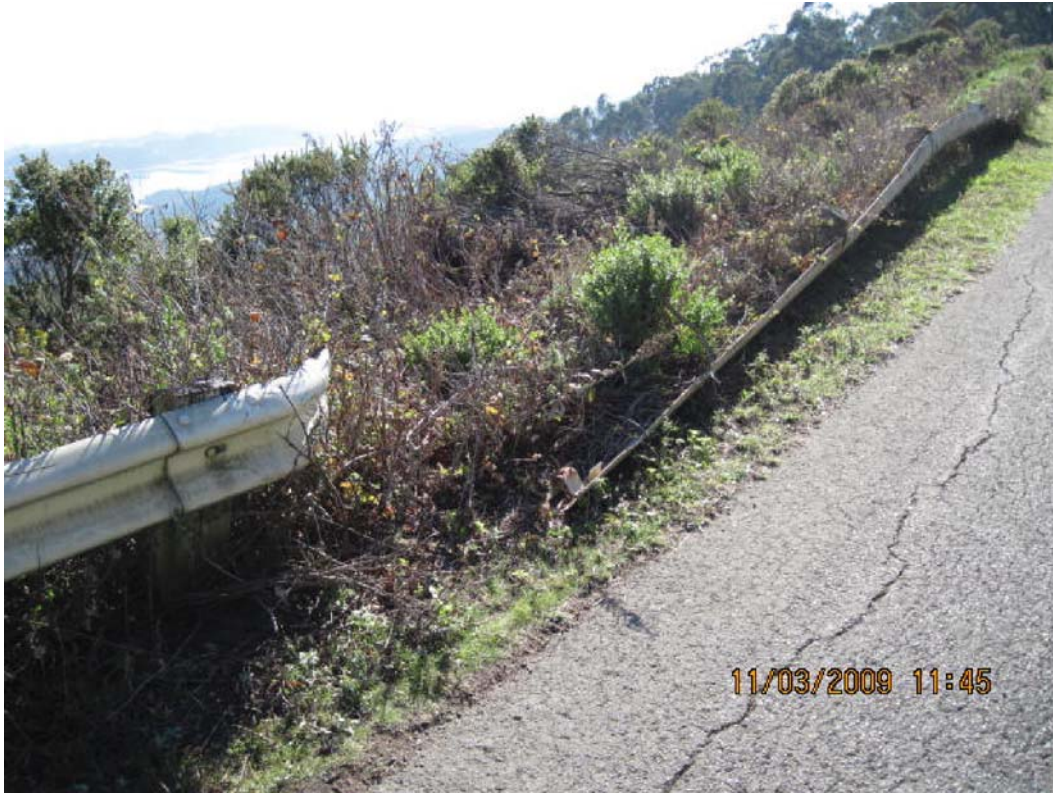
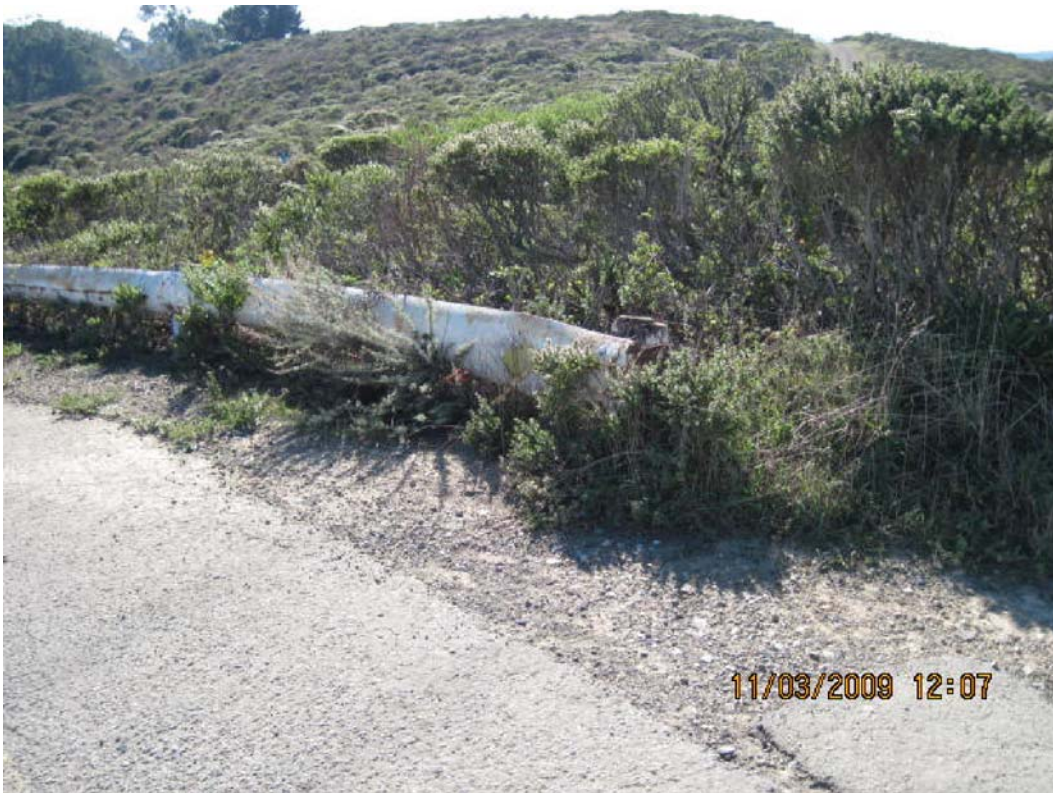
GOGA_0406_1.350_L_1.jpg

Barrier ID:	GOGA-0406-1.350-L				
Route Name:	SWEENEY RIDGE ROAD				
Inspection Date:	03/11/2009	Barrier Rating:	53.70		
Barrier Description					
Type:	OTHER: NON-STANDARD STEEL BARRIER	Barrier Function:	TRAFFIC		
Barrier Material:	WEATHERING STEEL/CORTEN	Post Material:	WOOD		
Blockout Type:	N/A	Length (ft.):	1917		
Speed Limit (MPH):	15	Placement with Respect to Road:	BOTH INSIDE AND OUTSIDE		
Hazard Behind Barrier:	MEDIUM				
Barrier Crashworthiness					
Appropriate Test Level:	TL-1	Barrier Test Level:	NCW	Is Barrier Crashworthy?:	NO
Beg. End Trtmt Type:	NONE	Is Beg. End Trtmt Crashworthy?:	N/A	Approach Transition Type:	NONE
Ending End Trtmt Type:	NONE	Ending End Trtmt Crashworthy?:	N/A		
Average Measurements					
Design Height (In.):	27	Width (In.):	0.0	Post Spacing (In.):	149.6
Height (In.):	22.0	Lateral Offset (In.):	42.0	Road Grade (%):	5.10
Physical Condition					
Barrier	Alignment and Height:	The alignment is off over a ft in some locations while having no deflection in others. Entire barrier is between 3-8in below the 27-in design height.
