GIP Report

NPS Guardwall/Rail Inventory Program
Grand Canyon National Park

Federal Highway Administration
Eastern Federal Lands Highway Division
Road Inventory Program (RIP)

Data Collection Date: October 2010
Report Date: November 2015

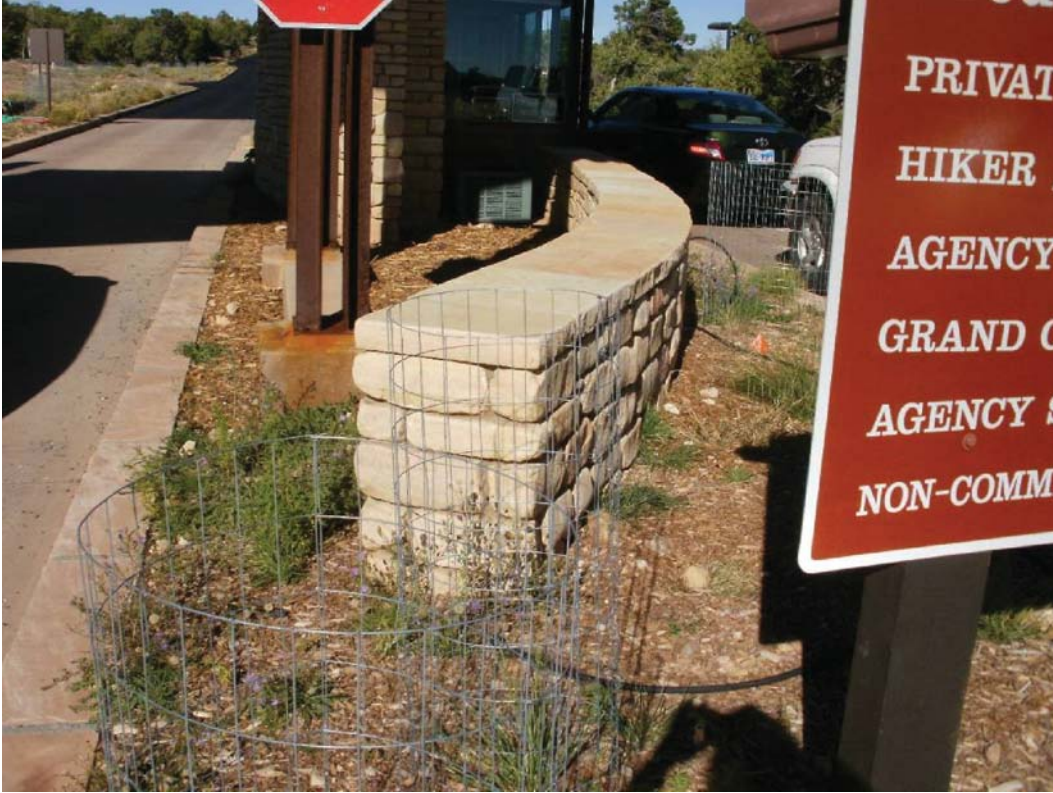
GRCA_0011_21.893_L_1.JPG

Barrier ID:	GRCA-0011-21.893-L				
Route Name:	DESERT VIEW DRIVE				
Inspection Date:	10/10/2010	Barrier Rating:	4.10		
Barrier Description					
Type:	STONE MASONRY WITH CONCRETE CORE WALL	Barrier Function:	NON-TRAFFIC		
Barrier Material:	CONCRETE	Post Material:	N/A		
Blockout Type:	N/A	Length (ft.):	30		
Speed Limit (MPH):	25	Placement with Respect to Road:	NON-TRAFFIC BARRIER		
Hazard Behind Barrier:	N/A				
Barrier Crashworthiness					
Appropriate Test Level:	TL-1	Barrier Test Level:	N/A	Is Barrier Crashworthy?:	N/A
Beg. End Trtmt Type:	NONE	Is Beg. End Trtmt Crashworthy?:	N/A	Approach Transition Type:	NONE
Ending End Trtmt Type:	NONE	Ending End Trtmt Crashworthy?:	N/A		
Average Measurements					
Design Height (In.):	27	Width (In.):	19.0	Post Spacing (In.):	0.0
Height (In.):	27.0	Lateral Offset (In.):	0.0	Road Grade (%):	0.00
Physical Condition					
Barrier	Alignment and Height:	No deviation in barrier alignment was observed. Barrier was at the 27 in design height throughout which was assumed based on field observations.

Breaking and Cracking:	No breaking or cracking was observed.			
	Missing Elements:	No missing elements were observed.			
	Corrosion and Weathering:	No corrosion or weathering was observed.			
End Treatments	Alignment and Height:				
	Breaking and Cracking:				
	Missing Elements:				
	Corrosion and Weathering:

Barrier ID:	GRCA-0011-21.893-L				
Route Name:	DESERT VIEW DRIVE				
Inspection Date:	10/10/2010	Barrier Rating:		4.10	
Repair Recommendations					
Repair Action:	NO ACTION	FMSS Work Type:	N/A	Repair Cost:	\$0
Brief Workorder:	N/A				
Workorder:

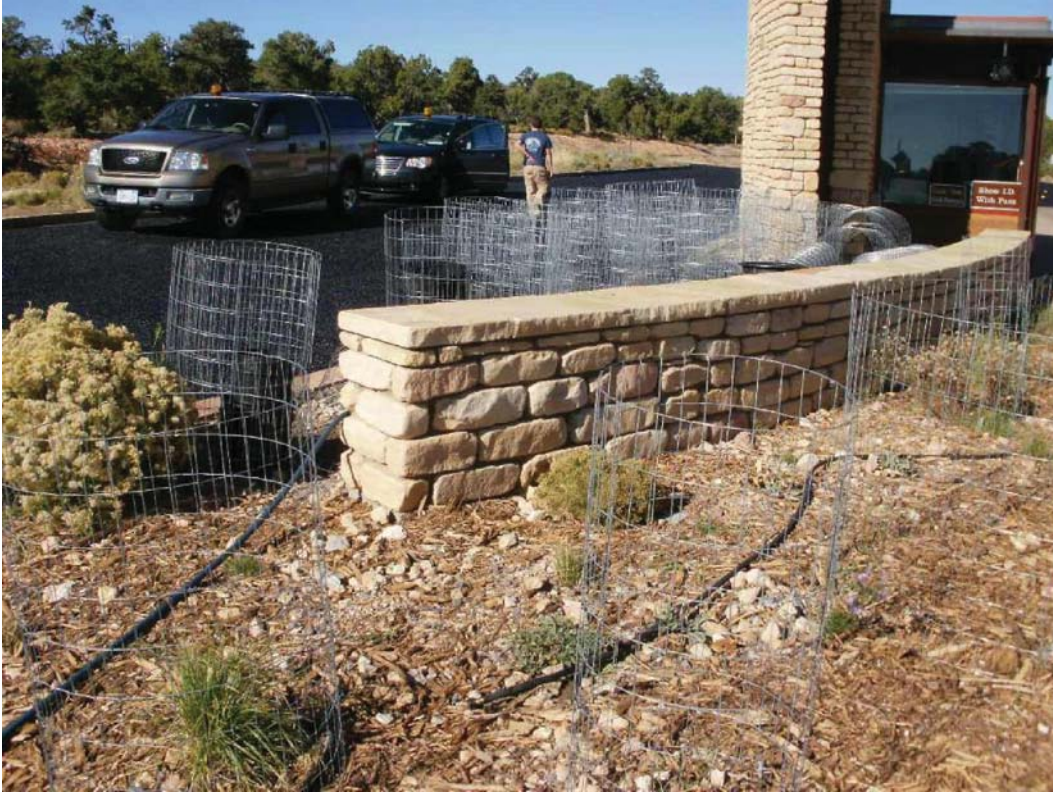
GRCA_0011_21.899_L_1.JPG

Barrier ID:	GRCA-0011-21.899-L				
Route Name:	DESERT VIEW DRIVE				
Inspection Date:	10/10/2010	Barrier Rating:	4.10		
Barrier Description					
Type:	STONE MASONRY WITH CONCRETE CORE WALL	Barrier Function:	NON-TRAFFIC		
Barrier Material:	CONCRETE	Post Material:	N/A		
Blockout Type:	N/A	Length (ft.):	30		
Speed Limit (MPH):	25	Placement with Respect to Road:	NON-TRAFFIC BARRIER		
Hazard Behind Barrier:	N/A				
Barrier Crashworthiness					
Appropriate Test Level:	TL-1	Barrier Test Level:	N/A	Is Barrier Crashworthy?:	N/A
Beg. End Trtmt Type:	NONE	Is Beg. End Trtmt Crashworthy?:	N/A	Approach Transition Type:	NONE
Ending End Trtmt Type:	NONE	Ending End Trtmt Crashworthy?:	N/A		
Average Measurements					
Design Height (In.):	27	Width (In.):	19.0	Post Spacing (In.):	0.0
Height (In.):	27.0	Lateral Offset (In.):	0.0	Road Grade (%):	0.00
Physical Condition					
Barrier	Alignment and Height:	No deviation in barrier alignment was observed. Barrier was at the 27 in design height throughout which was assumed based on field observation.

Breaking and Cracking:	No breaking or cracking was observed.			
	Missing Elements:	No missing elements was observed.			
	Corrosion and Weathering:	No corrosion or weathering was observed.			
End Treatments	Alignment and Height:				
	Breaking and Cracking:				
	Missing Elements:				
	Corrosion and Weathering:

Barrier ID:	GRCA-0011-21.899-L				
Route Name:	DESERT VIEW DRIVE				
Inspection Date:	10/10/2010	Barrier Rating:		4.10	
Repair Recommendations					
Repair Action:	NO ACTION	FMSS Work Type:	N/A	Repair Cost:	\$0
Brief Workorder:	N/A				
Workorder:

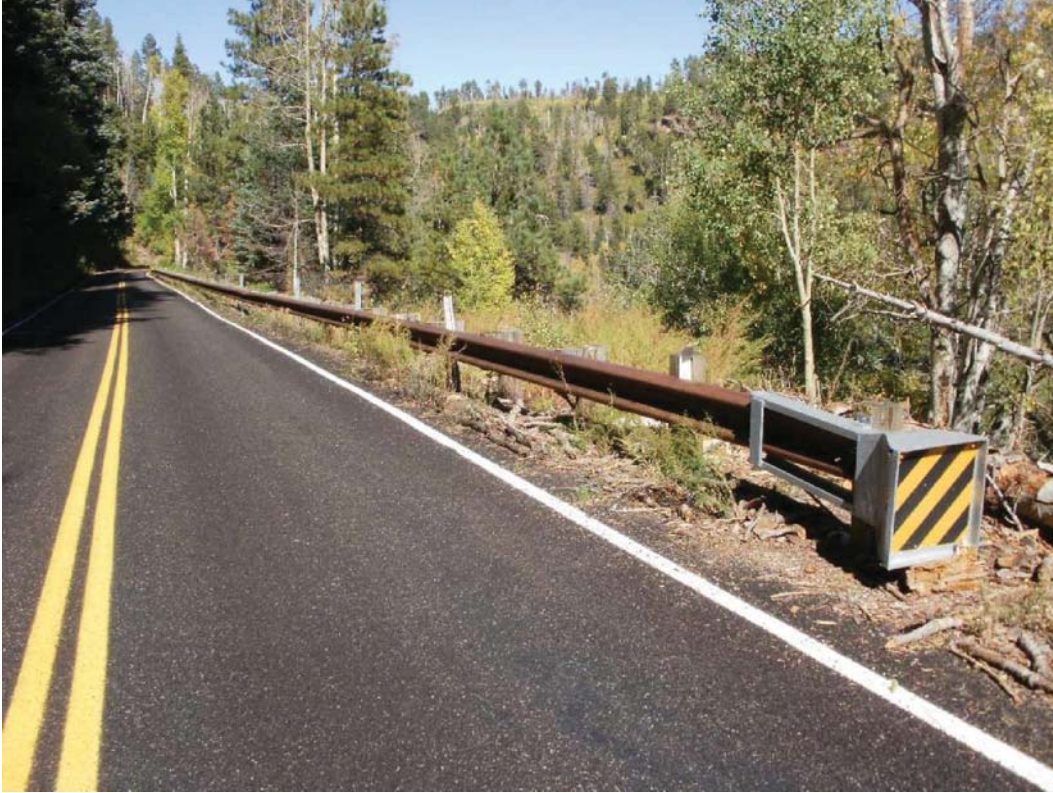
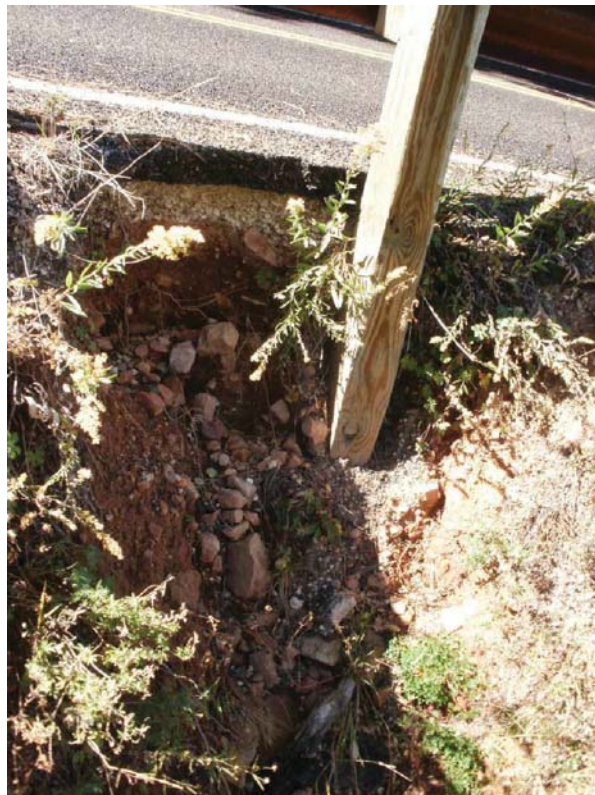
GRCA_0013_5.033_R_1.JPG

Barrier ID:	GRCA-0013-5.033-R				
Route Name:	CAPE ROYAL ROAD				
Inspection Date:	11/10/2010	Barrier Rating:	36.90		
Barrier Description					
Type:	W-BEAM STRONG POST	Barrier Function:	TRAFFIC		
Barrier Material:	WEATHERING STEEL/CORTEN	Post Material:	WOOD		
Blockout Type:	WOOD	Length (ft.):	406		
Speed Limit (MPH):	35	Placement with Respect to Road:	BOTH INSIDE AND OUTSIDE		
Hazard Behind Barrier:	HIGH				
Barrier Crashworthiness					
Appropriate Test Level:	TL-2	Barrier Test Level:	TL-3	Is Barrier Crashworthy?:	YES
Beg. End Trtmt Type:	W-BEAM TANGENT 350	Is Beg. End Trtmt Crashworthy?:	YES	Approach Transition Type:	NONE
Ending End Trtmt Type:	W-BEAM TANGENT 350	Ending End Trtmt Crashworthy?:	YES		
Average Measurements					
Design Height (In.):	27	Width (In.):	0.0	Post Spacing (In.):	75.6
Height (In.):	26.7	Lateral Offset (In.):	12.6	Road Grade (%):	5.60
Physical Condition					
Barrier	Alignment and Height:	No deviation was observed in guardrail alignment. 1 post was over 12 in off alignment. Height was within 1 in of the 27 in design height.

Breaking and Cracking:	18 ft of a 24 ft rail section was severely bent.			
	Missing Elements:	4 missing blockouts were observed.			
	Corrosion and Weathering:	Erosion greater than 8 in was observed around one post that has undercut the post and portion of asphalt shoulder.			
End Treatments	Alignment and Height:	No deviation was observed in alignment of end treatments. End treatments were within 1 in of the 27-in design height.			
	Breaking and Cracking:	No breaking or cracking was observed.			
	Missing Elements:	No missing elements were observed.			
	Corrosion and Weathering:	No corrosion or weathering was observed.

Repair Action:	REPAIR	FMSS Work Type:	DEFERRED MAINTENANCE	Repair Cost:	\$7513
Brief Workorder:	Replace 24 feet of rail replace 1 bent post replace 4 missing blocks fill eroded section with 6 CY of backfill and install 230 ft of asphalt curb in front of barrier to control erosion.				
Workorder:	<p>Replace Rail at \$25- per -Lin. Ft. for 24 LF = \$600. Replace 24 foot bent rail section.</p> <p>Replace Post at \$100- per -Each for 1 Post(s) = \$100. Replace one misaligned post.</p> <p>Replace Block at \$30- per -Each for 4 Block(s) = \$120.</p> <p>Structural Backfill at \$50- per -Cu. Yd. for 6 CY = \$300. Fill in eroded section.</p> <p>Asphalt Curb at \$12- per -Lin. Ft. for 230 LF = \$2760. Construct curb along barrier to divert water.</p> <p>Low Speed Traffic Control at \$1475- per -Day for 2 Day(s) = \$2950. 1 day for rail elements 1 day for asphalt curb and backfill.</p>

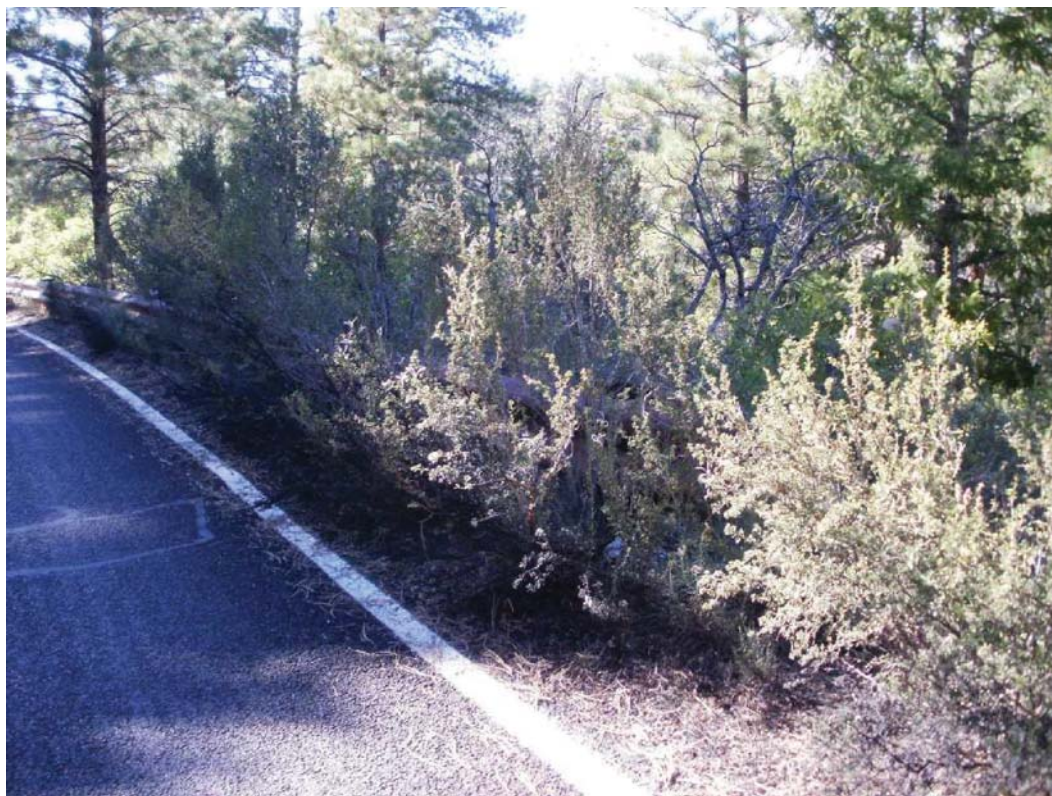
GRCA_0013_19.603_L_1.JPG

Barrier ID:	GRCA-0013-19.603-L				
Route Name:	CAPE ROYAL ROAD				
Inspection Date:	11/10/2010	Barrier Rating:	55.90		
Barrier Description					
Type:	W-BEAM WEAK POST	Barrier Function:	TRAFFIC		
Barrier Material:	GALVANIZED STEEL	Post Material:	WOOD		
Blockout Type:	N/A	Length (ft.):	393		
Speed Limit (MPH):	35	Placement with Respect to Road:	OUTSIDE OF CURVE		
Hazard Behind Barrier:	EXTREME				
Barrier Crashworthiness					
Appropriate Test Level:	TL-2	Barrier Test Level:	TL-2	Is Barrier Crashworthy?:	YES
Beg. End Trtmt Type:	NONE	Is Beg. End Trtmt Crashworthy?:	N/A	Approach Transition Type:	NONE
Ending End Trtmt Type:	NONE	Ending End Trtmt Crashworthy?:	N/A		
Average Measurements					
Design Height (In.):	27	Width (In.):	0.0	Post Spacing (In.):	150.6
Height (In.):	23.0	Lateral Offset (In.):	20.2	Road Grade (%):	6.90
Physical Condition					
Barrier	Alignment and Height:	No deviation in barrier alignment was observed. Barrier was 4 in below design height of 27 in for 377 linear ft and below by 3 in for 16 linear ft.

Breaking and Cracking:	90 percent of one post was burnt away.			
	Missing Elements:	2 barrier reflectors were detached and near barrier.			
	Corrosion and Weathering:	No corrosion or weathering was observed. Vegetation was growing over barrier. Debris was piled in front of barrier.			
End Treatments	Alignment and Height:				
	Breaking and Cracking:				
	Missing Elements:				
	Corrosion and Weathering:

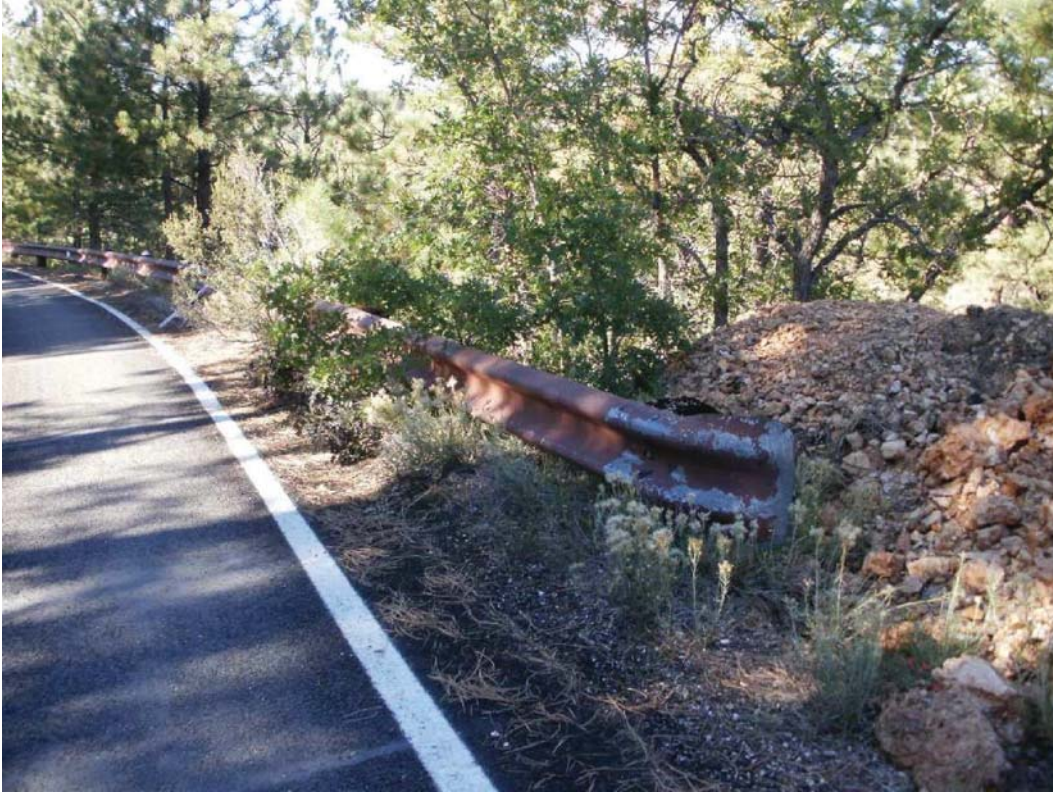
GRCA_0013_19.693_L_1.JPG

Barrier ID:	GRCA-0013-19.693-L				
Route Name:	CAPE ROYAL ROAD				
Inspection Date:	11/10/2010	Barrier Rating:	46.00		
Barrier Description					
Type:	W-BEAM WEAK POST	Barrier Function:	TRAFFIC		
Barrier Material:	GALVANIZED STEEL	Post Material:	WOOD		
Blockout Type:	N/A	Length (ft.):	243		
Speed Limit (MPH):	35	Placement with Respect to Road:	OUTSIDE OF CURVE		
Hazard Behind Barrier:	EXTREME				
Barrier Crashworthiness					
Appropriate Test Level:	TL-2	Barrier Test Level:	TL-2	Is Barrier Crashworthy?:	YES
Beg. End Trtmt Type:	NONE	Is Beg. End Trtmt Crashworthy?:	N/A	Approach Transition Type:	NONE
Ending End Trtmt Type:	NONE	Ending End Trtmt Crashworthy?:	N/A		
Average Measurements					
Design Height (In.):	27	Width (In.):	0.0	Post Spacing (In.):	151.0
Height (In.):	23.2	Lateral Offset (In.):	28.7	Road Grade (%):	7.20
Physical Condition					
Barrier	Alignment and Height:	No deviation was observed in barrier alignment. Height of barrier was 2 to 3 in below the 27 in design height for 118 ft and 3 to 6 in below for 125 ft. No evidence of impact was observed.

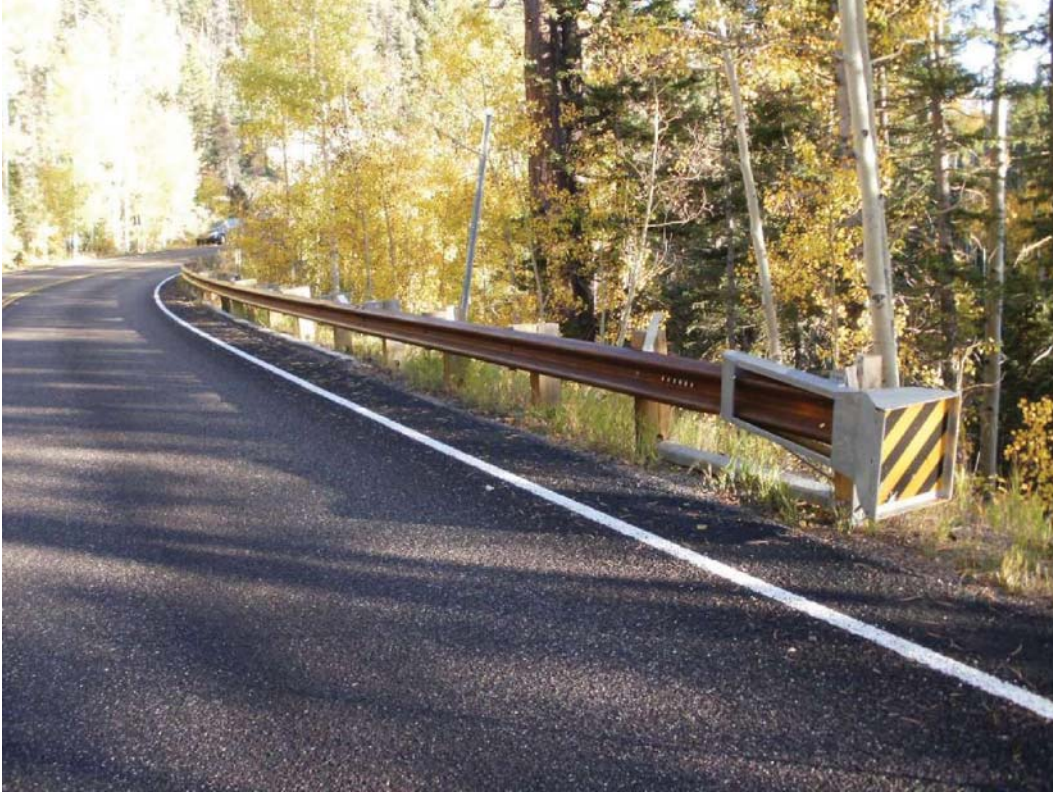
GRCA_0014_3.356_R_1.JPG

Barrier ID:	GRCA-0014-3.356-R				
Route Name:	NORTH ENTRANCE ROAD (HWY 67)				
Inspection Date:	11/10/2010	Barrier Rating:	35.50		
Barrier Description					
Type:	W-BEAM STRONG POST	Barrier Function:	TRAFFIC		
Barrier Material:	WEATHERING STEEL/CORTEN	Post Material:	WOOD		
Blockout Type:	WOOD	Length (ft.):	382		
Speed Limit (MPH):	45	Placement with Respect to Road:	INSIDE OF CURVE		
Hazard Behind Barrier:	HIGH				
Barrier Crashworthiness					
Appropriate Test Level:	TL-2	Barrier Test Level:	TL-3	Is Barrier Crashworthy?:	YES
Beg. End Trtmt Type:	W-BEAM TANGENT 350	Is Beg. End Trtmt Crashworthy?:	YES	Approach Transition Type:	NONE
Ending End Trtmt Type:	W-BEAM TANGENT 350	Ending End Trtmt Crashworthy?:	YES		
Average Measurements					
Design Height (In.):	27	Width (In.):	0.0	Post Spacing (In.):	75.0
Height (In.):	26.2	Lateral Offset (In.):	23.7	Road Grade (%):	2.10
Physical Condition					
Barrier	Alignment and Height:	No deviation was observed in barrier alignment. Height was 1 to 3 in below 27 in design height for 178 ft while the remaining height was within 1 in of the 27 in design height.

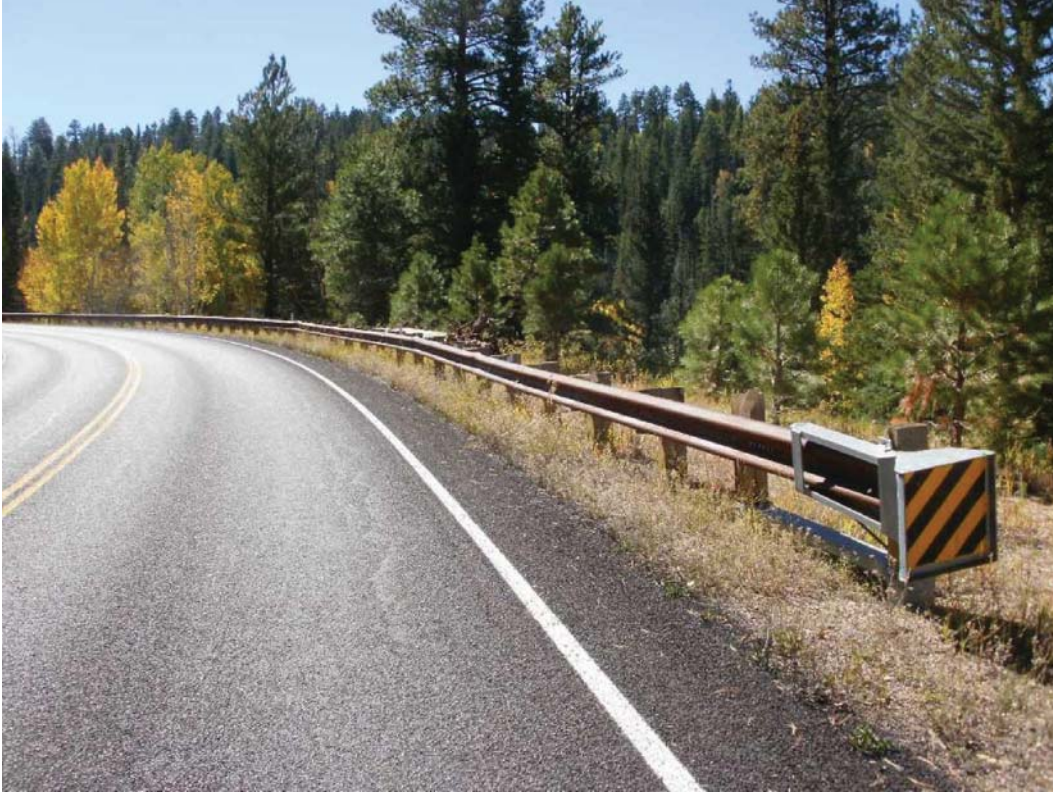
GRCA_0014_10.345_R_1.JPG

Barrier ID:	GRCA-0014-10.345-R				
Route Name:	NORTH ENTRANCE ROAD (HWY 67)				
Inspection Date:	11/10/2010	Barrier Rating:	26.80		
Barrier Description					
Type:	W-BEAM STRONG POST	Barrier Function:	TRAFFIC		
Barrier Material:	WEATHERING STEEL/CORTEN	Post Material:	WOOD		
Blockout Type:	WOOD	Length (ft.):	502		
Speed Limit (MPH):	35	Placement with Respect to Road:	OUTSIDE OF CURVE		
Hazard Behind Barrier:	HIGH				
Barrier Crashworthiness					
Appropriate Test Level:	TL-2	Barrier Test Level:	TL-3	Is Barrier Crashworthy?:	YES
Beg. End Trtmt Type:	W-BEAM TANGENT 350	Is Beg. End Trtmt Crashworthy?:	YES	Approach Transition Type:	NONE
Ending End Trtmt Type:	W-BEAM TANGENT 350	Ending End Trtmt Crashworthy?:	YES		
Average Measurements					
Design Height (In.):	27	Width (In.):	0.0	Post Spacing (In.):	74.6
Height (In.):	28.2	Lateral Offset (In.):	65.3	Road Grade (%):	4.80
Physical Condition					
Barrier	Alignment and Height:	No deviation in barrier alignment was observed. Barrier height ranged from 0-3in. above the 27-in design height.

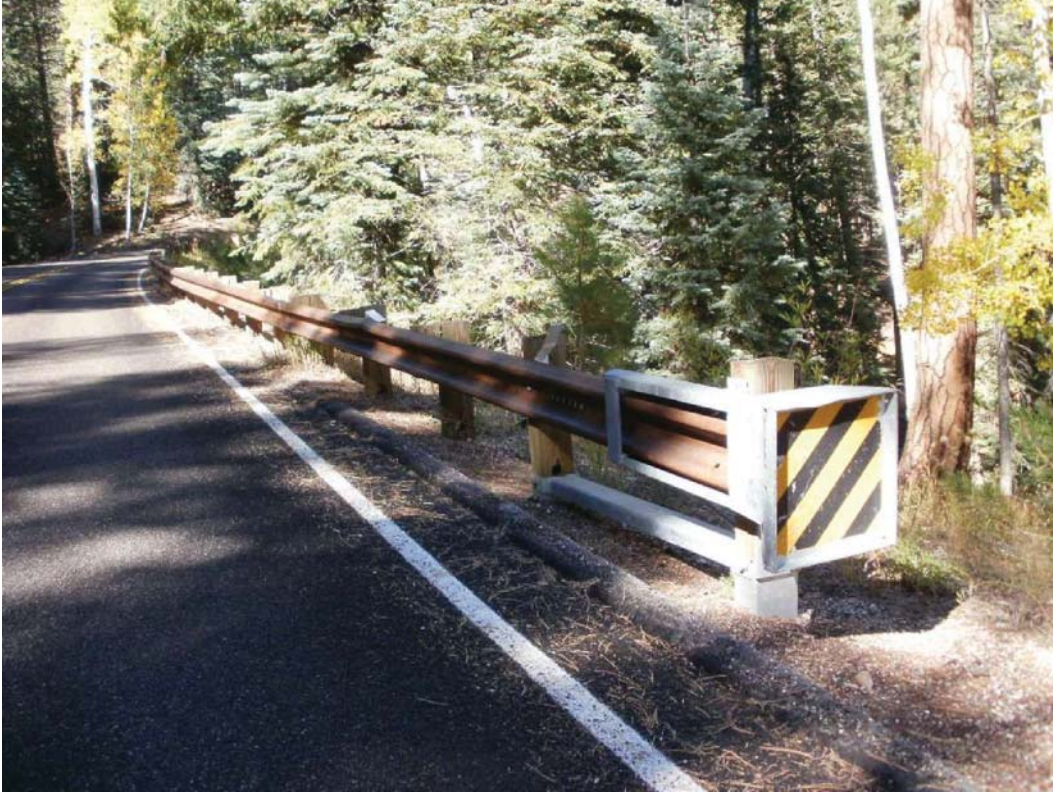
GRCA_0014_10.880_R_1.JPG

Barrier ID:	GRCA-0014-10.880-R				
Route Name:	NORTH ENTRANCE ROAD (HWY 67)				
Inspection Date:	11/10/2010	Barrier Rating:	27.00		
Barrier Description					
Type:	W-BEAM STRONG POST	Barrier Function:	TRAFFIC		
Barrier Material:	WEATHERING STEEL/CORTEN	Post Material:	WOOD		
Blockout Type:	WOOD	Length (ft.):	311		
Speed Limit (MPH):	25	Placement with Respect to Road:	INSIDE OF CURVE		
Hazard Behind Barrier:	HIGH				
Barrier Crashworthiness					
Appropriate Test Level:	TL-1	Barrier Test Level:	TL-3	Is Barrier Crashworthy?:	YES
Beg. End Trtmt Type:	W-BEAM TANGENT 350	Is Beg. End Trtmt Crashworthy?:	YES	Approach Transition Type:	NONE
Ending End Trtmt Type:	W-BEAM TANGENT 350	Ending End Trtmt Crashworthy?:	YES		
Average Measurements					
Design Height (In.):	27	Width (In.):	0.0	Post Spacing (In.):	74.0
Height (In.):	26.0	Lateral Offset (In.):	17.0	Road Grade (%):	5.50
Physical Condition					
Barrier	Alignment and Height:	No deviation was observed in barrier alignment. The height was within 1 in of the 27 in design height for 257 ft and was 1 to 3 in below for 54 ft.

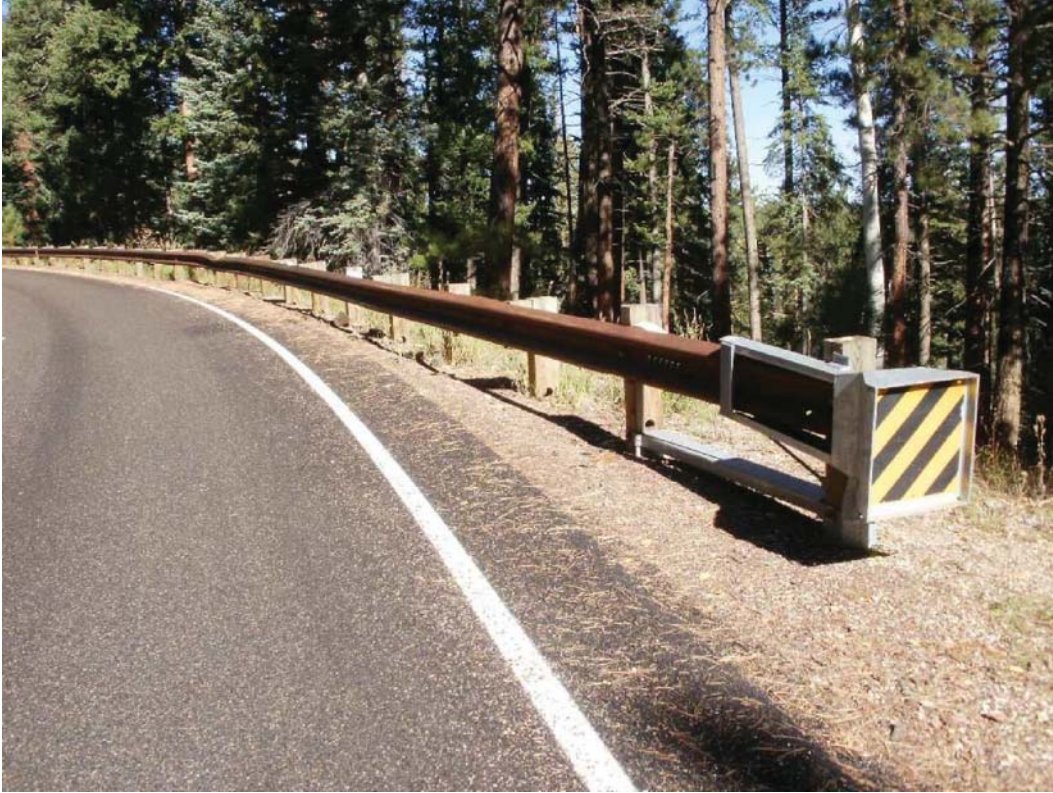
GRCA_0014_10.963_R_1.JPG

Barrier ID:	GRCA-0014-10.963-R				
Route Name:	NORTH ENTRANCE ROAD (HWY 67)				
Inspection Date:	11/10/2010	Barrier Rating:	30.80		
Barrier Description					
Type:	W-BEAM STRONG POST	Barrier Function:	TRAFFIC		
Barrier Material:	WEATHERING STEEL/CORTEN	Post Material:	WOOD		
Blockout Type:	WOOD	Length (ft.):	760		
Speed Limit (MPH):	25	Placement with Respect to Road:	BOTH INSIDE AND OUTSIDE		
Hazard Behind Barrier:	MEDIUM				
Barrier Crashworthiness					
Appropriate Test Level:	TL-1	Barrier Test Level:	TL-3	Is Barrier Crashworthy?:	YES
Beg. End Trtmt Type:	W-BEAM TANGENT 350	Is Beg. End Trtmt Crashworthy?:	YES	Approach Transition Type:	NONE
Ending End Trtmt Type:	W-BEAM TANGENT 350	Ending End Trtmt Crashworthy?:	YES		
Average Measurements					
Design Height (In.):	27	Width (In.):	0.0	Post Spacing (In.):	75.0
Height (In.):	26.0	Lateral Offset (In.):	24.0	Road Grade (%):	4.90
Physical Condition					
Barrier	Alignment and Height:	Alignment was off by greater than 12 in for 12 ft and alignment was off by 6 to 12 in for 26 ft. Height was 1 to 3 in below 27 in design height for 305 ft and was within 1 in of the design height for the remaining length.

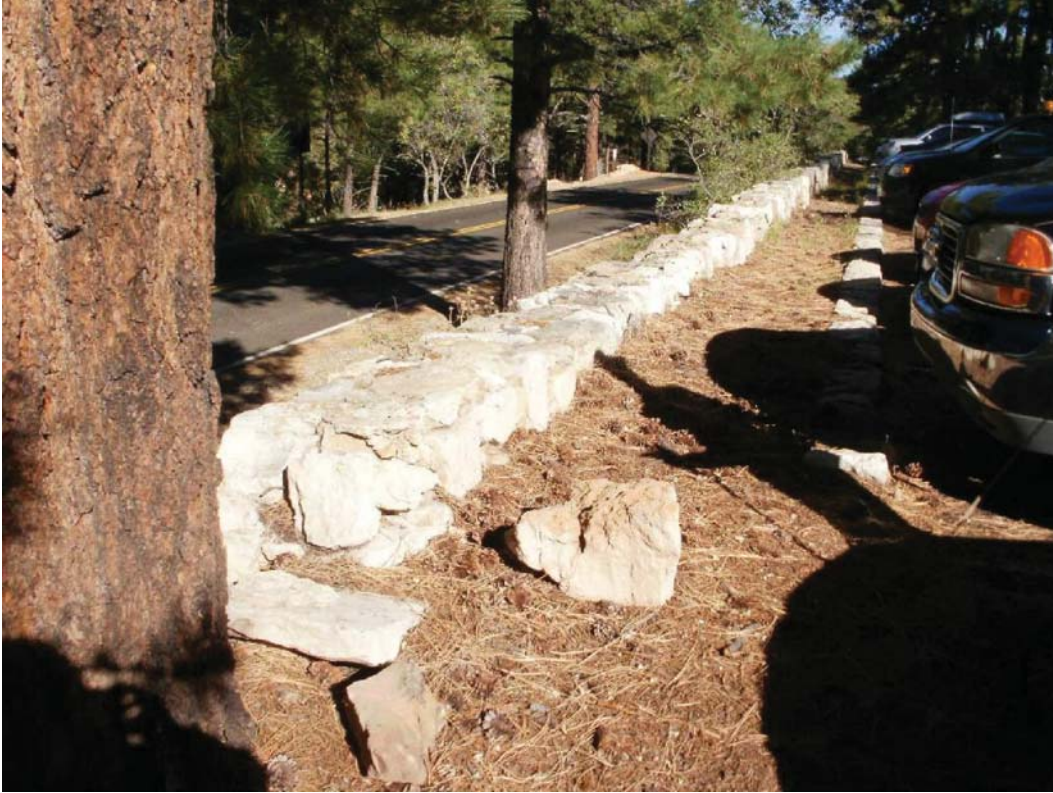
GRCA_0014_12.652_L_1.JPG

Barrier ID:	GRCA-0014-12.652-L				
Route Name:	NORTH ENTRANCE ROAD (HWY 67)				
Inspection Date:	11/10/2010	Barrier Rating:	21.50		
Barrier Description					
Type:	STONE MASONRY WITHOUT CONCRETE CORE WALL	Barrier Function:	NON-TRAFFIC		
Barrier Material:	STONE	Post Material:	N/A		
Blockout Type:	N/A	Length (ft.):	154		
Speed Limit (MPH):	15	Placement with Respect to Road:	NON-TRAFFIC BARRIER		
Hazard Behind Barrier:	N/A				
Barrier Crashworthiness					
Appropriate Test Level:	TL-1	Barrier Test Level:	N/A	Is Barrier Crashworthy?:	N/A
Beg. End Trtmt Type:	NONE	Is Beg. End Trtmt Crashworthy?:	N/A	Approach Transition Type:	NONE
Ending End Trtmt Type:	NONE	Ending End Trtmt Crashworthy?:	N/A		
Average Measurements					
Design Height (In.):	24	Width (In.):	23.0	Post Spacing (In.):	0.0
Height (In.):	19.2	Lateral Offset (In.):	0.0	Road Grade (%):	0.00
Physical Condition					
Barrier	Alignment and Height:	No deviation in barrier alignment was observed. Barrier height was between 4 to 6 in below the 24 in design height.

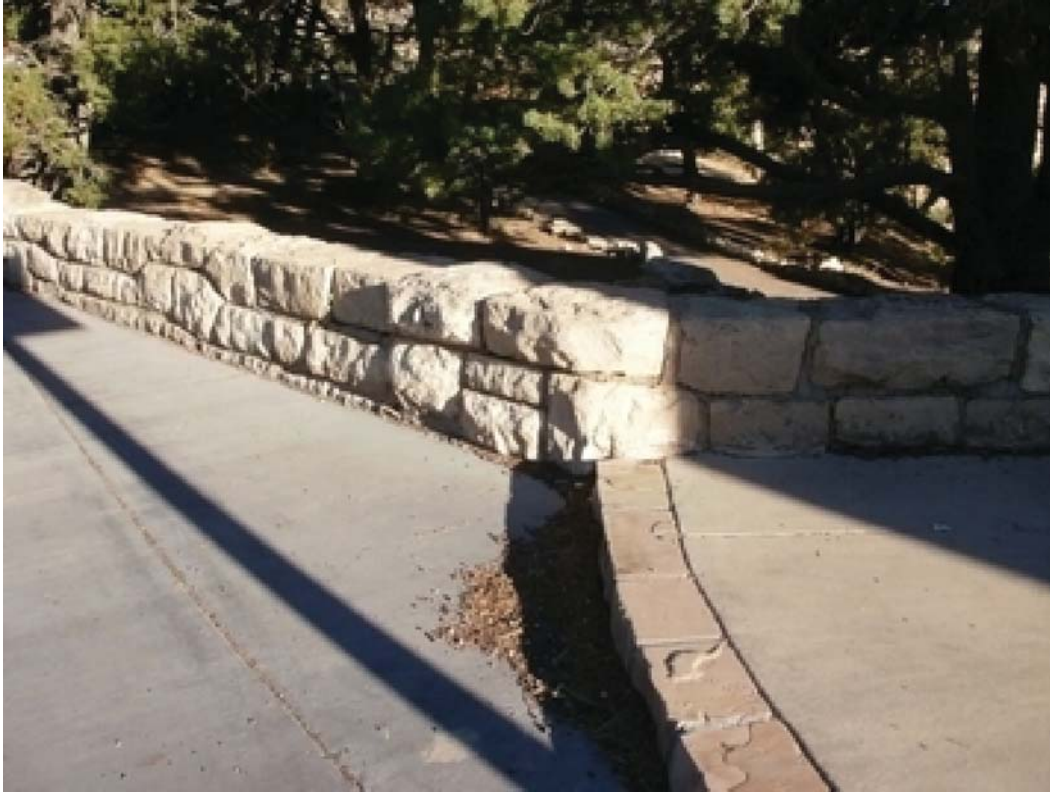
GRCA_0015_0.033_R_1.JPG

Barrier ID:	GRCA-0015-0.033-R				
Route Name:	HERMIT REST ROAD				
Inspection Date:	09/10/2010	Barrier Rating:	28.20		
Barrier Description					
Type:	STONE MASONRY WITHOUT CONCRETE CORE WALL	Barrier Function:	TRAFFIC		
Barrier Material:	STONE	Post Material:	N/A		
Blockout Type:	N/A	Length (ft.):	32		
Speed Limit (MPH):	15	Placement with Respect to Road:	OUTSIDE OF CURVE		
Hazard Behind Barrier:	HIGH				
Barrier Crashworthiness					
Appropriate Test Level:	TL-1	Barrier Test Level:	NCW	Is Barrier Crashworthy?:	NO
Beg. End Trtmt Type:	NONE	Is Beg. End Trtmt Crashworthy?:	N/A	Approach Transition Type:	NONE
Ending End Trtmt Type:	NONE	Ending End Trtmt Crashworthy?:	N/A		
Average Measurements					
Design Height (In.):	24	Width (In.):	23.0	Post Spacing (In.):	0.0
Height (In.):	26.0	Lateral Offset (In.):	34.7	Road Grade (%):	1.50
Physical Condition					
Barrier	Alignment and Height:	No deviation was observed in barrier alignment. The height ranged from 0-3in. above the 27-in design height.

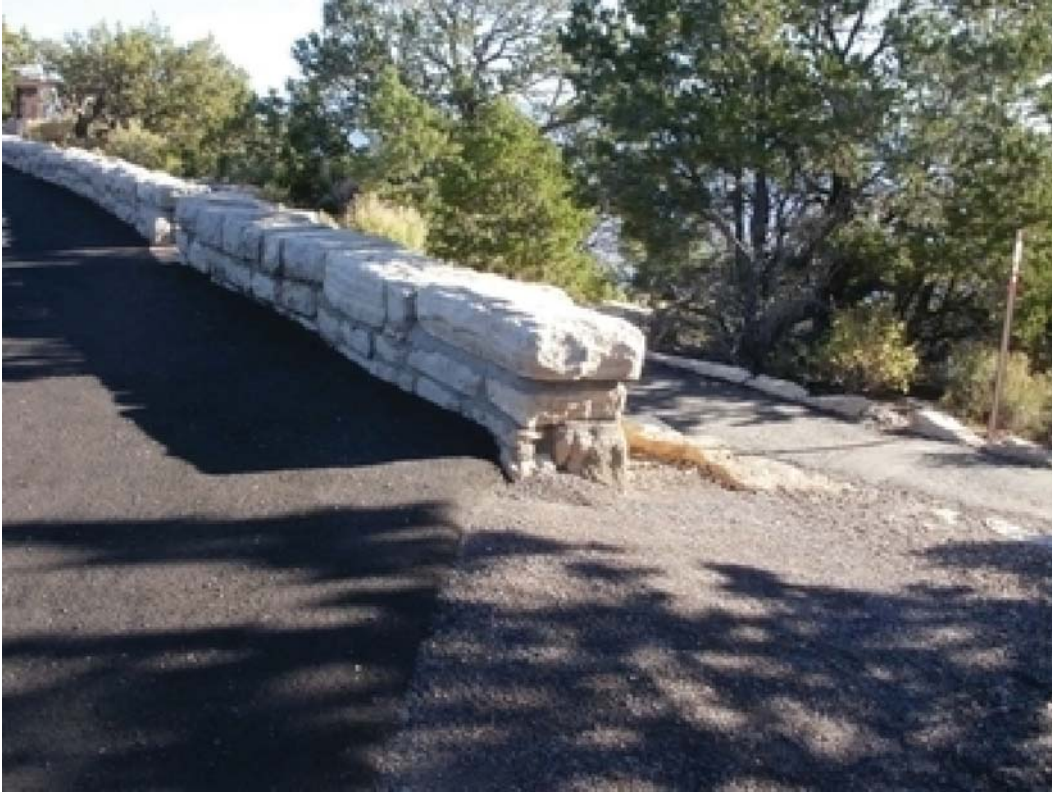
GRCA_0015_1.097_R_1.JPG

Barrier ID:	GRCA-0015-1.097-R				
Route Name:	HERMIT REST ROAD				
Inspection Date:	09/10/2010	Barrier Rating:	8.60		
Barrier Description					
Type:	STONE MASONRY WITHOUT CONCRETE CORE WALL	Barrier Function:	NON-TRAFFIC		
Barrier Material:	STONE	Post Material:	N/A		
Blockout Type:	N/A	Length (ft.):	73		
Speed Limit (MPH):	25	Placement with Respect to Road:	NON-TRAFFIC BARRIER		
Hazard Behind Barrier:	N/A				
Barrier Crashworthiness					
Appropriate Test Level:	TL-1	Barrier Test Level:	N/A	Is Barrier Crashworthy?:	N/A
Beg. End Trtmt Type:	NONE	Is Beg. End Trtmt Crashworthy?:	N/A	Approach Transition Type:	NONE
Ending End Trtmt Type:	NONE	Ending End Trtmt Crashworthy?:	N/A		
Average Measurements					
Design Height (In.):	24	Width (In.):	21.2	Post Spacing (In.):	0.0
Height (In.):	20.0	Lateral Offset (In.):	0.0	Road Grade (%):	0.00
Physical Condition					
Barrier	Alignment and Height:	No deviation was observed in barrier alignment. The barrier height was 4 in below the 24 in design height throughout.

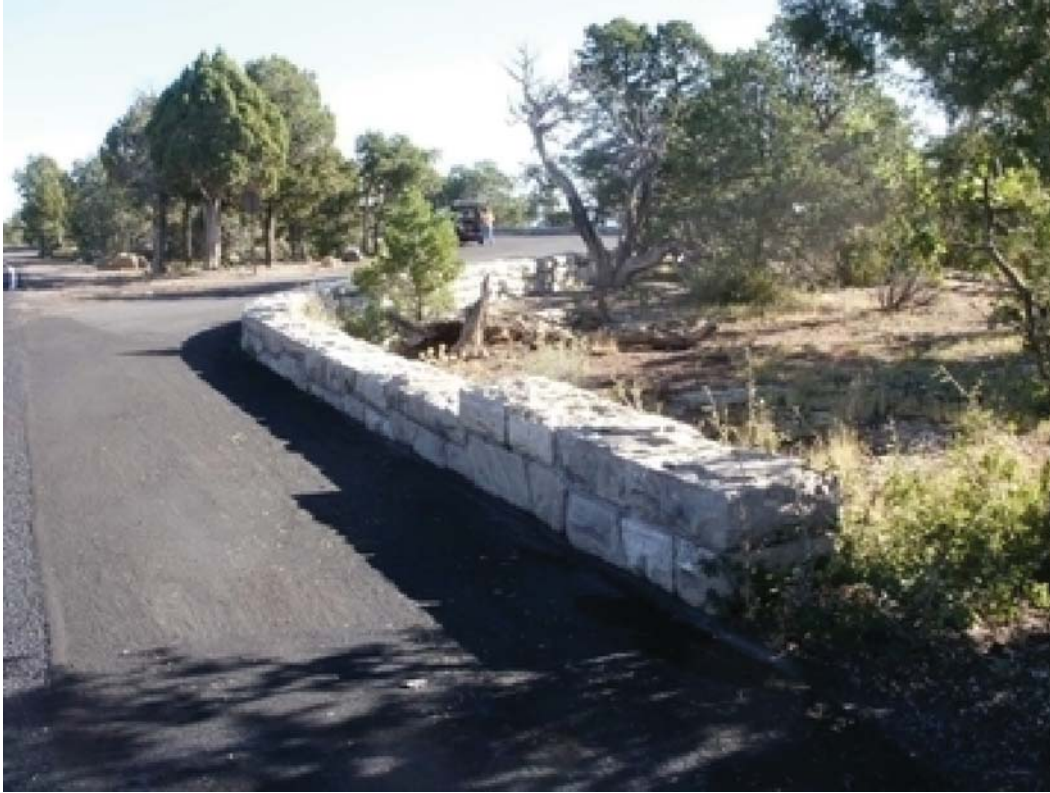
GRCA_0015_1.431_R_1.JPG

Barrier ID:	GRCA-0015-1.431-R				
Route Name:	HERMIT REST ROAD				
Inspection Date:	09/10/2010	Barrier Rating:	50.00		
Barrier Description					
Type:	STONE MASONRY WITHOUT CONCRETE CORE WALL	Barrier Function:	TRAFFIC		
Barrier Material:	STONE	Post Material:	N/A		
Blockout Type:	N/A	Length (ft.):	157		
Speed Limit (MPH):	25	Placement with Respect to Road:	OUTSIDE OF CURVE		
Hazard Behind Barrier:	EXTREME				
Barrier Crashworthiness					
Appropriate Test Level:	TL-1	Barrier Test Level:	NCW	Is Barrier Crashworthy?:	NO
Beg. End Trtmt Type:	NONE	Is Beg. End Trtmt Crashworthy?:	N/A	Approach Transition Type:	NONE
Ending End Trtmt Type:	NONE	Ending End Trtmt Crashworthy?:	N/A		
Average Measurements					
Design Height (In.):	24	Width (In.):	21.2	Post Spacing (In.):	0.0
Height (In.):	17.7	Lateral Offset (In.):	16.0	Road Grade (%):	1.20
Physical Condition					
Barrier	Alignment and Height:	No deviation in barrier alignment was observed. Barrier was 7 in below 24 in design height for 63 linear ft and 3 to 6 in below for 86 linear ft.

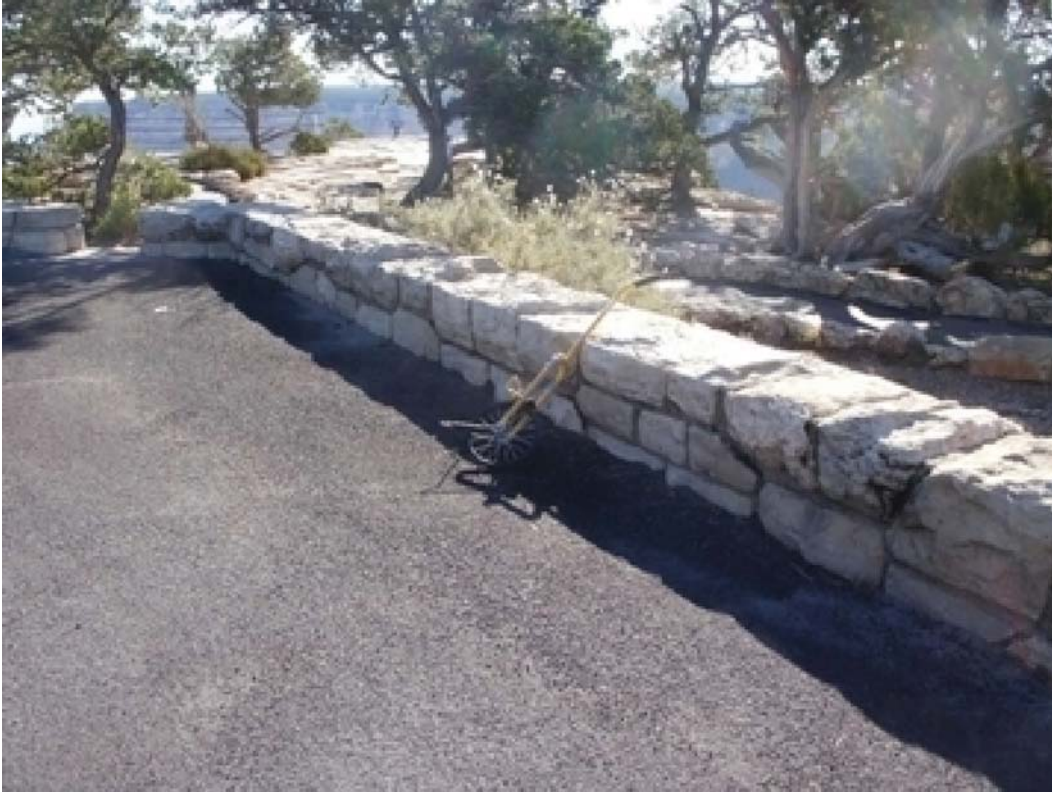
GRCA_0015_1.437_R_1.JPG

Barrier ID:	GRCA-0015-1.437-R				
Route Name:	HERMIT REST ROAD				
Inspection Date:	09/10/2010	Barrier Rating:	17.10		
Barrier Description					
Type:	STONE MASONRY WITHOUT CONCRETE CORE WALL	Barrier Function:	NON-TRAFFIC		
Barrier Material:	STONE	Post Material:	N/A		
Blockout Type:	N/A	Length (ft.):	178		
Speed Limit (MPH):	25	Placement with Respect to Road:	NON-TRAFFIC BARRIER		
Hazard Behind Barrier:	N/A				
Barrier Crashworthiness					
Appropriate Test Level:	TL-1	Barrier Test Level:	N/A	Is Barrier Crashworthy?:	N/A
Beg. End Trtmt Type:	NONE	Is Beg. End Trtmt Crashworthy?:	N/A	Approach Transition Type:	NONE
Ending End Trtmt Type:	NONE	Ending End Trtmt Crashworthy?:	N/A		
Average Measurements					
Design Height (In.):	24	Width (In.):	21.7	Post Spacing (In.):	0.0
Height (In.):	18.0	Lateral Offset (In.):	0.0	Road Grade (%):	0.00
Physical Condition					
Barrier	Alignment and Height:	No deviation was observed in barrier alignment. The height was 7 in below 24 in design height for 75 ft and 5 to 6 in below for 103 ft.

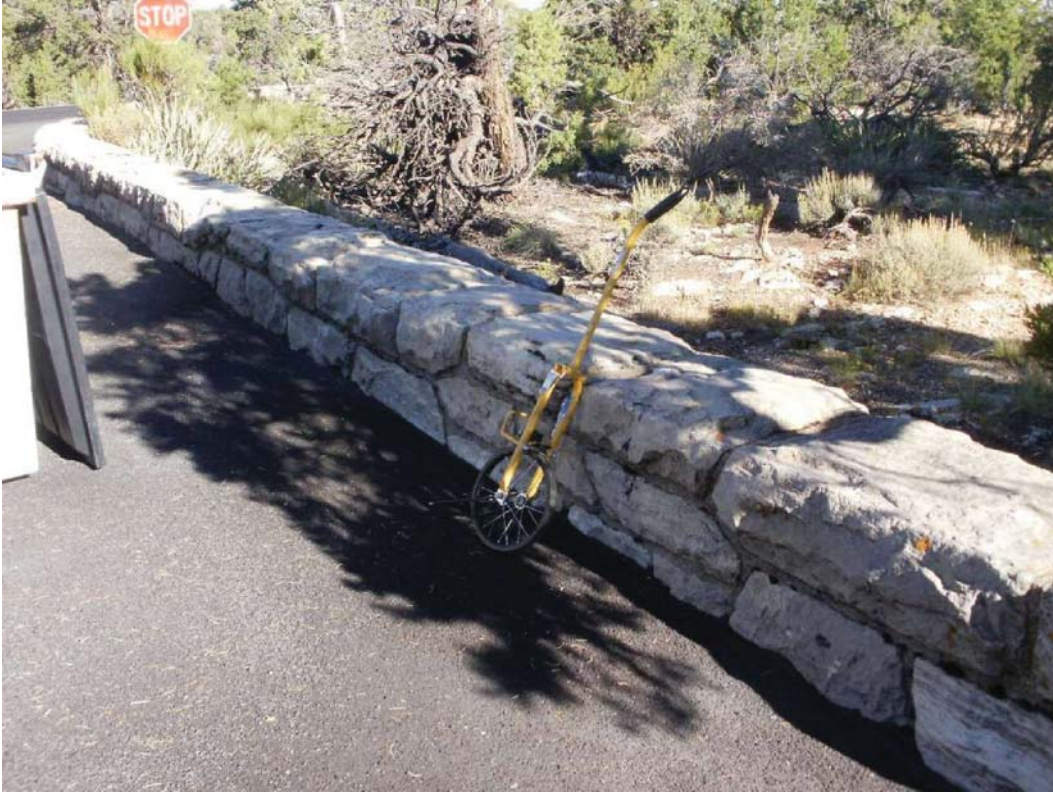
GRCA_0015_1.486_R_1.JPG

Barrier ID:	GRCA-0015-1.486-R				
Route Name:	HERMIT REST ROAD				
Inspection Date:	08/10/2010	Barrier Rating:	48.40		
Barrier Description					
Type:	STONE MASONRY WITHOUT CONCRETE CORE WALL	Barrier Function:	TRAFFIC		
Barrier Material:	STONE	Post Material:	N/A		
Blockout Type:	N/A	Length (ft.):	111		
Speed Limit (MPH):	25	Placement with Respect to Road:	OUTSIDE OF CURVE		
Hazard Behind Barrier:	HIGH				
Barrier Crashworthiness					
Appropriate Test Level:	TL-1	Barrier Test Level:	NCW	Is Barrier Crashworthy?:	NO
Beg. End Trtmt Type:	NONE	Is Beg. End Trtmt Crashworthy?:	N/A	Approach Transition Type:	NONE
Ending End Trtmt Type:	NONE	Ending End Trtmt Crashworthy?:	N/A		
Average Measurements					
Design Height (In.):	24	Width (In.):	21.2	Post Spacing (In.):	0.0
Height (In.):	17.0	Lateral Offset (In.):	16.0	Road Grade (%):	0.50
Physical Condition					
Barrier	Alignment and Height:	No deviation was observed in barrier alignment. Height of barrier was 4 to 6 in below the 24-in design height for 51 ft and 6 to 10 in below the design height for 60 ft.

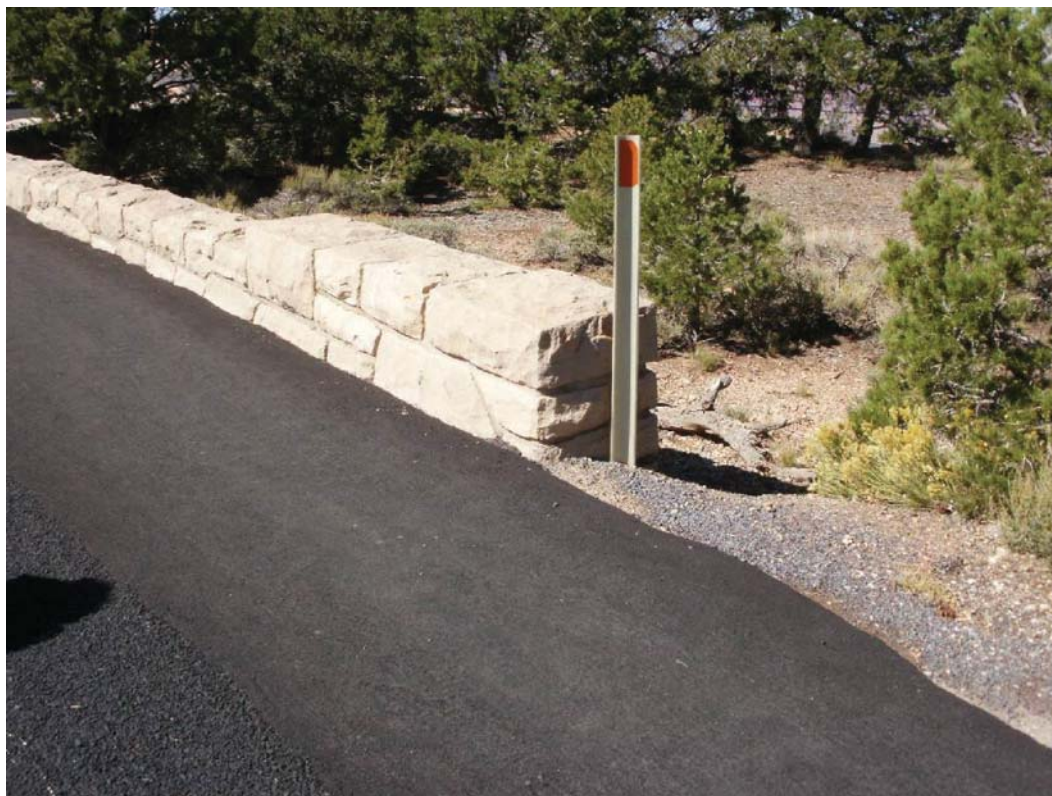
GRCA_0015_2.405_R_1.JPG

Barrier ID:	GRCA-0015-2.405-R				
Route Name:	HERMIT REST ROAD				
Inspection Date:	09/10/2010	Barrier Rating:	56.50		
Barrier Description					
Type:	STONE MASONRY WITHOUT CONCRETE CORE WALL	Barrier Function:	TRAFFIC		
Barrier Material:	STONE	Post Material:	N/A		
Blockout Type:	N/A	Length (ft.):	85		
Speed Limit (MPH):	25	Placement with Respect to Road:	OUTSIDE OF CURVE		
Hazard Behind Barrier:	EXTREME				
Barrier Crashworthiness					
Appropriate Test Level:	TL-1	Barrier Test Level:	NCW	Is Barrier Crashworthy?:	NO
Beg. End Trtmt Type:	NONE	Is Beg. End Trtmt Crashworthy?:	N/A	Approach Transition Type:	NONE
Ending End Trtmt Type:	NONE	Ending End Trtmt Crashworthy?:	N/A		
Average Measurements					
Design Height (In.):	24	Width (In.):	21.7	Post Spacing (In.):	0.0
Height (In.):	16.7	Lateral Offset (In.):	0.0	Road Grade (%):	0.50
Physical Condition					
Barrier	Alignment and Height:	No deviation was observed in barrier alignment. Height of barrier was 3 to 6 in below the 24 in design height for 26 ft and 6 to 9 in below the design height for 59 ft with 8 ft end higher by design.

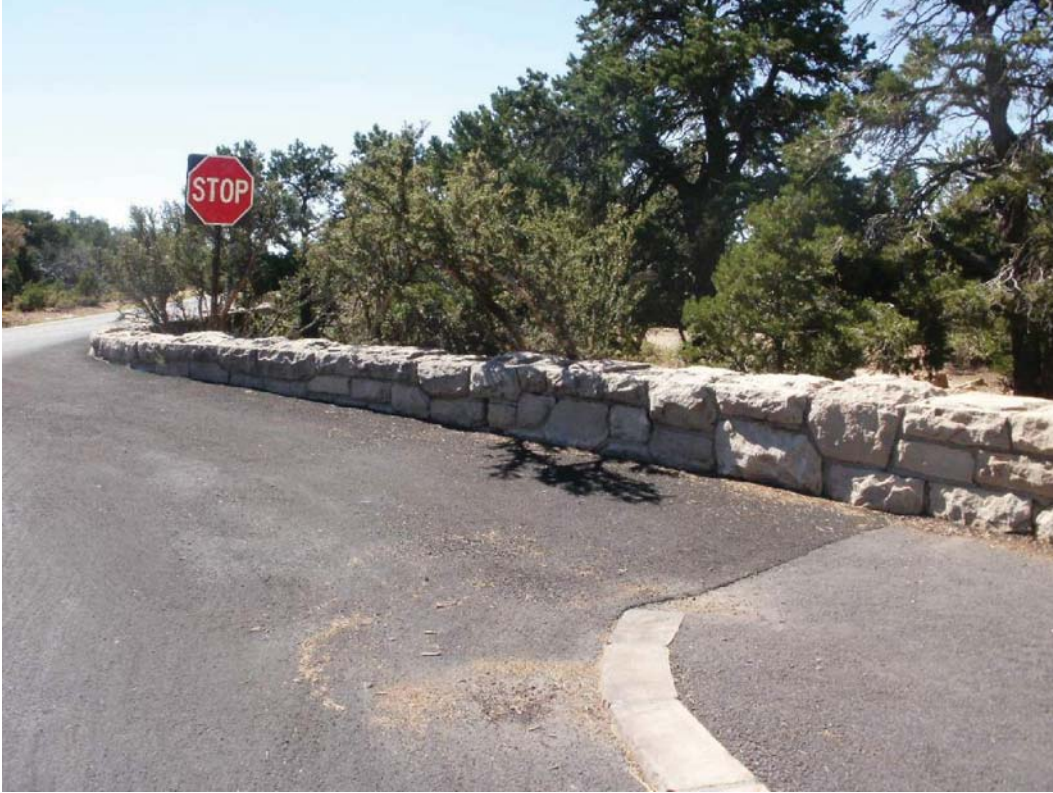
GRCA_0015_2.446_R_1.JPG

Barrier ID:	GRCA-0015-2.446-R				
Route Name:	HERMIT REST ROAD				
Inspection Date:	09/10/2010	Barrier Rating:	56.50		
Barrier Description					
Type:	STONE MASONRY WITHOUT CONCRETE CORE WALL	Barrier Function:	TRAFFIC		
Barrier Material:	STONE	Post Material:	N/A		
Blockout Type:	N/A	Length (ft.):	81		
Speed Limit (MPH):	25	Placement with Respect to Road:	OUTSIDE OF CURVE		
Hazard Behind Barrier:	EXTREME				
Barrier Crashworthiness					
Appropriate Test Level:	TL-1	Barrier Test Level:	NCW	Is Barrier Crashworthy?:	NO
Beg. End Trtmt Type:	NONE	Is Beg. End Trtmt Crashworthy?:	N/A	Approach Transition Type:	NONE
Ending End Trtmt Type:	NONE	Ending End Trtmt Crashworthy?:	N/A		
Average Measurements					
Design Height (In.):	24	Width (In.):	21.0	Post Spacing (In.):	0.0
Height (In.):	15.6	Lateral Offset (In.):	0.0	Road Grade (%):	3.40
Physical Condition					
Barrier	Alignment and Height:	No deviation in alignment of barrier was observed. Barrier was 7 to 12 in below 24 in design height for 61 linear and below by 3 to 6 in for 10 linear ft.

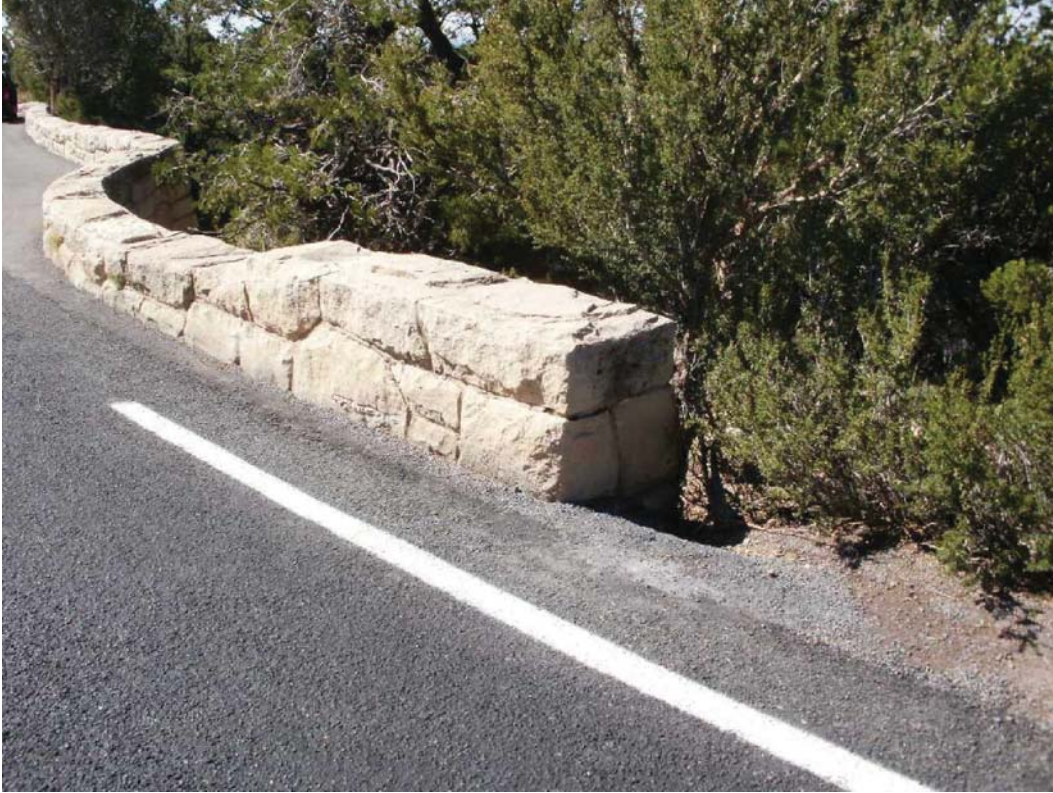
GRCA_0015_2.566_R_1.JPG

Barrier ID:	GRCA-0015-2.566-R				
Route Name:	HERMIT REST ROAD				
Inspection Date:	09/10/2010	Barrier Rating:	30.20		
Barrier Description					
Type:	STONE MASONRY WITHOUT CONCRETE CORE WALL	Barrier Function:	TRAFFIC		
Barrier Material:	STONE	Post Material:	N/A		
Blockout Type:	N/A	Length (ft.):	188		
Speed Limit (MPH):	25	Placement with Respect to Road:	INSIDE OF CURVE		
Hazard Behind Barrier:	EXTREME				
Barrier Crashworthiness					
Appropriate Test Level:	TL-1	Barrier Test Level:	NCW	Is Barrier Crashworthy?:	NO
Beg. End Trtmt Type:	NONE	Is Beg. End Trtmt Crashworthy?:	N/A	Approach Transition Type:	NONE
Ending End Trtmt Type:	NONE	Ending End Trtmt Crashworthy?:	N/A		
Average Measurements					
Design Height (In.):	24	Width (In.):	21.7	Post Spacing (In.):	0.0
Height (In.):	20.0	Lateral Offset (In.):	134.0	Road Grade (%):	2.10
Physical Condition					
Barrier	Alignment and Height:	No deviation was observed in barrier alignment. Height was 3 to 6 in below 24 in design height for 48 ft and was 6 to 11 in below for 66 ft.
