GIP Report

NPS Guardwall/Rail Inventory Program
Grand Canyon National Park

Federal Highway Administration
Eastern Federal Lands Highway Division
Road Inventory Program (RIP)

Data Collection Date: October 2010
Report Date: November 2015

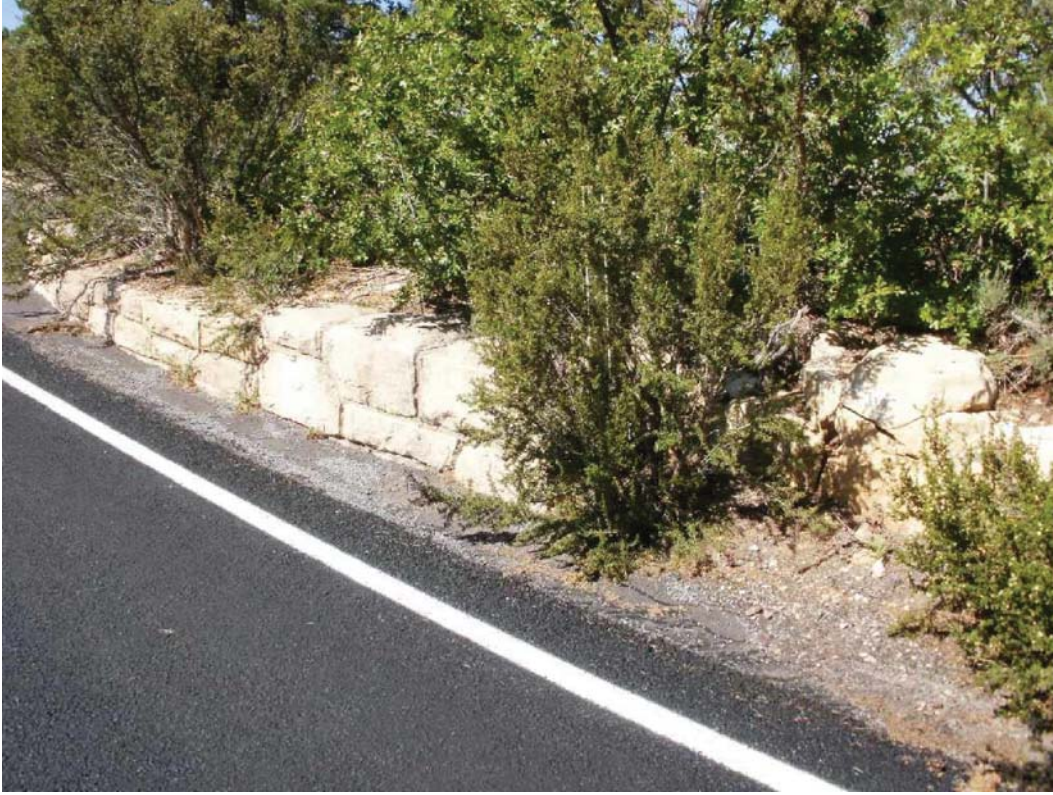
GRCA_0015_2.839_R_1.JPG

Barrier ID:	GRCA-0015-2.839-R				
Route Name:	HERMIT REST ROAD				
Inspection Date:	09/10/2010	Barrier Rating:	38.70		
Barrier Description					
Type:	STONE MASONRY WITHOUT CONCRETE CORE WALL	Barrier Function:	TRAFFIC		
Barrier Material:	STONE	Post Material:	N/A		
Blockout Type:	N/A	Length (ft.):	224		
Speed Limit (MPH):	25	Placement with Respect to Road:	INSIDE OF CURVE		
Hazard Behind Barrier:	EXTREME				
Barrier Crashworthiness					
Appropriate Test Level:	TL-1	Barrier Test Level:	NCW	Is Barrier Crashworthy?:	NO
Beg. End Trtmt Type:	NONE	Is Beg. End Trtmt Crashworthy?:	N/A	Approach Transition Type:	NONE
Ending End Trtmt Type:	NONE	Ending End Trtmt Crashworthy?:	N/A		
Average Measurements					
Design Height (In.):	24	Width (In.):	21.7	Post Spacing (In.):	0.0
Height (In.):	18.2	Lateral Offset (In.):	116.6	Road Grade (%):	0.60
Physical Condition					
Barrier	Alignment and Height:	No deviation was observed in barrier alignment. Barrier was 3 to 6 in below the design height of 24 in for 163 ft and 6 to 8 in below the design height for 53 ft.

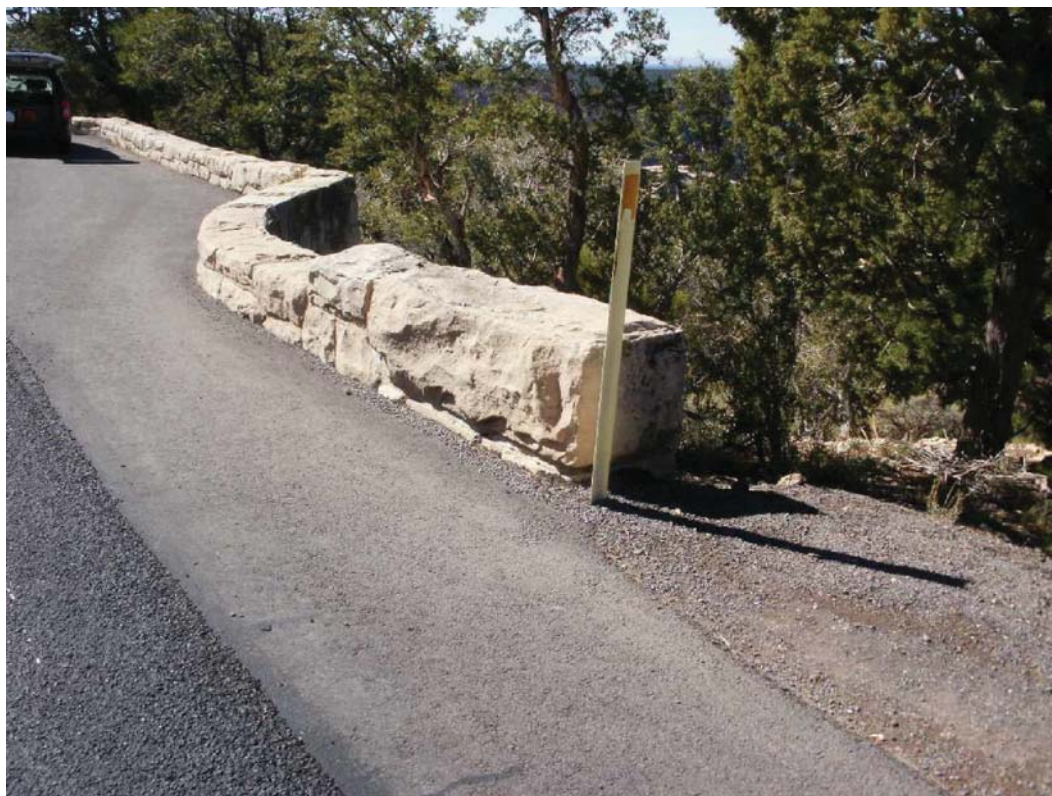
GRCA_0015_3.299_R_1.JPG

Barrier ID:	GRCA-0015-3.299-R				
Route Name:	HERMIT REST ROAD				
Inspection Date:	09/10/2010	Barrier Rating:	49.50		
Barrier Description					
Type:	STONE MASONRY WITHOUT CONCRETE CORE WALL	Barrier Function:	TRAFFIC		
Barrier Material:	STONE	Post Material:	N/A		
Blockout Type:	N/A	Length (ft.):	121		
Speed Limit (MPH):	30	Placement with Respect to Road:	INSIDE OF CURVE		
Hazard Behind Barrier:	EXTREME				
Barrier Crashworthiness					
Appropriate Test Level:	TL-1	Barrier Test Level:	NCW	Is Barrier Crashworthy?:	NO
Beg. End Trtmt Type:	NONE	Is Beg. End Trtmt Crashworthy?:	N/A	Approach Transition Type:	NONE
Ending End Trtmt Type:	NONE	Ending End Trtmt Crashworthy?:	N/A		
Average Measurements					
Design Height (In.):	24	Width (In.):	21.2	Post Spacing (In.):	0.0
Height (In.):	16.0	Lateral Offset (In.):	127.0	Road Grade (%):	0.70
Physical Condition					
Barrier	Alignment and Height:	No deviation in alignment was observed. The height was 7 to 9 in below the 24 in design height for 105 ft.

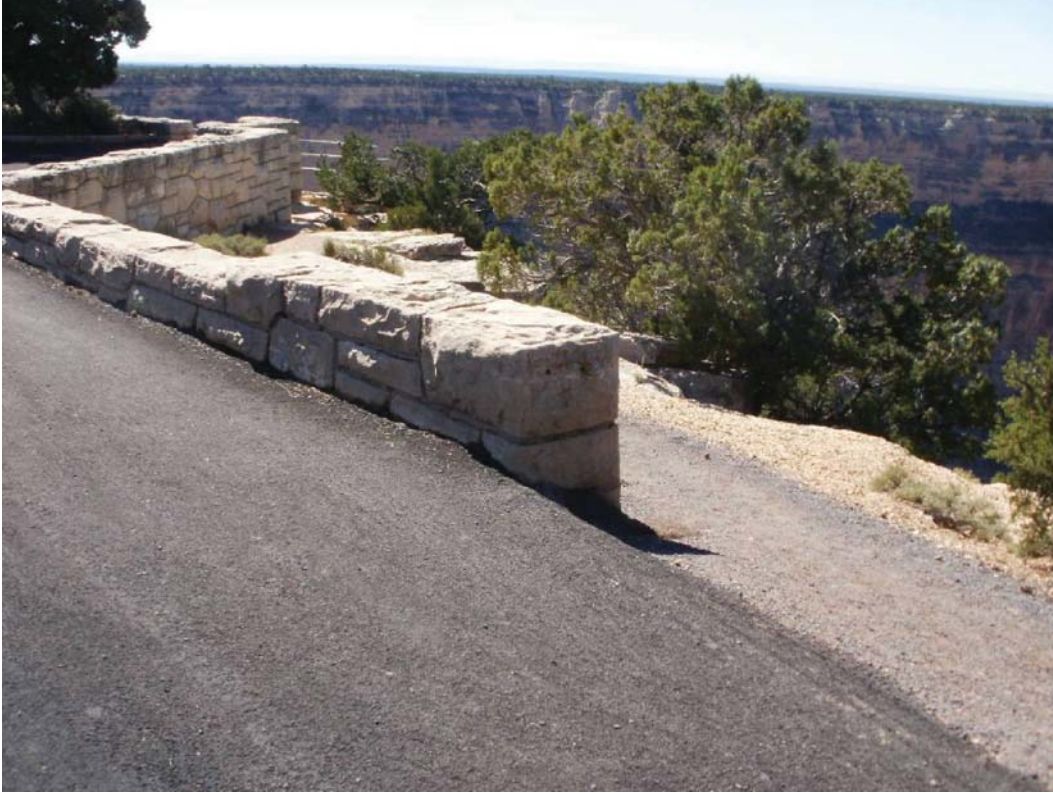
GRCA_0015_3.634_R_1.JPG

Barrier ID:	GRCA-0015-3.634-R				
Route Name:	HERMIT REST ROAD				
Inspection Date:	09/10/2010	Barrier Rating:	60.90		
Barrier Description					
Type:	STONE MASONRY WITHOUT CONCRETE CORE WALL	Barrier Function:	TRAFFIC		
Barrier Material:	STONE	Post Material:	N/A		
Blockout Type:	N/A	Length (ft.):	36		
Speed Limit (MPH):	30	Placement with Respect to Road:	OUTSIDE OF CURVE		
Hazard Behind Barrier:	EXTREME				
Barrier Crashworthiness					
Appropriate Test Level:	TL-1	Barrier Test Level:	NCW	Is Barrier Crashworthy?:	NO
Beg. End Trtmt Type:	NONE	Is Beg. End Trtmt Crashworthy?:	N/A	Approach Transition Type:	NONE
Ending End Trtmt Type:	NONE	Ending End Trtmt Crashworthy?:	N/A		
Average Measurements					
Design Height (In.):	24	Width (In.):	21.0	Post Spacing (In.):	0.0
Height (In.):	14.3	Lateral Offset (In.):	0.0	Road Grade (%):	1.70
Physical Condition					
Barrier	Alignment and Height:	No deviation in alignment was observed. Height of barrier was 9 to 11 in below the design height of 24 in for 28 linear ft.

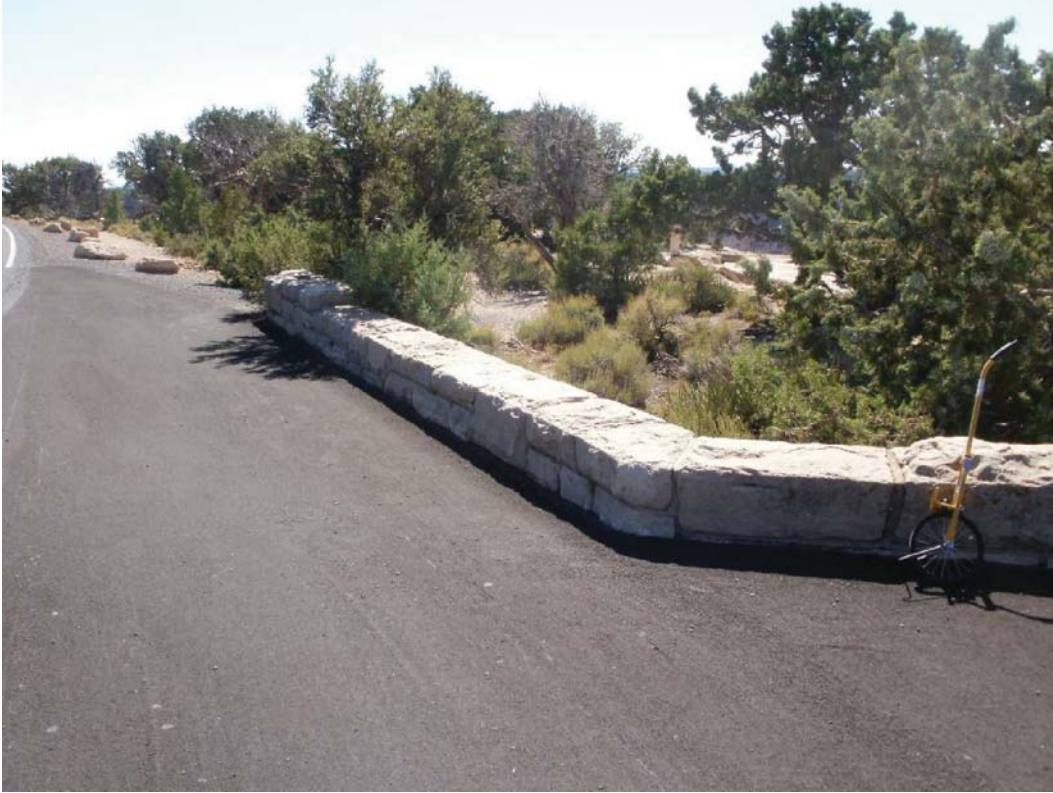
GRCA_0015_3.670_R_1.JPG

Barrier ID:	GRCA-0015-3.670-R				
Route Name:	HERMIT REST ROAD				
Inspection Date:	09/10/2010	Barrier Rating:	59.20		
Barrier Description					
Type:	STONE MASONRY WITHOUT CONCRETE CORE WALL	Barrier Function:	TRAFFIC		
Barrier Material:	STONE	Post Material:	N/A		
Blockout Type:	N/A	Length (ft.):	37		
Speed Limit (MPH):	30	Placement with Respect to Road:	OUTSIDE OF CURVE		
Hazard Behind Barrier:	HIGH				
Barrier Crashworthiness					
Appropriate Test Level:	TL-1	Barrier Test Level:	NCW	Is Barrier Crashworthy?:	NO
Beg. End Trtmt Type:	NONE	Is Beg. End Trtmt Crashworthy?:	N/A	Approach Transition Type:	NONE
Ending End Trtmt Type:	NONE	Ending End Trtmt Crashworthy?:	N/A		
Average Measurements					
Design Height (In.):	24	Width (In.):	21.2	Post Spacing (In.):	0.0
Height (In.):	14.6	Lateral Offset (In.):	0.0	Road Grade (%):	0.70
Physical Condition					
Barrier	Alignment and Height:	No deviation in alignment was observed. The height was 8 to 10 in below the 24 in design height. 8 ft on the end had an extra layer of stone design on top.

Breaking and Cracking:	No breaking or cracking was observed			
	Missing Elements:	No missing elements were observed.			
	Corrosion and Weathering:	No corrosion or weathering was observed.			
End Treatments	Alignment and Height:				
	Breaking and Cracking:				
	Missing Elements:				
	Corrosion and Weathering:

Repair Action:	REPAIR	FMSS Work Type:	DEFERRED MAINTENANCE	Repair Cost:	\$19443
Brief Workorder:	Raise guardwall 9-in. Remove and reset 37-ft of stone masonry guardwall on 1 row of new stone to raise barrier to the 24-in design height. Remove and reset the end section to retain original design.				
Workorder:	Remove & Reset Stone Masonry Guardwall at \$250- per -Cu. Ft. for 34 CF = \$8500. $[(0.5ft)(1.8ft)(37ft)] = 33.3$ CF. Remove top layer of stones in barrier for 37 feet. New Stones at \$250- per -Each for 19 Unit(s) = \$4750. $[(37ft) / (2ft/stone) \times 1 \text{ row}] = 19$ stones. Insert new stone on retaining wall to increase barrier he Low Speed Traffic Control at \$1475- per -Day for 3 Day(s) = \$4425. 1 day removal 2 days installation.

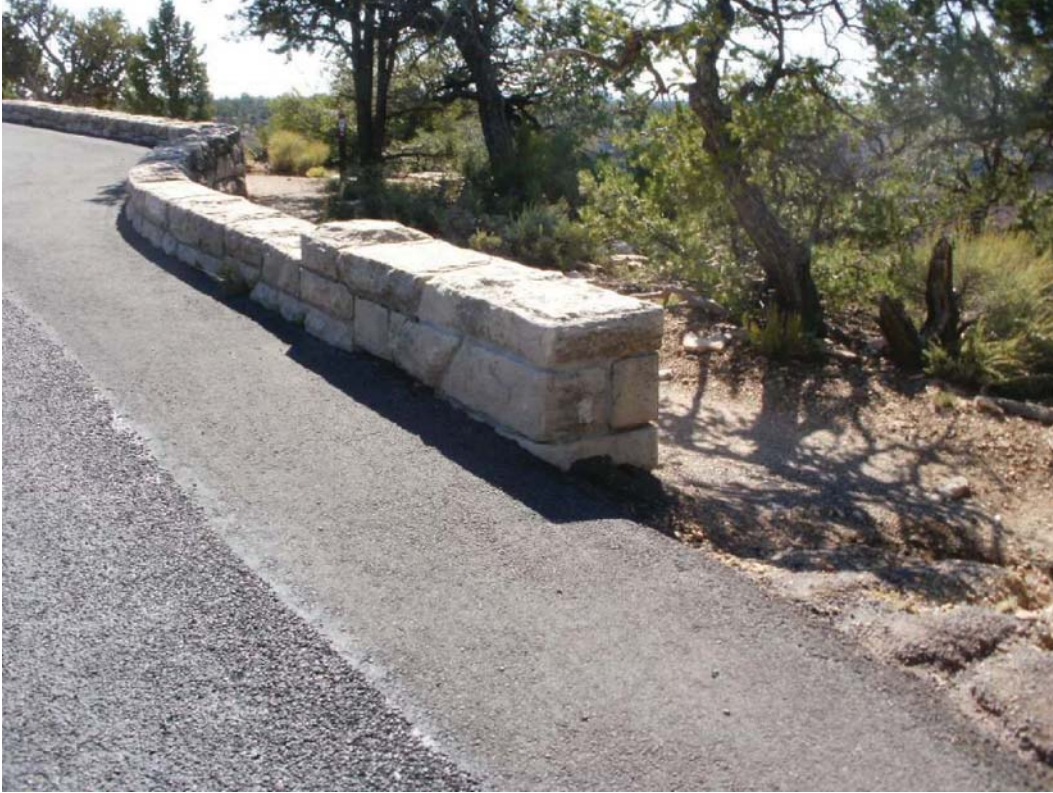
GRCA_0015_3.896_R_1.JPG

Barrier ID:	GRCA-0015-3.896-R				
Route Name:	HERMIT REST ROAD				
Inspection Date:	09/10/2010	Barrier Rating:	54.40		
Barrier Description					
Type:	STONE MASONRY WITHOUT CONCRETE CORE WALL	Barrier Function:	TRAFFIC		
Barrier Material:	STONE	Post Material:	N/A		
Blockout Type:	N/A	Length (ft.):	190		
Speed Limit (MPH):	30	Placement with Respect to Road:	OUTSIDE OF CURVE		
Hazard Behind Barrier:	EXTREME				
Barrier Crashworthiness					
Appropriate Test Level:	TL-1	Barrier Test Level:	NCW	Is Barrier Crashworthy?:	NO
Beg. End Trtmt Type:	NONE	Is Beg. End Trtmt Crashworthy?:	N/A	Approach Transition Type:	NONE
Ending End Trtmt Type:	NONE	Ending End Trtmt Crashworthy?:	N/A		
Average Measurements					
Design Height (In.):	24	Width (In.):	21.0	Post Spacing (In.):	0.0
Height (In.):	17.7	Lateral Offset (In.):	0.0	Road Grade (%):	2.50
Physical Condition					
Barrier	Alignment and Height:	No deviation in alignment was observed. Height of barrier was 3 to 6 in below the 24 in design height for 79 linear ft and 6 to 8 in below the design height for 95 linear ft.

Breaking and Cracking:	No breaking or cracking was observed.			
	Missing Elements:	No missing barrier elements were observed.			
	Corrosion and Weathering:	Minor cracking of mortar less than 1/4 in wide with minimal weathering of stones and mortar. No erosion was observed compromising stability of barrier.			
End Treatments	Alignment and Height:				
	Breaking and Cracking:				
	Missing Elements:				
	Corrosion and Weathering:

Repair Action:	REPAIR	FMSS Work Type:	DEFERRED MAINTENANCE	Repair Cost:	\$44413
Brief Workorder:	Raise guardwall 2-in. Remove and reset 95-ft stone masonry guardwall on 1 row of new stone to raise barrier to the adjacent 18-in height.				
Workorder:	Remove & Reset Stone Masonry Guardwall at \$250- per -Cu. Ft. for 84 CF = \$21000. $[(0.5\text{ft})(1.75\text{ft})(95\text{ft})] = 83.1 \text{ CF}$. Remove top layer of stones in barrier for 95 feet. New Stones at \$250- per -Each for 48 Unit(s) = \$12000. $[(95\text{ft}) / (2\text{ft}/\text{stone}) \times 1 \text{ row}] = 48 \text{ stones}$. Insert new stone on retaining wall to increase barrier height then reset top layer of barrier. Low Speed Traffic Control at \$1475- per -Day for 5 Day(s) = \$7375. 1 day removal 4 days installation.

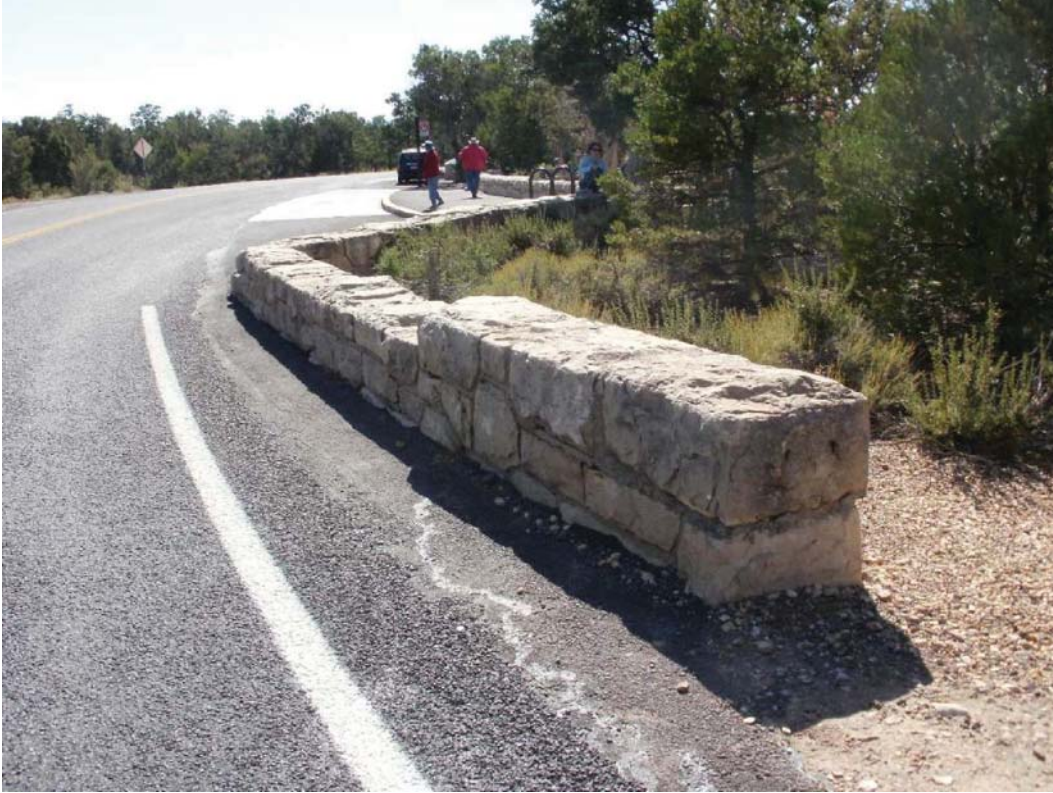
GRCA_0015_4.116_R_1.JPG

Barrier ID:	GRCA-0015-4.116-R				
Route Name:	HERMIT REST ROAD				
Inspection Date:	09/10/2010	Barrier Rating:	42.90		
Barrier Description					
Type:	STONE MASONRY WITHOUT CONCRETE CORE WALL	Barrier Function:	TRAFFIC		
Barrier Material:	STONE	Post Material:	N/A		
Blockout Type:	N/A	Length (ft.):	63		
Speed Limit (MPH):	30	Placement with Respect to Road:	INSIDE OF CURVE		
Hazard Behind Barrier:	EXTREME				
Barrier Crashworthiness					
Appropriate Test Level:	TL-1	Barrier Test Level:	NCW	Is Barrier Crashworthy?:	NO
Beg. End Trtmt Type:	NONE	Is Beg. End Trtmt Crashworthy?:	N/A	Approach Transition Type:	NONE
Ending End Trtmt Type:	NONE	Ending End Trtmt Crashworthy?:	N/A		
Average Measurements					
Design Height (In.):	24	Width (In.):	20.7	Post Spacing (In.):	0.0
Height (In.):	19.0	Lateral Offset (In.):	48.2	Road Grade (%):	3.50
Physical Condition					
Barrier	Alignment and Height:	No deviation in barrier alignment was observed. Barrier was 4 to 6 in below 24 in design height for 55 linear ft with an 8 ft section of higher stone design on the end.

Breaking and Cracking:	6 square yards of missing grout and chipped rocks were observed in impact area. Missing grout cracks were 1/2 to 3 in wide.			
	Missing Elements:	No missing elements were observed.			
	Corrosion and Weathering:	1 linear ft of rock was missing in area of deteriorating grout.			
End Treatments	Alignment and Height:				
	Breaking and Cracking:				
	Missing Elements:				
	Corrosion and Weathering:

Repair Action:	REPAIR	FMSS Work Type:	DEFERRED MAINTENANCE	Repair Cost:	\$3097
Brief Workorder:	Repoint 6 sy and replace a 1 foot missing section of stone masonry guardwall.				
Workorder:	Re-Point Masonry Barrier at \$140- per -Sq. Yd. for 6 SY = \$840. Repoint 6 sy of stone masonry barrier. Stone Masonry w/o Concrete Core at \$500- per -Lin. Ft. for 1 LF = \$500. Replace 1 ft of missing stone barrier. Low Speed Traffic Control at \$1475- per -Day for 1 Day(s) = \$1475.

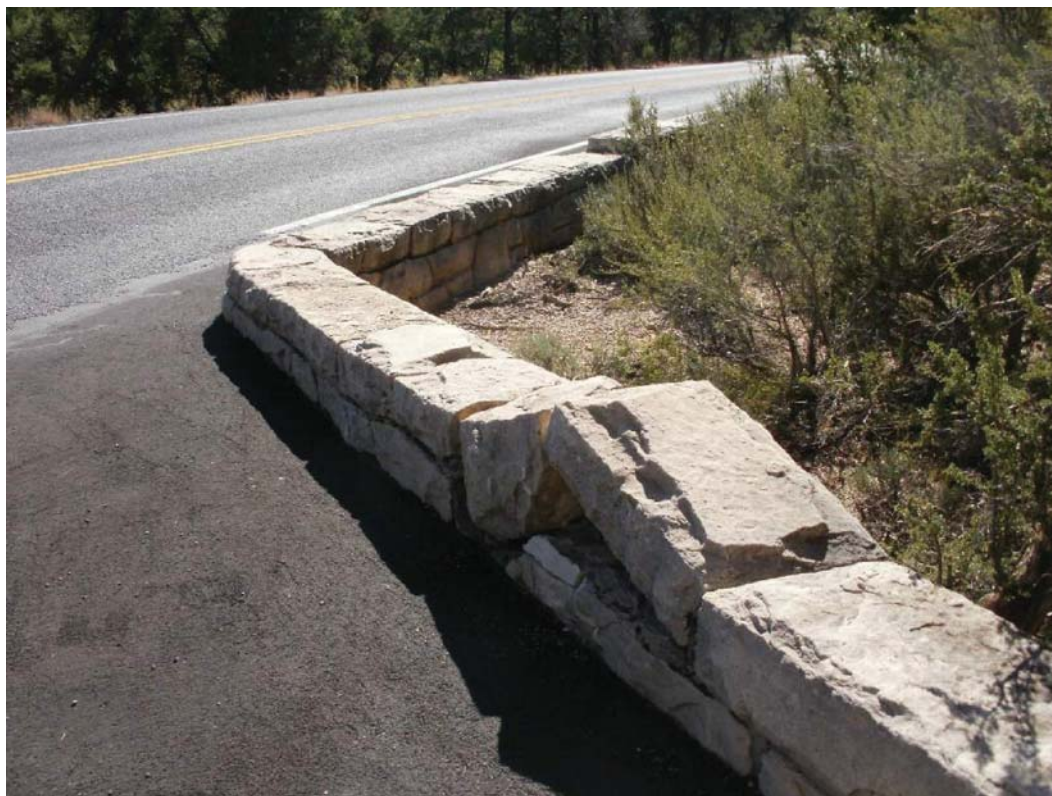
GRCA_0015_4.160_R_1.JPG

Barrier ID:	GRCA-0015-4.160-R				
Route Name:	HERMIT REST ROAD				
Inspection Date:	09/10/2010	Barrier Rating:	52.00		
Barrier Description					
Type:	STONE MASONRY WITHOUT CONCRETE CORE WALL	Barrier Function:	TRAFFIC		
Barrier Material:	STONE	Post Material:	N/A		
Blockout Type:	N/A	Length (ft.):	59		
Speed Limit (MPH):	30	Placement with Respect to Road:	INSIDE OF CURVE		
Hazard Behind Barrier:	HIGH				
Barrier Crashworthiness					
Appropriate Test Level:	TL-1	Barrier Test Level:	NCW	Is Barrier Crashworthy?:	NO
Beg. End Trtmt Type:	NONE	Is Beg. End Trtmt Crashworthy?:	N/A	Approach Transition Type:	NONE
Ending End Trtmt Type:	NONE	Ending End Trtmt Crashworthy?:	N/A		
Average Measurements					
Design Height (In.):	24	Width (In.):	21.2	Post Spacing (In.):	0.0
Height (In.):	14.0	Lateral Offset (In.):	64.3	Road Grade (%):	4.20
Physical Condition					
Barrier	Alignment and Height:	No deviation in alignment was observed. Height was 6 to 11 in below 24 in design height for 58 ft.

Breaking and Cracking:	Broken mortar and rotated blocks were observed in a 4 ft section of barrier at impact location.			
	Missing Elements:	No missing elements were observed.			
	Corrosion and Weathering:	No corrosion or weathering was observed.			
End Treatments	Alignment and Height:				
	Breaking and Cracking:				
	Missing Elements:				
	Corrosion and Weathering:

Repair Action:	REPAIR	FMSS Work Type:	DEFERRED MAINTENANCE	Repair Cost:	\$37565
Brief Workorder:	Raise guardwall 10-in. Remove and reset 59-ft stone masonry guardwall on 2 rows of new stone to raise barrier to the 24-in design height.				
Workorder:	Remove & Reset Stone Masonry Guardwall at \$250- per -Cu. Ft. for 54 CF = \$13500. $[(0.5ft)(1.8ft)(59ft)] = 53.1$ CF. Remove top layer of stones in barrier for 59 feet. New Stones at \$250- per -Each for 59 Unit(s) = \$14750. $[(59ft) / (2ft/stone) \times 2 \text{ rows}] = 59$ stones. Insert new stone on retaining wall to increase barrier height then reset top layer of barrier. Low Speed Traffic Control at \$1475- per -Day for 4 Day(s) = \$5900. 1 day removal 3 days installation.

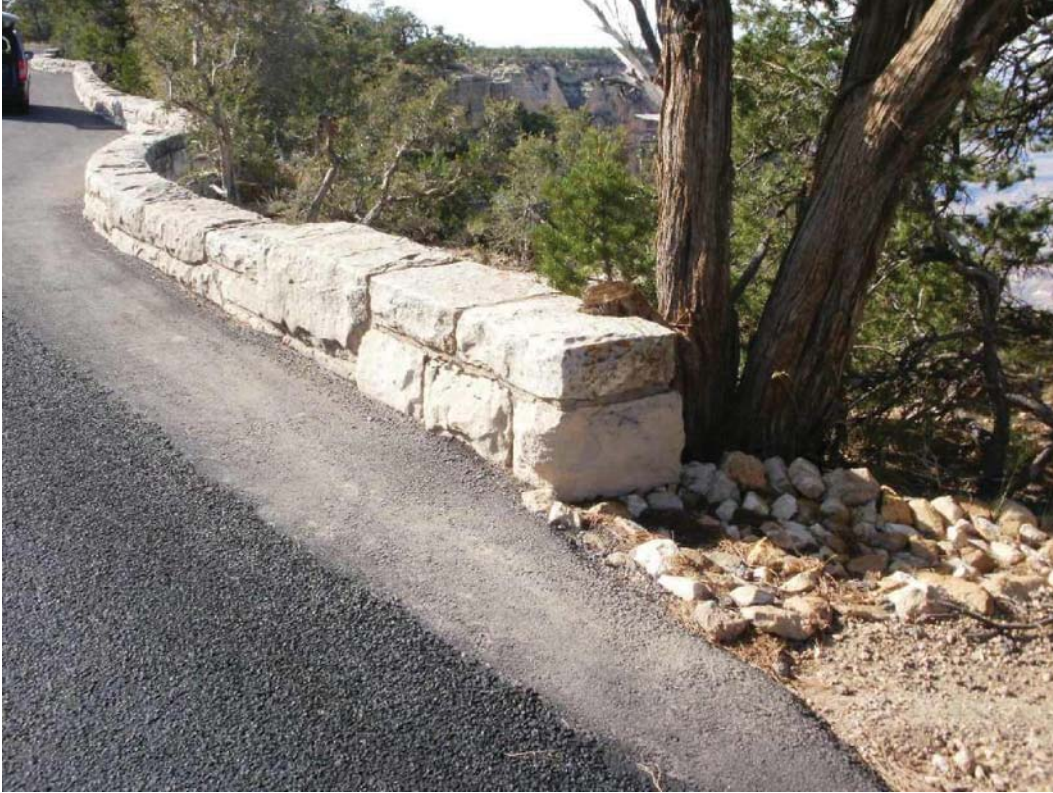
GRCA_0015_4.515_R_1.JPG

Barrier ID:	GRCA-0015-4.515-R				
Route Name:	HERMIT REST ROAD				
Inspection Date:	09/10/2010	Barrier Rating:	44.40		
Barrier Description					
Type:	STONE MASONRY WITHOUT CONCRETE CORE WALL	Barrier Function:	TRAFFIC		
Barrier Material:	STONE	Post Material:	N/A		
Blockout Type:	N/A	Length (ft.):	188		
Speed Limit (MPH):	25	Placement with Respect to Road:	INSIDE OF CURVE		
Hazard Behind Barrier:	EXTREME				
Barrier Crashworthiness					
Appropriate Test Level:	TL-1	Barrier Test Level:	NCW	Is Barrier Crashworthy?:	NO
Beg. End Trtmt Type:	NONE	Is Beg. End Trtmt Crashworthy?:	N/A	Approach Transition Type:	NONE
Ending End Trtmt Type:	NONE	Ending End Trtmt Crashworthy?:	N/A		
Average Measurements					
Design Height (In.):	24	Width (In.):	21.7	Post Spacing (In.):	0.0
Height (In.):	17.2	Lateral Offset (In.):	0.0	Road Grade (%):	1.60
Physical Condition					
Barrier	Alignment and Height:	No deviation in alignment was observed. Height of barrier was 3 to 6 in below the design height of 24 in for 81 ft and 6 to 8 in below the design height for 33 ft.

Breaking and Cracking:	No breaking or cracking was observed.			
	Missing Elements:	No missing elements were observed.			
	Corrosion and Weathering:	Approximately 6 square ft of missing/deteriorated mortar was observed. Minor cracking less than 1/4 in wide of mortar with minimal weathering of barrier mortar and stones. No erosion was observed compromising stability of the barrier.			
End Treatments	Alignment and Height:				
	Breaking and Cracking:				
	Missing Elements:				
	Corrosion and Weathering:

Repair Action:	REPAIR	FMSS Work Type:	DEFERRED MAINTENANCE	Repair Cost:	\$17793
Brief Workorder:	Raise guardwall 2-in. Remove and reset 33-ft stone masonry guardwall on 1 row of new stone to raise barrier to the adjacent 18-in height.				
Workorder:	Remove & Reset Stone Masonry Guardwall at \$250- per -Cu. Ft. for 30 CF = \$7500. $[(0.5ft)(1.8ft)(33ft)] = 29.7$ CF. Remove top layer of stones in barrier for 33 feet. New Stones at \$250- per -Each for 17 Unit(s) = \$4250. $[(33ft) / (2ft/stone) \times 1 \text{ row}] = 17$ stones. Insert new stone on retaining wall to increase barrier height then reset top layer of barrier. Low Speed Traffic Control at \$1475- per -Day for 3 Day(s) = \$4425. 1 day removal 2 days installation.

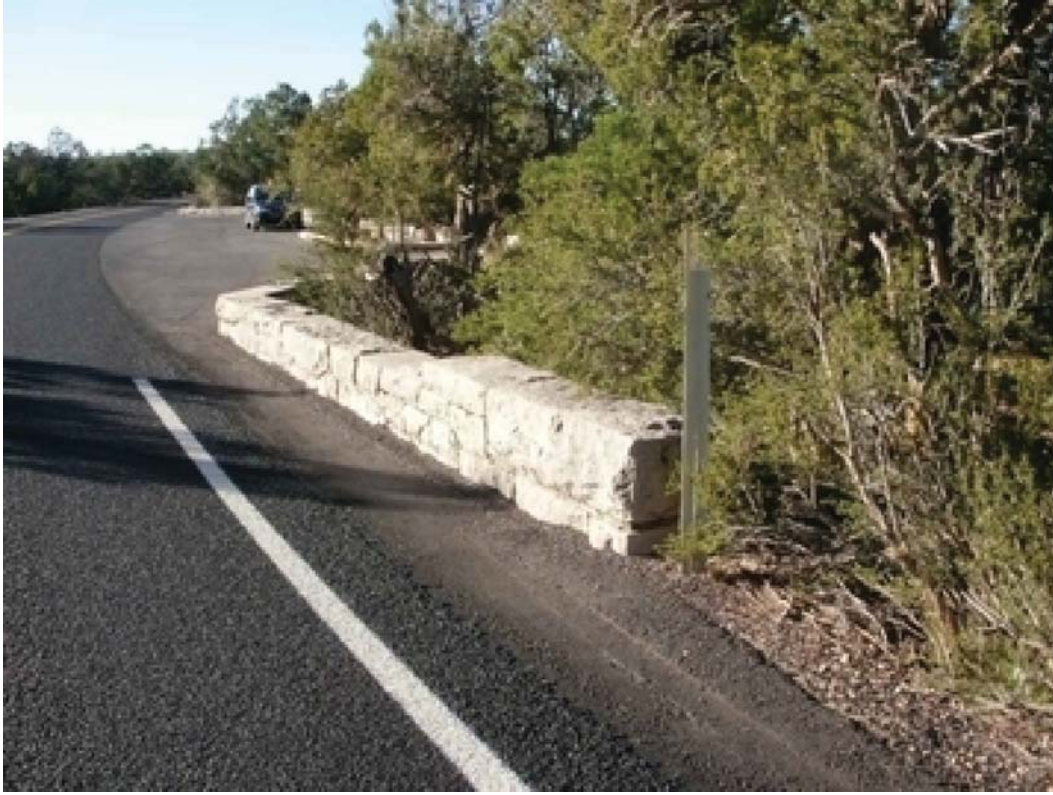
GRCA_0015_4.777_R_1.JPG

Barrier ID:	GRCA-0015-4.777-R				
Route Name:	HERMIT REST ROAD				
Inspection Date:	08/10/2010	Barrier Rating:	47.20		
Barrier Description					
Type:	STONE MASONRY WITHOUT CONCRETE CORE WALL	Barrier Function:	TRAFFIC		
Barrier Material:	STONE	Post Material:	N/A		
Blockout Type:	N/A	Length (ft.):	50		
Speed Limit (MPH):	30	Placement with Respect to Road:	INSIDE OF CURVE		
Hazard Behind Barrier:	EXTREME				
Barrier Crashworthiness					
Appropriate Test Level:	TL-1	Barrier Test Level:	NCW	Is Barrier Crashworthy?:	NO
Beg. End Trtmt Type:	NONE	Is Beg. End Trtmt Crashworthy?:	N/A	Approach Transition Type:	NONE
Ending End Trtmt Type:	NONE	Ending End Trtmt Crashworthy?:	N/A		
Average Measurements					
Design Height (In.):	24	Width (In.):	20.7	Post Spacing (In.):	0.0
Height (In.):	17.0	Lateral Offset (In.):	49.2	Road Grade (%):	3.00
Physical Condition					
Barrier	Alignment and Height:	No deviation was observed in barrier alignment. Barrier was 7 in below 24 in design height for 50 ft.

Breaking and Cracking:	No breaking or cracking was observed.			
	Missing Elements:	No missing elements were observed.			
	Corrosion and Weathering:	No corrosion or weathering was observed.			
End Treatments	Alignment and Height:				
	Breaking and Cracking:				
	Missing Elements:				
	Corrosion and Weathering:

Repair Action:	REPAIR	FMSS Work Type:	DEFERRED MAINTENANCE	Repair Cost:	\$23568
Brief Workorder:	Raise guardwall 7-in. Remove and reset 50-ft stone masonry guardwall on 1 row of new stone to raise barrier to the 24-in design height.				
Workorder:	Remove & Reset Stone Masonry Guardwall at \$250- per -Cu. Ft. for 43 CF = \$10750. $[(0.5ft)(1.7ft)(50ft)] = 42.5$ CF. Remove top layer of stones in barrier for 50 feet. New Stones at \$250- per -Each for 25 Unit(s) = \$6250. $[(50ft) / (2ft/stone) \times 1 \text{ row}] = 25$ stones Insert new stone on retaining wall to increase barrier height then reset top layer of barrier. Low Speed Traffic Control at \$1475- per -Day for 3 Day(s) = \$4425. 1 day removal 2 days installation.

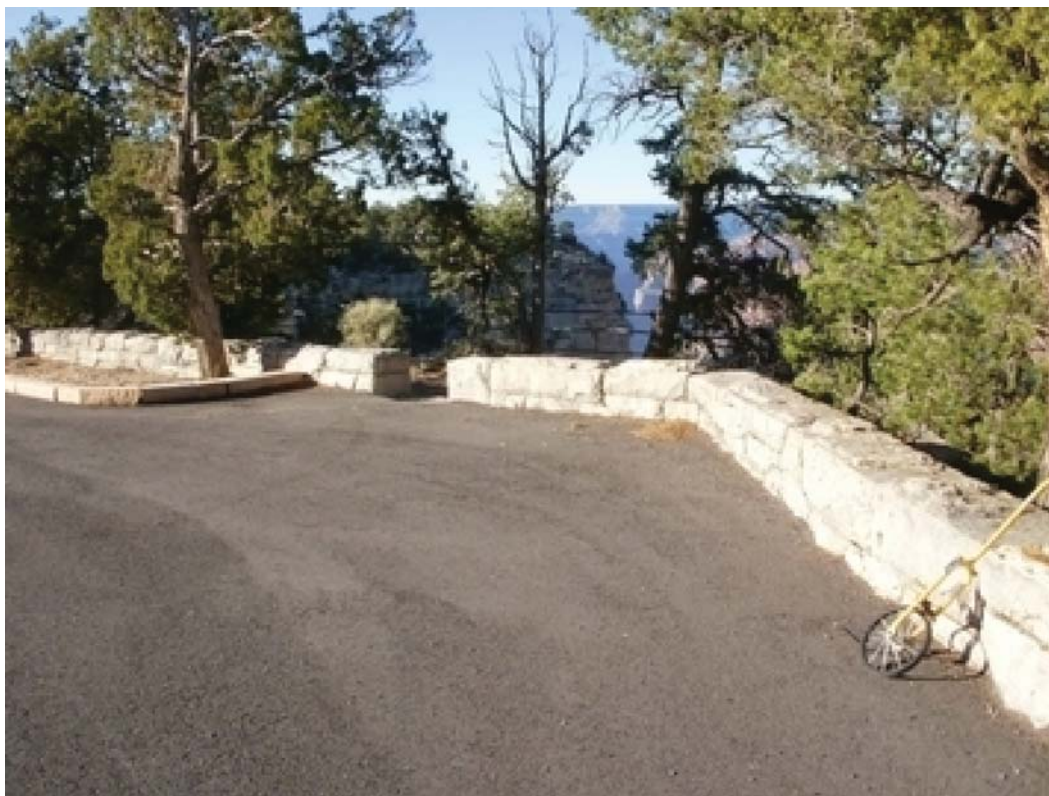
GRCA_0015_4.783_R_1.JPG

Barrier ID:	GRCA-0015-4.783-R				
Route Name:	HERMIT REST ROAD				
Inspection Date:	08/10/2010	Barrier Rating:	25.70		
Barrier Description					
Type:	STONE MASONRY WITHOUT CONCRETE CORE WALL	Barrier Function:	NON-TRAFFIC		
Barrier Material:	STONE	Post Material:	N/A		
Blockout Type:	N/A	Length (ft.):	193		
Speed Limit (MPH):	30	Placement with Respect to Road:	NON-TRAFFIC BARRIER		
Hazard Behind Barrier:	N/A				
Barrier Crashworthiness					
Appropriate Test Level:	TL-1	Barrier Test Level:	N/A	Is Barrier Crashworthy?:	N/A
Beg. End Trtmt Type:	NONE	Is Beg. End Trtmt Crashworthy?:	N/A	Approach Transition Type:	NONE
Ending End Trtmt Type:	NONE	Ending End Trtmt Crashworthy?:	N/A		
Average Measurements					
Design Height (In.):	24	Width (In.):	21.7	Post Spacing (In.):	0.0
Height (In.):	18.2	Lateral Offset (In.):	0.0	Road Grade (%):	0.00
Physical Condition					
Barrier	Alignment and Height:	No deviation was observed in barrier alignment. The height was 5 to 6 in below the 24 in design height for 147 ft and was 7 in below for 46 ft.

Breaking and Cracking:	No breaking or cracking was observed.			
	Missing Elements:	No missing elements were observed.			
	Corrosion and Weathering:	No corrosion or weathering was observed.			
End Treatments	Alignment and Height:				
	Breaking and Cracking:				
	Missing Elements:				
	Corrosion and Weathering:

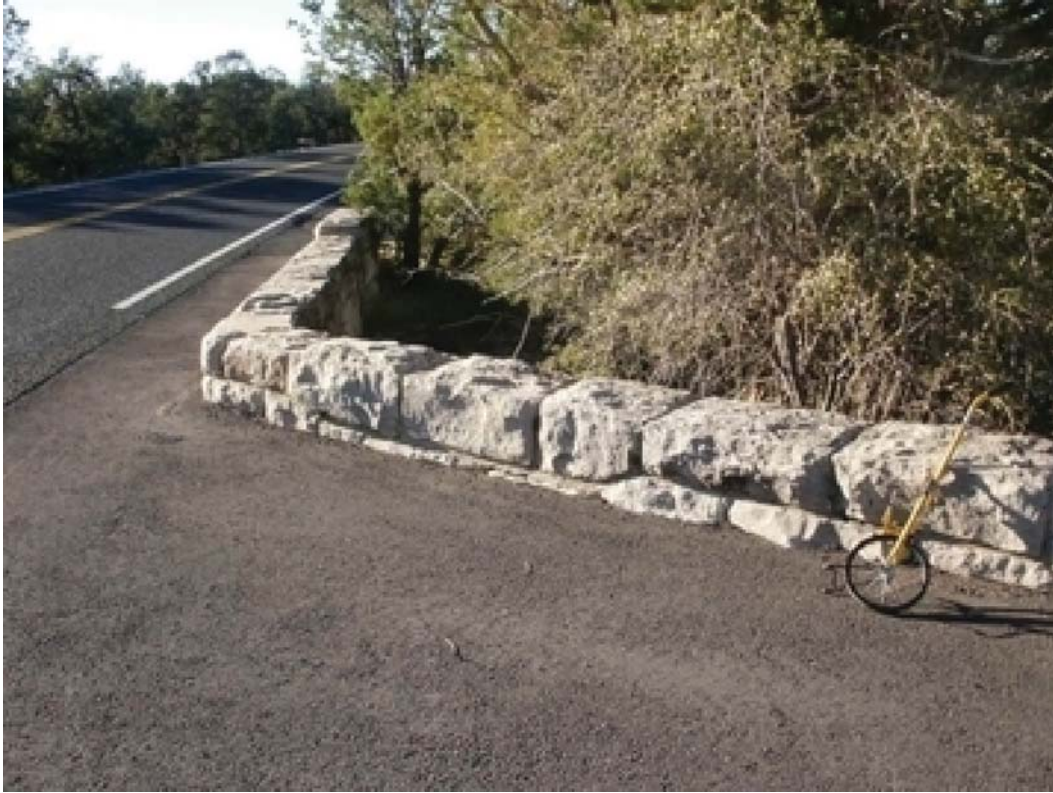
GRCA_0015_4.823_R_1.JPG

Barrier ID:	GRCA-0015-4.823-R				
Route Name:	HERMIT REST ROAD				
Inspection Date:	08/10/2010	Barrier Rating:	35.70		
Barrier Description					
Type:	STONE MASONRY WITHOUT CONCRETE CORE WALL	Barrier Function:	TRAFFIC		
Barrier Material:	STONE	Post Material:	N/A		
Blockout Type:	N/A	Length (ft.):	45		
Speed Limit (MPH):	30	Placement with Respect to Road:	TANGENT		
Hazard Behind Barrier:	EXTREME				
Barrier Crashworthiness					
Appropriate Test Level:	TL-1	Barrier Test Level:	NCW	Is Barrier Crashworthy?:	NO
Beg. End Trtmt Type:	NONE	Is Beg. End Trtmt Crashworthy?:	N/A	Approach Transition Type:	NONE
Ending End Trtmt Type:	NONE	Ending End Trtmt Crashworthy?:	N/A		
Average Measurements					
Design Height (In.):	24	Width (In.):	21.2	Post Spacing (In.):	0.0
Height (In.):	19.0	Lateral Offset (In.):	58.2	Road Grade (%):	2.50
Physical Condition					
Barrier	Alignment and Height:	No deviation in barrier alignment was observed. Height of barrier was 4 to 6 in below the design height of 24 in for 37 ft. Remaining 8 ft was 2 in below and is a higher design on the end.

Breaking and Cracking:	No breaking or cracking was observed.			
	Missing Elements:	No missing elements were observed.			
	Corrosion and Weathering:	Minor cracking less than 1/4 in wide was observed with minimal weathering of mortar and stones. No erosion was observed compromising stability of barrier.			
End Treatments	Alignment and Height:				
	Breaking and Cracking:				
	Missing Elements:				
	Corrosion and Weathering:

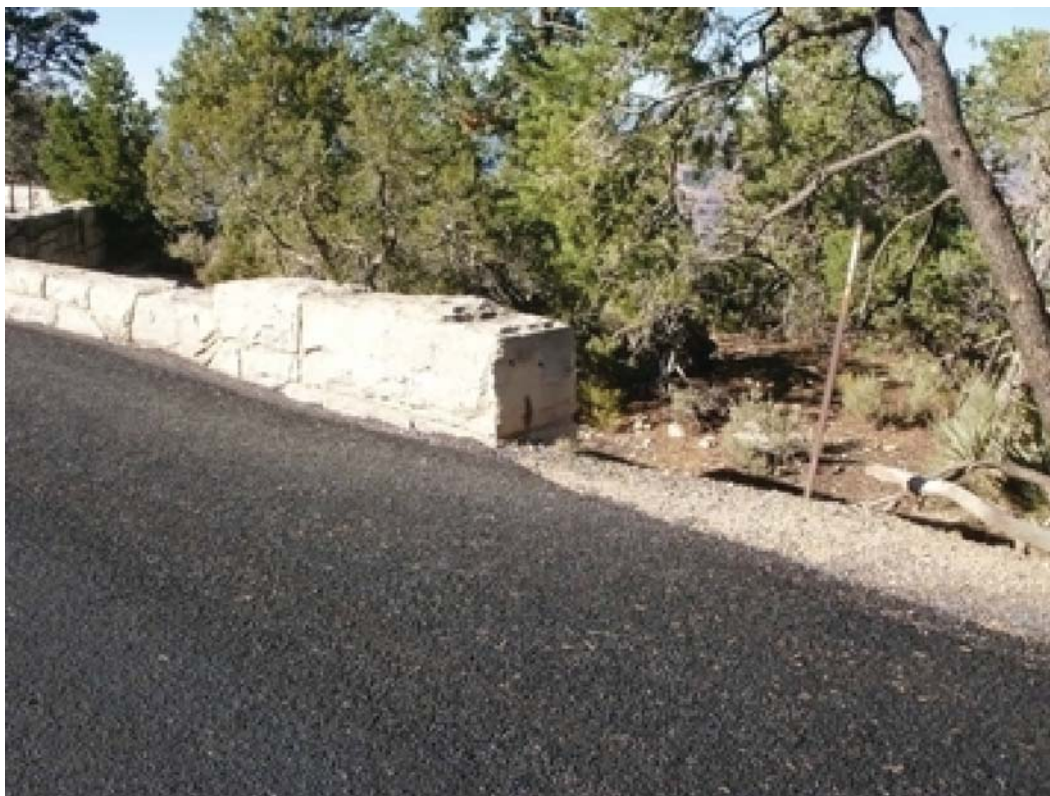
GRCA_0015_5.023_R_1.JPG

Barrier ID:	GRCA-0015-5.023-R				
Route Name:	HERMIT REST ROAD				
Inspection Date:	08/10/2010	Barrier Rating:	55.20		
Barrier Description					
Type:	STONE MASONRY WITHOUT CONCRETE CORE WALL	Barrier Function:	TRAFFIC		
Barrier Material:	STONE	Post Material:	N/A		
Blockout Type:	N/A	Length (ft.):	44		
Speed Limit (MPH):	30	Placement with Respect to Road:	OUTSIDE OF CURVE		
Hazard Behind Barrier:	EXTREME				
Barrier Crashworthiness					
Appropriate Test Level:	TL-1	Barrier Test Level:	NCW	Is Barrier Crashworthy?:	NO
Beg. End Trtmt Type:	NONE	Is Beg. End Trtmt Crashworthy?:	N/A	Approach Transition Type:	NONE
Ending End Trtmt Type:	NONE	Ending End Trtmt Crashworthy?:	N/A		
Average Measurements					
Design Height (In.):	24	Width (In.):	21.0	Post Spacing (In.):	0.0
Height (In.):	15.3	Lateral Offset (In.):	82.6	Road Grade (%):	2.10
Physical Condition					
Barrier	Alignment and Height:	No deviation was observed in barrier alignment. Height was 3 to 6 in below 24 in design height for 8 ft of higher design at end and was 6 to 9 in below for 36 ft.

Breaking and Cracking:	No breaking or cracking was observed.			
	Missing Elements:	No missing elements were observed.			
	Corrosion and Weathering:	No corrosion or weathering was observed.			
End Treatments	Alignment and Height:				
	Breaking and Cracking:				
	Missing Elements:				
	Corrosion and Weathering:

Repair Action:	REPAIR	FMSS Work Type:	DEFERRED MAINTENANCE	Repair Cost:	\$21643
Brief Workorder:	Raise guardwall 3-in. Remove and reset 44-ft of stone masonry guardwall on 1 row of new stone to raise barrier to the adjacent 18-in height.				
Workorder:	Remove & Reset Stone Masonry Guardwall at \$250- per -Cu. Ft. for 39 CF = \$9750. $[(0.5ft)(1.75ft)(44ft)] = 38.5$ CF. Remove top layer of stones in barrier for 44 feet. New Stones at \$250- per -Each for 22 Unit(s) = \$5500. $[(44ft) / (2ft/stone) \times 1 \text{ row}] = 22$ stones. Insert new stone on retaining wall to increase barrier height then reset top layer of barrier. Low Speed Traffic Control at \$1475- per -Day for 3 Day(s) = \$4425. 1 day removal 2 days installation.

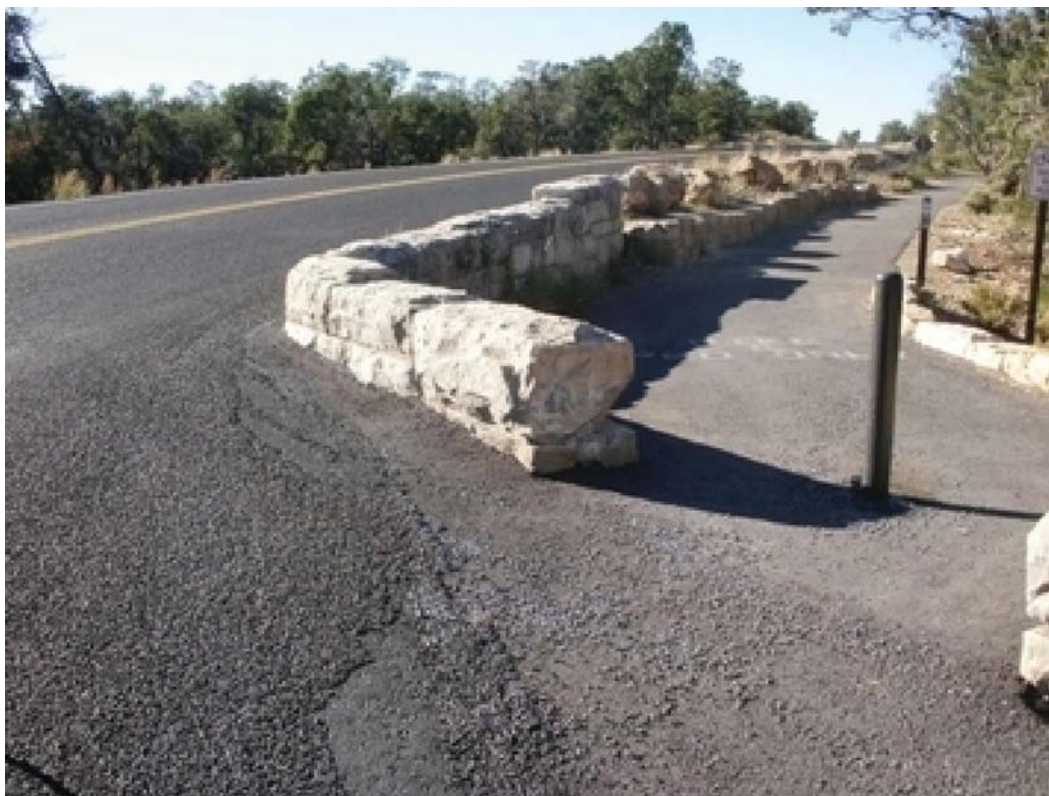
GRCA_0015_5.067_R_1.JPG

Barrier ID:	GRCA-0015-5.067-R				
Route Name:	HERMIT REST ROAD				
Inspection Date:	08/10/2010	Barrier Rating:	52.40		
Barrier Description					
Type:	STONE MASONRY WITHOUT CONCRETE CORE WALL	Barrier Function:	TRAFFIC		
Barrier Material:	STONE	Post Material:	N/A		
Blockout Type:	N/A	Length (ft.):	41		
Speed Limit (MPH):	30	Placement with Respect to Road:	INSIDE OF CURVE		
Hazard Behind Barrier:	EXTREME				
Barrier Crashworthiness					
Appropriate Test Level:	TL-1	Barrier Test Level:	NCW	Is Barrier Crashworthy?:	NO
Beg. End Trtmt Type:	NONE	Is Beg. End Trtmt Crashworthy?:	N/A	Approach Transition Type:	NONE
Ending End Trtmt Type:	NONE	Ending End Trtmt Crashworthy?:	N/A		
Average Measurements					
Design Height (In.):	24	Width (In.):	21.7	Post Spacing (In.):	0.0
Height (In.):	16.7	Lateral Offset (In.):	44.7	Road Grade (%):	2.90
Physical Condition					
Barrier	Alignment and Height:	No deviation was observed in barrier alignment. Height of barrier was 6-7 in below design height of 24 in for 41 linear ft.

Breaking and Cracking:	No breaking or cracking was observed.			
	Missing Elements:	No missing elements were observed.			
	Corrosion and Weathering:	Minor cracking less than 1/4 in wide was observed with minimal weathering of mortar and stones. No erosion was observed compromising stability of barrier.			
End Treatments	Alignment and Height:				
	Breaking and Cracking:				
	Missing Elements:				
	Corrosion and Weathering:

Repair Action:	REPAIR	FMSS Work Type:	DEFERRED MAINTENANCE	Repair Cost:	\$20818
Brief Workorder:	Raise guardwall 2-in. Remove and reset 41-ft of stone masonry guardwall on 1 row of new stone to raise barrier to the adjacent 18-in height.				
Workorder:	Remove & Reset Stone Masonry Guardwall at \$250- per -Cu. Ft. for 37 CF = \$9250. $[(0.5ft)(1.8ft)(41ft)] = 36.9$ CF. Remove top layer of stones in barrier for 41 feet. New Stones at \$250- per -Each for 21 Unit(s) = \$5250. $[(41ft) / (2ft/stone) \times 1 \text{ row}] = 21$ stones. Insert new stone on retaining wall to increase barrier height then reset top layer of barrier. Low Speed Traffic Control at \$1475- per -Day for 3 Day(s) = \$4425. 1 day removal 2 days installation.

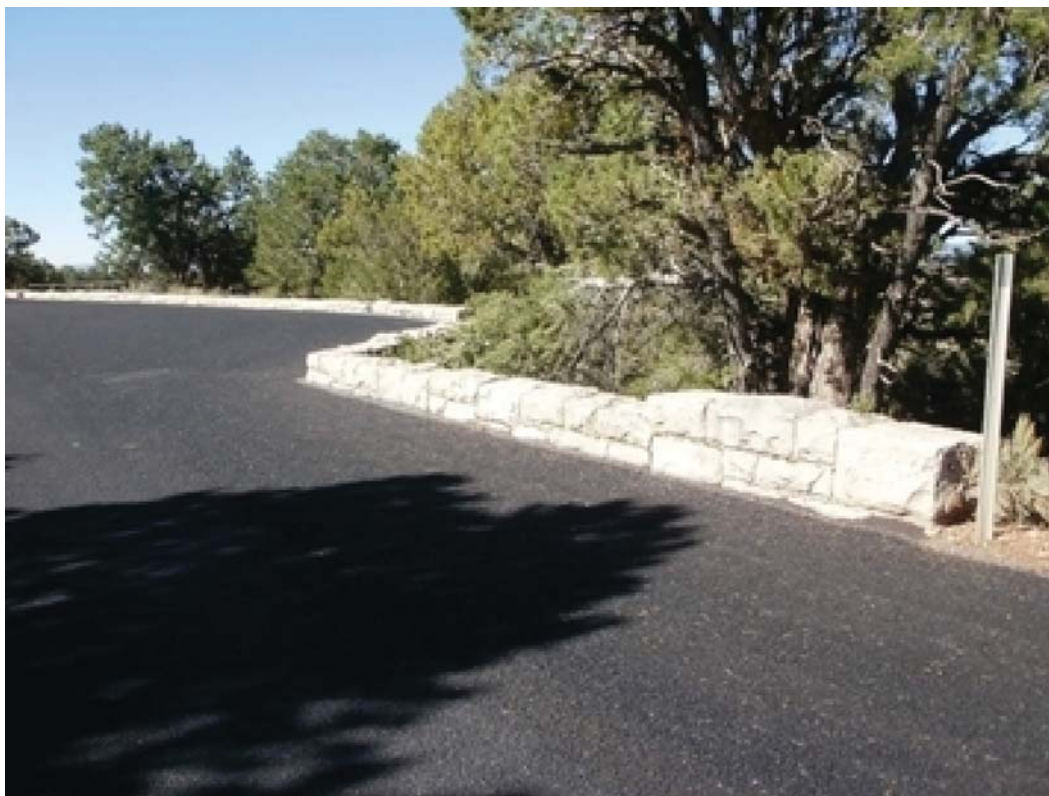
GRCA_0015_6.205_R_1.JPG

Barrier ID:	GRCA-0015-6.205-R				
Route Name:	HERMIT REST ROAD				
Inspection Date:	08/10/2010	Barrier Rating:	53.50		
Barrier Description					
Type:	STONE MASONRY WITHOUT CONCRETE CORE WALL	Barrier Function:	TRAFFIC		
Barrier Material:	STONE	Post Material:	N/A		
Blockout Type:	N/A	Length (ft.):	38		
Speed Limit (MPH):	30	Placement with Respect to Road:	OUTSIDE OF CURVE		
Hazard Behind Barrier:	HIGH				
Barrier Crashworthiness					
Appropriate Test Level:	TL-1	Barrier Test Level:	NCW	Is Barrier Crashworthy?:	NO
Beg. End Trtmt Type:	NONE	Is Beg. End Trtmt Crashworthy?:	N/A	Approach Transition Type:	NONE
Ending End Trtmt Type:	NONE	Ending End Trtmt Crashworthy?:	N/A		
Average Measurements					
Design Height (In.):	24	Width (In.):	21.7	Post Spacing (In.):	0.0
Height (In.):	13.3	Lateral Offset (In.):	96.0	Road Grade (%):	0.30
Physical Condition					
Barrier	Alignment and Height:	No deviation was observed in barrier alignment. The height was 3 to 6 in below 24 in design height for 8 ft which was a higher stone design on the end and was 6 to 11 in below for 30 ft.

Breaking and Cracking:	No breaking or cracking was observed.			
	Missing Elements:	No missing elements were observed.			
	Corrosion and Weathering:	No corrosion or weathering was observed.			
End Treatments	Alignment and Height:				
	Breaking and Cracking:				
	Missing Elements:				
	Corrosion and Weathering:

Repair Action:	REPAIR	FMSS Work Type:	DEFERRED MAINTENANCE	Repair Cost:	\$24943
Brief Workorder:	Raise guardwall 11-in. Remove and reset 38-ft of stone masonry guardwall on 2 rows of new stone to raise barrier to the 24-in design height.				
Workorder:	Remove & Reset Stone Masonry Guardwall at \$250- per -Cu. Ft. for 35 CF = \$8750. $[(0.5ft)(1.8ft)(38ft)] = 34.5$ CF. Remove top layer of stones in barrier for 38 feet. New Stones at \$250- per -Each for 38 Unit(s) = \$9500. $[(38ft) / (2ft/stone) \times 2 \text{ rows}] = 38$ stones. Insert new stone on retaining wall to increase barrier height then reset top layer of barrier. Low Speed Traffic Control at \$1475- per -Day for 3 Day(s) = \$4425. 1 day removal 2 days installation.

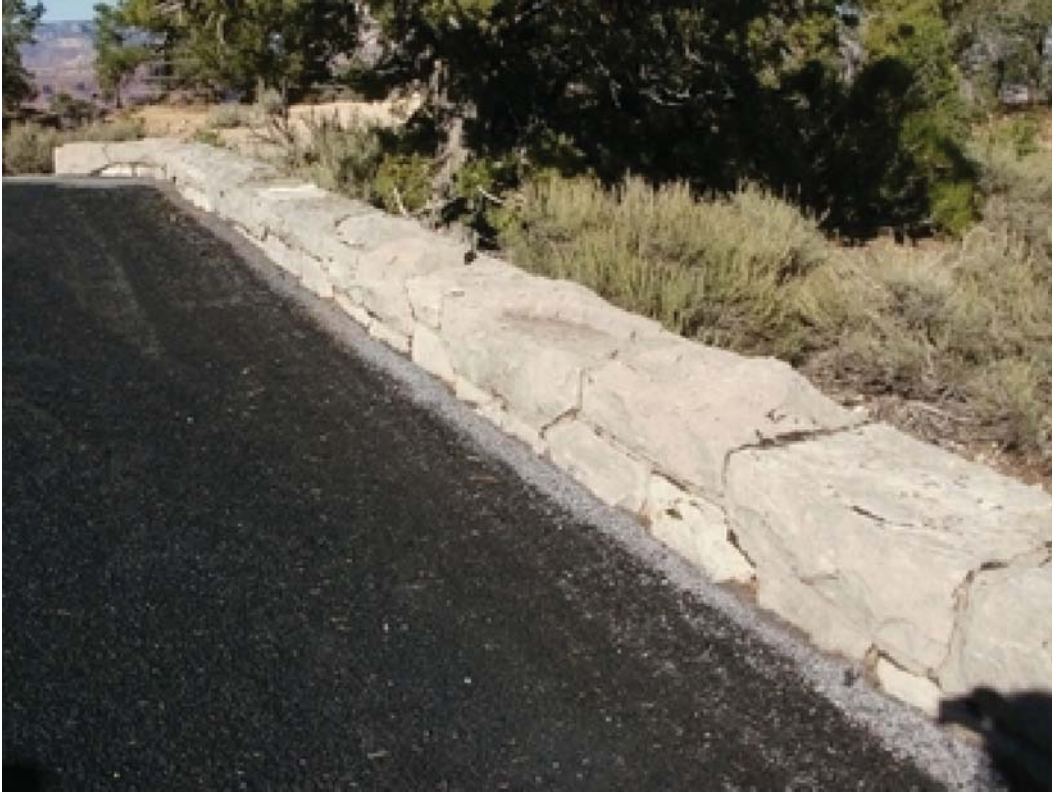
GRCA_0015_6.212_R_1.JPG

Barrier ID:	GRCA-0015-6.212-R				
Route Name:	HERMIT REST ROAD				
Inspection Date:	08/10/2010	Barrier Rating:	32.20		
Barrier Description					
Type:	STONE MASONRY WITHOUT CONCRETE CORE WALL	Barrier Function:	NON-TRAFFIC		
Barrier Material:	STONE	Post Material:	N/A		
Blockout Type:	N/A	Length (ft.):	187		
Speed Limit (MPH):	30	Placement with Respect to Road:	NON-TRAFFIC BARRIER		
Hazard Behind Barrier:	N/A				
Barrier Crashworthiness					
Appropriate Test Level:	TL-1	Barrier Test Level:	N/A	Is Barrier Crashworthy?:	N/A
Beg. End Trtmt Type:	NONE	Is Beg. End Trtmt Crashworthy?:	N/A	Approach Transition Type:	NONE
Ending End Trtmt Type:	NONE	Ending End Trtmt Crashworthy?:	N/A		
Average Measurements					
Design Height (In.):	24	Width (In.):	21.0	Post Spacing (In.):	0.0
Height (In.):	12.6	Lateral Offset (In.):	0.0	Road Grade (%):	0.00
Physical Condition					
Barrier	Alignment and Height:	No deviation was observed in barrier alignment. The height was 10 to 13 in below the 24 in design height throughout.

Breaking and Cracking:	No breaking cracking or evidence of impact was observed.			
	Missing Elements:	No missing elements were observed.			
	Corrosion and Weathering:	Minor cracking of mortar less than 1/4 in wide was observed with minimal weathering of mortar and stones. No erosion was observed compromising stability of barrier.			
End Treatments	Alignment and Height:				
	Breaking and Cracking:				
	Missing Elements:				
	Corrosion and Weathering:

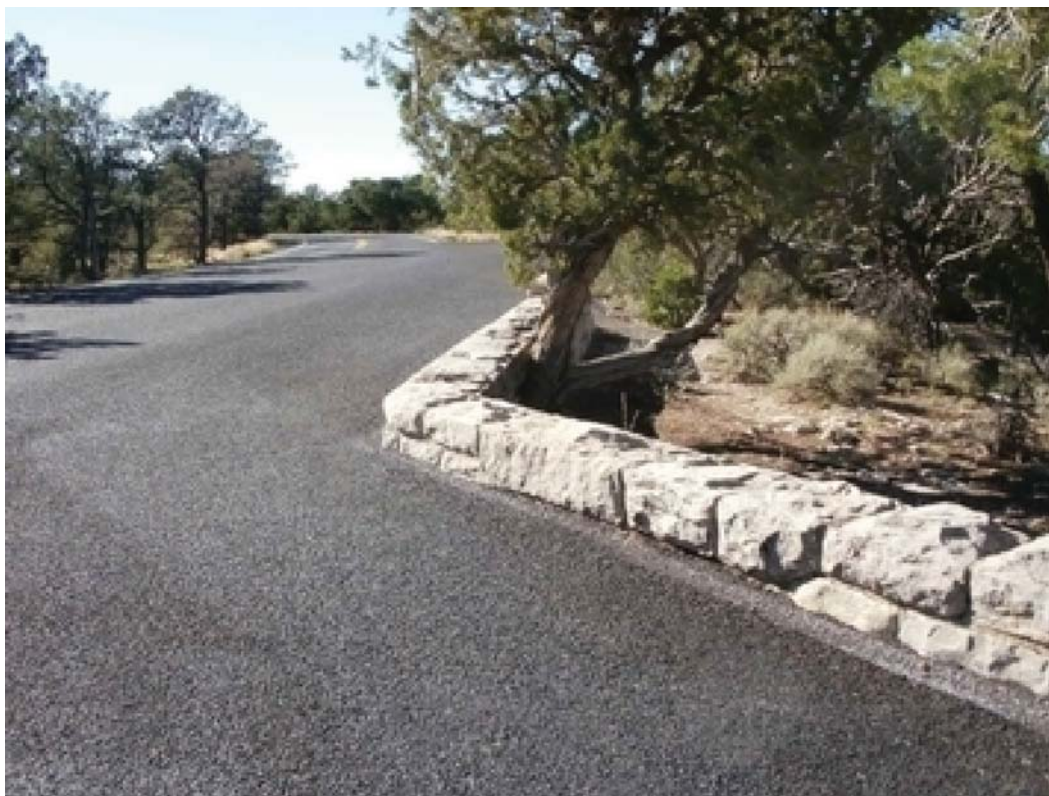
GRCA_0015_6.244_R_1.JPG

Barrier ID:	GRCA-0015-6.244-R				
Route Name:	HERMIT REST ROAD				
Inspection Date:	08/10/2010	Barrier Rating:	55.20		
Barrier Description					
Type:	STONE MASONRY WITHOUT CONCRETE CORE WALL	Barrier Function:	TRAFFIC		
Barrier Material:	STONE	Post Material:	N/A		
Blockout Type:	N/A	Length (ft.):	38		
Speed Limit (MPH):	30	Placement with Respect to Road:	OUTSIDE OF CURVE		
Hazard Behind Barrier:	EXTREME				
Barrier Crashworthiness					
Appropriate Test Level:	TL-1	Barrier Test Level:	NCW	Is Barrier Crashworthy?:	NO
Beg. End Trtmt Type:	NONE	Is Beg. End Trtmt Crashworthy?:	N/A	Approach Transition Type:	NONE
Ending End Trtmt Type:	NONE	Ending End Trtmt Crashworthy?:	N/A		
Average Measurements					
Design Height (In.):	24	Width (In.):	21.0	Post Spacing (In.):	0.0
Height (In.):	13.3	Lateral Offset (In.):	111.3	Road Grade (%):	0.30
Physical Condition					
Barrier	Alignment and Height:	No deviation was observed in barrier alignment. Barrier was 10 to 12 in below design height of 24 in for 30 linear ft and 4 to 6 ins below for 8 ft higher stone end design.

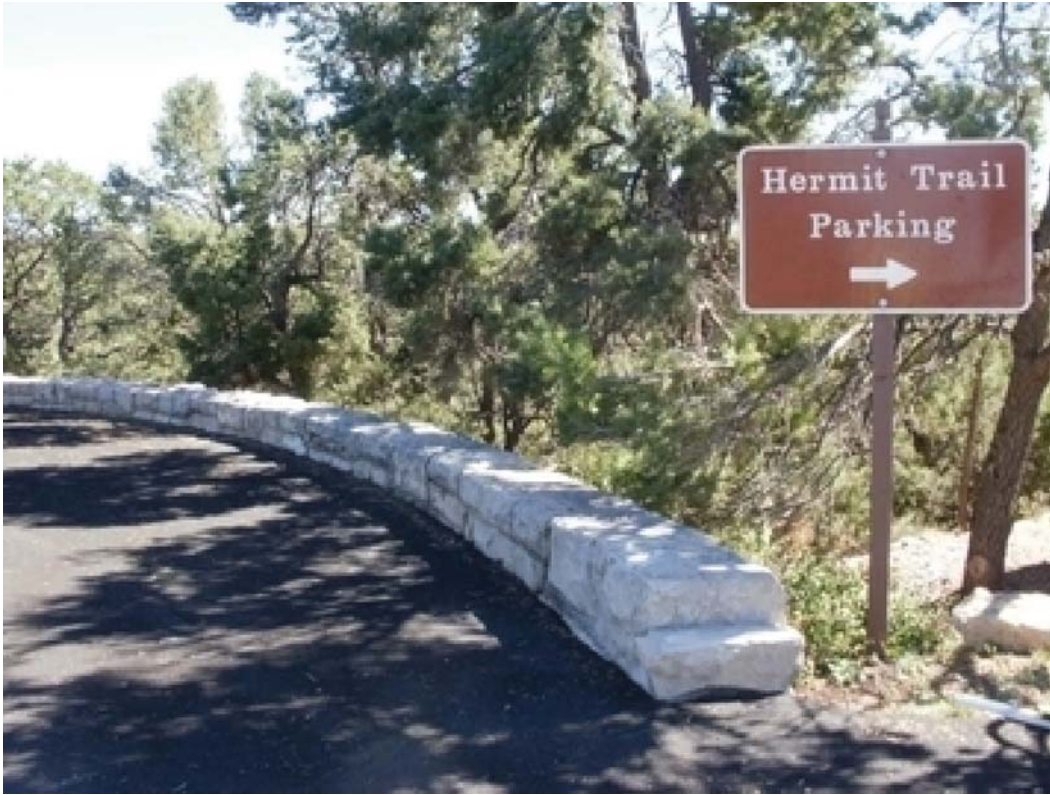
GRCA_0015_7.029_L_1.JPG

Barrier ID:	GRCA-0015-7.029-L				
Route Name:	HERMIT REST ROAD				
Inspection Date:	08/10/2010	Barrier Rating:	64.50		
Barrier Description					
Type:	STONE MASONRY WITHOUT CONCRETE CORE WALL	Barrier Function:	TRAFFIC		
Barrier Material:	STONE	Post Material:	N/A		
Blockout Type:	N/A	Length (ft.):	430		
Speed Limit (MPH):	30	Placement with Respect to Road:	BOTH INSIDE AND OUTSIDE		
Hazard Behind Barrier:	MEDIUM				
Barrier Crashworthiness					
Appropriate Test Level:	TL-1	Barrier Test Level:	NCW	Is Barrier Crashworthy?:	NO
Beg. End Trtmt Type:	NONE	Is Beg. End Trtmt Crashworthy?:	N/A	Approach Transition Type:	NONE
Ending End Trtmt Type:	NONE	Ending End Trtmt Crashworthy?:	N/A		
Average Measurements					
Design Height (In.):	24	Width (In.):	20.7	Post Spacing (In.):	0.0
Height (In.):	16.2	Lateral Offset (In.):	2.7	Road Grade (%):	1.30
Physical Condition					
Barrier	Alignment and Height:	No deviation was observed in barrier alignment. Barrier was 3 to 6 in below 24 in design height for 69 linear ft and below by 6 to 8 in for 353 linear ft.
