GIP Report

NPS Guardwall/Rail Inventory Program
Grand Canyon National Park

Federal Highway Administration
Eastern Federal Lands Highway Division
Road Inventory Program (RIP)

Data Collection Date: October 2010
Report Date: November 2015

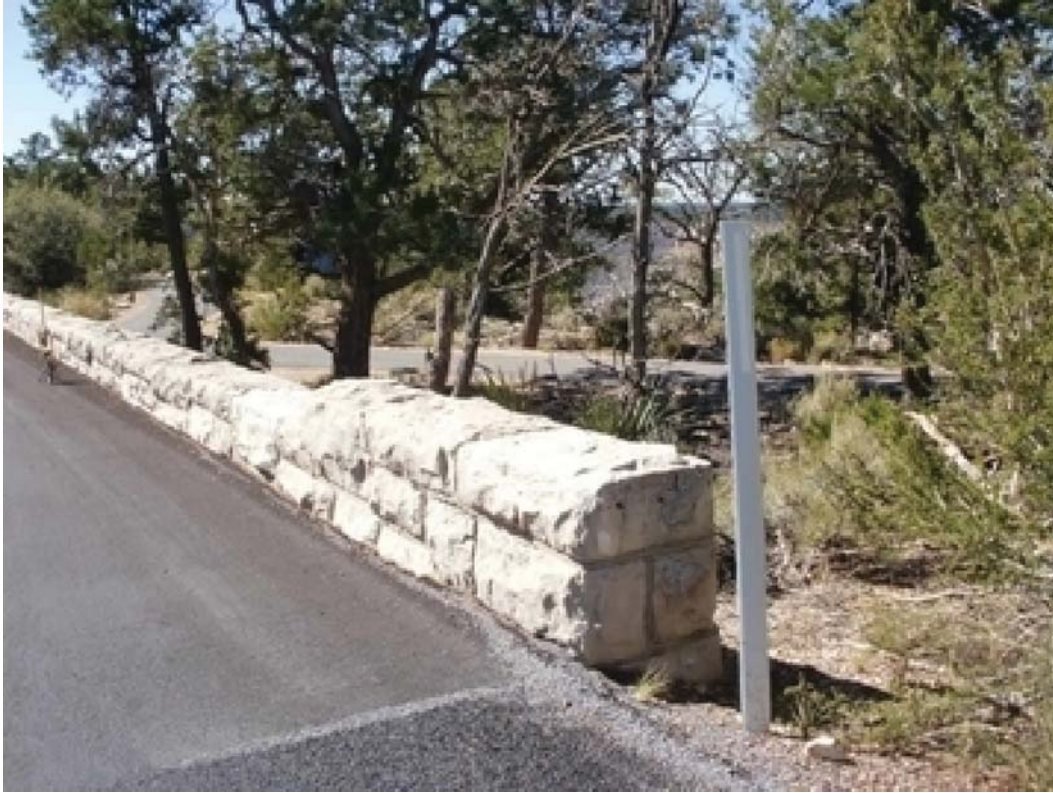
GRCA_0015_7.029_R_1.JPG

Barrier ID:	GRCA-0015-7.029-R				
Route Name:	HERMIT REST ROAD				
Inspection Date:	08/10/2010	Barrier Rating:	53.70		
Barrier Description					
Type:	STONE MASONRY WITHOUT CONCRETE CORE WALL	Barrier Function:	TRAFFIC		
Barrier Material:	STONE	Post Material:	N/A		
Blockout Type:	N/A	Length (ft.):	144		
Speed Limit (MPH):	30	Placement with Respect to Road:	TANGENT		
Hazard Behind Barrier:	EXTREME				
Barrier Crashworthiness					
Appropriate Test Level:	TL-1	Barrier Test Level:	NCW	Is Barrier Crashworthy?:	NO
Beg. End Trtmt Type:	NONE	Is Beg. End Trtmt Crashworthy?:	N/A	Approach Transition Type:	NONE
Ending End Trtmt Type:	NONE	Ending End Trtmt Crashworthy?:	N/A		
Average Measurements					
Design Height (In.):	24	Width (In.):	21.2	Post Spacing (In.):	0.0
Height (In.):	16.0	Lateral Offset (In.):	40.0	Road Grade (%):	3.10
Physical Condition					
Barrier	Alignment and Height:	No deviation was observed in barrier alignment. Height of barrier was 6 in below the 24 in design height for 29 linear ft and 6 to 12 in below design height for 108 linear ft.

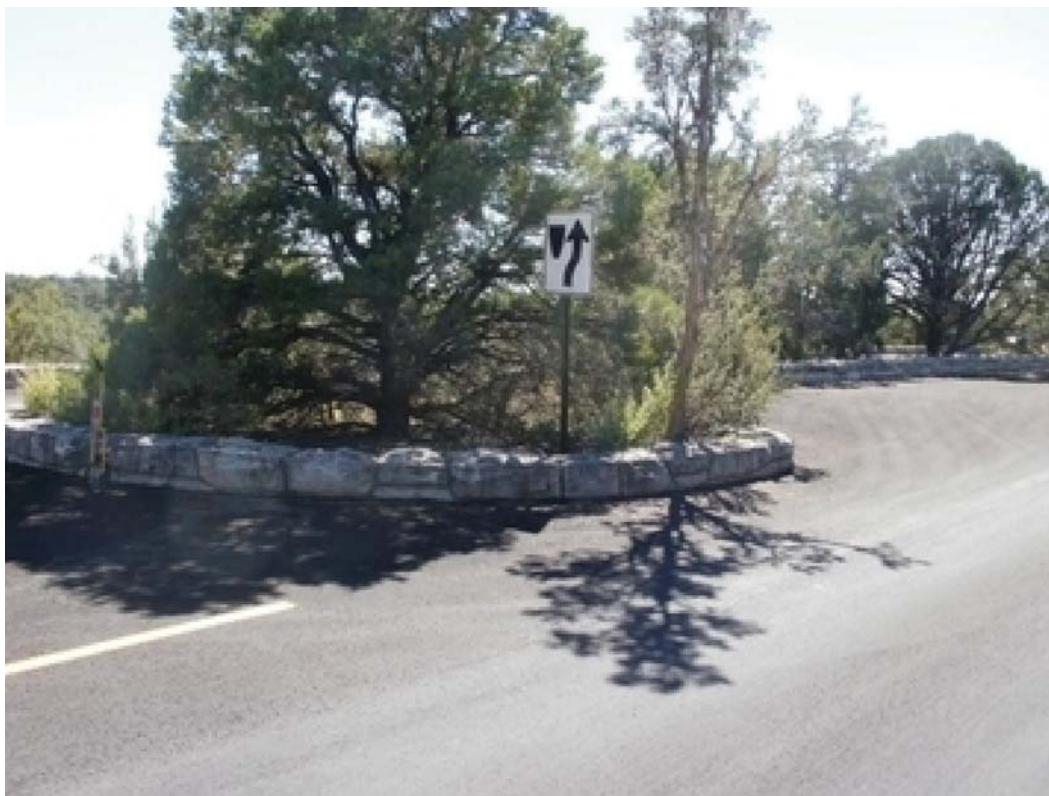
GRCA_0015_7.056_L_1.JPG

Barrier ID:	GRCA-0015-7.056-L				
Route Name:	HERMIT REST ROAD				
Inspection Date:	08/10/2010	Barrier Rating:	42.00		
Barrier Description					
Type:	STONE MASONRY WITHOUT CONCRETE CORE WALL	Barrier Function:	NON-TRAFFIC		
Barrier Material:	STONE	Post Material:	N/A		
Blockout Type:	N/A	Length (ft.):	537		
Speed Limit (MPH):	30	Placement with Respect to Road:	NON-TRAFFIC BARRIER		
Hazard Behind Barrier:	LOW				
Barrier Crashworthiness					
Appropriate Test Level:	TL-1	Barrier Test Level:	N/A	Is Barrier Crashworthy?:	N/A
Beg. End Trtmt Type:	NONE	Is Beg. End Trtmt Crashworthy?:	N/A	Approach Transition Type:	NONE
Ending End Trtmt Type:	NONE	Ending End Trtmt Crashworthy?:	N/A		
Average Measurements					
Design Height (In.):	24	Width (In.):	21.0	Post Spacing (In.):	0.0
Height (In.):	16.2	Lateral Offset (In.):	0.0	Road Grade (%):	0.00
Physical Condition					
Barrier	Alignment and Height:	No deviation was observed in barrier alignment. The height was 3 to 6 in below 24 in design height for 183 ft and 6 to 12 in below for 354 ft.

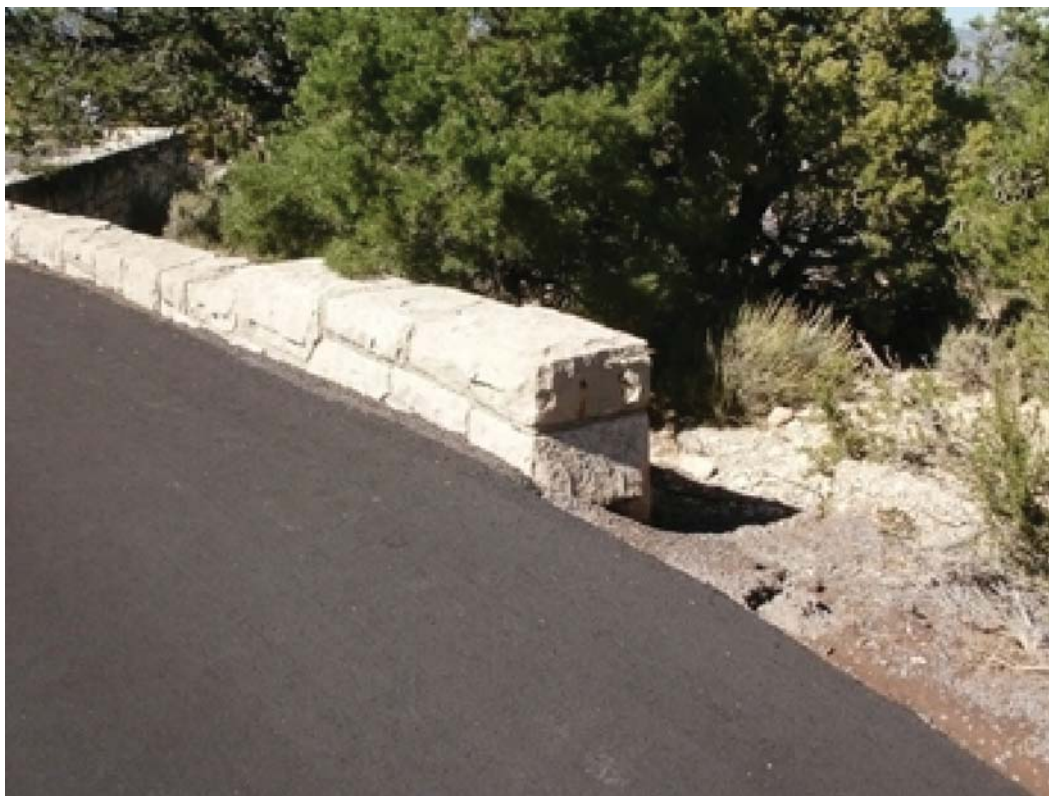
GRCA_0167_0.260_R_1.JPG

Barrier ID:	GRCA-0167-0.260-R				
Route Name:	PIMA POINT ROAD				
Inspection Date:	08/10/2010	Barrier Rating:	65.10		
Barrier Description					
Type:	STONE MASONRY WITHOUT CONCRETE CORE WALL	Barrier Function:	TRAFFIC		
Barrier Material:	STONE	Post Material:	N/A		
Blockout Type:	N/A	Length (ft.):	58		
Speed Limit (MPH):	15	Placement with Respect to Road:	OUTSIDE OF CURVE		
Hazard Behind Barrier:	EXTREME				
Barrier Crashworthiness					
Appropriate Test Level:	TL-1	Barrier Test Level:	NCW	Is Barrier Crashworthy?:	NO
Beg. End Trtmt Type:	NONE	Is Beg. End Trtmt Crashworthy?:	N/A	Approach Transition Type:	NONE
Ending End Trtmt Type:	NONE	Ending End Trtmt Crashworthy?:	N/A		
Average Measurements					
Design Height (In.):	24	Width (In.):	21.0	Post Spacing (In.):	0.0
Height (In.):	14.6	Lateral Offset (In.):	0.0	Road Grade (%):	8.50
Physical Condition					
Barrier	Alignment and Height:	No deviation was observed in alignment of barrier. Height of barrier was 3 to 6 in below 24 in design height for 5 linear ft and 6 to 13 in below design height for 34 linear ft.

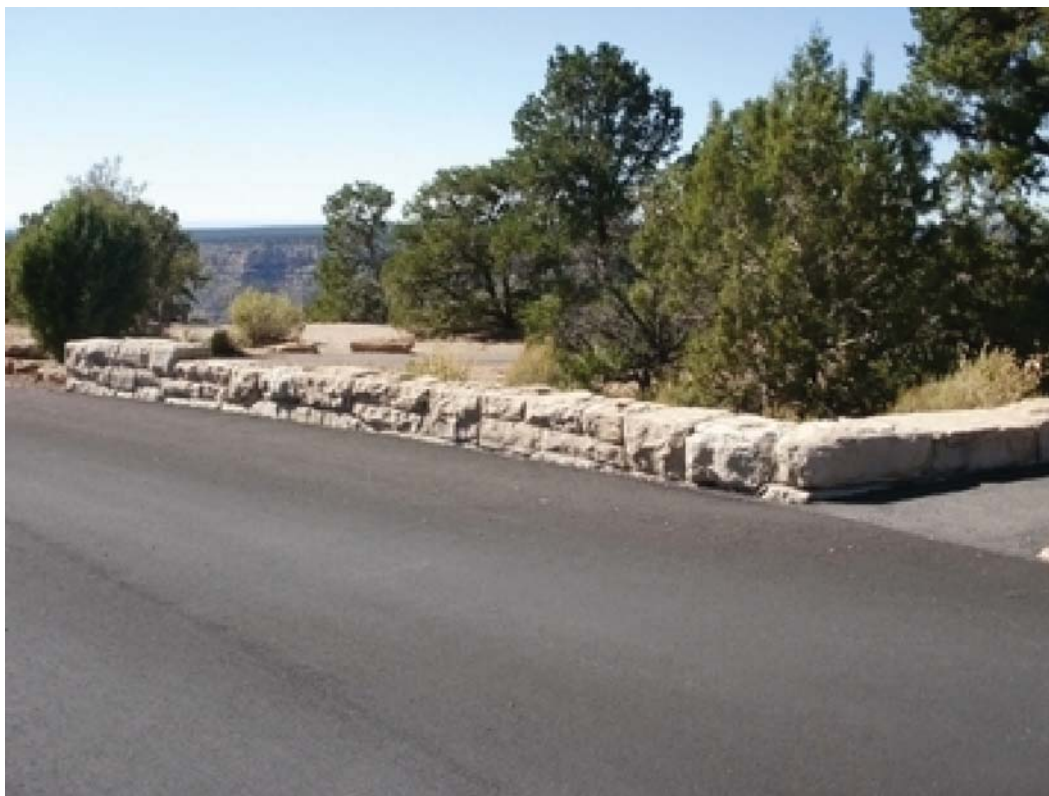
GRCA_0167_0.300_R_1.JPG

Barrier ID:	GRCA-0167-0.300-R				
Route Name:	PIMA POINT ROAD				
Inspection Date:	08/10/2010	Barrier Rating:	50.00		
Barrier Description					
Type:	STONE MASONRY WITHOUT CONCRETE CORE WALL	Barrier Function:	TRAFFIC		
Barrier Material:	STONE	Post Material:	N/A		
Blockout Type:	N/A	Length (ft.):	33		
Speed Limit (MPH):	15	Placement with Respect to Road:	OUTSIDE OF CURVE		
Hazard Behind Barrier:	EXTREME				
Barrier Crashworthiness					
Appropriate Test Level:	TL-1	Barrier Test Level:	NCW	Is Barrier Crashworthy?:	NO
Beg. End Trtmt Type:	NONE	Is Beg. End Trtmt Crashworthy?:	N/A	Approach Transition Type:	NONE
Ending End Trtmt Type:	NONE	Ending End Trtmt Crashworthy?:	N/A		
Average Measurements					
Design Height (In.):	24	Width (In.):	21.0	Post Spacing (In.):	0.0
Height (In.):	18.2	Lateral Offset (In.):	0.0	Road Grade (%):	4.70
Physical Condition					
Barrier	Alignment and Height:	No deviation in alignment was observed. Barrier was 3 to 6 in below 24 in design height for 25 linear ft with an 8 ft section of higher stone design on the end.

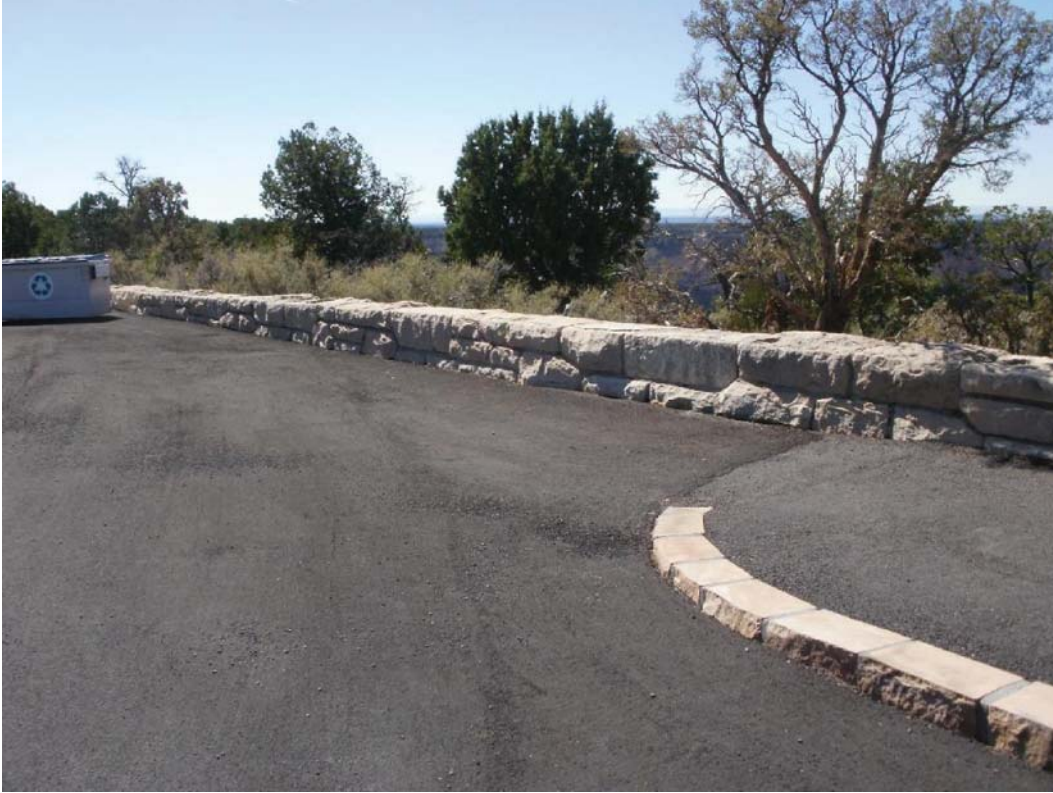
GRCA_0168_0.134_R_1.JPG

Barrier ID:	GRCA-0168-0.134-R				
Route Name:	MOHAVE POINT ROAD				
Inspection Date:	09/10/2010	Barrier Rating:	50.00		
Barrier Description					
Type:	STONE MASONRY WITHOUT CONCRETE CORE WALL	Barrier Function:	TRAFFIC		
Barrier Material:	STONE	Post Material:	N/A		
Blockout Type:	N/A	Length (ft.):	72		
Speed Limit (MPH):	15	Placement with Respect to Road:	OUTSIDE OF CURVE		
Hazard Behind Barrier:	EXTREME				
Barrier Crashworthiness					
Appropriate Test Level:	TL-1	Barrier Test Level:	NCW	Is Barrier Crashworthy?:	NO
Beg. End Trtmt Type:	NONE	Is Beg. End Trtmt Crashworthy?:	N/A	Approach Transition Type:	NONE
Ending End Trtmt Type:	NONE	Ending End Trtmt Crashworthy?:	N/A		
Average Measurements					
Design Height (In.):	24	Width (In.):	21.7	Post Spacing (In.):	0.0
Height (In.):	17.2	Lateral Offset (In.):	0.0	Road Grade (%):	1.60
Physical Condition					
Barrier	Alignment and Height:	No deviation in barrier alignment was observed. Barrier was 7 to 9 in below 24 in design height for 32 linear ft and below by 3 to 6 in for 23 linear ft.

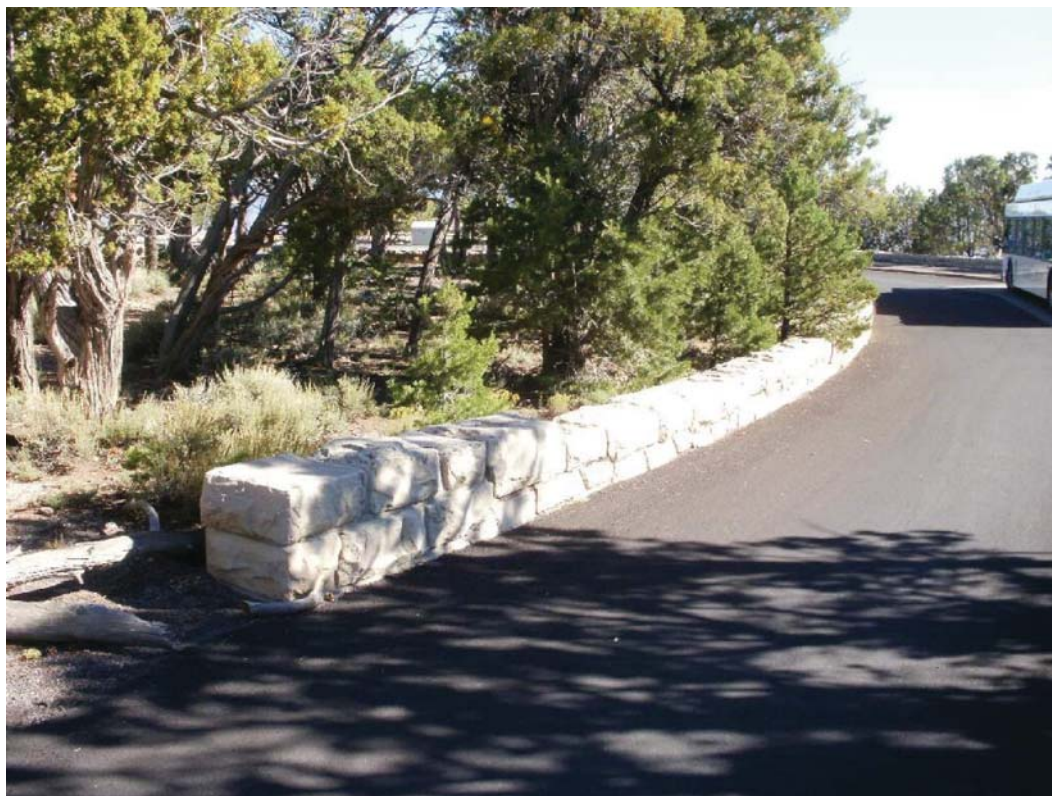
GRCA_0169_0.068_L_1.JPG

Barrier ID:	GRCA-0169-0.068-L				
Route Name:	POWELL MEMORIAL ROAD				
Inspection Date:	09/10/2010	Barrier Rating:	11.50		
Barrier Description					
Type:	STONE MASONRY WITHOUT CONCRETE CORE WALL	Barrier Function:	NON-TRAFFIC		
Barrier Material:	STONE	Post Material:	N/A		
Blockout Type:	N/A	Length (ft.):	304		
Speed Limit (MPH):	15	Placement with Respect to Road:	NON-TRAFFIC BARRIER		
Hazard Behind Barrier:	N/A				
Barrier Crashworthiness					
Appropriate Test Level:	TL-1	Barrier Test Level:	N/A	Is Barrier Crashworthy?:	N/A
Beg. End Trtmt Type:	NONE	Is Beg. End Trtmt Crashworthy?:	N/A	Approach Transition Type:	NONE
Ending End Trtmt Type:	NONE	Ending End Trtmt Crashworthy?:	N/A		
Average Measurements					
Design Height (In.):	24	Width (In.):	22.0	Post Spacing (In.):	0.0
Height (In.):	20.7	Lateral Offset (In.):	0.0	Road Grade (%):	0.00
Physical Condition					
Barrier	Alignment and Height:	No deviation was observed in barrier alignment. The height was between 3 to 4 in below the 24 in design height for 100 ft between 1 to 3 in below for 188 ft and the ends had an 8 ft section of higher stone design.

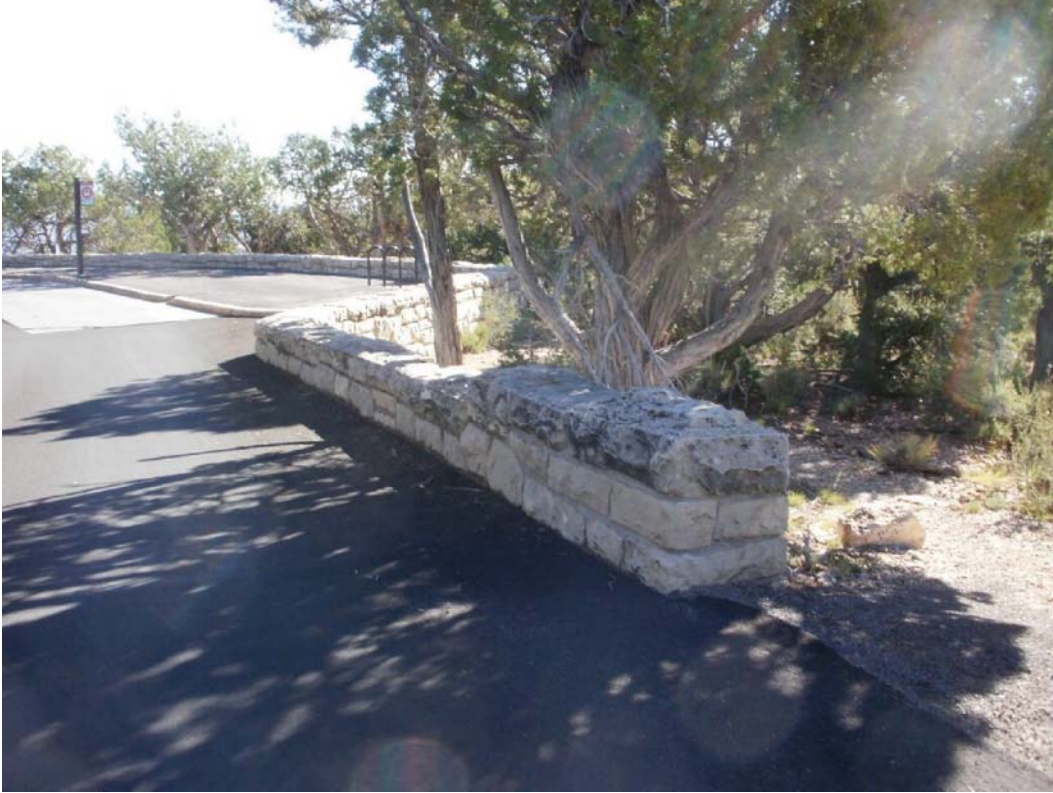
GRCA_0169_0.069_R_1.JPG

Barrier ID:	GRCA-0169-0.069-R				
Route Name:	POWELL MEMORIAL ROAD				
Inspection Date:	09/10/2010	Barrier Rating:	50.00		
Barrier Description					
Type:	STONE MASONRY WITHOUT CONCRETE CORE WALL	Barrier Function:	TRAFFIC		
Barrier Material:	STONE	Post Material:	N/A		
Blockout Type:	N/A	Length (ft.):	53		
Speed Limit (MPH):	15	Placement with Respect to Road:	OUTSIDE OF CURVE		
Hazard Behind Barrier:	EXTREME				
Barrier Crashworthiness					
Appropriate Test Level:	TL-1	Barrier Test Level:	NCW	Is Barrier Crashworthy?:	NO
Beg. End Trtmt Type:	NONE	Is Beg. End Trtmt Crashworthy?:	N/A	Approach Transition Type:	NONE
Ending End Trtmt Type:	NONE	Ending End Trtmt Crashworthy?:	N/A		
Average Measurements					
Design Height (In.):	24	Width (In.):	21.7	Post Spacing (In.):	0.0
Height (In.):	19.2	Lateral Offset (In.):	16.0	Road Grade (%):	3.10
Physical Condition					
Barrier	Alignment and Height:	No deviation in barrier alignment was observed. Barrier was 4 to 6 in below 24 in design height for 45 linear ft with an 8 ft section on end of higher stone design.

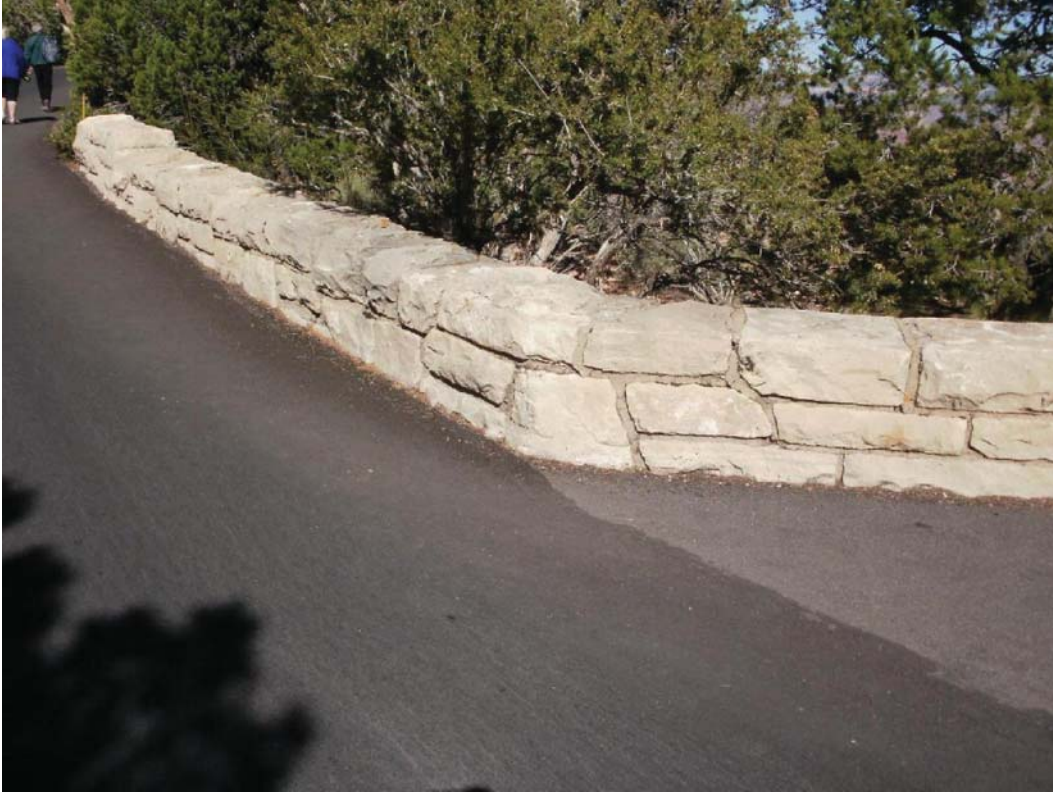
GRCA_0169_0.121_R_1.JPG

Barrier ID:	GRCA-0169-0.121-R				
Route Name:	POWELL MEMORIAL ROAD				
Inspection Date:	09/10/2010	Barrier Rating:	40.00		
Barrier Description					
Type:	STONE MASONRY WITHOUT CONCRETE CORE WALL	Barrier Function:	TRAFFIC		
Barrier Material:	STONE	Post Material:	N/A		
Blockout Type:	N/A	Length (ft.):	30		
Speed Limit (MPH):	15	Placement with Respect to Road:	INSIDE OF CURVE		
Hazard Behind Barrier:	EXTREME				
Barrier Crashworthiness					
Appropriate Test Level:	TL-1	Barrier Test Level:	NCW	Is Barrier Crashworthy?:	NO
Beg. End Trtmt Type:	NONE	Is Beg. End Trtmt Crashworthy?:	N/A	Approach Transition Type:	NONE
Ending End Trtmt Type:	NONE	Ending End Trtmt Crashworthy?:	N/A		
Average Measurements					
Design Height (In.):	24	Width (In.):	21.2	Post Spacing (In.):	0.0
Height (In.):	19.7	Lateral Offset (In.):	0.0	Road Grade (%):	4.30
Physical Condition					
Barrier	Alignment and Height:	No deviation was observed in barrier alignment. Height of barrier was 4 to 5 in below the design height of 24 in for 22 linear ft with an 8 ft section of higher stone design on the end.

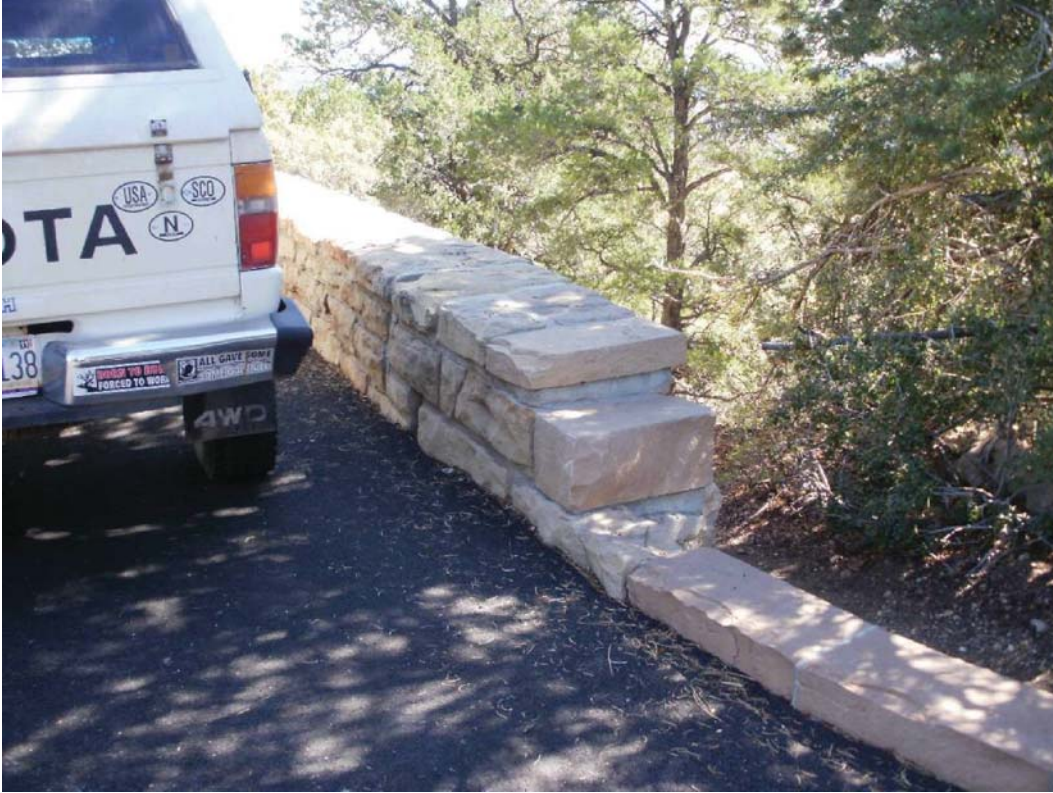
GRCA_0264_0.638_R_1.JPG

Barrier ID:	GRCA-0264-0.638-R				
Route Name:	GRANDVIEW POINT ROAD				
Inspection Date:	10/10/2010	Barrier Rating:	4.10		
Barrier Description					
Type:	STONE MASONRY WITHOUT CONCRETE CORE WALL	Barrier Function:	NON-TRAFFIC		
Barrier Material:	STONE	Post Material:	N/A		
Blockout Type:	N/A	Length (ft.):	13		
Speed Limit (MPH):	25	Placement with Respect to Road:	NON-TRAFFIC BARRIER		
Hazard Behind Barrier:	N/A				
Barrier Crashworthiness					
Appropriate Test Level:	TL-1	Barrier Test Level:	N/A	Is Barrier Crashworthy?:	N/A
Beg. End Trtmt Type:	NONE	Is Beg. End Trtmt Crashworthy?:	N/A	Approach Transition Type:	NONE
Ending End Trtmt Type:	NONE	Ending End Trtmt Crashworthy?:	N/A		
Average Measurements					
Design Height (In.):	24	Width (In.):	23.0	Post Spacing (In.):	0.0
Height (In.):	23.2	Lateral Offset (In.):	0.0	Road Grade (%):	0.00
Physical Condition					
Barrier	Alignment and Height:	No deviation was observed in barrier alignment. Barrier height ranged from 1 in above 24 in design height to 3 in below.

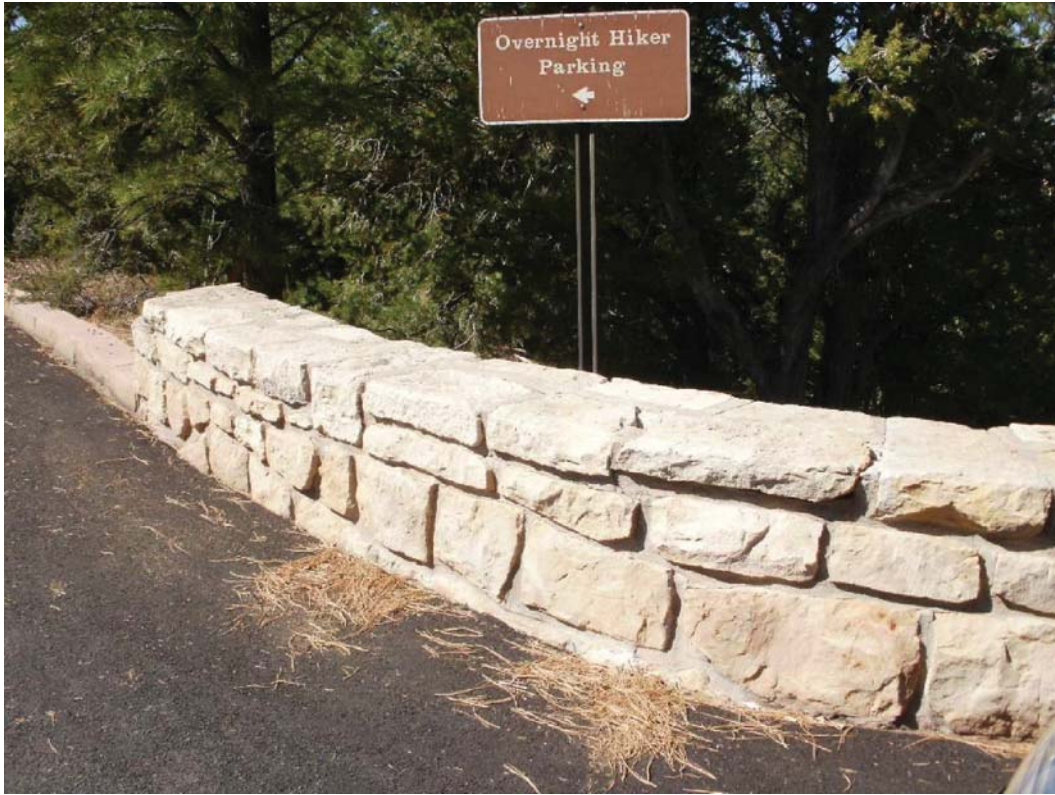
GRCA_0264_0.682_R_1.JPG

Barrier ID:	GRCA-0264-0.682-R				
Route Name:	GRANDVIEW POINT ROAD				
Inspection Date:	10/10/2010	Barrier Rating:	32.70		
Barrier Description					
Type:	STONE MASONRY WITHOUT CONCRETE CORE WALL	Barrier Function:	TRAFFIC		
Barrier Material:	STONE	Post Material:	N/A		
Blockout Type:	N/A	Length (ft.):	34		
Speed Limit (MPH):	25	Placement with Respect to Road:	OUTSIDE OF CURVE		
Hazard Behind Barrier:	EXTREME				
Barrier Crashworthiness					
Appropriate Test Level:	TL-1	Barrier Test Level:	NCW	Is Barrier Crashworthy?:	NO
Beg. End Trtmt Type:	NONE	Is Beg. End Trtmt Crashworthy?:	N/A	Approach Transition Type:	NONE
Ending End Trtmt Type:	NONE	Ending End Trtmt Crashworthy?:	N/A		
Average Measurements					
Design Height (In.):	24	Width (In.):	22.2	Post Spacing (In.):	0.0
Height (In.):	25.0	Lateral Offset (In.):	0.0	Road Grade (%):	1.50
Physical Condition					
Barrier	Alignment and Height:	No deviation in barrier alignment was observed. Barrier is at or above 24 in design height by up to 2 in.

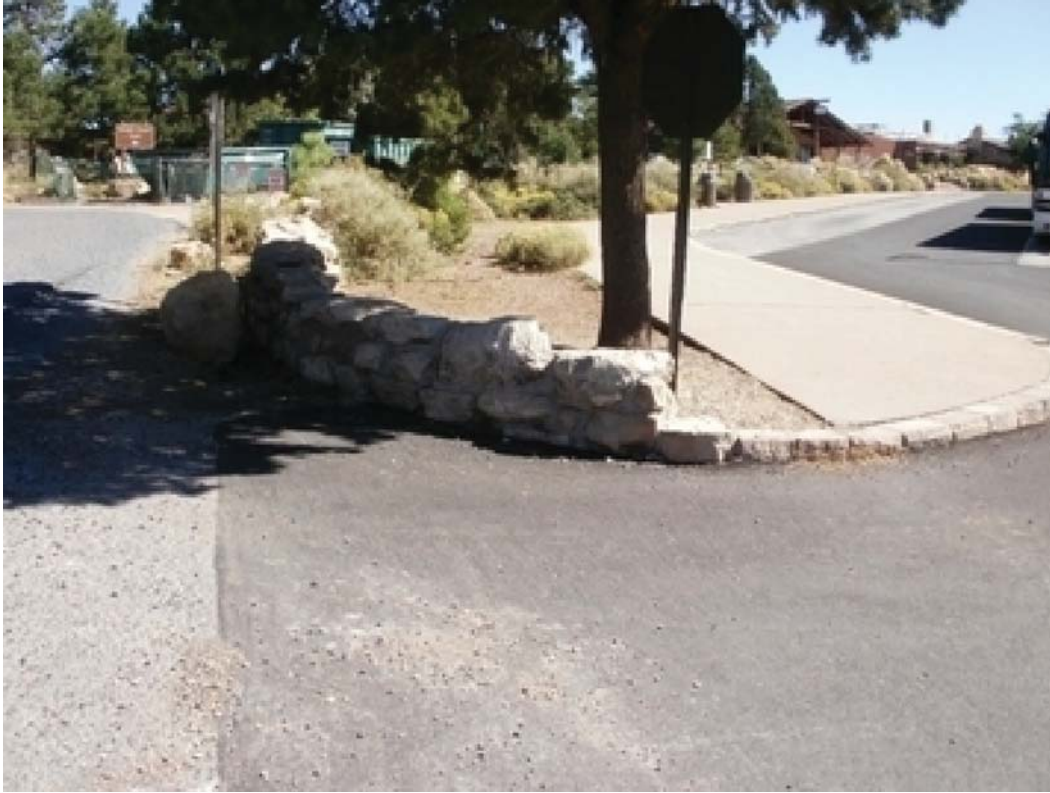
GRCA_0436ZZ_0.023_R_1.JPG

Barrier ID:	GRCA-0436ZZ-0.023-R				
Route Name:	BRIGHT ANGEL LOOP ROADS				
Inspection Date:	08/10/2010	Barrier Rating:	16.80		
Barrier Description					
Type:	STONE MASONRY WITHOUT CONCRETE CORE WALL	Barrier Function:	TRAFFIC		
Barrier Material:	STONE	Post Material:	N/A		
Blockout Type:	N/A	Length (ft.):	85		
Speed Limit (MPH):	15	Placement with Respect to Road:	OUTSIDE OF CURVE		
Hazard Behind Barrier:	LOW				
Barrier Crashworthiness					
Appropriate Test Level:	TL-1	Barrier Test Level:	NCW	Is Barrier Crashworthy?:	NO
Beg. End Trtmt Type:	NONE	Is Beg. End Trtmt Crashworthy?:	N/A	Approach Transition Type:	NONE
Ending End Trtmt Type:	NONE	Ending End Trtmt Crashworthy?:	N/A		
Average Measurements					
Design Height (In.):	24	Width (In.):	16.2	Post Spacing (In.):	0.0
Height (In.):	23.7	Lateral Offset (In.):	100.6	Road Grade (%):	6.10
Physical Condition					
Barrier	Alignment and Height:	No deviation was observed in barrier alignment. The height ranged between 1 in above the 24 in design height to 2 in below.

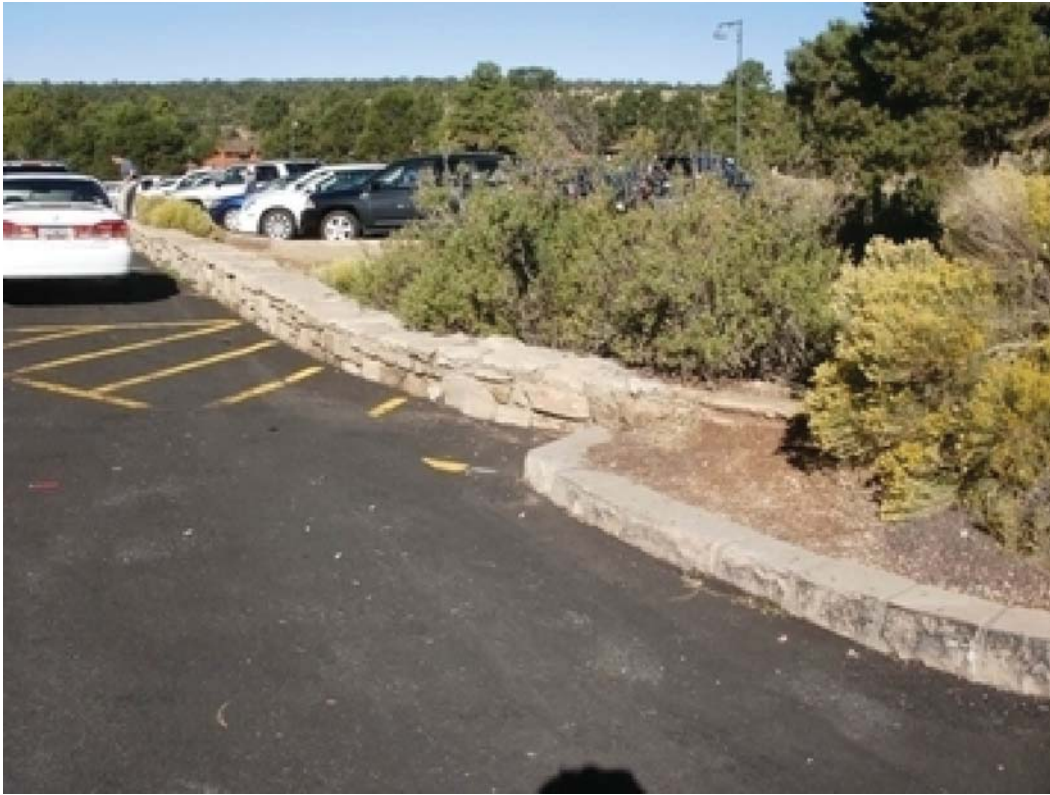
GRCA_0500_0.395_R_1.JPG

Barrier ID:	GRCA-0500-0.395-R				
Route Name:	VILLAGE LOOP DRIVE				
Inspection Date:	08/10/2010	Barrier Rating:	37.00		
Barrier Description					
Type:	STONE MASONRY WITHOUT CONCRETE CORE WALL	Barrier Function:	TRAFFIC		
Barrier Material:	STONE	Post Material:	N/A		
Blockout Type:	N/A	Length (ft.):	443		
Speed Limit (MPH):	20	Placement with Respect to Road:	TANGENT		
Hazard Behind Barrier:	LOW				
Barrier Crashworthiness					
Appropriate Test Level:	TL-1	Barrier Test Level:	NCW	Is Barrier Crashworthy?:	NO
Beg. End Trtmt Type:	NONE	Is Beg. End Trtmt Crashworthy?:	N/A	Approach Transition Type:	NONE
Ending End Trtmt Type:	NONE	Ending End Trtmt Crashworthy?:	N/A		
Average Measurements					
Design Height (In.):	24	Width (In.):	22.0	Post Spacing (In.):	0.0
Height (In.):	19.0	Lateral Offset (In.):	147.6	Road Grade (%):	4.30
Physical Condition					
Barrier	Alignment and Height:	No deviation was observed in barrier alignment. Height of barrier was 3 to 6 in below 24 in design height for 201 linear ft. Barrier was 6 to 8 in below design height for 93 linear ft.

Breaking and Cracking:	No breaking cracking or evidence of impact was observed.			
	Missing Elements:	There were 36 missing stones and 1 sq. ft. of missing grout observed.			
	Corrosion and Weathering:	Some grout was deteriorating included in the 1 sq. ft. of missing grout. No erosion was observed. A tree was growing under barrier but had not yet damaged barrier.			
End Treatments	Alignment and Height:				
	Breaking and Cracking:				
	Missing Elements:				
	Corrosion and Weathering:

Barrier ID:	GRCA-0500-0.395-R				
Route Name:	VILLAGE LOOP DRIVE				
Inspection Date:	08/10/2010	Barrier Rating:		37.00	
Repair Recommendations					
Repair Action:	REPAIR	FMSS Work Type:	DEFERRED MAINTENANCE	Repair Cost:	\$108092
Brief Workorder:	Raise guardwall 2-in. Remove and reset 93-ft of stone masonry guardwall on concrete footer to adjacent 18-in height. Replace 36 missing stones and replace 1 sq. ft. of grout.				
Workorder:	<p>Remove & Reset Stone Masonry Guardwall at \$250- per -Cu. Ft. for 341 CF = \$85250. $(93\text{ft})(2\text{ft})(1.8\text{ft}) = 341\text{ CF}$.</p> <p>Structural Concrete at \$1000- per -Cu. Yd. for 4 CY = \$4000. $(93\text{ft})(.5\text{ft})(1.8\text{ft}) / 27 = 3.15\text{ CY}$.</p> <p>Stone Masonry w/o Concrete Core at \$500- per -Lin. Ft. for 3 LF = \$1500. Replace 36 missing stones approximately equaling 3 total linear feet.</p> <p>Re-Point Masonry Barrier at \$140- per -Sq. Yd. for 1 SY = \$140. Replace missing mortar.</p> <p>Low Speed Traffic Control at \$1475- per -Day for 5 Day(s) = \$7375. 1 day to remove 4 days to reset.</p>

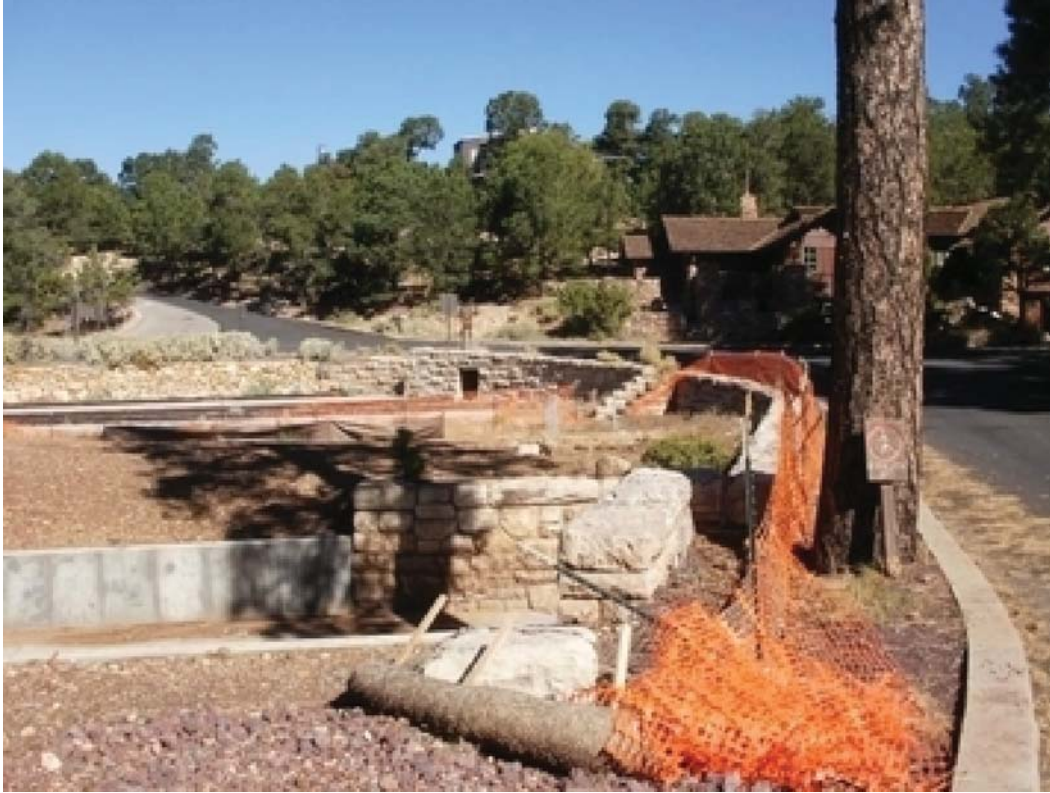
GRCA_0500_1.297_L_1.JPG

Barrier ID:	GRCA-0500-1.297-L				
Route Name:	VILLAGE LOOP DRIVE				
Inspection Date:	08/10/2010	Barrier Rating:	26.70		
Barrier Description					
Type:	STONE MASONRY WITHOUT CONCRETE CORE WALL	Barrier Function:	TRAFFIC		
Barrier Material:	STONE	Post Material:	N/A		
Blockout Type:	N/A	Length (ft.):	157		
Speed Limit (MPH):	20	Placement with Respect to Road:	INSIDE OF CURVE		
Hazard Behind Barrier:	MEDIUM				
Barrier Crashworthiness					
Appropriate Test Level:	TL-1	Barrier Test Level:	NCW	Is Barrier Crashworthy?:	NO
Beg. End Trtmt Type:	NONE	Is Beg. End Trtmt Crashworthy?:	N/A	Approach Transition Type:	NONE
Ending End Trtmt Type:	NONE	Ending End Trtmt Crashworthy?:	N/A		
Average Measurements					
Design Height (In.):	24	Width (In.):	21.2	Post Spacing (In.):	0.0
Height (In.):	20.0	Lateral Offset (In.):	63.2	Road Grade (%):	0.50
Physical Condition					
Barrier	Alignment and Height:	No deviation was observed in barrier alignment. Barrier was 3 to 6 in below 24 in design height for 68 linear ft and below by 6 to 8 in for 22 linear ft.

Breaking and Cracking:	No breaking or cracking was observed.			
	Missing Elements:	Barrier was missing one section of 2 square feet of grout.			
	Corrosion and Weathering:	No corrosion or weathering was observed.			
End Treatments	Alignment and Height:				
	Breaking and Cracking:				
	Missing Elements:				
	Corrosion and Weathering:

Repair Action:	REPAIR	FMSS Work Type:	DEFERRED MAINTENANCE	Repair Cost:	\$11924
Brief Workorder:	Raise guardwall 2-in. Remove and reset 22-ft of stone masonry guardwall on 1 row of new stone to raise barrier to the adjacent 18-in height. Repoint 2 sq. ft. of grout.				
Workorder:	<p>Remove & Reset Stone Masonry Guardwall at \$250- per -Cu. Ft. for 20 CF = \$5000. $[(0.5ft)(1.8ft)(22ft)] = 19.8$ CF. Remove top layer of stones in barrier for 22 feet.</p> <p>New Stones at \$250- per -Each for 11 Unit(s) = \$2750. $[(22ft) / (2ft/stone) \times 1 \text{ row}] = 11$ stones. Insert new stone on retaining wall to increase barrier height then reset top layer of barrier.</p> <p>Re-Point Masonry Barrier at \$140- per -Sq. Yd. for 1 SY = \$140.</p> <p>Low Speed Traffic Control at \$1475- per -Day for 2 Day(s) = \$2950. 1 day removal 1 day installation.</p>

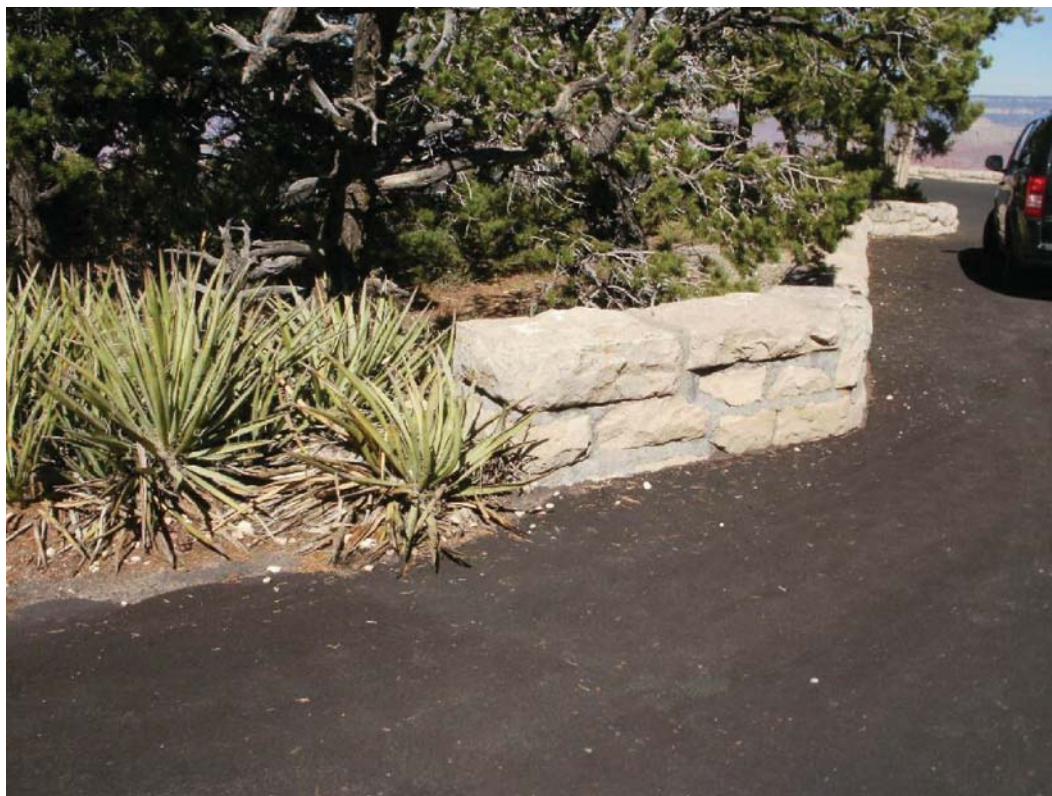
GRCA_0915_0.000_P1_1.JPG

Barrier ID:	GRCA-0915-0.000-P1				
Route Name:	HOPI POINT PARKING				
Inspection Date:	09/10/2010	Barrier Rating:	24.30		
Barrier Description					
Type:	STONE MASONRY WITHOUT CONCRETE CORE WALL	Barrier Function:	NON-TRAFFIC		
Barrier Material:	STONE	Post Material:	N/A		
Blockout Type:	N/A	Length (ft.):	0		
Speed Limit (MPH):	15	Placement with Respect to Road:	NON-TRAFFIC BARRIER		
Hazard Behind Barrier:	N/A				
Barrier Crashworthiness					
Appropriate Test Level:	TL-1	Barrier Test Level:	N/A	Is Barrier Crashworthy?:	N/A
Beg. End Trtmt Type:	NONE	Is Beg. End Trtmt Crashworthy?:	N/A	Approach Transition Type:	NONE
Ending End Trtmt Type:	NONE	Ending End Trtmt Crashworthy?:	N/A		
Average Measurements					
Design Height (In.):	24	Width (In.):	21.0	Post Spacing (In.):	0.0
Height (In.):	17.0	Lateral Offset (In.):	0.0	Road Grade (%):	0.00
Physical Condition					
Barrier	Alignment and Height:	No deviation was observed in barrier alignment. The height was 7 in below the 24 in design height throughout.

Breaking and Cracking:	No breaking or cracking was observed.			
	Missing Elements:	No missing elements were observed.			
	Corrosion and Weathering:	Mortar was completely deteriorated for 9 linear ft total in 2 sections. Rocks remained stacked.			
End Treatments	Alignment and Height:				
	Breaking and Cracking:				
	Missing Elements:				
	Corrosion and Weathering:

Repair Action:	REPAIR	FMSS Work Type:	DEFERRED MAINTENANCE	Repair Cost:	\$134613
Brief Workorder:	Raise guardwall 7-in. Remove and reset 291-ft of stone masonry guardwall on 1 row of new stone to raise barrier to the 24-in design height.				
Workorder:	<p>Remove & Reset Stone Masonry Guardwall at \$250- per -Cu. Ft. for 255 CF = \$63750. $[(0.5ft)(1.75ft)(291ft)] = 254.6 CF$.</p> <p>Remove top layer of stones in barrier for 291 feet.</p> <p>New Stones at \$250- per -Each for 146 Unit(s) = \$36500. $[(291ft) / (2ft/stone) \times 1 row] = 146 stones$. Insert new stone on retaining wall to increase barrier</p> <p>Low Speed Traffic Control at \$1475- per -Day for 15 Day(s) = \$22125. 3 days removal 12 days installation.</p>

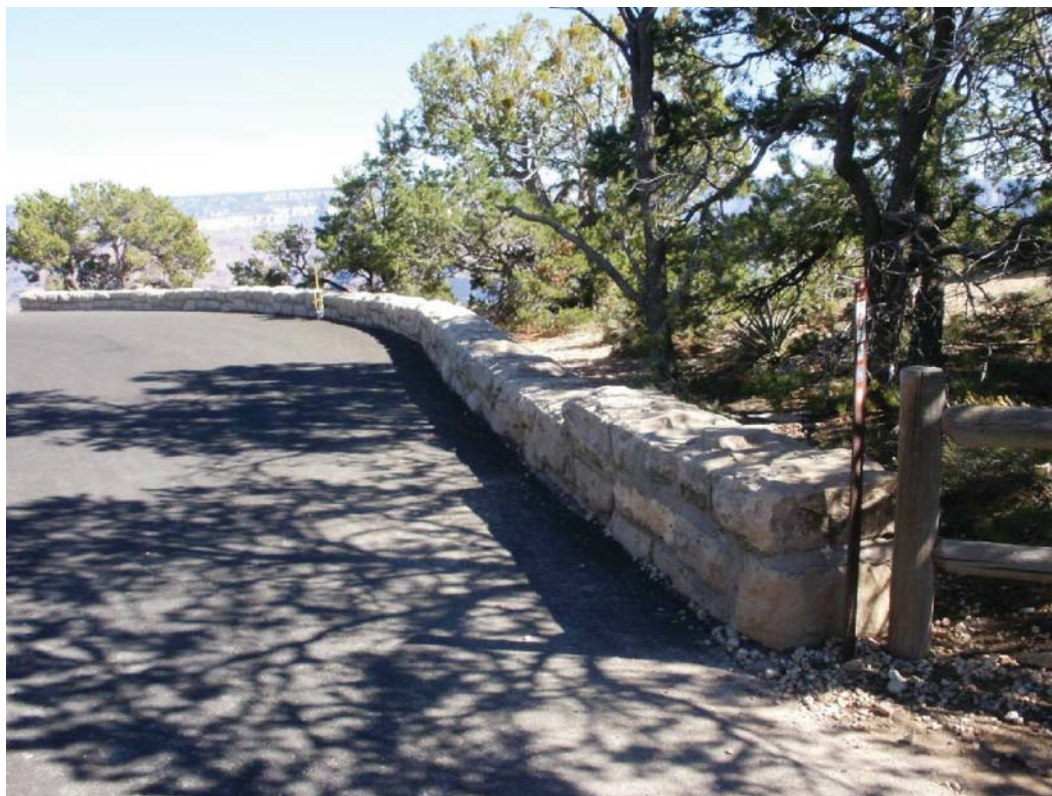
GRCA_0915_0.000_P2_1.JPG

Barrier ID:	GRCA-0915-0.000-P2				
Route Name:	HOPI POINT PARKING				
Inspection Date:	09/10/2010	Barrier Rating:	48.70		
Barrier Description					
Type:	STONE MASONRY WITHOUT CONCRETE CORE WALL	Barrier Function:	TRAFFIC		
Barrier Material:	STONE	Post Material:	N/A		
Blockout Type:	N/A	Length (ft.):	0		
Speed Limit (MPH):	15	Placement with Respect to Road:	OUTSIDE OF CURVE		
Hazard Behind Barrier:	EXTREME				
Barrier Crashworthiness					
Appropriate Test Level:	TL-1	Barrier Test Level:	NCW	Is Barrier Crashworthy?:	NO
Beg. End Trtmt Type:	NONE	Is Beg. End Trtmt Crashworthy?:	N/A	Approach Transition Type:	NONE
Ending End Trtmt Type:	NONE	Ending End Trtmt Crashworthy?:	N/A		
Average Measurements					
Design Height (In.):	24	Width (In.):	21.7	Post Spacing (In.):	0.0
Height (In.):	18.0	Lateral Offset (In.):	0.0	Road Grade (%):	1.80
Physical Condition					
Barrier	Alignment and Height:	No deviation in barrier alignment was observed. Barrier was 7 to 10 in below 24 in design height for 129 linear ft and below by 3 to 6 in for 275 linear ft.

Breaking and Cracking:	1 square yard of grout was missing in cracks 1 to 2 in wide for 3 linear ft.			
	Missing Elements:	No missing elements were observed.			
	Corrosion and Weathering:	No corrosion or weathering was observed.			
End Treatments	Alignment and Height:				
	Breaking and Cracking:				
	Missing Elements:				
	Corrosion and Weathering:

Repair Action:	REPAIR	FMSS Work Type:	DEFERRED MAINTENANCE	Repair Cost:	\$63184
Brief Workorder:	Raise guardwall 3-in. Remove and reset 129-ft of stone masonry guardwall on 1 row of new stone to raise barrier to the adjacent 18-in height. Repoint 1 sq. yd. of guardwall with cracked or missing grout.				
Workorder:	<p>Remove & Reset Stone Masonry Guardwall at \$250- per -Cu. Ft. for 117 CF = \$29250. $[(0.5ft)(1.8ft)(129ft)] = 116.1 CF$.</p> <p>Remove top layer of stones in barrier for 129 feet.</p> <p>New Stones at \$250- per -Each for 65 Unit(s) = \$16250. $[(129ft) / (2ft/stone) \times 1 row] = 65 stones$. Insert new stone on retaining wall to increase barrier height then reset top layer of barrier.</p> <p>Re-Point Masonry Barrier at \$140- per -Sq. Yd. for 1 SY = \$140. Repoint 1 SY. of guardwall.</p> <p>Low Speed Traffic Control at \$1475- per -Day for 8 Day(s) = \$11800. 2 days removal 6 days installation</p>
