# GRTE GIP Report

## NPS Guardwall/Rail Inventory Program Grand Teton National Park

**Federal Highway Administration  
Eastern Federal Lands Highway Division  
Road Inventory Program (RIP)**

**Data Collection Date: July 2010  
Report Date: November 2015**

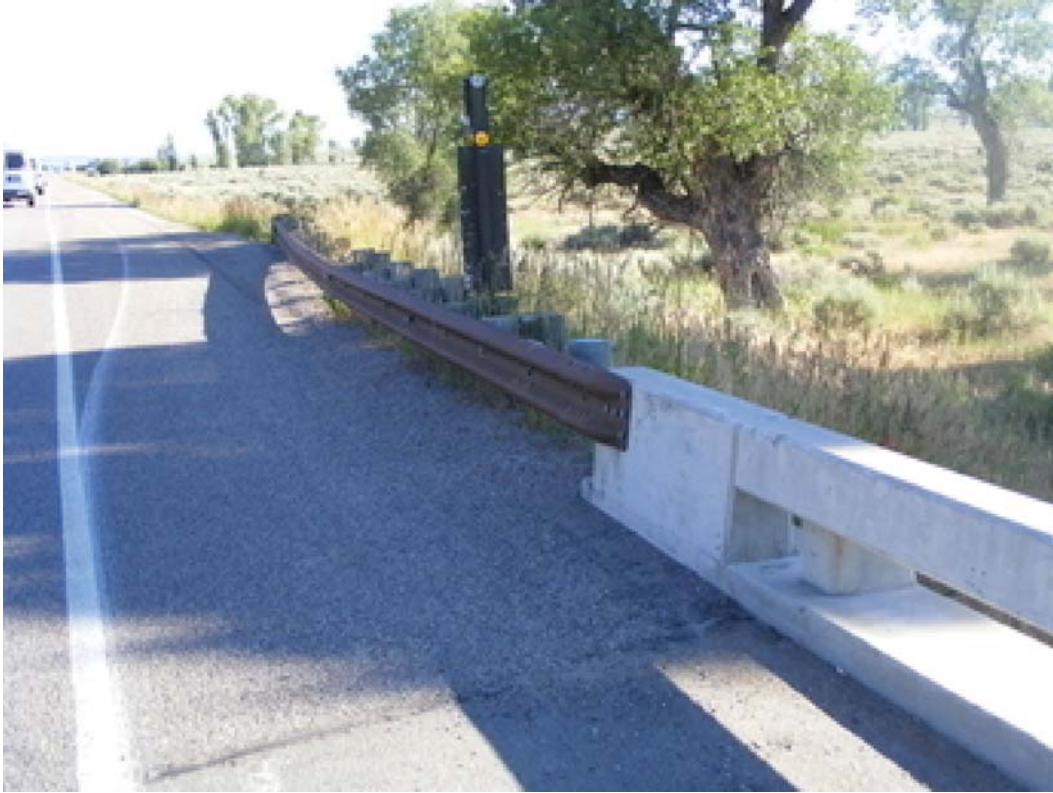
GRTE\_0010\_2.216\_R\_1.JPG

<b>Barrier ID:</b>	GRTE-0010-2.216-R				
<b>Route Name:</b>	U.S. HIGHWAY 26/89/191				
<b>Inspection Date:</b>	07/30/2010	<b>Barrier Rating:</b>	40.90		
<b>Barrier Description</b>					
<b>Type:</b>	W-BEAM STRONG POST	<b>Barrier Function:</b>	TRAFFIC		
<b>Barrier Material:</b>	WEATHERING STEEL/CORTEN	<b>Post Material:</b>	WOOD		
<b>Blockout Type:</b>	WOOD	<b>Length (ft.):</b>	66		
<b>Speed Limit (MPH):</b>	55	<b>Placement with Respect to Road:</b>	TANGENT		
<b>Hazard Behind Barrier:</b>	MEDIUM				
<b>Barrier Crashworthiness</b>					
<b>Appropriate Test Level:</b>	TL-3	<b>Barrier Test Level:</b>	TL-3	<b>Is Barrier Crashworthy?:</b>	YES
<b>Beg. End Trtmt Type:</b>	NONE	<b>Is Beg. End Trtmt Crashworthy?:</b>	N/A	<b>Approach Transition Type:</b>	RIGID W-BEAM - W-BEAM
<b>Ending End Trtmt Type:</b>	W-BEAM BCT	<b>Ending End Trtmt Crashworthy?:</b>	NO		
<b>Average Measurements</b>					
<b>Design Height (In.):</b>	27	<b>Width (In.):</b>	0.0	<b>Post Spacing (In.):</b>	75.0

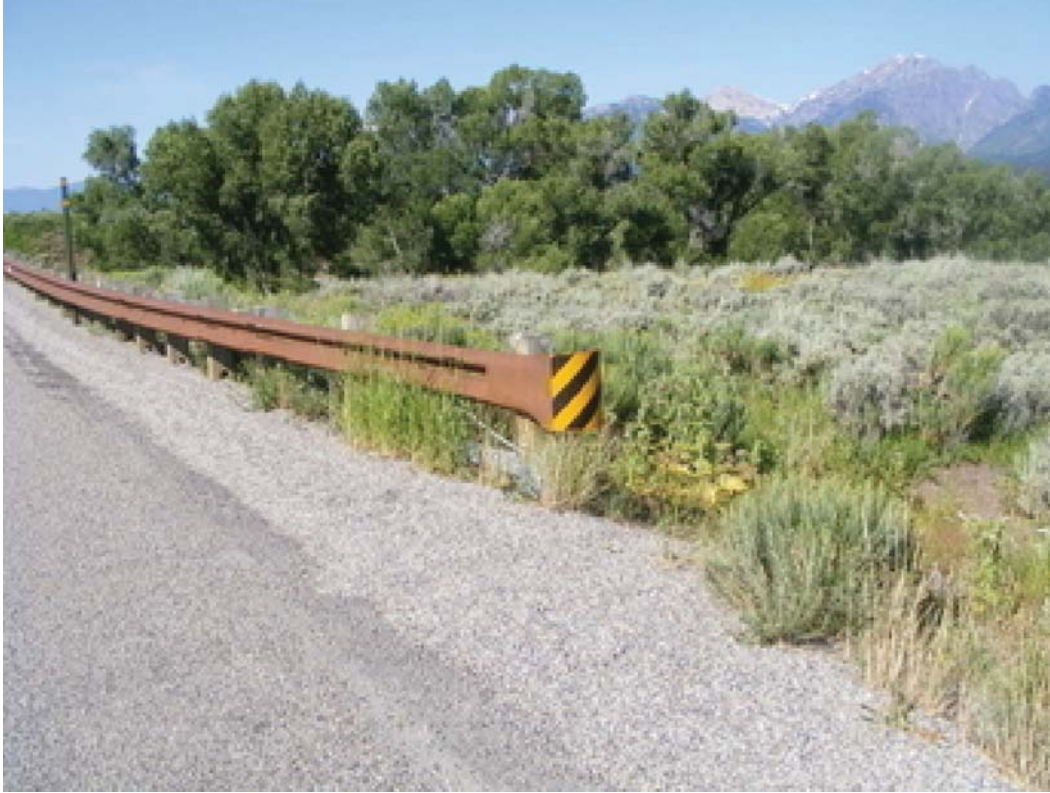
GRTE\_0010\_9.049\_L\_1.JPG

<b>Barrier ID:</b>	GRTE-0010-9.049-L				
<b>Route Name:</b>	U.S. HIGHWAY 26/89/191				
<b>Inspection Date:</b>	07/29/2010	<b>Barrier Rating:</b>	28.20		
<b>Barrier Description</b>					
<b>Type:</b>	W-BEAM STRONG POST	<b>Barrier Function:</b>	TRAFFIC		
<b>Barrier Material:</b>	WEATHERING STEEL/CORTEN	<b>Post Material:</b>	WOOD		
<b>Blockout Type:</b>	WOOD	<b>Length (ft.):</b>	607		
<b>Speed Limit (MPH):</b>	55	<b>Placement with Respect to Road:</b>	TANGENT		
<b>Hazard Behind Barrier:</b>	HIGH				
<b>Barrier Crashworthiness</b>					
<b>Appropriate Test Level:</b>	TL-3	<b>Barrier Test Level:</b>	TL-3	<b>Is Barrier Crashworthy?:</b>	YES
<b>Beg. End Trtmt Type:</b>	W-BEAM FLARED 350 COMPLIANT	<b>Is Beg. End Trtmt Crashworthy?:</b>	YES	<b>Approach Transition Type:</b>	NONE
<b>Ending End Trtmt Type:</b>	W-BEAM FLARED 350 COMPLIANT	<b>Ending End Trtmt Crashworthy?:</b>	YES		
<b>Average Measurements</b>					
<b>Design Height (In.):</b>	27	<b>Width (In.):</b>	0.0	<b>Post Spacing (In.):</b>	75.3

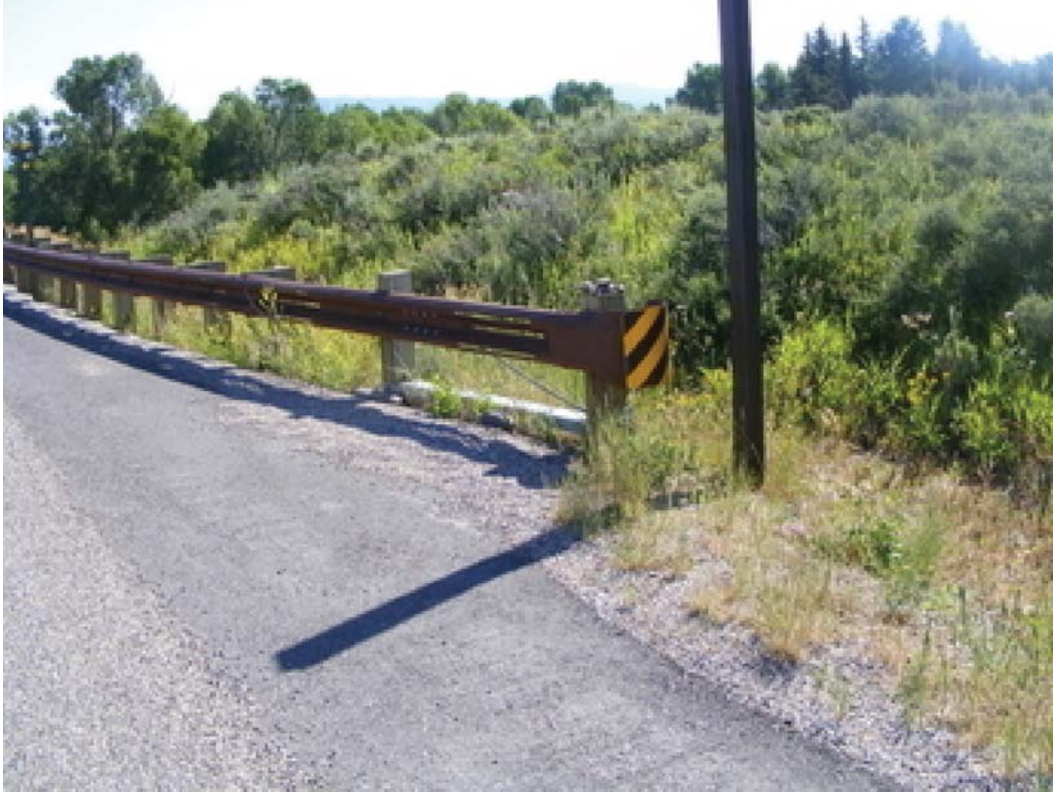
GRTE\_0010\_9.051\_R\_1.JPG

<b>Barrier ID:</b>	GRTE-0010-9.051-R				
<b>Route Name:</b>	U.S. HIGHWAY 26/89/191				
<b>Inspection Date:</b>	07/29/2010	<b>Barrier Rating:</b>	28.20		
<b>Barrier Description</b>					
<b>Type:</b>	W-BEAM STRONG POST	<b>Barrier Function:</b>	TRAFFIC		
<b>Barrier Material:</b>	WEATHERING STEEL/CORTEN	<b>Post Material:</b>	WOOD		
<b>Blockout Type:</b>	WOOD	<b>Length (ft.):</b>	603		
<b>Speed Limit (MPH):</b>	55	<b>Placement with Respect to Road:</b>	TANGENT		
<b>Hazard Behind Barrier:</b>	HIGH				
<b>Barrier Crashworthiness</b>					
<b>Appropriate Test Level:</b>	TL-3	<b>Barrier Test Level:</b>	TL-3	<b>Is Barrier Crashworthy?:</b>	YES
<b>Beg. End Trtmt Type:</b>	W-BEAM FLARED 350 COMPLIANT	<b>Is Beg. End Trtmt Crashworthy?:</b>	YES	<b>Approach Transition Type:</b>	NONE
<b>Ending End Trtmt Type:</b>	W-BEAM FLARED 350 COMPLIANT	<b>Ending End Trtmt Crashworthy?:</b>	YES		
<b>Average Measurements</b>					
<b>Design Height (In.):</b>	27	<b>Width (In.):</b>	0.0	<b>Post Spacing (In.):</b>	75.3

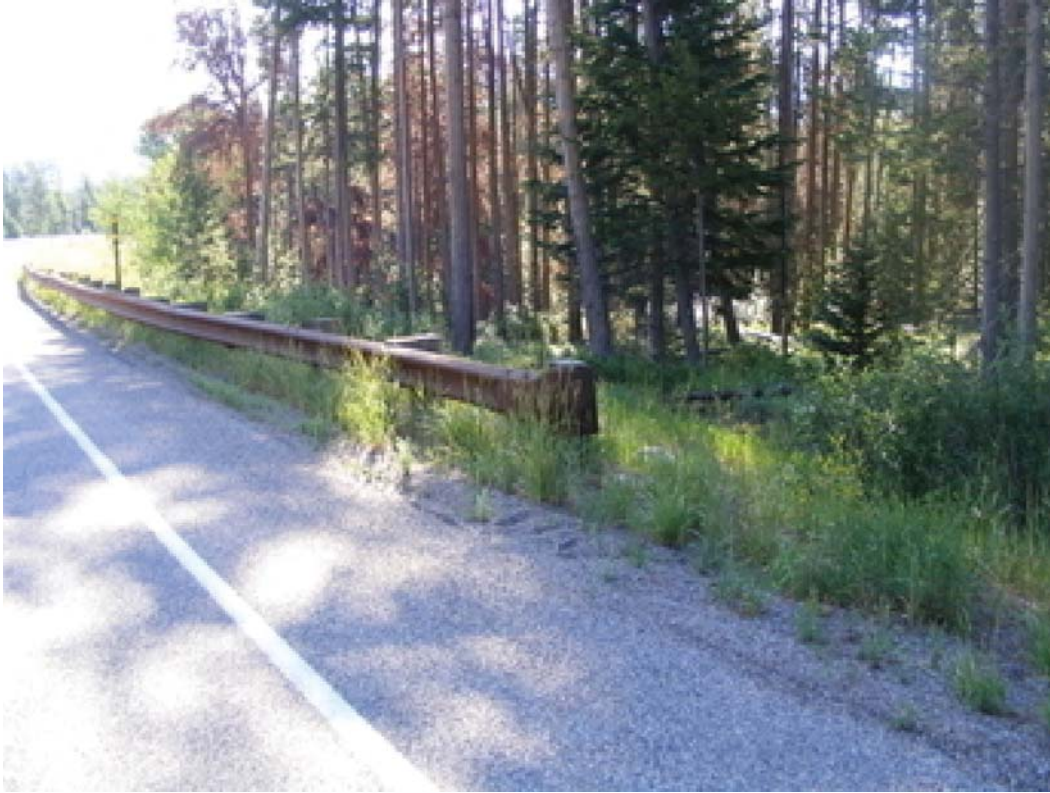
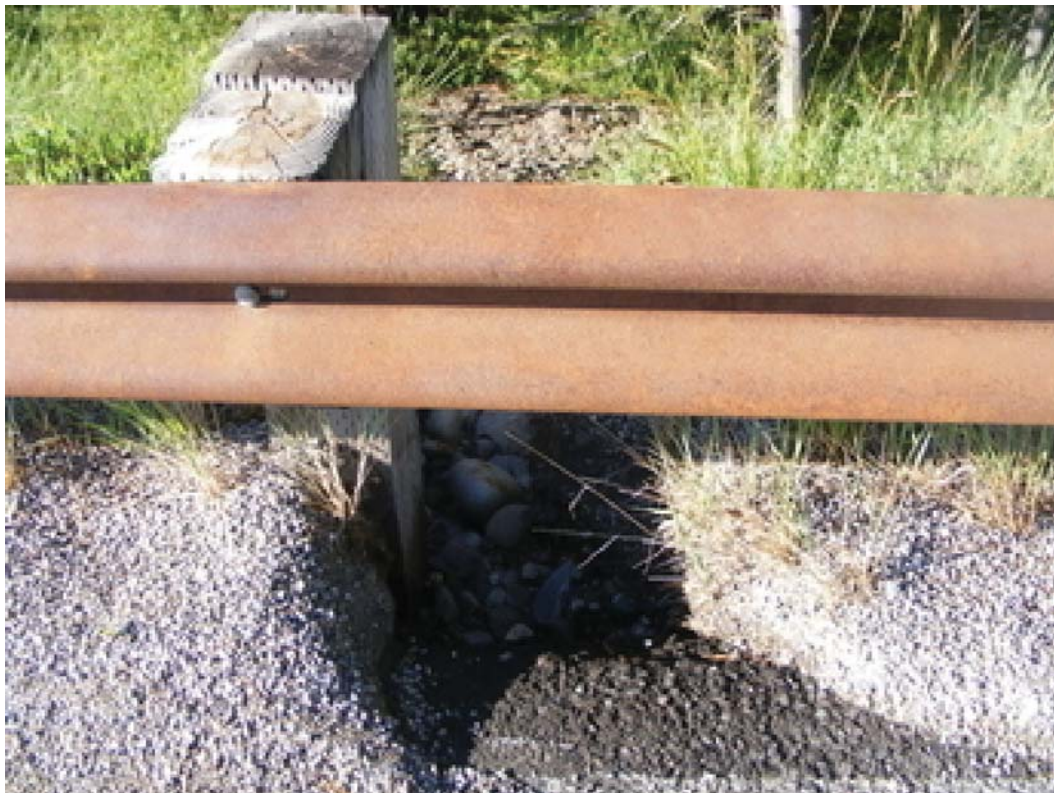
GRTE\_0010\_16.699\_R\_1.JPG

<b>Barrier ID:</b>	GRTE-0010-16.699-R				
<b>Route Name:</b>	U.S. HIGHWAY 26/89/191				
<b>Inspection Date:</b>	07/29/2010	<b>Barrier Rating:</b>	39.90		
<b>Barrier Description</b>					
<b>Type:</b>	W-BEAM STRONG POST	<b>Barrier Function:</b>	TRAFFIC		
<b>Barrier Material:</b>	WEATHERING STEEL/CORTEN	<b>Post Material:</b>	WOOD		
<b>Blockout Type:</b>	WOOD	<b>Length (ft.):</b>	1640		
<b>Speed Limit (MPH):</b>	55	<b>Placement with Respect to Road:</b>	INSIDE OF CURVE		
<b>Hazard Behind Barrier:</b>	HIGH				
<b>Barrier Crashworthiness</b>					
<b>Appropriate Test Level:</b>	TL-3	<b>Barrier Test Level:</b>	TL-3	<b>Is Barrier Crashworthy?:</b>	YES
<b>Beg. End Trtmt Type:</b>	NONE	<b>Is Beg. End Trtmt Crashworthy?:</b>	N/A	<b>Approach Transition Type:</b>	NONE
<b>Ending End Trtmt Type:</b>	W-BEAM BCT	<b>Ending End Trtmt Crashworthy?:</b>	NO		
<b>Average Measurements</b>					
<b>Design Height (In.):</b>	27	<b>Width (In.):</b>	0.0	<b>Post Spacing (In.):</b>	75.3

<b>Height (In.):</b>	27.6	<b>Lateral Offset (In.):</b>	57.5	<b>Road Grade (%):</b>	4.40
<b>Physical Condition</b>					
<b>Barrier</b>	<b>Alignment and Height:</b>	Alignment is acceptable. 36ft. of barrier was 1-3in. below the 27-in. design height. Minor impacted rails = 7 each minor. Impacted rails = 2 each major. Tilted blocks = 4 each.			
	<b>Breaking and Cracking:</b>	Cracked blocks = 5 each. Loose bolts = 3 each. Minor cracking of some barrier blocks and posts (< 1/4 in).			
	<b>Missing Elements:</b>	Missing barrier blocks = 5 each.			
	<b>Corrosion and Weathering:</b>	Moderate corrosion of barrier rail. Minor weathering of posts and blocks. Severe erosion at one post - water diversion required. Gravel built up in front of entire barrier.			
<b>End Treatments</b>	<b>Alignment and Height:</b>	Alignment of approach end is acceptable. Height of trailing end is more than 3 in below the 27-in. design height. Approach end treatment height is within 1-in of 27-in. design height.

<b>Breaking and Cracking:</b>	Trailing end treatment impacted.			
	<b>Missing Elements:</b>	Approach end treatment is missing 4 blocks (minor impact).			
	<b>Corrosion and Weathering:</b>	Minor corrosion and weathering of end treatment elements.

<b>Repair Action:</b>	REPLACE	<b>FMSS Work Type:</b>	CAPITAL IMPROVEMENT	<b>Repair Cost:</b>	\$14460
<b>Brief Workorder:</b>	Replace 26 feet of damaged rails 14 blocks replace ending end terminal install asphalt curb for 150 lf at trailing end and raise 36ft. of guardrail.				
<b>Workorder:</b>	<p>Labor at \$60- per -Hour for 4 Hrs = \$240. Backfill eroded post right tilted block and tighten bolts.</p> <p>Replace Rail at \$25- per -Lin. Ft. for 26 LF = \$650. Replace 2 impacted rails (26 lf).</p> <p>Replace Block at \$30- per -Each for 14 Block(s) = \$420. Replace 14 cracked and missing blocks.</p> <p>Grader at \$125- per -Hour for 1 Hrs = \$125. Remove gravel from face of barrier.</p> <p>Asphalt Curb at \$12- per -Lin. Ft. for 150 LF = \$1800. Install 150 lf of asphalt curb at trailing end to control runoff.</p> <p>W-beam Trailing End at \$2500- per -Each for 1 Unit(s) = \$2500. Replace trailing end terminal.</p> <p>Adjust Guardrail at \$10- per -Lin. Ft. for 36 LF = \$360. Raise 36ft. of guardrail to 27-in. design height.</p> <p>High Speed Traffic Control at \$2350- per -Day for 3 Day(s) = \$7050.</p>

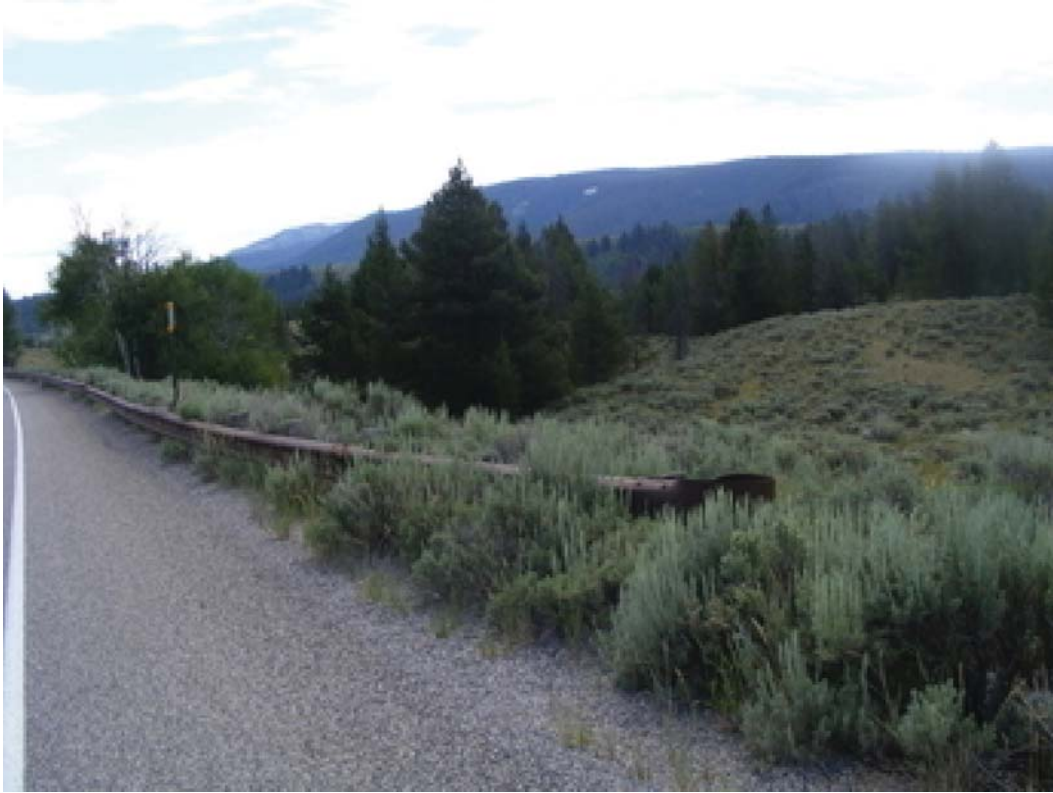
GRTE\_0010\_17.660\_R\_1.JPG

<b>Barrier ID:</b>	GRTE-0010-17.660-R				
<b>Route Name:</b>	U.S. HIGHWAY 26/89/191				
<b>Inspection Date:</b>	07/28/2010	<b>Barrier Rating:</b>	51.40		
<b>Barrier Description</b>					
<b>Type:</b>	W-BEAM STRONG POST	<b>Barrier Function:</b>	TRAFFIC		
<b>Barrier Material:</b>	WEATHERING STEEL/CORTEN	<b>Post Material:</b>	WOOD		
<b>Blockout Type:</b>	WOOD	<b>Length (ft.):</b>	635		
<b>Speed Limit (MPH):</b>	55	<b>Placement with Respect to Road:</b>	OUTSIDE OF CURVE		
<b>Hazard Behind Barrier:</b>	HIGH				
<b>Barrier Crashworthiness</b>					
<b>Appropriate Test Level:</b>	TL-3	<b>Barrier Test Level:</b>	TL-3	<b>Is Barrier Crashworthy?:</b>	YES
<b>Beg. End Trtmt Type:</b>	W-BEAM BCT	<b>Is Beg. End Trtmt Crashworthy?:</b>	NO	<b>Approach Transition Type:</b>	NONE
<b>Ending End Trtmt Type:</b>	W-BEAM BURIED END	<b>Ending End Trtmt Crashworthy?:</b>	YES		
<b>Average Measurements</b>					
<b>Design Height (In.):</b>	27	<b>Width (In.):</b>	0.0	<b>Post Spacing (In.):</b>	75.1

<b>Height (In.):</b>	24.5	<b>Lateral Offset (In.):</b>	96.5	<b>Road Grade (%):</b>	1.40
<b>Physical Condition</b>					
<b>Barrier</b>	<b>Alignment and Height:</b>	Alignment of barrier is acceptable for most of it's length - one impact area. 7-ft of barrier was between 1 and 3-in below the 27-in. design height and 565-ft was more than 3-in below the design height. 6 tilted blocks impacted rail (12 L.F.).			
	<b>Breaking and Cracking:</b>	Cracked posts = 1 each. Cracked blocks = 4 each.			
	<b>Missing Elements:</b>	Missing blocks = 2 each.			
	<b>Corrosion and Weathering:</b>	Moderate corrosion of rails and weathering of barrier posts. No soil erosion compromising barrier posts.			
<b>End Treatments</b>	<b>Alignment and Height:</b>	Alignment is acceptable. Height of approach end treatment is more than 3 in below the 27-in. design height.			
	<b>Breaking and Cracking:</b>	No cracked or broken end treatment elements.

<b>Missing Elements:</b>	No missing end treatment elements.			
	<b>Corrosion and Weathering:</b>	Moderate corrosion of rails and weathering of end treatment posts.

<b>Repair Action:</b>	REPAIR	<b>FMSS Work Type:</b>	DEFERRED MAINTENANCE	<b>Repair Cost:</b>	\$15092
<b>Brief Workorder:</b>	Replace 16 broken blocks and 1 post adjust tilted blocks and raise 572ft. of guardrail to 27-in. design height.				
<b>Workorder:</b>	Replace Post at \$100- per -Each for 1 Post(s) = \$100. Replace 1 missing post. Replace Block at \$30- per -Each for 6 Block(s) = \$180. Replace 6 cracked or missing blocks. Replace Rail at \$25- per -Lin. Ft. for 12 LF = \$300. Replace 1 bent rail. Adjust Guardrail at \$10- per -Lin. Ft. for 572 LF = \$5720. Raise 572ft. of guardrail to 27-in. design height. Grader at \$125- per -Hour for 1 Hrs = \$250. Remove gravel from face of barrier. Labor at \$60- per -Hour for 2 Hrs = \$120. Right tilted blocks and tighten bolts. High Speed Traffic Control at \$2350- per -Day for 3 Day(s) = \$7050.

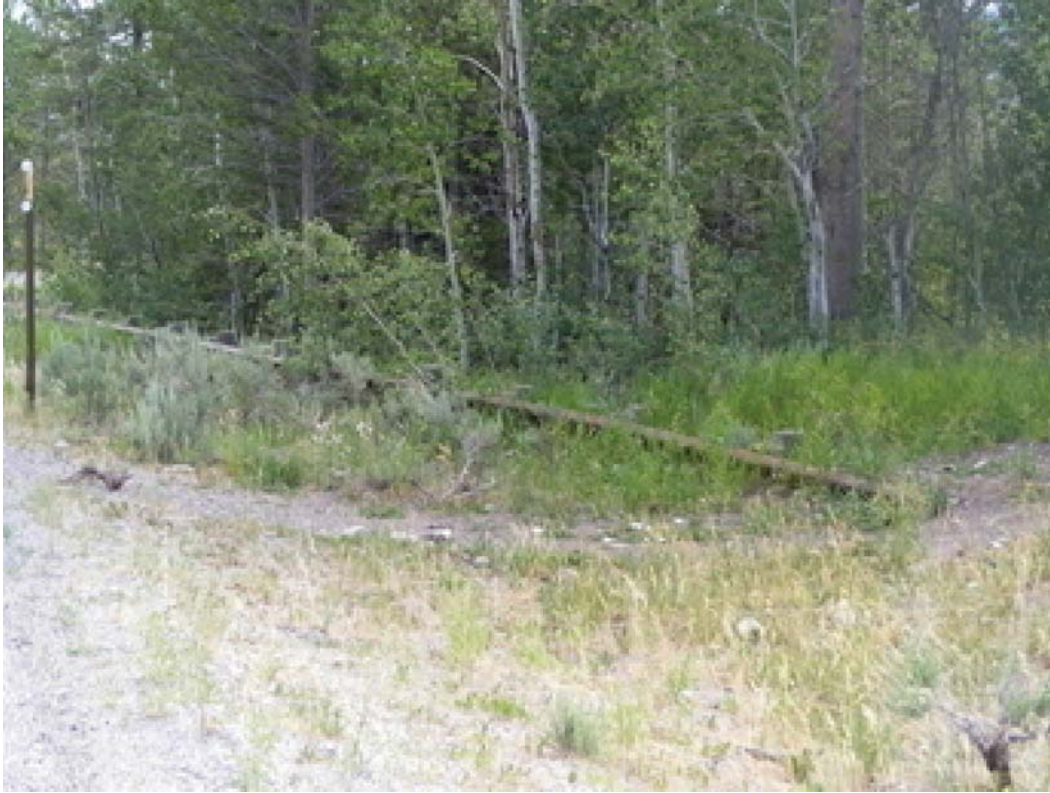
GRTE\_0010\_17.864\_R\_1.JPG

<b>Barrier ID:</b>	GRTE-0010-17.864-R				
<b>Route Name:</b>	U.S. HIGHWAY 26/89/191				
<b>Inspection Date:</b>	07/28/2010	<b>Barrier Rating:</b>	42.50		
<b>Barrier Description</b>					
<b>Type:</b>	W-BEAM STRONG POST	<b>Barrier Function:</b>	TRAFFIC		
<b>Barrier Material:</b>	WEATHERING STEEL/CORTEN	<b>Post Material:</b>	WOOD		
<b>Blockout Type:</b>	WOOD	<b>Length (ft.):</b>	813		
<b>Speed Limit (MPH):</b>	55	<b>Placement with Respect to Road:</b>	INSIDE OF CURVE		
<b>Hazard Behind Barrier:</b>	MEDIUM				
<b>Barrier Crashworthiness</b>					
<b>Appropriate Test Level:</b>	TL-3	<b>Barrier Test Level:</b>	TL-3	<b>Is Barrier Crashworthy?:</b>	YES
<b>Beg. End Trtmt Type:</b>	W-BEAM BURIED END	<b>Is Beg. End Trtmt Crashworthy?:</b>	YES	<b>Approach Transition Type:</b>	NONE
<b>Ending End Trtmt Type:</b>	W-BEAM BURIED END	<b>Ending End Trtmt Crashworthy?:</b>	YES		
<b>Average Measurements</b>					
<b>Design Height (In.):</b>	27	<b>Width (In.):</b>	0.0	<b>Post Spacing (In.):</b>	75.3

<b>Height (In.):</b>	25.2	<b>Lateral Offset (In.):</b>	90.0	<b>Road Grade (%):</b>	4.90
<b>Physical Condition</b>					
<b>Barrier</b>	<b>Alignment and Height:</b>	Alignment is acceptable. 538 LF of barrier is up to 3 in below the 27 in design height.			
	<b>Breaking and Cracking:</b>	No tears in beam cracking in 4 blocks and 15 LF of badly bent W-beam in barrier.			
	<b>Missing Elements:</b>	No missing barrier elements.			
	<b>Corrosion and Weathering:</b>	No major weathering of barrier. Chip seal sweepings piling up in front of barrier.			
<b>End Treatments</b>	<b>Alignment and Height:</b>	Alignment is acceptable. Height is within 1-in of 27-in. design height.			
	<b>Breaking and Cracking:</b>	No major breaking or cracking of the end treatment.			
	<b>Missing Elements:</b>	No missing elements in the end treatment.			
	<b>Corrosion and Weathering:</b>	No major weathering of the end treatments.

<b>Repair Action:</b>	REPAIR	<b>FMSS Work Type:</b>	DEFERRED MAINTENANCE	<b>Repair Cost:</b>	\$12161
<b>Brief Workorder:</b>	Replace 15ft. of bent rail 4 cracked blocks and raise 538-ft. of barrier up to 27-in design height.				
<b>Workorder:</b>	Replace Rail at \$25- per -Lin. Ft. for 15 LF = \$375. replace badly bent section of rail Replace Block at \$30- per -Each for 4 Block(s) = \$120. replace cracked blocks Adjust Guardrail at \$10- per -Lin. Ft. for 538 LF = \$5380. Raise 538-ft. of barrier up to 27-in design height. Labor at \$60- per -Hour for 8 Hrs = \$480. clean chip seal sweepings from front of rail. High Speed Traffic Control at \$2350- per -Day for 2 Day(s) = \$4700.

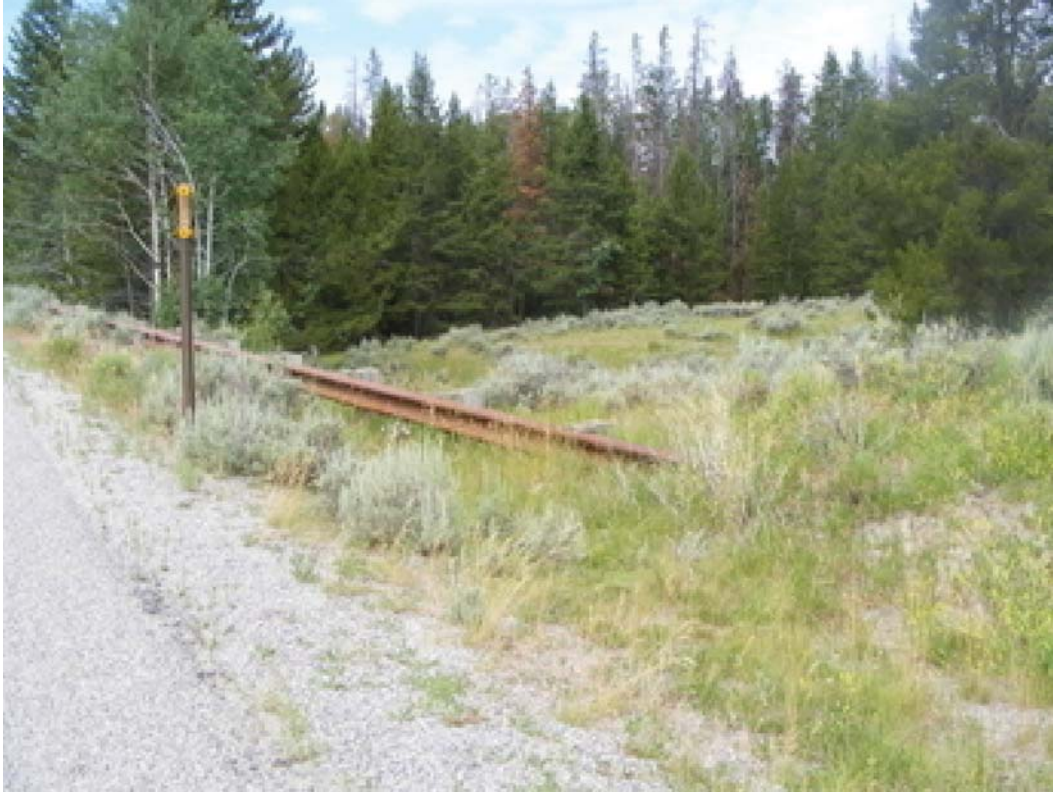
GRTE\_0010\_17.934\_L\_1.JPG

<b>Barrier ID:</b>	GRTE-0010-17.934-L				
<b>Route Name:</b>	U.S. HIGHWAY 26/89/191				
<b>Inspection Date:</b>	07/28/2010	<b>Barrier Rating:</b>	42.90		
<b>Barrier Description</b>					
<b>Type:</b>	W-BEAM STRONG POST	<b>Barrier Function:</b>	TRAFFIC		
<b>Barrier Material:</b>	WEATHERING STEEL/CORTEN	<b>Post Material:</b>	WOOD		
<b>Blockout Type:</b>	WOOD	<b>Length (ft.):</b>	449		
<b>Speed Limit (MPH):</b>	55	<b>Placement with Respect to Road:</b>	OUTSIDE OF CURVE		
<b>Hazard Behind Barrier:</b>	HIGH				
<b>Barrier Crashworthiness</b>					
<b>Appropriate Test Level:</b>	TL-3	<b>Barrier Test Level:</b>	TL-3	<b>Is Barrier Crashworthy?:</b>	YES
<b>Beg. End Trtmt Type:</b>	W-BEAM BURIED END	<b>Is Beg. End Trtmt Crashworthy?:</b>	YES	<b>Approach Transition Type:</b>	NONE
<b>Ending End Trtmt Type:</b>	W-BEAM BCT	<b>Ending End Trtmt Crashworthy?:</b>	NO		
<b>Average Measurements</b>					
<b>Design Height (In.):</b>	27	<b>Width (In.):</b>	0.0	<b>Post Spacing (In.):</b>	74.6

<b>Height (In.):</b>	24.7	<b>Lateral Offset (In.):</b>	83.3	<b>Road Grade (%):</b>	4.20
<b>Physical Condition</b>					
<b>Barrier</b>	<b>Alignment and Height:</b>	Alignment is acceptable. 40ft. of barrier was 1-3in. below the 27-in. design height and 80ft. was more than 3in. below the design height. One tilted block. Minor impact to one rail.			
	<b>Breaking and Cracking:</b>	Loose bolts = 2 each. No cracked or broken barrier elements.			
	<b>Missing Elements:</b>	No missing barrier elements.			
	<b>Corrosion and Weathering:</b>	Moderate corrosion of rails and weathering of barrier posts/blocks. Gravel built up in front of barrier.			
<b>End Treatments</b>	<b>Alignment and Height:</b>	Alignment of end treatments is good. Trailing end is more than 3in. below the 27-in. design height.			
	<b>Breaking and Cracking:</b>	No broken or cracked end treatment elements.			
	<b>Missing Elements:</b>	No missing end treatment elements.

<b>Corrosion and Weathering:</b>	Moderate corrosion of rails and weathering of end treatment posts.

<b>Repair Action:</b>	REPAIR	<b>FMSS Work Type:</b>	DEFERRED MAINTENANCE	<b>Repair Cost:</b>	\$4109
<b>Brief Workorder:</b>	Remove excess gravel from face of barrier right tilted blocks and tighten bolts and raise 120ft. of guardrail to 27-in. design height.				
<b>Workorder:</b>	Grader at \$125- per -Hour for 1 Hrs = \$125. Remove gravel from face of barrier. Labor at \$60- per -Hour for 1 Hrs = \$60. Right tilted blocks and tighten bolts. Adjust Guardrail at \$10- per -Lin. Ft. for 120 LF = \$1200. Raise 120ft. of guardrail to 27-in. design height. High Speed Traffic Control at \$2350- per -Day for 1 Day(s) = \$2350.

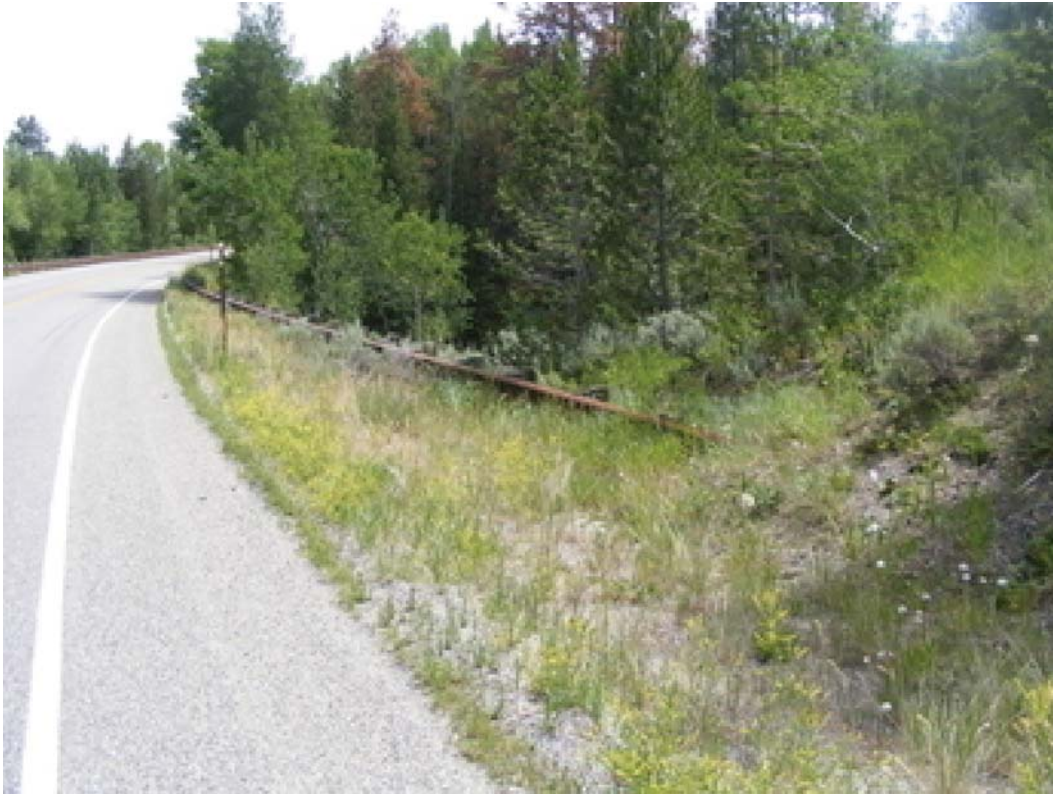
GRTE\_0010\_18.061\_R\_1.JPG

<b>Barrier ID:</b>	GRTE-0010-18.061-R				
<b>Route Name:</b>	U.S. HIGHWAY 26/89/191				
<b>Inspection Date:</b>	07/28/2010	<b>Barrier Rating:</b>	35.40		
<b>Barrier Description</b>					
<b>Type:</b>	W-BEAM STRONG POST	<b>Barrier Function:</b>	TRAFFIC		
<b>Barrier Material:</b>	WEATHERING STEEL/CORTEN	<b>Post Material:</b>	WOOD		
<b>Blockout Type:</b>	WOOD	<b>Length (ft.):</b>	580		
<b>Speed Limit (MPH):</b>	55	<b>Placement with Respect to Road:</b>	INSIDE OF CURVE		
<b>Hazard Behind Barrier:</b>	MEDIUM				
<b>Barrier Crashworthiness</b>					
<b>Appropriate Test Level:</b>	TL-3	<b>Barrier Test Level:</b>	TL-3	<b>Is Barrier Crashworthy?:</b>	YES
<b>Beg. End Trtmt Type:</b>	W-BEAM BURIED END	<b>Is Beg. End Trtmt Crashworthy?:</b>	YES	<b>Approach Transition Type:</b>	NONE
<b>Ending End Trtmt Type:</b>	W-BEAM BCT	<b>Ending End Trtmt Crashworthy?:</b>	NO		
<b>Average Measurements</b>					
<b>Design Height (In.):</b>	27	<b>Width (In.):</b>	0.0	<b>Post Spacing (In.):</b>	75.3

<b>Height (In.):</b>	25.2	<b>Lateral Offset (In.):</b>	85.3	<b>Road Grade (%):</b>	1.70
<b>Physical Condition</b>					
<b>Barrier</b>	<b>Alignment and Height:</b>	Barrier alignment is acceptable. Barrier height is low by 3 in or less from design height of 27 in.			
	<b>Breaking and Cracking:</b>	Major cracking in 2 blocks no tears in barrier rail.			
	<b>Missing Elements:</b>	Two missing barrier blocks.			
	<b>Corrosion and Weathering:</b>	No major weathering of barrier. Gravel buildup in front of barrier.			
<b>End Treatments</b>	<b>Alignment and Height:</b>	Alignment is acceptable. Height is within 1-in of 27-in. design height.			
	<b>Breaking and Cracking:</b>	No major breaking or cracking of the end treatments.			
	<b>Missing Elements:</b>	No missing elements in the end treatments.			
	<b>Corrosion and Weathering:</b>	No major weathering of the end treatments.

<b>Repair Action:</b>	REPAIR	<b>FMSS Work Type:</b>	DEFERRED MAINTENANCE	<b>Repair Cost:</b>	\$10670
<b>Brief Workorder:</b>	Raise 440ft. of guardrail to 27-in. design height replace 4 blocks and clean chip seal sweepings from front of barrier.				
<b>Workorder:</b>	Replace Block at \$30- per -Each for 4 Block(s) = \$120. Replace 2 missing and 2 cracked blocks Adjust Guardrail at \$10- per -Lin. Ft. for 440 LF = \$4400. Raise 440ft. of guardrail to 27-in. design height. Labor at \$60- per -Hour for 8 Hrs = \$480. Remove chip seal sweepings from front of barrier. High Speed Traffic Control at \$2350- per -Day for 2 Day(s) = \$4700.

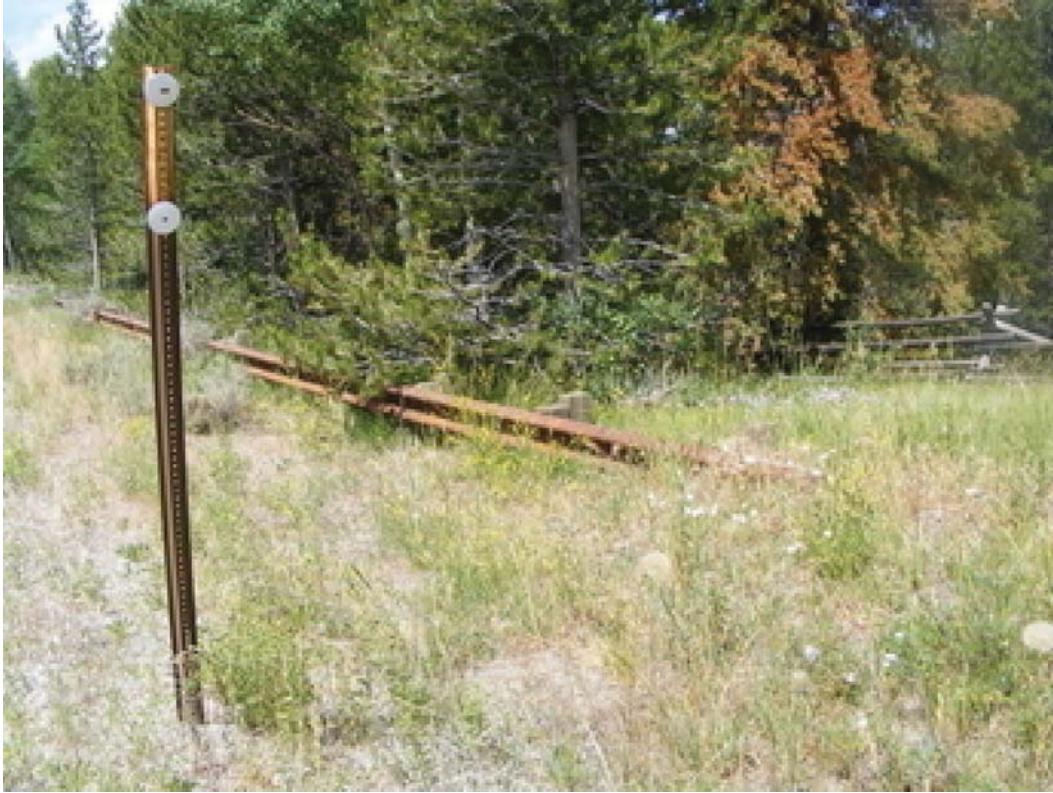
GRTE\_0010\_18.075\_L\_1.JPG

<b>Barrier ID:</b>	GRTE-0010-18.075-L				
<b>Route Name:</b>	U.S. HIGHWAY 26/89/191				
<b>Inspection Date:</b>	07/28/2010	<b>Barrier Rating:</b>	41.20		
<b>Barrier Description</b>					
<b>Type:</b>	W-BEAM STRONG POST	<b>Barrier Function:</b>	TRAFFIC		
<b>Barrier Material:</b>	WEATHERING STEEL/CORTEN	<b>Post Material:</b>	WOOD		
<b>Blockout Type:</b>	WOOD	<b>Length (ft.):</b>	766		
<b>Speed Limit (MPH):</b>	55	<b>Placement with Respect to Road:</b>	OUTSIDE OF CURVE		
<b>Hazard Behind Barrier:</b>	HIGH				
<b>Barrier Crashworthiness</b>					
<b>Appropriate Test Level:</b>	TL-3	<b>Barrier Test Level:</b>	TL-3	<b>Is Barrier Crashworthy?:</b>	YES
<b>Beg. End Trtmt Type:</b>	W-BEAM BURIED END	<b>Is Beg. End Trtmt Crashworthy?:</b>	YES	<b>Approach Transition Type:</b>	NONE
<b>Ending End Trtmt Type:</b>	W-BEAM BURIED END	<b>Ending End Trtmt Crashworthy?:</b>	YES		
<b>Average Measurements</b>					
<b>Design Height (In.):</b>	27	<b>Width (In.):</b>	0.0	<b>Post Spacing (In.):</b>	75.6

<b>Height (In.):</b>	26.2	<b>Lateral Offset (In.):</b>	120.3	<b>Road Grade (%):</b>	1.00
<b>Physical Condition</b>					
<b>Barrier</b>	<b>Alignment and Height:</b>	Barrier alignment is acceptable. Height of barrier was 1-3in. below the 27-in. design height for 145ft. and more than 3-in below the design height for 163ft. Tilted blocks = 4 each. Minor impact to two sections of rail.			
	<b>Breaking and Cracking:</b>	Cracked blocks = 7 each. Minor cracking of most posts and blocks (< 1/4 in).			
	<b>Missing Elements:</b>	Missing blocks = 1 each.			
	<b>Corrosion and Weathering:</b>	Minimal corrosion of rails and weathering of posts and blocks. Gravel piled up in front of barrier.			
<b>End Treatments</b>	<b>Alignment and Height:</b>	Alignment is acceptable. Height is within 1-in of 27-in. design height.			
	<b>Breaking and Cracking:</b>	No breaking or cracking of end treatments.			
	<b>Missing Elements:</b>	No missing end treatment elements.

<b>Corrosion and Weathering:</b>	No corrosion or weathering of end treatments.

<b>Repair Action:</b>	REPAIR	<b>FMSS Work Type:</b>	DEFERRED MAINTENANCE	<b>Repair Cost:</b>	\$8960
<b>Brief Workorder:</b>	Raise 308ft. of guardrail to 27-in. design height remove excess gravel from face of barrier and replace 8 cracked missing blocks.				
<b>Workorder:</b>	Grader at \$125- per -Hour for 1 Hrs = \$125. Remove excess gravel from face of barrier. Replace Block at \$30- per -Each for 8 Block(s) = \$240. Replace cracked and missing blocks. Adjust Guardrail at \$10- per -Lin. Ft. for 308 LF = \$3080. Raise 308ft. of guardrail to 27-in. design height. High Speed Traffic Control at \$2350- per -Day for 2 Day(s) = \$4700.

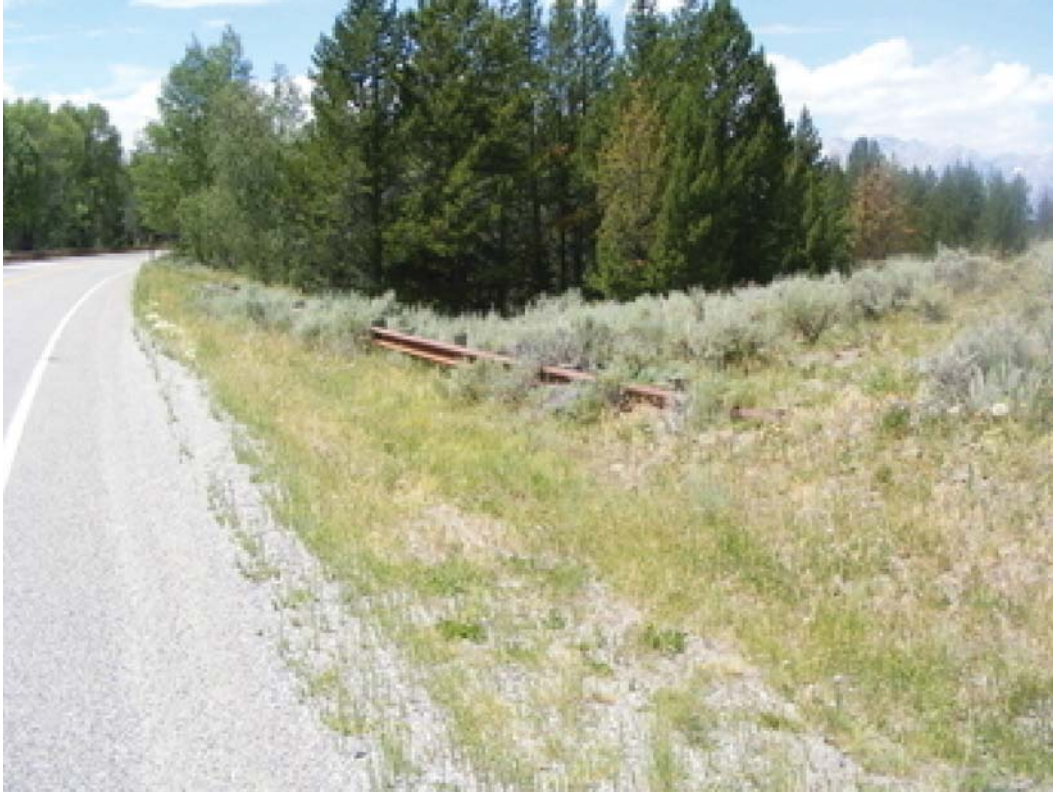
GRTE\_0010\_18.281\_L\_1.JPG

<b>Barrier ID:</b>	GRTE-0010-18.281-L				
<b>Route Name:</b>	U.S. HIGHWAY 26/89/191				
<b>Inspection Date:</b>	07/28/2010	<b>Barrier Rating:</b>	42.40		
<b>Barrier Description</b>					
<b>Type:</b>	W-BEAM STRONG POST	<b>Barrier Function:</b>	TRAFFIC		
<b>Barrier Material:</b>	WEATHERING STEEL/CORTEN	<b>Post Material:</b>	WOOD		
<b>Blockout Type:</b>	WOOD	<b>Length (ft.):</b>	915		
<b>Speed Limit (MPH):</b>	55	<b>Placement with Respect to Road:</b>	INSIDE OF CURVE		
<b>Hazard Behind Barrier:</b>	MEDIUM				
<b>Barrier Crashworthiness</b>					
<b>Appropriate Test Level:</b>	TL-3	<b>Barrier Test Level:</b>	TL-3	<b>Is Barrier Crashworthy?:</b>	YES
<b>Beg. End Trtmt Type:</b>	W-BEAM BURIED END	<b>Is Beg. End Trtmt Crashworthy?:</b>	YES	<b>Approach Transition Type:</b>	NONE
<b>Ending End Trtmt Type:</b>	W-BEAM BCT	<b>Ending End Trtmt Crashworthy?:</b>	NO		
<b>Average Measurements</b>					
<b>Design Height (In.):</b>	27	<b>Width (In.):</b>	0.0	<b>Post Spacing (In.):</b>	75.1

<b>Height (In.):</b>	25.0	<b>Lateral Offset (In.):</b>	59.5	<b>Road Grade (%):</b>	0.40
<b>Physical Condition</b>					
<b>Barrier</b>	<b>Alignment and Height:</b>	Barrier alignment is acceptable except for an impact zone of 50 LF. Barrier height is 1-3in. below the 27-in. design height for 425ft. and more than 3-in below the design height for 295ft.			
	<b>Breaking and Cracking:</b>	Barrier has 6 badly cracked or broken blocks and 50 LF of bent and torn W beam.			
	<b>Missing Elements:</b>	Two missing blocks in barrier.			
	<b>Corrosion and Weathering:</b>	Minor weathering of posts and blocks in barrier. Gravel built up in front of barrier.			
<b>End Treatments</b>	<b>Alignment and Height:</b>	Alignment is acceptable. Height is within 1-in of 27-in. design height.			
	<b>Breaking and Cracking:</b>	No breaking or cracking of end treatments.			
	<b>Missing Elements:</b>	No missing end treatment elements.

<b>Corrosion and Weathering:</b>	No corrosion or weathering of end treatments.

<b>Repair Action:</b>	REPAIR	<b>FMSS Work Type:</b>	DEFERRED MAINTENANCE	<b>Repair Cost:</b>	\$16566
<b>Brief Workorder:</b>	Raise 770ft. of guardrail up to 27-in. design height replace 6 blocks 50ft. of bent W- beam remove and adjust impact zone and remove chip seal sweepings from front of barrier.				
<b>Workorder:</b>	<p>Remove &amp; Reset Guardrail at \$25- per -Lin. Ft. for 50 LF = \$1250. Remove and reset posts in impact zone.</p> <p>Replace Block at \$30- per -Each for 6 Block(s) = \$180. Replace cracked and broken blocks.</p> <p>Replace Rail at \$25- per -Lin. Ft. for 50 LF = \$1250. Replace bent and torn rail in impact zone.</p> <p>Adjust Guardrail at \$10- per -Lin. Ft. for 720 LF = \$7200. Raise 770ft. of guardrail up to 27-in. design height.</p> <p>Labor at \$60- per -Hour for 8 Hrs = \$480. Remove chip seal sweepings from front of barrier.</p> <p>High Speed Traffic Control at \$2350- per -Day for 2 Day(s) = \$4700.</p>

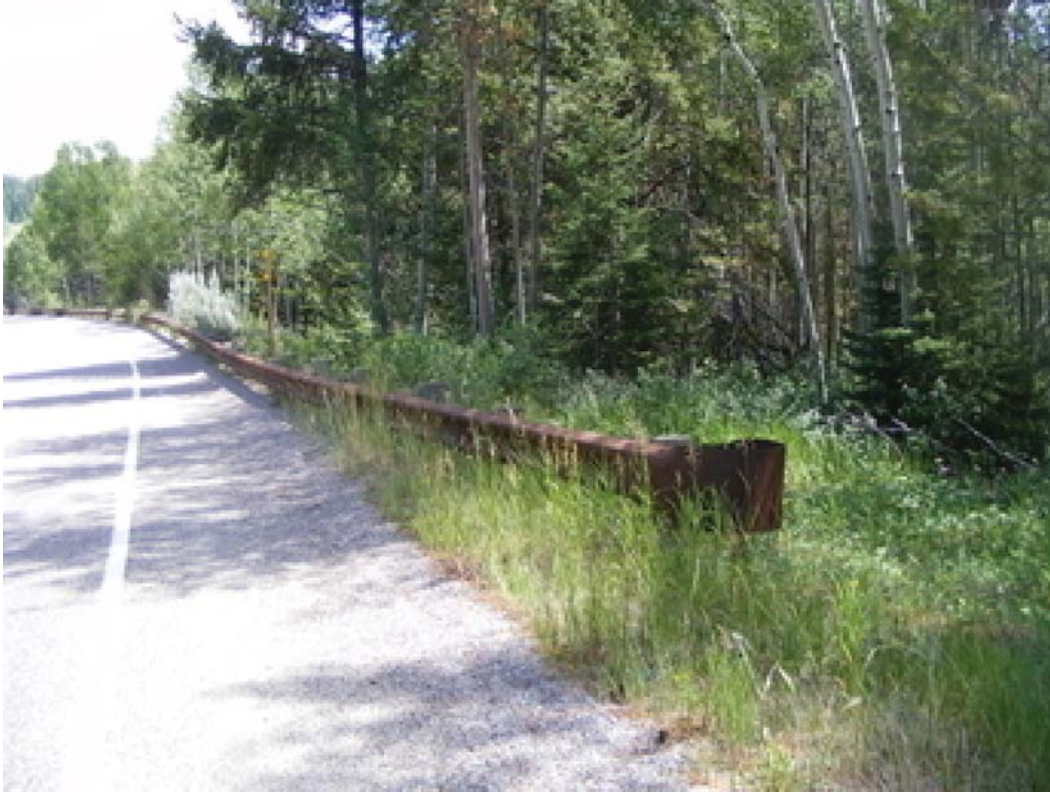
GRTE\_0010\_18.311\_R\_1.JPG

<b>Barrier ID:</b>	GRTE-0010-18.311-R				
<b>Route Name:</b>	U.S. HIGHWAY 26/89/191				
<b>Inspection Date:</b>	07/28/2010	<b>Barrier Rating:</b>	43.90		
<b>Barrier Description</b>					
<b>Type:</b>	W-BEAM STRONG POST	<b>Barrier Function:</b>	TRAFFIC		
<b>Barrier Material:</b>	WEATHERING STEEL/CORTEN	<b>Post Material:</b>	WOOD		
<b>Blockout Type:</b>	WOOD	<b>Length (ft.):</b>	792		
<b>Speed Limit (MPH):</b>	55	<b>Placement with Respect to Road:</b>	OUTSIDE OF CURVE		
<b>Hazard Behind Barrier:</b>	MEDIUM				
<b>Barrier Crashworthiness</b>					
<b>Appropriate Test Level:</b>	TL-3	<b>Barrier Test Level:</b>	TL-3	<b>Is Barrier Crashworthy?:</b>	YES
<b>Beg. End Trtmt Type:</b>	W-BEAM BCT	<b>Is Beg. End Trtmt Crashworthy?:</b>	NO	<b>Approach Transition Type:</b>	NONE
<b>Ending End Trtmt Type:</b>	W-BEAM BCT	<b>Ending End Trtmt Crashworthy?:</b>	NO		
<b>Average Measurements</b>					
<b>Design Height (In.):</b>	27	<b>Width (In.):</b>	0.0	<b>Post Spacing (In.):</b>	75.4

<b>Height (In.):</b>	24.7	<b>Lateral Offset (In.):</b>	61.5	<b>Road Grade (%):</b>	1.80
<b>Physical Condition</b>					
<b>Barrier</b>	<b>Alignment and Height:</b>	Barrier alignment is acceptable. Barrier height is 1-3in. below the 27-in. design height for 492ft. and more than 3-in below the design height for 67ft. Tilted blocks = 11 each. Two rails with minor impacts.			
	<b>Breaking and Cracking:</b>	Cracked blocks = 1 each. Minor breaking and cracking of blocks and posts (<1/4 in).			
	<b>Missing Elements:</b>	No missing barrier elements.			
	<b>Corrosion and Weathering:</b>	Minor corrosion and weathering of barrier elements. Gravel piled in front of barrier.			
<b>End Treatments</b>	<b>Alignment and Height:</b>	Trailing and approach end treatments are more than 3in. below the 27-in. design height.			
	<b>Breaking and Cracking:</b>	Impact at trailing end treatment.			
	<b>Missing Elements:</b>	No missing end treatment elements.

<b>Corrosion and Weathering:</b>	Minor corrosion and weathering of end treatment elements.

<b>Repair Action:</b>	REPLACE	<b>FMSS Work Type:</b>	CAPITAL IMPROVEMENT	<b>Repair Cost:</b>	\$16957
<b>Brief Workorder:</b>	Raise 559ft. of guardrail up to 27-in. design height replace trailing end treatment remove excess gravel from face of barrier right tilted blocks and replace one cracked block.				
<b>Workorder:</b>	<p>W-beam Trailing End at \$2500- per -Each for 1 Unit(s) = \$2500. Replace trailing end treatment.</p> <p>Grader at \$125- per -Hour for 1 Hrs = \$125. Remove excess gravel from face of barrier.</p> <p>Labor at \$60- per -Hour for 2 Hrs = \$120. Right tilted blocks.</p> <p>Replace Block at \$30- per -Each for 1 Block(s) = \$30. Replace one cracked block.</p> <p>Adjust Guardrail at \$10- per -Lin. Ft. for 559 LF = \$5590. Raise 559ft. of guardrail up to 27-in. design height.</p> <p>High Speed Traffic Control at \$2350- per -Day for 3 Day(s) = \$7050.</p>

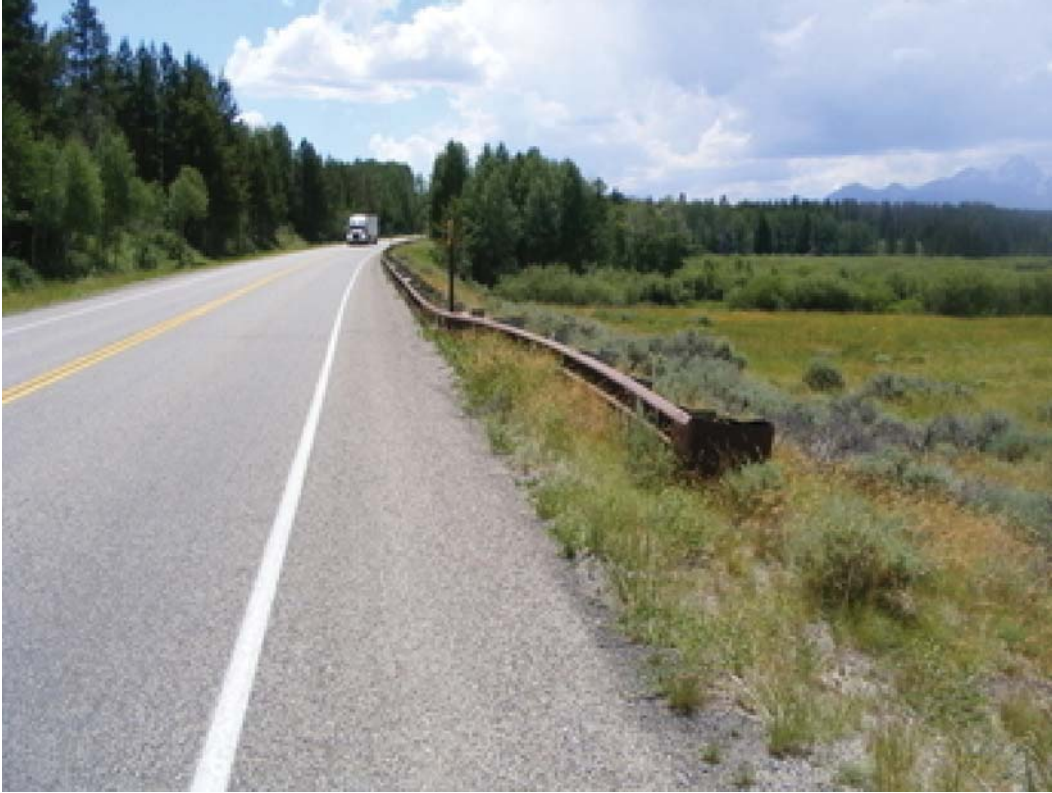
GRTE\_0010\_18.597\_L\_1.JPG

<b>Barrier ID:</b>	GRTE-0010-18.597-L				
<b>Route Name:</b>	U.S. HIGHWAY 26/89/191				
<b>Inspection Date:</b>	07/28/2010	<b>Barrier Rating:</b>	52.40		
<b>Barrier Description</b>					
<b>Type:</b>	W-BEAM STRONG POST	<b>Barrier Function:</b>	TRAFFIC		
<b>Barrier Material:</b>	WEATHERING STEEL/CORTEN	<b>Post Material:</b>	WOOD		
<b>Blockout Type:</b>	WOOD	<b>Length (ft.):</b>	986		
<b>Speed Limit (MPH):</b>	55	<b>Placement with Respect to Road:</b>	OUTSIDE OF CURVE		
<b>Hazard Behind Barrier:</b>	MEDIUM				
<b>Barrier Crashworthiness</b>					
<b>Appropriate Test Level:</b>	TL-3	<b>Barrier Test Level:</b>	TL-3	<b>Is Barrier Crashworthy?:</b>	YES
<b>Beg. End Trtmt Type:</b>	W-BEAM BCT	<b>Is Beg. End Trtmt Crashworthy?:</b>	NO	<b>Approach Transition Type:</b>	NONE
<b>Ending End Trtmt Type:</b>	W-BEAM BCT	<b>Ending End Trtmt Crashworthy?:</b>	NO		
<b>Average Measurements</b>					
<b>Design Height (In.):</b>	27	<b>Width (In.):</b>	0.0	<b>Post Spacing (In.):</b>	74.4

<b>Height (In.):</b>	24.3	<b>Lateral Offset (In.):</b>	55.7	<b>Road Grade (%):</b>	1.80
<b>Physical Condition</b>					
<b>Barrier</b>	<b>Alignment and Height:</b>	Alignment is acceptable. The barrier height is 1-3in. below the 27-in. design height for 730ft. and more than 3-in below the design height for 256ft.			
	<b>Breaking and Cracking:</b>	There is minor cracking of posts and blocks with 3 broken posts and 3 cracked or broken blocks.			
	<b>Missing Elements:</b>	There are 3 missing blocks in the barrier.			
	<b>Corrosion and Weathering:</b>	There is no major weathering of the barrier			
<b>End Treatments</b>	<b>Alignment and Height:</b>	Alignment of trailing end treatments is acceptable. Alignment of beginning end treatment is more than 12in. off. Both end treatments are more than 3in. below the 27-in. design height.			
	<b>Breaking and Cracking:</b>	No cracked or broken end treatment elements.

<b>Missing Elements:</b>	No missing end treatment elements.			
	<b>Corrosion and Weathering:</b>	Minimal corrosion/weathering of end treatment elements.

<b>Repair Action:</b>	REPLACE	<b>FMSS Work Type:</b>	CAPITAL IMPROVEMENT	<b>Repair Cost:</b>	\$26587
<b>Brief Workorder:</b>	Raise 861ft. of guardrail up to 27-in. design height replace end treatment replace 25ft. of rail 6 blocks 3 posts and remove chip seal sweepings from front of barrier.				
<b>Workorder:</b>	<p>Replace Rail at \$25- per -Lin. Ft. for 25 LF = \$625. Replace middle impact zone W-beam.  Adjust Guardrail at \$10- per -Lin. Ft. for 861 LF = \$8610. Raise 861ft. of guardrail up to 27-in. design height.  Replace Block at \$30- per -Each for 6 Block(s) = \$180. Replace cracked and missing blocks.  Replace Post at \$100- per -Each for 3 Post(s) = \$300. Replace cracked and broken posts.  Labor at \$60- per -Hour for 8 Hrs = \$480. Remove chip seal sweepings from face of barrier and right turned blocks.  Remove Guardrail at \$10- per -Lin. Ft. for 125 LF = \$1250. Remove approach end treatment.  W-Beam Strong Post at \$35- per -Lin. Ft. for 95 LF = \$3325. Install 95ft. of W-beam strong post guardrail.  W-beam flared 350 compliant at \$3500- per -Each for 1 Unit(s) = \$3500. Replace damaged approach end treatment with a W-beam flared end treatment.  Low Speed Traffic Control at \$1475- per -Day for 4 Day(s) = \$5900.</p>

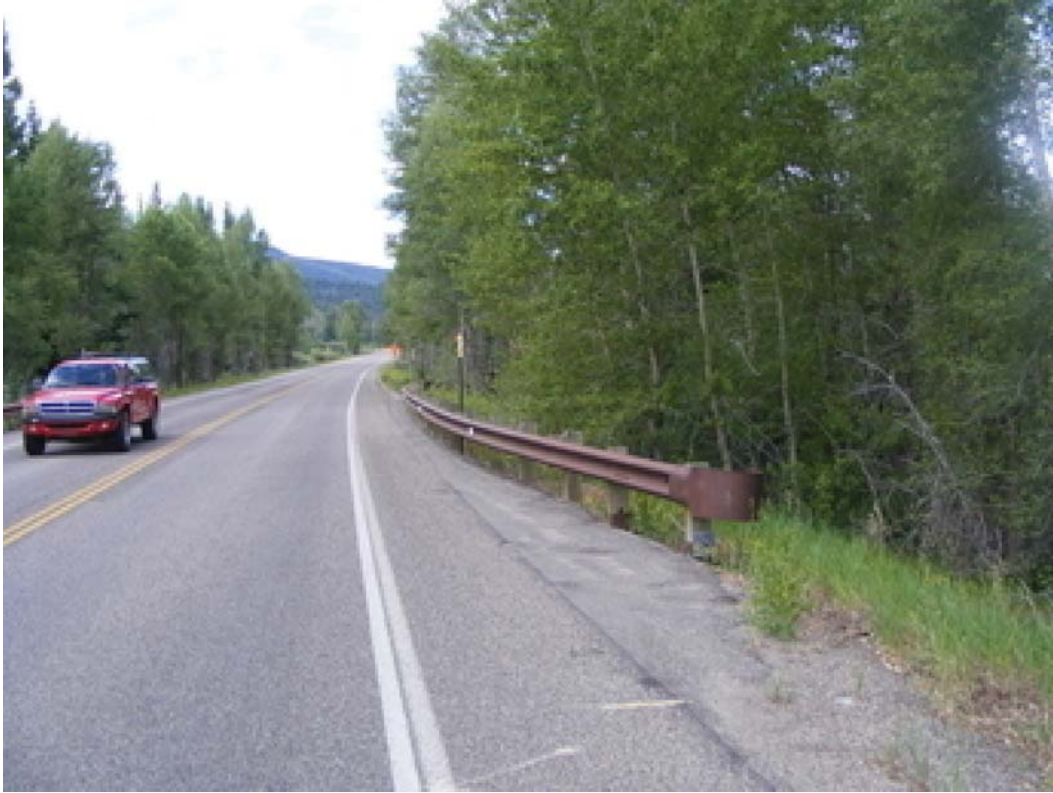
GRTE\_0010\_21.652\_L\_1.JPG

<b>Barrier ID:</b>	GRTE-0010-21.652-L				
<b>Route Name:</b>	U.S. HIGHWAY 26/89/191				
<b>Inspection Date:</b>	07/28/2010	<b>Barrier Rating:</b>	20.70		
<b>Barrier Description</b>					
<b>Type:</b>	W-BEAM STRONG POST	<b>Barrier Function:</b>	TRAFFIC		
<b>Barrier Material:</b>	WEATHERING STEEL/CORTEN	<b>Post Material:</b>	WOOD		
<b>Blockout Type:</b>	WOOD	<b>Length (ft.):</b>	128		
<b>Speed Limit (MPH):</b>	55	<b>Placement with Respect to Road:</b>	TANGENT		
<b>Hazard Behind Barrier:</b>	MEDIUM				
<b>Barrier Crashworthiness</b>					
<b>Appropriate Test Level:</b>	TL-3	<b>Barrier Test Level:</b>	TL-3	<b>Is Barrier Crashworthy?:</b>	YES
<b>Beg. End Trtmt Type:</b>	W-BEAM BCT	<b>Is Beg. End Trtmt Crashworthy?:</b>	NO	<b>Approach Transition Type:</b>	NONE
<b>Ending End Trtmt Type:</b>	W-BEAM BCT	<b>Ending End Trtmt Crashworthy?:</b>	NO		
<b>Average Measurements</b>					
<b>Design Height (In.):</b>	27	<b>Width (In.):</b>	0.0	<b>Post Spacing (In.):</b>	74.3

<b>Height (In.):</b>	27.2	<b>Lateral Offset (In.):</b>	70.5	<b>Road Grade (%):</b>	1.20
<b>Physical Condition</b>					
<b>Barrier</b>	<b>Alignment and Height:</b>	Alignment is acceptable. Height is within 1-in of 27-in. design height.			
	<b>Breaking and Cracking:</b>	No breaking or cracking on barrier.			
	<b>Missing Elements:</b>	No missing barrier elements.			
	<b>Corrosion and Weathering:</b>	No major weathering of barrier.			
<b>End Treatments</b>	<b>Alignment and Height:</b>	Alignment is acceptable. Height is within 1-in of 27-in. design height.			
	<b>Breaking and Cracking:</b>	No cracked or broken end treatment elements.			
	<b>Missing Elements:</b>	No missing end treatment elements.			
	<b>Corrosion and Weathering:</b>	Minimal corrosion/weathering of end treatment elements.

<b>Repair Action:</b>	NO ACTION	<b>FMSS Work Type:</b>	N/A	<b>Repair Cost:</b>	\$0
<b>Brief Workorder:</b>	N/A				
<b>Workorder:</b>

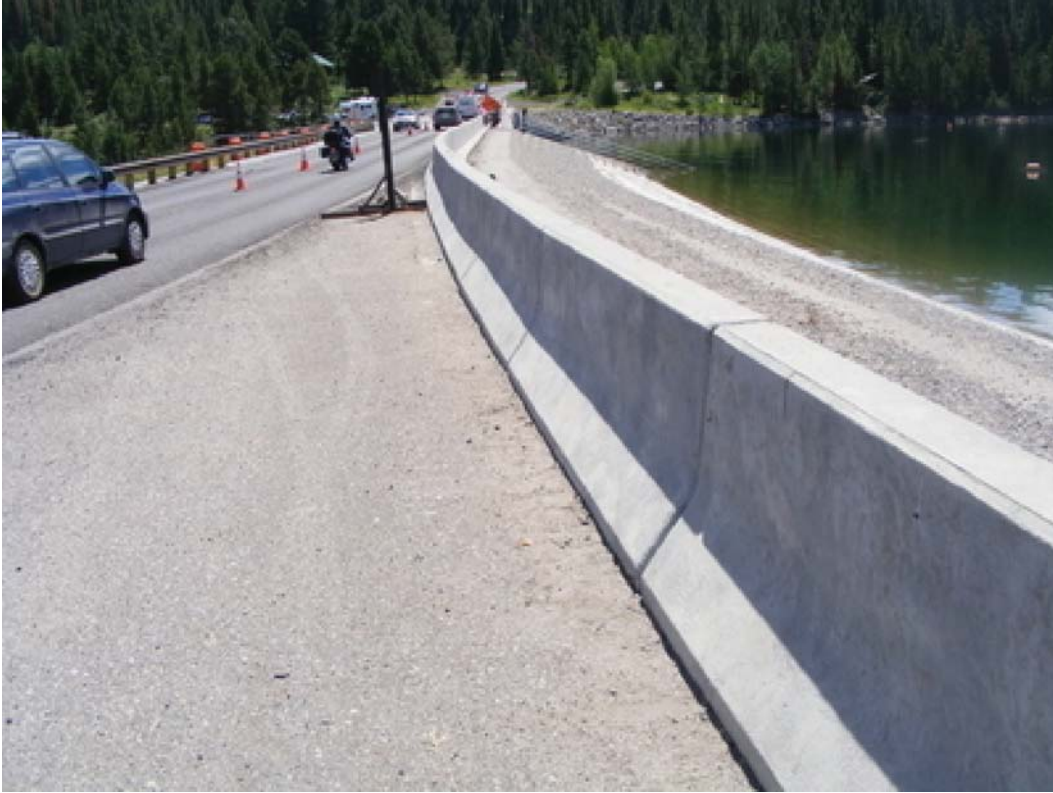
GRTE\_0011\_19.616\_L\_1.JPG

<b>Barrier ID:</b>	GRTE-0011-19.616-L				
<b>Route Name:</b>	TETON PARK ROAD				
<b>Inspection Date:</b>	07/27/2010	<b>Barrier Rating:</b>	19.70		
<b>Barrier Description</b>					
<b>Type:</b>	CONCRETE BARRIER	<b>Barrier Function:</b>	TRAFFIC		
<b>Barrier Material:</b>	CONCRETE	<b>Post Material:</b>	N/A		
<b>Blockout Type:</b>	N/A	<b>Length (ft.):</b>	283		
<b>Speed Limit (MPH):</b>	25	<b>Placement with Respect to Road:</b>	TANGENT		
<b>Hazard Behind Barrier:</b>	HIGH				
<b>Barrier Crashworthiness</b>					
<b>Appropriate Test Level:</b>	TL-1	<b>Barrier Test Level:</b>	TL-3	<b>Is Barrier Crashworthy?:</b>	YES
<b>Beg. End Trtmt Type:</b>	NONE	<b>Is Beg. End Trtmt Crashworthy?:</b>	N/A	<b>Approach Transition Type:</b>	NONE
<b>Ending End Trtmt Type:</b>	NONE	<b>Ending End Trtmt Crashworthy?:</b>	N/A		
<b>Average Measurements</b>					
<b>Design Height (In.):</b>	32	<b>Width (In.):</b>	8.0	<b>Post Spacing (In.):</b>	0.0

<b>Height (In.):</b>	32.0	<b>Lateral Offset (In.):</b>	38.0	<b>Road Grade (%):</b>	0.40
<b>Physical Condition</b>					
<b>Barrier</b>	<b>Alignment and Height:</b>	Alignment is acceptable. Height is within 1in. of the 32-in. design height.			
	<b>Breaking and Cracking:</b>	No breaking or cracking of barrier elements.			
	<b>Missing Elements:</b>	No missing barrier elements.			
	<b>Corrosion and Weathering:</b>	No major weathering of barrier elements.			
<b>End Treatments</b>	<b>Alignment and Height:</b>				
	<b>Breaking and Cracking:</b>				
	<b>Missing Elements:</b>				
	<b>Corrosion and Weathering:</b>

<b>Repair Action:</b>	NO ACTION	<b>FMSS Work Type:</b>	N/A	<b>Repair Cost:</b>	\$0
<b>Brief Workorder:</b>	N/A				
<b>Workorder:</b>
