# GRTE GIP Report

## NPS Guardwall/Rail Inventory Program Grand Teton National Park

**Federal Highway Administration  
Eastern Federal Lands Highway Division  
Road Inventory Program (RIP)**

**Data Collection Date: July 2010  
Report Date: November 2015**

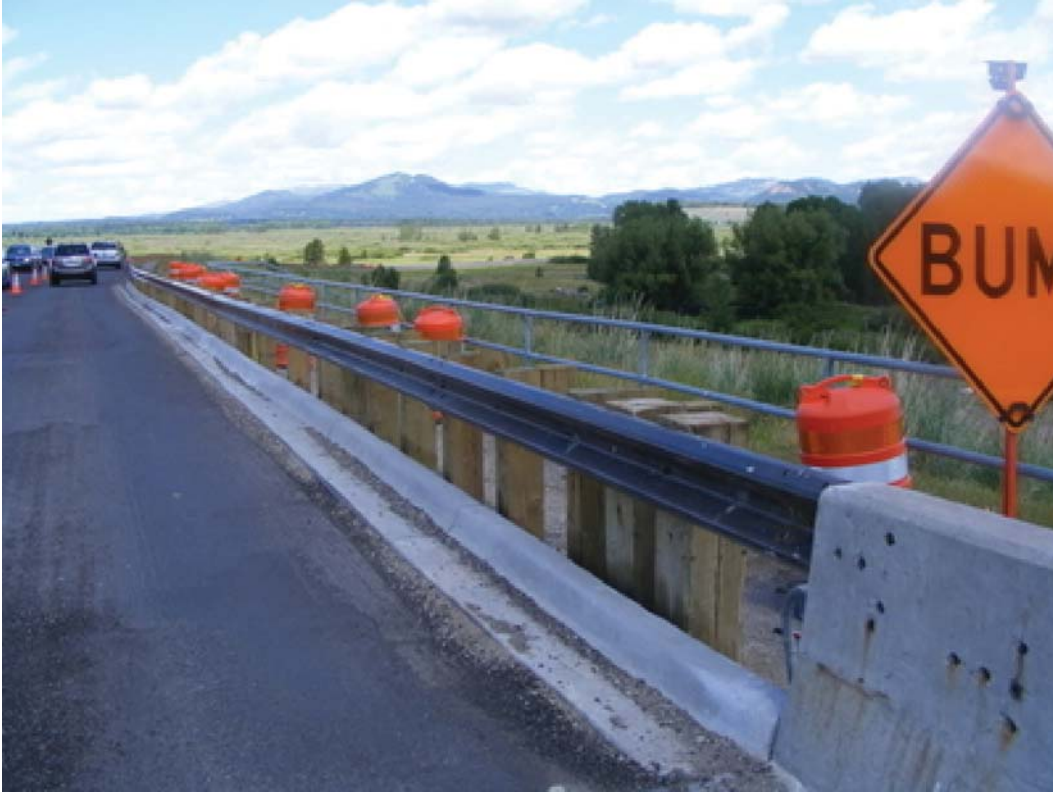
GRTE\_0011\_19.616\_R\_1.JPG

<b>Barrier ID:</b>	GRTE-0011-19.616-R				
<b>Route Name:</b>	TETON PARK ROAD				
<b>Inspection Date:</b>	07/27/2010	<b>Barrier Rating:</b>	26.80		
<b>Barrier Description</b>					
<b>Type:</b>	W-BEAM WEAK POST	<b>Barrier Function:</b>	TRAFFIC		
<b>Barrier Material:</b>	WEATHERING STEEL/CORTEN	<b>Post Material:</b>	WOOD		
<b>Blockout Type:</b>	N/A	<b>Length (ft.):</b>	994		
<b>Speed Limit (MPH):</b>	25	<b>Placement with Respect to Road:</b>	INSIDE OF CURVE		
<b>Hazard Behind Barrier:</b>	HIGH				
<b>Barrier Crashworthiness</b>					
<b>Appropriate Test Level:</b>	TL-1	<b>Barrier Test Level:</b>	TL-2	<b>Is Barrier Crashworthy?:</b>	YES
<b>Beg. End Trtmt Type:</b>	NONE	<b>Is Beg. End Trtmt Crashworthy?:</b>	N/A	<b>Approach Transition Type:</b>	NONE
<b>Ending End Trtmt Type:</b>	NONE	<b>Ending End Trtmt Crashworthy?:</b>	N/A		
<b>Average Measurements</b>					
<b>Design Height (In.):</b>	27	<b>Width (In.):</b>	0.0	<b>Post Spacing (In.):</b>	76.1

<b>Height (In.):</b>	28.7	<b>Lateral Offset (In.):</b>	33.0	<b>Road Grade (%):</b>	3.60
<b>Physical Condition</b>					
<b>Barrier</b>	<b>Alignment and Height:</b>	Alignment is acceptable. Height is 1-3in. above the 27-in. design height.			
	<b>Breaking and Cracking:</b>	No breaking or cracking of barrier elements.			
	<b>Missing Elements:</b>	No missing barrier elements except bolts which will be installed when barrier is completed. (Barrier currently being built.)			
	<b>Corrosion and Weathering:</b>	No corrosion or weathering of barrier elements.			
<b>End Treatments</b>	<b>Alignment and Height:</b>				
	<b>Breaking and Cracking:</b>				
	<b>Missing Elements:</b>				
	<b>Corrosion and Weathering:</b>

<b>Barrier ID:</b>	GRTE-0011-19.616-R				
<b>Route Name:</b>	TETON PARK ROAD				
<b>Inspection Date:</b>	07/27/2010	<b>Barrier Rating:</b>		26.80	
<b>Repair Recommendations</b>					
<b>Repair Action:</b>	NO ACTION	<b>FMSS Work Type:</b>	N/A	<b>Repair Cost:</b>	\$0
<b>Brief Workorder:</b>	N/A				
<b>Workorder:</b>

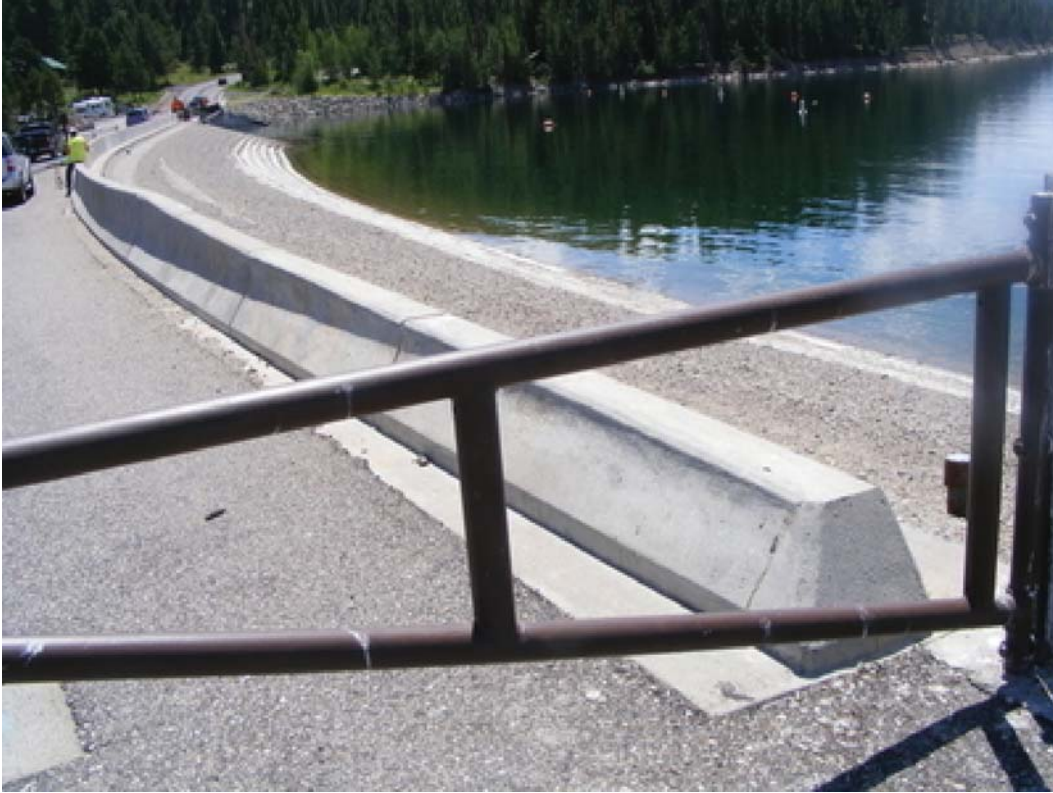
GRTE\_0011\_19.669\_L\_1.JPG

<b>Barrier ID:</b>	GRTE-0011-19.669-L				
<b>Route Name:</b>	TETON PARK ROAD				
<b>Inspection Date:</b>	07/27/2010	<b>Barrier Rating:</b>	7.00		
<b>Barrier Description</b>					
<b>Type:</b>	CONCRETE BARRIER	<b>Barrier Function:</b>	NON-TRAFFIC		
<b>Barrier Material:</b>	CONCRETE	<b>Post Material:</b>	N/A		
<b>Blockout Type:</b>	N/A	<b>Length (ft.):</b>	121		
<b>Speed Limit (MPH):</b>	25	<b>Placement with Respect to Road:</b>	NON-TRAFFIC BARRIER		
<b>Hazard Behind Barrier:</b>	N/A				
<b>Barrier Crashworthiness</b>					
<b>Appropriate Test Level:</b>	TL-1	<b>Barrier Test Level:</b>	N/A	<b>Is Barrier Crashworthy?:</b>	N/A
<b>Beg. End Trtmt Type:</b>	NONE	<b>Is Beg. End Trtmt Crashworthy?:</b>	N/A	<b>Approach Transition Type:</b>	NONE
<b>Ending End Trtmt Type:</b>	NONE	<b>Ending End Trtmt Crashworthy?:</b>	N/A		
<b>Average Measurements</b>					
<b>Design Height (In.):</b>	32	<b>Width (In.):</b>	8.0	<b>Post Spacing (In.):</b>	0.0

<b>Height (In.):</b>	33.0	<b>Lateral Offset (In.):</b>	0.0	<b>Road Grade (%):</b>	0.00
<b>Physical Condition</b>					
<b>Barrier</b>	<b>Alignment and Height:</b>	Alignment is acceptable. Height is within 1in. of the 32-in. design height.			
	<b>Breaking and Cracking:</b>	No breaking or cracking of barrier.			
	<b>Missing Elements:</b>	No missing barrier elements.			
	<b>Corrosion and Weathering:</b>	No major weathering of barrier.			
<b>End Treatments</b>	<b>Alignment and Height:</b>				
	<b>Breaking and Cracking:</b>				
	<b>Missing Elements:</b>				
	<b>Corrosion and Weathering:</b>

<b>Barrier ID:</b>	GRTE-0011-19.669-L				
<b>Route Name:</b>	TETON PARK ROAD				
<b>Inspection Date:</b>	07/27/2010	<b>Barrier Rating:</b>		7.00	
<b>Repair Recommendations</b>					
<b>Repair Action:</b>	NO ACTION	<b>FMSS Work Type:</b>	N/A	<b>Repair Cost:</b>	\$0
<b>Brief Workorder:</b>	N/A				
<b>Workorder:</b>

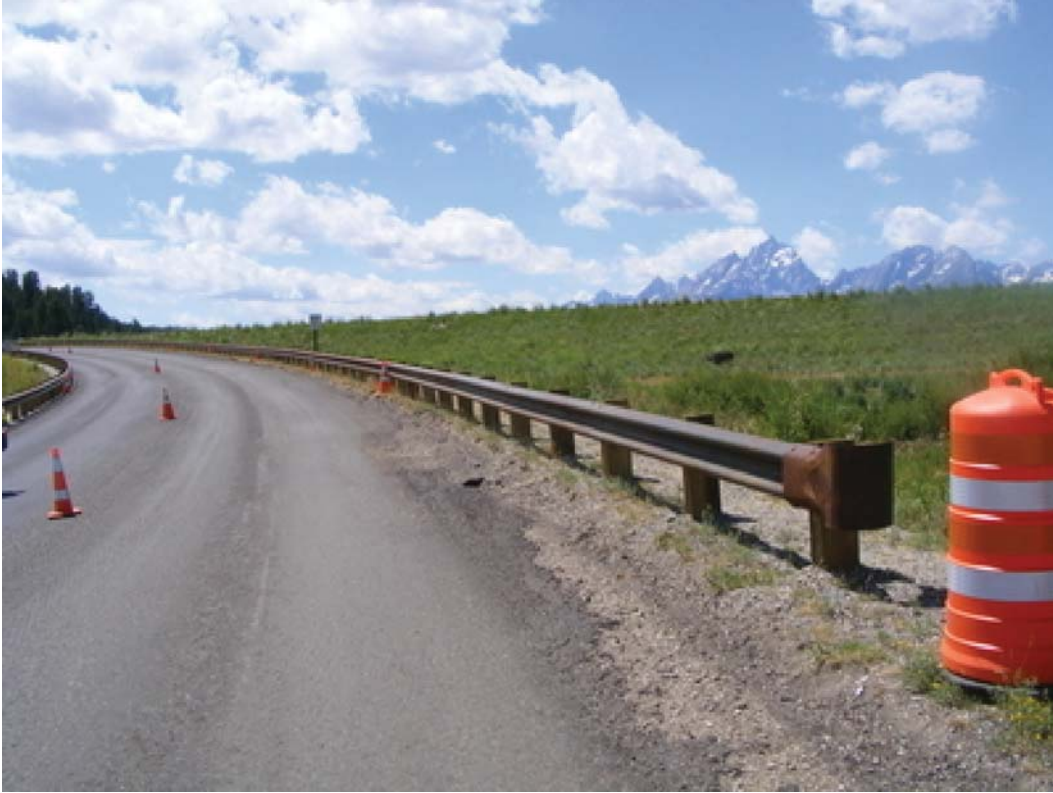
GRTE\_0011\_19.752\_L\_1.JPG

<b>Barrier ID:</b>	GRTE-0011-19.752-L				
<b>Route Name:</b>	TETON PARK ROAD				
<b>Inspection Date:</b>	07/27/2010	<b>Barrier Rating:</b>	23.70		
<b>Barrier Description</b>					
<b>Type:</b>	W-BEAM WEAK POST	<b>Barrier Function:</b>	TRAFFIC		
<b>Barrier Material:</b>	WEATHERING STEEL/CORTEN	<b>Post Material:</b>	WOOD		
<b>Blockout Type:</b>	N/A	<b>Length (ft.):</b>	704		
<b>Speed Limit (MPH):</b>	25	<b>Placement with Respect to Road:</b>	OUTSIDE OF CURVE		
<b>Hazard Behind Barrier:</b>	MEDIUM				
<b>Barrier Crashworthiness</b>					
<b>Appropriate Test Level:</b>	TL-1	<b>Barrier Test Level:</b>	TL-2	<b>Is Barrier Crashworthy?:</b>	YES
<b>Beg. End Trtmt Type:</b>	NONE	<b>Is Beg. End Trtmt Crashworthy?:</b>	N/A	<b>Approach Transition Type:</b>	NONE
<b>Ending End Trtmt Type:</b>	NONE	<b>Ending End Trtmt Crashworthy?:</b>	N/A		
<b>Average Measurements</b>					
<b>Design Height (In.):</b>	27	<b>Width (In.):</b>	0.0	<b>Post Spacing (In.):</b>	75.0

<b>Height (In.):</b>	30.5	<b>Lateral Offset (In.):</b>	40.5	<b>Road Grade (%):</b>	2.40
<b>Physical Condition</b>					
<b>Barrier</b>	<b>Alignment and Height:</b>	Alignment is acceptable. Height is 3-5in. above the 27-in. design height. However barrier is still being built and road needs to be paved.			
	<b>Breaking and Cracking:</b>	No breaking or cracking of barrier elements.			
	<b>Missing Elements:</b>	No missing elements except bolts. Bolts will be installed upon completion of the barrier.			
	<b>Corrosion and Weathering:</b>	No corrosion or weathering of barrier elements.			
<b>End Treatments</b>	<b>Alignment and Height:</b>				
	<b>Breaking and Cracking:</b>				
	<b>Missing Elements:</b>				
	<b>Corrosion and Weathering:</b>

<b>Repair Action:</b>	NO ACTION	<b>FMSS Work Type:</b>	N/A	<b>Repair Cost:</b>	\$0
<b>Brief Workorder:</b>	N/A				
<b>Workorder:</b>

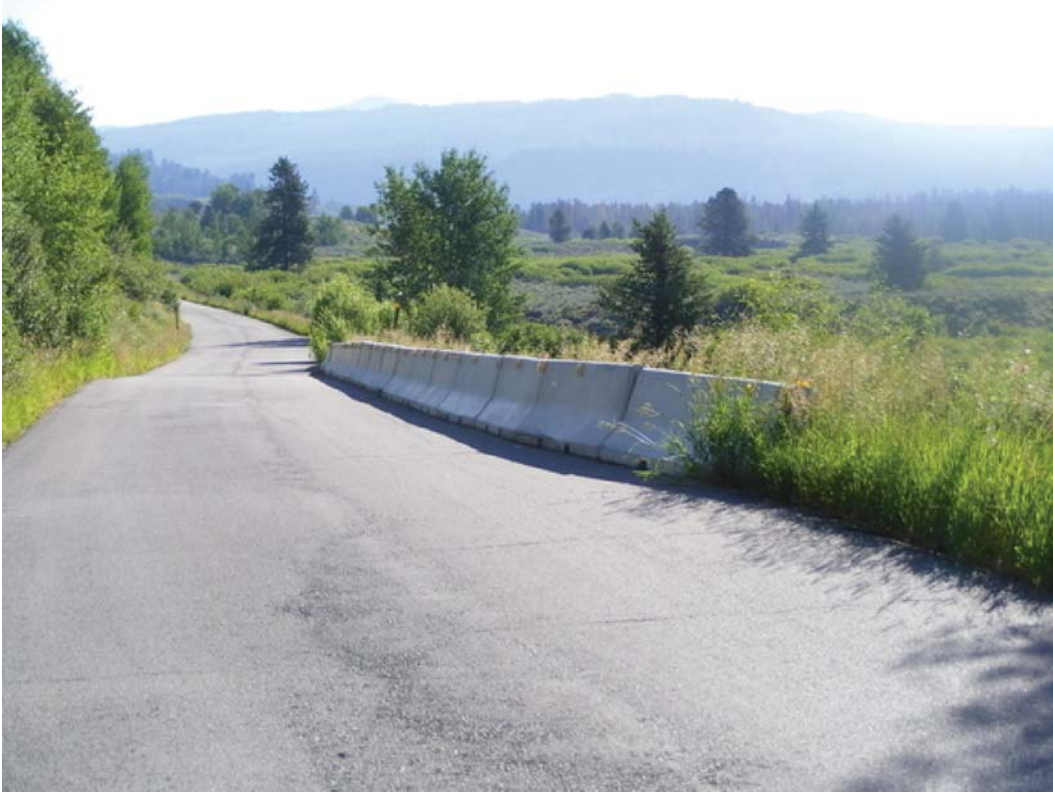
GRTE\_0114\_1.779\_R\_1.JPG

<b>Barrier ID:</b>	GRTE-0114-1.779-R				
<b>Route Name:</b>	PACIFIC CREEK ROAD				
<b>Inspection Date:</b>	07/27/2010	<b>Barrier Rating:</b>	22.70		
<b>Barrier Description</b>					
<b>Type:</b>	CONCRETE BARRIER	<b>Barrier Function:</b>	TRAFFIC		
<b>Barrier Material:</b>	CONCRETE	<b>Post Material:</b>	N/A		
<b>Blockout Type:</b>	N/A	<b>Length (ft.):</b>	202		
<b>Speed Limit (MPH):</b>	35	<b>Placement with Respect to Road:</b>	TANGENT		
<b>Hazard Behind Barrier:</b>	EXTREME				
<b>Barrier Crashworthiness</b>					
<b>Appropriate Test Level:</b>	TL-2	<b>Barrier Test Level:</b>	TL-3	<b>Is Barrier Crashworthy?:</b>	YES
<b>Beg. End Trtmt Type:</b>	NONE	<b>Is Beg. End Trtmt Crashworthy?:</b>	N/A	<b>Approach Transition Type:</b>	NONE
<b>Ending End Trtmt Type:</b>	NONE	<b>Ending End Trtmt Crashworthy?:</b>	N/A		
<b>Average Measurements</b>					
<b>Design Height (In.):</b>	32	<b>Width (In.):</b>	6.0	<b>Post Spacing (In.):</b>	0.0

<b>Height (In.):</b>	31.2	<b>Lateral Offset (In.):</b>	0.0	<b>Road Grade (%):</b>	1.50
<b>Physical Condition</b>					
<b>Barrier</b>	<b>Alignment and Height:</b>	Alignment is acceptable. Minor misalignment of trailing and approach ends - appears to be as constructed. Height is within 1in. of the 32-in. design height.			
	<b>Breaking and Cracking:</b>	Minor cracking/chipping of concrete at the base of barrier.			
	<b>Missing Elements:</b>	Barrier is missing 8 reflectors.			
	<b>Corrosion and Weathering:</b>	Barrier exhibits no corrosion or weathering.			
<b>End Treatments</b>	<b>Alignment and Height:</b>				
	<b>Breaking and Cracking:</b>				
	<b>Missing Elements:</b>				
	<b>Corrosion and Weathering:</b>

<b>Repair Action:</b>	NO ACTION	<b>FMSS Work Type:</b>	N/A	<b>Repair Cost:</b>	\$0
<b>Brief Workorder:</b>	N/A				
<b>Workorder:</b>

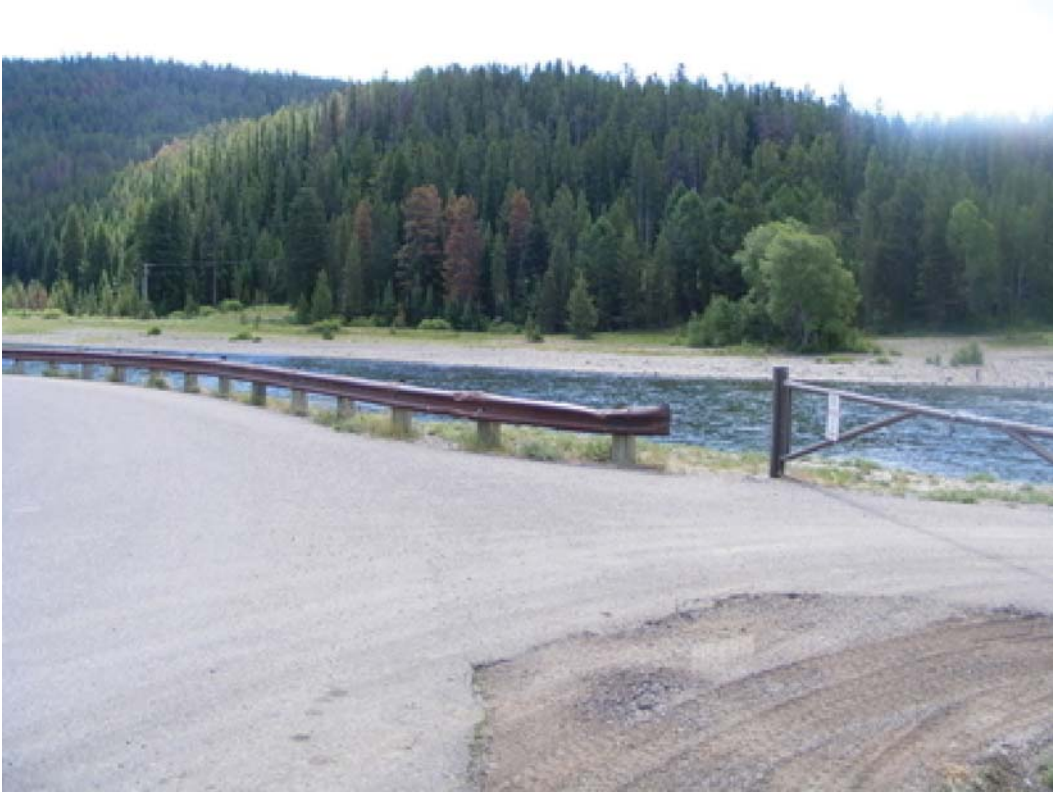
GRTE\_0212\_0.198\_R\_1.JPG

<b>Barrier ID:</b>	GRTE-0212-0.198-R				
<b>Route Name:</b>	JACKSON LAKE DAM FISHING ACCESS ROAD				
<b>Inspection Date:</b>	07/27/2010	<b>Barrier Rating:</b>	20.70		
<b>Barrier Description</b>					
<b>Type:</b>	W-BEAM WEAK POST	<b>Barrier Function:</b>	TRAFFIC		
<b>Barrier Material:</b>	WEATHERING STEEL/CORTEN	<b>Post Material:</b>	WOOD		
<b>Blockout Type:</b>	N/A	<b>Length (ft.):</b>	130		
<b>Speed Limit (MPH):</b>	15	<b>Placement with Respect to Road:</b>	OUTSIDE OF CURVE		
<b>Hazard Behind Barrier:</b>	MEDIUM				
<b>Barrier Crashworthiness</b>					
<b>Appropriate Test Level:</b>	TL-1	<b>Barrier Test Level:</b>	TL-2	<b>Is Barrier Crashworthy?:</b>	YES
<b>Beg. End Trtmt Type:</b>	NONE	<b>Is Beg. End Trtmt Crashworthy?:</b>	N/A	<b>Approach Transition Type:</b>	NONE
<b>Ending End Trtmt Type:</b>	NONE	<b>Ending End Trtmt Crashworthy?:</b>	N/A		
<b>Average Measurements</b>					
<b>Design Height (In.):</b>	27	<b>Width (In.):</b>	0.0	<b>Post Spacing (In.):</b>	75.3

<b>Height (In.):</b>	27.2	<b>Lateral Offset (In.):</b>	42.0	<b>Road Grade (%):</b>	1.30
<b>Physical Condition</b>					
<b>Barrier</b>	<b>Alignment and Height:</b>	Alignment is acceptable. Height is 1-3in. above the 27-in. design height.			
	<b>Breaking and Cracking:</b>	One cracked and broken post. One badly bent beam (15 lf).			
	<b>Missing Elements:</b>	No missing barrier elements.			
	<b>Corrosion and Weathering:</b>	No major corrosion/ minor weathering of barrier posts.			
<b>End Treatments</b>	<b>Alignment and Height:</b>				
	<b>Breaking and Cracking:</b>				
	<b>Missing Elements:</b>				
	<b>Corrosion and Weathering:</b>

<b>Repair Action:</b>	REPAIR	<b>FMSS Work Type:</b>	DEFERRED MAINTENANCE	<b>Repair Cost:</b>	\$2146
<b>Brief Workorder:</b>	Replace 15 LF of rail and 1 post.				
<b>Workorder:</b>	Replace Rail at \$25- per -Lin. Ft. for 15 LF = \$375. Replace 1 section of rail at impact zone Replace Post at \$100- per -Each for 1 Post(s) = \$100. Replace 1 post at impact zone Low Speed Traffic Control at \$1475- per -Day for 1 Day(s) = \$1475.
