LAKE GIP Report

NPS Guardwall/Rail Inventory Program Lake Mead National Recreation Area

**Data Collection Date: May 2010
Report Date: November 2015**

Lake Mead National Recreation Area in Arizona and Nevada

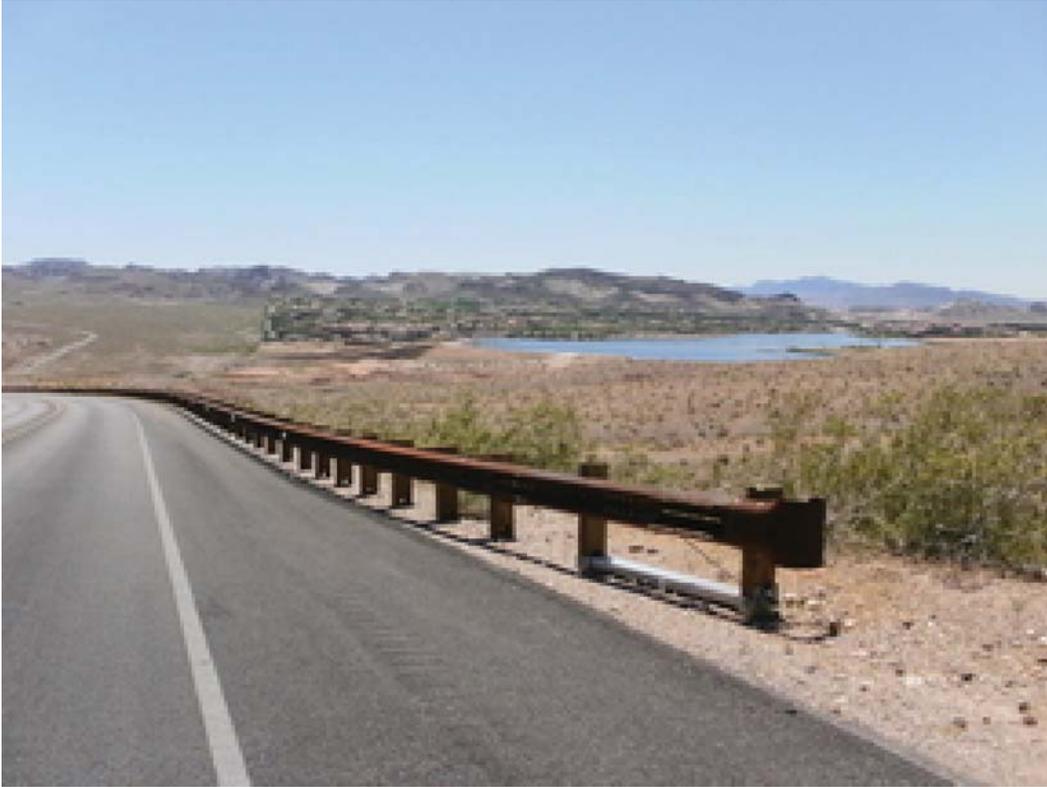
LAKE_0001_1.448_L_1.JPG

Barrier ID:	LAKE-0001-1.448-L				
Route Name:	EB NORTHSORE ROAD				
Inspection Date:	05/03/2010	Barrier Rating:	39.40		
Barrier Description					
Type:	W-BEAM STRONG POST	Barrier Function:	TRAFFIC		
Barrier Material:	WEATHERING STEEL/CORTEN	Post Material:	WOOD		
Blockout Type:	WOOD	Length (ft.):	1048		
Speed Limit (MPH):	50	Placement with Respect to Road:	OUTSIDE OF CURVE		
Hazard Behind Barrier:	MEDIUM				
Barrier Crashworthiness					
Appropriate Test Level:	TL-3	Barrier Test Level:	TL-3	Is Barrier Crashworthy?:	YES
Beg. End Trtmt Type:	W-BEAM FLARED 350 COMPLIANT	Is Beg. End Trtmt Crashworthy?:	YES	Approach Transition Type:	NONE
Ending End Trtmt Type:	W-BEAM TANGENT 350	Ending End Trtmt Crashworthy?:	YES		
Average Measurements					
Design Height (In.):	27	Width (In.):	0.0	Post Spacing (In.):	75.4
Height (In.):	27.5	Lateral Offset (In.):	85.5	Road Grade (%):	5.80
Physical Condition					
Barrier	Alignment and Height:	Alignment acceptable. Height within 1-in of 27-in design height.

Breaking and Cracking:	No breaking or cracking observed.			
	Missing Elements:	No missing barrier elements observed.			
	Corrosion and Weathering:	No corrosion or weathering observed.			
End Treatments	Alignment and Height:	Alignment acceptable. Height within 1-in of 27-in design height.			
	Breaking and Cracking:	No breaks or cracks were observed in the end treatments.			
	Missing Elements:	No missing end treatment elements observed.			
	Corrosion and Weathering:	No corrosion or weathering observed in end treatments.

Repair Action:	NO ACTION	FMSS Work Type:	N/A	Repair Cost:	\$0
Brief Workorder:	N/A				
Workorder:

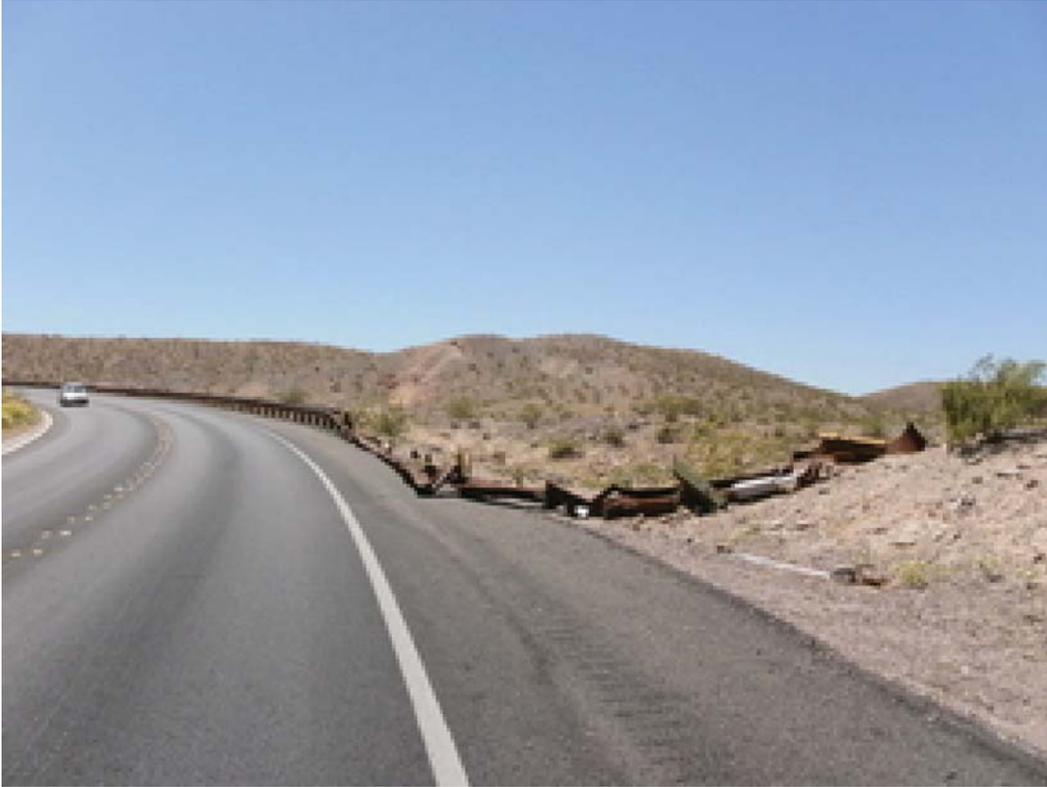
LAKE_0001_1.792_L_1.JPG

Barrier ID:	LAKE-0001-1.792-L				
Route Name:	EB NORTHSORE ROAD				
Inspection Date:	05/03/2010	Barrier Rating:	39.50		
Barrier Description					
Type:	W-BEAM STRONG POST	Barrier Function:	TRAFFIC		
Barrier Material:	WEATHERING STEEL/CORTEN	Post Material:	WOOD		
Blockout Type:	WOOD	Length (ft.):	926		
Speed Limit (MPH):	50	Placement with Respect to Road:	OUTSIDE OF CURVE		
Hazard Behind Barrier:	MEDIUM				
Barrier Crashworthiness					
Appropriate Test Level:	TL-3	Barrier Test Level:	TL-3	Is Barrier Crashworthy?:	YES
Beg. End Trtmt Type:	NONE	Is Beg. End Trtmt Crashworthy?:	N/A	Approach Transition Type:	NONE
Ending End Trtmt Type:	W-BEAM FLARED 350 COMPLIANT	Ending End Trtmt Crashworthy?:	YES		
Average Measurements					
Design Height (In.):	27	Width (In.):	0.0	Post Spacing (In.):	75.6
Height (In.):	26.3	Lateral Offset (In.):	82.5	Road Grade (%):	4.60
Physical Condition					
Barrier	Alignment and Height:	Barrier is in alignment. Barrier is below design height of 27 in by 1 to 2 in for 254 linear ft and is below by more than 6 in for 100 ft. Remainder of barrier is at design height.

Breaking and Cracking:	18 broken posts and 18 broken blocks in 100 ft of barrier that is torn down from major impact at approach end.			
	Missing Elements:	No missing elements in barrier.			
	Corrosion and Weathering:	No corrosion or weathering observed.			
End Treatments	Alignment and Height:	Trailing end treatment is in alignment and at 27 in design height. Approach end treatment is gone due to impact.			
	Breaking and Cracking:	Entire approach end treatment is broken off at road level due to impact.			
	Missing Elements:	No missing end treatment elements observed.			
	Corrosion and Weathering:	No corrosion or weathering observed in end treatments.

Repair Action:	REPAIR	FMSS Work Type:	DEFERRED MAINTENANCE	Repair Cost:	\$17924
Brief Workorder:	Replace the 100 LF of barrier that has been destroyed by vehicle impact and adjust the height of 254 LF up to the 27 inch design height.				
Workorder:	Remove Guardrail at \$10- per -Lin. Ft. for 100 LF = \$1000. Remove damaged guardrail W-Beam Strong Post at \$35- per -Lin. Ft. for 63 LF = \$2205. Replace damaged guardrail. W-beam flared 350 compliant at \$3500- per -Each for 1 Unit(s) = \$3500. Replace damaged end treatment Adjust Guardrail at \$10- per -Lin. Ft. for 254 LF = \$2540. Raise 254-ft. of barrier up to 27-in design height. High Speed Traffic Control at \$2350- per -Day for 3 Day(s) = \$7050. 1 day removal; 1 day install end treatment; 1 day to raise barrier.

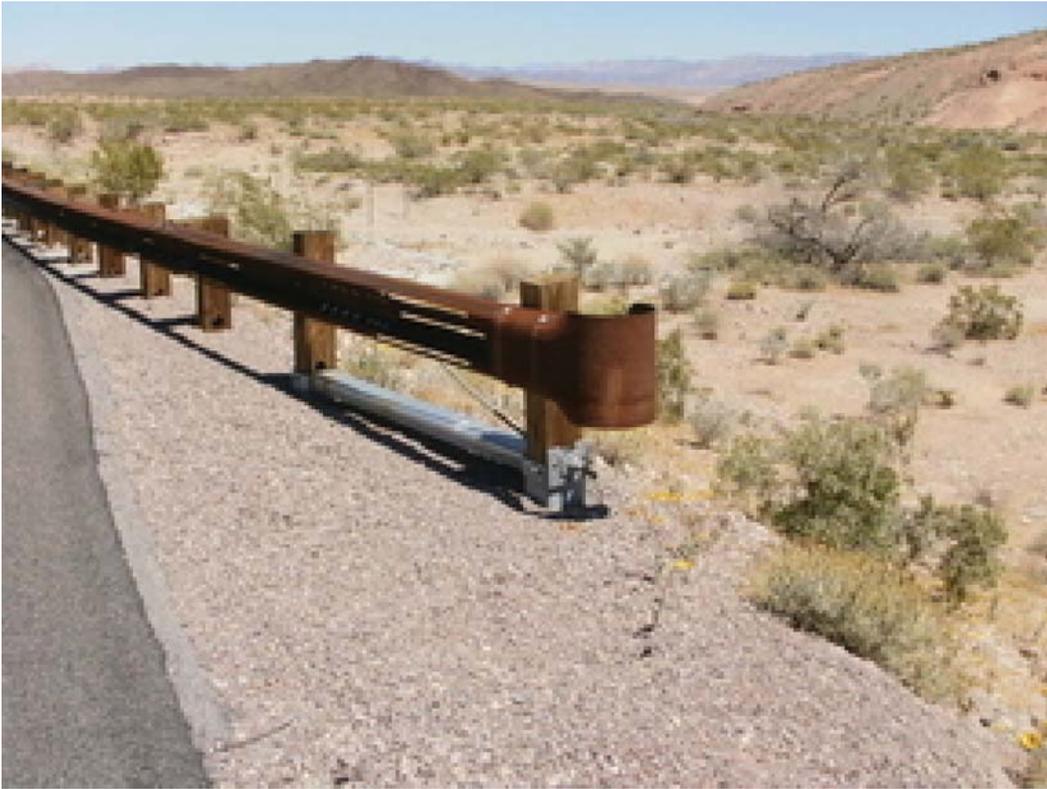
LAKE_0001_2.290_R_1.JPG

Barrier ID:	LAKE-0001-2.290-R				
Route Name:	EB NORTSHORE ROAD				
Inspection Date:	05/03/2010	Barrier Rating:	20.70		
Barrier Description					
Type:	W-BEAM STRONG POST	Barrier Function:	TRAFFIC		
Barrier Material:	WEATHERING STEEL/CORTEN	Post Material:	WOOD		
Blockout Type:	WOOD	Length (ft.):	167		
Speed Limit (MPH):	50	Placement with Respect to Road:	TANGENT		
Hazard Behind Barrier:	MEDIUM				
Barrier Crashworthiness					
Appropriate Test Level:	TL-3	Barrier Test Level:	TL-3	Is Barrier Crashworthy?:	YES
Beg. End Trtmt Type:	W-BEAM FLARED 350 COMPLIANT	Is Beg. End Trtmt Crashworthy?:	YES	Approach Transition Type:	NONE
Ending End Trtmt Type:	W-BEAM FLARED 350 COMPLIANT	Ending End Trtmt Crashworthy?:	YES		
Average Measurements					
Design Height (In.):	27	Width (In.):	0.0	Post Spacing (In.):	75.0
Height (In.):	27.0	Lateral Offset (In.):	73.6	Road Grade (%):	0.90
Physical Condition					
Barrier	Alignment and Height:	Alignment acceptable. Height within 1-in of 27-in design height.

Breaking and Cracking:	No breaking or cracking observed.			
	Missing Elements:	No missing barrier items were observed.			
	Corrosion and Weathering:	No corrosion or weathering observed.			
End Treatments	Alignment and Height:	Alignment acceptable. Height within 1-in of 27-in design height.			
	Breaking and Cracking:	No breaks or cracks were observed in the end treatments.			
	Missing Elements:	No missing end treatment elements observed.			
	Corrosion and Weathering:	No major corrosion or weathering of the end treatments was observed.

Barrier ID:	LAKE-0001-2.290-R				
Route Name:	EB NORTHSORE ROAD				
Inspection Date:	05/03/2010	Barrier Rating:		20.70	
Repair Recommendations					
Repair Action:	NO ACTION	FMSS Work Type:	N/A	Repair Cost:	\$0
Brief Workorder:	N/A				
Workorder:

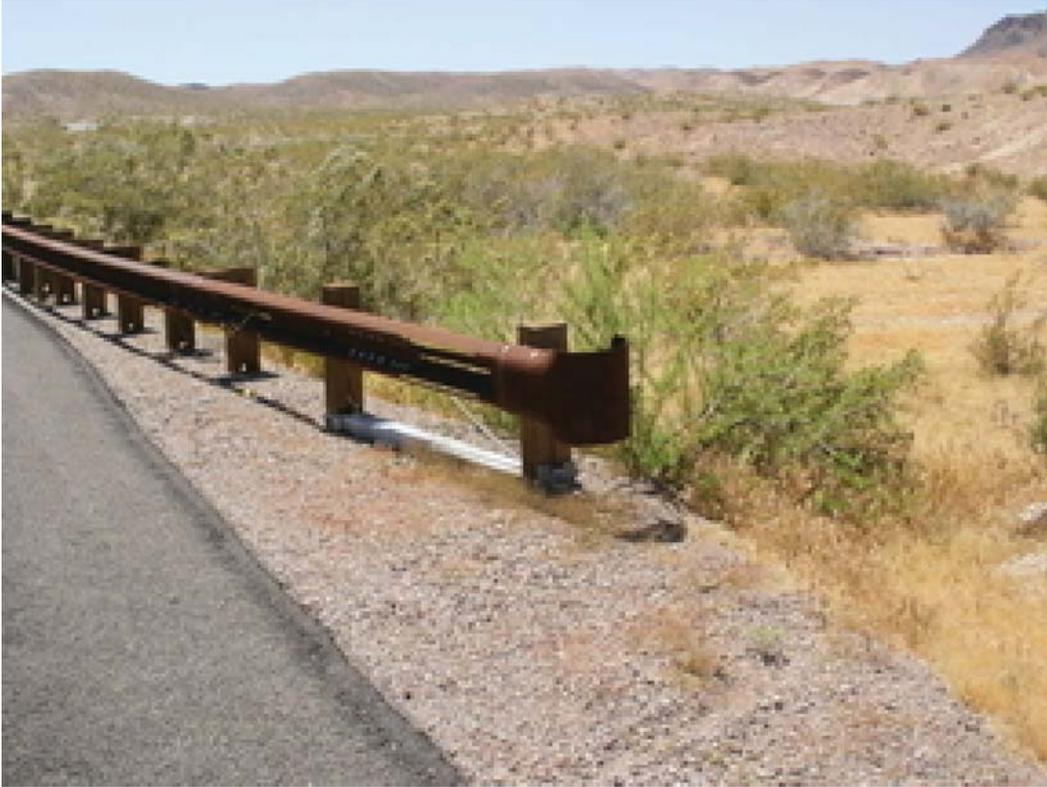
LAKE_0001_2.295_L_1.JPG

Barrier ID:	LAKE-0001-2.295-L				
Route Name:	EB NORTHSORE ROAD				
Inspection Date:	05/03/2010	Barrier Rating:	18.20		
Barrier Description					
Type:	W-BEAM STRONG POST	Barrier Function:	TRAFFIC		
Barrier Material:	WEATHERING STEEL/CORTEN	Post Material:	WOOD		
Blockout Type:	WOOD	Length (ft.):	156		
Speed Limit (MPH):	50	Placement with Respect to Road:	TANGENT		
Hazard Behind Barrier:	LOW				
Barrier Crashworthiness					
Appropriate Test Level:	TL-3	Barrier Test Level:	TL-3	Is Barrier Crashworthy?:	YES
Beg. End Trtmt Type:	W-BEAM FLARED 350 COMPLIANT	Is Beg. End Trtmt Crashworthy?:	YES	Approach Transition Type:	NONE
Ending End Trtmt Type:	W-BEAM FLARED 350 COMPLIANT	Ending End Trtmt Crashworthy?:	YES		
Average Measurements					
Design Height (In.):	27	Width (In.):	0.0	Post Spacing (In.):	74.6
Height (In.):	27.2	Lateral Offset (In.):	72.0	Road Grade (%):	0.70
Physical Condition					
Barrier	Alignment and Height:	Alignment acceptable. Height within 1-in of 27-in design height.

Breaking and Cracking:	No breaking or cracking observed.			
	Missing Elements:	No missing barrier elements were observed.			
	Corrosion and Weathering:	No corrosion or weathering observed.			
End Treatments	Alignment and Height:	Alignment acceptable. Height within 1-in of 27-in design height.			
	Breaking and Cracking:	No breaks or cracks were observed in the end treatments.			
	Missing Elements:	No missing end treatment elements observed.			
	Corrosion and Weathering:	No major corrosion or weathering of end treatments was observed.

Repair Action:	NO ACTION	FMSS Work Type:	N/A	Repair Cost:	\$0
Brief Workorder:	N/A				
Workorder:

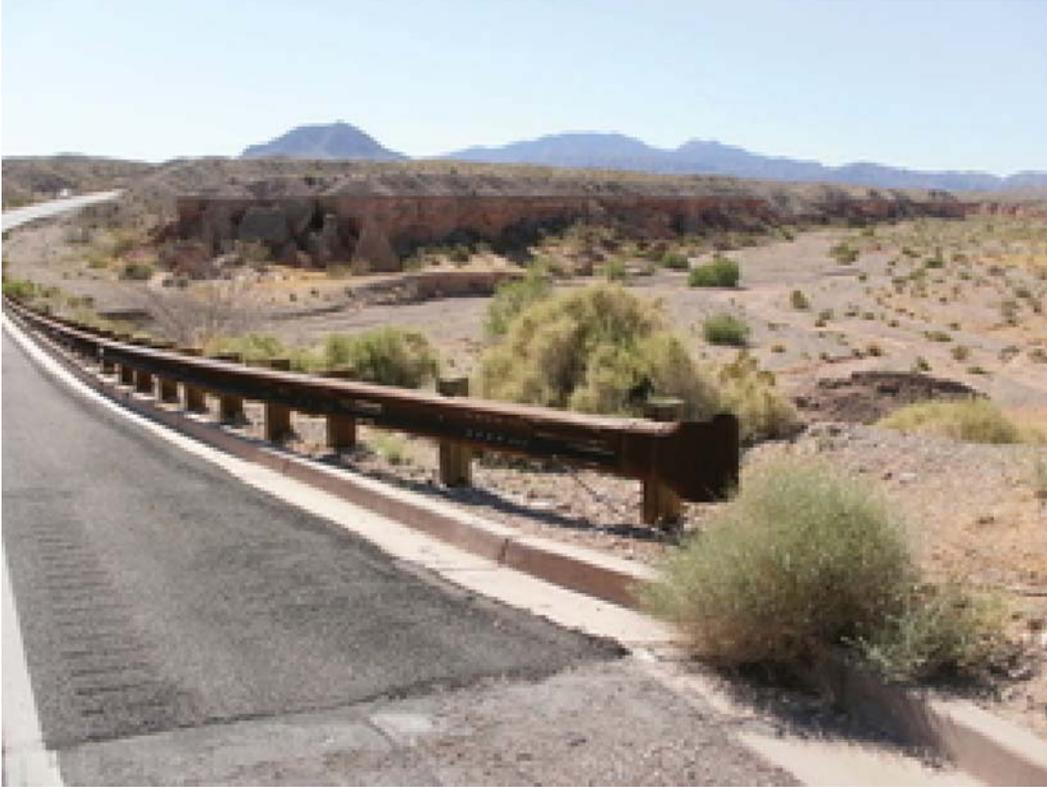
LAKE_0001_4.481_L_1.JPG

Barrier ID:	LAKE-0001-4.481-L				
Route Name:	EB NORTSHORE ROAD				
Inspection Date:	05/03/2010	Barrier Rating:	26.50		
Barrier Description					
Type:	W-BEAM STRONG POST	Barrier Function:	TRAFFIC		
Barrier Material:	WEATHERING STEEL/CORTEN	Post Material:	WOOD		
Blockout Type:	WOOD	Length (ft.):	831		
Speed Limit (MPH):	50	Placement with Respect to Road:	TANGENT		
Hazard Behind Barrier:	MEDIUM				
Barrier Crashworthiness					
Appropriate Test Level:	TL-3	Barrier Test Level:	TL-3	Is Barrier Crashworthy?:	YES
Beg. End Trtmt Type:	W-BEAM FLARED 350 COMPLIANT	Is Beg. End Trtmt Crashworthy?:	YES	Approach Transition Type:	NONE
Ending End Trtmt Type:	W-BEAM FLARED 350 COMPLIANT	Ending End Trtmt Crashworthy?:	YES		
Average Measurements					
Design Height (In.):	27	Width (In.):	0.0	Post Spacing (In.):	74.5
Height (In.):	27.0	Lateral Offset (In.):	68.0	Road Grade (%):	1.00
Physical Condition					
Barrier	Alignment and Height:	Alignment acceptable. Height within 1-in of 27-in design height.

Breaking and Cracking:	Three 12 ft rail sections and 13 blocks have substantial cracking from impact to the barrier.			
	Missing Elements:	No missing barrier elements observed.			
	Corrosion and Weathering:	No corrosion or weathering observed.			
End Treatments	Alignment and Height:	Alignment acceptable. Height within 1-in of 27-in design height.			
	Breaking and Cracking:	No breaks or cracks were observed in the end treatments.			
	Missing Elements:	No missing end treatment elements observed.			
	Corrosion and Weathering:	No corrosion or weathering observed in end treatments.

Repair Action:	REPAIR	FMSS Work Type:	DEFERRED MAINTENANCE	Repair Cost:	\$4004
Brief Workorder:	Replace damaged barrier items.				
Workorder:	Replace Rail at \$25- per -Lin. Ft. for 36 LF = \$900. Replace Block at \$30- per -Each for 13 Block(s) = \$390. High Speed Traffic Control at \$2350- per -Day for 1 Day(s) = \$2350.

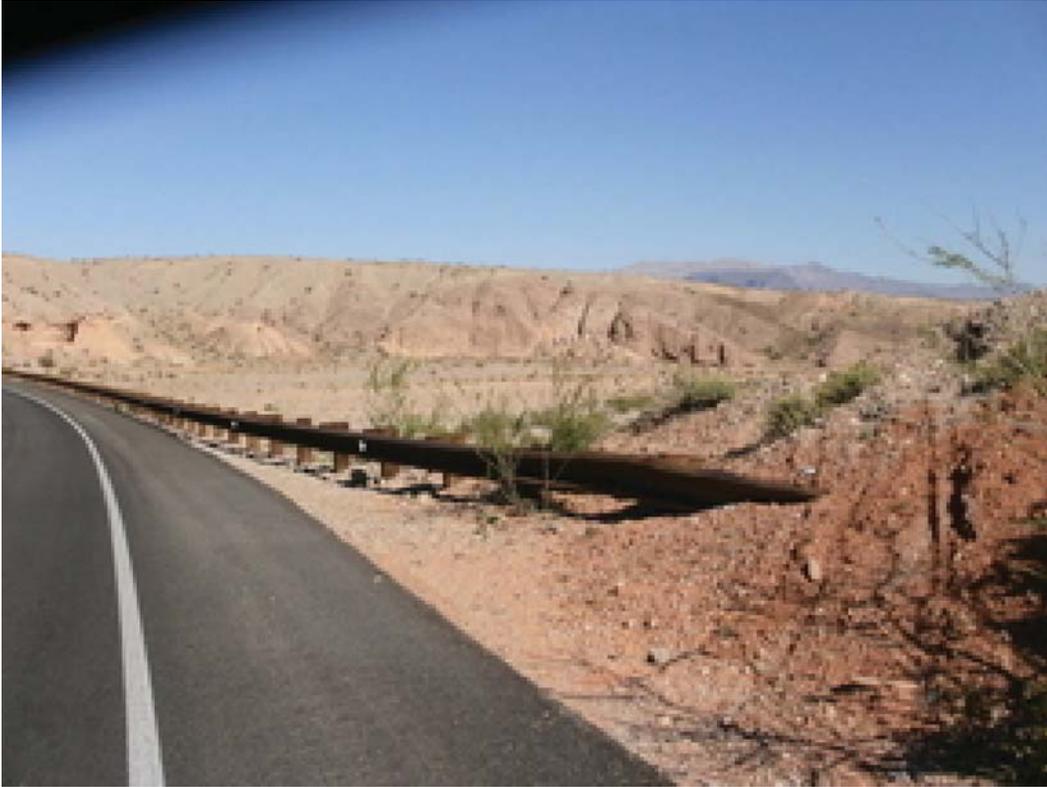
LAKE_0001_4.483_R_1.JPG

Barrier ID:	LAKE-0001-4.483-R				
Route Name:	EB NORTHSORE ROAD				
Inspection Date:	05/03/2010	Barrier Rating:	32.70		
Barrier Description					
Type:	W-BEAM STRONG POST	Barrier Function:	TRAFFIC		
Barrier Material:	WEATHERING STEEL/CORTEN	Post Material:	WOOD		
Blockout Type:	WOOD	Length (ft.):	787		
Speed Limit (MPH):	50	Placement with Respect to Road:	TANGENT		
Hazard Behind Barrier:	HIGH				
Barrier Crashworthiness					
Appropriate Test Level:	TL-3	Barrier Test Level:	TL-3	Is Barrier Crashworthy?:	YES
Beg. End Trtmt Type:	W-BEAM FLARED 350 COMPLIANT	Is Beg. End Trtmt Crashworthy?:	YES	Approach Transition Type:	NONE
Ending End Trtmt Type:	W-BEAM BURIED END	Ending End Trtmt Crashworthy?:	YES		
Average Measurements					
Design Height (In.):	27	Width (In.):	0.0	Post Spacing (In.):	75.5
Height (In.):	27.2	Lateral Offset (In.):	72.8	Road Grade (%):	0.70
Physical Condition					
Barrier	Alignment and Height:	Alignment acceptable. Height within 1-in of 27-in design height.

Breaking and Cracking:	No breaking or cracking observed.			
	Missing Elements:	No missing elements in barrier were observed.			
	Corrosion and Weathering:	No corrosion or weathering observed.			
End Treatments	Alignment and Height:	Trailing end treatment is in alignment but is 2-in below 27-in design height for 9 ft. Approach end treatment is out of alignment by more than 6-inches and is 4-inches below design height for 30 feet.			
	Breaking and Cracking:	37 ft. of approach end treatment is bent.			
	Missing Elements:	No missing end treatment elements observed.			
	Corrosion and Weathering:	No corrosion or weathering observed in end treatments.

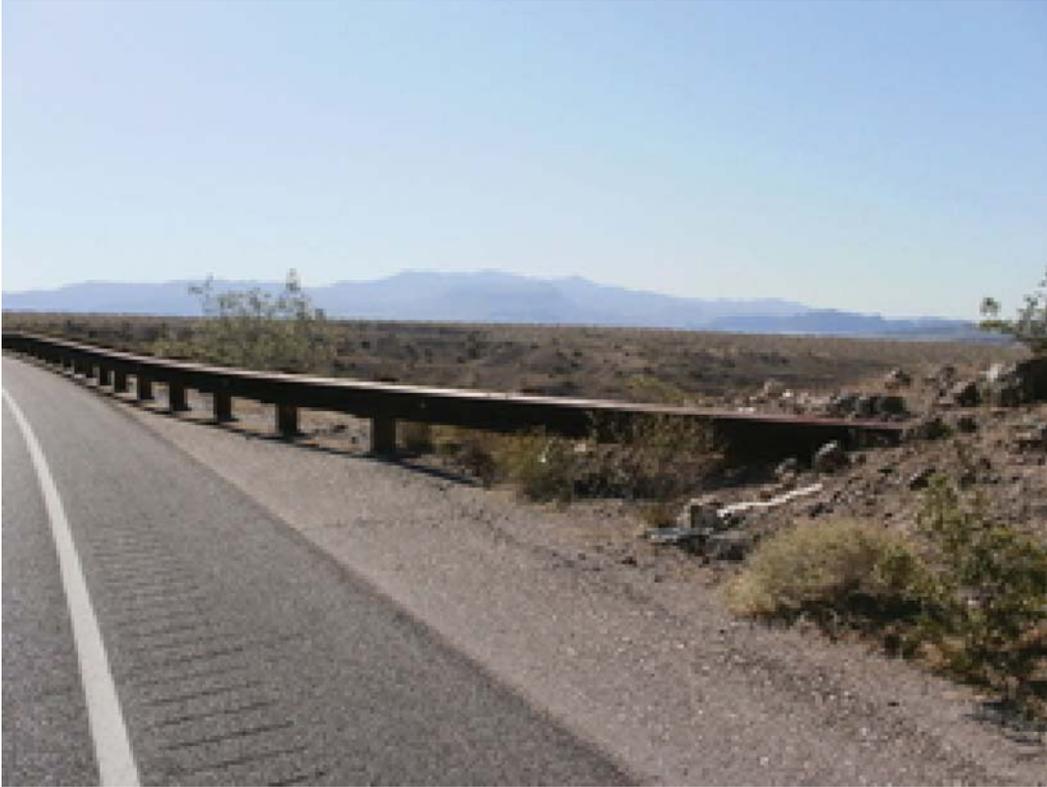
LAKE_0001_4.938_R_1.JPG

Barrier ID:	LAKE-0001-4.938-R				
Route Name:	EB NORTSHORE ROAD				
Inspection Date:	05/04/2010	Barrier Rating:	42.90		
Barrier Description					
Type:	W-BEAM STRONG POST	Barrier Function:	TRAFFIC		
Barrier Material:	WEATHERING STEEL/CORTEN	Post Material:	WOOD		
Blockout Type:	WOOD	Length (ft.):	635		
Speed Limit (MPH):	50	Placement with Respect to Road:	OUTSIDE OF CURVE		
Hazard Behind Barrier:	HIGH				
Barrier Crashworthiness					
Appropriate Test Level:	TL-3	Barrier Test Level:	TL-3	Is Barrier Crashworthy?:	YES
Beg. End Trtmt Type:	W-BEAM BURIED END	Is Beg. End Trtmt Crashworthy?:	YES	Approach Transition Type:	NONE
Ending End Trtmt Type:	W-BEAM BURIED END	Ending End Trtmt Crashworthy?:	YES		
Average Measurements					
Design Height (In.):	27	Width (In.):	0.0	Post Spacing (In.):	74.6
Height (In.):	25.2	Lateral Offset (In.):	56.2	Road Grade (%):	0.30
Physical Condition					
Barrier	Alignment and Height:	Alignment acceptable. Barrier is below 27-in design height by 1 to 3 in for 213 linear ft and by 3 to 4 in for 54 linear ft. Remainder of barrier is at design height.

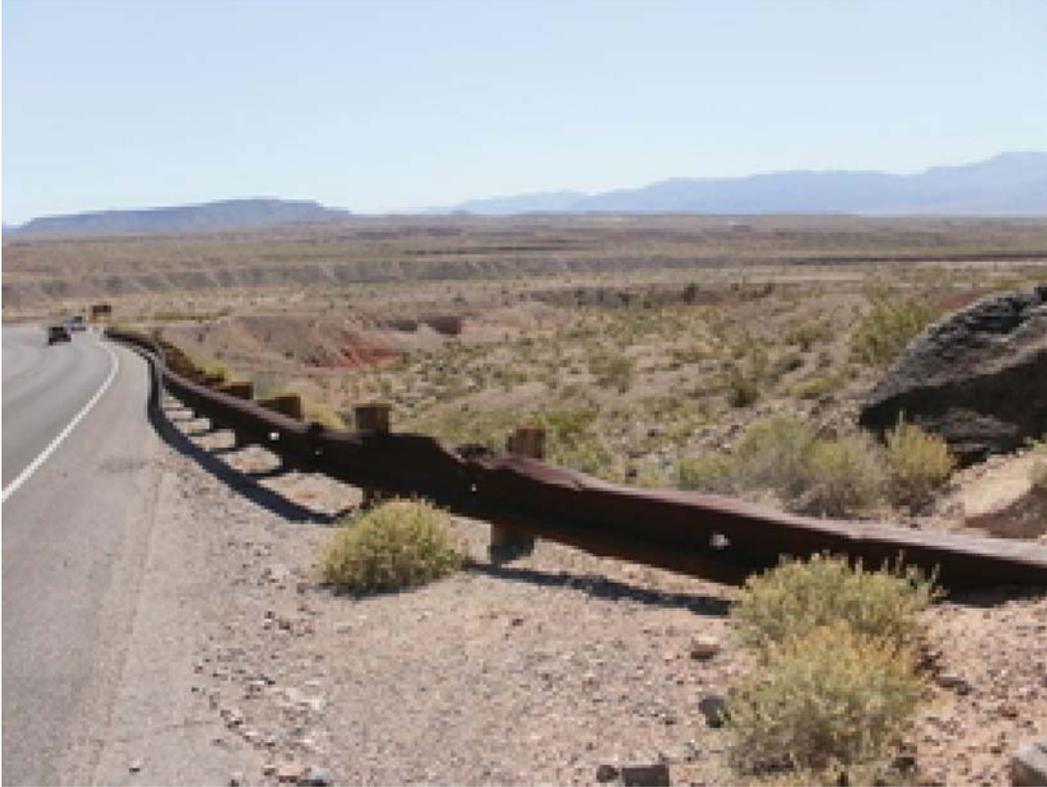
LAKE_0001_5.424_R_1.JPG

Barrier ID:	LAKE-0001-5.424-R				
Route Name:	EB NORTSHORE ROAD				
Inspection Date:	05/04/2010	Barrier Rating:	42.70		
Barrier Description					
Type:	W-BEAM STRONG POST	Barrier Function:	TRAFFIC		
Barrier Material:	WEATHERING STEEL/CORTEN	Post Material:	WOOD		
Blockout Type:	WOOD	Length (ft.):	356		
Speed Limit (MPH):	50	Placement with Respect to Road:	OUTSIDE OF CURVE		
Hazard Behind Barrier:	HIGH				
Barrier Crashworthiness					
Appropriate Test Level:	TL-3	Barrier Test Level:	TL-3	Is Barrier Crashworthy?:	YES
Beg. End Trtmt Type:	W-BEAM BURIED END	Is Beg. End Trtmt Crashworthy?:	YES	Approach Transition Type:	NONE
Ending End Trtmt Type:	W-BEAM BCT	Ending End Trtmt Crashworthy?:	NO		
Average Measurements					
Design Height (In.):	27	Width (In.):	0.0	Post Spacing (In.):	75.3
Height (In.):	26.2	Lateral Offset (In.):	50.7	Road Grade (%):	6.50
Physical Condition					
Barrier	Alignment and Height:	Alignment acceptable. Height within 1-in of 27-in design height.

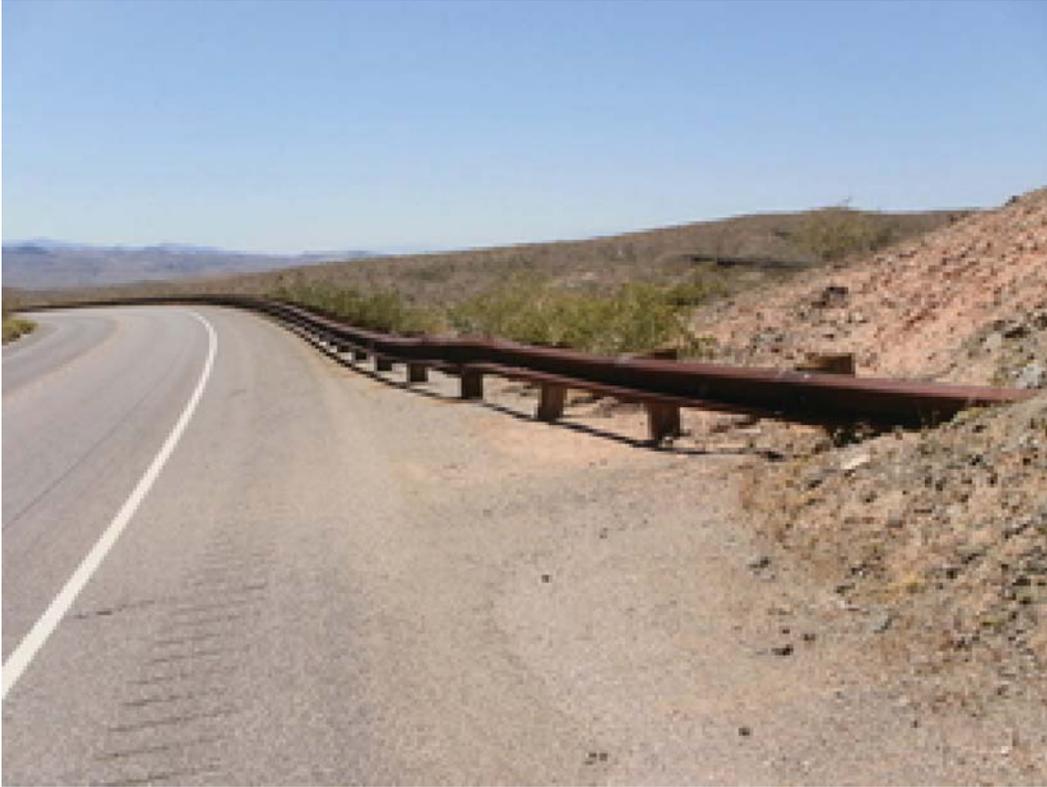
LAKE_0001_9.287_L_1.JPG

Barrier ID:	LAKE-0001-9.287-L				
Route Name:	EB NORTHSORE ROAD				
Inspection Date:	05/04/2010	Barrier Rating:	48.20		
Barrier Description					
Type:	W-BEAM STRONG POST	Barrier Function:	TRAFFIC		
Barrier Material:	WEATHERING STEEL/CORTEN	Post Material:	WOOD		
Blockout Type:	WOOD	Length (ft.):	996		
Speed Limit (MPH):	50	Placement with Respect to Road:	OUTSIDE OF CURVE		
Hazard Behind Barrier:	MEDIUM				
Barrier Crashworthiness					
Appropriate Test Level:	TL-3	Barrier Test Level:	TL-3	Is Barrier Crashworthy?:	YES
Beg. End Trtmt Type:	W-BEAM BURIED END	Is Beg. End Trtmt Crashworthy?:	YES	Approach Transition Type:	NONE
Ending End Trtmt Type:	W-BEAM BCT	Ending End Trtmt Crashworthy?:	NO		
Average Measurements					
Design Height (In.):	27	Width (In.):	0.0	Post Spacing (In.):	75.0
Height (In.):	25.0	Lateral Offset (In.):	65.5	Road Grade (%):	3.90
Physical Condition					
Barrier	Alignment and Height:	Barrier alignment is acceptable. 861-ft is 1 to 3 in below the design height of 27 in.

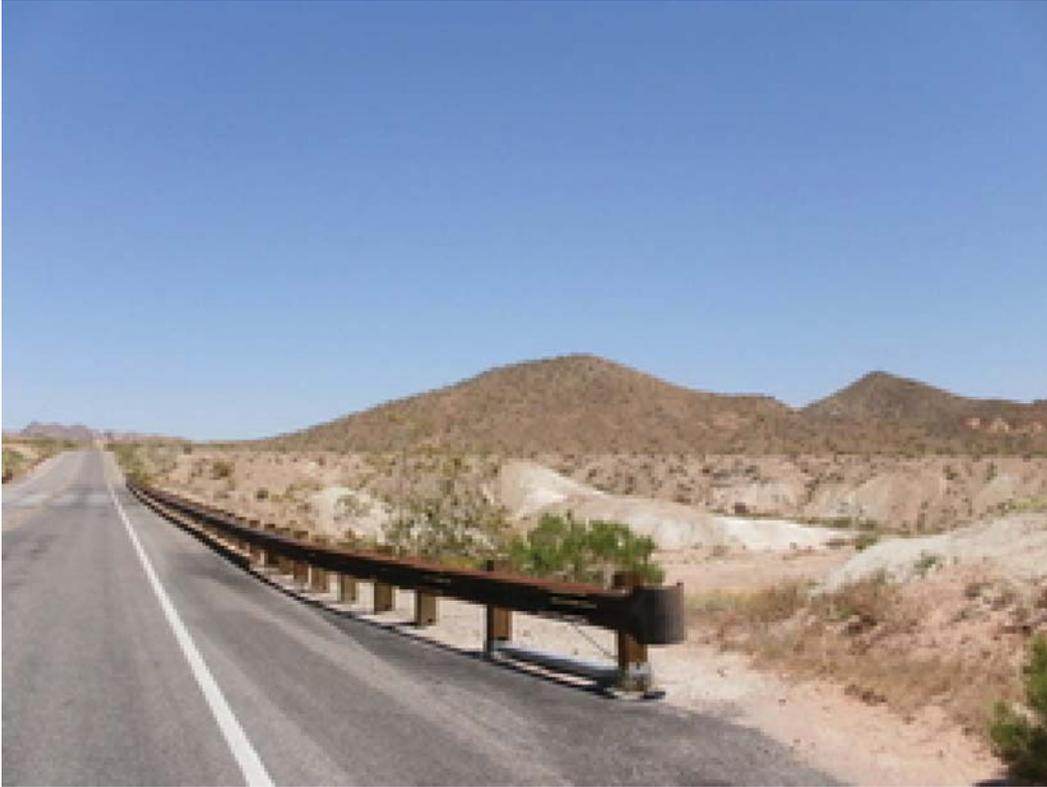
LAKE_0001_10.508_R_1.JPG

Barrier ID:	LAKE-0001-10.508-R				
Route Name:	EB NORTSHORE ROAD				
Inspection Date:	05/04/2010	Barrier Rating:	29.80		
Barrier Description					
Type:	W-BEAM STRONG POST	Barrier Function:	TRAFFIC		
Barrier Material:	WEATHERING STEEL/CORTEN	Post Material:	WOOD		
Blockout Type:	WOOD	Length (ft.):	354		
Speed Limit (MPH):	50	Placement with Respect to Road:	TANGENT		
Hazard Behind Barrier:	HIGH				
Barrier Crashworthiness					
Appropriate Test Level:	TL-3	Barrier Test Level:	TL-3	Is Barrier Crashworthy?:	YES
Beg. End Trtmt Type:	W-BEAM FLARED 350 COMPLIANT	Is Beg. End Trtmt Crashworthy?:	YES	Approach Transition Type:	NONE
Ending End Trtmt Type:	W-BEAM FLARED 350 COMPLIANT	Ending End Trtmt Crashworthy?:	YES		
Average Measurements					
Design Height (In.):	27	Width (In.):	0.0	Post Spacing (In.):	75.6
Height (In.):	25.7	Lateral Offset (In.):	57.7	Road Grade (%):	1.20
Physical Condition					
Barrier	Alignment and Height:	Barrier is in alignment and within 1 in of 27 in design height for entire length except 9 linear ft that is below the design height by more than 1 to 2 in.

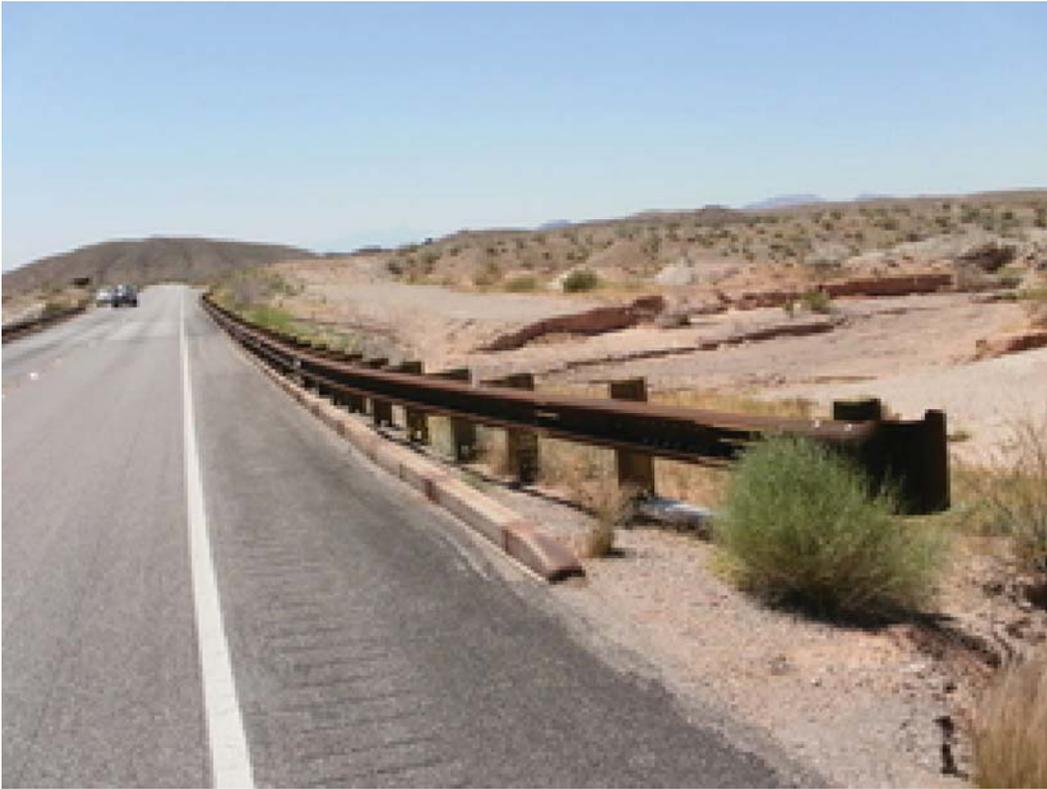
LAKE_0001_10.510_L_1.JPG

Barrier ID:	LAKE-0001-10.510-L				
Route Name:	EB NORTHSORE ROAD				
Inspection Date:	05/04/2010	Barrier Rating:	25.50		
Barrier Description					
Type:	W-BEAM STRONG POST	Barrier Function:	TRAFFIC		
Barrier Material:	WEATHERING STEEL/CORTEN	Post Material:	WOOD		
Blockout Type:	WOOD	Length (ft.):	355		
Speed Limit (MPH):	50	Placement with Respect to Road:	TANGENT		
Hazard Behind Barrier:	HIGH				
Barrier Crashworthiness					
Appropriate Test Level:	TL-3	Barrier Test Level:	TL-3	Is Barrier Crashworthy?:	YES
Beg. End Trtmt Type:	W-BEAM FLARED 350 COMPLIANT	Is Beg. End Trtmt Crashworthy?:	YES	Approach Transition Type:	NONE
Ending End Trtmt Type:	W-BEAM FLARED 350 COMPLIANT	Ending End Trtmt Crashworthy?:	YES		
Average Measurements					
Design Height (In.):	27	Width (In.):	0.0	Post Spacing (In.):	74.6
Height (In.):	27.0	Lateral Offset (In.):	56.7	Road Grade (%):	1.60
Physical Condition					
Barrier	Alignment and Height:	Alignment acceptable. Height within 1-in of 27-in design height.

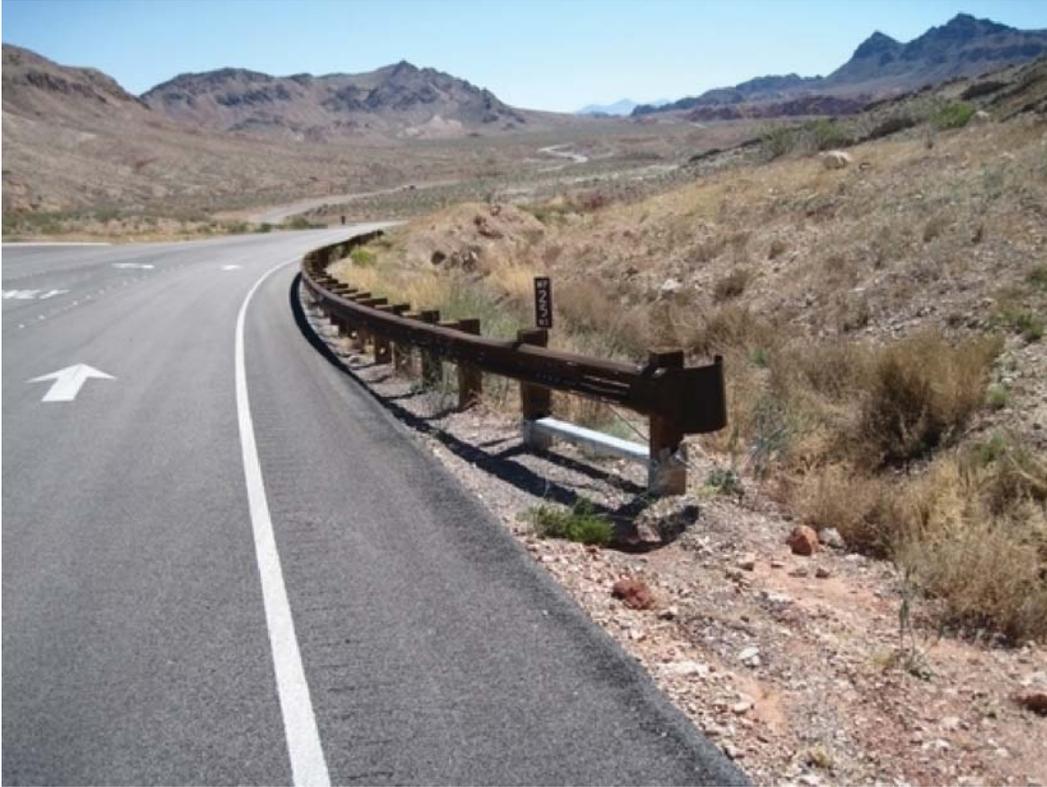
LAKE_0001_24.836_R_1.jpg

Barrier ID:	LAKE-0001-24.836-R				
Route Name:	EB NORTSHORE ROAD				
Inspection Date:	05/04/2010	Barrier Rating:	28.20		
Barrier Description					
Type:	W-BEAM STRONG POST	Barrier Function:	TRAFFIC		
Barrier Material:	WEATHERING STEEL/CORTEN	Post Material:	WOOD		
Blockout Type:	WOOD	Length (ft.):	242		
Speed Limit (MPH):	50	Placement with Respect to Road:	TANGENT		
Hazard Behind Barrier:	HIGH				
Barrier Crashworthiness					
Appropriate Test Level:	TL-3	Barrier Test Level:	TL-3	Is Barrier Crashworthy?:	YES
Beg. End Trtmt Type:	W-BEAM FLARED 350 COMPLIANT	Is Beg. End Trtmt Crashworthy?:	YES	Approach Transition Type:	NONE
Ending End Trtmt Type:	W-BEAM FLARED 350 COMPLIANT	Ending End Trtmt Crashworthy?:	YES		
Average Measurements					
Design Height (In.):	27	Width (In.):	0.0	Post Spacing (In.):	75.0
Height (In.):	26.7	Lateral Offset (In.):	55.2	Road Grade (%):	7.30
Physical Condition					
Barrier	Alignment and Height:	The alignment is acceptable. 50-ft is 2 in below the 27 in design height.

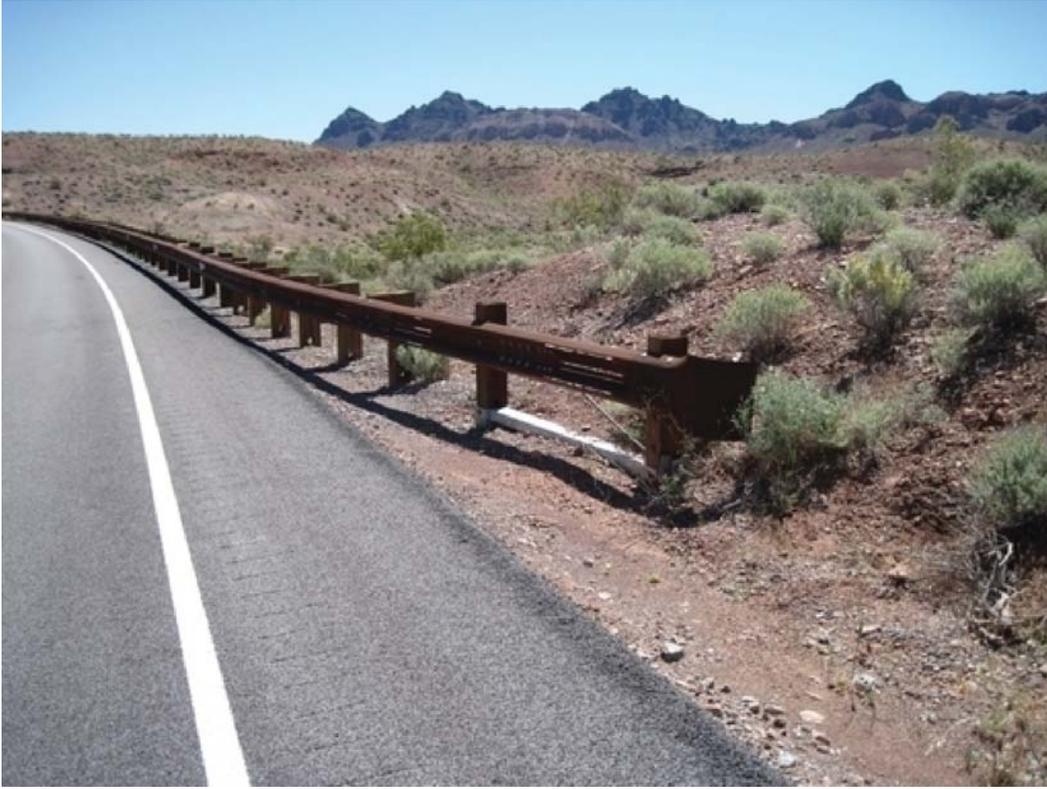
LAKE_0001_25.405_R_1.jpg

Barrier ID:	LAKE-0001-25.405-R				
Route Name:	EB NORTSHORE ROAD				
Inspection Date:	05/04/2010	Barrier Rating:	26.80		
Barrier Description					
Type:	W-BEAM STRONG POST	Barrier Function:	TRAFFIC		
Barrier Material:	WEATHERING STEEL/CORTEN	Post Material:	WOOD		
Blockout Type:	WOOD	Length (ft.):	455		
Speed Limit (MPH):	50	Placement with Respect to Road:	OUTSIDE OF CURVE		
Hazard Behind Barrier:	LOW				
Barrier Crashworthiness					
Appropriate Test Level:	TL-3	Barrier Test Level:	TL-3	Is Barrier Crashworthy?:	YES
Beg. End Trtmt Type:	W-BEAM FLARED 350 COMPLIANT	Is Beg. End Trtmt Crashworthy?:	YES	Approach Transition Type:	NONE
Ending End Trtmt Type:	W-BEAM FLARED 350 COMPLIANT	Ending End Trtmt Crashworthy?:	YES		
Average Measurements					
Design Height (In.):	27	Width (In.):	0.0	Post Spacing (In.):	75.1
Height (In.):	28.7	Lateral Offset (In.):	53.2	Road Grade (%):	1.90
Physical Condition					
Barrier	Alignment and Height:	Alignment acceptable. Height within 1-in of 27-in design height.

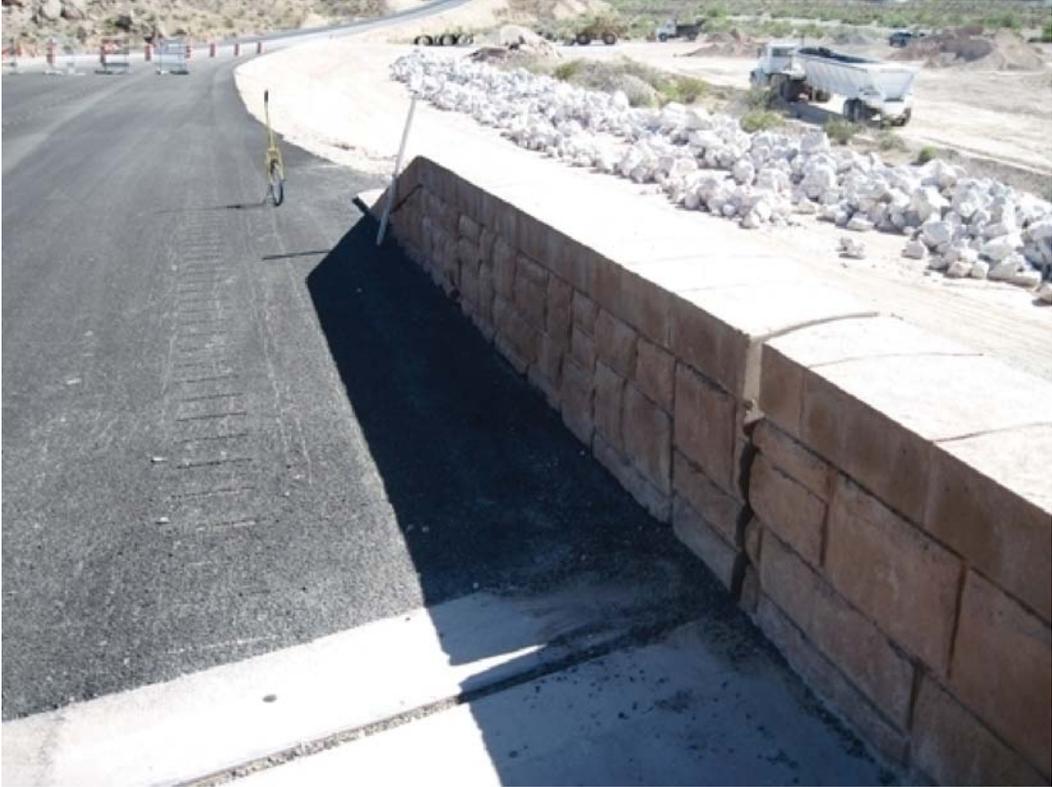
LAKE_0001_33.112_L_1.jpg

Barrier ID:	LAKE-0001-33.112-L				
Route Name:	EB NORTHSORE ROAD				
Inspection Date:	05/04/2010	Barrier Rating:	15.30		
Barrier Description					
Type:	CONCRETE WITH SIMULATED STONE FACE	Barrier Function:	TRAFFIC		
Barrier Material:	CONCRETE	Post Material:	N/A		
Blockout Type:	N/A	Length (ft.):	28		
Speed Limit (MPH):	50	Placement with Respect to Road:	TANGENT		
Hazard Behind Barrier:	LOW				
Barrier Crashworthiness					
Appropriate Test Level:	TL-3	Barrier Test Level:	TL-3	Is Barrier Crashworthy?:	YES
Beg. End Trtmt Type:	NONE	Is Beg. End Trtmt Crashworthy?:	N/A	Approach Transition Type:	NONE
Ending End Trtmt Type:	NONE	Ending End Trtmt Crashworthy?:	N/A		
Average Measurements					
Design Height (In.):	27	Width (In.):	25.7	Post Spacing (In.):	0.0
Height (In.):	31.7	Lateral Offset (In.):	66.0	Road Grade (%):	1.70
Physical Condition					
Barrier	Alignment and Height:	Alignment acceptable. Height within 3-in of 27-in design height.

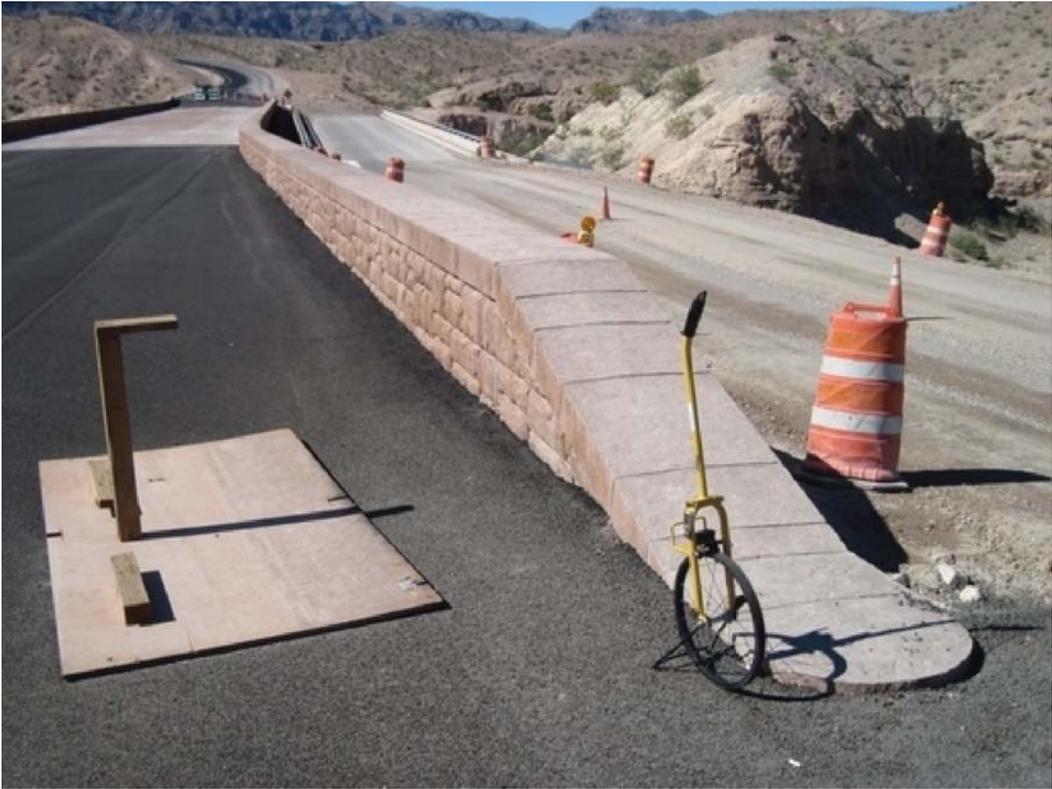
LAKE_0001_33.135_R_1.jpg

Barrier ID:	LAKE-0001-33.135-R				
Route Name:	EB NORTSHORE ROAD				
Inspection Date:	05/04/2010	Barrier Rating:	17.80		
Barrier Description					
Type:	CONCRETE WITH SIMULATED STONE FACE	Barrier Function:	TRAFFIC		
Barrier Material:	CONCRETE	Post Material:	N/A		
Blockout Type:	N/A	Length (ft.):	160		
Speed Limit (MPH):	50	Placement with Respect to Road:	TANGENT		
Hazard Behind Barrier:	MEDIUM				
Barrier Crashworthiness					
Appropriate Test Level:	TL-3	Barrier Test Level:	TL-3	Is Barrier Crashworthy?:	YES
Beg. End Trtmt Type:	NONE	Is Beg. End Trtmt Crashworthy?:	N/A	Approach Transition Type:	NONE
Ending End Trtmt Type:	NONE	Ending End Trtmt Crashworthy?:	N/A		
Average Measurements					
Design Height (In.):	27	Width (In.):	26.7	Post Spacing (In.):	0.0
Height (In.):	30.0	Lateral Offset (In.):	108.0	Road Grade (%):	0.60
Physical Condition					
Barrier	Alignment and Height:	Alignment acceptable. Height within 3-in of 27-in design height.

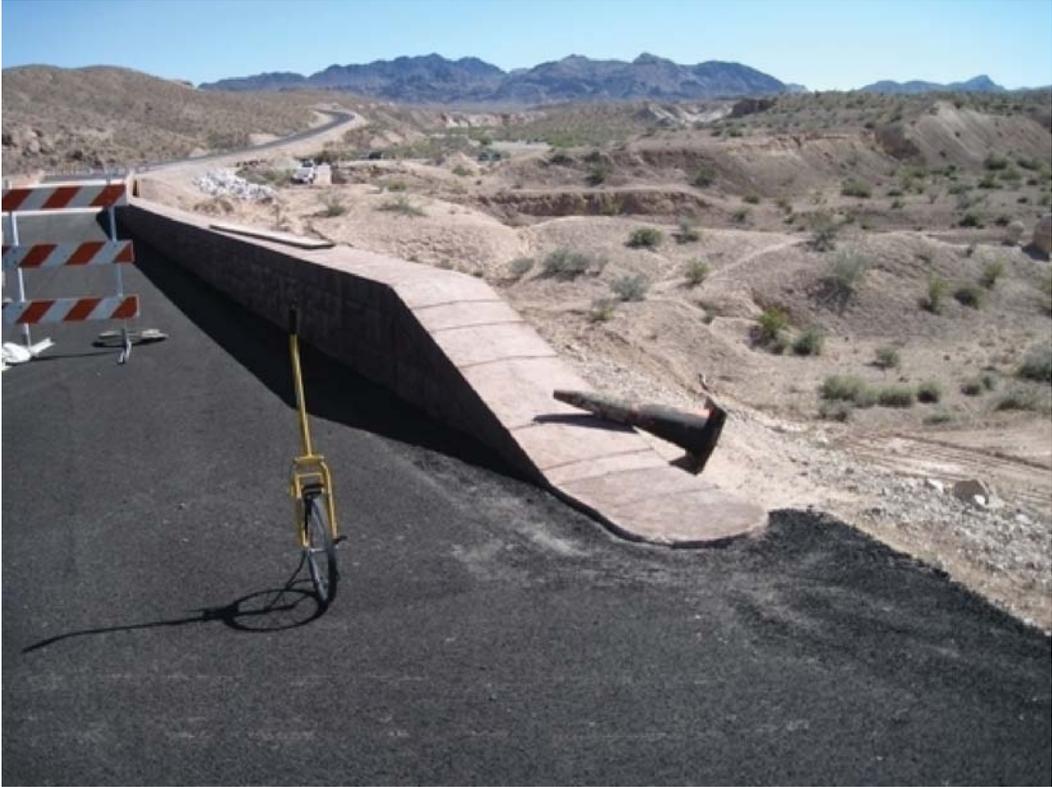
LAKE_0001_33.191_L_1.jpg

Barrier ID:	LAKE-0001-33.191-L				
Route Name:	EB NORTSHORE ROAD				
Inspection Date:	05/04/2010	Barrier Rating:	13.60		
Barrier Description					
Type:	CONCRETE WITH SIMULATED STONE FACE	Barrier Function:	TRAFFIC		
Barrier Material:	CONCRETE	Post Material:	N/A		
Blockout Type:	N/A	Length (ft.):	161		
Speed Limit (MPH):	50	Placement with Respect to Road:	TANGENT		
Hazard Behind Barrier:	MEDIUM				
Barrier Crashworthiness					
Appropriate Test Level:	TL-3	Barrier Test Level:	TL-3	Is Barrier Crashworthy?:	YES
Beg. End Trtmt Type:	NONE	Is Beg. End Trtmt Crashworthy?:	N/A	Approach Transition Type:	NONE
Ending End Trtmt Type:	NONE	Ending End Trtmt Crashworthy?:	N/A		
Average Measurements					
Design Height (In.):	27	Width (In.):	27.0	Post Spacing (In.):	0.0
Height (In.):	31.7	Lateral Offset (In.):	60.0	Road Grade (%):	2.30
Physical Condition					
Barrier	Alignment and Height:	Alignment acceptable. Height within 3-in of 27-in design height.

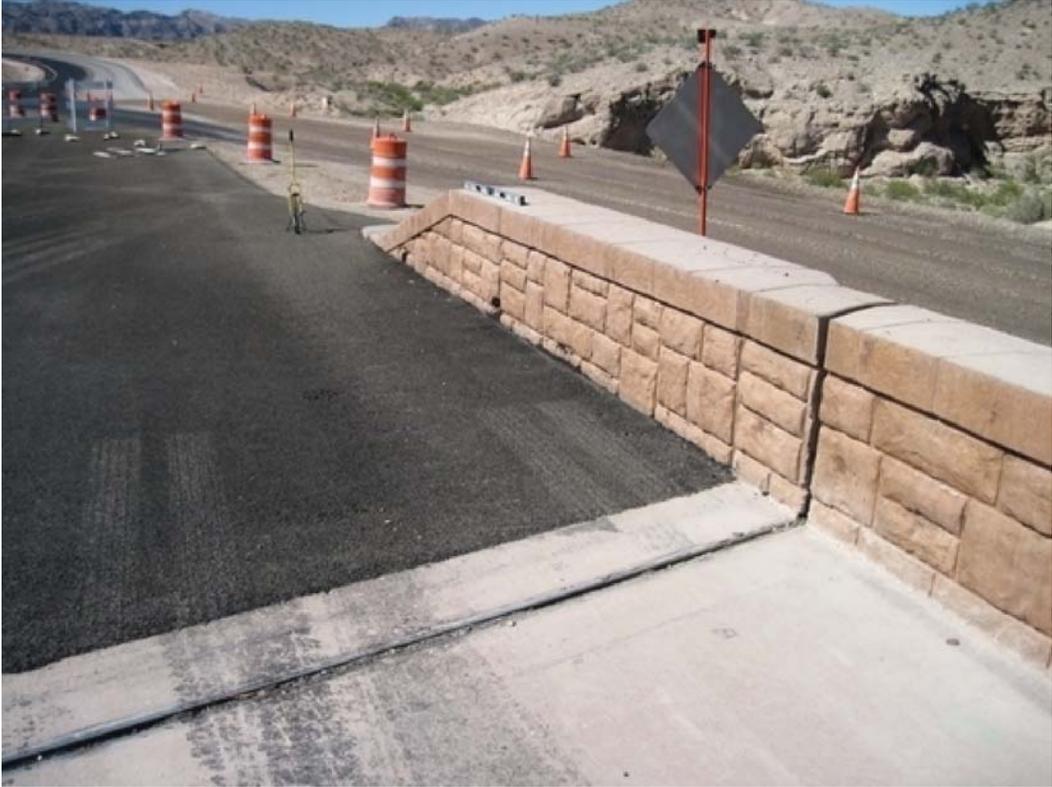
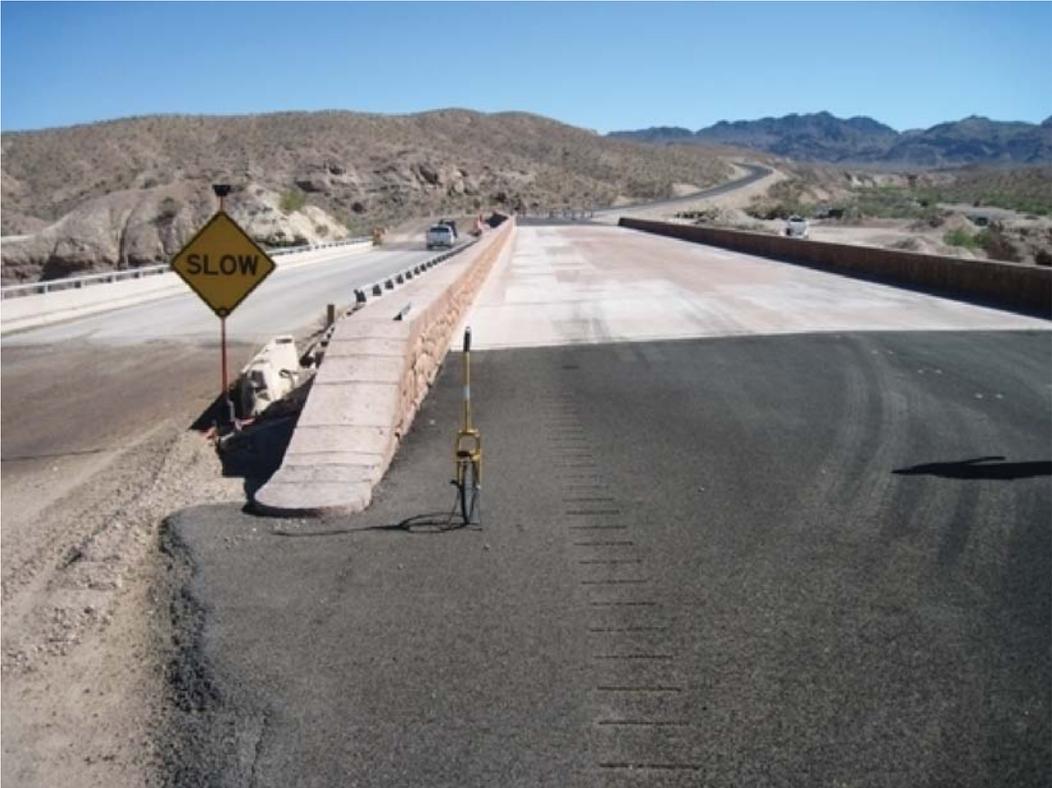
LAKE_0001_33.191_R_1.jpg

Barrier ID:	LAKE-0001-33.191-R				
Route Name:	EB NORTSHORE ROAD				
Inspection Date:	05/04/2010	Barrier Rating:	13.60		
Barrier Description					
Type:	CONCRETE WITH SIMULATED STONE FACE	Barrier Function:	TRAFFIC		
Barrier Material:	CONCRETE	Post Material:	N/A		
Blockout Type:	N/A	Length (ft.):	28		
Speed Limit (MPH):	50	Placement with Respect to Road:	TANGENT		
Hazard Behind Barrier:	MEDIUM				
Barrier Crashworthiness					
Appropriate Test Level:	TL-3	Barrier Test Level:	TL-3	Is Barrier Crashworthy?:	YES
Beg. End Trtmt Type:	NONE	Is Beg. End Trtmt Crashworthy?:	N/A	Approach Transition Type:	NONE
Ending End Trtmt Type:	NONE	Ending End Trtmt Crashworthy?:	N/A		
Average Measurements					
Design Height (In.):	27	Width (In.):	27.0	Post Spacing (In.):	0.0
Height (In.):	31.2	Lateral Offset (In.):	115.3	Road Grade (%):	2.70
Physical Condition					
Barrier	Alignment and Height:	Alignment acceptable. Height within 3-in of 27-in design height.

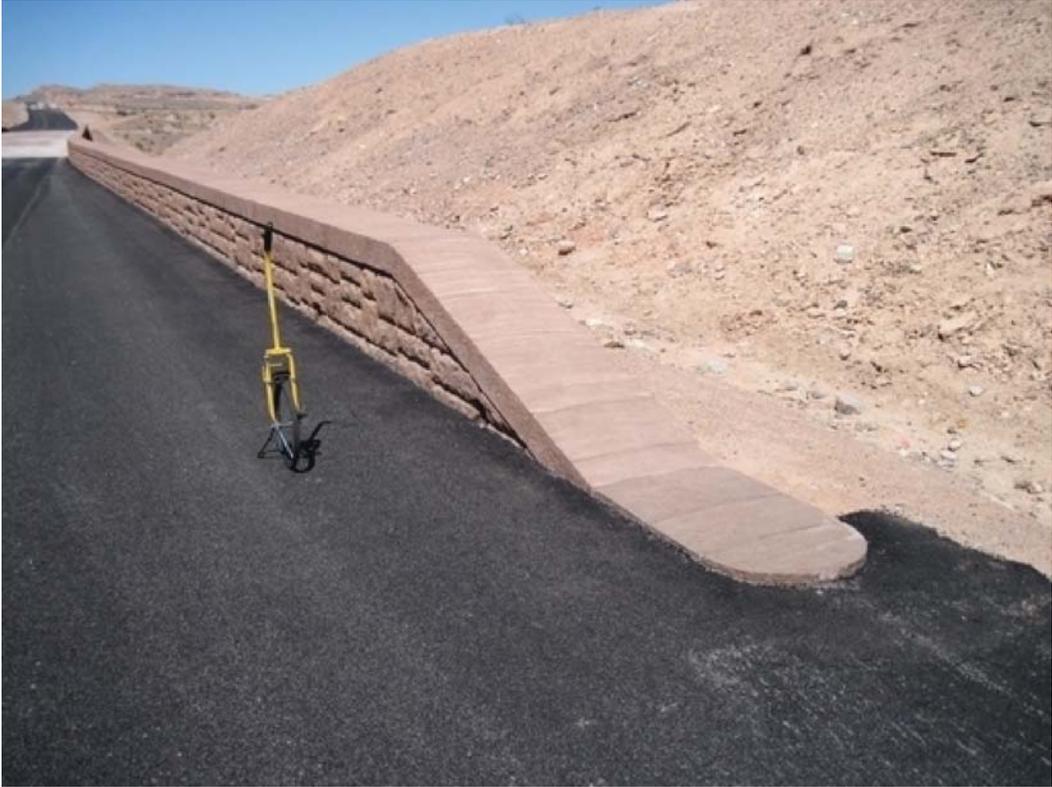
LAKE_0001_42.026_R_1.jpg

Barrier ID:	LAKE-0001-42.026-R				
Route Name:	EB NORTHSORE ROAD				
Inspection Date:	05/04/2010	Barrier Rating:	17.80		
Barrier Description					
Type:	CONCRETE WITH SIMULATED STONE FACE	Barrier Function:	TRAFFIC		
Barrier Material:	CONCRETE	Post Material:	N/A		
Blockout Type:	N/A	Length (ft.):	28		
Speed Limit (MPH):	50	Placement with Respect to Road:	TANGENT		
Hazard Behind Barrier:	MEDIUM				
Barrier Crashworthiness					
Appropriate Test Level:	TL-3	Barrier Test Level:	TL-3	Is Barrier Crashworthy?:	YES
Beg. End Trtmt Type:	NONE	Is Beg. End Trtmt Crashworthy?:	N/A	Approach Transition Type:	NONE
Ending End Trtmt Type:	NONE	Ending End Trtmt Crashworthy?:	N/A		
Average Measurements					
Design Height (In.):	27	Width (In.):	27.0	Post Spacing (In.):	0.0
Height (In.):	30.7	Lateral Offset (In.):	101.6	Road Grade (%):	0.90
Physical Condition					
Barrier	Alignment and Height:	Alignment acceptable. Height within 3-in of 27-in design height.
