LAKE GIP Report

NPS Guardwall/Rail Inventory Program Lake Mead National Recreation Area

**Data Collection Date: May 2010
Report Date: November 2015**

Lake Mead National Recreation Area in Arizona and Nevada

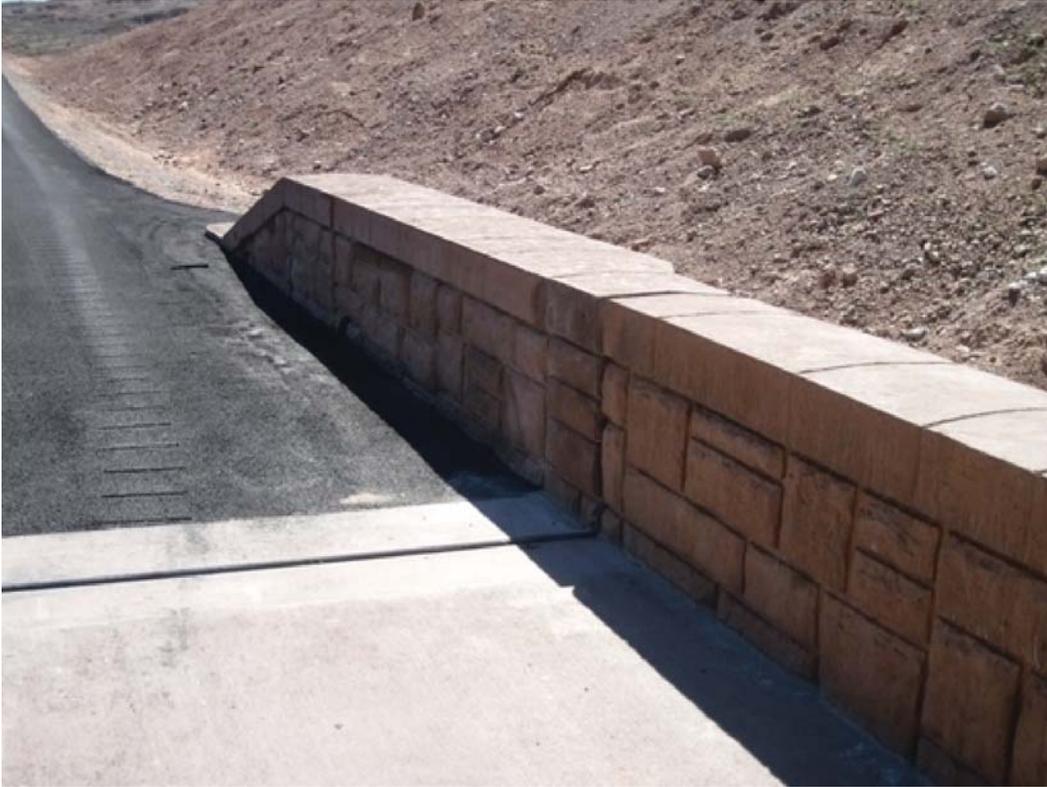
LAKE_0001_42.050_L_1.jpg

Barrier ID:	LAKE-0001-42.050-L				
Route Name:	EB NORTHSORE ROAD				
Inspection Date:	05/04/2010	Barrier Rating:	17.80		
Barrier Description					
Type:	CONCRETE WITH SIMULATED STONE FACE	Barrier Function:	TRAFFIC		
Barrier Material:	CONCRETE	Post Material:	N/A		
Blockout Type:	N/A	Length (ft.):	159		
Speed Limit (MPH):	50	Placement with Respect to Road:	TANGENT		
Hazard Behind Barrier:	MEDIUM				
Barrier Crashworthiness					
Appropriate Test Level:	TL-3	Barrier Test Level:	TL-3	Is Barrier Crashworthy?:	YES
Beg. End Trtmt Type:	NONE	Is Beg. End Trtmt Crashworthy?:	N/A	Approach Transition Type:	NONE
Ending End Trtmt Type:	NONE	Ending End Trtmt Crashworthy?:	N/A		
Average Measurements					
Design Height (In.):	27	Width (In.):	27.0	Post Spacing (In.):	0.0
Height (In.):	30.7	Lateral Offset (In.):	68.3	Road Grade (%):	0.70
Physical Condition					
Barrier	Alignment and Height:	Alignment acceptable. Height within 3-in of 27-in design height.

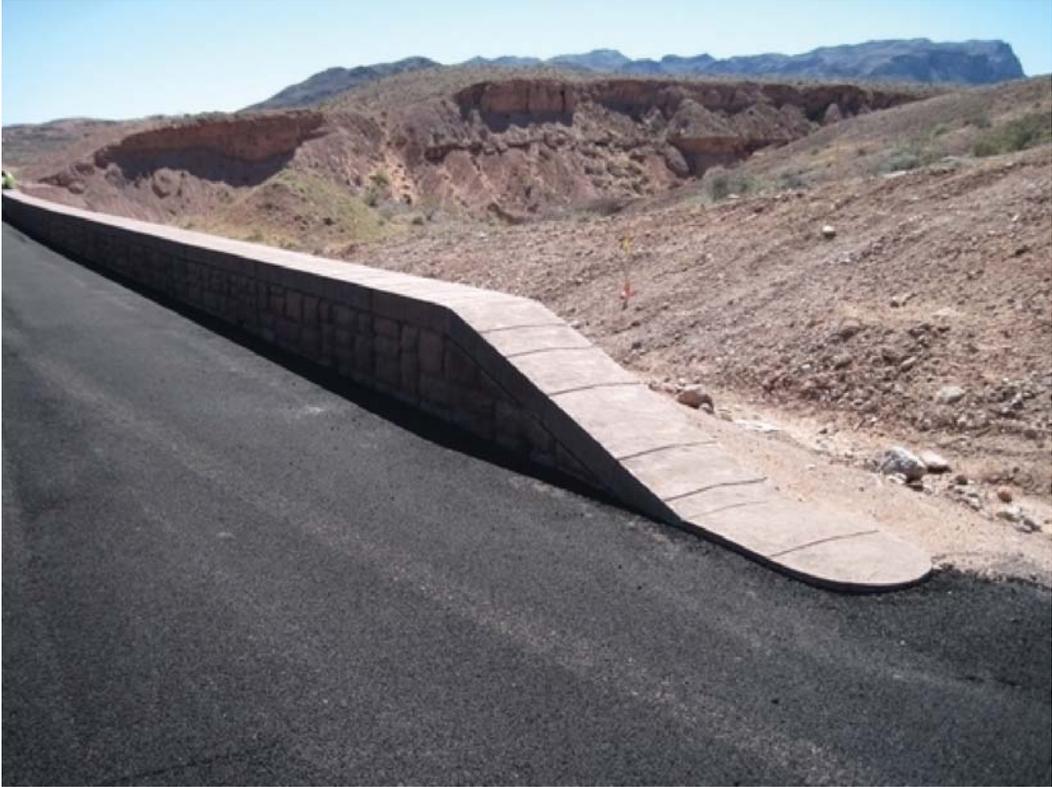
LAKE_0001_42.123_L_1.jpg

Barrier ID:	LAKE-0001-42.123-L				
Route Name:	EB NORTSHORE ROAD				
Inspection Date:	05/04/2010	Barrier Rating:	19.30		
Barrier Description					
Type:	CONCRETE WITH SIMULATED STONE FACE	Barrier Function:	TRAFFIC		
Barrier Material:	CONCRETE	Post Material:	N/A		
Blockout Type:	N/A	Length (ft.):	26		
Speed Limit (MPH):	50	Placement with Respect to Road:	TANGENT		
Hazard Behind Barrier:	N/A				
Barrier Crashworthiness					
Appropriate Test Level:	TL-3	Barrier Test Level:	TL-3	Is Barrier Crashworthy?:	YES
Beg. End Trtmt Type:	NONE	Is Beg. End Trtmt Crashworthy?:	N/A	Approach Transition Type:	NONE
Ending End Trtmt Type:	NONE	Ending End Trtmt Crashworthy?:	N/A		
Average Measurements					
Design Height (In.):	27	Width (In.):	27.0	Post Spacing (In.):	0.0
Height (In.):	31.2	Lateral Offset (In.):	0.0	Road Grade (%):	0.00
Physical Condition					
Barrier	Alignment and Height:	Alignment acceptable. Height within 3-in of 27-in design height.

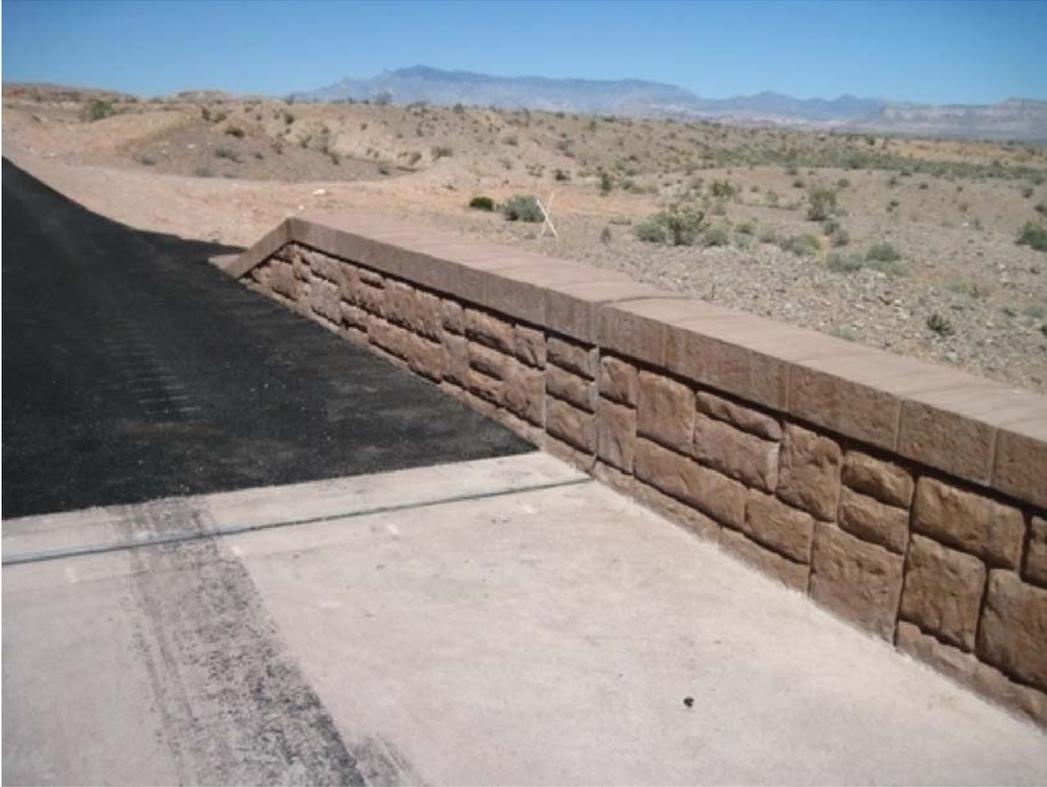
LAKE_0001_42.123_R_1.jpg

Barrier ID:	LAKE-0001-42.123-R				
Route Name:	EB NORTHSORE ROAD				
Inspection Date:	05/04/2010	Barrier Rating:	13.60		
Barrier Description					
Type:	CONCRETE WITH SIMULATED STONE FACE	Barrier Function:	TRAFFIC		
Barrier Material:	CONCRETE	Post Material:	N/A		
Blockout Type:	N/A	Length (ft.):	157		
Speed Limit (MPH):	50	Placement with Respect to Road:	TANGENT		
Hazard Behind Barrier:	MEDIUM				
Barrier Crashworthiness					
Appropriate Test Level:	TL-3	Barrier Test Level:	TL-3	Is Barrier Crashworthy?:	YES
Beg. End Trtmt Type:	NONE	Is Beg. End Trtmt Crashworthy?:	N/A	Approach Transition Type:	NONE
Ending End Trtmt Type:	NONE	Ending End Trtmt Crashworthy?:	N/A		
Average Measurements					
Design Height (In.):	27	Width (In.):	27.0	Post Spacing (In.):	0.0
Height (In.):	31.5	Lateral Offset (In.):	102.3	Road Grade (%):	0.90
Physical Condition					
Barrier	Alignment and Height:	Alignment acceptable. Height within 3-in of 27-in design height.

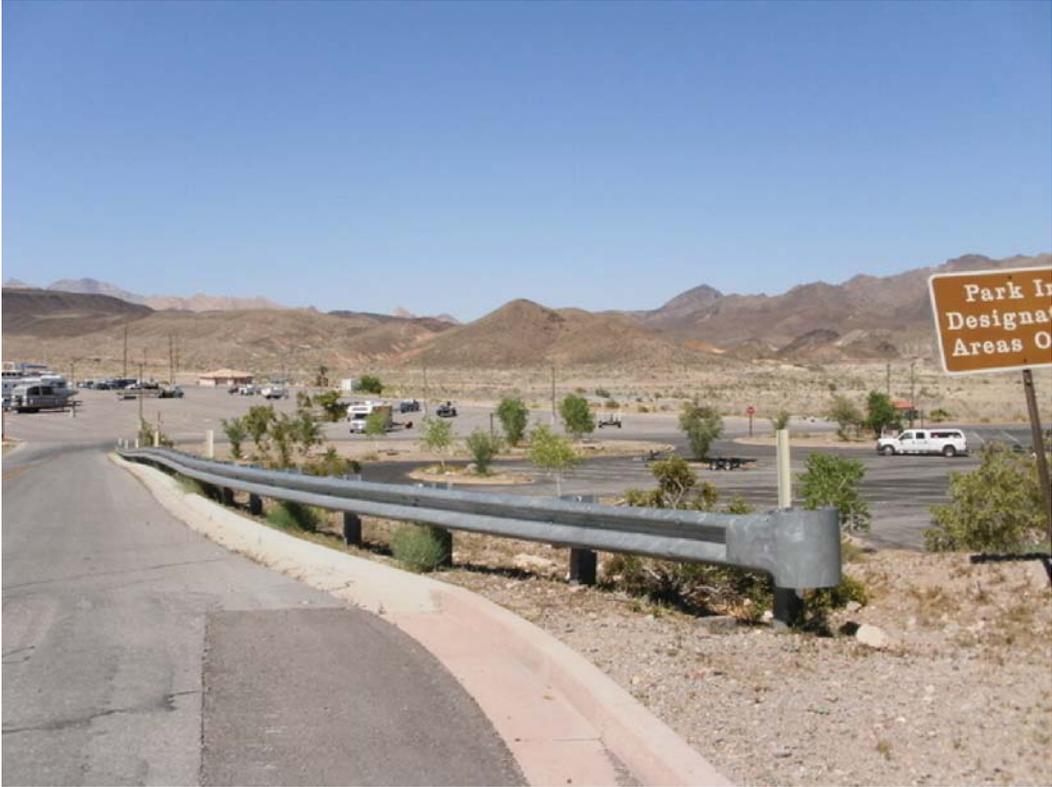
LAKE_0010_4.077_L_1.JPG

Barrier ID:	LAKE-0010-4.077-L				
Route Name:	CB CALLVILLE BAY ACCESS ROAD				
Inspection Date:	05/04/2010	Barrier Rating:	22.70		
Barrier Description					
Type:	W-BEAM STRONG POST	Barrier Function:	TRAFFIC		
Barrier Material:	GALVANIZED STEEL	Post Material:	GALVANIZED STEEL		
Blockout Type:	STEEL	Length (ft.):	238		
Speed Limit (MPH):	15	Placement with Respect to Road:	TANGENT		
Hazard Behind Barrier:	LOW				
Barrier Crashworthiness					
Appropriate Test Level:	TL-1	Barrier Test Level:	TL-3	Is Barrier Crashworthy?:	YES
Beg. End Trtmt Type:	NONE	Is Beg. End Trtmt Crashworthy?:	N/A	Approach Transition Type:	NONE
Ending End Trtmt Type:	NONE	Ending End Trtmt Crashworthy?:	N/A		
Average Measurements					
Design Height (In.):	27	Width (In.):	0.0	Post Spacing (In.):	75.0
Height (In.):	26.7	Lateral Offset (In.):	30.0	Road Grade (%):	6.70
Physical Condition					
Barrier	Alignment and Height:	Alignment acceptable. Height within 1-in of 27-in design height.

Breaking and Cracking:	No breaking or cracking observed.			
	Missing Elements:	No missing elements observed.			
	Corrosion and Weathering:	No corrosion or weathering observed.			
End Treatments	Alignment and Height:				
	Breaking and Cracking:				
	Missing Elements:				
	Corrosion and Weathering:

Repair Action:	NO ACTION	FMSS Work Type:	N/A	Repair Cost:	\$0
Brief Workorder:	N/A				
Workorder:

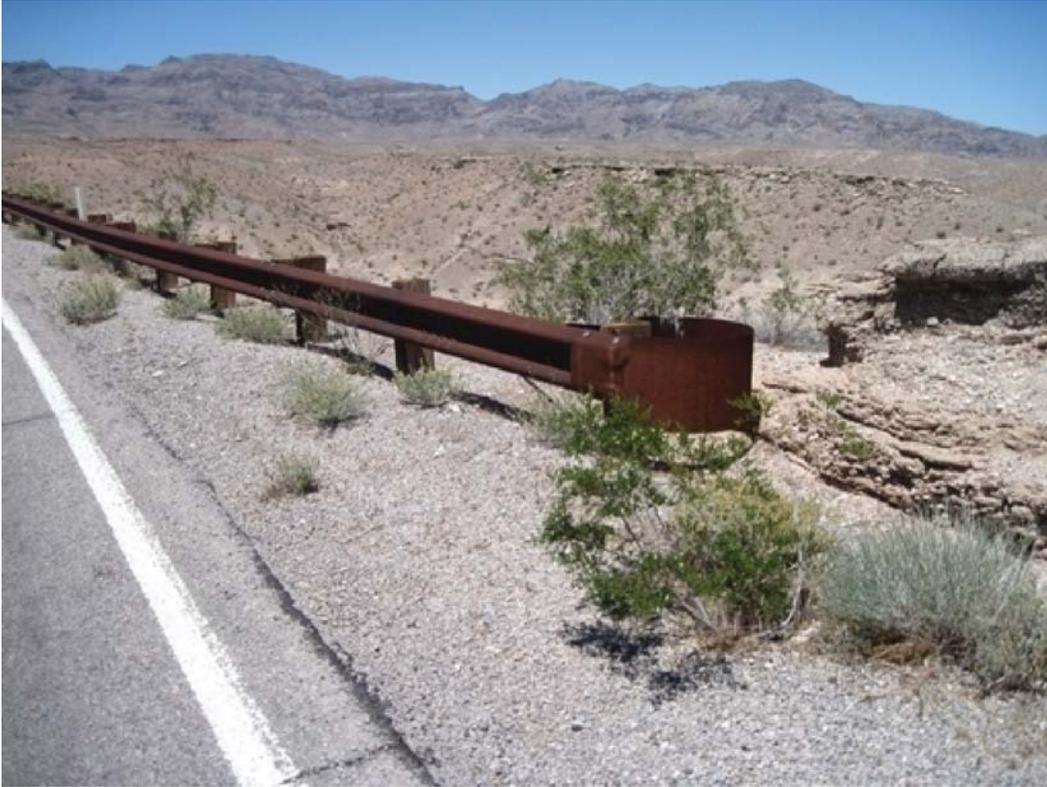
LAKE_0112_2.649_L_1.jpg

Barrier ID:	LAKE-0112-2.649-L				
Route Name:	EB ECHO BAY ACCESS ROAD				
Inspection Date:	05/04/2010	Barrier Rating:	42.40		
Barrier Description					
Type:	W-BEAM STRONG POST	Barrier Function:	TRAFFIC		
Barrier Material:	WEATHERING STEEL/CORTEN	Post Material:	WOOD		
Blockout Type:	WOOD	Length (ft.):	411		
Speed Limit (MPH):	50	Placement with Respect to Road:	OUTSIDE OF CURVE		
Hazard Behind Barrier:	MEDIUM				
Barrier Crashworthiness					
Appropriate Test Level:	TL-3	Barrier Test Level:	TL-3	Is Barrier Crashworthy?:	YES
Beg. End Trtmt Type:	W-BEAM BCT	Is Beg. End Trtmt Crashworthy?:	NO	Approach Transition Type:	NONE
Ending End Trtmt Type:	W-BEAM BCT	Ending End Trtmt Crashworthy?:	NO		
Average Measurements					
Design Height (In.):	27	Width (In.):	0.0	Post Spacing (In.):	74.3
Height (In.):	23.0	Lateral Offset (In.):	51.7	Road Grade (%):	1.90
Physical Condition					
Barrier	Alignment and Height:	The alignment is good. The height is between 2 and 5 in below the 27 in design height for the entire barrier.

Breaking and Cracking:	No breaking or cracking observed			
	Missing Elements:	No missing elements observed.			
	Corrosion and Weathering:	No corrosion or weathering observed.			
End Treatments	Alignment and Height:	The alignment of the end treatments is good. The height for both end treatments is 5 in below the 27 in design height.			
	Breaking and Cracking:	No breaks or cracks were observed in the end treatments.			
	Missing Elements:	No missing end treatment elements observed.			
	Corrosion and Weathering:	No corrosion or weathering observed in end treatments.

Repair Action:	REPAIR	FMSS Work Type:	DEFERRED MAINTENANCE	Repair Cost:	\$9691
Brief Workorder:	Adjust the height of the entire barrier up to 27-in. design height.				
Workorder:	Adjust Guardrail at \$10- per -Lin. Ft. for 411 LF = \$4110. Adjust the height of the entire barrier. High Speed Traffic Control at \$2350- per -Day for 2 Day(s) = \$4700.

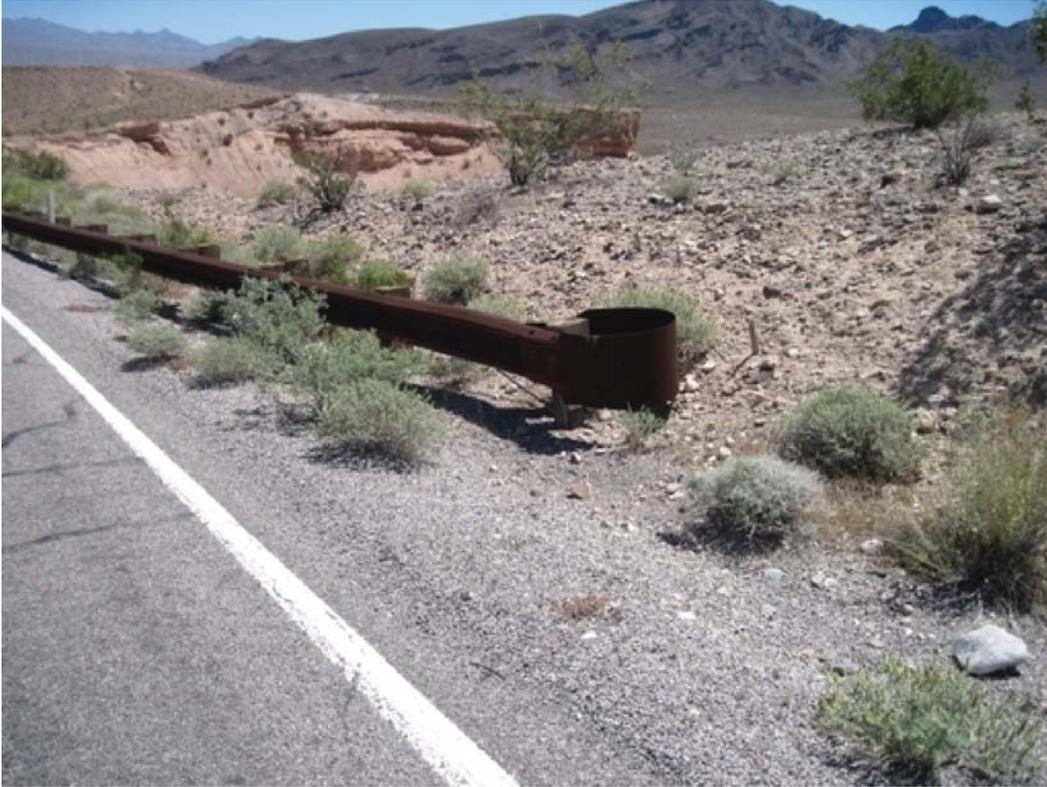
LAKE_0112_3.010_R_1.jpg

Barrier ID:	LAKE-0112-3.010-R				
Route Name:	EB ECHO BAY ACCESS ROAD				
Inspection Date:	05/04/2010	Barrier Rating:	41.50		
Barrier Description					
Type:	W-BEAM STRONG POST	Barrier Function:	TRAFFIC		
Barrier Material:	WEATHERING STEEL/CORTEN	Post Material:	WOOD		
Blockout Type:	WOOD	Length (ft.):	512		
Speed Limit (MPH):	50	Placement with Respect to Road:	INSIDE OF CURVE		
Hazard Behind Barrier:	HIGH				
Barrier Crashworthiness					
Appropriate Test Level:	TL-3	Barrier Test Level:	TL-3	Is Barrier Crashworthy?:	YES
Beg. End Trtmt Type:	W-BEAM BCT	Is Beg. End Trtmt Crashworthy?:	NO	Approach Transition Type:	NONE
Ending End Trtmt Type:	W-BEAM BCT	Ending End Trtmt Crashworthy?:	NO		
Average Measurements					
Design Height (In.):	27	Width (In.):	0.0	Post Spacing (In.):	75.0
Height (In.):	24.0	Lateral Offset (In.):	35.0	Road Grade (%):	5.00
Physical Condition					
Barrier	Alignment and Height:	The alignment is acceptable. 449-ft is 3 in below the 27 in design height.

Breaking and Cracking:	63 ft of barrier has been impacted. 2 posts are cracked more than 1/2 in.			
	Missing Elements:	No missing elements observed.			
	Corrosion and Weathering:	No corrosion or weathering observed.			
End Treatments	Alignment and Height:	The alignment is acceptable. Height is 3 in below the 27 in design height.			
	Breaking and Cracking:	The beginning end treatment rail is bent and/scraped for 25 LF.			
	Missing Elements:	End treatment cable is not attached.			
	Corrosion and Weathering:	No corrosion or weathering observed in end treatments.

Repair Action:	REPAIR	FMSS Work Type:	DEFERRED MAINTENANCE	Repair Cost:	\$16786
Brief Workorder:	Replace 63 ft. of barrier raise 449 ft. of barrier up to 27-in. design height and reattach the end treatment cable.				
Workorder:	<p>Remove Guardrail at \$10- per -Lin. Ft. for 63 LF = \$630. Remove the impacted sections of barrier.</p> <p>W-Beam Strong Post at \$35- per -Lin. Ft. for 63 LF = \$2205. Replace the impacted sections of barrier.</p> <p>Adjust Guardrail at \$10- per -Lin. Ft. for 449 LF = \$4490. Raise 449 ft. of barrier to 27-in. design height.</p> <p>Replace Post at \$100- per -Each for 2 Post(s) = \$200. Replace the damaged post.</p> <p>Replace Rail at \$25- per -Lin. Ft. for 25 LF = \$625. Replace the bent rail on the beginning end treatment.</p> <p>Labor at \$60- per -Hour for 1 Hrs = \$60. Reattach the cable on the end treatment.</p> <p>High Speed Traffic Control at \$2350- per -Day for 3 Day(s) = \$7050.</p>

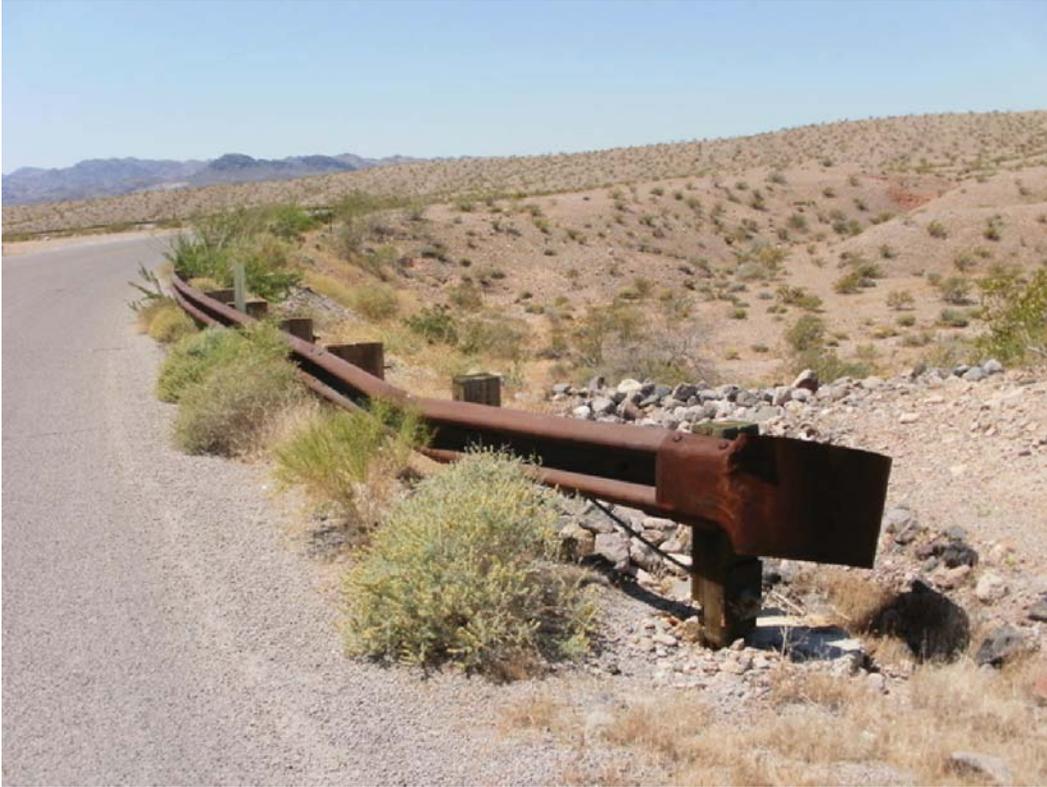
LAKE_0203_0.077_R_1.JPG

Barrier ID:	LAKE-0203-0.077-R				
Route Name:	LV GOVERNMENT WASH ROAD				
Inspection Date:	05/04/2010	Barrier Rating:	39.50		
Barrier Description					
Type:	W-BEAM STRONG POST	Barrier Function:	TRAFFIC		
Barrier Material:	WEATHERING STEEL/CORTEN	Post Material:	WOOD		
Blockout Type:	WOOD	Length (ft.):	1155		
Speed Limit (MPH):	25	Placement with Respect to Road:	OUTSIDE OF CURVE		
Hazard Behind Barrier:	MEDIUM				
Barrier Crashworthiness					
Appropriate Test Level:	TL-1	Barrier Test Level:	TL-3	Is Barrier Crashworthy?:	YES
Beg. End Trtmt Type:	W-BEAM BCT	Is Beg. End Trtmt Crashworthy?:	NO	Approach Transition Type:	NONE
Ending End Trtmt Type:	W-BEAM BCT	Ending End Trtmt Crashworthy?:	NO		
Average Measurements					
Design Height (In.):	27	Width (In.):	0.0	Post Spacing (In.):	74.8
Height (In.):	24.7	Lateral Offset (In.):	41.2	Road Grade (%):	0.90
Physical Condition					
Barrier	Alignment and Height:	38 ft of barrier is more than 6 in. out of alignment in impact area. 24 ft of barrier is 3 to 6 in. out of alignment in second impact area. Barrier is below 27-in. design height by more than 1 to 3 in. for 524 lin ft and below by 3 to 4 in. for 146 lin ft

Breaking and Cracking:	2 broken blocks and 50 ft of bent rail in impact zones.			
	Missing Elements:	No missing elements observed.			
	Corrosion and Weathering:	No corrosion or weathering observed in barrier. 2-in gravel buildup in front of 67-ft. of barrier.			
End Treatments	Alignment and Height:	Approach end out of alignment by more than 6 in and height is below 27 in design height by 4 inches.			
	Breaking and Cracking:	1 broken post and severely bent BCT buffer end in impact zone at approach end.			
	Missing Elements:	1 missing block in approach end.			
	Corrosion and Weathering:	No corrosion or weathering observed in end treatments.

Repair Action:	REPAIR	FMSS Work Type:	DEFERRED MAINTENANCE	Repair Cost:	\$23353
Brief Workorder:	Replace damaged end treatment 50 ft. of rail 2 blocks and raise 670 ft. of barrier up to the 27 inch design height.				
Workorder:	<p>Replace Rail at \$25- per -Lin. Ft. for 50 LF = \$1250. Replace 50 feet of damaged rail in 2 impact zones</p> <p>Replace Block at \$30- per -Each for 2 Block(s) = \$60. Replace 2 broken blocks</p> <p>Adjust Guardrail at \$10- per -Lin. Ft. for 670 LF = \$6700. Raise 670 ft. of barrier up to 27-in design height.</p> <p>Loader at \$125- per -Hour for 4 Hrs = \$500. Move 2 inch depth of gravel from in front of 67 linear ft of barrier</p> <p>W-beam flared 350 compliant at \$3500- per -Each for 1 Unit(s) = \$3500. Replace bent and broken approach end treatment</p> <p>Remove Guardrail at \$10- per -Lin. Ft. for 37 LF = \$370. Remove impacted end treatment in preparation for the new one.</p> <p>Low Speed Traffic Control at \$1475- per -Day for 6 Day(s) = \$8850. 3 days to raise guardrail 2 days to replace end treatment 1 day for remaining work.</p>

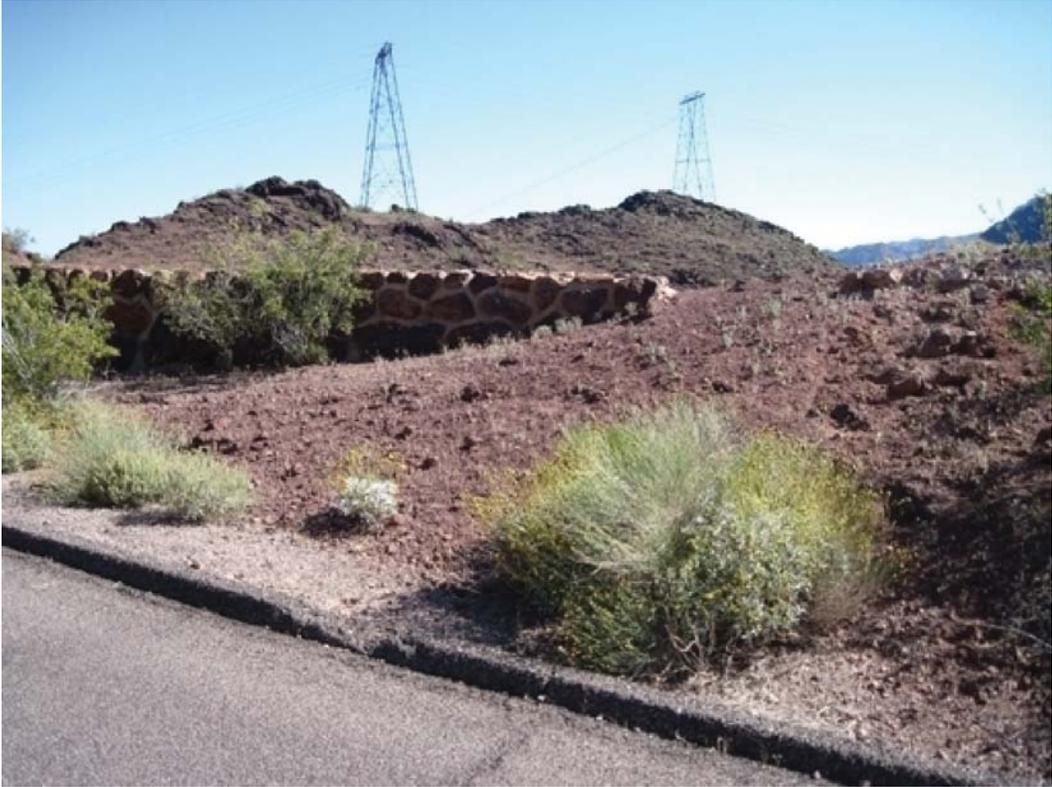
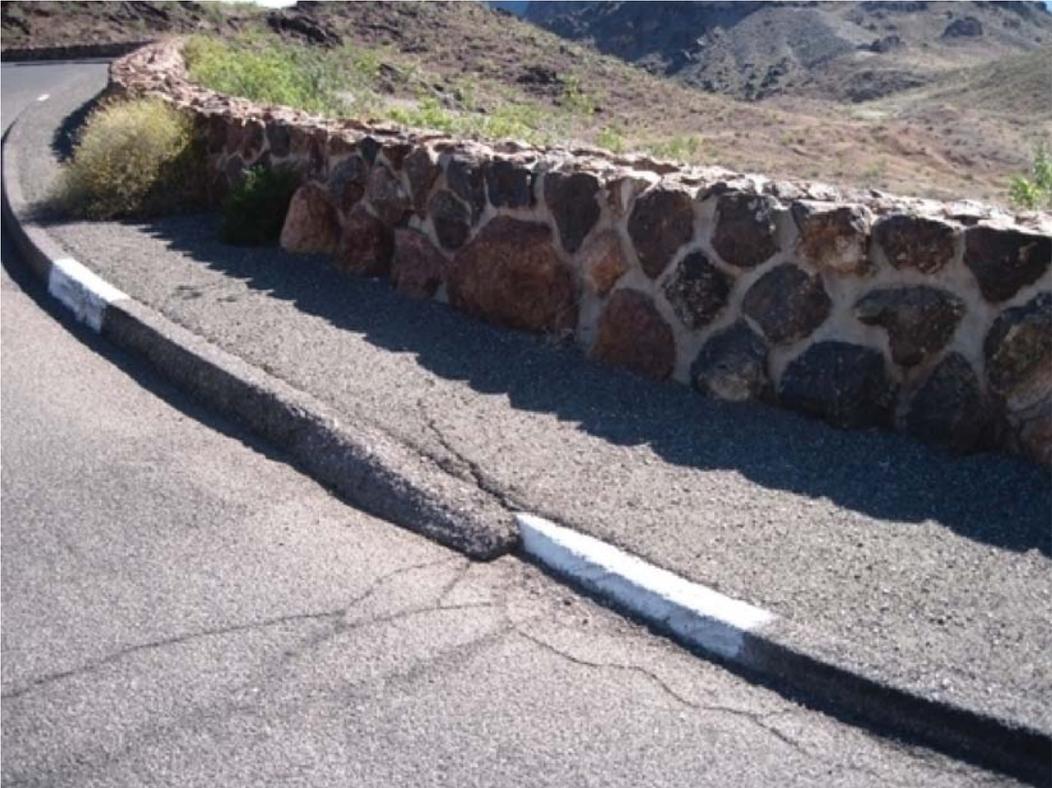
Barrier ID:	LAKE-0233-0.181-R				
Route Name:	BB LAKE VIEW ROAD				
Inspection Date:	05/04/2010	Barrier Rating:	15.00		
Barrier Description					
Type:	STONE MASONRY WITHOUT CONCRETE CORE WALL	Barrier Function:	TRAFFIC		
Barrier Material:	STONE	Post Material:	N/A		
Blockout Type:	N/A	Length (ft.):	204		
Speed Limit (MPH):	20	Placement with Respect to Road:	TANGENT		
Hazard Behind Barrier:	MEDIUM				
Barrier Crashworthiness					
Appropriate Test Level:	TL-1	Barrier Test Level:	NCW	Is Barrier Crashworthy?:	NO
Beg. End Trtmt Type:	NONE	Is Beg. End Trtmt Crashworthy?:	N/A	Approach Transition Type:	NONE
Ending End Trtmt Type:	NONE	Ending End Trtmt Crashworthy?:	N/A		
Average Measurements					
Design Height (In.):	24	Width (In.):	32.0	Post Spacing (In.):	0.0
Height (In.):	38.7	Lateral Offset (In.):	84.0	Road Grade (%):	5.80
Physical Condition					
Barrier	Alignment and Height:	The alignment had less than 6 in of deflection. The height of the barrier is between 37 and 40 in which appears to be the height it was designed to.

Breaking and Cracking:	No breaking or cracking observed.			
	Missing Elements:	No missing elements observed.			
	Corrosion and Weathering:	No corrosion or weathering observed.			
End Treatments	Alignment and Height:				
	Breaking and Cracking:				
	Missing Elements:				
	Corrosion and Weathering:

Barrier ID:	LAKE-0233-0.181-R				
Route Name:	BB LAKE VIEW ROAD				
Inspection Date:	05/04/2010	Barrier Rating:		15.00	
Repair Recommendations					
Repair Action:	NO ACTION	FMSS Work Type:	N/A	Repair Cost:	\$0
Brief Workorder:	N/A				
Workorder:	No Action

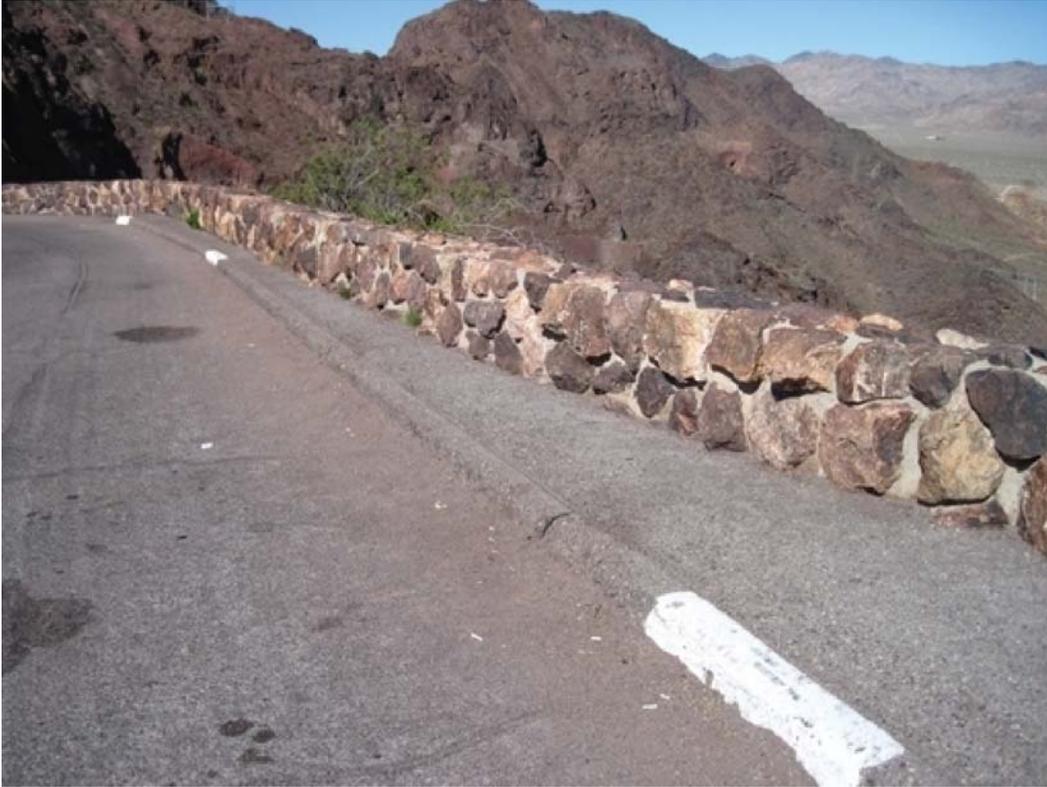
LAKE_0233_0.247_R_1.jpg

Barrier ID:	LAKE-0233-0.247-R				
Route Name:	BB LAKE VIEW ROAD				
Inspection Date:	05/04/2010	Barrier Rating:	24.10		
Barrier Description					
Type:	STONE MASONRY WITHOUT CONCRETE CORE WALL	Barrier Function:	TRAFFIC		
Barrier Material:	STONE	Post Material:	N/A		
Blockout Type:	N/A	Length (ft.):	132		
Speed Limit (MPH):	20	Placement with Respect to Road:	OUTSIDE OF CURVE		
Hazard Behind Barrier:	HIGH				
Barrier Crashworthiness					
Appropriate Test Level:	TL-1	Barrier Test Level:	NCW	Is Barrier Crashworthy?:	NO
Beg. End Trtmt Type:	NONE	Is Beg. End Trtmt Crashworthy?:	N/A	Approach Transition Type:	NONE
Ending End Trtmt Type:	NONE	Ending End Trtmt Crashworthy?:	N/A		
Average Measurements					
Design Height (In.):	24	Width (In.):	30.0	Post Spacing (In.):	0.0
Height (In.):	30.7	Lateral Offset (In.):	40.7	Road Grade (%):	0.20
Physical Condition					
Barrier	Alignment and Height:	The alignment had less than 6-in deflection. Height is between 28-35-in which appears to be the height it was designed to.

Breaking and Cracking:	No breaking or cracking observed.			
	Missing Elements:	No missing elements observed.			
	Corrosion and Weathering:	No corrosion or weathering observed.			
End Treatments	Alignment and Height:				
	Breaking and Cracking:				
	Missing Elements:				
	Corrosion and Weathering:

Repair Action:	NO ACTION	FMSS Work Type:	N/A	Repair Cost:	\$0
Brief Workorder:	N/A				
Workorder:

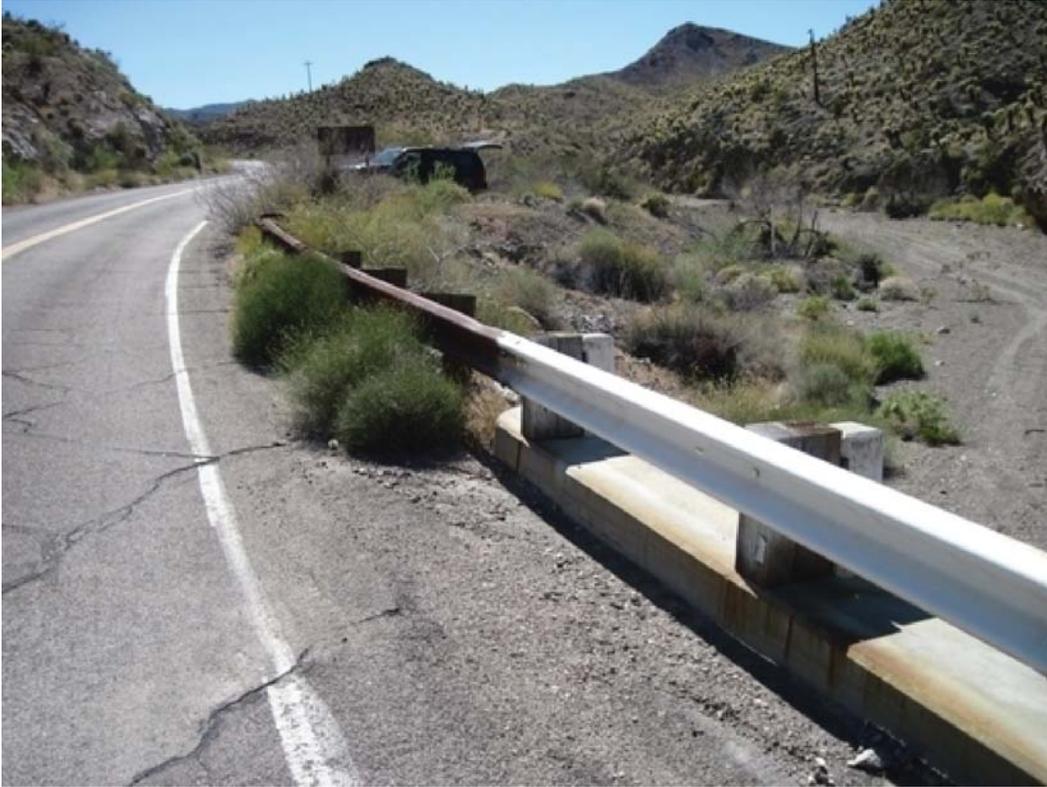
LAKE_0235_0.011_L_1.jpg

Barrier ID:	LAKE-0235-0.011-L				
Route Name:	CC EL DORADO CANYON ROAD				
Inspection Date:	05/05/2010	Barrier Rating:	13.60		
Barrier Description					
Type:	W-BEAM STRONG POST	Barrier Function:	TRAFFIC		
Barrier Material:	WEATHERING STEEL/CORTEN	Post Material:	WOOD		
Blockout Type:	WOOD	Length (ft.):	40		
Speed Limit (MPH):	35	Placement with Respect to Road:	TANGENT		
Hazard Behind Barrier:	MEDIUM				
Barrier Crashworthiness					
Appropriate Test Level:	TL-2	Barrier Test Level:	TL-3	Is Barrier Crashworthy?:	YES
Beg. End Trtmt Type:	NONE	Is Beg. End Trtmt Crashworthy?:	N/A	Approach Transition Type:	NONE
Ending End Trtmt Type:	NONE	Ending End Trtmt Crashworthy?:	N/A		
Average Measurements					
Design Height (In.):	27	Width (In.):	0.0	Post Spacing (In.):	75.0
Height (In.):	29.0	Lateral Offset (In.):	55.7	Road Grade (%):	5.80
Physical Condition					
Barrier	Alignment and Height:	Alignment acceptable. Height within 1-in of 27-in design height.

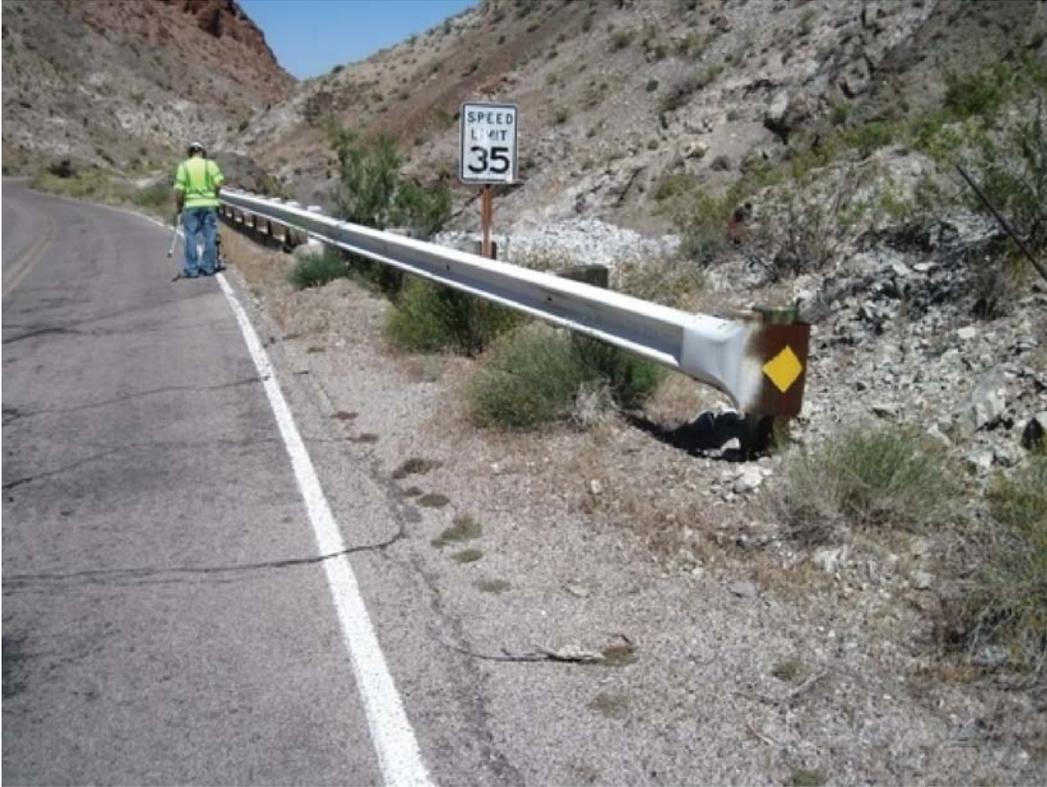
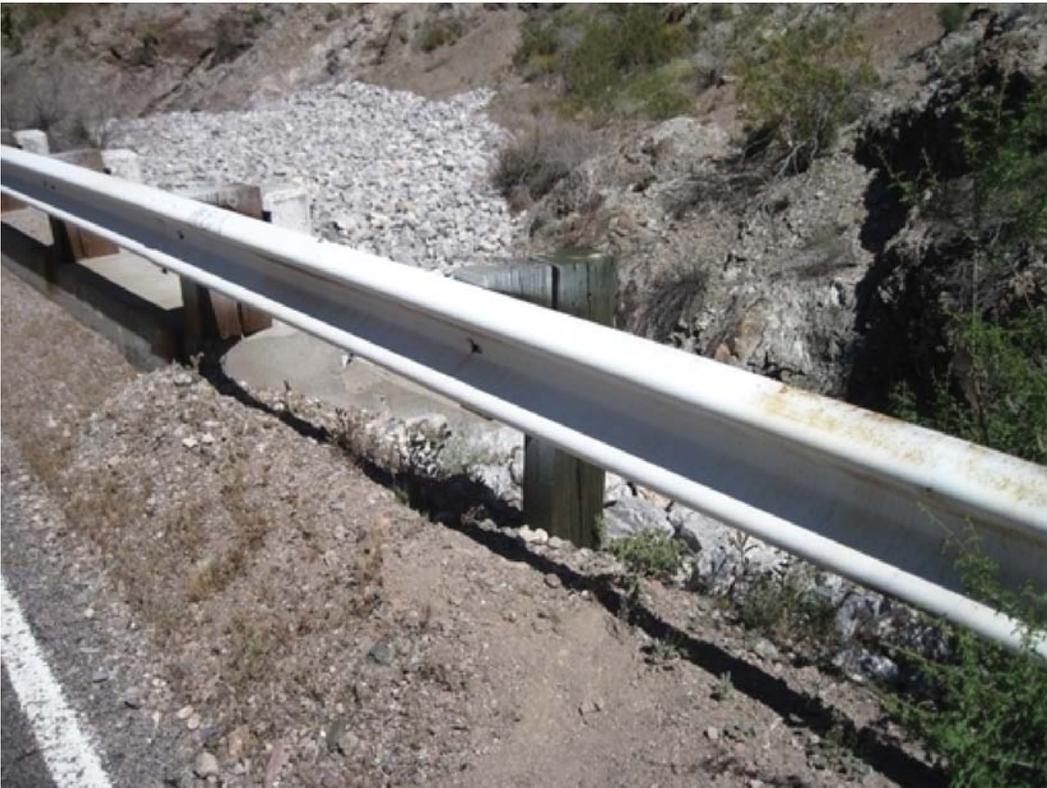
Barrier ID:	LAKE-0235-0.020-R				
Route Name:	CC EL DORADO CANYON ROAD				
Inspection Date:	05/05/2010	Barrier Rating:	19.70		
Barrier Description					
Type:	W-BEAM STRONG POST	Barrier Function:	TRAFFIC		
Barrier Material:	WEATHERING STEEL/CORTEN	Post Material:	WOOD		
Blockout Type:	WOOD	Length (ft.):	38		
Speed Limit (MPH):	35	Placement with Respect to Road:	TANGENT		
Hazard Behind Barrier:	HIGH				
Barrier Crashworthiness					
Appropriate Test Level:	TL-2	Barrier Test Level:	TL-3	Is Barrier Crashworthy?:	YES
Beg. End Trtmt Type:	NONE	Is Beg. End Trtmt Crashworthy?:	N/A	Approach Transition Type:	NONE
Ending End Trtmt Type:	NONE	Ending End Trtmt Crashworthy?:	N/A		
Average Measurements					
Design Height (In.):	27	Width (In.):	0.0	Post Spacing (In.):	74.6
Height (In.):	33.0	Lateral Offset (In.):	49.0	Road Grade (%):	4.50
Physical Condition					
Barrier	Alignment and Height:	The alignment is acceptable but the entire length of the barrier is between 4 and 9 in above the 27 in design height.

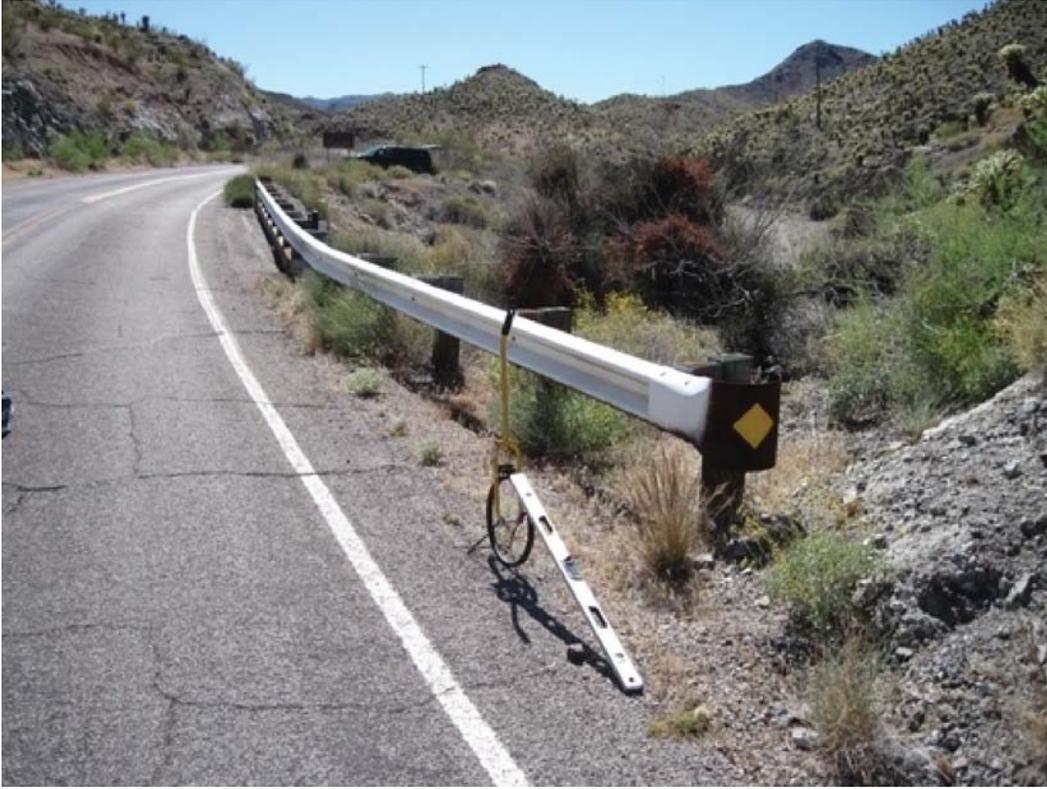
LAKE_0235_0.028_L_1.jpg

Barrier ID:	LAKE-0235-0.028-L				
Route Name:	CC EL DORADO CANYON ROAD				
Inspection Date:	05/05/2010	Barrier Rating:	15.10		
Barrier Description					
Type:	W-BEAM STRONG POST	Barrier Function:	TRAFFIC		
Barrier Material:	WEATHERING STEEL/CORTEN	Post Material:	WOOD		
Blockout Type:	WOOD	Length (ft.):	38		
Speed Limit (MPH):	35	Placement with Respect to Road:	INSIDE OF CURVE		
Hazard Behind Barrier:	MEDIUM				
Barrier Crashworthiness					
Appropriate Test Level:	TL-2	Barrier Test Level:	TL-3	Is Barrier Crashworthy?:	YES
Beg. End Trtmt Type:	NONE	Is Beg. End Trtmt Crashworthy?:	N/A	Approach Transition Type:	NONE
Ending End Trtmt Type:	W-BEAM BCT	Ending End Trtmt Crashworthy?:	N/A		
Average Measurements					
Design Height (In.):	27	Width (In.):	0.0	Post Spacing (In.):	74.0
Height (In.):	27.5	Lateral Offset (In.):	45.7	Road Grade (%):	5.80
Physical Condition					
Barrier	Alignment and Height:	Alignment acceptable. Height within 1-in of 27-in design height.

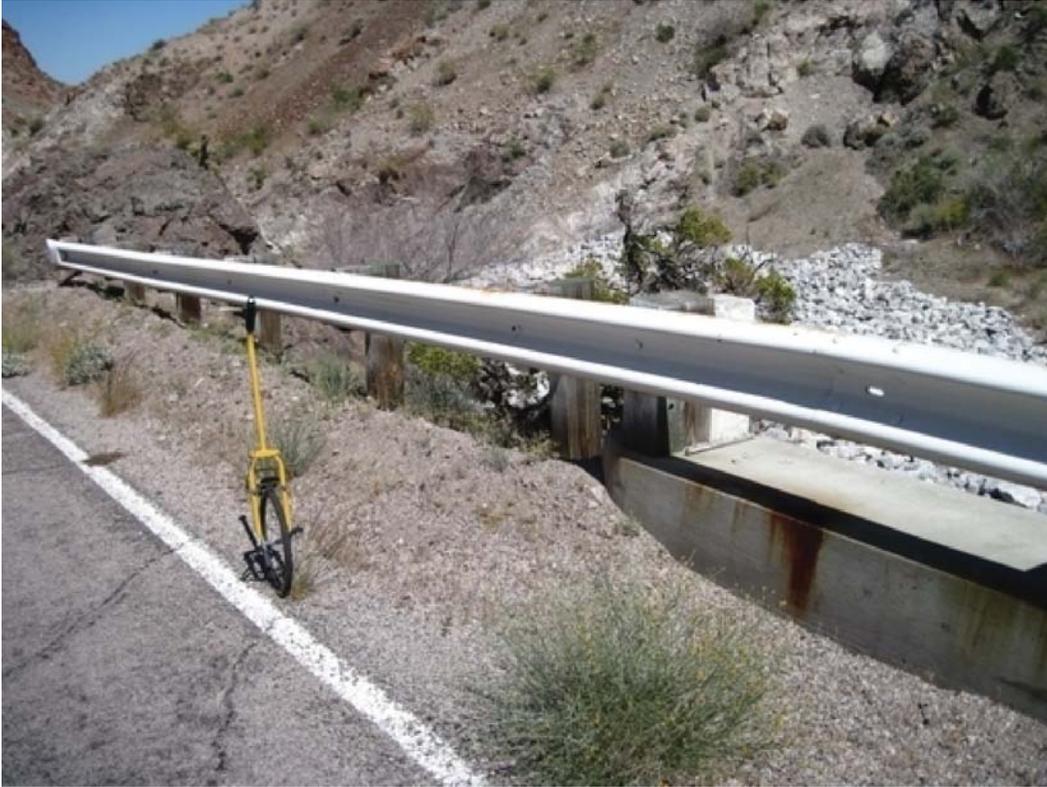
LAKE_0235_0.034_R_1.jpg

Barrier ID:	LAKE-0235-0.034-R				
Route Name:	CC EL DORADO CANYON ROAD				
Inspection Date:	05/05/2010	Barrier Rating:	26.60		
Barrier Description					
Type:	W-BEAM STRONG POST	Barrier Function:	TRAFFIC		
Barrier Material:	WEATHERING STEEL/CORTEN	Post Material:	WOOD		
Blockout Type:	WOOD	Length (ft.):	33		
Speed Limit (MPH):	35	Placement with Respect to Road:	OUTSIDE OF CURVE		
Hazard Behind Barrier:	MEDIUM				
Barrier Crashworthiness					
Appropriate Test Level:	TL-2	Barrier Test Level:	TL-3	Is Barrier Crashworthy?:	YES
Beg. End Trtmt Type:	NONE	Is Beg. End Trtmt Crashworthy?:	N/A	Approach Transition Type:	NONE
Ending End Trtmt Type:	NONE	Ending End Trtmt Crashworthy?:	N/A		
Average Measurements					
Design Height (In.):	27	Width (In.):	0.0	Post Spacing (In.):	74.3
Height (In.):	35.7	Lateral Offset (In.):	55.2	Road Grade (%):	7.10
Physical Condition					
Barrier	Alignment and Height:	The alignment has less than 6 in of deflection. The barrier height is between 35 and 37 in which is 8-10-in. above the 27-in. design height.

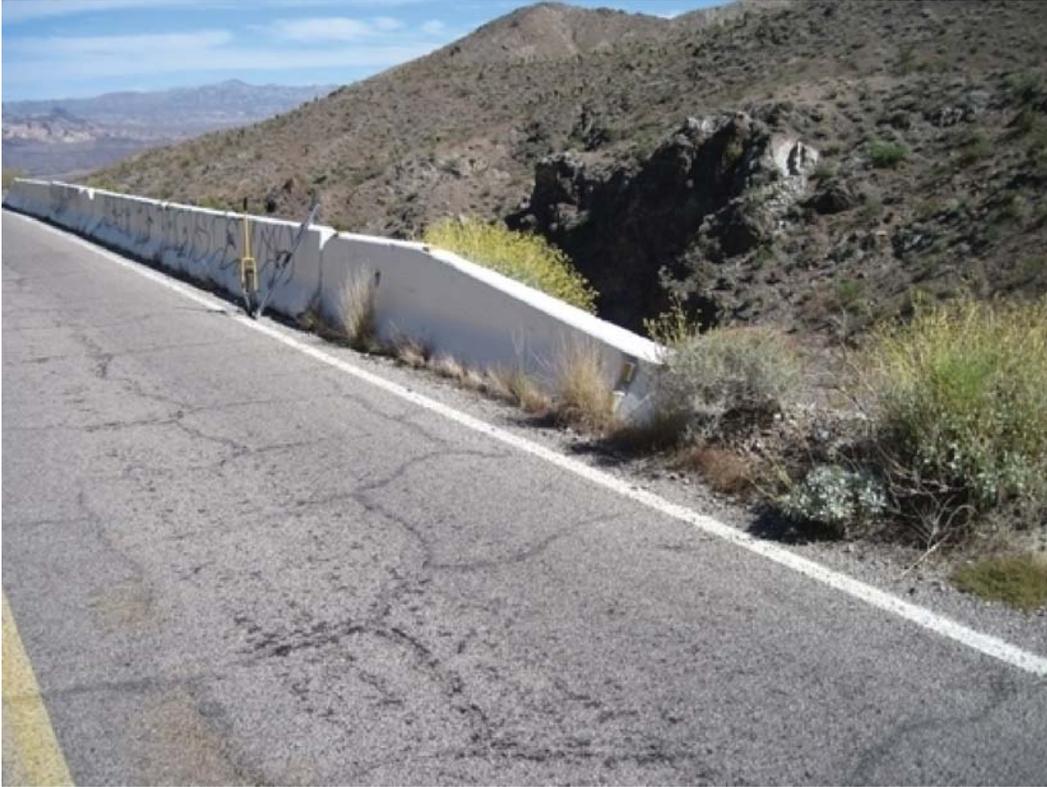
LAKE_0235_1.178_R_1.jpg

Barrier ID:	LAKE-0235-1.178-R				
Route Name:	CC EL DORADO CANYON ROAD				
Inspection Date:	05/05/2010	Barrier Rating:	24.00		
Barrier Description					
Type:	CONCRETE BARRIER	Barrier Function:	TRAFFIC		
Barrier Material:	CONCRETE	Post Material:	N/A		
Blockout Type:	N/A	Length (ft.):	108		
Speed Limit (MPH):	35	Placement with Respect to Road:	INSIDE OF CURVE		
Hazard Behind Barrier:	HIGH				
Barrier Crashworthiness					
Appropriate Test Level:	TL-2	Barrier Test Level:	TL-3	Is Barrier Crashworthy?:	YES
Beg. End Trtmt Type:	NONE	Is Beg. End Trtmt Crashworthy?:	N/A	Approach Transition Type:	NONE
Ending End Trtmt Type:	NONE	Ending End Trtmt Crashworthy?:	N/A		
Average Measurements					
Design Height (In.):	32	Width (In.):	6.0	Post Spacing (In.):	0.0
Height (In.):	32.2	Lateral Offset (In.):	13.6	Road Grade (%):	1.80
Physical Condition					
Barrier	Alignment and Height:	The concrete barriers are misaligned slightly but not significantly. The height was within 1-in of the 32-in design height.

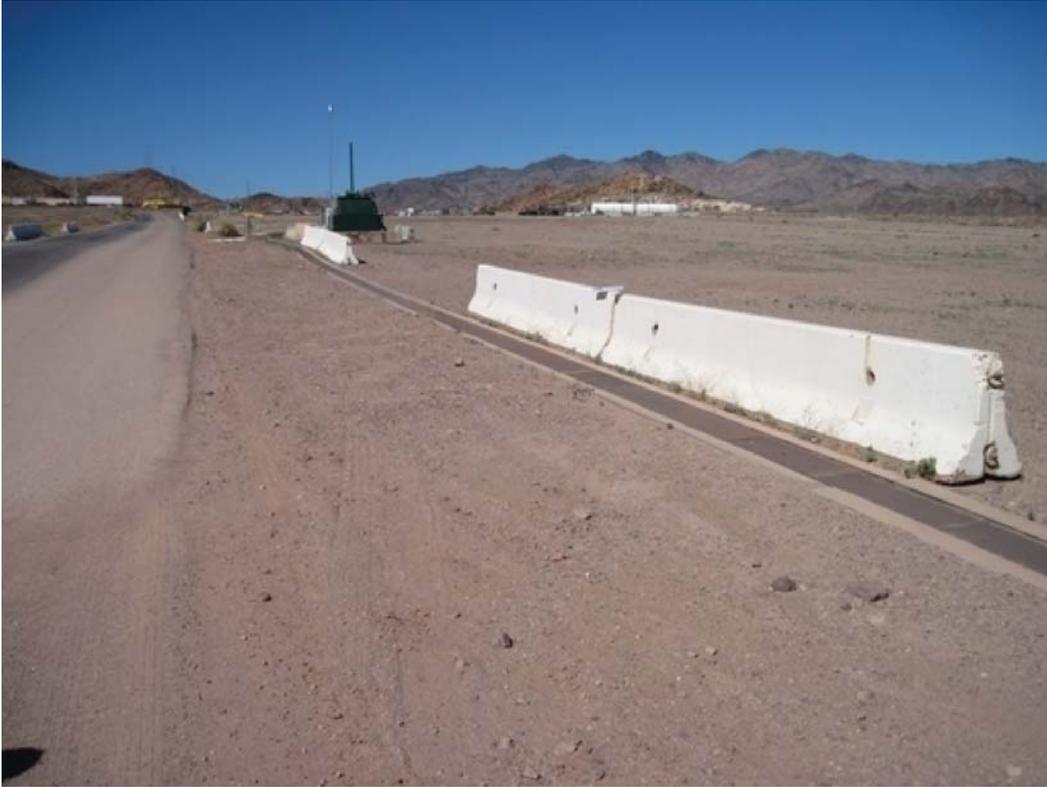
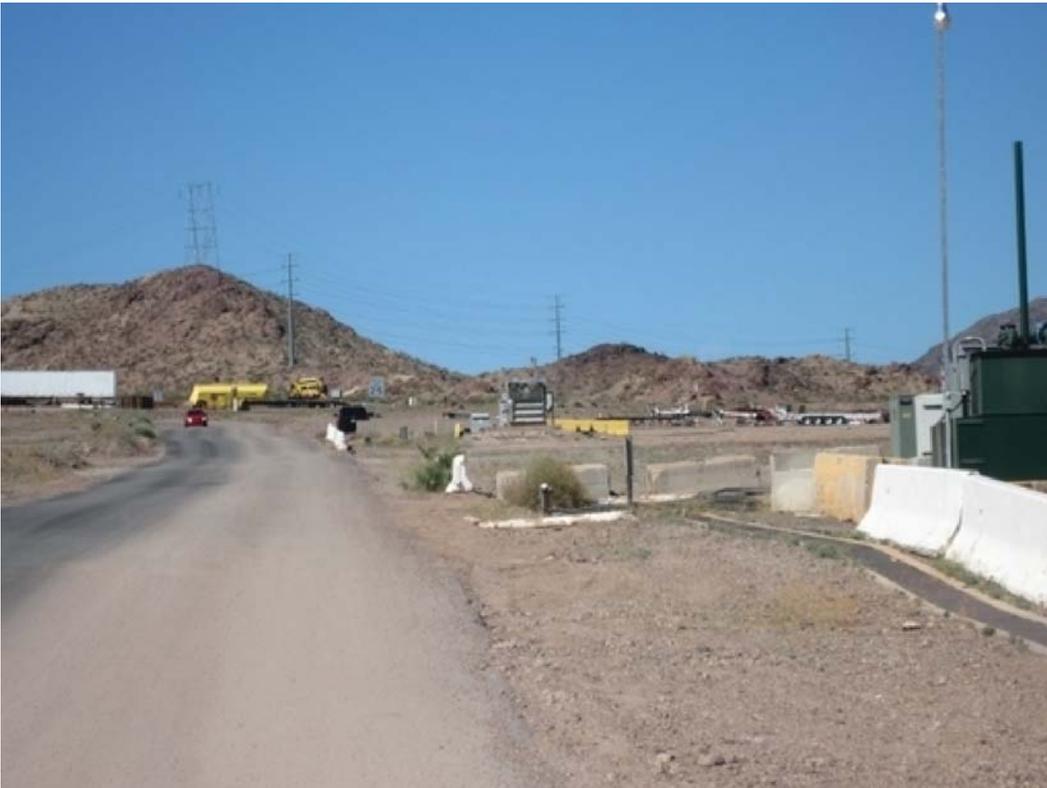
Barrier ID:	LAKE-0457ZZ-0.097-L				
Route Name:	BB CONC LAKE MEAD CRUISES ROADS				
Inspection Date:	05/03/2010	Barrier Rating:	5.50		
Barrier Description					
Type:	CONCRETE BARRIER	Barrier Function:	NON-TRAFFIC		
Barrier Material:	CONCRETE	Post Material:	N/A		
Blockout Type:	N/A	Length (ft.):	712		
Speed Limit (MPH):	25	Placement with Respect to Road:	NON-TRAFFIC BARRIER		
Hazard Behind Barrier:	N/A				
Barrier Crashworthiness					
Appropriate Test Level:	TL-1	Barrier Test Level:	N/A	Is Barrier Crashworthy?:	N/A
Beg. End Trtmt Type:	NONE	Is Beg. End Trtmt Crashworthy?:	N/A	Approach Transition Type:	NONE
Ending End Trtmt Type:	NONE	Ending End Trtmt Crashworthy?:	N/A		
Average Measurements					
Design Height (In.):	32	Width (In.):	6.0	Post Spacing (In.):	0.0
Height (In.):	31.3	Lateral Offset (In.):	0.0	Road Grade (%):	0.00
Physical Condition					
Barrier	Alignment and Height:	The two jersey barriers on the end are further from the road than the other barriers. The design height on the barriers is 32 in. 40 ft of barrier is between 29 and 30 in and the remaining is between 31 and 34 in.

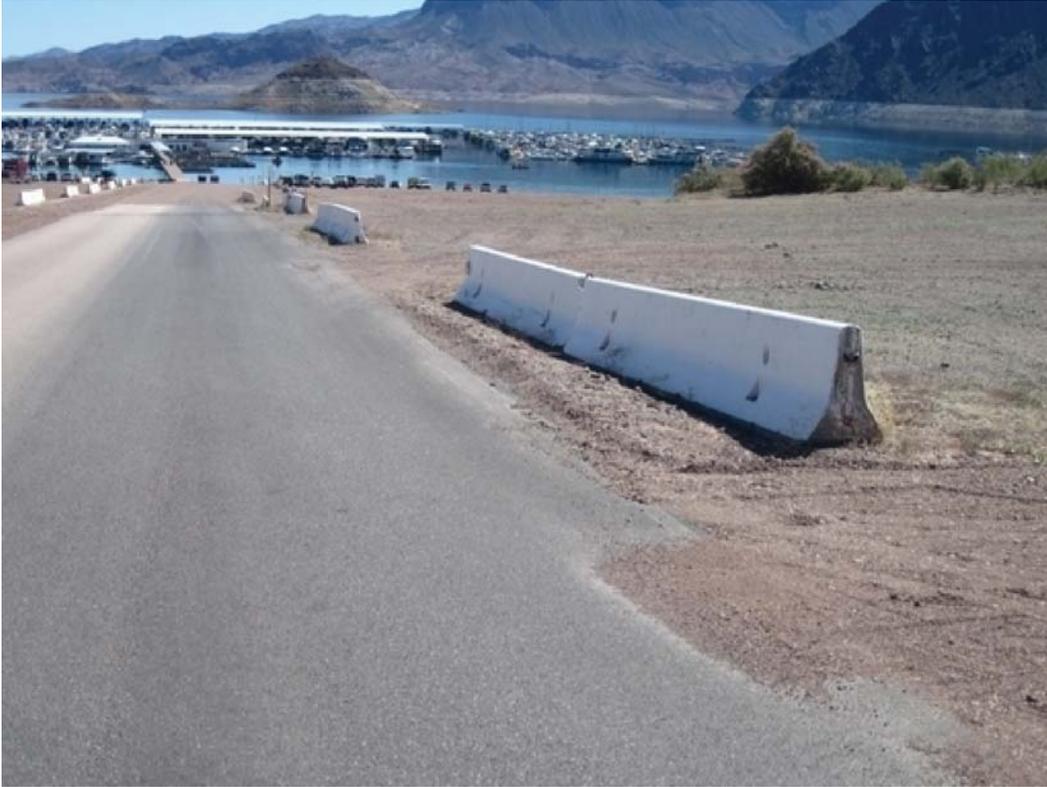
LAKE_0457ZZ_0.171_R_1.jpg

Barrier ID:	LAKE-0457ZZ-0.171-R				
Route Name:	BB CONC LAKE MEAD CRUISES ROADS				
Inspection Date:	05/03/2010	Barrier Rating:	2.90		
Barrier Description					
Type:	CONCRETE BARRIER	Barrier Function:	NON-TRAFFIC		
Barrier Material:	CONCRETE	Post Material:	N/A		
Blockout Type:	N/A	Length (ft.):	312		
Speed Limit (MPH):	25	Placement with Respect to Road:	NON-TRAFFIC BARRIER		
Hazard Behind Barrier:	N/A				
Barrier Crashworthiness					
Appropriate Test Level:	TL-1	Barrier Test Level:	N/A	Is Barrier Crashworthy?:	N/A
Beg. End Trtmt Type:	NONE	Is Beg. End Trtmt Crashworthy?:	N/A	Approach Transition Type:	NONE
Ending End Trtmt Type:	NONE	Ending End Trtmt Crashworthy?:	N/A		
Average Measurements					
Design Height (In.):	32	Width (In.):	6.0	Post Spacing (In.):	0.0
Height (In.):	32.0	Lateral Offset (In.):	0.0	Road Grade (%):	0.00
Physical Condition					
Barrier	Alignment and Height:	The alignment is acceptable but the height was 2 in below the 32 in design height for approximately 40 LF.
