LAKE GIP Report

NPS Guardwall/Rail Inventory Program Lake Mead National Recreation Area

**Data Collection Date: May 2010
Report Date: November 2015**

Lake Mead National Recreation Area in Arizona and Nevada

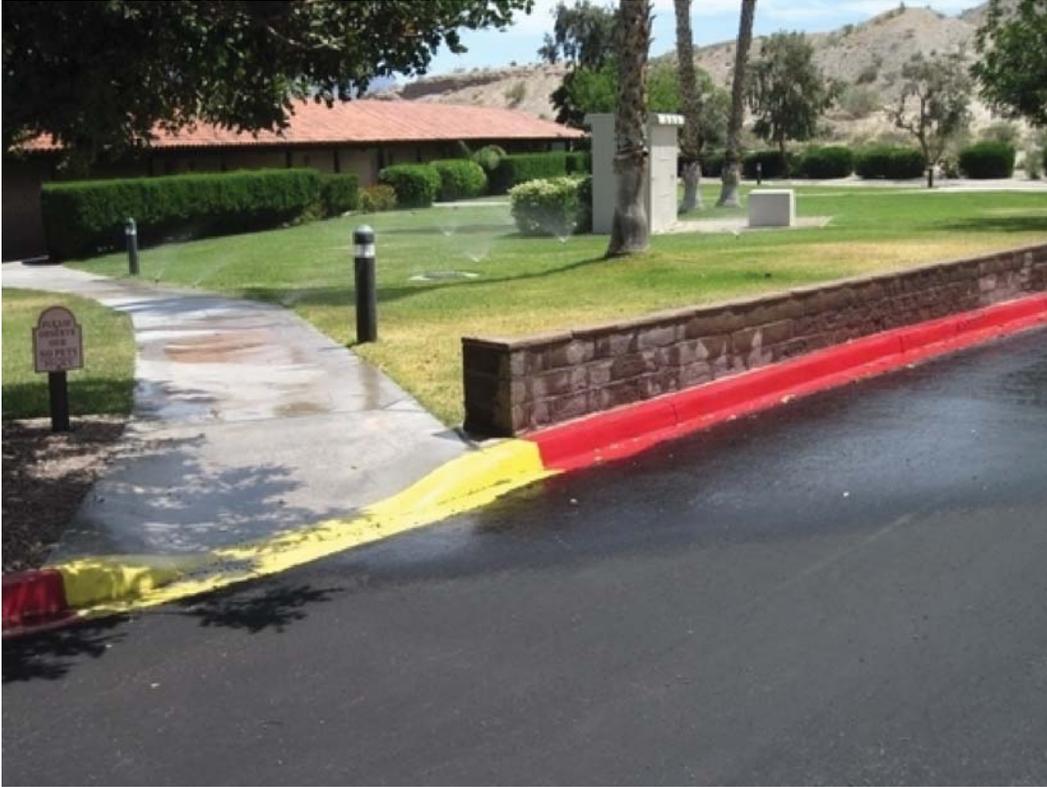
LAKE_0916ZZ_0.000_P1_1.jpg

Barrier ID:	LAKE-0916ZZ-0.000-P1				
Route Name:	CC COTTONWOOD COVE CONCESSION PARKING AREAS				
Inspection Date:	05/05/2010	Barrier Rating:	0.00		
Barrier Description					
Type:	OTHER: CONCRETE BLOCK	Barrier Function:	NON-TRAFFIC		
Barrier Material:	CONCRETE	Post Material:	N/A		
Blockout Type:	N/A	Length (ft.):	146		
Speed Limit (MPH):	15	Placement with Respect to Road:	NON-TRAFFIC BARRIER		
Hazard Behind Barrier:	N/A				
Barrier Crashworthiness					
Appropriate Test Level:	TL-1	Barrier Test Level:	N/A	Is Barrier Crashworthy?:	N/A
Beg. End Trtmt Type:	NONE	Is Beg. End Trtmt Crashworthy?:	N/A	Approach Transition Type:	NONE
Ending End Trtmt Type:	NONE	Ending End Trtmt Crashworthy?:	N/A		
Average Measurements					
Design Height (In.):	24	Width (In.):	6.0	Post Spacing (In.):	0.0
Height (In.):	25.0	Lateral Offset (In.):	0.0	Road Grade (%):	0.00
Physical Condition					
Barrier	Alignment and Height:	Alignment acceptable. Height within 3-in of 24-in design height.
