MACA GIP Report

NPS Guardwall/Rail Inventory Program Mammoth Cave National Park

**Federal Lands Highway
Road Inventory Program**

Data Collection Date: October 2010
Report Date: November 2015

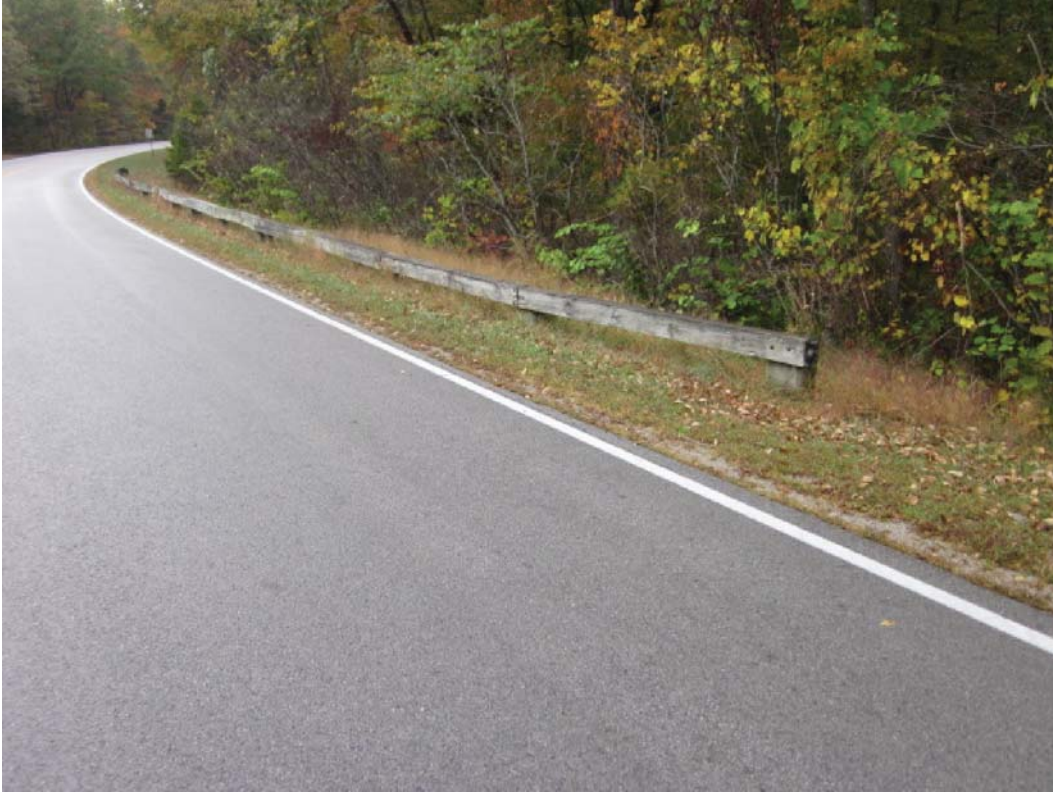
MACA_0015_1.725_L_1.JPG

Barrier ID:	MACA-0015-1.725-L				
Route Name:	BROWNSVILLE ROAD				
Inspection Date:	10/12/2010	Barrier Rating:	29.30		
Barrier Description					
Type:	OTHER: TIMBER RAIL ON CONCRETE POSTS	Barrier Function:	TRAFFIC		
Barrier Material:	LOG/TIMBER/WOOD	Post Material:	OTHER: CONCRETE		
Blockout Type:	N/A	Length (ft.):	149		
Speed Limit (MPH):	50	Placement with Respect to Road:	INSIDE OF CURVE		
Hazard Behind Barrier:	MEDIUM				
Barrier Crashworthiness					
Appropriate Test Level:	TL-3	Barrier Test Level:	NCW	Is Barrier Crashworthy?:	NO
Beg. End Trtmt Type:	NONE	Is Beg. End Trtmt Crashworthy?:	N/A	Approach Transition Type:	NONE
Ending End Trtmt Type:	NONE	Ending End Trtmt Crashworthy?:	N/A		
Average Measurements					
Design Height (In.):	20	Width (In.):	0.0	Post Spacing (In.):	120.3
Height (In.):	18.0	Lateral Offset (In.):	54.0	Road Grade (%):	1.40
Physical Condition					
Barrier	Alignment and Height:	20 ft of the alignment has been deviated over 7 in. Height is 2 to 3 in below the 20 in design height for 119 ft.

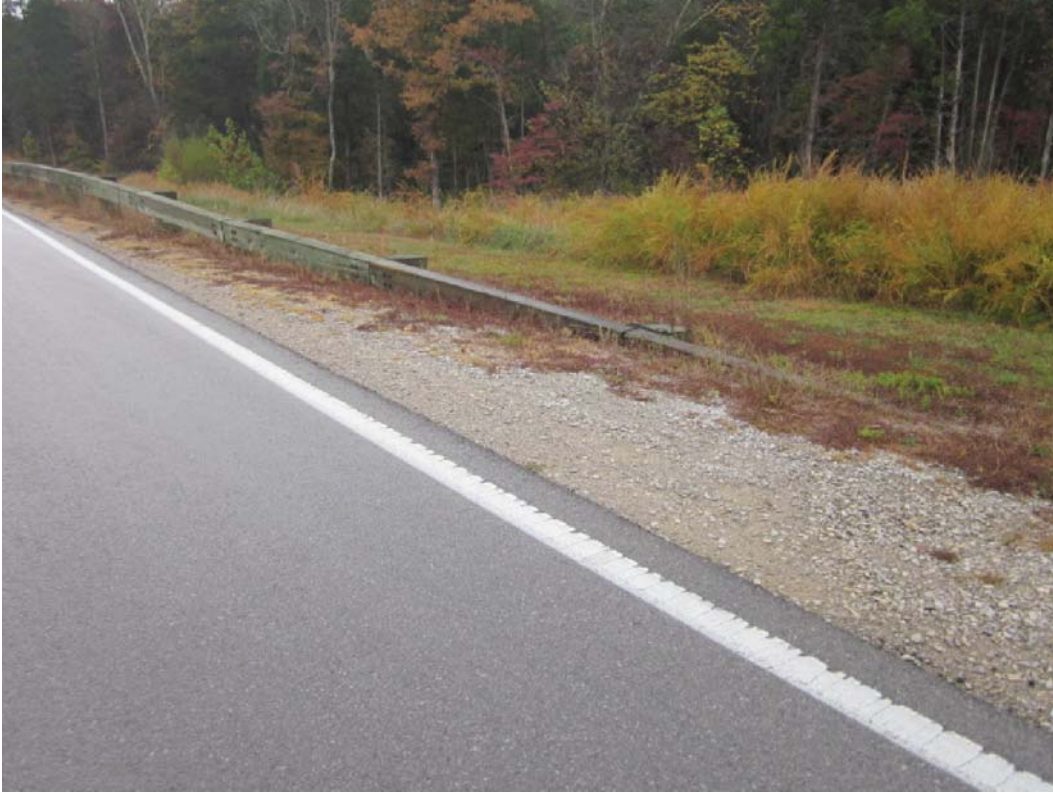
MACA_0015_4.998_L_1.JPG

Barrier ID:	MACA-0015-4.998-L				
Route Name:	BROWNSVILLE ROAD				
Inspection Date:	10/12/2010	Barrier Rating:	26.60		
Barrier Description					
Type:	STEEL-BACKED TIMBER WITH BLOCKOUT	Barrier Function:	TRAFFIC		
Barrier Material:	STEEL-BACKED TIMBER/LOG	Post Material:	WOOD		
Blockout Type:	WOOD	Length (ft.):	454		
Speed Limit (MPH):	50	Placement with Respect to Road:	TANGENT		
Hazard Behind Barrier:	MEDIUM				
Barrier Crashworthiness					
Appropriate Test Level:	TL-3	Barrier Test Level:	TL-3	Is Barrier Crashworthy?:	YES
Beg. End Trtmt Type:	SBT/LOG FLARED	Is Beg. End Trtmt Crashworthy?:	NO	Approach Transition Type:	NONE
Ending End Trtmt Type:	SBT/LOG FLARED	Ending End Trtmt Crashworthy?:	NO		
Average Measurements					
Design Height (In.):	27	Width (In.):	0.0	Post Spacing (In.):	119.6
Height (In.):	27.0	Lateral Offset (In.):	38.0	Road Grade (%):	2.20
Physical Condition					
Barrier	Alignment and Height:	Alignment has no deviation and height is within 1 in of the 27 in design height.

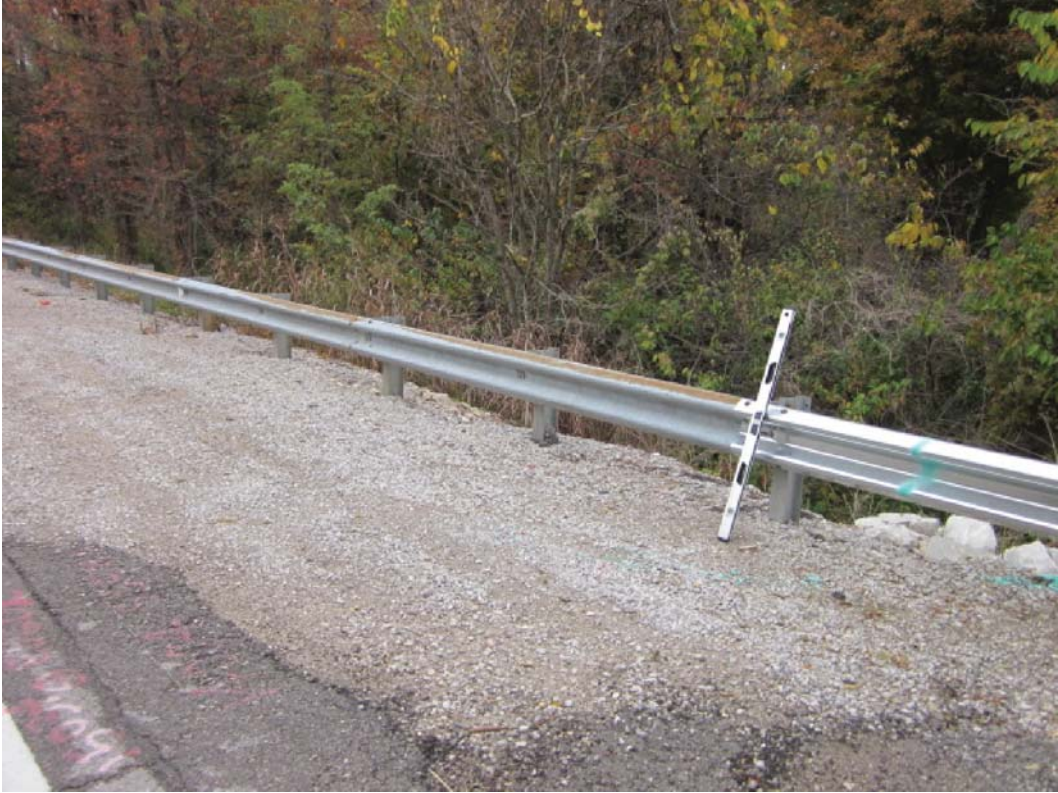
MACA_0020_0.003_R_1.JPG

Barrier ID:	MACA-0020-0.003-R				
Route Name:	PARK CITY ROAD				
Inspection Date:	10/12/2010	Barrier Rating:	29.60		
Barrier Description					
Type:	W-BEAM STRONG POST	Barrier Function:	TRAFFIC		
Barrier Material:	GALVANIZED STEEL	Post Material:	GALVANIZED STEEL		
Blockout Type:	STEEL	Length (ft.):	135		
Speed Limit (MPH):	45	Placement with Respect to Road:	TANGENT		
Hazard Behind Barrier:	MEDIUM				
Barrier Crashworthiness					
Appropriate Test Level:	TL-2	Barrier Test Level:	TL-3	Is Barrier Crashworthy?:	YES
Beg. End Trtmt Type:	NONE	Is Beg. End Trtmt Crashworthy?:	N/A	Approach Transition Type:	NONE
Ending End Trtmt Type:	W-BEAM TURN DOWN	Ending End Trtmt Crashworthy?:	NO		
Average Measurements					
Design Height (In.):	27	Width (In.):	0.0	Post Spacing (In.):	74.3
Height (In.):	24.2	Lateral Offset (In.):	128.6	Road Grade (%):	3.10
Physical Condition					
Barrier	Alignment and Height:	Alignment has no deviation and height is 2 to 3 in below the 27 in design height.

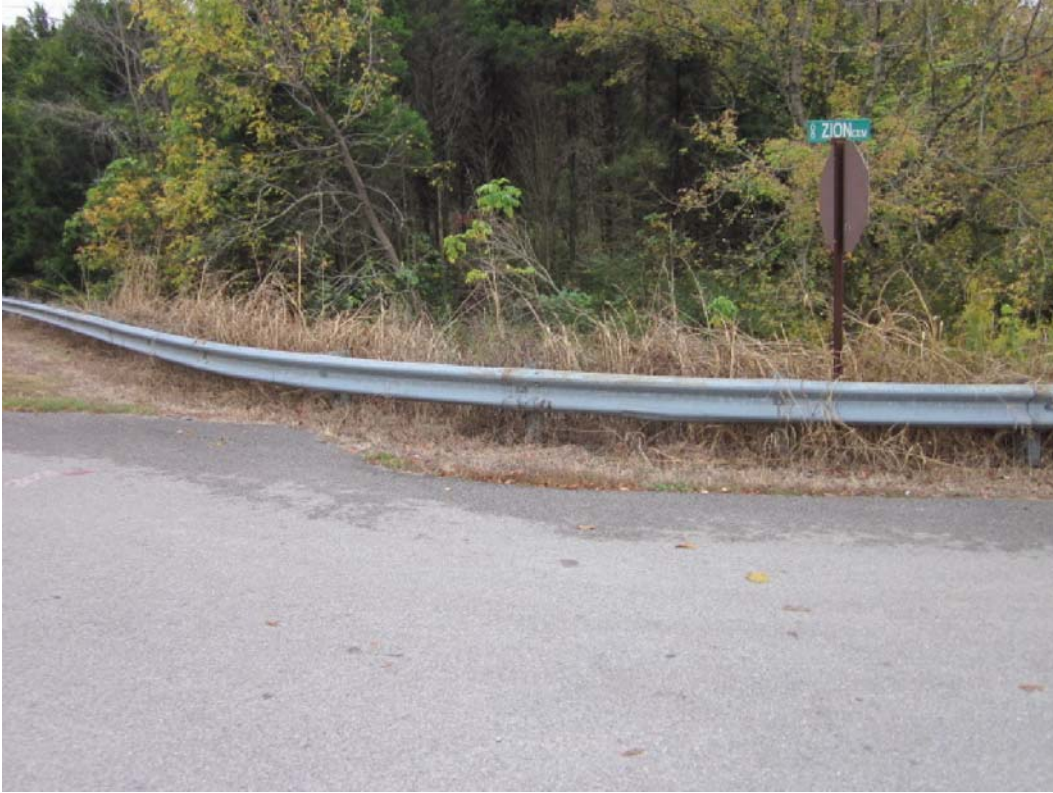
MACA_0020_0.146_L_1.JPG

Barrier ID:	MACA-0020-0.146-L				
Route Name:	PARK CITY ROAD				
Inspection Date:	10/12/2010	Barrier Rating:	30.00		
Barrier Description					
Type:	W-BEAM STRONG POST	Barrier Function:	TRAFFIC		
Barrier Material:	GALVANIZED STEEL	Post Material:	GALVANIZED STEEL		
Blockout Type:	STEEL	Length (ft.):	292		
Speed Limit (MPH):	45	Placement with Respect to Road:	TANGENT		
Hazard Behind Barrier:	LOW				
Barrier Crashworthiness					
Appropriate Test Level:	TL-2	Barrier Test Level:	TL-3	Is Barrier Crashworthy?:	YES
Beg. End Trtmt Type:	W-BEAM TURN DOWN	Is Beg. End Trtmt Crashworthy?:	NO	Approach Transition Type:	NONE
Ending End Trtmt Type:	NONE	Ending End Trtmt Crashworthy?:	N/A		
Average Measurements					
Design Height (In.):	27	Width (In.):	0.0	Post Spacing (In.):	75.0
Height (In.):	24.2	Lateral Offset (In.):	129.6	Road Grade (%):	1.30
Physical Condition					
Barrier	Alignment and Height:	Alignment has no deviation and height is low by 2 to 3 in from the 27 in design height.

Breaking and Cracking:	No breaking or cracking observed.			
	Missing Elements:	No missing elements observed.			
	Corrosion and Weathering:	No corrosion and some minor weathering observed.			
End Treatments	Alignment and Height:	Alignment acceptable. Height within 1-in of 27-in design height.			
	Breaking and Cracking:	No breaking or cracking observed.			
	Missing Elements:	No missing elements observed.			
	Corrosion and Weathering:	No corrosion or weathering observed.

Repair Action:	REPAIR	FMSS Work Type:	DEFERRED MAINTENANCE	Repair Cost:	\$6457
Brief Workorder:	Raise 292 feet of guardrail up to 27 inch design height.				
Workorder:	Adjust Guardrail at \$10- per -Lin. Ft. for 292 LF = \$2920. Raise 292 feet of guardrail up to 27 inch design height. Low Speed Traffic Control at \$1475- per -Day for 2 Day(s) = \$2950.

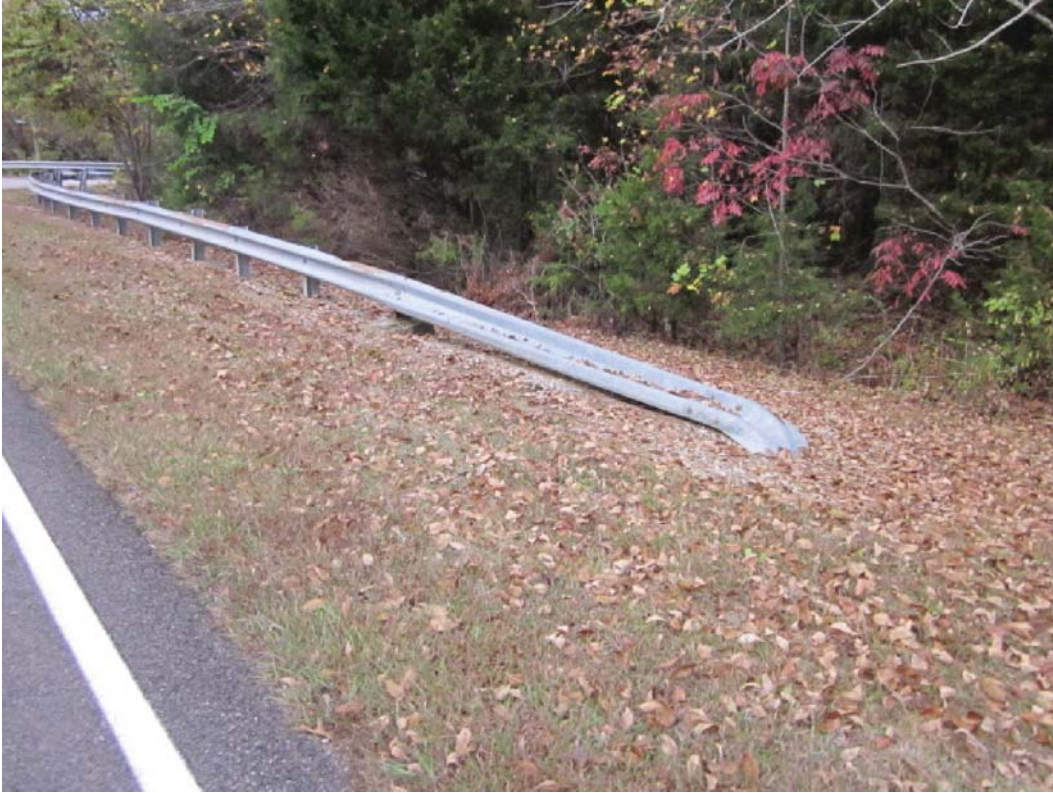
MACA_0020_0.180_R_1.JPG

Barrier ID:	MACA-0020-0.180-R				
Route Name:	PARK CITY ROAD				
Inspection Date:	10/12/2010	Barrier Rating:	25.20		
Barrier Description					
Type:	W-BEAM STRONG POST	Barrier Function:	TRAFFIC		
Barrier Material:	GALVANIZED STEEL	Post Material:	GALVANIZED STEEL		
Blockout Type:	STEEL	Length (ft.):	102		
Speed Limit (MPH):	45	Placement with Respect to Road:	TANGENT		
Hazard Behind Barrier:	MEDIUM				
Barrier Crashworthiness					
Appropriate Test Level:	TL-2	Barrier Test Level:	TL-3	Is Barrier Crashworthy?:	YES
Beg. End Trtmt Type:	W-BEAM TURN DOWN	Is Beg. End Trtmt Crashworthy?:	NO	Approach Transition Type:	NONE
Ending End Trtmt Type:	NONE	Ending End Trtmt Crashworthy?:	N/A		
Average Measurements					
Design Height (In.):	27	Width (In.):	0.0	Post Spacing (In.):	74.3
Height (In.):	26.0	Lateral Offset (In.):	132.3	Road Grade (%):	1.10
Physical Condition					
Barrier	Alignment and Height:	38 ft of alignment is deviated 1 to 2 ft from the roadway due to impact. Height is within 1 in below the 27 in design height.

Breaking and Cracking:	38 ft of guardrail is dented or bent due to impact.			
	Missing Elements:	No missing elements observed.			
	Corrosion and Weathering:	No corrosion or weathering observed.			
End Treatments	Alignment and Height:	Alignment acceptable. Height within 1-in of 27-in design height.			
	Breaking and Cracking:	No breaking or cracking observed.			
	Missing Elements:	No missing elements observed.			
	Corrosion and Weathering:	No corrosion or weathering observed.

Repair Action:	REPAIR	FMSS Work Type:	DEFERRED MAINTENANCE	Repair Cost:	\$3086
Brief Workorder:	Replace 38 feet of guardrail due to impact.				
Workorder:	Remove Guardrail at \$10- per -Lin. Ft. for 38 LF = \$380. Replace Rail at \$25- per -Lin. Ft. for 38 LF = \$950. Low Speed Traffic Control at \$1475- per -Day for 1 Day(s) = \$1475.

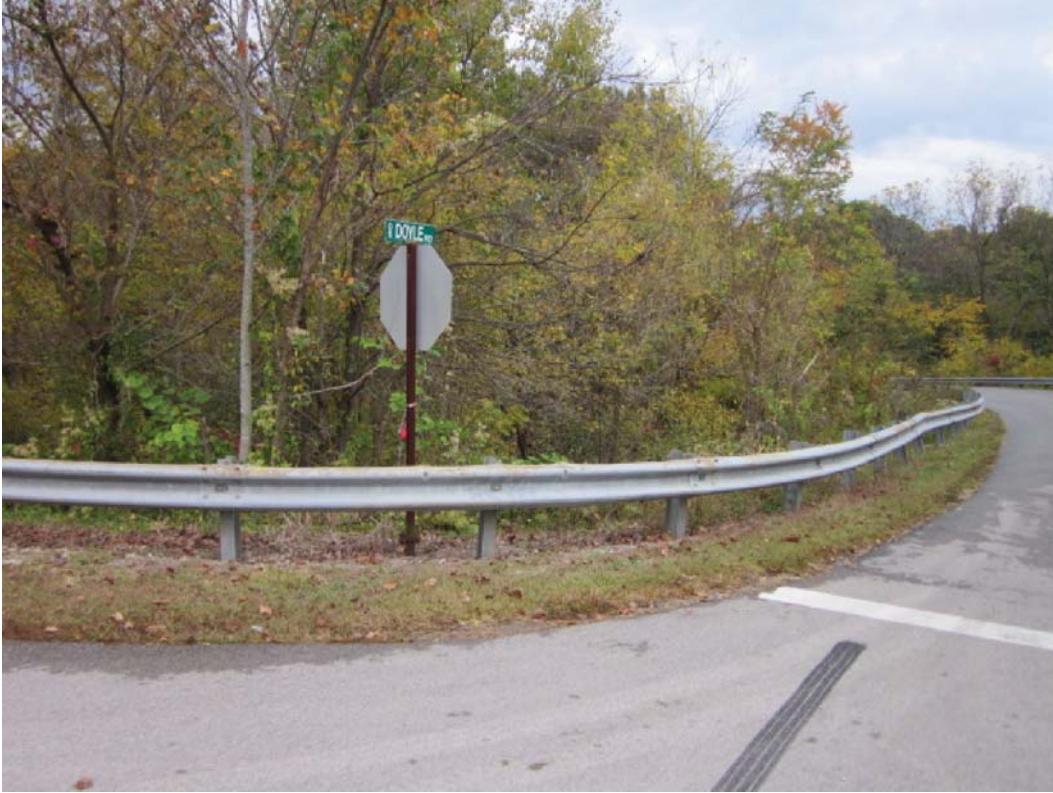
MACA_0020_0.209_R_1.JPG

Barrier ID:	MACA-0020-0.209-R				
Route Name:	PARK CITY ROAD				
Inspection Date:	10/12/2010	Barrier Rating:	18.20		
Barrier Description					
Type:	W-BEAM STRONG POST	Barrier Function:	TRAFFIC		
Barrier Material:	GALVANIZED STEEL	Post Material:	GALVANIZED STEEL		
Blockout Type:	STEEL	Length (ft.):	113		
Speed Limit (MPH):	45	Placement with Respect to Road:	TANGENT		
Hazard Behind Barrier:	LOW				
Barrier Crashworthiness					
Appropriate Test Level:	TL-2	Barrier Test Level:	TL-3	Is Barrier Crashworthy?:	YES
Beg. End Trtmt Type:	NONE	Is Beg. End Trtmt Crashworthy?:	N/A	Approach Transition Type:	NONE
Ending End Trtmt Type:	W-BEAM TURN DOWN	Ending End Trtmt Crashworthy?:	NO		
Average Measurements					
Design Height (In.):	27	Width (In.):	0.0	Post Spacing (In.):	75.3
Height (In.):	26.2	Lateral Offset (In.):	141.3	Road Grade (%):	0.30
Physical Condition					
Barrier	Alignment and Height:	Alignment has no deviation and height is within 1 in of the 27 in design height.

Breaking and Cracking:	No breaking or cracking observed.			
	Missing Elements:	No missing elements observed.			
	Corrosion and Weathering:	No corrosion or weathering observed.			
End Treatments	Alignment and Height:	Alignment acceptable. Height within 1-in of 27-in design height.			
	Breaking and Cracking:	No breaking or cracking observed.			
	Missing Elements:	No missing elements observed.			
	Corrosion and Weathering:	No corrosion or weathering observed.

Repair Action:	NO ACTION	FMSS Work Type:	N/A	Repair Cost:	\$0
Brief Workorder:	N/A				
Workorder:

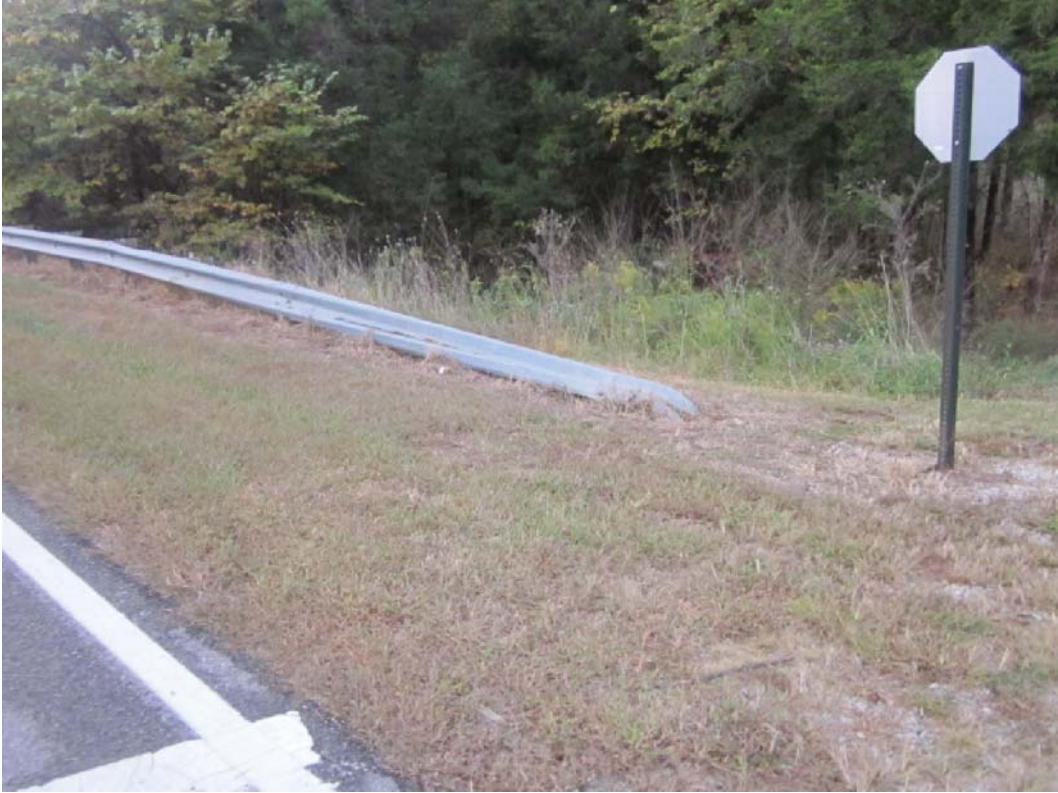
MACA_0020_0.211_L_1.JPG

Barrier ID:	MACA-0020-0.211-L				
Route Name:	PARK CITY ROAD				
Inspection Date:	10/12/2010	Barrier Rating:	30.00		
Barrier Description					
Type:	W-BEAM STRONG POST	Barrier Function:	TRAFFIC		
Barrier Material:	GALVANIZED STEEL	Post Material:	GALVANIZED STEEL		
Blockout Type:	STEEL	Length (ft.):	610		
Speed Limit (MPH):	45	Placement with Respect to Road:	TANGENT		
Hazard Behind Barrier:	LOW				
Barrier Crashworthiness					
Appropriate Test Level:	TL-2	Barrier Test Level:	TL-3	Is Barrier Crashworthy?:	YES
Beg. End Trtmt Type:	NONE	Is Beg. End Trtmt Crashworthy?:	N/A	Approach Transition Type:	NONE
Ending End Trtmt Type:	W-BEAM TURN DOWN	Ending End Trtmt Crashworthy?:	NO		
Average Measurements					
Design Height (In.):	27	Width (In.):	0.0	Post Spacing (In.):	75.3
Height (In.):	24.6	Lateral Offset (In.):	130.6	Road Grade (%):	0.50
Physical Condition					
Barrier	Alignment and Height:	Alignment has no deviation and height is low by 3 in from the 27 in design height for 460 ft.

Breaking and Cracking:	No breaking or cracking observed.			
	Missing Elements:	No missing elements observed.			
	Corrosion and Weathering:	No corrosion or weathering observed.			
End Treatments	Alignment and Height:	Alignment acceptable. Height within 1-in of 27-in design height.			
	Breaking and Cracking:	No breaking or cracking observed.			
	Missing Elements:	No missing elements observed.			
	Corrosion and Weathering:	No corrosion or weathering observed.

Repair Action:	REPAIR	FMSS Work Type:	DEFERRED MAINTENANCE	Repair Cost:	\$8305
Brief Workorder:	Raise 460 feet of guardrail to 27 inch design height.				
Workorder:	Adjust Guardrail at \$10- per -Lin. Ft. for 460 LF = \$4600. Raise 460 feet of guardrail to 27 inch design height. Low Speed Traffic Control at \$1475- per -Day for 2 Day(s) = \$2950.

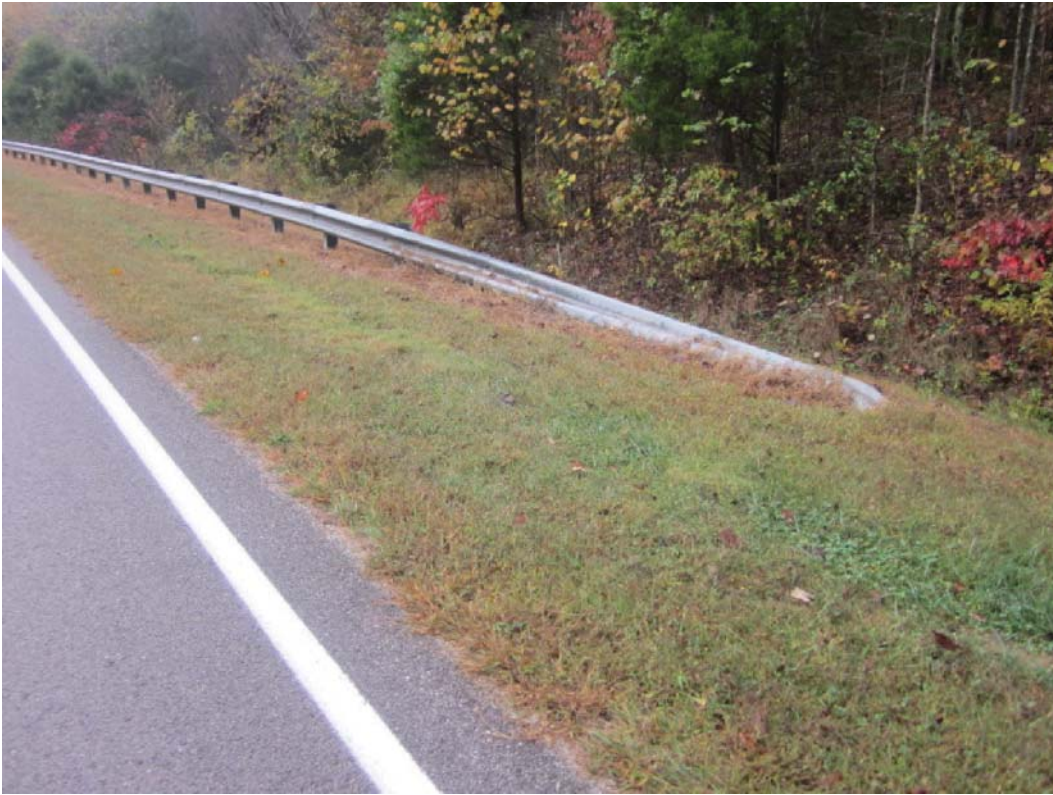
MACA_0020_0.404_L_1.JPG

Barrier ID:	MACA-0020-0.404-L				
Route Name:	PARK CITY ROAD				
Inspection Date:	10/13/2010	Barrier Rating:	43.90		
Barrier Description					
Type:	W-BEAM STRONG POST	Barrier Function:	TRAFFIC		
Barrier Material:	GALVANIZED STEEL	Post Material:	GALVANIZED STEEL		
Blockout Type:	STEEL	Length (ft.):	1297		
Speed Limit (MPH):	50	Placement with Respect to Road:	BOTH INSIDE AND OUTSIDE		
Hazard Behind Barrier:	MEDIUM				
Barrier Crashworthiness					
Appropriate Test Level:	TL-3	Barrier Test Level:	TL-3	Is Barrier Crashworthy?:	YES
Beg. End Trtmt Type:	W-BEAM TURN DOWN	Is Beg. End Trtmt Crashworthy?:	NO	Approach Transition Type:	NONE
Ending End Trtmt Type:	W-BEAM TURN DOWN	Ending End Trtmt Crashworthy?:	NO		
Average Measurements					
Design Height (In.):	27	Width (In.):	0.0	Post Spacing (In.):	75.8
Height (In.):	25.2	Lateral Offset (In.):	129.0	Road Grade (%):	0.10
Physical Condition					
Barrier	Alignment and Height:	Alignment has no deviation and height is 2 to 3 in below the 27 in design height for 930 ft.

Breaking and Cracking:	No breaking or cracking observed.			
	Missing Elements:	No missing elements observed.			
	Corrosion and Weathering:	No corrosion or weathering observed.			
End Treatments	Alignment and Height:	Alignment acceptable. Height within 1-in of 27-in design height.			
	Breaking and Cracking:	No breaking or cracking observed.			
	Missing Elements:	No missing elements observed.			
	Corrosion and Weathering:	No corrosion or weathering observed.

Repair Action:	REPAIR	FMSS Work Type:	DEFERRED MAINTENANCE	Repair Cost:	\$20570
Brief Workorder:	Raise 930 feet of guardrail up to 27 inch design height.				
Workorder:	Adjust Guardrail at \$10- per -Lin. Ft. for 930 LF = \$9300. Raise 930 feet of guardrail up to 27 inch design height. High Speed Traffic Control at \$2350- per -Day for 4 Day(s) = \$9400.

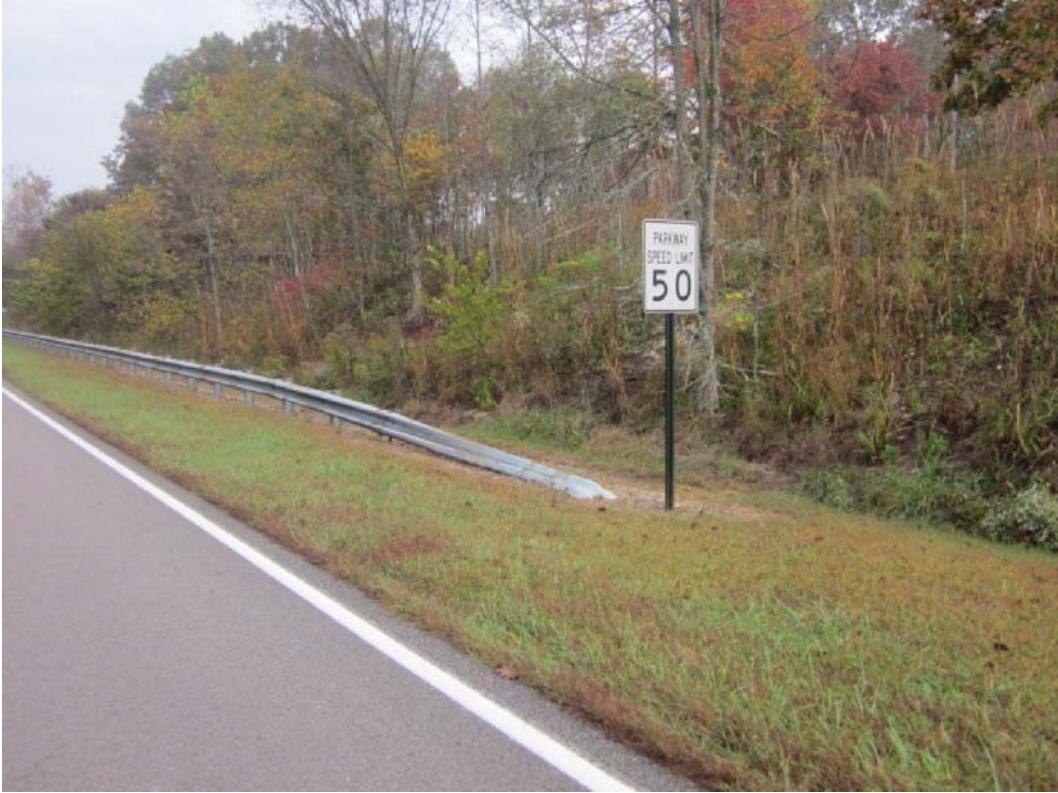
MACA_0020_0.509_R_1.JPG

Barrier ID:	MACA-0020-0.509-R				
Route Name:	PARK CITY ROAD				
Inspection Date:	10/13/2010	Barrier Rating:	27.10		
Barrier Description					
Type:	W-BEAM STRONG POST	Barrier Function:	TRAFFIC		
Barrier Material:	GALVANIZED STEEL	Post Material:	GALVANIZED STEEL		
Blockout Type:	STEEL	Length (ft.):	202		
Speed Limit (MPH):	50	Placement with Respect to Road:	TANGENT		
Hazard Behind Barrier:	LOW				
Barrier Crashworthiness					
Appropriate Test Level:	TL-3	Barrier Test Level:	TL-3	Is Barrier Crashworthy?:	YES
Beg. End Trtmt Type:	W-BEAM TURN DOWN	Is Beg. End Trtmt Crashworthy?:	NO	Approach Transition Type:	NONE
Ending End Trtmt Type:	W-BEAM TURN DOWN	Ending End Trtmt Crashworthy?:	NO		
Average Measurements					
Design Height (In.):	27	Width (In.):	0.0	Post Spacing (In.):	74.3
Height (In.):	24.6	Lateral Offset (In.):	125.5	Road Grade (%):	0.50
Physical Condition					
Barrier	Alignment and Height:	Alignment has no deviation and height is low by 2 to 3 in below the design height of 27 in.

Breaking and Cracking:	No breaking or cracking observed.			
	Missing Elements:	No missing elements observed.			
	Corrosion and Weathering:	No corrosion or weathering observed.			
End Treatments	Alignment and Height:	Alignment acceptable. Height within 1-in of 27-in design height.			
	Breaking and Cracking:	No breaking or cracking observed.			
	Missing Elements:	No missing elements observed.			
	Corrosion and Weathering:	No corrosion or weathering observed.

Repair Action:	REPAIR	FMSS Work Type:	DEFERRED MAINTENANCE	Repair Cost:	\$4807
Brief Workorder:	Raise 202 feet of guardrail up to 27 inch design height.				
Workorder:	Adjust Guardrail at \$10- per -Lin. Ft. for 202 LF = \$2020. Raise 202 feet of guardrail up to 27 inch design height. High Speed Traffic Control at \$2350- per -Day for 1 Day(s) = \$2350.

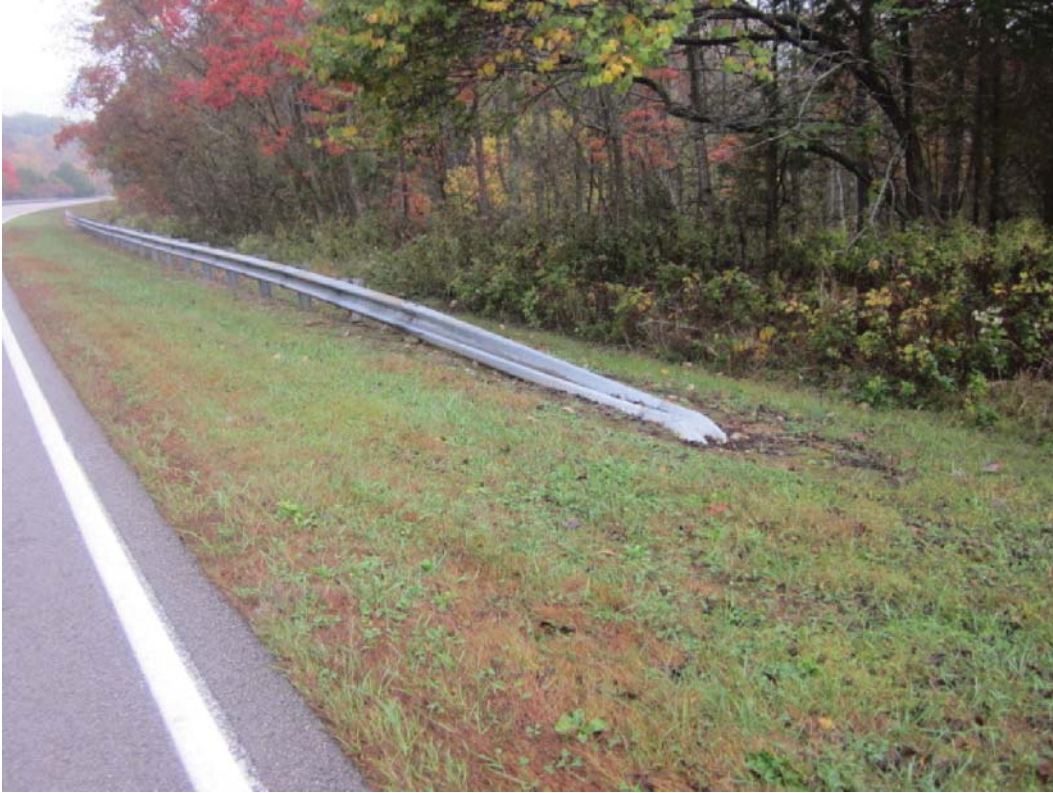
MACA_0020_0.654_R_1.JPG

Barrier ID:	MACA-0020-0.654-R				
Route Name:	PARK CITY ROAD				
Inspection Date:	10/13/2010	Barrier Rating:	32.90		
Barrier Description					
Type:	W-BEAM STRONG POST	Barrier Function:	TRAFFIC		
Barrier Material:	GALVANIZED STEEL	Post Material:	GALVANIZED STEEL		
Blockout Type:	STEEL	Length (ft.):	252		
Speed Limit (MPH):	50	Placement with Respect to Road:	INSIDE OF CURVE		
Hazard Behind Barrier:	LOW				
Barrier Crashworthiness					
Appropriate Test Level:	TL-3	Barrier Test Level:	TL-3	Is Barrier Crashworthy?:	YES
Beg. End Trtmt Type:	W-BEAM TURN DOWN	Is Beg. End Trtmt Crashworthy?:	NO	Approach Transition Type:	NONE
Ending End Trtmt Type:	W-BEAM TURN DOWN	Ending End Trtmt Crashworthy?:	NO		
Average Measurements					
Design Height (In.):	27	Width (In.):	0.0	Post Spacing (In.):	75.3
Height (In.):	25.0	Lateral Offset (In.):	130.3	Road Grade (%):	0.70
Physical Condition					
Barrier	Alignment and Height:	Alignment has no deviation and height is low by 2 in from the 27 in design height.

Breaking and Cracking:	No breaking or cracking observed.			
	Missing Elements:	No missing elements observed.			
	Corrosion and Weathering:	No corrosion or weathering observed.			
End Treatments	Alignment and Height:	Alignment acceptable. Height within 1-in of 27-in design height.			
	Breaking and Cracking:	No breaking or cracking observed.			
	Missing Elements:	No missing elements observed.			
	Corrosion and Weathering:	No corrosion or weathering observed.

Repair Action:	REPAIR	FMSS Work Type:	DEFERRED MAINTENANCE	Repair Cost:	\$5357
Brief Workorder:	Raise 252 feet of guardrail to 27 inch design height.				
Workorder:	Adjust Guardrail at \$10- per -Lin. Ft. for 252 LF = \$2520. Raise 252 feet of guardrail to 27 inch design height. High Speed Traffic Control at \$2350- per -Day for 1 Day(s) = \$2350.

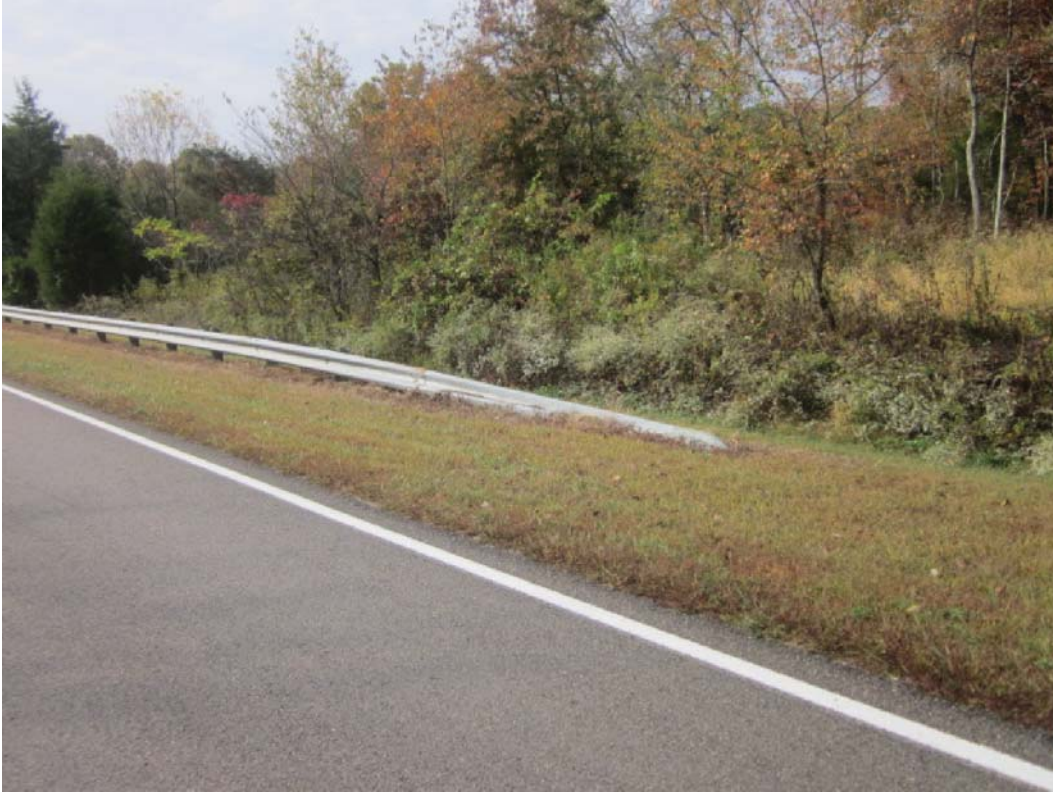
MACA_0020_0.708_L_1.JPG

Barrier ID:	MACA-0020-0.708-L				
Route Name:	PARK CITY ROAD				
Inspection Date:	10/13/2010	Barrier Rating:	38.50		
Barrier Description					
Type:	W-BEAM STRONG POST	Barrier Function:	TRAFFIC		
Barrier Material:	GALVANIZED STEEL	Post Material:	GALVANIZED STEEL		
Blockout Type:	STEEL	Length (ft.):	645		
Speed Limit (MPH):	50	Placement with Respect to Road:	OUTSIDE OF CURVE		
Hazard Behind Barrier:	LOW				
Barrier Crashworthiness					
Appropriate Test Level:	TL-3	Barrier Test Level:	TL-3	Is Barrier Crashworthy?:	YES
Beg. End Trtmt Type:	W-BEAM TURN DOWN	Is Beg. End Trtmt Crashworthy?:	NO	Approach Transition Type:	NONE
Ending End Trtmt Type:	W-BEAM TURN DOWN	Ending End Trtmt Crashworthy?:	NO		
Average Measurements					
Design Height (In.):	27	Width (In.):	0.0	Post Spacing (In.):	73.6
Height (In.):	24.7	Lateral Offset (In.):	130.0	Road Grade (%):	0.30
Physical Condition					
Barrier	Alignment and Height:	Alignment has no deviation and height is low by 2 to 3 in below the design height of 27 in.

Breaking and Cracking:	No breaking or cracking observed.			
	Missing Elements:	No missing elements observed.			
	Corrosion and Weathering:	No corrosion or weathering observed.			
End Treatments	Alignment and Height:	Alignment acceptable. Height within 1-in of 27-in design height.			
	Breaking and Cracking:	No breaking or cracking observed.			
	Missing Elements:	No missing elements observed.			
	Corrosion and Weathering:	No corrosion or weathering observed.

Repair Action:	REPAIR	FMSS Work Type:	DEFERRED MAINTENANCE	Repair Cost:	\$14850
Brief Workorder:	Raise 645 feet of guardrail to 27 inch design height.				
Workorder:	Adjust Guardrail at \$10- per -Lin. Ft. for 645 LF = \$6450. Raise 645 feet of guardrail to 27 inch design height. High Speed Traffic Control at \$2350- per -Day for 3 Day(s) = \$7050.

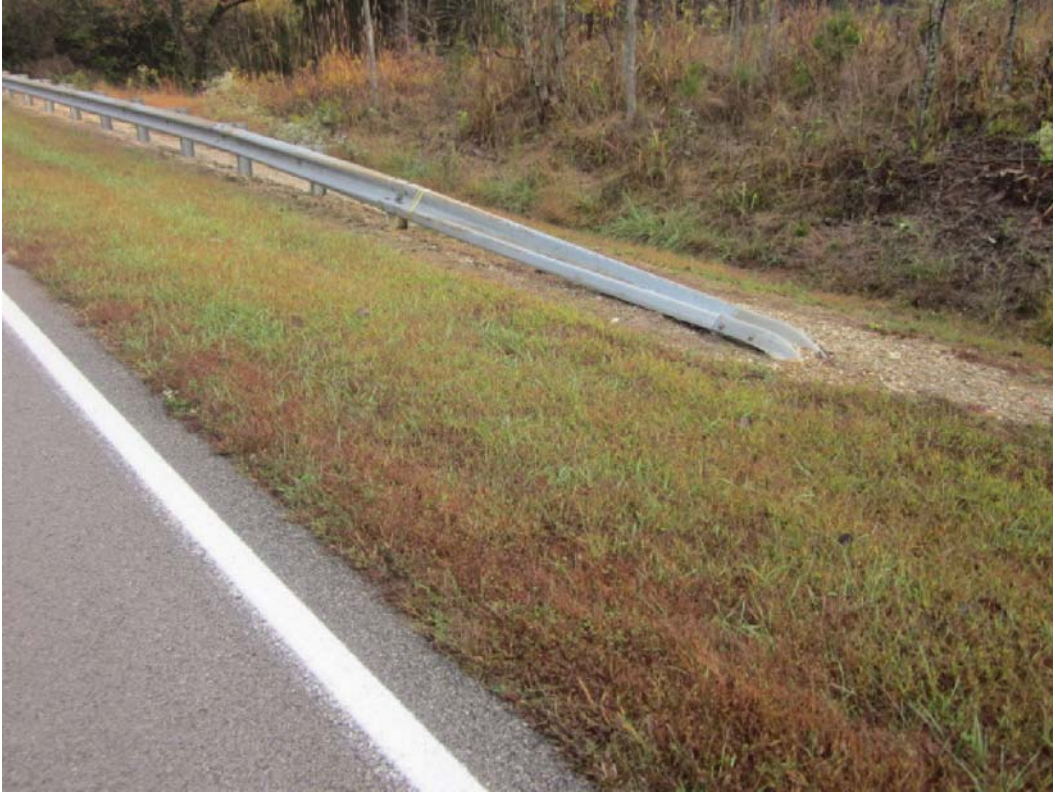
MACA_0020_0.799_R_1.JPG

Barrier ID:	MACA-0020-0.799-R				
Route Name:	PARK CITY ROAD				
Inspection Date:	10/13/2010	Barrier Rating:	48.00		
Barrier Description					
Type:	W-BEAM STRONG POST	Barrier Function:	TRAFFIC		
Barrier Material:	GALVANIZED STEEL	Post Material:	GALVANIZED STEEL		
Blockout Type:	STEEL	Length (ft.):	1915		
Speed Limit (MPH):	50	Placement with Respect to Road:	OUTSIDE OF CURVE		
Hazard Behind Barrier:	MEDIUM				
Barrier Crashworthiness					
Appropriate Test Level:	TL-3	Barrier Test Level:	TL-3	Is Barrier Crashworthy?:	YES
Beg. End Trtmt Type:	W-BEAM TURN DOWN	Is Beg. End Trtmt Crashworthy?:	NO	Approach Transition Type:	NONE
Ending End Trtmt Type:	W-BEAM TURN DOWN	Ending End Trtmt Crashworthy?:	NO		
Average Measurements					
Design Height (In.):	27	Width (In.):	0.0	Post Spacing (In.):	75.0
Height (In.):	25.1	Lateral Offset (In.):	132.6	Road Grade (%):	1.20
Physical Condition					
Barrier	Alignment and Height:	Alignment acceptable. 828-ft was between 1 and 3-in below the 27-in design height and 138-ft was more than 3-in below the design height.

Breaking and Cracking:	No breaking or cracking observed.			
	Missing Elements:	No missing elements observed.			
	Corrosion and Weathering:	No corrosion or weathering observed.			
End Treatments	Alignment and Height:	Alignment acceptable. Height within 1-in of 27-in design height.			
	Breaking and Cracking:	No breaking or cracking observed.			
	Missing Elements:	No missing elements observed.			
	Corrosion and Weathering:	No corrosion or weathering observed.

Repair Action:	REPAIR	FMSS Work Type:	DEFERRED MAINTENANCE	Repair Cost:	\$20966
Brief Workorder:	Raise 966 feet of guardrail up to 27 inch design height.				
Workorder:	Adjust Guardrail at \$10- per -Lin. Ft. for 966 LF = \$9660. Raise 966 feet of guardrail up to 27 inch design height. High Speed Traffic Control at \$2350- per -Day for 4 Day(s) = \$9400.

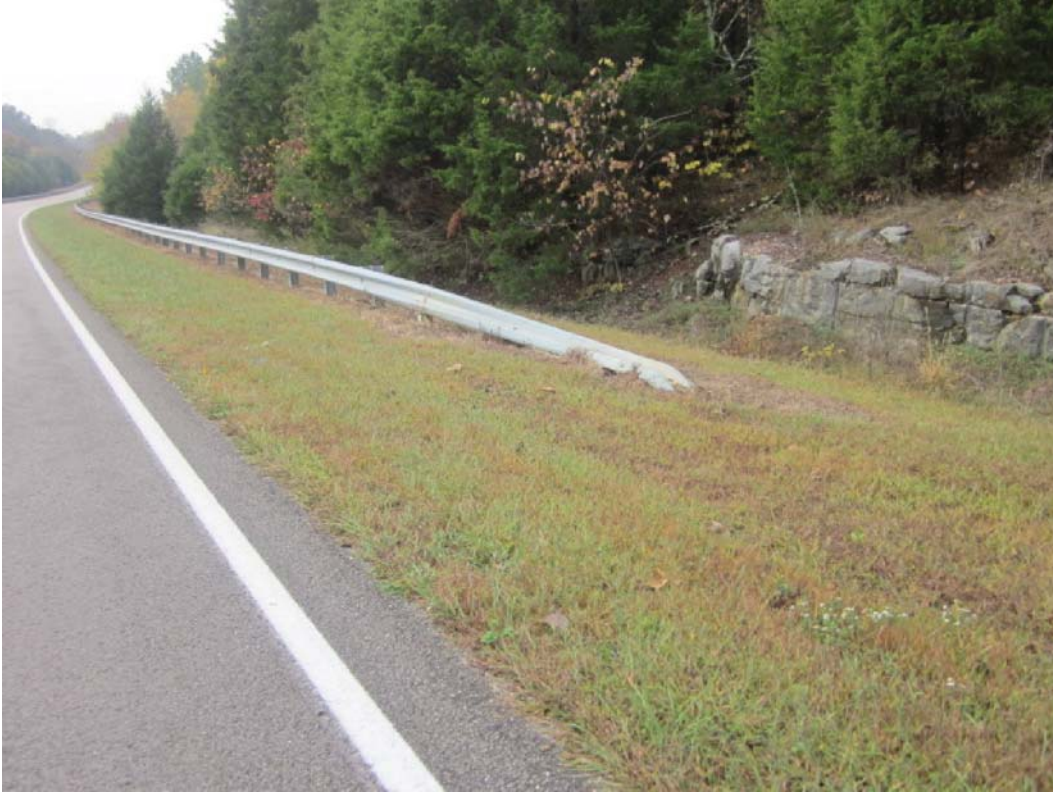
MACA_0020_0.941_L_1.JPG

Barrier ID:	MACA-0020-0.941-L				
Route Name:	PARK CITY ROAD				
Inspection Date:	10/13/2010	Barrier Rating:	39.70		
Barrier Description					
Type:	W-BEAM STRONG POST	Barrier Function:	TRAFFIC		
Barrier Material:	GALVANIZED STEEL	Post Material:	GALVANIZED STEEL		
Blockout Type:	STEEL	Length (ft.):	597		
Speed Limit (MPH):	50	Placement with Respect to Road:	INSIDE OF CURVE		
Hazard Behind Barrier:	MEDIUM				
Barrier Crashworthiness					
Appropriate Test Level:	TL-3	Barrier Test Level:	TL-3	Is Barrier Crashworthy?:	YES
Beg. End Trtmt Type:	W-BEAM TURN DOWN	Is Beg. End Trtmt Crashworthy?:	NO	Approach Transition Type:	NONE
Ending End Trtmt Type:	W-BEAM TURN DOWN	Ending End Trtmt Crashworthy?:	NO		
Average Measurements					
Design Height (In.):	27	Width (In.):	0.0	Post Spacing (In.):	77.0
Height (In.):	24.2	Lateral Offset (In.):	130.6	Road Grade (%):	3.40
Physical Condition					
Barrier	Alignment and Height:	Alignment acceptable. 497-ft was between 1 and 3-in below the 27-in design height and 100-ft was more than 3-in below the design height.

Breaking and Cracking:	No breaking or cracking observed.			
	Missing Elements:	No missing elements observed.			
	Corrosion and Weathering:	No corrosion or weathering observed.			
End Treatments	Alignment and Height:	Alignment acceptable. Height within 1-in of 27-in design height.			
	Breaking and Cracking:	No breaking or cracking observed.			
	Missing Elements:	No missing elements observed.			
	Corrosion and Weathering:	No corrosion or weathering observed.

Repair Action:	REPAIR	FMSS Work Type:	DEFERRED MAINTENANCE	Repair Cost:	\$14322
Brief Workorder:	Raise 597 feet of guardrail to 27 inch design height.				
Workorder:	Adjust Guardrail at \$10- per -Lin. Ft. for 597 LF = \$5970. Raise 597 feet of guardrail to 27 inch design height. High Speed Traffic Control at \$2350- per -Day for 3 Day(s) = \$7050.

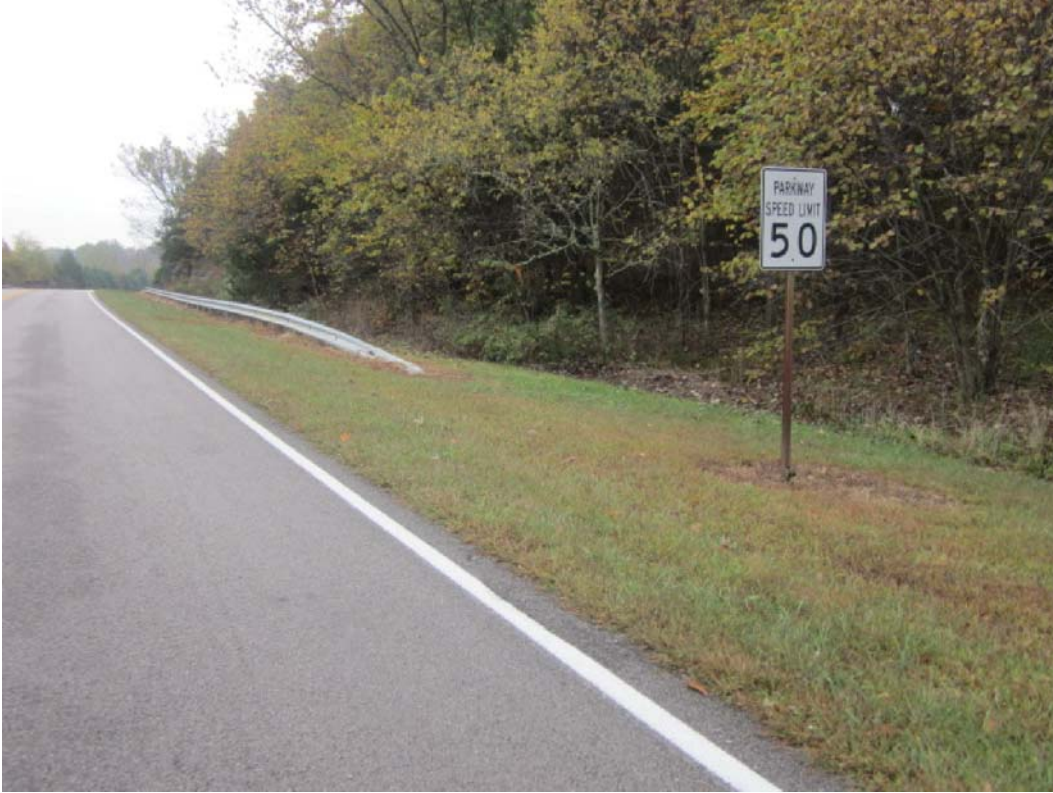
MACA_0020_1.107_L_1.JPG

Barrier ID:	MACA-0020-1.107-L				
Route Name:	PARK CITY ROAD				
Inspection Date:	10/13/2010	Barrier Rating:	30.00		
Barrier Description					
Type:	W-BEAM STRONG POST	Barrier Function:	TRAFFIC		
Barrier Material:	GALVANIZED STEEL	Post Material:	GALVANIZED STEEL		
Blockout Type:	STEEL	Length (ft.):	200		
Speed Limit (MPH):	50	Placement with Respect to Road:	INSIDE OF CURVE		
Hazard Behind Barrier:	LOW				
Barrier Crashworthiness					
Appropriate Test Level:	TL-3	Barrier Test Level:	TL-3	Is Barrier Crashworthy?:	YES
Beg. End Trtmt Type:	W-BEAM TURN DOWN	Is Beg. End Trtmt Crashworthy?:	NO	Approach Transition Type:	NONE
Ending End Trtmt Type:	W-BEAM TURN DOWN	Ending End Trtmt Crashworthy?:	NO		
Average Measurements					
Design Height (In.):	27	Width (In.):	0.0	Post Spacing (In.):	75.0
Height (In.):	23.0	Lateral Offset (In.):	135.0	Road Grade (%):	0.50
Physical Condition					
Barrier	Alignment and Height:	Alignment acceptable. 50-ft was between 1 and 3-in below the 27-in design height and 150-ft was more than 3-in below the design height.

Breaking and Cracking:	No breaking or cracking observed.			
	Missing Elements:	No missing elements observed.			
	Corrosion and Weathering:	No corrosion or weathering observed.			
End Treatments	Alignment and Height:	Alignment acceptable. Height within 1-in of 27-in design height.			
	Breaking and Cracking:	No breaking or cracking observed.			
	Missing Elements:	No missing elements observed.			
	Corrosion and Weathering:	No corrosion or weathering observed.

Repair Action:	REPAIR	FMSS Work Type:	DEFERRED MAINTENANCE	Repair Cost:	\$4785
Brief Workorder:	Raise 200 feet of guardrail to 27 inch design height.				
Workorder:	Adjust Guardrail at \$10- per -Lin. Ft. for 200 LF = \$2000. Raise 200 feet of guardrail to 27 inch design height. High Speed Traffic Control at \$2350- per -Day for 1 Day(s) = \$2350.

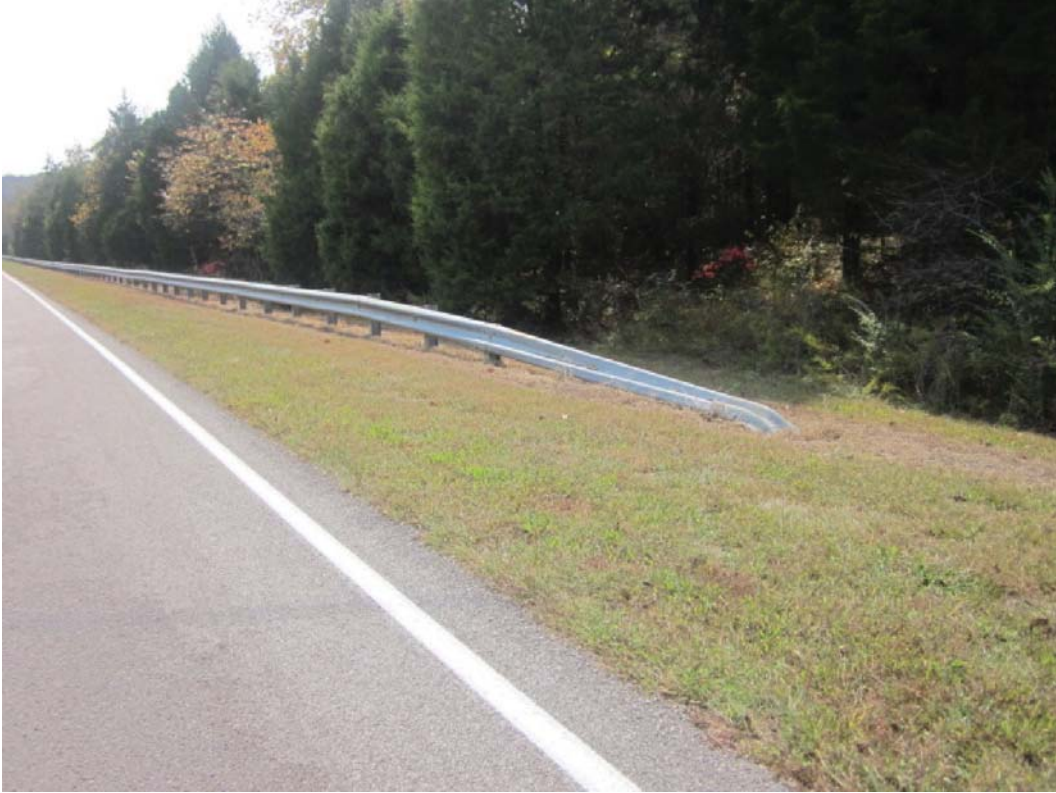
MACA_0020_1.321_L_1.JPG

Barrier ID:	MACA-0020-1.321-L				
Route Name:	PARK CITY ROAD				
Inspection Date:	10/13/2010	Barrier Rating:	45.50		
Barrier Description					
Type:	W-BEAM STRONG POST	Barrier Function:	TRAFFIC		
Barrier Material:	GALVANIZED STEEL	Post Material:	GALVANIZED STEEL		
Blockout Type:	STEEL	Length (ft.):	2140		
Speed Limit (MPH):	50	Placement with Respect to Road:	OUTSIDE OF CURVE		
Hazard Behind Barrier:	LOW				
Barrier Crashworthiness					
Appropriate Test Level:	TL-3	Barrier Test Level:	TL-3	Is Barrier Crashworthy?:	YES
Beg. End Trtmt Type:	W-BEAM TURN DOWN	Is Beg. End Trtmt Crashworthy?:	NO	Approach Transition Type:	NONE
Ending End Trtmt Type:	W-BEAM TURN DOWN	Ending End Trtmt Crashworthy?:	NO		
Average Measurements					
Design Height (In.):	27	Width (In.):	0.0	Post Spacing (In.):	74.8
Height (In.):	25.5	Lateral Offset (In.):	126.5	Road Grade (%):	2.70
Physical Condition					
Barrier	Alignment and Height:	Alignment has no deviation and height is low by 2 to 3 in from the 27 in design height for 1245 ft.

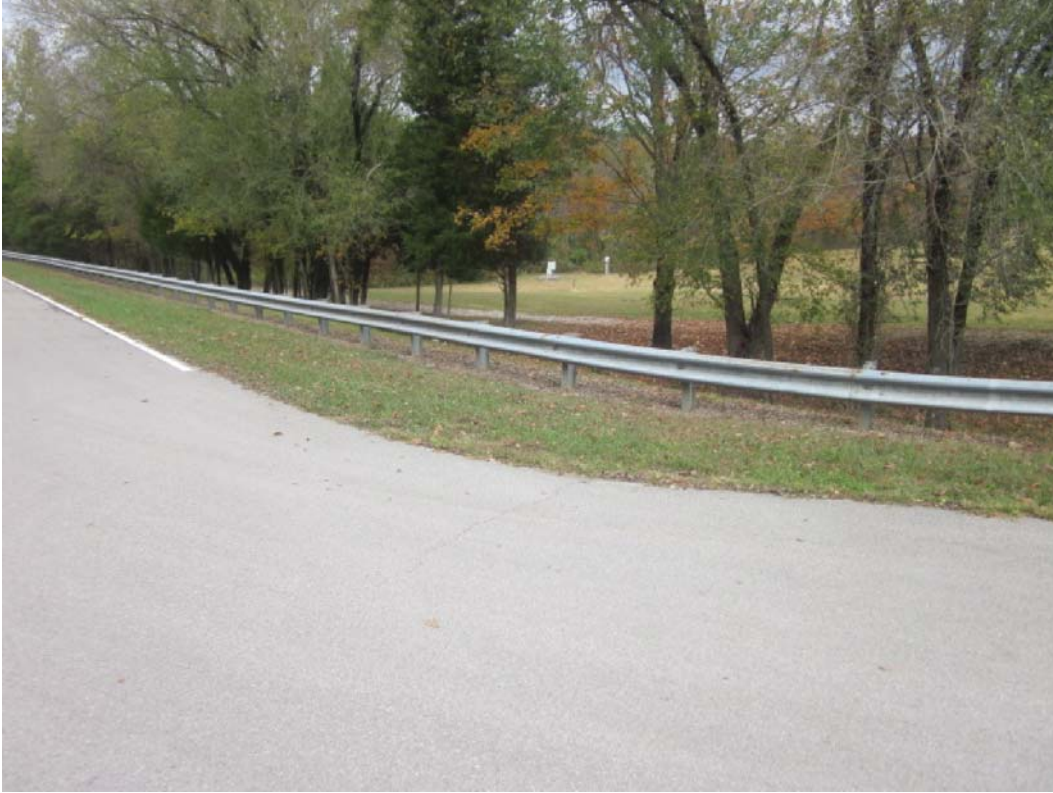
MACA_0020_1.324_R_1.JPG

Barrier ID:	MACA-0020-1.324-R				
Route Name:	PARK CITY ROAD				
Inspection Date:	10/13/2010	Barrier Rating:	39.50		
Barrier Description					
Type:	W-BEAM STRONG POST	Barrier Function:	TRAFFIC		
Barrier Material:	GALVANIZED STEEL	Post Material:	GALVANIZED STEEL		
Blockout Type:	STEEL	Length (ft.):	1797		
Speed Limit (MPH):	50	Placement with Respect to Road:	TANGENT		
Hazard Behind Barrier:	MEDIUM				
Barrier Crashworthiness					
Appropriate Test Level:	TL-3	Barrier Test Level:	TL-3	Is Barrier Crashworthy?:	YES
Beg. End Trtmt Type:	NONE	Is Beg. End Trtmt Crashworthy?:	N/A	Approach Transition Type:	NONE
Ending End Trtmt Type:	W-BEAM TURN DOWN	Ending End Trtmt Crashworthy?:	NO		
Average Measurements					
Design Height (In.):	27	Width (In.):	0.0	Post Spacing (In.):	74.8
Height (In.):	25.7	Lateral Offset (In.):	131.3	Road Grade (%):	2.80
Physical Condition					
Barrier	Alignment and Height:	20 ft of alignment has deviated up to 1.5 ft from impact. Height is 1 to 3 in below the 27 in design height for 1220 ft.

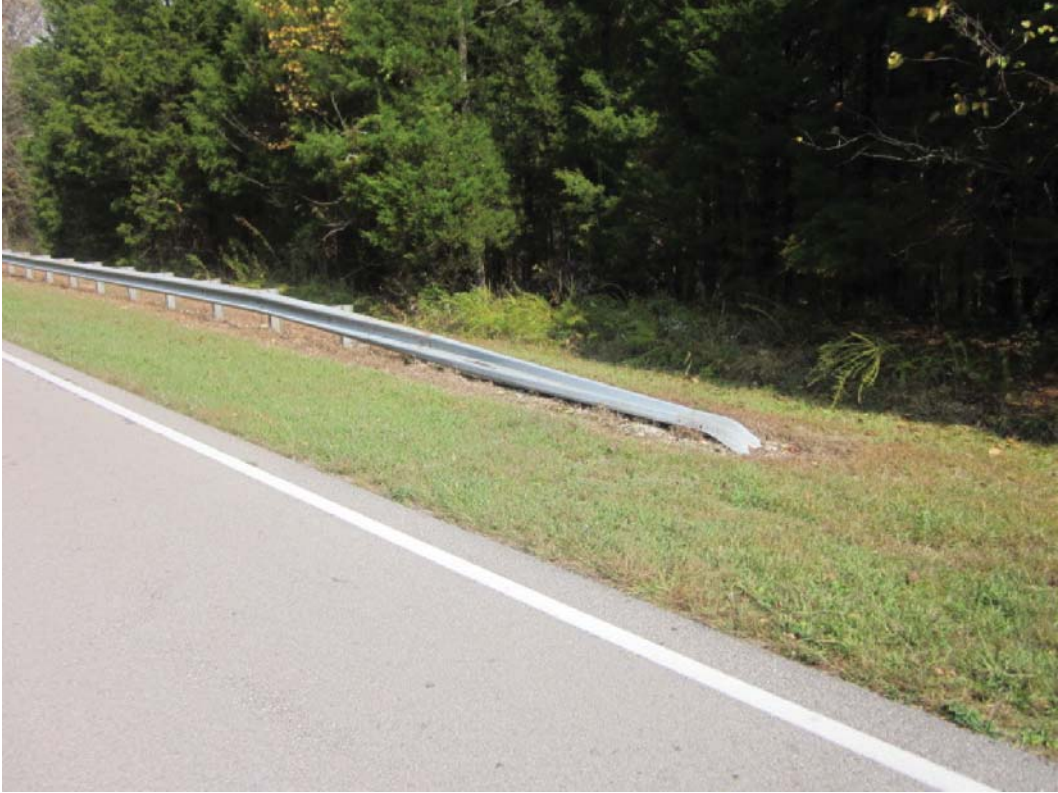
MACA_0020_1.871_R_1.JPG

Barrier ID:	MACA-0020-1.871-R				
Route Name:	PARK CITY ROAD				
Inspection Date:	10/13/2010	Barrier Rating:	35.40		
Barrier Description					
Type:	W-BEAM STRONG POST	Barrier Function:	TRAFFIC		
Barrier Material:	GALVANIZED STEEL	Post Material:	GALVANIZED STEEL		
Blockout Type:	STEEL	Length (ft.):	377		
Speed Limit (MPH):	50	Placement with Respect to Road:	INSIDE OF CURVE		
Hazard Behind Barrier:	MEDIUM				
Barrier Crashworthiness					
Appropriate Test Level:	TL-3	Barrier Test Level:	TL-3	Is Barrier Crashworthy?:	YES
Beg. End Trtmt Type:	W-BEAM TURN DOWN	Is Beg. End Trtmt Crashworthy?:	NO	Approach Transition Type:	NONE
Ending End Trtmt Type:	W-BEAM TURN DOWN	Ending End Trtmt Crashworthy?:	NO		
Average Measurements					
Design Height (In.):	27	Width (In.):	0.0	Post Spacing (In.):	75.6
Height (In.):	24.7	Lateral Offset (In.):	131.3	Road Grade (%):	5.20
Physical Condition					
Barrier	Alignment and Height:	Alignment has no deviation and height is 2 to 3 in below the 27 in design height.
