MACA GIP Report

NPS Guardwall/Rail Inventory Program Mammoth Cave National Park

**Federal Lands Highway
Road Inventory Program**

Data Collection Date: October 2010
Report Date: November 2015

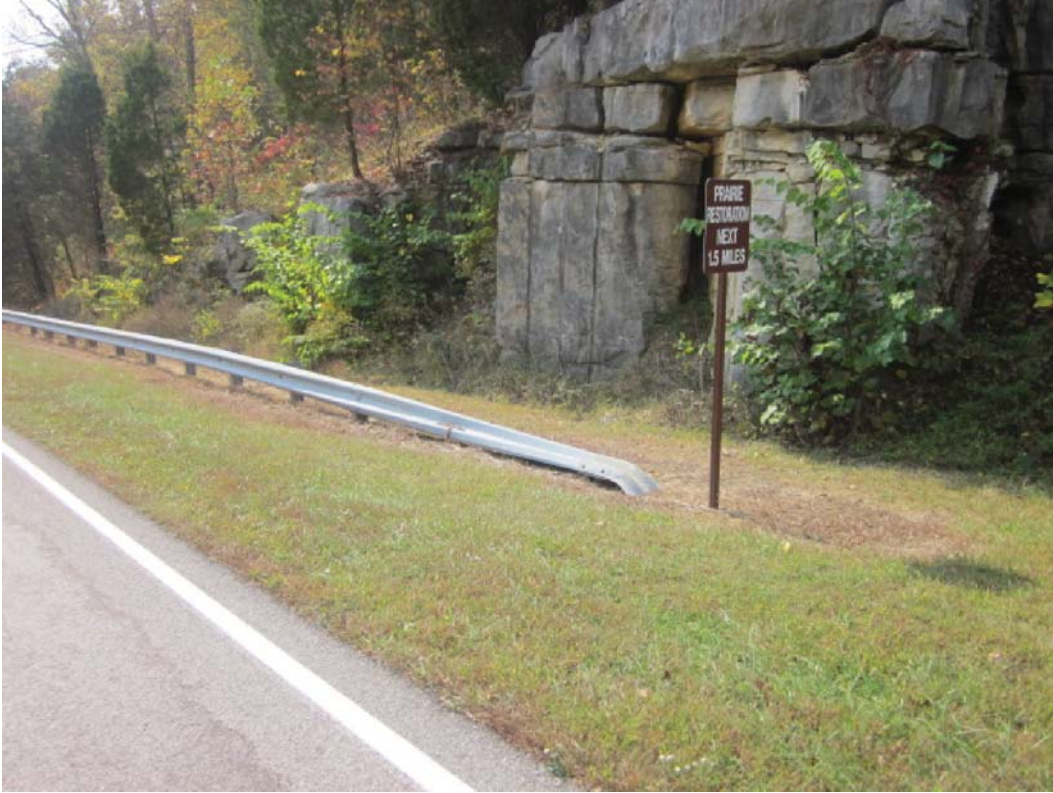
MACA_0020_1.910_L_1.JPG

Barrier ID:	MACA-0020-1.910-L				
Route Name:	PARK CITY ROAD				
Inspection Date:	10/13/2010	Barrier Rating:	27.00		
Barrier Description					
Type:	W-BEAM STRONG POST	Barrier Function:	TRAFFIC		
Barrier Material:	GALVANIZED STEEL	Post Material:	GALVANIZED STEEL		
Blockout Type:	STEEL	Length (ft.):	202		
Speed Limit (MPH):	50	Placement with Respect to Road:	TANGENT		
Hazard Behind Barrier:	LOW				
Barrier Crashworthiness					
Appropriate Test Level:	TL-3	Barrier Test Level:	TL-3	Is Barrier Crashworthy?:	YES
Beg. End Trtmt Type:	W-BEAM TURN DOWN	Is Beg. End Trtmt Crashworthy?:	NO	Approach Transition Type:	NONE
Ending End Trtmt Type:	W-BEAM TURN DOWN	Ending End Trtmt Crashworthy?:	NO		
Average Measurements					
Design Height (In.):	27	Width (In.):	0.0	Post Spacing (In.):	74.0
Height (In.):	25.2	Lateral Offset (In.):	127.6	Road Grade (%):	4.40
Physical Condition					
Barrier	Alignment and Height:	Alignment has no deviation and height is low by 1 to 3 in below the design height of 27 in for 108 ft.

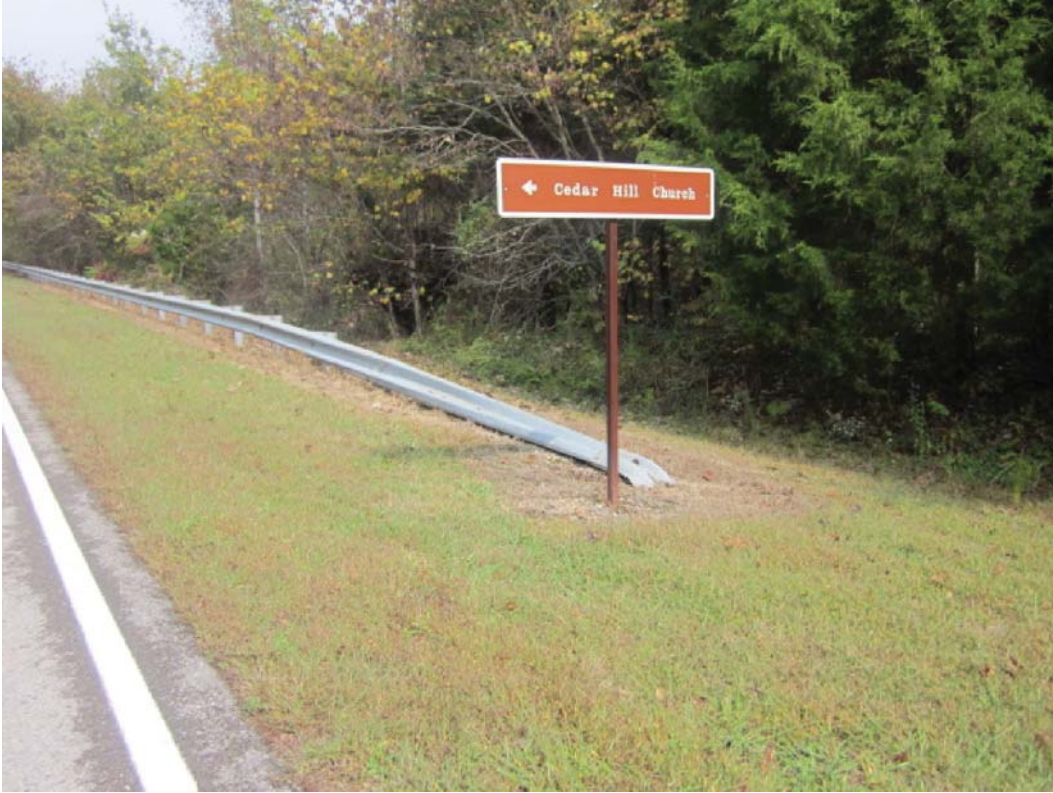
MACA_0020_1.996_R_1.JPG

Barrier ID:	MACA-0020-1.996-R				
Route Name:	PARK CITY ROAD				
Inspection Date:	10/13/2010	Barrier Rating:	34.20		
Barrier Description					
Type:	W-BEAM STRONG POST	Barrier Function:	TRAFFIC		
Barrier Material:	GALVANIZED STEEL	Post Material:	GALVANIZED STEEL		
Blockout Type:	STEEL	Length (ft.):	674		
Speed Limit (MPH):	50	Placement with Respect to Road:	TANGENT		
Hazard Behind Barrier:	LOW				
Barrier Crashworthiness					
Appropriate Test Level:	TL-3	Barrier Test Level:	TL-3	Is Barrier Crashworthy?:	YES
Beg. End Trtmt Type:	W-BEAM TURN DOWN	Is Beg. End Trtmt Crashworthy?:	NO	Approach Transition Type:	NONE
Ending End Trtmt Type:	W-BEAM TURN DOWN	Ending End Trtmt Crashworthy?:	NO		
Average Measurements					
Design Height (In.):	27	Width (In.):	0.0	Post Spacing (In.):	75.3
Height (In.):	25.0	Lateral Offset (In.):	129.3	Road Grade (%):	4.50
Physical Condition					
Barrier	Alignment and Height:	Alignment acceptable. 540-ft was between 1 and 3-in below the 27-in design height and 104-ft was more than 3-in below the design height.

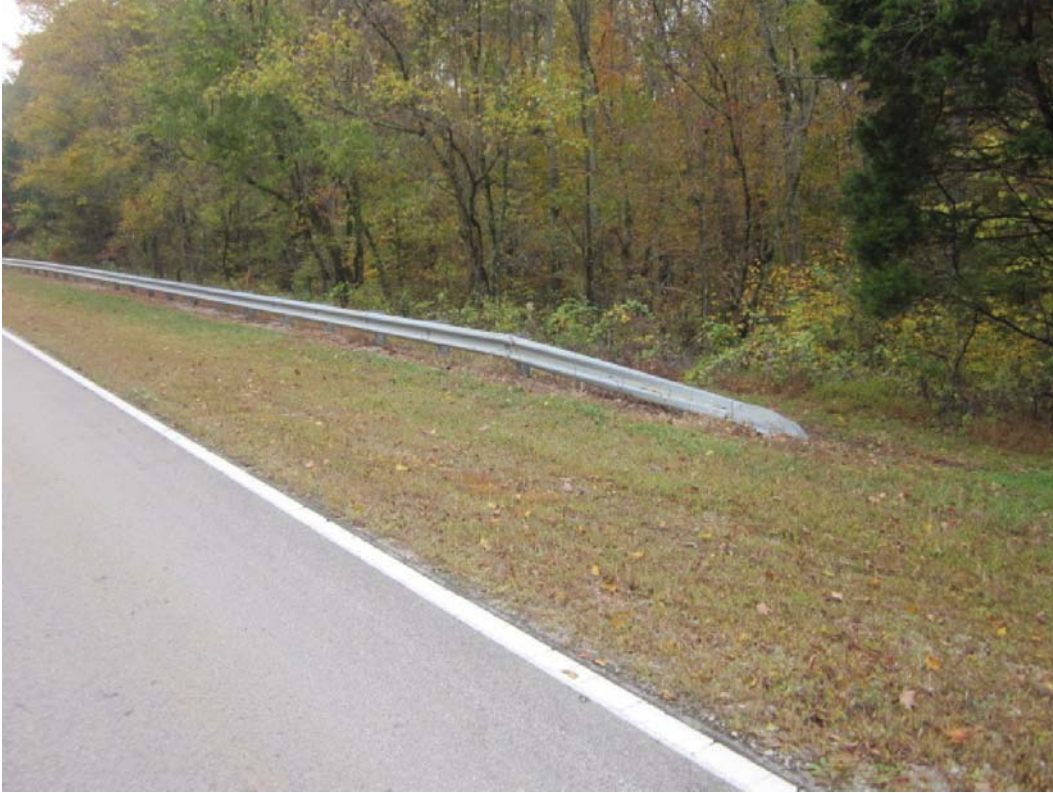
MACA_0020_2.116_L_1.JPG

Barrier ID:	MACA-0020-2.116-L				
Route Name:	PARK CITY ROAD				
Inspection Date:	10/13/2010	Barrier Rating:	39.70		
Barrier Description					
Type:	W-BEAM STRONG POST	Barrier Function:	TRAFFIC		
Barrier Material:	GALVANIZED STEEL	Post Material:	GALVANIZED STEEL		
Blockout Type:	STEEL	Length (ft.):	238		
Speed Limit (MPH):	50	Placement with Respect to Road:	TANGENT		
Hazard Behind Barrier:	LOW				
Barrier Crashworthiness					
Appropriate Test Level:	TL-3	Barrier Test Level:	TL-3	Is Barrier Crashworthy?:	YES
Beg. End Trtmt Type:	W-BEAM TURN DOWN	Is Beg. End Trtmt Crashworthy?:	NO	Approach Transition Type:	NONE
Ending End Trtmt Type:	W-BEAM TURN DOWN	Ending End Trtmt Crashworthy?:	NO		
Average Measurements					
Design Height (In.):	27	Width (In.):	0.0	Post Spacing (In.):	75.3
Height (In.):	22.0	Lateral Offset (In.):	169.6	Road Grade (%):	1.60
Physical Condition					
Barrier	Alignment and Height:	Alignment has no deviation and height is low by 4 to 6 in below the design height of 27 in.

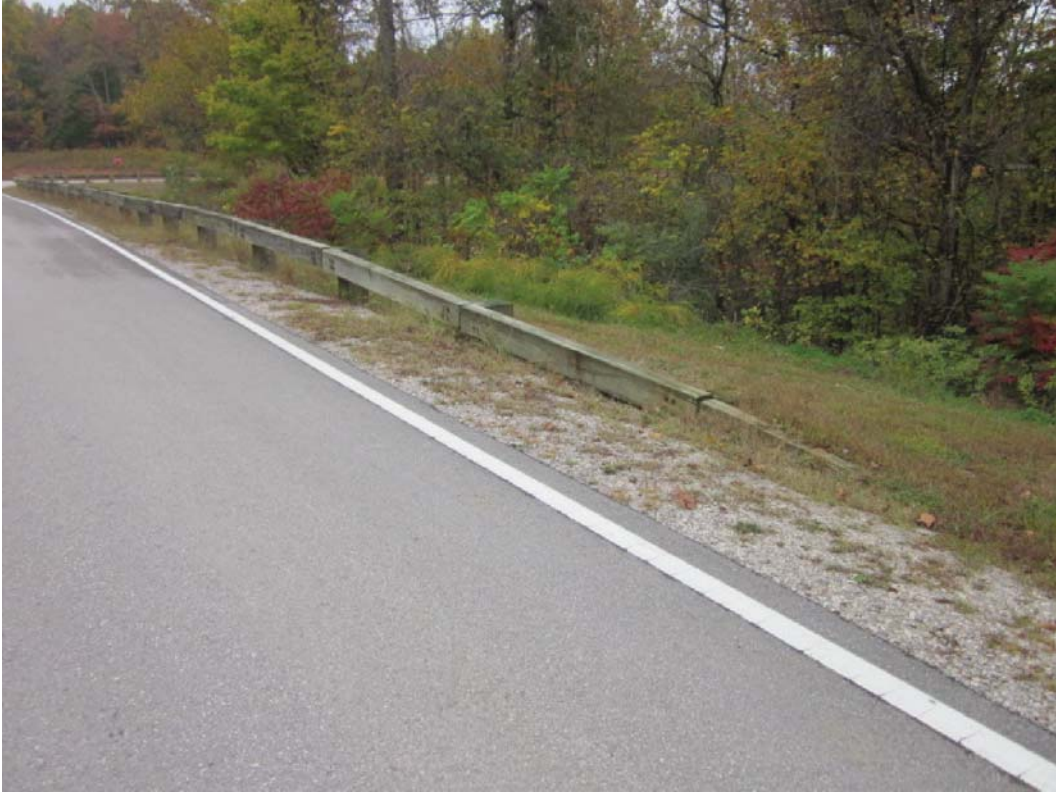
MACA_0020_2.216_R_1.JPG

Barrier ID:	MACA-0020-2.216-R				
Route Name:	PARK CITY ROAD				
Inspection Date:	10/13/2010	Barrier Rating:	27.00		
Barrier Description					
Type:	STEEL-BACKED TIMBER WITH BLOCKOUT	Barrier Function:	TRAFFIC		
Barrier Material:	STEEL-BACKED TIMBER/LOG	Post Material:	WOOD		
Blockout Type:	WOOD	Length (ft.):	283		
Speed Limit (MPH):	50	Placement with Respect to Road:	INSIDE OF CURVE		
Hazard Behind Barrier:	LOW				
Barrier Crashworthiness					
Appropriate Test Level:	TL-3	Barrier Test Level:	TL-3	Is Barrier Crashworthy?:	YES
Beg. End Trtmt Type:	SBT/LOG FLARED	Is Beg. End Trtmt Crashworthy?:	NO	Approach Transition Type:	NONE
Ending End Trtmt Type:	NONE	Ending End Trtmt Crashworthy?:	N/A		
Average Measurements					
Design Height (In.):	27	Width (In.):	0.0	Post Spacing (In.):	119.6
Height (In.):	28.7	Lateral Offset (In.):	42.7	Road Grade (%):	0.70
Physical Condition					
Barrier	Alignment and Height:	Alignment has no deviation and height is at or above the 27 in design height by up to 4 in.

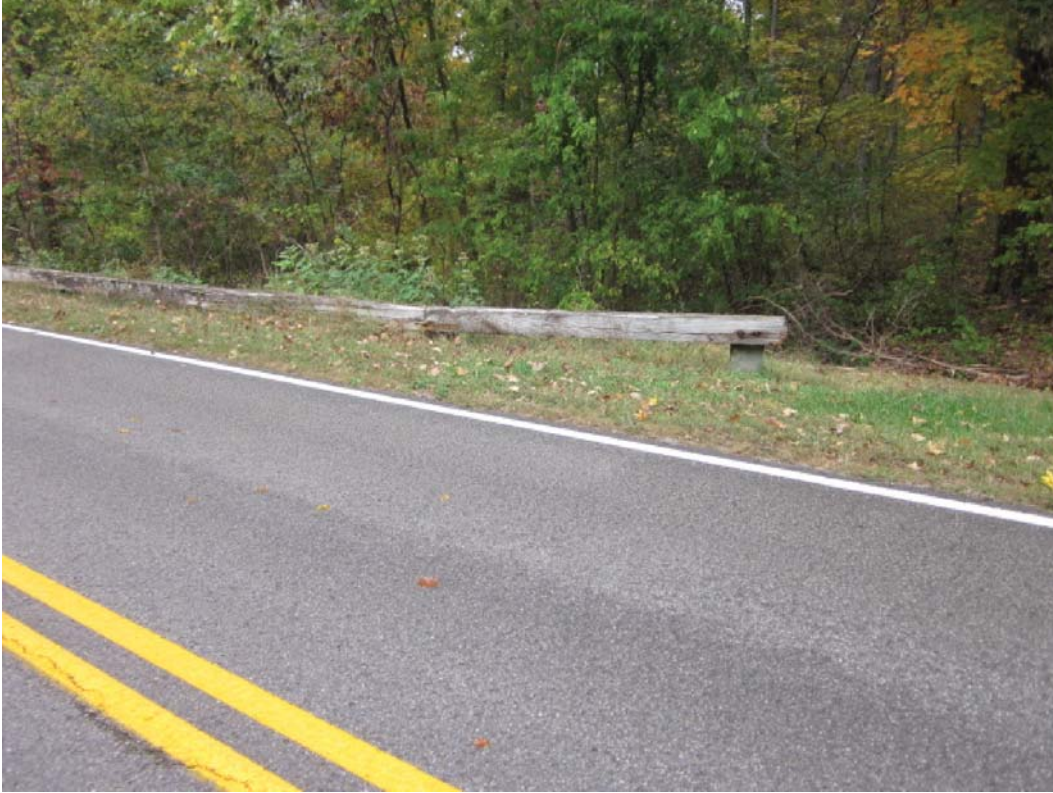
MACA_0102_0.180_R_1.JPG

Barrier ID:	MACA-0102-0.180-R				
Route Name:	CEDAR SINK ROAD				
Inspection Date:	10/12/2010	Barrier Rating:	36.50		
Barrier Description					
Type:	OTHER: TIMBER RAIL ON CONCRETE POSTS	Barrier Function:	TRAFFIC		
Barrier Material:	LOG/TIMBER/WOOD	Post Material:	OTHER: CONCRETE		
Blockout Type:	N/A	Length (ft.):	202		
Speed Limit (MPH):	45	Placement with Respect to Road:	TANGENT		
Hazard Behind Barrier:	MEDIUM				
Barrier Crashworthiness					
Appropriate Test Level:	TL-2	Barrier Test Level:	NCW	Is Barrier Crashworthy?:	NO
Beg. End Trtmt Type:	NONE	Is Beg. End Trtmt Crashworthy?:	N/A	Approach Transition Type:	NONE
Ending End Trtmt Type:	NONE	Ending End Trtmt Crashworthy?:	N/A		
Average Measurements					
Design Height (In.):	20	Width (In.):	0.0	Post Spacing (In.):	120.0
Height (In.):	15.6	Lateral Offset (In.):	50.0	Road Grade (%):	5.60
Physical Condition					
Barrier	Alignment and Height:	Alignment has no deviation and height is 1 to 5 in below the design height of 20 in.

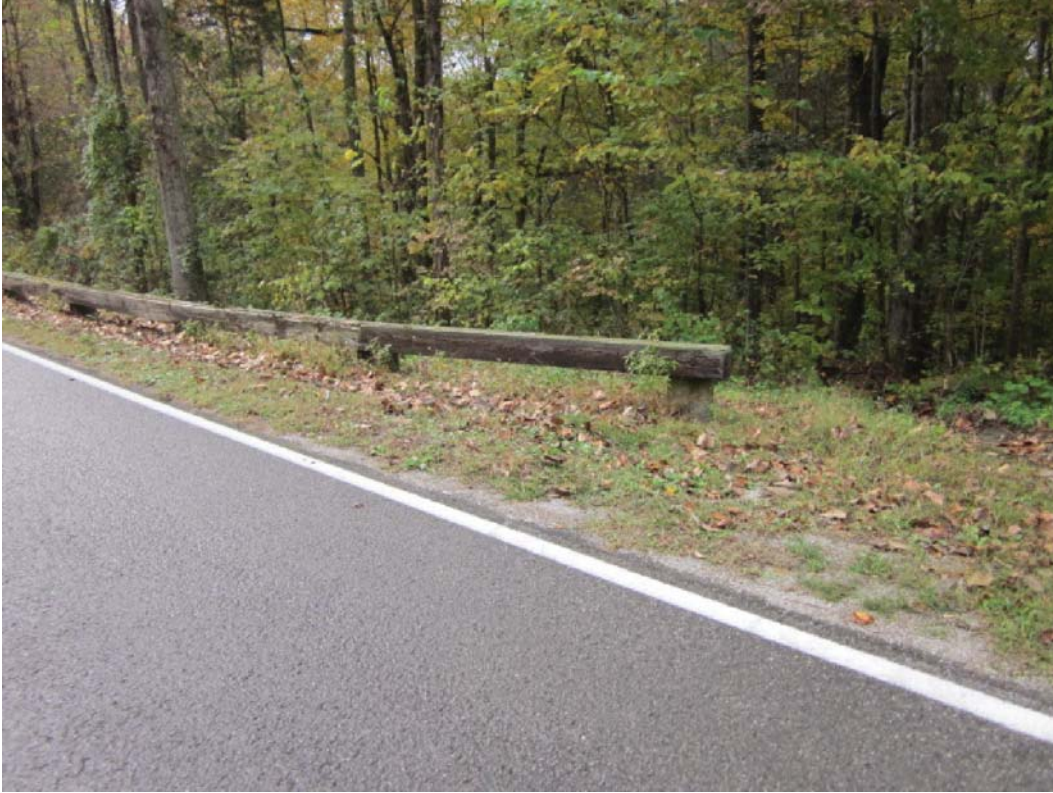
MACA_0102_0.346_R_1.JPG

Barrier ID:	MACA-0102-0.346-R				
Route Name:	CEDAR SINK ROAD				
Inspection Date:	10/12/2010	Barrier Rating:	50.90		
Barrier Description					
Type:	OTHER: TIMBER RAIL ON CONCRETE POSTS	Barrier Function:	TRAFFIC		
Barrier Material:	LOG/TIMBER/WOOD	Post Material:	OTHER: CONCRETE		
Blockout Type:	N/A	Length (ft.):	253		
Speed Limit (MPH):	45	Placement with Respect to Road:	OUTSIDE OF CURVE		
Hazard Behind Barrier:	MEDIUM				
Barrier Crashworthiness					
Appropriate Test Level:	TL-2	Barrier Test Level:	NCW	Is Barrier Crashworthy?:	NO
Beg. End Trtmt Type:	NONE	Is Beg. End Trtmt Crashworthy?:	N/A	Approach Transition Type:	NONE
Ending End Trtmt Type:	NONE	Ending End Trtmt Crashworthy?:	N/A		
Average Measurements					
Design Height (In.):	20	Width (In.):	0.0	Post Spacing (In.):	119.5
Height (In.):	12.3	Lateral Offset (In.):	46.2	Road Grade (%):	6.00
Physical Condition					
Barrier	Alignment and Height:	Alignment has no deviation and height is low by 7 to 8 in below the 20 in design height.

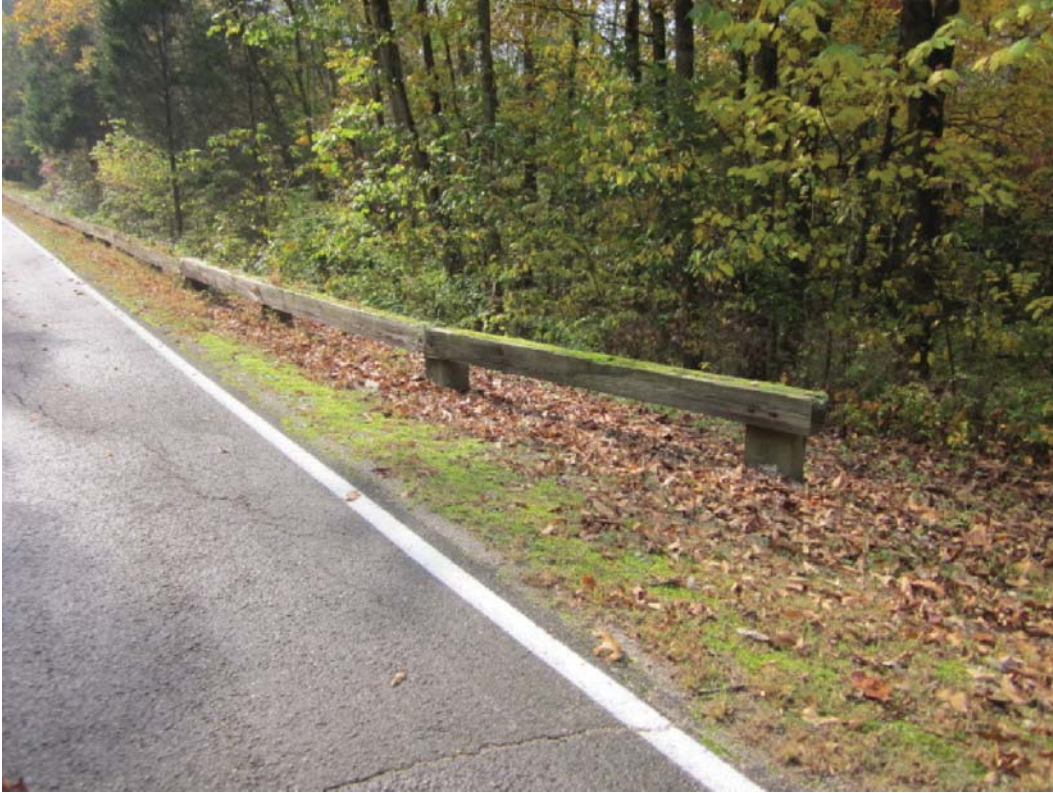
MACA_0102_0.432_R_1.JPG

Barrier ID:	MACA-0102-0.432-R				
Route Name:	CEDAR SINK ROAD				
Inspection Date:	10/12/2010	Barrier Rating:	39.40		
Barrier Description					
Type:	OTHER: TIMBER RAIL ON CONCRETE POSTS	Barrier Function:	TRAFFIC		
Barrier Material:	LOG/TIMBER/WOOD	Post Material:	OTHER: CONCRETE		
Blockout Type:	N/A	Length (ft.):	231		
Speed Limit (MPH):	45	Placement with Respect to Road:	TANGENT		
Hazard Behind Barrier:	MEDIUM				
Barrier Crashworthiness					
Appropriate Test Level:	TL-2	Barrier Test Level:	NCW	Is Barrier Crashworthy?:	NO
Beg. End Trtmt Type:	NONE	Is Beg. End Trtmt Crashworthy?:	N/A	Approach Transition Type:	NONE
Ending End Trtmt Type:	NONE	Ending End Trtmt Crashworthy?:	N/A		
Average Measurements					
Design Height (In.):	20	Width (In.):	0.0	Post Spacing (In.):	121.3
Height (In.):	13.0	Lateral Offset (In.):	44.7	Road Grade (%):	4.70
Physical Condition					
Barrier	Alignment and Height:	Alignment has no deviation and height is 2 to 8 in below the 20 in design height.

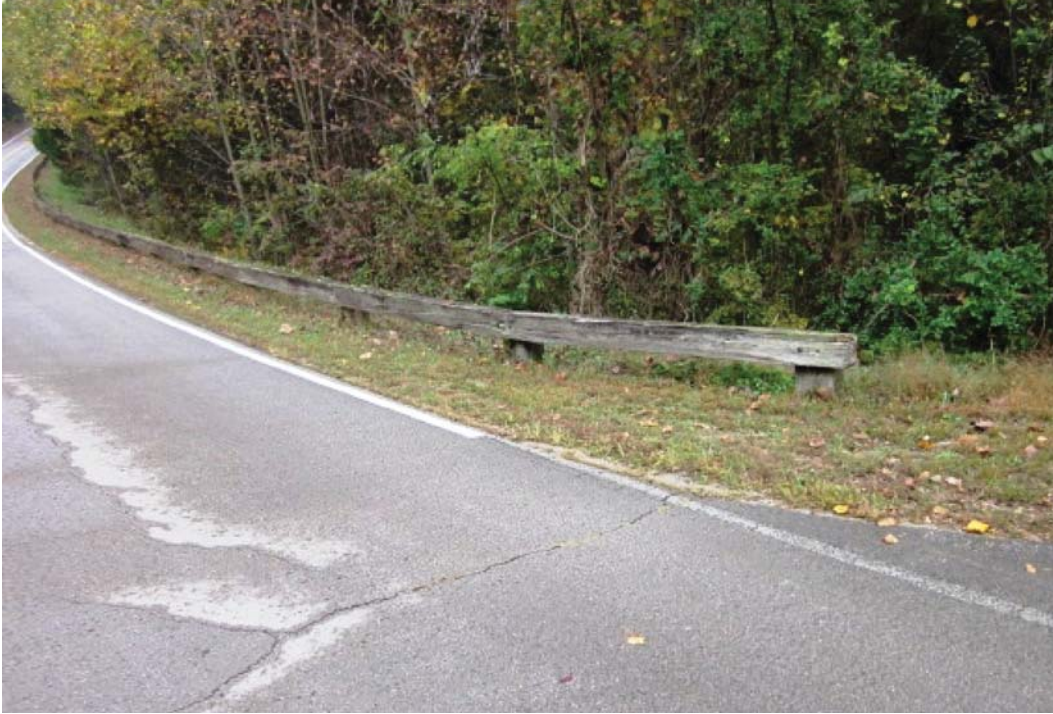
MACA_0102_0.476_L_1.JPG

Barrier ID:	MACA-0102-0.476-L				
Route Name:	CEDAR SINK ROAD				
Inspection Date:	10/12/2010	Barrier Rating:	42.20		
Barrier Description					
Type:	OTHER: TIMBER RAIL ON CONCRETE POSTS	Barrier Function:	TRAFFIC		
Barrier Material:	LOG/TIMBER/WOOD	Post Material:	OTHER: CONCRETE		
Blockout Type:	N/A	Length (ft.):	402		
Speed Limit (MPH):	45	Placement with Respect to Road:	INSIDE OF CURVE		
Hazard Behind Barrier:	MEDIUM				
Barrier Crashworthiness					
Appropriate Test Level:	TL-2	Barrier Test Level:	NCW	Is Barrier Crashworthy?:	NO
Beg. End Trtmt Type:	NONE	Is Beg. End Trtmt Crashworthy?:	N/A	Approach Transition Type:	NONE
Ending End Trtmt Type:	NONE	Ending End Trtmt Crashworthy?:	N/A		
Average Measurements					
Design Height (In.):	20	Width (In.):	0.0	Post Spacing (In.):	120.6
Height (In.):	14.6	Lateral Offset (In.):	50.7	Road Grade (%):	1.90
Physical Condition					
Barrier	Alignment and Height:	Alignment has no deviation and height is 2 to 7 in below the design height of 20 in.

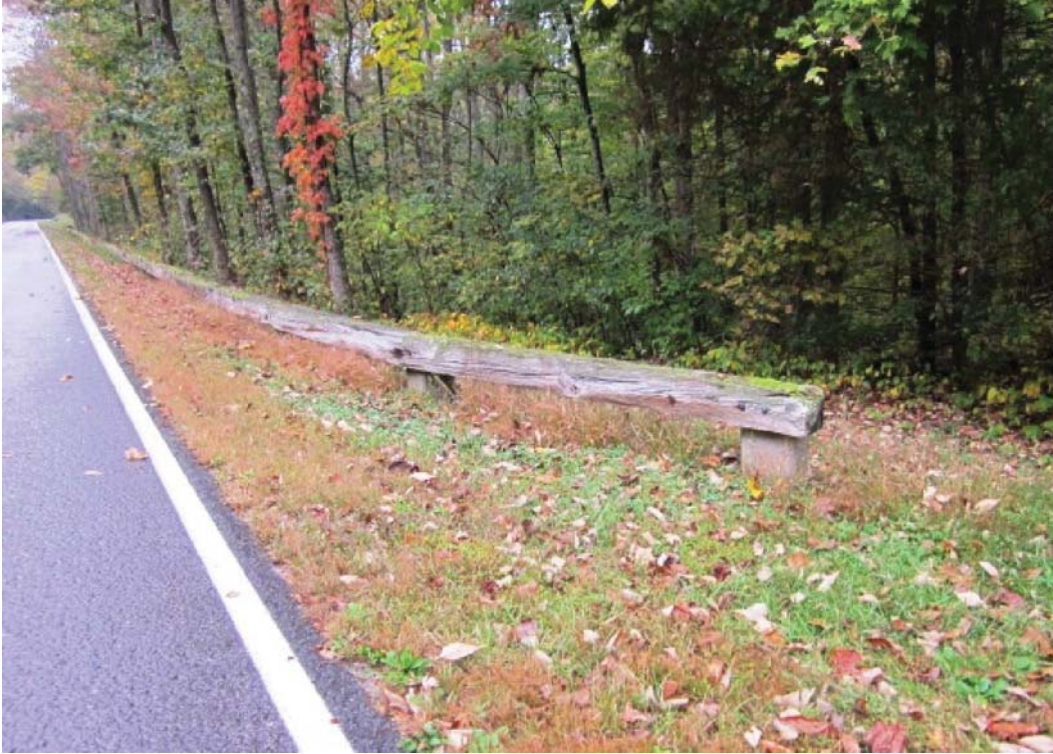
MACA_0102_0.860_L_1.JPG

Barrier ID:	MACA-0102-0.860-L				
Route Name:	CEDAR SINK ROAD				
Inspection Date:	10/12/2010	Barrier Rating:	36.90		
Barrier Description					
Type:	OTHER: TIMBER RAIL ON CONCRETE POSTS	Barrier Function:	TRAFFIC		
Barrier Material:	LOG/TIMBER/WOOD	Post Material:	OTHER: CONCRETE		
Blockout Type:	N/A	Length (ft.):	351		
Speed Limit (MPH):	45	Placement with Respect to Road:	TANGENT		
Hazard Behind Barrier:	LOW				
Barrier Crashworthiness					
Appropriate Test Level:	TL-2	Barrier Test Level:	NCW	Is Barrier Crashworthy?:	NO
Beg. End Trtmt Type:	NONE	Is Beg. End Trtmt Crashworthy?:	N/A	Approach Transition Type:	NONE
Ending End Trtmt Type:	NONE	Ending End Trtmt Crashworthy?:	N/A		
Average Measurements					
Design Height (In.):	20	Width (In.):	0.0	Post Spacing (In.):	120.3
Height (In.):	20.0	Lateral Offset (In.):	56.2	Road Grade (%):	5.00
Physical Condition					
Barrier	Alignment and Height:	Alignment has no deviation and height is low by 2 in below the 20 in design height for 50 ft.

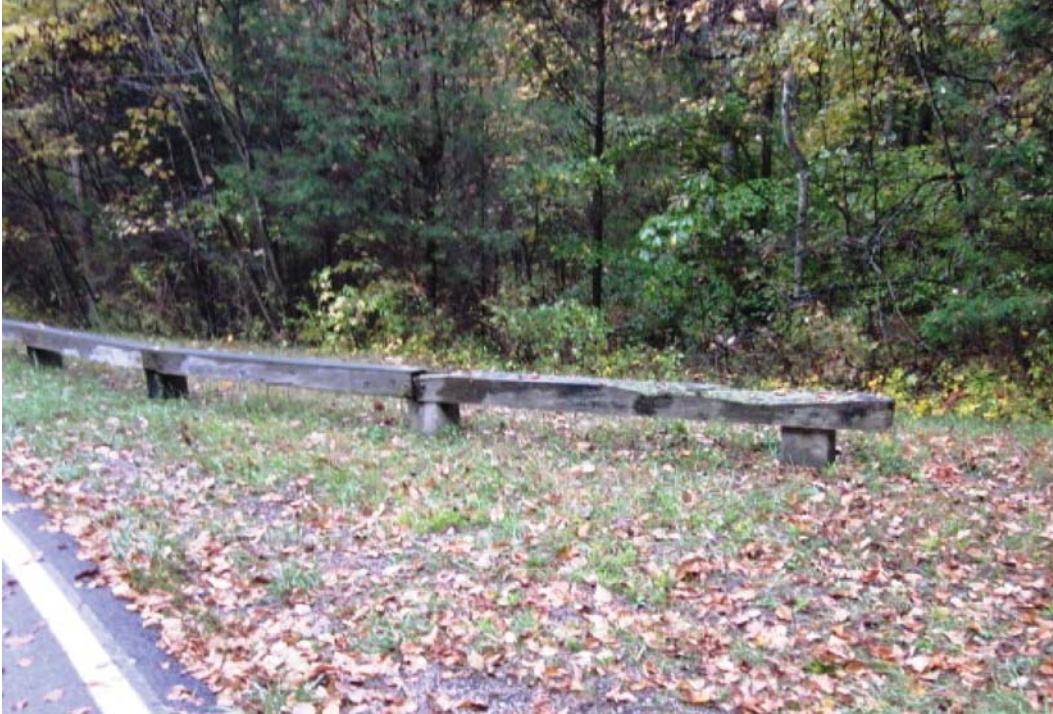
MACA_0103_0.393_R_1.JPG

Barrier ID:	MACA-0103-0.393-R				
Route Name:	HOUCHINS FERRY ROAD SOUTH				
Inspection Date:	10/12/2010	Barrier Rating:	38.40		
Barrier Description					
Type:	OTHER: TIMBER RAIL ON CONCRETE POSTS	Barrier Function:	TRAFFIC		
Barrier Material:	LOG/TIMBER/WOOD	Post Material:	OTHER: CONCRETE		
Blockout Type:	N/A	Length (ft.):	231		
Speed Limit (MPH):	35	Placement with Respect to Road:	OUTSIDE OF CURVE		
Hazard Behind Barrier:	LOW				
Barrier Crashworthiness					
Appropriate Test Level:	TL-2	Barrier Test Level:	NCW	Is Barrier Crashworthy?:	NO
Beg. End Trtmt Type:	NONE	Is Beg. End Trtmt Crashworthy?:	N/A	Approach Transition Type:	NONE
Ending End Trtmt Type:	NONE	Ending End Trtmt Crashworthy?:	N/A		
Average Measurements					
Design Height (In.):	20	Width (In.):	0.0	Post Spacing (In.):	121.4
Height (In.):	16.7	Lateral Offset (In.):	58.2	Road Grade (%):	16.30
Physical Condition					
Barrier	Alignment and Height:	The alignment is deviated by up to 2 ft for 20 ft due to impact. Height is low from 2 to 11 in from the 20 in design height.

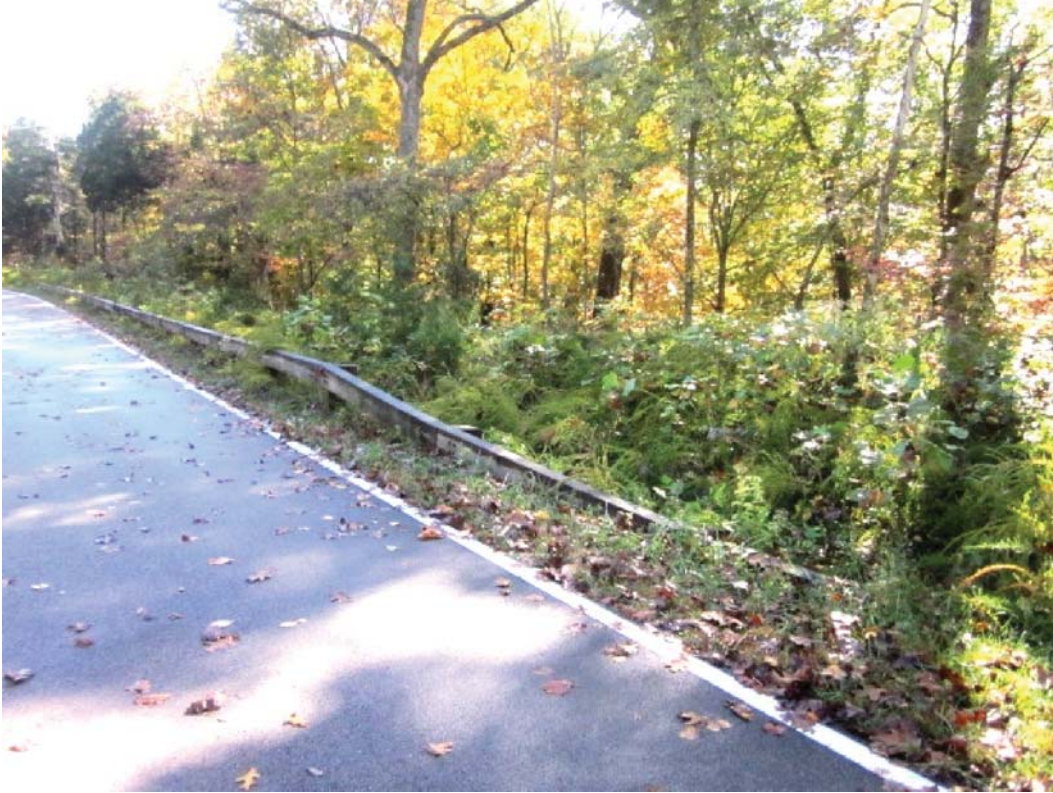
MACA_0110_1.509_R_1.JPG

Barrier ID:	MACA-0110-1.509-R				
Route Name:	MAPLE SPRINGS LOOP				
Inspection Date:	10/13/2010	Barrier Rating:	29.60		
Barrier Description					
Type:	STEEL-BACKED TIMBER WITHOUT BLOCKOUT	Barrier Function:	TRAFFIC		
Barrier Material:	STEEL-BACKED TIMBER/LOG	Post Material:	WOOD		
Blockout Type:	N/A	Length (ft.):	212		
Speed Limit (MPH):	25	Placement with Respect to Road:	OUTSIDE OF CURVE		
Hazard Behind Barrier:	MEDIUM				
Barrier Crashworthiness					
Appropriate Test Level:	TL-1	Barrier Test Level:	TL-2	Is Barrier Crashworthy?:	YES
Beg. End Trtmt Type:	SBT/LOG FLARED	Is Beg. End Trtmt Crashworthy?:	NO	Approach Transition Type:	NONE
Ending End Trtmt Type:	SBT/LOG FLARED	Ending End Trtmt Crashworthy?:	NO		
Average Measurements					
Design Height (In.):	27	Width (In.):	0.0	Post Spacing (In.):	120.0
Height (In.):	23.7	Lateral Offset (In.):	34.2	Road Grade (%):	0.30
Physical Condition					
Barrier	Alignment and Height:	Alignment has no deviation and height is 3 to 4 in below the 27 in design height.

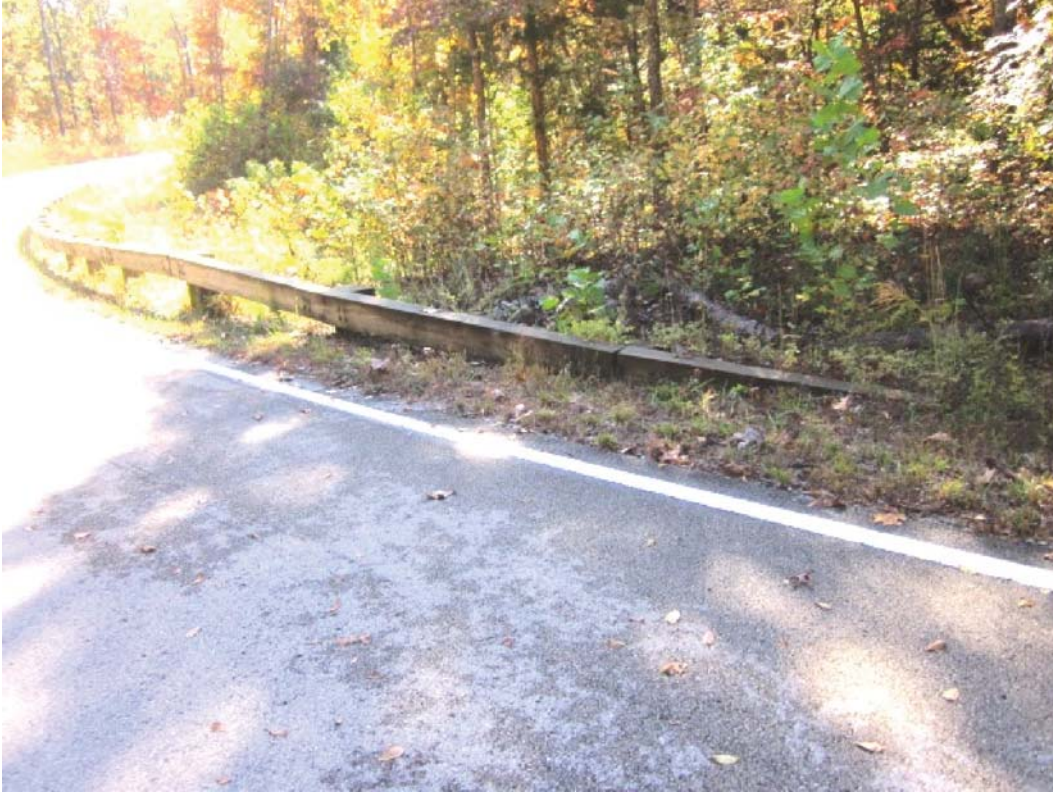
MACA_0110_1.738_R_1.JPG

Barrier ID:	MACA-0110-1.738-R				
Route Name:	MAPLE SPRINGS LOOP				
Inspection Date:	10/13/2010	Barrier Rating:	34.00		
Barrier Description					
Type:	STEEL-BACKED TIMBER WITHOUT BLOCKOUT	Barrier Function:	TRAFFIC		
Barrier Material:	STEEL-BACKED TIMBER/LOG	Post Material:	WOOD		
Blockout Type:	N/A	Length (ft.):	227		
Speed Limit (MPH):	25	Placement with Respect to Road:	INSIDE OF CURVE		
Hazard Behind Barrier:	LOW				
Barrier Crashworthiness					
Appropriate Test Level:	TL-1	Barrier Test Level:	TL-2	Is Barrier Crashworthy?:	YES
Beg. End Trtmt Type:	SBT/LOG FLARED	Is Beg. End Trtmt Crashworthy?:	NO	Approach Transition Type:	NONE
Ending End Trtmt Type:	SBT/LOG FLARED	Ending End Trtmt Crashworthy?:	NO		
Average Measurements					
Design Height (In.):	27	Width (In.):	0.0	Post Spacing (In.):	120.3
Height (In.):	22.6	Lateral Offset (In.):	32.2	Road Grade (%):	2.00
Physical Condition					
Barrier	Alignment and Height:	Alignment has no deviation and height is low by 4 to 5 in from the 27 in design height.

Breaking and Cracking:	No breaking or cracking observed.			
	Missing Elements:	No missing elements observed.			
	Corrosion and Weathering:	No corrosion or weathering observed.			
End Treatments	Alignment and Height:	Alignment acceptable. Height within 1-in of 27-in design height.			
	Breaking and Cracking:	No breaking or cracking observed.			
	Missing Elements:	No missing elements observed.			
	Corrosion and Weathering:	No corrosion or weathering observed.

Repair Action:	REPAIR	FMSS Work Type:	DEFERRED MAINTENANCE	Repair Cost:	\$4120
Brief Workorder:	Raise 227 feet of guardrail to 27 inch design height.				
Workorder:	Adjust Guardrail at \$10- per -Lin. Ft. for 227 LF = \$2270. Raise 227 feet of guardrail to 27 inch design height. Low Speed Traffic Control at \$1475- per -Day for 1 Day(s) = \$1475.
