MEVE GIP Report

NPS Guardwall/Rail Inventory Program Mesa Verde National Park

**Federal Lands Highway
Road Inventory Program**

**Data Collection Date: November 2009
Report Date: November 2015**

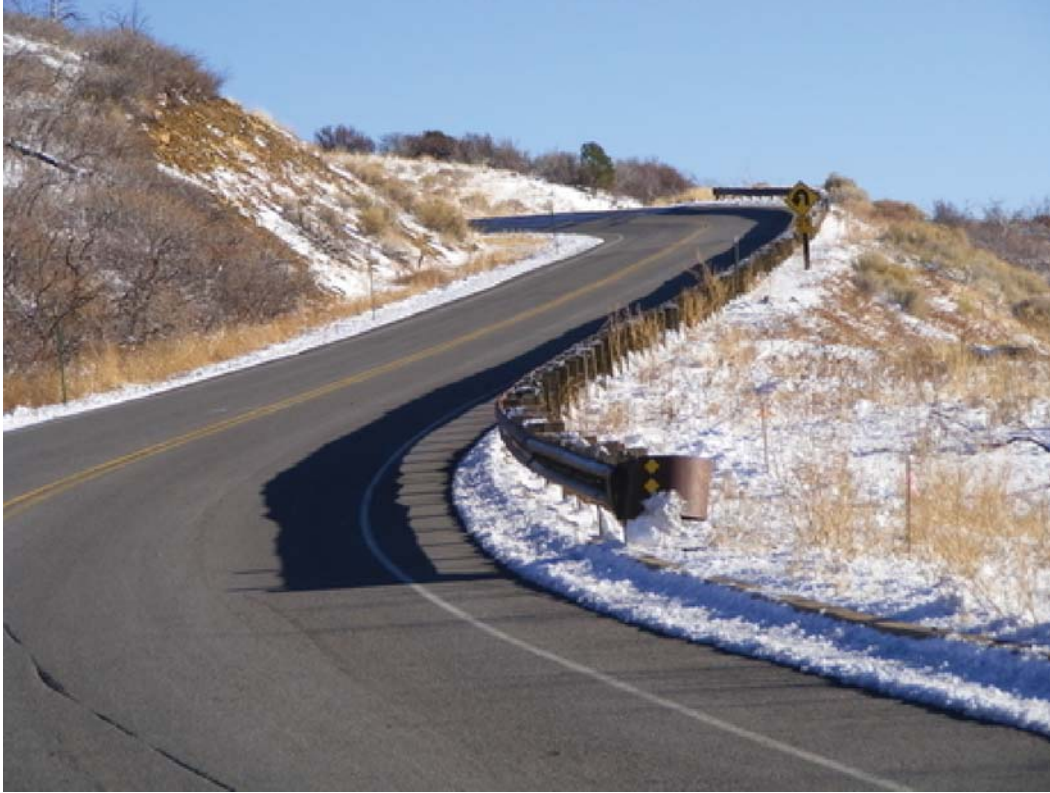
MEVE_0010_9.095_L_1.JPG

Barrier ID:	MEVE-0010-9.095-L				
Route Name:	ENTRANCE ROAD				
Inspection Date:	11/16/2009	Barrier Rating:	37.00		
Barrier Description					
Type:	W-BEAM STRONG POST	Barrier Function:	TRAFFIC		
Barrier Material:	WEATHERING STEEL/CORTEN	Post Material:	WOOD		
Blockout Type:	WOOD	Length (ft.):	630		
Speed Limit (MPH):	35	Placement with Respect to Road:	BOTH INSIDE AND OUTSIDE		
Hazard Behind Barrier:	HIGH				
Barrier Crashworthiness					
Appropriate Test Level:	TL-2	Barrier Test Level:	TL-3	Is Barrier Crashworthy?:	YES
Beg. End Trtmt Type:	W-BEAM TANGENT 350	Is Beg. End Trtmt Crashworthy?:	YES	Approach Transition Type:	NONE
Ending End Trtmt Type:	W-BEAM TRAILING END	Ending End Trtmt Crashworthy?:	YES		
Average Measurements					
Design Height (In.):	27	Width (In.):	0.0	Post Spacing (In.):	75.5
Height (In.):	26.5	Lateral Offset (In.):	47.0	Road Grade (%):	6.30
Physical Condition					
Barrier	Alignment and Height:	New posts in some areas. Several impacted rails with minor misalignment. Six impacted rails. 520-ft was 1-3in below 27-in design height.

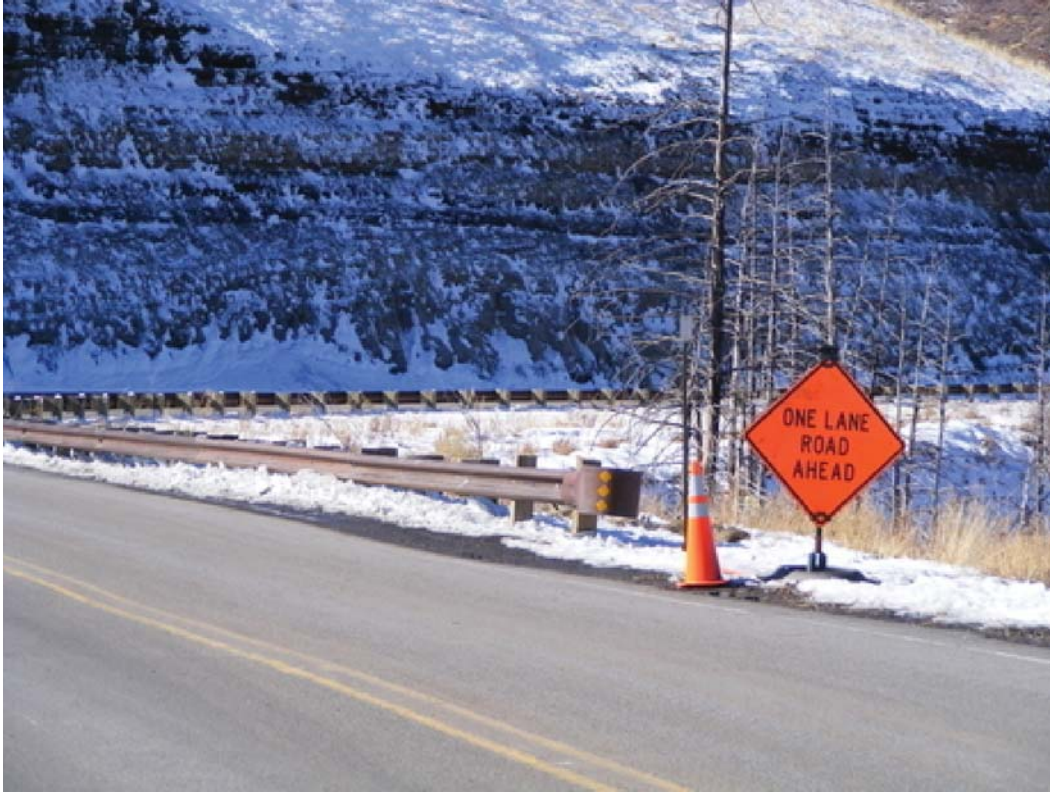
MEVE_0010_9.333_R_1.JPG

Barrier ID:	MEVE-0010-9.333-R				
Route Name:	ENTRANCE ROAD				
Inspection Date:	11/18/2009	Barrier Rating:	45.90		
Barrier Description					
Type:	W-BEAM STRONG POST	Barrier Function:	TRAFFIC		
Barrier Material:	WEATHERING STEEL/CORTEN	Post Material:	WOOD		
Blockout Type:	WOOD	Length (ft.):	1735		
Speed Limit (MPH):	35	Placement with Respect to Road:	OUTSIDE OF CURVE		
Hazard Behind Barrier:	EXTREME				
Barrier Crashworthiness					
Appropriate Test Level:	TL-2	Barrier Test Level:	TL-3	Is Barrier Crashworthy?:	YES
Beg. End Trtmt Type:	W-BEAM BCT	Is Beg. End Trtmt Crashworthy?:	NO	Approach Transition Type:	NONE
Ending End Trtmt Type:	W-BEAM BCT	Ending End Trtmt Crashworthy?:	NO		
Average Measurements					
Design Height (In.):	27	Width (In.):	0.0	Post Spacing (In.):	75.5
Height (In.):	26.5	Lateral Offset (In.):	45.0	Road Grade (%):	3.40
Physical Condition					
Barrier	Alignment and Height:	Alignment acceptable. 196-ft was 1-3in below the 27-in design height.

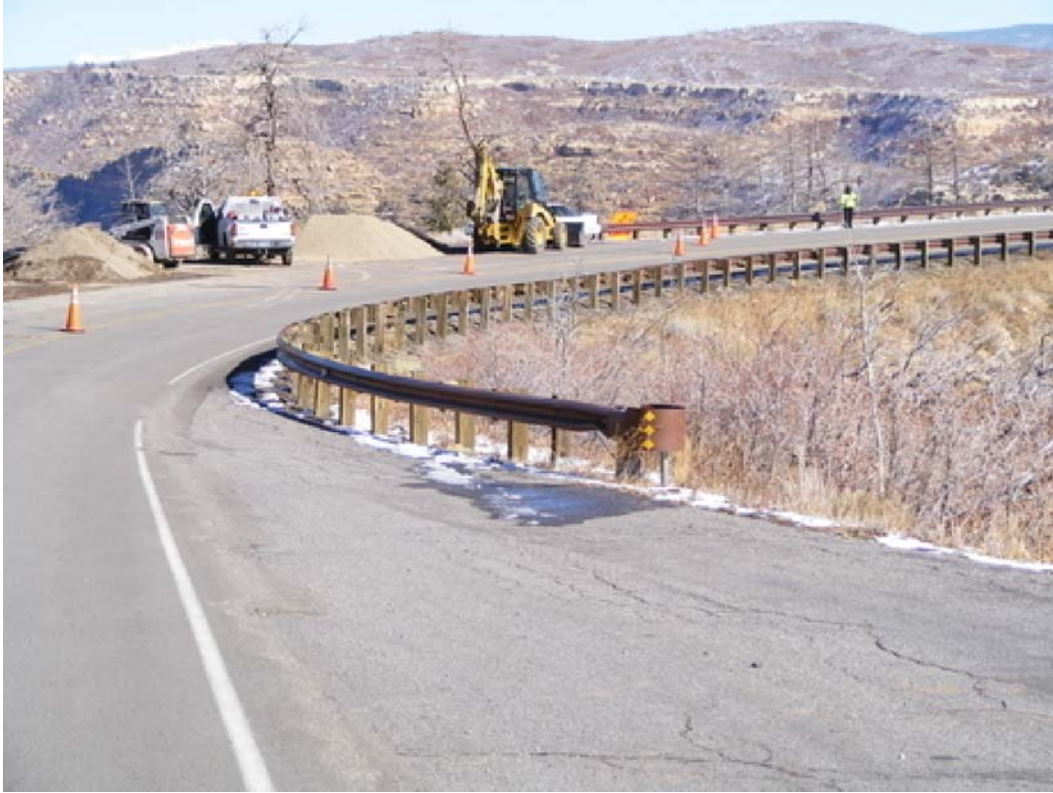
MEVE_0010_9.604_L_1.JPG

Barrier ID:	MEVE-0010-9.604-L				
Route Name:	ENTRANCE ROAD				
Inspection Date:	11/18/2009	Barrier Rating:	35.20		
Barrier Description					
Type:	W-BEAM STRONG POST	Barrier Function:	TRAFFIC		
Barrier Material:	WEATHERING STEEL/CORTEN	Post Material:	WOOD		
Blockout Type:	WOOD	Length (ft.):	503		
Speed Limit (MPH):	35	Placement with Respect to Road:	INSIDE OF CURVE		
Hazard Behind Barrier:	MEDIUM				
Barrier Crashworthiness					
Appropriate Test Level:	TL-2	Barrier Test Level:	TL-3	Is Barrier Crashworthy?:	YES
Beg. End Trtmt Type:	W-BEAM BCT	Is Beg. End Trtmt Crashworthy?:	NO	Approach Transition Type:	NONE
Ending End Trtmt Type:	W-BEAM BCT	Ending End Trtmt Crashworthy?:	NO		
Average Measurements					
Design Height (In.):	27	Width (In.):	0.0	Post Spacing (In.):	75.0
Height (In.):	30.2	Lateral Offset (In.):	59.0	Road Grade (%):	2.60
Physical Condition					
Barrier	Alignment and Height:	Alignment acceptable. 125-ft was 1-5in below the 27-in design height 100-ft was between 1-in below to 5-in above and 278-ft was 5-9in above the design height.

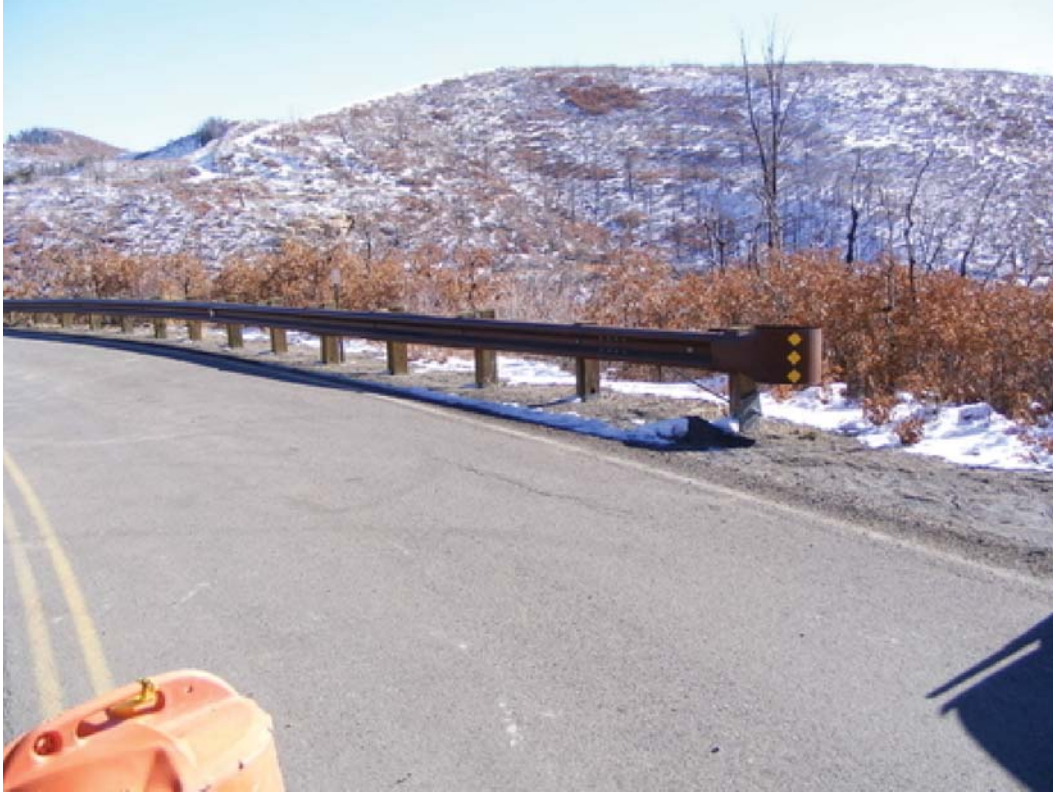
MEVE_0010_9.748_L_1.JPG

Barrier ID:	MEVE-0010-9.748-L				
Route Name:	ENTRANCE ROAD				
Inspection Date:	11/18/2009	Barrier Rating:	37.00		
Barrier Description					
Type:	W-BEAM STRONG POST	Barrier Function:	TRAFFIC		
Barrier Material:	WEATHERING STEEL/CORTEN	Post Material:	WOOD		
Blockout Type:	WOOD	Length (ft.):	355		
Speed Limit (MPH):	35	Placement with Respect to Road:	OUTSIDE OF CURVE		
Hazard Behind Barrier:	HIGH				
Barrier Crashworthiness					
Appropriate Test Level:	TL-2	Barrier Test Level:	TL-3	Is Barrier Crashworthy?:	YES
Beg. End Trtmt Type:	W-BEAM BCT	Is Beg. End Trtmt Crashworthy?:	NO	Approach Transition Type:	NONE
Ending End Trtmt Type:	W-BEAM BCT	Ending End Trtmt Crashworthy?:	NO		
Average Measurements					
Design Height (In.):	27	Width (In.):	0.0	Post Spacing (In.):	75.3
Height (In.):	27.0	Lateral Offset (In.):	27.0	Road Grade (%):	6.00
Physical Condition					
Barrier	Alignment and Height:	Alignment acceptable. Height is within 1-in of 27-in design height.

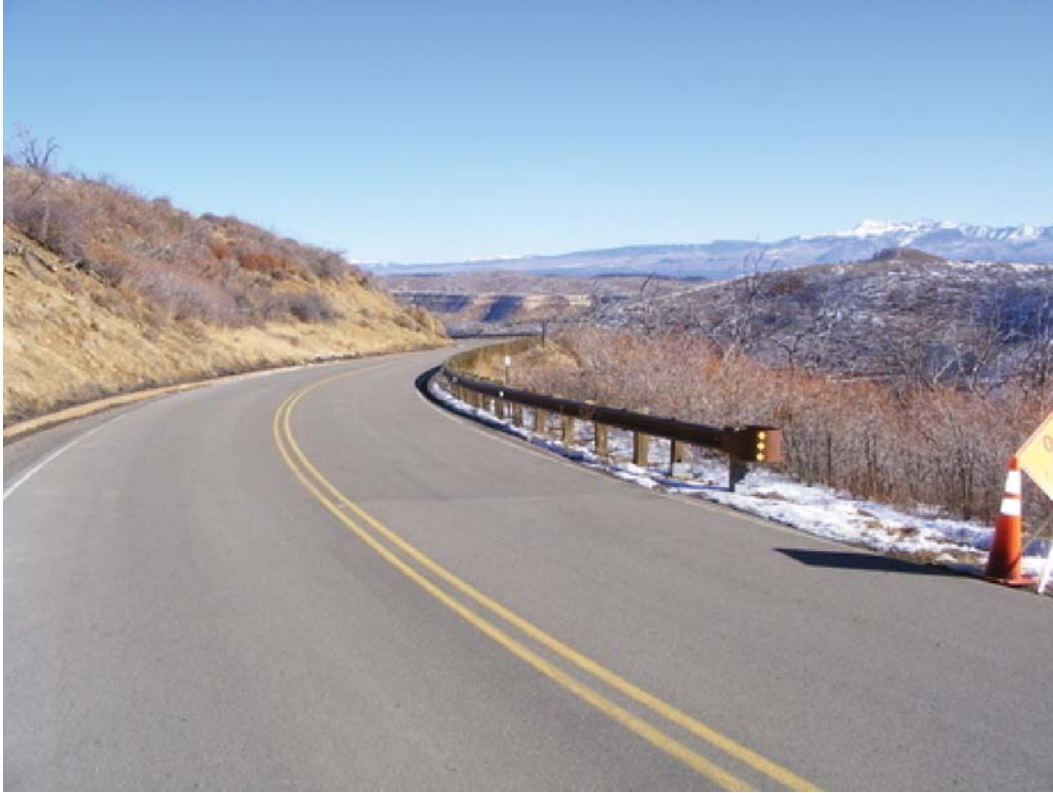
MEVE_0010_10.009_L_1.JPG

Barrier ID:	MEVE-0010-10.009-L				
Route Name:	ENTRANCE ROAD				
Inspection Date:	11/18/2009	Barrier Rating:	53.00		
Barrier Description					
Type:	W-BEAM STRONG POST	Barrier Function:	TRAFFIC		
Barrier Material:	WEATHERING STEEL/CORTEN	Post Material:	WOOD		
Blockout Type:	WOOD	Length (ft.):	2089		
Speed Limit (MPH):	35	Placement with Respect to Road:	BOTH INSIDE AND OUTSIDE		
Hazard Behind Barrier:	EXTREME				
Barrier Crashworthiness					
Appropriate Test Level:	TL-2	Barrier Test Level:	TL-3	Is Barrier Crashworthy?:	YES
Beg. End Trtmt Type:	W-BEAM BCT	Is Beg. End Trtmt Crashworthy?:	NO	Approach Transition Type:	NONE
Ending End Trtmt Type:	W-BEAM TRAILING END	Ending End Trtmt Crashworthy?:	YES		
Average Measurements					
Design Height (In.):	27	Width (In.):	0.0	Post Spacing (In.):	74.6
Height (In.):	25.2	Lateral Offset (In.):	22.1	Road Grade (%):	4.10
Physical Condition					
Barrier	Alignment and Height:	Alignment acceptable. 600-ft was between 1 and 3-in below the 27-in design height and 80-ft was more than 3-in below the design height. Rails have minor impacts with little deflection.

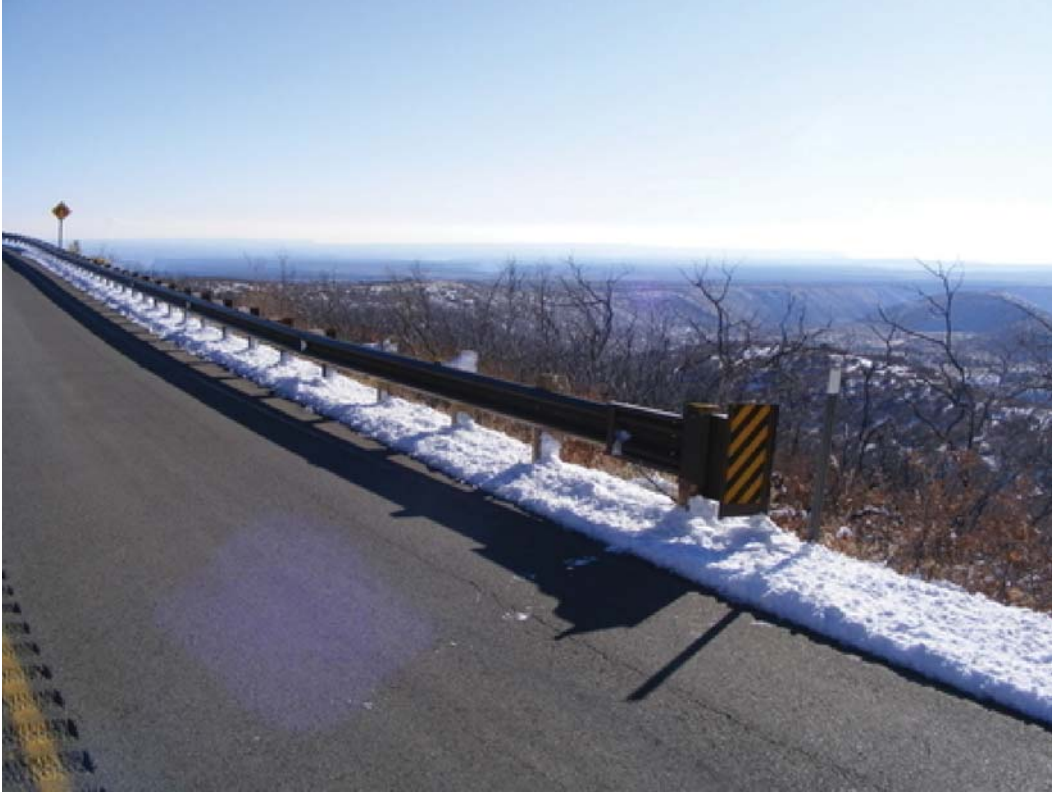
MEVE_0010_10.630_L_1.JPG

Barrier ID:	MEVE-0010-10.630-L				
Route Name:	ENTRANCE ROAD				
Inspection Date:	11/18/2009	Barrier Rating:	29.70		
Barrier Description					
Type:	W-BEAM STRONG POST	Barrier Function:	TRAFFIC		
Barrier Material:	WEATHERING STEEL/CORTEN	Post Material:	GALVANIZED STEEL		
Blockout Type:	WOOD	Length (ft.):	425		
Speed Limit (MPH):	35	Placement with Respect to Road:	OUTSIDE OF CURVE		
Hazard Behind Barrier:	HIGH				
Barrier Crashworthiness					
Appropriate Test Level:	TL-2	Barrier Test Level:	TL-3	Is Barrier Crashworthy?:	YES
Beg. End Trtmt Type:	W-BEAM TANGENT 350	Is Beg. End Trtmt Crashworthy?:	YES	Approach Transition Type:	NONE
Ending End Trtmt Type:	W-BEAM FLARED 350 COMPLIANT	Ending End Trtmt Crashworthy?:	YES		
Average Measurements					
Design Height (In.):	27	Width (In.):	0.0	Post Spacing (In.):	75.3
Height (In.):	28.6	Lateral Offset (In.):	48.2	Road Grade (%):	1.30
Physical Condition					
Barrier	Alignment and Height:	Alignment acceptable. Height was 1-4in above the 27-in design height.

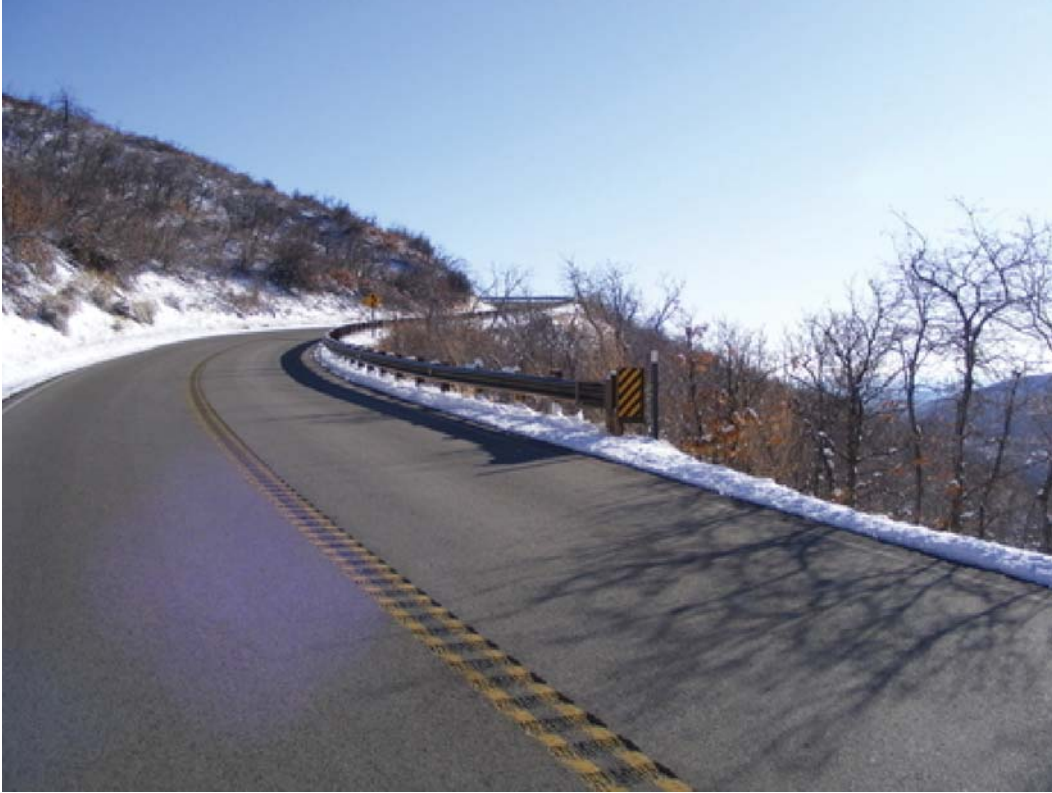
MEVE_0010_10.872_L_1.JPG

Barrier ID:	MEVE-0010-10.872-L				
Route Name:	ENTRANCE ROAD				
Inspection Date:	11/16/2009	Barrier Rating:	35.50		
Barrier Description					
Type:	W-BEAM STRONG POST	Barrier Function:	TRAFFIC		
Barrier Material:	WEATHERING STEEL/CORTEN	Post Material:	GALVANIZED STEEL		
Blockout Type:	WOOD	Length (ft.):	906		
Speed Limit (MPH):	35	Placement with Respect to Road:	BOTH INSIDE AND OUTSIDE		
Hazard Behind Barrier:	HIGH				
Barrier Crashworthiness					
Appropriate Test Level:	TL-2	Barrier Test Level:	TL-3	Is Barrier Crashworthy?:	YES
Beg. End Trtmt Type:	W-BEAM TANGENT 350	Is Beg. End Trtmt Crashworthy?:	YES	Approach Transition Type:	NONE
Ending End Trtmt Type:	W-BEAM TANGENT 350	Ending End Trtmt Crashworthy?:	YES		
Average Measurements					
Design Height (In.):	27	Width (In.):	0.0	Post Spacing (In.):	75.0
Height (In.):	28.6	Lateral Offset (In.):	34.7	Road Grade (%):	6.80
Physical Condition					
Barrier	Alignment and Height:	Alignment acceptable. Height was 1-3in above the 27-in design height.

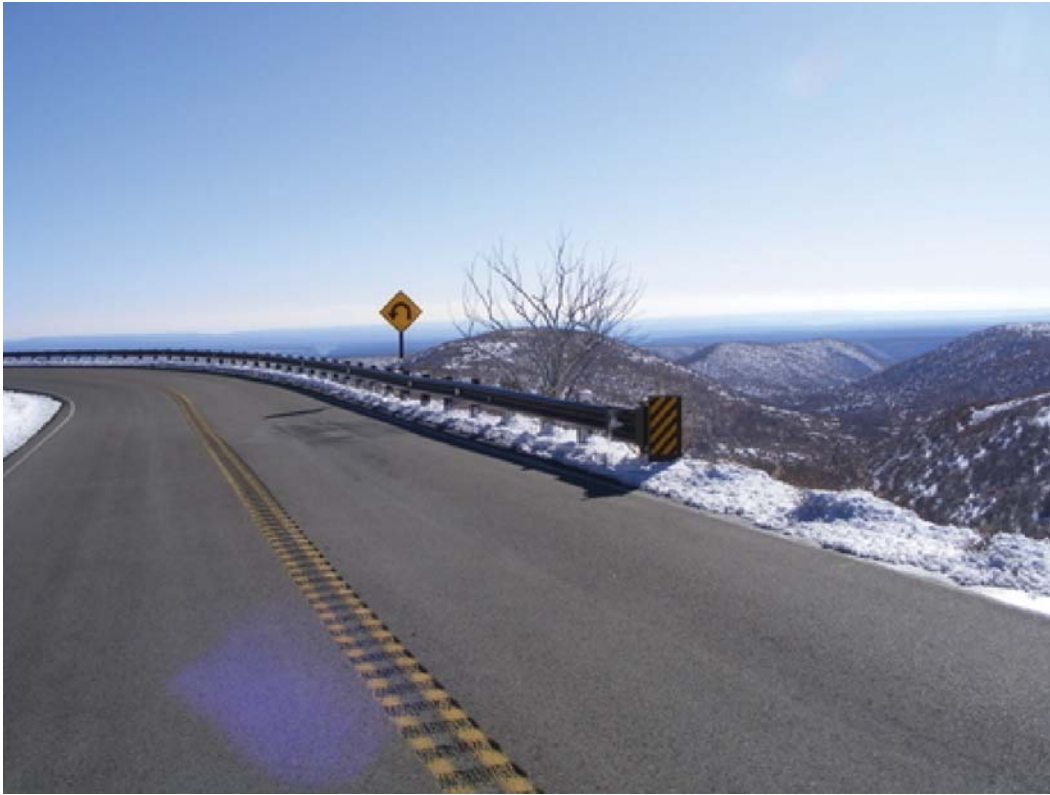
MEVE_0010_11.604_L_1.JPG

Barrier ID:	MEVE-0010-11.604-L				
Route Name:	ENTRANCE ROAD				
Inspection Date:	11/16/2009	Barrier Rating:	39.70		
Barrier Description					
Type:	W-BEAM STRONG POST	Barrier Function:	TRAFFIC		
Barrier Material:	WEATHERING STEEL/CORTEN	Post Material:	GALVANIZED STEEL		
Blockout Type:	WOOD	Length (ft.):	2588		
Speed Limit (MPH):	35	Placement with Respect to Road:	BOTH INSIDE AND OUTSIDE		
Hazard Behind Barrier:	HIGH				
Barrier Crashworthiness					
Appropriate Test Level:	TL-2	Barrier Test Level:	TL-3	Is Barrier Crashworthy?:	YES
Beg. End Trtmt Type:	W-BEAM TANGENT 350	Is Beg. End Trtmt Crashworthy?:	YES	Approach Transition Type:	NONE
Ending End Trtmt Type:	W-BEAM TANGENT 350	Ending End Trtmt Crashworthy?:	YES		
Average Measurements					
Design Height (In.):	27	Width (In.):	0.0	Post Spacing (In.):	74.9
Height (In.):	28.3	Lateral Offset (In.):	29.6	Road Grade (%):	4.40
Physical Condition					
Barrier	Alignment and Height:	Alignment acceptable. Entire barrier is between 1-in below to 4-in above the 27-in design height. No evidence of impact.

Breaking and Cracking:	No breaks or cracks.			
	Missing Elements:	No missing elements.			
	Corrosion and Weathering:	No erosion along back of barrier.			
End Treatments	Alignment and Height:	Alignment acceptable. Height is within 1-in of 27-in design height.			
	Breaking and Cracking:	No breaks or cracks.			
	Missing Elements:	No missing elements.			
	Corrosion and Weathering:	No corrosion or weathering observed.

Repair Action:	NO ACTION	FMSS Work Type:	N/A	Repair Cost:	\$0
Brief Workorder:	N/A				
Workorder:

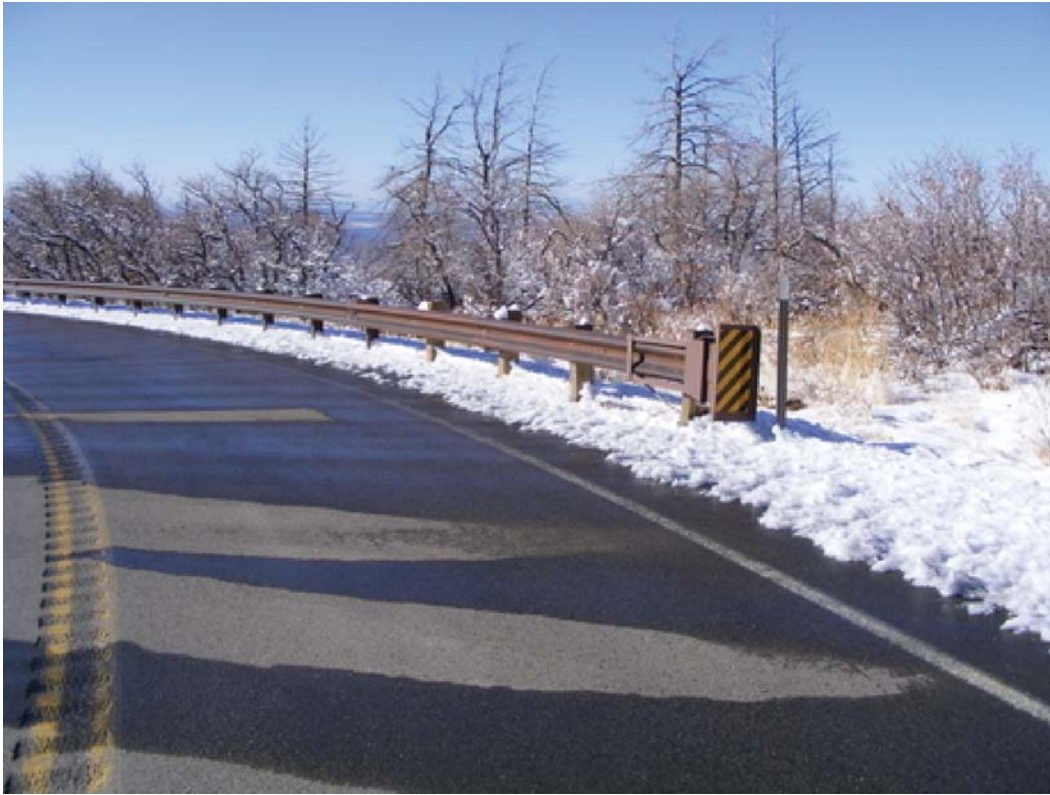
MEVE_0010_12.217_R_1.JPG

Barrier ID:	MEVE-0010-12.217-R				
Route Name:	ENTRANCE ROAD				
Inspection Date:	11/16/2009	Barrier Rating:	34.00		
Barrier Description					
Type:	W-BEAM STRONG POST	Barrier Function:	TRAFFIC		
Barrier Material:	WEATHERING STEEL/CORTEN	Post Material:	GALVANIZED STEEL		
Blockout Type:	WOOD	Length (ft.):	250		
Speed Limit (MPH):	35	Placement with Respect to Road:	OUTSIDE OF CURVE		
Hazard Behind Barrier:	HIGH				
Barrier Crashworthiness					
Appropriate Test Level:	TL-2	Barrier Test Level:	TL-3	Is Barrier Crashworthy?:	YES
Beg. End Trtmt Type:	W-BEAM TANGENT 350	Is Beg. End Trtmt Crashworthy?:	YES	Approach Transition Type:	NONE
Ending End Trtmt Type:	W-BEAM TANGENT 350	Ending End Trtmt Crashworthy?:	YES		
Average Measurements					
Design Height (In.):	27	Width (In.):	0.0	Post Spacing (In.):	75.3
Height (In.):	30.0	Lateral Offset (In.):	46.5	Road Grade (%):	3.70
Physical Condition					
Barrier	Alignment and Height:	Alignment acceptable. Height was 1-5in above the 27-in design height.

Breaking and Cracking:	No cracking 1 broken block.			
	Missing Elements:	No missing elements.			
	Corrosion and Weathering:	No corrosion or weathering observed.			
End Treatments	Alignment and Height:	Alignment acceptable. Height is within 1-in of 27-in design height.			
	Breaking and Cracking:	No breaks or cracks.			
	Missing Elements:	No missing elements observed.			
	Corrosion and Weathering:	No corrosion or weathering observed.

Repair Action:	REPAIR	FMSS Work Type:	DEFERRED MAINTENANCE	Repair Cost:	\$1656
Brief Workorder:	Replace 1 block on barrier.				
Workorder:	Replace block at \$30- per -Each for 1 Block(s) = \$30. Low Speed Traffic Control at \$1475- per -Day for 1 Day(s) = \$1475.

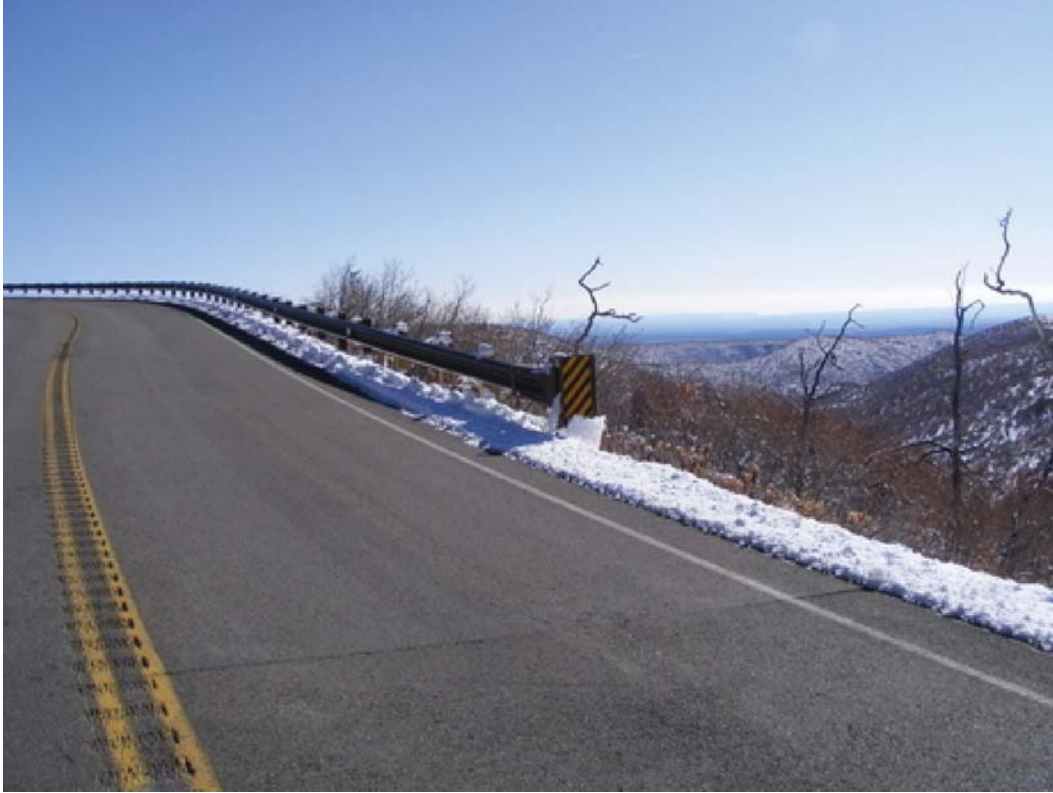
MEVE_0010_12.363_L_1.JPG

Barrier ID:	MEVE-0010-12.363-L				
Route Name:	ENTRANCE ROAD				
Inspection Date:	11/16/2009	Barrier Rating:	35.50		
Barrier Description					
Type:	W-BEAM STRONG POST	Barrier Function:	TRAFFIC		
Barrier Material:	WEATHERING STEEL/CORTEN	Post Material:	GALVANIZED STEEL		
Blockout Type:	WOOD	Length (ft.):	773		
Speed Limit (MPH):	35	Placement with Respect to Road:	OUTSIDE OF CURVE		
Hazard Behind Barrier:	HIGH				
Barrier Crashworthiness					
Appropriate Test Level:	TL-2	Barrier Test Level:	TL-3	Is Barrier Crashworthy?:	YES
Beg. End Trtmt Type:	W-BEAM TANGENT 350	Is Beg. End Trtmt Crashworthy?:	YES	Approach Transition Type:	NONE
Ending End Trtmt Type:	W-BEAM TANGENT 350	Ending End Trtmt Crashworthy?:	YES		
Average Measurements					
Design Height (In.):	27	Width (In.):	0.0	Post Spacing (In.):	75.1
Height (In.):	29.2	Lateral Offset (In.):	39.0	Road Grade (%):	4.20
Physical Condition					
Barrier	Alignment and Height:	Alignment acceptable. Height was 0-4in above the 27-in design height. No evidence of impact.

Breaking and Cracking:	1 cracked block. No breaks.			
	Missing Elements:	No missing elements.			
	Corrosion and Weathering:	No erosion along back of barrier.			
End Treatments	Alignment and Height:	Alignment acceptable. Height is within 1-in of 27-in design height.			
	Breaking and Cracking:	No breaks or cracks.			
	Missing Elements:	No missing elements.			
	Corrosion and Weathering:	No corrosion or weathering observed.

Repair Action:	REPAIR	FMSS Work Type:	DEFERRED MAINTENANCE	Repair Cost:	\$1656
Brief Workorder:	Replace 1 block on barrier.				
Workorder:	Replace block at \$30- per -Each for 1 Block(s) = \$30. Low Speed Traffic Control at \$1475- per -Day for 1 Day(s) = \$1475.

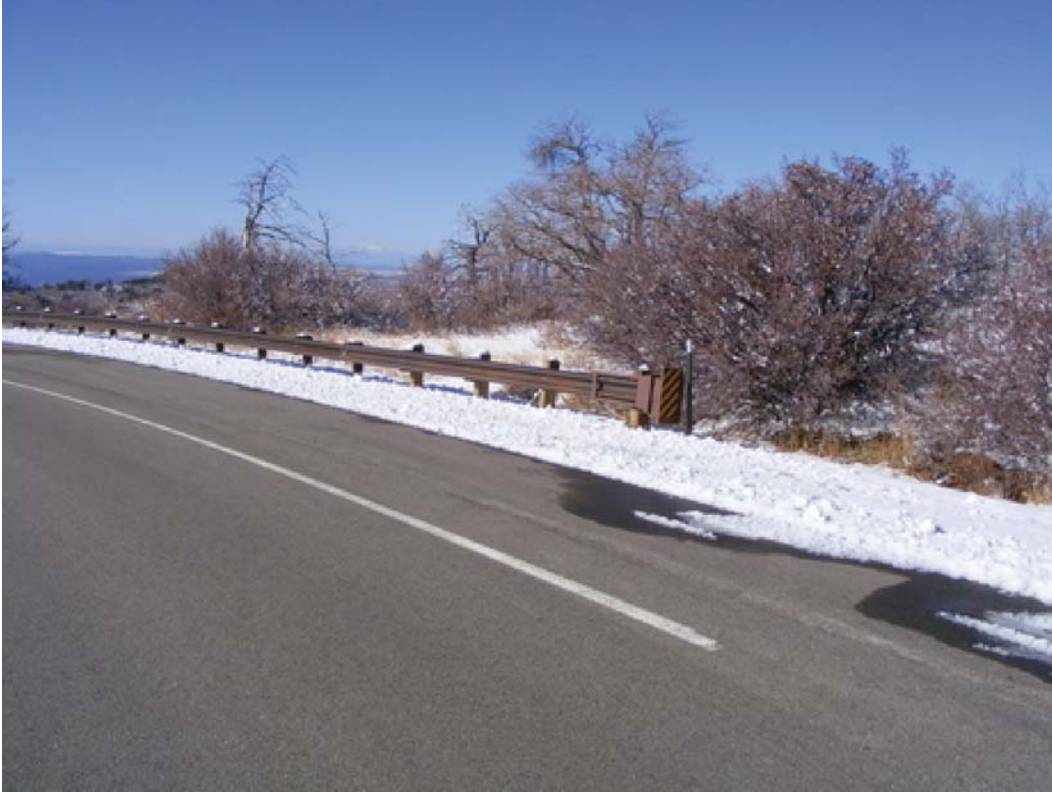
MEVE_0010_12.558_R_1.JPG

Barrier ID:	MEVE-0010-12.558-R				
Route Name:	ENTRANCE ROAD				
Inspection Date:	11/16/2009	Barrier Rating:	38.50		
Barrier Description					
Type:	W-BEAM STRONG POST	Barrier Function:	TRAFFIC		
Barrier Material:	WEATHERING STEEL/CORTEN	Post Material:	GALVANIZED STEEL		
Blockout Type:	WOOD	Length (ft.):	1558		
Speed Limit (MPH):	35	Placement with Respect to Road:	BOTH INSIDE AND OUTSIDE		
Hazard Behind Barrier:	EXTREME				
Barrier Crashworthiness					
Appropriate Test Level:	TL-2	Barrier Test Level:	TL-3	Is Barrier Crashworthy?:	YES
Beg. End Trtmt Type:	W-BEAM FLARED 350 COMPLIANT	Is Beg. End Trtmt Crashworthy?:	YES	Approach Transition Type:	NONE
Ending End Trtmt Type:	W-BEAM FLARED 350 COMPLIANT	Ending End Trtmt Crashworthy?:	YES		
Average Measurements					
Design Height (In.):	27	Width (In.):	0.0	Post Spacing (In.):	74.8
Height (In.):	27.6	Lateral Offset (In.):	121.9	Road Grade (%):	4.90
Physical Condition

Barrier	Alignment and Height:	Alignment acceptable. Height was 0-2in above the 27-in design height. No evidence of impact.			
	Breaking and Cracking:	No breaks or cracks.			
	Missing Elements:	No missing elements.			
	Corrosion and Weathering:	No erosion along back of barrier.			
End Treatments	Alignment and Height:	Alignment acceptable. Height is within 1-in of 27-in design height. No evidence of impact.			
	Breaking and Cracking:	No breaks or cracks.			
	Missing Elements:	No missing elements.			
	Corrosion and Weathering:	No corrosion or weathering observed.

Repair Action:	NO ACTION	FMSS Work Type:	N/A	Repair Cost:	\$0
Brief Workorder:	N/A				
Workorder:

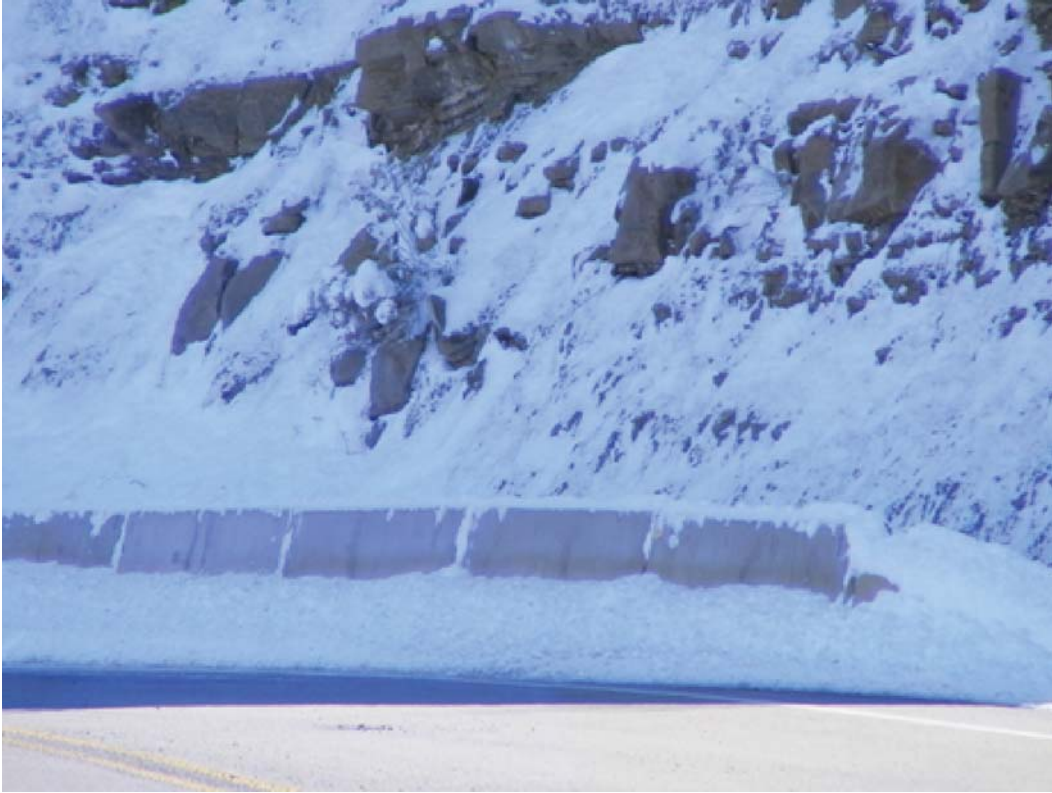
MEVE_0010_12.608_L_1.JPG

Barrier ID:	MEVE-0010-12.608-L				
Route Name:	ENTRANCE ROAD				
Inspection Date:	11/16/2009	Barrier Rating:	31.20		
Barrier Description					
Type:	CONCRETE BARRIER	Barrier Function:	TRAFFIC		
Barrier Material:	CONCRETE	Post Material:	N/A		
Blockout Type:	N/A	Length (ft.):	1000		
Speed Limit (MPH):	35	Placement with Respect to Road:	BOTH INSIDE AND OUTSIDE		
Hazard Behind Barrier:	LOW				
Barrier Crashworthiness					
Appropriate Test Level:	TL-2	Barrier Test Level:	TL-3	Is Barrier Crashworthy?:	YES
Beg. End Trtmt Type:	NONE	Is Beg. End Trtmt Crashworthy?:	N/A	Approach Transition Type:	NONE
Ending End Trtmt Type:	NONE	Ending End Trtmt Crashworthy?:	N/A		
Average Measurements					
Design Height (In.):	32	Width (In.):	6.0	Post Spacing (In.):	0.0
Height (In.):	31.7	Lateral Offset (In.):	37.7	Road Grade (%):	5.20
Physical Condition					
Barrier	Alignment and Height:	Alignment acceptable. Height is within 1-in of 32-in design height.

Breaking and Cracking:	Some cracking less than 1/4in minor breaks, no rebar showing.			
	Missing Elements:	No missing elements.			
	Corrosion and Weathering:	No major weathering.			
End Treatments	Alignment and Height:				
	Breaking and Cracking:				
	Missing Elements:	N/A.			
	Corrosion and Weathering:

Barrier ID:	MEVE-0010-12.608-L				
Route Name:	ENTRANCE ROAD				
Inspection Date:	11/16/2009	Barrier Rating:		31.20	
Repair Recommendations					
Repair Action:	NO ACTION	FMSS Work Type:	N/A	Repair Cost:	\$0
Brief Workorder:	N/A				
Workorder:

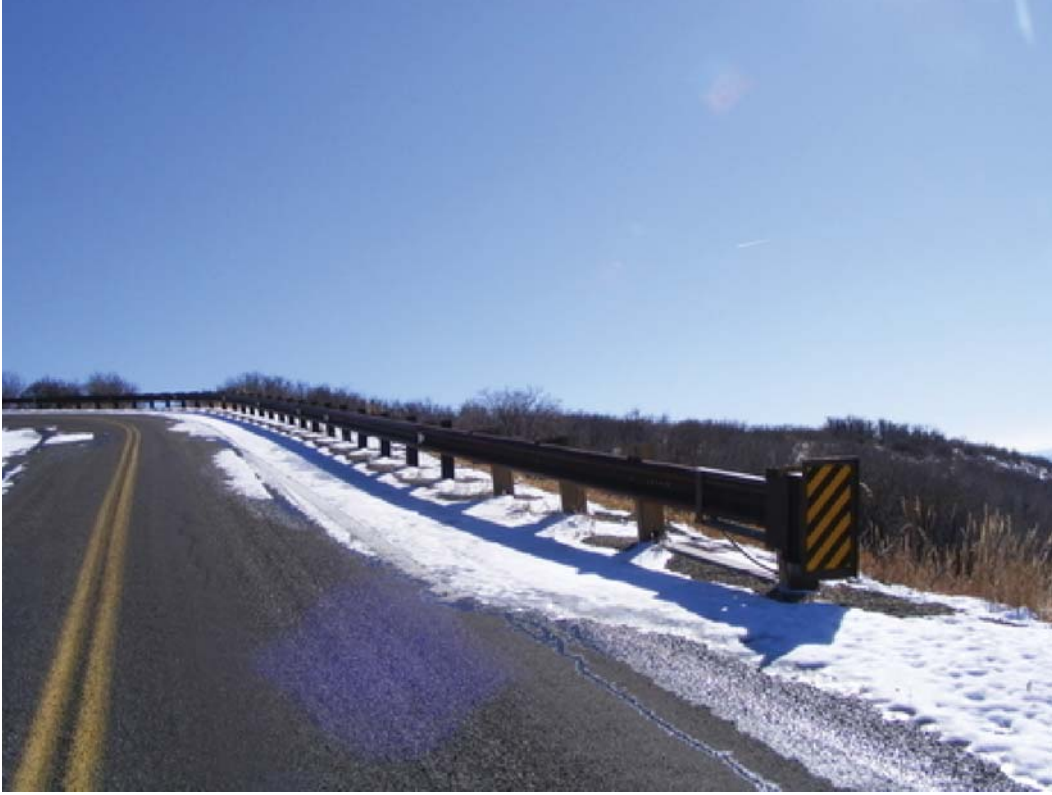
MEVE_0200_4.178_L_1.JPG

Barrier ID:	MEVE-0200-4.178-L				
Route Name:	WETHERILL MESA ROAD				
Inspection Date:	11/17/2009	Barrier Rating:	20.70		
Barrier Description					
Type:	W-BEAM STRONG POST	Barrier Function:	TRAFFIC		
Barrier Material:	WEATHERING STEEL/CORTEN	Post Material:	GALVANIZED STEEL		
Blockout Type:	WOOD	Length (ft.):	207		
Speed Limit (MPH):	25	Placement with Respect to Road:	OUTSIDE OF CURVE		
Hazard Behind Barrier:	MEDIUM				
Barrier Crashworthiness					
Appropriate Test Level:	TL-1	Barrier Test Level:	TL-3	Is Barrier Crashworthy?:	YES
Beg. End Trtmt Type:	W-BEAM FLARED 350 COMPLIANT	Is Beg. End Trtmt Crashworthy?:	YES	Approach Transition Type:	NONE
Ending End Trtmt Type:	W-BEAM TANGENT 350	Ending End Trtmt Crashworthy?:	YES		
Average Measurements					
Design Height (In.):	27	Width (In.):	0.0	Post Spacing (In.):	74.0
Height (In.):	27.0	Lateral Offset (In.):	30.0	Road Grade (%):	12.30
Physical Condition					
Barrier	Alignment and Height:	Alignment acceptable. Height is within 1-in of 27-in design height.

Breaking and Cracking:	No breaks or cracks.			
	Missing Elements:	No missing elements.			
	Corrosion and Weathering:	No corrosion or weathering observed.			
End Treatments	Alignment and Height:	Alignment acceptable. Height is within 1-in of 27-in design height.			
	Breaking and Cracking:	No breaks or cracks.			
	Missing Elements:	No missing elements observed.			
	Corrosion and Weathering:	No corrosion or weathering observed.

Repair Action:	NO ACTION	FMSS Work Type:	N/A	Repair Cost:	\$0
Brief Workorder:	N/A				
Workorder:

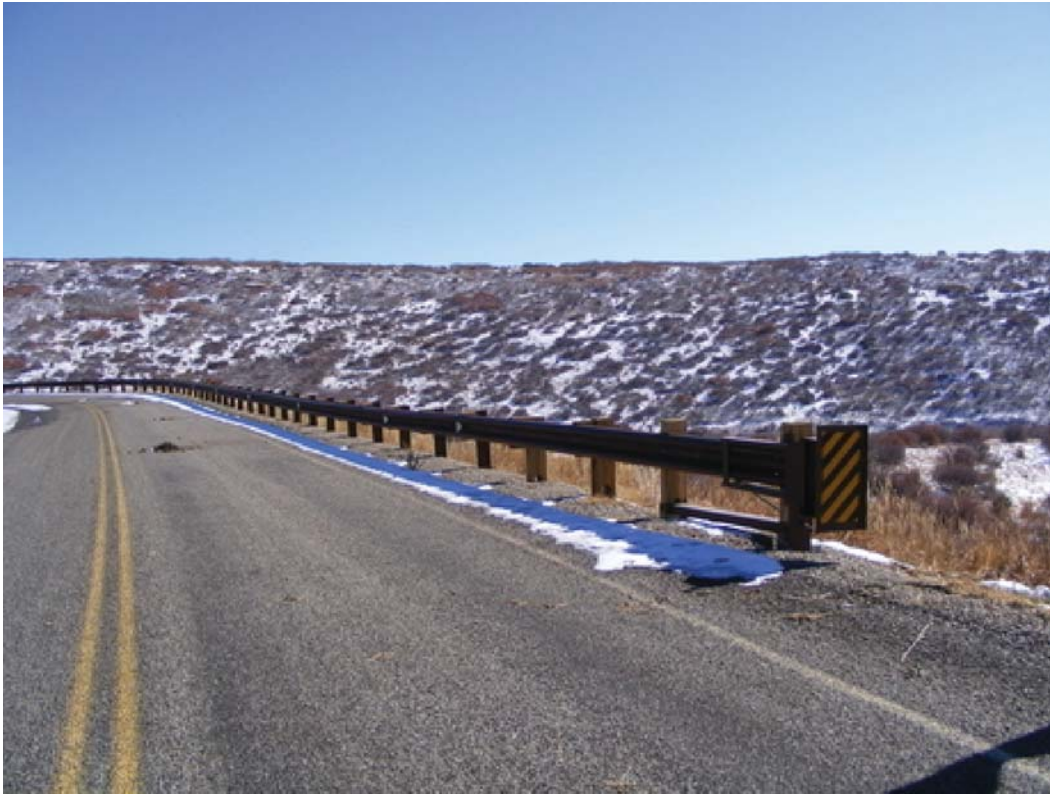
MEVE_0200_6.694_L_1.JPG

Barrier ID:	MEVE-0200-6.694-L				
Route Name:	WETHERILL MESA ROAD				
Inspection Date:	11/17/2009	Barrier Rating:	23.70		
Barrier Description					
Type:	W-BEAM STRONG POST	Barrier Function:	TRAFFIC		
Barrier Material:	WEATHERING STEEL/CORTEN	Post Material:	GALVANIZED STEEL		
Blockout Type:	WOOD	Length (ft.):	388		
Speed Limit (MPH):	25	Placement with Respect to Road:	OUTSIDE OF CURVE		
Hazard Behind Barrier:	MEDIUM				
Barrier Crashworthiness					
Appropriate Test Level:	TL-1	Barrier Test Level:	TL-3	Is Barrier Crashworthy?:	YES
Beg. End Trtmt Type:	W-BEAM FLARED 350 COMPLIANT	Is Beg. End Trtmt Crashworthy?:	YES	Approach Transition Type:	NONE
Ending End Trtmt Type:	W-BEAM FLARED 350 COMPLIANT	Ending End Trtmt Crashworthy?:	YES		
Average Measurements					
Design Height (In.):	27	Width (In.):	0.0	Post Spacing (In.):	74.6
Height (In.):	28.0	Lateral Offset (In.):	43.0	Road Grade (%):	1.10
Physical Condition

Barrier	Alignment and Height:	Alignment acceptable. Entire barrier is between 1-in below to 3-in above the 27-in design height. No evidence of impact.			
	Breaking and Cracking:	No breaks or cracks.			
	Missing Elements:	3 loose bolts.			
	Corrosion and Weathering:	No erosion along barrier.			
End Treatments	Alignment and Height:	Alignment acceptable. Height is within 1-in of 27-in design height. No evidence of impact.			
	Breaking and Cracking:	No breaks or cracks.			
	Missing Elements:	No missing elements.			
	Corrosion and Weathering:	No corrosion or weathering observed.

Repair Action:	REPAIR	FMSS Work Type:	DEFERRED MAINTENANCE	Repair Cost:	\$66
Brief Workorder:	Tighten loose bolts on barrier.				
Workorder:	Labor at \$60- per -Hour for 1 = \$60. Tighten bolts on barrier.

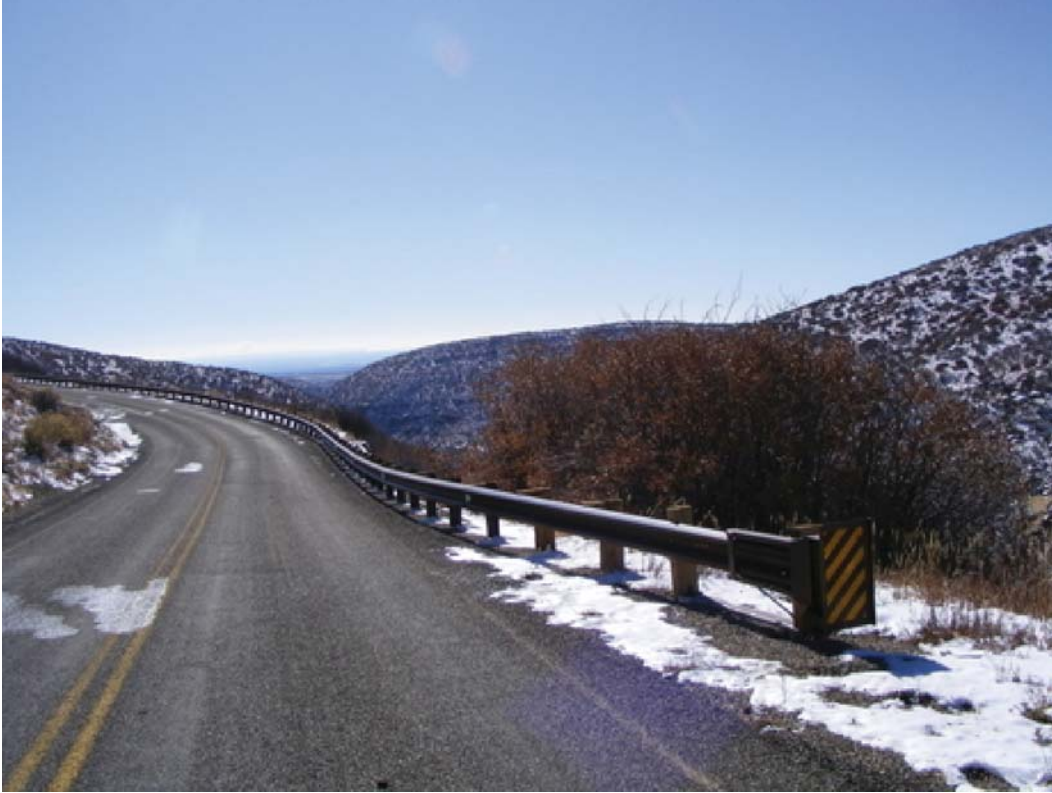
MEVE_0200_6.807_L_1.JPG

Barrier ID:	MEVE-0200-6.807-L				
Route Name:	WETHERILL MESA ROAD				
Inspection Date:	11/17/2009	Barrier Rating:	25.50		
Barrier Description					
Type:	W-BEAM STRONG POST	Barrier Function:	TRAFFIC		
Barrier Material:	WEATHERING STEEL/CORTEN	Post Material:	GALVANIZED STEEL		
Blockout Type:	WOOD	Length (ft.):	500		
Speed Limit (MPH):	25	Placement with Respect to Road:	OUTSIDE OF CURVE		
Hazard Behind Barrier:	HIGH				
Barrier Crashworthiness					
Appropriate Test Level:	TL-1	Barrier Test Level:	TL-3	Is Barrier Crashworthy?:	YES
Beg. End Trtmt Type:	W-BEAM FLARED 350 COMPLIANT	Is Beg. End Trtmt Crashworthy?:	YES	Approach Transition Type:	NONE
Ending End Trtmt Type:	W-BEAM TANGENT 350	Ending End Trtmt Crashworthy?:	YES		
Average Measurements					
Design Height (In.):	27	Width (In.):	0.0	Post Spacing (In.):	74.5
Height (In.):	28.2	Lateral Offset (In.):	28.2	Road Grade (%):	3.30
Physical Condition					
Barrier	Alignment and Height:	Alignment acceptable. Height was 0-3in above the 27-in design height.

Breaking and Cracking:	No breaks or cracks.			
	Missing Elements:	No missing elements.			
	Corrosion and Weathering:	No corrosion or weathering observed.			
End Treatments	Alignment and Height:	Alignment acceptable. Height is within 1-in of 27-in design height.			
	Breaking and Cracking:	No breaks or cracks.			
	Missing Elements:	No missing elements observed.			
	Corrosion and Weathering:	No corrosion or weathering observed.

Repair Action:	NO ACTION	FMSS Work Type:	N/A	Repair Cost:	\$0
Brief Workorder:	N/A				
Workorder:

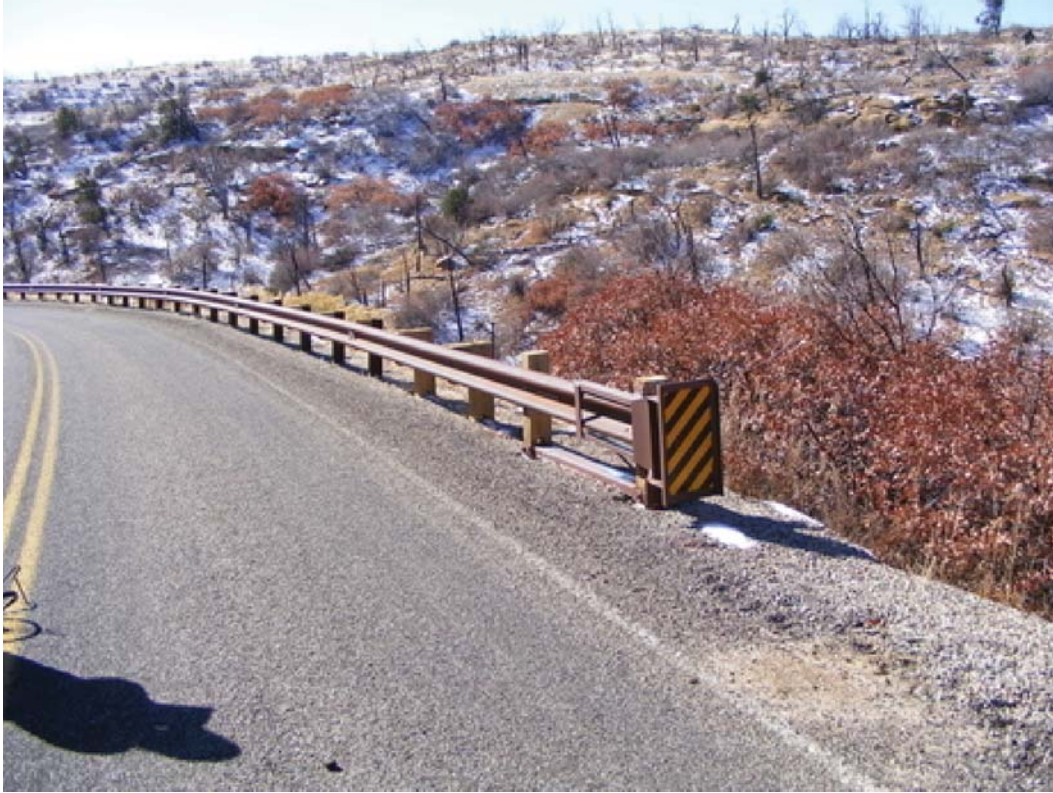
MEVE_0200_11.250_R_1.JPG

Barrier ID:	MEVE-0200-11.250-R				
Route Name:	WETHERILL MESA ROAD				
Inspection Date:	11/17/2009	Barrier Rating:	32.20		
Barrier Description					
Type:	W-BEAM STRONG POST	Barrier Function:	TRAFFIC		
Barrier Material:	WEATHERING STEEL/CORTEN	Post Material:	GALVANIZED STEEL		
Blockout Type:	WOOD	Length (ft.):	304		
Speed Limit (MPH):	25	Placement with Respect to Road:	OUTSIDE OF CURVE		
Hazard Behind Barrier:	MEDIUM				
Barrier Crashworthiness					
Appropriate Test Level:	TL-1	Barrier Test Level:	TL-3	Is Barrier Crashworthy?:	YES
Beg. End Trtmt Type:	W-BEAM TANGENT 350	Is Beg. End Trtmt Crashworthy?:	YES	Approach Transition Type:	NONE
Ending End Trtmt Type:	W-BEAM TANGENT 350	Ending End Trtmt Crashworthy?:	YES		
Average Measurements					
Design Height (In.):	27	Width (In.):	0.0	Post Spacing (In.):	75.3
Height (In.):	27.7	Lateral Offset (In.):	31.7	Road Grade (%):	11.80
Physical Condition					
Barrier	Alignment and Height:	Alignment acceptable. Entire barrier is between 1-in below to 2-in above the 27-in design height. No evidence of impact.

Breaking and Cracking:	No breaks or cracks.			
	Missing Elements:	No missing elements.			
	Corrosion and Weathering:	No erosion along barrier.			
End Treatments	Alignment and Height:	Alignment acceptable. Height is within 1-in of 27-in design height. No evidence of impact.			
	Breaking and Cracking:	No breaks or cracks.			
	Missing Elements:	No missing elements.			
	Corrosion and Weathering:	No corrosion or weathering observed.

Repair Action:	NO ACTION	FMSS Work Type:	N/A	Repair Cost:	\$0
Brief Workorder:	N/A				
Workorder:

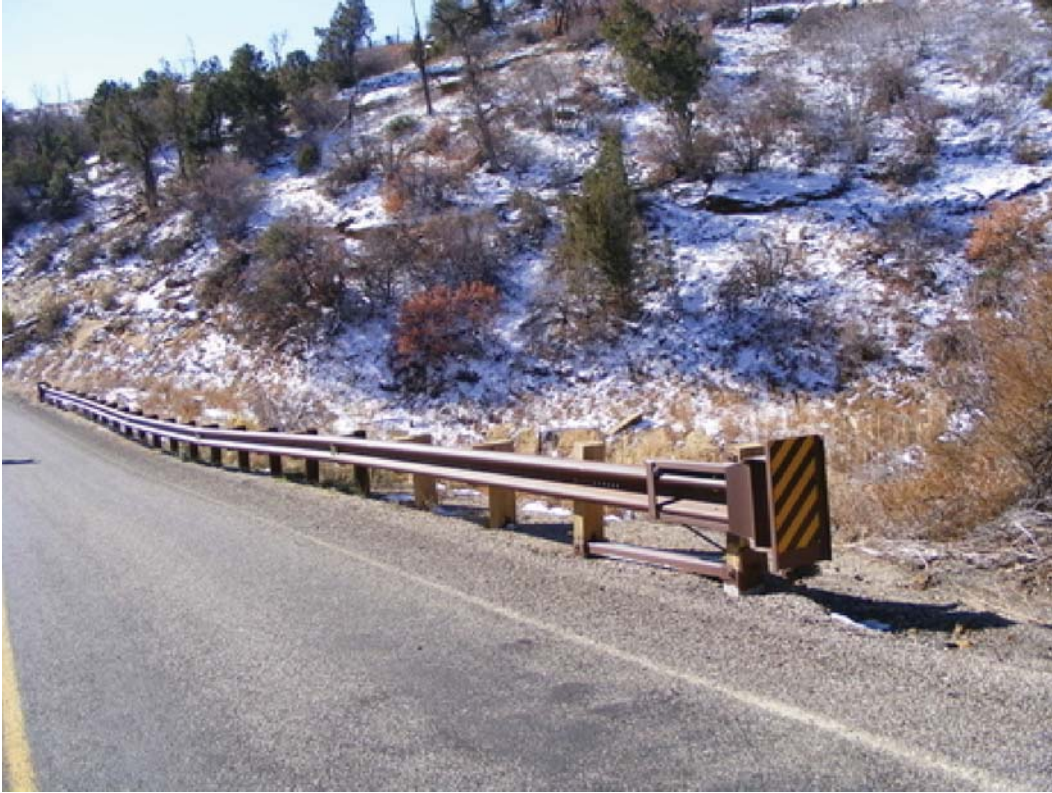
MEVE_0200_11.378_R_1.JPG

Barrier ID:	MEVE-0200-11.378-R				
Route Name:	WETHERILL MESA ROAD				
Inspection Date:	11/17/2009	Barrier Rating:	22.60		
Barrier Description					
Type:	W-BEAM STRONG POST	Barrier Function:	TRAFFIC		
Barrier Material:	WEATHERING STEEL/CORTEN	Post Material:	GALVANIZED STEEL		
Blockout Type:	WOOD	Length (ft.):	130		
Speed Limit (MPH):	25	Placement with Respect to Road:	TANGENT		
Hazard Behind Barrier:	HIGH				
Barrier Crashworthiness					
Appropriate Test Level:	TL-1	Barrier Test Level:	TL-3	Is Barrier Crashworthy?:	YES
Beg. End Trtmt Type:	W-BEAM TANGENT 350	Is Beg. End Trtmt Crashworthy?:	YES	Approach Transition Type:	NONE
Ending End Trtmt Type:	W-BEAM TANGENT 350	Ending End Trtmt Crashworthy?:	YES		
Average Measurements					
Design Height (In.):	27	Width (In.):	0.0	Post Spacing (In.):	74.0
Height (In.):	28.0	Lateral Offset (In.):	36.0	Road Grade (%):	9.10
Physical Condition					
Barrier	Alignment and Height:	Alignment acceptable. Height is within 1-in of 27-in design height.

Breaking and Cracking:	No breaks or cracks.			
	Missing Elements:	No missing elements.			
	Corrosion and Weathering:	No corrosion or weathering observed.			
End Treatments	Alignment and Height:	Alignment acceptable. Height is within 1-in of 27-in design height.			
	Breaking and Cracking:	No breaks or cracks.			
	Missing Elements:	No missing elements observed.			
	Corrosion and Weathering:	No corrosion or weathering observed.

Repair Action:	NO ACTION	FMSS Work Type:	N/A	Repair Cost:	\$0
Brief Workorder:	N/A				
Workorder:

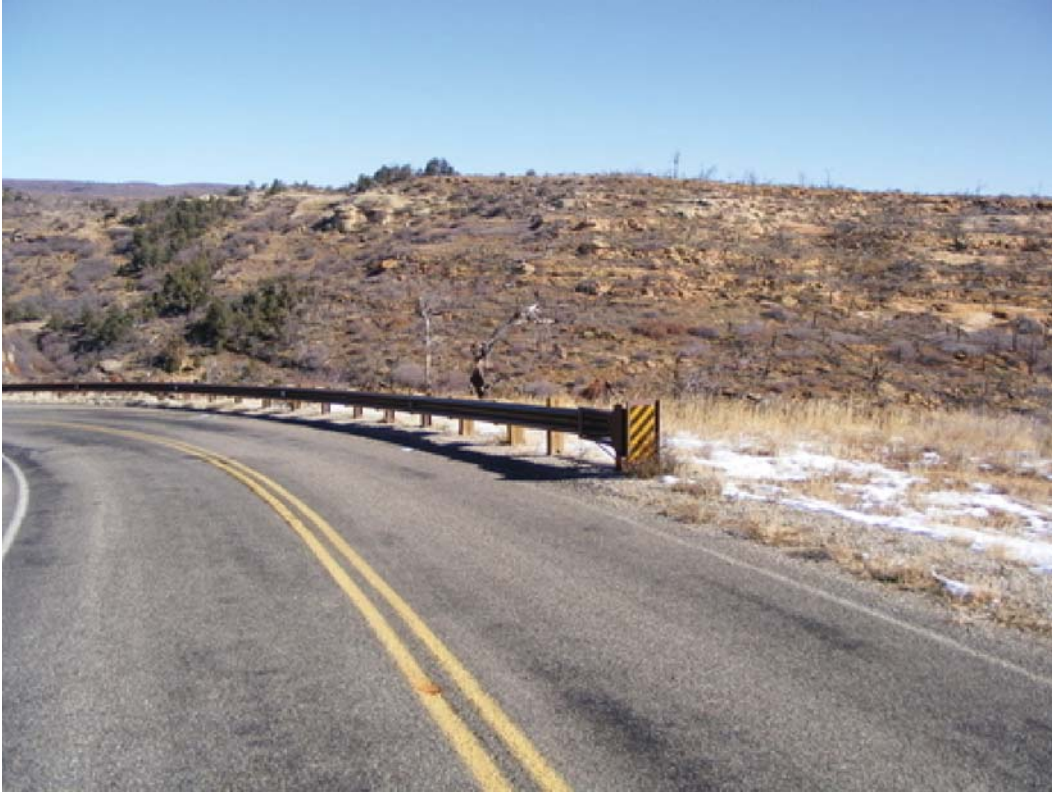
MEVE_0200_11.797_L_1.JPG

Barrier ID:	MEVE-0200-11.797-L				
Route Name:	WETHERILL MESA ROAD				
Inspection Date:	11/17/2009	Barrier Rating:	29.30		
Barrier Description					
Type:	W-BEAM STRONG POST	Barrier Function:	TRAFFIC		
Barrier Material:	WEATHERING STEEL/CORTEN	Post Material:	GALVANIZED STEEL		
Blockout Type:	WOOD	Length (ft.):	216		
Speed Limit (MPH):	25	Placement with Respect to Road:	OUTSIDE OF CURVE		
Hazard Behind Barrier:	MEDIUM				
Barrier Crashworthiness					
Appropriate Test Level:	TL-1	Barrier Test Level:	TL-3	Is Barrier Crashworthy?:	YES
Beg. End Trtmt Type:	W-BEAM TANGENT 350	Is Beg. End Trtmt Crashworthy?:	YES	Approach Transition Type:	NONE
Ending End Trtmt Type:	W-BEAM TANGENT 350	Ending End Trtmt Crashworthy?:	YES		
Average Measurements					
Design Height (In.):	27	Width (In.):	0.0	Post Spacing (In.):	75.3
Height (In.):	29.0	Lateral Offset (In.):	33.2	Road Grade (%):	10.00
Physical Condition					
Barrier	Alignment and Height:	Alignment acceptable. Height was 2in above the 27-in design height. No evidence of impact.

Repair Action:	NO ACTION	FMSS Work Type:	N/A	Repair Cost:	\$0
Brief Workorder:	N/A				
Workorder:
