**NPS Guardwall/Rail Inventory Program
Mount Rainier National Park**

**Federal Lands Highway
Road Inventory Program**

**Federal Highway Administration
Eastern Federal Lands Highway Division
Road Inventory Program (RIP)**

**Data Collection Date: October 2009
Report Date: December 2015**

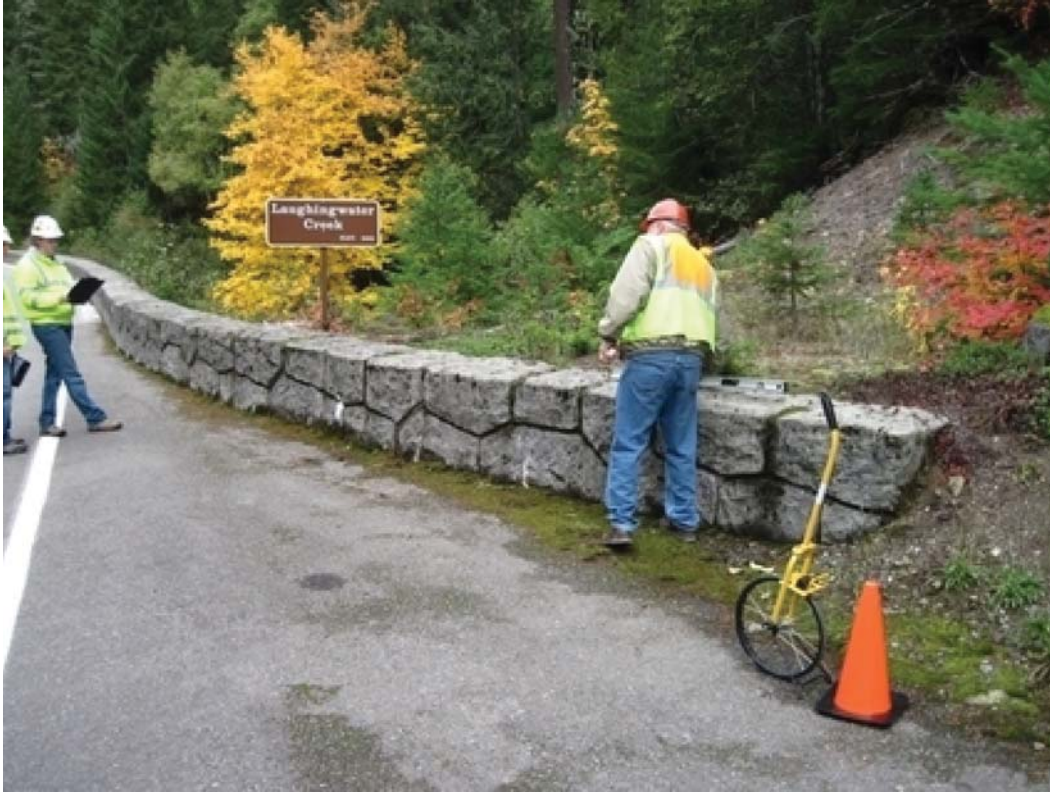
MORA_0010_2.432_R_1.jpg

Barrier ID:	MORA-0010-2.432-R				
Route Name:	STATE ROUTE 123 (EAST SIDE HIGHWAY)				
Inspection Date:	10/19/2009	Barrier Rating:	29.70		
Barrier Description					
Type:	CONCRETE WITH SIMULATED STONE FACE	Barrier Function:	TRAFFIC		
Barrier Material:	CONCRETE	Post Material:	N/A		
Blockout Type:	N/A	Length (ft.):	57		
Speed Limit (MPH):	45	Placement with Respect to Road:	OUTSIDE OF CURVE		
Hazard Behind Barrier:	LOW				
Barrier Crashworthiness					
Appropriate Test Level:	TL-2	Barrier Test Level:	TL-3	Is Barrier Crashworthy?:	YES
Beg. End Trtmt Type:	NONE	Is Beg. End Trtmt Crashworthy?:	N/A	Approach Transition Type:	NONE
Ending End Trtmt Type:	NONE	Ending End Trtmt Crashworthy?:	N/A		
Average Measurements					
Design Height (In.):	27	Width (In.):	27.0	Post Spacing (In.):	0.0
Height (In.):	30.0	Lateral Offset (In.):	24.5	Road Grade (%):	2.10
Physical Condition					
Barrier	Alignment and Height:	Alignment acceptable. Height was 0-5-in above the 27-in design height.

Breaking and Cracking:	No breaking or cracking observed.			
	Missing Elements:	No missing elements observed.			
	Corrosion and Weathering:	No corrosion or weathering observed.			
End Treatments	Alignment and Height:				
	Breaking and Cracking:				
	Missing Elements:				
	Corrosion and Weathering:

Repair Action:	NO ACTION	FMSS Work Type:	N/A	Repair Cost:	\$0
Brief Workorder:	N/A				
Workorder:

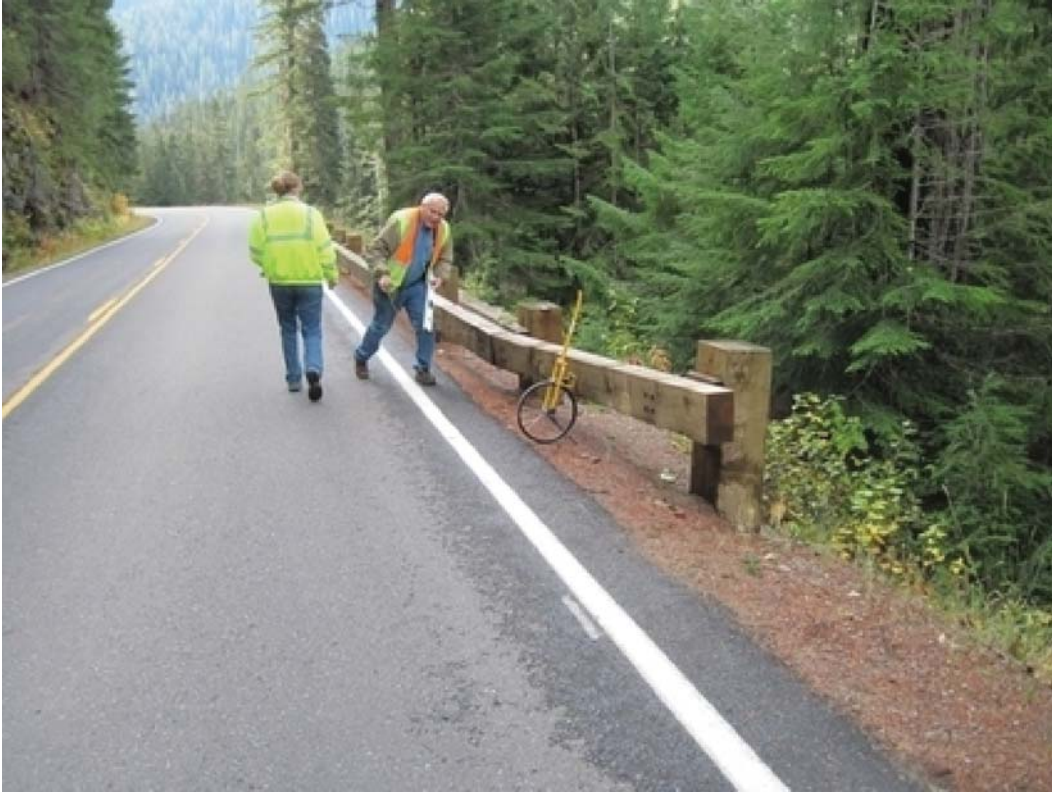
MORA_0010_7.336_L_1.jpg

Barrier ID:	MORA-0010-7.336-L				
Route Name:	STATE ROUTE 123 (EAST SIDE HIGHWAY)				
Inspection Date:	10/19/2009	Barrier Rating:	58.00		
Barrier Description					
Type:	STEEL-BACKED TIMBER WITH BLOCKOUT	Barrier Function:	TRAFFIC		
Barrier Material:	STEEL-BACKED TIMBER/LOG	Post Material:	WOOD		
Blockout Type:	WOOD	Length (ft.):	93		
Speed Limit (MPH):	45	Placement with Respect to Road:	TANGENT		
Hazard Behind Barrier:	EXTREME				
Barrier Crashworthiness					
Appropriate Test Level:	TL-2	Barrier Test Level:	TL-3	Is Barrier Crashworthy?:	YES
Beg. End Trtmt Type:	NONE	Is Beg. End Trtmt Crashworthy?:	N/A	Approach Transition Type:	NONE
Ending End Trtmt Type:	NONE	Ending End Trtmt Crashworthy?:	N/A		
Average Measurements					
Design Height (In.):	27	Width (In.):	0.0	Post Spacing (In.):	120.0
Height (In.):	19.7	Lateral Offset (In.):	14.6	Road Grade (%):	5.90
Physical Condition					
Barrier	Alignment and Height:	Alignment is off by 6-in. Rail is rotated towards road most of barrier length. Entire barrier is 6-9in. below 27-in design height.

Breaking and Cracking:	One rail is splintered. 7 blockouts separated from posts.			
	Missing Elements:	No missing elements observed.			
	Corrosion and Weathering:	Erosion around 10 posts causing rotated posts. 1 post had settled.			
End Treatments	Alignment and Height:				
	Breaking and Cracking:				
	Missing Elements:				
	Corrosion and Weathering:

Repair Action:	REPAIR	FMSS Work Type:	DEFERRED MAINTENANCE	Repair Cost:	\$3119
Brief Workorder:	Raise 93-ft of barrier up to 27-in design height. Tighten/adjust hardware to repair rotated rail & separated blocks. Replace one 10-ft. rail.				
Workorder:	Adjust Guardrail at \$10- per -Lin. Ft. for 93 LF = \$930. Raise 93-ft of barrier up to 27-in design height. Replace rail at \$25- per -Lin. Ft. for 10 LF = \$250. Replace 10 ft. of timber rail. Labor at \$60- per -Hour for 3 Hrs = \$180. Realign rotated blocks and tighten. Low Speed Traffic Control at \$1475- per -Day for 1 Day(s) = \$1475.

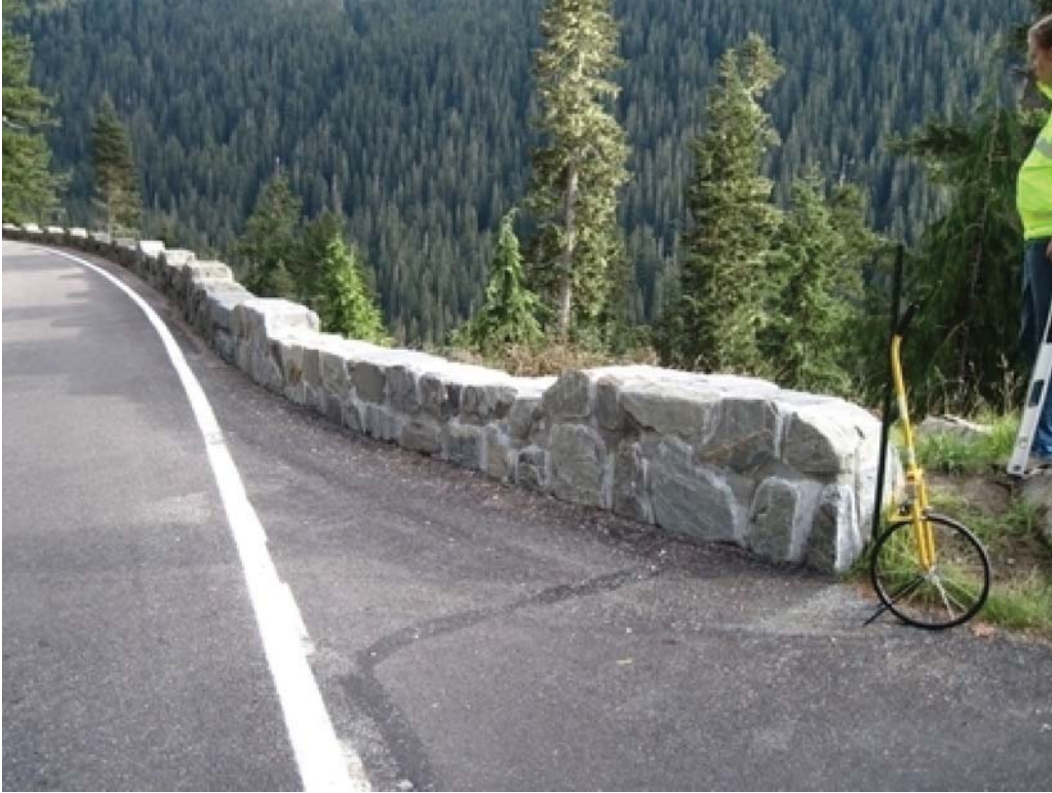
MORA_0010_12.422_L_1.jpg

Barrier ID:	MORA-0010-12.422-L				
Route Name:	STATE ROUTE 123 (EAST SIDE HIGHWAY)				
Inspection Date:	10/19/2009	Barrier Rating:	64.40		
Barrier Description					
Type:	STONE MASONRY CRENELLATED WITHOUT	Barrier Function:	TRAFFIC		
Barrier Material:	STONE	Post Material:	N/A		
Blockout Type:	N/A	Length (ft.):	1530		
Speed Limit (MPH):	45	Placement with Respect to Road:	BOTH INSIDE AND OUTSIDE		
Hazard Behind Barrier:	EXTREME				
Barrier Crashworthiness					
Appropriate Test Level:	TL-2	Barrier Test Level:	NCW	Is Barrier Crashworthy?:	NO
Beg. End Trtmt Type:	NONE	Is Beg. End Trtmt Crashworthy?:	N/A	Approach Transition Type:	NONE
Ending End Trtmt Type:	NONE	Ending End Trtmt Crashworthy?:	N/A		
Average Measurements					
Design Height (In.):	18	Width (In.):	18.8	Post Spacing (In.):	0.0
Height (In.):	19.7	Lateral Offset (In.):	24.1	Road Grade (%):	5.80
Physical Condition					
Barrier	Alignment and Height:	Alignment acceptable. Height was between 6-in below to 3-in above the 18-in/24-in crenellated design height.

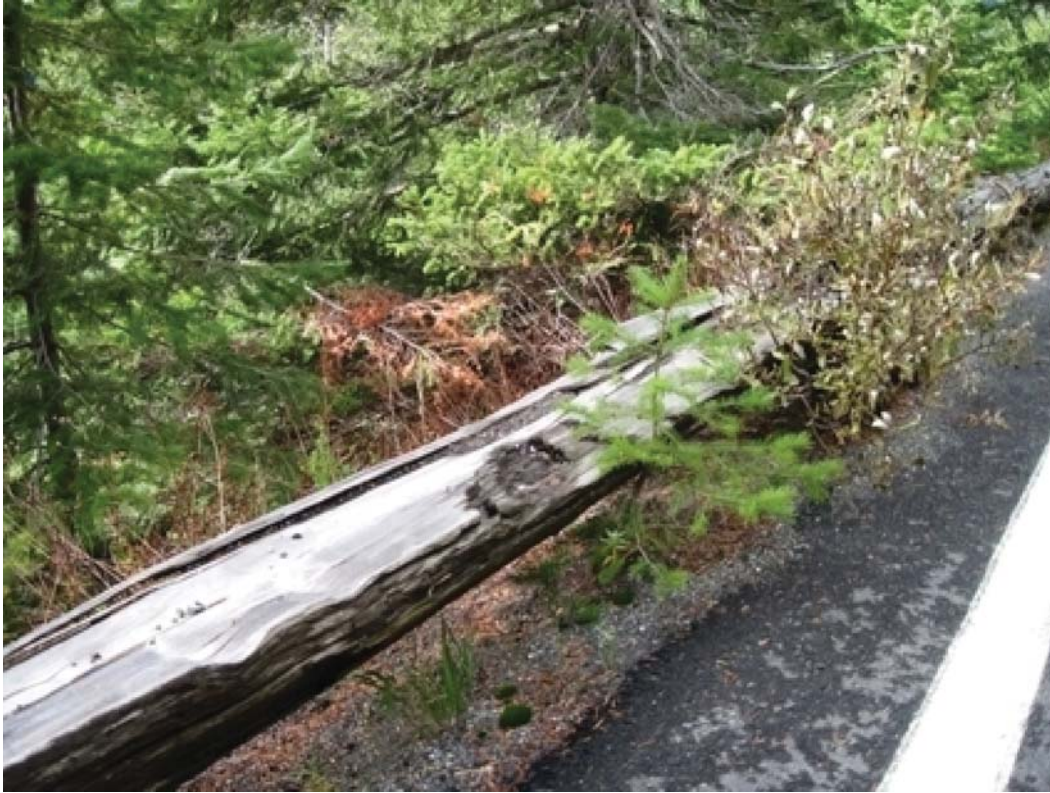
MORA_0012_5.082_L_1.jpg

Barrier ID:	MORA-0012-5.082-L				
Route Name:	STATE ROUTE 410 (MATHER MEMORIAL PARKWAY)				
Inspection Date:	10/18/2009	Barrier Rating:	65.80		
Barrier Description					
Type:	OTHER: TIMBER RAIL ON CONCRETE POSTS	Barrier Function:	TRAFFIC		
Barrier Material:	LOG/TIMBER/WOOD	Post Material:	OTHER: CONCRETE		
Blockout Type:	N/A	Length (ft.):	1167		
Speed Limit (MPH):	45	Placement with Respect to Road:	OUTSIDE OF CURVE		
Hazard Behind Barrier:	EXTREME				
Barrier Crashworthiness					
Appropriate Test Level:	TL-2	Barrier Test Level:	NCW	Is Barrier Crashworthy?:	NO
Beg. End Trtmt Type:	NONE	Is Beg. End Trtmt Crashworthy?:	N/A	Approach Transition Type:	NONE
Ending End Trtmt Type:	NONE	Ending End Trtmt Crashworthy?:	N/A		
Average Measurements					
Design Height (In.):	20	Width (In.):	11.8	Post Spacing (In.):	121.8
Height (In.):	15.3	Lateral Offset (In.):	65.0	Road Grade (%):	5.80
Physical Condition					
Barrier	Alignment and Height:	Alignment off by 6in-12" for various significant lengths. Height was between 1-9in below the 20-in design height.

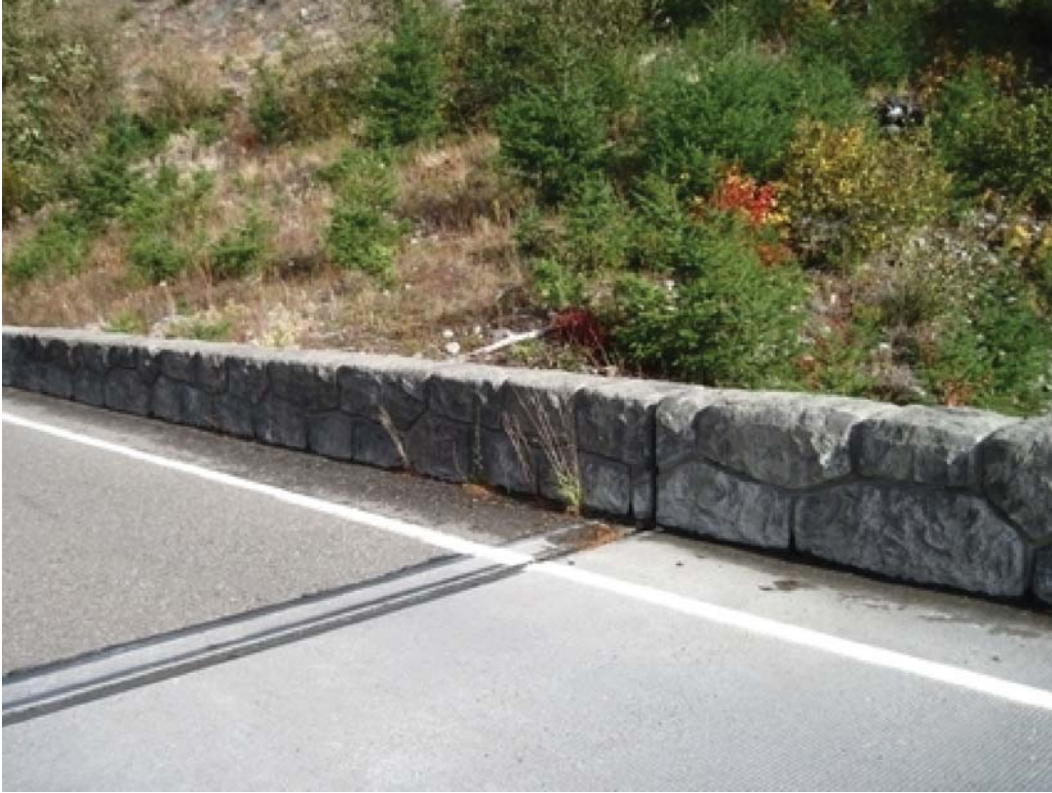
MORA_0012_6.267_R_1.jpg

Barrier ID:	MORA-0012-6.267-R				
Route Name:	STATE ROUTE 410 (MATHER MEMORIAL PARKWAY)				
Inspection Date:	10/18/2009	Barrier Rating:	18.30		
Barrier Description					
Type:	CONCRETE WITH SIMULATED STONE FACE	Barrier Function:	TRAFFIC		
Barrier Material:	CONCRETE	Post Material:	N/A		
Blockout Type:	N/A	Length (ft.):	162		
Speed Limit (MPH):	45	Placement with Respect to Road:	TANGENT		
Hazard Behind Barrier:	LOW				
Barrier Crashworthiness					
Appropriate Test Level:	TL-2	Barrier Test Level:	TL-3	Is Barrier Crashworthy?:	YES
Beg. End Trtmt Type:	NONE	Is Beg. End Trtmt Crashworthy?:	N/A	Approach Transition Type:	NONE
Ending End Trtmt Type:	NONE	Ending End Trtmt Crashworthy?:	N/A		
Average Measurements					
Design Height (In.):	27	Width (In.):	23.2	Post Spacing (In.):	0.0
Height (In.):	28.0	Lateral Offset (In.):	32.7	Road Grade (%):	5.90
Physical Condition					
Barrier	Alignment and Height:	Alignment acceptable. Height within 3-in of 27-in design height.

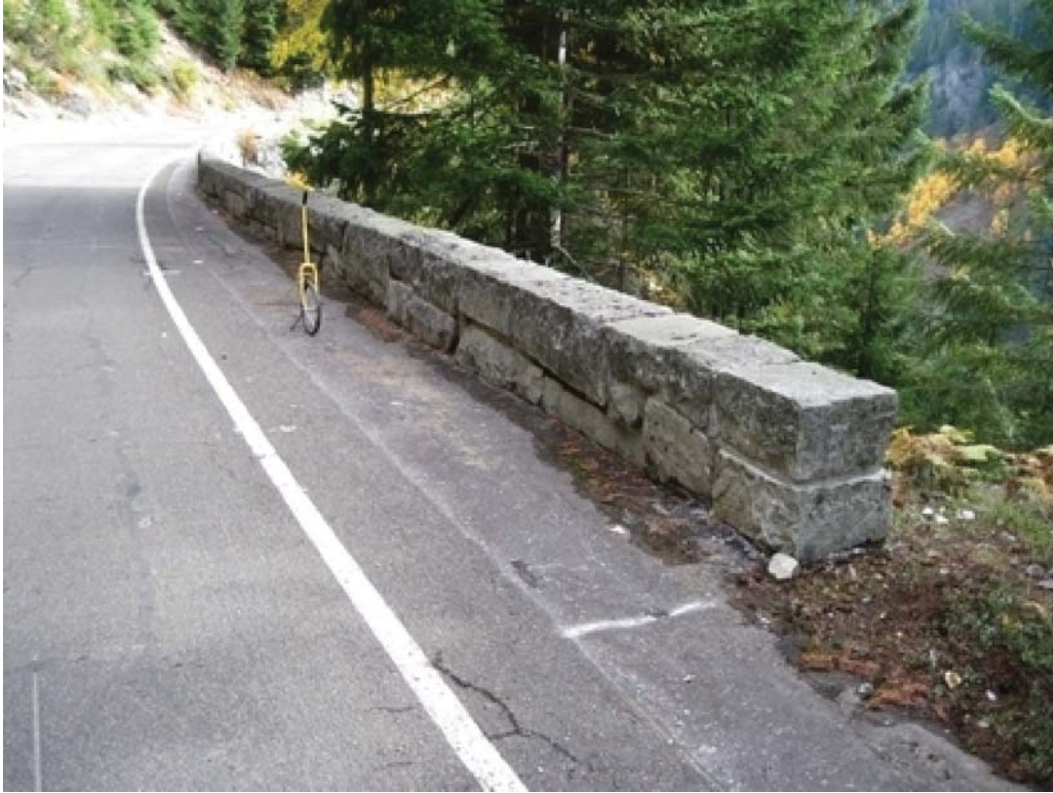
MORA_0013_6.727_R_1.jpg

Barrier ID:	MORA-0013-6.727-R				
Route Name:	STEVENS CANYON ROAD				
Inspection Date:	10/20/2009	Barrier Rating:	32.90		
Barrier Description					
Type:	STONE MASONRY WITHOUT CONCRETE CORE WALL	Barrier Function:	TRAFFIC		
Barrier Material:	STONE	Post Material:	N/A		
Blockout Type:	N/A	Length (ft.):	144		
Speed Limit (MPH):	35	Placement with Respect to Road:	INSIDE OF CURVE		
Hazard Behind Barrier:	EXTREME				
Barrier Crashworthiness					
Appropriate Test Level:	TL-2	Barrier Test Level:	NCW	Is Barrier Crashworthy?:	NO
Beg. End Trtmt Type:	NONE	Is Beg. End Trtmt Crashworthy?:	N/A	Approach Transition Type:	NONE
Ending End Trtmt Type:	NONE	Ending End Trtmt Crashworthy?:	N/A		
Average Measurements					
Design Height (In.):	24	Width (In.):	19.7	Post Spacing (In.):	0.0
Height (In.):	24.2	Lateral Offset (In.):	49.5	Road Grade (%):	5.70
Physical Condition					
Barrier	Alignment and Height:	Alignment acceptable. Height within 3-in of 24-in design height. The last 41 ft of barrier (end section) was rebuilt.

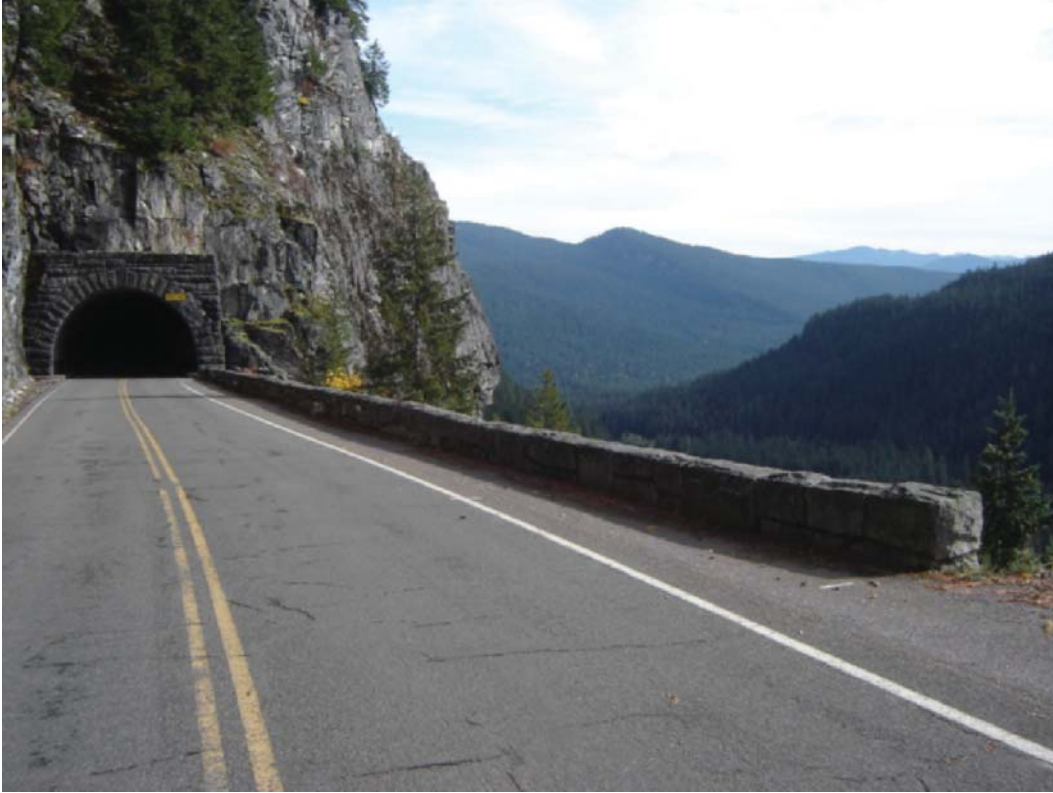
MORA_0013_6.893_R_1.JPG

Barrier ID:	MORA-0013-6.893-R				
Route Name:	STEVENS CANYON ROAD				
Inspection Date:	10/20/2009	Barrier Rating:	30.00		
Barrier Description					
Type:	STONE MASONRY WITHOUT CONCRETE CORE WALL	Barrier Function:	TRAFFIC		
Barrier Material:	STONE	Post Material:	N/A		
Blockout Type:	N/A	Length (ft.):	220		
Speed Limit (MPH):	35	Placement with Respect to Road:	TANGENT		
Hazard Behind Barrier:	EXTREME				
Barrier Crashworthiness					
Appropriate Test Level:	TL-2	Barrier Test Level:	NCW	Is Barrier Crashworthy?:	NO
Beg. End Trtmt Type:	NONE	Is Beg. End Trtmt Crashworthy?:	N/A	Approach Transition Type:	NONE
Ending End Trtmt Type:	NONE	Ending End Trtmt Crashworthy?:	N/A		
Average Measurements					
Design Height (In.):	24	Width (In.):	18.7	Post Spacing (In.):	0.0
Height (In.):	26.7	Lateral Offset (In.):	70.5	Road Grade (%):	4.80
Physical Condition					
Barrier	Alignment and Height:	Alignment acceptable. Height within 3-in of 24-in design height.

Breaking and Cracking:	Minor cracking of mortar loose mortar missing mortar joints, at individual locations.			
	Missing Elements:	No missing elements observed.			
	Corrosion and Weathering:	No corrosion or weathering observed.			
End Treatments	Alignment and Height:				
	Breaking and Cracking:				
	Missing Elements:				
	Corrosion and Weathering:

Repair Action:	REPAIR	FMSS Work Type:	DEFERRED MAINTENANCE	Repair Cost:	\$1777
Brief Workorder:	Repoint 1 SY of stone masonry barrier.				
Workorder:	Re-point masonry barrier at \$140- per -Sq. Yd. for 1 SY = \$140. Low Speed Traffic Control at \$1475- per -Day for 1 Day(s) = \$1475.

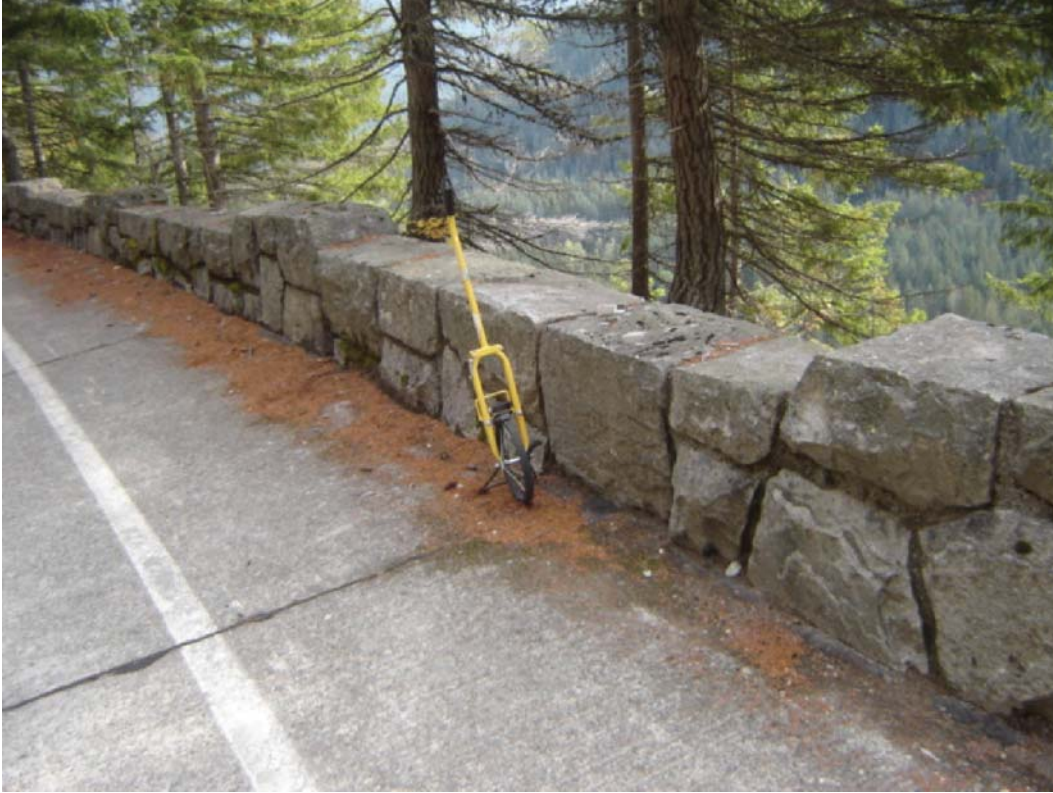
MORA_0013_6.989_R_1.JPG

Barrier ID:	MORA-0013-6.989-R				
Route Name:	STEVENS CANYON ROAD				
Inspection Date:	10/20/2009	Barrier Rating:	38.50		
Barrier Description					
Type:	STONE MASONRY CRENELLATED WITHOUT	Barrier Function:	TRAFFIC		
Barrier Material:	STONE	Post Material:	N/A		
Blockout Type:	N/A	Length (ft.):	138		
Speed Limit (MPH):	35	Placement with Respect to Road:	OUTSIDE OF CURVE		
Hazard Behind Barrier:	EXTREME				
Barrier Crashworthiness					
Appropriate Test Level:	TL-2	Barrier Test Level:	NCW	Is Barrier Crashworthy?:	NO
Beg. End Trtmt Type:	NONE	Is Beg. End Trtmt Crashworthy?:	N/A	Approach Transition Type:	NONE
Ending End Trtmt Type:	NONE	Ending End Trtmt Crashworthy?:	N/A		
Average Measurements					
Design Height (In.):	18	Width (In.):	20.0	Post Spacing (In.):	0.0
Height (In.):	21.2	Lateral Offset (In.):	55.0	Road Grade (%):	4.50
Physical Condition					
Barrier	Alignment and Height:	Alignment acceptable. Height was between 2-in to 5-in above the 18-in/24-in crenellated design height.

Breaking and Cracking:	No breaking or cracking observed.			
	Missing Elements:	No missing elements observed.			
	Corrosion and Weathering:	Moss is covering about 80% of mortar.			
End Treatments	Alignment and Height:				
	Breaking and Cracking:				
	Missing Elements:				
	Corrosion and Weathering:

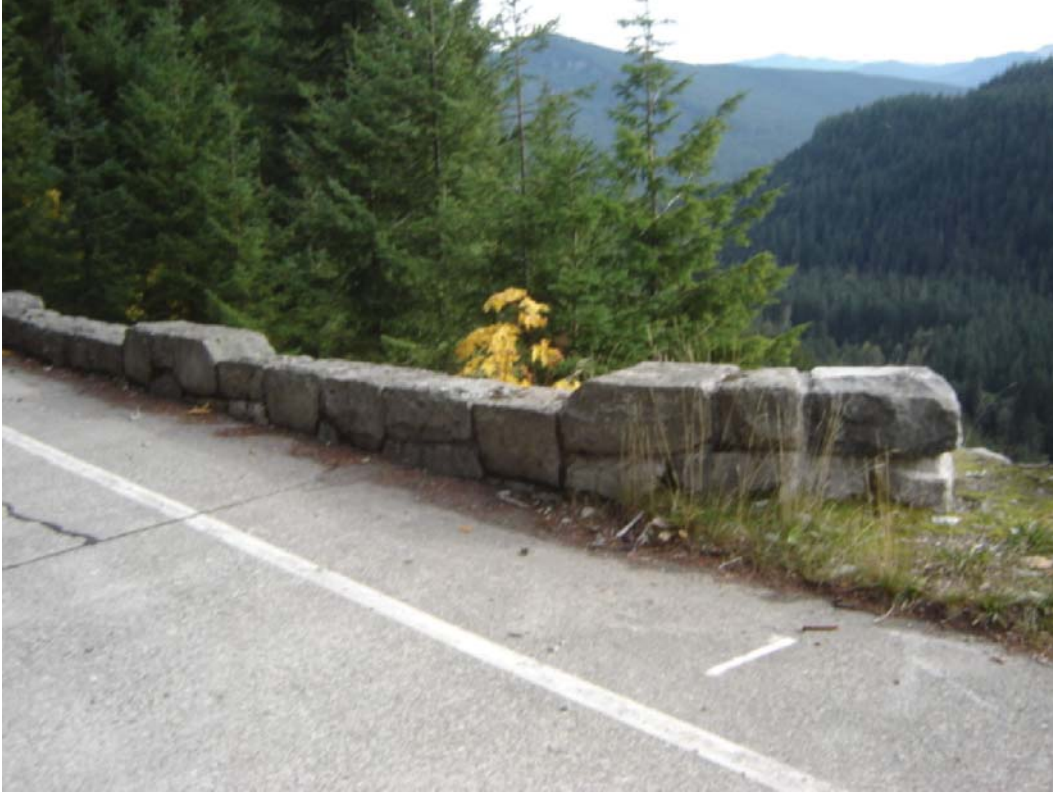
MORA_0013_7.065_R_1.JPG

Barrier ID:	MORA-0013-7.065-R				
Route Name:	STEVENS CANYON ROAD				
Inspection Date:	10/20/2009	Barrier Rating:	47.20		
Barrier Description					
Type:	STONE MASONRY CRENELLATED WITHOUT	Barrier Function:	TRAFFIC		
Barrier Material:	STONE	Post Material:	N/A		
Blockout Type:	N/A	Length (ft.):	1002		
Speed Limit (MPH):	35	Placement with Respect to Road:	INSIDE OF CURVE		
Hazard Behind Barrier:	EXTREME				
Barrier Crashworthiness					
Appropriate Test Level:	TL-2	Barrier Test Level:	NCW	Is Barrier Crashworthy?:	NO
Beg. End Trtmt Type:	NONE	Is Beg. End Trtmt Crashworthy?:	N/A	Approach Transition Type:	NONE
Ending End Trtmt Type:	NONE	Ending End Trtmt Crashworthy?:	N/A		
Average Measurements					
Design Height (In.):	18	Width (In.):	19.3	Post Spacing (In.):	0.0
Height (In.):	21.3	Lateral Offset (In.):	58.7	Road Grade (%):	7.70
Physical Condition					
Barrier	Alignment and Height:	Alignment acceptable. Height was between 4-in below to 9-in above the 18-in/24-in crenellated design height.

Breaking and Cracking:	Minor cracking of mortar (<0.5in wide) about 20 ft. Road and barrier undercut and eroding (20 + 5 ft) in two locations.			
	Missing Elements:	Retaining wall under barrier gone/missing in two locations. Barrier starting to lose stones.			
	Corrosion and Weathering:	Severe undermining of barrier and roadway in two locations.			
End Treatments	Alignment and Height:				
	Breaking and Cracking:				
	Missing Elements:				
	Corrosion and Weathering:

Repair Action:	REPAIR	FMSS Work Type:	DEFERRED MAINTENANCE	Repair Cost:	\$3009
Brief Workorder:	Repoint 9 SY of barrier.				
Workorder:	Re-Point Masonry Barrier at \$140- per -Sq. Yd. for 9 SY = \$1260. [(20 ft) (4 ft)]/9 = 8.9 SY Low Speed Traffic Control at \$1475- per -Day for 1 Day(s) = \$1475.

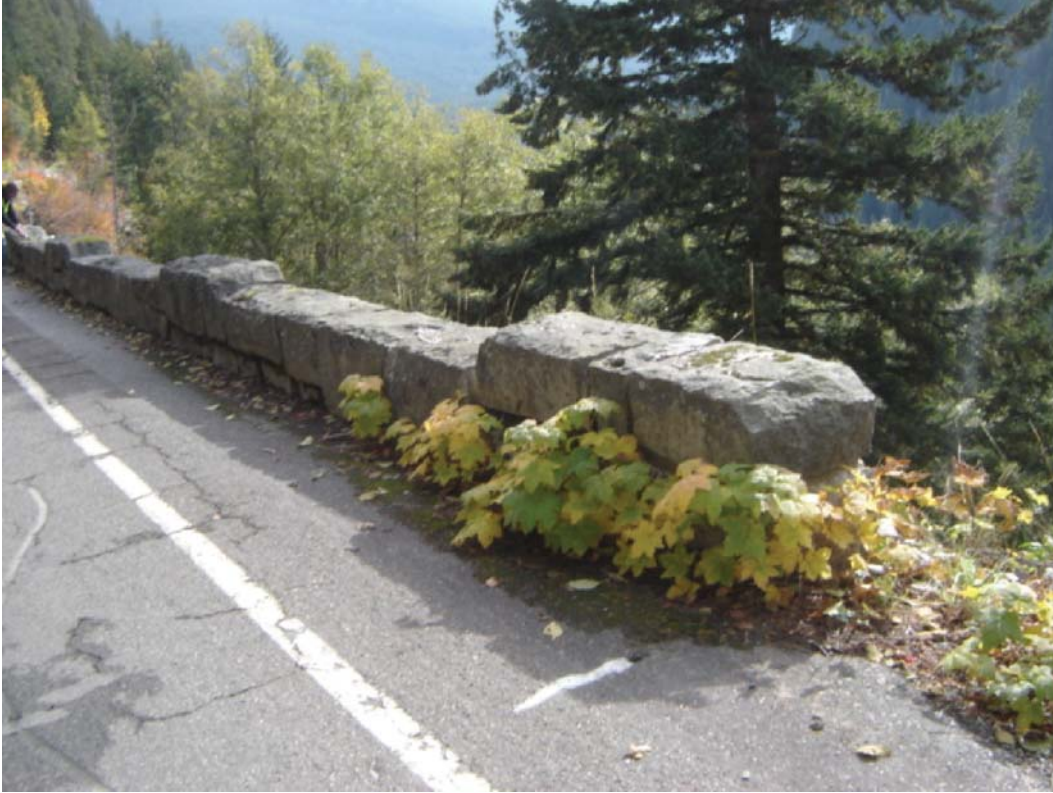
MORA_0013_7.386_R_1.JPG

Barrier ID:	MORA-0013-7.386-R				
Route Name:	STEVENS CANYON ROAD				
Inspection Date:	10/20/2009	Barrier Rating:	51.50		
Barrier Description					
Type:	STONE MASONRY CRENELLATED WITHOUT	Barrier Function:	TRAFFIC		
Barrier Material:	STONE	Post Material:	N/A		
Blockout Type:	N/A	Length (ft.):	460		
Speed Limit (MPH):	35	Placement with Respect to Road:	INSIDE OF CURVE		
Hazard Behind Barrier:	EXTREME				
Barrier Crashworthiness					
Appropriate Test Level:	TL-2	Barrier Test Level:	NCW	Is Barrier Crashworthy?:	NO
Beg. End Trtmt Type:	NONE	Is Beg. End Trtmt Crashworthy?:	N/A	Approach Transition Type:	NONE
Ending End Trtmt Type:	NONE	Ending End Trtmt Crashworthy?:	N/A		
Average Measurements					
Design Height (In.):	18	Width (In.):	18.7	Post Spacing (In.):	0.0
Height (In.):	18.2	Lateral Offset (In.):	44.7	Road Grade (%):	5.60
Physical Condition					
Barrier	Alignment and Height:	Alignment acceptable. Height was within 3-in of the 18-in/24-in crenellated design height.

Breaking and Cracking:	Minor cracking less than 1/4 in.			
	Missing Elements:	No missing elements observed.			
	Corrosion and Weathering:	No corrosion or weathering observed.			
End Treatments	Alignment and Height:				
	Breaking and Cracking:				
	Missing Elements:				
	Corrosion and Weathering:

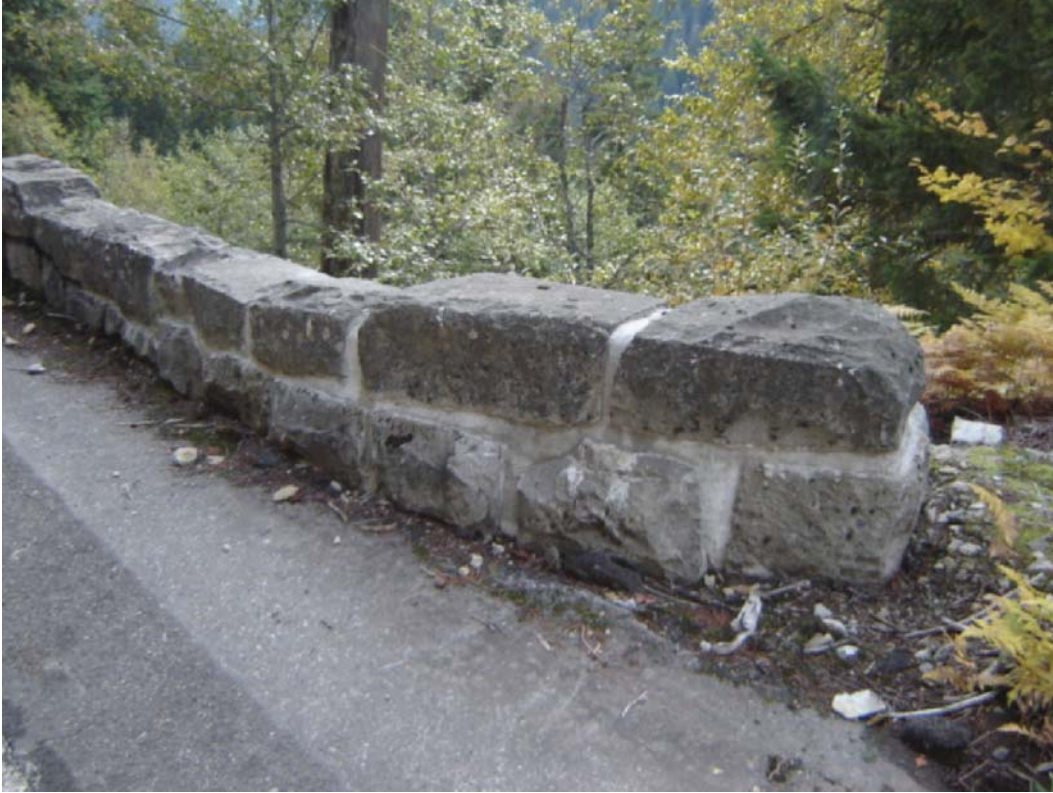
MORA_0013_7.502_R_1.JPG

Barrier ID:	MORA-0013-7.502-R				
Route Name:	STEVENS CANYON ROAD				
Inspection Date:	10/20/2009	Barrier Rating:	37.20		
Barrier Description					
Type:	STONE MASONRY CRENELLATED WITHOUT	Barrier Function:	TRAFFIC		
Barrier Material:	STONE	Post Material:	N/A		
Blockout Type:	N/A	Length (ft.):	330		
Speed Limit (MPH):	35	Placement with Respect to Road:	TANGENT		
Hazard Behind Barrier:	EXTREME				
Barrier Crashworthiness					
Appropriate Test Level:	TL-2	Barrier Test Level:	NCW	Is Barrier Crashworthy?:	NO
Beg. End Trtmt Type:	NONE	Is Beg. End Trtmt Crashworthy?:	N/A	Approach Transition Type:	NONE
Ending End Trtmt Type:	NONE	Ending End Trtmt Crashworthy?:	N/A		
Average Measurements					
Design Height (In.):	18	Width (In.):	18.7	Post Spacing (In.):	0.0
Height (In.):	22.0	Lateral Offset (In.):	65.6	Road Grade (%):	6.20
Physical Condition					
Barrier	Alignment and Height:	Alignment acceptable. Height was between 2-in to 6-in above the 18-in/24-in crenellated design height.

Breaking and Cracking:	Minor cracking of grout less than 0.25 in wide.			
	Missing Elements:	No missing elements observed.			
	Corrosion and Weathering:	No corrosion or weathering observed.			
End Treatments	Alignment and Height:				
	Breaking and Cracking:				
	Missing Elements:				
	Corrosion and Weathering:

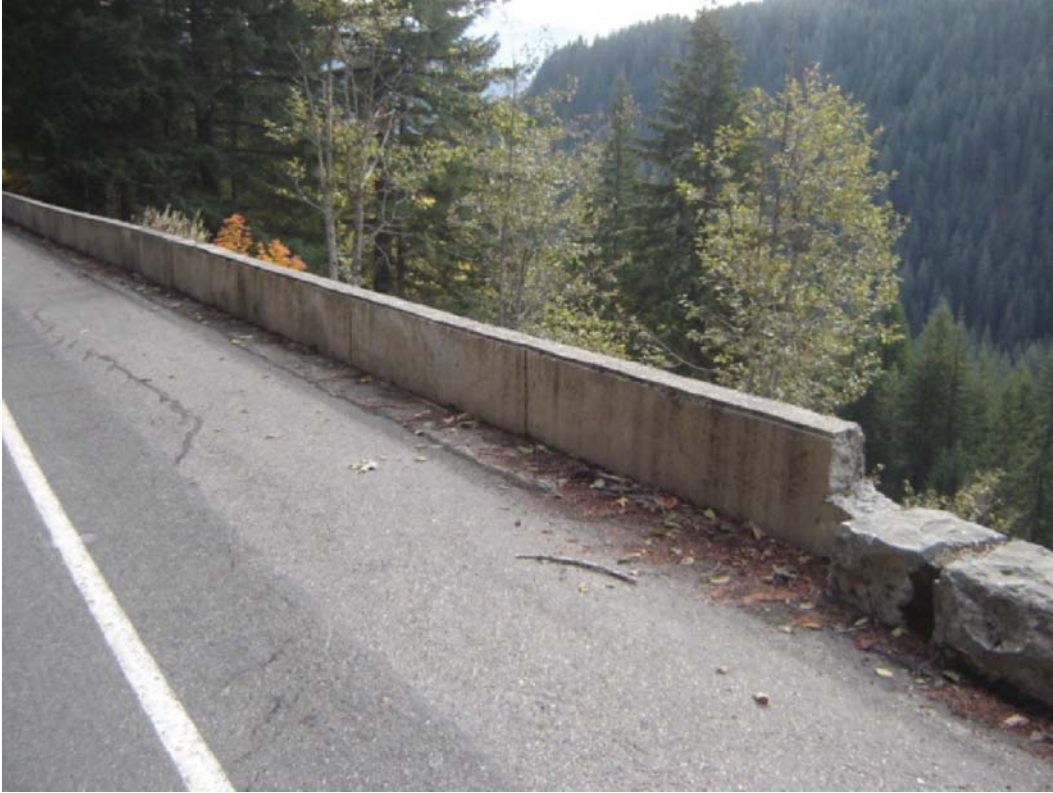
MORA_0013_7.564_R_1.JPG

Barrier ID:	MORA-0013-7.564-R				
Route Name:	STEVENS CANYON ROAD				
Inspection Date:	10/20/2009	Barrier Rating:	41.50		
Barrier Description					
Type:	STONE MASONRY WITH CONCRETE CORE WALL	Barrier Function:	TRAFFIC		
Barrier Material:	CONCRETE	Post Material:	N/A		
Blockout Type:	N/A	Length (ft.):	185		
Speed Limit (MPH):	35	Placement with Respect to Road:	TANGENT		
Hazard Behind Barrier:	EXTREME				
Barrier Crashworthiness					
Appropriate Test Level:	TL-2	Barrier Test Level:	TL-3	Is Barrier Crashworthy?:	YES
Beg. End Trtmt Type:	NONE	Is Beg. End Trtmt Crashworthy?:	N/A	Approach Transition Type:	NONE
Ending End Trtmt Type:	NONE	Ending End Trtmt Crashworthy?:	N/A		
Average Measurements					
Design Height (In.):	27	Width (In.):	8.0	Post Spacing (In.):	0.0
Height (In.):	22.5	Lateral Offset (In.):	58.7	Road Grade (%):	5.80
Physical Condition					
Barrier	Alignment and Height:	Alignment acceptable. Height within 3-in of 24-in design height.

Breaking and Cracking:	Minor cracking at beginning.			
	Missing Elements:	Entire stone face missing.			
	Corrosion and Weathering:	No corrosion or weathering observed.			
End Treatments	Alignment and Height:				
	Breaking and Cracking:				
	Missing Elements:				
	Corrosion and Weathering:

Repair Action:	REPAIR	FMSS Work Type:	DEFERRED MAINTENANCE	Repair Cost:	\$45458
Brief Workorder:	Install 96 SY of stone masonry face on concrete core wall.				
Workorder:	Add stone facing to bare concrete core barrier at \$200- per -Sq. Yd. for 96 SY = \$19200. $[(2 \text{ ft} + 0.75\text{ft} + 2 \text{ ft})(864 \text{ ft})]/9 = 96$ SY Low Speed Traffic Control at \$1475- per -Day for 15 Day(s) = \$22125.

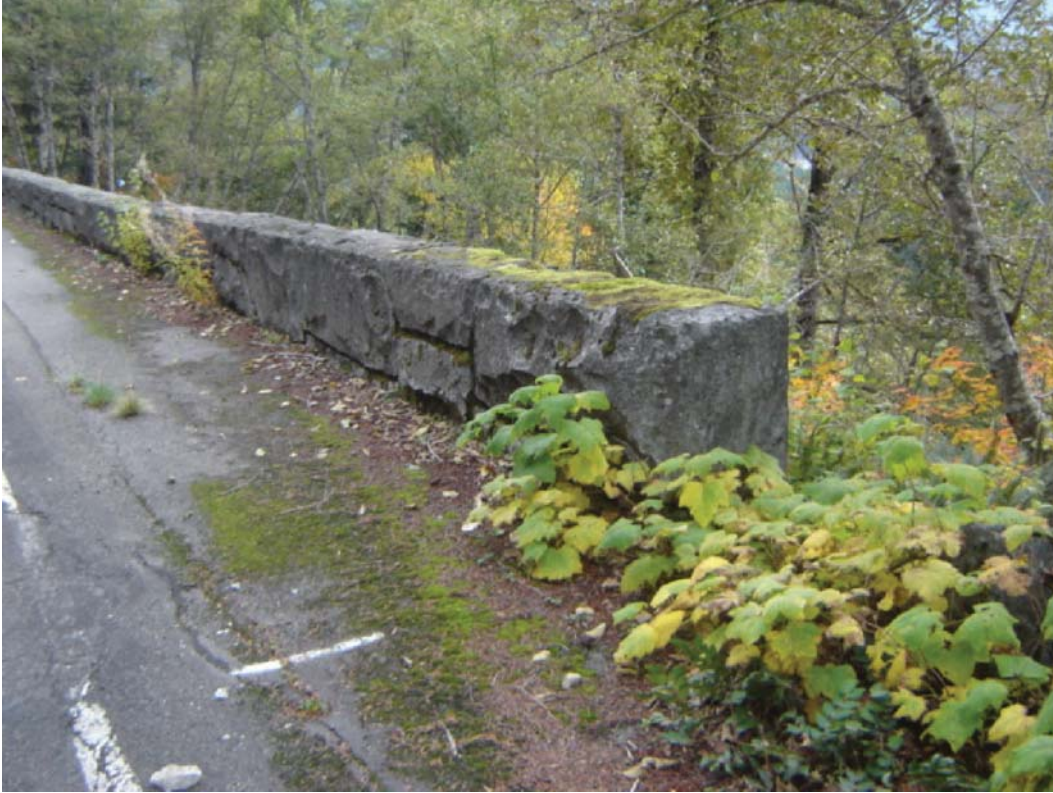
MORA_0013_7.790_R_1.JPG

Barrier ID:	MORA-0013-7.790-R				
Route Name:	STEVENS CANYON ROAD				
Inspection Date:	10/20/2009	Barrier Rating:	38.50		
Barrier Description					
Type:	STONE MASONRY WITHOUT CONCRETE CORE WALL	Barrier Function:	TRAFFIC		
Barrier Material:	STONE	Post Material:	N/A		
Blockout Type:	N/A	Length (ft.):	145		
Speed Limit (MPH):	35	Placement with Respect to Road:	OUTSIDE OF CURVE		
Hazard Behind Barrier:	EXTREME				
Barrier Crashworthiness					
Appropriate Test Level:	TL-2	Barrier Test Level:	NCW	Is Barrier Crashworthy?:	NO
Beg. End Trtmt Type:	NONE	Is Beg. End Trtmt Crashworthy?:	N/A	Approach Transition Type:	NONE
Ending End Trtmt Type:	NONE	Ending End Trtmt Crashworthy?:	N/A		
Average Measurements					
Design Height (In.):	24	Width (In.):	19.0	Post Spacing (In.):	0.0
Height (In.):	26.7	Lateral Offset (In.):	79.0	Road Grade (%):	5.30
Physical Condition					
Barrier	Alignment and Height:	Alignment acceptable. Height within 3-in of 24-in design height.

Breaking and Cracking:	Mortar missing in 5 locations 1 sq. yd. total.			
	Missing Elements:	No missing elements observed.			
	Corrosion and Weathering:	Moss covering 90% of mortar.			
End Treatments	Alignment and Height:				
	Breaking and Cracking:				
	Missing Elements:				
	Corrosion and Weathering:

Repair Action:	REPAIR	FMSS Work Type:	DEFERRED MAINTENANCE	Repair Cost:	\$1777
Brief Workorder:	Re-point 1 SY of masonry barrier in 5 locations where mortar is missing.				
Workorder:	Re-point masonry barrier at \$140- per -Sq. Yd. for 1 SY = \$140. Re-point mortar in 5 locations where missing. Low Speed Traffic Control at \$1475- per -Day for 1 Day(s) = \$1475.

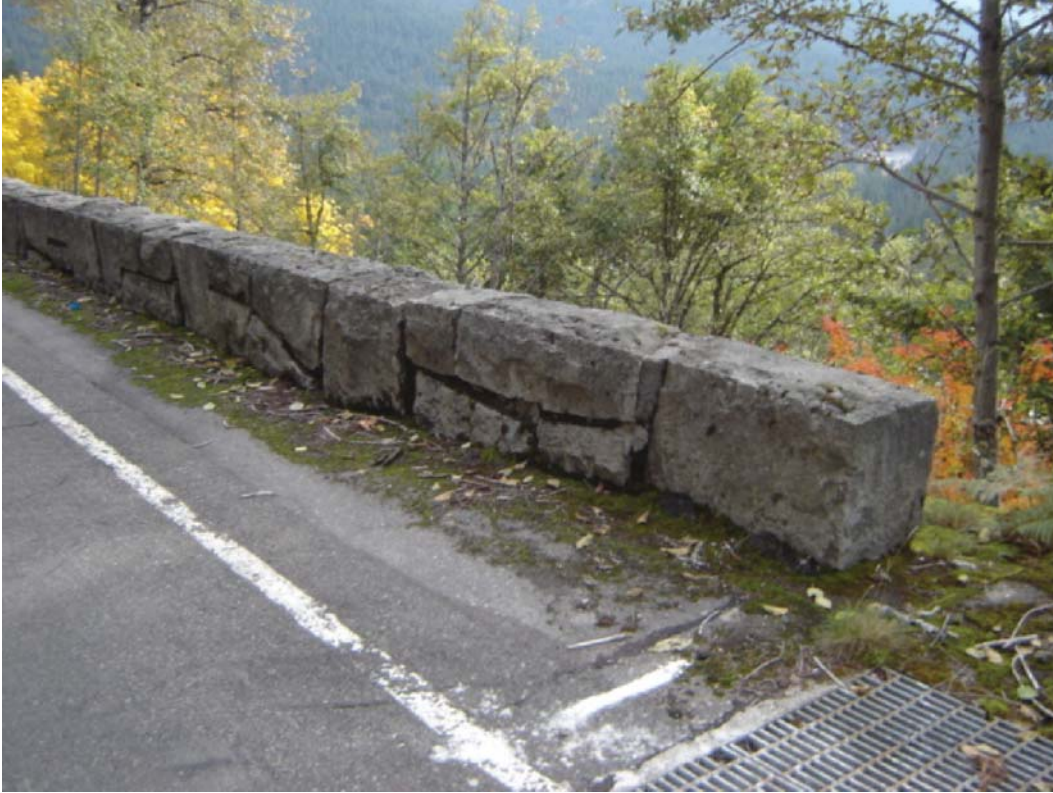
MORA_0013_7.896_R_1.JPG

Barrier ID:	MORA-0013-7.896-R				
Route Name:	STEVENS CANYON ROAD				
Inspection Date:	10/20/2009	Barrier Rating:	32.90		
Barrier Description					
Type:	STONE MASONRY WITHOUT CONCRETE CORE WALL	Barrier Function:	TRAFFIC		
Barrier Material:	STONE	Post Material:	N/A		
Blockout Type:	N/A	Length (ft.):	268		
Speed Limit (MPH):	35	Placement with Respect to Road:	TANGENT		
Hazard Behind Barrier:	EXTREME				
Barrier Crashworthiness					
Appropriate Test Level:	TL-2	Barrier Test Level:	NCW	Is Barrier Crashworthy?:	NO
Beg. End Trtmt Type:	NONE	Is Beg. End Trtmt Crashworthy?:	N/A	Approach Transition Type:	NONE
Ending End Trtmt Type:	NONE	Ending End Trtmt Crashworthy?:	N/A		
Average Measurements					
Design Height (In.):	24	Width (In.):	19.7	Post Spacing (In.):	0.0
Height (In.):	26.0	Lateral Offset (In.):	53.7	Road Grade (%):	5.40
Physical Condition					
Barrier	Alignment and Height:	Alignment acceptable. Height within 3-in of 24-in design height.

Breaking and Cracking:	Minor mortar cracking/missing up to 1/2-in wide drilled hole through mortar.			
	Missing Elements:	No missing elements observed.			
	Corrosion and Weathering:	No corrosion or weathering observed.			
End Treatments	Alignment and Height:				
	Breaking and Cracking:				
	Missing Elements:				
	Corrosion and Weathering:

Repair Action:	REPAIR	FMSS Work Type:	DEFERRED MAINTENANCE	Repair Cost:	\$1777
Brief Workorder:	Repoint 1 SY of barrier.				
Workorder:	Re-point masonry barrier at \$140- per -Sq. Yd. for 1 SY = \$140. [(2ft)(3ft)] /9 = .67 SY. Repoint small cracks and area with hole drilled through mortar. Low Speed Traffic Control at \$1475- per -Day for 1 Day(s) = \$1475.

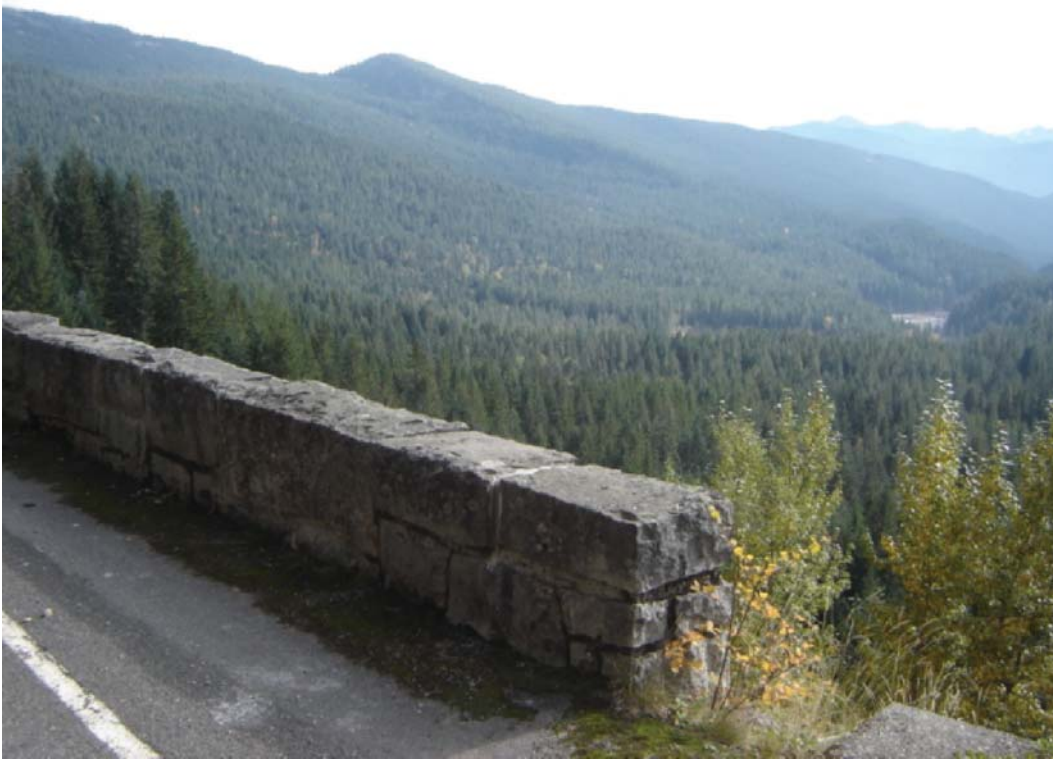
MORA_0013_7.971_R_1.JPG

Barrier ID:	MORA-0013-7.971-R				
Route Name:	STEVENS CANYON ROAD				
Inspection Date:	10/20/2009	Barrier Rating:	44.40		
Barrier Description					
Type:	STONE MASONRY WITHOUT CONCRETE CORE WALL	Barrier Function:	TRAFFIC		
Barrier Material:	STONE	Post Material:	N/A		
Blockout Type:	N/A	Length (ft.):	304		
Speed Limit (MPH):	35	Placement with Respect to Road:	OUTSIDE OF CURVE		
Hazard Behind Barrier:	EXTREME				
Barrier Crashworthiness					
Appropriate Test Level:	TL-2	Barrier Test Level:	NCW	Is Barrier Crashworthy?:	NO
Beg. End Trtmt Type:	NONE	Is Beg. End Trtmt Crashworthy?:	N/A	Approach Transition Type:	NONE
Ending End Trtmt Type:	NONE	Ending End Trtmt Crashworthy?:	N/A		
Average Measurements					
Design Height (In.):	24	Width (In.):	19.7	Post Spacing (In.):	0.0
Height (In.):	30.0	Lateral Offset (In.):	46.0	Road Grade (%):	5.40
Physical Condition					
Barrier	Alignment and Height:	Alignment acceptable. Height was 4– 8in above the 24-in design height.

Breaking and Cracking:	Minor cracking less than 1/4 in. wide.			
	Missing Elements:	No missing elements observed.			
	Corrosion and Weathering:	Moss covering 90% of mortar.			
End Treatments	Alignment and Height:				
	Breaking and Cracking:				
	Missing Elements:				
	Corrosion and Weathering:

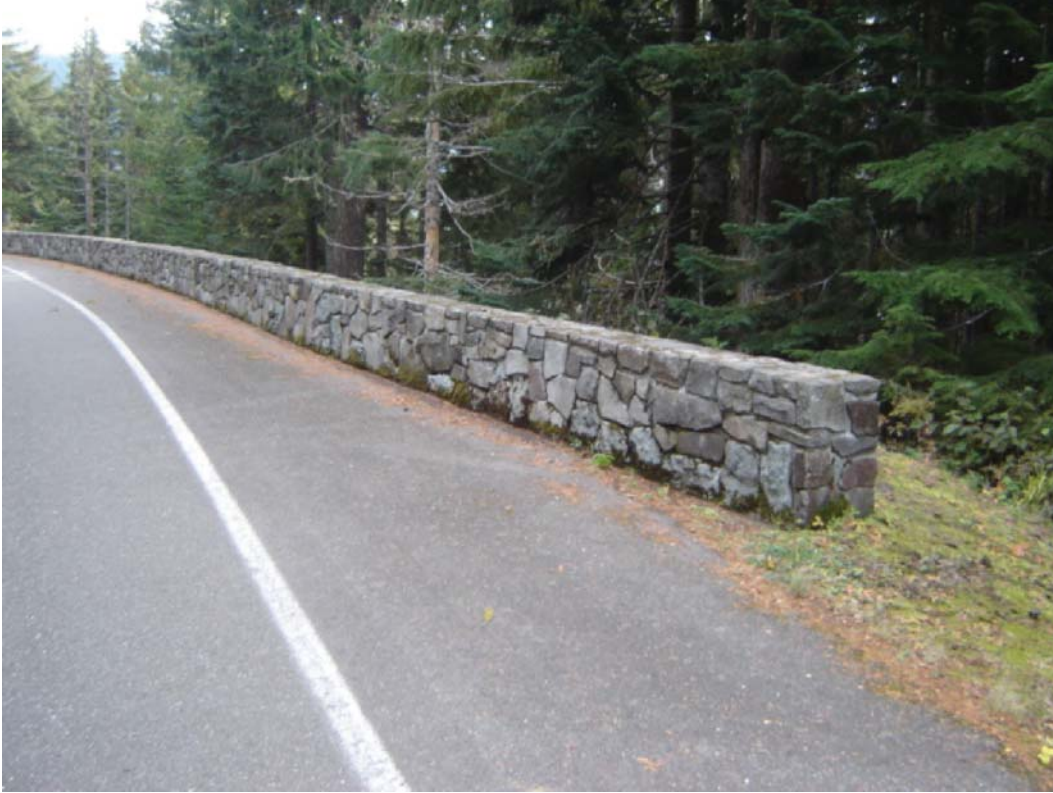
MORA_0013_13.538_R_1.JPG

Barrier ID:	MORA-0013-13.538-R				
Route Name:	STEVENS CANYON ROAD				
Inspection Date:	10/20/2009	Barrier Rating:	35.70		
Barrier Description					
Type:	STONE MASONRY WITH CONCRETE CORE WALL	Barrier Function:	TRAFFIC		
Barrier Material:	CONCRETE	Post Material:	N/A		
Blockout Type:	N/A	Length (ft.):	370		
Speed Limit (MPH):	35	Placement with Respect to Road:	OUTSIDE OF CURVE		
Hazard Behind Barrier:	EXTREME				
Barrier Crashworthiness					
Appropriate Test Level:	TL-2	Barrier Test Level:	TL-3	Is Barrier Crashworthy?:	YES
Beg. End Trtmt Type:	NONE	Is Beg. End Trtmt Crashworthy?:	N/A	Approach Transition Type:	NONE
Ending End Trtmt Type:	NONE	Ending End Trtmt Crashworthy?:	N/A		
Average Measurements					
Design Height (In.):	27	Width (In.):	18.0	Post Spacing (In.):	0.0
Height (In.):	27.7	Lateral Offset (In.):	60.0	Road Grade (%):	4.70
Physical Condition					
Barrier	Alignment and Height:	Alignment acceptable. Height within 3-in of 27-in design height.

Breaking and Cracking:	No breaking or cracking observed.			
	Missing Elements:	No missing elements observed.			
	Corrosion and Weathering:	No corrosion or weathering observed.			
End Treatments	Alignment and Height:				
	Breaking and Cracking:				
	Missing Elements:				
	Corrosion and Weathering:

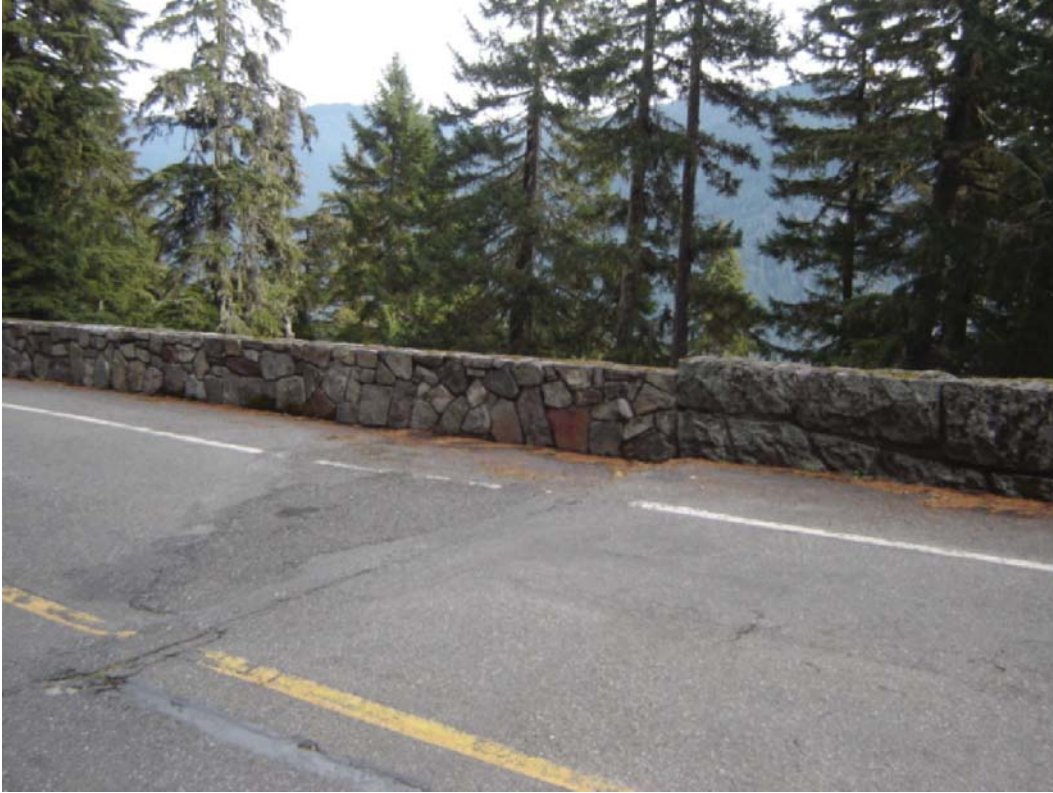
MORA_0013_13.664_R_1.JPG

Barrier ID:	MORA-0013-13.664-R				
Route Name:	STEVENS CANYON ROAD				
Inspection Date:	10/20/2009	Barrier Rating:	28.70		
Barrier Description					
Type:	STONE MASONRY WITH CONCRETE CORE WALL	Barrier Function:	TRAFFIC		
Barrier Material:	CONCRETE	Post Material:	N/A		
Blockout Type:	N/A	Length (ft.):	600		
Speed Limit (MPH):	35	Placement with Respect to Road:	OUTSIDE OF CURVE		
Hazard Behind Barrier:	EXTREME				
Barrier Crashworthiness					
Appropriate Test Level:	TL-2	Barrier Test Level:	TL-3	Is Barrier Crashworthy?:	YES
Beg. End Trtmt Type:	NONE	Is Beg. End Trtmt Crashworthy?:	N/A	Approach Transition Type:	NONE
Ending End Trtmt Type:	NONE	Ending End Trtmt Crashworthy?:	N/A		
Average Measurements					
Design Height (In.):	27	Width (In.):	18.0	Post Spacing (In.):	0.0
Height (In.):	27.7	Lateral Offset (In.):	55.7	Road Grade (%):	5.20
Physical Condition					
Barrier	Alignment and Height:	Alignment acceptable. Height within 3-in of 27-in design height.

Breaking and Cracking:	No breaking or cracking observed.			
	Missing Elements:	No missing elements observed.			
	Corrosion and Weathering:	No corrosion or weathering observed.			
End Treatments	Alignment and Height:				
	Breaking and Cracking:				
	Missing Elements:				
	Corrosion and Weathering:

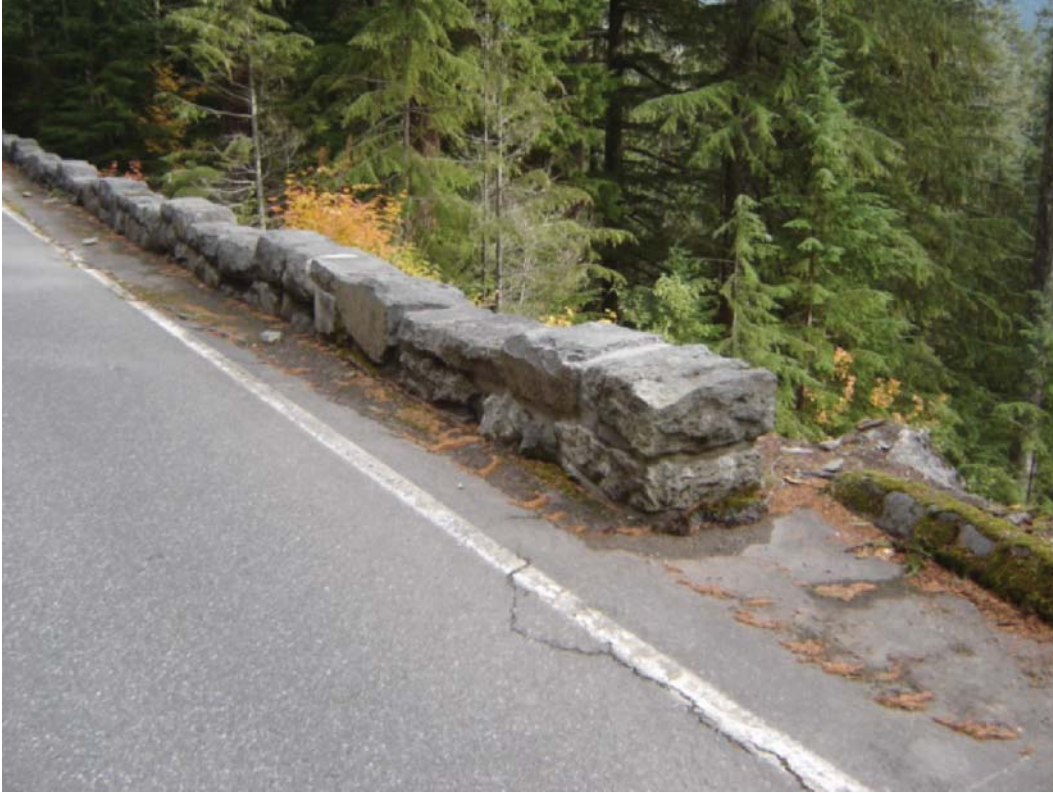
MORA_0013_13.928_R_1.JPG

Barrier ID:	MORA-0013-13.928-R				
Route Name:	STEVENS CANYON ROAD				
Inspection Date:	10/20/2009	Barrier Rating:	34.00		
Barrier Description					
Type:	STONE MASONRY CRENELLATED WITHOUT	Barrier Function:	TRAFFIC		
Barrier Material:	STONE	Post Material:	N/A		
Blockout Type:	N/A	Length (ft.):	329		
Speed Limit (MPH):	35	Placement with Respect to Road:	TANGENT		
Hazard Behind Barrier:	HIGH				
Barrier Crashworthiness					
Appropriate Test Level:	TL-2	Barrier Test Level:	NCW	Is Barrier Crashworthy?:	NO
Beg. End Trtmt Type:	NONE	Is Beg. End Trtmt Crashworthy?:	N/A	Approach Transition Type:	NONE
Ending End Trtmt Type:	NONE	Ending End Trtmt Crashworthy?:	N/A		
Average Measurements					
Design Height (In.):	18	Width (In.):	18.7	Post Spacing (In.):	0.0
Height (In.):	22.2	Lateral Offset (In.):	46.2	Road Grade (%):	5.00
Physical Condition					
Barrier	Alignment and Height:	Alignment acceptable. Height was between 4-in to 11-in above the 18-in/24-in crenellated design height.

Breaking and Cracking:	Minor cracking mortar on road side less than 1/4 in wide. Cracking and spalling 0.25 to 0.5in wide on retaining wall side, for 120 linear ft.			
	Missing Elements:	No missing elements observed.			
	Corrosion and Weathering:	No corrosion or weathering observed.			
End Treatments	Alignment and Height:				
	Breaking and Cracking:				
	Missing Elements:				
	Corrosion and Weathering:
