**NPS Guardwall/Rail Inventory Program
Mount Rainier National Park**

**Federal Lands Highway
Road Inventory Program**

**Federal Highway Administration
Eastern Federal Lands Highway Division
Road Inventory Program (RIP)**

**Data Collection Date: October 2009
Report Date: December 2015**

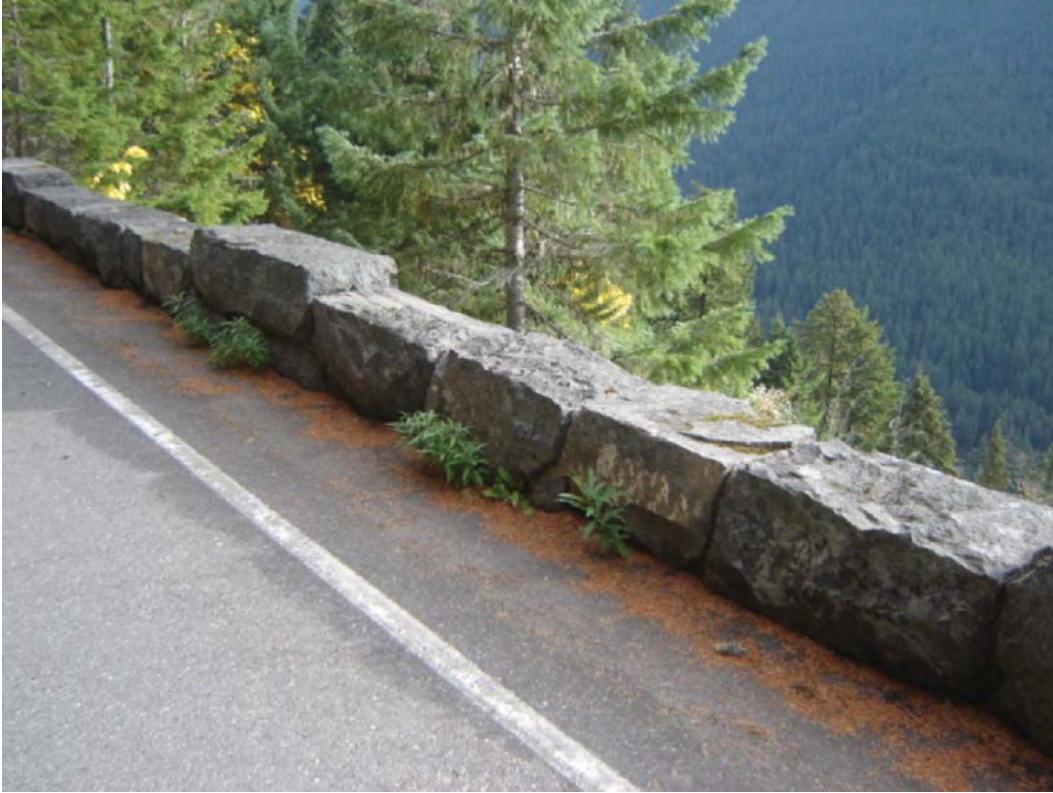
MORA_0013_15.165_R_1.JPG

Barrier ID:	MORA-0013-15.165-R				
Route Name:	STEVENS CANYON ROAD				
Inspection Date:	10/20/2009	Barrier Rating:	50.20		
Barrier Description					
Type:	STONE MASONRY CRENELLATED WITHOUT	Barrier Function:	TRAFFIC		
Barrier Material:	STONE	Post Material:	N/A		
Blockout Type:	N/A	Length (ft.):	226		
Speed Limit (MPH):	35	Placement with Respect to Road:	OUTSIDE OF CURVE		
Hazard Behind Barrier:	EXTREME				
Barrier Crashworthiness					
Appropriate Test Level:	TL-2	Barrier Test Level:	NCW	Is Barrier Crashworthy?:	NO
Beg. End Trtmt Type:	NONE	Is Beg. End Trtmt Crashworthy?:	N/A	Approach Transition Type:	NONE
Ending End Trtmt Type:	NONE	Ending End Trtmt Crashworthy?:	N/A		
Average Measurements					
Design Height (In.):	18	Width (In.):	19.0	Post Spacing (In.):	0.0
Height (In.):	14.3	Lateral Offset (In.):	30.0	Road Grade (%):	0.60
Physical Condition					
Barrier	Alignment and Height:	Alignment acceptable. Height was between 1-in to 6-in below the 18-in/24-in crenellated design height.

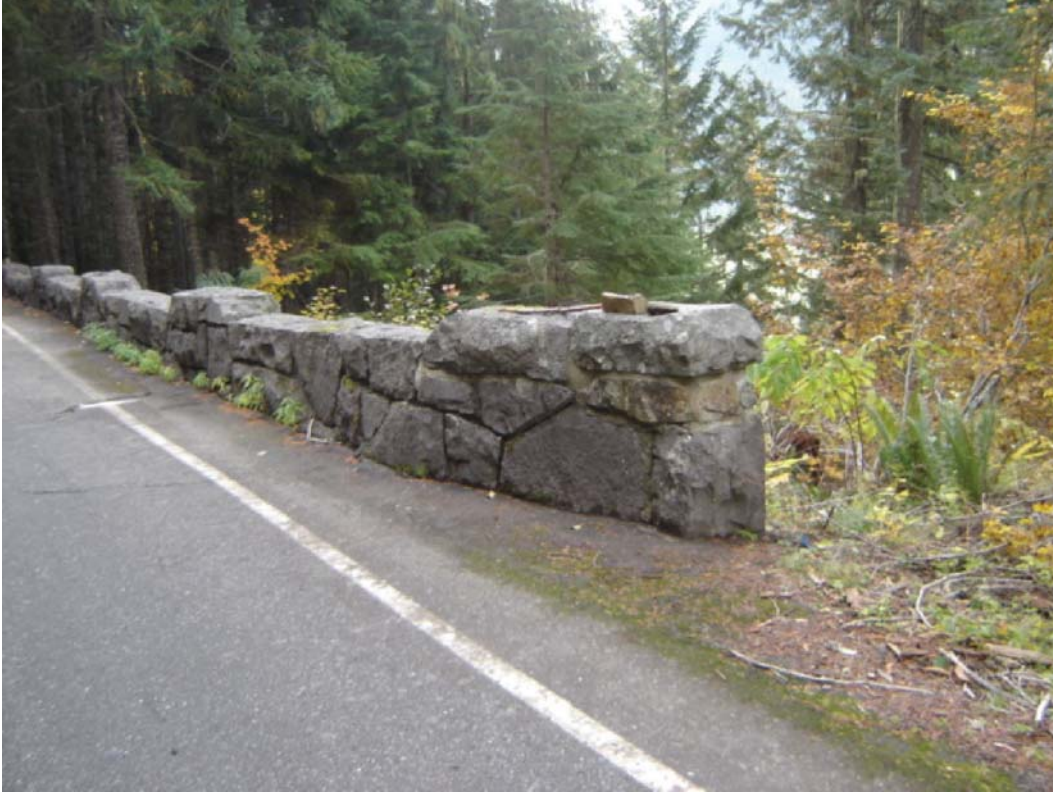
MORA_0013_15.506_R_1.JPG

Barrier ID:	MORA-0013-15.506-R				
Route Name:	STEVENS CANYON ROAD				
Inspection Date:	10/19/2009	Barrier Rating:	60.00		
Barrier Description					
Type:	STONE MASONRY CRENELLATED WITHOUT	Barrier Function:	TRAFFIC		
Barrier Material:	STONE	Post Material:	N/A		
Blockout Type:	N/A	Length (ft.):	2224		
Speed Limit (MPH):	35	Placement with Respect to Road:	BOTH INSIDE AND OUTSIDE		
Hazard Behind Barrier:	EXTREME				
Barrier Crashworthiness					
Appropriate Test Level:	TL-2	Barrier Test Level:	NCW	Is Barrier Crashworthy?:	NO
Beg. End Trtmt Type:	NONE	Is Beg. End Trtmt Crashworthy?:	N/A	Approach Transition Type:	NONE
Ending End Trtmt Type:	NONE	Ending End Trtmt Crashworthy?:	N/A		
Average Measurements					
Design Height (In.):	18	Width (In.):	18.7	Post Spacing (In.):	0.0
Height (In.):	20.2	Lateral Offset (In.):	37.2	Road Grade (%):	5.70
Physical Condition					
Barrier	Alignment and Height:	Alignment acceptable. Height ranged between 11-in below to 13-in above 18-in/24-in crenellated design height with 441-ft being 6-in to 11-in below.

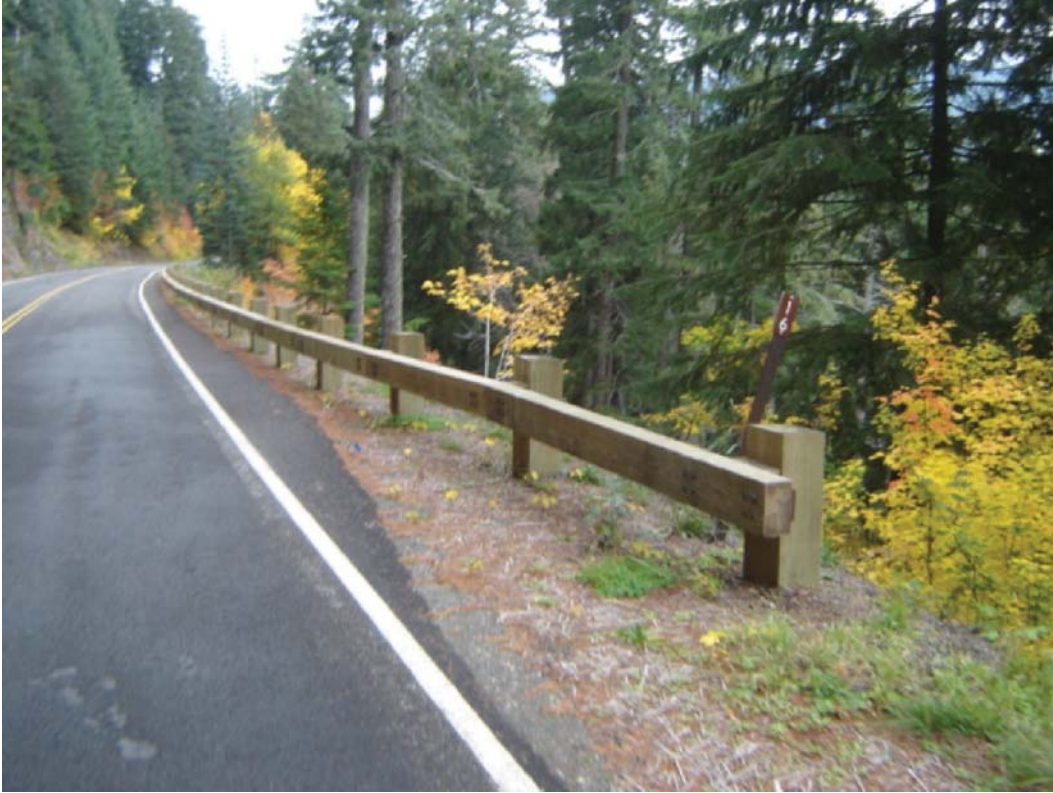
MORA_0013_15.974_R_1.JPG

Barrier ID:	MORA-0013-15.974-R				
Route Name:	STEVENS CANYON ROAD				
Inspection Date:	10/19/2009	Barrier Rating:	27.30		
Barrier Description					
Type:	STEEL-BACKED TIMBER WITH BLOCKOUT	Barrier Function:	TRAFFIC		
Barrier Material:	STEEL-BACKED TIMBER/LOG	Post Material:	WOOD		
Blockout Type:	WOOD	Length (ft.):	254		
Speed Limit (MPH):	35	Placement with Respect to Road:	TANGENT		
Hazard Behind Barrier:	EXTREME				
Barrier Crashworthiness					
Appropriate Test Level:	TL-2	Barrier Test Level:	TL-3	Is Barrier Crashworthy?:	YES
Beg. End Trtmt Type:	NONE	Is Beg. End Trtmt Crashworthy?:	N/A	Approach Transition Type:	NONE
Ending End Trtmt Type:	NONE	Ending End Trtmt Crashworthy?:	N/A		
Average Measurements					
Design Height (In.):	27	Width (In.):	0.0	Post Spacing (In.):	108.0
Height (In.):	24.7	Lateral Offset (In.):	35.7	Road Grade (%):	4.50
Physical Condition					
Barrier	Alignment and Height:	Alignment acceptable. 254-ft was between 1 and 3-in below the 27-in design height.

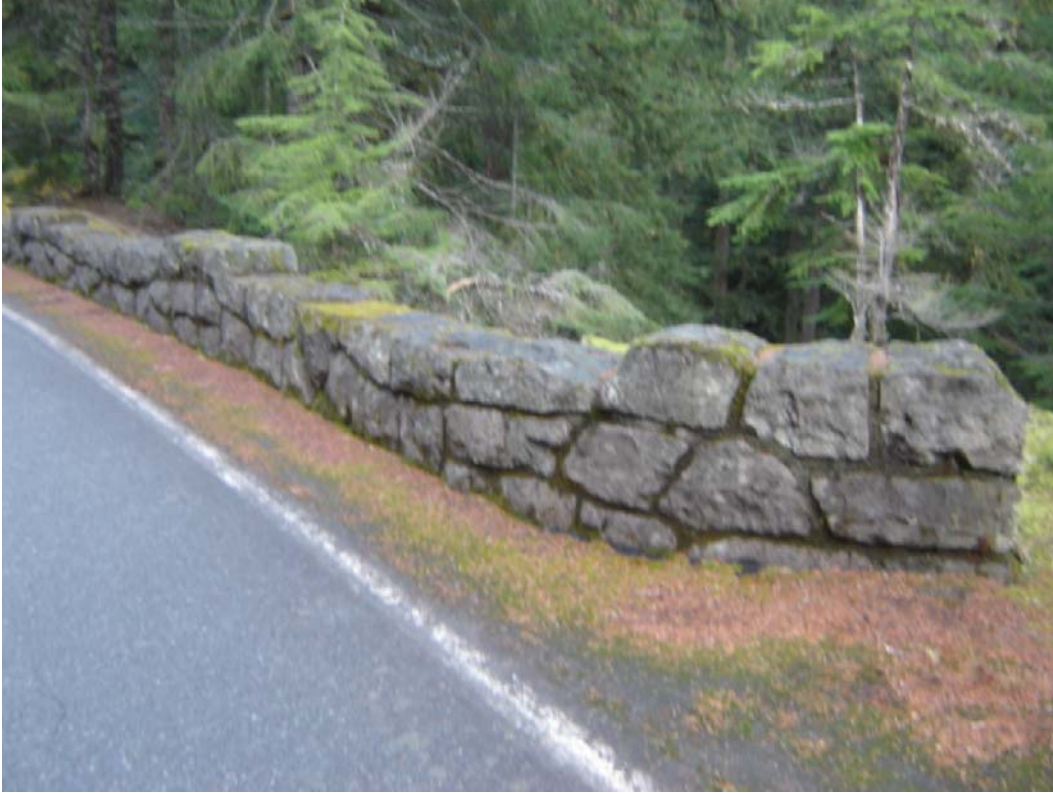
MORA_0013_17.416_R_1.JPG

Barrier ID:	MORA-0013-17.416-R				
Route Name:	STEVENS CANYON ROAD				
Inspection Date:	10/19/2009	Barrier Rating:	44.40		
Barrier Description					
Type:	STONE MASONRY CRENELLATED WITHOUT	Barrier Function:	TRAFFIC		
Barrier Material:	STONE	Post Material:	N/A		
Blockout Type:	N/A	Length (ft.):	375		
Speed Limit (MPH):	35	Placement with Respect to Road:	OUTSIDE OF CURVE		
Hazard Behind Barrier:	EXTREME				
Barrier Crashworthiness					
Appropriate Test Level:	TL-2	Barrier Test Level:	NCW	Is Barrier Crashworthy?:	NO
Beg. End Trtmt Type:	NONE	Is Beg. End Trtmt Crashworthy?:	N/A	Approach Transition Type:	NONE
Ending End Trtmt Type:	NONE	Ending End Trtmt Crashworthy?:	N/A		
Average Measurements					
Design Height (In.):	18	Width (In.):	19.2	Post Spacing (In.):	0.0
Height (In.):	25.7	Lateral Offset (In.):	31.7	Road Grade (%):	3.60
Physical Condition					
Barrier	Alignment and Height:	Alignment acceptable. Height was between 4-in to 10-in above the 18-in/24-in crenellated design height.

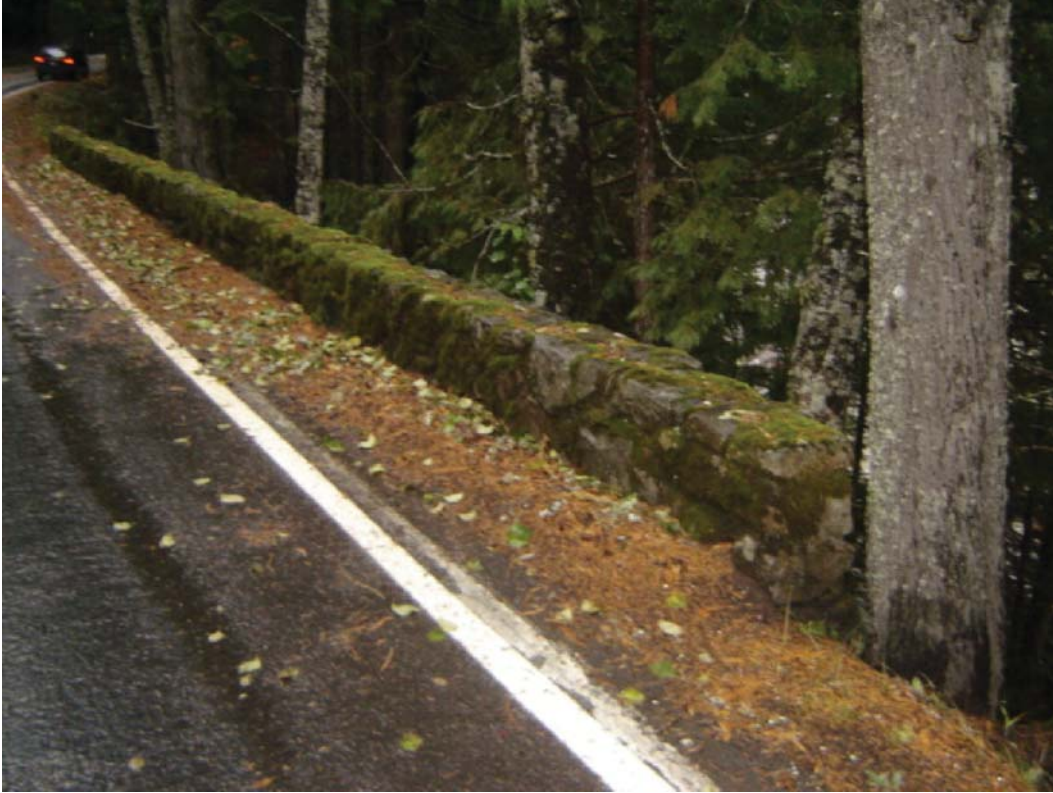
MORA_0014_7.361_R_1.JPG

Barrier ID:	MORA-0014-7.361-R				
Route Name:	STATE ROUTE 706 (NISQUALLY ROAD)				
Inspection Date:	10/21/2009	Barrier Rating:	48.40		
Barrier Description					
Type:	STONE MASONRY WITHOUT CONCRETE CORE WALL	Barrier Function:	TRAFFIC		
Barrier Material:	STONE	Post Material:	N/A		
Blockout Type:	N/A	Length (ft.):	50		
Speed Limit (MPH):	35	Placement with Respect to Road:	OUTSIDE OF CURVE		
Hazard Behind Barrier:	HIGH				
Barrier Crashworthiness					
Appropriate Test Level:	TL-2	Barrier Test Level:	NCW	Is Barrier Crashworthy?:	NO
Beg. End Trtmt Type:	NONE	Is Beg. End Trtmt Crashworthy?:	N/A	Approach Transition Type:	NONE
Ending End Trtmt Type:	NONE	Ending End Trtmt Crashworthy?:	N/A		
Average Measurements					
Design Height (In.):	24	Width (In.):	12.6	Post Spacing (In.):	0.0
Height (In.):	18.0	Lateral Offset (In.):	27.0	Road Grade (%):	3.40
Physical Condition					
Barrier	Alignment and Height:	Alignment is off by less than 6in. Height is 3.1 to 6" lower than 24-in design height.

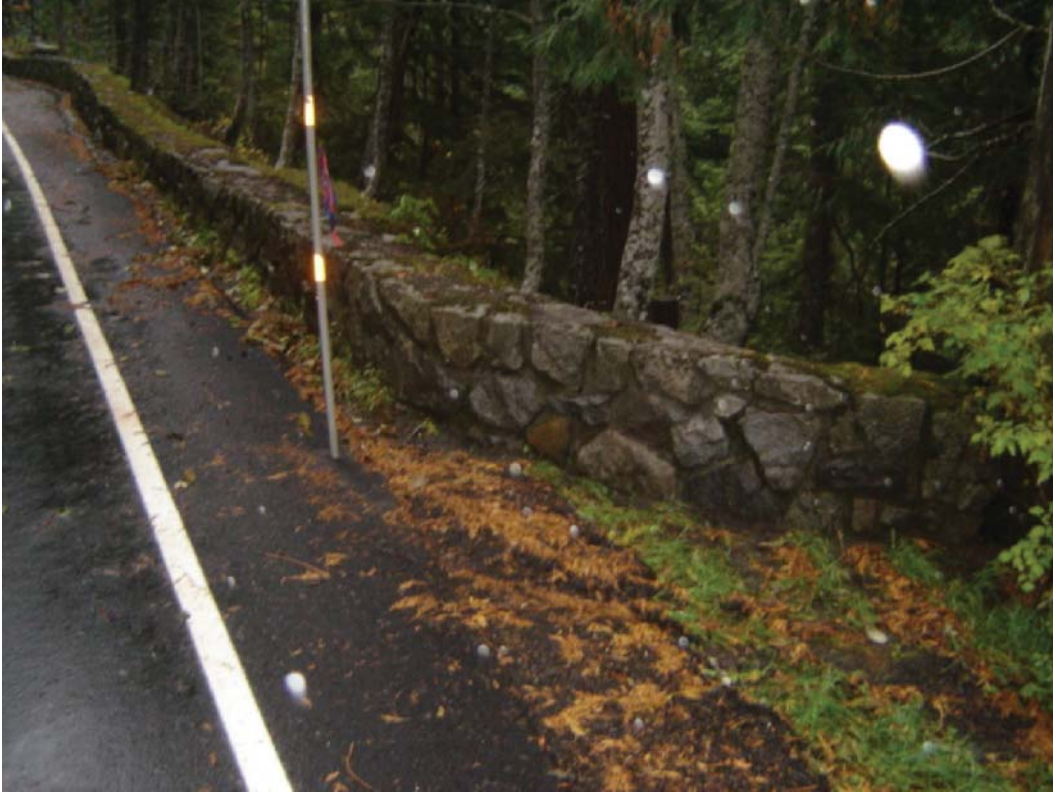
MORA_0014_10.703_R_1.JPG

Barrier ID:	MORA-0014-10.703-R				
Route Name:	STATE ROUTE 706 (NISQUALLY ROAD)				
Inspection Date:	10/21/2009	Barrier Rating:	28.30		
Barrier Description					
Type:	STONE MASONRY WITHOUT CONCRETE CORE WALL	Barrier Function:	TRAFFIC		
Barrier Material:	STONE	Post Material:	N/A		
Blockout Type:	N/A	Length (ft.):	162		
Speed Limit (MPH):	35	Placement with Respect to Road:	TANGENT		
Hazard Behind Barrier:	HIGH				
Barrier Crashworthiness					
Appropriate Test Level:	TL-2	Barrier Test Level:	NCW	Is Barrier Crashworthy?:	NO
Beg. End Trtmt Type:	NONE	Is Beg. End Trtmt Crashworthy?:	N/A	Approach Transition Type:	NONE
Ending End Trtmt Type:	NONE	Ending End Trtmt Crashworthy?:	N/A		
Average Measurements					
Design Height (In.):	24	Width (In.):	25.2	Post Spacing (In.):	0.0
Height (In.):	26.0	Lateral Offset (In.):	72.5	Road Grade (%):	3.80
Physical Condition					
Barrier	Alignment and Height:	Beginning end dropping because of landslide entire section moving/sinking/out of alignment 55ft.

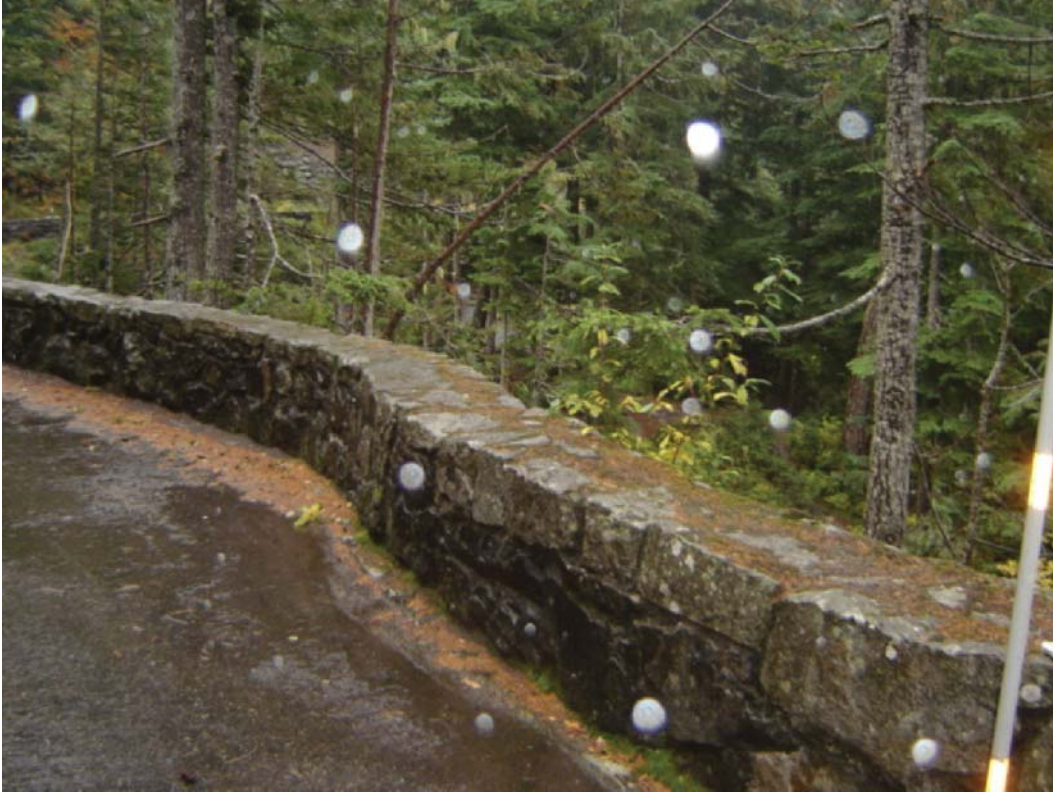
MORA_0014_10.734_R_1.JPG

Barrier ID:	MORA-0014-10.734-R				
Route Name:	STATE ROUTE 706 (NISQUALLY ROAD)				
Inspection Date:	10/21/2009	Barrier Rating:	4.30		
Barrier Description					
Type:	STONE MASONRY WITHOUT CONCRETE CORE WALL	Barrier Function:	NON-TRAFFIC		
Barrier Material:	STONE	Post Material:	N/A		
Blockout Type:	N/A	Length (ft.):	98		
Speed Limit (MPH):	35	Placement with Respect to Road:	NON-TRAFFIC BARRIER		
Hazard Behind Barrier:	N/A				
Barrier Crashworthiness					
Appropriate Test Level:	TL-2	Barrier Test Level:	N/A	Is Barrier Crashworthy?:	N/A
Beg. End Trtmt Type:	NONE	Is Beg. End Trtmt Crashworthy?:	N/A	Approach Transition Type:	NONE
Ending End Trtmt Type:	NONE	Ending End Trtmt Crashworthy?:	N/A		
Average Measurements					
Design Height (In.):	24	Width (In.):	24.2	Post Spacing (In.):	0.0
Height (In.):	33.0	Lateral Offset (In.):	0.0	Road Grade (%):	0.00
Physical Condition					
Barrier	Alignment and Height:	Alignment acceptable. Height was 7–13in above the 24-in design height.

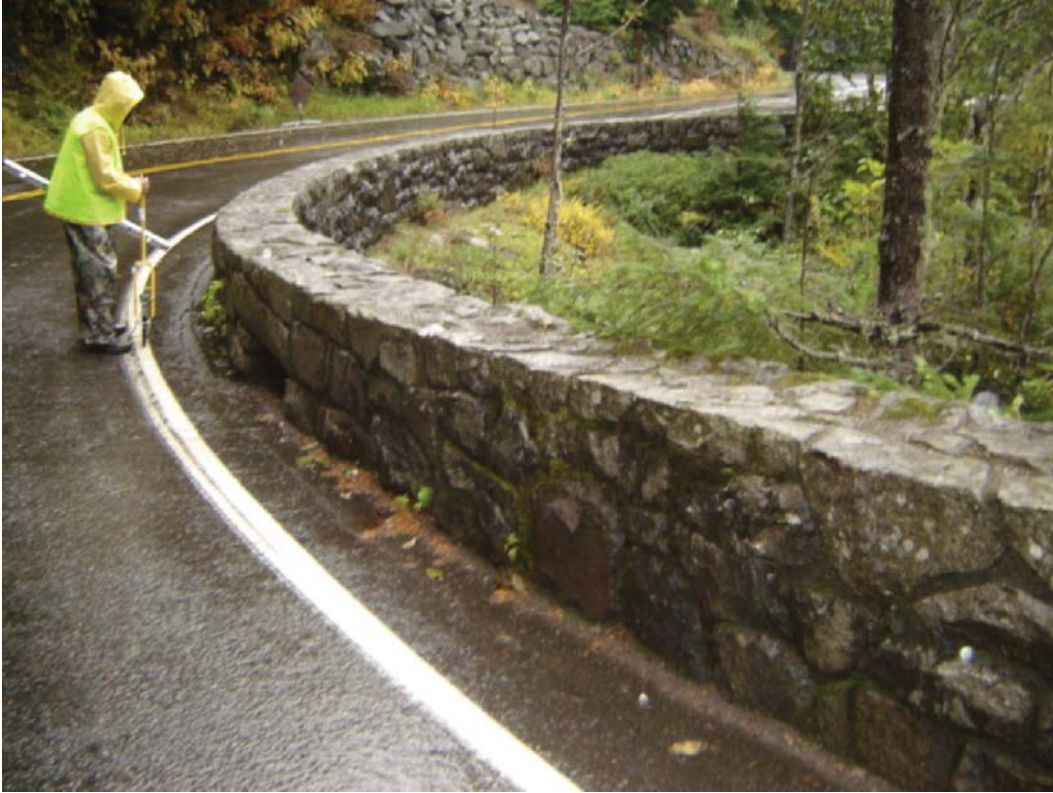
MORA_0014_10.766_R_1.JPG

Barrier ID:	MORA-0014-10.766-R				
Route Name:	STATE ROUTE 706 (NISQUALLY ROAD)				
Inspection Date:	10/21/2009	Barrier Rating:	24.30		
Barrier Description					
Type:	STONE MASONRY WITHOUT CONCRETE CORE WALL	Barrier Function:	TRAFFIC		
Barrier Material:	STONE	Post Material:	N/A		
Blockout Type:	N/A	Length (ft.):	116		
Speed Limit (MPH):	35	Placement with Respect to Road:	INSIDE OF CURVE		
Hazard Behind Barrier:	EXTREME				
Barrier Crashworthiness					
Appropriate Test Level:	TL-2	Barrier Test Level:	NCW	Is Barrier Crashworthy?:	NO
Beg. End Trtmt Type:	NONE	Is Beg. End Trtmt Crashworthy?:	N/A	Approach Transition Type:	NONE
Ending End Trtmt Type:	NONE	Ending End Trtmt Crashworthy?:	N/A		
Average Measurements					
Design Height (In.):	24	Width (In.):	24.7	Post Spacing (In.):	0.0
Height (In.):	24.2	Lateral Offset (In.):	32.7	Road Grade (%):	1.90
Physical Condition					
Barrier	Alignment and Height:	Alignment acceptable. Height within 3-in of 24-in design height.

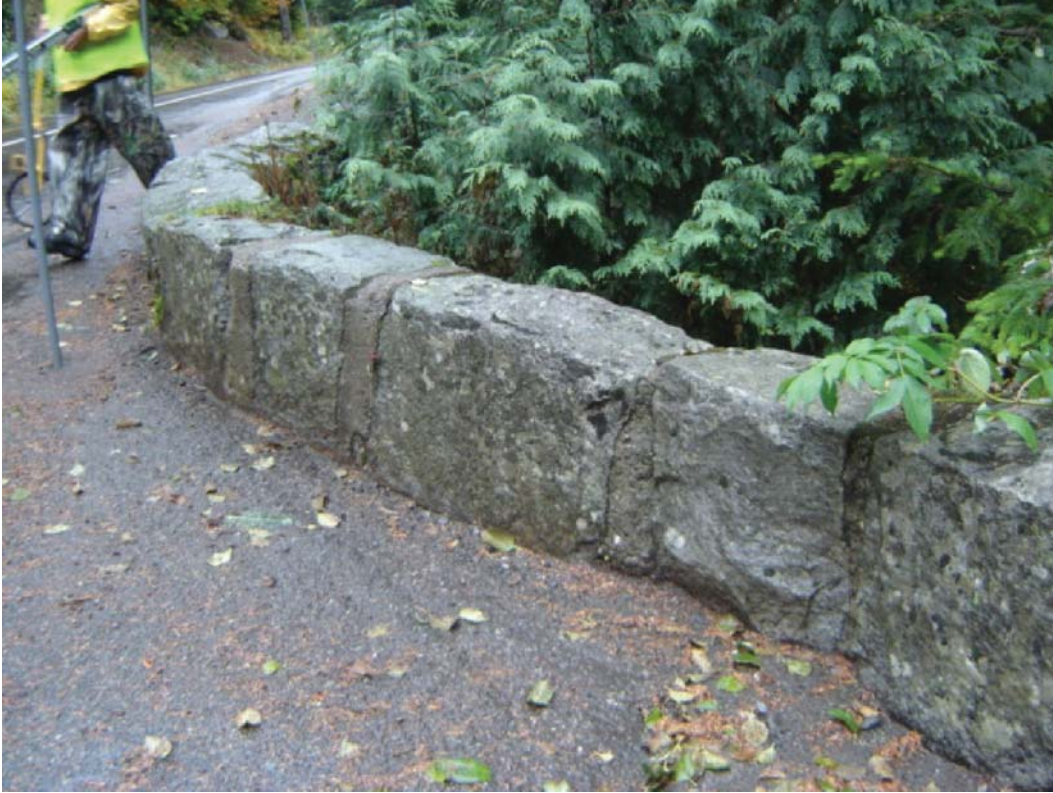
MORA_0014_10.808_R_1.JPG

Barrier ID:	MORA-0014-10.808-R				
Route Name:	STATE ROUTE 706 (NISQUALLY ROAD)				
Inspection Date:	10/21/2009	Barrier Rating:	15.60		
Barrier Description					
Type:	STONE MASONRY WITHOUT CONCRETE CORE WALL	Barrier Function:	NON-TRAFFIC		
Barrier Material:	STONE	Post Material:	N/A		
Blockout Type:	N/A	Length (ft.):	19		
Speed Limit (MPH):	35	Placement with Respect to Road:	NON-TRAFFIC BARRIER		
Hazard Behind Barrier:	HIGH				
Barrier Crashworthiness					
Appropriate Test Level:	TL-2	Barrier Test Level:	N/A	Is Barrier Crashworthy?:	N/A
Beg. End Trtmt Type:	NONE	Is Beg. End Trtmt Crashworthy?:	N/A	Approach Transition Type:	NONE
Ending End Trtmt Type:	NONE	Ending End Trtmt Crashworthy?:	N/A		
Average Measurements					
Design Height (In.):	24	Width (In.):	20.0	Post Spacing (In.):	0.0
Height (In.):	22.7	Lateral Offset (In.):	0.0	Road Grade (%):	0.00
Physical Condition					
Barrier	Alignment and Height:	Alignment is less than 6in off. Height is 0 to 3-in below 24-in design height.

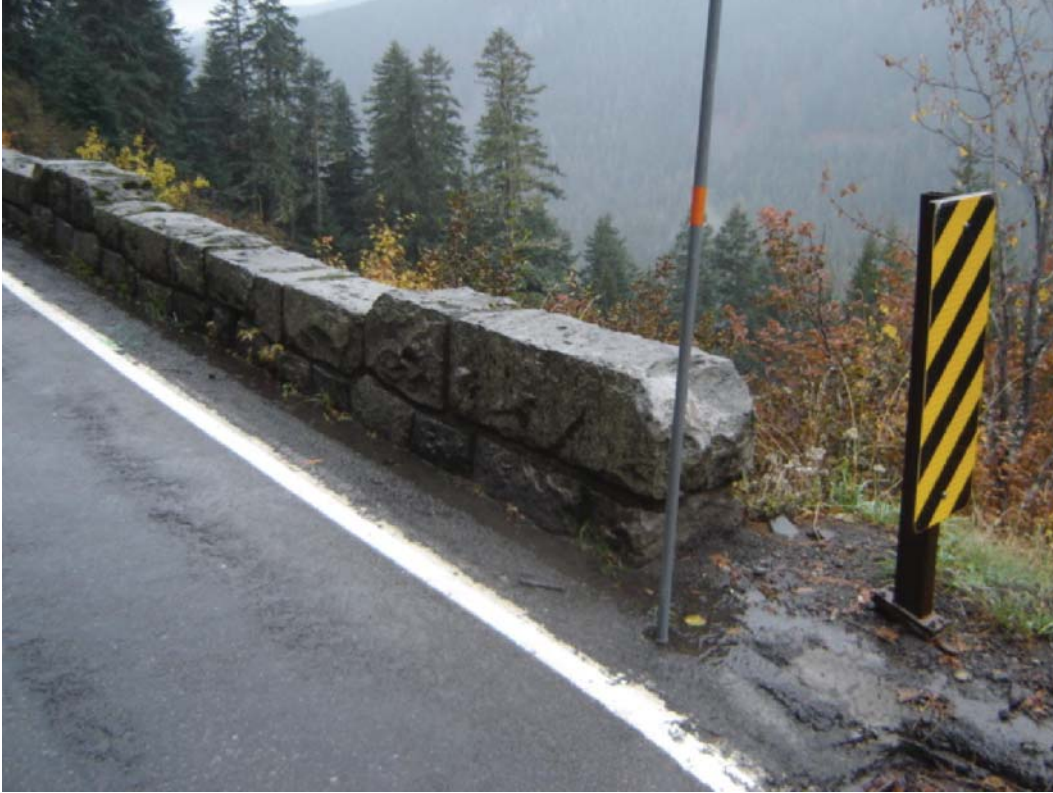
MORA_0014_12.394_R_1.JPG

Barrier ID:	MORA-0014-12.394-R				
Route Name:	STATE ROUTE 706 (NISQUALLY ROAD)				
Inspection Date:	10/21/2009	Barrier Rating:	52.90		
Barrier Description					
Type:	STONE MASONRY CRENELLATED WITHOUT	Barrier Function:	TRAFFIC		
Barrier Material:	STONE	Post Material:	N/A		
Blockout Type:	N/A	Length (ft.):	1573		
Speed Limit (MPH):	35	Placement with Respect to Road:	INSIDE OF CURVE		
Hazard Behind Barrier:	EXTREME				
Barrier Crashworthiness					
Appropriate Test Level:	TL-2	Barrier Test Level:	NCW	Is Barrier Crashworthy?:	NO
Beg. End Trtmt Type:	NONE	Is Beg. End Trtmt Crashworthy?:	N/A	Approach Transition Type:	NONE
Ending End Trtmt Type:	NONE	Ending End Trtmt Crashworthy?:	N/A		
Average Measurements					
Design Height (In.):	18	Width (In.):	18.6	Post Spacing (In.):	0.0
Height (In.):	17.2	Lateral Offset (In.):	19.0	Road Grade (%):	4.10
Physical Condition					
Barrier	Alignment and Height:	Alignment acceptable. Height was between 3-in below to 2-in above the 18-in/24-in crenellated design height.

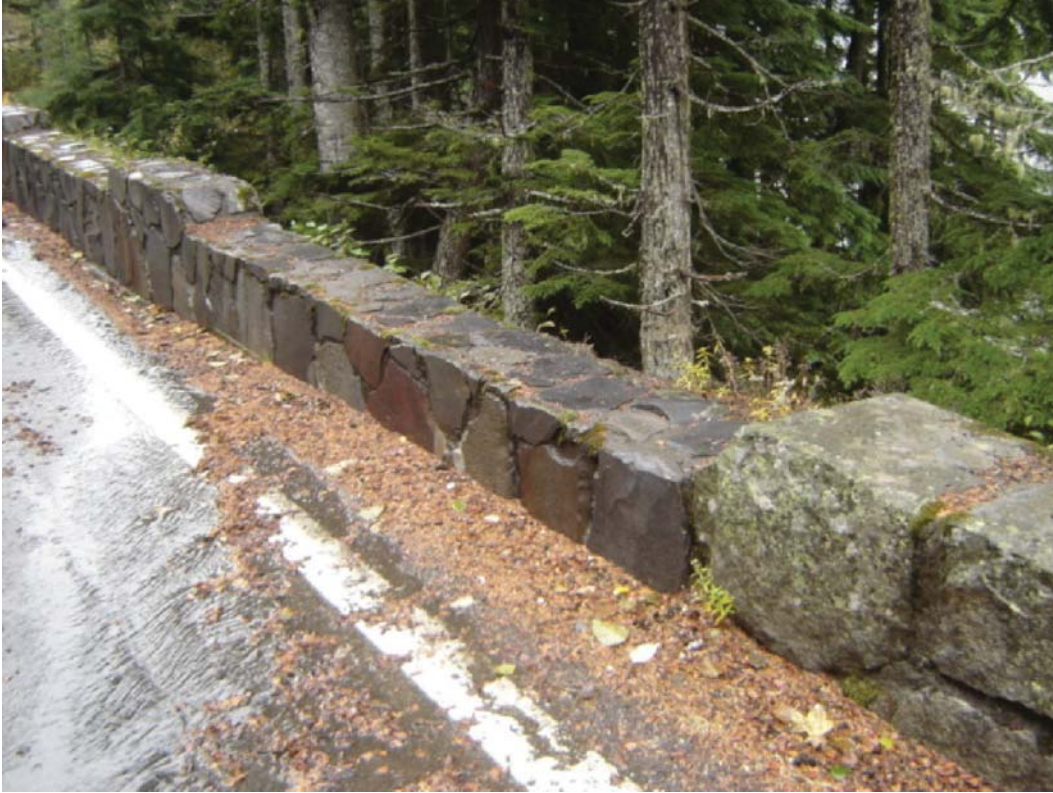
MORA_0014_12.692_R_1.JPG

Barrier ID:	MORA-0014-12.692-R				
Route Name:	STATE ROUTE 706 (NISQUALLY ROAD)				
Inspection Date:	10/21/2009	Barrier Rating:	31.70		
Barrier Description					
Type:	STONE MASONRY WITH CONCRETE CORE WALL	Barrier Function:	TRAFFIC		
Barrier Material:	CONCRETE	Post Material:	N/A		
Blockout Type:	N/A	Length (ft.):	336		
Speed Limit (MPH):	35	Placement with Respect to Road:	OUTSIDE OF CURVE		
Hazard Behind Barrier:	EXTREME				
Barrier Crashworthiness					
Appropriate Test Level:	TL-2	Barrier Test Level:	TL-3	Is Barrier Crashworthy?:	YES
Beg. End Trtmt Type:	NONE	Is Beg. End Trtmt Crashworthy?:	N/A	Approach Transition Type:	NONE
Ending End Trtmt Type:	NONE	Ending End Trtmt Crashworthy?:	N/A		
Average Measurements					
Design Height (In.):	27	Width (In.):	17.7	Post Spacing (In.):	0.0
Height (In.):	24.7	Lateral Offset (In.):	33.2	Road Grade (%):	5.50
Physical Condition					
Barrier	Alignment and Height:	Alignment acceptable. Height within 3-in of 27-in design height.

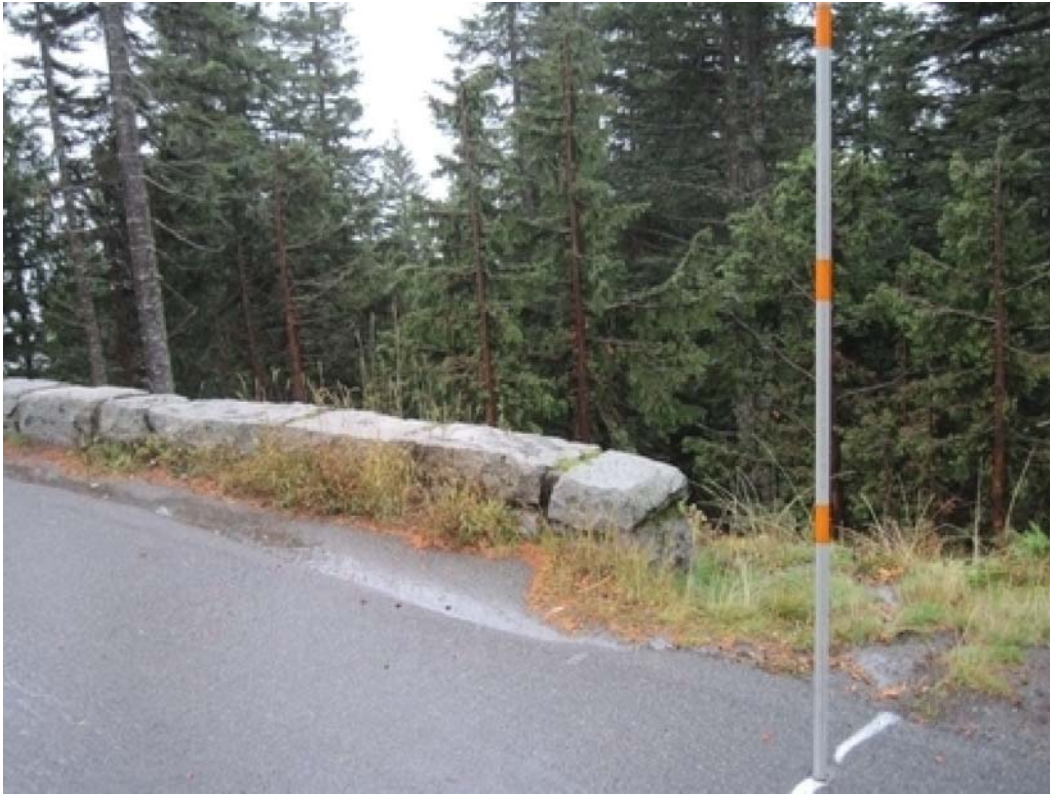
MORA_0014_14.591_R_1.jpg

Barrier ID:	MORA-0014-14.591-R				
Route Name:	STATE ROUTE 706 (NISQUALLY ROAD)				
Inspection Date:	10/21/2009	Barrier Rating:	43.00		
Barrier Description					
Type:	STONE MASONRY WITHOUT CONCRETE CORE WALL	Barrier Function:	NON-TRAFFIC		
Barrier Material:	STONE	Post Material:	N/A		
Blockout Type:	N/A	Length (ft.):	206		
Speed Limit (MPH):	35	Placement with Respect to Road:	NON-TRAFFIC BARRIER		
Hazard Behind Barrier:	N/A				
Barrier Crashworthiness					
Appropriate Test Level:	TL-2	Barrier Test Level:	N/A	Is Barrier Crashworthy?:	N/A
Beg. End Trtmt Type:	NONE	Is Beg. End Trtmt Crashworthy?:	N/A	Approach Transition Type:	NONE
Ending End Trtmt Type:	NONE	Ending End Trtmt Crashworthy?:	N/A		
Average Measurements					
Design Height (In.):	24	Width (In.):	19.2	Post Spacing (In.):	0.0
Height (In.):	17.5	Lateral Offset (In.):	0.0	Road Grade (%):	0.00
Physical Condition					
Barrier	Alignment and Height:	Alignment acceptable. Height was 4–10in below the 24-in design height.

Breaking and Cracking:	No breaking or cracking.			
	Missing Elements:	No missing elements.			
	Corrosion and Weathering:	No corrosion/weathering or erosion.			
End Treatments	Alignment and Height:				
	Breaking and Cracking:				
	Missing Elements:				
	Corrosion and Weathering:

Repair Action:	REPAIR	FMSS Work Type:	DEFERRED MAINTENANCE	Repair Cost:	\$94188
Brief Workorder:	Raise guardwall 4-in. Remove and reset 94-ft of stone masonry guardwall on concrete footer to adjacent 18-in height.				
Workorder:	Remove & reset stone masonry guardwall at \$250- per -Cu. Ft. for 301 CF = \$75250. [(2ft)(1.6ft)(94ft)] = 301 CF. Structural Concrete at \$1000- per -Cu. Yd. for 3 CY = \$3000. [(1.6ft)(0.5ft)(94ft)] /27 = 2.8 CF. Low Speed Traffic Control at \$1475- per -Day for 5 Day(s) = \$7375. 1 day removal 4 days installation.

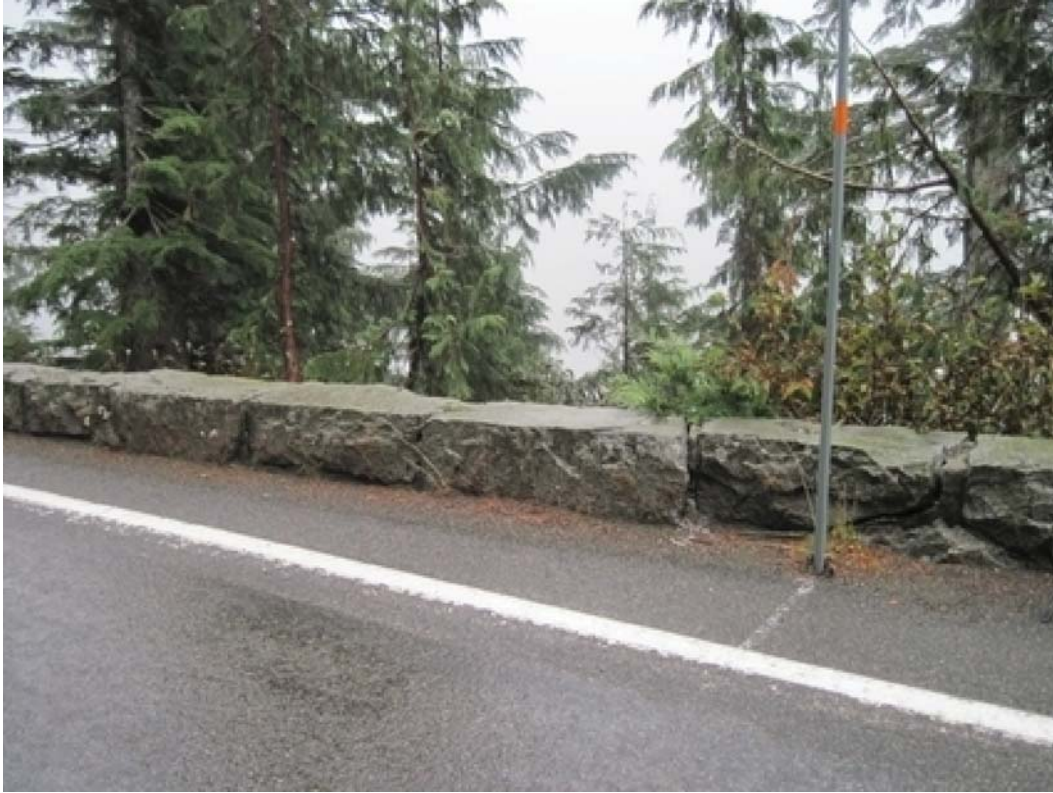
MORA_0014_14.620_R_1.jpg

Barrier ID:	MORA-0014-14.620-R				
Route Name:	STATE ROUTE 706 (NISQUALLY ROAD)				
Inspection Date:	10/20/2009	Barrier Rating:	79.50		
Barrier Description					
Type:	STONE MASONRY WITHOUT CONCRETE CORE WALL	Barrier Function:	TRAFFIC		
Barrier Material:	STONE	Post Material:	N/A		
Blockout Type:	N/A	Length (ft.):	850		
Speed Limit (MPH):	35	Placement with Respect to Road:	BOTH INSIDE AND OUTSIDE		
Hazard Behind Barrier:	EXTREME				
Barrier Crashworthiness					
Appropriate Test Level:	TL-2	Barrier Test Level:	NCW	Is Barrier Crashworthy?:	NO
Beg. End Trtmt Type:	NONE	Is Beg. End Trtmt Crashworthy?:	N/A	Approach Transition Type:	NONE
Ending End Trtmt Type:	NONE	Ending End Trtmt Crashworthy?:	N/A		
Average Measurements					
Design Height (In.):	24	Width (In.):	19.0	Post Spacing (In.):	0.0
Height (In.):	13.8	Lateral Offset (In.):	14.0	Road Grade (%):	2.00
Physical Condition					
Barrier	Alignment and Height:	Alignment acceptable. Height was 9–12in below the 24-in design height.

Breaking and Cracking:	There is less than 10 percent of the total barrier length which is cracked or broken.			
	Missing Elements:	No missing elements.			
	Corrosion and Weathering:	There is less than 5 percent of the barrier length which is corroding or cracking. There is approximately a 50 by 10 ft section (ending RIP mile direction) where the asphalt has collapsed and erosion is significant.			
End Treatments	Alignment and Height:				
	Breaking and Cracking:				
	Missing Elements:				
	Corrosion and Weathering:

Repair Action:	REPAIR	FMSS Work Type:	DEFERRED MAINTENANCE	Repair Cost:	\$883317
Brief Workorder:	Raise guardwall 11-in. Remove and reset 850-ft of stone masonry guardwall on concrete footer to design height of 24-in. Replace 56-sy of asphalt.				
Workorder:	Remove asphalt pavement at \$10- per -Sq. Yd. for 56 SY = \$840. Removal of asphalt 10ft*50ft equals 500 sq ft/9 equals 56 sq yds Asphalt patch at \$175- per -Sq. Yd. for 56 SY = \$9800. Asphalt patching 10ft*50ft equals 500 sq ft/9 equals 56 sq yds Remove & Reset Stone Masonry Guardwall at \$250- per -Cu. Ft. for 2720 CF = \$680000. [(2ft)(1.6ft)(850ft)] = 2720 CF. Structural Concrete at \$1000- per -Cu. Yd. for 46 CY = \$46000. [(1.6ft)(0.9ft)(850ft)] /27 = 45.3 CY. Low Speed Traffic Control at \$1475- per -Day for 45 Day(s) = \$66375. 9 days removal 34 days installation 2 days asphalt.

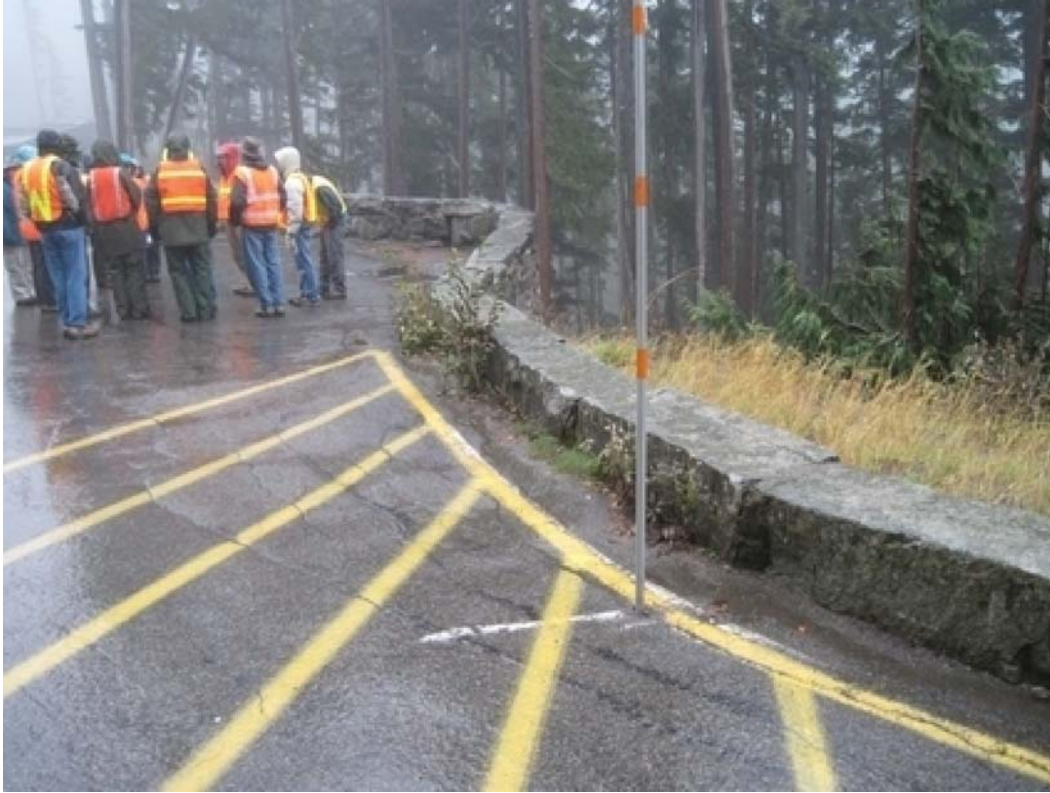
MORA_0014_14.781_R_1.jpg

Barrier ID:	MORA-0014-14.781-R				
Route Name:	STATE ROUTE 706 (NISQUALLY ROAD)				
Inspection Date:	10/21/2009	Barrier Rating:	11.60		
Barrier Description					
Type:	STONE MASONRY WITHOUT CONCRETE CORE WALL	Barrier Function:	NON-TRAFFIC		
Barrier Material:	STONE	Post Material:	N/A		
Blockout Type:	N/A	Length (ft.):	289		
Speed Limit (MPH):	35	Placement with Respect to Road:	NON-TRAFFIC BARRIER		
Hazard Behind Barrier:	N/A				
Barrier Crashworthiness					
Appropriate Test Level:	TL-2	Barrier Test Level:	N/A	Is Barrier Crashworthy?:	N/A
Beg. End Trtmt Type:	NONE	Is Beg. End Trtmt Crashworthy?:	N/A	Approach Transition Type:	NONE
Ending End Trtmt Type:	NONE	Ending End Trtmt Crashworthy?:	N/A		
Average Measurements					
Design Height (In.):	24	Width (In.):	18.0	Post Spacing (In.):	0.0
Height (In.):	20.0	Lateral Offset (In.):	0.0	Road Grade (%):	0.00
Physical Condition					
Barrier	Alignment and Height:	Alignment acceptable. Height between 3 and 6-in below 24-in design height.

Breaking and Cracking:	Minor cracking 1/4 to 1/2 in. Large hole through barrier weep hole has been eroded up into the mortar above original hole.			
	Missing Elements:	2 missing stones.			
	Corrosion and Weathering:	No corrosion or weathering observed.			
End Treatments	Alignment and Height:				
	Breaking and Cracking:				
	Missing Elements:				
	Corrosion and Weathering:

Repair Action:	REPAIR	FMSS Work Type:	DEFERRED MAINTENANCE	Repair Cost:	\$2327
Brief Workorder:	Replace 2 stones and re-point 1 SY of mortar.				
Workorder:	Re-point masonry barrier at \$140- per -Sq. Yd. for 1 SY = \$140. Re-point 1 sq. yd. of mortar. Replace Stones at \$250- per -Each for 2 Unit(s) = \$500. Replace 2 missing stones. Low Speed Traffic Control at \$1475- per -Day for 1 Day(s) = \$1475.

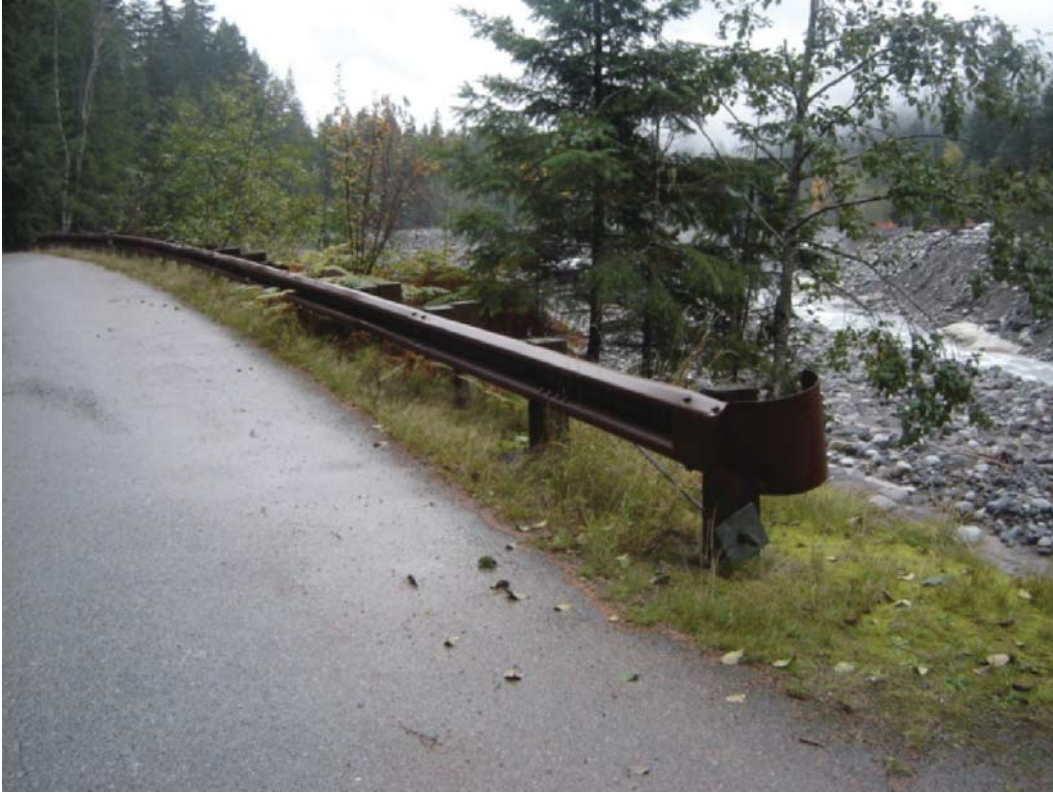
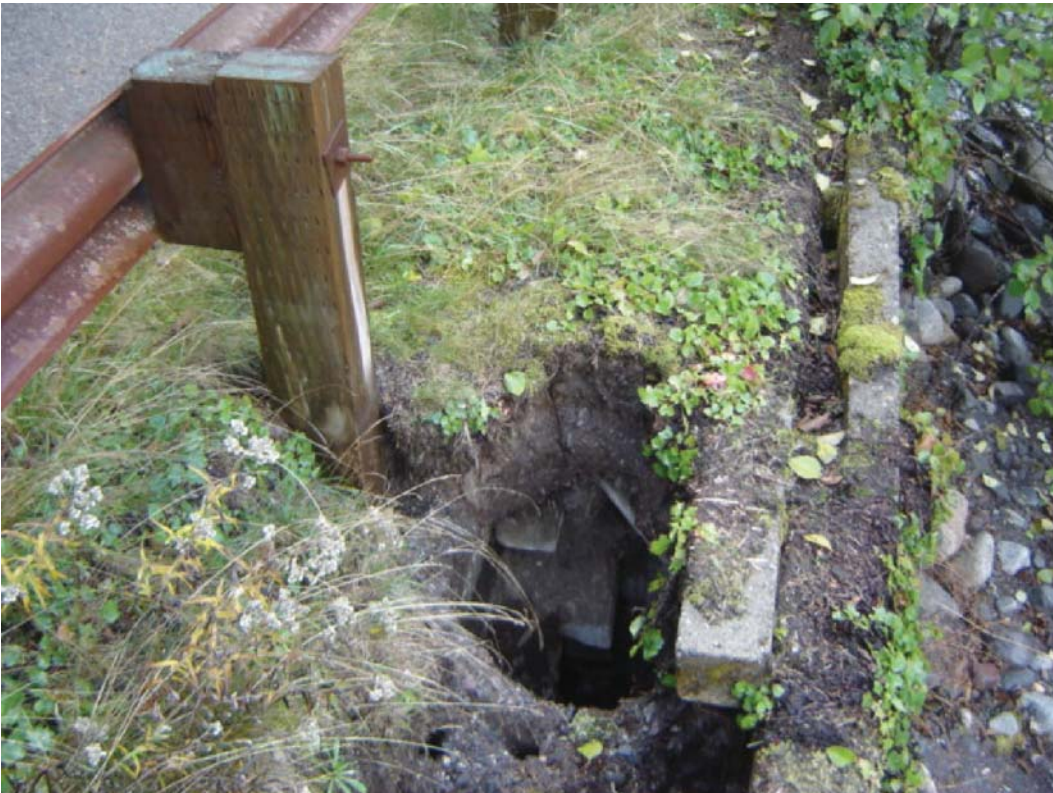
Barrier ID:	MORA-0100-0.366-R				
Route Name:	LONGMIRE SOUTH BACK GATE ROAD				
Inspection Date:	10/21/2009	Barrier Rating:	22.80		
Barrier Description					
Type:	W-BEAM STRONG POST	Barrier Function:	TRAFFIC		
Barrier Material:	WEATHERING STEEL/CORTEN	Post Material:	WOOD		
Blockout Type:	WOOD	Length (ft.):	151		
Speed Limit (MPH):	25	Placement with Respect to Road:	OUTSIDE OF CURVE		
Hazard Behind Barrier:	EXTREME				
Barrier Crashworthiness					
Appropriate Test Level:	TL-1	Barrier Test Level:	TL-3	Is Barrier Crashworthy?:	YES
Beg. End Trtmt Type:	W-BEAM BCT	Is Beg. End Trtmt Crashworthy?:	NO	Approach Transition Type:	NONE
Ending End Trtmt Type:	W-BEAM BCT	Ending End Trtmt Crashworthy?:	NO		
Average Measurements					
Design Height (In.):	27	Width (In.):	0.0	Post Spacing (In.):	74.6
Height (In.):	27.0	Lateral Offset (In.):	14.6	Road Grade (%):	2.20
Physical Condition					
Barrier	Alignment and Height:	Alignment acceptable. Height within 1-in of 27-in design height.

Breaking and Cracking:	1 blockout is in poor condition with deformed cracked cross section. Metal has minor twisting bending but no tears or cracking.			
	Missing Elements:	No missing elements observed.			
	Corrosion and Weathering:	Erosion more than 8in of post exposed below ground level on posts.			
End Treatments	Alignment and Height:	Alignment acceptable. Height within 1-in of 27-in design height.			
	Breaking and Cracking:	2 posts have deformed cross section due to cracks.			
	Missing Elements:	No missing elements observed.			
	Corrosion and Weathering:	Loss of 5% or less of cross section. Erosion less than 8in of post exposed below ground.

Repair Action:	REPAIR	FMSS Work Type:	DEFERRED MAINTENANCE	Repair Cost:	\$9658
Brief Workorder:	Replace blocks and posts and structural backfill on W-beam.				
Workorder:	Replace post at \$100- per -Each for 2 Post(s) = \$200. 1 on each end terminal. Replace block at \$30- per -Each for 1 Block(s) = \$30. 1 on barrier. Structural backfill at \$50- per -Cu. Yd. for 80 CY = \$5600. Erosion area behind and around posts of barrier. [(36ft)(6ft)(10ft)]/27 = 80 CY. Low Speed Traffic Control at \$1475- per -Day for 2 Day(s) = \$2950.

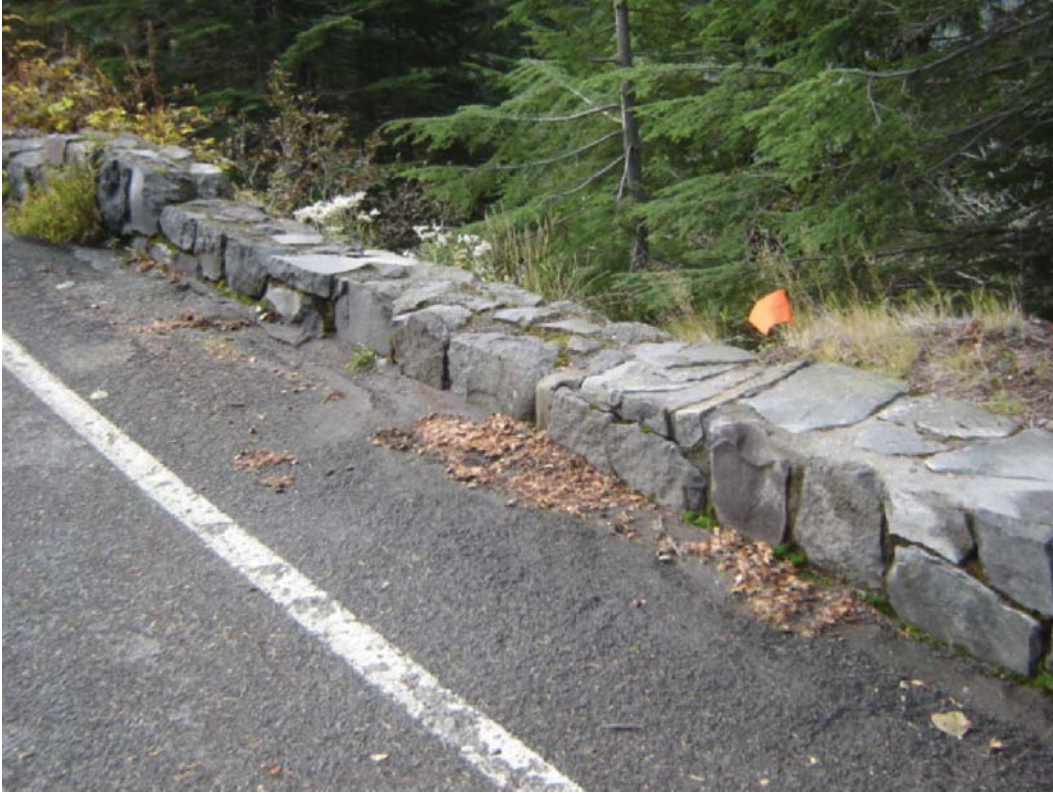
MORA_0203_0.016_R_1.JPG

Barrier ID:	MORA-0203-0.016-R				
Route Name:	MILLER CUT OFF / RICKSECKER POINT LOOP ROAD				
Inspection Date:	10/20/2009	Barrier Rating:	43.00		
Barrier Description					
Type:	STONE MASONRY CRENELLATED WITHOUT	Barrier Function:	TRAFFIC		
Barrier Material:	STONE	Post Material:	N/A		
Blockout Type:	N/A	Length (ft.):	135		
Speed Limit (MPH):	25	Placement with Respect to Road:	OUTSIDE OF CURVE		
Hazard Behind Barrier:	EXTREME				
Barrier Crashworthiness					
Appropriate Test Level:	TL-1	Barrier Test Level:	NCW	Is Barrier Crashworthy?:	NO
Beg. End Trtmt Type:	NONE	Is Beg. End Trtmt Crashworthy?:	N/A	Approach Transition Type:	NONE
Ending End Trtmt Type:	NONE	Ending End Trtmt Crashworthy?:	N/A		
Average Measurements					
Design Height (In.):	18	Width (In.):	18.0	Post Spacing (In.):	0.0
Height (In.):	14.0	Lateral Offset (In.):	33.0	Road Grade (%):	5.20
Physical Condition					
Barrier	Alignment and Height:	Alignment acceptable. 15-ft was 3-6-in below the 18-in/24-in crenellated design height and 50-ft was 6-14-in below.

Breaking and Cracking:	Minor cracking less than 1/4 in. 2 loose stones.			
	Missing Elements:	No missing elements observed.			
	Corrosion and Weathering:	No corrosion or weathering observed.			
End Treatments	Alignment and Height:				
	Breaking and Cracking:				
	Missing Elements:				
	Corrosion and Weathering:

Repair Action:	REPAIR	FMSS Work Type:	DEFERRED MAINTENANCE	Repair Cost:	\$50094
Brief Workorder:	Raise guardwall 6-in. Remove and reset 50-ft of stone masonry guardwall on concrete footer to adjacent 12-in height.				
Workorder:	Re-point masonry barrier at \$140- per -Sq. Yd. for 1 SY = \$140. Re-point mortar to secure 2 loose stones. Remove & Reset Stone Masonry Guardwall at \$250- per -Cu. Ft. for 150 CF = \$37500. $[(2ft)(1.5ft)(50ft)] = 150 CF$. Structural Concrete at \$1000- per -Cu. Yd. for 2 CY = \$2000. $[(1.5ft)(0.5ft)(50ft)] / 27 = 1.4 CY$. Low Speed Traffic Control at \$1475- per -Day for 4 Day(s) = \$5900. 1 day for repointing 3 days installation.

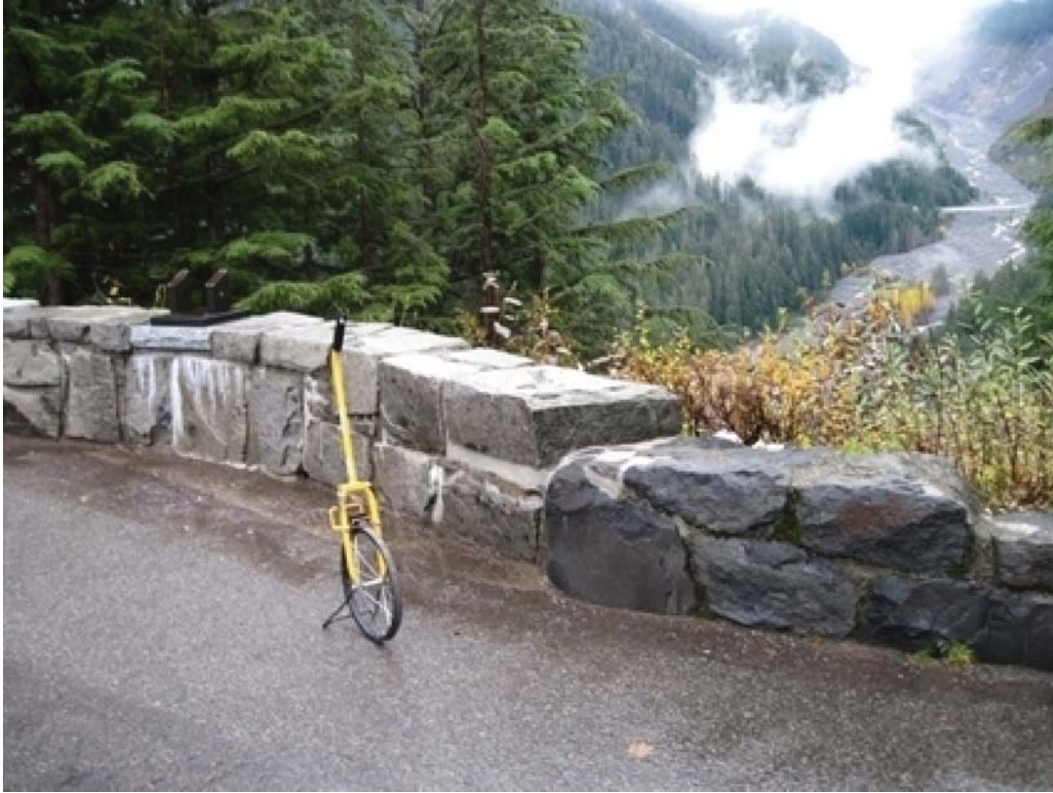
MORA_0203_0.038_R_1.jpg

Barrier ID:	MORA-0203-0.038-R				
Route Name:	MILLER CUT OFF / RICKSECKER POINT LOOP ROAD				
Inspection Date:	10/21/2009	Barrier Rating:	0.00		
Barrier Description					
Type:	STONE MASONRY CRENELLATED WITHOUT	Barrier Function:	NON-TRAFFIC		
Barrier Material:	STONE	Post Material:	N/A		
Blockout Type:	N/A	Length (ft.):	129		
Speed Limit (MPH):	25	Placement with Respect to Road:	NON-TRAFFIC BARRIER		
Hazard Behind Barrier:	N/A				
Barrier Crashworthiness					
Appropriate Test Level:	TL-1	Barrier Test Level:	N/A	Is Barrier Crashworthy?:	N/A
Beg. End Trtmt Type:	NONE	Is Beg. End Trtmt Crashworthy?:	N/A	Approach Transition Type:	NONE
Ending End Trtmt Type:	NONE	Ending End Trtmt Crashworthy?:	N/A		
Average Measurements					
Design Height (In.):	18	Width (In.):	19.0	Post Spacing (In.):	0.0
Height (In.):	23.0	Lateral Offset (In.):	0.0	Road Grade (%):	0.00
Physical Condition					
Barrier	Alignment and Height:	Alignment acceptable. Height was 4-in to 6-in above the 18-in/24-in crenellated design height.

Breaking and Cracking:	No breaking or cracking observed.			
	Missing Elements:	No missing elements observed.			
	Corrosion and Weathering:	Moss covering 60% of mortar.			
End Treatments	Alignment and Height:				
	Breaking and Cracking:				
	Missing Elements:				
	Corrosion and Weathering:
