**NPS Guardwall/Rail Inventory Program
Mount Rainier National Park**

**Federal Lands Highway
Road Inventory Program**

**Federal Highway Administration
Eastern Federal Lands Highway Division
Road Inventory Program (RIP)**

**Data Collection Date: October 2009
Report Date: December 2015**

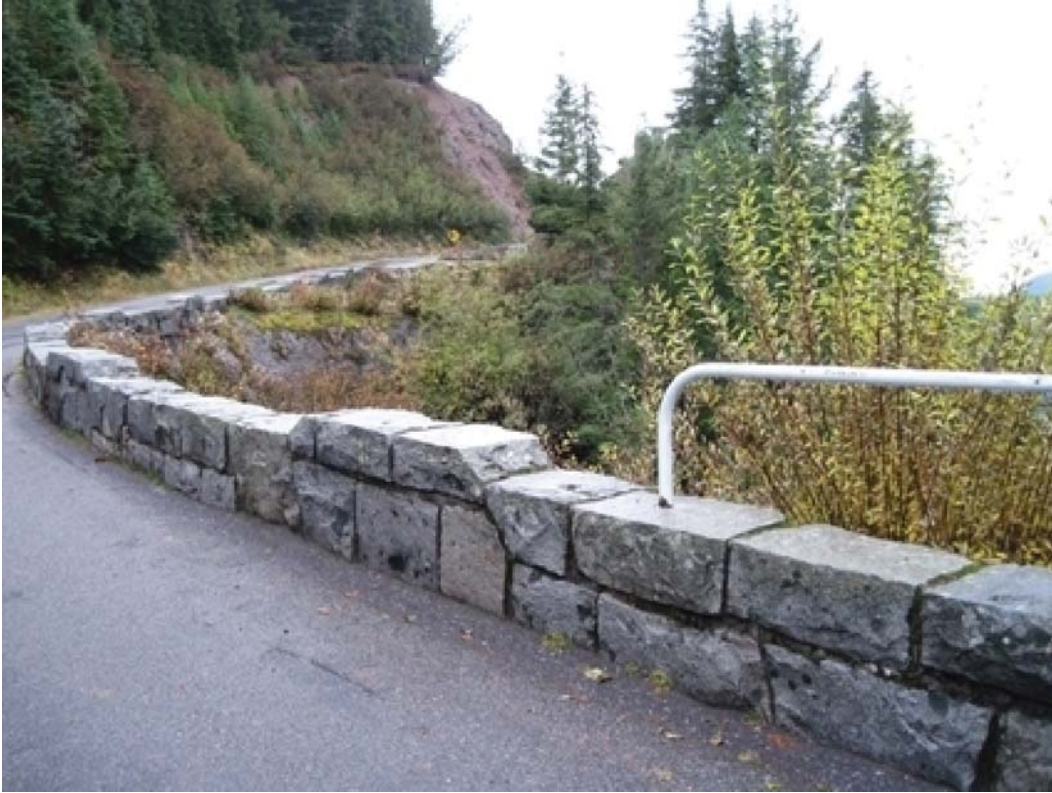
MORA_0203_0.056_R_1.jpg

Barrier ID:	MORA-0203-0.056-R				
Route Name:	MILLER CUT OFF / RICKSECKER POINT LOOP ROAD				
Inspection Date:	10/21/2009	Barrier Rating:	41.50		
Barrier Description					
Type:	STONE MASONRY CRENELLATED WITHOUT	Barrier Function:	TRAFFIC		
Barrier Material:	STONE	Post Material:	N/A		
Blockout Type:	N/A	Length (ft.):	205		
Speed Limit (MPH):	25	Placement with Respect to Road:	OUTSIDE OF CURVE		
Hazard Behind Barrier:	EXTREME				
Barrier Crashworthiness					
Appropriate Test Level:	TL-1	Barrier Test Level:	NCW	Is Barrier Crashworthy?:	NO
Beg. End Trtmt Type:	NONE	Is Beg. End Trtmt Crashworthy?:	N/A	Approach Transition Type:	NONE
Ending End Trtmt Type:	NONE	Ending End Trtmt Crashworthy?:	N/A		
Average Measurements					
Design Height (In.):	18	Width (In.):	19.2	Post Spacing (In.):	0.0
Height (In.):	17.0	Lateral Offset (In.):	22.7	Road Grade (%):	5.00
Physical Condition					
Barrier	Alignment and Height:	Alignment acceptable. Height was within 3-in of the 18-in/24-in crenellated design height.

Breaking and Cracking:	Cracking of less than 1/4in in a few locations and a couple of those locations the cracking was through the entire barrier.			
	Missing Elements:	No missing elements observed.			
	Corrosion and Weathering:	No notable corrosion/weathering or erosion.			
End Treatments	Alignment and Height:				
	Breaking and Cracking:				
	Missing Elements:				
	Corrosion and Weathering:

Repair Action:	REPAIR	FMSS Work Type:	DEFERRED MAINTENANCE	Repair Cost:	\$1931
Brief Workorder:	Repoint 2 SY of masonry barrier.				
Workorder:	Re-Point Masonry Barrier at \$140- per -Sq. Yd. for 2 SY = \$280. Low Speed Traffic Control at \$1475- per -Day for 1 Day(s) = \$1475.

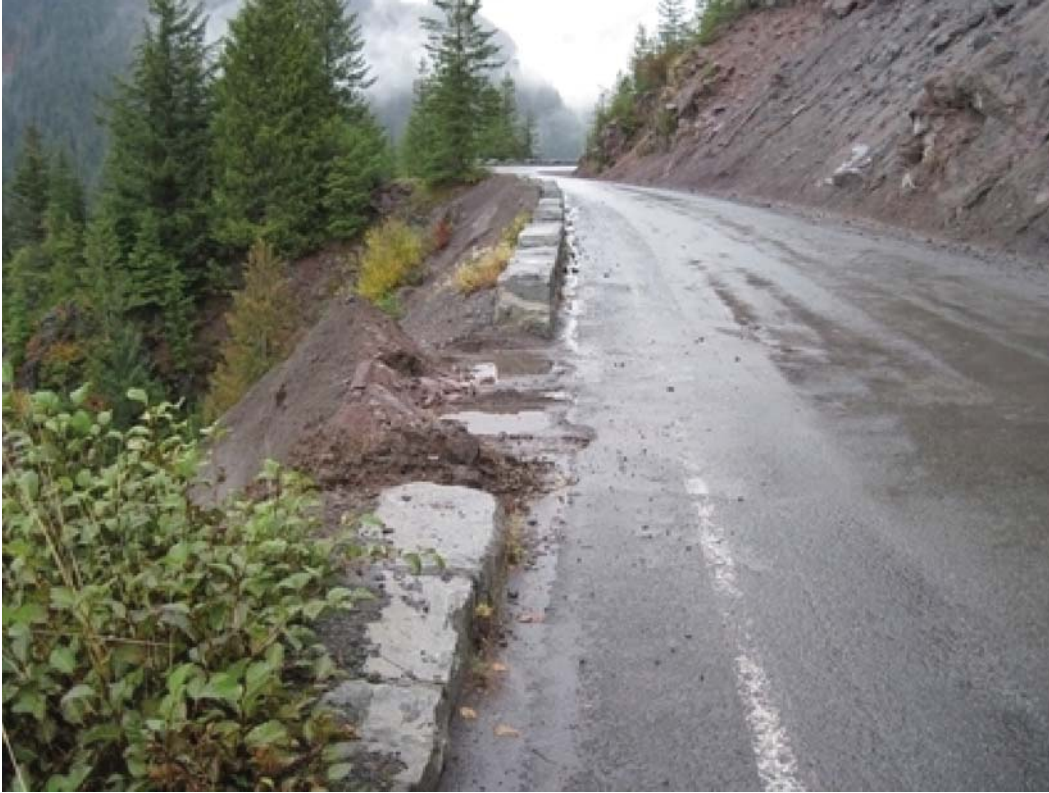
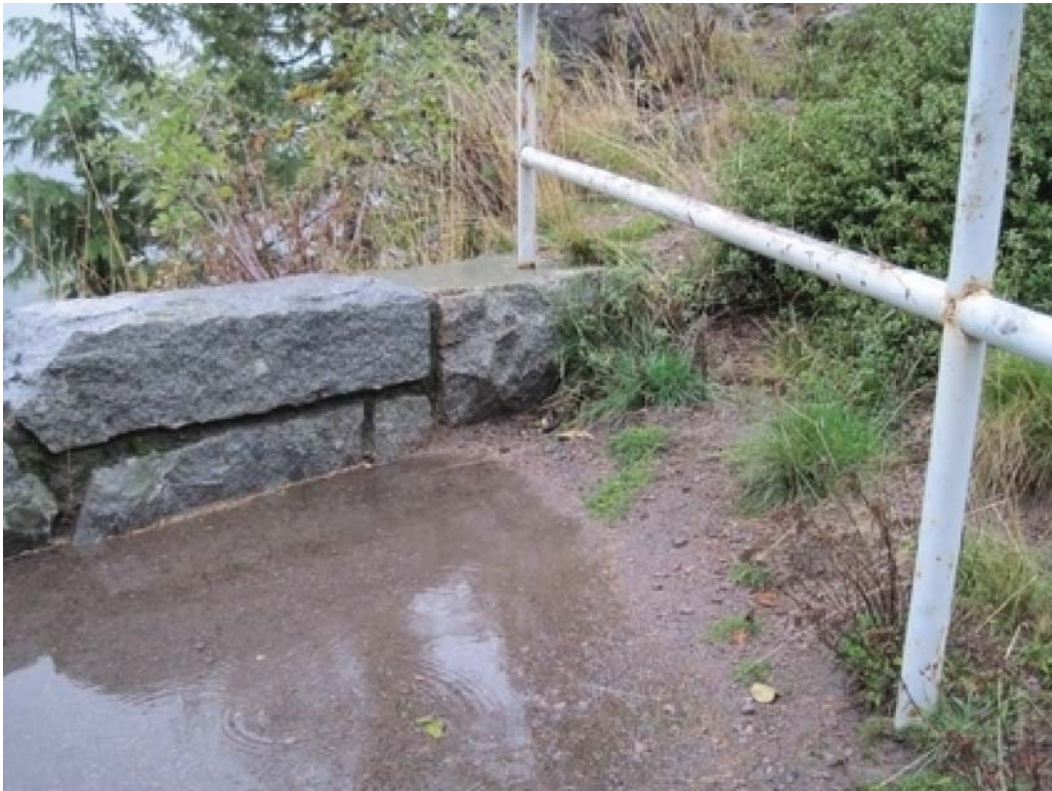
Barrier ID:	MORA-0203-0.094-R				
Route Name:	MILLER CUT OFF / RICKSECKER POINT LOOP ROAD				
Inspection Date:	10/21/2009	Barrier Rating:	43.00		
Barrier Description					
Type:	STONE MASONRY WITHOUT CONCRETE CORE WALL	Barrier Function:	TRAFFIC		
Barrier Material:	STONE	Post Material:	N/A		
Blockout Type:	N/A	Length (ft.):	861		
Speed Limit (MPH):	25	Placement with Respect to Road:	INSIDE OF CURVE		
Hazard Behind Barrier:	EXTREME				
Barrier Crashworthiness					
Appropriate Test Level:	TL-1	Barrier Test Level:	NCW	Is Barrier Crashworthy?:	NO
Beg. End Trtmt Type:	NONE	Is Beg. End Trtmt Crashworthy?:	N/A	Approach Transition Type:	NONE
Ending End Trtmt Type:	NONE	Ending End Trtmt Crashworthy?:	N/A		
Average Measurements					
Design Height (In.):	24	Width (In.):	19.0	Post Spacing (In.):	0.0
Height (In.):	18.3	Lateral Offset (In.):	29.6	Road Grade (%):	2.90
Physical Condition					
Barrier	Alignment and Height:	Height is within 3 in of 18-in design height for approximately 765-ft of barrier and the barrier is missing for 99-ft (due to possible mud slide).

Breaking and Cracking:	Approximately 10 percent of the barrier total has minor cracking of less than 1/4in. 5 stones are chipped and less than 5 percent of the barrier is breaking.			
	Missing Elements:	No missing elements observed.			
	Corrosion and Weathering:	Corrosion and weathering is less than 5 percent. Erosion at the barrier foundation is less than 5 percent.			
End Treatments	Alignment and Height:				
	Breaking and Cracking:				
	Missing Elements:				
	Corrosion and Weathering:

Repair Action:	REPAIR	FMSS Work Type:	DEFERRED MAINTENANCE	Repair Cost:	\$74773
Brief Workorder:	Replace 99 feet of stone masonry barrier to 24-inch design height and repair adjacent asphalt.				
Workorder:	<p>Stone Masonry with Concrete Core at \$500- per -Lin. Ft. for 99 LF = \$49500. Asphalt patch at \$175- per -Sq. Yd. for 55 SY = \$9625. $[(99\text{ft})(5\text{ft})]/9 = 55 \text{ SY}$. Low Speed Traffic Control at \$1475- per -Day for 6 Day(s) = \$8850. 1 day removal 1 day asphalt work 4 days installation.</p>

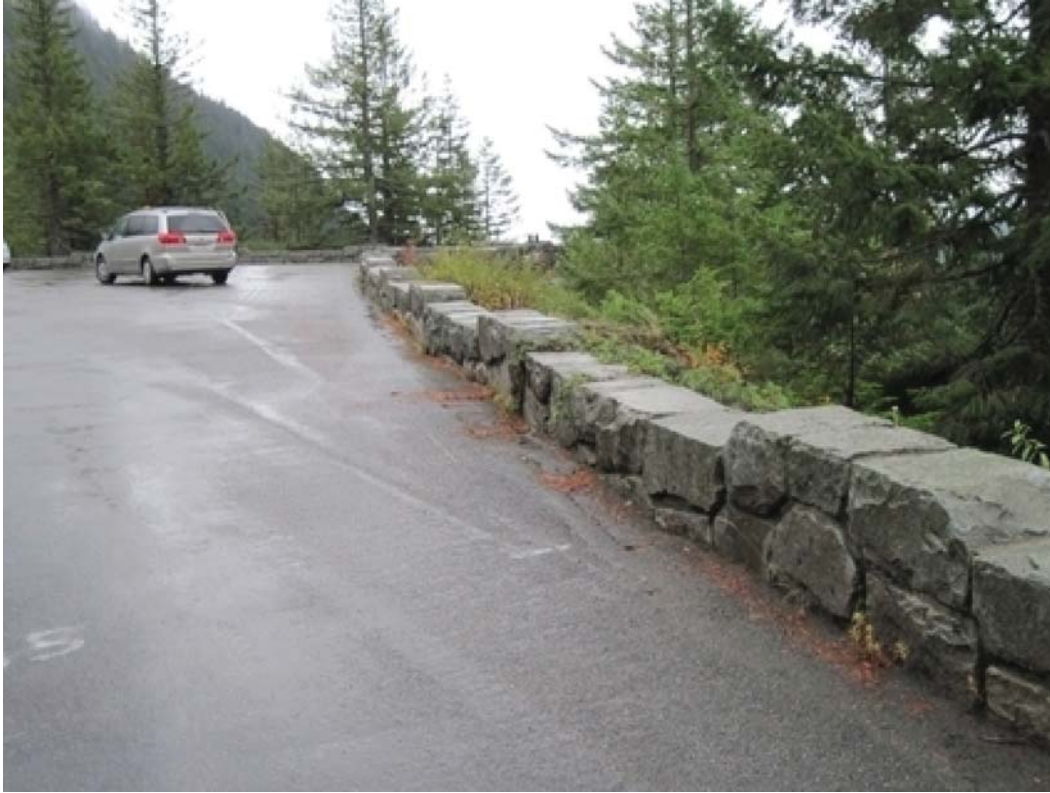
MORA_0203_0.255_R_1.jpg

Barrier ID:	MORA-0203-0.255-R				
Route Name:	MILLER CUT OFF / RICKSECKER POINT LOOP ROAD				
Inspection Date:	10/21/2009	Barrier Rating:	7.30		
Barrier Description					
Type:	STONE MASONRY CRENELLATED WITHOUT	Barrier Function:	NON-TRAFFIC		
Barrier Material:	STONE	Post Material:	N/A		
Blockout Type:	N/A	Length (ft.):	400		
Speed Limit (MPH):	25	Placement with Respect to Road:	NON-TRAFFIC BARRIER		
Hazard Behind Barrier:	N/A				
Barrier Crashworthiness					
Appropriate Test Level:	TL-1	Barrier Test Level:	N/A	Is Barrier Crashworthy?:	N/A
Beg. End Trtmt Type:	NONE	Is Beg. End Trtmt Crashworthy?:	N/A	Approach Transition Type:	NONE
Ending End Trtmt Type:	NONE	Ending End Trtmt Crashworthy?:	N/A		
Average Measurements					
Design Height (In.):	18	Width (In.):	20.2	Post Spacing (In.):	0.0
Height (In.):	20.2	Lateral Offset (In.):	0.0	Road Grade (%):	0.00
Physical Condition					
Barrier	Alignment and Height:	Alignment acceptable. Height was between 1-in to 4-in above the 18-in/24-in crenellated design height.

Breaking and Cracking:	Minor cracking less than 1/4 in. One crack in mortar 1/4in to 1/2", 1 ft. long.			
	Missing Elements:	No missing elements observed.			
	Corrosion and Weathering:	No corrosion or weathering observed.			
End Treatments	Alignment and Height:				
	Breaking and Cracking:				
	Missing Elements:				
	Corrosion and Weathering:

Repair Action:	REPAIR	FMSS Work Type:	DEFERRED MAINTENANCE	Repair Cost:	\$1777
Brief Workorder:	Re-point 1 SY of mortar.				
Workorder:	Re-point masonry barrier at \$140- per -Sq. Yd. for 1 SY = \$140. Low Speed Traffic Control at \$1475- per -Day for 1 Day(s) = \$1475.

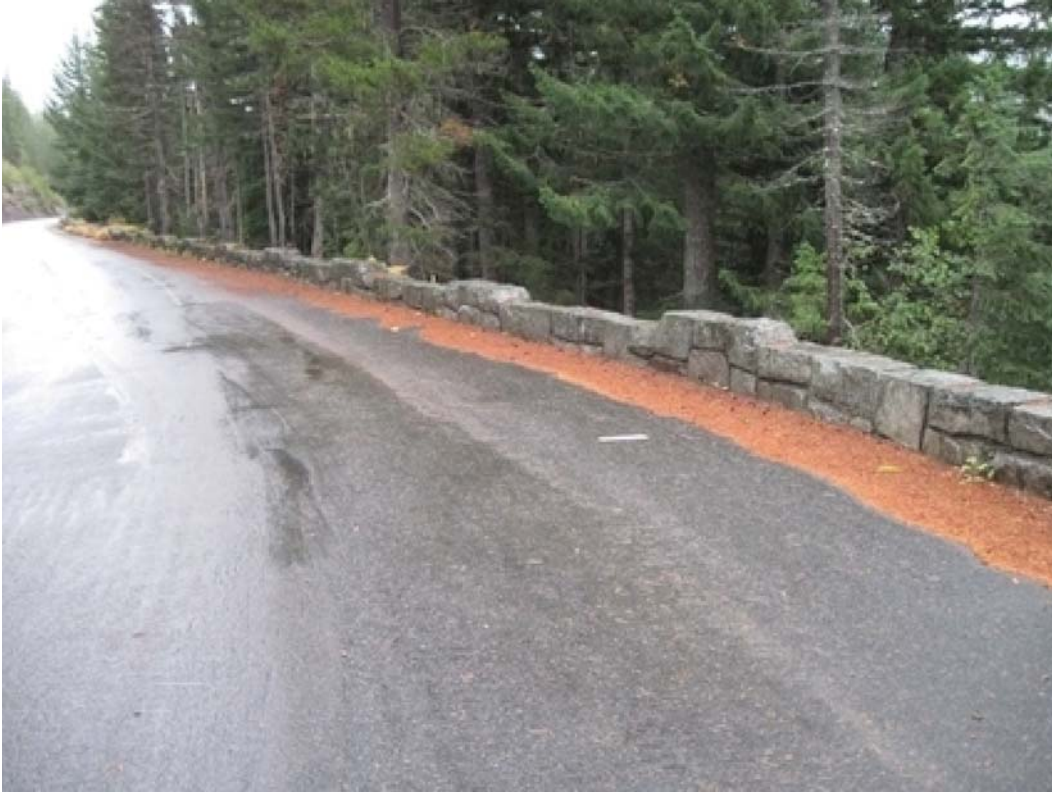
MORA_0203_0.296_R_1.jpg

Barrier ID:	MORA-0203-0.296-R				
Route Name:	MILLER CUT OFF / RICKSECKER POINT LOOP ROAD				
Inspection Date:	10/21/2009	Barrier Rating:	37.00		
Barrier Description					
Type:	STONE MASONRY CRENELLATED WITHOUT	Barrier Function:	TRAFFIC		
Barrier Material:	STONE	Post Material:	N/A		
Blockout Type:	N/A	Length (ft.):	621		
Speed Limit (MPH):	25	Placement with Respect to Road:	BOTH INSIDE AND OUTSIDE		
Hazard Behind Barrier:	HIGH				
Barrier Crashworthiness					
Appropriate Test Level:	TL-1	Barrier Test Level:	NCW	Is Barrier Crashworthy?:	NO
Beg. End Trtmt Type:	NONE	Is Beg. End Trtmt Crashworthy?:	N/A	Approach Transition Type:	NONE
Ending End Trtmt Type:	NONE	Ending End Trtmt Crashworthy?:	N/A		
Average Measurements					
Design Height (In.):	18	Width (In.):	19.5	Post Spacing (In.):	0.0
Height (In.):	18.3	Lateral Offset (In.):	81.3	Road Grade (%):	1.70
Physical Condition					
Barrier	Alignment and Height:	Alignment acceptable. Height was within 3-in of the 18-in/24-in crenellated design height.

Breaking and Cracking:	Cracking of less than 1/4in exists in less than 5% of barrier.			
	Missing Elements:	No missing elements observed.			
	Corrosion and Weathering:	No notable corrosion/weathering or erosion.			
End Treatments	Alignment and Height:				
	Breaking and Cracking:				
	Missing Elements:				
	Corrosion and Weathering:

Repair Action:	REPAIR	FMSS Work Type:	DEFERRED MAINTENANCE	Repair Cost:	\$1931
Brief Workorder:	Repoint 2 SY of stone masonry barrier.				
Workorder:	Re-Point Masonry Barrier at \$140- per -Sq. Yd. for 2 SY = \$280. Low Speed Traffic Control at \$1475- per -Day for 1 Day(s) = \$1475.

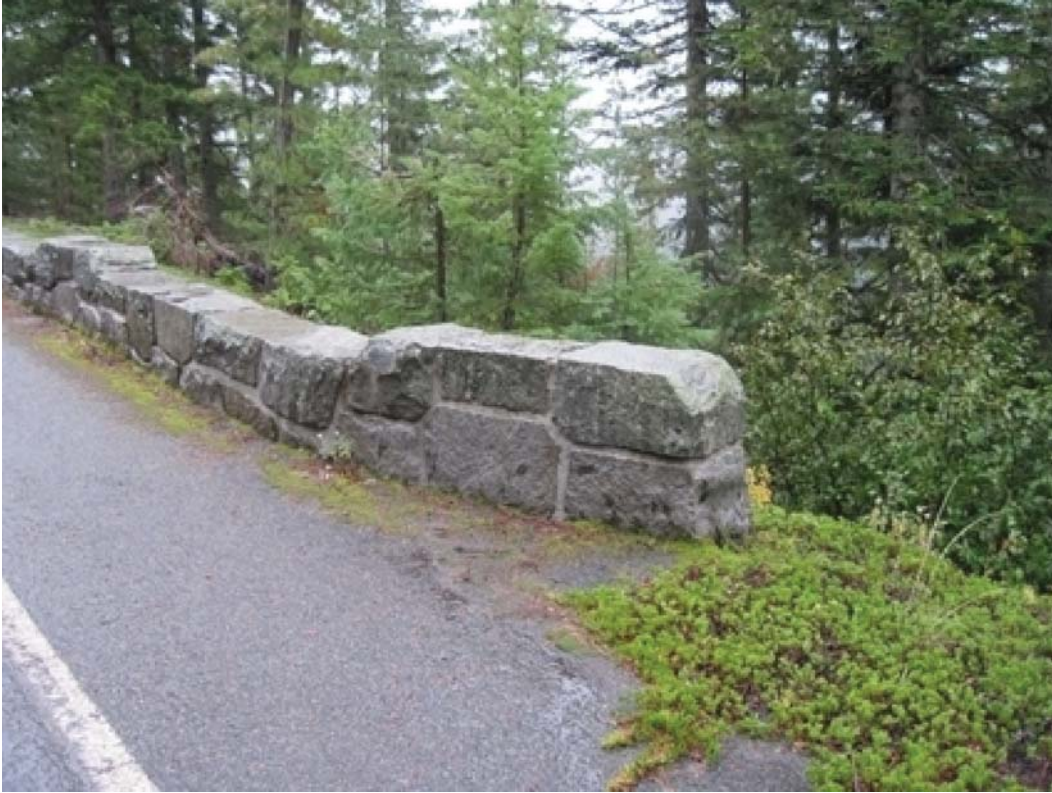
MORA_0203_0.620_R_1.jpg

Barrier ID:	MORA-0203-0.620-R				
Route Name:	MILLER CUT OFF / RICKSECKER POINT LOOP ROAD				
Inspection Date:	10/20/2009	Barrier Rating:	45.70		
Barrier Description					
Type:	STONE MASONRY CRENELLATED WITHOUT	Barrier Function:	TRAFFIC		
Barrier Material:	STONE	Post Material:	N/A		
Blockout Type:	N/A	Length (ft.):	1417		
Speed Limit (MPH):	25	Placement with Respect to Road:	BOTH INSIDE AND OUTSIDE		
Hazard Behind Barrier:	EXTREME				
Barrier Crashworthiness					
Appropriate Test Level:	TL-1	Barrier Test Level:	NCW	Is Barrier Crashworthy?:	NO
Beg. End Trtmt Type:	NONE	Is Beg. End Trtmt Crashworthy?:	N/A	Approach Transition Type:	NONE
Ending End Trtmt Type:	NONE	Ending End Trtmt Crashworthy?:	N/A		
Average Measurements					
Design Height (In.):	18	Width (In.):	19.0	Post Spacing (In.):	0.0
Height (In.):	19.3	Lateral Offset (In.):	68.0	Road Grade (%):	2.80
Physical Condition					
Barrier	Alignment and Height:	Alignment is off by 8in for a 37 section of barrier. Height was within 3 in of 18-in/24-in crenellated design height for the barrier length.

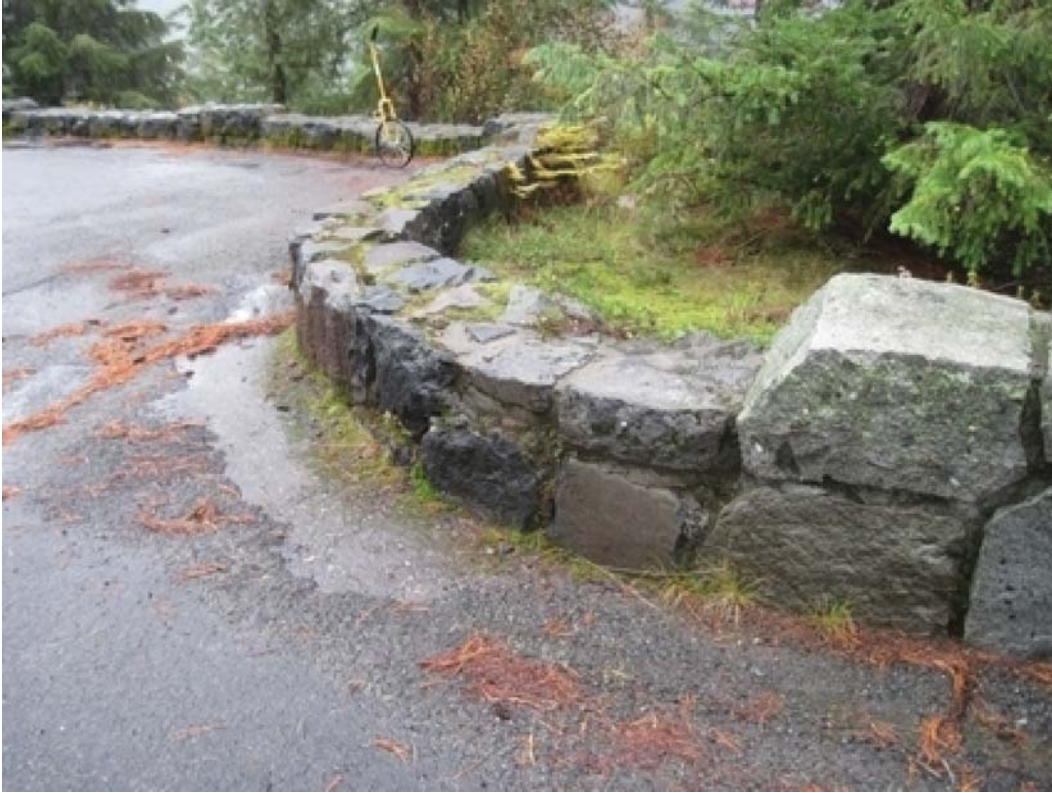
MORA_0203_0.886_R_1.jpg

Barrier ID:	MORA-0203-0.886-R				
Route Name:	MILLER CUT OFF / RICKSECKER POINT LOOP ROAD				
Inspection Date:	10/21/2009	Barrier Rating:	25.80		
Barrier Description					
Type:	STONE MASONRY CRENELLATED WITHOUT	Barrier Function:	NON-TRAFFIC		
Barrier Material:	STONE	Post Material:	N/A		
Blockout Type:	N/A	Length (ft.):	182		
Speed Limit (MPH):	25	Placement with Respect to Road:	NON-TRAFFIC BARRIER		
Hazard Behind Barrier:	N/A				
Barrier Crashworthiness					
Appropriate Test Level:	TL-1	Barrier Test Level:	N/A	Is Barrier Crashworthy?:	N/A
Beg. End Trtmt Type:	NONE	Is Beg. End Trtmt Crashworthy?:	N/A	Approach Transition Type:	NONE
Ending End Trtmt Type:	NONE	Ending End Trtmt Crashworthy?:	N/A		
Average Measurements					
Design Height (In.):	18	Width (In.):	18.7	Post Spacing (In.):	0.0
Height (In.):	11.0	Lateral Offset (In.):	0.0	Road Grade (%):	0.00
Physical Condition					
Barrier	Alignment and Height:	Barrier is rotated by about 20 degrees from vertical for 60 linear ft. Height was between 9-in to 6-in below the 18-in/24-in crenellated design height for 81-ft and 3-6 in below design height for 101-ft.

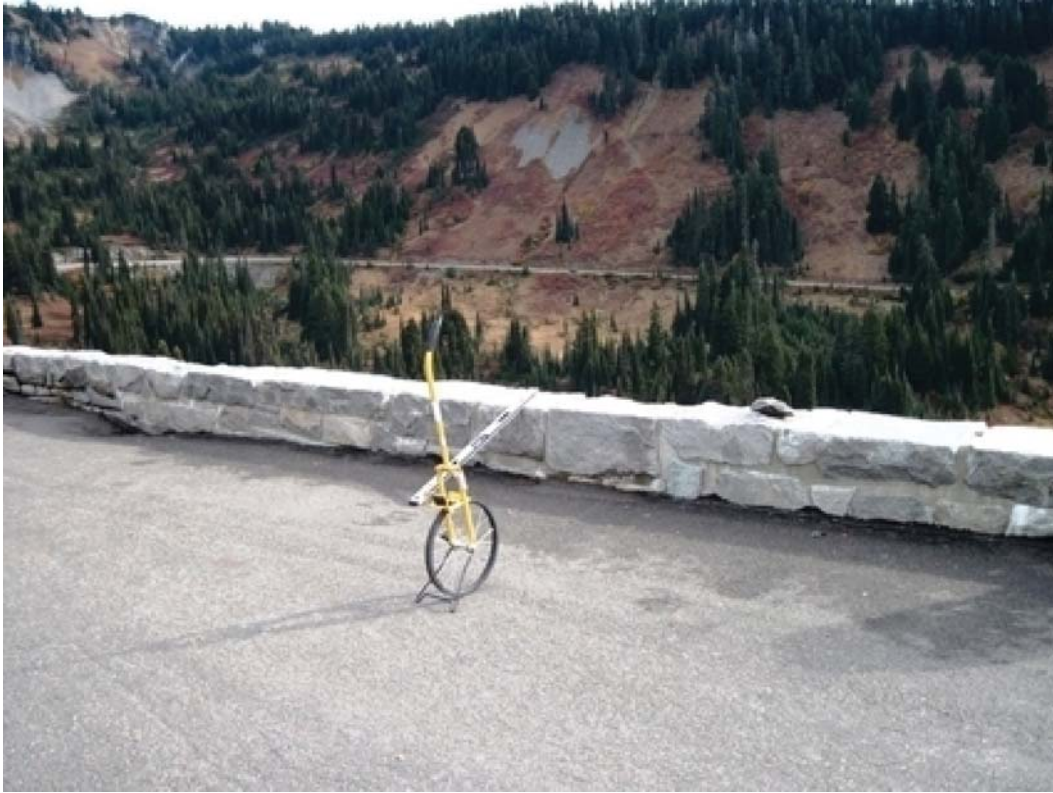
MORA_0500_0.070_R_1.jpg

Barrier ID:	MORA-0500-0.070-R				
Route Name:	VALLEY ROAD				
Inspection Date:	10/20/2009	Barrier Rating:	62.40		
Barrier Description					
Type:	STONE MASONRY WITHOUT CONCRETE CORE WALL	Barrier Function:	TRAFFIC		
Barrier Material:	STONE	Post Material:	N/A		
Blockout Type:	N/A	Length (ft.):	422		
Speed Limit (MPH):	20	Placement with Respect to Road:	OUTSIDE OF CURVE		
Hazard Behind Barrier:	EXTREME				
Barrier Crashworthiness					
Appropriate Test Level:	TL-1	Barrier Test Level:	NCW	Is Barrier Crashworthy?:	NO
Beg. End Trtmt Type:	NONE	Is Beg. End Trtmt Crashworthy?:	N/A	Approach Transition Type:	NONE
Ending End Trtmt Type:	NONE	Ending End Trtmt Crashworthy?:	N/A		
Average Measurements					
Design Height (In.):	24	Width (In.):	18.7	Post Spacing (In.):	0.0
Height (In.):	15.0	Lateral Offset (In.):	54.0	Road Grade (%):	4.70
Physical Condition					
Barrier	Alignment and Height:	Alignment acceptable. Height was 8–10in below the 24-in design height.
