PEFO GIP Report

NPS Guardwall/Rail Inventory Program Petrified Forest National Park

Data Collection Date: April 2010
Report Date: November 2015

Petrified Forest National Park in Arizona

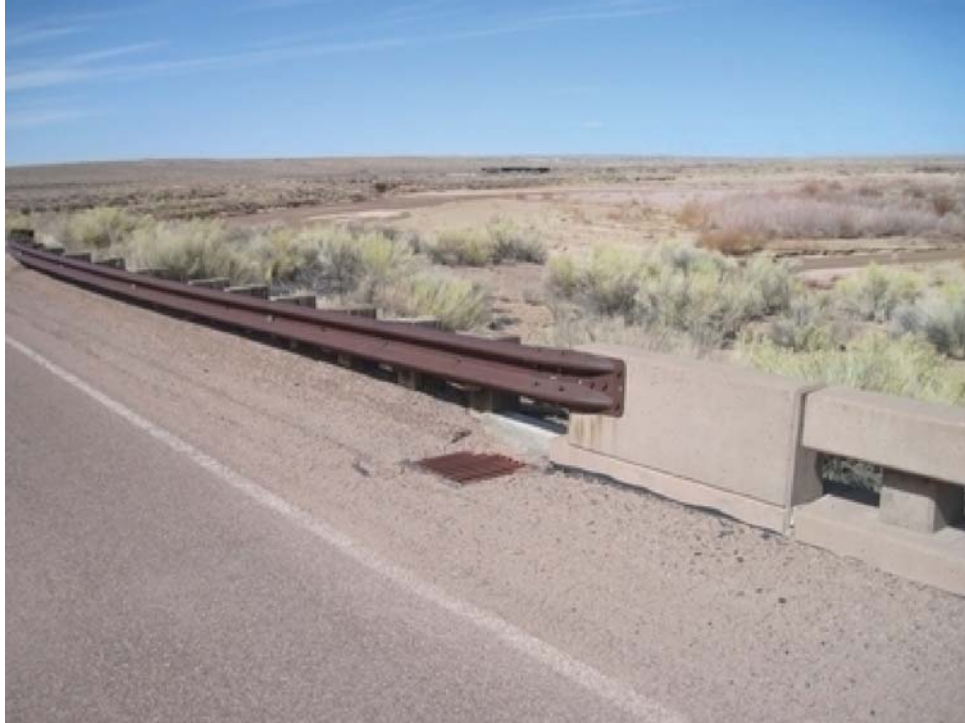
PEFO_0010_10.899_L_1.jpg

Barrier ID:	PEFO-0010-10.899-L				
Route Name:	NORTH-SOUTH HIGHWAY				
Inspection Date:	02/04/2010	Barrier Rating:	22.20		
Barrier Description					
Type:	W-BEAM STRONG POST	Barrier Function:	TRAFFIC		
Barrier Material:	WEATHERING STEEL/CORTEN	Post Material:	WOOD		
Blockout Type:	WOOD	Length (ft.):	78		
Speed Limit (MPH):	45	Placement with Respect to Road:	TANGENT		
Hazard Behind Barrier:	MEDIUM				
Barrier Crashworthiness					
Appropriate Test Level:	TL-2	Barrier Test Level:	TL-3	Is Barrier Crashworthy?:	YES
Beg. End Trtmt Type:	W-BEAM BCT	Is Beg. End Trtmt Crashworthy?:	NO	Approach Transition Type:	CONC/MASON W-BEAM
Ending End Trtmt Type:	NONE	Ending End Trtmt Crashworthy?:	N/A		
Average Measurements					
Design Height (In.):	27	Width (In.):	0.0	Post Spacing (In.):	74.3
Height (In.):	24.5	Lateral Offset (In.):	59.0	Road Grade (%):	0.40
Physical Condition					
Barrier	Alignment and Height:	Alignment acceptable. 78-ft was between 1 and 3-in below the 27-in design height.

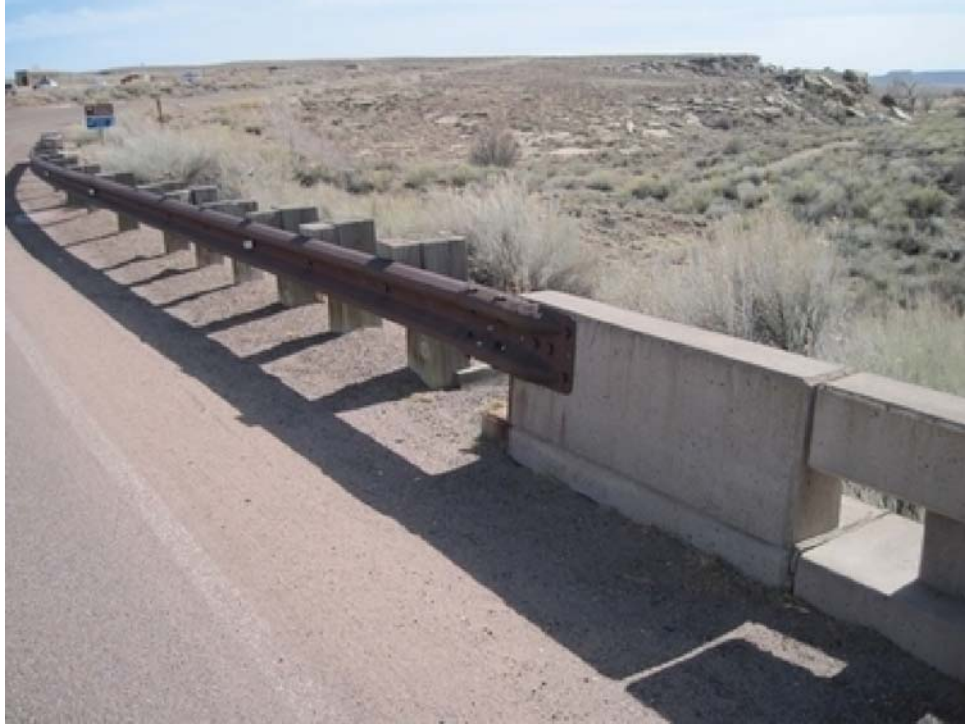
PEFO_0010_11.015_R_1.jpg

Barrier ID:	PEFO-0010-11.015-R				
Route Name:	NORTH-SOUTH HIGHWAY				
Inspection Date:	02/04/2010	Barrier Rating:	16.50		
Barrier Description					
Type:	W-BEAM STRONG POST	Barrier Function:	TRAFFIC		
Barrier Material:	WEATHERING STEEL/CORTEN	Post Material:	WOOD		
Blockout Type:	WOOD	Length (ft.):	79		
Speed Limit (MPH):	35	Placement with Respect to Road:	INSIDE OF CURVE		
Hazard Behind Barrier:	MEDIUM				
Barrier Crashworthiness					
Appropriate Test Level:	TL-2	Barrier Test Level:	TL-3	Is Barrier Crashworthy?:	YES
Beg. End Trtmt Type:	NONE	Is Beg. End Trtmt Crashworthy?:	N/A	Approach Transition Type:	CONC/MASON W-BEAM
Ending End Trtmt Type:	W-BEAM BCT	Ending End Trtmt Crashworthy?:	NO		
Average Measurements					
Design Height (In.):	27	Width (In.):	0.0	Post Spacing (In.):	73.6
Height (In.):	26.5	Lateral Offset (In.):	51.7	Road Grade (%):	0.30
Physical Condition					
Barrier	Alignment and Height:	Alignment is acceptable. Height is within 1-in of 27-in design height.

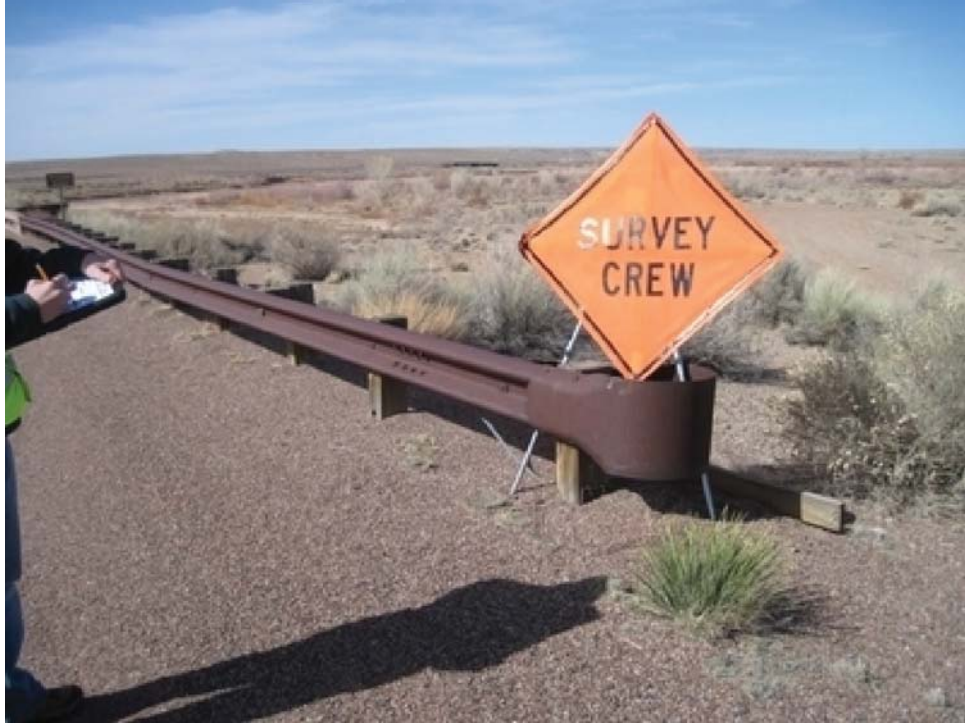
PEFO_0010_11.016_L_1.jpg

Barrier ID:	PEFO-0010-11.016-L				
Route Name:	NORTH-SOUTH HIGHWAY				
Inspection Date:	02/04/2010	Barrier Rating:	24.00		
Barrier Description					
Type:	W-BEAM STRONG POST	Barrier Function:	TRAFFIC		
Barrier Material:	WEATHERING STEEL/CORTEN	Post Material:	WOOD		
Blockout Type:	WOOD	Length (ft.):	102		
Speed Limit (MPH):	45	Placement with Respect to Road:	OUTSIDE OF CURVE		
Hazard Behind Barrier:	LOW				
Barrier Crashworthiness					
Appropriate Test Level:	TL-2	Barrier Test Level:	TL-3	Is Barrier Crashworthy?:	YES
Beg. End Trtmt Type:	NONE	Is Beg. End Trtmt Crashworthy?:	N/A	Approach Transition Type:	CONC/MASON W-BEAM
Ending End Trtmt Type:	W-BEAM BCT	Ending End Trtmt Crashworthy?:	NO		
Average Measurements					
Design Height (In.):	27	Width (In.):	0.0	Post Spacing (In.):	75.6
Height (In.):	27.0	Lateral Offset (In.):	70.6	Road Grade (%):	1.50
Physical Condition					
Barrier	Alignment and Height:	Alignment is acceptable. Height is within 1-in of 27-in design height.

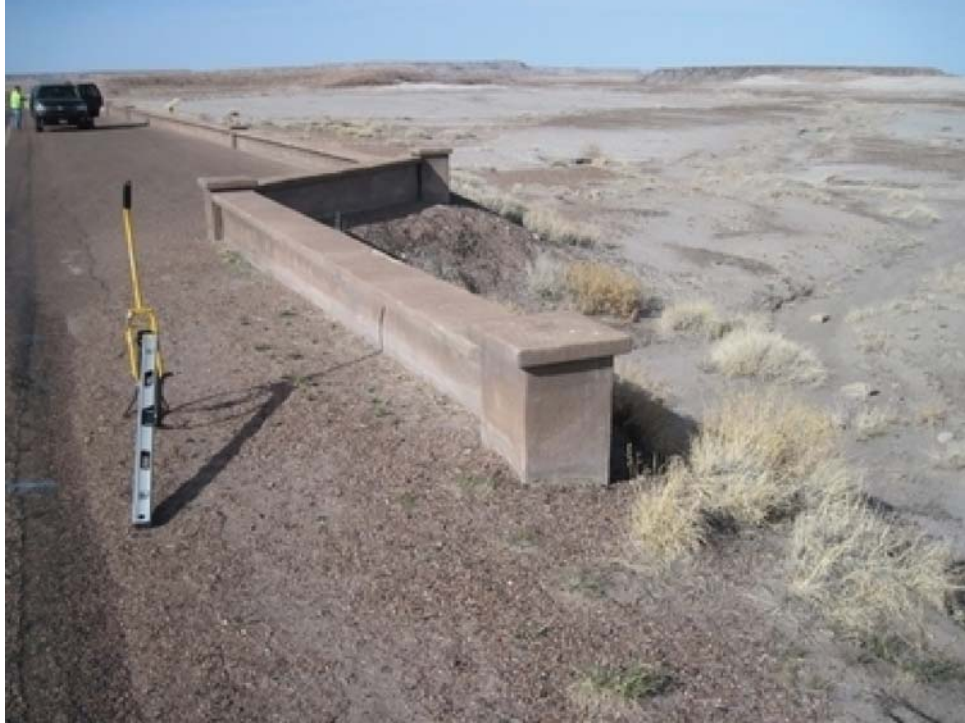
PEFO_0010_14.085_R_1.jpg

Barrier ID:	PEFO-0010-14.085-R				
Route Name:	NORTH-SOUTH HIGHWAY				
Inspection Date:	03/04/2010	Barrier Rating:	12.80		
Barrier Description					
Type:	OTHER: CONCRETE BLOCK	Barrier Function:	NON-TRAFFIC		
Barrier Material:	CONCRETE	Post Material:	N/A		
Blockout Type:	N/A	Length (ft.):	220		
Speed Limit (MPH):	45	Placement with Respect to Road:	NON-TRAFFIC BARRIER		
Hazard Behind Barrier:	N/A				
Barrier Crashworthiness					
Appropriate Test Level:	TL-2	Barrier Test Level:	N/A	Is Barrier Crashworthy?:	N/A
Beg. End Trtmt Type:	NONE	Is Beg. End Trtmt Crashworthy?:	N/A	Approach Transition Type:	NONE
Ending End Trtmt Type:	NONE	Ending End Trtmt Crashworthy?:	N/A		
Average Measurements					
Design Height (In.):	24	Width (In.):	8.0	Post Spacing (In.):	0.0
Height (In.):	21.7	Lateral Offset (In.):	0.0	Road Grade (%):	0.00
Physical Condition					
Barrier	Alignment and Height:	Alignment is acceptable. Height is within 3-in of 24-in design height.

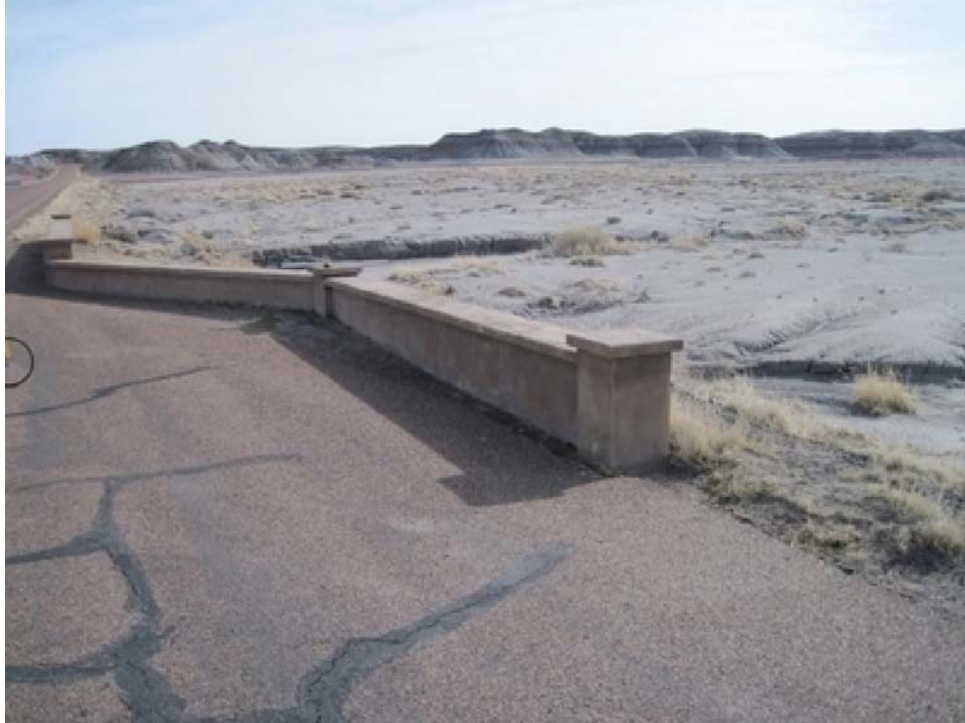
PEFO_0010_14.204_L_1.jpg

Barrier ID:	PEFO-0010-14.204-L				
Route Name:	NORTH-SOUTH HIGHWAY				
Inspection Date:	03/04/2010	Barrier Rating:	21.10		
Barrier Description					
Type:	OTHER: CONCRETE BLOCK	Barrier Function:	NON-TRAFFIC		
Barrier Material:	CONCRETE	Post Material:	N/A		
Blockout Type:	N/A	Length (ft.):	75		
Speed Limit (MPH):	45	Placement with Respect to Road:	NON-TRAFFIC BARRIER		
Hazard Behind Barrier:	N/A				
Barrier Crashworthiness					
Appropriate Test Level:	TL-2	Barrier Test Level:	N/A	Is Barrier Crashworthy?:	N/A
Beg. End Trtmt Type:	NONE	Is Beg. End Trtmt Crashworthy?:	N/A	Approach Transition Type:	NONE
Ending End Trtmt Type:	NONE	Ending End Trtmt Crashworthy?:	N/A		
Average Measurements					
Design Height (In.):	24	Width (In.):	8.0	Post Spacing (In.):	0.0
Height (In.):	21.7	Lateral Offset (In.):	0.0	Road Grade (%):	0.00
Physical Condition					
Barrier	Alignment and Height:	Alignment is acceptable. Height is within 3-in of 24-in design height.

Breaking and Cracking:	There was only minor cracking and peeling of the painted finish.			
	Missing Elements:	There were no missing elements observed.			
	Corrosion and Weathering:	There was no corrosion or weathering observed.			
End Treatments	Alignment and Height:				
	Breaking and Cracking:				
	Missing Elements:				
	Corrosion and Weathering:

Barrier ID:	PEFO-0010-14.204-L				
Route Name:	NORTH-SOUTH HIGHWAY				
Inspection Date:	03/04/2010	Barrier Rating:		21.10	
Repair Recommendations					
Repair Action:	NO ACTION	FMSS Work Type:	N/A	Repair Cost:	\$0
Brief Workorder:	N/A				
Workorder:

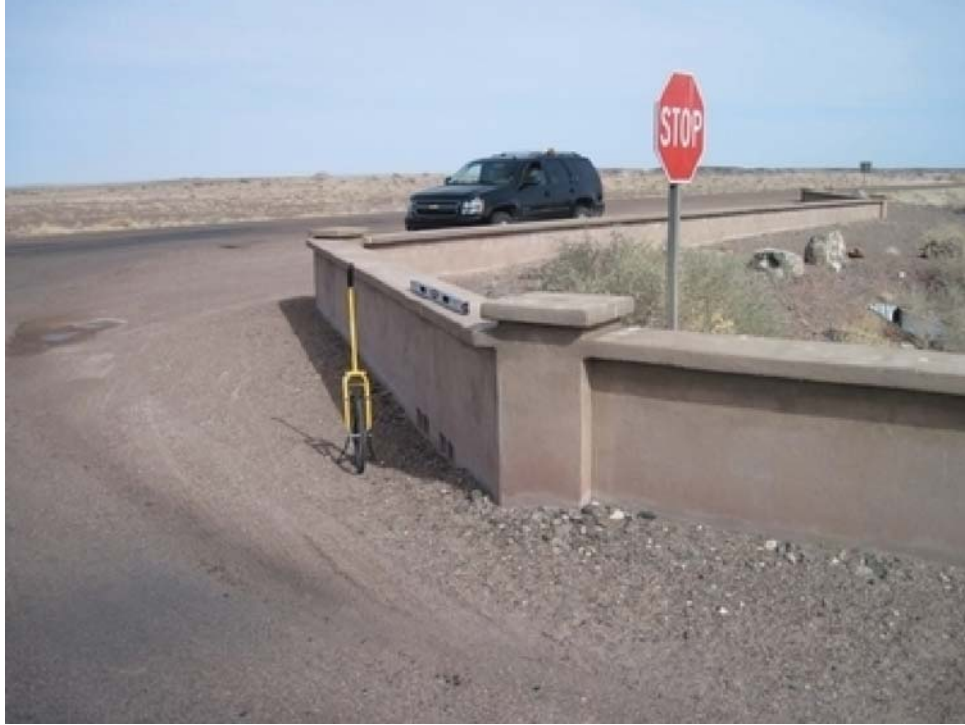
PEFO_0010_15.778_L_1.jpg

Barrier ID:	PEFO-0010-15.778-L				
Route Name:	NORTH-SOUTH HIGHWAY				
Inspection Date:	03/04/2010	Barrier Rating:	12.80		
Barrier Description					
Type:	OTHER: CONCRETE BLOCK	Barrier Function:	NON-TRAFFIC		
Barrier Material:	CONCRETE	Post Material:	N/A		
Blockout Type:	N/A	Length (ft.):	163		
Speed Limit (MPH):	45	Placement with Respect to Road:	NON-TRAFFIC BARRIER		
Hazard Behind Barrier:	N/A				
Barrier Crashworthiness					
Appropriate Test Level:	TL-2	Barrier Test Level:	N/A	Is Barrier Crashworthy?:	N/A
Beg. End Trtmt Type:	NONE	Is Beg. End Trtmt Crashworthy?:	N/A	Approach Transition Type:	NONE
Ending End Trtmt Type:	NONE	Ending End Trtmt Crashworthy?:	N/A		
Average Measurements					
Design Height (In.):	24	Width (In.):	8.0	Post Spacing (In.):	0.0
Height (In.):	26.7	Lateral Offset (In.):	0.0	Road Grade (%):	0.00
Physical Condition					
Barrier	Alignment and Height:	Alignment is acceptable. Height ranges from 0-8 in above 24-in design height.

Breaking and Cracking:	There was no breaking or cracking observed.			
	Missing Elements:	There were no missing elements observed.			
	Corrosion and Weathering:	There was no corrosion or weathering observed.			
End Treatments	Alignment and Height:				
	Breaking and Cracking:				
	Missing Elements:				
	Corrosion and Weathering:

Repair Action:	NO ACTION	FMSS Work Type:	N/A	Repair Cost:	\$0
Brief Workorder:	N/A				
Workorder:

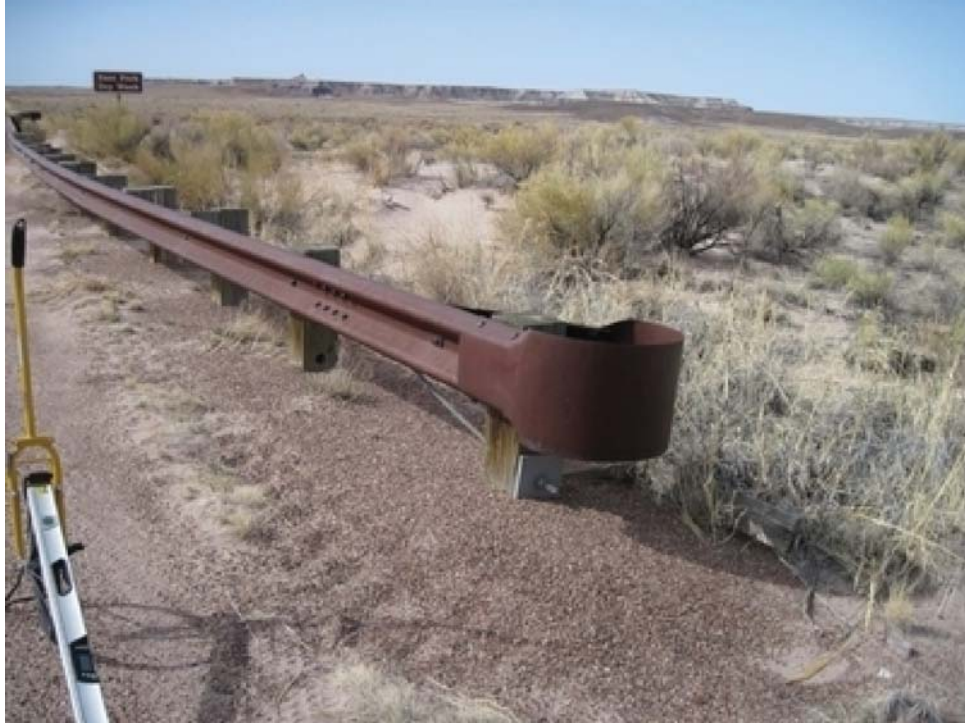
PEFO_0010_15.950_R_1.jpg

Barrier ID:	PEFO-0010-15.950-R				
Route Name:	NORTH-SOUTH HIGHWAY				
Inspection Date:	03/04/2010	Barrier Rating:	22.70		
Barrier Description					
Type:	W-BEAM STRONG POST	Barrier Function:	TRAFFIC		
Barrier Material:	WEATHERING STEEL/CORTEN	Post Material:	WOOD		
Blockout Type:	WOOD	Length (ft.):	77		
Speed Limit (MPH):	45	Placement with Respect to Road:	TANGENT		
Hazard Behind Barrier:	LOW				
Barrier Crashworthiness					
Appropriate Test Level:	TL-2	Barrier Test Level:	TL-3	Is Barrier Crashworthy?:	YES
Beg. End Trtmt Type:	W-BEAM BCT	Is Beg. End Trtmt Crashworthy?:	NO	Approach Transition Type:	RIGID W-BEAM - W-BEAM
Ending End Trtmt Type:	NONE	Ending End Trtmt Crashworthy?:	N/A		
Average Measurements					
Design Height (In.):	27	Width (In.):	0.0	Post Spacing (In.):	74.6
Height (In.):	24.7	Lateral Offset (In.):	29.0	Road Grade (%):	0.10
Physical Condition					
Barrier	Alignment and Height:	Alignment acceptable. 77-ft was between 1 and 3-in below the 27-in design height.

Breaking and Cracking:	There is one post that is cracked down the center.			
	Missing Elements:	There were no missing elements observed.			
	Corrosion and Weathering:	There was no corrosion or weathering observed.			
End Treatments	Alignment and Height:	Alignment acceptable. 30-ft was between 1 and 3-in below the 27-in design height.			
	Breaking and Cracking:	There was no breaking or cracking observed.			
	Missing Elements:	There were no missing elements observed.			
	Corrosion and Weathering:	There was no corrosion or weathering observed.

Repair Action:	REPAIR	FMSS Work Type:	DEFERRED MAINTENANCE	Repair Cost:	\$2580
Brief Workorder:	Raise 77 L.F. of barrier up to the 27 inch design height and replace one post.				
Workorder:	Adjust Guardrail at \$10- per -Lin. Ft. for 77 LF = \$770. Raise 77-ft. of barrier up to 27-in design height. Replace Post at \$100- per -Each for 1 Post(s) = \$100. Replace one cracked post. Low Speed Traffic Control at \$1475- per -Day for 1 Day(s) = \$1475.

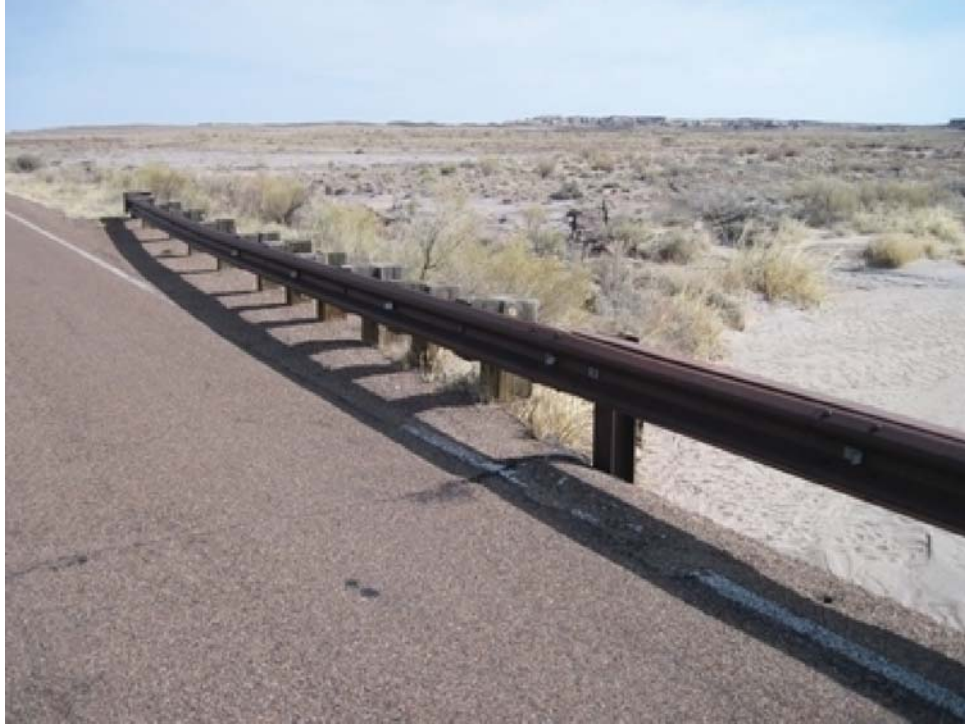
PEFO_0010_15.955_L_1.jpg

Barrier ID:	PEFO-0010-15.955-L				
Route Name:	NORTH-SOUTH HIGHWAY				
Inspection Date:	03/04/2010	Barrier Rating:	22.70		
Barrier Description					
Type:	W-BEAM STRONG POST	Barrier Function:	TRAFFIC		
Barrier Material:	WEATHERING STEEL/CORTEN	Post Material:	WOOD		
Blockout Type:	WOOD	Length (ft.):	52		
Speed Limit (MPH):	45	Placement with Respect to Road:	TANGENT		
Hazard Behind Barrier:	LOW				
Barrier Crashworthiness					
Appropriate Test Level:	TL-2	Barrier Test Level:	TL-3	Is Barrier Crashworthy?:	YES
Beg. End Trtmt Type:	W-BEAM BCT	Is Beg. End Trtmt Crashworthy?:	NO	Approach Transition Type:	RIGID W-BEAM - W-BEAM
Ending End Trtmt Type:	NONE	Ending End Trtmt Crashworthy?:	N/A		
Average Measurements					
Design Height (In.):	27	Width (In.):	0.0	Post Spacing (In.):	76.1
Height (In.):	24.7	Lateral Offset (In.):	46.2	Road Grade (%):	0.30
Physical Condition					
Barrier	Alignment and Height:	Alignment acceptable. 52-ft was between 1 and 3-in below the 27-in design height.

Breaking and Cracking:	There is only minor cracking in posts and blocks.			
	Missing Elements:	There were no missing elements observed.			
	Corrosion and Weathering:	There is some gravel and sediment build-up next to the guardrail.			
End Treatments	Alignment and Height:	Alignment acceptable. 30-ft was between 1 and 3-in below the 27-in design height.			
	Breaking and Cracking:	There is only minor cracking in posts and blocks.			
	Missing Elements:	There were no missing elements observed.			
	Corrosion and Weathering:	There is some gravel and sediment build-up next to the guardrail.

Repair Action:	REPAIR	FMSS Work Type:	DEFERRED MAINTENANCE	Repair Cost:	\$2332
Brief Workorder:	Raise 52 L.F. of guardrail to 27-in design height and remove sediment build-up from the base of the barrier.				
Workorder:	Adjust Guardrail at \$10- per -Lin. Ft. for 52 LF = \$520. Raise 52-ft. of barrier up to 27-in design height. Loader at \$125- per -Hour for 1 Hrs = \$125. Remove gravel buildup next to guardrail. Low Speed Traffic Control at \$1475- per -Day for 1 Day(s) = \$1475.

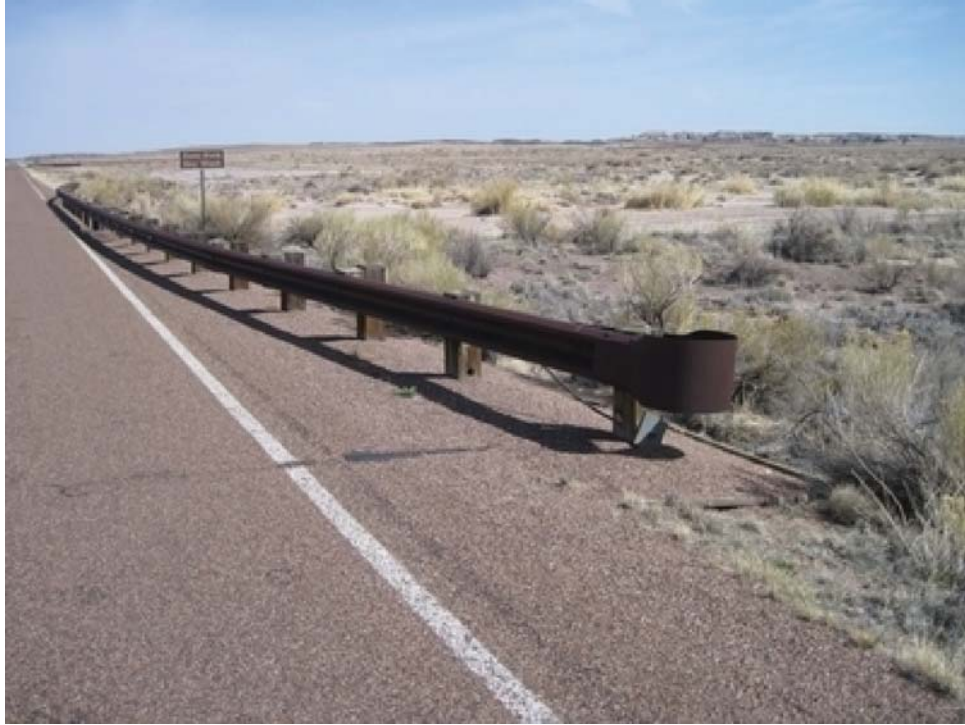
PEFO_0010_15.974_L_1.jpg

Barrier ID:	PEFO-0010-15.974-L				
Route Name:	NORTH-SOUTH HIGHWAY				
Inspection Date:	03/04/2010	Barrier Rating:	25.60		
Barrier Description					
Type:	W-BEAM STRONG POST	Barrier Function:	TRAFFIC		
Barrier Material:	WEATHERING STEEL/CORTEN	Post Material:	WOOD		
Blockout Type:	WOOD	Length (ft.):	77		
Speed Limit (MPH):	45	Placement with Respect to Road:	TANGENT		
Hazard Behind Barrier:	LOW				
Barrier Crashworthiness					
Appropriate Test Level:	TL-2	Barrier Test Level:	TL-3	Is Barrier Crashworthy?:	YES
Beg. End Trtmt Type:	NONE	Is Beg. End Trtmt Crashworthy?:	N/A	Approach Transition Type:	RIGID W-BEAM - W-BEAM
Ending End Trtmt Type:	W-BEAM BCT	Ending End Trtmt Crashworthy?:	NO		
Average Measurements					
Design Height (In.):	27	Width (In.):	0.0	Post Spacing (In.):	74.0
Height (In.):	25.0	Lateral Offset (In.):	25.0	Road Grade (%):	0.30
Physical Condition					
Barrier	Alignment and Height:	Alignment acceptable. 57-ft was between 1 and 3-in below the 27-in design height.

Breaking and Cracking:	There was no breaking or cracking observed.			
	Missing Elements:	There were no missing elements observed.			
	Corrosion and Weathering:	There was no corrosion or weathering observed.			
End Treatments	Alignment and Height:	Alignment acceptable. 30-ft was between 1 and 3-in below the 27-in design height.			
	Breaking and Cracking:	There was no breaking or cracking observed.			
	Missing Elements:	There were no missing elements observed.			
	Corrosion and Weathering:	There was no corrosion or weathering observed.

Repair Action:	REPAIR	FMSS Work Type:	DEFERRED MAINTENANCE	Repair Cost:	\$2250
Brief Workorder:	Raise 57 L.F. of barrier to the 27 inch design height.				
Workorder:	Adjust Guardrail at \$10- per -Lin. Ft. for 57 LF = \$570. Raise 57 ft of guardrail up to the 27 inch design height. Low Speed Traffic Control at \$1475- per -Day for 1 Day(s) = \$1475.

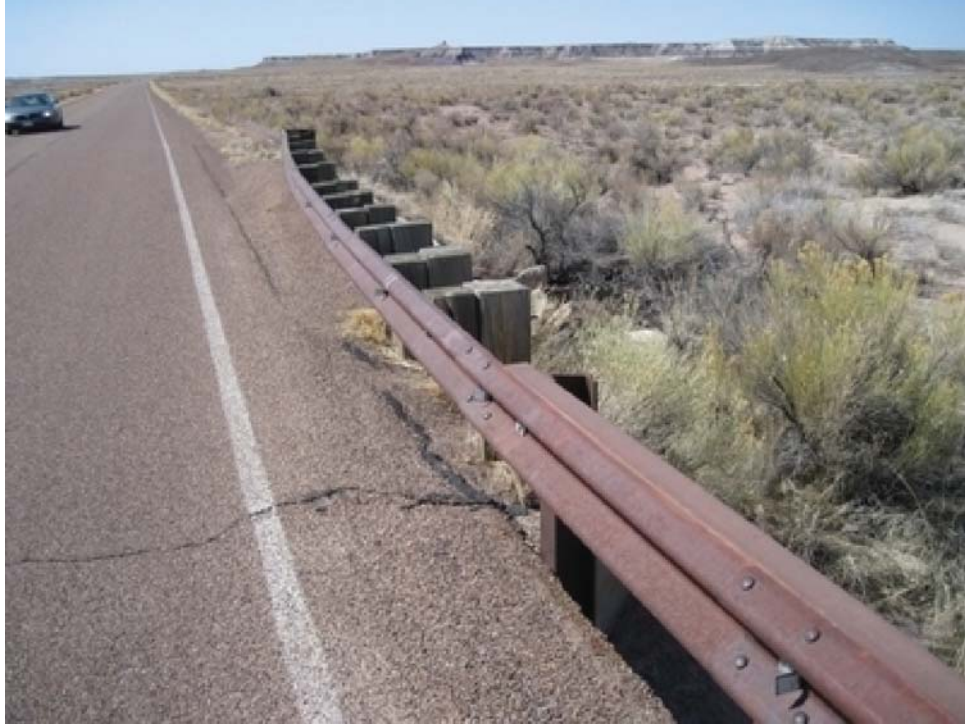
PEFO_0010_15.974_R_1.jpg

Barrier ID:	PEFO-0010-15.974-R				
Route Name:	NORTH-SOUTH HIGHWAY				
Inspection Date:	03/04/2010	Barrier Rating:	18.20		
Barrier Description					
Type:	W-BEAM STRONG POST	Barrier Function:	TRAFFIC		
Barrier Material:	WEATHERING STEEL/CORTEN	Post Material:	WOOD		
Blockout Type:	WOOD	Length (ft.):	52		
Speed Limit (MPH):	45	Placement with Respect to Road:	TANGENT		
Hazard Behind Barrier:	LOW				
Barrier Crashworthiness					
Appropriate Test Level:	TL-2	Barrier Test Level:	TL-3	Is Barrier Crashworthy?:	YES
Beg. End Trtmt Type:	NONE	Is Beg. End Trtmt Crashworthy?:	N/A	Approach Transition Type:	RIGID W-BEAM - W-BEAM
Ending End Trtmt Type:	W-BEAM BCT	Ending End Trtmt Crashworthy?:	NO		
Average Measurements					
Design Height (In.):	27	Width (In.):	0.0	Post Spacing (In.):	74.0
Height (In.):	26.7	Lateral Offset (In.):	50.0	Road Grade (%):	0.10
Physical Condition					
Barrier	Alignment and Height:	Alignment is acceptable. Height is within 1-in of 27-in design height.

Breaking and Cracking:	There was no breaking or cracking observed.			
	Missing Elements:	There were no missing elements observed.			
	Corrosion and Weathering:	There is a large amount of material deposited at the base of the barrier.			
End Treatments	Alignment and Height:	Alignment is acceptable. Height is within 1-in of 27-in design height.			
	Breaking and Cracking:	There was no breaking or cracking observed.			
	Missing Elements:	There were no missing elements observed.			
	Corrosion and Weathering:	There is a large amount of material deposited at the base of the barrier.

Repair Action:	REPAIR	FMSS Work Type:	DEFERRED MAINTENANCE	Repair Cost:	\$1936
Brief Workorder:	Replace 2 blocks and 1 post and remove the material at the base of the barrier.				
Workorder:	Replace Block at \$30- per -Each for 2 Block(s) = \$60. Replace the 2 damaged blocks in the transition section. Replace Post at \$100- per -Each for 1 Post(s) = \$100. Replace the 1 damaged post in the transition section. Loader at \$125- per -Hour for 1 Hrs = \$125. Use loader to remove the deposited material at the base of barrier. Low Speed Traffic Control at \$1475- per -Day for 1 Day(s) = \$1475.

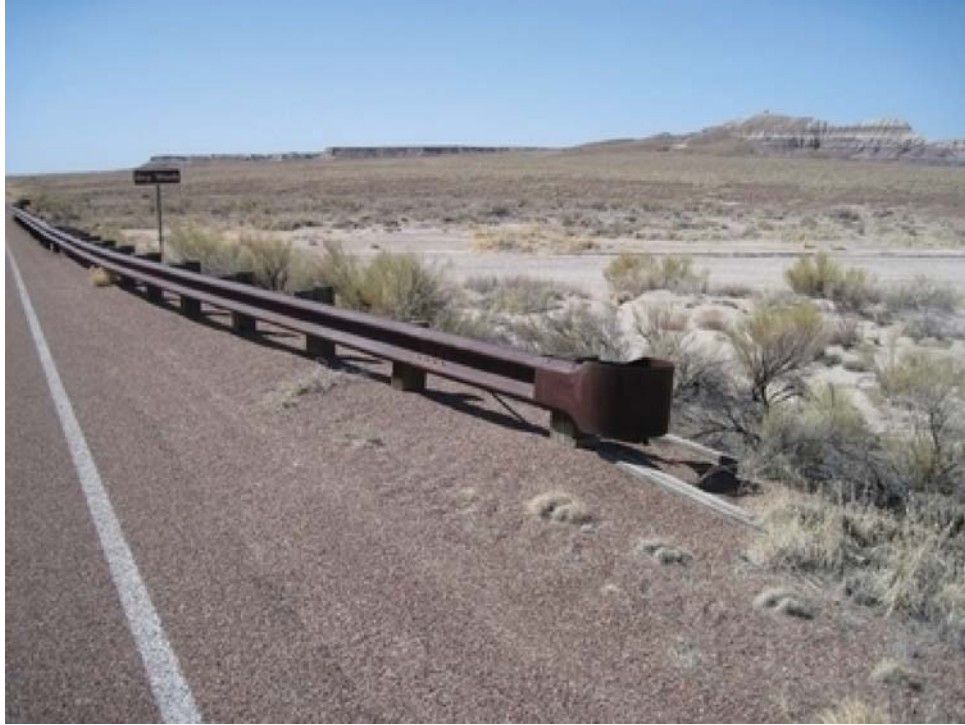
PEFO_0010_16.525_R_1.jpg

Barrier ID:	PEFO-0010-16.525-R				
Route Name:	NORTH-SOUTH HIGHWAY				
Inspection Date:	03/04/2010	Barrier Rating:	22.70		
Barrier Description					
Type:	W-BEAM STRONG POST	Barrier Function:	TRAFFIC		
Barrier Material:	WEATHERING STEEL/CORTEN	Post Material:	WOOD		
Blockout Type:	WOOD	Length (ft.):	78		
Speed Limit (MPH):	45	Placement with Respect to Road:	TANGENT		
Hazard Behind Barrier:	LOW				
Barrier Crashworthiness					
Appropriate Test Level:	TL-2	Barrier Test Level:	TL-3	Is Barrier Crashworthy?:	YES
Beg. End Trtmt Type:	W-BEAM BCT	Is Beg. End Trtmt Crashworthy?:	NO	Approach Transition Type:	RIGID W-BEAM - W-BEAM
Ending End Trtmt Type:	NONE	Ending End Trtmt Crashworthy?:	N/A		
Average Measurements					
Design Height (In.):	27	Width (In.):	0.0	Post Spacing (In.):	75.3
Height (In.):	25.7	Lateral Offset (In.):	48.0	Road Grade (%):	0.20
Physical Condition					
Barrier	Alignment and Height:	Alignment acceptable. 46-ft was between 1 and 3-in below the 27-in design height.

Breaking and Cracking:	1 block is broken.			
	Missing Elements:	There were no missing elements observed.			
	Corrosion and Weathering:	There was some gravel/sediment build-up next to the guardrail.			
End Treatments	Alignment and Height:	Alignment is acceptable. Height is within 1-in of 27-in design height.			
	Breaking and Cracking:	1 block and 1 post were broken.			
	Missing Elements:	There were no missing elements observed.			
	Corrosion and Weathering:	There is some gravel/sediment build-up next to the guardrail.

Repair Action:	REPAIR	FMSS Work Type:	DEFERRED MAINTENANCE	Repair Cost:	\$2442
Brief Workorder:	Raise 46 Lf of guardrail up to the 27 inch design height and replace 2 blocks and 1 post.				
Workorder:	Adjust Guardrail at \$10- per -Lin. Ft. for 46 LF = \$460. Raise 46-ft. of barrier up to 27-in design height. Replace Block at \$30- per -Each for 2 Block(s) = \$60. Replace 2 broken blocks. Replace Post at \$100- per -Each for 1 Post(s) = \$100. Replace 1 broken post. Loader at \$125- per -Hour for 1 Hrs = \$125. Remove sediment/gravel build-up. Low Speed Traffic Control at \$1475- per -Day for 1 Day(s) = \$1475.

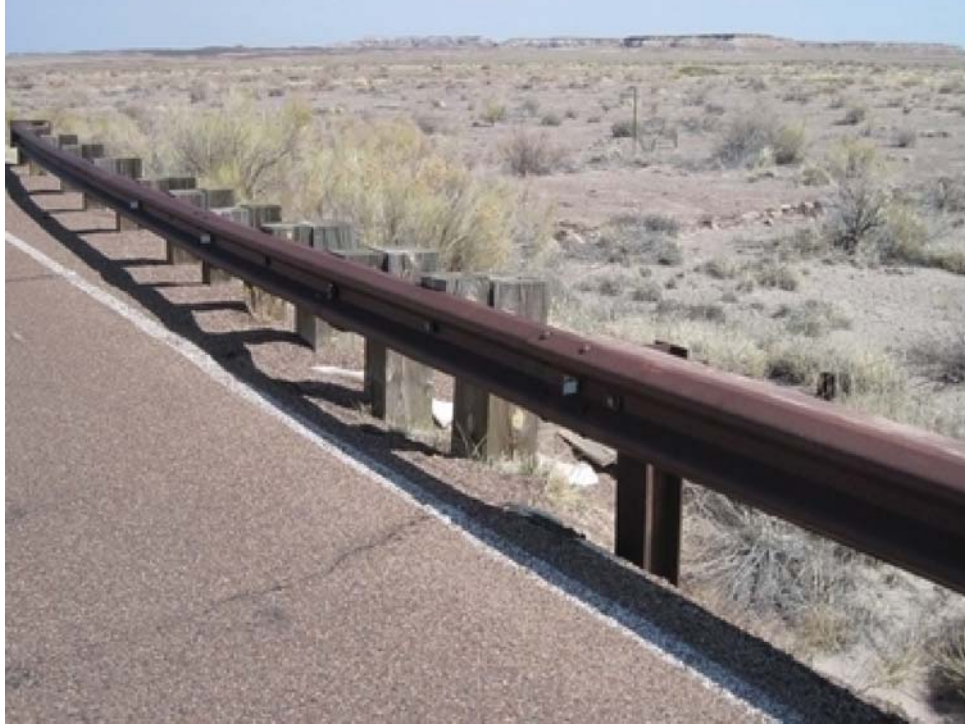
PEFO_0010_16.529_L_1.jpg

Barrier ID:	PEFO-0010-16.529-L				
Route Name:	NORTH-SOUTH HIGHWAY				
Inspection Date:	03/04/2010	Barrier Rating:	22.70		
Barrier Description					
Type:	W-BEAM STRONG POST	Barrier Function:	TRAFFIC		
Barrier Material:	WEATHERING STEEL/CORTEN	Post Material:	WOOD		
Blockout Type:	WOOD	Length (ft.):	55		
Speed Limit (MPH):	45	Placement with Respect to Road:	TANGENT		
Hazard Behind Barrier:	LOW				
Barrier Crashworthiness					
Appropriate Test Level:	TL-2	Barrier Test Level:	TL-3	Is Barrier Crashworthy?:	YES
Beg. End Trtmt Type:	W-BEAM BCT	Is Beg. End Trtmt Crashworthy?:	NO	Approach Transition Type:	RIGID W-BEAM - W-BEAM
Ending End Trtmt Type:	NONE	Ending End Trtmt Crashworthy?:	N/A		
Average Measurements					
Design Height (In.):	27	Width (In.):	0.0	Post Spacing (In.):	75.0
Height (In.):	24.5	Lateral Offset (In.):	26.2	Road Grade (%):	0.10
Physical Condition					
Barrier	Alignment and Height:	Alignment acceptable. 55-ft was between 1 and 3-in below the 27-in design height.

Breaking and Cracking:	There is 12.5 ft of rail that is bent.			
	Missing Elements:	There were no missing elements observed.			
	Corrosion and Weathering:	There was no corrosion or weathering observed.			
End Treatments	Alignment and Height:	Alignment acceptable. 30-ft was between 1 and 3-in below the 27-in design height.			
	Breaking and Cracking:	There was no breaking or cracking observed.			
	Missing Elements:	There were no missing elements observed.			
	Corrosion and Weathering:	There was no corrosion or weathering observed.

Repair Action:	REPAIR	FMSS Work Type:	DEFERRED MAINTENANCE	Repair Cost:	\$2585
Brief Workorder:	Raise 55 L.F. of barrier to the 27 inch design height and replace 13 feet of rail.				
Workorder:	Adjust Guardrail at \$10- per -Lin. Ft. for 55 LF = \$550. Raise 55-ft. of barrier up to 27-in design height. Replace Rail at \$25- per -Lin. Ft. for 13 LF = \$325. Replace the bent rail section. Low Speed Traffic Control at \$1475- per -Day for 1 Day(s) = \$1475.

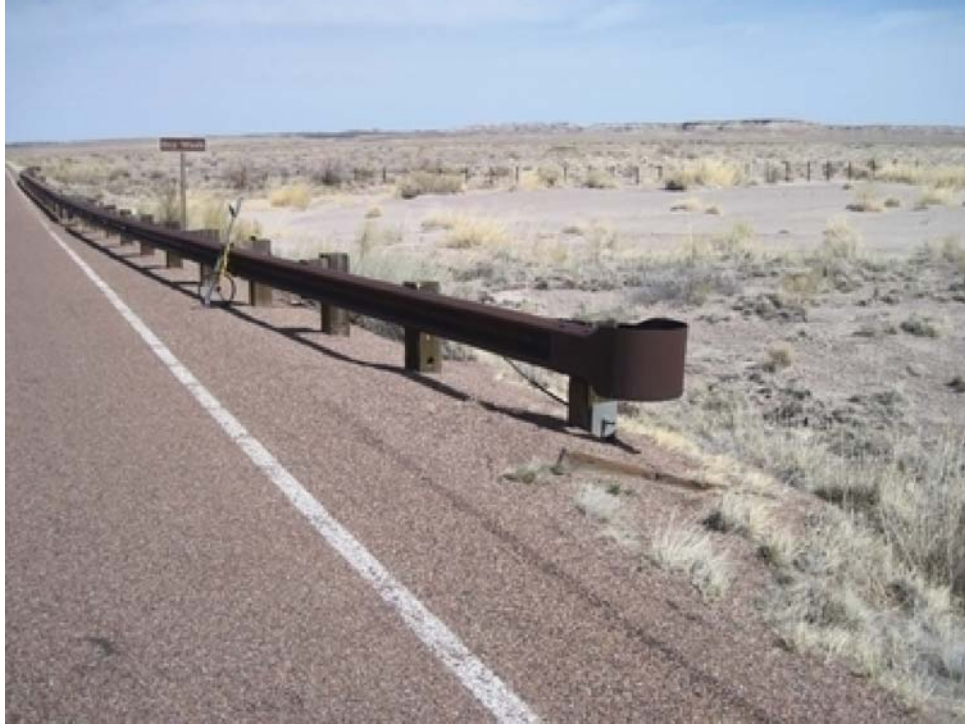
PEFO_0010_16.556_L_1.jpg

Barrier ID:	PEFO-0010-16.556-L				
Route Name:	NORTH-SOUTH HIGHWAY				
Inspection Date:	03/04/2010	Barrier Rating:	21.20		
Barrier Description					
Type:	W-BEAM STRONG POST	Barrier Function:	TRAFFIC		
Barrier Material:	WEATHERING STEEL/CORTEN	Post Material:	WOOD		
Blockout Type:	WOOD	Length (ft.):	80		
Speed Limit (MPH):	45	Placement with Respect to Road:	TANGENT		
Hazard Behind Barrier:	LOW				
Barrier Crashworthiness					
Appropriate Test Level:	TL-2	Barrier Test Level:	TL-3	Is Barrier Crashworthy?:	YES
Beg. End Trtmt Type:	NONE	Is Beg. End Trtmt Crashworthy?:	N/A	Approach Transition Type:	RIGID W-BEAM - W-BEAM
Ending End Trtmt Type:	W-BEAM BCT	Ending End Trtmt Crashworthy?:	NO		
Average Measurements					
Design Height (In.):	27	Width (In.):	0.0	Post Spacing (In.):	74.6
Height (In.):	26.0	Lateral Offset (In.):	28.7	Road Grade (%):	1.20
Physical Condition					
Barrier	Alignment and Height:	Alignment acceptable. 25-ft was between 1 and 3-in below the 27-in design height.

Breaking and Cracking:	1 block is broken.			
	Missing Elements:	There were no missing elements observed.			
	Corrosion and Weathering:	There was no corrosion or weathering observed.			
End Treatments	Alignment and Height:	Alignment is acceptable. Height is within 1-in of 27-in design height.			
	Breaking and Cracking:	There was only minor cracking in posts and blocks but still in good condition.			
	Missing Elements:	There were no missing elements observed.			
	Corrosion and Weathering:	There was no corrosion or weathering observed.

Repair Action:	REPAIR	FMSS Work Type:	DEFERRED MAINTENANCE	Repair Cost:	\$1931
Brief Workorder:	Raise 25 L.F. of guardrail up to the 27 inch design height and replace 1 broken block.				
Workorder:	Adjust Guardrail at \$10- per -Lin. Ft. for 25 LF = \$250. Raise 25-ft. of barrier up to 27-in design height. Replace Block at \$30- per -Each for 1 Block(s) = \$30. Replace 1 broken block. Low Speed Traffic Control at \$1475- per -Day for 1 Day(s) = \$1475.

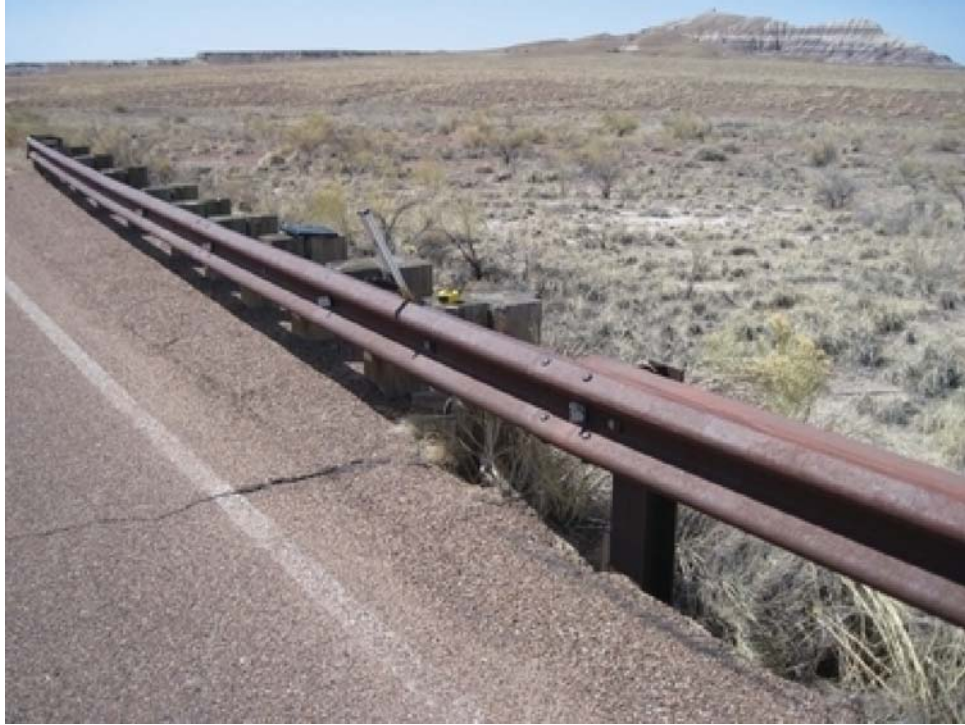
PEFO_0010_16.556_R_1.jpg

Barrier ID:	PEFO-0010-16.556-R				
Route Name:	NORTH-SOUTH HIGHWAY				
Inspection Date:	03/04/2010	Barrier Rating:	25.60		
Barrier Description					
Type:	W-BEAM STRONG POST	Barrier Function:	TRAFFIC		
Barrier Material:	WEATHERING STEEL/CORTEN	Post Material:	WOOD		
Blockout Type:	WOOD	Length (ft.):	55		
Speed Limit (MPH):	45	Placement with Respect to Road:	TANGENT		
Hazard Behind Barrier:	LOW				
Barrier Crashworthiness					
Appropriate Test Level:	TL-2	Barrier Test Level:	TL-3	Is Barrier Crashworthy?:	YES
Beg. End Trtmt Type:	NONE	Is Beg. End Trtmt Crashworthy?:	N/A	Approach Transition Type:	RIGID W-BEAM - W-BEAM
Ending End Trtmt Type:	W-BEAM BCT	Ending End Trtmt Crashworthy?:	NO		
Average Measurements					
Design Height (In.):	27	Width (In.):	0.0	Post Spacing (In.):	74.6
Height (In.):	24.5	Lateral Offset (In.):	45.2	Road Grade (%):	1.10
Physical Condition					
Barrier	Alignment and Height:	Alignment acceptable. 55-ft was between 1 and 3-in below the 27-in design height.

Breaking and Cracking:	There was no breaking or cracking observed.			
	Missing Elements:	There were no missing elements observed.			
	Corrosion and Weathering:	There was no corrosion or weathering observed.			
End Treatments	Alignment and Height:	Alignment acceptable. 30-ft was between 1 and 3-in below the 27-in design height.			
	Breaking and Cracking:	There was no breaking or cracking observed.			
	Missing Elements:	There were no missing elements observed.			
	Corrosion and Weathering:	There was no corrosion or weathering observed.

Repair Action:	REPAIR	FMSS Work Type:	DEFERRED MAINTENANCE	Repair Cost:	\$2228
Brief Workorder:	Raise 55 L.F. of guardrail up to the 27" design height.				
Workorder:	Adjust Guardrail at \$10- per -Lin. Ft. for 55 LF = \$550. Raise 55-ft. of barrier up to 27-in design height. Low Speed Traffic Control at \$1475- per -Day for 1 Day(s) = \$1475.

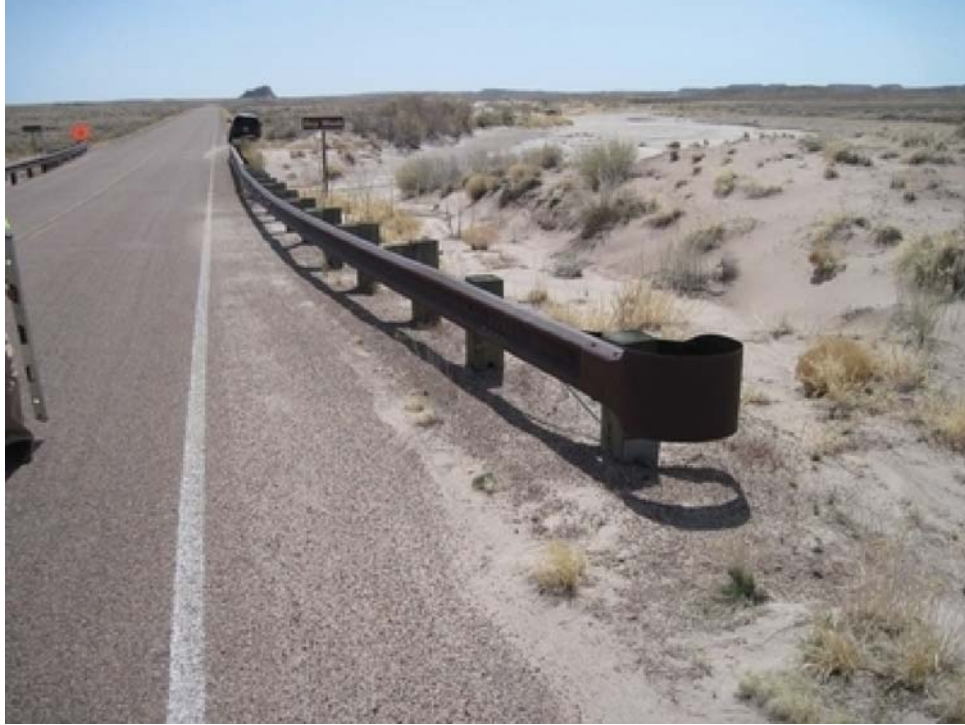
PEFO_0010_19.425_R_1.jpg

Barrier ID:	PEFO-0010-19.425-R				
Route Name:	NORTH-SOUTH HIGHWAY				
Inspection Date:	03/04/2010	Barrier Rating:	28.10		
Barrier Description					
Type:	W-BEAM STRONG POST	Barrier Function:	TRAFFIC		
Barrier Material:	WEATHERING STEEL/CORTEN	Post Material:	WOOD		
Blockout Type:	WOOD	Length (ft.):	79		
Speed Limit (MPH):	45	Placement with Respect to Road:	INSIDE OF CURVE		
Hazard Behind Barrier:	MEDIUM				
Barrier Crashworthiness					
Appropriate Test Level:	TL-2	Barrier Test Level:	TL-3	Is Barrier Crashworthy?:	YES
Beg. End Trtmt Type:	W-BEAM BCT	Is Beg. End Trtmt Crashworthy?:	NO	Approach Transition Type:	RIGID W-BEAM - W-BEAM
Ending End Trtmt Type:	NONE	Ending End Trtmt Crashworthy?:	N/A		
Average Measurements					
Design Height (In.):	27	Width (In.):	0.0	Post Spacing (In.):	75.0
Height (In.):	25.0	Lateral Offset (In.):	37.2	Road Grade (%):	1.50
Physical Condition					
Barrier	Alignment and Height:	Alignment acceptable. 79-ft was between 1 and 3-in below the 27-in design height.

Breaking and Cracking:	There is one broken block.			
	Missing Elements:	There were no missing elements observed.			
	Corrosion and Weathering:	There was no corrosion or weathering observed.			
End Treatments	Alignment and Height:	Alignment acceptable. 30-ft was between 1 and 3-in below the 27-in design height.			
	Breaking and Cracking:	There was no breaking or cracking observed.			
	Missing Elements:	There were no missing elements observed.			
	Corrosion and Weathering:	There was no corrosion or weathering observed.

Repair Action:	REPAIR	FMSS Work Type:	DEFERRED MAINTENANCE	Repair Cost:	\$2525
Brief Workorder:	Raise 79 L.F. of barrier to the 27 inch design height and replace one broken block.				
Workorder:	Adjust Guardrail at \$10- per -Lin. Ft. for 79 LF = \$790. Raise 79-ft. of barrier up to 27-in design height. Replace Block at \$30- per -Each for 1 Block(s) = \$30. Replace the 1 broken block. Low Speed Traffic Control at \$1475- per -Day for 1 Day(s) = \$1475.

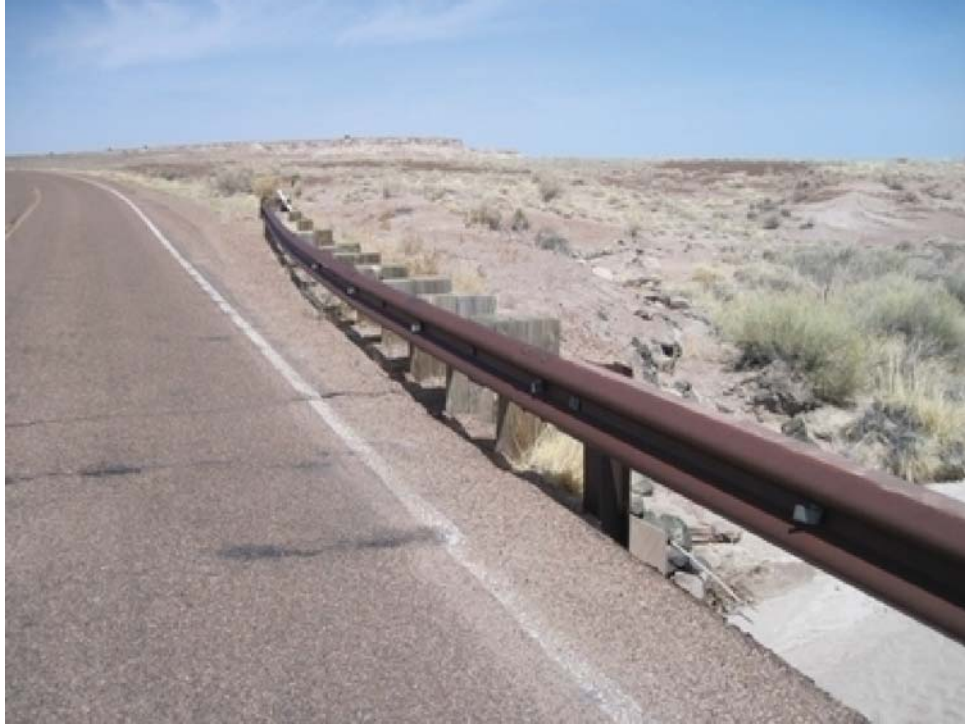
PEFO_0010_19.431_L_1.jpg

Barrier ID:	PEFO-0010-19.431-L				
Route Name:	NORTH-SOUTH HIGHWAY				
Inspection Date:	03/04/2010	Barrier Rating:	31.20		
Barrier Description					
Type:	W-BEAM STRONG POST	Barrier Function:	TRAFFIC		
Barrier Material:	WEATHERING STEEL/CORTEN	Post Material:	WOOD		
Blockout Type:	WOOD	Length (ft.):	52		
Speed Limit (MPH):	45	Placement with Respect to Road:	OUTSIDE OF CURVE		
Hazard Behind Barrier:	LOW				
Barrier Crashworthiness					
Appropriate Test Level:	TL-2	Barrier Test Level:	TL-3	Is Barrier Crashworthy?:	YES
Beg. End Trtmt Type:	W-BEAM BCT	Is Beg. End Trtmt Crashworthy?:	NO	Approach Transition Type:	RIGID W-BEAM - W-BEAM
Ending End Trtmt Type:	NONE	Ending End Trtmt Crashworthy?:	N/A		
Average Measurements					
Design Height (In.):	27	Width (In.):	0.0	Post Spacing (In.):	75.5
Height (In.):	25.0	Lateral Offset (In.):	43.2	Road Grade (%):	1.50
Physical Condition					
Barrier	Alignment and Height:	Alignment acceptable. 52-ft was between 1 and 3-in below the 27-in design height.

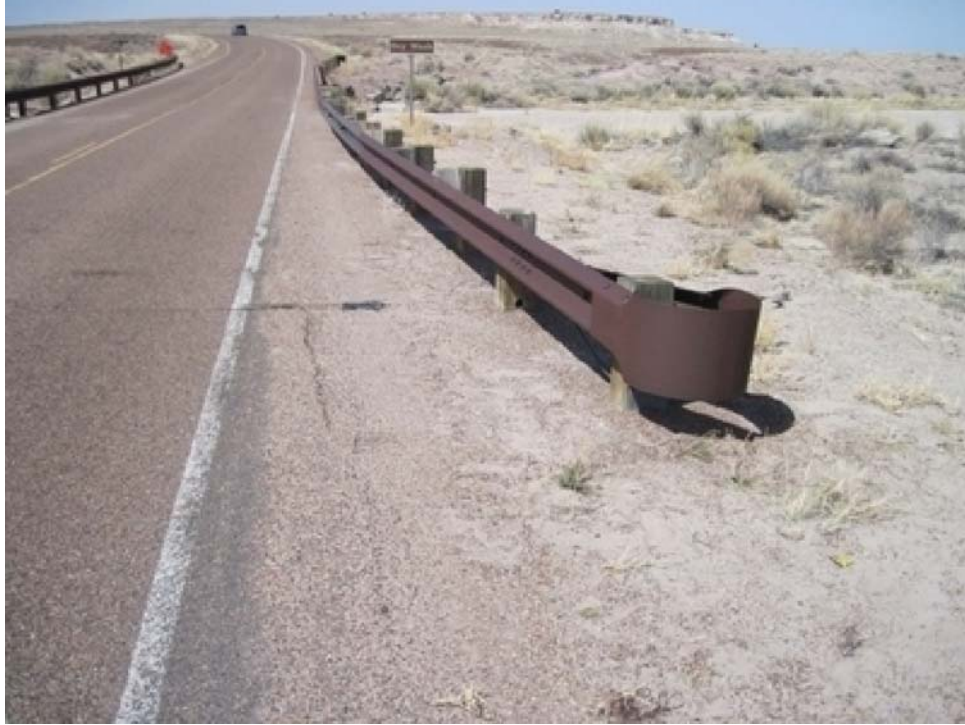
PEFO_0010_19.448_L_1.jpg

Barrier ID:	PEFO-0010-19.448-L				
Route Name:	NORTH-SOUTH HIGHWAY				
Inspection Date:	03/04/2010	Barrier Rating:	28.10		
Barrier Description					
Type:	W-BEAM STRONG POST	Barrier Function:	TRAFFIC		
Barrier Material:	WEATHERING STEEL/CORTEN	Post Material:	WOOD		
Blockout Type:	WOOD	Length (ft.):	76		
Speed Limit (MPH):	45	Placement with Respect to Road:	TANGENT		
Hazard Behind Barrier:	MEDIUM				
Barrier Crashworthiness					
Appropriate Test Level:	TL-2	Barrier Test Level:	TL-3	Is Barrier Crashworthy?:	YES
Beg. End Trtmt Type:	NONE	Is Beg. End Trtmt Crashworthy?:	N/A	Approach Transition Type:	RIGID W-BEAM - W-BEAM
Ending End Trtmt Type:	W-BEAM BCT	Ending End Trtmt Crashworthy?:	NO		
Average Measurements					
Design Height (In.):	27	Width (In.):	0.0	Post Spacing (In.):	75.1
Height (In.):	24.7	Lateral Offset (In.):	33.2	Road Grade (%):	0.60
Physical Condition					
Barrier	Alignment and Height:	Alignment acceptable. 76-ft was between 1 and 3-in below the 27-in design height.

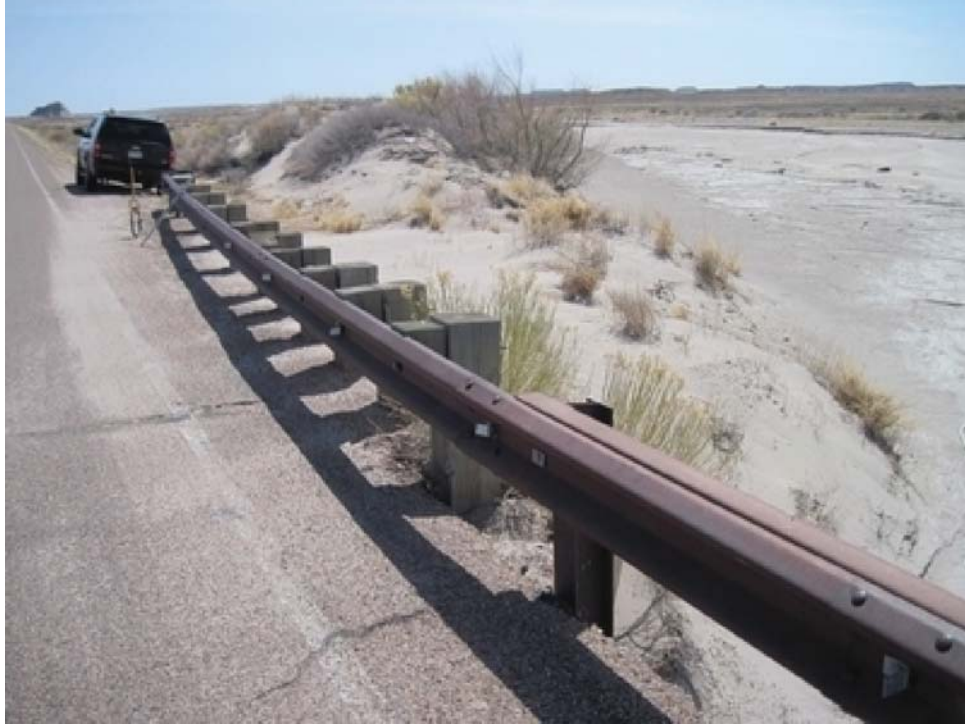
PEFO_0010_19.448_R_1.jpg

Barrier ID:	PEFO-0010-19.448-R				
Route Name:	NORTH-SOUTH HIGHWAY				
Inspection Date:	03/04/2010	Barrier Rating:	21.20		
Barrier Description					
Type:	W-BEAM STRONG POST	Barrier Function:	TRAFFIC		
Barrier Material:	WEATHERING STEEL/CORTEN	Post Material:	WOOD		
Blockout Type:	WOOD	Length (ft.):	52		
Speed Limit (MPH):	45	Placement with Respect to Road:	TANGENT		
Hazard Behind Barrier:	LOW				
Barrier Crashworthiness					
Appropriate Test Level:	TL-2	Barrier Test Level:	TL-3	Is Barrier Crashworthy?:	YES
Beg. End Trtmt Type:	NONE	Is Beg. End Trtmt Crashworthy?:	N/A	Approach Transition Type:	RIGID W-BEAM - W-BEAM
Ending End Trtmt Type:	W-BEAM BCT	Ending End Trtmt Crashworthy?:	NO		
Average Measurements					
Design Height (In.):	27	Width (In.):	0.0	Post Spacing (In.):	75.0
Height (In.):	26.2	Lateral Offset (In.):	44.7	Road Grade (%):	0.80
Physical Condition					
Barrier	Alignment and Height:	Alignment is acceptable. Height is within 1-in of 27-in design height.

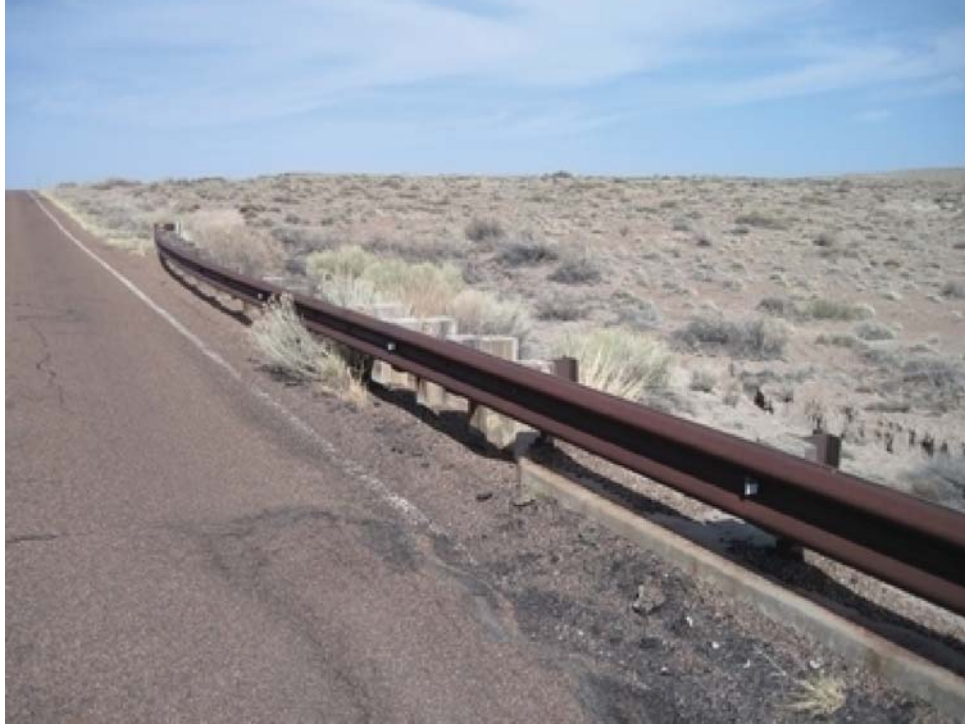
PEFO_0010_22.315_L_1.jpg

Barrier ID:	PEFO-0010-22.315-L				
Route Name:	NORTH-SOUTH HIGHWAY				
Inspection Date:	03/04/2010	Barrier Rating:	25.20		
Barrier Description					
Type:	W-BEAM STRONG POST	Barrier Function:	TRAFFIC		
Barrier Material:	WEATHERING STEEL/CORTEN	Post Material:	WOOD		
Blockout Type:	WOOD	Length (ft.):	77		
Speed Limit (MPH):	45	Placement with Respect to Road:	TANGENT		
Hazard Behind Barrier:	MEDIUM				
Barrier Crashworthiness					
Appropriate Test Level:	TL-2	Barrier Test Level:	TL-3	Is Barrier Crashworthy?:	YES
Beg. End Trtmt Type:	W-BEAM BCT	Is Beg. End Trtmt Crashworthy?:	NO	Approach Transition Type:	RIGID W-BEAM - W-BEAM
Ending End Trtmt Type:	NONE	Ending End Trtmt Crashworthy?:	N/A		
Average Measurements					
Design Height (In.):	27	Width (In.):	0.0	Post Spacing (In.):	75.0
Height (In.):	25.2	Lateral Offset (In.):	24.2	Road Grade (%):	2.00
Physical Condition					
Barrier	Alignment and Height:	Alignment acceptable. 47-ft was between 1 and 3-in below the 27-in design height.
