PEFO GIP Report

NPS Guardwall/Rail Inventory Program Petrified Forest National Park

Data Collection Date: April 2010
Report Date: November 2015

Petrified Forest National Park in Arizona

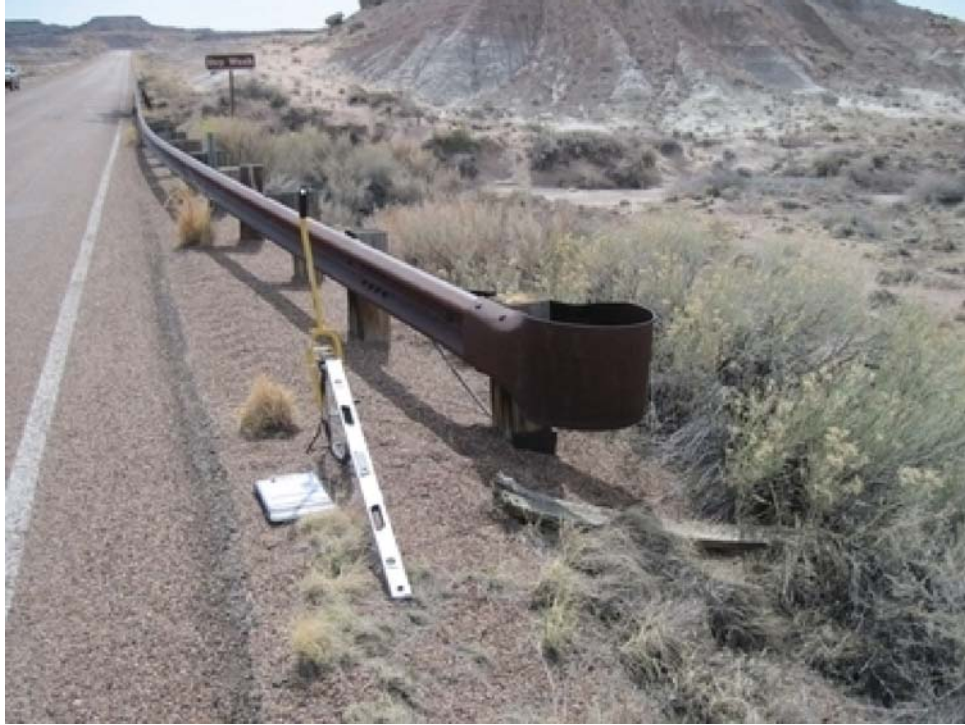
PEFO_0010_22.318_R_1.jpg

Barrier ID:	PEFO-0010-22.318-R				
Route Name:	NORTH-SOUTH HIGHWAY				
Inspection Date:	03/04/2010	Barrier Rating:	22.70		
Barrier Description					
Type:	W-BEAM STRONG POST	Barrier Function:	TRAFFIC		
Barrier Material:	WEATHERING STEEL/CORTEN	Post Material:	WOOD		
Blockout Type:	WOOD	Length (ft.):	70		
Speed Limit (MPH):	45	Placement with Respect to Road:	TANGENT		
Hazard Behind Barrier:	LOW				
Barrier Crashworthiness					
Appropriate Test Level:	TL-2	Barrier Test Level:	TL-3	Is Barrier Crashworthy?:	YES
Beg. End Trtmt Type:	W-BEAM BCT	Is Beg. End Trtmt Crashworthy?:	NO	Approach Transition Type:	RIGID W-BEAM - W-BEAM
Ending End Trtmt Type:	NONE	Ending End Trtmt Crashworthy?:	N/A		
Average Measurements					
Design Height (In.):	27	Width (In.):	0.0	Post Spacing (In.):	74.8
Height (In.):	24.5	Lateral Offset (In.):	29.2	Road Grade (%):	1.60
Physical Condition					
Barrier	Alignment and Height:	Alignment acceptable. 70-ft was between 1 and 3-in below the 27-in design height.

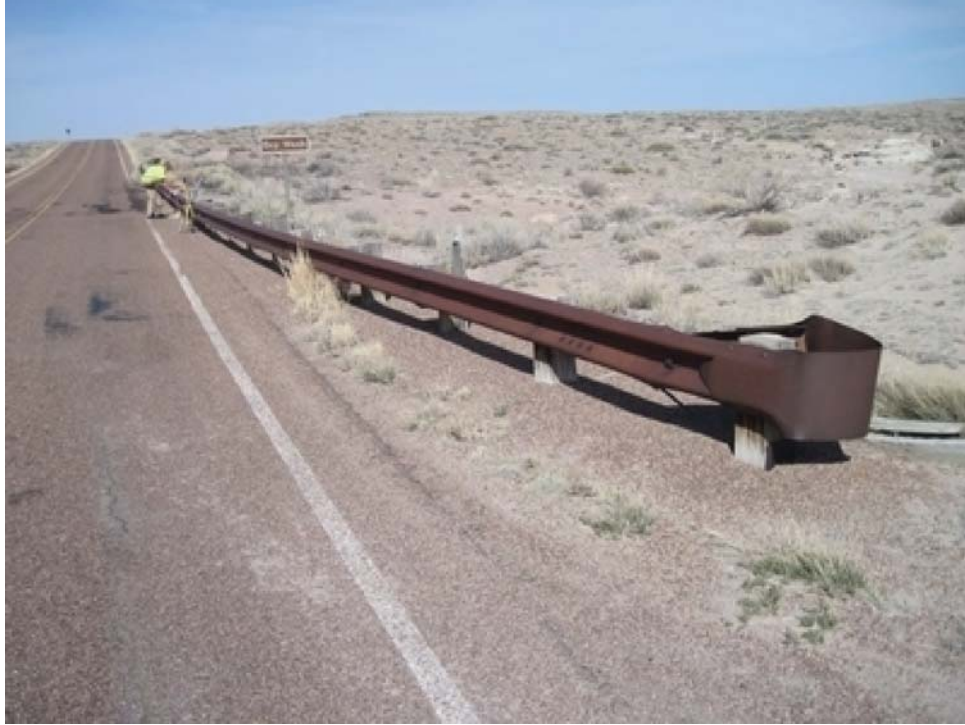
PEFO_0010_22.342_L_1.jpg

Barrier ID:	PEFO-0010-22.342-L				
Route Name:	NORTH-SOUTH HIGHWAY				
Inspection Date:	03/04/2010	Barrier Rating:	30.00		
Barrier Description					
Type:	W-BEAM STRONG POST	Barrier Function:	TRAFFIC		
Barrier Material:	WEATHERING STEEL/CORTEN	Post Material:	WOOD		
Blockout Type:	WOOD	Length (ft.):	70		
Speed Limit (MPH):	45	Placement with Respect to Road:	TANGENT		
Hazard Behind Barrier:	LOW				
Barrier Crashworthiness					
Appropriate Test Level:	TL-2	Barrier Test Level:	TL-3	Is Barrier Crashworthy?:	YES
Beg. End Trtmt Type:	NONE	Is Beg. End Trtmt Crashworthy?:	N/A	Approach Transition Type:	RIGID W-BEAM - W-BEAM
Ending End Trtmt Type:	W-BEAM BCT	Ending End Trtmt Crashworthy?:	NO		
Average Measurements					
Design Height (In.):	27	Width (In.):	0.0	Post Spacing (In.):	73.8
Height (In.):	24.7	Lateral Offset (In.):	35.2	Road Grade (%):	0.20
Physical Condition					
Barrier	Alignment and Height:	Alignment acceptable. 70-ft was between 1 and 3-in below the 27-in design height.

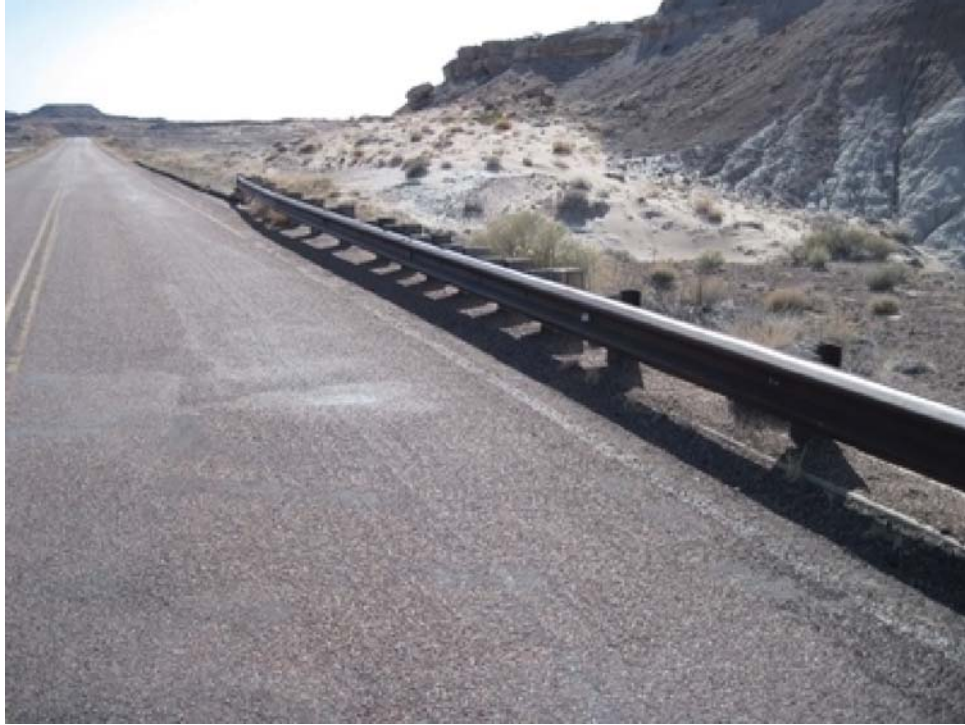
PEFO_0010_22.342_R_1.jpg

Barrier ID:	PEFO-0010-22.342-R				
Route Name:	NORTH-SOUTH HIGHWAY				
Inspection Date:	03/04/2010	Barrier Rating:	32.70		
Barrier Description					
Type:	W-BEAM STRONG POST	Barrier Function:	TRAFFIC		
Barrier Material:	WEATHERING STEEL/CORTEN	Post Material:	WOOD		
Blockout Type:	WOOD	Length (ft.):	76		
Speed Limit (MPH):	45	Placement with Respect to Road:	TANGENT		
Hazard Behind Barrier:	LOW				
Barrier Crashworthiness					
Appropriate Test Level:	TL-2	Barrier Test Level:	TL-3	Is Barrier Crashworthy?:	YES
Beg. End Trtmt Type:	NONE	Is Beg. End Trtmt Crashworthy?:	N/A	Approach Transition Type:	RIGID W-BEAM - W-BEAM
Ending End Trtmt Type:	W-BEAM BCT	Ending End Trtmt Crashworthy?:	NO		
Average Measurements					
Design Height (In.):	27	Width (In.):	0.0	Post Spacing (In.):	75.0
Height (In.):	24.5	Lateral Offset (In.):	22.0	Road Grade (%):	0.10
Physical Condition					
Barrier	Alignment and Height:	Alignment acceptable. 76-ft was between 1 and 3-in below the 27-in design height.

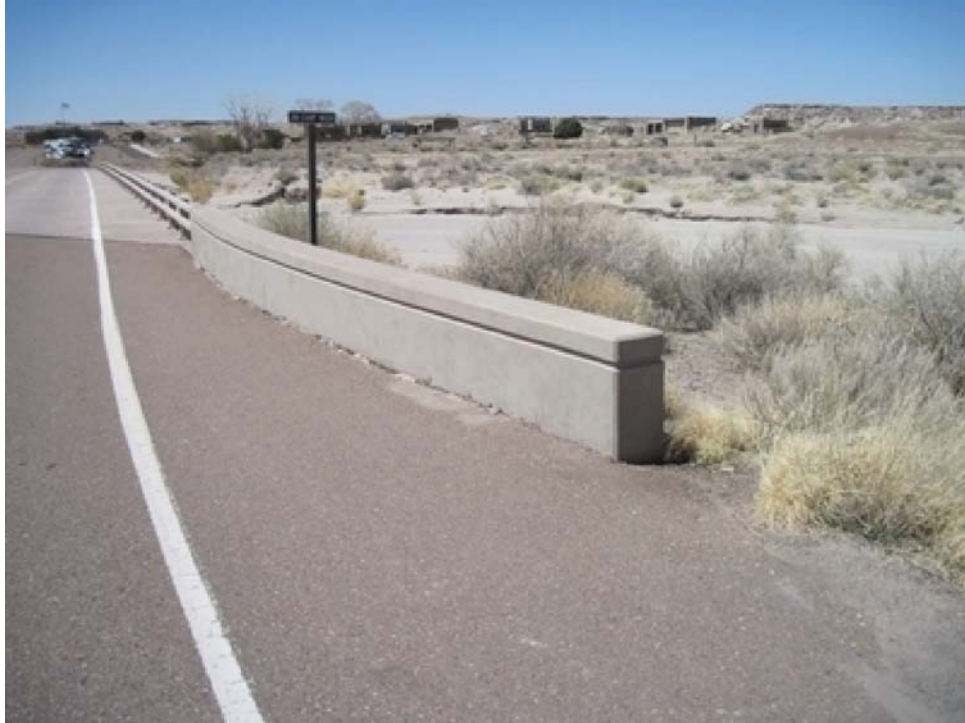
PEFO_0010_26.084_R_1.jpg

Barrier ID:	PEFO-0010-26.084-R				
Route Name:	NORTH-SOUTH HIGHWAY				
Inspection Date:	04/04/2010	Barrier Rating:	17.80		
Barrier Description					
Type:	OTHER: CONCRETE BLOCK	Barrier Function:	TRAFFIC		
Barrier Material:	CONCRETE	Post Material:	N/A		
Blockout Type:	N/A	Length (ft.):	34		
Speed Limit (MPH):	15	Placement with Respect to Road:	INSIDE OF CURVE		
Hazard Behind Barrier:	MEDIUM				
Barrier Crashworthiness					
Appropriate Test Level:	TL-1	Barrier Test Level:	NCW	Is Barrier Crashworthy?:	NO
Beg. End Trtmt Type:	NONE	Is Beg. End Trtmt Crashworthy?:	N/A	Approach Transition Type:	NONE
Ending End Trtmt Type:	NONE	Ending End Trtmt Crashworthy?:	N/A		
Average Measurements					
Design Height (In.):	24	Width (In.):	15.0	Post Spacing (In.):	0.0
Height (In.):	26.5	Lateral Offset (In.):	56.0	Road Grade (%):	1.40
Physical Condition					
Barrier	Alignment and Height:	Alignment is acceptable. Height is within 3-in of 24-in design height.

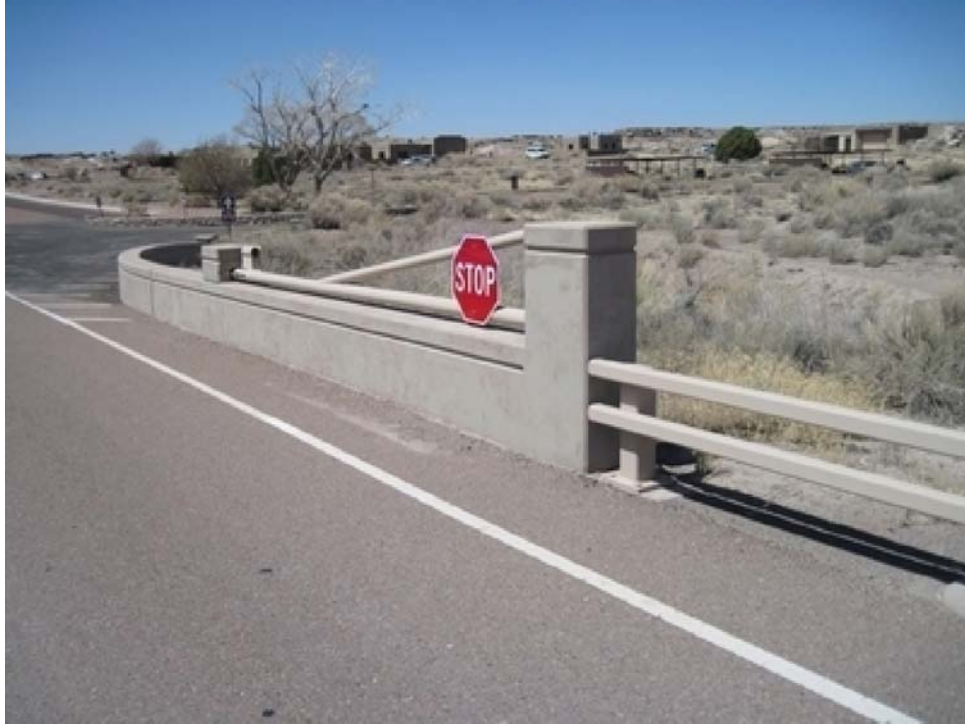
PEFO_0010_26.146_R_1.jpg

Barrier ID:	PEFO-0010-26.146-R				
Route Name:	NORTH-SOUTH HIGHWAY				
Inspection Date:	04/04/2010	Barrier Rating:	15.00		
Barrier Description					
Type:	OTHER: CONCRETE BLOCK	Barrier Function:	TRAFFIC		
Barrier Material:	CONCRETE	Post Material:	N/A		
Blockout Type:	N/A	Length (ft.):	78		
Speed Limit (MPH):	15	Placement with Respect to Road:	TANGENT		
Hazard Behind Barrier:	MEDIUM				
Barrier Crashworthiness					
Appropriate Test Level:	TL-1	Barrier Test Level:	NCW	Is Barrier Crashworthy?:	NO
Beg. End Trtmt Type:	NONE	Is Beg. End Trtmt Crashworthy?:	N/A	Approach Transition Type:	NONE
Ending End Trtmt Type:	NONE	Ending End Trtmt Crashworthy?:	N/A		
Average Measurements					
Design Height (In.):	24	Width (In.):	16.0	Post Spacing (In.):	0.0
Height (In.):	27.5	Lateral Offset (In.):	70.0	Road Grade (%):	1.40
Physical Condition					
Barrier	Alignment and Height:	Alignment is acceptable. Height is within 3-in of 24-in design height.

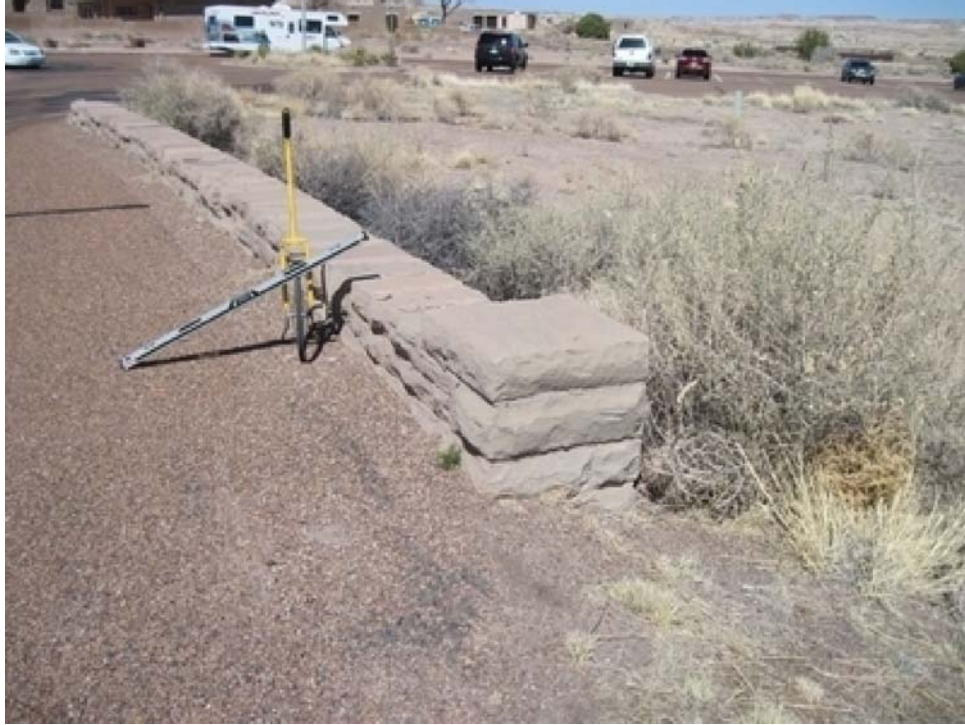
PEFO_0010_26.282_L_1.jpg

Barrier ID:	PEFO-0010-26.282-L				
Route Name:	NORTH-SOUTH HIGHWAY				
Inspection Date:	04/04/2010	Barrier Rating:	36.20		
Barrier Description					
Type:	STONE MASONRY WITHOUT CONCRETE CORE WALL	Barrier Function:	TRAFFIC		
Barrier Material:	STONE	Post Material:	N/A		
Blockout Type:	N/A	Length (ft.):	47		
Speed Limit (MPH):	15	Placement with Respect to Road:	TANGENT		
Hazard Behind Barrier:	LOW				
Barrier Crashworthiness					
Appropriate Test Level:	TL-1	Barrier Test Level:	NCW	Is Barrier Crashworthy?:	NO
Beg. End Trtmt Type:	NONE	Is Beg. End Trtmt Crashworthy?:	N/A	Approach Transition Type:	NONE
Ending End Trtmt Type:	NONE	Ending End Trtmt Crashworthy?:	N/A		
Average Measurements					
Design Height (In.):	24	Width (In.):	20.0	Post Spacing (In.):	0.0
Height (In.):	13.0	Lateral Offset (In.):	99.3	Road Grade (%):	0.20
Physical Condition					
Barrier	Alignment and Height:	The alignment has no deflection. The entire length of the wall is below 11 in below the 24 in design height.

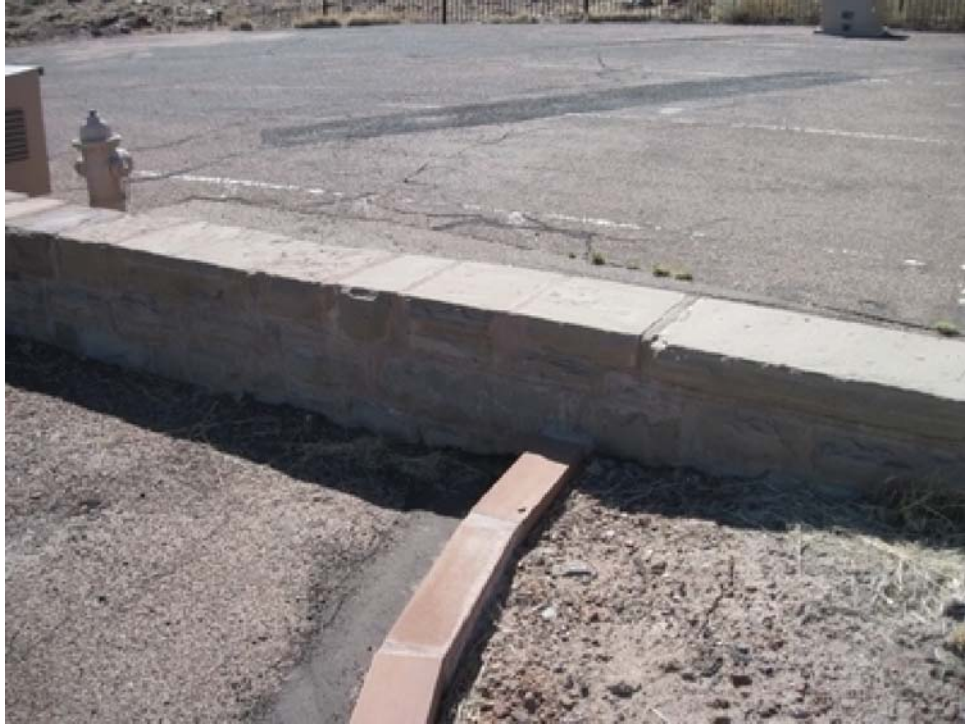
PEFO_0010_26.284_R_1.jpg

Barrier ID:	PEFO-0010-26.284-R				
Route Name:	NORTH-SOUTH HIGHWAY				
Inspection Date:	04/04/2010	Barrier Rating:	4.10		
Barrier Description					
Type:	STONE MASONRY WITHOUT CONCRETE CORE WALL	Barrier Function:	NON-TRAFFIC		
Barrier Material:	STONE	Post Material:	N/A		
Blockout Type:	N/A	Length (ft.):	44		
Speed Limit (MPH):	15	Placement with Respect to Road:	NON-TRAFFIC BARRIER		
Hazard Behind Barrier:	N/A				
Barrier Crashworthiness					
Appropriate Test Level:	TL-1	Barrier Test Level:	N/A	Is Barrier Crashworthy?:	N/A
Beg. End Trtmt Type:	NONE	Is Beg. End Trtmt Crashworthy?:	N/A	Approach Transition Type:	NONE
Ending End Trtmt Type:	NONE	Ending End Trtmt Crashworthy?:	N/A		
Average Measurements					
Design Height (In.):	24	Width (In.):	20.0	Post Spacing (In.):	0.0
Height (In.):	24.0	Lateral Offset (In.):	0.0	Road Grade (%):	0.00
Physical Condition					
Barrier	Alignment and Height:	Alignment is acceptable. Height is within 3-in of 24-in design height.

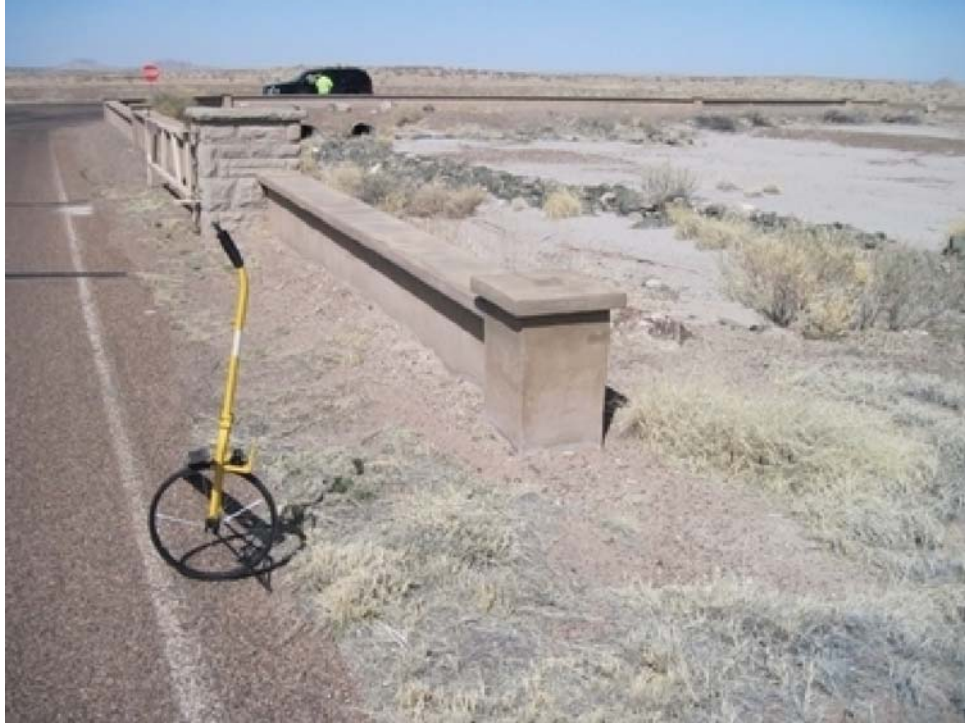
PEFO_0011_0.008_L_1.jpg

Barrier ID:	PEFO-0011-0.008-L				
Route Name:	BLUE MESA ROAD				
Inspection Date:	04/04/2010	Barrier Rating:	19.20		
Barrier Description					
Type:	OTHER: CONCRETE BLOCK	Barrier Function:	TRAFFIC		
Barrier Material:	CONCRETE	Post Material:	N/A		
Blockout Type:	N/A	Length (ft.):	114		
Speed Limit (MPH):	35	Placement with Respect to Road:	TANGENT		
Hazard Behind Barrier:	MEDIUM				
Barrier Crashworthiness					
Appropriate Test Level:	TL-2	Barrier Test Level:	NCW	Is Barrier Crashworthy?:	NO
Beg. End Trtmt Type:	NONE	Is Beg. End Trtmt Crashworthy?:	N/A	Approach Transition Type:	NONE
Ending End Trtmt Type:	NONE	Ending End Trtmt Crashworthy?:	N/A		
Average Measurements					
Design Height (In.):	24	Width (In.):	8.0	Post Spacing (In.):	0.0
Height (In.):	28.7	Lateral Offset (In.):	70.3	Road Grade (%):	1.20
Physical Condition					
Barrier	Alignment and Height:	Alignment is acceptable. Height is 0-10 in above 24-in design height.

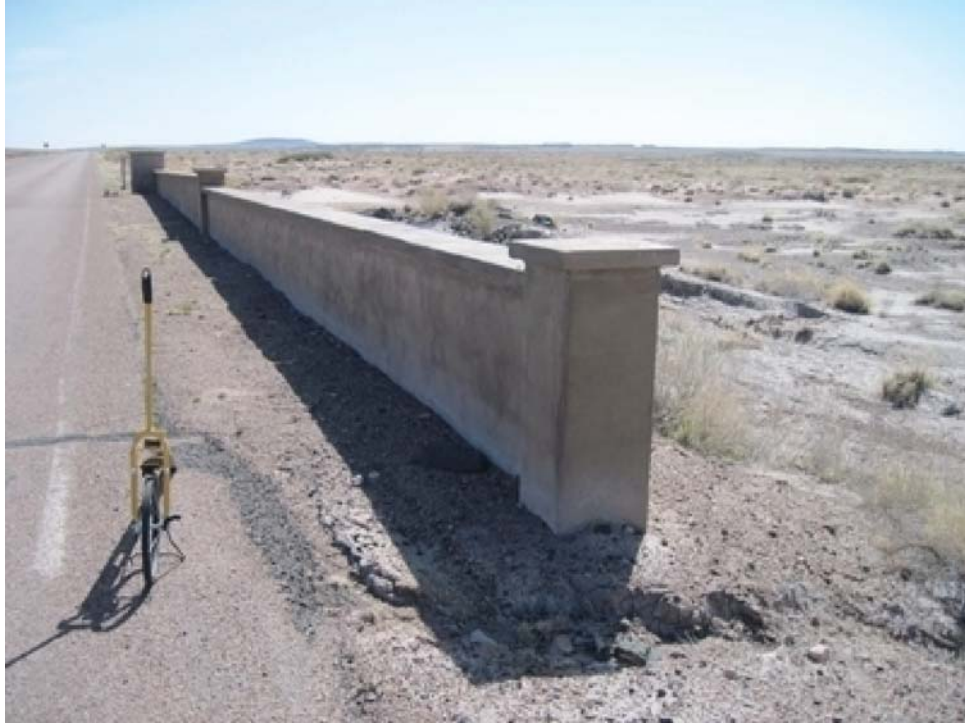
PEFO_0011_0.012_R_1.jpg

Barrier ID:	PEFO-0011-0.012-R				
Route Name:	BLUE MESA ROAD				
Inspection Date:	04/04/2010	Barrier Rating:	16.70		
Barrier Description					
Type:	OTHER: CONCRETE BLOCK	Barrier Function:	TRAFFIC		
Barrier Material:	CONCRETE	Post Material:	N/A		
Blockout Type:	N/A	Length (ft.):	111		
Speed Limit (MPH):	35	Placement with Respect to Road:	TANGENT		
Hazard Behind Barrier:	LOW				
Barrier Crashworthiness					
Appropriate Test Level:	TL-2	Barrier Test Level:	NCW	Is Barrier Crashworthy?:	NO
Beg. End Trtmt Type:	NONE	Is Beg. End Trtmt Crashworthy?:	N/A	Approach Transition Type:	NONE
Ending End Trtmt Type:	NONE	Ending End Trtmt Crashworthy?:	N/A		
Average Measurements					
Design Height (In.):	24	Width (In.):	8.0	Post Spacing (In.):	0.0
Height (In.):	28.7	Lateral Offset (In.):	69.0	Road Grade (%):	2.20
Physical Condition					
Barrier	Alignment and Height:	Alignment is acceptable. Height is 0-9 in above 24-in design height.

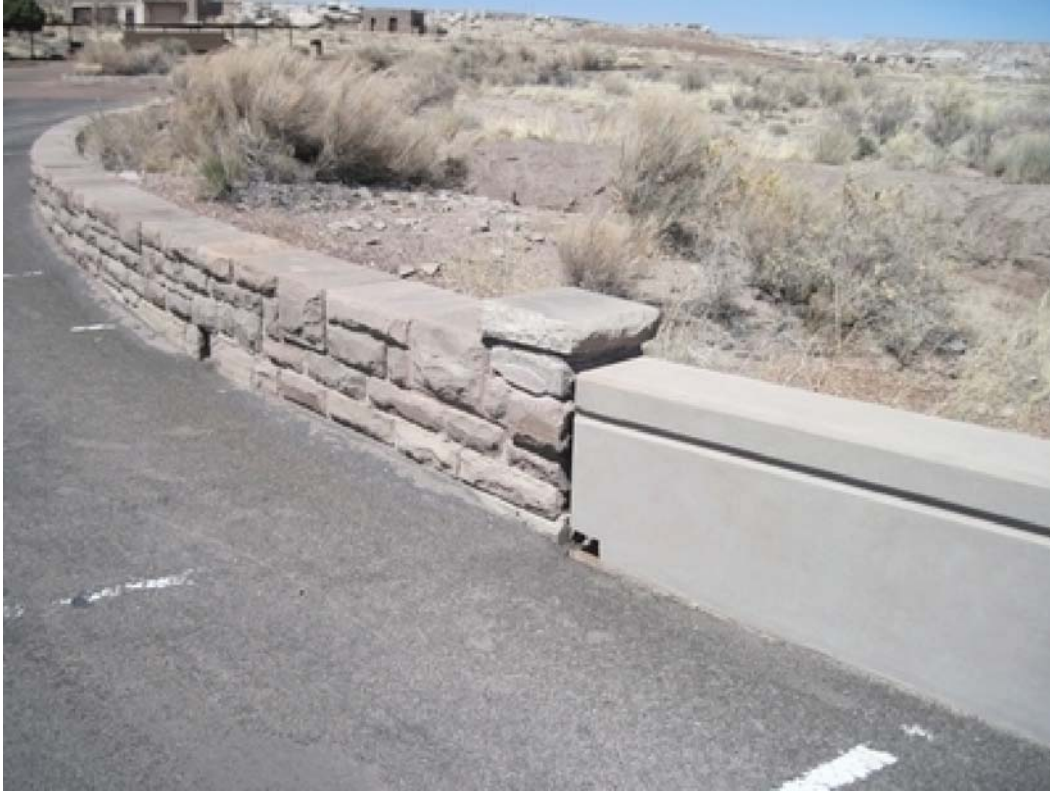
PEFO_0901_0.000_P1_1.jpg

Barrier ID:	PEFO-0901-0.000-P1				
Route Name:	RF MUSEUM AND PICNIC PARKING				
Inspection Date:	04/04/2010	Barrier Rating:	19.80		
Barrier Description					
Type:	STONE MASONRY WITHOUT CONCRETE CORE WALL	Barrier Function:	NON-TRAFFIC		
Barrier Material:	STONE	Post Material:	N/A		
Blockout Type:	N/A	Length (ft.):	84		
Speed Limit (MPH):	15	Placement with Respect to Road:	NON-TRAFFIC BARRIER		
Hazard Behind Barrier:	LOW				
Barrier Crashworthiness					
Appropriate Test Level:	TL-1	Barrier Test Level:	N/A	Is Barrier Crashworthy?:	N/A
Beg. End Trtmt Type:	NONE	Is Beg. End Trtmt Crashworthy?:	N/A	Approach Transition Type:	NONE
Ending End Trtmt Type:	NONE	Ending End Trtmt Crashworthy?:	N/A		
Average Measurements					
Design Height (In.):	24	Width (In.):	19.0	Post Spacing (In.):	0.0
Height (In.):	18.7	Lateral Offset (In.):	0.0	Road Grade (%):	0.00
Physical Condition					
Barrier	Alignment and Height:	Alignment is acceptable. Height is 3-6 in below 24-in design height for 14 ft and more than 6 in below the 24-in design height for 30 ft.

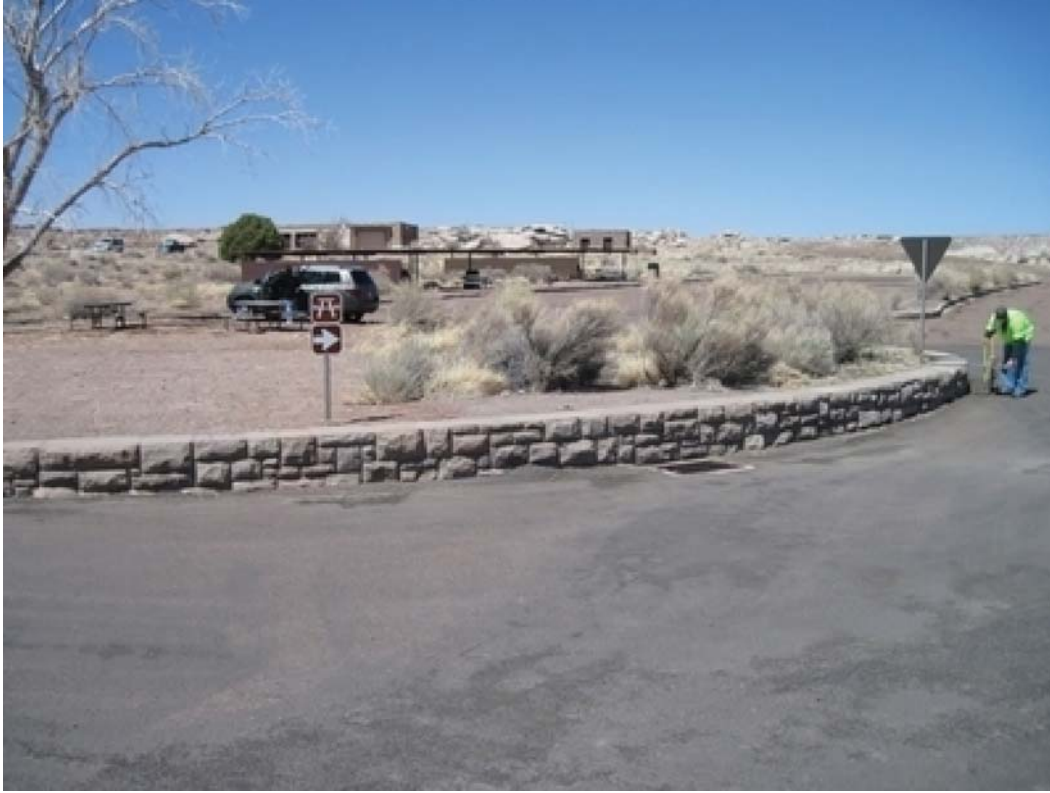
PEFO_0901_0.000_P2_1.jpg

Barrier ID:	PEFO-0901-0.000-P2				
Route Name:	RF MUSEUM AND PICNIC PARKING				
Inspection Date:	04/04/2010	Barrier Rating:	26.30		
Barrier Description					
Type:	STONE MASONRY WITHOUT CONCRETE CORE WALL	Barrier Function:	NON-TRAFFIC		
Barrier Material:	STONE	Post Material:	N/A		
Blockout Type:	N/A	Length (ft.):	118		
Speed Limit (MPH):	15	Placement with Respect to Road:	NON-TRAFFIC BARRIER		
Hazard Behind Barrier:	LOW				
Barrier Crashworthiness					
Appropriate Test Level:	TL-1	Barrier Test Level:	N/A	Is Barrier Crashworthy?:	N/A
Beg. End Trtmt Type:	NONE	Is Beg. End Trtmt Crashworthy?:	N/A	Approach Transition Type:	NONE
Ending End Trtmt Type:	NONE	Ending End Trtmt Crashworthy?:	N/A		
Average Measurements					
Design Height (In.):	24	Width (In.):	19.0	Post Spacing (In.):	0.0
Height (In.):	14.6	Lateral Offset (In.):	0.0	Road Grade (%):	0.00
Physical Condition					
Barrier	Alignment and Height:	Alignment is acceptable. 72ft. was 3-6 in below 24-in design height and 46ft. was more than 6 in below the 24-in design height.

Breaking and Cracking:	There was no breaking or cracking observed.			
	Missing Elements:	There are no missing elements.			
	Corrosion and Weathering:	There was no corrosion or weathering observed.			
End Treatments	Alignment and Height:				
	Breaking and Cracking:				
	Missing Elements:				
	Corrosion and Weathering:

Repair Action:	REPAIR	FMSS Work Type:	DEFERRED MAINTENANCE	Repair Cost:	\$47658
Brief Workorder:	Raise guardwall 6-in. Remove and reset 46-ft. of stone masonry guardwall on concrete footer to adjacent 18-in height.				
Workorder:	<p>Remove & Reset Stone Masonry Guardwall at \$250- per -Cu. Ft. for 147 CF = \$36750. Remove and reset guardwall. [(1.6ft)(2ft)(46ft)] = 147CF.</p> <p>Structural Concrete at \$1000- per -Cu. Yd. for 2 CY = \$2000. Structural concrete for stability. [(1.6ft)(0.5ft)(46ft)] /27 = 1.4CY.</p> <p>Replace Block at \$30- per -Each for 5 Block(s) = \$150. Replace 5 cracked blocks.</p> <p>Low Speed Traffic Control at \$1475- per -Day for 3 Day(s) = \$4425. Parking lot but traffic control may be needed. 1 day removal 2 days installation.</p>
