GIP Report

NPS Guardwall/Rail Inventory Program  
Rock Creek Park

Federal Lands Highway  
Road Inventory Program

Data Collection Date: November 2010  
Report Date: December 2015

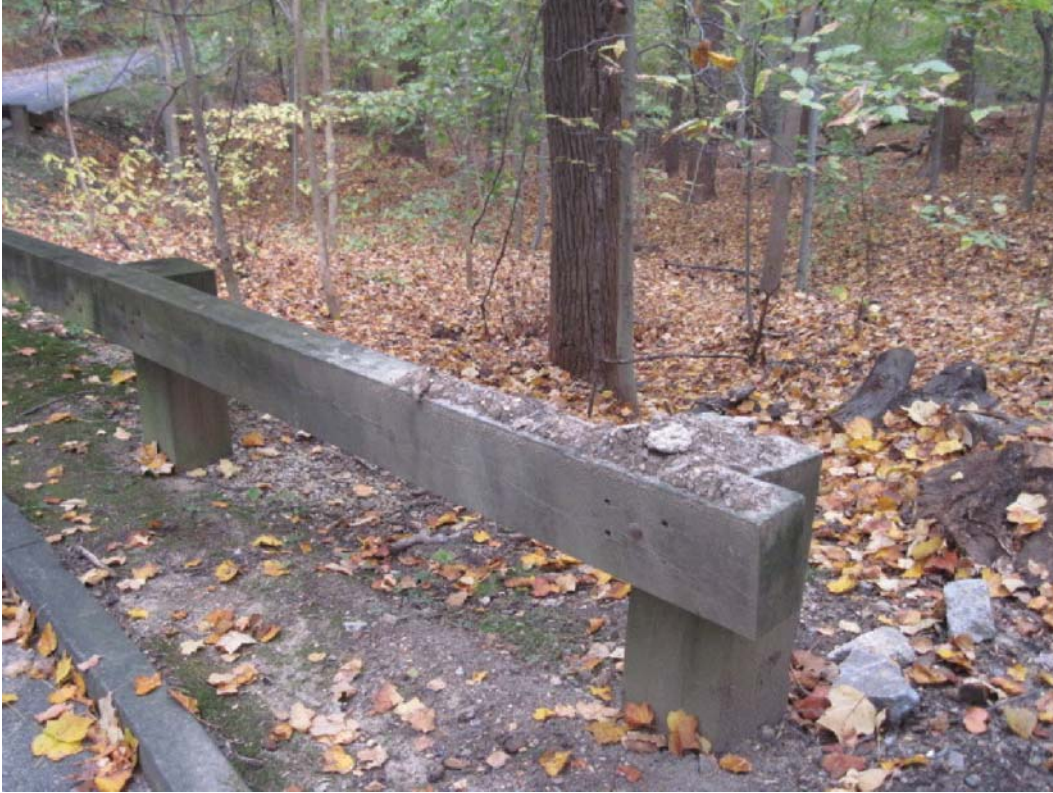
**ROCR\_0927\_0.000\_P1\_1.jpg**

| <b>Barrier</b> | <b>Alignment and Height:</b> | No alignment deflection observed. Height is 3 in above 27 in design height. | | | |
| | <b>Breaking and Cracking:</b> | No breaking or cracking observed. | | | |
| | <b>Missing Elements:</b> | No missing elements observed. | | | |
| | <b>Corrosion and Weathering:</b> | No corrosion or weathering observed. | | | |

| <b>Repair Action:</b> | NO ACTION | <b>FMSS Work Type:</b> | N/A | <b>Repair Cost:</b> | \$0 |

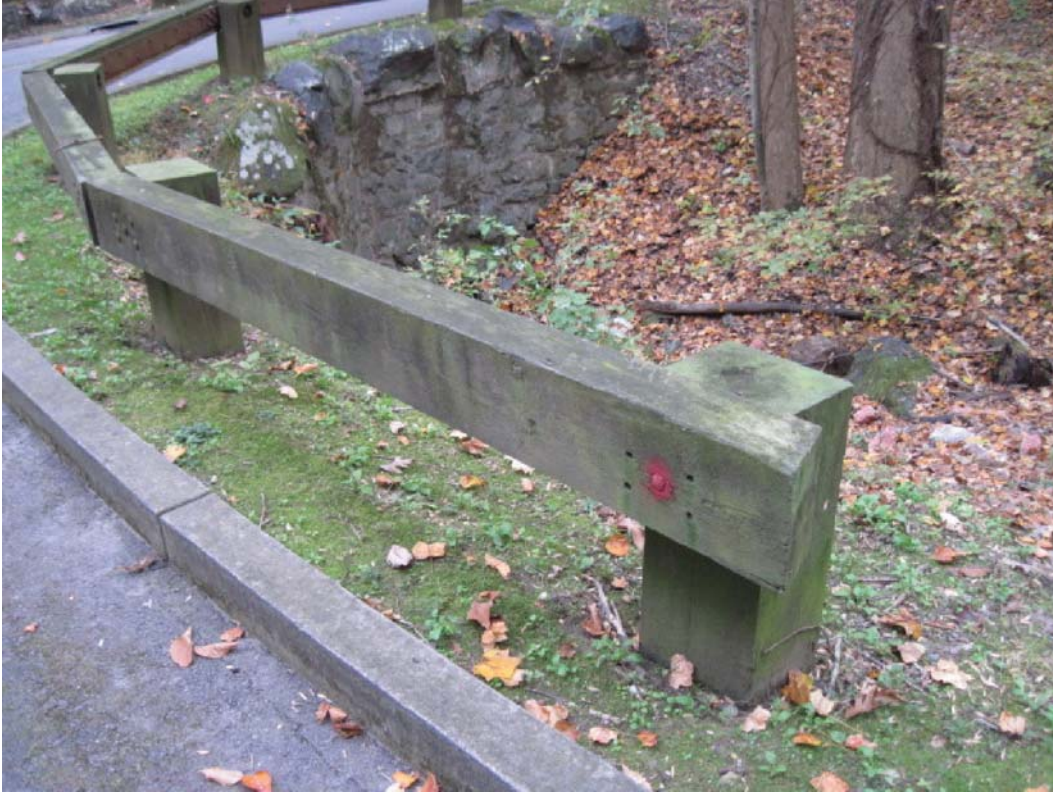
**ROCR\_0929\_0.000\_P1\_1.jpg**

| <b>Barrier</b> | <b>Alignment and Height:</b> | No alignment deflection observed. Height is 1-in or less below the 27-in design height. | | | |
| | <b>Breaking and Cracking:</b> | No breaking or cracking observed. | | | |
| | <b>Missing Elements:</b> | No missing elements observed. | | | |
| | <b>Corrosion and Weathering:</b> | No corrosion or weathering observed. | | | |

| <b>Repair Action:</b> | NO ACTION | <b>FMSS Work Type:</b> | N/A | <b>Repair Cost:</b> | \$0 |
