# ROMO GIP Report

## NPS Guardwall/Rail Inventory Program Rocky Mountain National Park

**Federal Highway Administration  
Eastern Federal Lands Highway Division  
Road Inventory Program (RIP)**

**Data Collection Date: October 2009  
Report Date: November 2015**

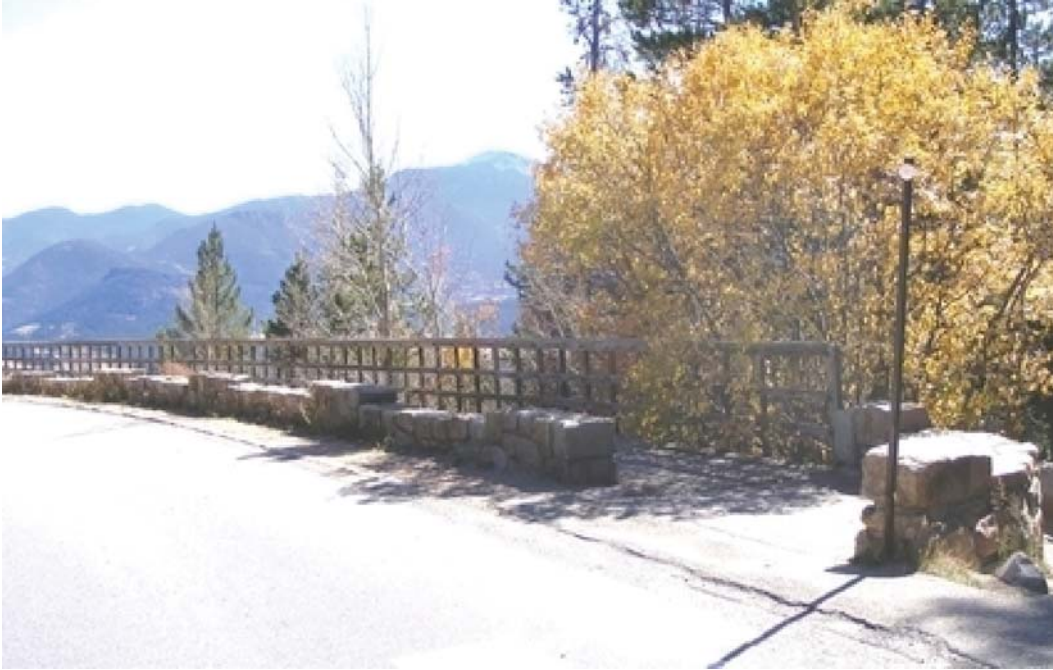
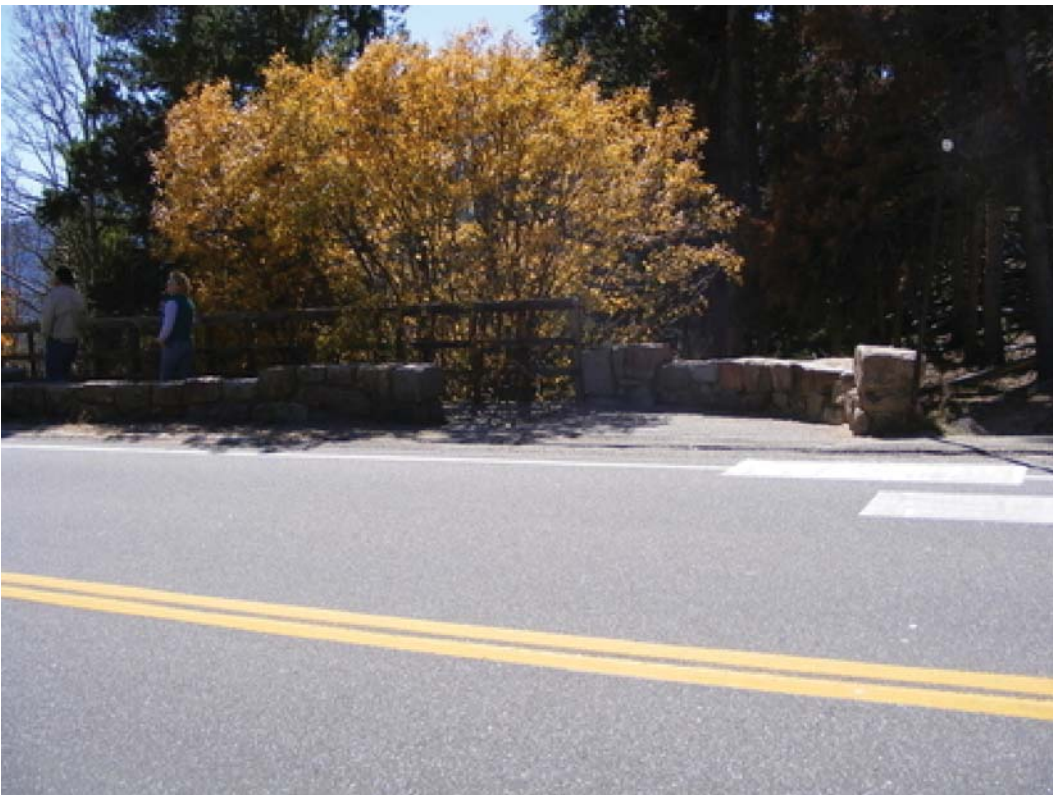
**ROMO\_0010\_8.021\_L\_1.jpg**

<b>Barrier ID:</b>	ROMO-0010-8.021-L				
<b>Route Name:</b>	TRAIL RIDGE ROAD				
<b>Inspection Date:</b>	10/02/2009	<b>Barrier Rating:</b>	61.40		
<b>Barrier Description</b>					
<b>Type:</b>	STONE MASONRY WITHOUT CONCRETE CORE WALL	<b>Barrier Function:</b>	TRAFFIC		
<b>Barrier Material:</b>	STONE	<b>Post Material:</b>	N/A		
<b>Blockout Type:</b>	N/A	<b>Length (ft.):</b>	443		
<b>Speed Limit (MPH):</b>	35	<b>Placement with Respect to Road:</b>	OUTSIDE OF CURVE		
<b>Hazard Behind Barrier:</b>	HIGH				
<b>Barrier Crashworthiness</b>					
<b>Appropriate Test Level:</b>	TL-2	<b>Barrier Test Level:</b>	NCW	<b>Is Barrier Crashworthy?:</b>	NO
<b>Beg. End Trtmt Type:</b>	NONE	<b>Is Beg. End Trtmt Crashworthy?:</b>	N/A	<b>Approach Transition Type:</b>	NONE
<b>Ending End Trtmt Type:</b>	NONE	<b>Ending End Trtmt Crashworthy?:</b>	N/A		
<b>Average Measurements</b>					
<b>Design Height (In.):</b>	24	<b>Width (In.):</b>	18.2	<b>Post Spacing (In.):</b>	0.0

<b>Height (In.):</b>	17.2	<b>Lateral Offset (In.):</b>	73.0	<b>Road Grade (%):</b>	6.30
<b>Physical Condition</b>					
<b>Barrier</b>	<b>Alignment and Height:</b>	Alignment acceptable. Height was within 3-in of the 18-in/24-in crenellated design height.			
	<b>Breaking and Cracking:</b>	No breaking or cracking observed.			
	<b>Missing Elements:</b>	No missing elements observed.			
	<b>Corrosion and Weathering:</b>	No corrosion or weathering observed.			
<b>End Treatments</b>	<b>Alignment and Height:</b>				
	<b>Breaking and Cracking:</b>				
	<b>Missing Elements:</b>				
	<b>Corrosion and Weathering:</b>

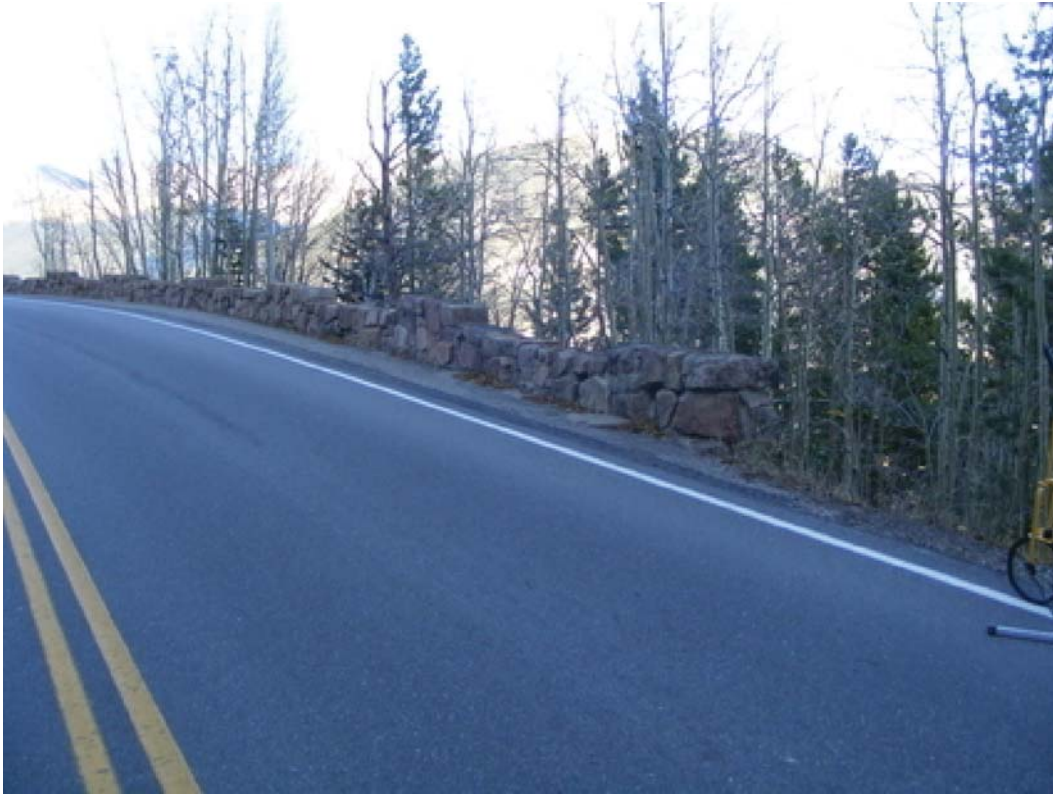
ROMO\_0010\_8.418\_R\_1.jpg

<b>Barrier ID:</b>	ROMO-0010-8.418-R				
<b>Route Name:</b>	TRAIL RIDGE ROAD				
<b>Inspection Date:</b>	10/02/2009	<b>Barrier Rating:</b>	48.40		
<b>Barrier Description</b>					
<b>Type:</b>	STONE MASONRY WITHOUT CONCRETE CORE WALL	<b>Barrier Function:</b>	TRAFFIC		
<b>Barrier Material:</b>	STONE	<b>Post Material:</b>	N/A		
<b>Blockout Type:</b>	N/A	<b>Length (ft.):</b>	490		
<b>Speed Limit (MPH):</b>	35	<b>Placement with Respect to Road:</b>	OUTSIDE OF CURVE		
<b>Hazard Behind Barrier:</b>	HIGH				
<b>Barrier Crashworthiness</b>					
<b>Appropriate Test Level:</b>	TL-2	<b>Barrier Test Level:</b>	NCW	<b>Is Barrier Crashworthy?:</b>	NO
<b>Beg. End Trtmt Type:</b>	NONE	<b>Is Beg. End Trtmt Crashworthy?:</b>	N/A	<b>Approach Transition Type:</b>	NONE
<b>Ending End Trtmt Type:</b>	NONE	<b>Ending End Trtmt Crashworthy?:</b>	N/A		
<b>Average Measurements</b>					
<b>Design Height (In.):</b>	24	<b>Width (In.):</b>	19.7	<b>Post Spacing (In.):</b>	0.0

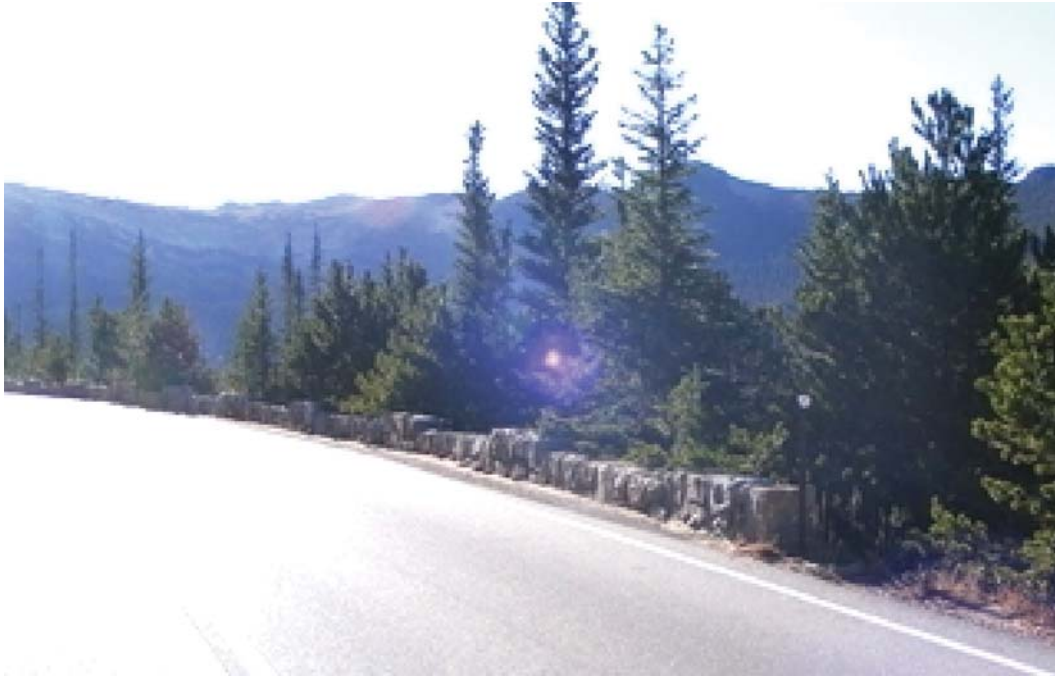
**ROMO\_0010\_9.075\_R\_1.jpg**

<b>Barrier ID:</b>	ROMO-0010-9.075-R				
<b>Route Name:</b>	TRAIL RIDGE ROAD				
<b>Inspection Date:</b>	10/02/2009	<b>Barrier Rating:</b>	59.20		
<b>Barrier Description</b>					
<b>Type:</b>	STONE MASONRY WITHOUT CONCRETE CORE WALL	<b>Barrier Function:</b>	TRAFFIC		
<b>Barrier Material:</b>	STONE	<b>Post Material:</b>	N/A		
<b>Blockout Type:</b>	N/A	<b>Length (ft.):</b>	168		
<b>Speed Limit (MPH):</b>	35	<b>Placement with Respect to Road:</b>	OUTSIDE OF CURVE		
<b>Hazard Behind Barrier:</b>	HIGH				
<b>Barrier Crashworthiness</b>					
<b>Appropriate Test Level:</b>	TL-2	<b>Barrier Test Level:</b>	NCW	<b>Is Barrier Crashworthy?:</b>	NO
<b>Beg. End Trtmt Type:</b>	NONE	<b>Is Beg. End Trtmt Crashworthy?:</b>	N/A	<b>Approach Transition Type:</b>	NONE
<b>Ending End Trtmt Type:</b>	NONE	<b>Ending End Trtmt Crashworthy?:</b>	N/A		
<b>Average Measurements</b>					
<b>Design Height (In.):</b>	24	<b>Width (In.):</b>	17.0	<b>Post Spacing (In.):</b>	0.0

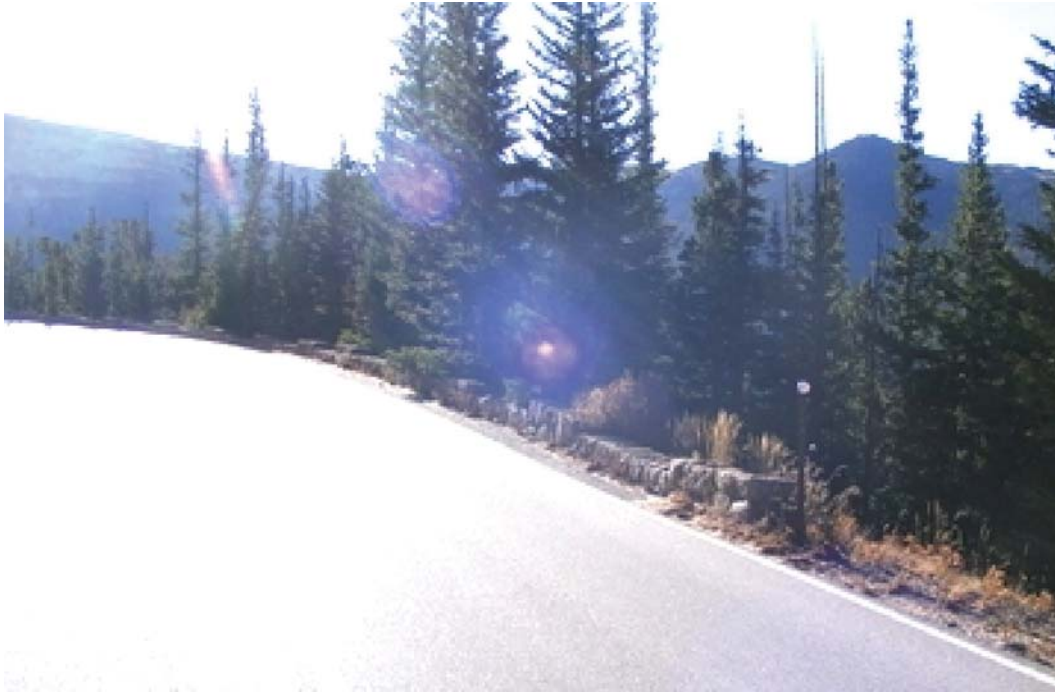
**ROMO\_0010\_9.220\_R\_1.jpg**

<b>Barrier ID:</b>	ROMO-0010-9.220-R				
<b>Route Name:</b>	TRAIL RIDGE ROAD				
<b>Inspection Date:</b>	10/02/2009	<b>Barrier Rating:</b>	70.60		
<b>Barrier Description</b>					
<b>Type:</b>	STONE MASONRY WITHOUT CONCRETE CORE WALL	<b>Barrier Function:</b>	TRAFFIC		
<b>Barrier Material:</b>	STONE	<b>Post Material:</b>	N/A		
<b>Blockout Type:</b>	N/A	<b>Length (ft.):</b>	608		
<b>Speed Limit (MPH):</b>	35	<b>Placement with Respect to Road:</b>	OUTSIDE OF CURVE		
<b>Hazard Behind Barrier:</b>	HIGH				
<b>Barrier Crashworthiness</b>					
<b>Appropriate Test Level:</b>	TL-2	<b>Barrier Test Level:</b>	NCW	<b>Is Barrier Crashworthy?:</b>	NO
<b>Beg. End Trtmt Type:</b>	NONE	<b>Is Beg. End Trtmt Crashworthy?:</b>	N/A	<b>Approach Transition Type:</b>	NONE
<b>Ending End Trtmt Type:</b>	NONE	<b>Ending End Trtmt Crashworthy?:</b>	N/A		
<b>Average Measurements</b>					
<b>Design Height (In.):</b>	24	<b>Width (In.):</b>	18.5	<b>Post Spacing (In.):</b>	0.0

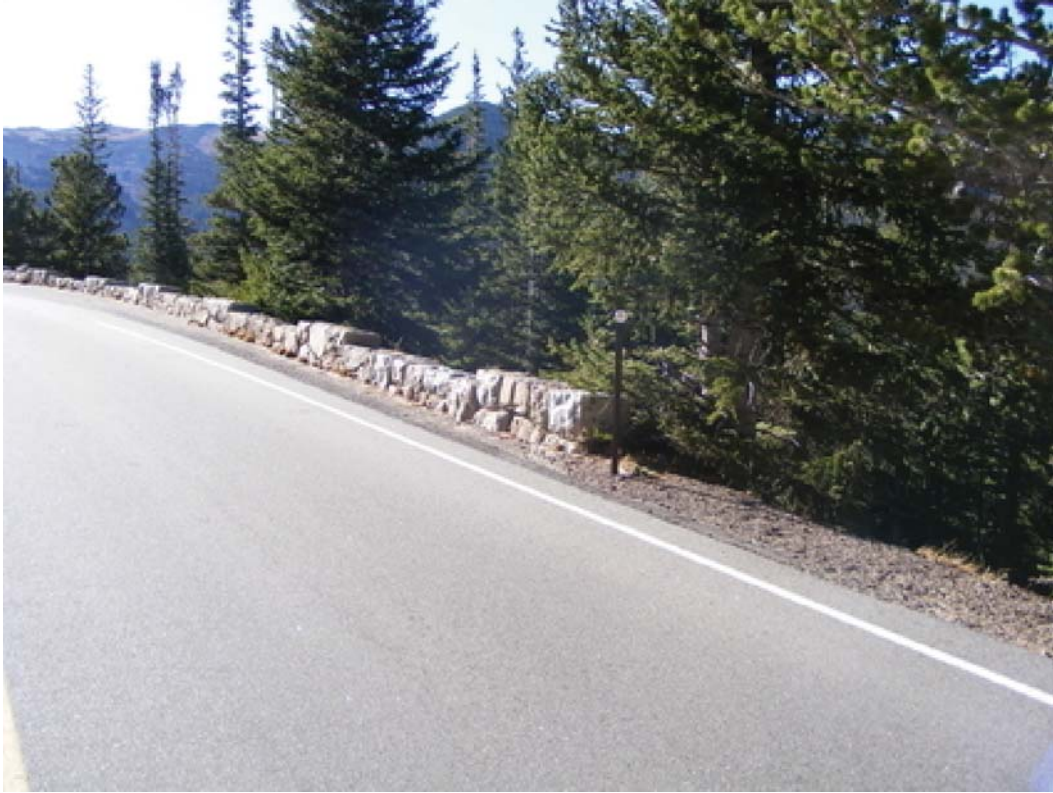
**ROMO\_0010\_9.519\_R\_1.jpg**

<b>Barrier ID:</b>	ROMO-0010-9.519-R				
<b>Route Name:</b>	TRAIL RIDGE ROAD				
<b>Inspection Date:</b>	10/02/2009	<b>Barrier Rating:</b>	57.50		
<b>Barrier Description</b>					
<b>Type:</b>	STONE MASONRY WITHOUT CONCRETE CORE WALL	<b>Barrier Function:</b>	TRAFFIC		
<b>Barrier Material:</b>	STONE	<b>Post Material:</b>	N/A		
<b>Blockout Type:</b>	N/A	<b>Length (ft.):</b>	292		
<b>Speed Limit (MPH):</b>	35	<b>Placement with Respect to Road:</b>	OUTSIDE OF CURVE		
<b>Hazard Behind Barrier:</b>	MEDIUM				
<b>Barrier Crashworthiness</b>					
<b>Appropriate Test Level:</b>	TL-2	<b>Barrier Test Level:</b>	NCW	<b>Is Barrier Crashworthy?:</b>	NO
<b>Beg. End Trtmt Type:</b>	NONE	<b>Is Beg. End Trtmt Crashworthy?:</b>	N/A	<b>Approach Transition Type:</b>	NONE
<b>Ending End Trtmt Type:</b>	NONE	<b>Ending End Trtmt Crashworthy?:</b>	N/A		
<b>Average Measurements</b>					
<b>Design Height (In.):</b>	24	<b>Width (In.):</b>	19.6	<b>Post Spacing (In.):</b>	0.0

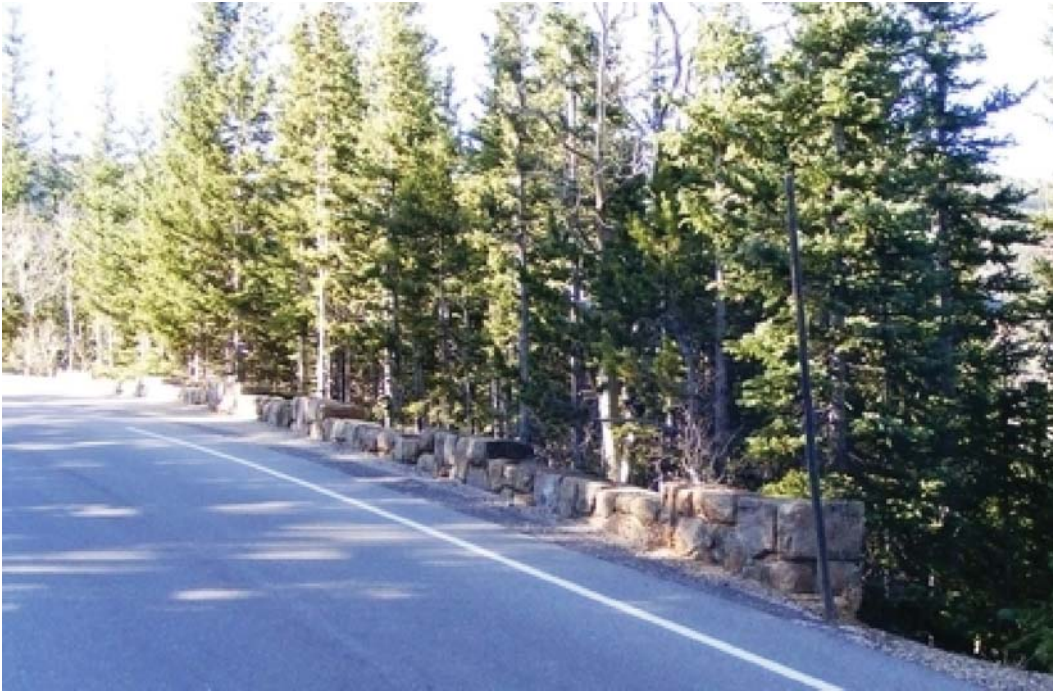
**ROMO\_0010\_10.074\_R\_1.jpg**

<b>Barrier ID:</b>	ROMO-0010-10.074-R				
<b>Route Name:</b>	TRAIL RIDGE ROAD				
<b>Inspection Date:</b>	10/02/2009	<b>Barrier Rating:</b>	58.50		
<b>Barrier Description</b>					
<b>Type:</b>	STONE MASONRY WITHOUT CONCRETE CORE WALL	<b>Barrier Function:</b>	TRAFFIC		
<b>Barrier Material:</b>	STONE	<b>Post Material:</b>	N/A		
<b>Blockout Type:</b>	N/A	<b>Length (ft.):</b>	203		
<b>Speed Limit (MPH):</b>	35	<b>Placement with Respect to Road:</b>	OUTSIDE OF CURVE		
<b>Hazard Behind Barrier:</b>	HIGH				
<b>Barrier Crashworthiness</b>					
<b>Appropriate Test Level:</b>	TL-2	<b>Barrier Test Level:</b>	NCW	<b>Is Barrier Crashworthy?:</b>	NO
<b>Beg. End Trtmt Type:</b>	NONE	<b>Is Beg. End Trtmt Crashworthy?:</b>	N/A	<b>Approach Transition Type:</b>	NONE
<b>Ending End Trtmt Type:</b>	NONE	<b>Ending End Trtmt Crashworthy?:</b>	N/A		
<b>Average Measurements</b>					
<b>Design Height (In.):</b>	24	<b>Width (In.):</b>	18.6	<b>Post Spacing (In.):</b>	0.0

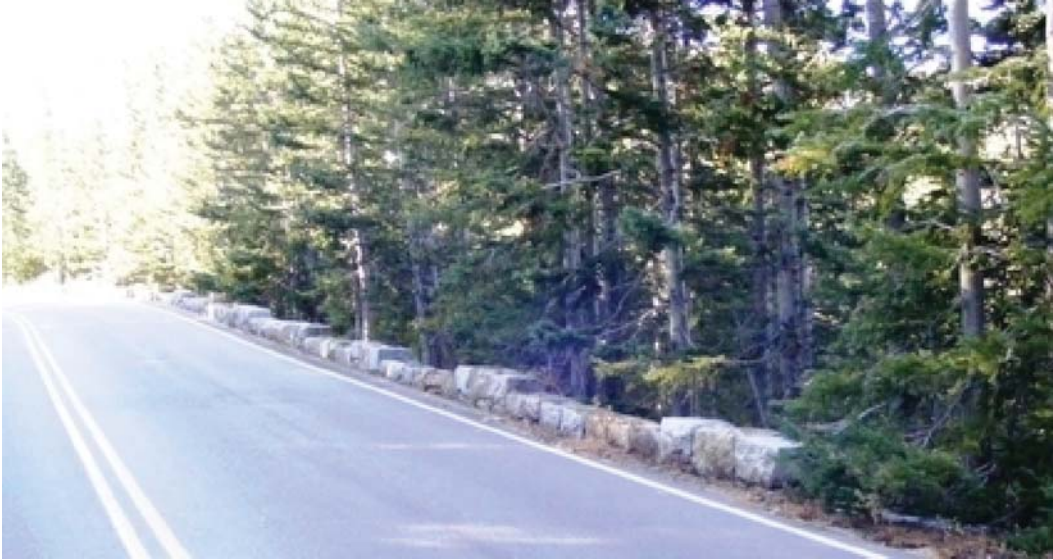
ROMO\_0010\_10.409\_R\_1.jpg

<b>Barrier ID:</b>	ROMO-0010-10.409-R				
<b>Route Name:</b>	TRAIL RIDGE ROAD				
<b>Inspection Date:</b>	10/02/2009	<b>Barrier Rating:</b>	66.40		
<b>Barrier Description</b>					
<b>Type:</b>	STONE MASONRY WITHOUT CONCRETE CORE WALL	<b>Barrier Function:</b>	TRAFFIC		
<b>Barrier Material:</b>	STONE	<b>Post Material:</b>	N/A		
<b>Blockout Type:</b>	N/A	<b>Length (ft.):</b>	299		
<b>Speed Limit (MPH):</b>	35	<b>Placement with Respect to Road:</b>	OUTSIDE OF CURVE		
<b>Hazard Behind Barrier:</b>	HIGH				
<b>Barrier Crashworthiness</b>					
<b>Appropriate Test Level:</b>	TL-2	<b>Barrier Test Level:</b>	NCW	<b>Is Barrier Crashworthy?:</b>	NO
<b>Beg. End Trtmt Type:</b>	NONE	<b>Is Beg. End Trtmt Crashworthy?:</b>	N/A	<b>Approach Transition Type:</b>	NONE
<b>Ending End Trtmt Type:</b>	NONE	<b>Ending End Trtmt Crashworthy?:</b>	N/A		
<b>Average Measurements</b>					
<b>Design Height (In.):</b>	24	<b>Width (In.):</b>	18.2	<b>Post Spacing (In.):</b>	0.0

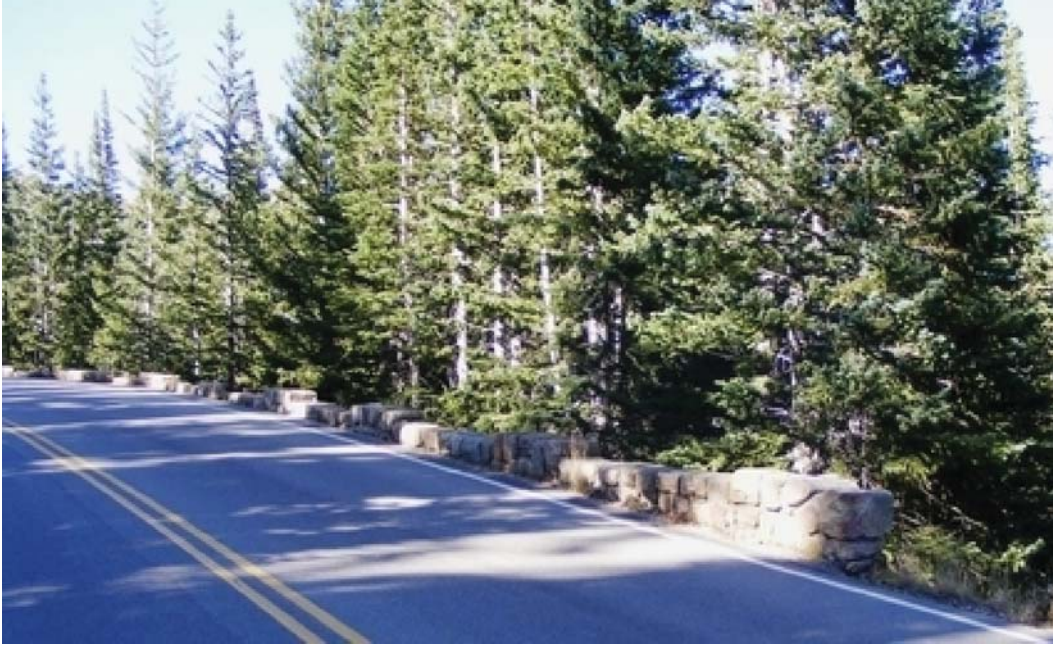
**ROMO\_0010\_10.636\_R\_1.jpg**

<b>Barrier ID:</b>	ROMO-0010-10.636-R				
<b>Route Name:</b>	TRAIL RIDGE ROAD				
<b>Inspection Date:</b>	10/02/2009	<b>Barrier Rating:</b>	65.50		
<b>Barrier Description</b>					
<b>Type:</b>	STONE MASONRY WITHOUT CONCRETE CORE WALL	<b>Barrier Function:</b>	TRAFFIC		
<b>Barrier Material:</b>	STONE	<b>Post Material:</b>	N/A		
<b>Blockout Type:</b>	N/A	<b>Length (ft.):</b>	242		
<b>Speed Limit (MPH):</b>	35	<b>Placement with Respect to Road:</b>	OUTSIDE OF CURVE		
<b>Hazard Behind Barrier:</b>	HIGH				
<b>Barrier Crashworthiness</b>					
<b>Appropriate Test Level:</b>	TL-2	<b>Barrier Test Level:</b>	NCW	<b>Is Barrier Crashworthy?:</b>	NO
<b>Beg. End Trtmt Type:</b>	NONE	<b>Is Beg. End Trtmt Crashworthy?:</b>	N/A	<b>Approach Transition Type:</b>	NONE
<b>Ending End Trtmt Type:</b>	NONE	<b>Ending End Trtmt Crashworthy?:</b>	N/A		
<b>Average Measurements</b>					
<b>Design Height (In.):</b>	24	<b>Width (In.):</b>	17.7	<b>Post Spacing (In.):</b>	0.0

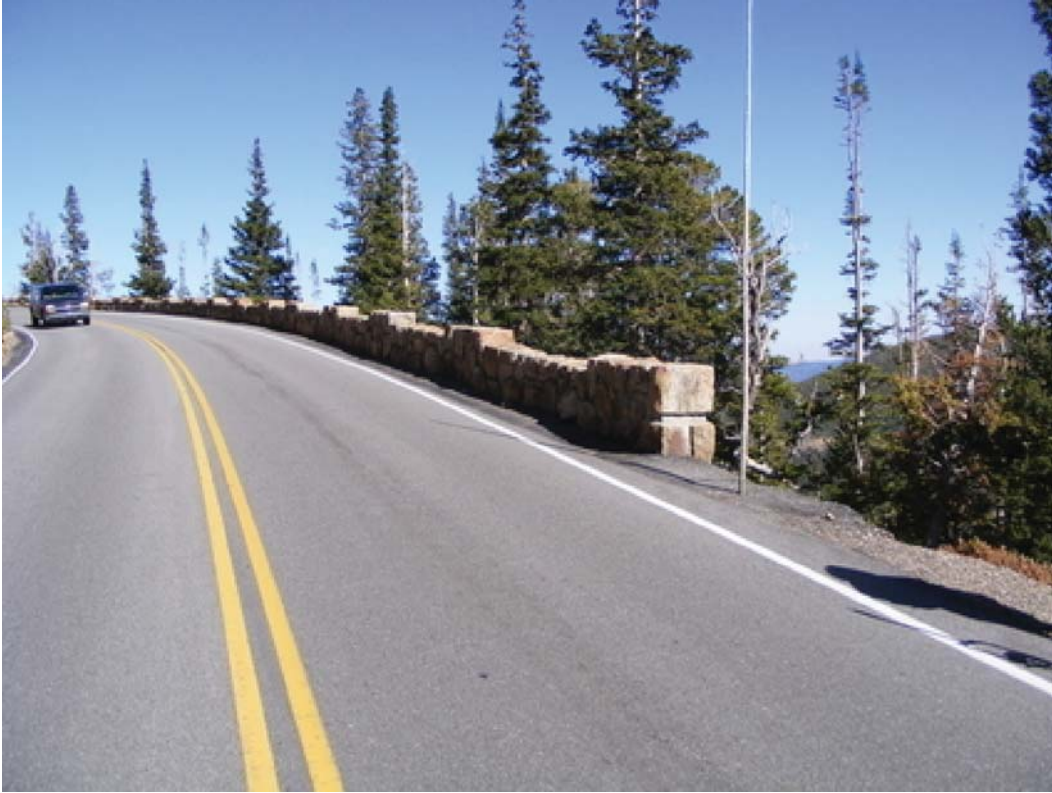
**ROMO\_0010\_11.375\_R\_1.jpg**

<b>Barrier ID:</b>	ROMO-0010-11.375-R				
<b>Route Name:</b>	TRAIL RIDGE ROAD				
<b>Inspection Date:</b>	10/02/2009	<b>Barrier Rating:</b>	38.40		
<b>Barrier Description</b>					
<b>Type:</b>	STONE MASONRY WITHOUT CONCRETE CORE WALL	<b>Barrier Function:</b>	TRAFFIC		
<b>Barrier Material:</b>	STONE	<b>Post Material:</b>	N/A		
<b>Blockout Type:</b>	N/A	<b>Length (ft.):</b>	575		
<b>Speed Limit (MPH):</b>	35	<b>Placement with Respect to Road:</b>	OUTSIDE OF CURVE		
<b>Hazard Behind Barrier:</b>	HIGH				
<b>Barrier Crashworthiness</b>					
<b>Appropriate Test Level:</b>	TL-2	<b>Barrier Test Level:</b>	NCW	<b>Is Barrier Crashworthy?:</b>	NO
<b>Beg. End Trtmt Type:</b>	NONE	<b>Is Beg. End Trtmt Crashworthy?:</b>	N/A	<b>Approach Transition Type:</b>	NONE
<b>Ending End Trtmt Type:</b>	NONE	<b>Ending End Trtmt Crashworthy?:</b>	N/A		
<b>Average Measurements</b>					
<b>Design Height (In.):</b>	24	<b>Width (In.):</b>	18.7	<b>Post Spacing (In.):</b>	0.0

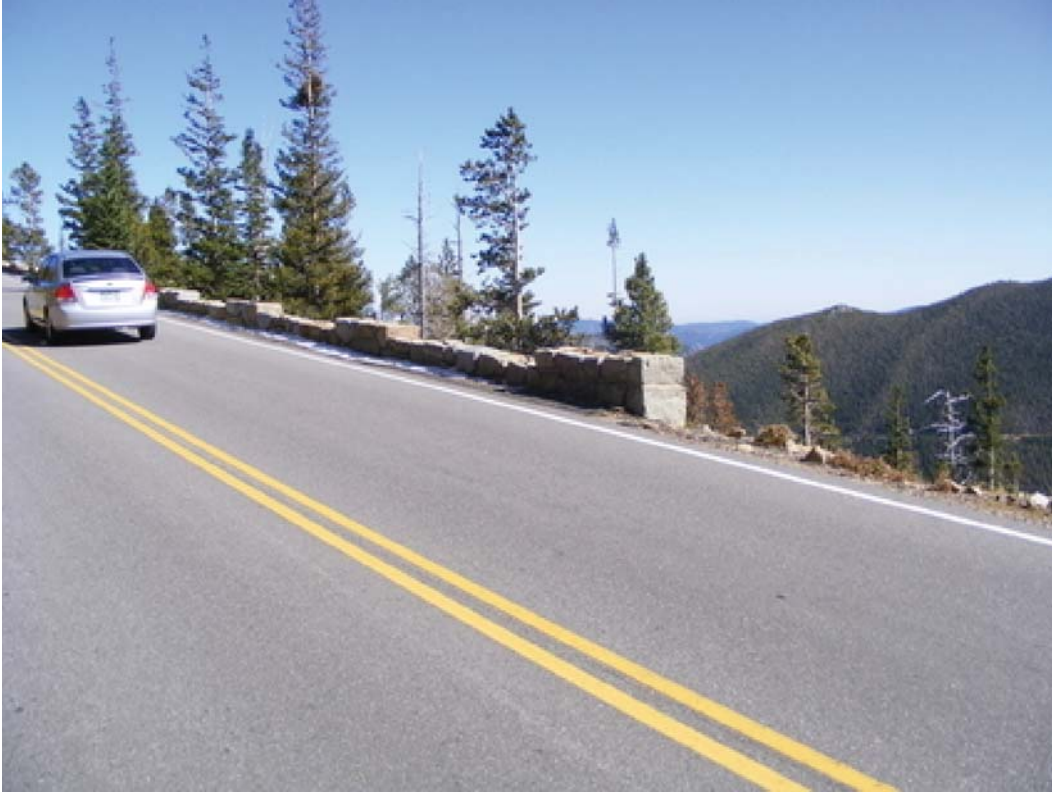
**ROMO\_0010\_11.891\_R\_1.jpg**

<b>Barrier ID:</b>	ROMO-0010-11.891-R				
<b>Route Name:</b>	TRAIL RIDGE ROAD				
<b>Inspection Date:</b>	10/02/2009	<b>Barrier Rating:</b>	85.90		
<b>Barrier Description</b>					
<b>Type:</b>	STONE MASONRY WITHOUT CONCRETE CORE WALL	<b>Barrier Function:</b>	TRAFFIC		
<b>Barrier Material:</b>	STONE	<b>Post Material:</b>	N/A		
<b>Blockout Type:</b>	N/A	<b>Length (ft.):</b>	1295		
<b>Speed Limit (MPH):</b>	35	<b>Placement with Respect to Road:</b>	BOTH INSIDE AND OUTSIDE		
<b>Hazard Behind Barrier:</b>	EXTREME				
<b>Barrier Crashworthiness</b>					
<b>Appropriate Test Level:</b>	TL-2	<b>Barrier Test Level:</b>	NCW	<b>Is Barrier Crashworthy?:</b>	NO
<b>Beg. End Trtmt Type:</b>	NONE	<b>Is Beg. End Trtmt Crashworthy?:</b>	N/A	<b>Approach Transition Type:</b>	NONE
<b>Ending End Trtmt Type:</b>	NONE	<b>Ending End Trtmt Crashworthy?:</b>	N/A		
<b>Average Measurements</b>					
<b>Design Height (In.):</b>	24	<b>Width (In.):</b>	18.6	<b>Post Spacing (In.):</b>	0.0

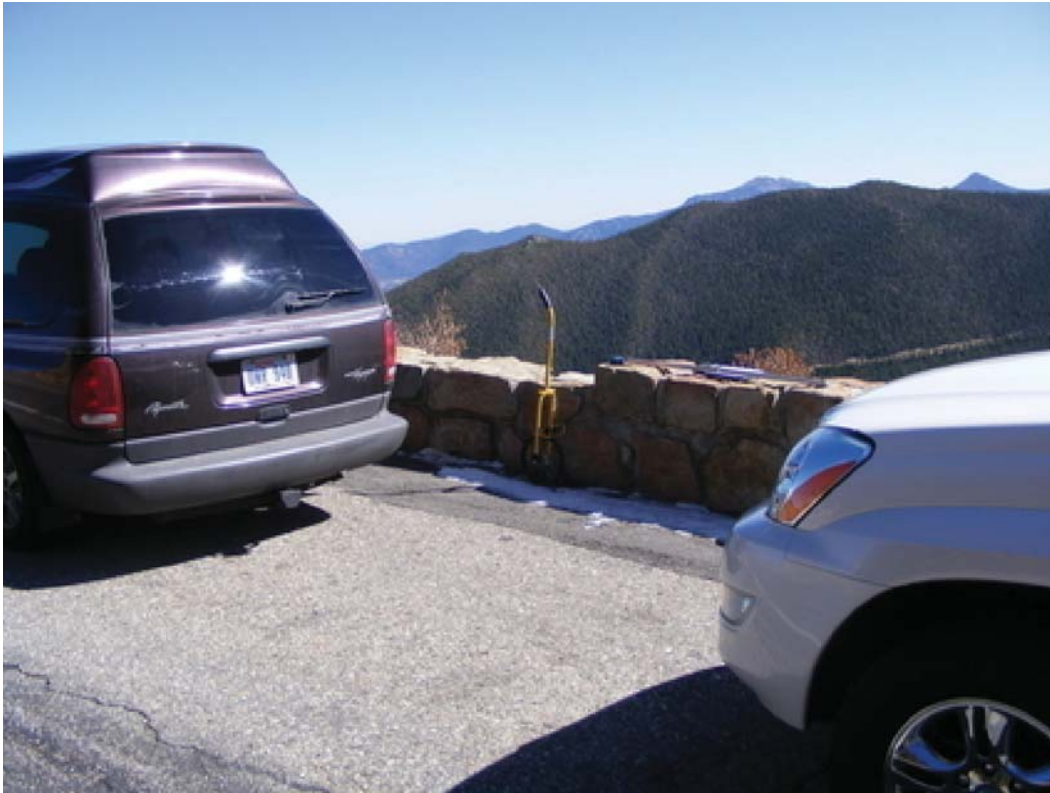
**ROMO\_0010\_12.135\_R\_1.jpg**

<b>Barrier ID:</b>	ROMO-0010-12.135-R				
<b>Route Name:</b>	TRAIL RIDGE ROAD				
<b>Inspection Date:</b>	10/02/2009	<b>Barrier Rating:</b>	18.60		
<b>Barrier Description</b>					
<b>Type:</b>	STONE MASONRY WITHOUT CONCRETE CORE WALL	<b>Barrier Function:</b>	NON-TRAFFIC		
<b>Barrier Material:</b>	STONE	<b>Post Material:</b>	N/A		
<b>Blockout Type:</b>	N/A	<b>Length (ft.):</b>	135		
<b>Speed Limit (MPH):</b>	35	<b>Placement with Respect to Road:</b>	NON-TRAFFIC BARRIER		
<b>Hazard Behind Barrier:</b>	N/A				
<b>Barrier Crashworthiness</b>					
<b>Appropriate Test Level:</b>	TL-2	<b>Barrier Test Level:</b>	N/A	<b>Is Barrier Crashworthy?:</b>	N/A
<b>Beg. End Trtmt Type:</b>	NONE	<b>Is Beg. End Trtmt Crashworthy?:</b>	N/A	<b>Approach Transition Type:</b>	NONE
<b>Ending End Trtmt Type:</b>	NONE	<b>Ending End Trtmt Crashworthy?:</b>	N/A		
<b>Average Measurements</b>					
<b>Design Height (In.):</b>	24	<b>Width (In.):</b>	18.0	<b>Post Spacing (In.):</b>	0.0

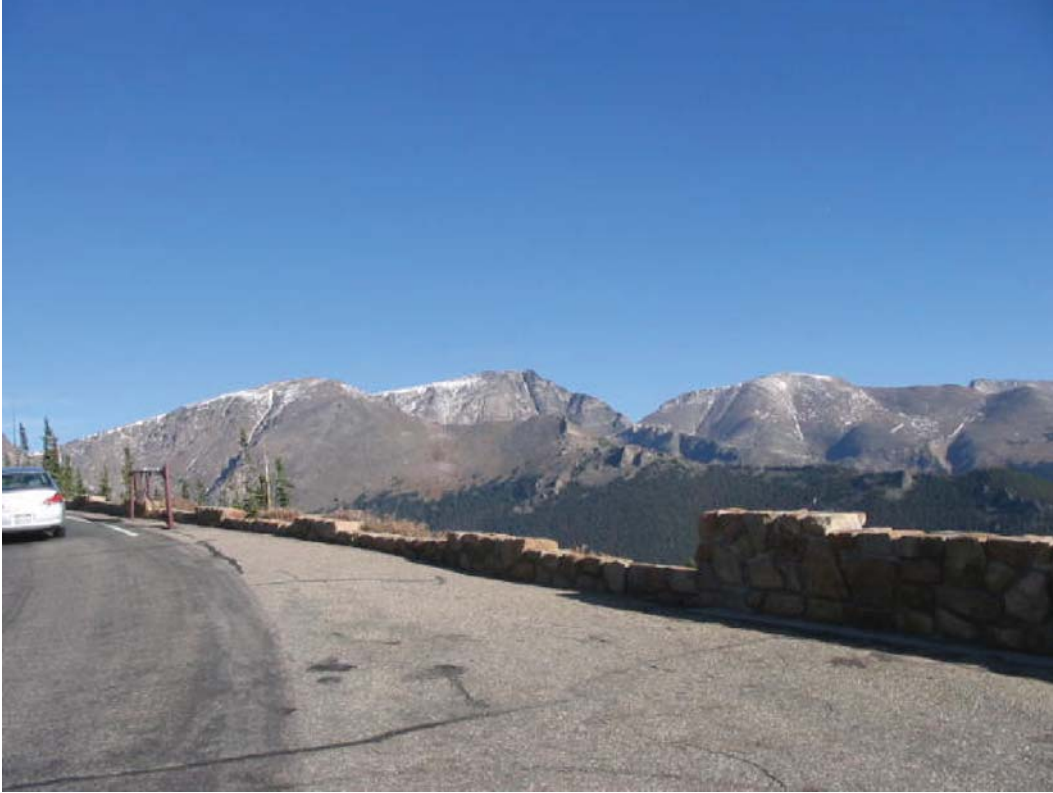
**ROMO\_0010\_12.237\_R\_1.jpg**

<b>Barrier ID:</b>	ROMO-0010-12.237-R				
<b>Route Name:</b>	TRAIL RIDGE ROAD				
<b>Inspection Date:</b>	09/29/2009	<b>Barrier Rating:</b>	88.60		
<b>Barrier Description</b>					
<b>Type:</b>	STONE MASONRY WITHOUT CONCRETE CORE WALL	<b>Barrier Function:</b>	TRAFFIC		
<b>Barrier Material:</b>	STONE	<b>Post Material:</b>	N/A		
<b>Blockout Type:</b>	N/A	<b>Length (ft.):</b>	2272		
<b>Speed Limit (MPH):</b>	35	<b>Placement with Respect to Road:</b>	OUTSIDE OF CURVE		
<b>Hazard Behind Barrier:</b>	EXTREME				
<b>Barrier Crashworthiness</b>					
<b>Appropriate Test Level:</b>	TL-2	<b>Barrier Test Level:</b>	NCW	<b>Is Barrier Crashworthy?:</b>	NO
<b>Beg. End Trtmt Type:</b>	NONE	<b>Is Beg. End Trtmt Crashworthy?:</b>	N/A	<b>Approach Transition Type:</b>	NONE
<b>Ending End Trtmt Type:</b>	NONE	<b>Ending End Trtmt Crashworthy?:</b>	N/A		
<b>Average Measurements</b>					
<b>Design Height (In.):</b>	24	<b>Width (In.):</b>	18.7	<b>Post Spacing (In.):</b>	0.0

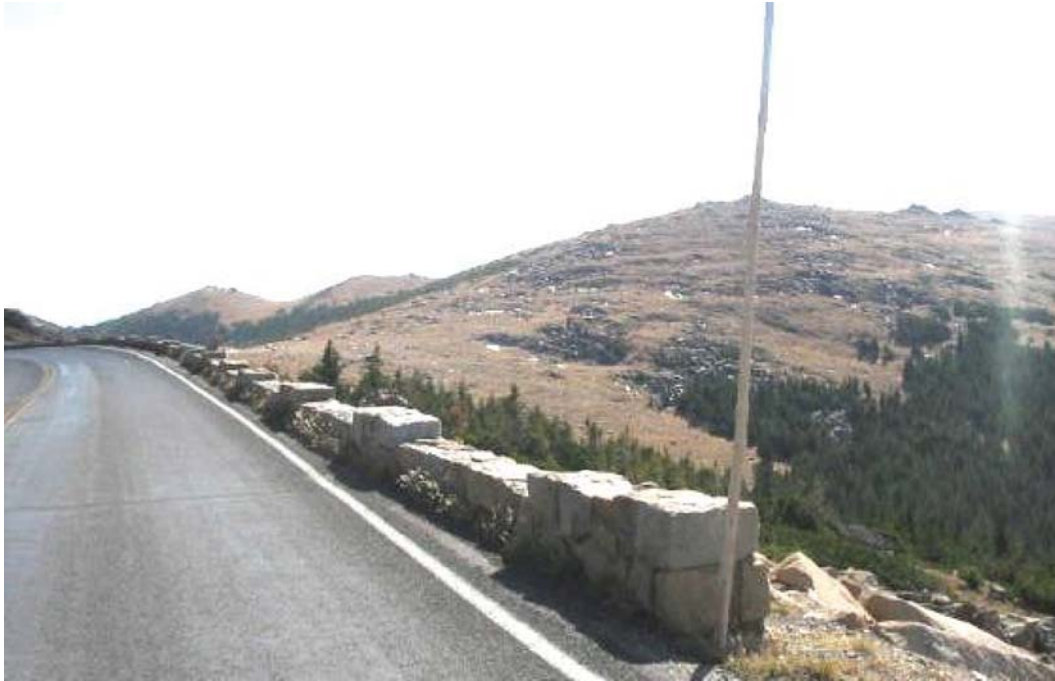
ROMO\_0010\_14.465\_L\_1.jpg

<b>Barrier ID:</b>	ROMO-0010-14.465-L				
<b>Route Name:</b>	TRAIL RIDGE ROAD				
<b>Inspection Date:</b>	09/29/2009	<b>Barrier Rating:</b>	72.80		
<b>Barrier Description</b>					
<b>Type:</b>	STONE MASONRY WITHOUT CONCRETE CORE WALL	<b>Barrier Function:</b>	TRAFFIC		
<b>Barrier Material:</b>	STONE	<b>Post Material:</b>	N/A		
<b>Blockout Type:</b>	N/A	<b>Length (ft.):</b>	423		
<b>Speed Limit (MPH):</b>	35	<b>Placement with Respect to Road:</b>	OUTSIDE OF CURVE		
<b>Hazard Behind Barrier:</b>	HIGH				
<b>Barrier Crashworthiness</b>					
<b>Appropriate Test Level:</b>	TL-2	<b>Barrier Test Level:</b>	NCW	<b>Is Barrier Crashworthy?:</b>	NO
<b>Beg. End Trtmt Type:</b>	NONE	<b>Is Beg. End Trtmt Crashworthy?:</b>	N/A	<b>Approach Transition Type:</b>	NONE
<b>Ending End Trtmt Type:</b>	NONE	<b>Ending End Trtmt Crashworthy?:</b>	N/A		
<b>Average Measurements</b>					
<b>Design Height (In.):</b>	24	<b>Width (In.):</b>	17.7	<b>Post Spacing (In.):</b>	0.0

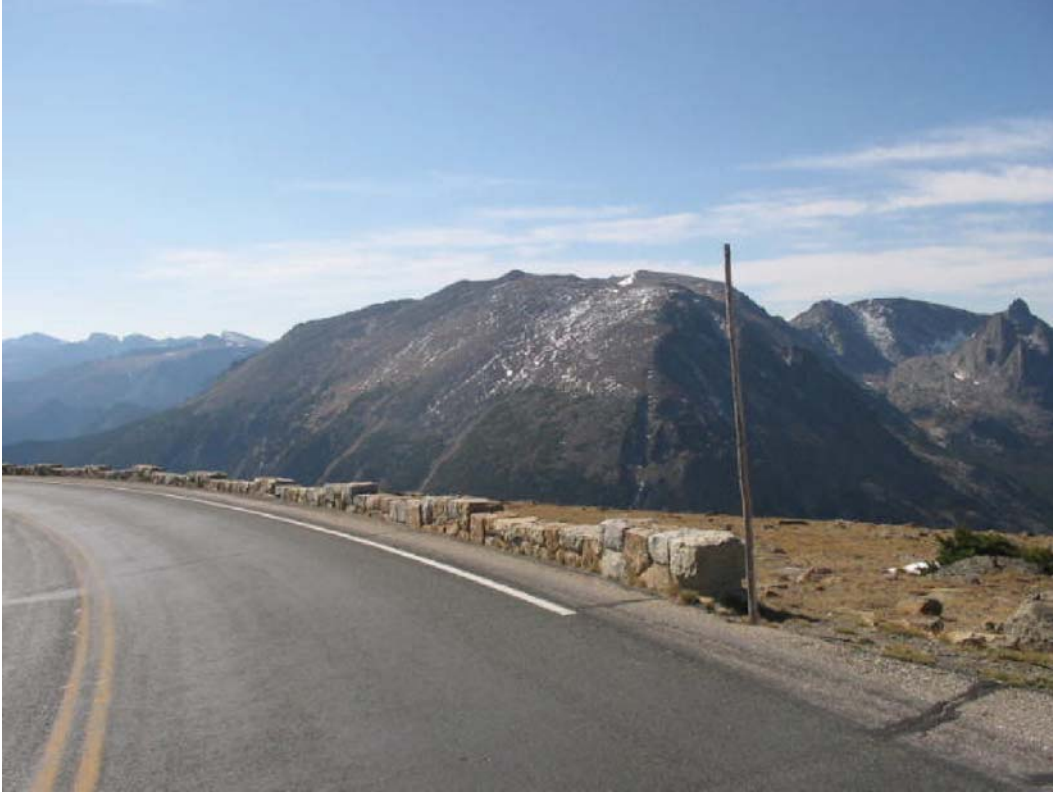
**ROMO\_0010\_15.059\_L\_1.jpg**

<b>Barrier ID:</b>	ROMO-0010-15.059-L				
<b>Route Name:</b>	TRAIL RIDGE ROAD				
<b>Inspection Date:</b>	09/29/2009	<b>Barrier Rating:</b>	63.90		
<b>Barrier Description</b>					
<b>Type:</b>	STONE MASONRY WITHOUT CONCRETE CORE WALL	<b>Barrier Function:</b>	TRAFFIC		
<b>Barrier Material:</b>	STONE	<b>Post Material:</b>	N/A		
<b>Blockout Type:</b>	N/A	<b>Length (ft.):</b>	188		
<b>Speed Limit (MPH):</b>	35	<b>Placement with Respect to Road:</b>	OUTSIDE OF CURVE		
<b>Hazard Behind Barrier:</b>	MEDIUM				
<b>Barrier Crashworthiness</b>					
<b>Appropriate Test Level:</b>	TL-2	<b>Barrier Test Level:</b>	NCW	<b>Is Barrier Crashworthy?:</b>	NO
<b>Beg. End Trtmt Type:</b>	NONE	<b>Is Beg. End Trtmt Crashworthy?:</b>	N/A	<b>Approach Transition Type:</b>	NONE
<b>Ending End Trtmt Type:</b>	NONE	<b>Ending End Trtmt Crashworthy?:</b>	N/A		
<b>Average Measurements</b>					
<b>Design Height (In.):</b>	24	<b>Width (In.):</b>	19.2	<b>Post Spacing (In.):</b>	0.0

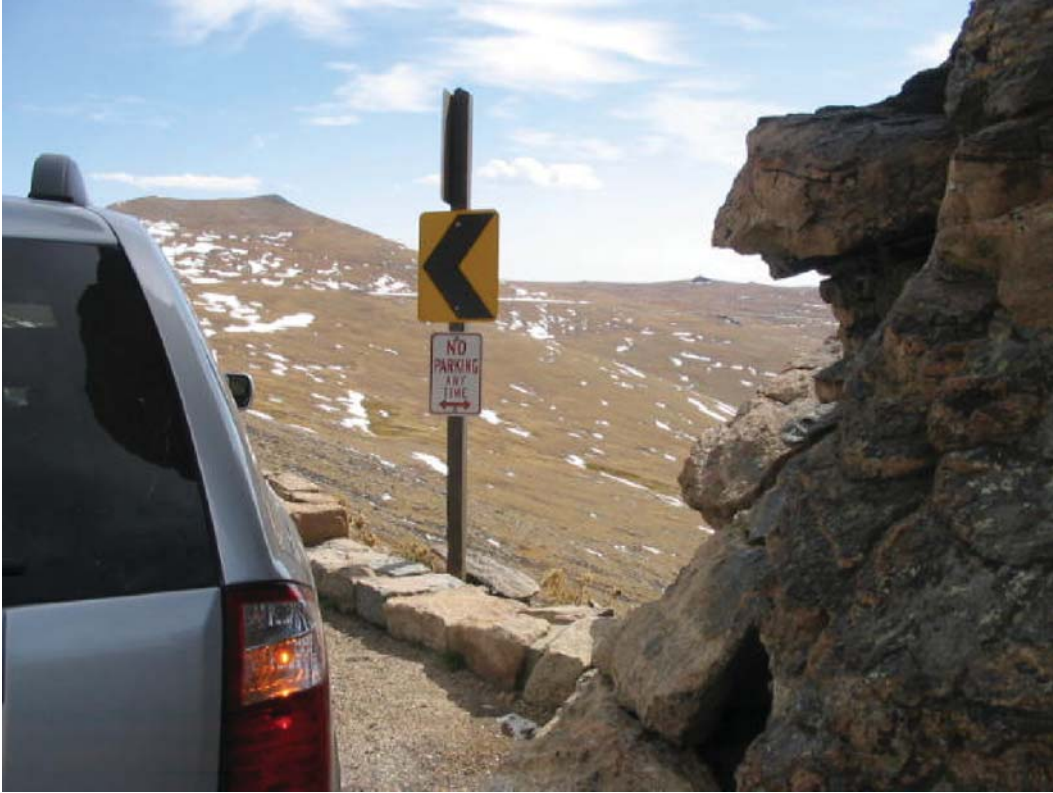
ROMO\_0010\_16.987\_L\_1.jpg

<b>Barrier ID:</b>	ROMO-0010-16.987-L				
<b>Route Name:</b>	TRAIL RIDGE ROAD				
<b>Inspection Date:</b>	09/29/2009	<b>Barrier Rating:</b>	68.50		
<b>Barrier Description</b>					
<b>Type:</b>	STONE MASONRY WITHOUT CONCRETE CORE WALL	<b>Barrier Function:</b>	TRAFFIC		
<b>Barrier Material:</b>	STONE	<b>Post Material:</b>	N/A		
<b>Blockout Type:</b>	N/A	<b>Length (ft.):</b>	379		
<b>Speed Limit (MPH):</b>	35	<b>Placement with Respect to Road:</b>	OUTSIDE OF CURVE		
<b>Hazard Behind Barrier:</b>	HIGH				
<b>Barrier Crashworthiness</b>					
<b>Appropriate Test Level:</b>	TL-2	<b>Barrier Test Level:</b>	NCW	<b>Is Barrier Crashworthy?:</b>	NO
<b>Beg. End Trtmt Type:</b>	NONE	<b>Is Beg. End Trtmt Crashworthy?:</b>	N/A	<b>Approach Transition Type:</b>	NONE
<b>Ending End Trtmt Type:</b>	NONE	<b>Ending End Trtmt Crashworthy?:</b>	N/A		
<b>Average Measurements</b>					
<b>Design Height (In.):</b>	24	<b>Width (In.):</b>	19.2	<b>Post Spacing (In.):</b>	0.0

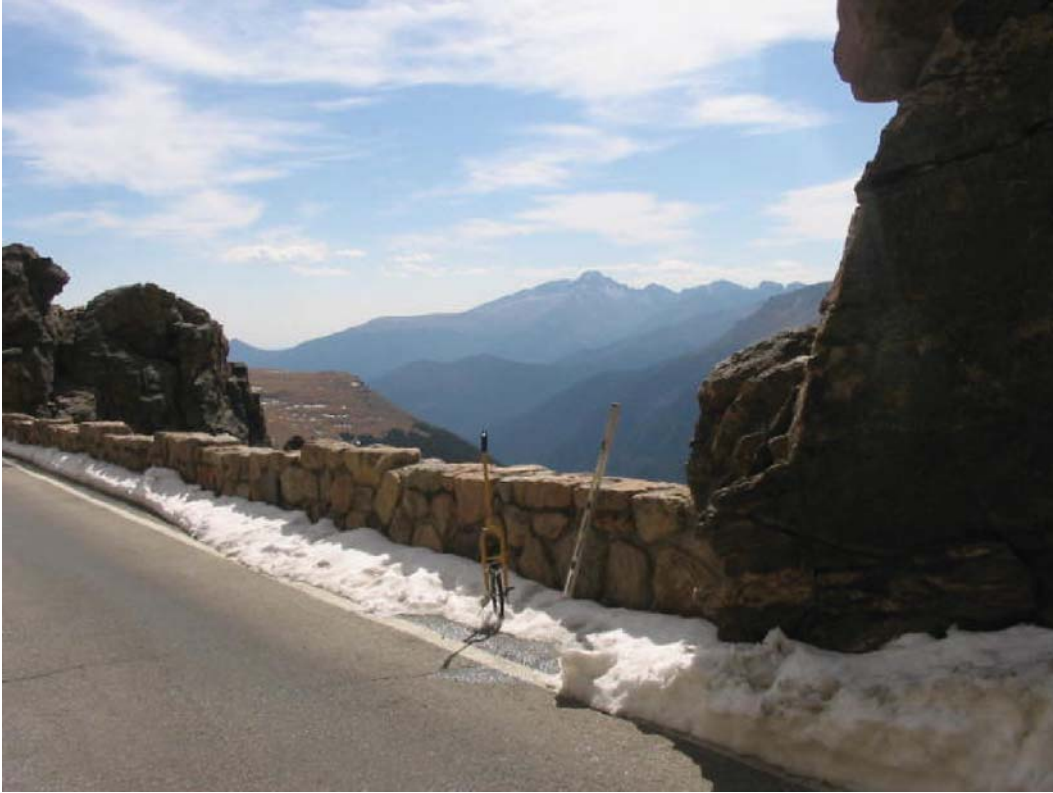
**ROMO\_0010\_17.060\_L\_1.jpg**

<b>Barrier ID:</b>	ROMO-0010-17.060-L				
<b>Route Name:</b>	TRAIL RIDGE ROAD				
<b>Inspection Date:</b>	09/29/2009	<b>Barrier Rating:</b>	30.00		
<b>Barrier Description</b>					
<b>Type:</b>	STONE MASONRY WITHOUT CONCRETE CORE WALL	<b>Barrier Function:</b>	TRAFFIC		
<b>Barrier Material:</b>	STONE	<b>Post Material:</b>	N/A		
<b>Blockout Type:</b>	N/A	<b>Length (ft.):</b>	203		
<b>Speed Limit (MPH):</b>	35	<b>Placement with Respect to Road:</b>	TANGENT		
<b>Hazard Behind Barrier:</b>	EXTREME				
<b>Barrier Crashworthiness</b>					
<b>Appropriate Test Level:</b>	TL-2	<b>Barrier Test Level:</b>	NCW	<b>Is Barrier Crashworthy?:</b>	NO
<b>Beg. End Trtmt Type:</b>	NONE	<b>Is Beg. End Trtmt Crashworthy?:</b>	N/A	<b>Approach Transition Type:</b>	NONE
<b>Ending End Trtmt Type:</b>	NONE	<b>Ending End Trtmt Crashworthy?:</b>	N/A		
<b>Average Measurements</b>					
<b>Design Height (In.):</b>	24	<b>Width (In.):</b>	24.0	<b>Post Spacing (In.):</b>	0.0

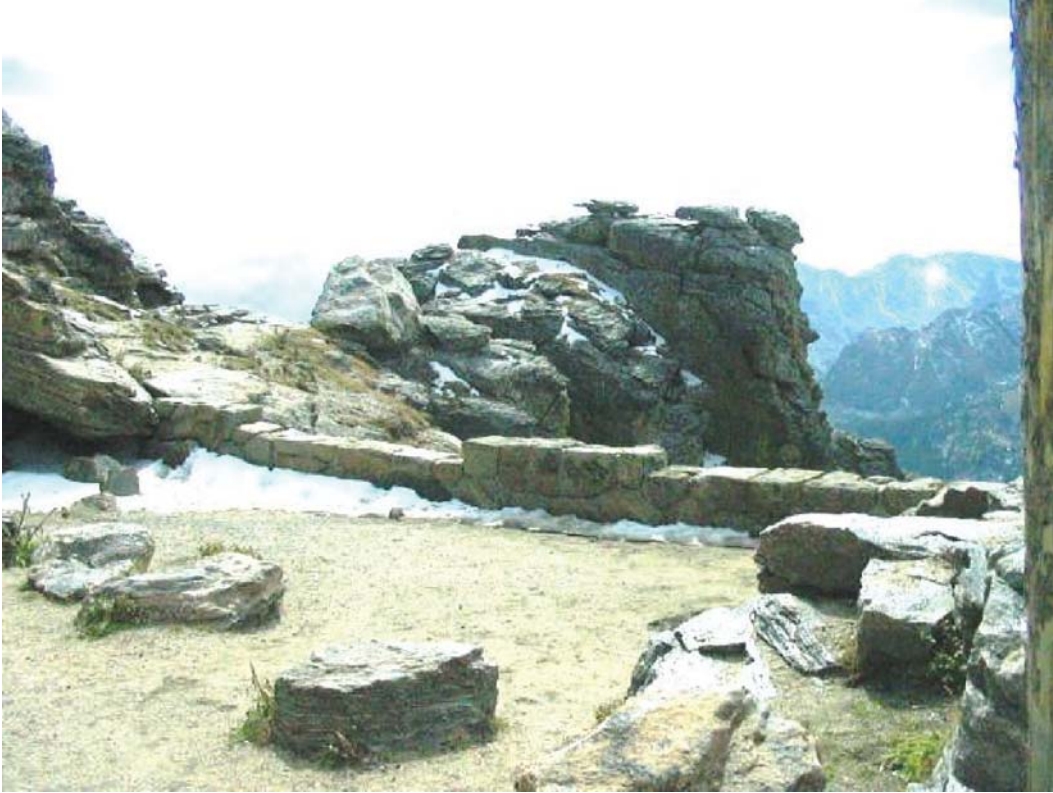
**ROMO\_0010\_17.116\_L\_1.jpg**

<b>Barrier ID:</b>	ROMO-0010-17.116-L				
<b>Route Name:</b>	TRAIL RIDGE ROAD				
<b>Inspection Date:</b>	09/29/2009	<b>Barrier Rating:</b>	8.50		
<b>Barrier Description</b>					
<b>Type:</b>	STONE MASONRY WITHOUT CONCRETE CORE WALL	<b>Barrier Function:</b>	NON-TRAFFIC		
<b>Barrier Material:</b>	STONE	<b>Post Material:</b>	N/A		
<b>Blockout Type:</b>	N/A	<b>Length (ft.):</b>	34		
<b>Speed Limit (MPH):</b>	35	<b>Placement with Respect to Road:</b>	NON-TRAFFIC BARRIER		
<b>Hazard Behind Barrier:</b>	N/A				
<b>Barrier Crashworthiness</b>					
<b>Appropriate Test Level:</b>	TL-2	<b>Barrier Test Level:</b>	N/A	<b>Is Barrier Crashworthy?:</b>	N/A
<b>Beg. End Trtmt Type:</b>	NONE	<b>Is Beg. End Trtmt Crashworthy?:</b>	N/A	<b>Approach Transition Type:</b>	NONE
<b>Ending End Trtmt Type:</b>	NONE	<b>Ending End Trtmt Crashworthy?:</b>	N/A		
<b>Average Measurements</b>					
<b>Design Height (In.):</b>	24	<b>Width (In.):</b>	20.0	<b>Post Spacing (In.):</b>	0.0

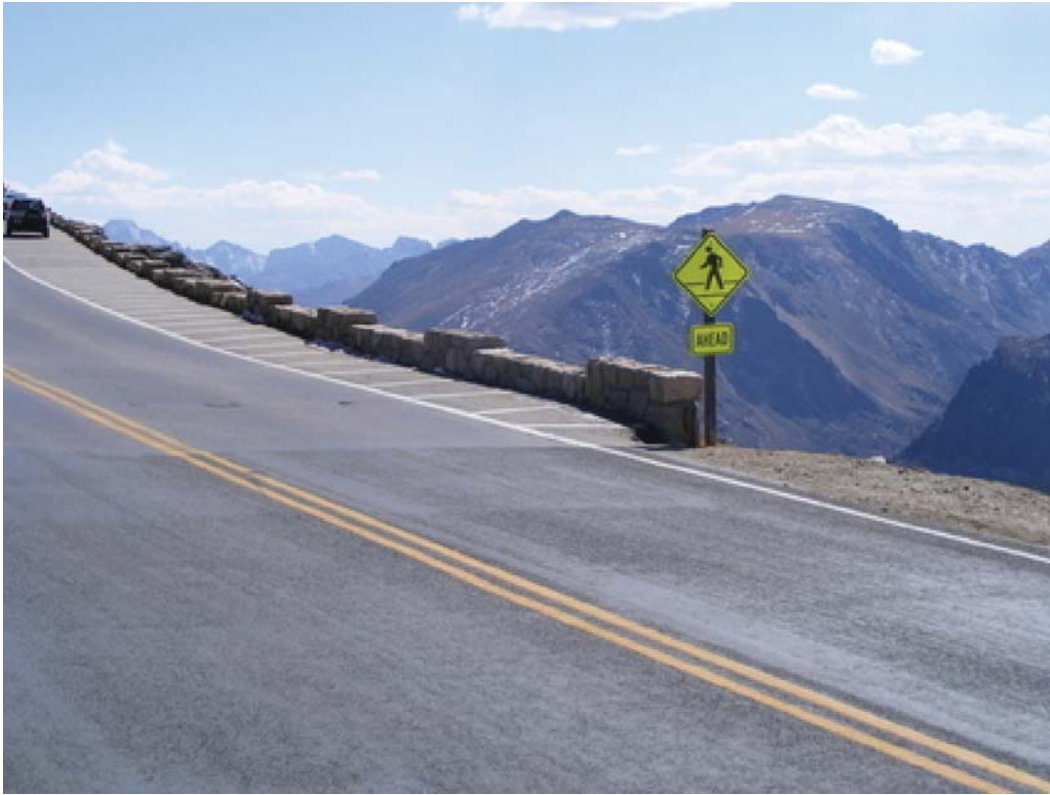
ROMO\_0010\_17.150\_L\_1.jpg

<b>Barrier ID:</b>	ROMO-0010-17.150-L				
<b>Route Name:</b>	TRAIL RIDGE ROAD				
<b>Inspection Date:</b>	09/29/2009	<b>Barrier Rating:</b>	56.50		
<b>Barrier Description</b>					
<b>Type:</b>	STONE MASONRY WITHOUT CONCRETE CORE WALL	<b>Barrier Function:</b>	NON-TRAFFIC		
<b>Barrier Material:</b>	STONE	<b>Post Material:</b>	N/A		
<b>Blockout Type:</b>	N/A	<b>Length (ft.):</b>	593		
<b>Speed Limit (MPH):</b>	35	<b>Placement with Respect to Road:</b>	NON-TRAFFIC BARRIER		
<b>Hazard Behind Barrier:</b>	N/A				
<b>Barrier Crashworthiness</b>					
<b>Appropriate Test Level:</b>	TL-2	<b>Barrier Test Level:</b>	NCW	<b>Is Barrier Crashworthy?:</b>	N/A
<b>Beg. End Trtmt Type:</b>	NONE	<b>Is Beg. End Trtmt Crashworthy?:</b>	N/A	<b>Approach Transition Type:</b>	NONE
<b>Ending End Trtmt Type:</b>	NONE	<b>Ending End Trtmt Crashworthy?:</b>	N/A		
<b>Average Measurements</b>					
<b>Design Height (In.):</b>	24	<b>Width (In.):</b>	19.0	<b>Post Spacing (In.):</b>	0.0

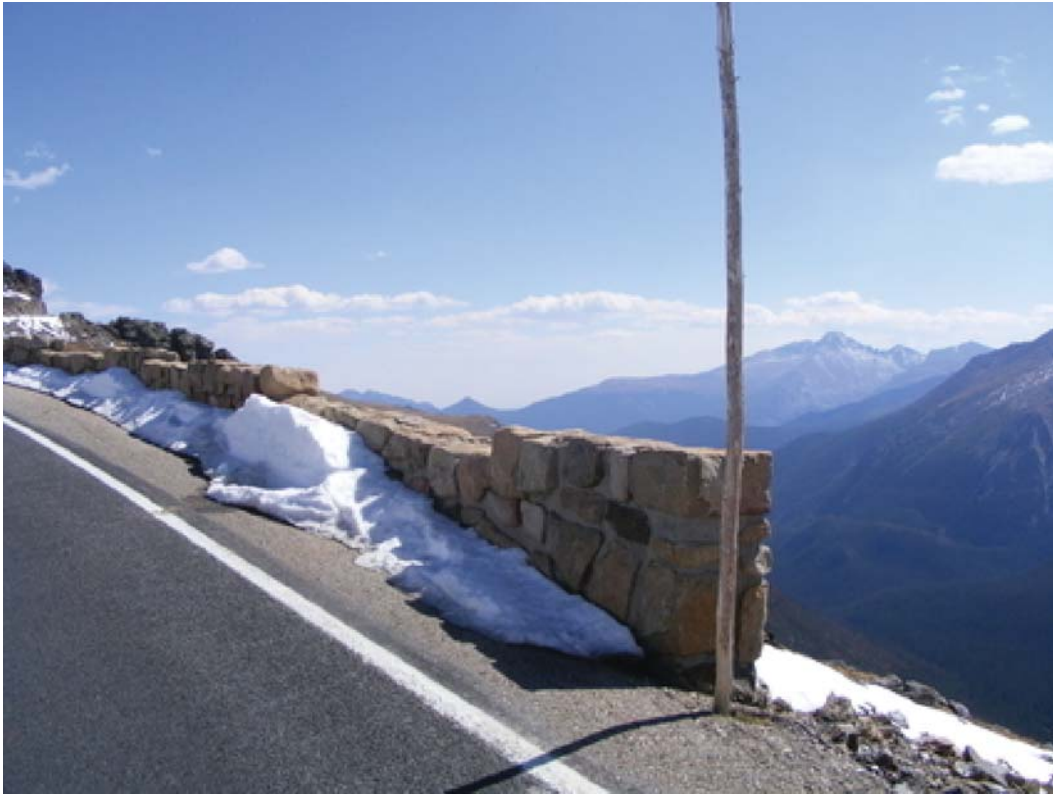
**ROMO\_0010\_17.460\_L\_1.jpg**

<b>Barrier ID:</b>	ROMO-0010-17.460-L				
<b>Route Name:</b>	TRAIL RIDGE ROAD				
<b>Inspection Date:</b>	09/29/2009	<b>Barrier Rating:</b>	41.50		
<b>Barrier Description</b>					
<b>Type:</b>	STONE MASONRY WITHOUT CONCRETE CORE WALL	<b>Barrier Function:</b>	TRAFFIC		
<b>Barrier Material:</b>	STONE	<b>Post Material:</b>	N/A		
<b>Blockout Type:</b>	N/A	<b>Length (ft.):</b>	150		
<b>Speed Limit (MPH):</b>	35	<b>Placement with Respect to Road:</b>	OUTSIDE OF CURVE		
<b>Hazard Behind Barrier:</b>	EXTREME				
<b>Barrier Crashworthiness</b>					
<b>Appropriate Test Level:</b>	TL-2	<b>Barrier Test Level:</b>	NCW	<b>Is Barrier Crashworthy?:</b>	NO
<b>Beg. End Trtmt Type:</b>	NONE	<b>Is Beg. End Trtmt Crashworthy?:</b>	N/A	<b>Approach Transition Type:</b>	NONE
<b>Ending End Trtmt Type:</b>	NONE	<b>Ending End Trtmt Crashworthy?:</b>	N/A		
<b>Average Measurements</b>					
<b>Design Height (In.):</b>	24	<b>Width (In.):</b>	20.7	<b>Post Spacing (In.):</b>	0.0

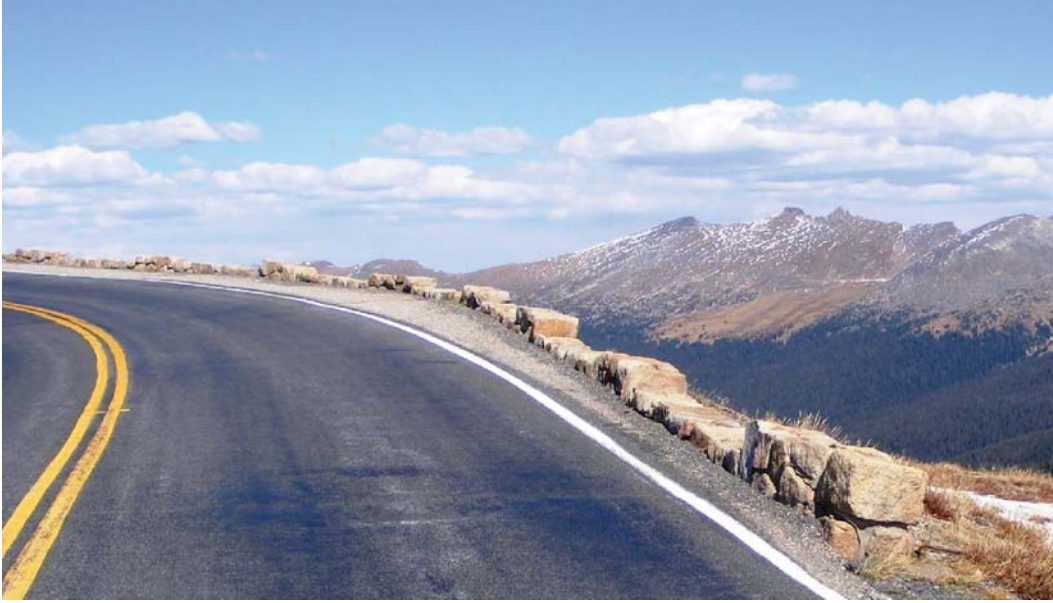
**ROMO\_0010\_18.667\_R\_1.jpg**

<b>Barrier ID:</b>	ROMO-0010-18.667-R				
<b>Route Name:</b>	TRAIL RIDGE ROAD				
<b>Inspection Date:</b>	09/29/2009	<b>Barrier Rating:</b>	63.70		
<b>Barrier Description</b>					
<b>Type:</b>	STONE MASONRY WITHOUT CONCRETE CORE WALL	<b>Barrier Function:</b>	TRAFFIC		
<b>Barrier Material:</b>	STONE	<b>Post Material:</b>	N/A		
<b>Blockout Type:</b>	N/A	<b>Length (ft.):</b>	292		
<b>Speed Limit (MPH):</b>	35	<b>Placement with Respect to Road:</b>	OUTSIDE OF CURVE		
<b>Hazard Behind Barrier:</b>	MEDIUM				
<b>Barrier Crashworthiness</b>					
<b>Appropriate Test Level:</b>	TL-2	<b>Barrier Test Level:</b>	NCW	<b>Is Barrier Crashworthy?:</b>	NO
<b>Beg. End Trtmt Type:</b>	NONE	<b>Is Beg. End Trtmt Crashworthy?:</b>	N/A	<b>Approach Transition Type:</b>	NONE
<b>Ending End Trtmt Type:</b>	NONE	<b>Ending End Trtmt Crashworthy?:</b>	N/A		
<b>Average Measurements</b>					
<b>Design Height (In.):</b>	24	<b>Width (In.):</b>	18.2	<b>Post Spacing (In.):</b>	0.0
