# ROMO GIP Report

## NPS Guardwall/Rail Inventory Program Rocky Mountain National Park

**Federal Highway Administration  
Eastern Federal Lands Highway Division  
Road Inventory Program (RIP)**

**Data Collection Date: October 2009  
Report Date: November 2015**

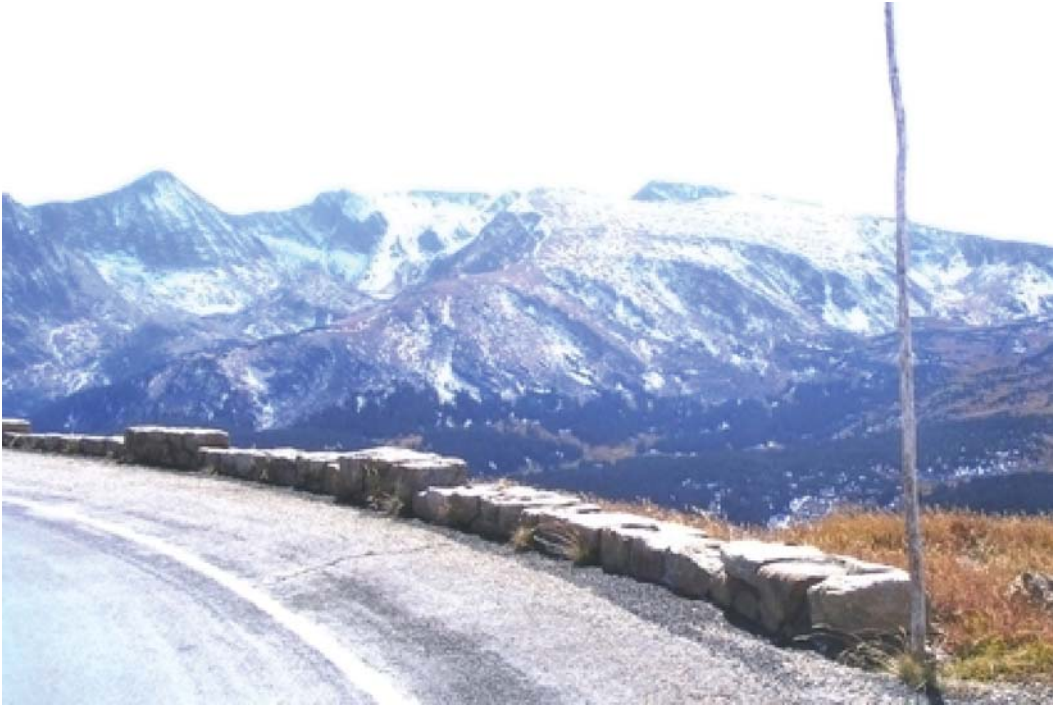
**ROMO\_0010\_18.937\_L\_1.jpg**

<b>Barrier ID:</b>	ROMO-0010-18.937-L				
<b>Route Name:</b>	TRAIL RIDGE ROAD				
<b>Inspection Date:</b>	09/29/2009	<b>Barrier Rating:</b>	69.90		
<b>Barrier Description</b>					
<b>Type:</b>	STONE MASONRY WITHOUT CONCRETE CORE WALL	<b>Barrier Function:</b>	TRAFFIC		
<b>Barrier Material:</b>	STONE	<b>Post Material:</b>	N/A		
<b>Blockout Type:</b>	N/A	<b>Length (ft.):</b>	324		
<b>Speed Limit (MPH):</b>	35	<b>Placement with Respect to Road:</b>	OUTSIDE OF CURVE		
<b>Hazard Behind Barrier:</b>	HIGH				
<b>Barrier Crashworthiness</b>					
<b>Appropriate Test Level:</b>	TL-2	<b>Barrier Test Level:</b>	NCW	<b>Is Barrier Crashworthy?:</b>	NO
<b>Beg. End Trtmt Type:</b>	NONE	<b>Is Beg. End Trtmt Crashworthy?:</b>	N/A	<b>Approach Transition Type:</b>	NONE
<b>Ending End Trtmt Type:</b>	NONE	<b>Ending End Trtmt Crashworthy?:</b>	N/A		
<b>Average Measurements</b>					
<b>Design Height (In.):</b>	24	<b>Width (In.):</b>	18.2	<b>Post Spacing (In.):</b>	0.0

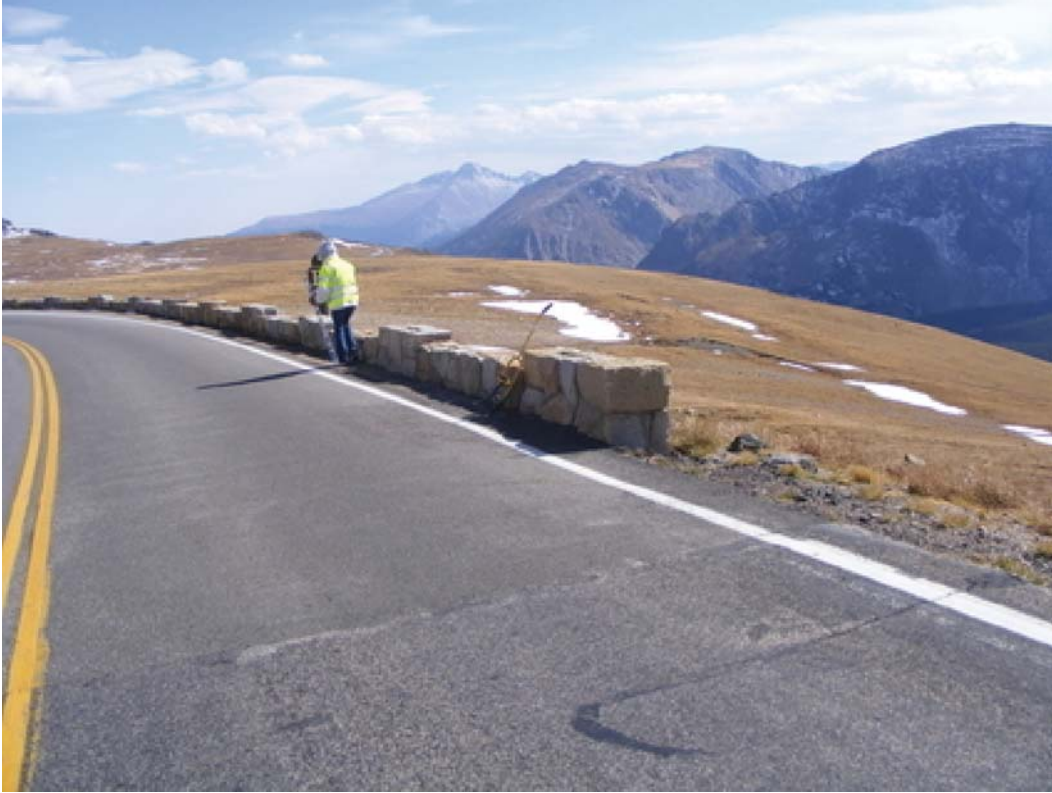
ROMO\_0010\_19.353\_L\_1.jpg

<b>Barrier ID:</b>	ROMO-0010-19.353-L				
<b>Route Name:</b>	TRAIL RIDGE ROAD				
<b>Inspection Date:</b>	09/29/2009	<b>Barrier Rating:</b>	62.20		
<b>Barrier Description</b>					
<b>Type:</b>	STONE MASONRY WITHOUT CONCRETE CORE WALL	<b>Barrier Function:</b>	TRAFFIC		
<b>Barrier Material:</b>	STONE	<b>Post Material:</b>	N/A		
<b>Blockout Type:</b>	N/A	<b>Length (ft.):</b>	257		
<b>Speed Limit (MPH):</b>	35	<b>Placement with Respect to Road:</b>	OUTSIDE OF CURVE		
<b>Hazard Behind Barrier:</b>	N/A				
<b>Barrier Crashworthiness</b>					
<b>Appropriate Test Level:</b>	TL-2	<b>Barrier Test Level:</b>	NCW	<b>Is Barrier Crashworthy?:</b>	NO
<b>Beg. End Trtmt Type:</b>	NONE	<b>Is Beg. End Trtmt Crashworthy?:</b>	N/A	<b>Approach Transition Type:</b>	NONE
<b>Ending End Trtmt Type:</b>	NONE	<b>Ending End Trtmt Crashworthy?:</b>	N/A		
<b>Average Measurements</b>					
<b>Design Height (In.):</b>	24	<b>Width (In.):</b>	19.6	<b>Post Spacing (In.):</b>	0.0

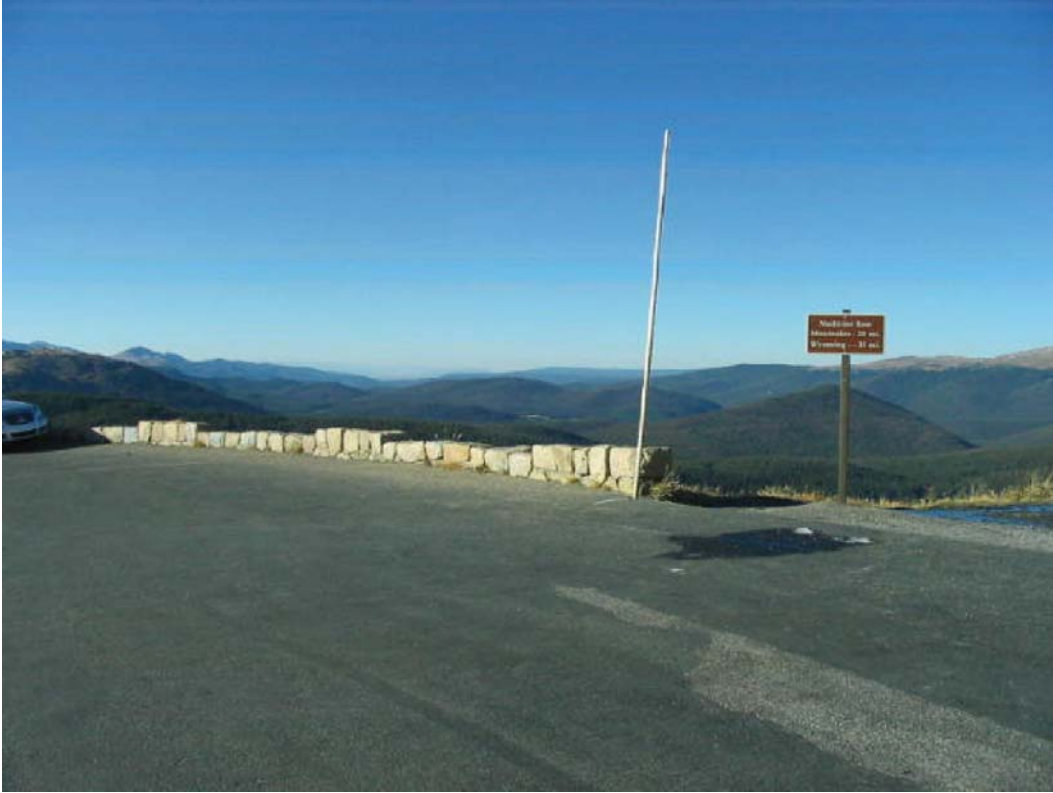
**ROMO\_0010\_21.717\_R\_1.jpg**

<b>Barrier ID:</b>	ROMO-0010-21.717-R				
<b>Route Name:</b>	TRAIL RIDGE ROAD				
<b>Inspection Date:</b>	09/28/2009	<b>Barrier Rating:</b>	27.80		
<b>Barrier Description</b>					
<b>Type:</b>	STONE MASONRY WITHOUT CONCRETE CORE WALL	<b>Barrier Function:</b>	NON-TRAFFIC		
<b>Barrier Material:</b>	STONE	<b>Post Material:</b>	N/A		
<b>Blockout Type:</b>	N/A	<b>Length (ft.):</b>	234		
<b>Speed Limit (MPH):</b>	35	<b>Placement with Respect to Road:</b>	NON-TRAFFIC BARRIER		
<b>Hazard Behind Barrier:</b>	N/A				
<b>Barrier Crashworthiness</b>					
<b>Appropriate Test Level:</b>	TL-2	<b>Barrier Test Level:</b>	N/A	<b>Is Barrier Crashworthy?:</b>	N/A
<b>Beg. End Trtmt Type:</b>	NONE	<b>Is Beg. End Trtmt Crashworthy?:</b>	N/A	<b>Approach Transition Type:</b>	NONE
<b>Ending End Trtmt Type:</b>	NONE	<b>Ending End Trtmt Crashworthy?:</b>	N/A		
<b>Average Measurements</b>					
<b>Design Height (In.):</b>	24	<b>Width (In.):</b>	18.5	<b>Post Spacing (In.):</b>	0.0

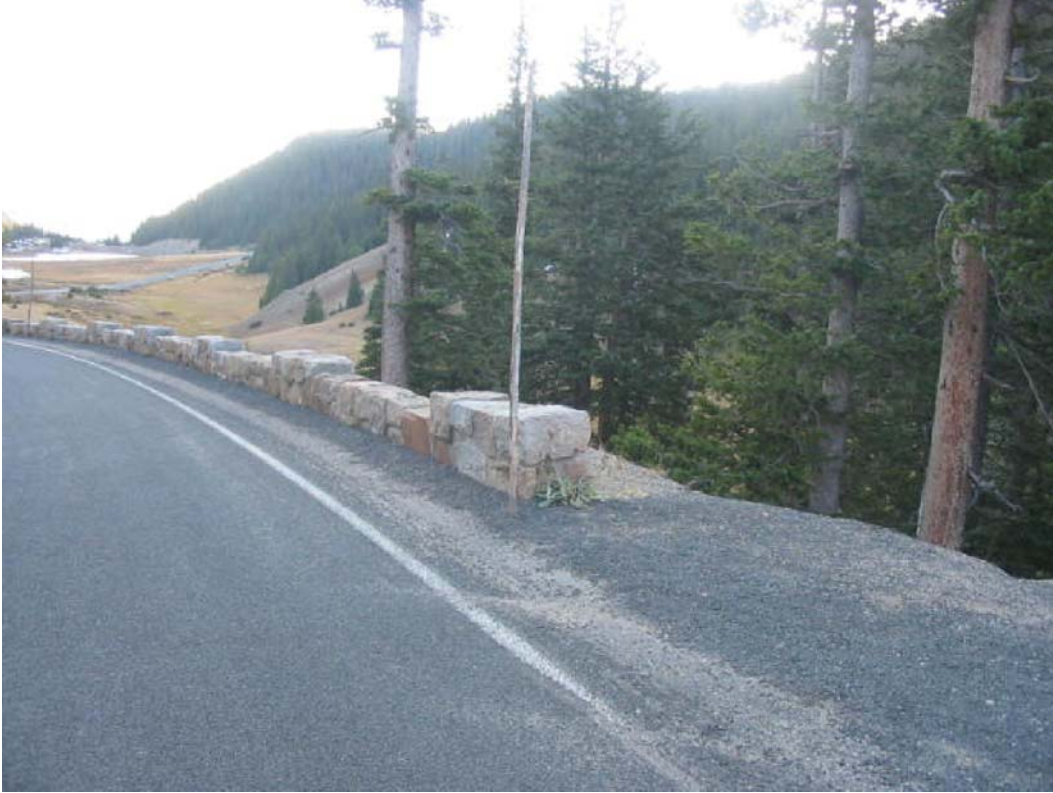
**ROMO\_0010\_24.791\_R\_1.jpg**

<b>Barrier ID:</b>	ROMO-0010-24.791-R				
<b>Route Name:</b>	TRAIL RIDGE ROAD				
<b>Inspection Date:</b>	09/28/2009	<b>Barrier Rating:</b>	53.70		
<b>Barrier Description</b>					
<b>Type:</b>	STONE MASONRY WITHOUT CONCRETE CORE WALL	<b>Barrier Function:</b>	TRAFFIC		
<b>Barrier Material:</b>	STONE	<b>Post Material:</b>	N/A		
<b>Blockout Type:</b>	N/A	<b>Length (ft.):</b>	311		
<b>Speed Limit (MPH):</b>	35	<b>Placement with Respect to Road:</b>	OUTSIDE OF CURVE		
<b>Hazard Behind Barrier:</b>	MEDIUM				
<b>Barrier Crashworthiness</b>					
<b>Appropriate Test Level:</b>	TL-2	<b>Barrier Test Level:</b>	NCW	<b>Is Barrier Crashworthy?:</b>	NO
<b>Beg. End Trtmt Type:</b>	NONE	<b>Is Beg. End Trtmt Crashworthy?:</b>	N/A	<b>Approach Transition Type:</b>	NONE
<b>Ending End Trtmt Type:</b>	NONE	<b>Ending End Trtmt Crashworthy?:</b>	N/A		
<b>Average Measurements</b>					
<b>Design Height (In.):</b>	24	<b>Width (In.):</b>	18.2	<b>Post Spacing (In.):</b>	0.0

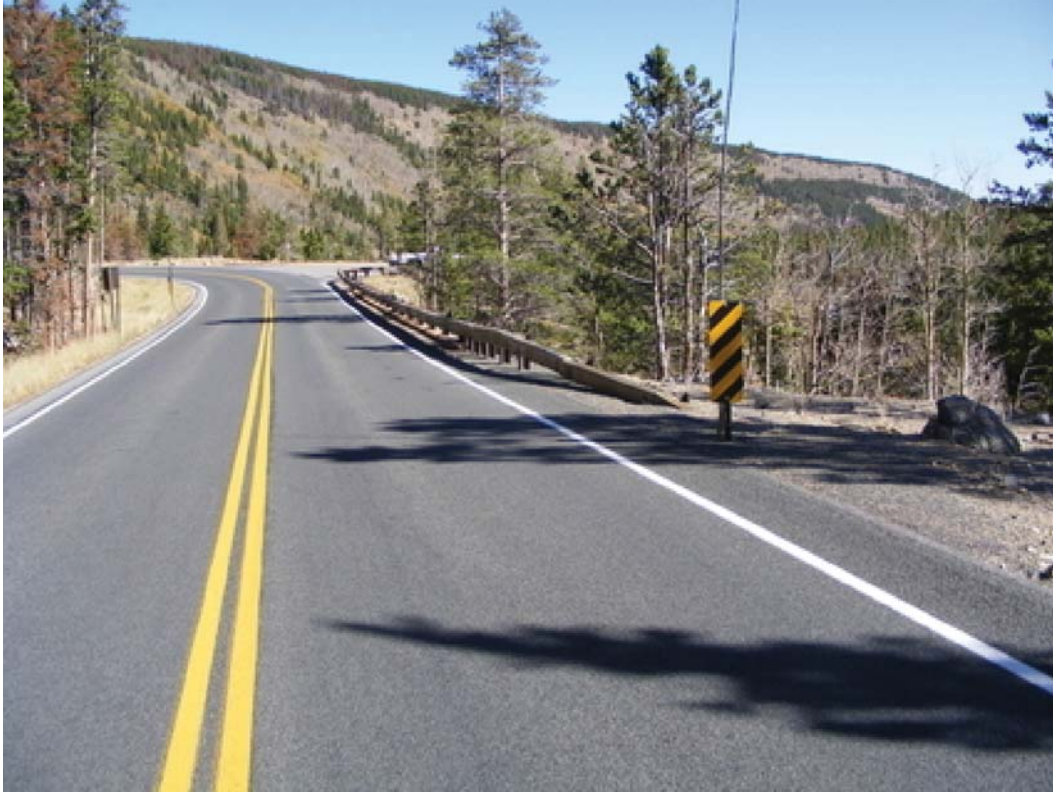
**ROMO\_0012\_7.641\_L\_1.jpg**

<b>Barrier ID:</b>	ROMO-0012-7.641-L				
<b>Route Name:</b>	BEAR LAKE ROAD				
<b>Inspection Date:</b>	10/02/2009	<b>Barrier Rating:</b>	15.60		
<b>Barrier Description</b>					
<b>Type:</b>	STEEL-BACKED TIMBER WITH BLOCKOUT	<b>Barrier Function:</b>	TRAFFIC		
<b>Barrier Material:</b>	STEEL-BACKED TIMBER/LOG	<b>Post Material:</b>	CORTEN		
<b>Blockout Type:</b>	WOOD	<b>Length (ft.):</b>	248		
<b>Speed Limit (MPH):</b>	25	<b>Placement with Respect to Road:</b>	TANGENT		
<b>Hazard Behind Barrier:</b>	EXTREME				
<b>Barrier Crashworthiness</b>					
<b>Appropriate Test Level:</b>	TL-1	<b>Barrier Test Level:</b>	TL-3	<b>Is Barrier Crashworthy?:</b>	YES
<b>Beg. End Trtmt Type:</b>	SBT/LOG FLARED	<b>Is Beg. End Trtmt Crashworthy?:</b>	NO	<b>Approach Transition Type:</b>	NONE
<b>Ending End Trtmt Type:</b>	NONE	<b>Ending End Trtmt Crashworthy?:</b>	N/A		
<b>Average Measurements</b>					
<b>Design Height (In.):</b>	27	<b>Width (In.):</b>	0.0	<b>Post Spacing (In.):</b>	99.5

<b>Height (In.):</b>	26.6	<b>Lateral Offset (In.):</b>	29.0	<b>Road Grade (%):</b>	1.80
<b>Physical Condition</b>					
<b>Barrier</b>	<b>Alignment and Height:</b>	Alignment acceptable. Height within 1-in of 27-in design height.			
	<b>Breaking and Cracking:</b>	No breaking or cracking observed.			
	<b>Missing Elements:</b>	No missing elements observed.			
	<b>Corrosion and Weathering:</b>	No corrosion or weathering observed.			
<b>End Treatments</b>	<b>Alignment and Height:</b>	Alignment acceptable. Height within 1-in of 27-in design height.			
	<b>Breaking and Cracking:</b>	No breaking or cracking observed.			
	<b>Missing Elements:</b>	No missing elements observed.			
	<b>Corrosion and Weathering:</b>	No corrosion or weathering observed.

<b>Barrier ID:</b>	ROMO-0012-7.641-L				
<b>Route Name:</b>	BEAR LAKE ROAD				
<b>Inspection Date:</b>	10/02/2009	<b>Barrier Rating:</b>		15.60	
<b>Repair Recommendations</b>					
<b>Repair Action:</b>	NO ACTION	<b>FMSS Work Type:</b>	N/A	<b>Repair Cost:</b>	\$0
<b>Brief Workorder:</b>	N/A				
<b>Workorder:</b>

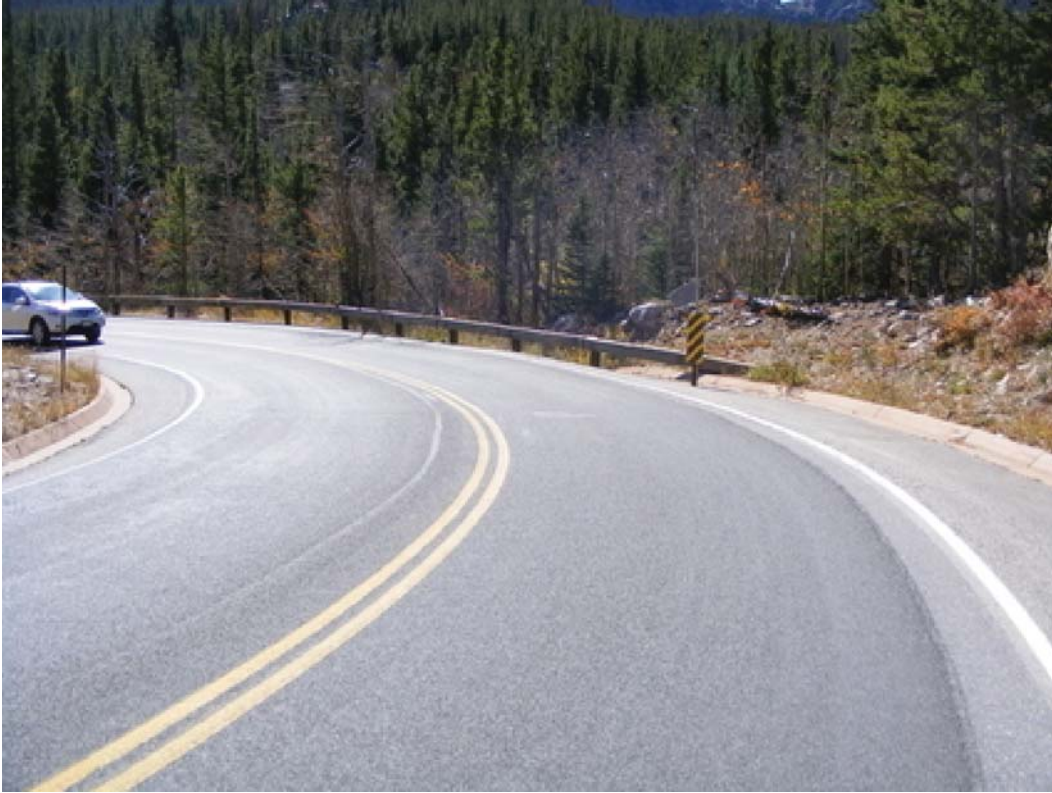
**ROMO\_0012\_7.799\_L\_1.jpg**

<b>Barrier ID:</b>	ROMO-0012-7.799-L				
<b>Route Name:</b>	BEAR LAKE ROAD				
<b>Inspection Date:</b>	10/02/2009	<b>Barrier Rating:</b>	28.00		
<b>Barrier Description</b>					
<b>Type:</b>	STEEL-BACKED TIMBER WITH BLOCKOUT	<b>Barrier Function:</b>	TRAFFIC		
<b>Barrier Material:</b>	STEEL-BACKED TIMBER/LOG	<b>Post Material:</b>	CORTEN		
<b>Blockout Type:</b>	WOOD	<b>Length (ft.):</b>	525		
<b>Speed Limit (MPH):</b>	25	<b>Placement with Respect to Road:</b>	BOTH INSIDE AND OUTSIDE		
<b>Hazard Behind Barrier:</b>	MEDIUM				
<b>Barrier Crashworthiness</b>					
<b>Appropriate Test Level:</b>	TL-1	<b>Barrier Test Level:</b>	TL-3	<b>Is Barrier Crashworthy?:</b>	YES
<b>Beg. End Trtmt Type:</b>	SBT/LOG BURIED	<b>Is Beg. End Trtmt Crashworthy?:</b>	YES	<b>Approach Transition Type:</b>	NONE
<b>Ending End Trtmt Type:</b>	SBT/LOG FLARED	<b>Ending End Trtmt Crashworthy?:</b>	NO		
<b>Average Measurements</b>					
<b>Design Height (In.):</b>	27	<b>Width (In.):</b>	0.0	<b>Post Spacing (In.):</b>	118.0

<b>Height (In.):</b>	27.2	<b>Lateral Offset (In.):</b>	31.2	<b>Road Grade (%):</b>	5.10
<b>Physical Condition</b>					
<b>Barrier</b>	<b>Alignment and Height:</b>	Alignment acceptable. Height within 1-in of 27-in design height.			
	<b>Breaking and Cracking:</b>	No breaking or cracking observed.			
	<b>Missing Elements:</b>	No missing elements observed.			
	<b>Corrosion and Weathering:</b>	No corrosion or weathering observed.			
<b>End Treatments</b>	<b>Alignment and Height:</b>	Alignment acceptable. Height within 1-in of 27-in design height.			
	<b>Breaking and Cracking:</b>	No breaking or cracking observed.			
	<b>Missing Elements:</b>	No missing elements observed.			
	<b>Corrosion and Weathering:</b>	No corrosion or weathering observed.

<b>Barrier ID:</b>	ROMO-0012-7.799-L				
<b>Route Name:</b>	BEAR LAKE ROAD				
<b>Inspection Date:</b>	10/02/2009	<b>Barrier Rating:</b>		28.00	
<b>Repair Recommendations</b>					
<b>Repair Action:</b>	NO ACTION	<b>FMSS Work Type:</b>	N/A	<b>Repair Cost:</b>	\$0
<b>Brief Workorder:</b>	N/A				
<b>Workorder:</b>

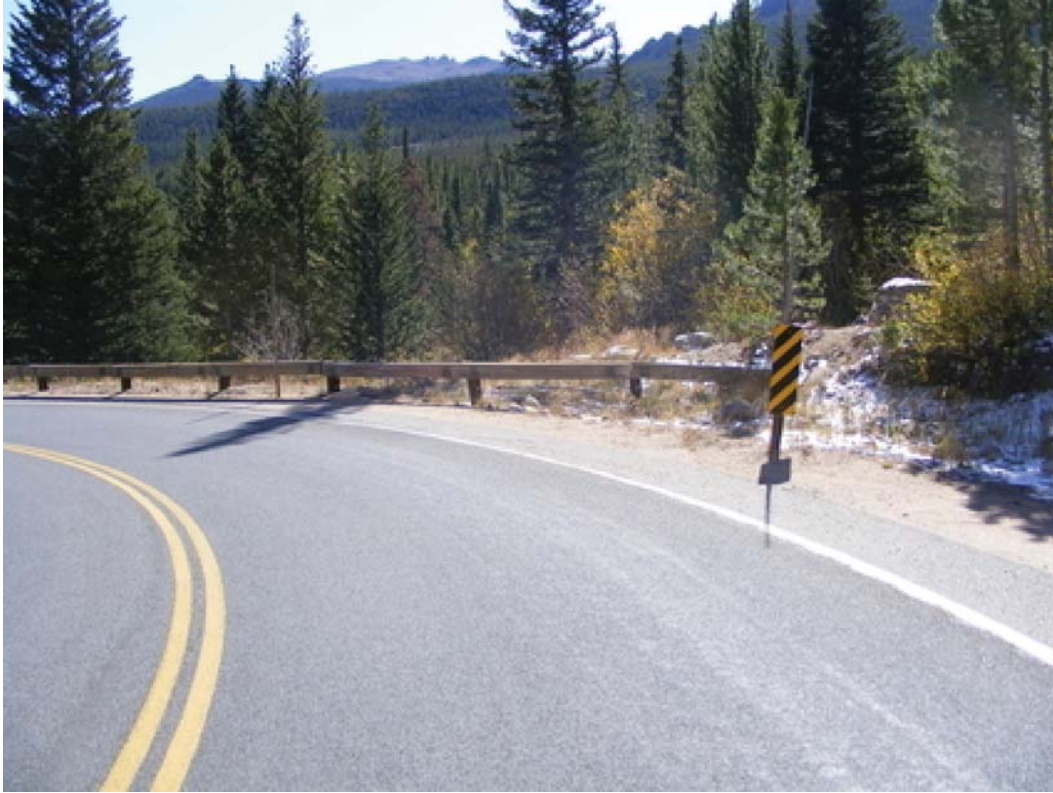
ROMO\_0012\_8.403\_L\_1.jpg

<b>Barrier ID:</b>	ROMO-0012-8.403-L				
<b>Route Name:</b>	BEAR LAKE ROAD				
<b>Inspection Date:</b>	10/02/2009	<b>Barrier Rating:</b>	26.80		
<b>Barrier Description</b>					
<b>Type:</b>	STEEL-BACKED TIMBER WITH BLOCKOUT	<b>Barrier Function:</b>	TRAFFIC		
<b>Barrier Material:</b>	STEEL-BACKED TIMBER/LOG	<b>Post Material:</b>	CORTEN		
<b>Blockout Type:</b>	WOOD	<b>Length (ft.):</b>	190		
<b>Speed Limit (MPH):</b>	25	<b>Placement with Respect to Road:</b>	OUTSIDE OF CURVE		
<b>Hazard Behind Barrier:</b>	HIGH				
<b>Barrier Crashworthiness</b>					
<b>Appropriate Test Level:</b>	TL-1	<b>Barrier Test Level:</b>	TL-3	<b>Is Barrier Crashworthy?:</b>	YES
<b>Beg. End Trtmt Type:</b>	SBT/LOG BURIED	<b>Is Beg. End Trtmt Crashworthy?:</b>	YES	<b>Approach Transition Type:</b>	NONE
<b>Ending End Trtmt Type:</b>	SBT/LOG FLARED	<b>Ending End Trtmt Crashworthy?:</b>	NO		
<b>Average Measurements</b>					
<b>Design Height (In.):</b>	27	<b>Width (In.):</b>	0.0	<b>Post Spacing (In.):</b>	119.5

<b>Height (In.):</b>	27.2	<b>Lateral Offset (In.):</b>	46.2	<b>Road Grade (%):</b>	4.40
<b>Physical Condition</b>					
<b>Barrier</b>	<b>Alignment and Height:</b>	Alignment acceptable. Height within 1-in of 27-in design height.			
	<b>Breaking and Cracking:</b>	No breaking or cracking observed.			
	<b>Missing Elements:</b>	No missing elements observed.			
	<b>Corrosion and Weathering:</b>	No corrosion or weathering observed.			
<b>End Treatments</b>	<b>Alignment and Height:</b>	Alignment acceptable. Height within 1-in of 27-in design height.			
	<b>Breaking and Cracking:</b>	No breaking or cracking observed.			
	<b>Missing Elements:</b>	No missing elements observed.			
	<b>Corrosion and Weathering:</b>	No corrosion or weathering observed.

<b>Repair Action:</b>	NO ACTION	<b>FMSS Work Type:</b>	N/A	<b>Repair Cost:</b>	\$0
<b>Brief Workorder:</b>	N/A				
<b>Workorder:</b>

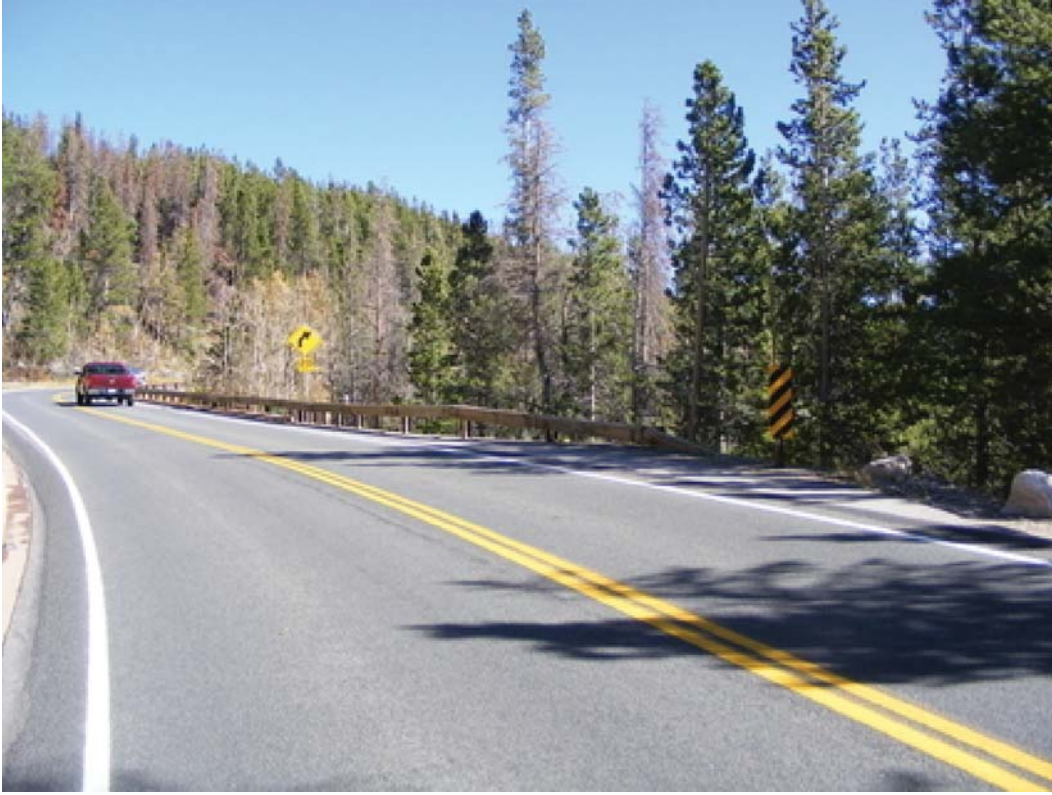
ROMO\_0012\_8.550\_R\_1.jpg

<b>Barrier ID:</b>	ROMO-0012-8.550-R				
<b>Route Name:</b>	BEAR LAKE ROAD				
<b>Inspection Date:</b>	10/01/2009	<b>Barrier Rating:</b>	34.20		
<b>Barrier Description</b>					
<b>Type:</b>	STEEL-BACKED TIMBER WITH BLOCKOUT	<b>Barrier Function:</b>	TRAFFIC		
<b>Barrier Material:</b>	STEEL-BACKED TIMBER/LOG	<b>Post Material:</b>	CORTEN		
<b>Blockout Type:</b>	WOOD	<b>Length (ft.):</b>	583		
<b>Speed Limit (MPH):</b>	25	<b>Placement with Respect to Road:</b>	BOTH INSIDE AND OUTSIDE		
<b>Hazard Behind Barrier:</b>	HIGH				
<b>Barrier Crashworthiness</b>					
<b>Appropriate Test Level:</b>	TL-1	<b>Barrier Test Level:</b>	TL-3	<b>Is Barrier Crashworthy?:</b>	YES
<b>Beg. End Trtmt Type:</b>	SBT/LOG FLARED	<b>Is Beg. End Trtmt Crashworthy?:</b>	NO	<b>Approach Transition Type:</b>	NONE
<b>Ending End Trtmt Type:</b>	SBT/LOG FLARED	<b>Ending End Trtmt Crashworthy?:</b>	NO		
<b>Average Measurements</b>					
<b>Design Height (In.):</b>	27	<b>Width (In.):</b>	0.0	<b>Post Spacing (In.):</b>	99.0

<b>Height (In.):</b>	25.7	<b>Lateral Offset (In.):</b>	33.5	<b>Road Grade (%):</b>	4.00
<b>Physical Condition</b>					
<b>Barrier</b>	<b>Alignment and Height:</b>	Alignment acceptable. 245-ft was between 1 and 3-in below the 27-in design height.			
	<b>Breaking and Cracking:</b>	No breaking or cracking observed.			
	<b>Missing Elements:</b>	No missing elements observed.			
	<b>Corrosion and Weathering:</b>	No corrosion or weathering observed.			
<b>End Treatments</b>	<b>Alignment and Height:</b>	Alignment acceptable. Height within 1-in of 27-in design height.			
	<b>Breaking and Cracking:</b>	No breaking or cracking observed.			
	<b>Missing Elements:</b>	No missing elements observed.			
	<b>Corrosion and Weathering:</b>	No corrosion or weathering observed.

<b>Repair Action:</b>	REPAIR	<b>FMSS Work Type:</b>	DEFERRED MAINTENANCE	<b>Repair Cost:</b>	\$4318
<b>Brief Workorder:</b>	Raise 245ft. of barrier up to 27-in design height.				
<b>Workorder:</b>	Adjust guardrail at \$10- per -Lin. Ft. for 245 LF = \$2450. Raise 245ft. of barrier up to 27-in design height. Low Speed Traffic Control at \$1475- per -Day for 1 Day(s) = \$1475.

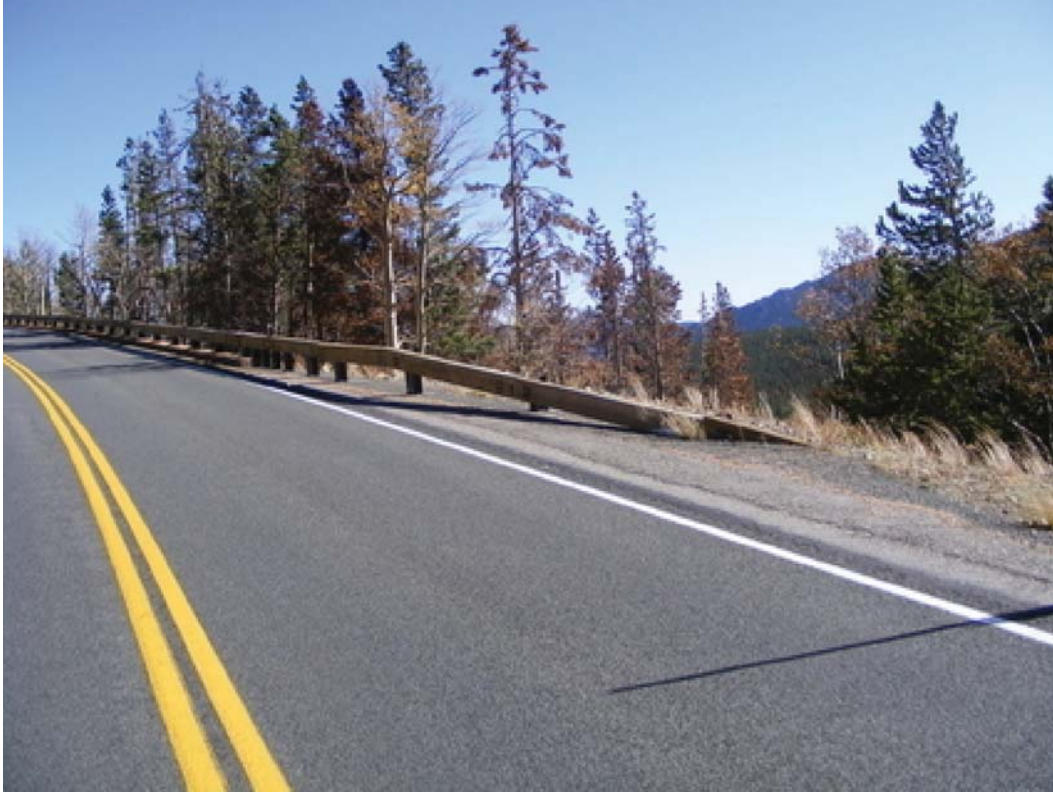
ROMO\_0012\_8.718\_R\_1.jpg

<b>Barrier ID:</b>	ROMO-0012-8.718-R				
<b>Route Name:</b>	BEAR LAKE ROAD				
<b>Inspection Date:</b>	10/01/2009	<b>Barrier Rating:</b>	28.20		
<b>Barrier Description</b>					
<b>Type:</b>	STEEL-BACKED TIMBER WITH BLOCKOUT	<b>Barrier Function:</b>	TRAFFIC		
<b>Barrier Material:</b>	STEEL-BACKED TIMBER/LOG	<b>Post Material:</b>	CORTEN		
<b>Blockout Type:</b>	WOOD	<b>Length (ft.):</b>	968		
<b>Speed Limit (MPH):</b>	25	<b>Placement with Respect to Road:</b>	BOTH INSIDE AND OUTSIDE		
<b>Hazard Behind Barrier:</b>	HIGH				
<b>Barrier Crashworthiness</b>					
<b>Appropriate Test Level:</b>	TL-1	<b>Barrier Test Level:</b>	TL-3	<b>Is Barrier Crashworthy?:</b>	YES
<b>Beg. End Trtmt Type:</b>	SBT/LOG FLARED	<b>Is Beg. End Trtmt Crashworthy?:</b>	NO	<b>Approach Transition Type:</b>	NONE
<b>Ending End Trtmt Type:</b>	SBT/LOG BURIED	<b>Ending End Trtmt Crashworthy?:</b>	YES		
<b>Average Measurements</b>					
<b>Design Height (In.):</b>	27	<b>Width (In.):</b>	0.0	<b>Post Spacing (In.):</b>	99.0

<b>Height (In.):</b>	26.3	<b>Lateral Offset (In.):</b>	27.0	<b>Road Grade (%):</b>	3.90
<b>Physical Condition</b>					
<b>Barrier</b>	<b>Alignment and Height:</b>	Alignment acceptable. Height within 1-in of 27-in design height.			
	<b>Breaking and Cracking:</b>	No breaking or cracking observed.			
	<b>Missing Elements:</b>	No missing elements observed.			
	<b>Corrosion and Weathering:</b>	No corrosion or weathering observed.			
<b>End Treatments</b>	<b>Alignment and Height:</b>	Alignment acceptable. Height within 1-in of 27-in design height.			
	<b>Breaking and Cracking:</b>	No breaking or cracking observed.			
	<b>Missing Elements:</b>	No missing elements observed.			
	<b>Corrosion and Weathering:</b>	No corrosion or weathering observed.

<b>Barrier ID:</b>	ROMO-0012-8.718-R				
<b>Route Name:</b>	BEAR LAKE ROAD				
<b>Inspection Date:</b>	10/01/2009	<b>Barrier Rating:</b>		28.20	
<b>Repair Recommendations</b>					
<b>Repair Action:</b>	NO ACTION	<b>FMSS Work Type:</b>	N/A	<b>Repair Cost:</b>	\$0
<b>Brief Workorder:</b>	N/A				
<b>Workorder:</b>

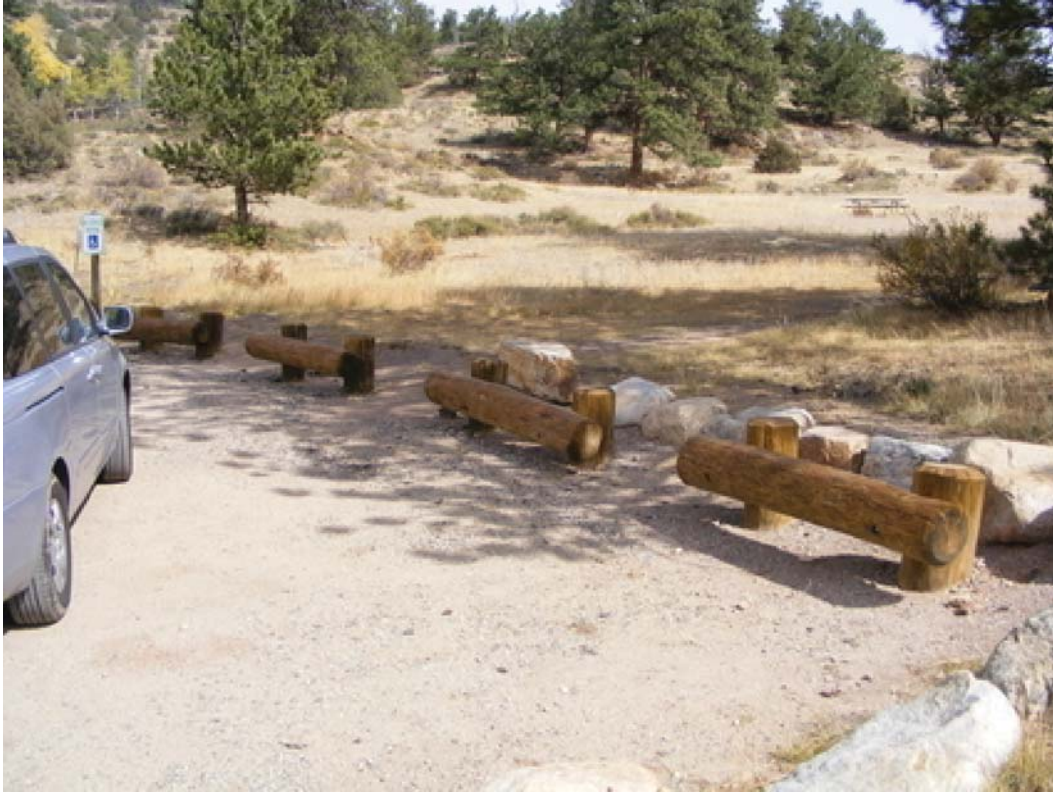
**ROMO\_0201\_1.450\_R\_1.jpg**

<b>Barrier ID:</b>	ROMO-0201-1.450-R				
<b>Route Name:</b>	CUB LAKE / STABLES ROAD				
<b>Inspection Date:</b>	10/01/2009	<b>Barrier Rating:</b>	0.00		
<b>Barrier Description</b>					
<b>Type:</b>	OTHER: LOG RAIL ON LOG POSTS	<b>Barrier Function:</b>	NON-TRAFFIC		
<b>Barrier Material:</b>	LOG/TIMBER/WOOD	<b>Post Material:</b>	WOOD		
<b>Blockout Type:</b>	N/A	<b>Length (ft.):</b>	133		
<b>Speed Limit (MPH):</b>	15	<b>Placement with Respect to Road:</b>	NON-TRAFFIC BARRIER		
<b>Hazard Behind Barrier:</b>	N/A				
<b>Barrier Crashworthiness</b>					
<b>Appropriate Test Level:</b>	TL-1	<b>Barrier Test Level:</b>	N/A	<b>Is Barrier Crashworthy?:</b>	N/A
<b>Beg. End Trtmt Type:</b>	NONE	<b>Is Beg. End Trtmt Crashworthy?:</b>	N/A	<b>Approach Transition Type:</b>	NONE
<b>Ending End Trtmt Type:</b>	NONE	<b>Ending End Trtmt Crashworthy?:</b>	N/A		
<b>Average Measurements</b>					
<b>Design Height (In.):</b>	20	<b>Width (In.):</b>	12.0	<b>Post Spacing (In.):</b>	60.0

<b>Height (In.):</b>	22.0	<b>Lateral Offset (In.):</b>	0.0	<b>Road Grade (%):</b>	0.00
<b>Physical Condition</b>					
<b>Barrier</b>	<b>Alignment and Height:</b>	Alignment acceptable. Height was 2-in above the 20-in design height.			
	<b>Breaking and Cracking:</b>	No breaking or cracking observed.			
	<b>Missing Elements:</b>	No missing elements observed.			
	<b>Corrosion and Weathering:</b>	No corrosion or weathering observed.			
<b>End Treatments</b>	<b>Alignment and Height:</b>	Alignment acceptable. Height was 2-in above the 20-in design height.			
	<b>Breaking and Cracking:</b>	No breaking or cracking observed.			
	<b>Missing Elements:</b>	No missing elements observed.			
	<b>Corrosion and Weathering:</b>	No corrosion or weathering observed.

<b>Barrier ID:</b>	ROMO-0201-1.450-R				
<b>Route Name:</b>	CUB LAKE / STABLES ROAD				
<b>Inspection Date:</b>	10/01/2009	<b>Barrier Rating:</b>		0.00	
<b>Repair Recommendations</b>					
<b>Repair Action:</b>	NO ACTION	<b>FMSS Work Type:</b>	N/A	<b>Repair Cost:</b>	\$0
<b>Brief Workorder:</b>	N/A				
<b>Workorder:</b>
