GIP Report

NPS Guardwall/Rail Inventory Program
Sequoia National Park

Federal Lands Highway
Road Inventory Program

Data Collection Date: October 2009
Report Date: November 2015

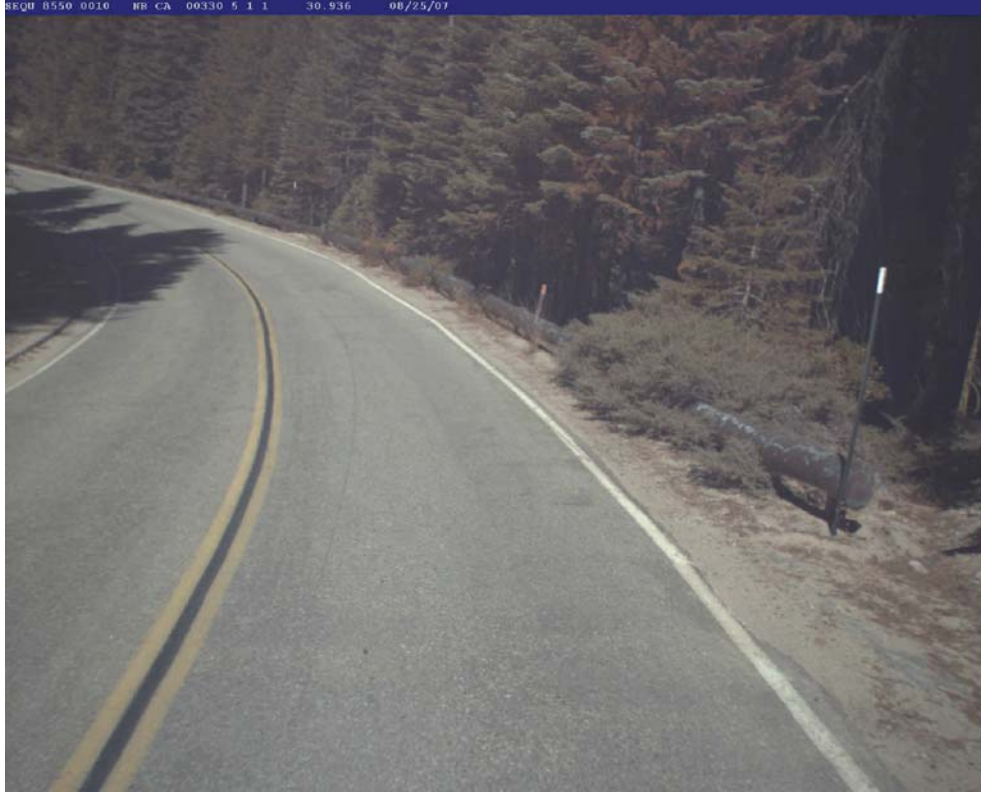
SEQU_0010_30.939_R_1.jpg

Barrier ID:	SEQU-0010-30.939-R				
Route Name:	GENERALS HIGHWAY HISTORIC				
Inspection Date:	10/20/2009	Barrier Rating:	38.00		
Barrier Description					
Type:	OTHER: NON-STANDARD STEEL BARRIER	Barrier Function:	TRAFFIC		
Barrier Material:	WEATHERING STEEL/CORTEN	Post Material:	CORTEN		
Blockout Type:	N/A	Length (ft.):	300		
Speed Limit (MPH):	25	Placement with Respect to Road:	OUTSIDE OF CURVE		
Hazard Behind Barrier:	MEDIUM				
Barrier Crashworthiness					
Appropriate Test Level:	TL-1	Barrier Test Level:	NCW	Is Barrier Crashworthy?:	NO
Beg. End Trtmt Type:	NONE	Is Beg. End Trtmt Crashworthy?:	N/A	Approach Transition Type:	NONE
Ending End Trtmt Type:	NONE	Ending End Trtmt Crashworthy?:	N/A		
Average Measurements					
Design Height (In.):	27	Width (In.):	0.0	Post Spacing (In.):	118.6
Height (In.):	23.2	Lateral Offset (In.):	42.2	Road Grade (%):	2.60
Physical Condition					
Barrier	Alignment and Height:	Alignment is acceptable. Entire barrier is between 3-4in below the 27-in design height.

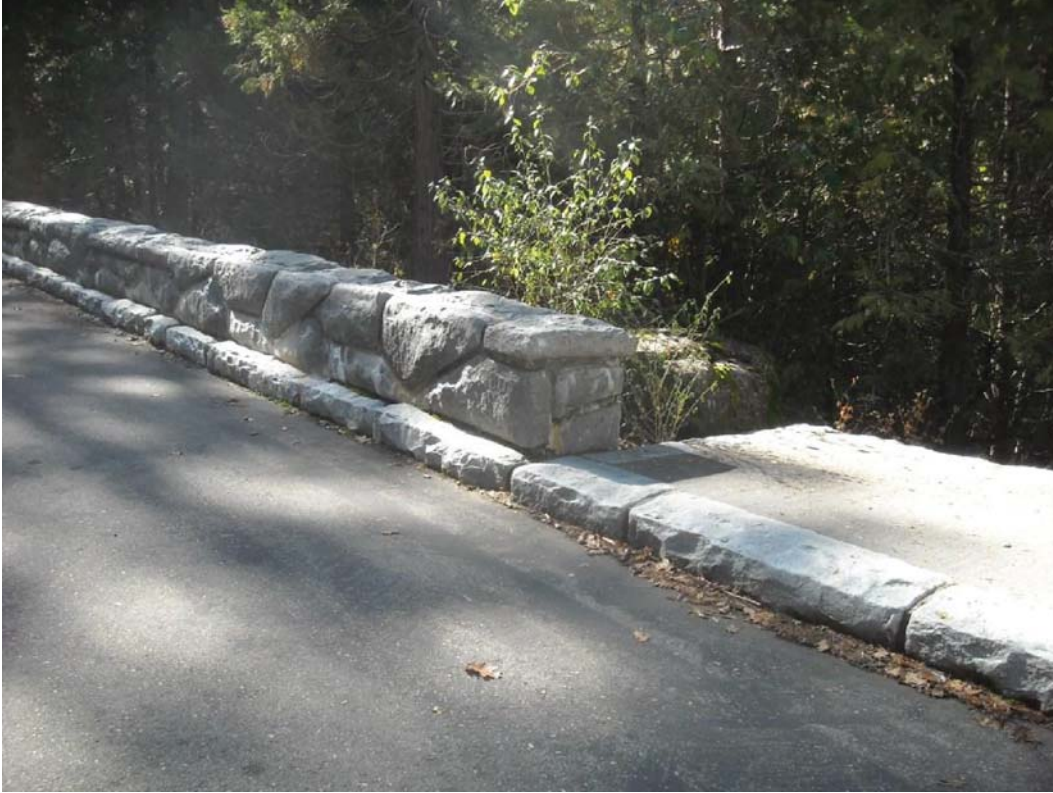
SEQU_0100_1.593_L_1.JPG

Barrier ID:	SEQU-0100-1.593-L				
Route Name:	CRYSTAL CAVE ROAD				
Inspection Date:	10/21/2009	Barrier Rating:	11.10		
Barrier Description					
Type:	STONE MASONRY WITH CONCRETE CORE WALL	Barrier Function:	TRAFFIC		
Barrier Material:	CONCRETE	Post Material:	N/A		
Blockout Type:	N/A	Length (ft.):	60		
Speed Limit (MPH):	25	Placement with Respect to Road:	TANGENT		
Hazard Behind Barrier:	HIGH				
Barrier Crashworthiness					
Appropriate Test Level:	TL-1	Barrier Test Level:	TL-3	Is Barrier Crashworthy?:	YES
Beg. End Trtmt Type:	NONE	Is Beg. End Trtmt Crashworthy?:	N/A	Approach Transition Type:	NONE
Ending End Trtmt Type:	NONE	Ending End Trtmt Crashworthy?:	N/A		
Average Measurements					
Design Height (In.):	27	Width (In.):	26.7	Post Spacing (In.):	0.0
Height (In.):	31.7	Lateral Offset (In.):	96.0	Road Grade (%):	5.50
Physical Condition					
Barrier	Alignment and Height:	Alignment acceptable. Height was 4-5in above the 27-in design height.

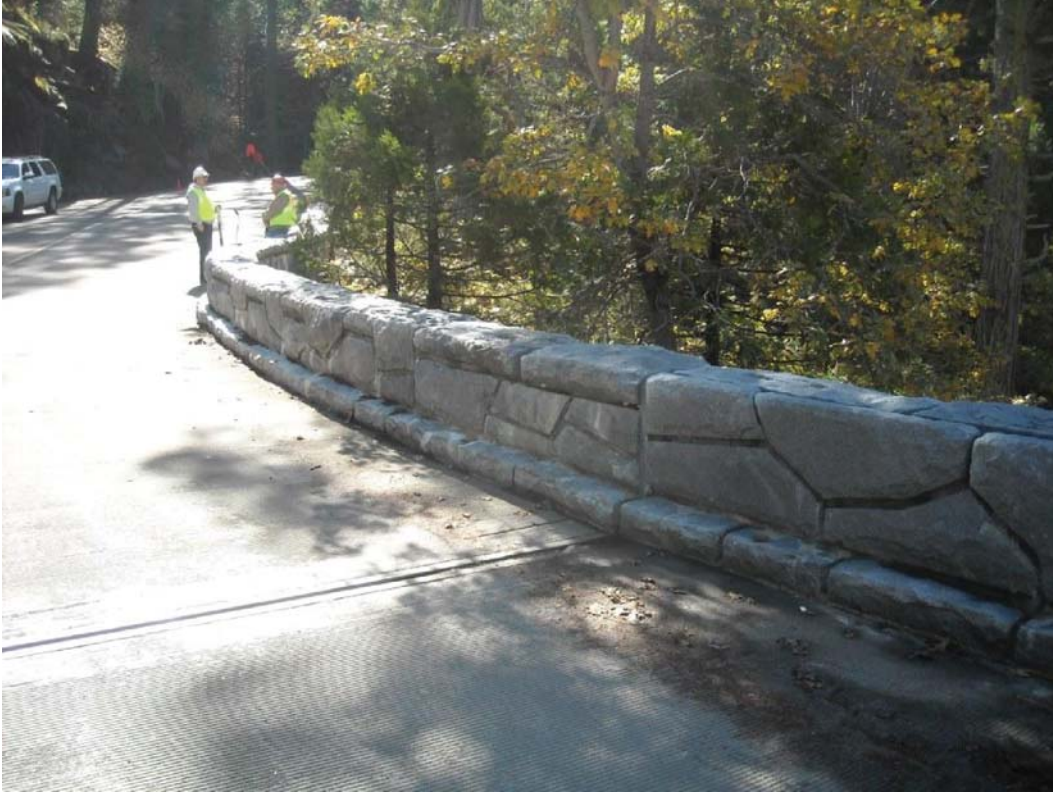
SEQU_0100_1.607_L_1.JPG

Barrier ID:	SEQU-0100-1.607-L				
Route Name:	CRYSTAL CAVE ROAD				
Inspection Date:	10/21/2009	Barrier Rating:	14.00		
Barrier Description					
Type:	STONE MASONRY WITH CONCRETE CORE WALL	Barrier Function:	TRAFFIC		
Barrier Material:	CONCRETE	Post Material:	N/A		
Blockout Type:	N/A	Length (ft.):	75		
Speed Limit (MPH):	25	Placement with Respect to Road:	TANGENT		
Hazard Behind Barrier:	HIGH				
Barrier Crashworthiness					
Appropriate Test Level:	TL-1	Barrier Test Level:	TL-3	Is Barrier Crashworthy?:	YES
Beg. End Trtmt Type:	NONE	Is Beg. End Trtmt Crashworthy?:	N/A	Approach Transition Type:	NONE
Ending End Trtmt Type:	NONE	Ending End Trtmt Crashworthy?:	N/A		
Average Measurements					
Design Height (In.):	27	Width (In.):	26.0	Post Spacing (In.):	0.0
Height (In.):	29.7	Lateral Offset (In.):	32.0	Road Grade (%):	5.70
Physical Condition					
Barrier	Alignment and Height:	Alignment acceptable. Height was 2-3in above the 27-in design height.

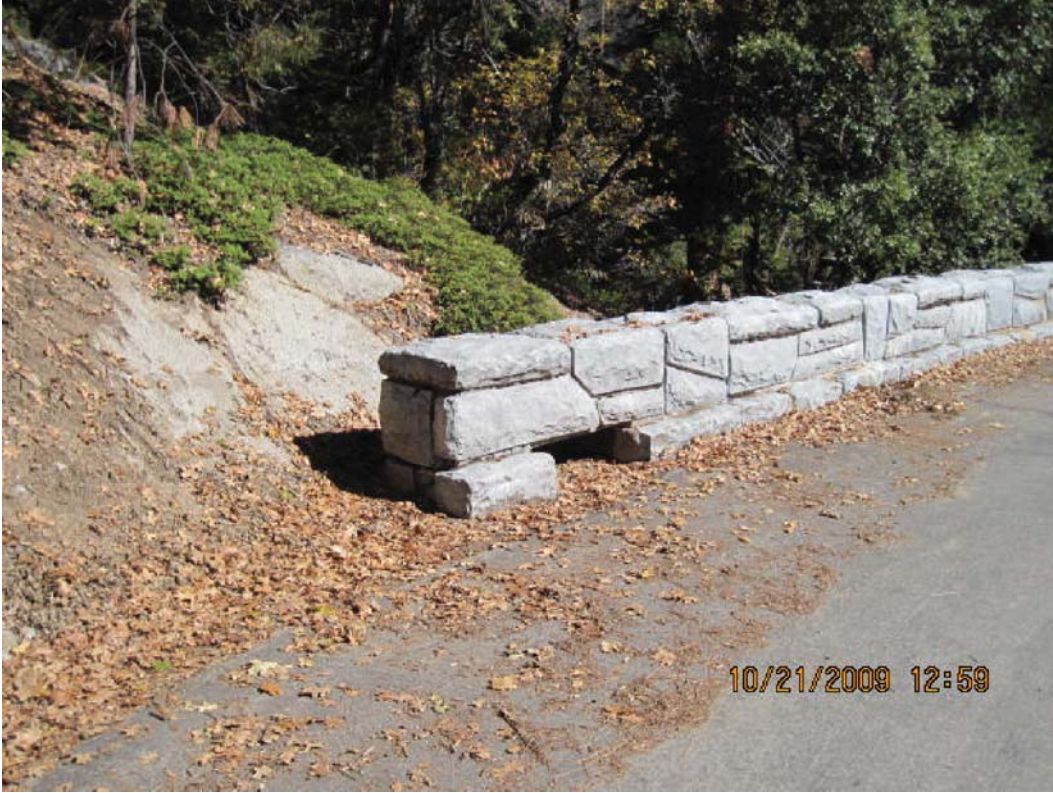
SEQU_0100_1.644_R_1.jpg

Barrier ID:	SEQU-0100-1.644-R				
Route Name:	CRYSTAL CAVE ROAD				
Inspection Date:	10/21/2009	Barrier Rating:	21.20		
Barrier Description					
Type:	STONE MASONRY WITH CONCRETE CORE WALL	Barrier Function:	TRAFFIC		
Barrier Material:	CONCRETE	Post Material:	N/A		
Blockout Type:	N/A	Length (ft.):	52		
Speed Limit (MPH):	25	Placement with Respect to Road:	OUTSIDE OF CURVE		
Hazard Behind Barrier:	HIGH				
Barrier Crashworthiness					
Appropriate Test Level:	TL-1	Barrier Test Level:	TL-3	Is Barrier Crashworthy?:	YES
Beg. End Trtmt Type:	NONE	Is Beg. End Trtmt Crashworthy?:	N/A	Approach Transition Type:	NONE
Ending End Trtmt Type:	NONE	Ending End Trtmt Crashworthy?:	N/A		
Average Measurements					
Design Height (In.):	27	Width (In.):	26.0	Post Spacing (In.):	0.0
Height (In.):	30.7	Lateral Offset (In.):	18.0	Road Grade (%):	0.50
Physical Condition					
Barrier	Alignment and Height:	Alignment acceptable. Height was 3-5in above the 27-in design height.

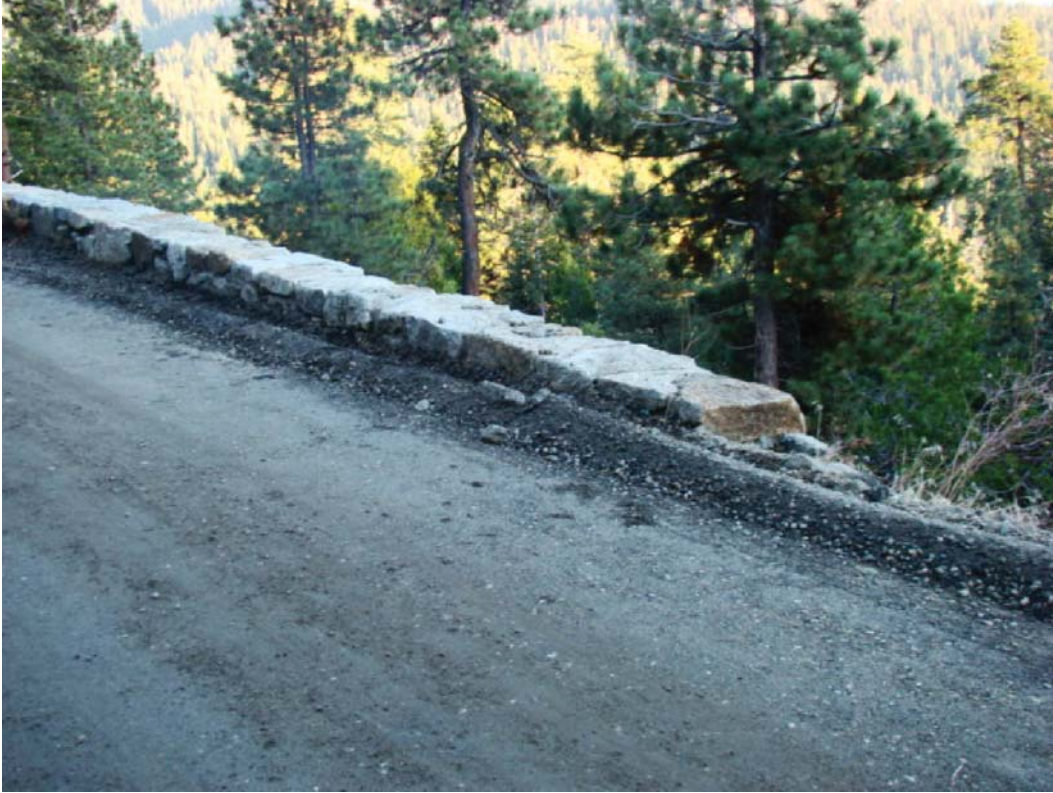
SEQU_0101_0.112_R_1.JPG

Barrier ID:	SEQU-0101-0.112-R				
Route Name:	WUKSACHI ROAD				
Inspection Date:	10/20/2009	Barrier Rating:	53.00		
Barrier Description					
Type:	STONE MASONRY WITHOUT CONCRETE CORE WALL	Barrier Function:	TRAFFIC		
Barrier Material:	STONE	Post Material:	N/A		
Blockout Type:	N/A	Length (ft.):	185		
Speed Limit (MPH):	25	Placement with Respect to Road:	OUTSIDE OF CURVE		
Hazard Behind Barrier:	MEDIUM				
Barrier Crashworthiness					
Appropriate Test Level:	TL-1	Barrier Test Level:	NCW	Is Barrier Crashworthy?:	NO
Beg. End Trtmt Type:	NONE	Is Beg. End Trtmt Crashworthy?:	N/A	Approach Transition Type:	NONE
Ending End Trtmt Type:	NONE	Ending End Trtmt Crashworthy?:	N/A		
Average Measurements					
Design Height (In.):	24	Width (In.):	22.7	Post Spacing (In.):	0.0
Height (In.):	16.5	Lateral Offset (In.):	14.6	Road Grade (%):	6.40
Physical Condition					
Barrier	Alignment and Height:	Alignment acceptable. Height was 7-9in below the 24-in design height
