GIP Report

NPS Guardwall/Rail Inventory Program
Suitland Parkway National Capital Parks - East

Federal Highway Administration
Eastern Federal Lands Highway Division
Road Inventory Program (RIP)

Data Collection Date: November 2010
Report Date: November 2015

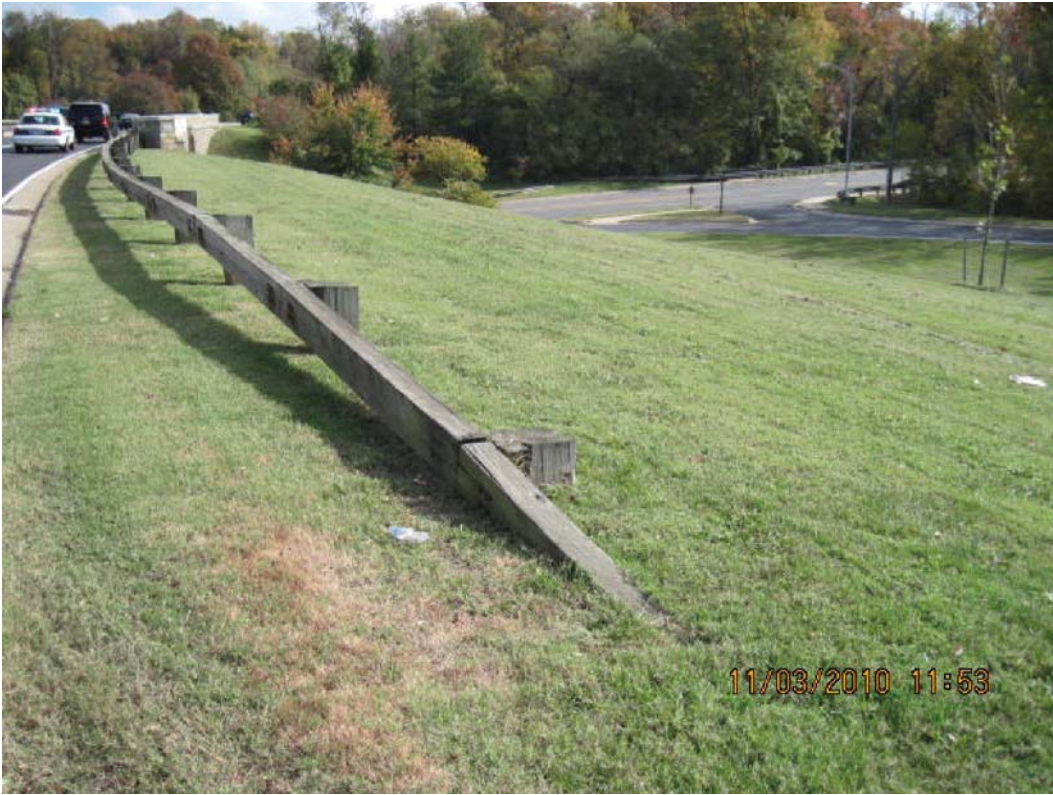
SUIT_0001_0.547_R_1.jpg

Barrier ID:	SUIT-0001-0.547-R				
Route Name:	EASTBOUND SUITLAND PARKWAY				
Inspection Date:	03/11/2010	Barrier Rating:	38.20		
Barrier Description					
Type:	STEEL-BACKED TIMBER WITH BLOCKOUT	Barrier Function:	TRAFFIC		
Barrier Material:	STEEL-BACKED TIMBER/LOG	Post Material:	WOOD		
Blockout Type:	WOOD	Length (ft.):	145		
Speed Limit (MPH):	45	Placement with Respect to Road:	INSIDE OF CURVE		
Hazard Behind Barrier:	MEDIUM				
Barrier Crashworthiness					
Appropriate Test Level:	TL-2	Barrier Test Level:	TL-3	Is Barrier Crashworthy?:	YES
Beg. End Trtmt Type:	SBT/LOG FLARED	Is Beg. End Trtmt Crashworthy?:	NO	Approach Transition Type:	CONC/MASON SBT
Ending End Trtmt Type:	NONE	Ending End Trtmt Crashworthy?:	N/A		
Average Measurements					
Design Height (In.):	27	Width (In.):	0.0	Post Spacing (In.):	119.6
Height (In.):	25.0	Lateral Offset (In.):	69.0	Road Grade (%):	2.50
Physical Condition					
Barrier	Alignment and Height:	No deflections observed in alignment. 100 ft of barrier is 1 to 3 in below 27 in design height.

Breaking and Cracking:	No impact related breaking or cracking observed.			
	Missing Elements:	No elements were observed to be missing.			
	Corrosion and Weathering:	No loss of cross section or erosion around posts observed.			
End Treatments	Alignment and Height:	Alignment acceptable. Height within 1-in of 27-in design height.			
	Breaking and Cracking:	No impact related breaking or cracking observed.			
	Missing Elements:	No elements were observed to be missing.			
	Corrosion and Weathering:	No loss of cross section or erosion around posts observed.

Repair Action:	REPAIR	FMSS Work Type:	DEFERRED MAINTENANCE	Repair Cost:	\$2723
Brief Workorder:	Raise 100-ft of guardrail up to the 27-in design height.				
Workorder:	Adjust Guardrail at \$10- per -Lin. Ft. for 100 LF = \$1000. Raise 100 feet of guardrail to 27 inch design height. Low Speed Traffic Control at \$1475- per -Day for 1 Day(s) = \$1475.

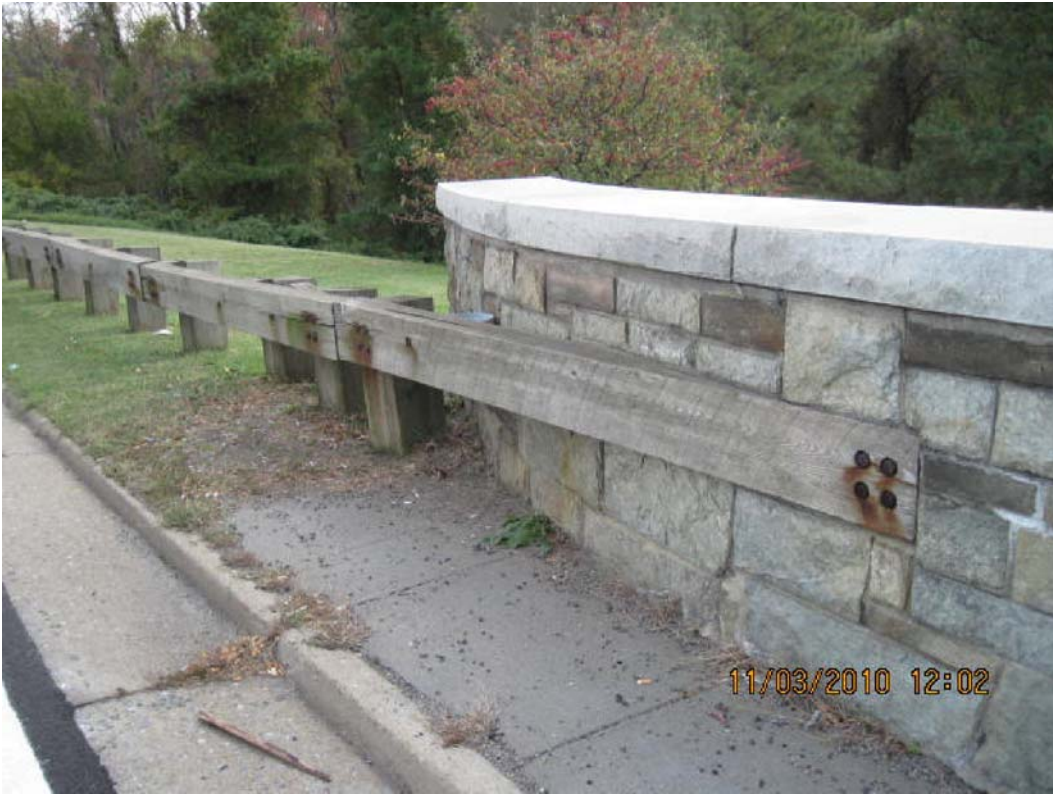
SUIT_0001_0.604_R_1.jpg

Barrier ID:	SUIT-0001-0.604-R				
Route Name:	EASTBOUND SUITLAND PARKWAY				
Inspection Date:	03/11/2010	Barrier Rating:	33.90		
Barrier Description					
Type:	STEEL-BACKED TIMBER WITH BLOCKOUT	Barrier Function:	TRAFFIC		
Barrier Material:	STEEL-BACKED TIMBER/LOG	Post Material:	WOOD		
Blockout Type:	WOOD	Length (ft.):	81		
Speed Limit (MPH):	45	Placement with Respect to Road:	INSIDE OF CURVE		
Hazard Behind Barrier:	MEDIUM				
Barrier Crashworthiness					
Appropriate Test Level:	TL-2	Barrier Test Level:	TL-3	Is Barrier Crashworthy?:	YES
Beg. End Trtmt Type:	NONE	Is Beg. End Trtmt Crashworthy?:	N/A	Approach Transition Type:	CONC/MASON SBT
Ending End Trtmt Type:	SBT/LOG FLARED	Ending End Trtmt Crashworthy?:	NO		
Average Measurements					
Design Height (In.):	27	Width (In.):	0.0	Post Spacing (In.):	79.8
Height (In.):	29.7	Lateral Offset (In.):	68.0	Road Grade (%):	1.10
Physical Condition					
Barrier	Alignment and Height:	No deflections observed in alignment. Entire barrier exceeds 27 in design height by 2 to 3.5 in.

Breaking and Cracking:	No impact related breaking or cracking observed. 3 blockouts were longitudinally broken.			
	Missing Elements:	No elements were observed to be missing.			
	Corrosion and Weathering:	No loss of cross section or erosion around posts observed.			
End Treatments	Alignment and Height:	Alignment acceptable. Height within 1-in of 27-in design height.			
	Breaking and Cracking:	No impact related breaking or cracking observed.			
	Missing Elements:	No elements were observed to be missing.			
	Corrosion and Weathering:	No loss of cross section or erosion around posts observed.

Repair Action:	REPAIR	FMSS Work Type:	DEFERRED MAINTENANCE	Repair Cost:	\$1722
Brief Workorder:	Replace 3 blockouts.				
Workorder:	Replace Block at \$30- per -Each for 3 Block(s) = \$90. Replace 3 blockouts. Low Speed Traffic Control at \$1475- per -Day for 1 Day(s) = \$1475.

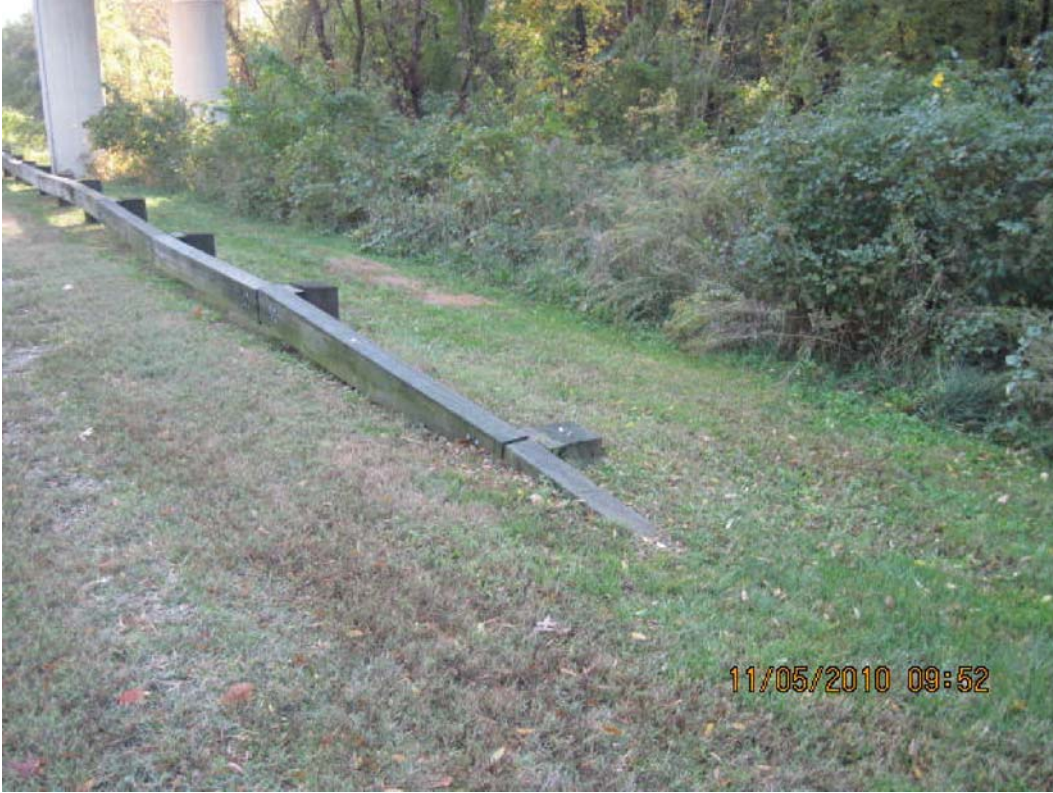
SUIT_0001_0.836_R_1.jpg

Barrier ID:	SUIT-0001-0.836-R				
Route Name:	EASTBOUND SUITLAND PARKWAY				
Inspection Date:	05/11/2010	Barrier Rating:	39.70		
Barrier Description					
Type:	STEEL-BACKED TIMBER WITH BLOCKOUT	Barrier Function:	TRAFFIC		
Barrier Material:	STEEL-BACKED TIMBER/LOG	Post Material:	WOOD		
Blockout Type:	WOOD	Length (ft.):	139		
Speed Limit (MPH):	50	Placement with Respect to Road:	TANGENT		
Hazard Behind Barrier:	MEDIUM				
Barrier Crashworthiness					
Appropriate Test Level:	TL-3	Barrier Test Level:	TL-3	Is Barrier Crashworthy?:	YES
Beg. End Trtmt Type:	SBT/LOG FLARED	Is Beg. End Trtmt Crashworthy?:	NO	Approach Transition Type:	NONE
Ending End Trtmt Type:	SBT/LOG FLARED	Ending End Trtmt Crashworthy?:	NO		
Average Measurements					
Design Height (In.):	27	Width (In.):	0.0	Post Spacing (In.):	120.3
Height (In.):	23.7	Lateral Offset (In.):	128.0	Road Grade (%):	0.80
Physical Condition					
Barrier	Alignment and Height:	No deflections greater than 6 in observed in the alignment. The barrier height was within 1 in of the 27 in design height for 10 ft between 1 and 3 in below the design height for 10 ft and between 3 and 5 in below for 50 ft.

Breaking and Cracking:	There was some minor damage to a rail from a rub impact that should be monitored. No other breaking or cracking was observed.			
	Missing Elements:	No elements were observed to be missing.			
	Corrosion and Weathering:	Less than 5 percent of the cross section has been lost due to weathering and no erosion was observed.			
End Treatments	Alignment and Height:	Alignment acceptable. Height within 1-in of 27-in design height.			
	Breaking and Cracking:	No impact related breaking or cracking was observed.			
	Missing Elements:	No elements were observed to be missing.			
	Corrosion and Weathering:	No loss of the cross section or erosion was observed.

Repair Action:	REPAIR	FMSS Work Type:	DEFERRED MAINTENANCE	Repair Cost:	\$3245
Brief Workorder:	Raise 60-ft of guardrail up to the 27-in design height.				
Workorder:	Adjust Guardrail at \$10- per -Lin. Ft. for 60 LF = \$600. Raise 60 feet of guardrail to the design height of 27 inches. High Speed Traffic Control at \$2350- per -Day for 1 Day(s) = \$2350.

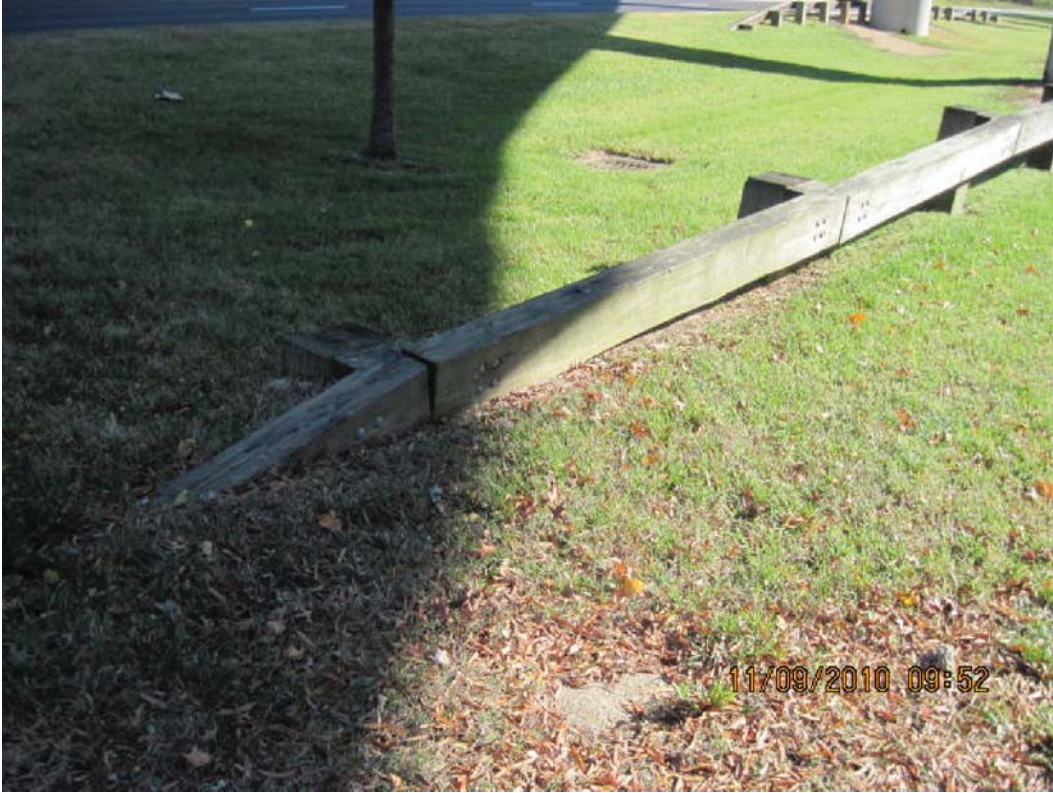
SUIT_0001_0.866_L_1.jpg

Barrier ID:	SUIT-0001-0.866-L				
Route Name:	EASTBOUND SUITLAND PARKWAY				
Inspection Date:	09/11/2010	Barrier Rating:	50.20		
Barrier Description					
Type:	STEEL-BACKED TIMBER WITH BLOCKOUT	Barrier Function:	TRAFFIC		
Barrier Material:	STEEL-BACKED TIMBER/LOG	Post Material:	WOOD		
Blockout Type:	WOOD	Length (ft.):	137		
Speed Limit (MPH):	50	Placement with Respect to Road:	OUTSIDE OF CURVE		
Hazard Behind Barrier:	HIGH				
Barrier Crashworthiness					
Appropriate Test Level:	TL-3	Barrier Test Level:	TL-3	Is Barrier Crashworthy?:	YES
Beg. End Trtmt Type:	SBT/LOG FLARED	Is Beg. End Trtmt Crashworthy?:	NO	Approach Transition Type:	NONE
Ending End Trtmt Type:	SBT/LOG FLARED	Ending End Trtmt Crashworthy?:	NO		
Average Measurements					
Design Height (In.):	27	Width (In.):	0.0	Post Spacing (In.):	120.5
Height (In.):	25.2	Lateral Offset (In.):	100.1	Road Grade (%):	0.80
Physical Condition					
Barrier	Alignment and Height:	Alignment deflection was less than 6 in. 10 ft of the barrier was between 1 and 3 in below design height (27 in). 30 ft of the barrier was 3-5 in below design height (27 in).

Breaking and Cracking:	20ft of rail had impact related breaking/cracking.			
	Missing Elements:	No elements appeared to be missing.			
	Corrosion and Weathering:	No cross section loss observed. Monitor erosion at the base of posts.			
End Treatments	Alignment and Height:	Alignment acceptable. Height within 1-in of 27-in design height.			
	Breaking and Cracking:	No impact related breaking/cracking observed.			
	Missing Elements:	No elements appeared to be missing.			
	Corrosion and Weathering:	No cross section loss observed. Monitor erosion at the base of the posts.

Repair Action:	REPAIR	FMSS Work Type:	DEFERRED MAINTENANCE	Repair Cost:	\$3575
Brief Workorder:	Raise 40-ft of guardrail up to the 27-in design height and replace 20-ft of rail.				
Workorder:	Adjust Guardrail at \$10- per -Lin. Ft. for 40 LF = \$400. Raise 40 ft of the barrier to 27in design height. Replace Rail at \$25- per -Lin. Ft. for 20 LF = \$500. Replace 20 ft of rail due to impact related breaking/cracking High Speed Traffic Control at \$2350- per -Day for 1 Day(s) = \$2350.

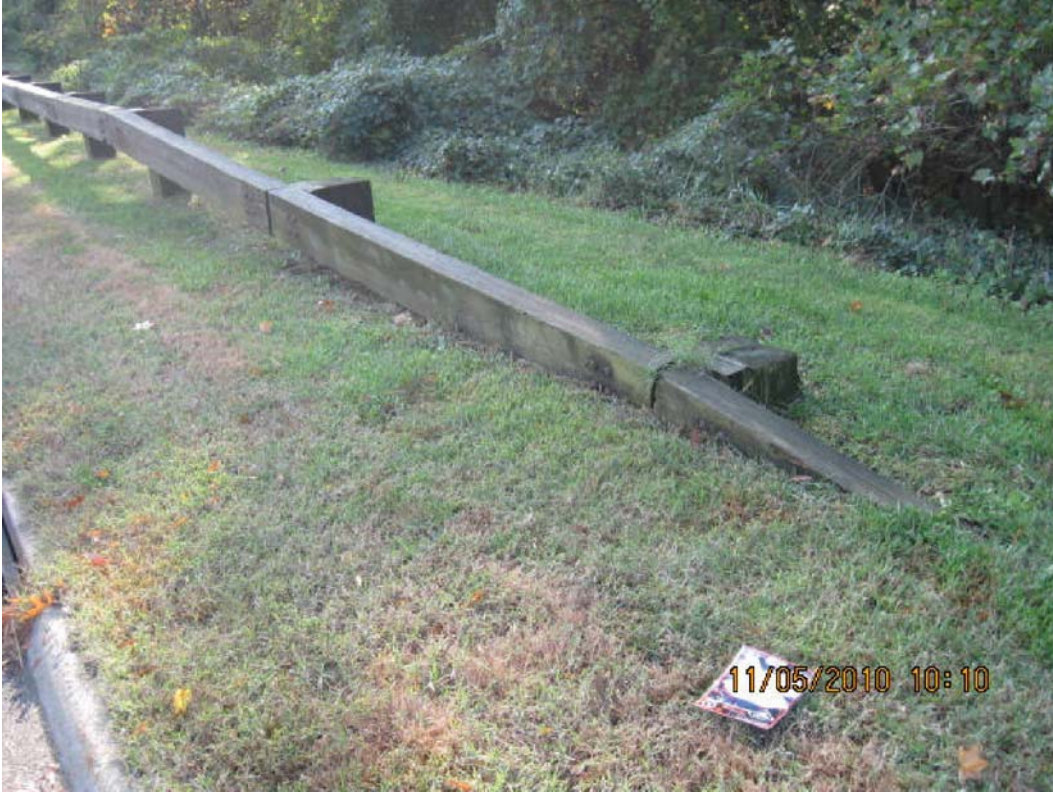
SUIT_0001_1.007_R_1.jpg

Barrier ID:	SUIT-0001-1.007-R				
Route Name:	EASTBOUND SUITLAND PARKWAY				
Inspection Date:	05/11/2010	Barrier Rating:	36.70		
Barrier Description					
Type:	STEEL-BACKED TIMBER WITH BLOCKOUT	Barrier Function:	TRAFFIC		
Barrier Material:	STEEL-BACKED TIMBER/LOG	Post Material:	WOOD		
Blockout Type:	WOOD	Length (ft.):	330		
Speed Limit (MPH):	50	Placement with Respect to Road:	INSIDE OF CURVE		
Hazard Behind Barrier:	MEDIUM				
Barrier Crashworthiness					
Appropriate Test Level:	TL-3	Barrier Test Level:	TL-3	Is Barrier Crashworthy?:	YES
Beg. End Trtmt Type:	SBT/LOG FLARED	Is Beg. End Trtmt Crashworthy?:	NO	Approach Transition Type:	NONE
Ending End Trtmt Type:	SBT/LOG FLARED	Ending End Trtmt Crashworthy?:	NO		
Average Measurements					
Design Height (In.):	27	Width (In.):	0.0	Post Spacing (In.):	120.3
Height (In.):	26.2	Lateral Offset (In.):	89.0	Road Grade (%):	0.50
Physical Condition					
Barrier	Alignment and Height:	Alignment deflection was less than 6 in. The entire barrier was within 1 in below design height (27 in).

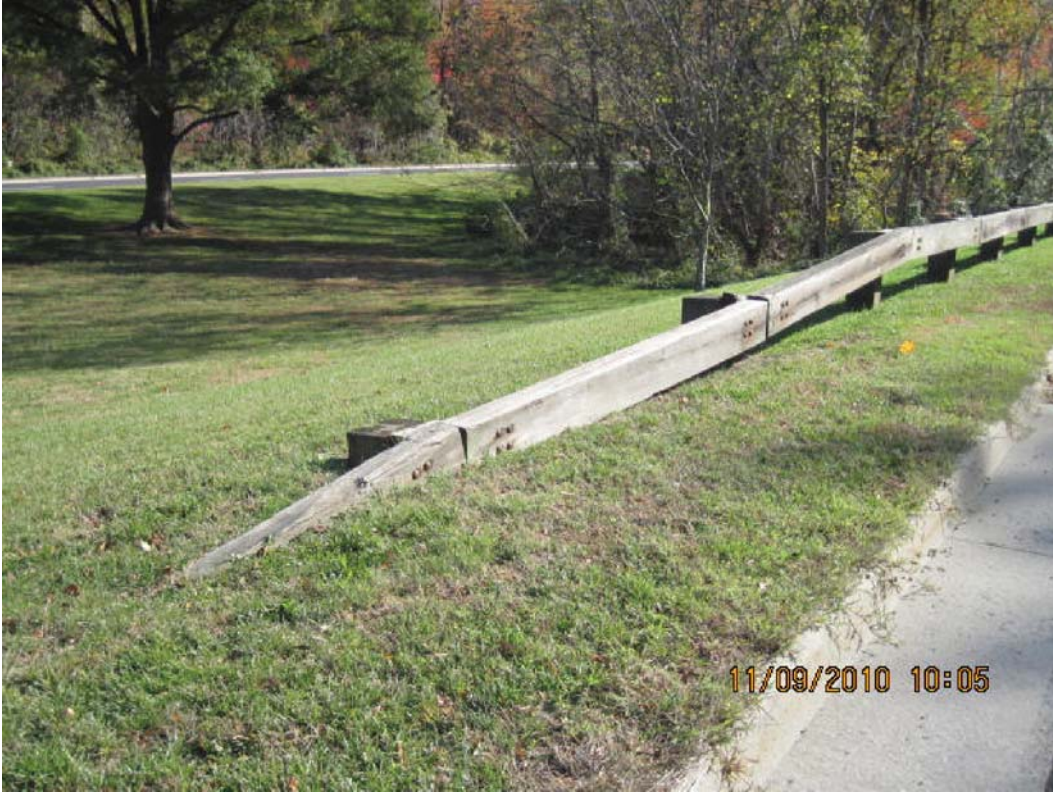
SUIT_0001_1.044_L_1.jpg

Barrier ID:	SUIT-0001-1.044-L				
Route Name:	EASTBOUND SUITLAND PARKWAY				
Inspection Date:	09/11/2010	Barrier Rating:	39.50		
Barrier Description					
Type:	STEEL-BACKED TIMBER WITH BLOCKOUT	Barrier Function:	TRAFFIC		
Barrier Material:	STEEL-BACKED TIMBER/LOG	Post Material:	WOOD		
Blockout Type:	WOOD	Length (ft.):	153		
Speed Limit (MPH):	50	Placement with Respect to Road:	OUTSIDE OF CURVE		
Hazard Behind Barrier:	MEDIUM				
Barrier Crashworthiness					
Appropriate Test Level:	TL-3	Barrier Test Level:	TL-3	Is Barrier Crashworthy?:	YES
Beg. End Trtmt Type:	SBT/LOG FLARED	Is Beg. End Trtmt Crashworthy?:	NO	Approach Transition Type:	NONE
Ending End Trtmt Type:	SBT/LOG FLARED	Ending End Trtmt Crashworthy?:	NO		
Average Measurements					
Design Height (In.):	27	Width (In.):	0.0	Post Spacing (In.):	120.1
Height (In.):	28.0	Lateral Offset (In.):	82.6	Road Grade (%):	0.60
Physical Condition					
Barrier	Alignment and Height:	No deflections observed in alignment. Entire barrier exceeds 27 in design height by 0.5 to 2 in.

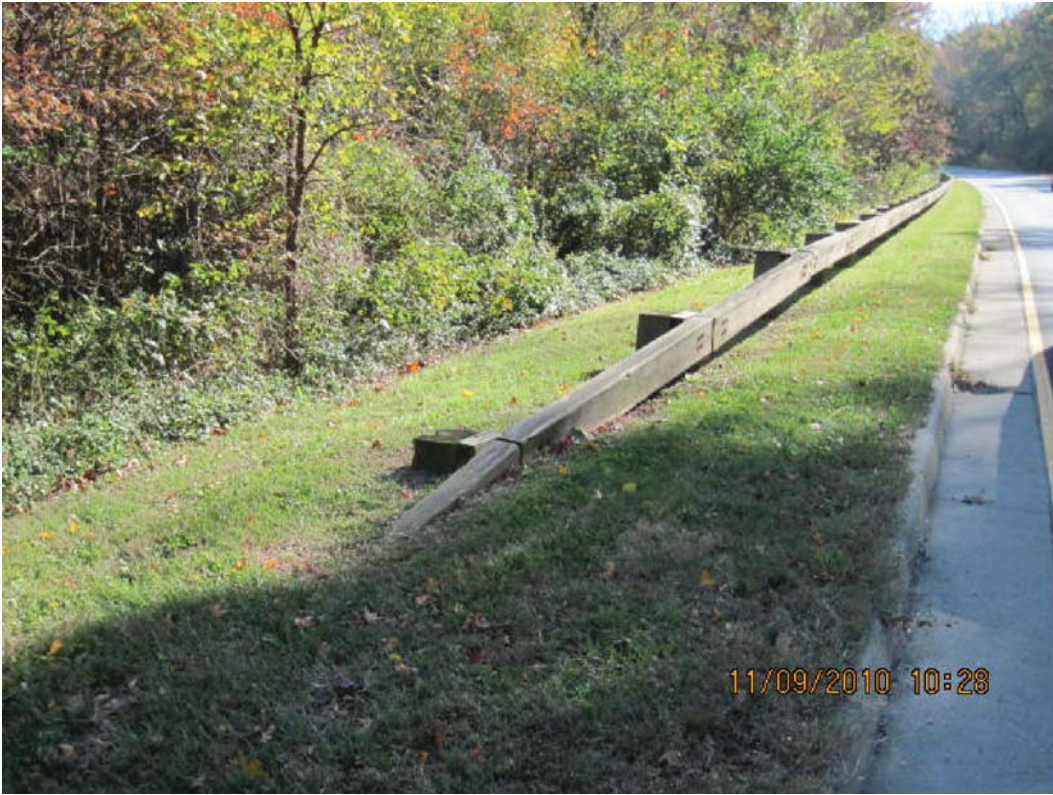
SUIT_0001_1.309_L_1.jpg

Barrier ID:	SUIT-0001-1.309-L				
Route Name:	EASTBOUND SUITLAND PARKWAY				
Inspection Date:	09/11/2010	Barrier Rating:	36.70		
Barrier Description					
Type:	STEEL-BACKED TIMBER WITH BLOCKOUT	Barrier Function:	TRAFFIC		
Barrier Material:	STEEL-BACKED TIMBER/LOG	Post Material:	WOOD		
Blockout Type:	WOOD	Length (ft.):	351		
Speed Limit (MPH):	50	Placement with Respect to Road:	INSIDE OF CURVE		
Hazard Behind Barrier:	MEDIUM				
Barrier Crashworthiness					
Appropriate Test Level:	TL-3	Barrier Test Level:	TL-3	Is Barrier Crashworthy?:	YES
Beg. End Trtmt Type:	SBT/LOG FLARED	Is Beg. End Trtmt Crashworthy?:	NO	Approach Transition Type:	NONE
Ending End Trtmt Type:	SBT/LOG FLARED	Ending End Trtmt Crashworthy?:	NO		
Average Measurements					
Design Height (In.):	27	Width (In.):	0.0	Post Spacing (In.):	120.1
Height (In.):	27.5	Lateral Offset (In.):	85.1	Road Grade (%):	1.70
Physical Condition					
Barrier	Alignment and Height:	No deflections greater than 6 in were observed in the alignment. The barrier height was 1/2 in greater than the 27 in design height for the entire length.

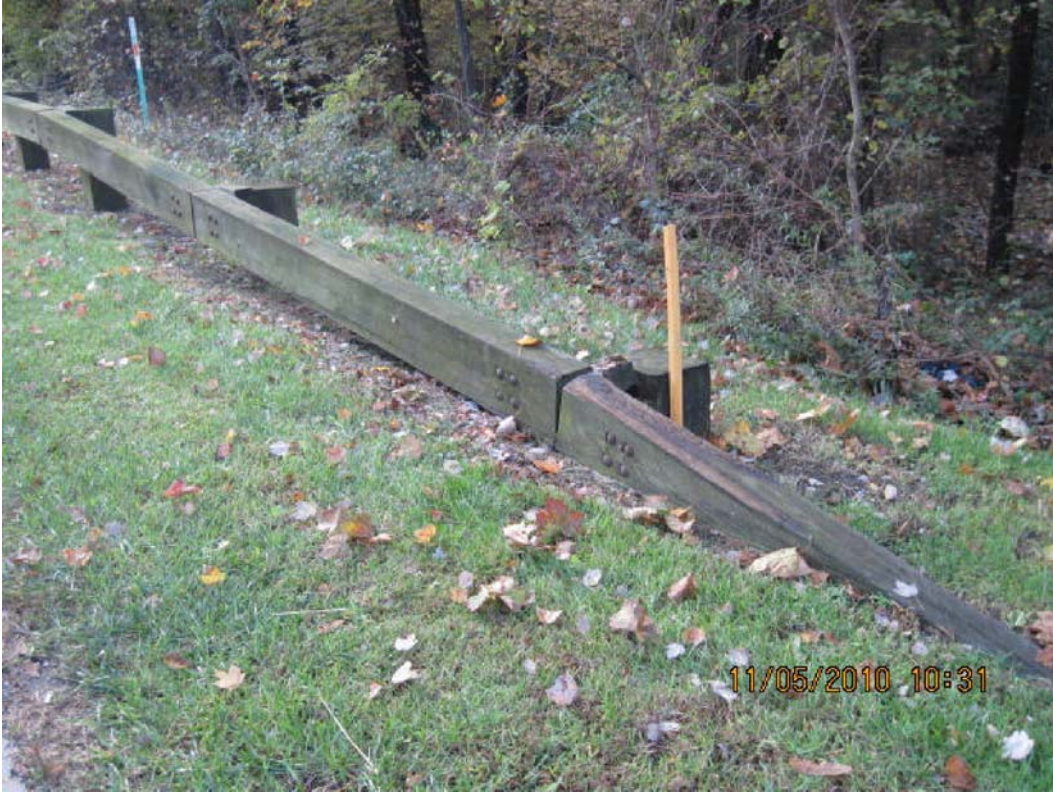
SUIT_0001_1.312_R_1.jpg

Barrier ID:	SUIT-0001-1.312-R				
Route Name:	EASTBOUND SUITLAND PARKWAY				
Inspection Date:	05/11/2010	Barrier Rating:	31.00		
Barrier Description					
Type:	STEEL-BACKED TIMBER WITH BLOCKOUT	Barrier Function:	TRAFFIC		
Barrier Material:	STEEL-BACKED TIMBER/LOG	Post Material:	WOOD		
Blockout Type:	WOOD	Length (ft.):	158		
Speed Limit (MPH):	50	Placement with Respect to Road:	TANGENT		
Hazard Behind Barrier:	MEDIUM				
Barrier Crashworthiness					
Appropriate Test Level:	TL-3	Barrier Test Level:	TL-3	Is Barrier Crashworthy?:	YES
Beg. End Trtmt Type:	SBT/LOG FLARED	Is Beg. End Trtmt Crashworthy?:	NO	Approach Transition Type:	NONE
Ending End Trtmt Type:	SBT/LOG FLARED	Ending End Trtmt Crashworthy?:	NO		
Average Measurements					
Design Height (In.):	27	Width (In.):	0.0	Post Spacing (In.):	120.5
Height (In.):	29.7	Lateral Offset (In.):	87.6	Road Grade (%):	2.10
Physical Condition					
Barrier	Alignment and Height:	No deflections observed in alignment. Entire barrier exceeds 27 in design height by 2.5 to 3.5 in.

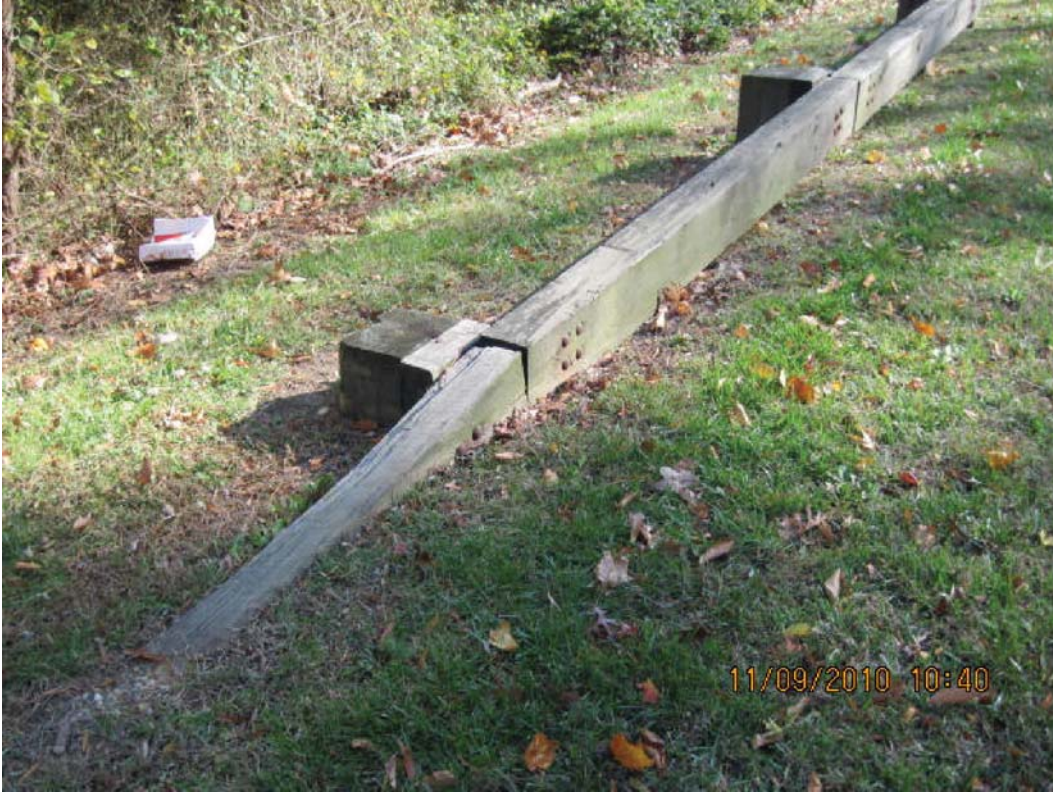
SUIT_0001_1.470_L_1.jpg

Barrier ID:	SUIT-0001-1.470-L				
Route Name:	EASTBOUND SUITLAND PARKWAY				
Inspection Date:	09/11/2010	Barrier Rating:	33.90		
Barrier Description					
Type:	STEEL-BACKED TIMBER WITH BLOCKOUT	Barrier Function:	TRAFFIC		
Barrier Material:	STEEL-BACKED TIMBER/LOG	Post Material:	WOOD		
Blockout Type:	WOOD	Length (ft.):	151		
Speed Limit (MPH):	50	Placement with Respect to Road:	INSIDE OF CURVE		
Hazard Behind Barrier:	MEDIUM				
Barrier Crashworthiness					
Appropriate Test Level:	TL-3	Barrier Test Level:	TL-3	Is Barrier Crashworthy?:	YES
Beg. End Trtmt Type:	SBT/LOG FLARED	Is Beg. End Trtmt Crashworthy?:	NO	Approach Transition Type:	NONE
Ending End Trtmt Type:	SBT/LOG FLARED	Ending End Trtmt Crashworthy?:	NO		
Average Measurements					
Design Height (In.):	27	Width (In.):	0.0	Post Spacing (In.):	120.0
Height (In.):	27.2	Lateral Offset (In.):	86.3	Road Grade (%):	1.80
Physical Condition					
Barrier	Alignment and Height:	Alignment deflection was less than 6 in. The entire barrier was equal to or exceeded design height (27 in) by 1/2 in.

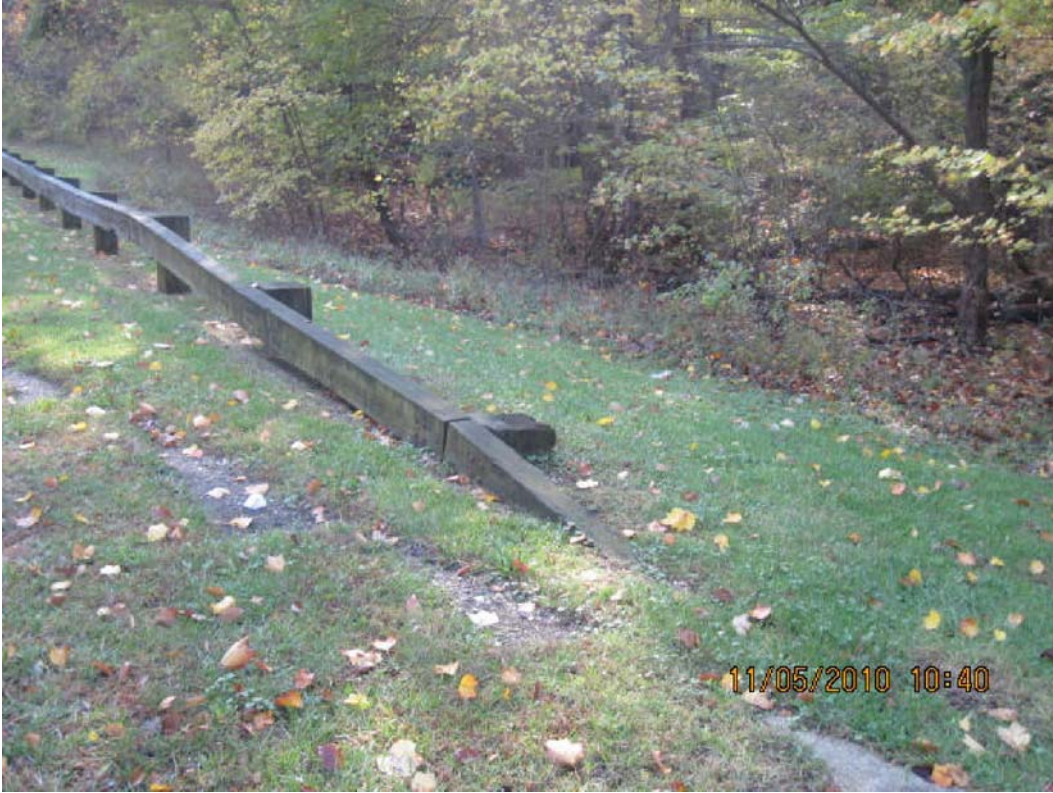
SUIT_0001_1.474_R_1.jpg

Barrier ID:	SUIT-0001-1.474-R				
Route Name:	EASTBOUND SUITLAND PARKWAY				
Inspection Date:	05/11/2010	Barrier Rating:	39.50		
Barrier Description					
Type:	STEEL-BACKED TIMBER WITH BLOCKOUT	Barrier Function:	TRAFFIC		
Barrier Material:	STEEL-BACKED TIMBER/LOG	Post Material:	WOOD		
Blockout Type:	WOOD	Length (ft.):	125		
Speed Limit (MPH):	50	Placement with Respect to Road:	OUTSIDE OF CURVE		
Hazard Behind Barrier:	MEDIUM				
Barrier Crashworthiness					
Appropriate Test Level:	TL-3	Barrier Test Level:	TL-3	Is Barrier Crashworthy?:	YES
Beg. End Trtmt Type:	SBT/LOG FLARED	Is Beg. End Trtmt Crashworthy?:	NO	Approach Transition Type:	NONE
Ending End Trtmt Type:	SBT/LOG FLARED	Ending End Trtmt Crashworthy?:	NO		
Average Measurements					
Design Height (In.):	27	Width (In.):	0.0	Post Spacing (In.):	120.0
Height (In.):	27.2	Lateral Offset (In.):	104.6	Road Grade (%):	1.40
Physical Condition					
Barrier	Alignment and Height:	No deflections greater than 6 in were observed in the alignment. The barrier height was equal to or 1/2 in greater than the 27 in design height for the entire length.

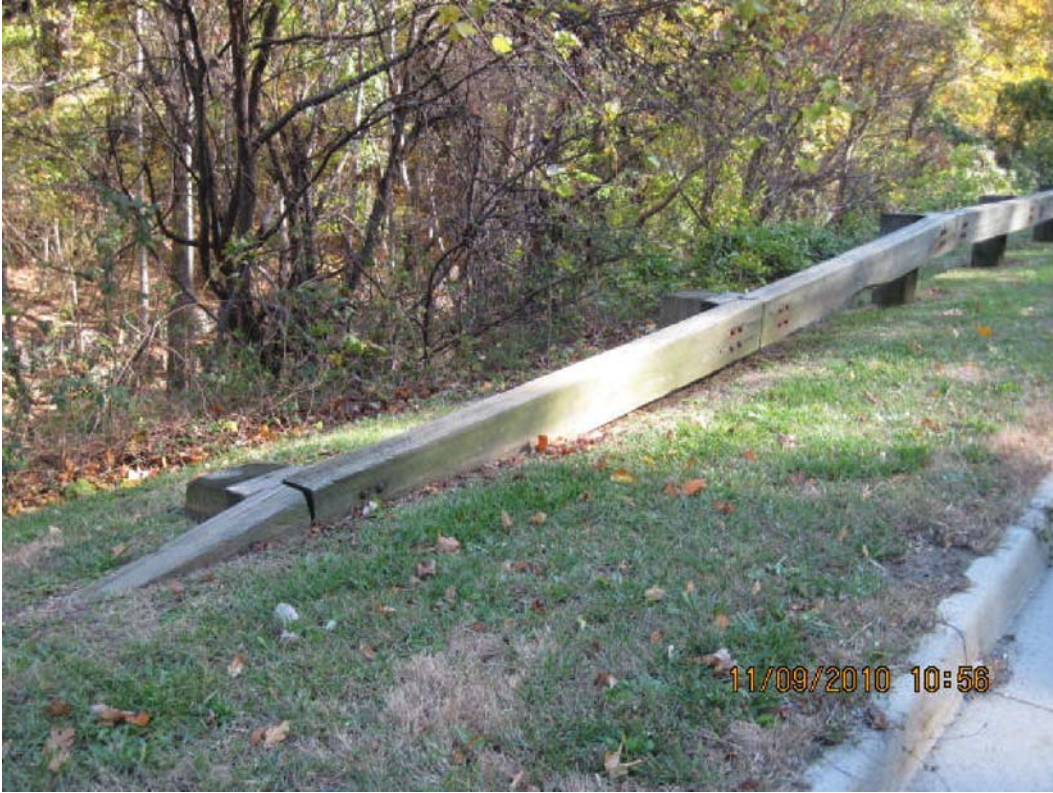
SUIT_0001_1.665_L_1.jpg

Barrier ID:	SUIT-0001-1.665-L				
Route Name:	EASTBOUND SUITLAND PARKWAY				
Inspection Date:	09/11/2010	Barrier Rating:	42.70		
Barrier Description					
Type:	STEEL-BACKED TIMBER WITH BLOCKOUT	Barrier Function:	TRAFFIC		
Barrier Material:	STEEL-BACKED TIMBER/LOG	Post Material:	WOOD		
Blockout Type:	WOOD	Length (ft.):	567		
Speed Limit (MPH):	50	Placement with Respect to Road:	TANGENT		
Hazard Behind Barrier:	MEDIUM				
Barrier Crashworthiness					
Appropriate Test Level:	TL-3	Barrier Test Level:	TL-3	Is Barrier Crashworthy?:	YES
Beg. End Trtmt Type:	SBT/LOG FLARED	Is Beg. End Trtmt Crashworthy?:	NO	Approach Transition Type:	NONE
Ending End Trtmt Type:	SBT/LOG FLARED	Ending End Trtmt Crashworthy?:	NO		
Average Measurements					
Design Height (In.):	27	Width (In.):	0.0	Post Spacing (In.):	119.3
Height (In.):	25.3	Lateral Offset (In.):	87.5	Road Grade (%):	1.90
Physical Condition					
Barrier	Alignment and Height:	No deflections observed in alignment. 240 ft of the barrier is 1 to 3 in below 27 in design height.

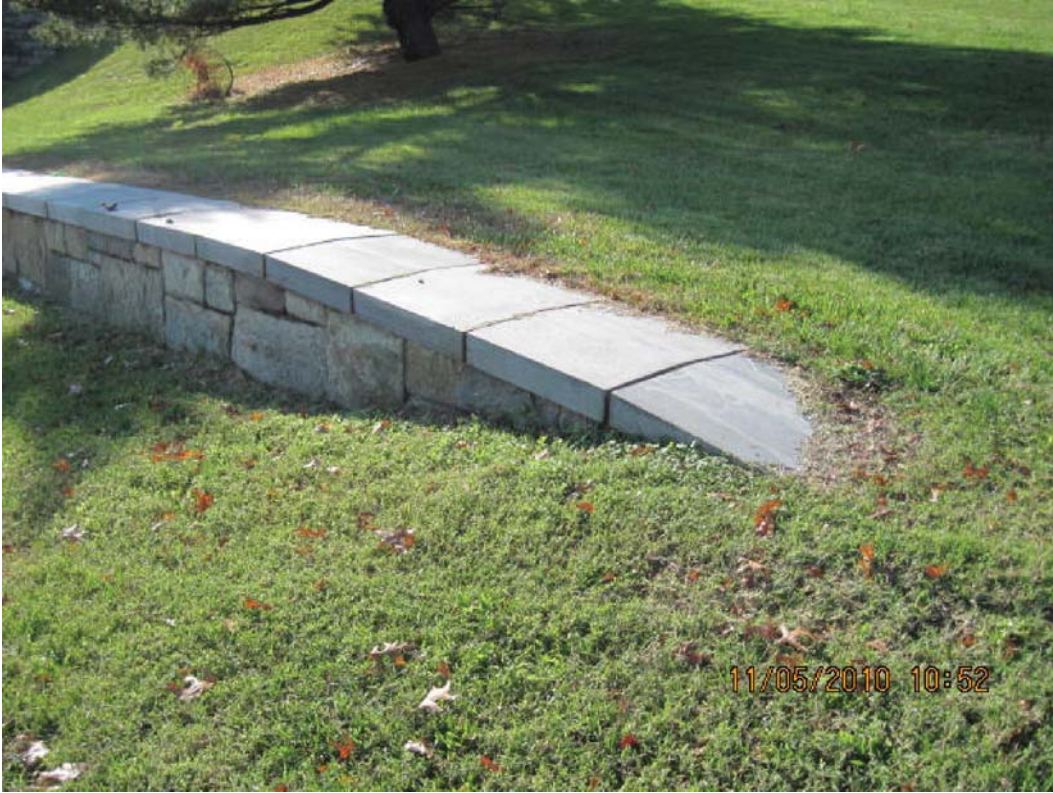
SUIT_0001_2.046_R_1.jpg

Barrier ID:	SUIT-0001-2.046-R				
Route Name:	EASTBOUND SUITLAND PARKWAY				
Inspection Date:	05/11/2010	Barrier Rating:	31.30		
Barrier Description					
Type:	CONCRETE WITH SIMULATED STONE FACE	Barrier Function:	TRAFFIC		
Barrier Material:	CONCRETE	Post Material:	N/A		
Blockout Type:	N/A	Length (ft.):	137		
Speed Limit (MPH):	50	Placement with Respect to Road:	INSIDE OF CURVE		
Hazard Behind Barrier:	LOW				
Barrier Crashworthiness					
Appropriate Test Level:	TL-3	Barrier Test Level:	TL-3	Is Barrier Crashworthy?:	YES
Beg. End Trtmt Type:	OTHER: CONCRETE WITH	Is Beg. End Trtmt Crashworthy?:	NO	Approach Transition Type:	NONE
Ending End Trtmt Type:	NONE	Ending End Trtmt Crashworthy?:	N/A		
Average Measurements					
Design Height (In.):	27	Width (In.):	26.0	Post Spacing (In.):	0.0
Height (In.):	27.5	Lateral Offset (In.):	51.7	Road Grade (%):	2.20
Physical Condition					
Barrier	Alignment and Height:	Alignment deflection was less than 6 in. The entire barrier was 1 in below or exceeded design height (27 in) by up to 3.5 in.

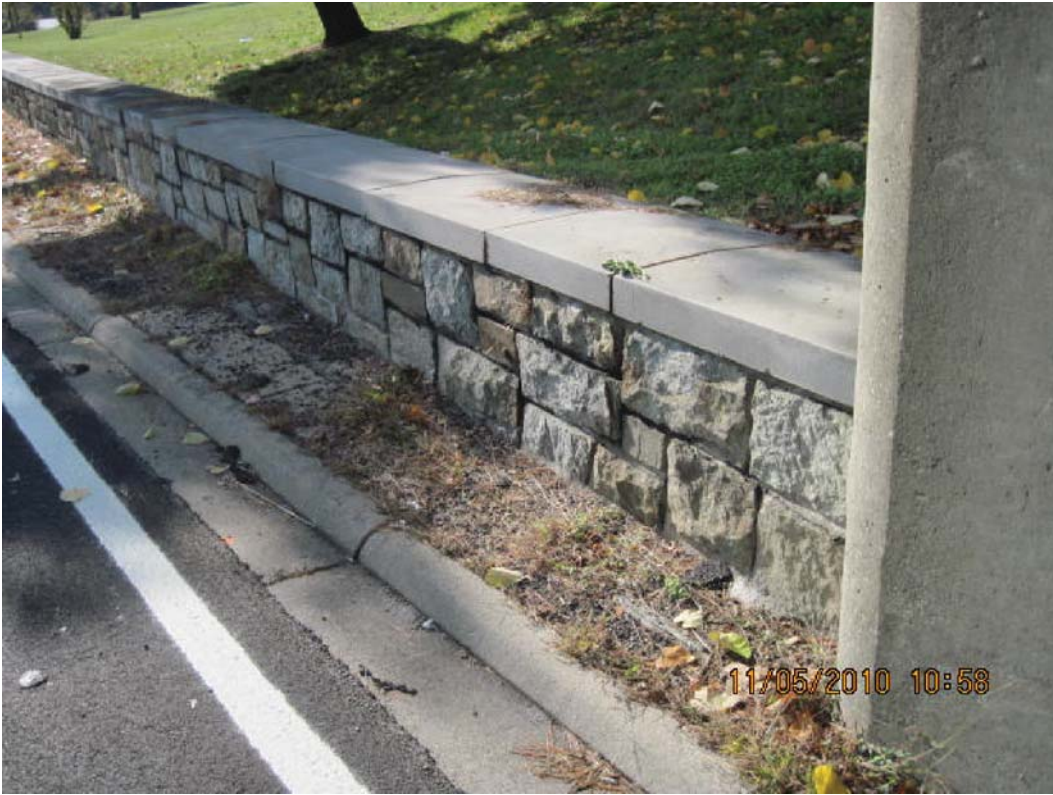
SUIT_0001_2.090_R_1.jpg

Barrier ID:	SUIT-0001-2.090-R				
Route Name:	EASTBOUND SUITLAND PARKWAY				
Inspection Date:	05/11/2010	Barrier Rating:	28.50		
Barrier Description					
Type:	CONCRETE WITH SIMULATED STONE FACE	Barrier Function:	TRAFFIC		
Barrier Material:	CONCRETE	Post Material:	N/A		
Blockout Type:	N/A	Length (ft.):	137		
Speed Limit (MPH):	50	Placement with Respect to Road:	TANGENT		
Hazard Behind Barrier:	LOW				
Barrier Crashworthiness					
Appropriate Test Level:	TL-3	Barrier Test Level:	TL-3	Is Barrier Crashworthy?:	YES
Beg. End Trtmt Type:	NONE	Is Beg. End Trtmt Crashworthy?:	N/A	Approach Transition Type:	NONE
Ending End Trtmt Type:	NONE	Ending End Trtmt Crashworthy?:	N/A		
Average Measurements					
Design Height (In.):	27	Width (In.):	26.0	Post Spacing (In.):	0.0
Height (In.):	26.2	Lateral Offset (In.):	104.0	Road Grade (%):	1.80
Physical Condition					
Barrier	Alignment and Height:	No deflections observed in alignment. Entire barrier is 1 in or less below 27 in design height.

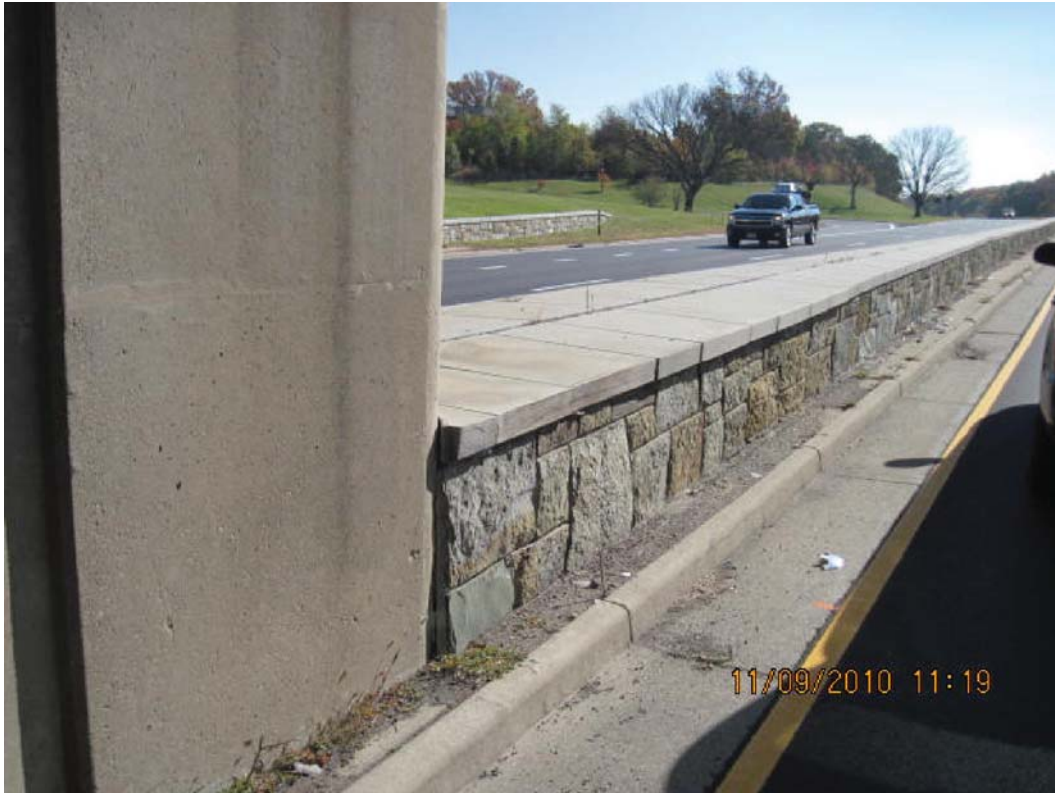
SUIT_0001_2.093_L_1.jpg

Barrier ID:	SUIT-0001-2.093-L				
Route Name:	EASTBOUND SUITLAND PARKWAY				
Inspection Date:	09/11/2010	Barrier Rating:	47.50		
Barrier Description					
Type:	CONCRETE WITH SIMULATED STONE FACE	Barrier Function:	TRAFFIC		
Barrier Material:	CONCRETE	Post Material:	N/A		
Blockout Type:	N/A	Length (ft.):	993		
Speed Limit (MPH):	50	Placement with Respect to Road:	INSIDE OF CURVE		
Hazard Behind Barrier:	EXTREME				
Barrier Crashworthiness					
Appropriate Test Level:	TL-3	Barrier Test Level:	TL-3	Is Barrier Crashworthy?:	YES
Beg. End Trtmt Type:	NONE	Is Beg. End Trtmt Crashworthy?:	N/A	Approach Transition Type:	NONE
Ending End Trtmt Type:	NONE	Ending End Trtmt Crashworthy?:	N/A		
Average Measurements					
Design Height (In.):	27	Width (In.):	29.2	Post Spacing (In.):	0.0
Height (In.):	32.2	Lateral Offset (In.):	60.5	Road Grade (%):	0.80
Physical Condition					
Barrier	Alignment and Height:	No deflections were observed in the alignment. The barrier height was between 1.5 to 6.5 in greater than the 27 in design height for the entire length.

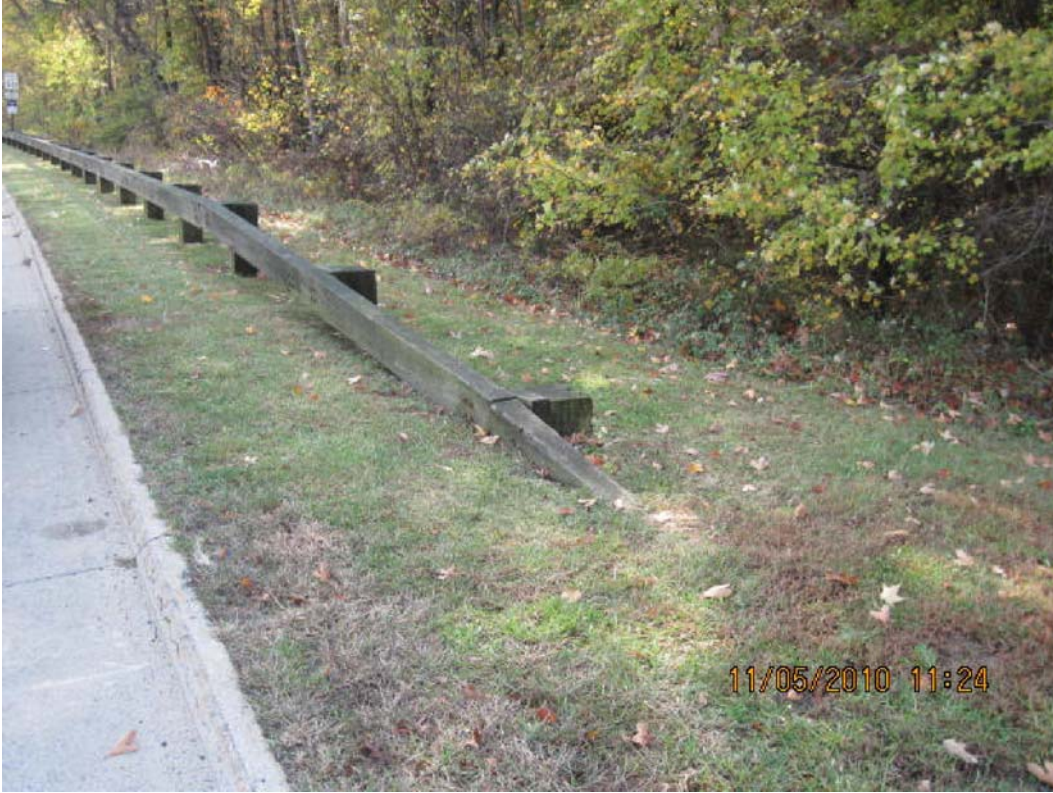
SUIT_0001_2.537_R_1.jpg

Barrier ID:	SUIT-0001-2.537-R				
Route Name:	EASTBOUND SUITLAND PARKWAY				
Inspection Date:	05/11/2010	Barrier Rating:	45.20		
Barrier Description					
Type:	STEEL-BACKED TIMBER WITH BLOCKOUT	Barrier Function:	TRAFFIC		
Barrier Material:	STEEL-BACKED TIMBER/LOG	Post Material:	WOOD		
Blockout Type:	WOOD	Length (ft.):	1037		
Speed Limit (MPH):	50	Placement with Respect to Road:	OUTSIDE OF CURVE		
Hazard Behind Barrier:	MEDIUM				
Barrier Crashworthiness					
Appropriate Test Level:	TL-3	Barrier Test Level:	TL-3	Is Barrier Crashworthy?:	YES
Beg. End Trtmt Type:	SBT/LOG FLARED	Is Beg. End Trtmt Crashworthy?:	NO	Approach Transition Type:	NONE
Ending End Trtmt Type:	SBT/LOG FLARED	Ending End Trtmt Crashworthy?:	NO		
Average Measurements					
Design Height (In.):	27	Width (In.):	0.0	Post Spacing (In.):	120.0
Height (In.):	27.2	Lateral Offset (In.):	87.5	Road Grade (%):	1.60
Physical Condition					
Barrier	Alignment and Height:	No deflections greater than 6 in were observed in the alignment. The barrier height was within 1 in of the 27 in of the design height for the entire length.

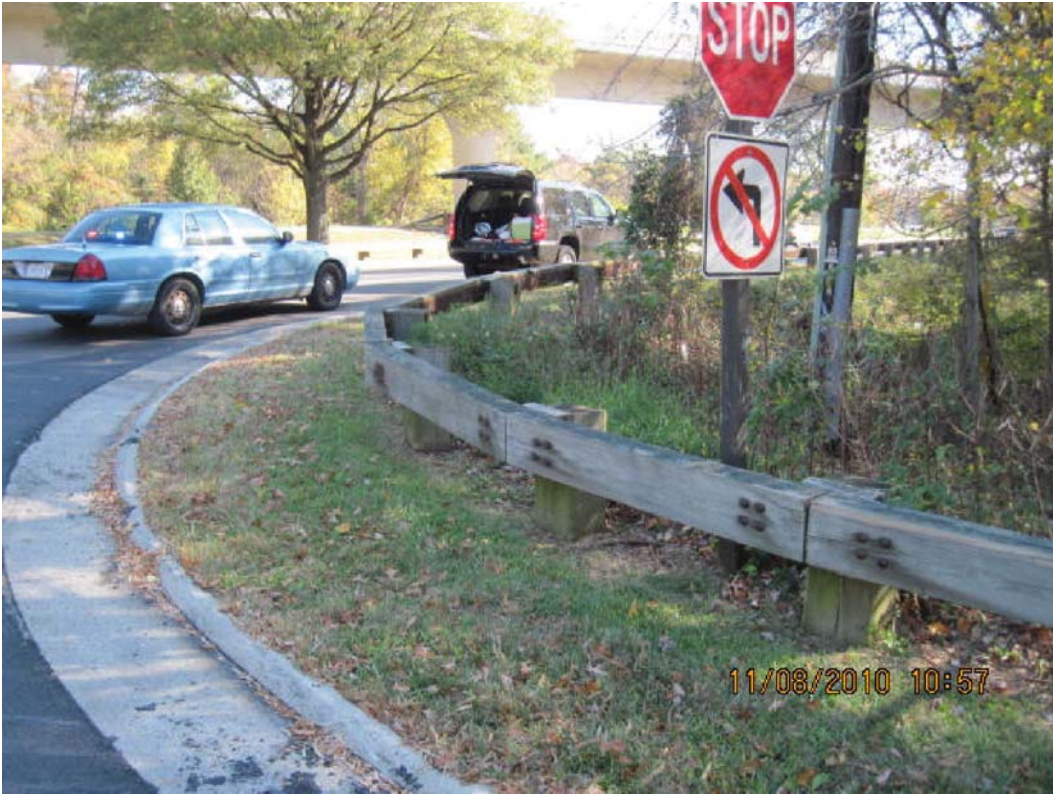
SUIT_0001_2.922_R_1.jpg

Barrier ID:	SUIT-0001-2.922-R				
Route Name:	EASTBOUND SUITLAND PARKWAY				
Inspection Date:	08/11/2010	Barrier Rating:	42.70		
Barrier Description					
Type:	STEEL-BACKED TIMBER WITH BLOCKOUT	Barrier Function:	TRAFFIC		
Barrier Material:	STEEL-BACKED TIMBER/LOG	Post Material:	WOOD		
Blockout Type:	WOOD	Length (ft.):	348		
Speed Limit (MPH):	50	Placement with Respect to Road:	TANGENT		
Hazard Behind Barrier:	MEDIUM				
Barrier Crashworthiness					
Appropriate Test Level:	TL-3	Barrier Test Level:	TL-3	Is Barrier Crashworthy?:	YES
Beg. End Trtmt Type:	NONE	Is Beg. End Trtmt Crashworthy?:	N/A	Approach Transition Type:	NONE
Ending End Trtmt Type:	SBT/LOG FLARED	Ending End Trtmt Crashworthy?:	NO		
Average Measurements					
Design Height (In.):	27	Width (In.):	0.0	Post Spacing (In.):	119.6
Height (In.):	25.5	Lateral Offset (In.):	87.0	Road Grade (%):	1.70
Physical Condition					
Barrier	Alignment and Height:	No deflections greater than 6 in were observed in the alignment. The barrier height was within 1 in of the 27 in design height for 100 ft and between 1 and 3 in below the design height for 213 ft.

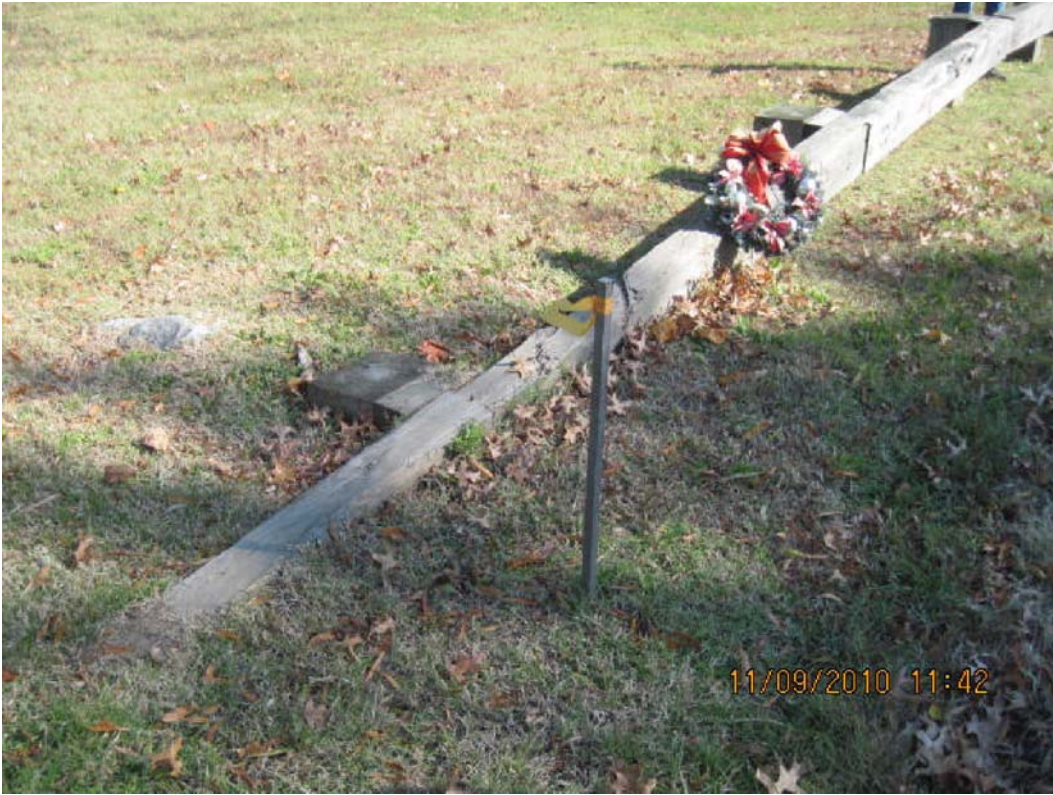
SUIT_0001_2.926_L_1.jpg

Barrier ID:	SUIT-0001-2.926-L				
Route Name:	EASTBOUND SUITLAND PARKWAY				
Inspection Date:	09/11/2010	Barrier Rating:	37.20		
Barrier Description					
Type:	STEEL-BACKED TIMBER WITH BLOCKOUT	Barrier Function:	TRAFFIC		
Barrier Material:	STEEL-BACKED TIMBER/LOG	Post Material:	WOOD		
Blockout Type:	WOOD	Length (ft.):	210		
Speed Limit (MPH):	50	Placement with Respect to Road:	TANGENT		
Hazard Behind Barrier:	HIGH				
Barrier Crashworthiness					
Appropriate Test Level:	TL-3	Barrier Test Level:	TL-3	Is Barrier Crashworthy?:	YES
Beg. End Trtmt Type:	SBT/LOG FLARED	Is Beg. End Trtmt Crashworthy?:	NO	Approach Transition Type:	NONE
Ending End Trtmt Type:	SBT/LOG FLARED	Ending End Trtmt Crashworthy?:	NO		
Average Measurements					
Design Height (In.):	27	Width (In.):	0.0	Post Spacing (In.):	119.6
Height (In.):	26.0	Lateral Offset (In.):	94.5	Road Grade (%):	1.70
Physical Condition					
Barrier	Alignment and Height:	Alignment deflection was less than 6 in. 55 ft of the barrier was 1 to 3 in below design height (27 in).

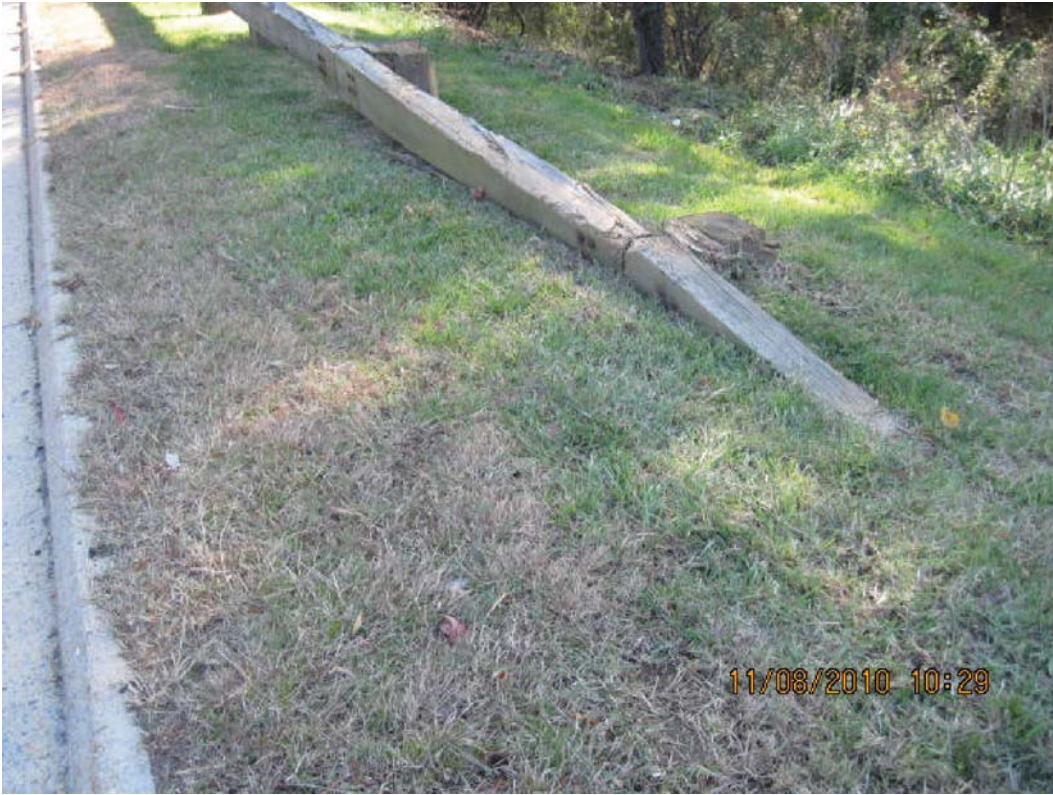
SUIT_0001_3.123_R_1.jpg

Barrier ID:	SUIT-0001-3.123-R				
Route Name:	EASTBOUND SUITLAND PARKWAY				
Inspection Date:	08/11/2010	Barrier Rating:	49.70		
Barrier Description					
Type:	STEEL-BACKED TIMBER WITH BLOCKOUT	Barrier Function:	TRAFFIC		
Barrier Material:	STEEL-BACKED TIMBER/LOG	Post Material:	WOOD		
Blockout Type:	WOOD	Length (ft.):	1486		
Speed Limit (MPH):	50	Placement with Respect to Road:	OUTSIDE OF CURVE		
Hazard Behind Barrier:	MEDIUM				
Barrier Crashworthiness					
Appropriate Test Level:	TL-3	Barrier Test Level:	TL-3	Is Barrier Crashworthy?:	YES
Beg. End Trtmt Type:	SBT/LOG FLARED	Is Beg. End Trtmt Crashworthy?:	NO	Approach Transition Type:	NONE
Ending End Trtmt Type:	SBT/LOG FLARED	Ending End Trtmt Crashworthy?:	NO		
Average Measurements					
Design Height (In.):	27	Width (In.):	0.0	Post Spacing (In.):	120.0
Height (In.):	26.7	Lateral Offset (In.):	88.0	Road Grade (%):	1.00
Physical Condition					
Barrier	Alignment and Height:	50 ft of the barrier had a 6 to 8 in deflection. The entire barrier was 1 in below or exceeded design height (27 in) by up to 1.5 in.
