GIP Report

NPS Guardwall/Rail Inventory Program
Suitland Parkway National Capital Parks - East

Federal Highway Administration
Eastern Federal Lands Highway Division
Road Inventory Program (RIP)

Data Collection Date: November 2010
Report Date: November 2015

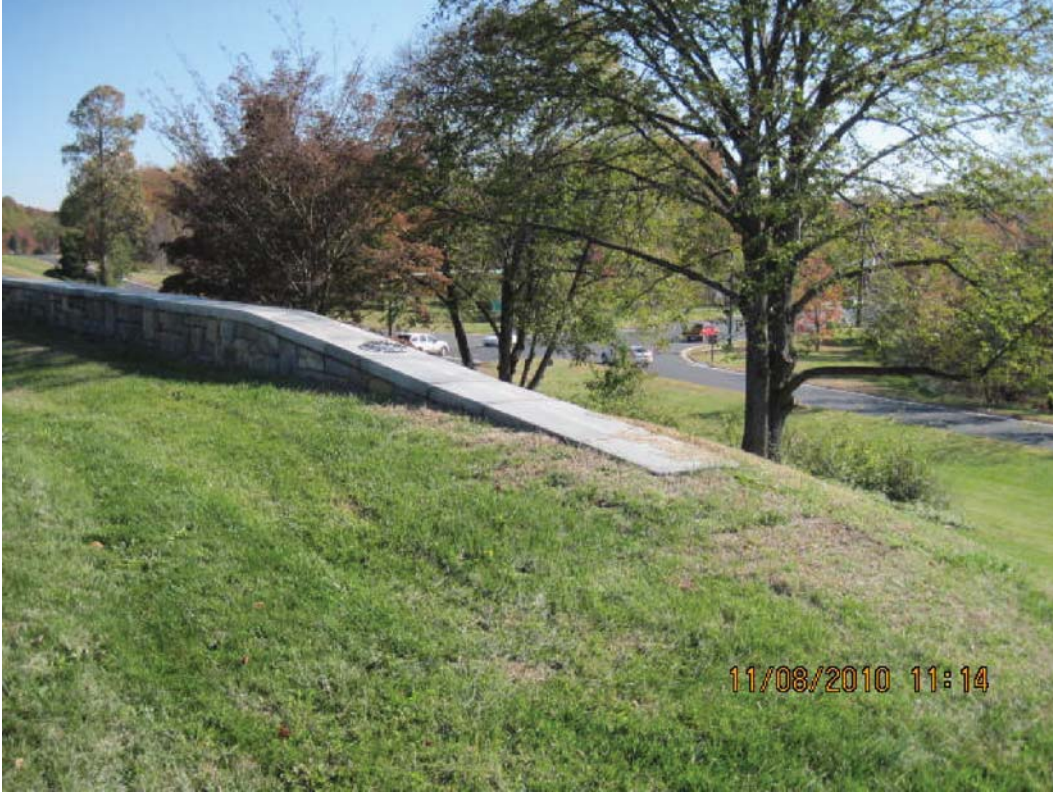
SUIT_0001_3.875_R_1.jpg

Barrier ID:	SUIT-0001-3.875-R				
Route Name:	EASTBOUND SUITLAND PARKWAY				
Inspection Date:	08/11/2010	Barrier Rating:	31.00		
Barrier Description					
Type:	CONCRETE WITH SIMULATED STONE FACE	Barrier Function:	TRAFFIC		
Barrier Material:	CONCRETE	Post Material:	N/A		
Blockout Type:	N/A	Length (ft.):	102		
Speed Limit (MPH):	50	Placement with Respect to Road:	TANGENT		
Hazard Behind Barrier:	MEDIUM				
Barrier Crashworthiness					
Appropriate Test Level:	TL-3	Barrier Test Level:	TL-3	Is Barrier Crashworthy?:	YES
Beg. End Trtmt Type:	OTHER: CONCRETE WITH	Is Beg. End Trtmt Crashworthy?:	NO	Approach Transition Type:	NONE
Ending End Trtmt Type:	NONE	Ending End Trtmt Crashworthy?:	N/A		
Average Measurements					
Design Height (In.):	27	Width (In.):	25.2	Post Spacing (In.):	0.0
Height (In.):	27.0	Lateral Offset (In.):	150.1	Road Grade (%):	0.90
Physical Condition					
Barrier	Alignment and Height:	No deflections were observed in the alignment. The barrier height ranged between 3 in above to 2 in below the 27 in design height.

Breaking and Cracking:	No breaking or cracking was observed.			
	Missing Elements:	No elements were observed to be missing.			
	Corrosion and Weathering:	No cracks in the mortar joints were observed and no stones were loose or missing. No erosion was observed.			
End Treatments	Alignment and Height:	Alignment acceptable. Height within 3-in of 27-in design height.			
	Breaking and Cracking:	No breaking or cracking was observed.			
	Missing Elements:	No elements were observed to be missing.			
	Corrosion and Weathering:	No weathering or erosion was observed.

Repair Action:	NO ACTION	FMSS Work Type:	N/A	Repair Cost:	\$0
Brief Workorder:	N/A				
Workorder:	No action required.

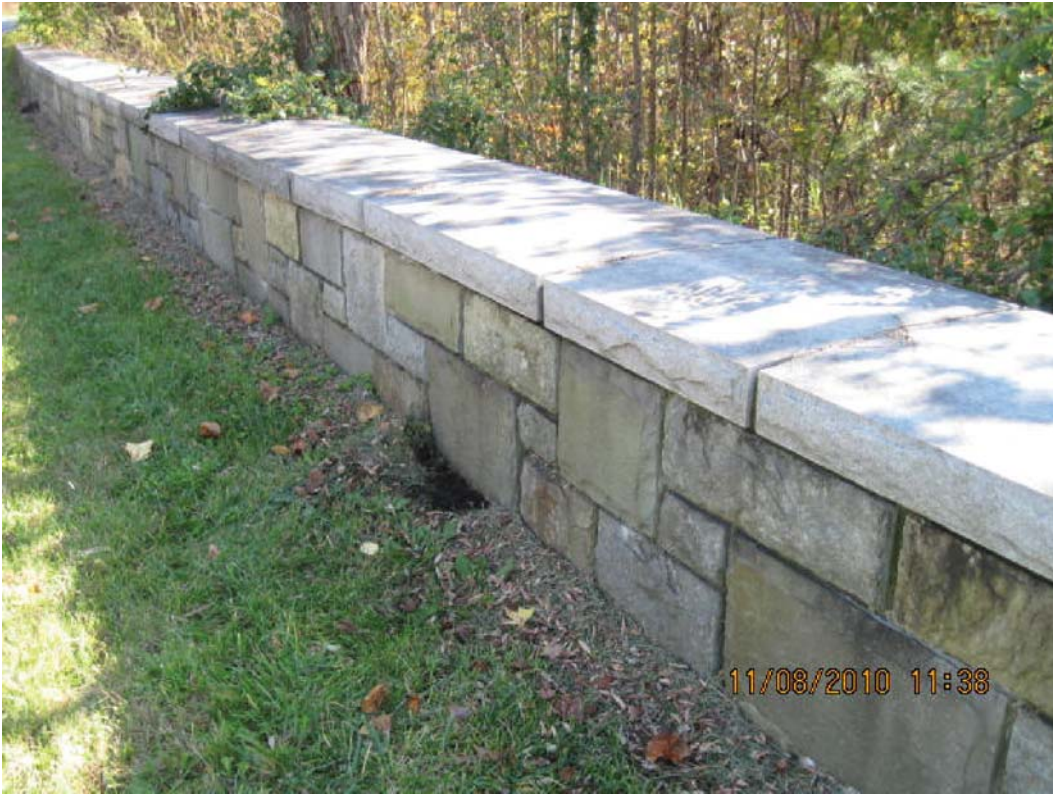
SUIT_0001_4.057_R_1.jpg

Barrier ID:	SUIT-0001-4.057-R				
Route Name:	EASTBOUND SUITLAND PARKWAY				
Inspection Date:	08/11/2010	Barrier Rating:	33.90		
Barrier Description					
Type:	CONCRETE WITH SIMULATED STONE FACE	Barrier Function:	TRAFFIC		
Barrier Material:	CONCRETE	Post Material:	N/A		
Blockout Type:	N/A	Length (ft.):	200		
Speed Limit (MPH):	50	Placement with Respect to Road:	INSIDE OF CURVE		
Hazard Behind Barrier:	MEDIUM				
Barrier Crashworthiness					
Appropriate Test Level:	TL-3	Barrier Test Level:	TL-3	Is Barrier Crashworthy?:	YES
Beg. End Trtmt Type:	NONE	Is Beg. End Trtmt Crashworthy?:	N/A	Approach Transition Type:	NONE
Ending End Trtmt Type:	OTHER: STONE WITH CONCRETE	Ending End Trtmt Crashworthy?:	NO		
Average Measurements					
Design Height (In.):	27	Width (In.):	26.0	Post Spacing (In.):	0.0
Height (In.):	26.7	Lateral Offset (In.):	138.3	Road Grade (%):	0.20
Physical Condition					
Barrier	Alignment and Height:	Alignment deflection was less than 6 in. The entire barrier was within 1 in of design height (27 in).

Breaking and Cracking:	No cracks of more than 1/4 in observed.			
	Missing Elements:	No elements appeared to be missing.			
	Corrosion and Weathering:	No cracks in mortar loose stones or erosion observed.			
End Treatments	Alignment and Height:	Alignment acceptable. Height within 3-in of 27-in design height.			
	Breaking and Cracking:	Alignment acceptable. Height within 1-in of 27-in design height.			
	Missing Elements:	No elements appeared to be missing.			
	Corrosion and Weathering:	No cracks in mortar loose stones or erosion observed.

Repair Action:	NO ACTION	FMSS Work Type:	N/A	Repair Cost:	\$0
Brief Workorder:	N/A				
Workorder:	No action required.

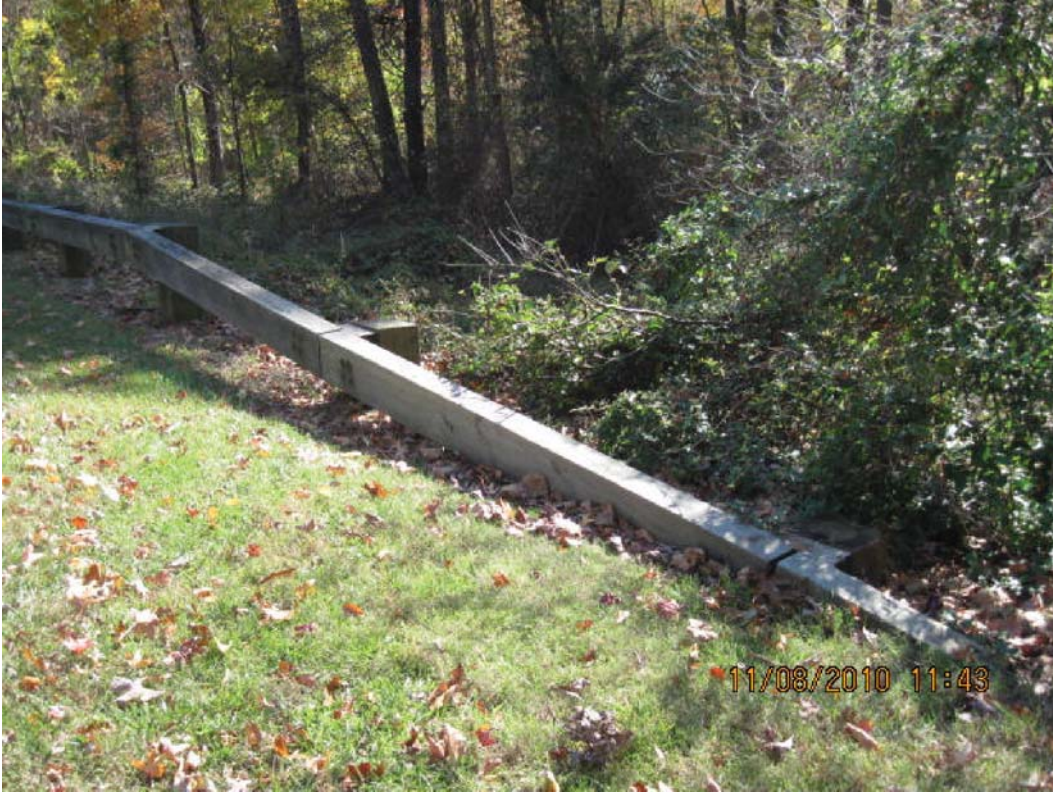
SUIT_0001_4.549_R_1.jpg

Barrier ID:	SUIT-0001-4.549-R				
Route Name:	EASTBOUND SUITLAND PARKWAY				
Inspection Date:	08/11/2010	Barrier Rating:	31.00		
Barrier Description					
Type:	STEEL-BACKED TIMBER WITH BLOCKOUT	Barrier Function:	TRAFFIC		
Barrier Material:	STEEL-BACKED TIMBER/LOG	Post Material:	WOOD		
Blockout Type:	WOOD	Length (ft.):	240		
Speed Limit (MPH):	50	Placement with Respect to Road:	TANGENT		
Hazard Behind Barrier:	MEDIUM				
Barrier Crashworthiness					
Appropriate Test Level:	TL-3	Barrier Test Level:	TL-3	Is Barrier Crashworthy?:	YES
Beg. End Trtmt Type:	SBT/LOG FLARED	Is Beg. End Trtmt Crashworthy?:	NO	Approach Transition Type:	NONE
Ending End Trtmt Type:	SBT/LOG FLARED	Ending End Trtmt Crashworthy?:	NO		
Average Measurements					
Design Height (In.):	27	Width (In.):	0.0	Post Spacing (In.):	120.1
Height (In.):	28.0	Lateral Offset (In.):	140.0	Road Grade (%):	0.40
Physical Condition					
Barrier	Alignment and Height:	No deflections greater than 2 in observed in alignment. Entire barrier is 1 in or less below or exceeds 27 in design height up to 3 in.

Breaking and Cracking:	2 blockouts were cracked and broken.			
	Missing Elements:	No elements were observed to be missing.			
	Corrosion and Weathering:	No loss of cross section or erosion around posts observed.			
End Treatments	Alignment and Height:	Alignment acceptable. Height within 1-in of 27-in design height.			
	Breaking and Cracking:	1 blockout was broken in half.			
	Missing Elements:	No elements were observed to be missing.			
	Corrosion and Weathering:	No loss of cross section or erosion around posts observed.

Repair Action:	REPAIR	FMSS Work Type:	DEFERRED MAINTENANCE	Repair Cost:	\$2684
Brief Workorder:	Replace 3 blockouts.				
Workorder:	Replace Block at \$30- per -Each for 3 Block(s) = \$90. Replace 3 blockouts. High Speed Traffic Control at \$2350- per -Day for 1 Day(s) = \$2350.

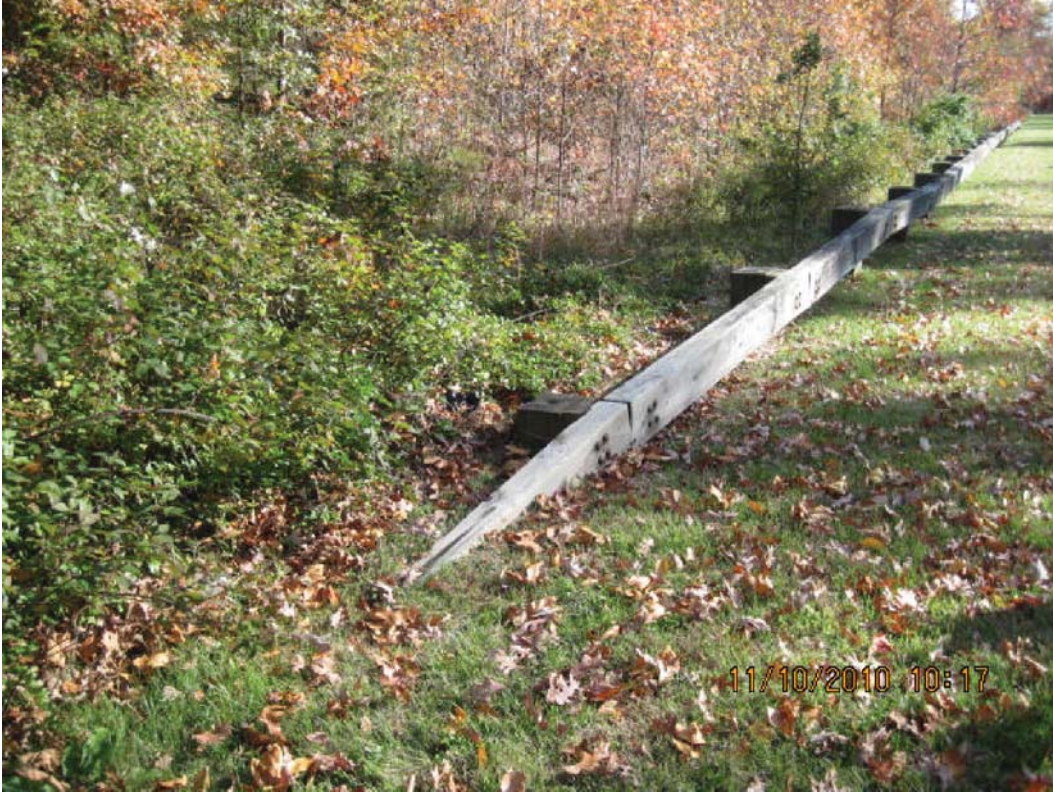
SUIT_0001_4.550_L_1.jpg

Barrier ID:	SUIT-0001-4.550-L				
Route Name:	EASTBOUND SUITLAND PARKWAY				
Inspection Date:	10/11/2010	Barrier Rating:	48.40		
Barrier Description					
Type:	STEEL-BACKED TIMBER WITH BLOCKOUT	Barrier Function:	TRAFFIC		
Barrier Material:	STEEL-BACKED TIMBER/LOG	Post Material:	WOOD		
Blockout Type:	WOOD	Length (ft.):	245		
Speed Limit (MPH):	50	Placement with Respect to Road:	OUTSIDE OF CURVE		
Hazard Behind Barrier:	MEDIUM				
Barrier Crashworthiness					
Appropriate Test Level:	TL-3	Barrier Test Level:	TL-3	Is Barrier Crashworthy?:	YES
Beg. End Trtmt Type:	SBT/LOG FLARED	Is Beg. End Trtmt Crashworthy?:	NO	Approach Transition Type:	NONE
Ending End Trtmt Type:	SBT/LOG FLARED	Ending End Trtmt Crashworthy?:	NO		
Average Measurements					
Design Height (In.):	27	Width (In.):	0.0	Post Spacing (In.):	119.6
Height (In.):	25.2	Lateral Offset (In.):	139.1	Road Grade (%):	0.50
Physical Condition					
Barrier	Alignment and Height:	No deflections greater than 6 in were observed in the alignment. The barrier height was within 1 in of the 27 in design height for 55 ft and 1 to 3 in below the design height for 130 ft.

Breaking and Cracking:	No impact related breaking or cracking was observed.			
	Missing Elements:	No elements were observed to be missing.			
	Corrosion and Weathering:	10 ft of rail was rotted. The rest of the barrier should be monitored for further weathering. No erosion was observed.			
End Treatments	Alignment and Height:	Alignment acceptable. Height within 1-in of 27-in design height.			
	Breaking and Cracking:	1 blockout was broken on the beginning end.			
	Missing Elements:	No elements were observed to be missing.			
	Corrosion and Weathering:	Less than 5 percent of the cross section has been lost due to weathering.

Repair Action:	REPAIR	FMSS Work Type:	DEFERRED MAINTENANCE	Repair Cost:	\$4323
Brief Workorder:	Raise 130 ft of guardrail to the 27 inch design height. Replace 10 ft of rail and 1 block.				
Workorder:	Adjust Guardrail at \$10- per -Lin. Ft. for 130 LF = \$1300. Raise 130 feet of guardrail to the design height of 27 inches. Replace Rail at \$25- per -Lin. Ft. for 10 LF = \$250. Replace 10 ft of rail. Replace Block at \$30- per -Each for 1 Block(s) = \$30. Replace 1 broken blockout. High Speed Traffic Control at \$2350- per -Day for 1 Day(s) = \$2350.

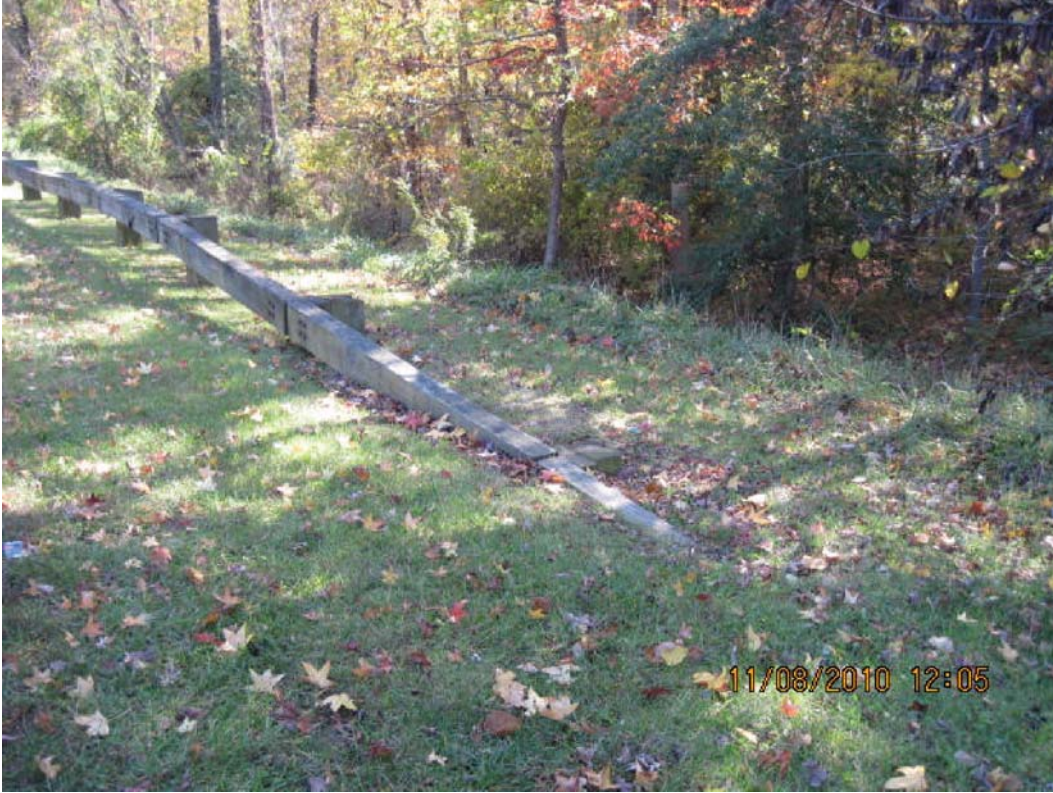
SUIT_0001_5.410_R_1.jpg

Barrier ID:	SUIT-0001-5.410-R				
Route Name:	EASTBOUND SUITLAND PARKWAY				
Inspection Date:	08/11/2010	Barrier Rating:	46.90		
Barrier Description					
Type:	STEEL-BACKED TIMBER WITH BLOCKOUT	Barrier Function:	TRAFFIC		
Barrier Material:	STEEL-BACKED TIMBER/LOG	Post Material:	WOOD		
Blockout Type:	WOOD	Length (ft.):	649		
Speed Limit (MPH):	45	Placement with Respect to Road:	OUTSIDE OF CURVE		
Hazard Behind Barrier:	MEDIUM				
Barrier Crashworthiness					
Appropriate Test Level:	TL-2	Barrier Test Level:	TL-3	Is Barrier Crashworthy?:	YES
Beg. End Trtmt Type:	SBT/LOG FLARED	Is Beg. End Trtmt Crashworthy?:	NO	Approach Transition Type:	NONE
Ending End Trtmt Type:	NONE	Ending End Trtmt Crashworthy?:	N/A		
Average Measurements					
Design Height (In.):	27	Width (In.):	0.0	Post Spacing (In.):	120.0
Height (In.):	26.0	Lateral Offset (In.):	79.4	Road Grade (%):	1.70
Physical Condition					
Barrier	Alignment and Height:	2 separate 30 ft sections had horizontal deflections greater than 12 in. The height was 1.5 in greater to within 1 in below the 27 in design height for 474 ft between 1 in and 3 in below for 70 ft and 3 to 5 in below for 70 ft.

Breaking and Cracking:	30 ft of rail and 3 blocks were cracked and broken due to impact.			
	Missing Elements:	1 block was missing.			
	Corrosion and Weathering:	Less than 5 percent of the cross section has been lost due to weathering. No erosion was observed.			
End Treatments	Alignment and Height:	Alignment acceptable. Height within 1-in of 27-in design height.			
	Breaking and Cracking:	No impact related breaking or cracking was observed.			
	Missing Elements:	No elements were observed to be missing.			
	Corrosion and Weathering:	Less than 5 percent of the cross section has been lost due to weathering.

Repair Action:	REPAIR	FMSS Work Type:	DEFERRED MAINTENANCE	Repair Cost:	\$4780
Brief Workorder:	Raise 140-ft of barrier up to 27-in design height adjust 60 ft to correct horizontal deflection replace 30 ft of rail and 4 blocks.				
Workorder:	Adjust Guardrail at \$10- per -Lin. Ft. for 200 LF = \$2000. Adjust 60 feet of guardrail to correct horizontal deflections and raise 140 feet of guardrail to the design height of 27 inches. Replace Rail at \$25- per -Lin. Ft. for 30 LF = \$750. Replace 30 ft of rail. Replace Block at \$30- per -Each for 4 Block(s) = \$120. Replace 4 blocks. Low Speed Traffic Control at \$1475- per -Day for 1 Day(s) = \$1475.

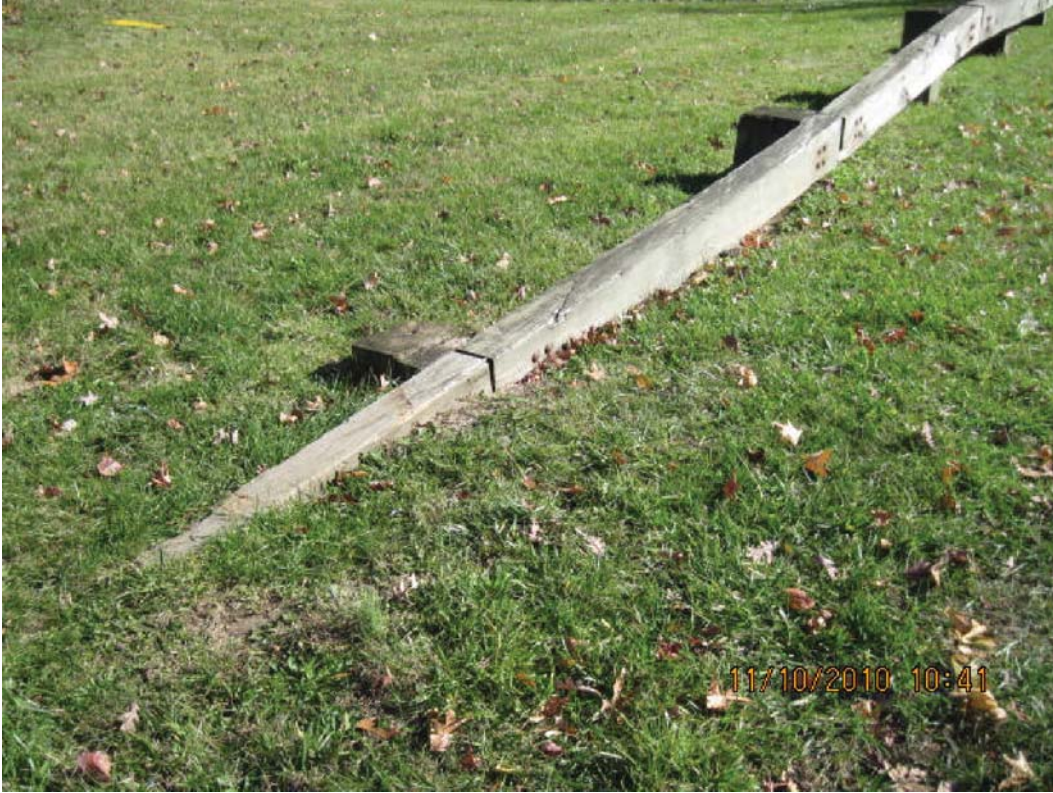
SUIT_0001_5.411_L_1.jpg

Barrier ID:	SUIT-0001-5.411-L				
Route Name:	EASTBOUND SUITLAND PARKWAY				
Inspection Date:	10/11/2010	Barrier Rating:	41.20		
Barrier Description					
Type:	STEEL-BACKED TIMBER WITH BLOCKOUT	Barrier Function:	TRAFFIC		
Barrier Material:	STEEL-BACKED TIMBER/LOG	Post Material:	WOOD		
Blockout Type:	WOOD	Length (ft.):	641		
Speed Limit (MPH):	45	Placement with Respect to Road:	INSIDE OF CURVE		
Hazard Behind Barrier:	MEDIUM				
Barrier Crashworthiness					
Appropriate Test Level:	TL-2	Barrier Test Level:	TL-3	Is Barrier Crashworthy?:	YES
Beg. End Trtmt Type:	SBT/LOG FLARED	Is Beg. End Trtmt Crashworthy?:	NO	Approach Transition Type:	NONE
Ending End Trtmt Type:	NONE	Ending End Trtmt Crashworthy?:	N/A		
Average Measurements					
Design Height (In.):	27	Width (In.):	0.0	Post Spacing (In.):	119.8
Height (In.):	26.0	Lateral Offset (In.):	95.5	Road Grade (%):	1.70
Physical Condition					
Barrier	Alignment and Height:	Alignment deflection was less than 6 in. 295 ft of the barrier was between 1 and 3 in below design height (27 ins). 20 ft of the barrier was greater than 3 ins below design height (27 ins).

Breaking and Cracking:	No impact related breaking/cracking observed.			
	Missing Elements:	No elements appeared to be missing.			
	Corrosion and Weathering:	No loss of cross section observed. Monitor erosion at base of posts under the bridge.			
End Treatments	Alignment and Height:	Alignment acceptable. Height within 1-in of 27-in design height.			
	Breaking and Cracking:	1 block was cracked.			
	Missing Elements:	No elements appeared to be missing.			
	Corrosion and Weathering:	No loss of cross section or erosion observed.

Repair Action:	REPAIR	FMSS Work Type:	DEFERRED MAINTENANCE	Repair Cost:	\$6743
Brief Workorder:	Raise 315-ft of guardrail up to 27-in design height and replace 1 block.				
Workorder:	Adjust Guardrail at \$10- per -Lin. Ft. for 315 LF = \$3150. Raise 315 ft barrier to 27-in design height Replace Block at \$30- per -Each for 1 Block(s) = \$30. Replace 1 block due to cracking Low Speed Traffic Control at \$1475- per -Day for 2 Day(s) = \$2950.

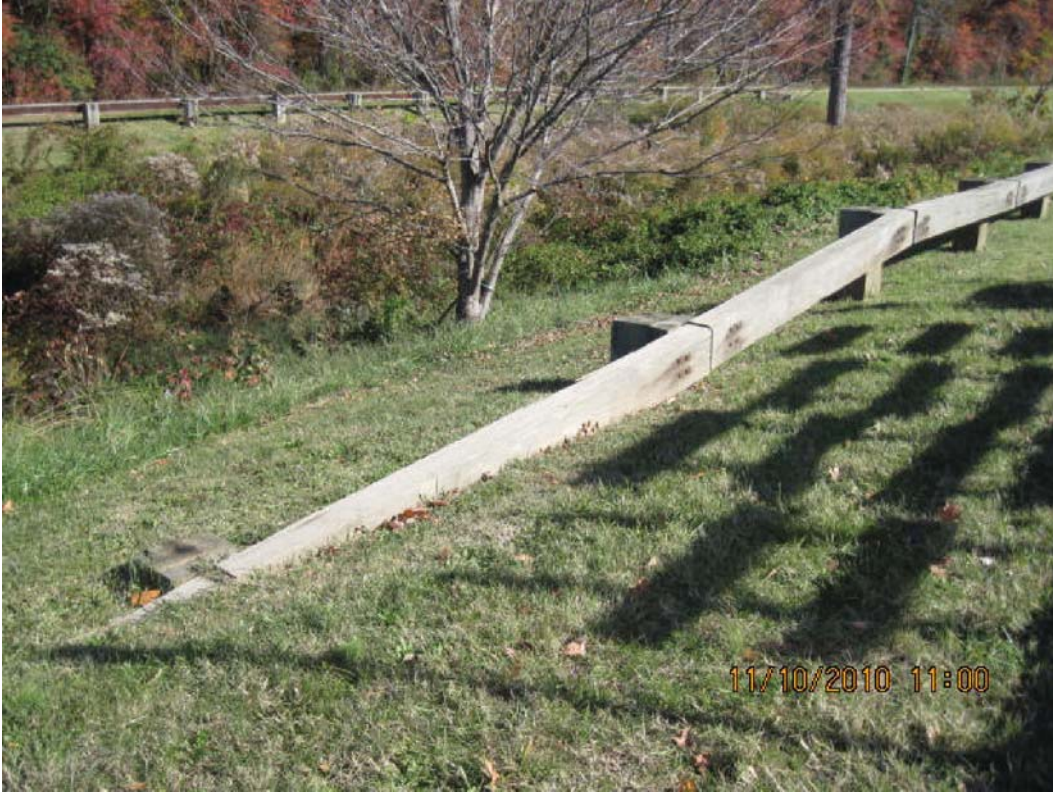
SUIT_0001_5.824_L_1.jpg

Barrier ID:	SUIT-0001-5.824-L				
Route Name:	EASTBOUND SUITLAND PARKWAY				
Inspection Date:	10/11/2010	Barrier Rating:	31.00		
Barrier Description					
Type:	STEEL-BACKED TIMBER WITH BLOCKOUT	Barrier Function:	TRAFFIC		
Barrier Material:	STEEL-BACKED TIMBER/LOG	Post Material:	WOOD		
Blockout Type:	WOOD	Length (ft.):	162		
Speed Limit (MPH):	45	Placement with Respect to Road:	TANGENT		
Hazard Behind Barrier:	MEDIUM				
Barrier Crashworthiness					
Appropriate Test Level:	TL-2	Barrier Test Level:	TL-3	Is Barrier Crashworthy?:	YES
Beg. End Trtmt Type:	SBT/LOG FLARED	Is Beg. End Trtmt Crashworthy?:	NO	Approach Transition Type:	NONE
Ending End Trtmt Type:	NONE	Ending End Trtmt Crashworthy?:	N/A		
Average Measurements					
Design Height (In.):	27	Width (In.):	0.0	Post Spacing (In.):	120.3
Height (In.):	27.2	Lateral Offset (In.):	93.3	Road Grade (%):	0.20
Physical Condition					
Barrier	Alignment and Height:	No deflections observed in alignment. Entire barrier is 1 in or less below or exceeds 27 in design height up to 3 in.

Breaking and Cracking:	No impact related breaking or cracking observed.			
	Missing Elements:	No elements were observed to be missing.			
	Corrosion and Weathering:	No loss of cross section or erosion around posts observed.			
End Treatments	Alignment and Height:	Alignment acceptable. Height within 1-in of 27-in design height.			
	Breaking and Cracking:	No impact related breaking or cracking observed.			
	Missing Elements:	No elements were observed to be missing.			
	Corrosion and Weathering:	No loss of cross section or erosion around posts observed.

Repair Action:	NO ACTION	FMSS Work Type:	N/A	Repair Cost:	\$0
Brief Workorder:	N/A				
Workorder:	No action required.

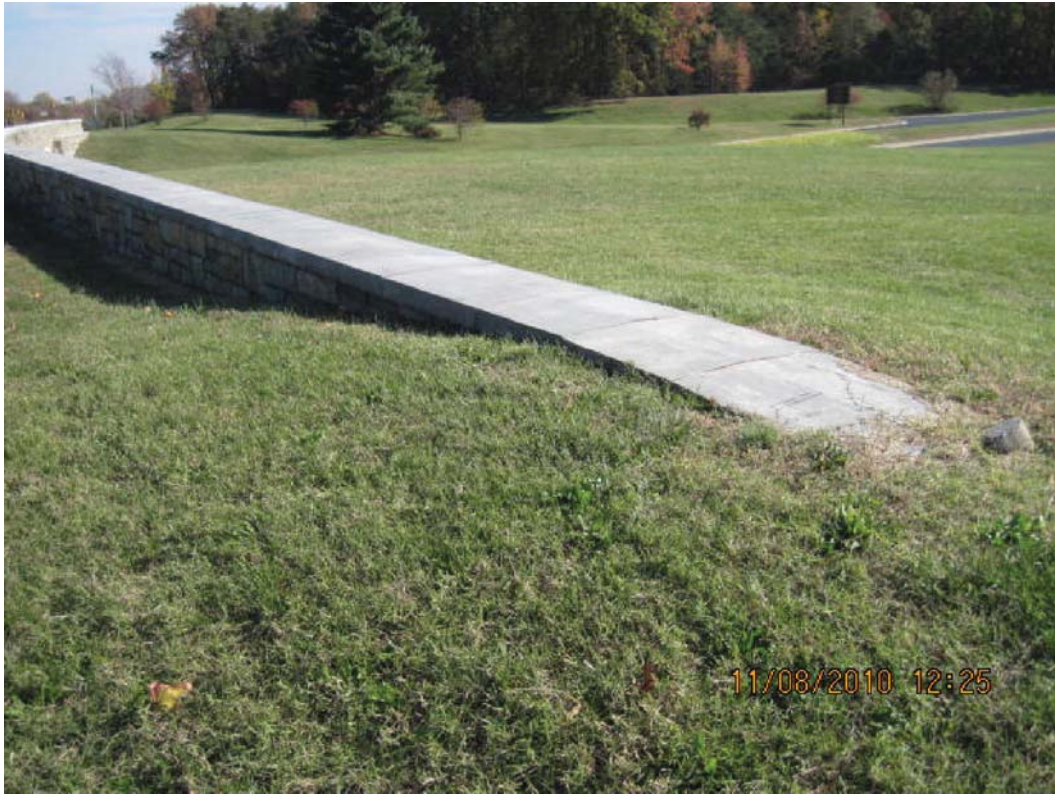
SUIT_0001_6.300_R_1.jpg

Barrier ID:	SUIT-0001-6.300-R				
Route Name:	EASTBOUND SUITLAND PARKWAY				
Inspection Date:	08/11/2010	Barrier Rating:	28.50		
Barrier Description					
Type:	CONCRETE WITH SIMULATED STONE FACE	Barrier Function:	TRAFFIC		
Barrier Material:	CONCRETE	Post Material:	N/A		
Blockout Type:	N/A	Length (ft.):	88		
Speed Limit (MPH):	45	Placement with Respect to Road:	TANGENT		
Hazard Behind Barrier:	LOW				
Barrier Crashworthiness					
Appropriate Test Level:	TL-2	Barrier Test Level:	TL-3	Is Barrier Crashworthy?:	YES
Beg. End Trtmt Type:	OTHER: CONCRETE WITH	Is Beg. End Trtmt Crashworthy?:	NO	Approach Transition Type:	NONE
Ending End Trtmt Type:	NONE	Ending End Trtmt Crashworthy?:	N/A		
Average Measurements					
Design Height (In.):	27	Width (In.):	25.2	Post Spacing (In.):	0.0
Height (In.):	33.7	Lateral Offset (In.):	159.6	Road Grade (%):	0.00
Physical Condition					
Barrier	Alignment and Height:	Alignment deflection was less than 6 in. The entire barrier exceeds design height (27 in) by 4.5 to 10 in.

Breaking and Cracking:	Minor cracks of less than 1/4 in observed.			
	Missing Elements:	No elements appeared to be missing.			
	Corrosion and Weathering:	Cracks in mortar of less than 1/4 in no loose stones or erosion observed.			
End Treatments	Alignment and Height:	Alignment acceptable. Height within 3-in of 27-in design height.			
	Breaking and Cracking:	Minor cracks of less than 1/4 in observed.			
	Missing Elements:	No elements appeared to be missing.			
	Corrosion and Weathering:	Cracks in mortar of less than 1/4 in no loose stones or erosion observed.

Repair Action:	NO ACTION	FMSS Work Type:	N/A	Repair Cost:	\$0
Brief Workorder:	N/A				
Workorder:	No action required.

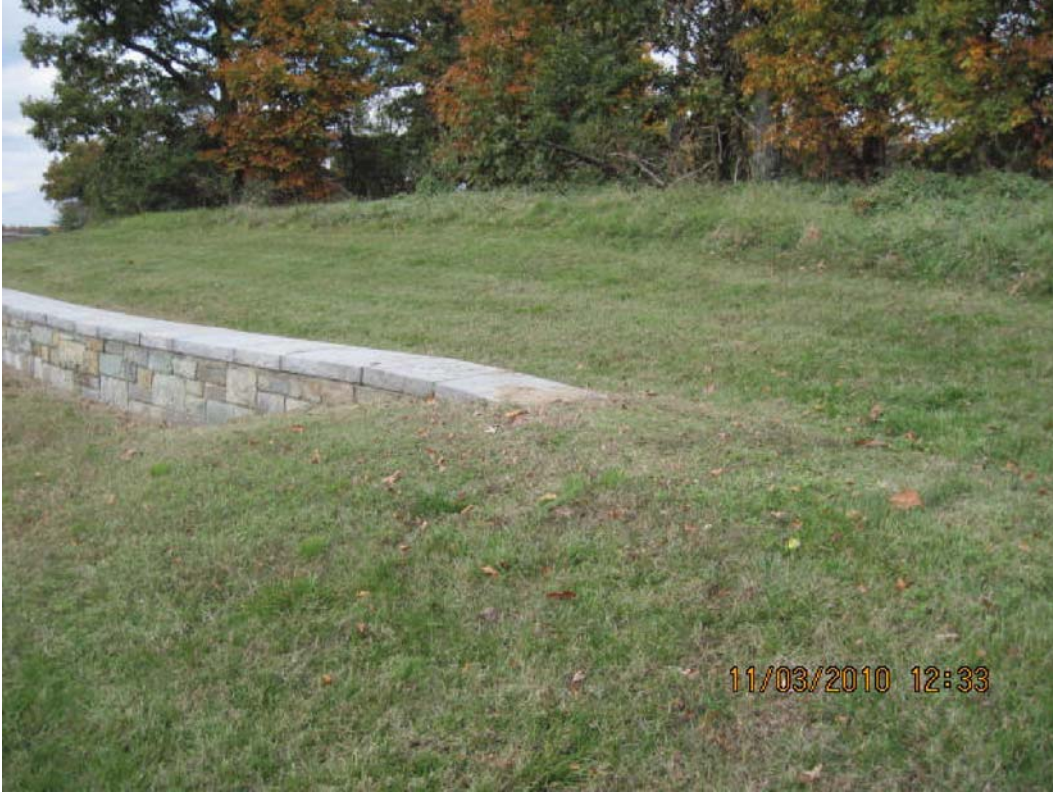
SUIT_0002_0.067_R_1.jpg

Barrier ID:	SUIT-0002-0.067-R				
Route Name:	WESTBOUND SUITLAND PARKWAY				
Inspection Date:	03/11/2010	Barrier Rating:	26.70		
Barrier Description					
Type:	CONCRETE WITH SIMULATED STONE FACE	Barrier Function:	TRAFFIC		
Barrier Material:	CONCRETE	Post Material:	N/A		
Blockout Type:	N/A	Length (ft.):	161		
Speed Limit (MPH):	35	Placement with Respect to Road:	TANGENT		
Hazard Behind Barrier:	MEDIUM				
Barrier Crashworthiness					
Appropriate Test Level:	TL-2	Barrier Test Level:	TL-3	Is Barrier Crashworthy?:	YES
Beg. End Trtmt Type:	OTHER: CONCRETE WITH	Is Beg. End Trtmt Crashworthy?:	NO	Approach Transition Type:	NONE
Ending End Trtmt Type:	NONE	Ending End Trtmt Crashworthy?:	N/A		
Average Measurements					
Design Height (In.):	27	Width (In.):	25.2	Post Spacing (In.):	0.0
Height (In.):	29.5	Lateral Offset (In.):	96.6	Road Grade (%):	1.80
Physical Condition					
Barrier	Alignment and Height:	No deflections greater than 6 in were observed in the alignment. The barrier height was equal to or exceeded the 27 in design height ranging up to 34 in.

Breaking and Cracking:	No breaking or cracking was observed.			
	Missing Elements:	No elements were observed to be missing.			
	Corrosion and Weathering:	No weathering or erosion was observed.			
End Treatments	Alignment and Height:	Alignment acceptable. Height within 3-in of 27-in design height.			
	Breaking and Cracking:	No breaking or cracking was observed.			
	Missing Elements:	No elements were observed to be missing.			
	Corrosion and Weathering:	No weathering or erosion was observed.

Repair Action:	NO ACTION	FMSS Work Type:	N/A	Repair Cost:	\$0
Brief Workorder:	N/A				
Workorder:	No action required.

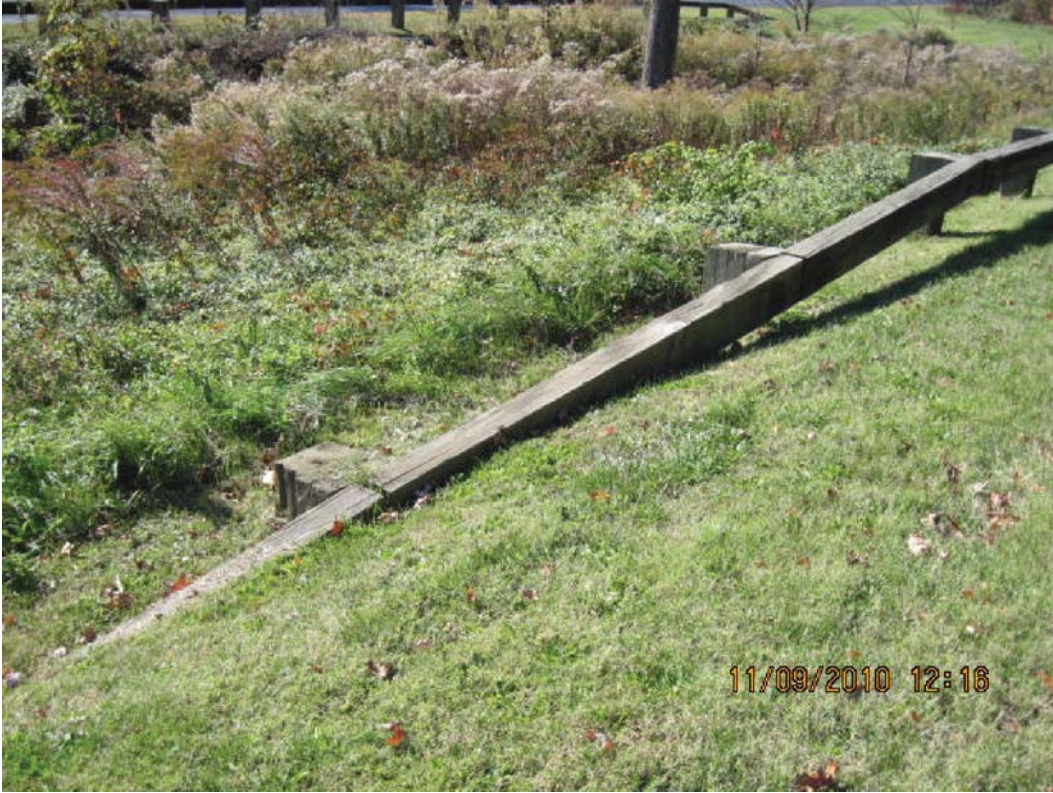
SUIT_0002_0.587_L_1.jpg

Barrier ID:	SUIT-0002-0.587-L				
Route Name:	WESTBOUND SUITLAND PARKWAY				
Inspection Date:	09/11/2010	Barrier Rating:	31.00		
Barrier Description					
Type:	STEEL-BACKED TIMBER WITH BLOCKOUT	Barrier Function:	TRAFFIC		
Barrier Material:	STEEL-BACKED TIMBER/LOG	Post Material:	WOOD		
Blockout Type:	WOOD	Length (ft.):	187		
Speed Limit (MPH):	45	Placement with Respect to Road:	TANGENT		
Hazard Behind Barrier:	MEDIUM				
Barrier Crashworthiness					
Appropriate Test Level:	TL-2	Barrier Test Level:	TL-3	Is Barrier Crashworthy?:	YES
Beg. End Trtmt Type:	SBT/LOG FLARED	Is Beg. End Trtmt Crashworthy?:	NO	Approach Transition Type:	NONE
Ending End Trtmt Type:	NONE	Ending End Trtmt Crashworthy?:	N/A		
Average Measurements					
Design Height (In.):	27	Width (In.):	0.0	Post Spacing (In.):	120.1
Height (In.):	26.2	Lateral Offset (In.):	142.3	Road Grade (%):	0.60
Physical Condition					
Barrier	Alignment and Height:	No deflections observed in alignment. Entire barrier is 1 in or less below 27 in design height.

Breaking and Cracking:	No impact related breaking or cracking observed.			
	Missing Elements:	No elements were observed to be missing.			
	Corrosion and Weathering:	No loss of cross section or erosion around posts observed.			
End Treatments	Alignment and Height:	Alignment acceptable. Height within 1-in of 27-in design height.			
	Breaking and Cracking:	No impact related breaking or cracking observed.			
	Missing Elements:	No elements were observed to be missing.			
	Corrosion and Weathering:	No loss of cross section or erosion around posts observed.

Repair Action:	NO ACTION	FMSS Work Type:	N/A	Repair Cost:	\$0
Brief Workorder:	N/A				
Workorder:	No action required.

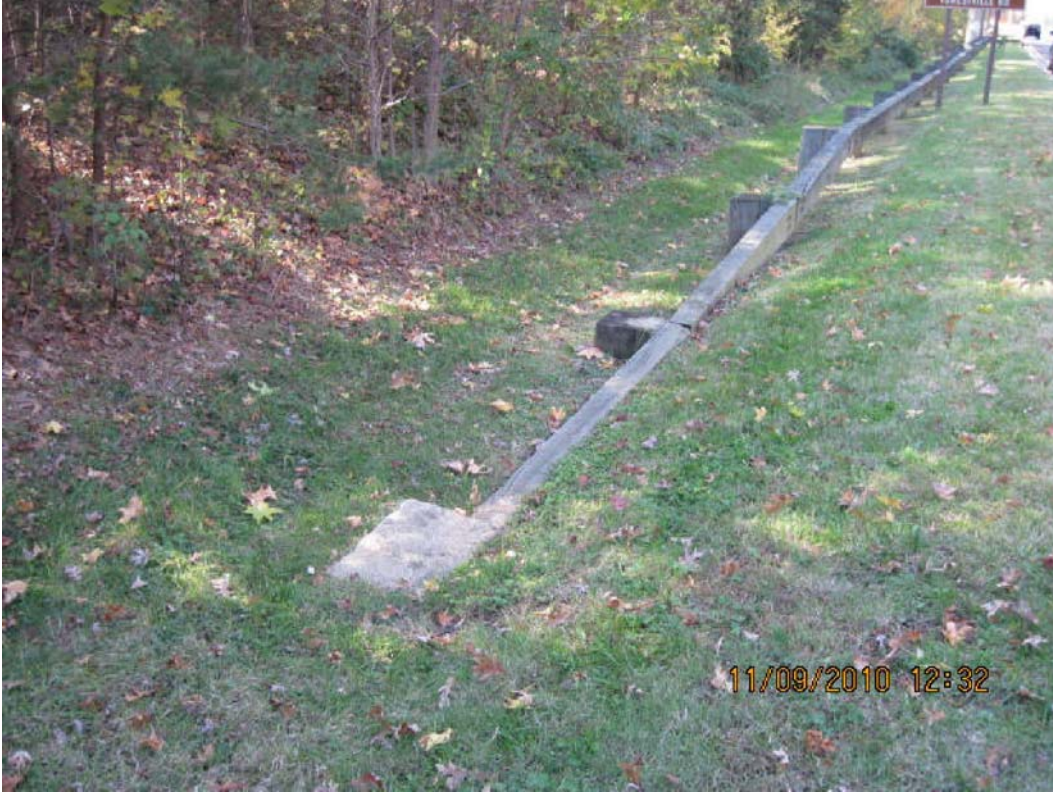
SUIT_0002_0.846_L_1.jpg

Barrier ID:	SUIT-0002-0.846-L				
Route Name:	WESTBOUND SUITLAND PARKWAY				
Inspection Date:	09/11/2010	Barrier Rating:	46.90		
Barrier Description					
Type:	STEEL-BACKED TIMBER WITH BLOCKOUT	Barrier Function:	TRAFFIC		
Barrier Material:	STEEL-BACKED TIMBER/LOG	Post Material:	WOOD		
Blockout Type:	WOOD	Length (ft.):	448		
Speed Limit (MPH):	45	Placement with Respect to Road:	OUTSIDE OF CURVE		
Hazard Behind Barrier:	MEDIUM				
Barrier Crashworthiness					
Appropriate Test Level:	TL-2	Barrier Test Level:	TL-3	Is Barrier Crashworthy?:	YES
Beg. End Trtmt Type:	SBT/LOG FLARED	Is Beg. End Trtmt Crashworthy?:	NO	Approach Transition Type:	NONE
Ending End Trtmt Type:	NONE	Ending End Trtmt Crashworthy?:	N/A		
Average Measurements					
Design Height (In.):	27	Width (In.):	0.0	Post Spacing (In.):	120.0
Height (In.):	27.0	Lateral Offset (In.):	118.3	Road Grade (%):	0.10
Physical Condition					
Barrier	Alignment and Height:	20 ft of barrier was deflected 13 in due to impact. The barrier height was within 1 in of the 27 in of design height for 303 ft and between 1 and 3 in below the design height for 100 ft.

Breaking and Cracking:	20 ft of rail and 4 blocks were cracked and broken.			
	Missing Elements:	No elements were observed to be missing.			
	Corrosion and Weathering:	Less than 5 percent of the cross section has been lost due to weathering and no erosion was observed.			
End Treatments	Alignment and Height:	Alignment acceptable. Height within 1-in of 27-in design height.			
	Breaking and Cracking:	No impact related breaking or cracking was observed.			
	Missing Elements:	No elements were observed to be missing.			
	Corrosion and Weathering:	Less than 5 percent of the cross section has been lost due to weathering.

Repair Action:	REPAIR	FMSS Work Type:	DEFERRED MAINTENANCE	Repair Cost:	\$3625
Brief Workorder:	Raise 100-ft of guardrail up to 27-in design height realign 20-ft of guardrail replace 20-ft of rail and 4 blocks.				
Workorder:	Adjust Guardrail at \$10- per -Lin. Ft. for 120 LF = \$1200. Raise 100 feet of guardrail to the 27 inch design height and adjust 20 feet of misligned barrier Replace Rail at \$25- per -Lin. Ft. for 20 LF = \$500. Replace 20 ft of rail Replace Block at \$30- per -Each for 4 Block(s) = \$120. Replace 4 blocks. Low Speed Traffic Control at \$1475- per -Day for 1 Day(s) = \$1475.

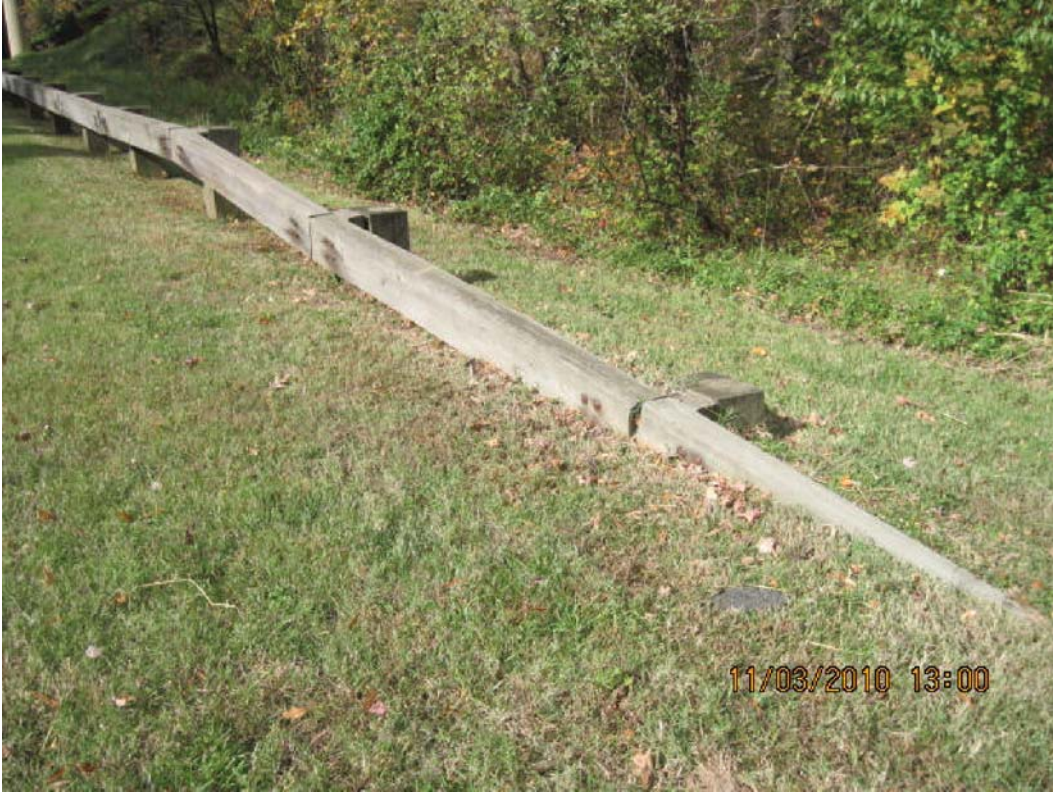
SUIT_0002_0.857_R_1.jpg

Barrier ID:	SUIT-0002-0.857-R				
Route Name:	WESTBOUND SUITLAND PARKWAY				
Inspection Date:	03/11/2010	Barrier Rating:	31.30		
Barrier Description					
Type:	STEEL-BACKED TIMBER WITH BLOCKOUT	Barrier Function:	TRAFFIC		
Barrier Material:	STEEL-BACKED TIMBER/LOG	Post Material:	WOOD		
Blockout Type:	WOOD	Length (ft.):	362		
Speed Limit (MPH):	45	Placement with Respect to Road:	TANGENT		
Hazard Behind Barrier:	LOW				
Barrier Crashworthiness					
Appropriate Test Level:	TL-2	Barrier Test Level:	TL-3	Is Barrier Crashworthy?:	YES
Beg. End Trtmt Type:	SBT/LOG FLARED	Is Beg. End Trtmt Crashworthy?:	NO	Approach Transition Type:	NONE
Ending End Trtmt Type:	SBT/LOG FLARED	Ending End Trtmt Crashworthy?:	NO		
Average Measurements					
Design Height (In.):	27	Width (In.):	0.0	Post Spacing (In.):	118.8
Height (In.):	27.0	Lateral Offset (In.):	101.6	Road Grade (%):	0.20
Physical Condition					
Barrier	Alignment and Height:	Alignment deflection was less than 6 in. The entire barrier was 1 in below or exceeded design height (27 in) up to 1.5 in.

Breaking and Cracking:	No impact related breaking or cracking observed.			
	Missing Elements:	No elements appeared to be missing.			
	Corrosion and Weathering:	No cross section loss or erosion observed.			
End Treatments	Alignment and Height:	Alignment acceptable. Height within 1-in of 27-in design height.			
	Breaking and Cracking:	No impact related breaking or cracking observed.			
	Missing Elements:	No elements appeared to be missing.			
	Corrosion and Weathering:	No cross section loss or erosion observed.

Barrier ID:	SUIT-0002-0.857-R				
Route Name:	WESTBOUND SUITLAND PARKWAY				
Inspection Date:	03/11/2010	Barrier Rating:		31.30	
Repair Recommendations					
Repair Action:	NO ACTION	FMSS Work Type:	N/A	Repair Cost:	\$0
Brief Workorder:	N/A				
Workorder:	No action required.

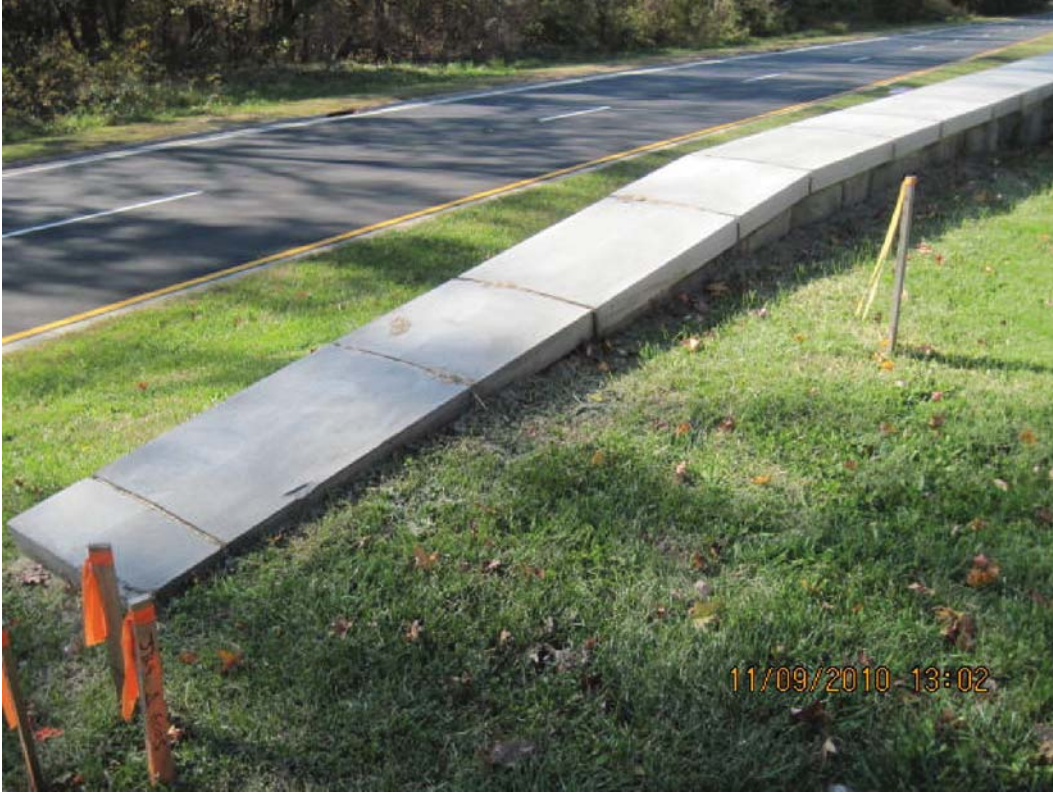
SUIT_0002_1.530_L_1.jpg

Barrier ID:	SUIT-0002-1.530-L				
Route Name:	WESTBOUND SUITLAND PARKWAY				
Inspection Date:	09/11/2010	Barrier Rating:	41.40		
Barrier Description					
Type:	CONCRETE WITH SIMULATED STONE FACE	Barrier Function:	TRAFFIC		
Barrier Material:	CONCRETE	Post Material:	N/A		
Blockout Type:	N/A	Length (ft.):	1451		
Speed Limit (MPH):	50	Placement with Respect to Road:	INSIDE OF CURVE		
Hazard Behind Barrier:	HIGH				
Barrier Crashworthiness					
Appropriate Test Level:	TL-3	Barrier Test Level:	TL-3	Is Barrier Crashworthy?:	YES
Beg. End Trtmt Type:	OTHER: CONCRETE WITH	Is Beg. End Trtmt Crashworthy?:	NO	Approach Transition Type:	NONE
Ending End Trtmt Type:	NONE	Ending End Trtmt Crashworthy?:	N/A		
Average Measurements					
Design Height (In.):	27	Width (In.):	26.0	Post Spacing (In.):	0.0
Height (In.):	30.2	Lateral Offset (In.):	140.0	Road Grade (%):	0.40
Physical Condition					
Barrier	Alignment and Height:	Alignment deflection was less than 6 in. The entire barrier exceeded design height (27 in) by 1 to 5 in.

Breaking and Cracking:	Minor cracks of less than 1/4 in observed.			
	Missing Elements:	No elements appeared to be missing.			
	Corrosion and Weathering:	Monitor cracks in the mortar joints of less than 1/2 in. No erosion observed.			
End Treatments	Alignment and Height:	Alignment acceptable. Height within 3-in of 27-in design height.			
	Breaking and Cracking:	Minor cracks of less than 1/4 in observed.			
	Missing Elements:	No elements appeared to be missing.			
	Corrosion and Weathering:	Cracks of less than 1/4 in in mortar joints observed.

Repair Action:	MONITOR	FMSS Work Type:	N/A	Repair Cost:	\$0
Brief Workorder:	Monitor cracks in mortar joints of less than 1/2 inch.				
Workorder:

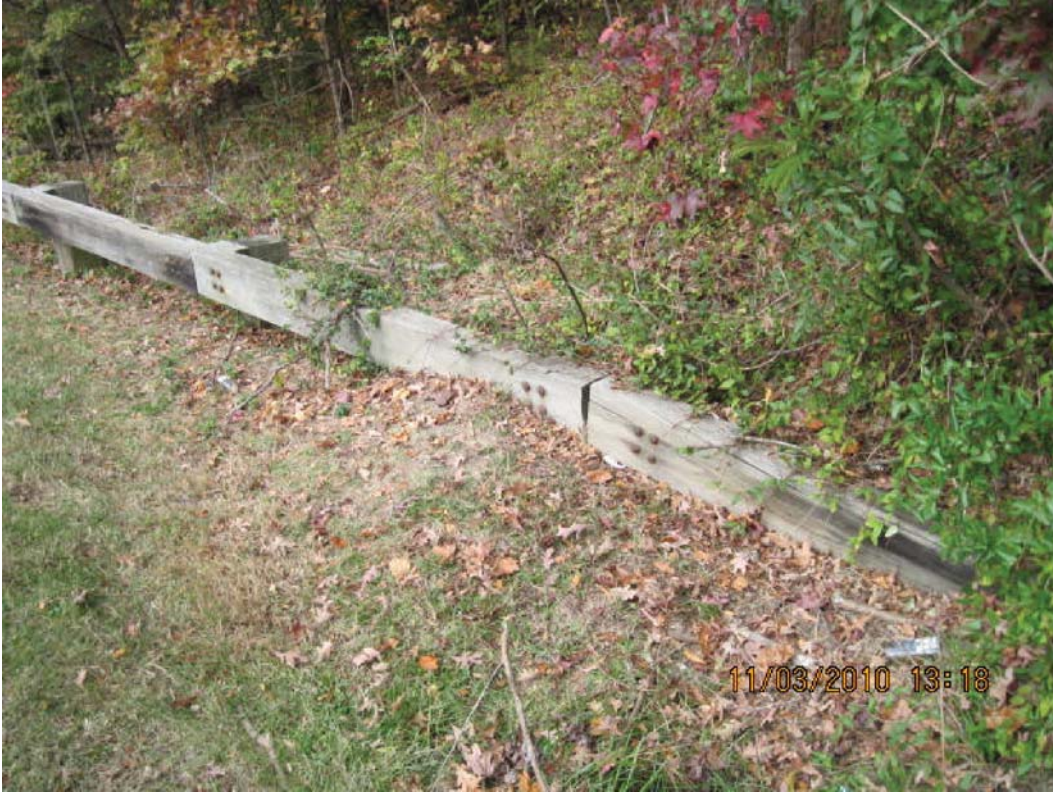
SUIT_0002_1.781_R_1.jpg

Barrier ID:	SUIT-0002-1.781-R				
Route Name:	WESTBOUND SUITLAND PARKWAY				
Inspection Date:	03/11/2010	Barrier Rating:	42.70		
Barrier Description					
Type:	STEEL-BACKED TIMBER WITH BLOCKOUT	Barrier Function:	TRAFFIC		
Barrier Material:	STEEL-BACKED TIMBER/LOG	Post Material:	WOOD		
Blockout Type:	WOOD	Length (ft.):	523		
Speed Limit (MPH):	45	Placement with Respect to Road:	TANGENT		
Hazard Behind Barrier:	MEDIUM				
Barrier Crashworthiness					
Appropriate Test Level:	TL-2	Barrier Test Level:	TL-3	Is Barrier Crashworthy?:	YES
Beg. End Trtmt Type:	SBT/LOG FLARED	Is Beg. End Trtmt Crashworthy?:	NO	Approach Transition Type:	NONE
Ending End Trtmt Type:	SBT/LOG FLARED	Ending End Trtmt Crashworthy?:	NO		
Average Measurements					
Design Height (In.):	27	Width (In.):	0.0	Post Spacing (In.):	120.0
Height (In.):	24.0	Lateral Offset (In.):	131.6	Road Grade (%):	0.70
Physical Condition					
Barrier	Alignment and Height:	No deflections observed in alignment. 270 ft of barrier is 1 to 3 in below 27 in design height. 55 ft of barrier is 3 to 4 in below the 27 in design height.

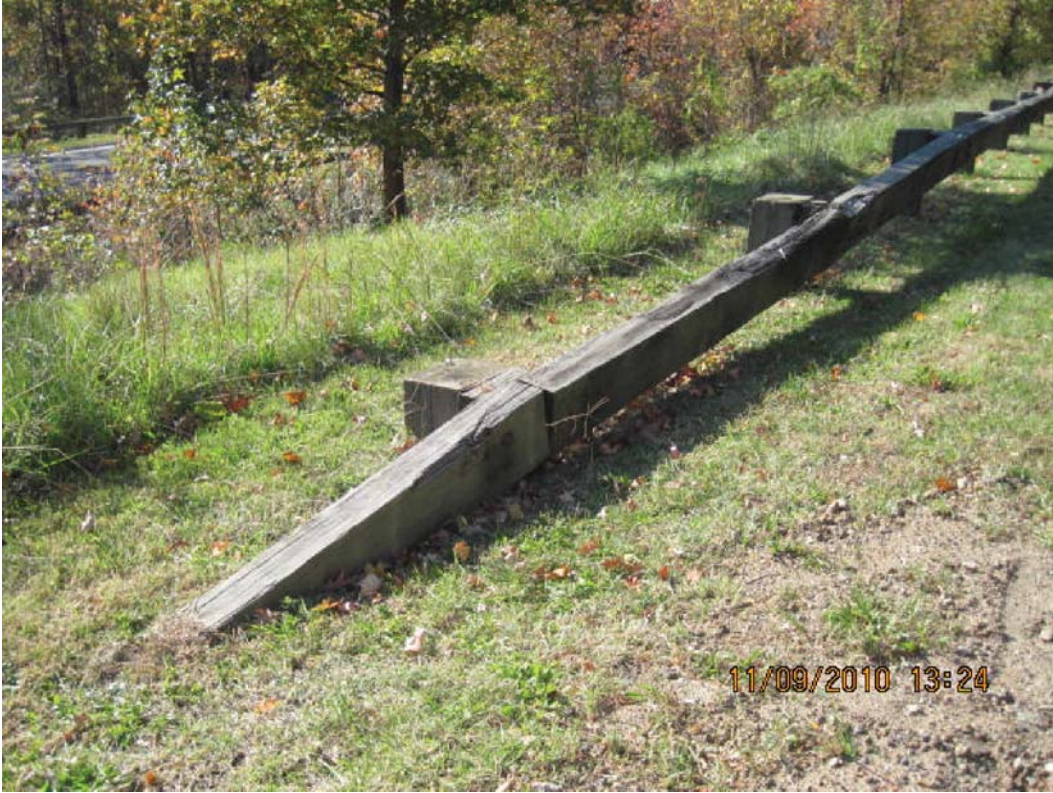
SUIT_0002_1.832_L_1.jpg

Barrier ID:	SUIT-0002-1.832-L				
Route Name:	WESTBOUND SUITLAND PARKWAY				
Inspection Date:	09/11/2010	Barrier Rating:	38.20		
Barrier Description					
Type:	STEEL-BACKED TIMBER WITH BLOCKOUT	Barrier Function:	TRAFFIC		
Barrier Material:	STEEL-BACKED TIMBER/LOG	Post Material:	WOOD		
Blockout Type:	WOOD	Length (ft.):	174		
Speed Limit (MPH):	50	Placement with Respect to Road:	INSIDE OF CURVE		
Hazard Behind Barrier:	MEDIUM				
Barrier Crashworthiness					
Appropriate Test Level:	TL-3	Barrier Test Level:	TL-3	Is Barrier Crashworthy?:	YES
Beg. End Trtmt Type:	SBT/LOG FLARED	Is Beg. End Trtmt Crashworthy?:	NO	Approach Transition Type:	NONE
Ending End Trtmt Type:	SBT/LOG FLARED	Ending End Trtmt Crashworthy?:	NO		
Average Measurements					
Design Height (In.):	27	Width (In.):	0.0	Post Spacing (In.):	121.0
Height (In.):	27.7	Lateral Offset (In.):	82.1	Road Grade (%):	0.70
Physical Condition					
Barrier	Alignment and Height:	No deflections observed in alignment. Entire barrier meets or exceeds 27 in design height by up to 1.5 in.

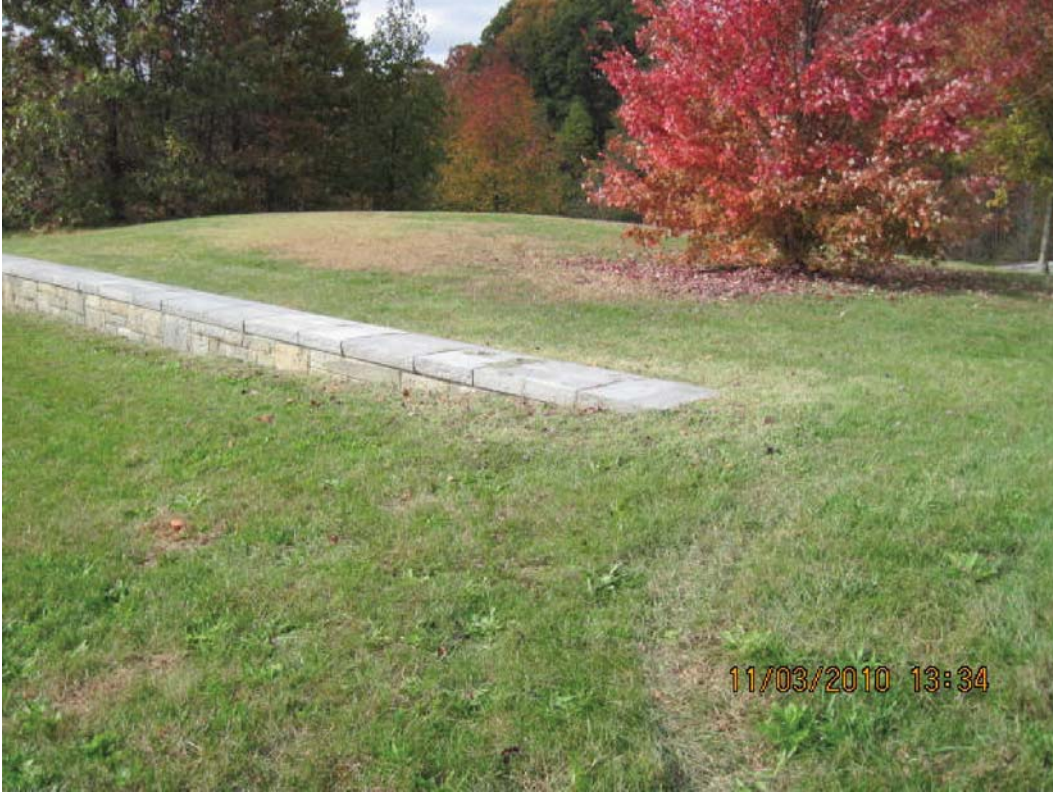
SUIT_0002_2.507_R_1.jpg

Barrier ID:	SUIT-0002-2.507-R				
Route Name:	WESTBOUND SUITLAND PARKWAY				
Inspection Date:	03/11/2010	Barrier Rating:	28.50		
Barrier Description					
Type:	CONCRETE WITH SIMULATED STONE FACE	Barrier Function:	TRAFFIC		
Barrier Material:	CONCRETE	Post Material:	N/A		
Blockout Type:	N/A	Length (ft.):	91		
Speed Limit (MPH):	45	Placement with Respect to Road:	TANGENT		
Hazard Behind Barrier:	LOW				
Barrier Crashworthiness					
Appropriate Test Level:	TL-2	Barrier Test Level:	TL-3	Is Barrier Crashworthy?:	YES
Beg. End Trtmt Type:	OTHER: CONCRETE WITH	Is Beg. End Trtmt Crashworthy?:	NO	Approach Transition Type:	NONE
Ending End Trtmt Type:	NONE	Ending End Trtmt Crashworthy?:	N/A		
Average Measurements					
Design Height (In.):	27	Width (In.):	26.0	Post Spacing (In.):	0.0
Height (In.):	29.0	Lateral Offset (In.):	153.0	Road Grade (%):	1.40
Physical Condition					
Barrier	Alignment and Height:	No deflections were observed in the alignment. The barrier height ranged from the 27 in design height up to 30.5 in throughout.

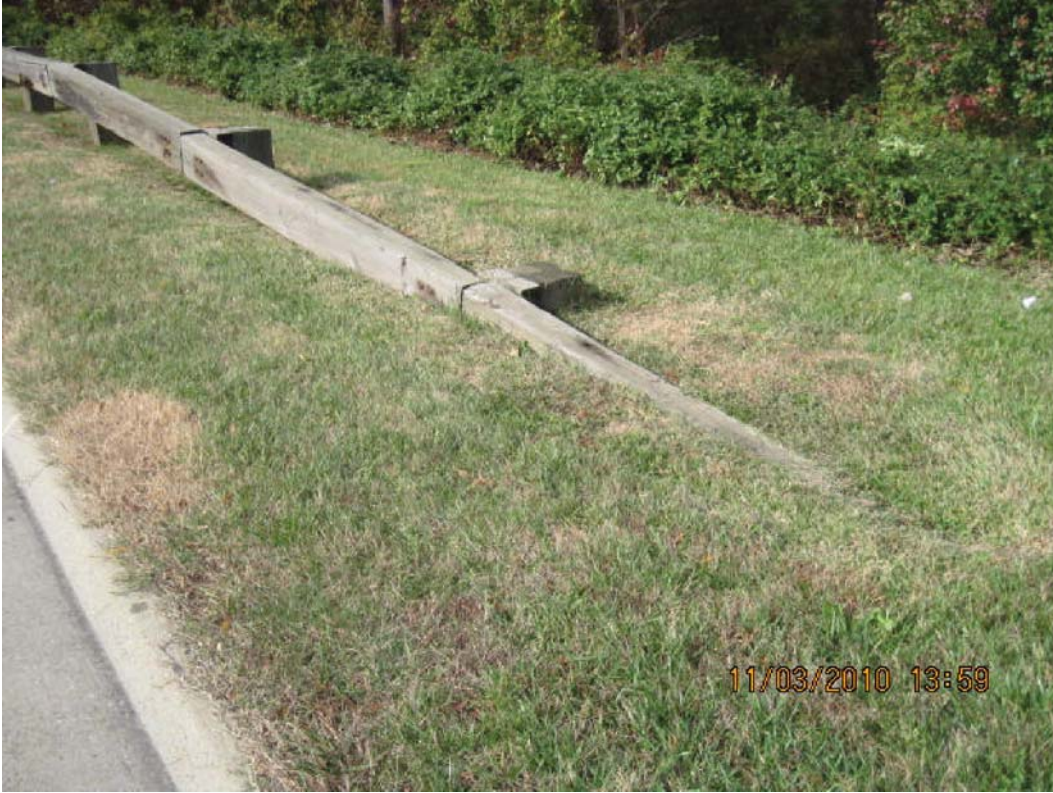
SUIT_0002_3.270_R_1.jpg

Barrier ID:	SUIT-0002-3.270-R				
Route Name:	WESTBOUND SUITLAND PARKWAY				
Inspection Date:	03/11/2010	Barrier Rating:	39.70		
Barrier Description					
Type:	STEEL-BACKED TIMBER WITH BLOCKOUT	Barrier Function:	TRAFFIC		
Barrier Material:	STEEL-BACKED TIMBER/LOG	Post Material:	WOOD		
Blockout Type:	WOOD	Length (ft.):	176		
Speed Limit (MPH):	45	Placement with Respect to Road:	TANGENT		
Hazard Behind Barrier:	MEDIUM				
Barrier Crashworthiness					
Appropriate Test Level:	TL-2	Barrier Test Level:	TL-3	Is Barrier Crashworthy?:	YES
Beg. End Trtmt Type:	SBT/LOG FLARED	Is Beg. End Trtmt Crashworthy?:	NO	Approach Transition Type:	NONE
Ending End Trtmt Type:	SBT/LOG FLARED	Ending End Trtmt Crashworthy?:	NO		
Average Measurements					
Design Height (In.):	27	Width (In.):	0.0	Post Spacing (In.):	120.3
Height (In.):	24.7	Lateral Offset (In.):	84.3	Road Grade (%):	2.30
Physical Condition					
Barrier	Alignment and Height:	Alignment deflection was less than 6 in. 35 ft of the barrier was 1 to 3 in below design height (27 ines). 35 ft of the barrier was 3 to 4 ines below design height (27 ines).
