GIP Report

NPS Guardwall/Rail Inventory Program
Suitland Parkway National Capital Parks - East

Federal Highway Administration
Eastern Federal Lands Highway Division
Road Inventory Program (RIP)

Data Collection Date: November 2010
Report Date: November 2015

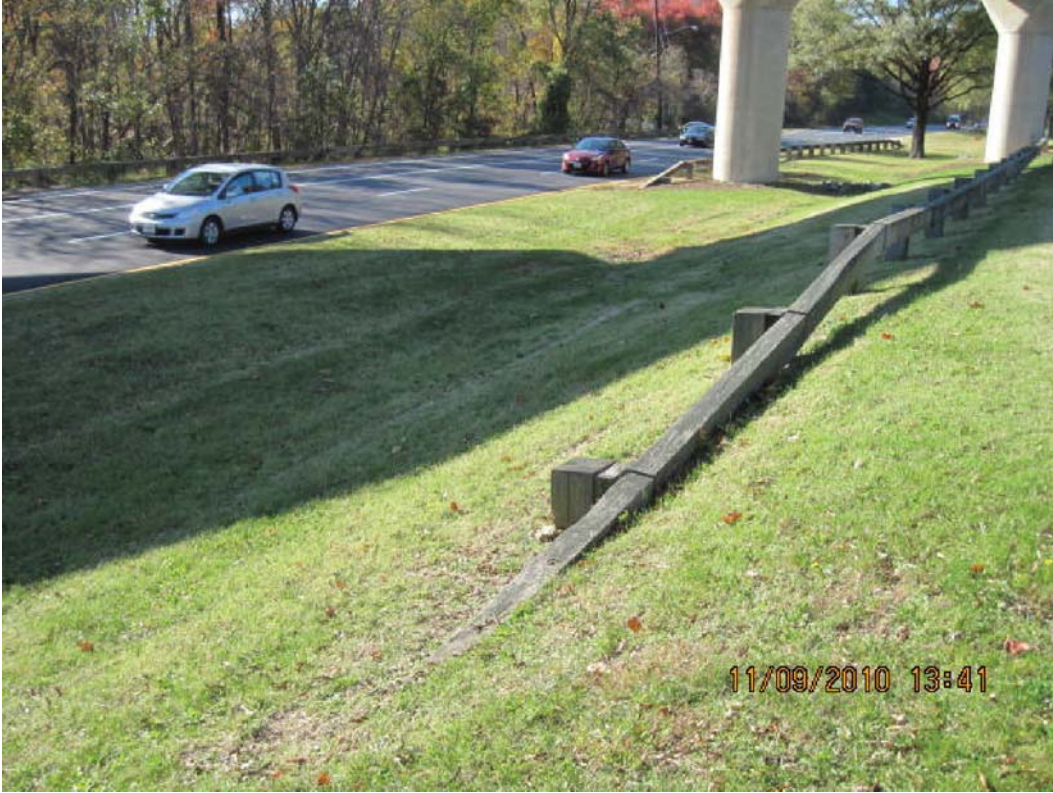
SUIT_0002_3.452_L_1.jpg

Barrier ID:	SUIT-0002-3.452-L				
Route Name:	WESTBOUND SUITLAND PARKWAY				
Inspection Date:	09/11/2010	Barrier Rating:	41.40		
Barrier Description					
Type:	STEEL-BACKED TIMBER WITH BLOCKOUT	Barrier Function:	TRAFFIC		
Barrier Material:	STEEL-BACKED TIMBER/LOG	Post Material:	WOOD		
Blockout Type:	WOOD	Length (ft.):	193		
Speed Limit (MPH):	50	Placement with Respect to Road:	OUTSIDE OF CURVE		
Hazard Behind Barrier:	HIGH				
Barrier Crashworthiness					
Appropriate Test Level:	TL-3	Barrier Test Level:	TL-3	Is Barrier Crashworthy?:	YES
Beg. End Trtmt Type:	SBT/LOG FLARED	Is Beg. End Trtmt Crashworthy?:	NO	Approach Transition Type:	NONE
Ending End Trtmt Type:	SBT/LOG FLARED	Ending End Trtmt Crashworthy?:	NO		
Average Measurements					
Design Height (In.):	27	Width (In.):	0.0	Post Spacing (In.):	120.1
Height (In.):	27.2	Lateral Offset (In.):	94.6	Road Grade (%):	2.20
Physical Condition					
Barrier	Alignment and Height:	No deflections greater than 6 in were observed in the alignment. The height was within 2 in greater than equal to or within 1 in of the 27 in design height for the entire length.

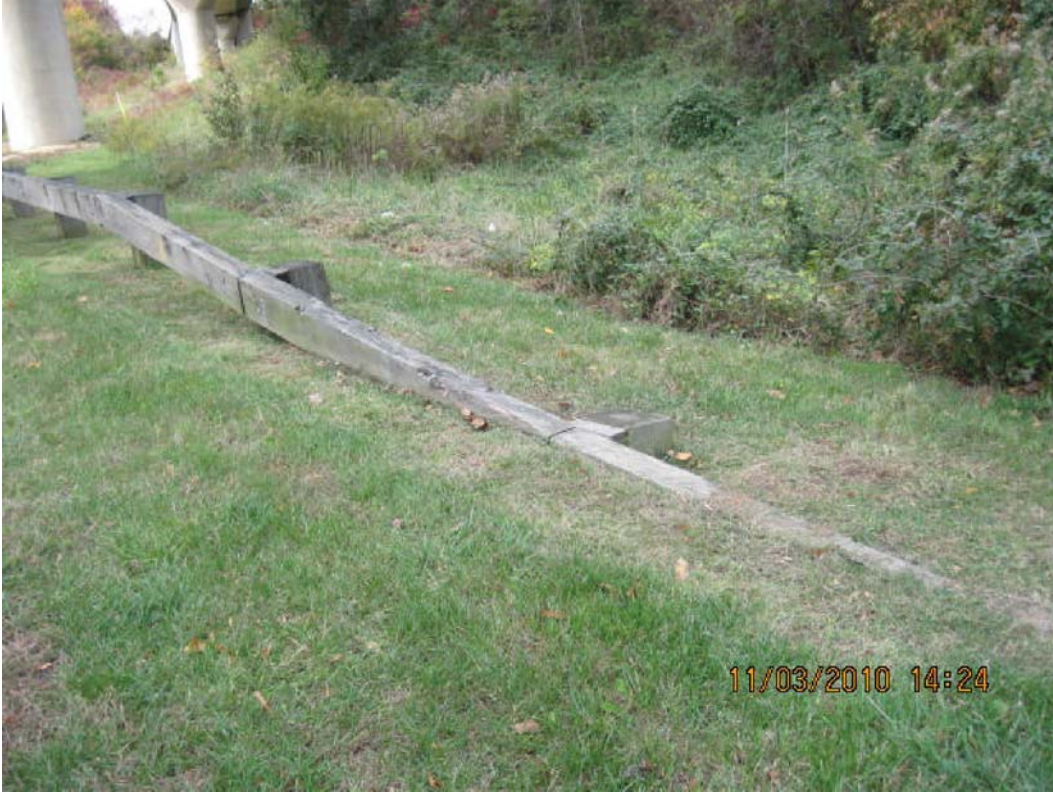
SUIT_0002_3.483_R_1.jpg

Barrier ID:	SUIT-0002-3.483-R				
Route Name:	WESTBOUND SUITLAND PARKWAY				
Inspection Date:	03/11/2010	Barrier Rating:	31.00		
Barrier Description					
Type:	STEEL-BACKED TIMBER WITH BLOCKOUT	Barrier Function:	TRAFFIC		
Barrier Material:	STEEL-BACKED TIMBER/LOG	Post Material:	WOOD		
Blockout Type:	WOOD	Length (ft.):	147		
Speed Limit (MPH):	45	Placement with Respect to Road:	TANGENT		
Hazard Behind Barrier:	MEDIUM				
Barrier Crashworthiness					
Appropriate Test Level:	TL-2	Barrier Test Level:	TL-3	Is Barrier Crashworthy?:	YES
Beg. End Trtmt Type:	SBT/LOG FLARED	Is Beg. End Trtmt Crashworthy?:	NO	Approach Transition Type:	NONE
Ending End Trtmt Type:	SBT/LOG FLARED	Ending End Trtmt Crashworthy?:	NO		
Average Measurements					
Design Height (In.):	27	Width (In.):	0.0	Post Spacing (In.):	120.0
Height (In.):	27.2	Lateral Offset (In.):	87.5	Road Grade (%):	0.90
Physical Condition					
Barrier	Alignment and Height:	No deflections in alignment observed. Entire barrier meets or exceeds 27 in design height up to 1 in.

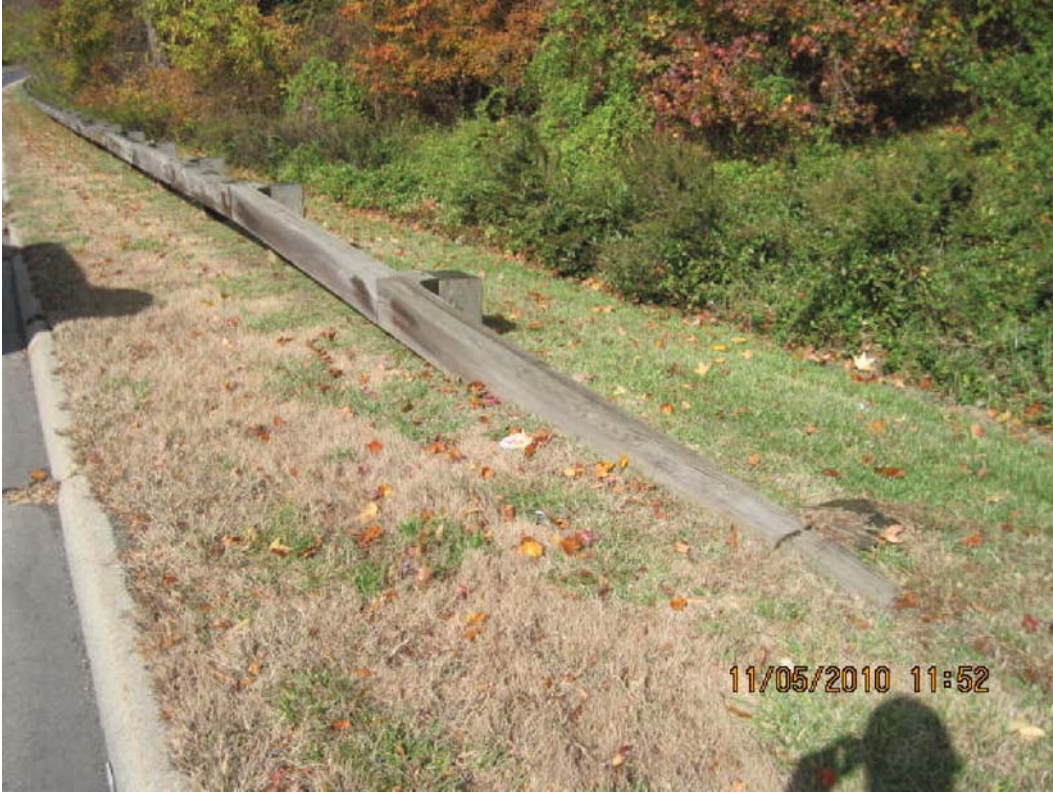
SUIT_0002_3.741_R_1.jpg

Barrier ID:	SUIT-0002-3.741-R				
Route Name:	WESTBOUND SUITLAND PARKWAY				
Inspection Date:	05/11/2010	Barrier Rating:	45.50		
Barrier Description					
Type:	STEEL-BACKED TIMBER WITH BLOCKOUT	Barrier Function:	TRAFFIC		
Barrier Material:	STEEL-BACKED TIMBER/LOG	Post Material:	WOOD		
Blockout Type:	WOOD	Length (ft.):	510		
Speed Limit (MPH):	45	Placement with Respect to Road:	INSIDE OF CURVE		
Hazard Behind Barrier:	MEDIUM				
Barrier Crashworthiness					
Appropriate Test Level:	TL-2	Barrier Test Level:	TL-3	Is Barrier Crashworthy?:	YES
Beg. End Trtmt Type:	SBT/LOG FLARED	Is Beg. End Trtmt Crashworthy?:	NO	Approach Transition Type:	NONE
Ending End Trtmt Type:	SBT/LOG FLARED	Ending End Trtmt Crashworthy?:	NO		
Average Measurements					
Design Height (In.):	27	Width (In.):	0.0	Post Spacing (In.):	119.3
Height (In.):	25.0	Lateral Offset (In.):	85.0	Road Grade (%):	1.30
Physical Condition					
Barrier	Alignment and Height:	Alignment deflection was less than 6 in. The entire barrier was between 1 and 3 in below design height (27 in).

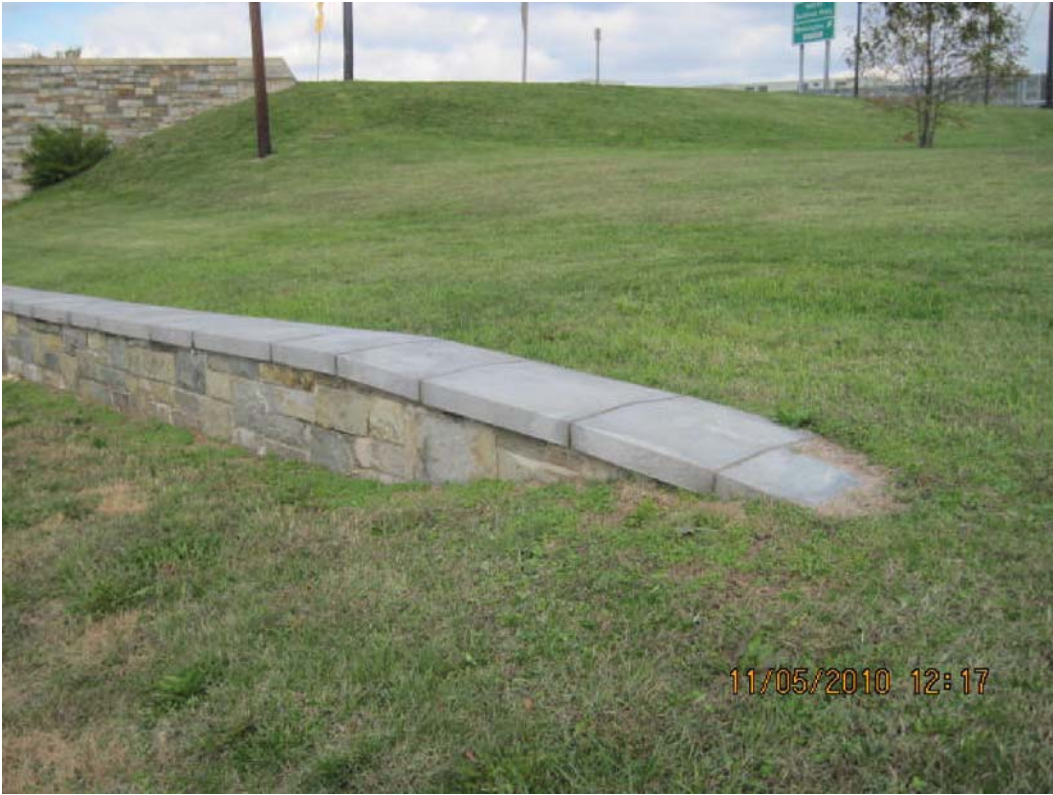
SUIT_0002_4.294_R_1.jpg

Barrier ID:	SUIT-0002-4.294-R				
Route Name:	WESTBOUND SUITLAND PARKWAY				
Inspection Date:	05/11/2010	Barrier Rating:	28.50		
Barrier Description					
Type:	CONCRETE WITH SIMULATED STONE FACE	Barrier Function:	TRAFFIC		
Barrier Material:	CONCRETE	Post Material:	N/A		
Blockout Type:	N/A	Length (ft.):	132		
Speed Limit (MPH):	45	Placement with Respect to Road:	TANGENT		
Hazard Behind Barrier:	LOW				
Barrier Crashworthiness					
Appropriate Test Level:	TL-2	Barrier Test Level:	TL-3	Is Barrier Crashworthy?:	YES
Beg. End Trtmt Type:	OTHER: CONCRETE WITH	Is Beg. End Trtmt Crashworthy?:	NO	Approach Transition Type:	NONE
Ending End Trtmt Type:	NONE	Ending End Trtmt Crashworthy?:	N/A		
Average Measurements					
Design Height (In.):	27	Width (In.):	26.0	Post Spacing (In.):	0.0
Height (In.):	28.0	Lateral Offset (In.):	79.6	Road Grade (%):	1.80
Physical Condition					
Barrier	Alignment and Height:	No deflections observed in alignment. Entire barrier exceeds 27 in design height by up to 2 in.

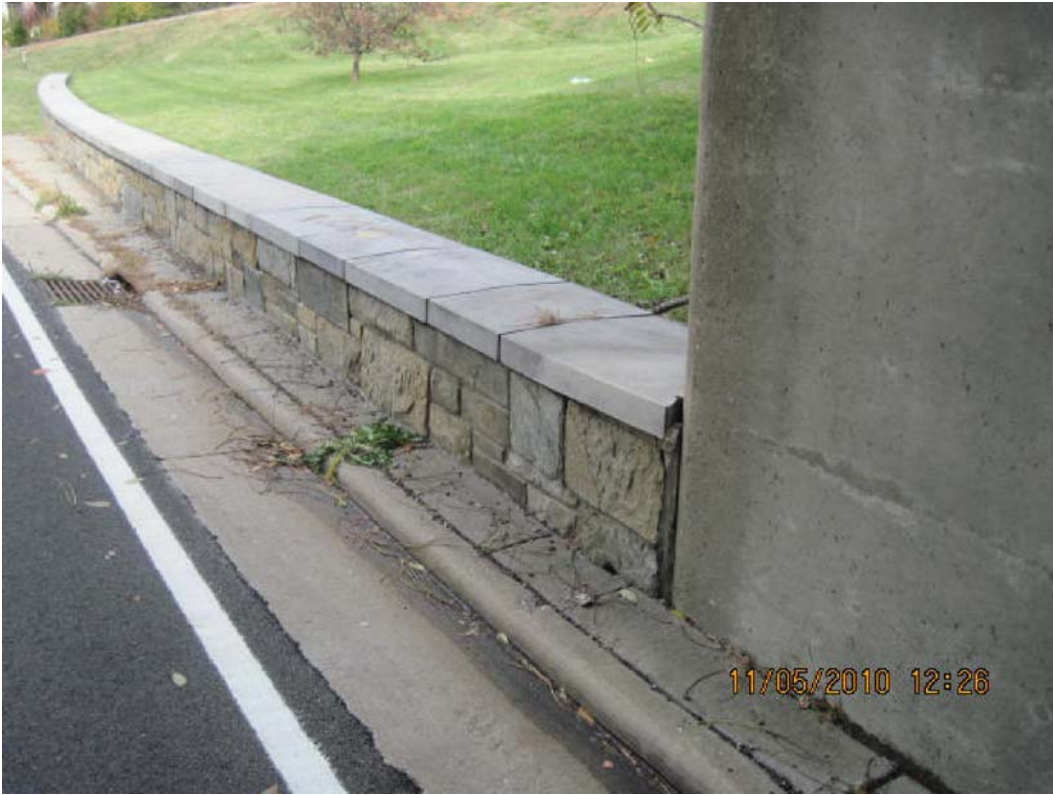
SUIT_0002_4.336_R_1.jpg

Barrier ID:	SUIT-0002-4.336-R				
Route Name:	WESTBOUND SUITLAND PARKWAY				
Inspection Date:	05/11/2010	Barrier Rating:	32.90		
Barrier Description					
Type:	CONCRETE WITH SIMULATED STONE FACE	Barrier Function:	TRAFFIC		
Barrier Material:	CONCRETE	Post Material:	N/A		
Blockout Type:	N/A	Length (ft.):	131		
Speed Limit (MPH):	45	Placement with Respect to Road:	TANGENT		
Hazard Behind Barrier:	LOW				
Barrier Crashworthiness					
Appropriate Test Level:	TL-2	Barrier Test Level:	TL-3	Is Barrier Crashworthy?:	YES
Beg. End Trtmt Type:	NONE	Is Beg. End Trtmt Crashworthy?:	N/A	Approach Transition Type:	NONE
Ending End Trtmt Type:	OTHER: STONE WITH CONCRETE	Ending End Trtmt Crashworthy?:	NO		
Average Measurements					
Design Height (In.):	27	Width (In.):	26.0	Post Spacing (In.):	0.0
Height (In.):	25.2	Lateral Offset (In.):	92.6	Road Grade (%):	1.70
Physical Condition					
Barrier	Alignment and Height:	No deflections were observed in the alignment. The barrier height was within 3 in below the 27 in design height for the entire length.

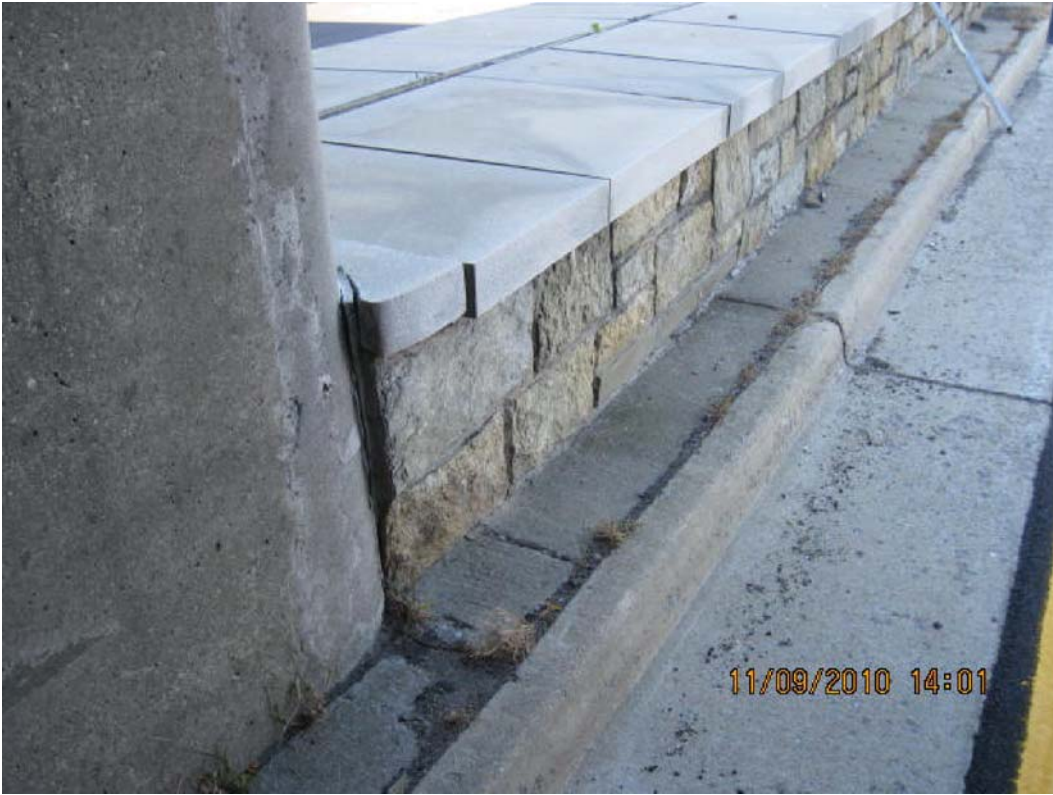
SUIT_0002_4.338_L_1.jpg

Barrier ID:	SUIT-0002-4.338-L				
Route Name:	WESTBOUND SUITLAND PARKWAY				
Inspection Date:	09/11/2010	Barrier Rating:	37.40		
Barrier Description					
Type:	CONCRETE WITH SIMULATED STONE FACE	Barrier Function:	TRAFFIC		
Barrier Material:	CONCRETE	Post Material:	N/A		
Blockout Type:	N/A	Length (ft.):	341		
Speed Limit (MPH):	50	Placement with Respect to Road:	TANGENT		
Hazard Behind Barrier:	EXTREME				
Barrier Crashworthiness					
Appropriate Test Level:	TL-3	Barrier Test Level:	TL-3	Is Barrier Crashworthy?:	YES
Beg. End Trtmt Type:	NONE	Is Beg. End Trtmt Crashworthy?:	N/A	Approach Transition Type:	NONE
Ending End Trtmt Type:	OTHER: STONE WITH CONCRETE	Ending End Trtmt Crashworthy?:	NO		
Average Measurements					
Design Height (In.):	27	Width (In.):	32.2	Post Spacing (In.):	0.0
Height (In.):	33.0	Lateral Offset (In.):	60.7	Road Grade (%):	1.60
Physical Condition					
Barrier	Alignment and Height:	Alignment deflection was less than 6 in. The entire barrier exceeded design height (27 in) by 5 to 7 in.

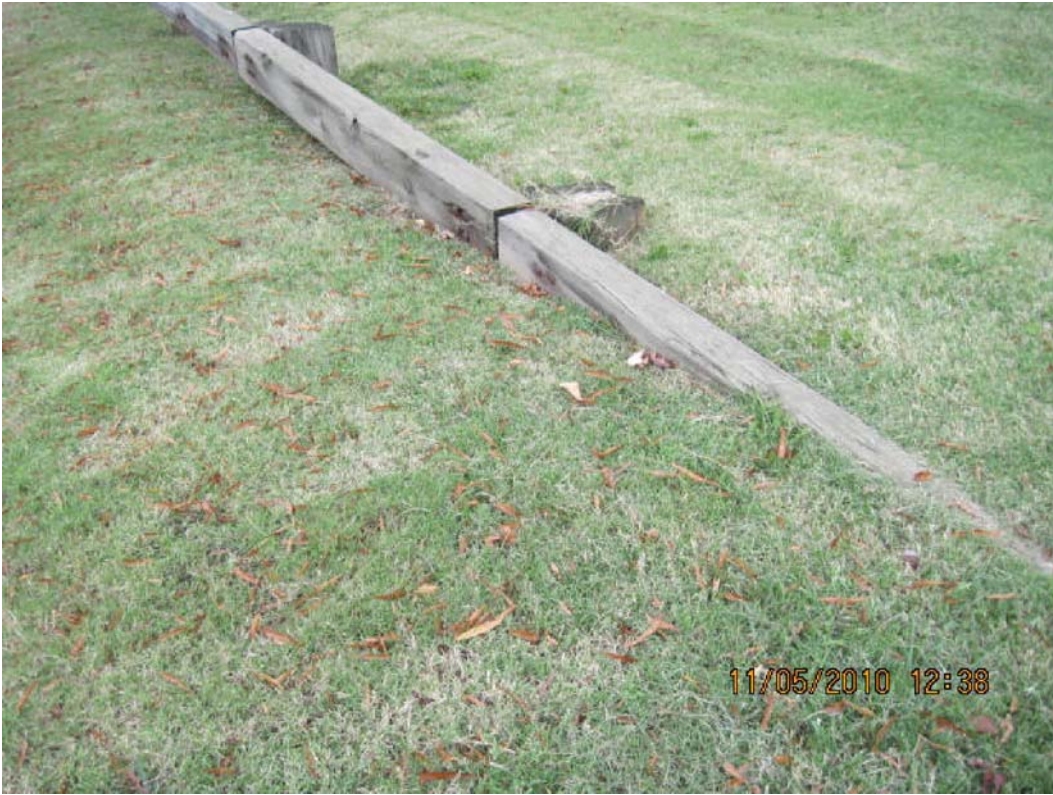
SUIT_0002_4.421_R_1.jpg

Barrier ID:	SUIT-0002-4.421-R				
Route Name:	WESTBOUND SUITLAND PARKWAY				
Inspection Date:	05/11/2010	Barrier Rating:	37.00		
Barrier Description					
Type:	STEEL-BACKED TIMBER WITH BLOCKOUT	Barrier Function:	TRAFFIC		
Barrier Material:	STEEL-BACKED TIMBER/LOG	Post Material:	WOOD		
Blockout Type:	WOOD	Length (ft.):	138		
Speed Limit (MPH):	45	Placement with Respect to Road:	OUTSIDE OF CURVE		
Hazard Behind Barrier:	LOW				
Barrier Crashworthiness					
Appropriate Test Level:	TL-2	Barrier Test Level:	TL-3	Is Barrier Crashworthy?:	YES
Beg. End Trtmt Type:	SBT/LOG FLARED	Is Beg. End Trtmt Crashworthy?:	NO	Approach Transition Type:	NONE
Ending End Trtmt Type:	SBT/LOG FLARED	Ending End Trtmt Crashworthy?:	NO		
Average Measurements					
Design Height (In.):	27	Width (In.):	0.0	Post Spacing (In.):	119.8
Height (In.):	26.7	Lateral Offset (In.):	85.0	Road Grade (%):	1.80
Physical Condition					
Barrier	Alignment and Height:	Alignment deflection was less than 6 in. 25 ft of the barrier was between 1 in and 3 in below design height (27 in).

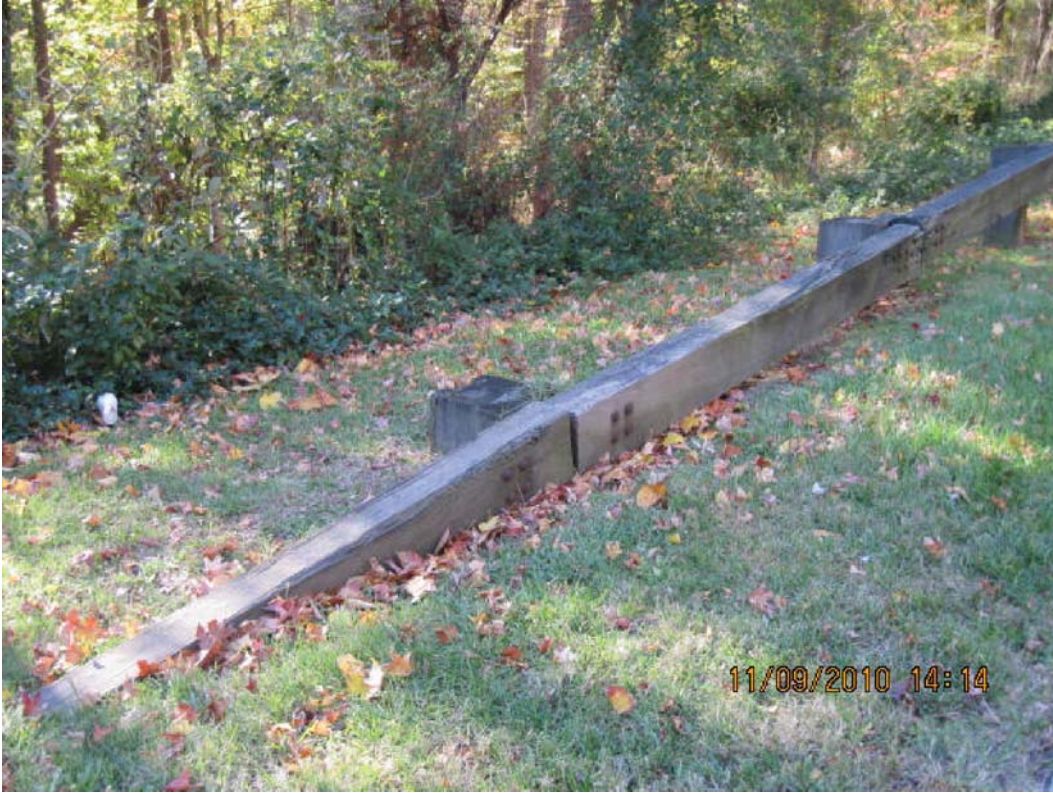
SUIT_0002_4.970_L_1.jpg

Barrier ID:	SUIT-0002-4.970-L				
Route Name:	WESTBOUND SUITLAND PARKWAY				
Inspection Date:	09/11/2010	Barrier Rating:	39.50		
Barrier Description					
Type:	STEEL-BACKED TIMBER WITH BLOCKOUT	Barrier Function:	TRAFFIC		
Barrier Material:	STEEL-BACKED TIMBER/LOG	Post Material:	WOOD		
Blockout Type:	WOOD	Length (ft.):	243		
Speed Limit (MPH):	50	Placement with Respect to Road:	OUTSIDE OF CURVE		
Hazard Behind Barrier:	MEDIUM				
Barrier Crashworthiness					
Appropriate Test Level:	TL-3	Barrier Test Level:	TL-3	Is Barrier Crashworthy?:	YES
Beg. End Trtmt Type:	SBT/LOG FLARED	Is Beg. End Trtmt Crashworthy?:	NO	Approach Transition Type:	NONE
Ending End Trtmt Type:	SBT/LOG FLARED	Ending End Trtmt Crashworthy?:	NO		
Average Measurements					
Design Height (In.):	27	Width (In.):	0.0	Post Spacing (In.):	120.1
Height (In.):	28.0	Lateral Offset (In.):	82.1	Road Grade (%):	1.50
Physical Condition					
Barrier	Alignment and Height:	No deflections observed in alignment. Entire barrier meets or exceeds 27 in design height by up to 2.5 in.

Breaking and Cracking:	No impact related breaking or cracking observed. 20 ft of rail is showing signs of a surface impact that should be monitored.			
	Missing Elements:	No elements were observed to be missing.			
	Corrosion and Weathering:	No loss of cross section or erosion around posts observed.			
End Treatments	Alignment and Height:	Alignment acceptable. Height within 1-in of 27-in design height.			
	Breaking and Cracking:	No impact related breaking or cracking observed.			
	Missing Elements:	No elements were observed to be missing.			
	Corrosion and Weathering:	No loss of cross section or erosion around posts observed.

Repair Action:	MONITOR	FMSS Work Type:	N/A	Repair Cost:	\$0
Brief Workorder:	Monitor 20 ft of rail with signs of surface impact.				
Workorder:

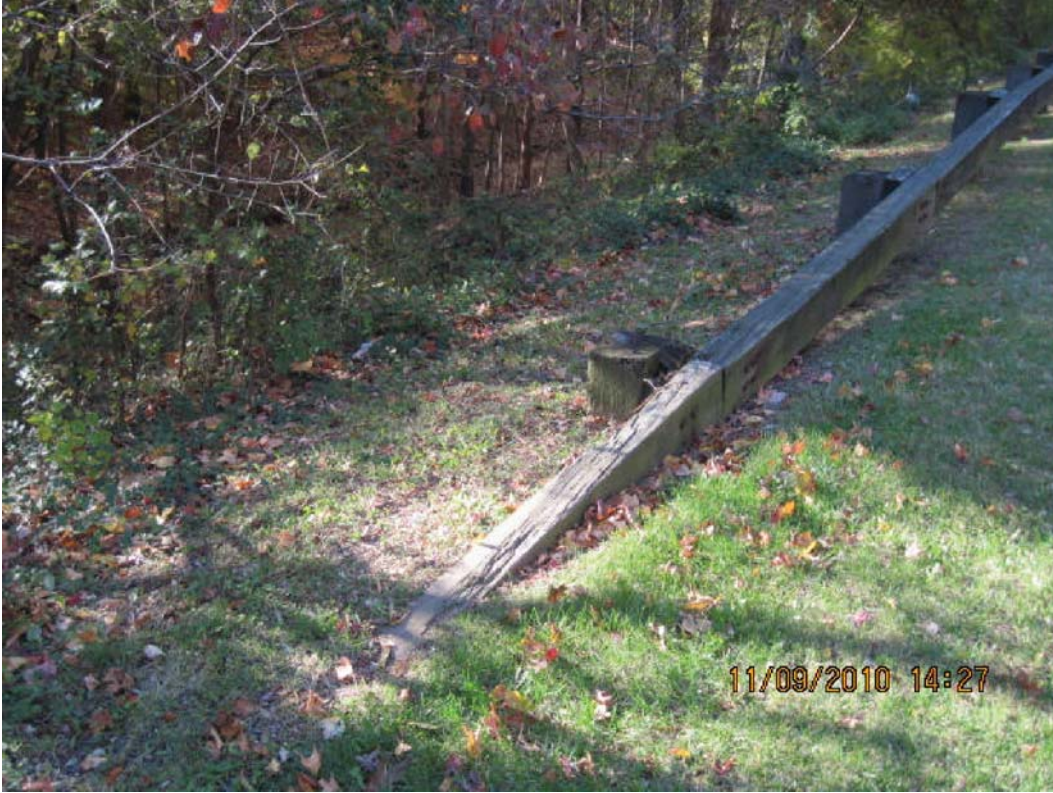
SUIT_0002_5.175_L_1.jpg

Barrier ID:	SUIT-0002-5.175-L				
Route Name:	WESTBOUND SUITLAND PARKWAY				
Inspection Date:	09/11/2010	Barrier Rating:	33.90		
Barrier Description					
Type:	STEEL-BACKED TIMBER WITH BLOCKOUT	Barrier Function:	TRAFFIC		
Barrier Material:	STEEL-BACKED TIMBER/LOG	Post Material:	WOOD		
Blockout Type:	WOOD	Length (ft.):	195		
Speed Limit (MPH):	50	Placement with Respect to Road:	INSIDE OF CURVE		
Hazard Behind Barrier:	MEDIUM				
Barrier Crashworthiness					
Appropriate Test Level:	TL-3	Barrier Test Level:	TL-3	Is Barrier Crashworthy?:	YES
Beg. End Trtmt Type:	SBT/LOG FLARED	Is Beg. End Trtmt Crashworthy?:	NO	Approach Transition Type:	NONE
Ending End Trtmt Type:	SBT/LOG FLARED	Ending End Trtmt Crashworthy?:	NO		
Average Measurements					
Design Height (In.):	27	Width (In.):	0.0	Post Spacing (In.):	119.6
Height (In.):	30.0	Lateral Offset (In.):	78.6	Road Grade (%):	1.60
Physical Condition					
Barrier	Alignment and Height:	No deflections greater than 6 in were observed in the alignment. The barrier height was greater than the 27 in design height for the entire length by 1 to 4 in.

Breaking and Cracking:	2 blocks were broken.			
	Missing Elements:	No elements were observed to be missing.			
	Corrosion and Weathering:	Less than 5 percent of the cross section has been lost due to weathering and no erosion was observed.			
End Treatments	Alignment and Height:	Alignment acceptable. Height within 1-in of 27-in design height.			
	Breaking and Cracking:	1 block was broken on the beginning end.			
	Missing Elements:	No elements were observed to be missing.			
	Corrosion and Weathering:	Less than 5 percent of the cross section has been lost due to weathering.

Repair Action:	REPAIR	FMSS Work Type:	DEFERRED MAINTENANCE	Repair Cost:	\$2684
Brief Workorder:	Replace 3 blocks.				
Workorder:	Replace Block at \$30- per -Each for 3 Block(s) = \$90. Replace 3 broken blocks. High Speed Traffic Control at \$2350- per -Day for 1 Day(s) = \$2350.

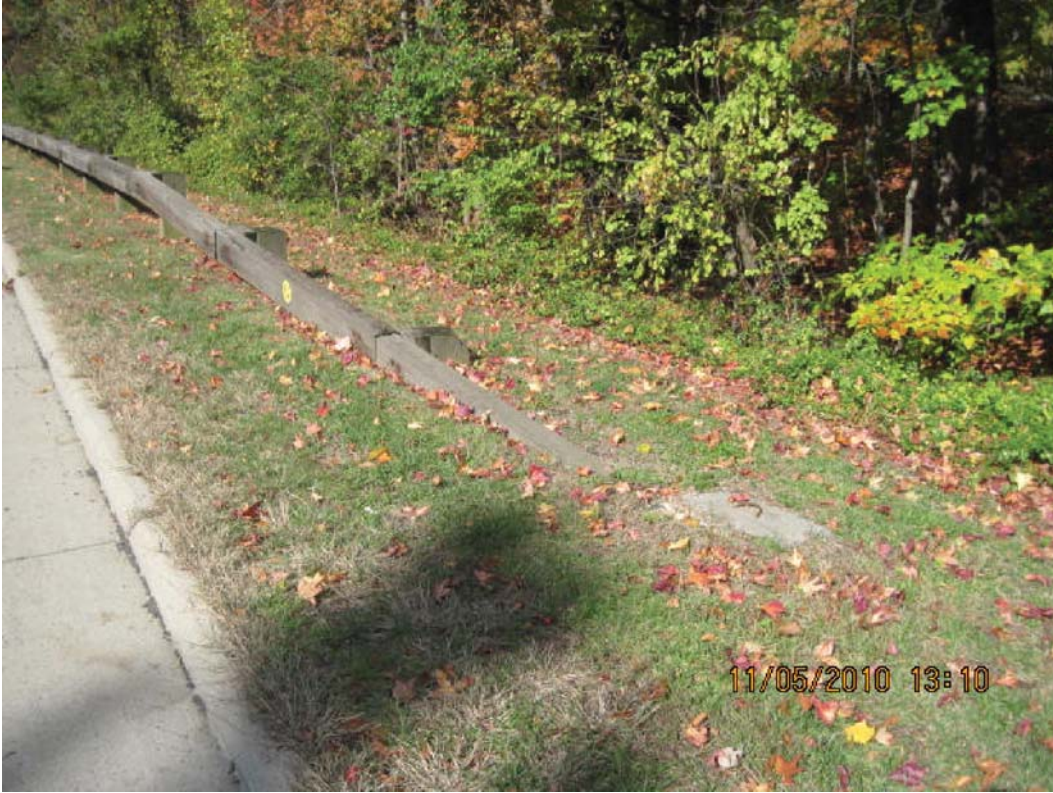
SUIT_0002_5.209_R_1.jpg

Barrier ID:	SUIT-0002-5.209-R				
Route Name:	WESTBOUND SUITLAND PARKWAY				
Inspection Date:	05/11/2010	Barrier Rating:	39.50		
Barrier Description					
Type:	STEEL-BACKED TIMBER WITH BLOCKOUT	Barrier Function:	TRAFFIC		
Barrier Material:	STEEL-BACKED TIMBER/LOG	Post Material:	WOOD		
Blockout Type:	WOOD	Length (ft.):	144		
Speed Limit (MPH):	50	Placement with Respect to Road:	OUTSIDE OF CURVE		
Hazard Behind Barrier:	MEDIUM				
Barrier Crashworthiness					
Appropriate Test Level:	TL-3	Barrier Test Level:	TL-3	Is Barrier Crashworthy?:	YES
Beg. End Trtmt Type:	SBT/LOG FLARED	Is Beg. End Trtmt Crashworthy?:	NO	Approach Transition Type:	NONE
Ending End Trtmt Type:	SBT/LOG FLARED	Ending End Trtmt Crashworthy?:	NO		
Average Measurements					
Design Height (In.):	27	Width (In.):	0.0	Post Spacing (In.):	119.6
Height (In.):	28.2	Lateral Offset (In.):	84.0	Road Grade (%):	1.60
Physical Condition					
Barrier	Alignment and Height:	No deflections greater than 6 in were observed in the alignment. The barrier height was greater than the 27 in design height for the entire length by 1 to 2 in.

Breaking and Cracking:	No impact related breaking or cracking was observed.			
	Missing Elements:	No elements were observed to be missing.			
	Corrosion and Weathering:	Minor splintering was observed along the entire length of the barrier but less than 5 percent of the cross section has been lost. The barrier should be monitored for further weathering. No erosion was observed.			
End Treatments	Alignment and Height:	Alignment acceptable. Height within 1-in of 27-in design height.			
	Breaking and Cracking:	No impact related breaking or cracking was observed.			
	Missing Elements:	No elements were observed to be missing.			
	Corrosion and Weathering:	Minor splintering was observed and should be monitored.

Repair Action:	MONITOR	FMSS Work Type:	N/A	Repair Cost:	\$0
Brief Workorder:	Monitor for further weathering.				
Workorder:

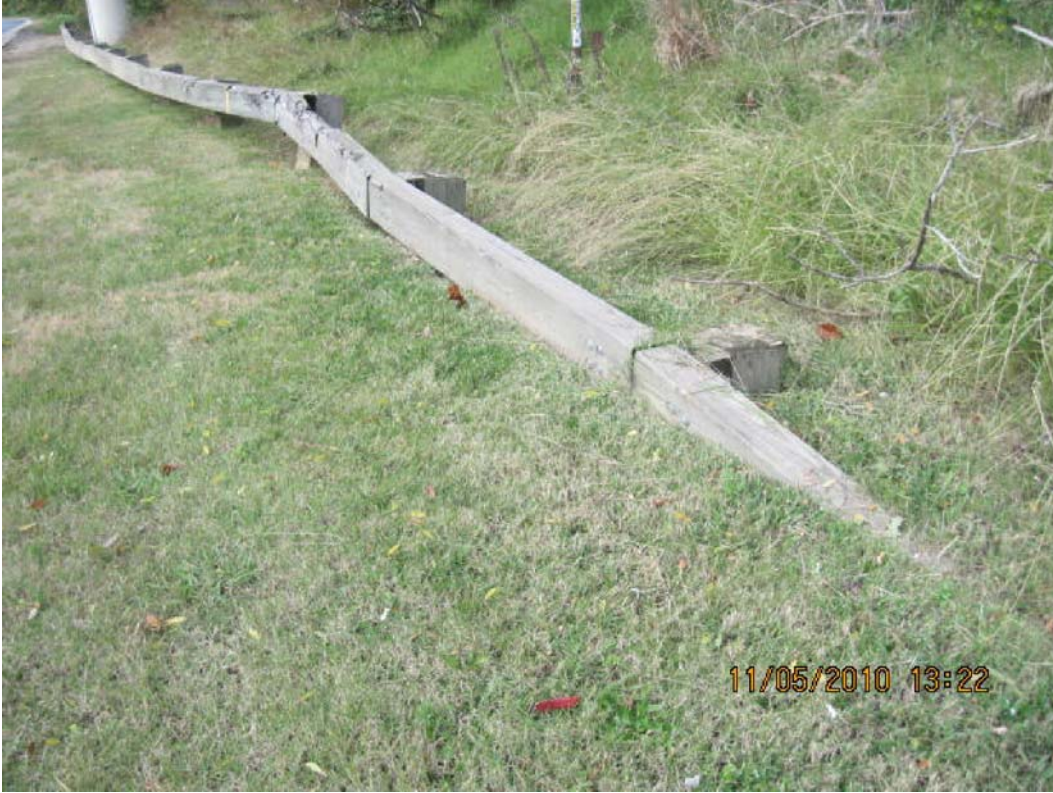
SUIT_0002_5.486_R_1.jpg

Barrier ID:	SUIT-0002-5.486-R				
Route Name:	WESTBOUND SUITLAND PARKWAY				
Inspection Date:	05/11/2010	Barrier Rating:	54.40		
Barrier Description					
Type:	STEEL-BACKED TIMBER WITH BLOCKOUT	Barrier Function:	TRAFFIC		
Barrier Material:	STEEL-BACKED TIMBER/LOG	Post Material:	WOOD		
Blockout Type:	WOOD	Length (ft.):	167		
Speed Limit (MPH):	50	Placement with Respect to Road:	OUTSIDE OF CURVE		
Hazard Behind Barrier:	LOW				
Barrier Crashworthiness					
Appropriate Test Level:	TL-3	Barrier Test Level:	TL-3	Is Barrier Crashworthy?:	YES
Beg. End Trtmt Type:	SBT/LOG FLARED	Is Beg. End Trtmt Crashworthy?:	NO	Approach Transition Type:	NONE
Ending End Trtmt Type:	SBT/LOG FLARED	Ending End Trtmt Crashworthy?:	NO		
Average Measurements					
Design Height (In.):	27	Width (In.):	0.0	Post Spacing (In.):	120.5
Height (In.):	20.5	Lateral Offset (In.):	136.3	Road Grade (%):	0.50
Physical Condition					
Barrier	Alignment and Height:	Alignment deflection was less than 6 in. The entire barrier was 5 - 9 in below design height (27 in).

Breaking and Cracking:	1 post had cracking.			
	Missing Elements:	No elements appeared to be missing.			
	Corrosion and Weathering:	No cross section loss or erosion observed.			
End Treatments	Alignment and Height:	30 ft of barrier alignment was deflected greater than 12 in height within 1in of 27in design height.			
	Breaking and Cracking:	20 ft of rail had impact related cracking.			
	Missing Elements:	No elements appeared to be missing.			
	Corrosion and Weathering:	No cross section loss or erosion observed.

Repair Action:	REPAIR	FMSS Work Type:	DEFERRED MAINTENANCE	Repair Cost:	\$4752
Brief Workorder:	Raise 137 ft of barrier to the 27 inch design height. Replace 20 ft of rail and 1 post.				
Workorder:	Adjust Guardrail at \$10- per -Lin. Ft. for 137 LF = \$1370. Raise 137 ft of barrier to 27 inch design height. Replace Rail at \$25- per -Lin. Ft. for 20 LF = \$500. Replace 20 ft of rail due to impact related cracking Replace Post at \$100- per -Each for 1 Post(s) = \$100. Replace 1 post due to cracking High Speed Traffic Control at \$2350- per -Day for 1 Day(s) = \$2350.

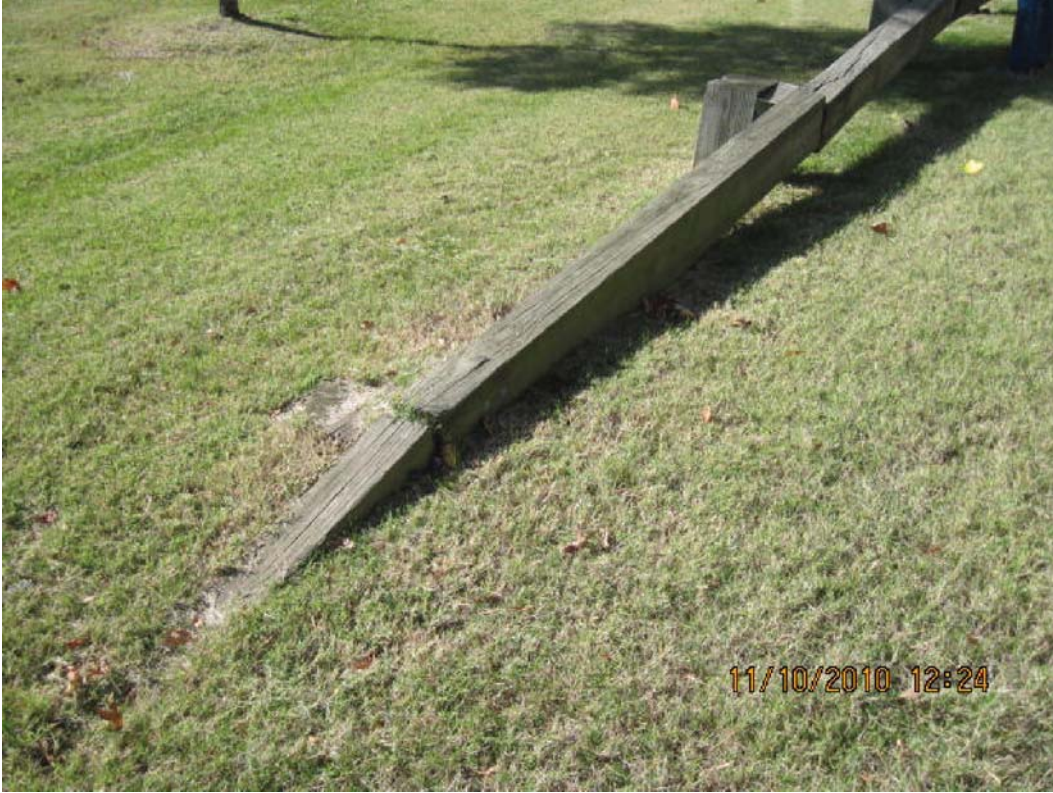
SUIT_0002_5.516_L_1.jpg

Barrier ID:	SUIT-0002-5.516-L				
Route Name:	WESTBOUND SUITLAND PARKWAY				
Inspection Date:	10/11/2010	Barrier Rating:	44.50		
Barrier Description					
Type:	STEEL-BACKED TIMBER WITH BLOCKOUT	Barrier Function:	TRAFFIC		
Barrier Material:	STEEL-BACKED TIMBER/LOG	Post Material:	WOOD		
Blockout Type:	WOOD	Length (ft.):	166		
Speed Limit (MPH):	50	Placement with Respect to Road:	INSIDE OF CURVE		
Hazard Behind Barrier:	HIGH				
Barrier Crashworthiness					
Appropriate Test Level:	TL-3	Barrier Test Level:	TL-3	Is Barrier Crashworthy?:	YES
Beg. End Trtmt Type:	SBT/LOG FLARED	Is Beg. End Trtmt Crashworthy?:	NO	Approach Transition Type:	NONE
Ending End Trtmt Type:	SBT/LOG FLARED	Ending End Trtmt Crashworthy?:	NO		
Average Measurements					
Design Height (In.):	27	Width (In.):	0.0	Post Spacing (In.):	120.6
Height (In.):	24.7	Lateral Offset (In.):	98.5	Road Grade (%):	0.40
Physical Condition					
Barrier	Alignment and Height:	20 ft section was impacted and had a 2 ft deflection. 65 ft of the barrier was 1 to 3 in below design height (27 in). 20 ft of the barrier was more than 3 in below design height (27 in).

Breaking and Cracking:	20 ft of rail 2 posts and 3 blocks had cracking/breaking due to impacts.			
	Missing Elements:	No elements appeared to be missing.			
	Corrosion and Weathering:	No loss of cross section observed. Monitor erosion at base of posts under bridge.			
End Treatments	Alignment and Height:	Alignment acceptable. Height within 1-in of 27-in design height.			
	Breaking and Cracking:	No impact related breaking/cracking observed.			
	Missing Elements:	No elements appeared to be missing.			
	Corrosion and Weathering:	No loss of cross section or erosion observed.

Repair Action:	REPAIR	FMSS Work Type:	DEFERRED MAINTENANCE	Repair Cost:	\$4389
Brief Workorder:	Raise 65-ft of guardrail up to 27-in design height realign 20-ft of guardrail replace 20-ft of rail 2 posts and 3 blocks.				
Workorder:	Adjust Guardrail at \$10- per -Lin. Ft. for 85 LF = \$850. Adjust 65 ft + 20 ft of barrier to 27- in design height. Replace Post at \$100- per -Each for 2 Post(s) = \$200. Replace 2 post due to impacts Replace Block at \$30- per -Each for 3 Block(s) = \$90. Replace 3 blocks due to impacts Replace Rail at \$25- per -Lin. Ft. for 20 LF = \$500. Replace 20 ft of rail due to impacts High Speed Traffic Control at \$2350- per -Day for 1 Day(s) = \$2350.

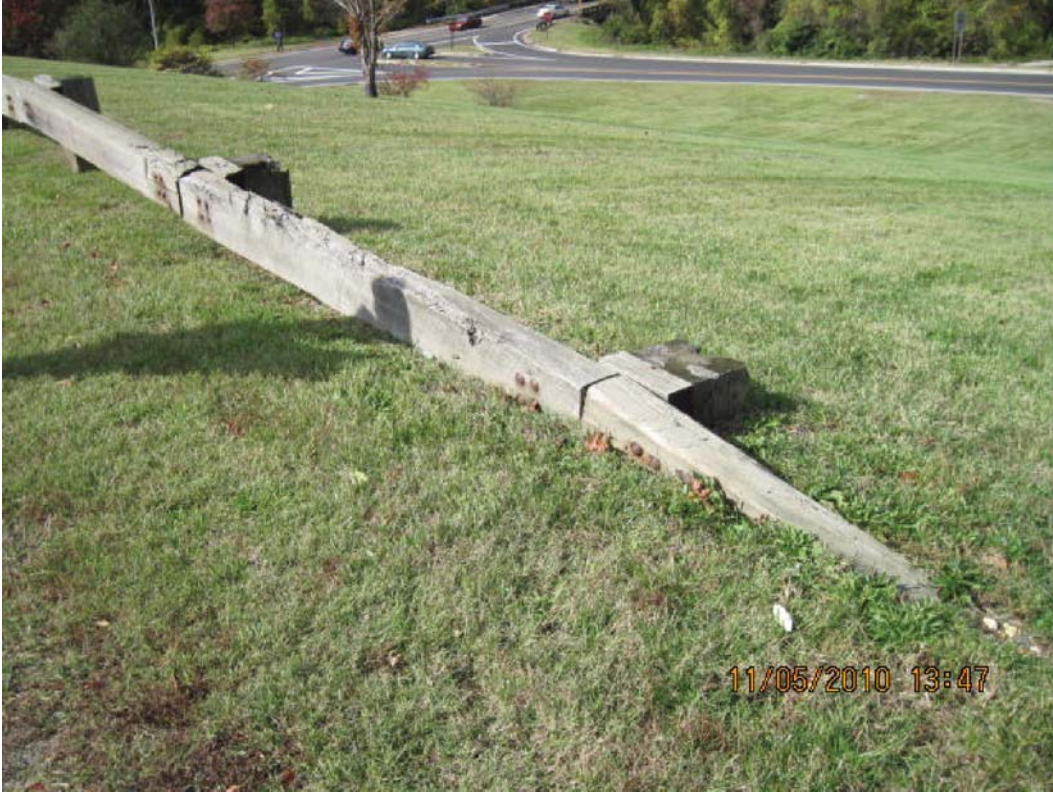
SUIT_0002_5.798_R_1.jpg

Barrier ID:	SUIT-0002-5.798-R				
Route Name:	WESTBOUND SUITLAND PARKWAY				
Inspection Date:	05/11/2010	Barrier Rating:	31.00		
Barrier Description					
Type:	STEEL-BACKED TIMBER WITH BLOCKOUT	Barrier Function:	TRAFFIC		
Barrier Material:	STEEL-BACKED TIMBER/LOG	Post Material:	WOOD		
Blockout Type:	WOOD	Length (ft.):	174		
Speed Limit (MPH):	45	Placement with Respect to Road:	TANGENT		
Hazard Behind Barrier:	MEDIUM				
Barrier Crashworthiness					
Appropriate Test Level:	TL-2	Barrier Test Level:	TL-3	Is Barrier Crashworthy?:	YES
Beg. End Trtmt Type:	SBT/LOG FLARED	Is Beg. End Trtmt Crashworthy?:	NO	Approach Transition Type:	CONC/MASON SBT
Ending End Trtmt Type:	NONE	Ending End Trtmt Crashworthy?:	N/A		
Average Measurements					
Design Height (In.):	27	Width (In.):	0.0	Post Spacing (In.):	120.3
Height (In.):	26.2	Lateral Offset (In.):	91.3	Road Grade (%):	1.50
Physical Condition					
Barrier	Alignment and Height:	No deflections were observed in alignment. Entire barrier is 1 in or less below or meets 27 in design height.

Breaking and Cracking:	No impact related breaking or cracking observed.			
	Missing Elements:	No elements were observed to be missing.			
	Corrosion and Weathering:	No loss of cross section or erosion around posts observed.			
End Treatments	Alignment and Height:	Alignment acceptable. Height within 1-in of 27-in design height.			
	Breaking and Cracking:	No impact related breaking or cracking observed.			
	Missing Elements:	No elements were observed to be missing.			
	Corrosion and Weathering:	10 ft of rail had more than 50% loss of cross section.

Repair Action:	REPAIR	FMSS Work Type:	DEFERRED MAINTENANCE	Repair Cost:	\$2173
Brief Workorder:	Replace 20-ft of rail.				
Workorder:	Replace Rail at \$25- per -Lin. Ft. for 20 LF = \$500. Replace 20 ft of rail. Low Speed Traffic Control at \$1475- per -Day for 1 Day(s) = \$1475.

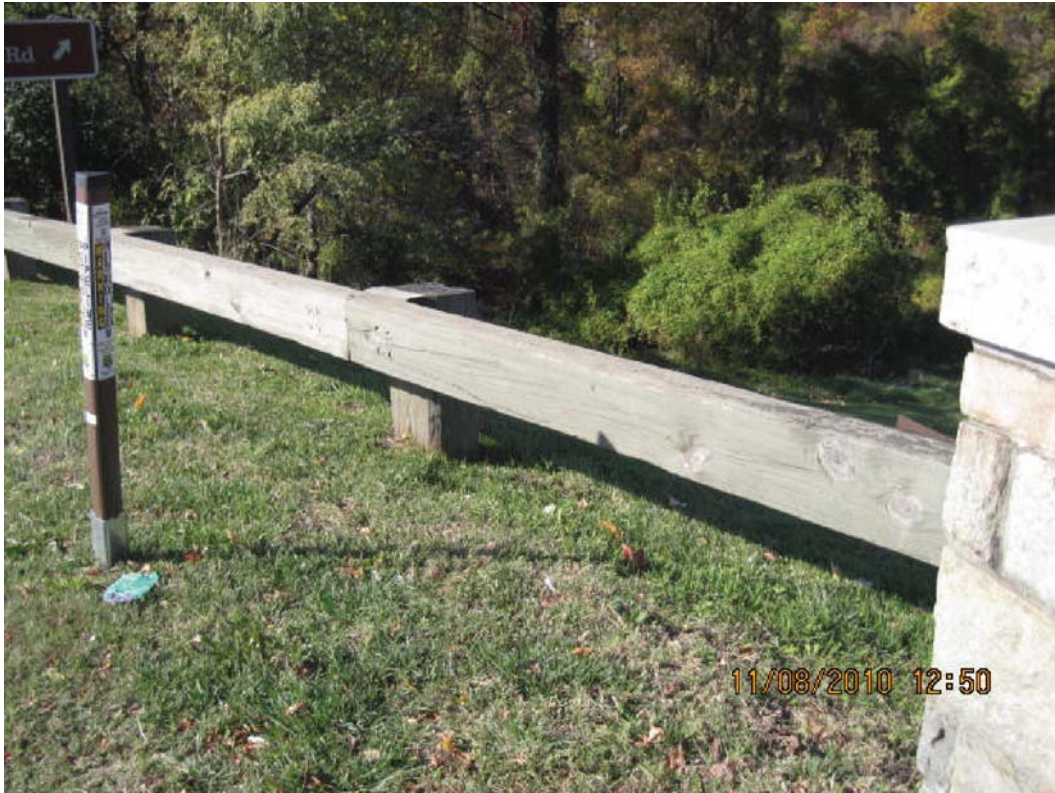
SUIT_0002_5.864_R_1.jpg

Barrier ID:	SUIT-0002-5.864-R				
Route Name:	WESTBOUND SUITLAND PARKWAY				
Inspection Date:	08/11/2010	Barrier Rating:	49.70		
Barrier Description					
Type:	STEEL-BACKED TIMBER WITH BLOCKOUT	Barrier Function:	TRAFFIC		
Barrier Material:	STEEL-BACKED TIMBER/LOG	Post Material:	WOOD		
Blockout Type:	WOOD	Length (ft.):	883		
Speed Limit (MPH):	45	Placement with Respect to Road:	OUTSIDE OF CURVE		
Hazard Behind Barrier:	MEDIUM				
Barrier Crashworthiness					
Appropriate Test Level:	TL-2	Barrier Test Level:	TL-3	Is Barrier Crashworthy?:	YES
Beg. End Trtmt Type:	NONE	Is Beg. End Trtmt Crashworthy?:	N/A	Approach Transition Type:	NONE
Ending End Trtmt Type:	NONE	Ending End Trtmt Crashworthy?:	N/A		
Average Measurements					
Design Height (In.):	27	Width (In.):	0.0	Post Spacing (In.):	120.3
Height (In.):	26.2	Lateral Offset (In.):	136.8	Road Grade (%):	2.60
Physical Condition					
Barrier	Alignment and Height:	No deflections observed in alignment. 180 ft of the barrier is 1 to 3 in below 27 in design height. 703 ft of barrier is 1 in or less below or meets 27 in design height.

Breaking and Cracking:	2 posts 6 blocks and 70 ft of rail was broken and/or bent due to impact loading.			
	Missing Elements:	No elements were observed to be missing.			
	Corrosion and Weathering:	2 posts and 10 ft of rail were cracked and rotted causing more than 50% loss of cross section. No erosion around posts observed.			
End Treatments	Alignment and Height:				
	Breaking and Cracking:				
	Missing Elements:				
	Corrosion and Weathering:

Repair Action:	REPAIR	FMSS Work Type:	DEFERRED MAINTENANCE	Repair Cost:	\$8063
Brief Workorder:	Raise 180-ft of guardrail up to 27-in design height replace 80-ft of rail 6 blocks and 4 posts.				
Workorder:	Replace Rail at \$25- per -Lin. Ft. for 80 LF = \$2000. Replace 80 ft of rail Replace Block at \$30- per -Each for 6 Block(s) = \$180. Replace 6 blocks. Replace Post at \$100- per -Each for 4 Post(s) = \$400. Replace 4 posts. Adjust Guardrail at \$10- per -Lin. Ft. for 180 LF = \$1800. Raise 180 ft of guardrail to 27 inch design height. Low Speed Traffic Control at \$1475- per -Day for 2 Day(s) = \$2950.

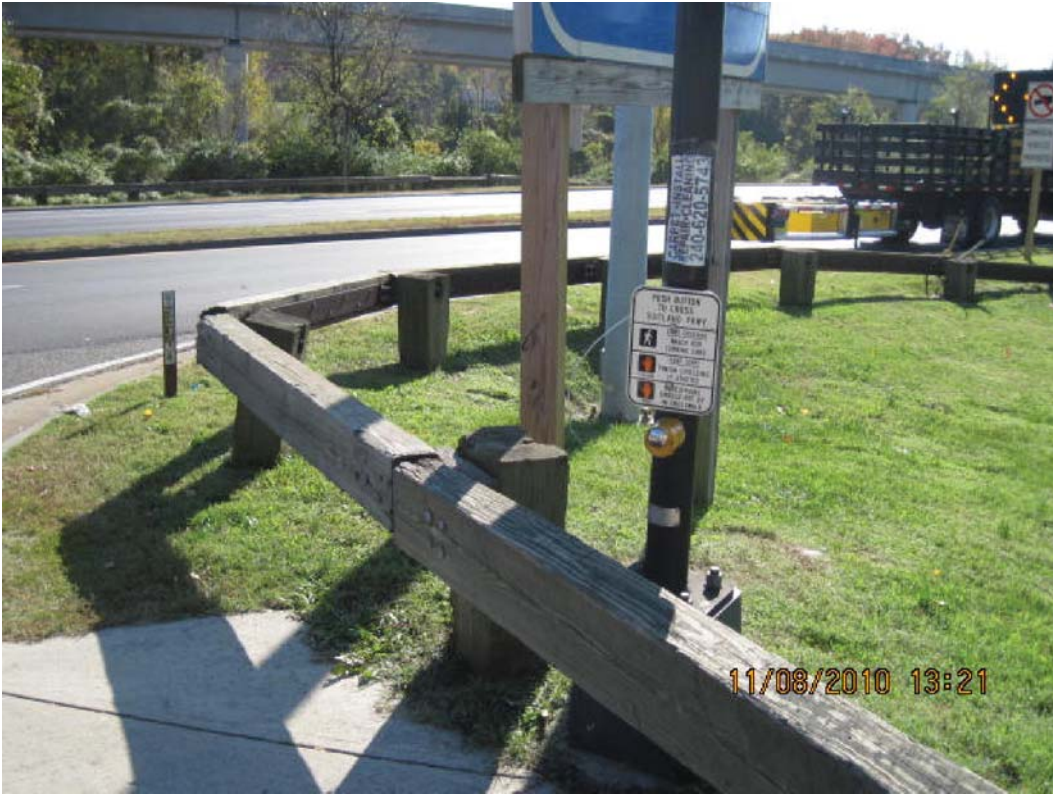
SUIT_0002_6.035_R_1.jpg

Barrier ID:	SUIT-0002-6.035-R				
Route Name:	WESTBOUND SUITLAND PARKWAY				
Inspection Date:	08/11/2010	Barrier Rating:	32.70		
Barrier Description					
Type:	STEEL-BACKED TIMBER WITH BLOCKOUT	Barrier Function:	TRAFFIC		
Barrier Material:	STEEL-BACKED TIMBER/LOG	Post Material:	WOOD		
Blockout Type:	WOOD	Length (ft.):	65		
Speed Limit (MPH):	45	Placement with Respect to Road:	TANGENT		
Hazard Behind Barrier:	LOW				
Barrier Crashworthiness					
Appropriate Test Level:	TL-2	Barrier Test Level:	TL-3	Is Barrier Crashworthy?:	YES
Beg. End Trtmt Type:	NONE	Is Beg. End Trtmt Crashworthy?:	N/A	Approach Transition Type:	NONE
Ending End Trtmt Type:	SBT/LOG FLARED	Ending End Trtmt Crashworthy?:	NO		
Average Measurements					
Design Height (In.):	27	Width (In.):	0.0	Post Spacing (In.):	108.5
Height (In.):	27.5	Lateral Offset (In.):	81.0	Road Grade (%):	3.40
Physical Condition					
Barrier	Alignment and Height:	No deflections greater than 6 in were observed in the alignment. The height was within 3 in greater than the 27 in design height for 15 ft and between 1 in and 3 in below the design height for 15 ft.

Breaking and Cracking:	No impact related breaking or cracking was observed.			
	Missing Elements:	7 sets of nuts and washers were missing.			
	Corrosion and Weathering:	20 ft of rail and 2 blocks were cracked and broken due to weathering. No erosion was observed.			
End Treatments	Alignment and Height:	Alignment acceptable. Height within 1-in of 27-in design height.			
	Breaking and Cracking:	No impact related breaking or cracking was observed.			
	Missing Elements:	No elements were observed to be missing.			
	Corrosion and Weathering:	Less than 5 percent of the cross section has been lost due to weathering.

Repair Action:	REPAIR	FMSS Work Type:	DEFERRED MAINTENANCE	Repair Cost:	\$2536
Brief Workorder:	Raise 15-ft of barrier up to the 27-in design height replace 20-ft of rail 2 blocks and 7 nuts/washers.				
Workorder:	Adjust Guardrail at \$10- per -Lin. Ft. for 15 LF = \$150. Raise 15 feet of guardrail to the design height of 27 inches. Replace Rail at \$25- per -Lin. Ft. for 20 LF = \$500. Replace 20 ft of rail. Replace Block at \$30- per -Each for 2 Block(s) = \$60. Replace 2 blocks. Labor at \$60- per -Hour for 2 Hrs = \$120. Replace 7 washers and nuts. Low Speed Traffic Control at \$1475- per -Day for 1 Day(s) = \$1475.

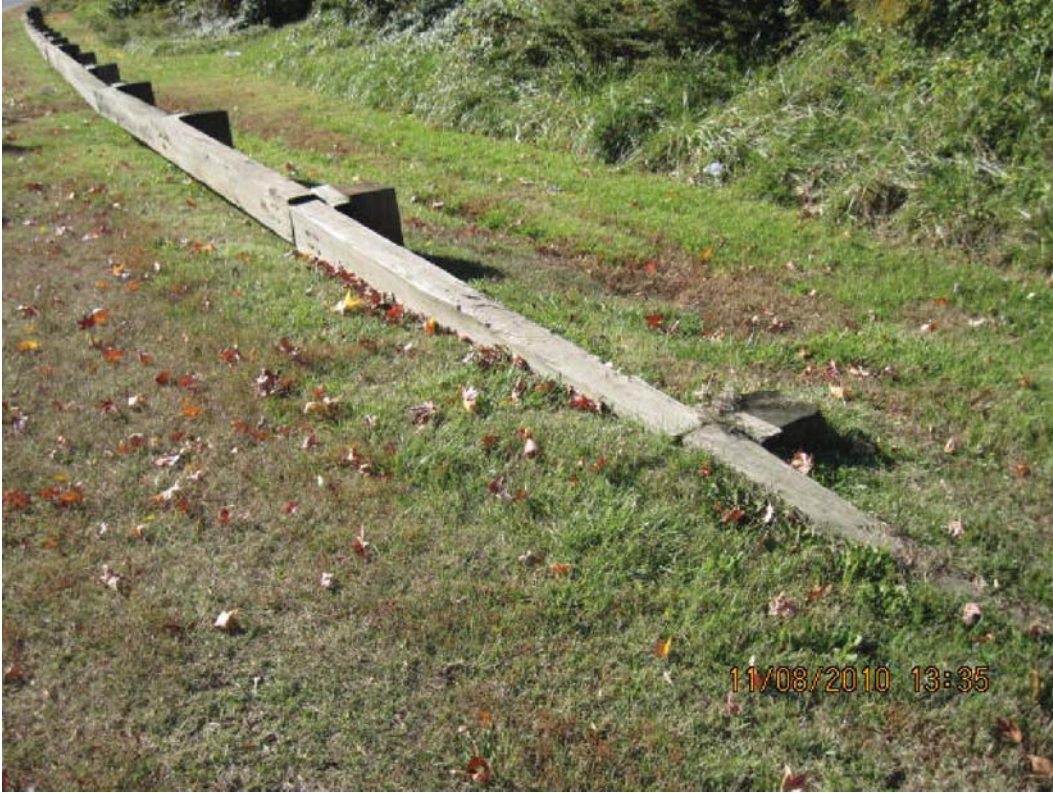
SUIT_0002_6.208_R_1.jpg

Barrier ID:	SUIT-0002-6.208-R				
Route Name:	WESTBOUND SUITLAND PARKWAY				
Inspection Date:	08/11/2010	Barrier Rating:	42.70		
Barrier Description					
Type:	STEEL-BACKED TIMBER WITH BLOCKOUT	Barrier Function:	TRAFFIC		
Barrier Material:	STEEL-BACKED TIMBER/LOG	Post Material:	WOOD		
Blockout Type:	WOOD	Length (ft.):	240		
Speed Limit (MPH):	45	Placement with Respect to Road:	INSIDE OF CURVE		
Hazard Behind Barrier:	MEDIUM				
Barrier Crashworthiness					
Appropriate Test Level:	TL-2	Barrier Test Level:	TL-3	Is Barrier Crashworthy?:	YES
Beg. End Trtmt Type:	SBT/LOG FLARED	Is Beg. End Trtmt Crashworthy?:	NO	Approach Transition Type:	NONE
Ending End Trtmt Type:	SBT/LOG FLARED	Ending End Trtmt Crashworthy?:	NO		
Average Measurements					
Design Height (In.):	27	Width (In.):	0.0	Post Spacing (In.):	119.6
Height (In.):	24.7	Lateral Offset (In.):	136.1	Road Grade (%):	1.10
Physical Condition					
Barrier	Alignment and Height:	A 20 ft section had a deflection of more than 12 in. 100 ft of the barrier was between 1 and 3 in below design height (27 in).

Breaking and Cracking:	40 ft of rail 1 post and 2 blocks had impact related breaking/cracking.			
	Missing Elements:	6 bolts were missing.			
	Corrosion and Weathering:	No loss of cross section or erosion observed.			
End Treatments	Alignment and Height:	Alignment acceptable. Height within 1-in of 27-in design height.			
	Breaking and Cracking:	No impact related breaking/cracking observed.			
	Missing Elements:	No elements appeared to be missing.			
	Corrosion and Weathering:	No loss of cross section or erosion observed.

Repair Action:	REPAIR	FMSS Work Type:	DEFERRED MAINTENANCE	Repair Cost:	\$4131
Brief Workorder:	Raise 100-ft of guardrail up to 27-in design height correct 20-ft section that is misaligned replace 1 post 2 blocks 40 ft of rail and missing bolts.				
Workorder:	<p>Adjust Guardrail at \$10- per -Lin. Ft. for 100 LF = \$1000. Raise 100 ft of barrier to 27 inch design height and correct 20-ft section that is out of alignment.</p> <p>Replace Post at \$100- per -Each for 1 Post(s) = \$100. Replace 1 post due to impact.</p> <p>Replace Block at \$30- per -Each for 2 Block(s) = \$60. Replace 2 blockouts due to impact.</p> <p>Replace Rail at \$25- per -Lin. Ft. for 40 LF = \$1000. Replace 40 ft of rail due to impact</p> <p>Labor at \$60- per -Hour for 2 Hrs = \$120. 2 hrs to replace 6 missing bolts</p> <p>Low Speed Traffic Control at \$1475- per -Day for 1 Day(s) = \$1475.</p>

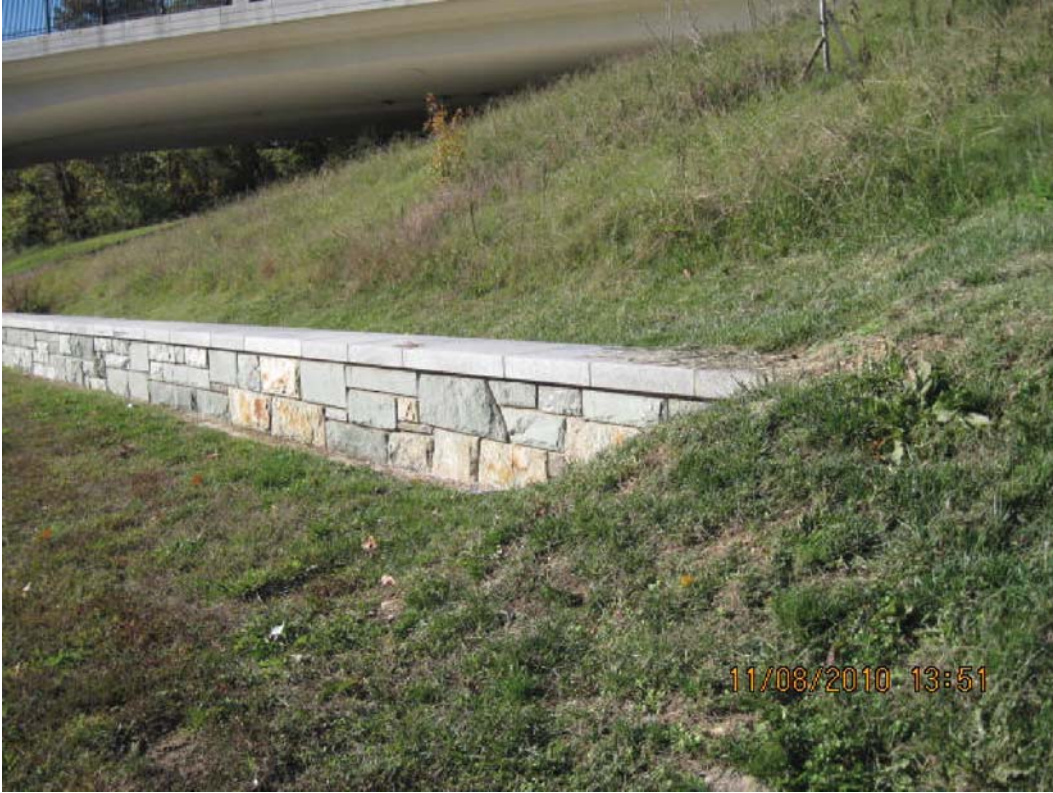
SUIT_0002_6.365_R_1.jpg

Barrier ID:	SUIT-0002-6.365-R				
Route Name:	WESTBOUND SUITLAND PARKWAY				
Inspection Date:	08/11/2010	Barrier Rating:	36.70		
Barrier Description					
Type:	CONCRETE WITH SIMULATED STONE FACE	Barrier Function:	TRAFFIC		
Barrier Material:	CONCRETE	Post Material:	N/A		
Blockout Type:	N/A	Length (ft.):	277		
Speed Limit (MPH):	45	Placement with Respect to Road:	INSIDE OF CURVE		
Hazard Behind Barrier:	MEDIUM				
Barrier Crashworthiness					
Appropriate Test Level:	TL-2	Barrier Test Level:	TL-3	Is Barrier Crashworthy?:	YES
Beg. End Trtmt Type:	OTHER: CONCRETE WITH	Is Beg. End Trtmt Crashworthy?:	NO	Approach Transition Type:	NONE
Ending End Trtmt Type:	NONE	Ending End Trtmt Crashworthy?:	N/A		
Average Measurements					
Design Height (In.):	27	Width (In.):	26.0	Post Spacing (In.):	0.0
Height (In.):	26.7	Lateral Offset (In.):	192.6	Road Grade (%):	3.50
Physical Condition					
Barrier	Alignment and Height:	No deflections observed in alignment. Entire barrier is 1 in or less below or exceeds 27 in design height by 1/2 in.

Breaking and Cracking:	No impact related breaking or cracking observed.			
	Missing Elements:	No elements were observed to be missing.			
	Corrosion and Weathering:	No erosion or undermining of base observed.			
End Treatments	Alignment and Height:	Alignment acceptable. Height within 3-in of 27-in design height.			
	Breaking and Cracking:	No impact related breaking or cracking observed.			
	Missing Elements:	No elements were observed to be missing.			
	Corrosion and Weathering:	No erosion or undermining of base observed.

Repair Action:	NO ACTION	FMSS Work Type:	N/A	Repair Cost:	\$0
Brief Workorder:	N/A				
Workorder:	No action required.
