GIP Report

NPS Guardwall/Rail Inventory Program
Suitland Parkway National Capital Parks - East

Federal Highway Administration
Eastern Federal Lands Highway Division
Road Inventory Program (RIP)

Data Collection Date: November 2010
Report Date: November 2015

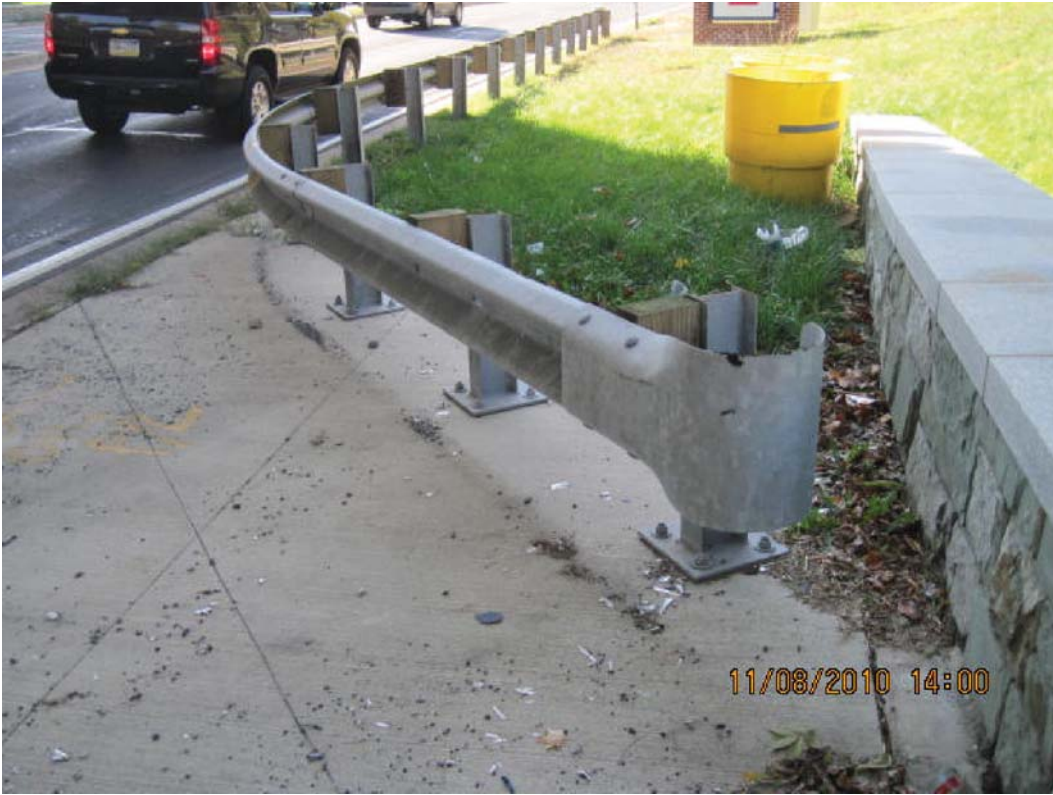
SUIT_0002_6.411_R_12.jpg

Barrier ID:	SUIT-0002-6.411-R				
Route Name:	WESTBOUND SUITLAND PARKWAY				
Inspection Date:	08/11/2010	Barrier Rating:	31.30		
Barrier Description					
Type:	W-BEAM STRONG POST	Barrier Function:	TRAFFIC		
Barrier Material:	GALVANIZED STEEL	Post Material:	GALVANIZED STEEL		
Blockout Type:	WOOD	Length (ft.):	89		
Speed Limit (MPH):	45	Placement with Respect to Road:	TANGENT		
Hazard Behind Barrier:	LOW				
Barrier Crashworthiness					
Appropriate Test Level:	TL-2	Barrier Test Level:	TL-3	Is Barrier Crashworthy?:	YES
Beg. End Trtmt Type:	OTHER: W-BEAM FLARED	Is Beg. End Trtmt Crashworthy?:	NO	Approach Transition Type:	NONE
Ending End Trtmt Type:	W-BEAM BCT	Ending End Trtmt Crashworthy?:	NO		
Average Measurements					
Design Height (In.):	27	Width (In.):	0.0	Post Spacing (In.):	75.0
Height (In.):	31.2	Lateral Offset (In.):	29.2	Road Grade (%):	4.70
Physical Condition					
Barrier	Alignment and Height:	No deflections were observed in the alignment. The barrier height was greater than the 27 in design height for the entire length by 3.5 to 5 in.

Breaking and Cracking:	No twisting bending tearing, or cracking was observed.			
	Missing Elements:	No elements were observed to be missing.			
	Corrosion and Weathering:	Less than 5 percent of the cross section has been lost due to weathering and no erosion was observed.			
End Treatments	Alignment and Height:	Alignment acceptable. Height within 1-in of 27-in design height.			
	Breaking and Cracking:	No twisting bending tearing, or cracking was observed.			
	Missing Elements:	No elements were observed to be missing.			
	Corrosion and Weathering:	Less than 5 percent of the cross section has been lost due to weathering.

Barrier ID:	SUIT-0002-6.411-R				
Route Name:	WESTBOUND SUITLAND PARKWAY				
Inspection Date:	08/11/2010	Barrier Rating:		31.30	
Repair Recommendations					
Repair Action:	NO ACTION	FMSS Work Type:	N/A	Repair Cost:	\$0
Brief Workorder:	N/A				
Workorder:	No action required.

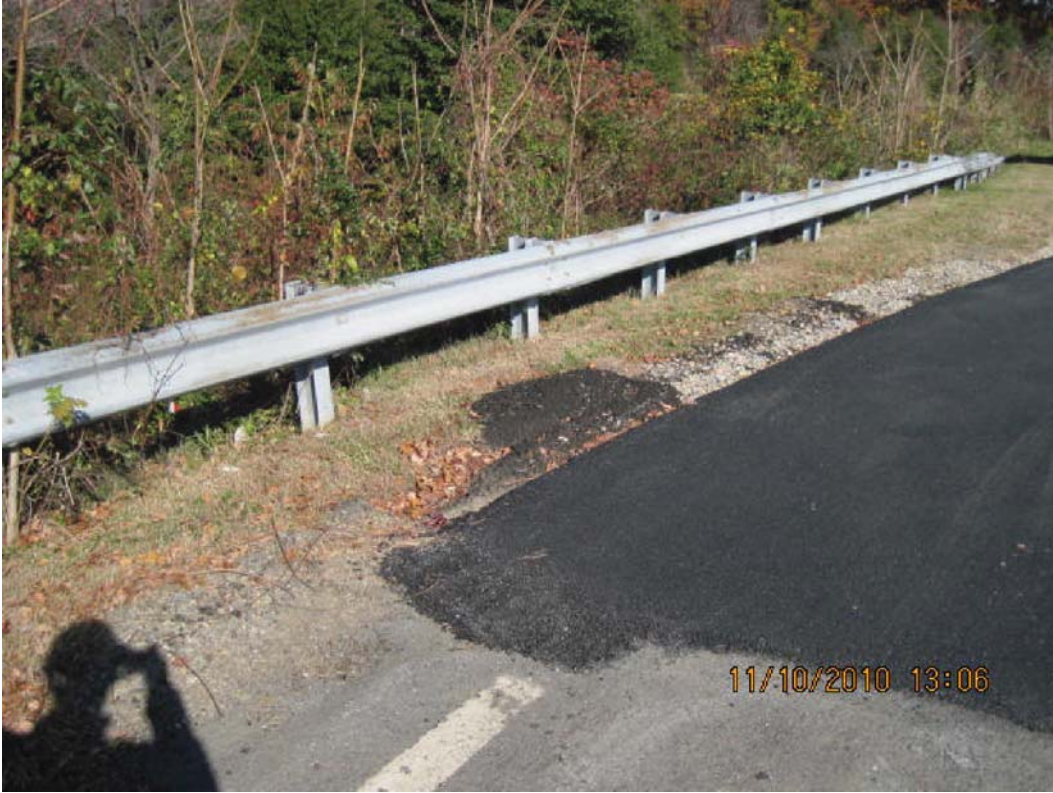
SUIT_0010_0.004_L_1.jpg

Barrier ID:	SUIT-0010-0.004-L				
Route Name:	ALLENTOWN ROAD RAMP TO EB SUITLAND PARKWAY				
Inspection Date:	10/11/2010	Barrier Rating:	22.20		
Barrier Description					
Type:	W-BEAM STRONG POST	Barrier Function:	TRAFFIC		
Barrier Material:	GALVANIZED STEEL	Post Material:	GALVANIZED STEEL		
Blockout Type:	STEEL	Length (ft.):	87		
Speed Limit (MPH):	35	Placement with Respect to Road:	TANGENT		
Hazard Behind Barrier:	MEDIUM				
Barrier Crashworthiness					
Appropriate Test Level:	TL-2	Barrier Test Level:	TL-3	Is Barrier Crashworthy?:	YES
Beg. End Trtmt Type:	NONE	Is Beg. End Trtmt Crashworthy?:	N/A	Approach Transition Type:	NONE
Ending End Trtmt Type:	W-BEAM TURN DOWN	Ending End Trtmt Crashworthy?:	NO		
Average Measurements					
Design Height (In.):	27	Width (In.):	0.0	Post Spacing (In.):	75.1
Height (In.):	26.2	Lateral Offset (In.):	185.0	Road Grade (%):	1.40
Physical Condition					
Barrier	Alignment and Height:	No deflections were observed in the alignment. The barrier height was within 1 in of the 27 in design height for the entire length.

Breaking and Cracking:	No twisting bending tearing, or cracking was observed.			
	Missing Elements:	No elements were observed to be missing.			
	Corrosion and Weathering:	Less than 5 percent of the cross section has been lost due to weathering. No erosion was observed.			
End Treatments	Alignment and Height:	Alignment acceptable. Height within 1-in of 27-in design height.			
	Breaking and Cracking:	No twisting bending tearing, or cracking was observed.			
	Missing Elements:	No elements were observed to be missing.			
	Corrosion and Weathering:	Less than 5 percent of the cross section has been lost due to weathering.

Repair Action:	NO ACTION	FMSS Work Type:	N/A	Repair Cost:	\$0
Brief Workorder:	N/A				
Workorder:	No action required.

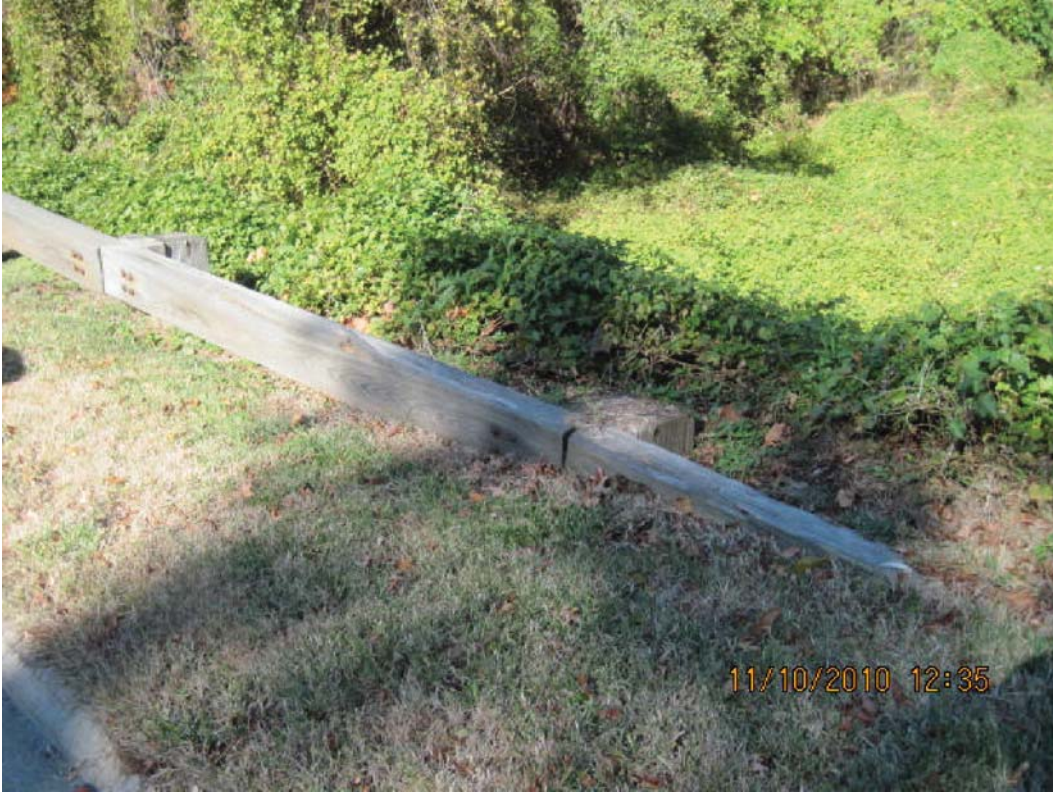
SUIT_0500ZZ_0.066_R_1.jpg

Barrier ID:	SUIT-0500ZZ-0.066-R				
Route Name:	BRANCH AVENUE INTERCHANGE RAMPS				
Inspection Date:	10/11/2010	Barrier Rating:	38.20		
Barrier Description					
Type:	STEEL-BACKED TIMBER WITH BLOCKOUT	Barrier Function:	TRAFFIC		
Barrier Material:	STEEL-BACKED TIMBER/LOG	Post Material:	WOOD		
Blockout Type:	WOOD	Length (ft.):	615		
Speed Limit (MPH):	25	Placement with Respect to Road:	OUTSIDE OF CURVE		
Hazard Behind Barrier:	MEDIUM				
Barrier Crashworthiness					
Appropriate Test Level:	TL-1	Barrier Test Level:	TL-3	Is Barrier Crashworthy?:	YES
Beg. End Trtmt Type:	SBT/LOG FLARED	Is Beg. End Trtmt Crashworthy?:	NO	Approach Transition Type:	NONE
Ending End Trtmt Type:	SBT/LOG FLARED	Ending End Trtmt Crashworthy?:	NO		
Average Measurements					
Design Height (In.):	27	Width (In.):	0.0	Post Spacing (In.):	120.0
Height (In.):	27.6	Lateral Offset (In.):	84.0	Road Grade (%):	4.60
Physical Condition					
Barrier	Alignment and Height:	20 ft of rail was deflected 6 in. Entire barrier meets or exceeds 27 in design height by up to 1.5 in.

Breaking and Cracking:	10 ft of rail was broken in half and 10 ft of rail was cracking up to 2 in width.			
	Missing Elements:	No elements were observed to be missing.			
	Corrosion and Weathering:	No loss of cross section or erosion around posts observed.			
End Treatments	Alignment and Height:	Alignment acceptable. Height within 1-in of 27-in design height.			
	Breaking and Cracking:	No impact related breaking or cracking observed.			
	Missing Elements:	No elements were observed to be missing.			
	Corrosion and Weathering:	No loss of cross section or erosion around posts observed.

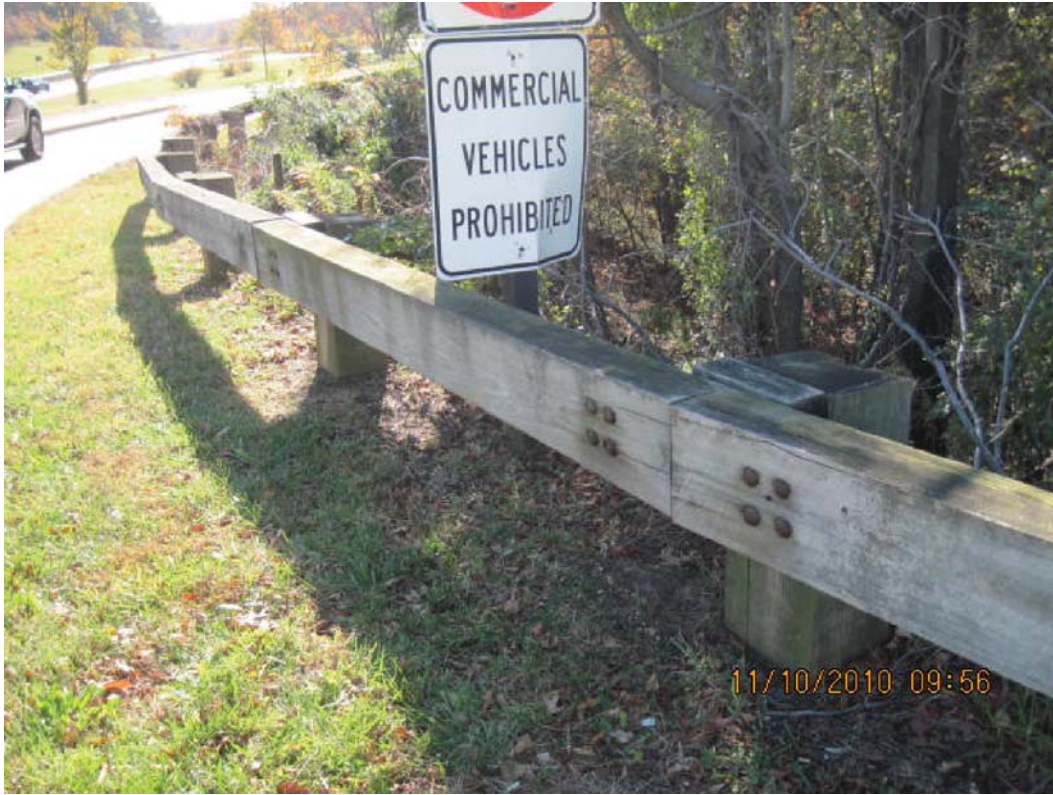
SUIT_0501ZZ_0.008_R_1.JPG

Barrier ID:	SUIT-0501ZZ-0.008-R				
Route Name:	SILVER HILL ROAD INTERCHANGE RAMP				
Inspection Date:	10/11/2010	Barrier Rating:	23.70		
Barrier Description					
Type:	STEEL-BACKED TIMBER WITH BLOCKOUT	Barrier Function:	TRAFFIC		
Barrier Material:	STEEL-BACKED TIMBER/LOG	Post Material:	WOOD		
Blockout Type:	WOOD	Length (ft.):	268		
Speed Limit (MPH):	25	Placement with Respect to Road:	INSIDE OF CURVE		
Hazard Behind Barrier:	MEDIUM				
Barrier Crashworthiness					
Appropriate Test Level:	TL-1	Barrier Test Level:	TL-3	Is Barrier Crashworthy?:	YES
Beg. End Trtmt Type:	NONE	Is Beg. End Trtmt Crashworthy?:	N/A	Approach Transition Type:	NONE
Ending End Trtmt Type:	SBT/LOG FLARED	Ending End Trtmt Crashworthy?:	NO		
Average Measurements					
Design Height (In.):	27	Width (In.):	0.0	Post Spacing (In.):	120.1
Height (In.):	29.7	Lateral Offset (In.):	66.3	Road Grade (%):	2.30
Physical Condition					
Barrier	Alignment and Height:	Alignment deflection was less than 6 in. The entire barrier exceeded design height (27 in) by 2 to 4.5 in.

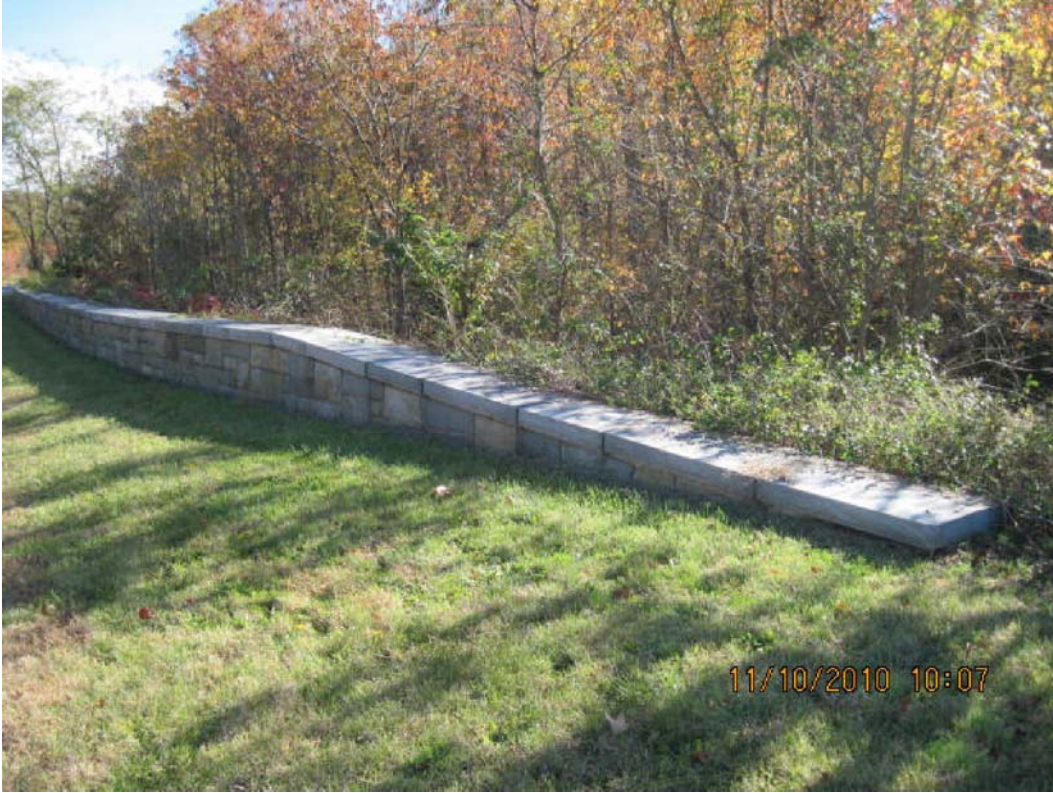
SUIT_0502ZZ_0.100_R_1.jpg

Barrier ID:	SUIT-0502ZZ-0.100-R				
Route Name:	SUITLAND ROAD INTERCHANGE RAMPS				
Inspection Date:	10/11/2010	Barrier Rating:	25.20		
Barrier Description					
Type:	CONCRETE WITH SIMULATED STONE FACE	Barrier Function:	TRAFFIC		
Barrier Material:	CONCRETE	Post Material:	N/A		
Blockout Type:	N/A	Length (ft.):	172		
Speed Limit (MPH):	25	Placement with Respect to Road:	INSIDE OF CURVE		
Hazard Behind Barrier:	MEDIUM				
Barrier Crashworthiness					
Appropriate Test Level:	TL-1	Barrier Test Level:	TL-3	Is Barrier Crashworthy?:	YES
Beg. End Trtmt Type:	OTHER: CONCRETE WITH	Is Beg. End Trtmt Crashworthy?:	NO	Approach Transition Type:	NONE
Ending End Trtmt Type:	NONE	Ending End Trtmt Crashworthy?:	N/A		
Average Measurements					
Design Height (In.):	27	Width (In.):	26.0	Post Spacing (In.):	0.0
Height (In.):	26.7	Lateral Offset (In.):	138.3	Road Grade (%):	0.50
Physical Condition					
Barrier	Alignment and Height:	No deflections observed in alignment. Entire barrier is less than 1 in below or meets 27 in design height.

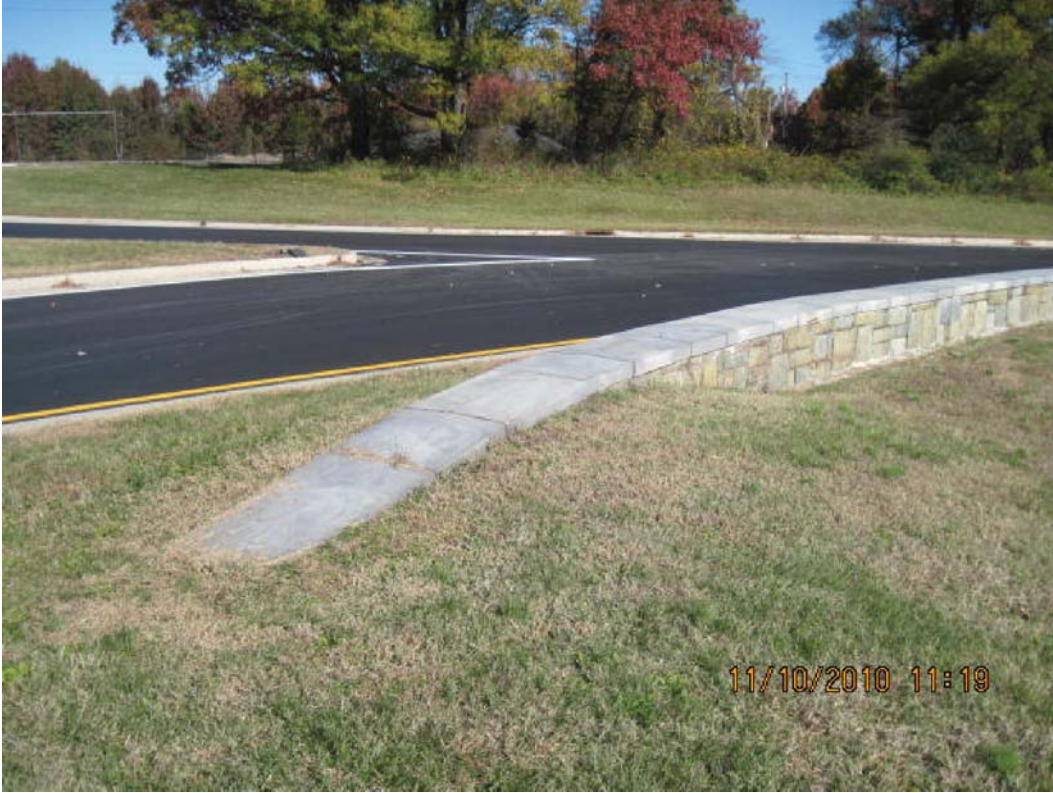
SUIT_0503ZZ_0.045_L_1.jpg

Barrier ID:	SUIT-0503ZZ-0.045-L				
Route Name:	ANDREWS AFB NORTH GATE INTERCHANGE RAMPS				
Inspection Date:	10/11/2010	Barrier Rating:	33.90		
Barrier Description					
Type:	CONCRETE WITH SIMULATED STONE FACE	Barrier Function:	TRAFFIC		
Barrier Material:	CONCRETE	Post Material:	N/A		
Blockout Type:	N/A	Length (ft.):	543		
Speed Limit (MPH):	25	Placement with Respect to Road:	OUTSIDE OF CURVE		
Hazard Behind Barrier:	MEDIUM				
Barrier Crashworthiness					
Appropriate Test Level:	TL-1	Barrier Test Level:	TL-3	Is Barrier Crashworthy?:	YES
Beg. End Trtmt Type:	NONE	Is Beg. End Trtmt Crashworthy?:	N/A	Approach Transition Type:	NONE
Ending End Trtmt Type:	NONE	Ending End Trtmt Crashworthy?:	N/A		
Average Measurements					
Design Height (In.):	27	Width (In.):	26.0	Post Spacing (In.):	0.0
Height (In.):	26.7	Lateral Offset (In.):	66.3	Road Grade (%):	2.00
Physical Condition					
Barrier	Alignment and Height:	No deflections were observed in the alignment. The barrier height was equal to or within 1 in of the 27 in design height for the entire length.

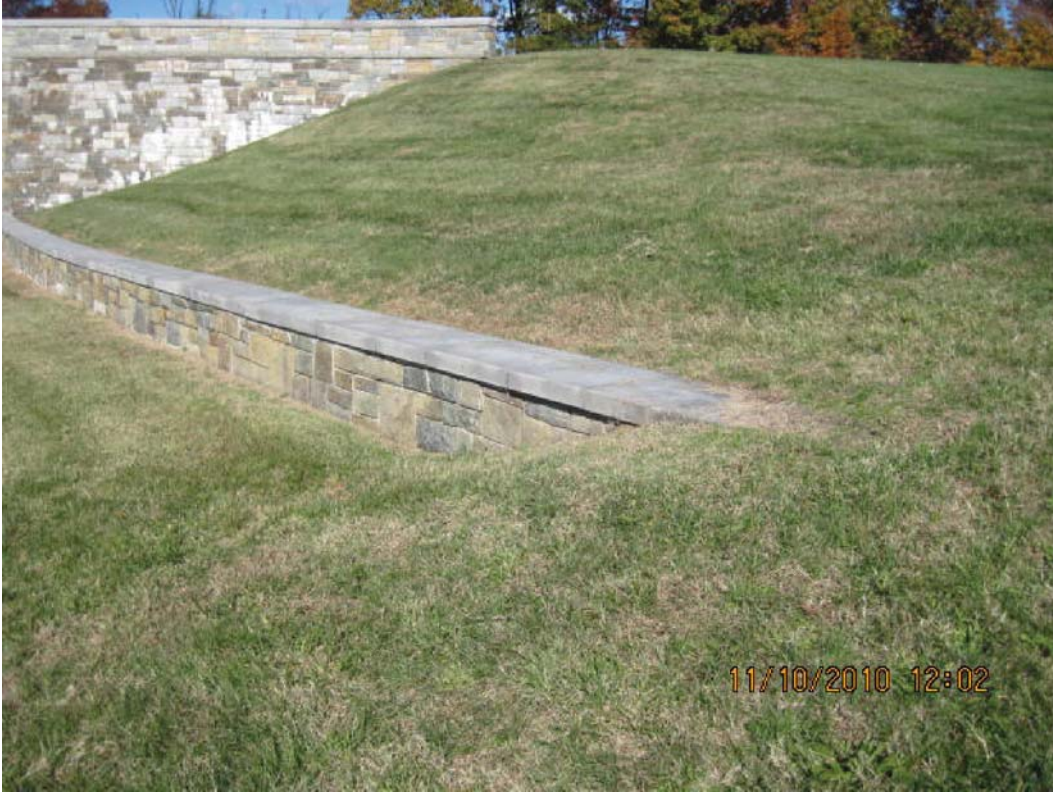
SUIT_0503ZZ_0.094_R_1.jpg

Barrier ID:	SUIT-0503ZZ-0.094-R				
Route Name:	ANDREWS AFB NORTH GATE INTERCHANGE RAMPS				
Inspection Date:	10/11/2010	Barrier Rating:	28.50		
Barrier Description					
Type:	CONCRETE WITH SIMULATED STONE FACE	Barrier Function:	TRAFFIC		
Barrier Material:	CONCRETE	Post Material:	N/A		
Blockout Type:	N/A	Length (ft.):	120		
Speed Limit (MPH):	25	Placement with Respect to Road:	OUTSIDE OF CURVE		
Hazard Behind Barrier:	LOW				
Barrier Crashworthiness					
Appropriate Test Level:	TL-1	Barrier Test Level:	TL-3	Is Barrier Crashworthy?:	YES
Beg. End Trtmt Type:	OTHER: CONCRETE WITH	Is Beg. End Trtmt Crashworthy?:	NO	Approach Transition Type:	NONE
Ending End Trtmt Type:	NONE	Ending End Trtmt Crashworthy?:	N/A		
Average Measurements					
Design Height (In.):	27	Width (In.):	26.0	Post Spacing (In.):	0.0
Height (In.):	28.0	Lateral Offset (In.):	156.0	Road Grade (%):	1.90
Physical Condition					
Barrier	Alignment and Height:	No deflections were observed in the alignment. The barrier height was equal to or greater than the 27 in design height by up to 2 in.

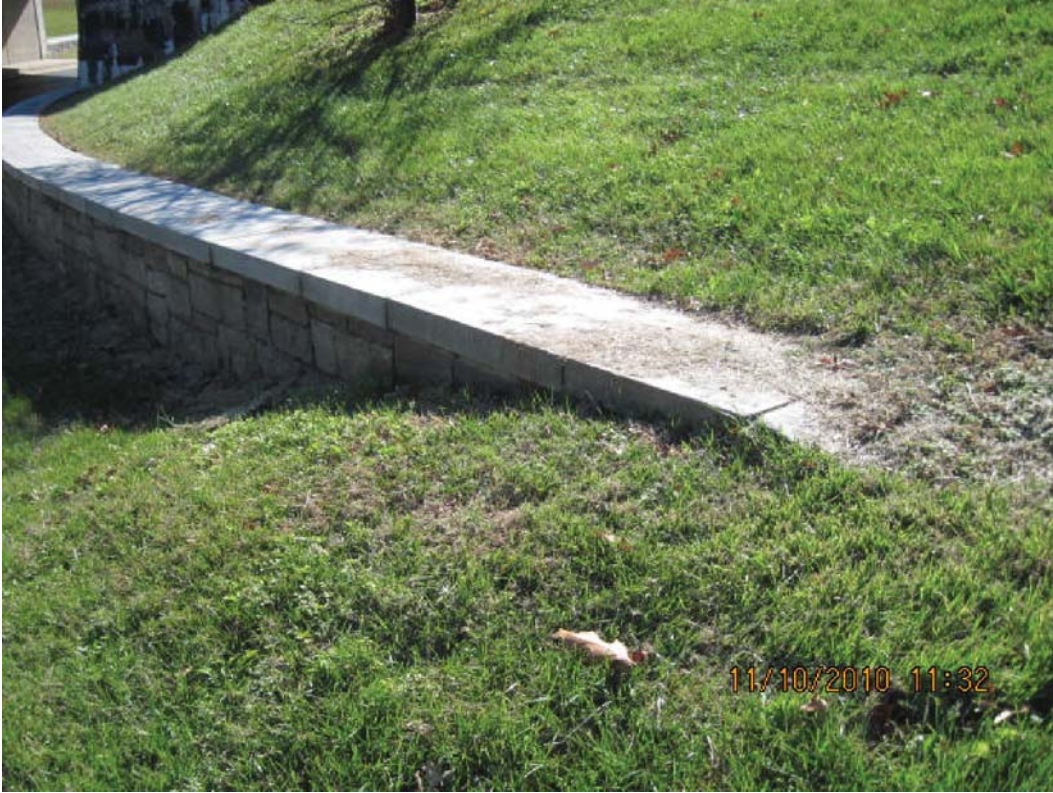
SUIT_0503ZZ_0.119_R_1.JPG

Barrier ID:	SUIT-0503ZZ-0.119-R				
Route Name:	ANDREWS AFB NORTH GATE INTERCHANGE RAMPS				
Inspection Date:	10/11/2010	Barrier Rating:	22.70		
Barrier Description					
Type:	CONCRETE WITH SIMULATED STONE FACE	Barrier Function:	TRAFFIC		
Barrier Material:	CONCRETE	Post Material:	N/A		
Blockout Type:	N/A	Length (ft.):	101		
Speed Limit (MPH):	25	Placement with Respect to Road:	INSIDE OF CURVE		
Hazard Behind Barrier:	LOW				
Barrier Crashworthiness					
Appropriate Test Level:	TL-1	Barrier Test Level:	TL-3	Is Barrier Crashworthy?:	YES
Beg. End Trtmt Type:	OTHER: CONCRETE WITH	Is Beg. End Trtmt Crashworthy?:	NO	Approach Transition Type:	NONE
Ending End Trtmt Type:	NONE	Ending End Trtmt Crashworthy?:	N/A		
Average Measurements					
Design Height (In.):	27	Width (In.):	26.0	Post Spacing (In.):	0.0
Height (In.):	27.0	Lateral Offset (In.):	131.3	Road Grade (%):	1.40
Physical Condition					
Barrier	Alignment and Height:	Alignment deflection was less than 6 in. The entire barrier was equal to design height (27 in).

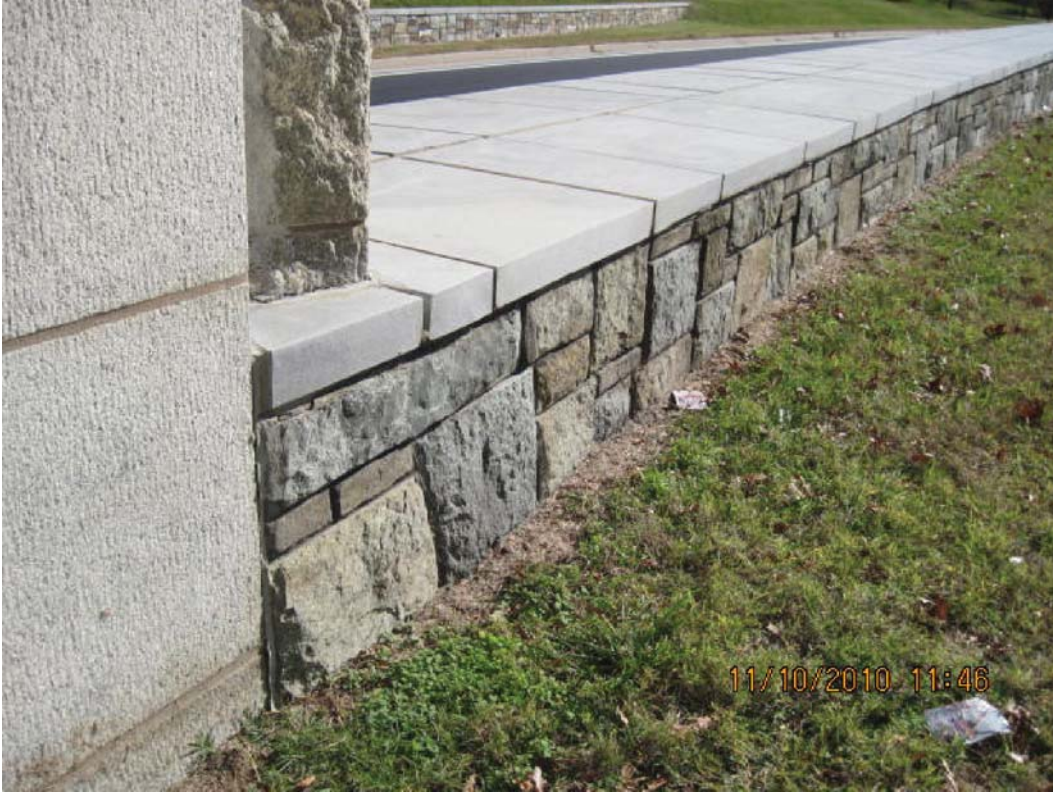
SUIT_0503ZZ_0.151_L_1.JPG

Barrier ID:	SUIT-0503ZZ-0.151-L				
Route Name:	ANDREWS AFB NORTH GATE INTERCHANGE RAMPS				
Inspection Date:	10/11/2010	Barrier Rating:	31.00		
Barrier Description					
Type:	CONCRETE WITH SIMULATED STONE FACE	Barrier Function:	TRAFFIC		
Barrier Material:	CONCRETE	Post Material:	N/A		
Blockout Type:	N/A	Length (ft.):	124		
Speed Limit (MPH):	25	Placement with Respect to Road:	OUTSIDE OF CURVE		
Hazard Behind Barrier:	MEDIUM				
Barrier Crashworthiness					
Appropriate Test Level:	TL-1	Barrier Test Level:	TL-3	Is Barrier Crashworthy?:	YES
Beg. End Trtmt Type:	NONE	Is Beg. End Trtmt Crashworthy?:	N/A	Approach Transition Type:	NONE
Ending End Trtmt Type:	NONE	Ending End Trtmt Crashworthy?:	N/A		
Average Measurements					
Design Height (In.):	27	Width (In.):	48.0	Post Spacing (In.):	0.0
Height (In.):	28.2	Lateral Offset (In.):	233.0	Road Grade (%):	4.30
Physical Condition					
Barrier	Alignment and Height:	No deflections observed in alignment. Entire barrier exceeds 27 in design height by 0 to 2 in.
