GIP Report

**NPS Guardwall/Rail Inventory Program
Theodore Roosevelt National Park**

**Federal Lands Highway
Road Inventory Program**

**Data Collection Date: August 2010
Report Date: November 2015**

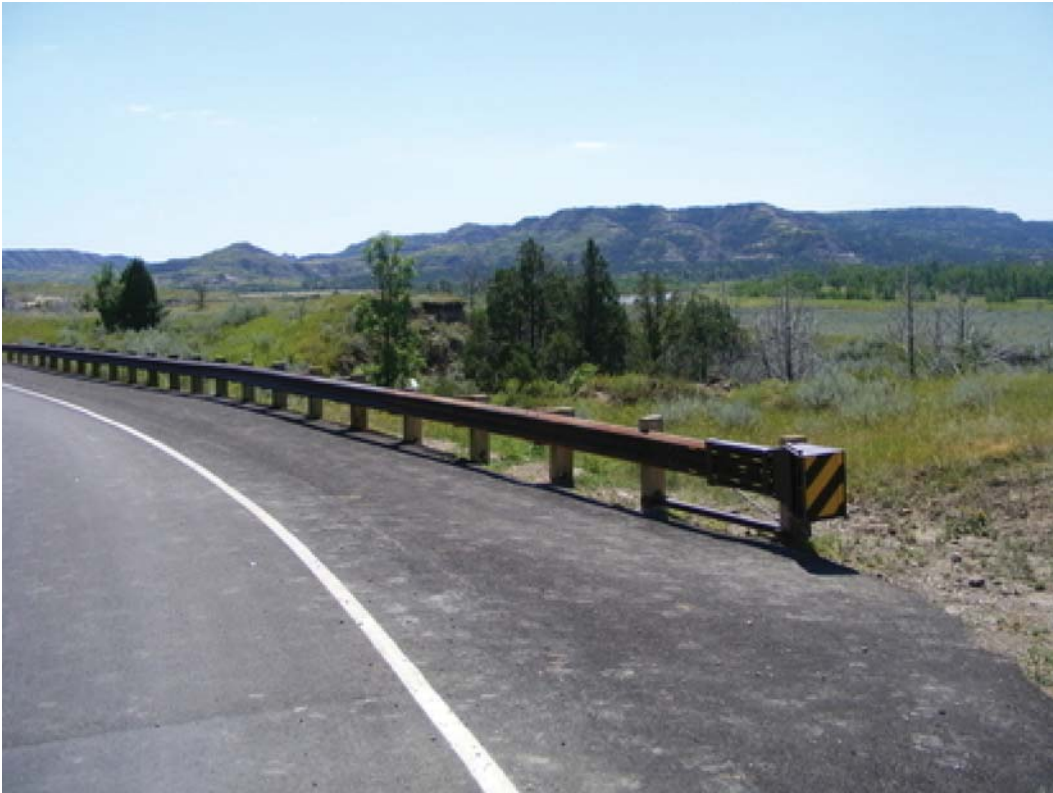
THRO_0010_3.318_L_1.JPG

Barrier ID:	THRO-0010-3.318-L				
Route Name:	SCENIC DRIVE				
Inspection Date:	10/08/2010	Barrier Rating:	17.80		
Barrier Description					
Type:	W-BEAM STRONG POST	Barrier Function:	TRAFFIC		
Barrier Material:	WEATHERING STEEL/CORTEN	Post Material:	WOOD		
Blockout Type:	WOOD	Length (ft.):	154		
Speed Limit (MPH):	25	Placement with Respect to Road:	OUTSIDE OF CURVE		
Hazard Behind Barrier:	MEDIUM				
Barrier Crashworthiness					
Appropriate Test Level:	TL-1	Barrier Test Level:	TL-3	Is Barrier Crashworthy?:	YES
Beg. End Trtmt Type:	W-BEAM TANGENT 350	Is Beg. End Trtmt Crashworthy?:	YES	Approach Transition Type:	NONE
Ending End Trtmt Type:	W-BEAM TANGENT 350	Ending End Trtmt Crashworthy?:	YES		
Average Measurements					
Design Height (In.):	27	Width (In.):	0.0	Post Spacing (In.):	73.5
Height (In.):	29.0	Lateral Offset (In.):	97.0	Road Grade (%):	1.30
Physical Condition					
Barrier	Alignment and Height:	Alignment acceptable. Height was 1 to 3-in above the 27-in design height.

Breaking and Cracking:	No cracked or broken barrier elements.			
	Missing Elements:	No missing barrier elements.			
	Corrosion and Weathering:	No major weathering of the barrier.			
End Treatments	Alignment and Height:	Alignment acceptable. Height was 1 to 3-in above the 27-in design height.			
	Breaking and Cracking:	No major cracking or breaking of the end treatments.			
	Missing Elements:	No missing end treatment elements.			
	Corrosion and Weathering:	No major weathering of the end treatments.

Repair Action:	NO ACTION	FMSS Work Type:	N/A	Repair Cost:	\$0
Brief Workorder:	N/A				
Workorder:

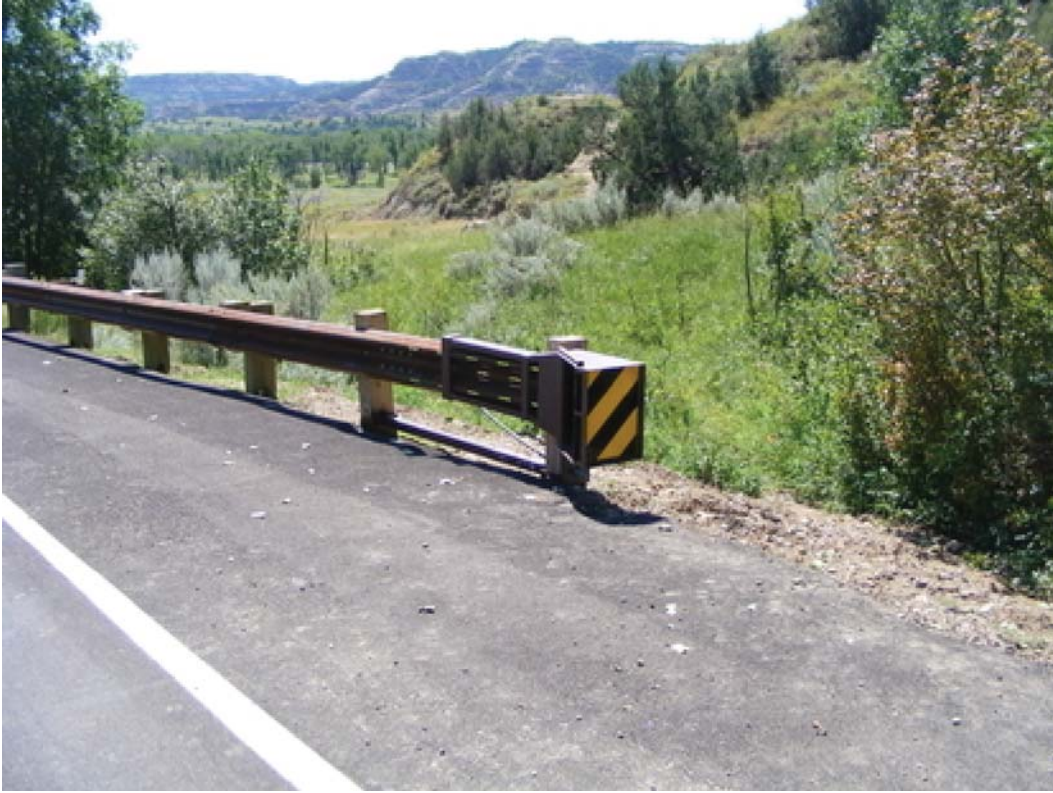
THRO_0010_4.080_L_1.JPG

Barrier ID:	THRO-0010-4.080-L				
Route Name:	SCENIC DRIVE				
Inspection Date:	10/08/2010	Barrier Rating:	25.10		
Barrier Description					
Type:	W-BEAM STRONG POST	Barrier Function:	TRAFFIC		
Barrier Material:	WEATHERING STEEL/CORTEN	Post Material:	WOOD		
Blockout Type:	WOOD	Length (ft.):	679		
Speed Limit (MPH):	25	Placement with Respect to Road:	OUTSIDE OF CURVE		
Hazard Behind Barrier:	MEDIUM				
Barrier Crashworthiness					
Appropriate Test Level:	TL-1	Barrier Test Level:	TL-3	Is Barrier Crashworthy?:	YES
Beg. End Trtmt Type:	W-BEAM TANGENT 350	Is Beg. End Trtmt Crashworthy?:	YES	Approach Transition Type:	NONE
Ending End Trtmt Type:	W-BEAM TANGENT 350	Ending End Trtmt Crashworthy?:	YES		
Average Measurements					
Design Height (In.):	27	Width (In.):	0.0	Post Spacing (In.):	74.5
Height (In.):	28.0	Lateral Offset (In.):	54.5	Road Grade (%):	4.70
Physical Condition					
Barrier	Alignment and Height:	Alignment acceptable. Height was 1 to 3-in above the 27-in design height.

Breaking and Cracking:	No cracked or broken barrier elements.			
	Missing Elements:	No missing barrier elements.			
	Corrosion and Weathering:	Minimal corrosion/weathering of barrier elements.			
End Treatments	Alignment and Height:	Height of trailing end is within 1-in of 27-in design height. 24-ft of approach end treatment is 1 to 3-inin below the 27-in design height.			
	Breaking and Cracking:	No cracked or broken end treatment elements.			
	Missing Elements:	No missing end treatment elements.			
	Corrosion and Weathering:	Minimal corrosion/weathering of end treatment elements.

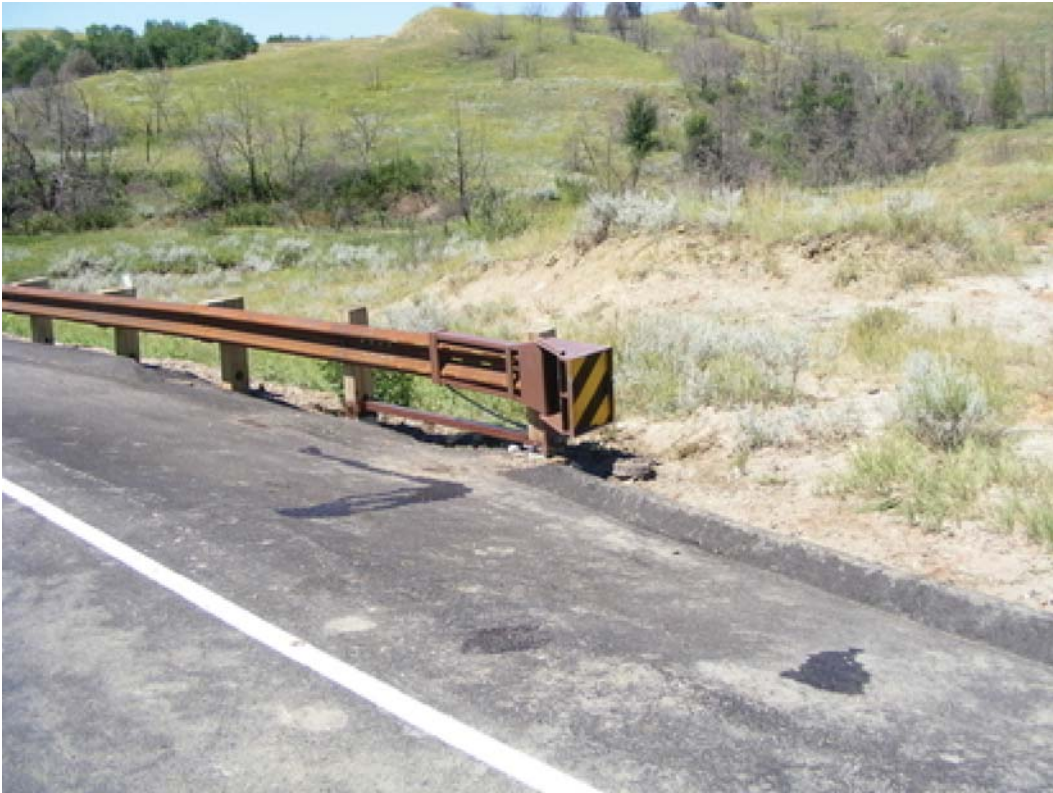
THRO_0010_4.080_R_1.JPG

Barrier ID:	THRO-0010-4.080-R				
Route Name:	SCENIC DRIVE				
Inspection Date:	10/08/2010	Barrier Rating:	19.30		
Barrier Description					
Type:	W-BEAM STRONG POST	Barrier Function:	TRAFFIC		
Barrier Material:	WEATHERING STEEL/CORTEN	Post Material:	WOOD		
Blockout Type:	WOOD	Length (ft.):	402		
Speed Limit (MPH):	25	Placement with Respect to Road:	INSIDE OF CURVE		
Hazard Behind Barrier:	MEDIUM				
Barrier Crashworthiness					
Appropriate Test Level:	TL-1	Barrier Test Level:	TL-3	Is Barrier Crashworthy?:	YES
Beg. End Trtmt Type:	W-BEAM FLARED 350 COMPLIANT	Is Beg. End Trtmt Crashworthy?:	YES	Approach Transition Type:	NONE
Ending End Trtmt Type:	W-BEAM TANGENT 350	Ending End Trtmt Crashworthy?:	YES		
Average Measurements					
Design Height (In.):	27	Width (In.):	0.0	Post Spacing (In.):	74.6
Height (In.):	28.7	Lateral Offset (In.):	64.0	Road Grade (%):	3.20
Physical Condition					
Barrier	Alignment and Height:	Alignment acceptable. Height within 1-in of 27-in design height.

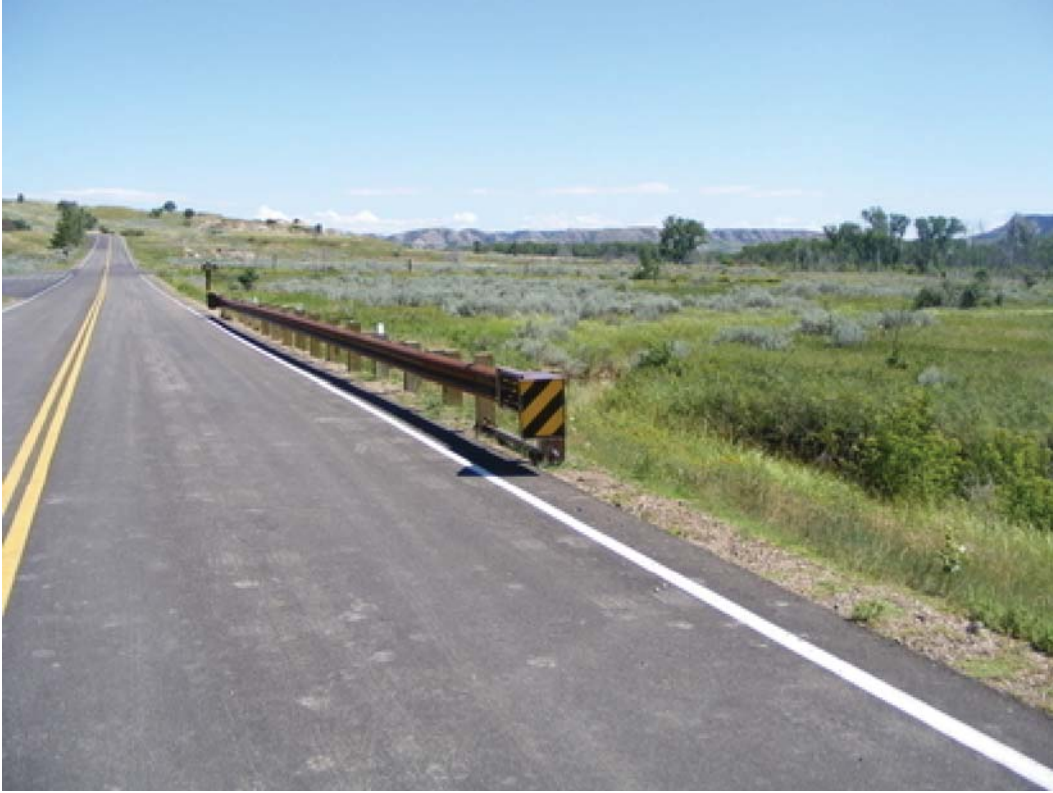
THRO_0010_4.839_L_1.JPG

Barrier ID:	THRO-0010-4.839-L				
Route Name:	SCENIC DRIVE				
Inspection Date:	10/08/2010	Barrier Rating:	15.00		
Barrier Description					
Type:	W-BEAM STRONG POST	Barrier Function:	TRAFFIC		
Barrier Material:	WEATHERING STEEL/CORTEN	Post Material:	WOOD		
Blockout Type:	WOOD	Length (ft.):	105		
Speed Limit (MPH):	25	Placement with Respect to Road:	TANGENT		
Hazard Behind Barrier:	MEDIUM				
Barrier Crashworthiness					
Appropriate Test Level:	TL-1	Barrier Test Level:	TL-3	Is Barrier Crashworthy?:	YES
Beg. End Trtmt Type:	W-BEAM TANGENT 350	Is Beg. End Trtmt Crashworthy?:	YES	Approach Transition Type:	NONE
Ending End Trtmt Type:	W-BEAM TANGENT 350	Ending End Trtmt Crashworthy?:	YES		
Average Measurements					
Design Height (In.):	27	Width (In.):	0.0	Post Spacing (In.):	74.5
Height (In.):	27.6	Lateral Offset (In.):	18.0	Road Grade (%):	0.50
Physical Condition					
Barrier	Alignment and Height:	Alignment acceptable. Height within 1-in of 27-in design height.

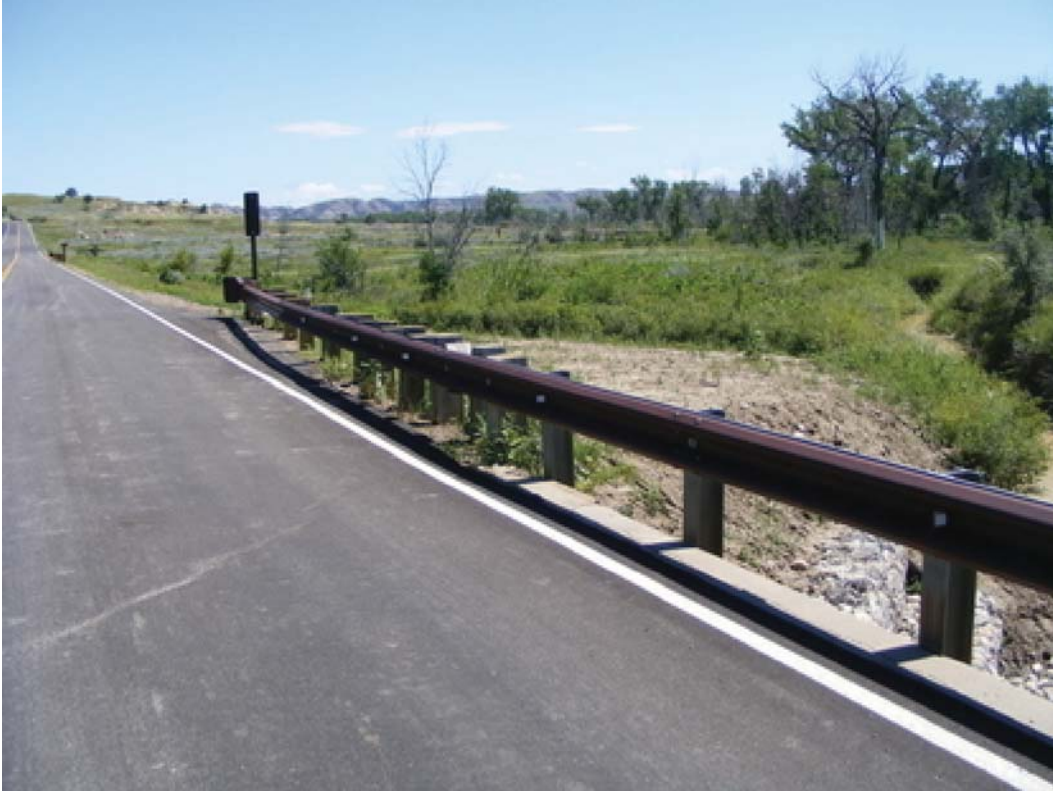
THRO_0010_4.909_L_1.JPG

Barrier ID:	THRO-0010-4.909-L				
Route Name:	SCENIC DRIVE				
Inspection Date:	10/08/2010	Barrier Rating:	12.10		
Barrier Description					
Type:	W-BEAM STRONG POST	Barrier Function:	TRAFFIC		
Barrier Material:	WEATHERING STEEL/CORTEN	Post Material:	WOOD		
Blockout Type:	WOOD	Length (ft.):	57		
Speed Limit (MPH):	25	Placement with Respect to Road:	TANGENT		
Hazard Behind Barrier:	MEDIUM				
Barrier Crashworthiness					
Appropriate Test Level:	TL-1	Barrier Test Level:	TL-3	Is Barrier Crashworthy?:	YES
Beg. End Trtmt Type:	NONE	Is Beg. End Trtmt Crashworthy?:	N/A	Approach Transition Type:	RIGID W-BEAM - W-BEAM
Ending End Trtmt Type:	W-BEAM FLARED 350 COMPLIANT	Ending End Trtmt Crashworthy?:	YES		
Average Measurements					
Design Height (In.):	27	Width (In.):	0.0	Post Spacing (In.):	75.0
Height (In.):	27.6	Lateral Offset (In.):	26.0	Road Grade (%):	0.20
Physical Condition					
Barrier	Alignment and Height:	Alignment acceptable. Height within 1-in of 27-in design height.

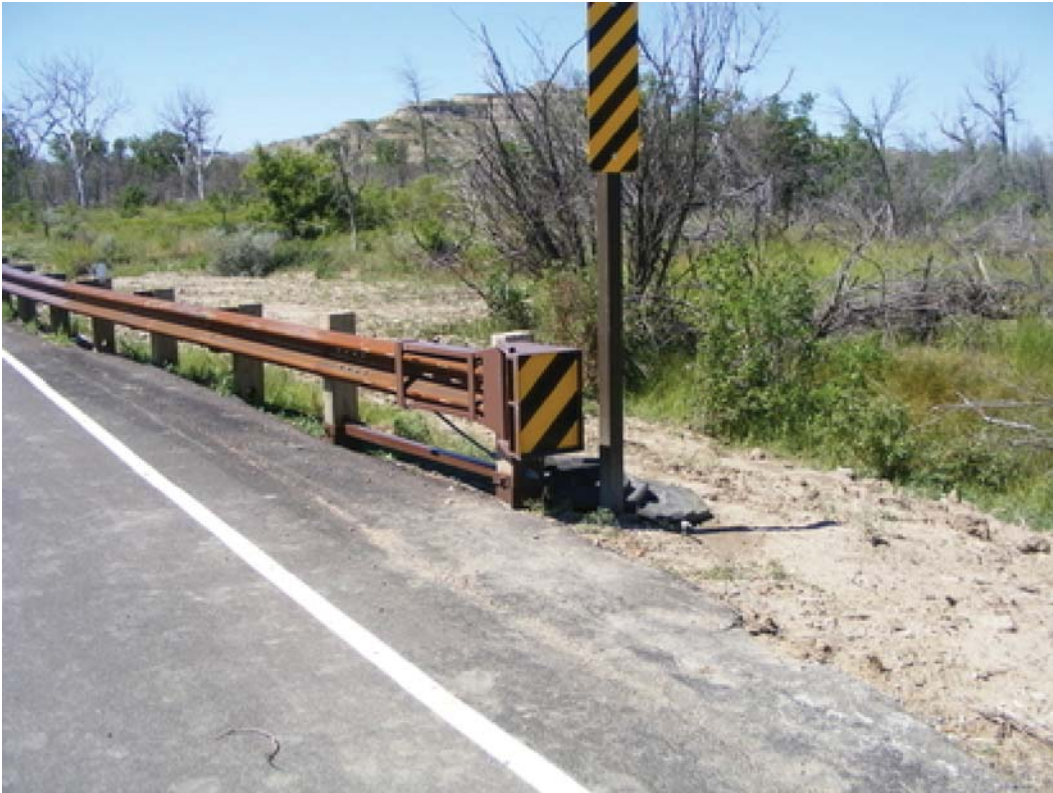
THRO_0010_4.909_R_1.JPG

Barrier ID:	THRO-0010-4.909-R				
Route Name:	SCENIC DRIVE				
Inspection Date:	10/08/2010	Barrier Rating:	12.50		
Barrier Description					
Type:	W-BEAM STRONG POST	Barrier Function:	TRAFFIC		
Barrier Material:	WEATHERING STEEL/CORTEN	Post Material:	WOOD		
Blockout Type:	WOOD	Length (ft.):	88		
Speed Limit (MPH):	25	Placement with Respect to Road:	TANGENT		
Hazard Behind Barrier:	LOW				
Barrier Crashworthiness					
Appropriate Test Level:	TL-1	Barrier Test Level:	TL-3	Is Barrier Crashworthy?:	YES
Beg. End Trtmt Type:	W-BEAM FLARED 350 COMPLIANT	Is Beg. End Trtmt Crashworthy?:	YES	Approach Transition Type:	RIGID W-BEAM - W-BEAM
Ending End Trtmt Type:	NONE	Ending End Trtmt Crashworthy?:	N/A		
Average Measurements					
Design Height (In.):	27	Width (In.):	0.0	Post Spacing (In.):	75.5
Height (In.):	27.7	Lateral Offset (In.):	16.7	Road Grade (%):	0.30
Physical Condition					
Barrier	Alignment and Height:	Alignment acceptable. Height within 1-in of 27-in design height.

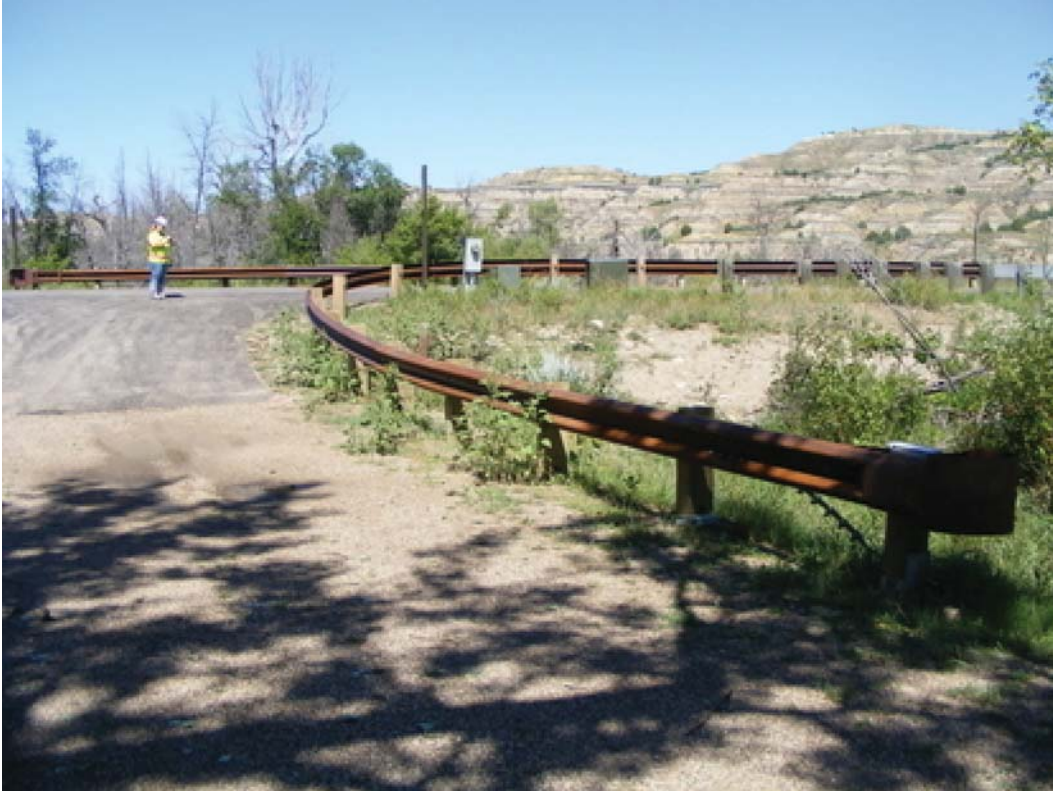
THRO_0010_4.932_L_1.JPG

Barrier ID:	THRO-0010-4.932-L				
Route Name:	SCENIC DRIVE				
Inspection Date:	10/08/2010	Barrier Rating:	15.10		
Barrier Description					
Type:	W-BEAM STRONG POST	Barrier Function:	TRAFFIC		
Barrier Material:	WEATHERING STEEL/CORTEN	Post Material:	WOOD		
Blockout Type:	WOOD	Length (ft.):	120		
Speed Limit (MPH):	25	Placement with Respect to Road:	INSIDE OF CURVE		
Hazard Behind Barrier:	MEDIUM				
Barrier Crashworthiness					
Appropriate Test Level:	TL-1	Barrier Test Level:	TL-3	Is Barrier Crashworthy?:	YES
Beg. End Trtmt Type:	W-BEAM BCT	Is Beg. End Trtmt Crashworthy?:	NO	Approach Transition Type:	RIGID W-BEAM - W-BEAM
Ending End Trtmt Type:	NONE	Ending End Trtmt Crashworthy?:	N/A		
Average Measurements					
Design Height (In.):	27	Width (In.):	0.0	Post Spacing (In.):	74.3
Height (In.):	30.6	Lateral Offset (In.):	42.0	Road Grade (%):	3.10
Physical Condition					
Barrier	Alignment and Height:	Alignment acceptable. Height was 1 to 5-in above the 27-in design height.

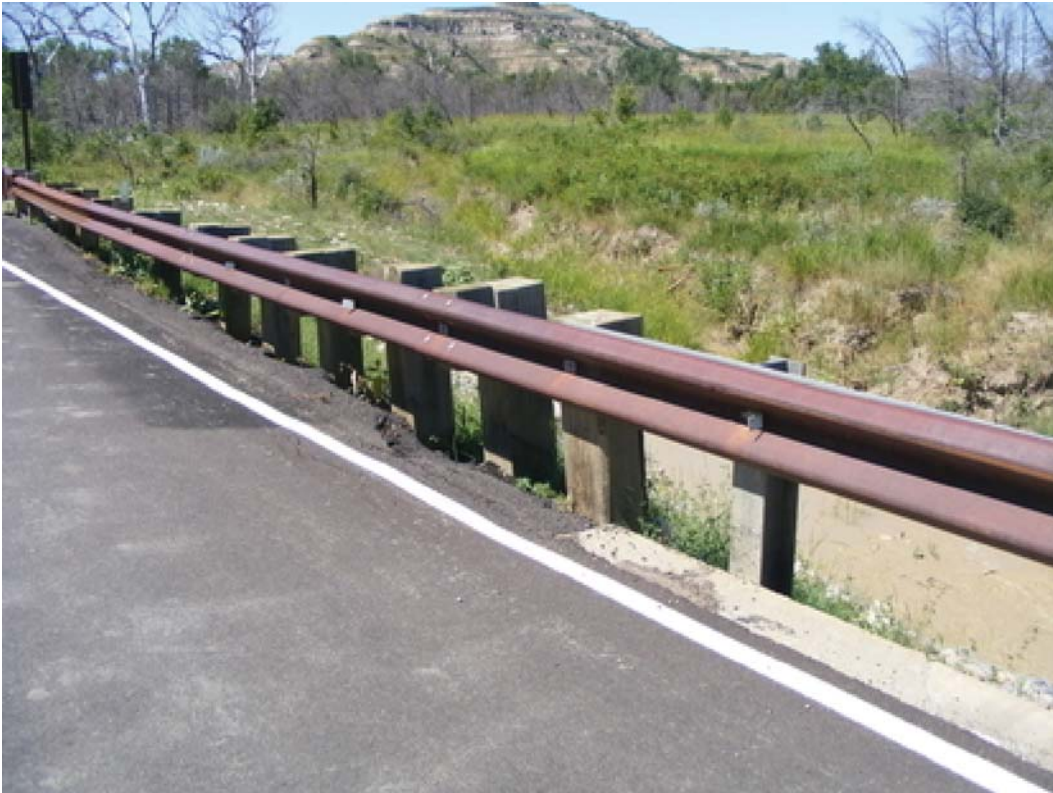
THRO_0010_4.939_R_1.JPG

Barrier ID:	THRO-0010-4.939-R				
Route Name:	SCENIC DRIVE				
Inspection Date:	10/08/2010	Barrier Rating:	19.30		
Barrier Description					
Type:	W-BEAM STRONG POST	Barrier Function:	TRAFFIC		
Barrier Material:	WEATHERING STEEL/CORTEN	Post Material:	WOOD		
Blockout Type:	WOOD	Length (ft.):	57		
Speed Limit (MPH):	25	Placement with Respect to Road:	TANGENT		
Hazard Behind Barrier:	MEDIUM				
Barrier Crashworthiness					
Appropriate Test Level:	TL-1	Barrier Test Level:	TL-3	Is Barrier Crashworthy?:	YES
Beg. End Trtmt Type:	NONE	Is Beg. End Trtmt Crashworthy?:	N/A	Approach Transition Type:	RIGID W-BEAM - W-BEAM
Ending End Trtmt Type:	W-BEAM TANGENT 350	Ending End Trtmt Crashworthy?:	YES		
Average Measurements					
Design Height (In.):	27	Width (In.):	0.0	Post Spacing (In.):	75.0
Height (In.):	25.7	Lateral Offset (In.):	20.0	Road Grade (%):	0.80
Physical Condition					
Barrier	Alignment and Height:	End treatment and transition only.

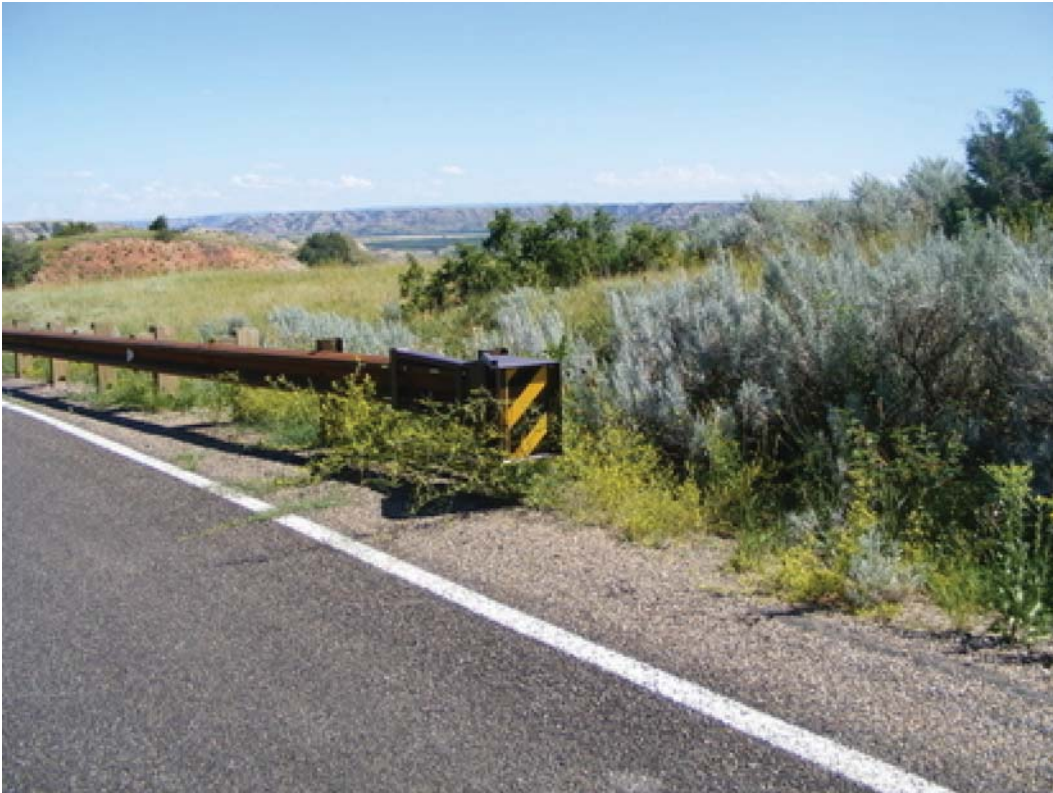
THRO_0010_7.870_L_1.JPG

Barrier ID:	THRO-0010-7.870-L				
Route Name:	SCENIC DRIVE				
Inspection Date:	10/08/2010	Barrier Rating:	31.50		
Barrier Description					
Type:	W-BEAM STRONG POST	Barrier Function:	TRAFFIC		
Barrier Material:	WEATHERING STEEL/CORTEN	Post Material:	WOOD		
Blockout Type:	WOOD	Length (ft.):	340		
Speed Limit (MPH):	25	Placement with Respect to Road:	OUTSIDE OF CURVE		
Hazard Behind Barrier:	EXTREME				
Barrier Crashworthiness					
Appropriate Test Level:	TL-1	Barrier Test Level:	TL-3	Is Barrier Crashworthy?:	YES
Beg. End Trtmt Type:	W-BEAM TANGENT 350	Is Beg. End Trtmt Crashworthy?:	YES	Approach Transition Type:	NONE
Ending End Trtmt Type:	W-BEAM TANGENT 350	Ending End Trtmt Crashworthy?:	YES		
Average Measurements					
Design Height (In.):	27	Width (In.):	0.0	Post Spacing (In.):	75.0
Height (In.):	29.2	Lateral Offset (In.):	38.2	Road Grade (%):	6.00
Physical Condition					
Barrier	Alignment and Height:	Alignment acceptable. Height was 2 to 3-in above the 27-in design height.

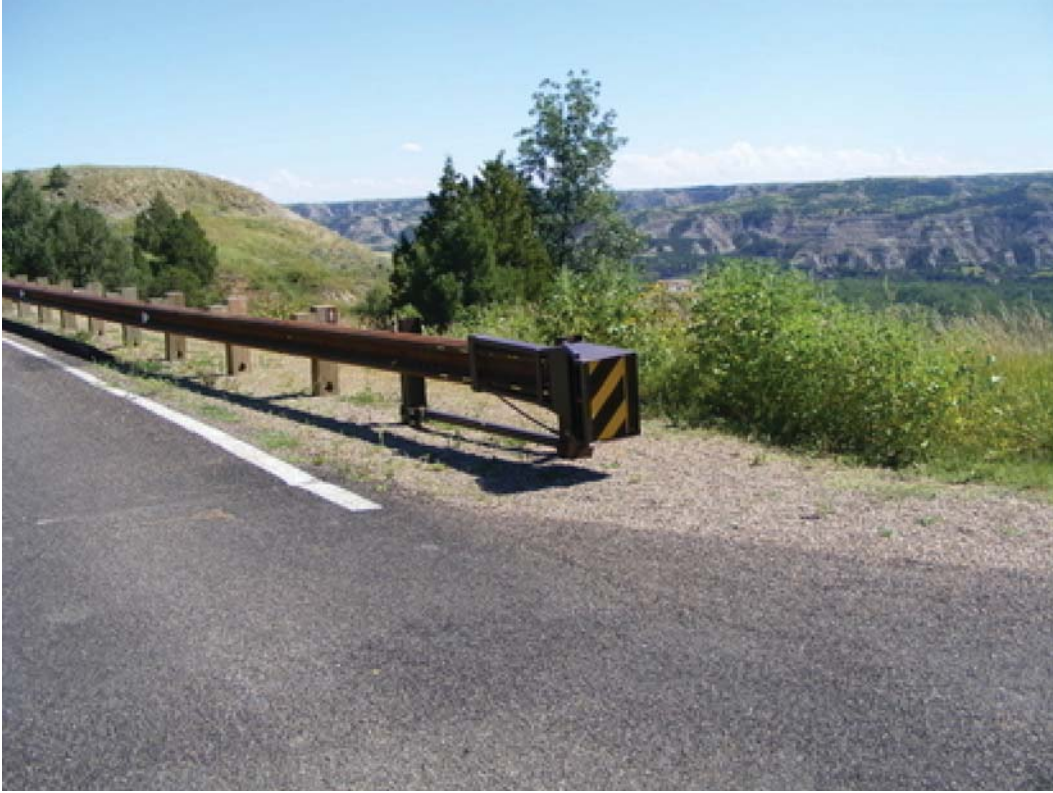
THRO_0010_7.973_L_1.JPG

Barrier ID:	THRO-0010-7.973-L				
Route Name:	SCENIC DRIVE				
Inspection Date:	10/08/2010	Barrier Rating:	27.20		
Barrier Description					
Type:	W-BEAM STRONG POST	Barrier Function:	TRAFFIC		
Barrier Material:	WEATHERING STEEL/CORTEN	Post Material:	WOOD		
Blockout Type:	WOOD	Length (ft.):	368		
Speed Limit (MPH):	25	Placement with Respect to Road:	OUTSIDE OF CURVE		
Hazard Behind Barrier:	EXTREME				
Barrier Crashworthiness					
Appropriate Test Level:	TL-1	Barrier Test Level:	TL-3	Is Barrier Crashworthy?:	YES
Beg. End Trtmt Type:	W-BEAM TANGENT 350	Is Beg. End Trtmt Crashworthy?:	YES	Approach Transition Type:	NONE
Ending End Trtmt Type:	W-BEAM TANGENT 350	Ending End Trtmt Crashworthy?:	YES		
Average Measurements					
Design Height (In.):	27	Width (In.):	0.0	Post Spacing (In.):	76.0
Height (In.):	27.2	Lateral Offset (In.):	24.2	Road Grade (%):	1.10
Physical Condition					
Barrier	Alignment and Height:	Alignment acceptable. Height within 1-in of 27-in design height.

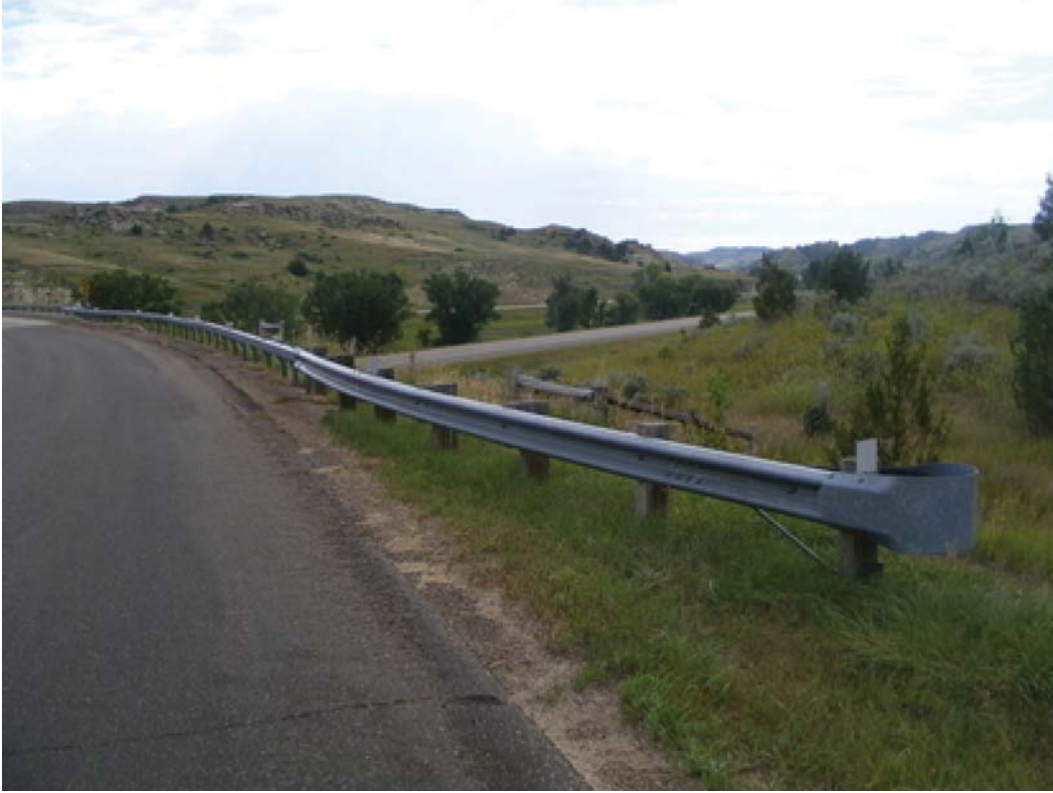
THRO_0011_2.050_R_1.JPG

Barrier ID:	THRO-0011-2.050-R				
Route Name:	SCENIC LOOP				
Inspection Date:	09/08/2010	Barrier Rating:	22.20		
Barrier Description					
Type:	BOX BEAM	Barrier Function:	TRAFFIC		
Barrier Material:	GALVANIZED STEEL	Post Material:	GALVANIZED STEEL		
Blockout Type:	STEEL	Length (ft.):	202		
Speed Limit (MPH):	35	Placement with Respect to Road:	OUTSIDE OF CURVE		
Hazard Behind Barrier:	MEDIUM				
Barrier Crashworthiness					
Appropriate Test Level:	TL-2	Barrier Test Level:	TL-3	Is Barrier Crashworthy?:	YES
Beg. End Trtmt Type:	W-BEAM BCT	Is Beg. End Trtmt Crashworthy?:	NO	Approach Transition Type:	OTHER: BRIDGE RAIL BOX BEAM
Ending End Trtmt Type:	NONE	Ending End Trtmt Crashworthy?:	N/A		
Average Measurements					
Design Height (In.):	27	Width (In.):	6.0	Post Spacing (In.):	72.0
Height (In.):	26.2	Lateral Offset (In.):	61.2	Road Grade (%):	1.20
Physical Condition					
Barrier	Alignment and Height:	Alignment acceptable. 160-ft was within 1-in of the 27-in design height and 42-ft was 1 to 2-in below because of a build up of chip seal in front of barrier.

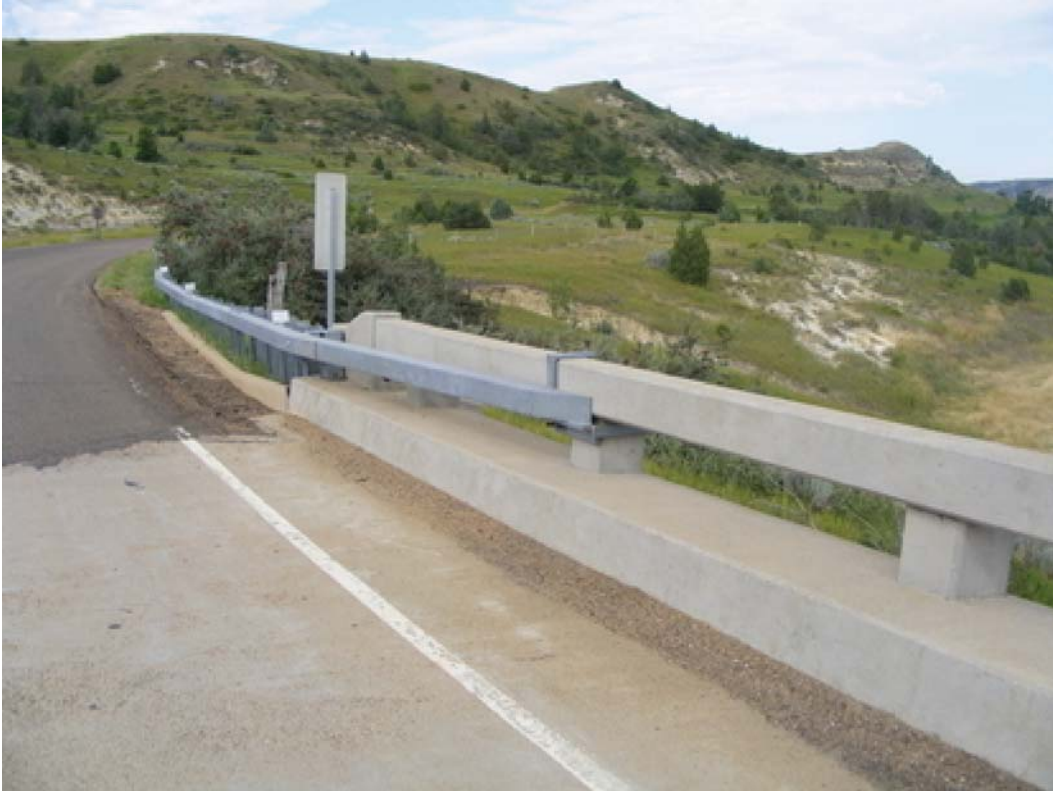
THRO_0011_2.052_L_1.JPG

Barrier ID:	THRO-0011-2.052-L				
Route Name:	SCENIC LOOP				
Inspection Date:	09/08/2010	Barrier Rating:	18.20		
Barrier Description					
Type:	BOX BEAM	Barrier Function:	TRAFFIC		
Barrier Material:	GALVANIZED STEEL	Post Material:	GALVANIZED STEEL		
Blockout Type:	STEEL	Length (ft.):	173		
Speed Limit (MPH):	35	Placement with Respect to Road:	INSIDE OF CURVE		
Hazard Behind Barrier:	HIGH				
Barrier Crashworthiness					
Appropriate Test Level:	TL-2	Barrier Test Level:	TL-3	Is Barrier Crashworthy?:	YES
Beg. End Trtmt Type:	NONE	Is Beg. End Trtmt Crashworthy?:	N/A	Approach Transition Type:	OTHER: BRIDGE RAIL BOX BEAM
Ending End Trtmt Type:	W-BEAM BCT	Ending End Trtmt Crashworthy?:	NO		
Average Measurements					
Design Height (In.):	27	Width (In.):	6.0	Post Spacing (In.):	72.0
Height (In.):	26.7	Lateral Offset (In.):	77.0	Road Grade (%):	0.30
Physical Condition					
Barrier	Alignment and Height:	Alignment acceptable. Height within 1-in of 27-in design height.

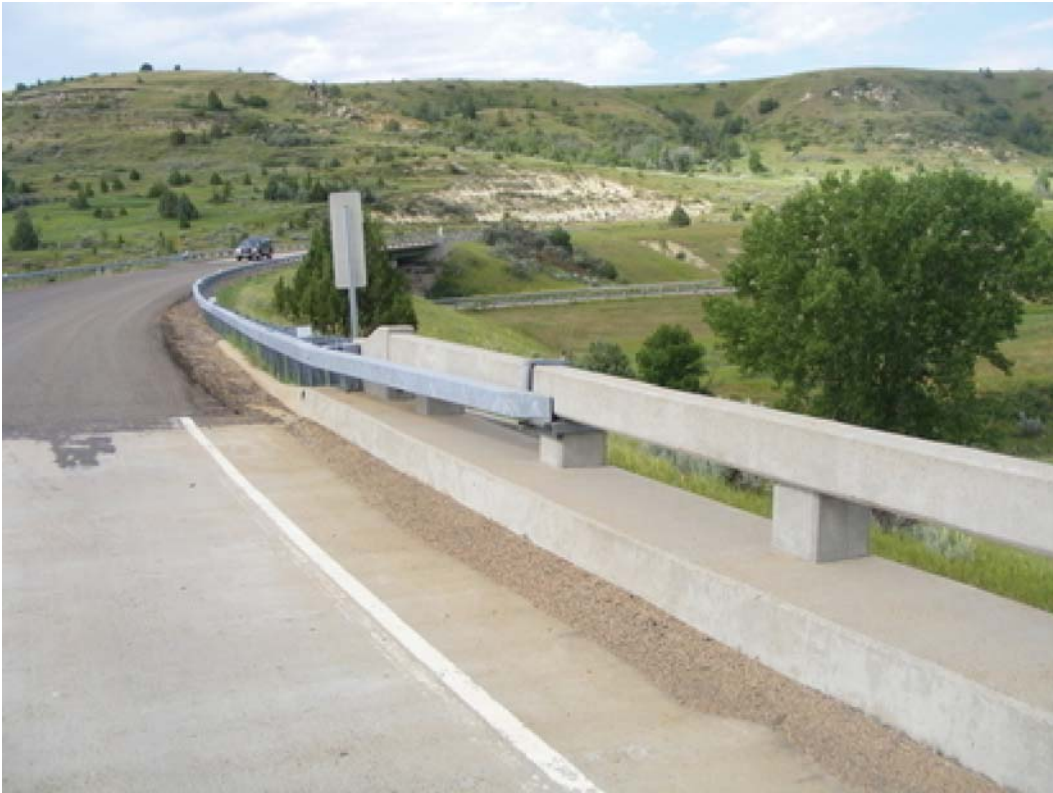
THRO_0011_2.106_L_1.JPG

Barrier ID:	THRO-0011-2.106-L				
Route Name:	SCENIC LOOP				
Inspection Date:	09/08/2010	Barrier Rating:	45.50		
Barrier Description					
Type:	BOX BEAM	Barrier Function:	TRAFFIC		
Barrier Material:	GALVANIZED STEEL	Post Material:	GALVANIZED STEEL		
Blockout Type:	STEEL	Length (ft.):	325		
Speed Limit (MPH):	35	Placement with Respect to Road:	INSIDE OF CURVE		
Hazard Behind Barrier:	HIGH				
Barrier Crashworthiness					
Appropriate Test Level:	TL-2	Barrier Test Level:	TL-3	Is Barrier Crashworthy?:	YES
Beg. End Trtmt Type:	NONE	Is Beg. End Trtmt Crashworthy?:	N/A	Approach Transition Type:	OTHER: BRIDGE RAIL BOX BEAM
Ending End Trtmt Type:	NONE	Ending End Trtmt Crashworthy?:	N/A		
Average Measurements					
Design Height (In.):	27	Width (In.):	6.0	Post Spacing (In.):	72.0
Height (In.):	21.0	Lateral Offset (In.):	44.0	Road Grade (%):	0.30
Physical Condition					
Barrier	Alignment and Height:	Alignment acceptable. Height was 5 to 7-in below the 27-in design height.

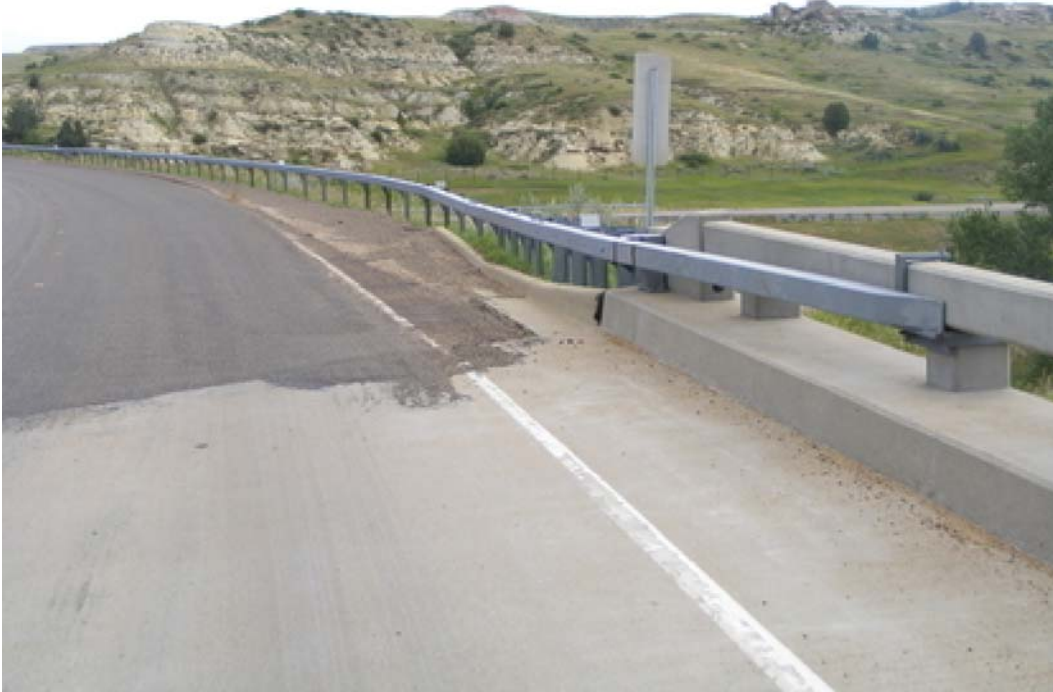
THRO_0011_2.110_R_1.JPG

Barrier ID:	THRO-0011-2.110-R				
Route Name:	SCENIC LOOP				
Inspection Date:	09/08/2010	Barrier Rating:	26.80		
Barrier Description					
Type:	BOX BEAM	Barrier Function:	TRAFFIC		
Barrier Material:	GALVANIZED STEEL	Post Material:	GALVANIZED STEEL		
Blockout Type:	STEEL	Length (ft.):	312		
Speed Limit (MPH):	35	Placement with Respect to Road:	OUTSIDE OF CURVE		
Hazard Behind Barrier:	HIGH				
Barrier Crashworthiness					
Appropriate Test Level:	TL-2	Barrier Test Level:	TL-3	Is Barrier Crashworthy?:	YES
Beg. End Trtmt Type:	NONE	Is Beg. End Trtmt Crashworthy?:	N/A	Approach Transition Type:	OTHER: BRIDGE RAIL BOX BEAM
Ending End Trtmt Type:	NONE	Ending End Trtmt Crashworthy?:	N/A		
Average Measurements					
Design Height (In.):	27	Width (In.):	6.0	Post Spacing (In.):	72.0
Height (In.):	27.0	Lateral Offset (In.):	74.3	Road Grade (%):	0.70
Physical Condition					
Barrier	Alignment and Height:	Alignment acceptable. Height within 1-in of 27-in design height.

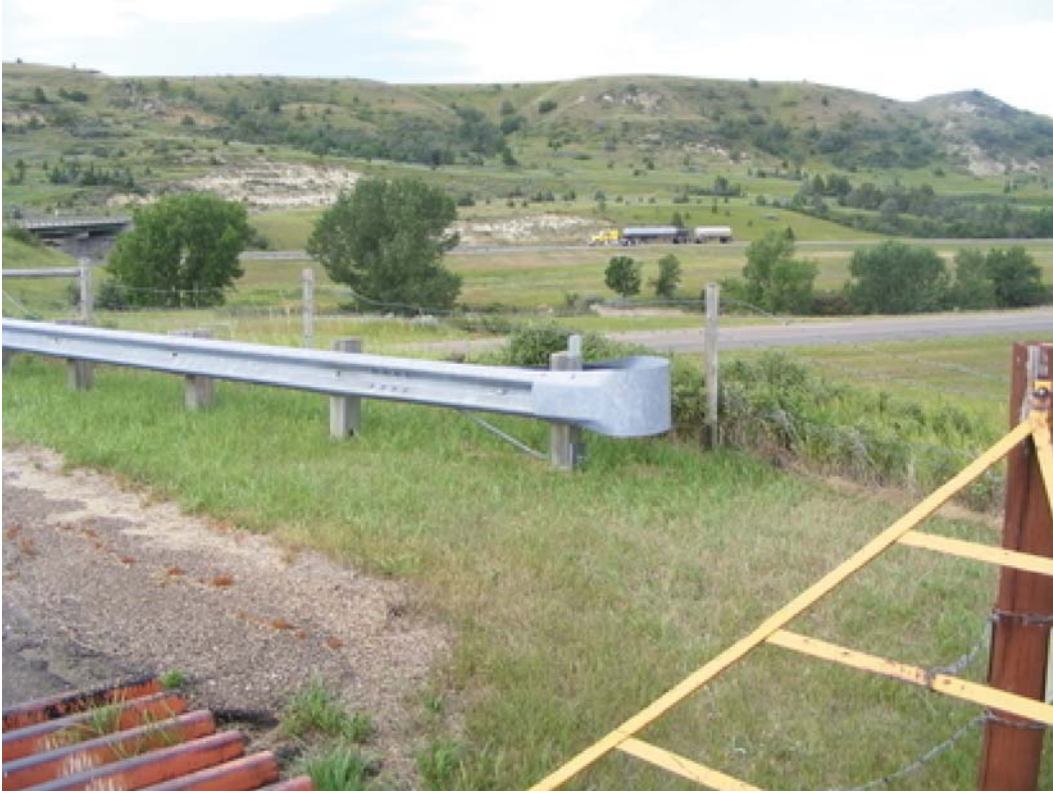
THRO_0011_2.189_L_1.JPG

Barrier ID:	THRO-0011-2.189-L				
Route Name:	SCENIC LOOP				
Inspection Date:	09/08/2010	Barrier Rating:	35.50		
Barrier Description					
Type:	BOX BEAM	Barrier Function:	TRAFFIC		
Barrier Material:	GALVANIZED STEEL	Post Material:	GALVANIZED STEEL		
Blockout Type:	STEEL	Length (ft.):	150		
Speed Limit (MPH):	35	Placement with Respect to Road:	INSIDE OF CURVE		
Hazard Behind Barrier:	HIGH				
Barrier Crashworthiness					
Appropriate Test Level:	TL-2	Barrier Test Level:	TL-3	Is Barrier Crashworthy?:	YES
Beg. End Trtmt Type:	W-BEAM BCT	Is Beg. End Trtmt Crashworthy?:	NO	Approach Transition Type:	OTHER: BRIDGE RAIL BOX BEAM
Ending End Trtmt Type:	NONE	Ending End Trtmt Crashworthy?:	N/A		
Average Measurements					
Design Height (In.):	27	Width (In.):	6.0	Post Spacing (In.):	71.6
Height (In.):	22.7	Lateral Offset (In.):	56.2	Road Grade (%):	0.10
Physical Condition					
Barrier	Alignment and Height:	Alignment acceptable. Height was 2 to 8-in below the 27-in design height.

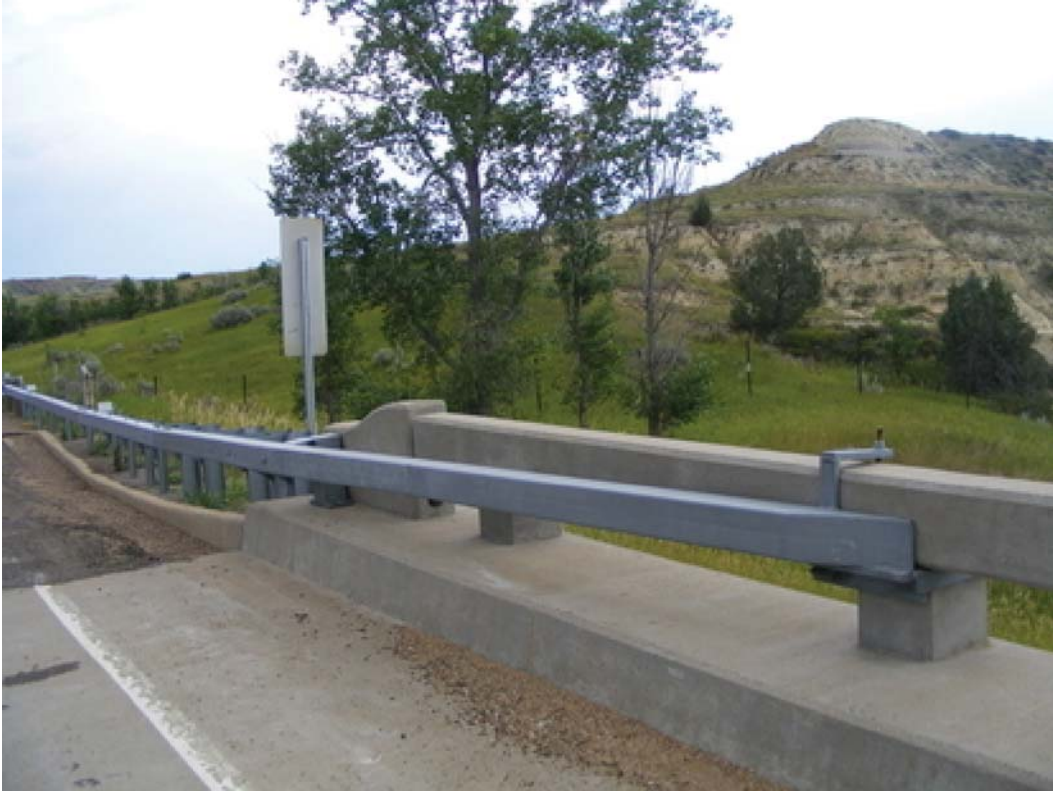
THRO_0011_2.189_R_1.JPG

Barrier ID:	THRO-0011-2.189-R				
Route Name:	SCENIC LOOP				
Inspection Date:	09/08/2010	Barrier Rating:	19.70		
Barrier Description					
Type:	BOX BEAM	Barrier Function:	TRAFFIC		
Barrier Material:	GALVANIZED STEEL	Post Material:	GALVANIZED STEEL		
Blockout Type:	STEEL	Length (ft.):	110		
Speed Limit (MPH):	35	Placement with Respect to Road:	OUTSIDE OF CURVE		
Hazard Behind Barrier:	LOW				
Barrier Crashworthiness					
Appropriate Test Level:	TL-2	Barrier Test Level:	TL-3	Is Barrier Crashworthy?:	YES
Beg. End Trtmt Type:	NONE	Is Beg. End Trtmt Crashworthy?:	N/A	Approach Transition Type:	OTHER: BRIDGE RAIL BOX BEAM
Ending End Trtmt Type:	W-BEAM BCT	Ending End Trtmt Crashworthy?:	NO		
Average Measurements					
Design Height (In.):	27	Width (In.):	6.0	Post Spacing (In.):	64.0
Height (In.):	27.6	Lateral Offset (In.):	77.3	Road Grade (%):	0.90
Physical Condition					
Barrier	Alignment and Height:	Alignment acceptable. Height was between 1-in below to 3-in above the 27-in design height.

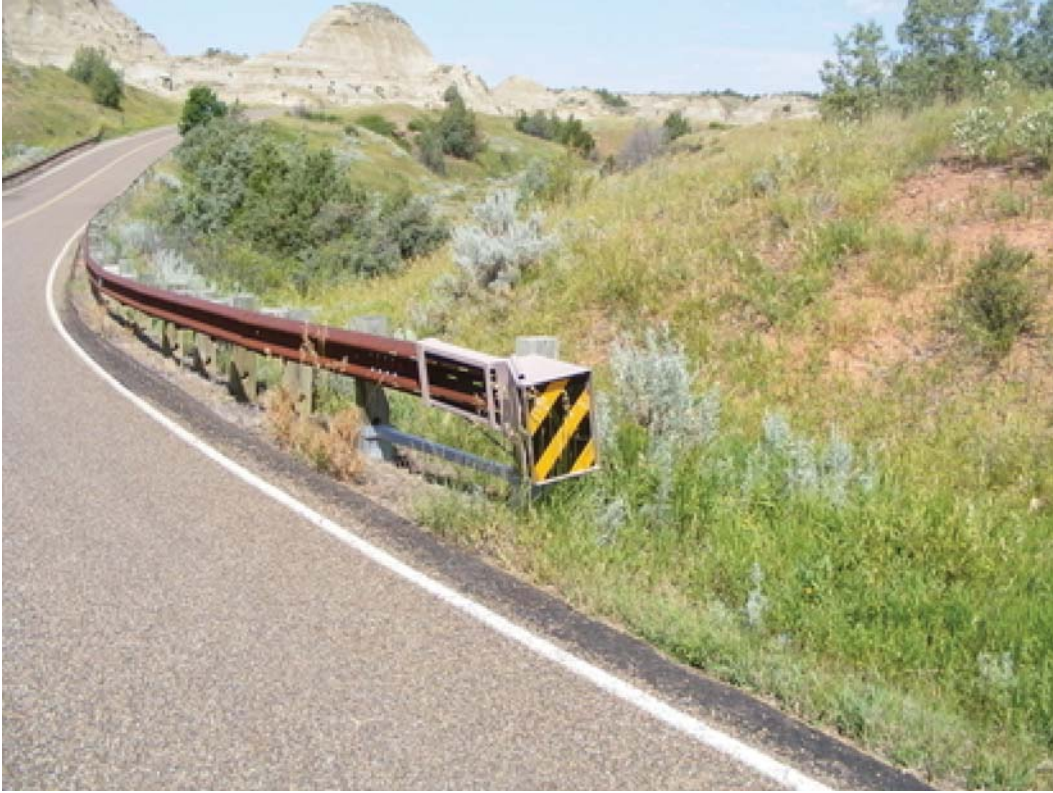
THRO_0011_10.069_L_1.JPG

Barrier ID:	THRO-0011-10.069-L				
Route Name:	SCENIC LOOP				
Inspection Date:	09/08/2010	Barrier Rating:	29.60		
Barrier Description					
Type:	W-BEAM STRONG POST	Barrier Function:	TRAFFIC		
Barrier Material:	WEATHERING STEEL/CORTEN	Post Material:	WOOD		
Blockout Type:	WOOD	Length (ft.):	421		
Speed Limit (MPH):	25	Placement with Respect to Road:	INSIDE OF CURVE		
Hazard Behind Barrier:	MEDIUM				
Barrier Crashworthiness					
Appropriate Test Level:	TL-1	Barrier Test Level:	TL-3	Is Barrier Crashworthy?:	YES
Beg. End Trtmt Type:	W-BEAM TANGENT 350	Is Beg. End Trtmt Crashworthy?:	YES	Approach Transition Type:	NONE
Ending End Trtmt Type:	W-BEAM TANGENT 350	Ending End Trtmt Crashworthy?:	YES		
Average Measurements					
Design Height (In.):	27	Width (In.):	0.0	Post Spacing (In.):	74.0
Height (In.):	25.0	Lateral Offset (In.):	23.2	Road Grade (%):	2.90
Physical Condition					
Barrier	Alignment and Height:	Alignment acceptable. 126-ft was within 1-in of the 27-in design height and 245-ft was 1 to 3-in below.

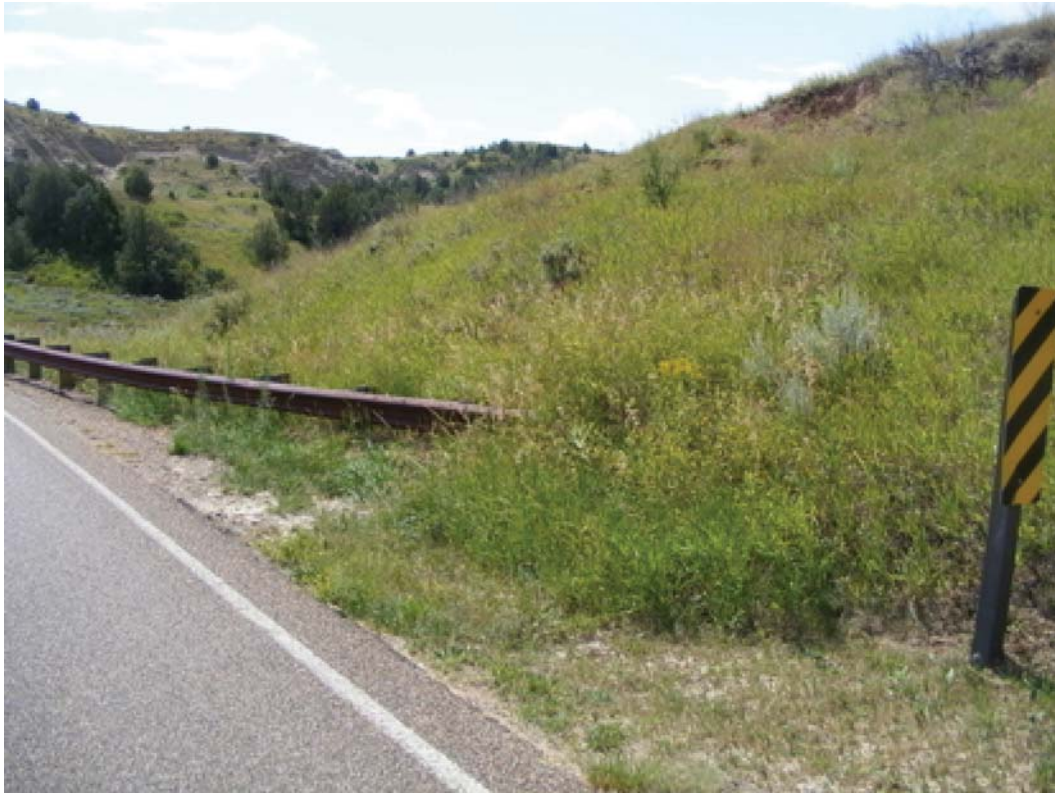
THRO_0011_10.077_R_1.JPG

Barrier ID:	THRO-0011-10.077-R				
Route Name:	SCENIC LOOP				
Inspection Date:	09/08/2010	Barrier Rating:	34.20		
Barrier Description					
Type:	W-BEAM STRONG POST	Barrier Function:	TRAFFIC		
Barrier Material:	WEATHERING STEEL/CORTEN	Post Material:	WOOD		
Blockout Type:	WOOD	Length (ft.):	372		
Speed Limit (MPH):	25	Placement with Respect to Road:	OUTSIDE OF CURVE		
Hazard Behind Barrier:	HIGH				
Barrier Crashworthiness					
Appropriate Test Level:	TL-1	Barrier Test Level:	TL-3	Is Barrier Crashworthy?:	YES
Beg. End Trtmt Type:	W-BEAM BURIED END	Is Beg. End Trtmt Crashworthy?:	YES	Approach Transition Type:	NONE
Ending End Trtmt Type:	W-BEAM TANGENT 350	Ending End Trtmt Crashworthy?:	YES		
Average Measurements					
Design Height (In.):	27	Width (In.):	0.0	Post Spacing (In.):	74.5
Height (In.):	25.6	Lateral Offset (In.):	27.2	Road Grade (%):	1.80
Physical Condition					
Barrier	Alignment and Height:	Alignment acceptable. The height is 1 to 3-in below the 27 in design height for 372-ft.

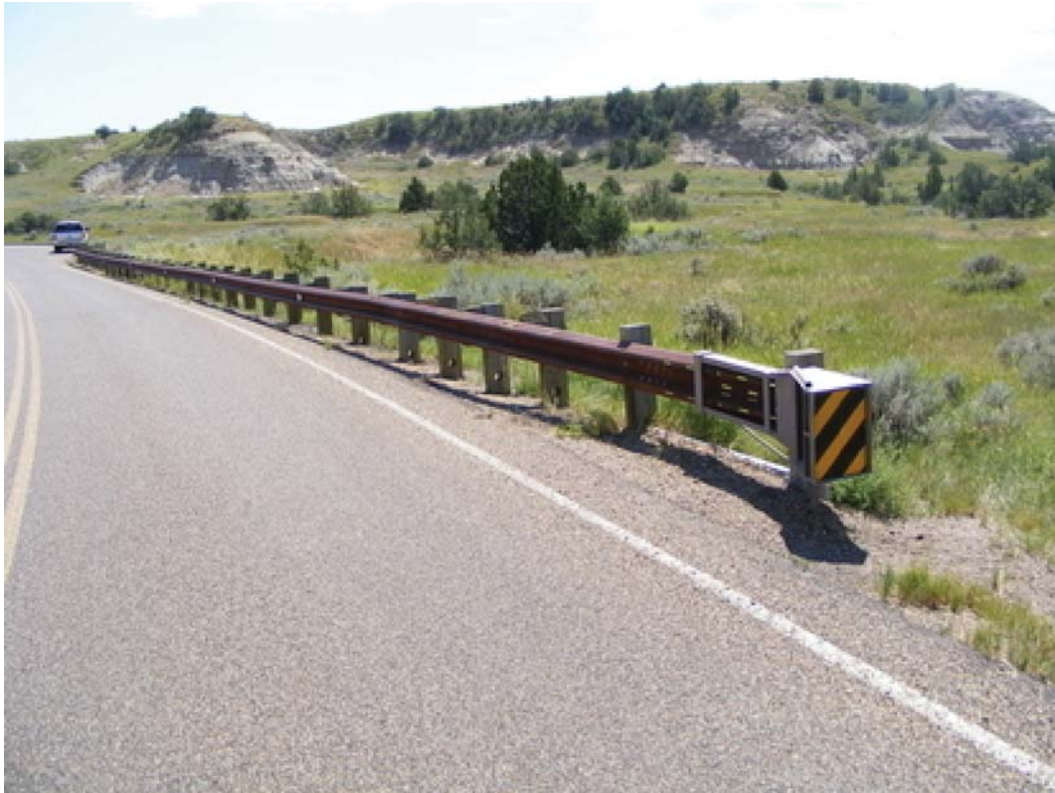
THRO_0011_11.795_R_1.JPG

Barrier ID:	THRO-0011-11.795-R				
Route Name:	SCENIC LOOP				
Inspection Date:	09/08/2010	Barrier Rating:	25.20		
Barrier Description					
Type:	W-BEAM STRONG POST	Barrier Function:	TRAFFIC		
Barrier Material:	WEATHERING STEEL/CORTEN	Post Material:	WOOD		
Blockout Type:	WOOD	Length (ft.):	230		
Speed Limit (MPH):	25	Placement with Respect to Road:	OUTSIDE OF CURVE		
Hazard Behind Barrier:	MEDIUM				
Barrier Crashworthiness					
Appropriate Test Level:	TL-1	Barrier Test Level:	TL-3	Is Barrier Crashworthy?:	YES
Beg. End Trtmt Type:	W-BEAM TANGENT 350	Is Beg. End Trtmt Crashworthy?:	YES	Approach Transition Type:	NONE
Ending End Trtmt Type:	W-BEAM FLARED 350 COMPLIANT	Ending End Trtmt Crashworthy?:	YES		
Average Measurements					
Design Height (In.):	27	Width (In.):	0.0	Post Spacing (In.):	74.5
Height (In.):	26.0	Lateral Offset (In.):	24.2	Road Grade (%):	2.80
Physical Condition					
Barrier	Alignment and Height:	Alignment acceptable. 132-ft was 1 to 2-in below the 27-in design height and 98-ft was within 1-in.

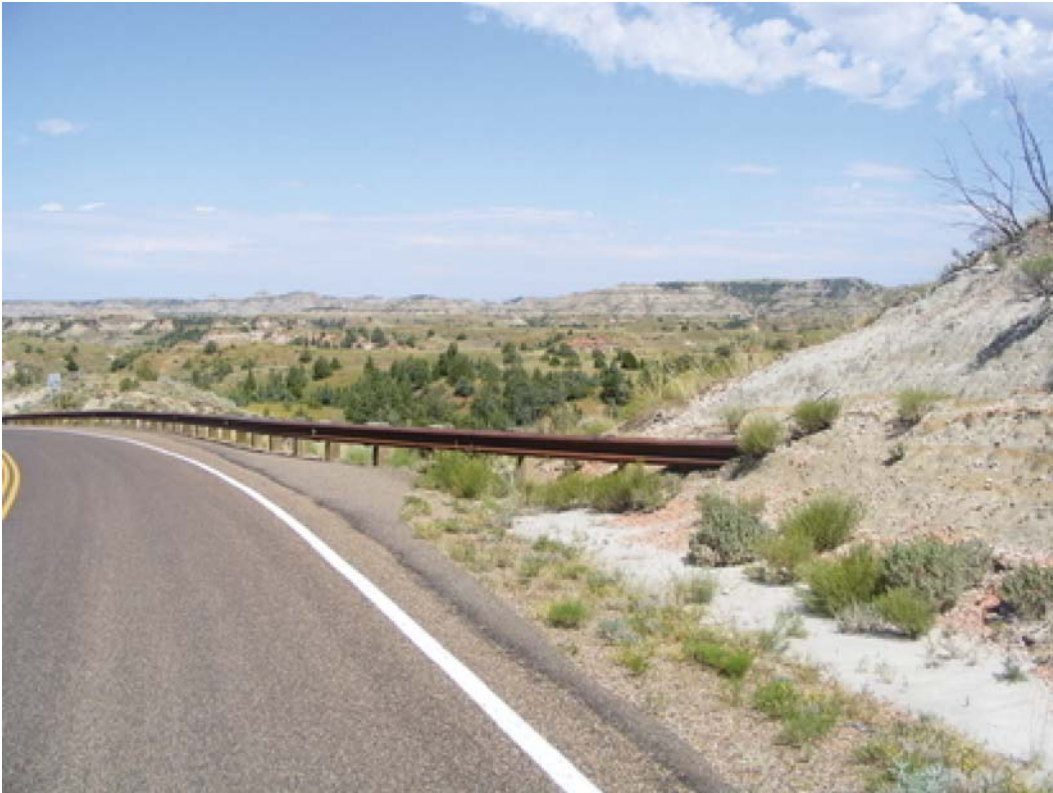
THRO_0011_12.887_R_1.JPG

Barrier ID:	THRO-0011-12.887-R				
Route Name:	SCENIC LOOP				
Inspection Date:	09/08/2010	Barrier Rating:	26.50		
Barrier Description					
Type:	W-BEAM STRONG POST	Barrier Function:	TRAFFIC		
Barrier Material:	WEATHERING STEEL/CORTEN	Post Material:	WOOD		
Blockout Type:	WOOD	Length (ft.):	214		
Speed Limit (MPH):	25	Placement with Respect to Road:	OUTSIDE OF CURVE		
Hazard Behind Barrier:	MEDIUM				
Barrier Crashworthiness					
Appropriate Test Level:	TL-1	Barrier Test Level:	TL-3	Is Barrier Crashworthy?:	YES
Beg. End Trtmt Type:	NONE	Is Beg. End Trtmt Crashworthy?:	N/A	Approach Transition Type:	NONE
Ending End Trtmt Type:	W-BEAM TANGENT 350	Ending End Trtmt Crashworthy?:	YES		
Average Measurements					
Design Height (In.):	27	Width (In.):	0.0	Post Spacing (In.):	74.5
Height (In.):	26.2	Lateral Offset (In.):	51.2	Road Grade (%):	6.90
Physical Condition					
Barrier	Alignment and Height:	Alignment acceptable. Height within 1-in of 27-in design height.
