GIP Report

**NPS Guardwall/Rail Inventory Program
Theodore Roosevelt National Park**

**Federal Lands Highway
Road Inventory Program**

**Data Collection Date: August 2010
Report Date: November 2015**

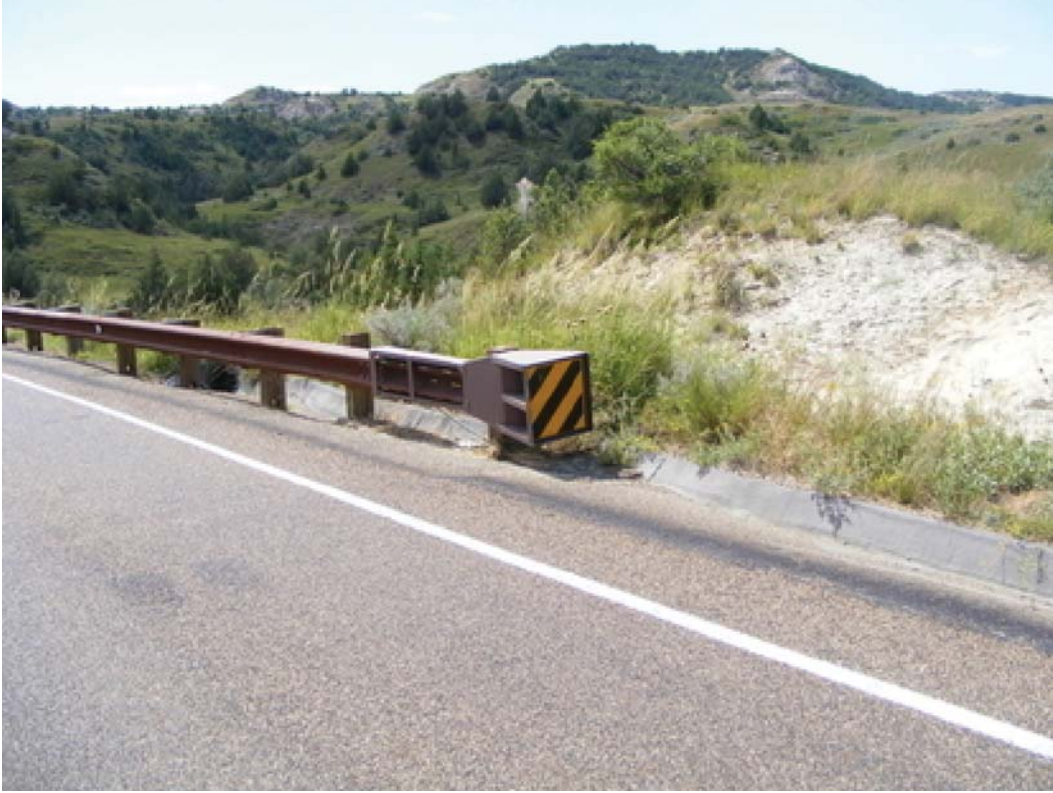
THRO_0011_13.643_L_1.JPG

Barrier ID:	THRO-0011-13.643-L				
Route Name:	SCENIC LOOP				
Inspection Date:	09/08/2010	Barrier Rating:	34.00		
Barrier Description					
Type:	W-BEAM STRONG POST	Barrier Function:	TRAFFIC		
Barrier Material:	WEATHERING STEEL/CORTEN	Post Material:	WOOD		
Blockout Type:	WOOD	Length (ft.):	382		
Speed Limit (MPH):	25	Placement with Respect to Road:	OUTSIDE OF CURVE		
Hazard Behind Barrier:	HIGH				
Barrier Crashworthiness					
Appropriate Test Level:	TL-1	Barrier Test Level:	TL-3	Is Barrier Crashworthy?:	YES
Beg. End Trtmt Type:	W-BEAM TANGENT 350	Is Beg. End Trtmt Crashworthy?:	YES	Approach Transition Type:	NONE
Ending End Trtmt Type:	W-BEAM TANGENT 350	Ending End Trtmt Crashworthy?:	YES		
Average Measurements					
Design Height (In.):	27	Width (In.):	0.0	Post Spacing (In.):	74.6
Height (In.):	27.7	Lateral Offset (In.):	32.0	Road Grade (%):	6.90
Physical Condition					
Barrier	Alignment and Height:	Alignment acceptable. 40-ft was 1 to 3-in below the 27-in design height and 342-ft was within 1-in.

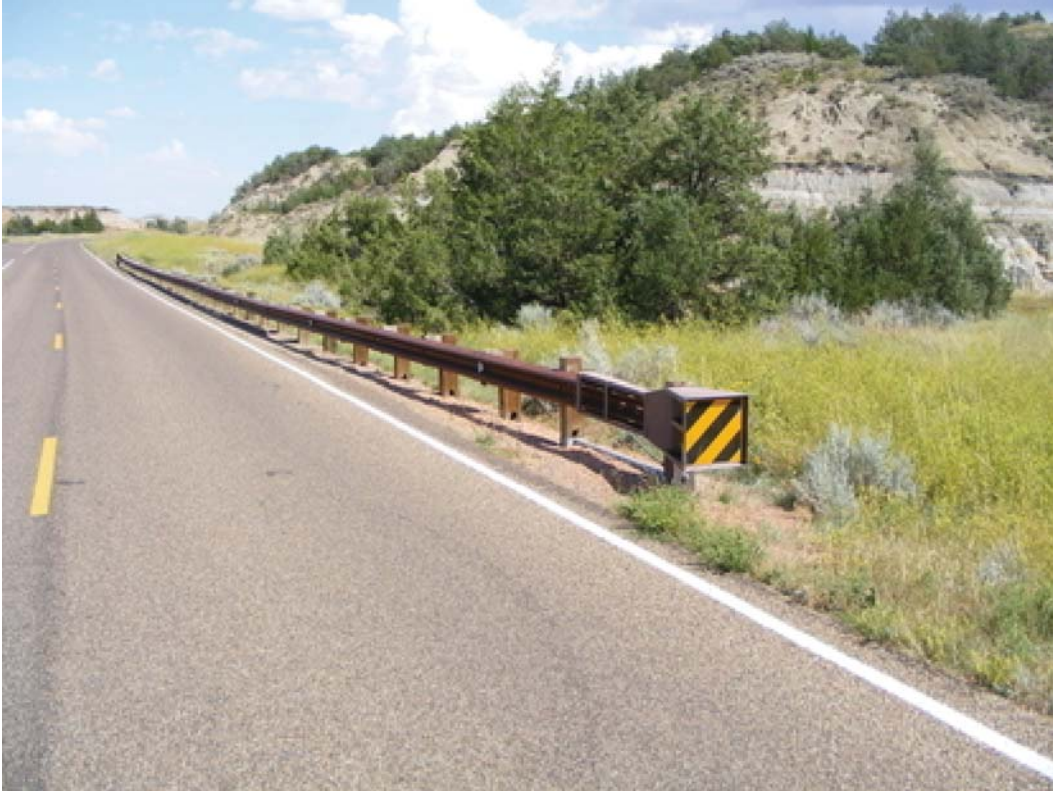
THRO_0011_16.062_R_1.JPG

Barrier ID:	THRO-0011-16.062-R				
Route Name:	SCENIC LOOP				
Inspection Date:	09/08/2010	Barrier Rating:	15.10		
Barrier Description					
Type:	W-BEAM STRONG POST	Barrier Function:	TRAFFIC		
Barrier Material:	WEATHERING STEEL/CORTEN	Post Material:	WOOD		
Blockout Type:	WOOD	Length (ft.):	283		
Speed Limit (MPH):	25	Placement with Respect to Road:	TANGENT		
Hazard Behind Barrier:	MEDIUM				
Barrier Crashworthiness					
Appropriate Test Level:	TL-1	Barrier Test Level:	TL-3	Is Barrier Crashworthy?:	YES
Beg. End Trtmt Type:	W-BEAM TANGENT 350	Is Beg. End Trtmt Crashworthy?:	YES	Approach Transition Type:	NONE
Ending End Trtmt Type:	W-BEAM TANGENT 350	Ending End Trtmt Crashworthy?:	YES		
Average Measurements					
Design Height (In.):	27	Width (In.):	0.0	Post Spacing (In.):	74.5
Height (In.):	26.2	Lateral Offset (In.):	27.6	Road Grade (%):	0.40
Physical Condition					
Barrier	Alignment and Height:	Alignment acceptable. Height within 1-in of 27-in design height.

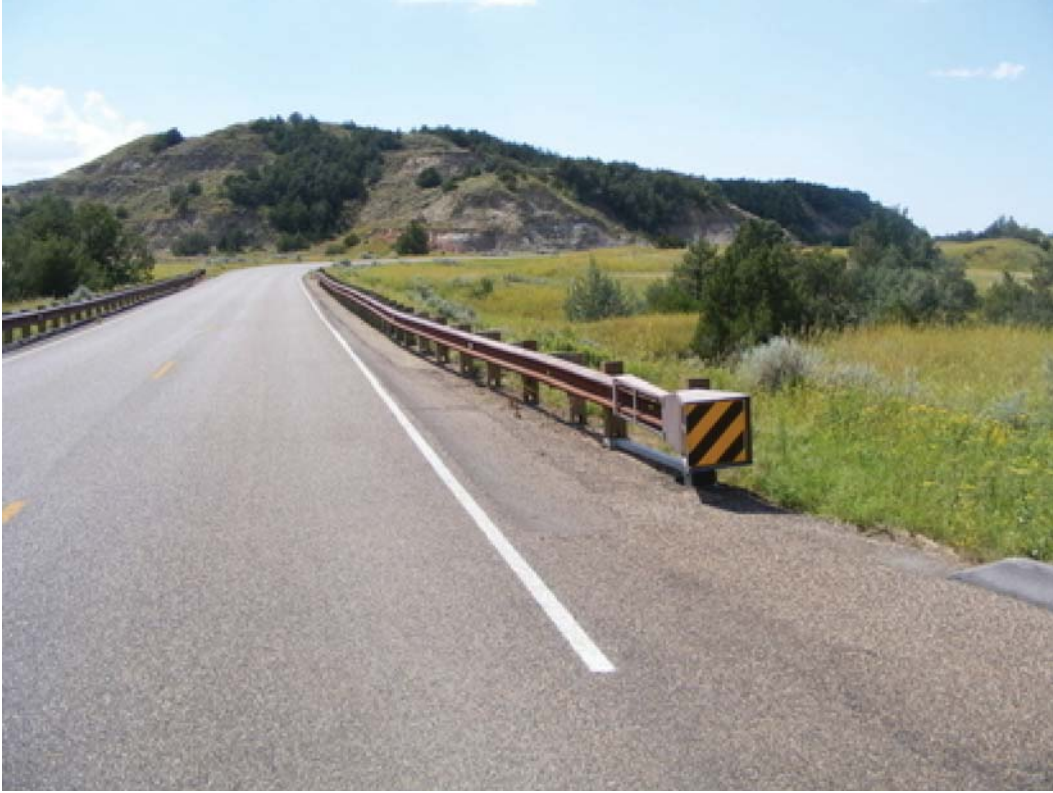
THRO_0011_16.063_L_1.JPG

Barrier ID:	THRO-0011-16.063-L				
Route Name:	SCENIC LOOP				
Inspection Date:	09/08/2010	Barrier Rating:	15.10		
Barrier Description					
Type:	W-BEAM STRONG POST	Barrier Function:	TRAFFIC		
Barrier Material:	WEATHERING STEEL/CORTEN	Post Material:	WOOD		
Blockout Type:	WOOD	Length (ft.):	280		
Speed Limit (MPH):	25	Placement with Respect to Road:	TANGENT		
Hazard Behind Barrier:	MEDIUM				
Barrier Crashworthiness					
Appropriate Test Level:	TL-1	Barrier Test Level:	TL-3	Is Barrier Crashworthy?:	YES
Beg. End Trtmt Type:	W-BEAM FLARED 350 COMPLIANT	Is Beg. End Trtmt Crashworthy?:	YES	Approach Transition Type:	NONE
Ending End Trtmt Type:	W-BEAM TANGENT 350	Ending End Trtmt Crashworthy?:	YES		
Average Measurements					
Design Height (In.):	27	Width (In.):	0.0	Post Spacing (In.):	75.0
Height (In.):	29.0	Lateral Offset (In.):	35.0	Road Grade (%):	0.80
Physical Condition					
Barrier	Alignment and Height:	Alignment acceptable. Height was 1 to 3-in above the 27-in design height.

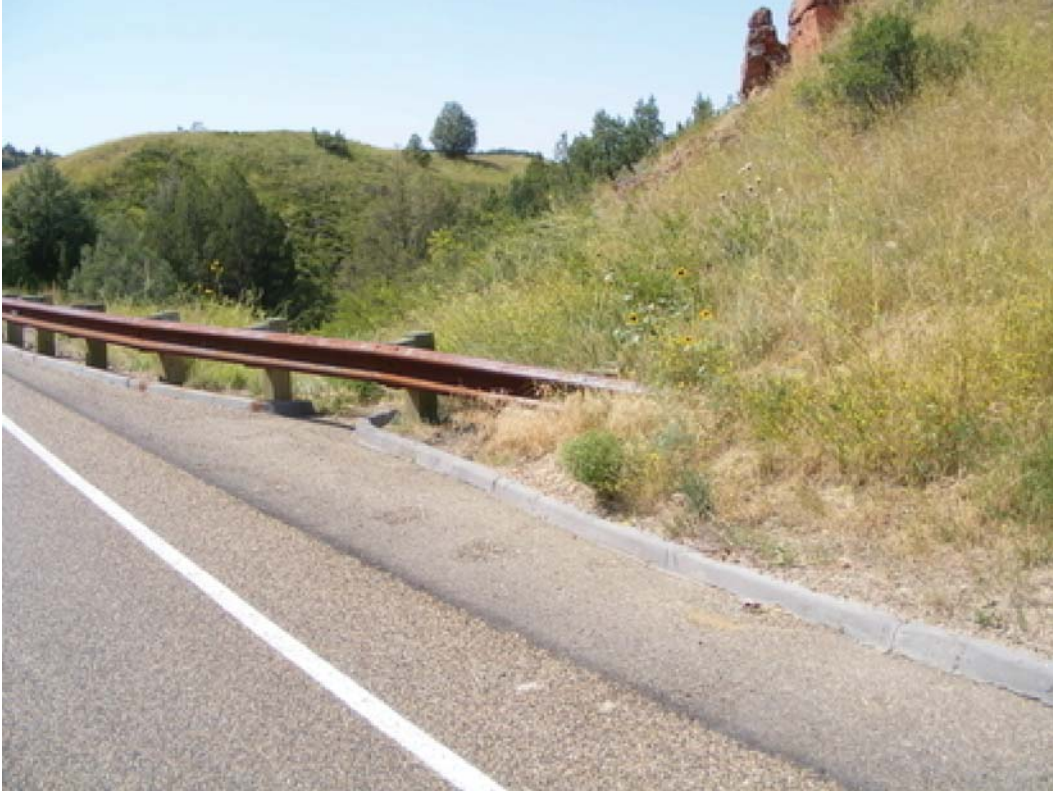
THRO_0011_16.649_L_1.JPG

Barrier ID:	THRO-0011-16.649-L				
Route Name:	SCENIC LOOP				
Inspection Date:	09/08/2010	Barrier Rating:	14.00		
Barrier Description					
Type:	W-BEAM STRONG POST	Barrier Function:	TRAFFIC		
Barrier Material:	WEATHERING STEEL/CORTEN	Post Material:	WOOD		
Blockout Type:	WOOD	Length (ft.):	238		
Speed Limit (MPH):	25	Placement with Respect to Road:	TANGENT		
Hazard Behind Barrier:	HIGH				
Barrier Crashworthiness					
Appropriate Test Level:	TL-1	Barrier Test Level:	TL-3	Is Barrier Crashworthy?:	YES
Beg. End Trtmt Type:	W-BEAM BURIED END	Is Beg. End Trtmt Crashworthy?:	YES	Approach Transition Type:	NONE
Ending End Trtmt Type:	W-BEAM FLARED 350 COMPLIANT	Ending End Trtmt Crashworthy?:	YES		
Average Measurements					
Design Height (In.):	27	Width (In.):	0.0	Post Spacing (In.):	75.0
Height (In.):	27.2	Lateral Offset (In.):	30.0	Road Grade (%):	1.40
Physical Condition					
Barrier	Alignment and Height:	Alignment acceptable. Height within 1-in of 27-in design height.

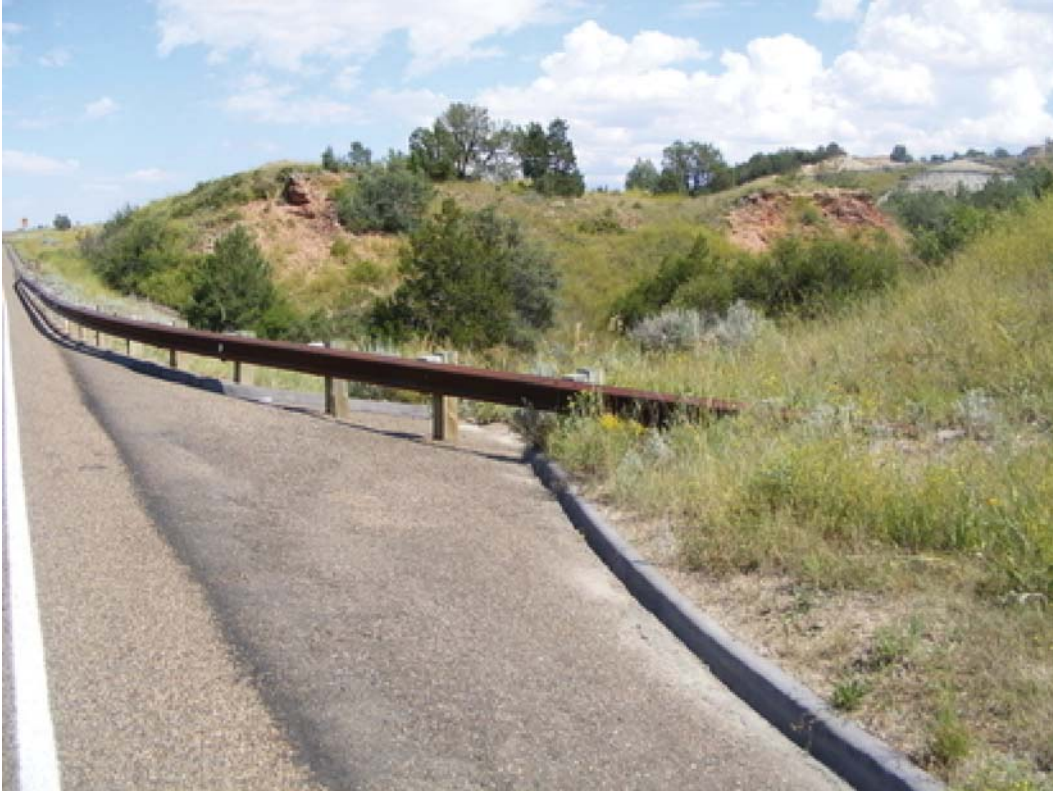
THRO_0011_16.659_R_1.JPG

Barrier ID:	THRO-0011-16.659-R				
Route Name:	SCENIC LOOP				
Inspection Date:	09/08/2010	Barrier Rating:	14.00		
Barrier Description					
Type:	W-BEAM STRONG POST	Barrier Function:	TRAFFIC		
Barrier Material:	WEATHERING STEEL/CORTEN	Post Material:	WOOD		
Blockout Type:	WOOD	Length (ft.):	215		
Speed Limit (MPH):	25	Placement with Respect to Road:	TANGENT		
Hazard Behind Barrier:	HIGH				
Barrier Crashworthiness					
Appropriate Test Level:	TL-1	Barrier Test Level:	TL-3	Is Barrier Crashworthy?:	YES
Beg. End Trtmt Type:	W-BEAM BURIED END	Is Beg. End Trtmt Crashworthy?:	YES	Approach Transition Type:	NONE
Ending End Trtmt Type:	W-BEAM FLARED 350 COMPLIANT	Ending End Trtmt Crashworthy?:	YES		
Average Measurements					
Design Height (In.):	27	Width (In.):	0.0	Post Spacing (In.):	75.0
Height (In.):	26.2	Lateral Offset (In.):	29.7	Road Grade (%):	1.70
Physical Condition					
Barrier	Alignment and Height:	Alignment acceptable. 55-ft was 1 to 3-in below the 27-in design height and 160-ft was within 1-in.

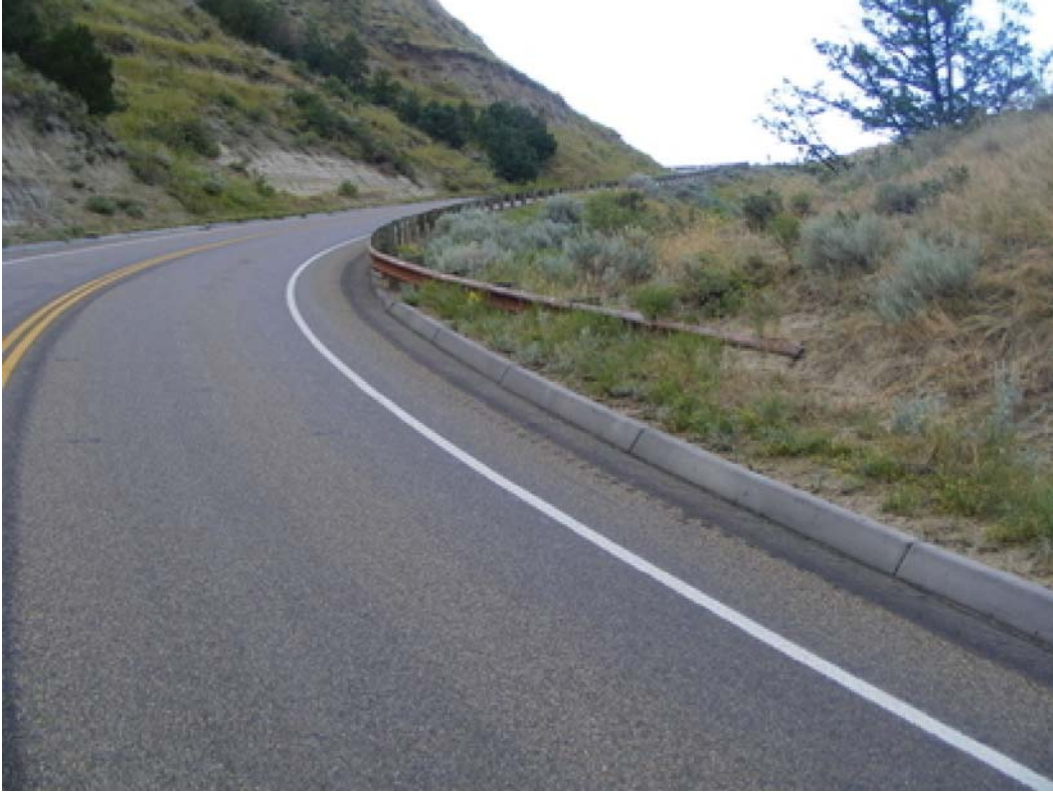
THRO_0011_18.762_R_1.JPG

Barrier ID:	THRO-0011-18.762-R				
Route Name:	SCENIC LOOP				
Inspection Date:	09/08/2010	Barrier Rating:	28.10		
Barrier Description					
Type:	W-BEAM STRONG POST	Barrier Function:	TRAFFIC		
Barrier Material:	WEATHERING STEEL/CORTEN	Post Material:	WOOD		
Blockout Type:	WOOD	Length (ft.):	670		
Speed Limit (MPH):	25	Placement with Respect to Road:	OUTSIDE OF CURVE		
Hazard Behind Barrier:	MEDIUM				
Barrier Crashworthiness					
Appropriate Test Level:	TL-1	Barrier Test Level:	TL-3	Is Barrier Crashworthy?:	YES
Beg. End Trtmt Type:	W-BEAM BURIED END	Is Beg. End Trtmt Crashworthy?:	YES	Approach Transition Type:	NONE
Ending End Trtmt Type:	W-BEAM FLARED 350 COMPLIANT	Ending End Trtmt Crashworthy?:	YES		
Average Measurements					
Design Height (In.):	27	Width (In.):	0.0	Post Spacing (In.):	76.0
Height (In.):	26.2	Lateral Offset (In.):	38.0	Road Grade (%):	8.10
Physical Condition					
Barrier	Alignment and Height:	Alignment acceptable. 255-ft was 1 to 3-in below the 27-in design height and 415-ft was within 1-in.

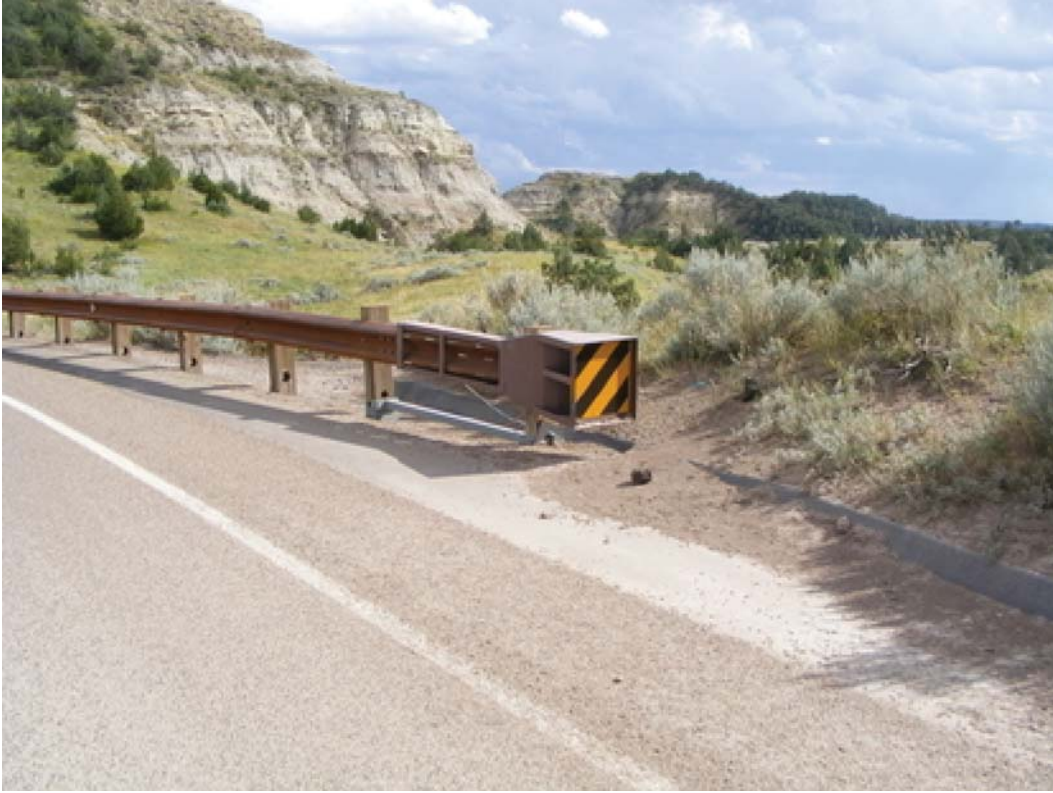
THRO_0011_18.952_L_1.JPG

Barrier ID:	THRO-0011-18.952-L				
Route Name:	SCENIC LOOP				
Inspection Date:	09/08/2010	Barrier Rating:	19.70		
Barrier Description					
Type:	W-BEAM STRONG POST	Barrier Function:	TRAFFIC		
Barrier Material:	WEATHERING STEEL/CORTEN	Post Material:	WOOD		
Blockout Type:	WOOD	Length (ft.):	240		
Speed Limit (MPH):	25	Placement with Respect to Road:	OUTSIDE OF CURVE		
Hazard Behind Barrier:	HIGH				
Barrier Crashworthiness					
Appropriate Test Level:	TL-1	Barrier Test Level:	TL-3	Is Barrier Crashworthy?:	YES
Beg. End Trtmt Type:	W-BEAM TANGENT 350	Is Beg. End Trtmt Crashworthy?:	YES	Approach Transition Type:	NONE
Ending End Trtmt Type:	W-BEAM TANGENT 350	Ending End Trtmt Crashworthy?:	YES		
Average Measurements					
Design Height (In.):	27	Width (In.):	0.0	Post Spacing (In.):	74.0
Height (In.):	28.2	Lateral Offset (In.):	50.7	Road Grade (%):	1.40
Physical Condition					
Barrier	Alignment and Height:	Alignment acceptable. Height was 1 to 2-in above the 27-in design height.

Breaking and Cracking:	No cracked or broken barrier elements.			
	Missing Elements:	No missing barrier elements.			
	Corrosion and Weathering:	Minimal corrosion/weathering of barrier elements.			
End Treatments	Alignment and Height:	Alignment acceptable. Height within 1-in of 27-in design height.			
	Breaking and Cracking:	No cracked or broken end treatment elements.			
	Missing Elements:	No missing end treatment elements.			
	Corrosion and Weathering:	Minimal corrosion/weathering of end treatment elements.

Barrier ID:	THRO-0011-18.952-L				
Route Name:	SCENIC LOOP				
Inspection Date:	09/08/2010	Barrier Rating:		19.70	
Repair Recommendations					
Repair Action:	NO ACTION	FMSS Work Type:	N/A	Repair Cost:	\$0
Brief Workorder:	N/A				
Workorder:

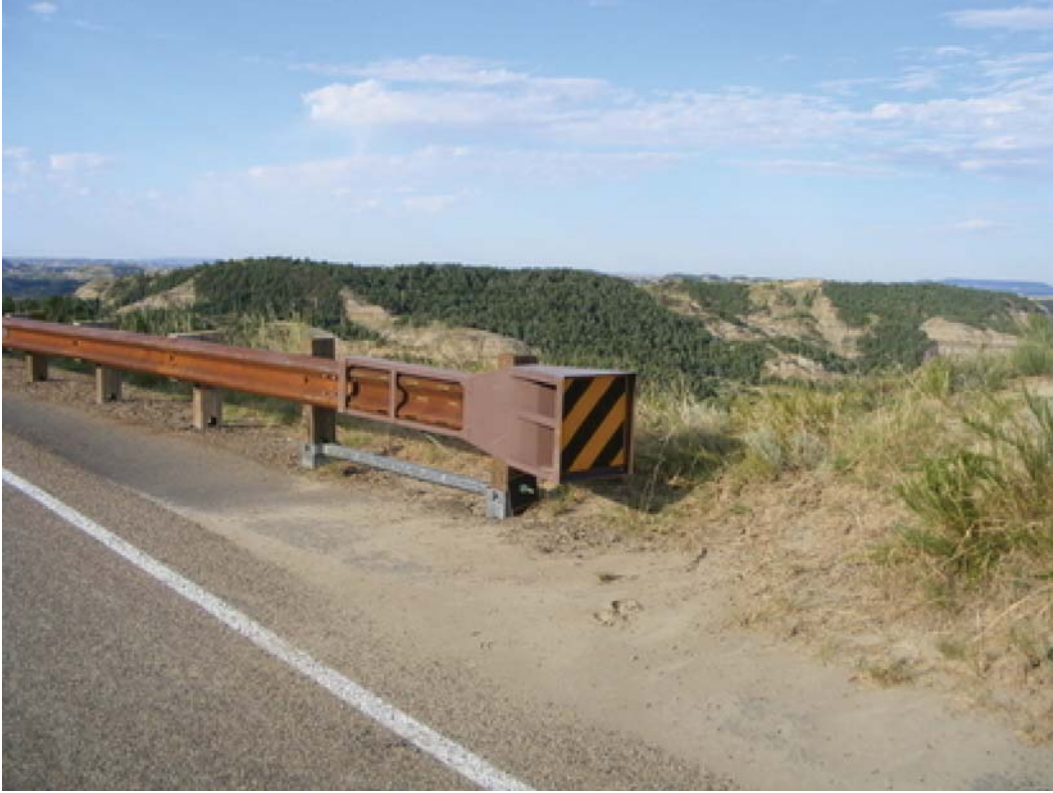
THRO_0011_19.735_L_1.JPG

Barrier ID:	THRO-0011-19.735-L				
Route Name:	SCENIC LOOP				
Inspection Date:	11/08/2010	Barrier Rating:	22.60		
Barrier Description					
Type:	W-BEAM STRONG POST	Barrier Function:	TRAFFIC		
Barrier Material:	WEATHERING STEEL/CORTEN	Post Material:	WOOD		
Blockout Type:	WOOD	Length (ft.):	218		
Speed Limit (MPH):	25	Placement with Respect to Road:	OUTSIDE OF CURVE		
Hazard Behind Barrier:	HIGH				
Barrier Crashworthiness					
Appropriate Test Level:	TL-1	Barrier Test Level:	TL-3	Is Barrier Crashworthy?:	YES
Beg. End Trtmt Type:	W-BEAM TANGENT 350	Is Beg. End Trtmt Crashworthy?:	YES	Approach Transition Type:	NONE
Ending End Trtmt Type:	W-BEAM FLARED 350 COMPLIANT	Ending End Trtmt Crashworthy?:	YES		
Average Measurements					
Design Height (In.):	27	Width (In.):	0.0	Post Spacing (In.):	74.0
Height (In.):	28.7	Lateral Offset (In.):	47.7	Road Grade (%):	0.40
Physical Condition					
Barrier	Alignment and Height:	Alignment acceptable. Height was 1 to 2-in above the 27-in design height.

Breaking and Cracking:	2 loose bolts. No cracked or broken barrier elements.			
	Missing Elements:	No missing barrier elements.			
	Corrosion and Weathering:	Minimal corrosion/weathering of barrier elements. No erosion around posts.			
End Treatments	Alignment and Height:	Alignment acceptable. Height within 1-in of 27-in design height.			
	Breaking and Cracking:	No cracked or broken end treatment elements.			
	Missing Elements:	No missing end treatment elements.			
	Corrosion and Weathering:	Minimal corrosion/weathering of end treatment elements.

Repair Action:	REPAIR	FMSS Work Type:	DEFERRED MAINTENANCE	Repair Cost:	\$132
Brief Workorder:	Tighten loose bolts.				
Workorder:	Labor at \$60- per -Hour for 2 Hrs = \$120. Tighten loose bolts.

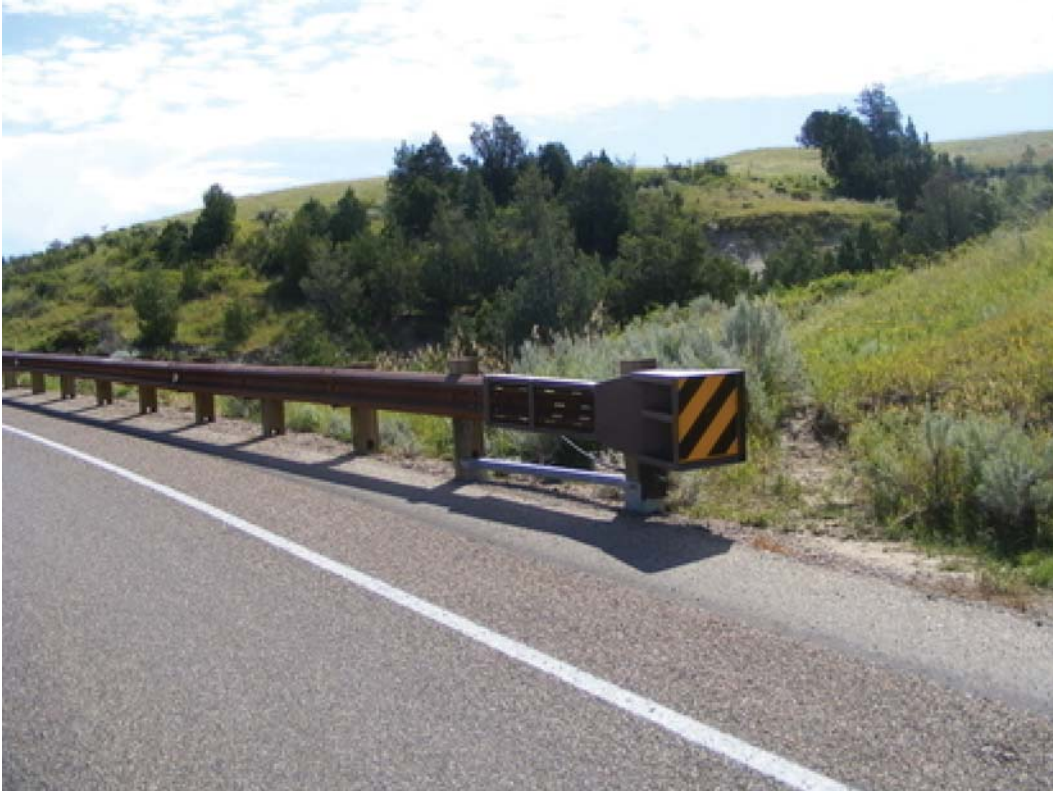
THRO_0011_19.999_L_1.JPG

Barrier ID:	THRO-0011-19.999-L				
Route Name:	SCENIC LOOP				
Inspection Date:	11/08/2010	Barrier Rating:	23.70		
Barrier Description					
Type:	W-BEAM STRONG POST	Barrier Function:	TRAFFIC		
Barrier Material:	WEATHERING STEEL/CORTEN	Post Material:	WOOD		
Blockout Type:	WOOD	Length (ft.):	430		
Speed Limit (MPH):	25	Placement with Respect to Road:	OUTSIDE OF CURVE		
Hazard Behind Barrier:	MEDIUM				
Barrier Crashworthiness					
Appropriate Test Level:	TL-1	Barrier Test Level:	TL-3	Is Barrier Crashworthy?:	YES
Beg. End Trtmt Type:	W-BEAM TANGENT 350	Is Beg. End Trtmt Crashworthy?:	YES	Approach Transition Type:	NONE
Ending End Trtmt Type:	W-BEAM FLARED 350 COMPLIANT	Ending End Trtmt Crashworthy?:	YES		
Average Measurements					
Design Height (In.):	27	Width (In.):	0.0	Post Spacing (In.):	75.0
Height (In.):	28.2	Lateral Offset (In.):	42.0	Road Grade (%):	7.20
Physical Condition					
Barrier	Alignment and Height:	Alignment acceptable. Height was 0 to 2-in above the 27-in design height.

Breaking and Cracking:	No breaking or cracking of barrier.			
	Missing Elements:	No missing barrier elements.			
	Corrosion and Weathering:	There is some minor erosion starting behind the new barrier need to extend the curb another 45 LF down the hill.			
End Treatments	Alignment and Height:	Alignment acceptable. Height within 1-in of 27-in design height.			
	Breaking and Cracking:	No breaking or cracking of end treatments.			
	Missing Elements:	No missing end treatment elements.			
	Corrosion and Weathering:	No weathering of the end treatments.

Repair Action:	REPAIR	FMSS Work Type:	DEFERRED MAINTENANCE	Repair Cost:	\$4235
Brief Workorder:	Extend existing curb 45 feet farther down the hill.				
Workorder:	Concrete Curb at \$20- per -Lin. Ft. for 45-ft = \$900. Extend existing curb 45 feet farther down the hill. Low Speed Traffic Control at \$1475- per -Day for 2 Day(s) = \$2950.

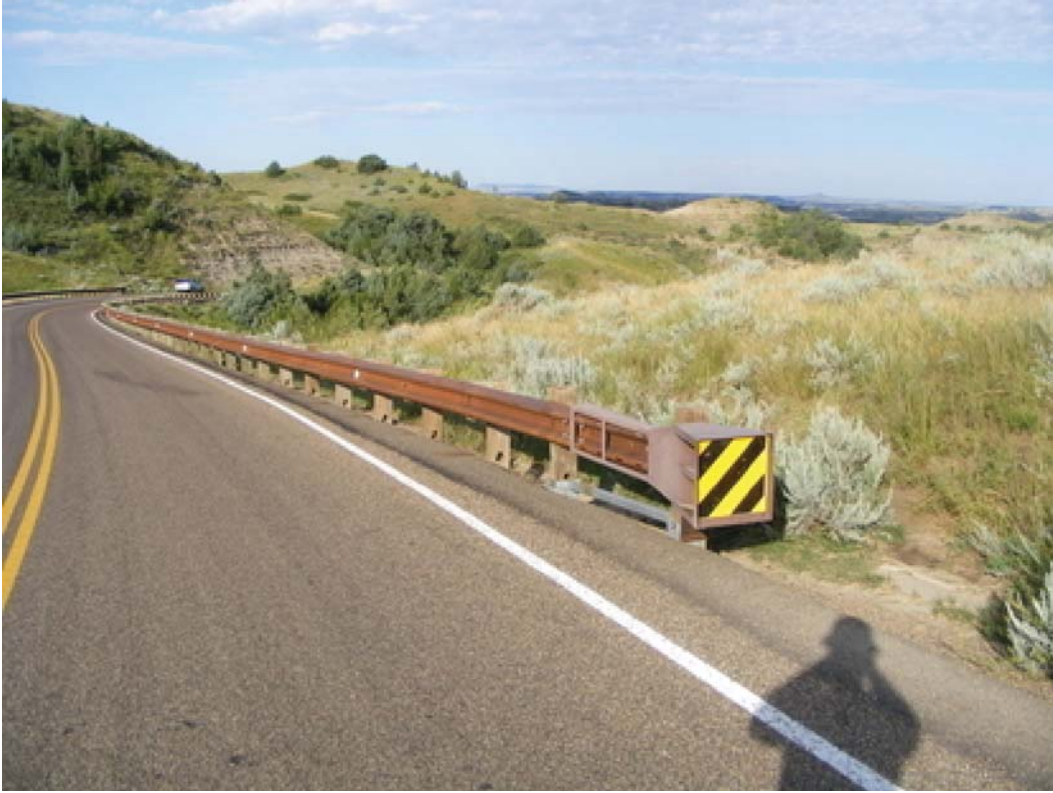
THRO_0011_19.999_R_1.JPG

Barrier ID:	THRO-0011-19.999-R				
Route Name:	SCENIC LOOP				
Inspection Date:	11/08/2010	Barrier Rating:	32.20		
Barrier Description					
Type:	W-BEAM STRONG POST	Barrier Function:	TRAFFIC		
Barrier Material:	WEATHERING STEEL/CORTEN	Post Material:	WOOD		
Blockout Type:	WOOD	Length (ft.):	830		
Speed Limit (MPH):	25	Placement with Respect to Road:	INSIDE OF CURVE		
Hazard Behind Barrier:	MEDIUM				
Barrier Crashworthiness					
Appropriate Test Level:	TL-1	Barrier Test Level:	TL-3	Is Barrier Crashworthy?:	YES
Beg. End Trtmt Type:	W-BEAM TANGENT 350	Is Beg. End Trtmt Crashworthy?:	YES	Approach Transition Type:	NONE
Ending End Trtmt Type:	W-BEAM TANGENT 350	Ending End Trtmt Crashworthy?:	YES		
Average Measurements					
Design Height (In.):	27	Width (In.):	0.0	Post Spacing (In.):	75.5
Height (In.):	26.3	Lateral Offset (In.):	20.7	Road Grade (%):	8.30
Physical Condition					
Barrier	Alignment and Height:	Alignment acceptable. 55-ft was 1 to 3-in below the 27-in design height and 775-ft was within 1-in.

Breaking and Cracking:	No breaking or cracking of barrier.			
	Missing Elements:	No missing barrier elements.			
	Corrosion and Weathering:	No weathering of the barrier.			
End Treatments	Alignment and Height:	Alignment acceptable. The ending end is 2-in below the 27-in design height and the approach end was within 1-in.			
	Breaking and Cracking:	No breaking or cracking of end treatments.			
	Missing Elements:	No missing end treatment elements.			
	Corrosion and Weathering:	No weathering of the end treatments.

Repair Action:	REPAIR	FMSS Work Type:	DEFERRED MAINTENANCE	Repair Cost:	\$2228
Brief Workorder:	Raise 55 feet of ending end treatment up to 27 inch design height.				
Workorder:	Adjust Guardrail at \$10- per -Lin. Ft. for 55-ft = \$550. Raise ending end treatment to 27 inch design height. Low Speed Traffic Control at \$1475- per -Day for 1 Day(s) = \$1475.

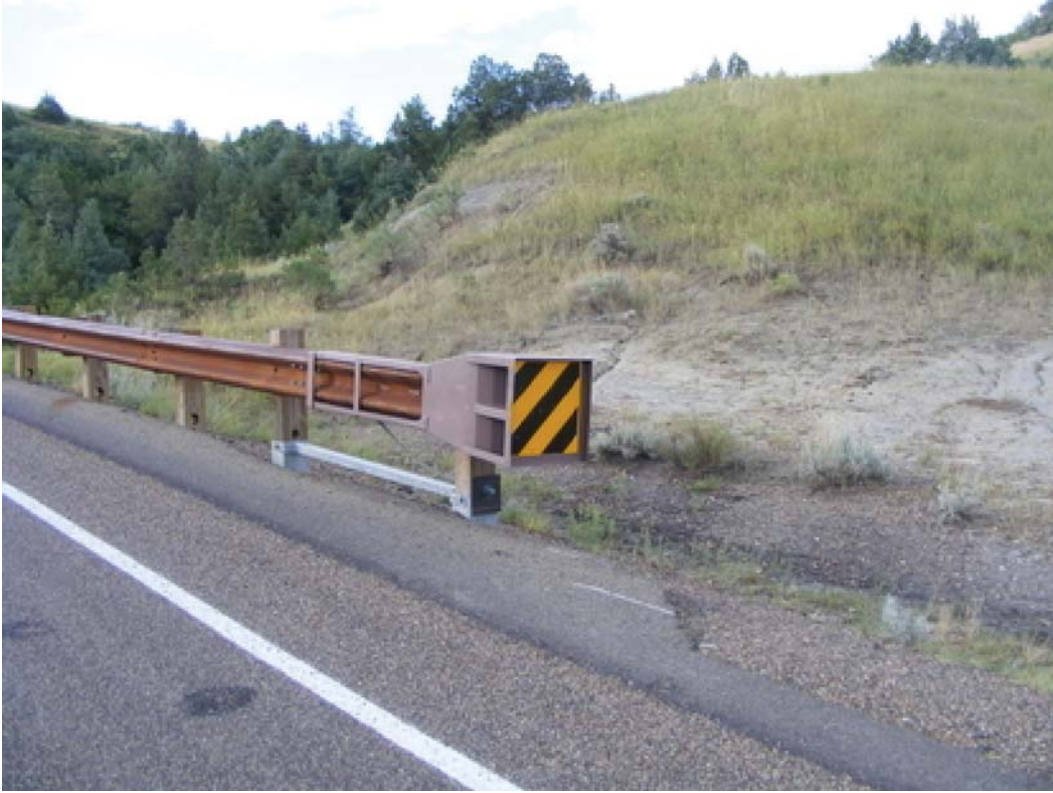
THRO_0011_20.127_L_1.JPG

Barrier ID:	THRO-0011-20.127-L				
Route Name:	SCENIC LOOP				
Inspection Date:	11/08/2010	Barrier Rating:	20.70		
Barrier Description					
Type:	W-BEAM STRONG POST	Barrier Function:	TRAFFIC		
Barrier Material:	WEATHERING STEEL/CORTEN	Post Material:	WOOD		
Blockout Type:	WOOD	Length (ft.):	306		
Speed Limit (MPH):	25	Placement with Respect to Road:	OUTSIDE OF CURVE		
Hazard Behind Barrier:	MEDIUM				
Barrier Crashworthiness					
Appropriate Test Level:	TL-1	Barrier Test Level:	TL-3	Is Barrier Crashworthy?:	YES
Beg. End Trtmt Type:	W-BEAM TANGENT 350	Is Beg. End Trtmt Crashworthy?:	YES	Approach Transition Type:	NONE
Ending End Trtmt Type:	W-BEAM TANGENT 350	Ending End Trtmt Crashworthy?:	YES		
Average Measurements					
Design Height (In.):	27	Width (In.):	0.0	Post Spacing (In.):	75.0
Height (In.):	27.7	Lateral Offset (In.):	49.2	Road Grade (%):	9.10
Physical Condition					
Barrier	Alignment and Height:	Alignment acceptable. Height within 1-in of 27-in design height.

Breaking and Cracking:	3 loose bolts. No cracked or broken barrier elements. 1 tilted block.			
	Missing Elements:	No missing barrier elements.			
	Corrosion and Weathering:	Minimal corrosion/weathering of barrier elements. No erosion around posts.			
End Treatments	Alignment and Height:	Alignment acceptable. Height within 1-in of 27-in design height.			
	Breaking and Cracking:	No cracked or broken end treatment elements.			
	Missing Elements:	No missing end treatment elements.			
	Corrosion and Weathering:	Minimal corrosion/weathering of end treatment elements.

Repair Action:	REPAIR	FMSS Work Type:	DEFERRED MAINTENANCE	Repair Cost:	\$132
Brief Workorder:	Right tilted blocks and tighten loose bolts.				
Workorder:	Labor at \$60- per -Hour for 2 Hrs = \$120. Right tilted blocks and tighten loose bolts.

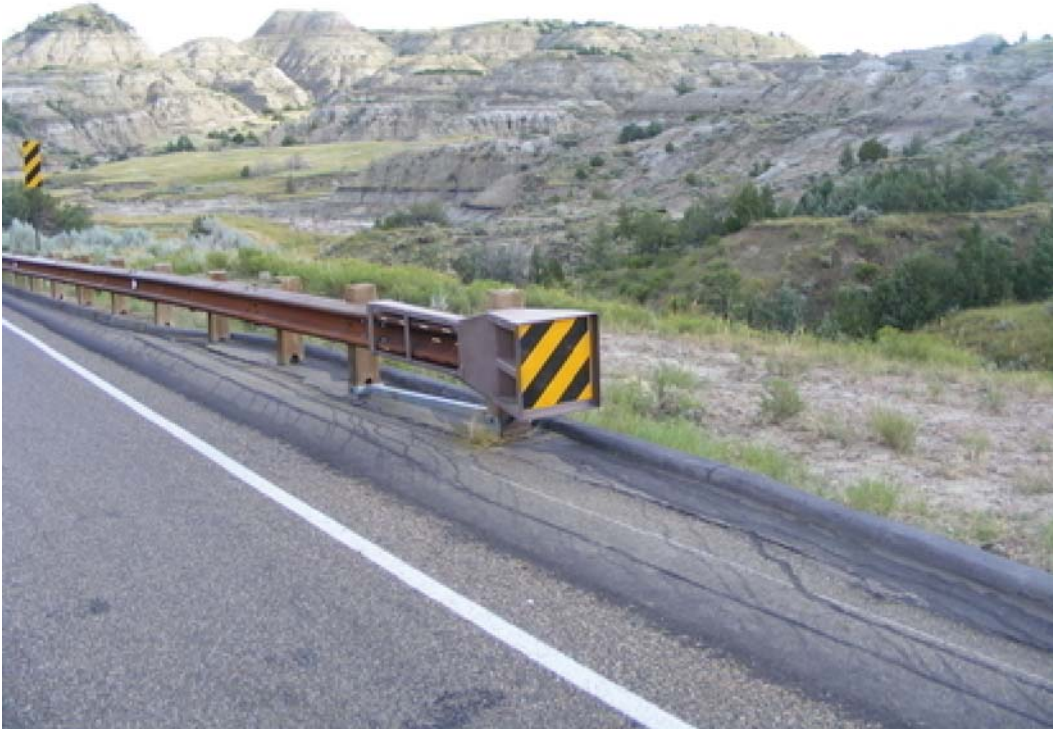
THRO_0011_20.221_R_1.JPG

Barrier ID:	THRO-0011-20.221-R				
Route Name:	SCENIC LOOP				
Inspection Date:	11/08/2010	Barrier Rating:	38.50		
Barrier Description					
Type:	W-BEAM STRONG POST	Barrier Function:	TRAFFIC		
Barrier Material:	WEATHERING STEEL/CORTEN	Post Material:	WOOD		
Blockout Type:	WOOD	Length (ft.):	1351		
Speed Limit (MPH):	25	Placement with Respect to Road:	BOTH INSIDE AND OUTSIDE		
Hazard Behind Barrier:	EXTREME				
Barrier Crashworthiness					
Appropriate Test Level:	TL-1	Barrier Test Level:	TL-3	Is Barrier Crashworthy?:	YES
Beg. End Trtmt Type:	W-BEAM TANGENT 350	Is Beg. End Trtmt Crashworthy?:	YES	Approach Transition Type:	NONE
Ending End Trtmt Type:	W-BEAM TANGENT 350	Ending End Trtmt Crashworthy?:	YES		
Average Measurements					
Design Height (In.):	27	Width (In.):	0.0	Post Spacing (In.):	75.0
Height (In.):	27.6	Lateral Offset (In.):	31.3	Road Grade (%):	6.70
Physical Condition					
Barrier	Alignment and Height:	Alignment acceptable. 120-ft was 2-in below the 27-in design height and 1231-ft was within 1-in.

Breaking and Cracking:	12 loose bolts 1 broken post and 2 tilted blocks.			
	Missing Elements:	No missing barrier elements.			
	Corrosion and Weathering:	Minimal corrosion/weathering of barrier elements. Moderate erosion around posts past curb at trailing end.			
End Treatments	Alignment and Height:	Alignment acceptable. Height within 1-in of 27-in design height.			
	Breaking and Cracking:	No cracked or broken end treatment elements.			
	Missing Elements:	No missing end treatment elements.			
	Corrosion and Weathering:	Minimal corrosion/weathering of end treatment elements.

Repair Action:	REPAIR	FMSS Work Type:	DEFERRED MAINTENANCE	Repair Cost:	\$2942
Brief Workorder:	Raise 120 feet of guardrail up to 27 inch design height right tilted blocks and tighten loose bolts.				
Workorder:	Adjust Guardrail at \$10- per -Lin. Ft. for 120-ft = \$1200. Raise 120-ft of guardrail up to 27 inch design height. Low Speed Traffic Control at \$1475- per -Day for 1 Day(s) = \$1475.

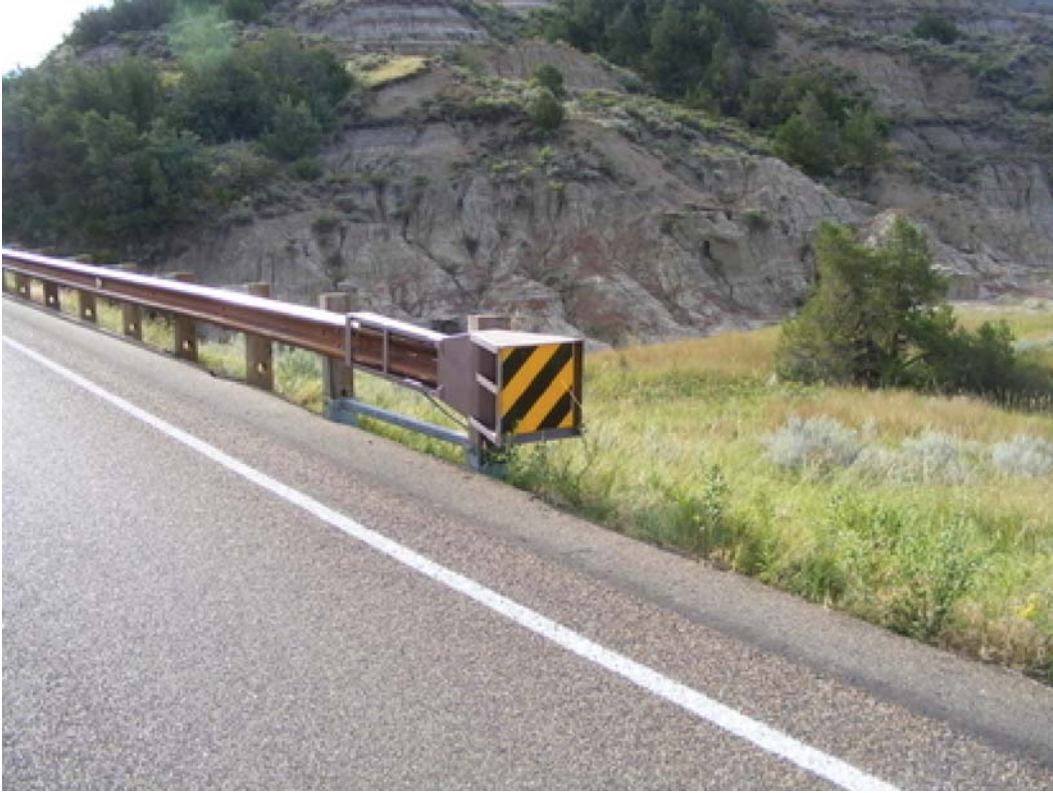
THRO_0011_20.405_L_1.JPG

Barrier ID:	THRO-0011-20.405-L				
Route Name:	SCENIC LOOP				
Inspection Date:	11/08/2010	Barrier Rating:	15.10		
Barrier Description					
Type:	W-BEAM STRONG POST	Barrier Function:	TRAFFIC		
Barrier Material:	WEATHERING STEEL/CORTEN	Post Material:	WOOD		
Blockout Type:	WOOD	Length (ft.):	307		
Speed Limit (MPH):	25	Placement with Respect to Road:	TANGENT		
Hazard Behind Barrier:	MEDIUM				
Barrier Crashworthiness					
Appropriate Test Level:	TL-1	Barrier Test Level:	TL-3	Is Barrier Crashworthy?:	YES
Beg. End Trtmt Type:	W-BEAM TANGENT 350	Is Beg. End Trtmt Crashworthy?:	YES	Approach Transition Type:	NONE
Ending End Trtmt Type:	W-BEAM TANGENT 350	Ending End Trtmt Crashworthy?:	YES		
Average Measurements					
Design Height (In.):	27	Width (In.):	0.0	Post Spacing (In.):	75.0
Height (In.):	26.7	Lateral Offset (In.):	36.0	Road Grade (%):	6.80
Physical Condition					
Barrier	Alignment and Height:	Alignment acceptable. Height within 1-in of 27-in design height.

Breaking and Cracking:	2 loose bolts. One broken post.			
	Missing Elements:	No missing barrier elements.			
	Corrosion and Weathering:	Minimal corrosion/weathering of barrier elements. Moderate erosion around posts at middle of barrier.			
End Treatments	Alignment and Height:	Alignment acceptable. Height within 1-in of 27-in design height.			
	Breaking and Cracking:	Broken posts = 1 each. Possible impact at trailing end treatment. No other cracked or broken end treatment elements.			
	Missing Elements:	No missing end treatment elements.			
	Corrosion and Weathering:	Minimal corrosion/weathering of end treatment elements. Moderate erosion at approach end treatment.

Repair Action:	REPAIR	FMSS Work Type:	DEFERRED MAINTENANCE	Repair Cost:	\$1798
Brief Workorder:	Tighten loose bolts and replace broken post. Monitor erosion at approach end treatment and middle of barrier.				
Workorder:	Labor at \$60- per -Hour for 1 Hrs = \$60. Tighten loose bolts. Replace Post at \$100- per -Each for 1 Post(s) = \$100. Replace one broken post. Low Speed Traffic Control at \$1475- per -Day for 1 Day(s) = \$1475.

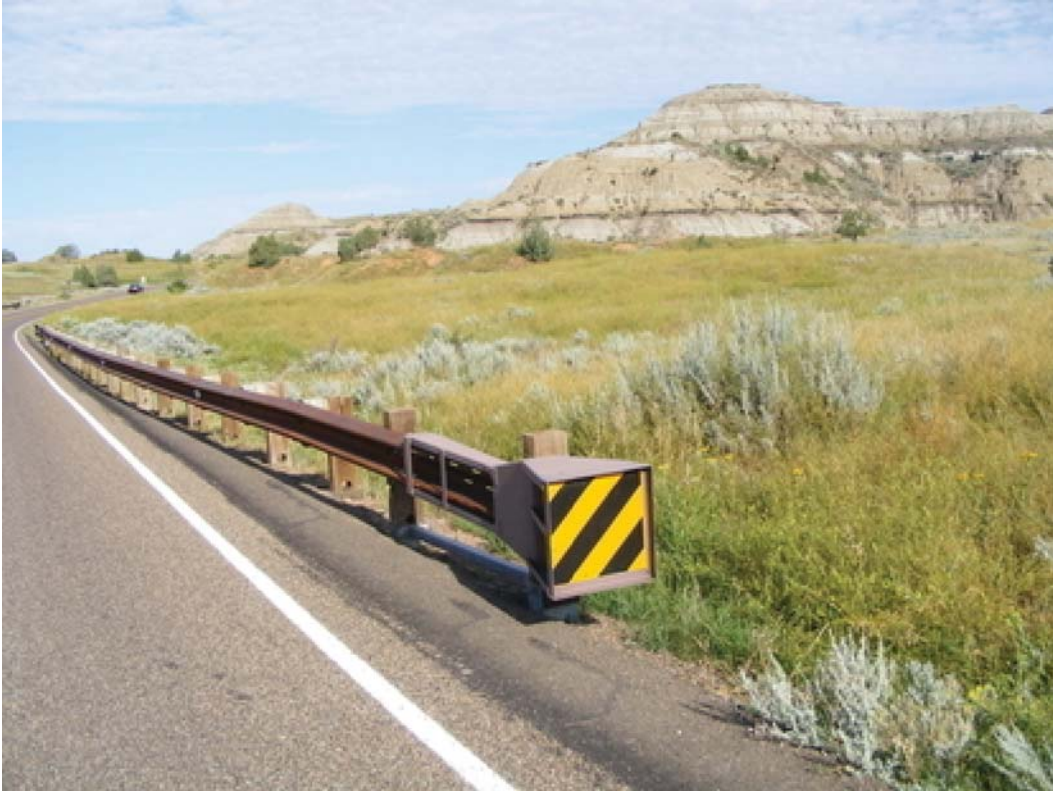
THRO_0011_20.517_L_1.JPG

Barrier ID:	THRO-0011-20.517-L				
Route Name:	SCENIC LOOP				
Inspection Date:	11/08/2010	Barrier Rating:	15.00		
Barrier Description					
Type:	W-BEAM STRONG POST	Barrier Function:	TRAFFIC		
Barrier Material:	WEATHERING STEEL/CORTEN	Post Material:	WOOD		
Blockout Type:	WOOD	Length (ft.):	156		
Speed Limit (MPH):	25	Placement with Respect to Road:	TANGENT		
Hazard Behind Barrier:	MEDIUM				
Barrier Crashworthiness					
Appropriate Test Level:	TL-1	Barrier Test Level:	TL-3	Is Barrier Crashworthy?:	YES
Beg. End Trtmt Type:	W-BEAM FLARED 350 COMPLIANT	Is Beg. End Trtmt Crashworthy?:	YES	Approach Transition Type:	NONE
Ending End Trtmt Type:	W-BEAM TANGENT 350	Ending End Trtmt Crashworthy?:	YES		
Average Measurements					
Design Height (In.):	27	Width (In.):	0.0	Post Spacing (In.):	75.3
Height (In.):	28.0	Lateral Offset (In.):	21.2	Road Grade (%):	1.30
Physical Condition					
Barrier	Alignment and Height:	Alignment acceptable. Height was 1 to 2-in above the 27-in design height.

Breaking and Cracking:	No breaking or cracking of barrier.			
	Missing Elements:	No missing barrier elements.			
	Corrosion and Weathering:	No weathering of the barrier.			
End Treatments	Alignment and Height:	Alignment acceptable. Height within 1-in of 27-in design height.			
	Breaking and Cracking:	No breaking or cracking of end treatments.			
	Missing Elements:	No missing end treatment elements.			
	Corrosion and Weathering:	No weathering of the end treatments.

Barrier ID:	THRO-0011-20.517-L				
Route Name:	SCENIC LOOP				
Inspection Date:	11/08/2010	Barrier Rating:		15.00	
Repair Recommendations					
Repair Action:	NO ACTION	FMSS Work Type:	N/A	Repair Cost:	\$0
Brief Workorder:	N/A				
Workorder:

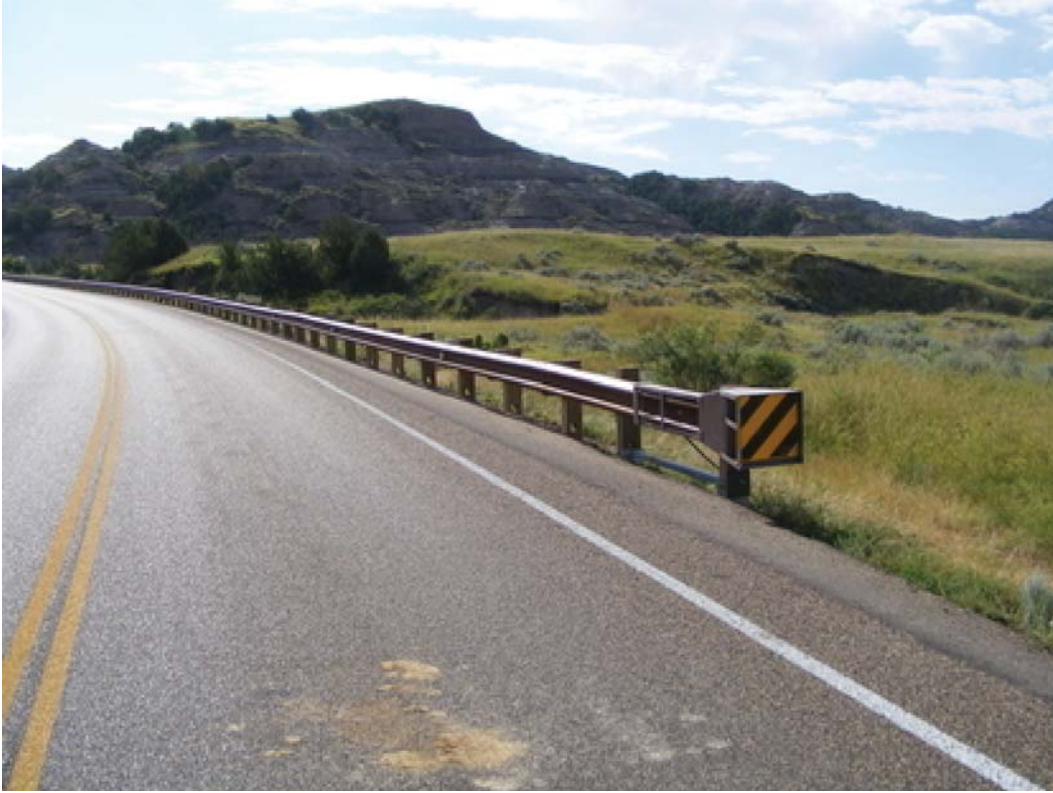
THRO_0011_20.519_R_1.JPG

Barrier ID:	THRO-0011-20.519-R				
Route Name:	SCENIC LOOP				
Inspection Date:	11/08/2010	Barrier Rating:	23.70		
Barrier Description					
Type:	W-BEAM STRONG POST	Barrier Function:	TRAFFIC		
Barrier Material:	WEATHERING STEEL/CORTEN	Post Material:	WOOD		
Blockout Type:	WOOD	Length (ft.):	492		
Speed Limit (MPH):	25	Placement with Respect to Road:	OUTSIDE OF CURVE		
Hazard Behind Barrier:	MEDIUM				
Barrier Crashworthiness					
Appropriate Test Level:	TL-1	Barrier Test Level:	TL-3	Is Barrier Crashworthy?:	YES
Beg. End Trtmt Type:	W-BEAM TANGENT 350	Is Beg. End Trtmt Crashworthy?:	YES	Approach Transition Type:	NONE
Ending End Trtmt Type:	W-BEAM FLARED 350 COMPLIANT	Ending End Trtmt Crashworthy?:	YES		
Average Measurements					
Design Height (In.):	27	Width (In.):	0.0	Post Spacing (In.):	74.3
Height (In.):	27.0	Lateral Offset (In.):	31.6	Road Grade (%):	1.00
Physical Condition					
Barrier	Alignment and Height:	Alignment acceptable. Height within 1-in of 27-in design height.

Breaking and Cracking:	1 cracked block. No other cracked or broken barrier elements.			
	Missing Elements:	No missing barrier elements.			
	Corrosion and Weathering:	No weathering of the barrier.			
End Treatments	Alignment and Height:	Alignment acceptable. Height within 1-in of 27-in design height.			
	Breaking and Cracking:	No breaking or cracking of end treatments.			
	Missing Elements:	No missing end treatment elements.			
	Corrosion and Weathering:	No weathering of the end treatments.

Repair Action:	REPAIR	FMSS Work Type:	DEFERRED MAINTENANCE	Repair Cost:	\$33
Brief Workorder:	Replace block.				
Workorder:	Replace Block at \$30- per -Each for 1 Block(s) = \$30. Replace one cracked block.

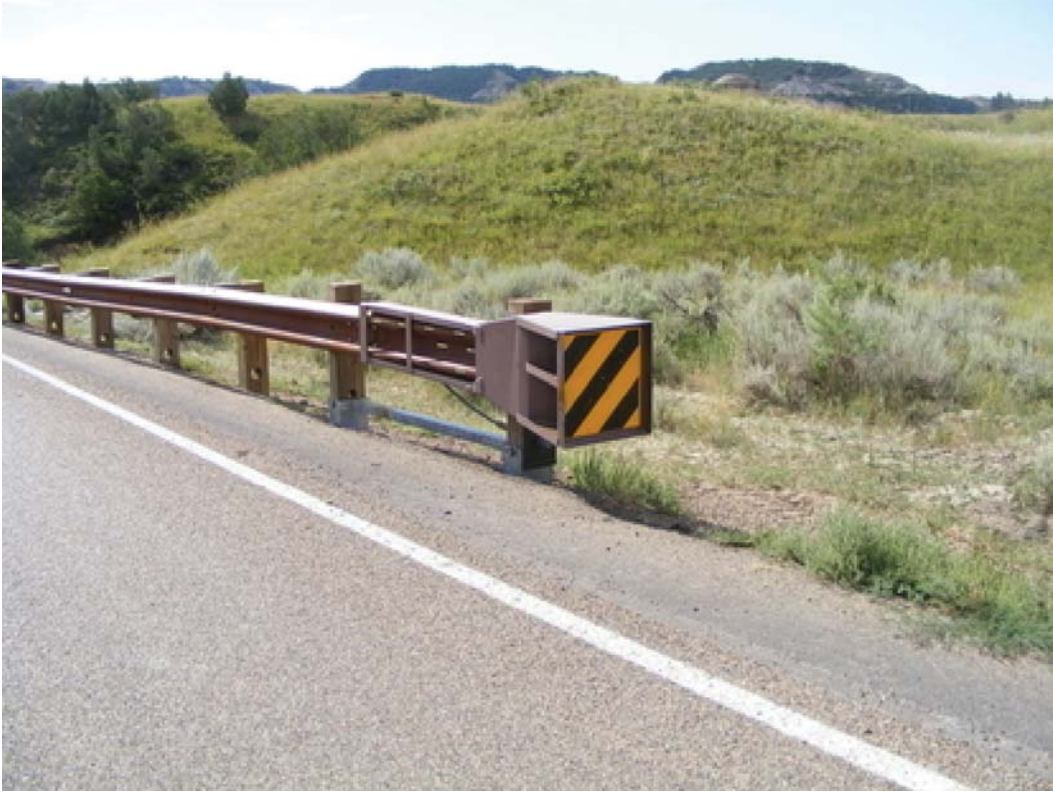
THRO_0011_20.843_L_1.JPG

Barrier ID:	THRO-0011-20.843-L				
Route Name:	SCENIC LOOP				
Inspection Date:	11/08/2010	Barrier Rating:	22.20		
Barrier Description					
Type:	W-BEAM STRONG POST	Barrier Function:	TRAFFIC		
Barrier Material:	WEATHERING STEEL/CORTEN	Post Material:	WOOD		
Blockout Type:	WOOD	Length (ft.):	421		
Speed Limit (MPH):	25	Placement with Respect to Road:	TANGENT		
Hazard Behind Barrier:	MEDIUM				
Barrier Crashworthiness					
Appropriate Test Level:	TL-1	Barrier Test Level:	TL-3	Is Barrier Crashworthy?:	YES
Beg. End Trtmt Type:	W-BEAM TANGENT 350	Is Beg. End Trtmt Crashworthy?:	YES	Approach Transition Type:	NONE
Ending End Trtmt Type:	W-BEAM TANGENT 350	Ending End Trtmt Crashworthy?:	YES		
Average Measurements					
Design Height (In.):	27	Width (In.):	0.0	Post Spacing (In.):	74.3
Height (In.):	28.0	Lateral Offset (In.):	17.2	Road Grade (%):	3.30
Physical Condition					
Barrier	Alignment and Height:	Alignment acceptable. Height within 1-in of 27-in design height.

Breaking and Cracking:	1 broken block. No other cracked or broken barrier elements.			
	Missing Elements:	No missing barrier elements.			
	Corrosion and Weathering:	Minimal corrosion/weathering of barrier elements. No erosion around posts.			
End Treatments	Alignment and Height:	Alignment acceptable. Height within 1-in of 27-in design height.			
	Breaking and Cracking:	No cracked or broken end treatment elements.			
	Missing Elements:	No missing end treatment elements.			
	Corrosion and Weathering:	Minimal corrosion/weathering of end treatment elements.

Repair Action:	REPAIR	FMSS Work Type:	DEFERRED MAINTENANCE	Repair Cost:	\$33
Brief Workorder:	Replace broken block.				
Workorder:	Replace Block at \$30- per -Each for 1 Block(s) = \$30. Replace broken block.

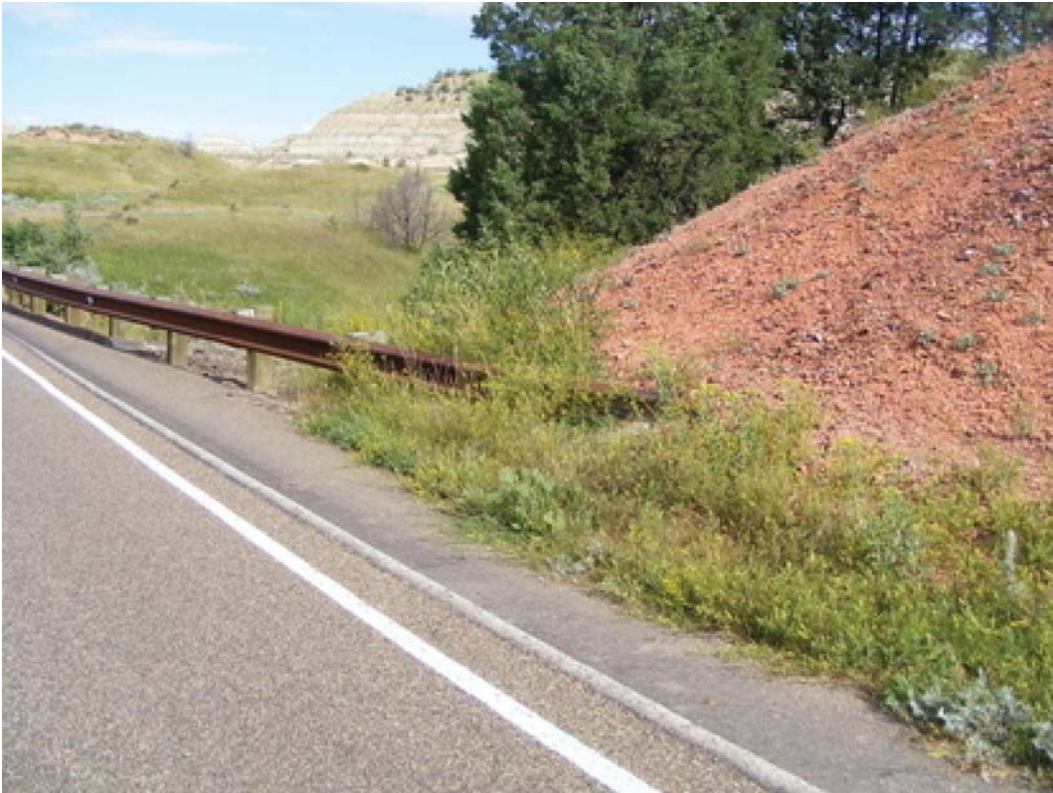
THRO_0011_20.853_R_1.JPG

Barrier ID:	THRO-0011-20.853-R				
Route Name:	SCENIC LOOP				
Inspection Date:	11/08/2010	Barrier Rating:	12.10		
Barrier Description					
Type:	W-BEAM STRONG POST	Barrier Function:	TRAFFIC		
Barrier Material:	WEATHERING STEEL/CORTEN	Post Material:	WOOD		
Blockout Type:	WOOD	Length (ft.):	196		
Speed Limit (MPH):	25	Placement with Respect to Road:	TANGENT		
Hazard Behind Barrier:	MEDIUM				
Barrier Crashworthiness					
Appropriate Test Level:	TL-1	Barrier Test Level:	TL-3	Is Barrier Crashworthy?:	YES
Beg. End Trtmt Type:	W-BEAM BURIED END	Is Beg. End Trtmt Crashworthy?:	YES	Approach Transition Type:	NONE
Ending End Trtmt Type:	W-BEAM TANGENT 350	Ending End Trtmt Crashworthy?:	YES		
Average Measurements					
Design Height (In.):	27	Width (In.):	0.0	Post Spacing (In.):	75.0
Height (In.):	27.2	Lateral Offset (In.):	27.0	Road Grade (%):	2.10
Physical Condition					
Barrier	Alignment and Height:	Alignment acceptable. Height within 1-in of 27-in design height.

Breaking and Cracking:	3 loose bolts. No cracked or broken barrier elements.			
	Missing Elements:	No missing barrier elements.			
	Corrosion and Weathering:	Minimal corrosion/weathering of barrier elements. No erosion around posts.			
End Treatments	Alignment and Height:	Alignment acceptable. Height within 1-in of 27-in design height.			
	Breaking and Cracking:	No cracked or broken end treatment elements.			
	Missing Elements:	No missing end treatment elements.			
	Corrosion and Weathering:	Minimal corrosion/weathering of end treatment elements.

Repair Action:	REPAIR	FMSS Work Type:	DEFERRED MAINTENANCE	Repair Cost:	\$132
Brief Workorder:	Tighten loose bolts.				
Workorder:	Labor at \$60- per -Hour for 2 Hrs = \$120. Tighten loose bolts.
