GIP Report

**NPS Guardwall/Rail Inventory Program
Theodore Roosevelt National Park**

**Federal Lands Highway
Road Inventory Program**

**Data Collection Date: August 2010
Report Date: November 2015**

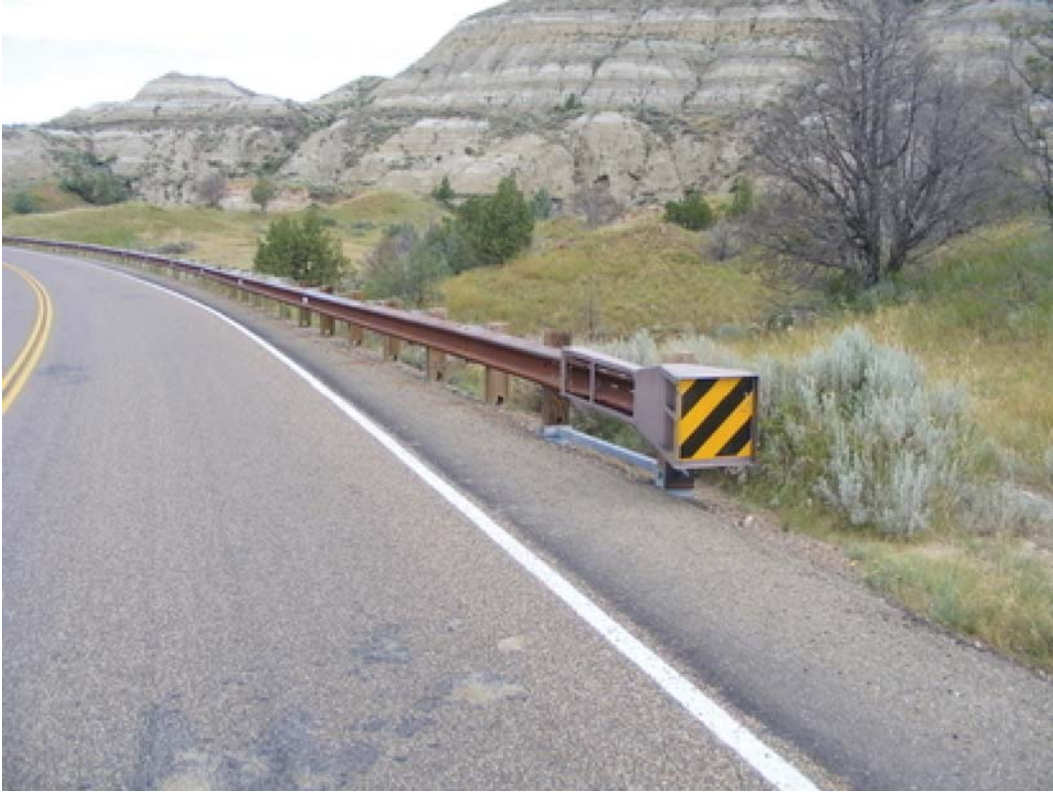
THRO_0011_21.090_R_1.JPG

Barrier ID:	THRO-0011-21.090-R				
Route Name:	SCENIC LOOP				
Inspection Date:	11/08/2010	Barrier Rating:	23.70		
Barrier Description					
Type:	W-BEAM STRONG POST	Barrier Function:	TRAFFIC		
Barrier Material:	WEATHERING STEEL/CORTEN	Post Material:	WOOD		
Blockout Type:	WOOD	Length (ft.):	343		
Speed Limit (MPH):	25	Placement with Respect to Road:	OUTSIDE OF CURVE		
Hazard Behind Barrier:	MEDIUM				
Barrier Crashworthiness					
Appropriate Test Level:	TL-1	Barrier Test Level:	TL-3	Is Barrier Crashworthy?:	YES
Beg. End Trtmt Type:	W-BEAM TANGENT 350	Is Beg. End Trtmt Crashworthy?:	YES	Approach Transition Type:	NONE
Ending End Trtmt Type:	W-BEAM TANGENT 350	Ending End Trtmt Crashworthy?:	YES		
Average Measurements					
Design Height (In.):	27	Width (In.):	0.0	Post Spacing (In.):	75.3
Height (In.):	30.0	Lateral Offset (In.):	24.2	Road Grade (%):	1.00
Physical Condition					
Barrier	Alignment and Height:	Alignment acceptable. Height was 3-in above the 27-in design height.

Breaking and Cracking:	No breaking or cracking of barrier.			
	Missing Elements:	No missing barrier elements.			
	Corrosion and Weathering:	No weathering of the barrier.			
End Treatments	Alignment and Height:	Alignment acceptable. Height was 3-in above the 27-in design height.			
	Breaking and Cracking:	No breaking or cracking of end treatments.			
	Missing Elements:	No missing end treatment elements.			
	Corrosion and Weathering:	No weathering of the end treatments.

Barrier ID:	THRO-0011-21.090-R				
Route Name:	SCENIC LOOP				
Inspection Date:	11/08/2010	Barrier Rating:		23.70	
Repair Recommendations					
Repair Action:	NO ACTION	FMSS Work Type:	N/A	Repair Cost:	\$0
Brief Workorder:	N/A				
Workorder:

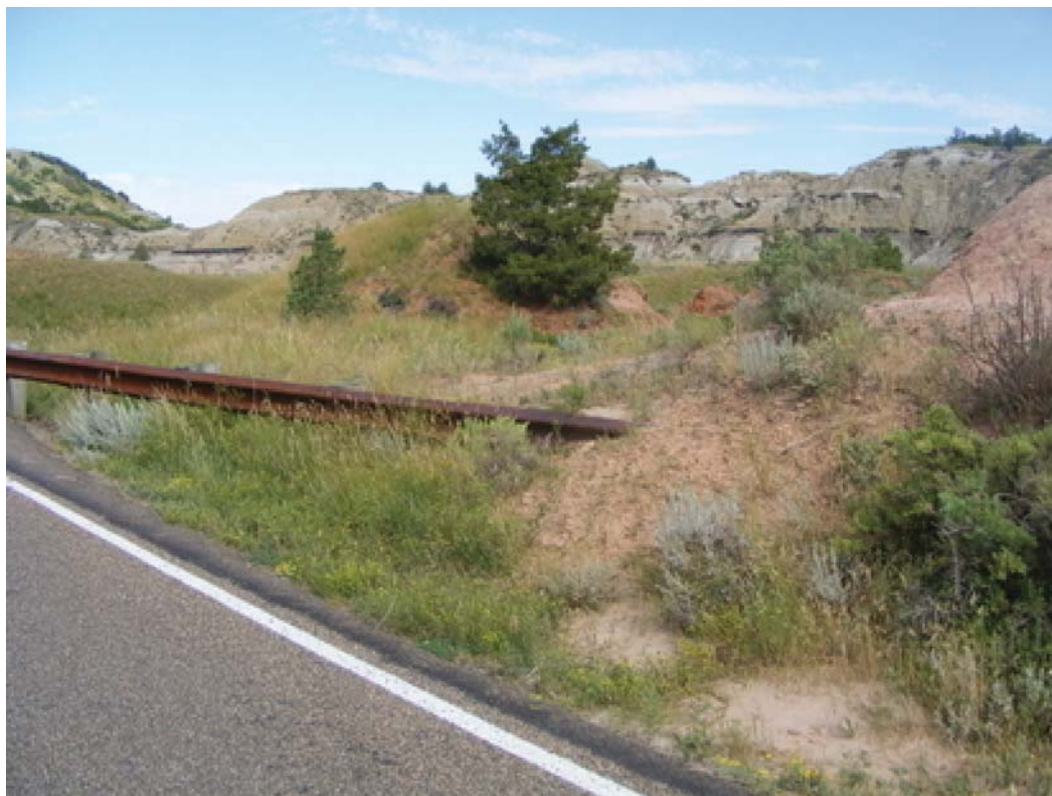
THRO_0011_21.273_R_1.JPG

Barrier ID:	THRO-0011-21.273-R				
Route Name:	SCENIC LOOP				
Inspection Date:	11/08/2010	Barrier Rating:	15.10		
Barrier Description					
Type:	W-BEAM STRONG POST	Barrier Function:	TRAFFIC		
Barrier Material:	WEATHERING STEEL/CORTEN	Post Material:	WOOD		
Blockout Type:	WOOD	Length (ft.):	287		
Speed Limit (MPH):	25	Placement with Respect to Road:	TANGENT		
Hazard Behind Barrier:	MEDIUM				
Barrier Crashworthiness					
Appropriate Test Level:	TL-1	Barrier Test Level:	TL-3	Is Barrier Crashworthy?:	YES
Beg. End Trtmt Type:	W-BEAM BURIED END	Is Beg. End Trtmt Crashworthy?:	YES	Approach Transition Type:	NONE
Ending End Trtmt Type:	W-BEAM TANGENT 350	Ending End Trtmt Crashworthy?:	YES		
Average Measurements					
Design Height (In.):	27	Width (In.):	0.0	Post Spacing (In.):	74.6
Height (In.):	26.2	Lateral Offset (In.):	24.7	Road Grade (%):	1.10
Physical Condition					
Barrier	Alignment and Height:	Alignment acceptable. Height within 1-in of 27-in design height.

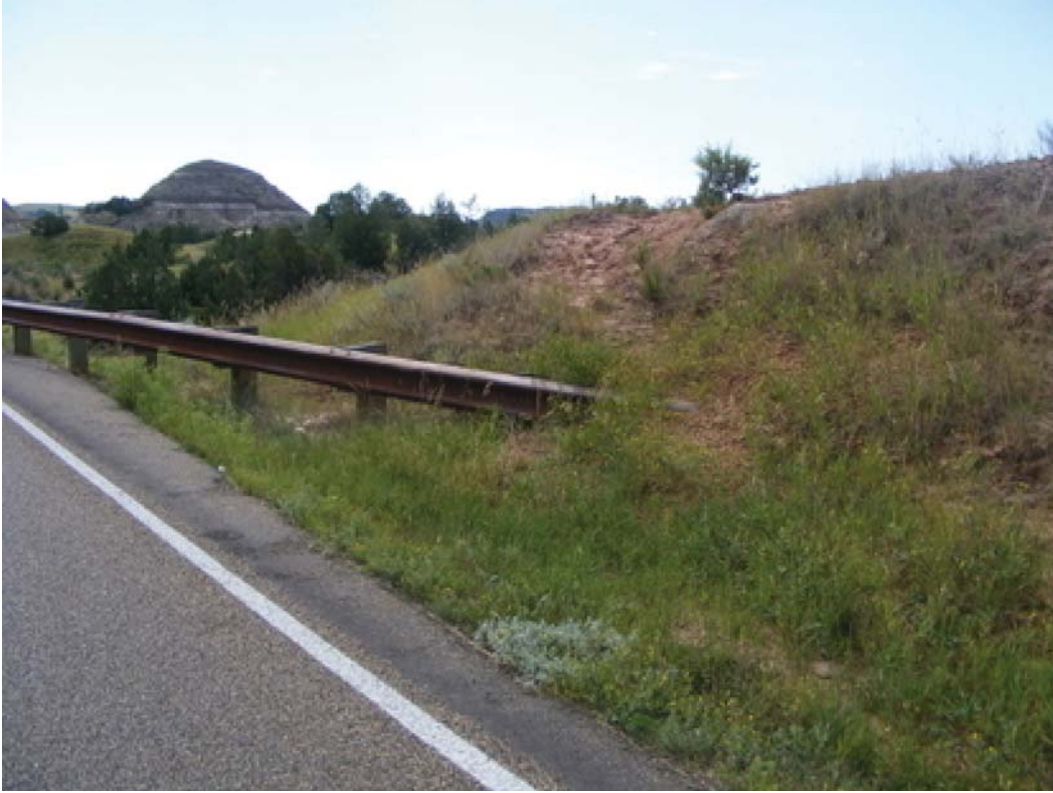
THRO_0011_21.285_L_1.JPG

Barrier ID:	THRO-0011-21.285-L				
Route Name:	SCENIC LOOP				
Inspection Date:	11/08/2010	Barrier Rating:	17.80		
Barrier Description					
Type:	W-BEAM STRONG POST	Barrier Function:	TRAFFIC		
Barrier Material:	WEATHERING STEEL/CORTEN	Post Material:	WOOD		
Blockout Type:	WOOD	Length (ft.):	252		
Speed Limit (MPH):	25	Placement with Respect to Road:	TANGENT		
Hazard Behind Barrier:	MEDIUM				
Barrier Crashworthiness					
Appropriate Test Level:	TL-1	Barrier Test Level:	TL-3	Is Barrier Crashworthy?:	YES
Beg. End Trtmt Type:	W-BEAM BURIED END	Is Beg. End Trtmt Crashworthy?:	YES	Approach Transition Type:	NONE
Ending End Trtmt Type:	W-BEAM TANGENT 350	Ending End Trtmt Crashworthy?:	YES		
Average Measurements					
Design Height (In.):	27	Width (In.):	0.0	Post Spacing (In.):	75.0
Height (In.):	27.0	Lateral Offset (In.):	15.3	Road Grade (%):	0.70
Physical Condition					
Barrier	Alignment and Height:	Alignment acceptable. Height within 1-in of 27-in design height.

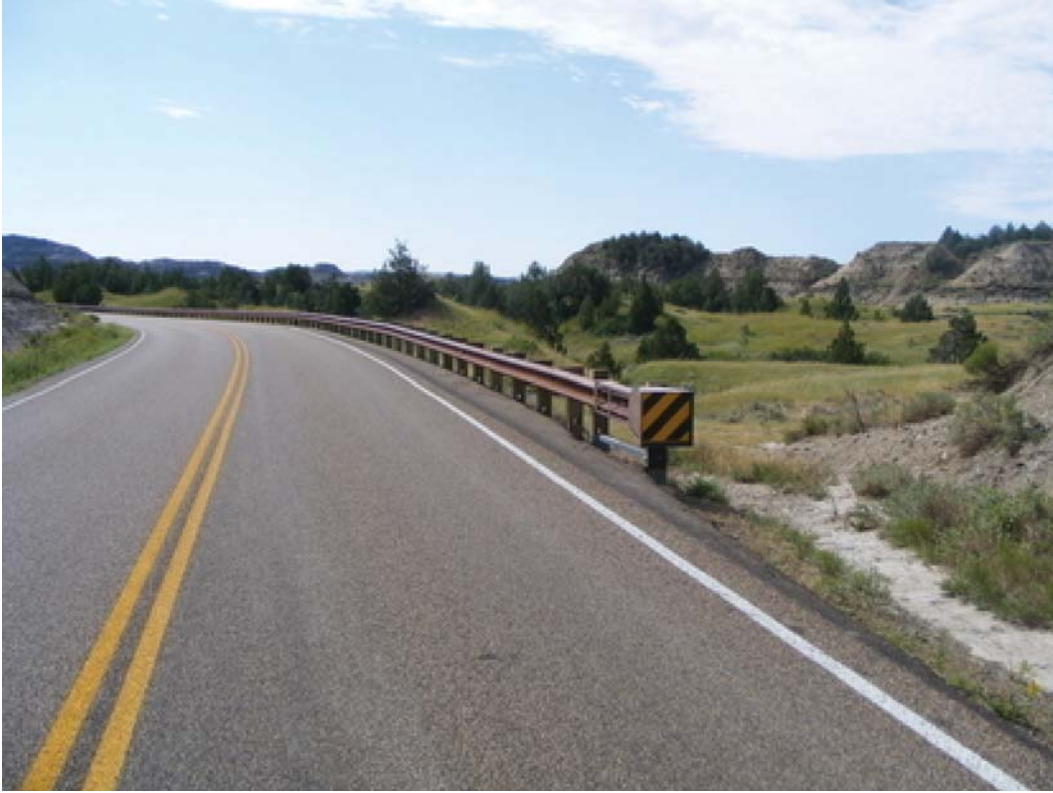
THRO_0011_21.412_L_1.JPG

Barrier ID:	THRO-0011-21.412-L				
Route Name:	SCENIC LOOP				
Inspection Date:	11/08/2010	Barrier Rating:	23.70		
Barrier Description					
Type:	W-BEAM STRONG POST	Barrier Function:	TRAFFIC		
Barrier Material:	WEATHERING STEEL/CORTEN	Post Material:	WOOD		
Blockout Type:	WOOD	Length (ft.):	545		
Speed Limit (MPH):	25	Placement with Respect to Road:	OUTSIDE OF CURVE		
Hazard Behind Barrier:	MEDIUM				
Barrier Crashworthiness					
Appropriate Test Level:	TL-1	Barrier Test Level:	TL-3	Is Barrier Crashworthy?:	YES
Beg. End Trtmt Type:	W-BEAM TANGENT 350	Is Beg. End Trtmt Crashworthy?:	YES	Approach Transition Type:	NONE
Ending End Trtmt Type:	W-BEAM TANGENT 350	Ending End Trtmt Crashworthy?:	YES		
Average Measurements					
Design Height (In.):	27	Width (In.):	0.0	Post Spacing (In.):	75.3
Height (In.):	28.2	Lateral Offset (In.):	29.2	Road Grade (%):	1.40
Physical Condition					
Barrier	Alignment and Height:	Alignment acceptable. Height was 1 to 2-in above the 27-in design height.

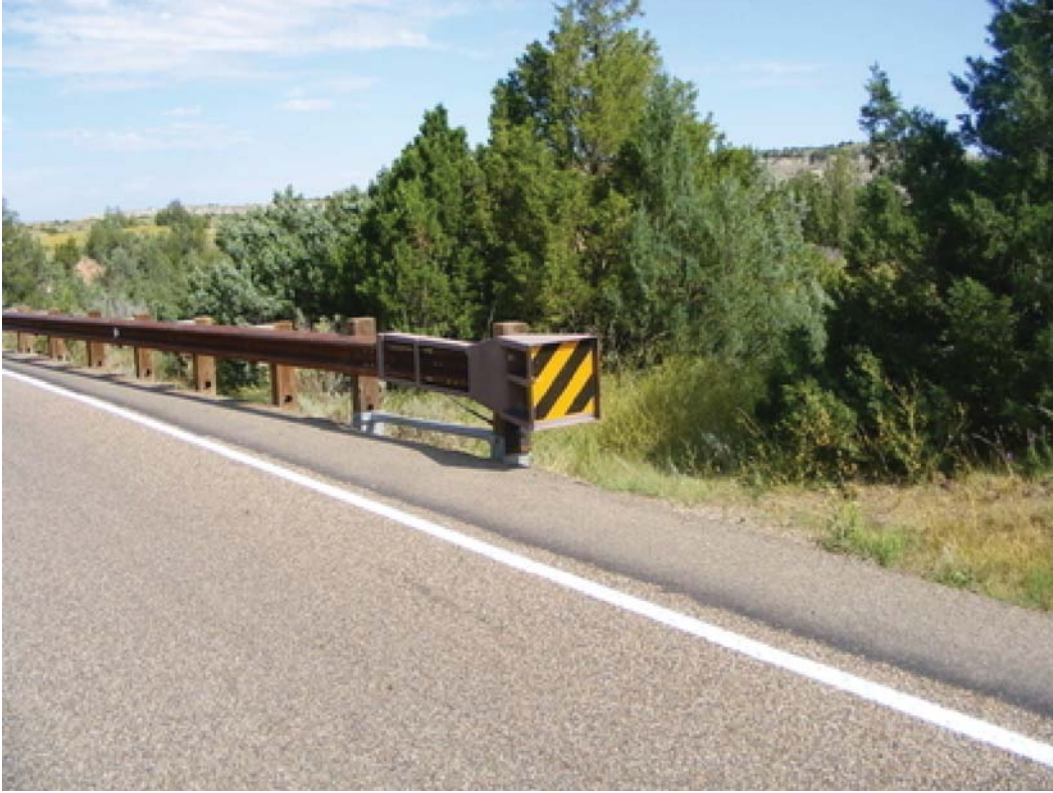
THRO_0011_21.600_R_1.JPG

Barrier ID:	THRO-0011-21.600-R				
Route Name:	SCENIC LOOP				
Inspection Date:	11/08/2010	Barrier Rating:	23.70		
Barrier Description					
Type:	W-BEAM STRONG POST	Barrier Function:	TRAFFIC		
Barrier Material:	WEATHERING STEEL/CORTEN	Post Material:	WOOD		
Blockout Type:	WOOD	Length (ft.):	345		
Speed Limit (MPH):	25	Placement with Respect to Road:	OUTSIDE OF CURVE		
Hazard Behind Barrier:	MEDIUM				
Barrier Crashworthiness					
Appropriate Test Level:	TL-1	Barrier Test Level:	TL-3	Is Barrier Crashworthy?:	YES
Beg. End Trtmt Type:	W-BEAM TANGENT 350	Is Beg. End Trtmt Crashworthy?:	YES	Approach Transition Type:	NONE
Ending End Trtmt Type:	W-BEAM TANGENT 350	Ending End Trtmt Crashworthy?:	YES		
Average Measurements					
Design Height (In.):	27	Width (In.):	0.0	Post Spacing (In.):	75.0
Height (In.):	27.7	Lateral Offset (In.):	27.7	Road Grade (%):	2.20
Physical Condition					
Barrier	Alignment and Height:	Alignment acceptable. Height within 1-in of 27-in design height.

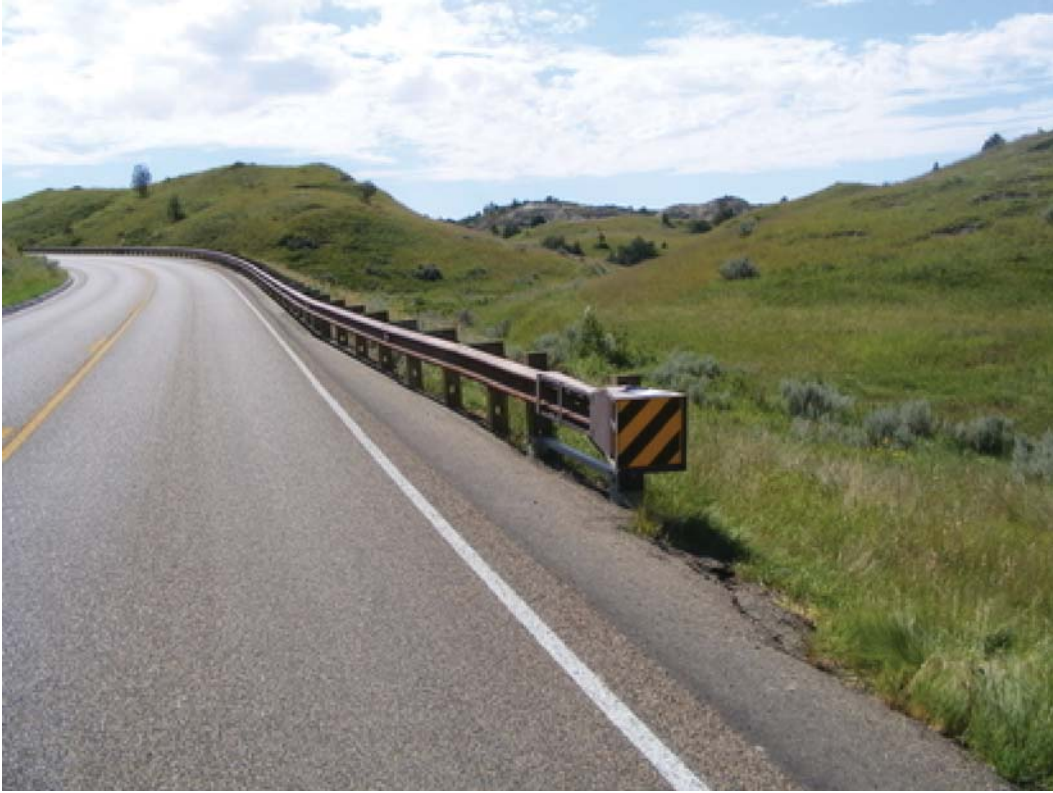
THRO_0011_22.089_L_1.JPG

Barrier ID:	THRO-0011-22.089-L				
Route Name:	SCENIC LOOP				
Inspection Date:	11/08/2010	Barrier Rating:	23.70		
Barrier Description					
Type:	W-BEAM STRONG POST	Barrier Function:	TRAFFIC		
Barrier Material:	WEATHERING STEEL/CORTEN	Post Material:	WOOD		
Blockout Type:	WOOD	Length (ft.):	645		
Speed Limit (MPH):	25	Placement with Respect to Road:	OUTSIDE OF CURVE		
Hazard Behind Barrier:	MEDIUM				
Barrier Crashworthiness					
Appropriate Test Level:	TL-1	Barrier Test Level:	TL-3	Is Barrier Crashworthy?:	YES
Beg. End Trtmt Type:	W-BEAM TANGENT 350	Is Beg. End Trtmt Crashworthy?:	YES	Approach Transition Type:	NONE
Ending End Trtmt Type:	W-BEAM TANGENT 350	Ending End Trtmt Crashworthy?:	YES		
Average Measurements					
Design Height (In.):	27	Width (In.):	0.0	Post Spacing (In.):	75.0
Height (In.):	28.7	Lateral Offset (In.):	30.0	Road Grade (%):	5.60
Physical Condition					
Barrier	Alignment and Height:	Alignment acceptable. Height was 0 to 3-in above the 27-in design height.

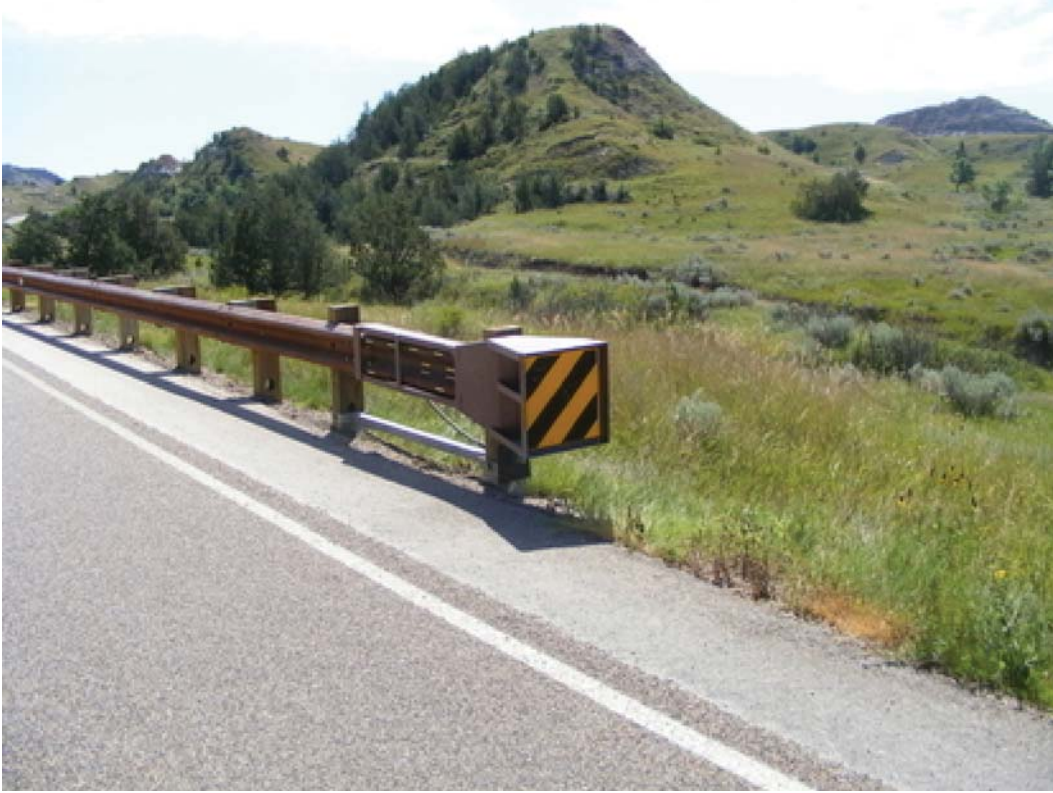
THRO_0011_22.611_L_1.JPG

Barrier ID:	THRO-0011-22.611-L				
Route Name:	SCENIC LOOP				
Inspection Date:	11/08/2010	Barrier Rating:	18.00		
Barrier Description					
Type:	W-BEAM STRONG POST	Barrier Function:	TRAFFIC		
Barrier Material:	WEATHERING STEEL/CORTEN	Post Material:	WOOD		
Blockout Type:	WOOD	Length (ft.):	369		
Speed Limit (MPH):	25	Placement with Respect to Road:	INSIDE OF CURVE		
Hazard Behind Barrier:	MEDIUM				
Barrier Crashworthiness					
Appropriate Test Level:	TL-1	Barrier Test Level:	TL-3	Is Barrier Crashworthy?:	YES
Beg. End Trtmt Type:	W-BEAM TANGENT 350	Is Beg. End Trtmt Crashworthy?:	YES	Approach Transition Type:	NONE
Ending End Trtmt Type:	W-BEAM TANGENT 350	Ending End Trtmt Crashworthy?:	YES		
Average Measurements					
Design Height (In.):	27	Width (In.):	0.0	Post Spacing (In.):	74.6
Height (In.):	27.7	Lateral Offset (In.):	33.0	Road Grade (%):	0.50
Physical Condition					
Barrier	Alignment and Height:	Alignment acceptable. Height within 1-in of 27-in design height.

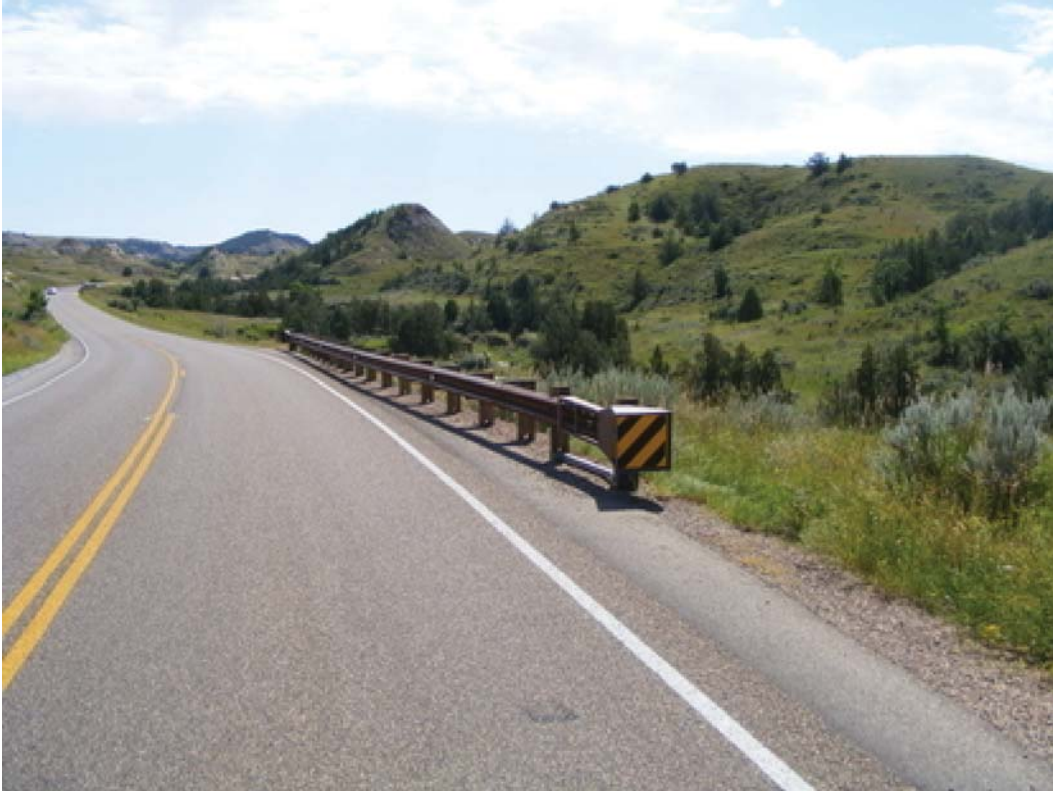
THRO_0011_22.816_L_1.JPG

Barrier ID:	THRO-0011-22.816-L				
Route Name:	SCENIC LOOP				
Inspection Date:	11/08/2010	Barrier Rating:	22.60		
Barrier Description					
Type:	W-BEAM STRONG POST	Barrier Function:	TRAFFIC		
Barrier Material:	WEATHERING STEEL/CORTEN	Post Material:	WOOD		
Blockout Type:	WOOD	Length (ft.):	132		
Speed Limit (MPH):	25	Placement with Respect to Road:	OUTSIDE OF CURVE		
Hazard Behind Barrier:	HIGH				
Barrier Crashworthiness					
Appropriate Test Level:	TL-1	Barrier Test Level:	TL-3	Is Barrier Crashworthy?:	YES
Beg. End Trtmt Type:	W-BEAM TANGENT 350	Is Beg. End Trtmt Crashworthy?:	YES	Approach Transition Type:	NONE
Ending End Trtmt Type:	W-BEAM TANGENT 350	Ending End Trtmt Crashworthy?:	YES		
Average Measurements					
Design Height (In.):	27	Width (In.):	0.0	Post Spacing (In.):	74.5
Height (In.):	28.0	Lateral Offset (In.):	25.6	Road Grade (%):	2.60
Physical Condition					
Barrier	Alignment and Height:	Alignment acceptable. Height within 1-in of 27-in design height.

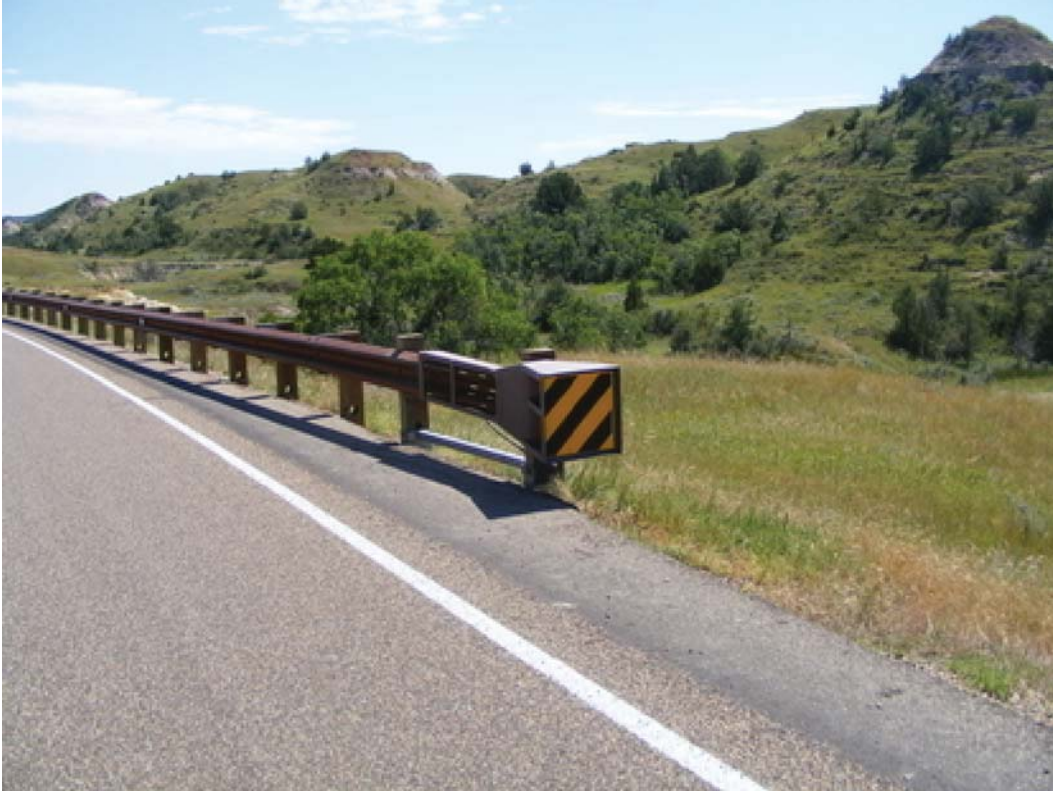
THRO_0011_22.997_L_1.JPG

Barrier ID:	THRO-0011-22.997-L				
Route Name:	SCENIC LOOP				
Inspection Date:	11/08/2010	Barrier Rating:	25.50		
Barrier Description					
Type:	W-BEAM STRONG POST	Barrier Function:	TRAFFIC		
Barrier Material:	WEATHERING STEEL/CORTEN	Post Material:	WOOD		
Blockout Type:	WOOD	Length (ft.):	293		
Speed Limit (MPH):	25	Placement with Respect to Road:	OUTSIDE OF CURVE		
Hazard Behind Barrier:	HIGH				
Barrier Crashworthiness					
Appropriate Test Level:	TL-1	Barrier Test Level:	TL-3	Is Barrier Crashworthy?:	YES
Beg. End Trtmt Type:	W-BEAM TANGENT 350	Is Beg. End Trtmt Crashworthy?:	YES	Approach Transition Type:	NONE
Ending End Trtmt Type:	W-BEAM TANGENT 350	Ending End Trtmt Crashworthy?:	YES		
Average Measurements					
Design Height (In.):	27	Width (In.):	0.0	Post Spacing (In.):	74.3
Height (In.):	29.2	Lateral Offset (In.):	24.7	Road Grade (%):	0.60
Physical Condition					
Barrier	Alignment and Height:	Alignment acceptable. Height was 2 to 3-in above the 27-in design height.

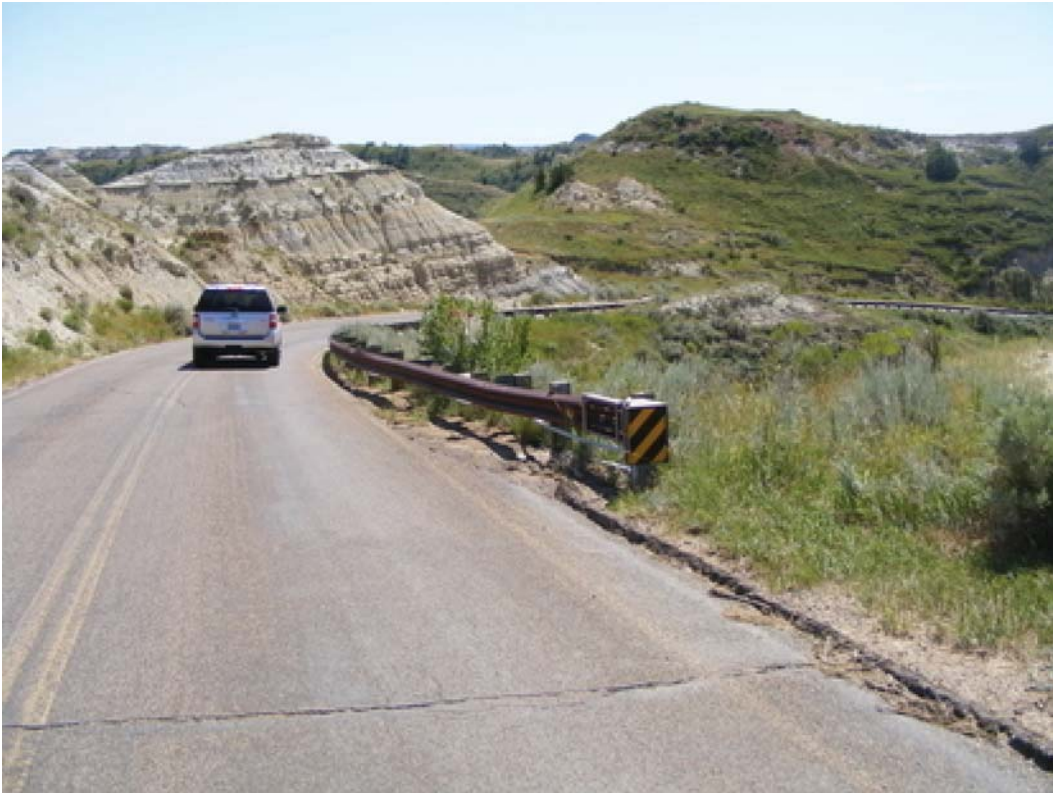
THRO_0011_25.424_R_1.JPG

Barrier ID:	THRO-0011-25.424-R				
Route Name:	SCENIC LOOP				
Inspection Date:	11/08/2010	Barrier Rating:	57.00		
Barrier Description					
Type:	W-BEAM STRONG POST	Barrier Function:	TRAFFIC		
Barrier Material:	WEATHERING STEEL/CORTEN	Post Material:	WOOD		
Blockout Type:	WOOD	Length (ft.):	1043		
Speed Limit (MPH):	25	Placement with Respect to Road:	BOTH INSIDE AND OUTSIDE		
Hazard Behind Barrier:	HIGH				
Barrier Crashworthiness					
Appropriate Test Level:	TL-1	Barrier Test Level:	TL-3	Is Barrier Crashworthy?:	YES
Beg. End Trtmt Type:	W-BEAM FLARED 350 COMPLIANT	Is Beg. End Trtmt Crashworthy?:	YES	Approach Transition Type:	NONE
Ending End Trtmt Type:	W-BEAM FLARED 350 COMPLIANT	Ending End Trtmt Crashworthy?:	YES		
Average Measurements					
Design Height (In.):	27	Width (In.):	0.0	Post Spacing (In.):	75.0
Height (In.):	23.7	Lateral Offset (In.):	19.2	Road Grade (%):	10.10
Physical Condition					
Barrier	Alignment and Height:	Alignment acceptable. 328-ft was 3 to 6 in below the 27-in design height 380-ft was 1 to 3-in below and 335-ft was within 1-in.

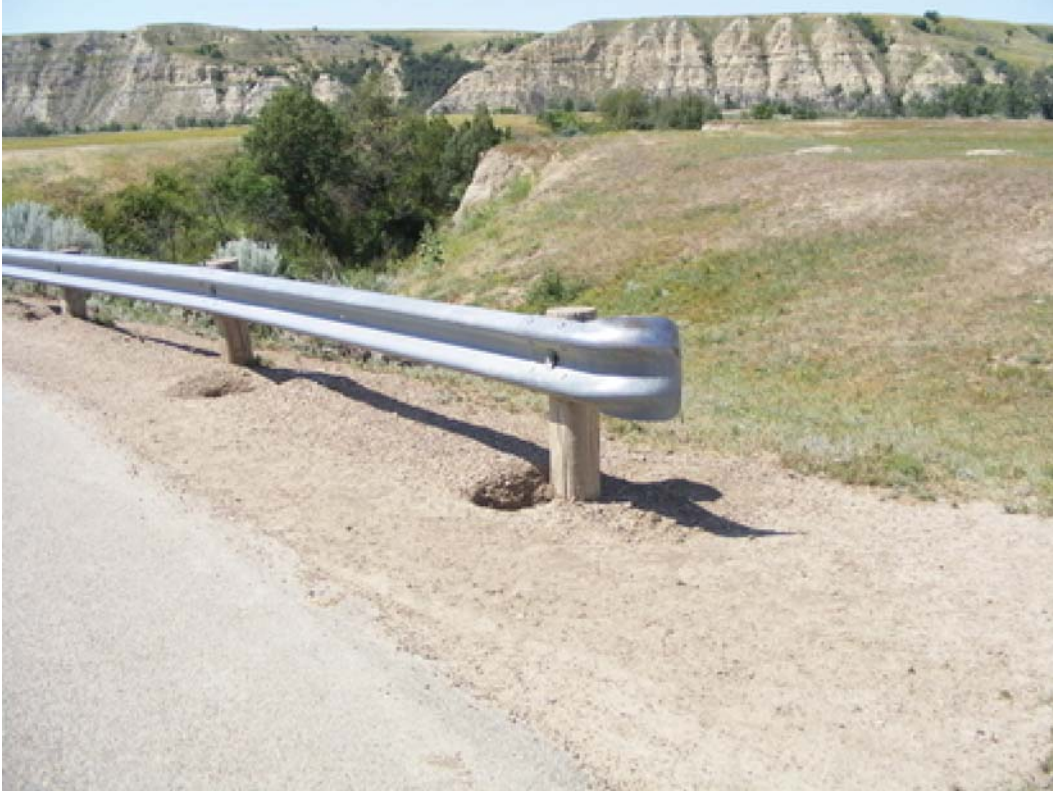
THRO_0011_26.158_R_1.JPG

Barrier ID:	THRO-0011-26.158-R				
Route Name:	SCENIC LOOP				
Inspection Date:	11/08/2010	Barrier Rating:	29.60		
Barrier Description					
Type:	W-BEAM WEAK POST	Barrier Function:	TRAFFIC		
Barrier Material:	GALVANIZED STEEL	Post Material:	WOOD		
Blockout Type:	N/A	Length (ft.):	117		
Speed Limit (MPH):	25	Placement with Respect to Road:	OUTSIDE OF CURVE		
Hazard Behind Barrier:	MEDIUM				
Barrier Crashworthiness					
Appropriate Test Level:	TL-1	Barrier Test Level:	TL-2	Is Barrier Crashworthy?:	YES
Beg. End Trtmt Type:	NONE	Is Beg. End Trtmt Crashworthy?:	N/A	Approach Transition Type:	NONE
Ending End Trtmt Type:	NONE	Ending End Trtmt Crashworthy?:	N/A		
Average Measurements					
Design Height (In.):	27	Width (In.):	0.0	Post Spacing (In.):	149.3
Height (In.):	23.2	Lateral Offset (In.):	41.2	Road Grade (%):	2.60
Physical Condition					
Barrier	Alignment and Height:	Alignment acceptable. 90-ft was 3 to 5 in below the 27-in design height and 27-ft was 1 to 3-in below.

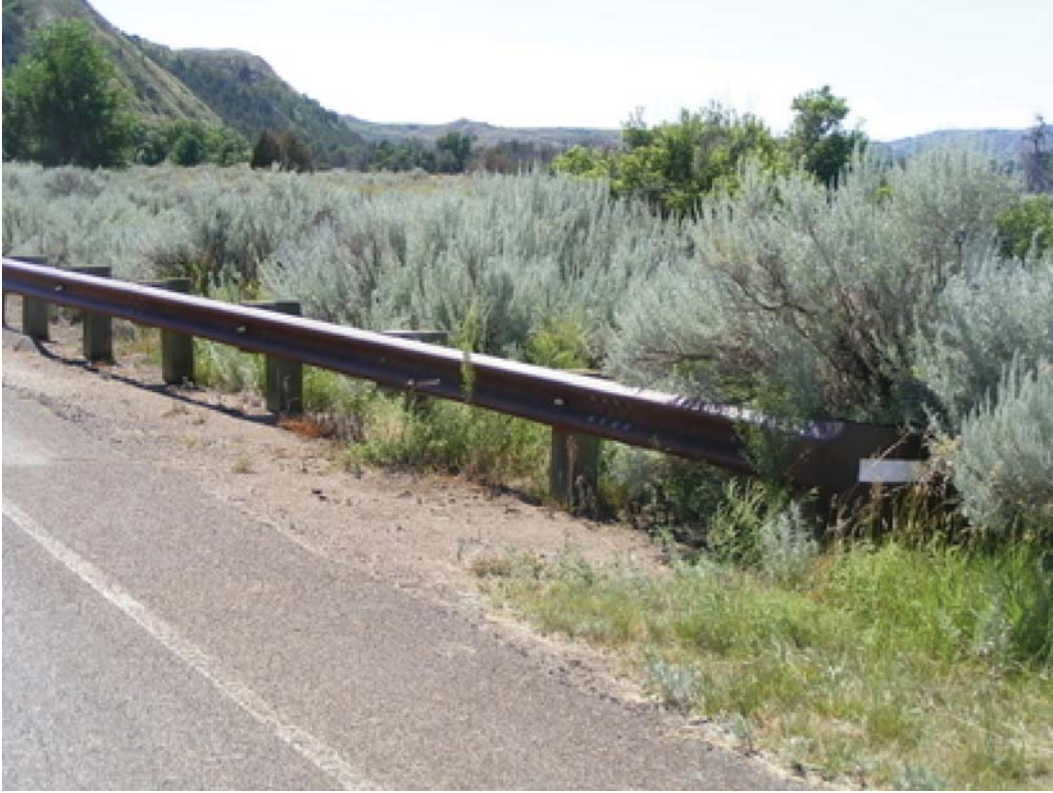
THRO_0011_27.260_R_1.JPG

Barrier ID:	THRO-0011-27.260-R				
Route Name:	SCENIC LOOP				
Inspection Date:	11/08/2010	Barrier Rating:	9.30		
Barrier Description					
Type:	W-BEAM STRONG POST	Barrier Function:	TRAFFIC		
Barrier Material:	WEATHERING STEEL/CORTEN	Post Material:	WOOD		
Blockout Type:	WOOD	Length (ft.):	135		
Speed Limit (MPH):	25	Placement with Respect to Road:	TANGENT		
Hazard Behind Barrier:	MEDIUM				
Barrier Crashworthiness					
Appropriate Test Level:	TL-1	Barrier Test Level:	TL-3	Is Barrier Crashworthy?:	YES
Beg. End Trtmt Type:	W-BEAM BCT	Is Beg. End Trtmt Crashworthy?:	NO	Approach Transition Type:	NONE
Ending End Trtmt Type:	W-BEAM BCT	Ending End Trtmt Crashworthy?:	NO		
Average Measurements					
Design Height (In.):	27	Width (In.):	0.0	Post Spacing (In.):	75.0
Height (In.):	28.2	Lateral Offset (In.):	49.5	Road Grade (%):	0.30
Physical Condition					
Barrier	Alignment and Height:	Alignment acceptable. Height was 1 to 2-in above the 27-in design height.

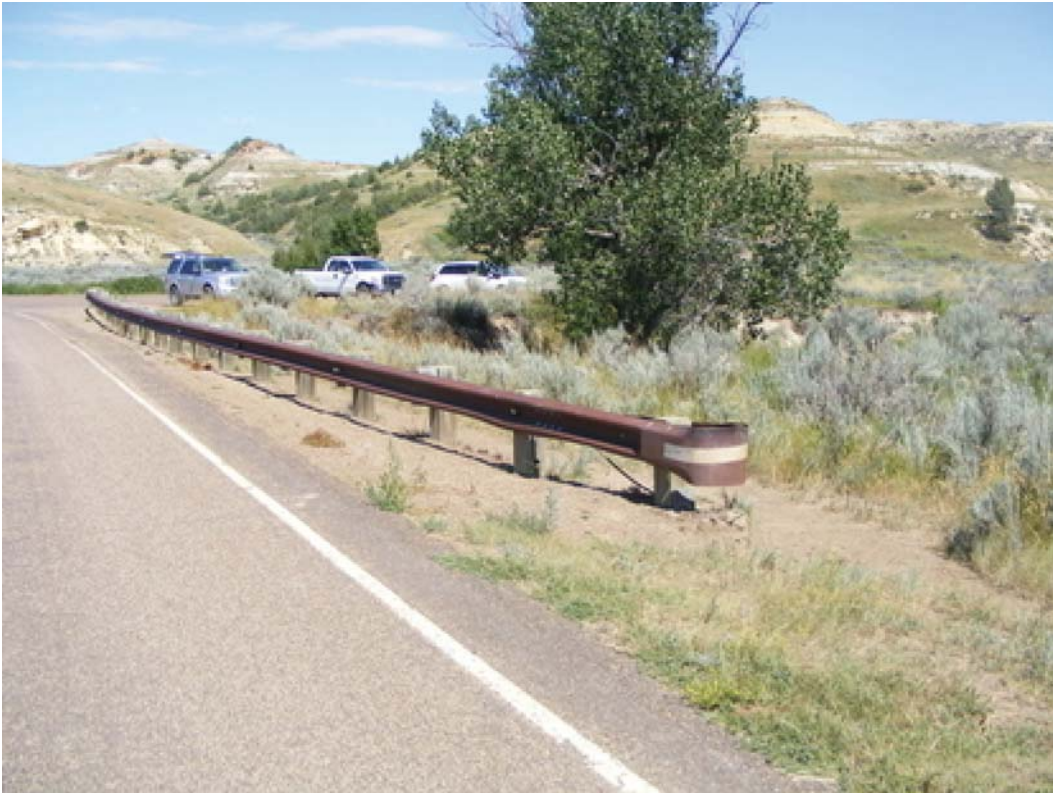
THRO_0011_27.265_L_1.JPG

Barrier ID:	THRO-0011-27.265-L				
Route Name:	SCENIC LOOP				
Inspection Date:	11/08/2010	Barrier Rating:	9.30		
Barrier Description					
Type:	W-BEAM STRONG POST	Barrier Function:	TRAFFIC		
Barrier Material:	WEATHERING STEEL/CORTEN	Post Material:	WOOD		
Blockout Type:	WOOD	Length (ft.):	132		
Speed Limit (MPH):	25	Placement with Respect to Road:	TANGENT		
Hazard Behind Barrier:	MEDIUM				
Barrier Crashworthiness					
Appropriate Test Level:	TL-1	Barrier Test Level:	TL-3	Is Barrier Crashworthy?:	YES
Beg. End Trtmt Type:	W-BEAM BCT	Is Beg. End Trtmt Crashworthy?:	NO	Approach Transition Type:	NONE
Ending End Trtmt Type:	W-BEAM BCT	Ending End Trtmt Crashworthy?:	NO		
Average Measurements					
Design Height (In.):	27	Width (In.):	0.0	Post Spacing (In.):	75.3
Height (In.):	28.0	Lateral Offset (In.):	61.2	Road Grade (%):	0.70
Physical Condition					
Barrier	Alignment and Height:	Alignment acceptable. 20-ft was 2-in below the 27 in design height and 112-ft was within 1-in.

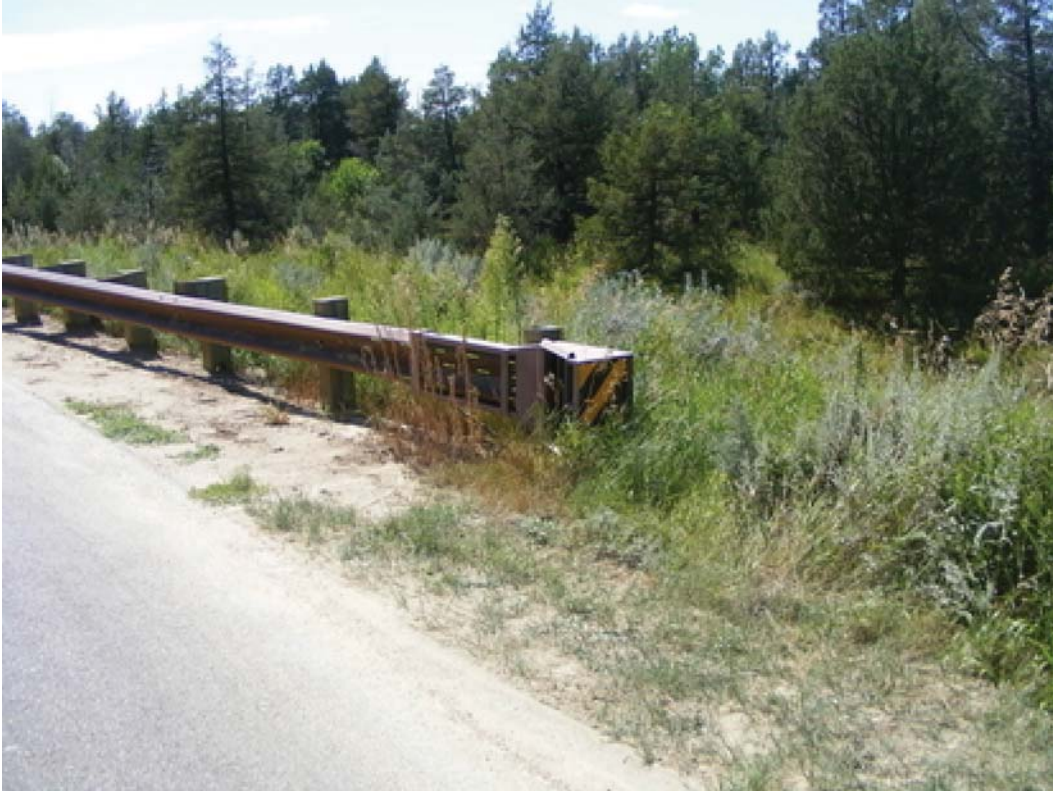
THRO_0011_27.898_R_1.JPG

Barrier ID:	THRO-0011-27.898-R				
Route Name:	SCENIC LOOP				
Inspection Date:	11/08/2010	Barrier Rating:	30.80		
Barrier Description					
Type:	W-BEAM STRONG POST	Barrier Function:	TRAFFIC		
Barrier Material:	WEATHERING STEEL/CORTEN	Post Material:	WOOD		
Blockout Type:	WOOD	Length (ft.):	356		
Speed Limit (MPH):	25	Placement with Respect to Road:	OUTSIDE OF CURVE		
Hazard Behind Barrier:	MEDIUM				
Barrier Crashworthiness					
Appropriate Test Level:	TL-1	Barrier Test Level:	TL-3	Is Barrier Crashworthy?:	YES
Beg. End Trtmt Type:	W-BEAM FLARED 350 COMPLIANT	Is Beg. End Trtmt Crashworthy?:	YES	Approach Transition Type:	NONE
Ending End Trtmt Type:	W-BEAM FLARED 350 COMPLIANT	Ending End Trtmt Crashworthy?:	YES		
Average Measurements					
Design Height (In.):	27	Width (In.):	0.0	Post Spacing (In.):	74.6
Height (In.):	26.0	Lateral Offset (In.):	17.7	Road Grade (%):	0.80
Physical Condition					
Barrier	Alignment and Height:	Alignment acceptable. 85-ft was 1 to 2-in below the 27 in design height and 271-ft was within 1-in.

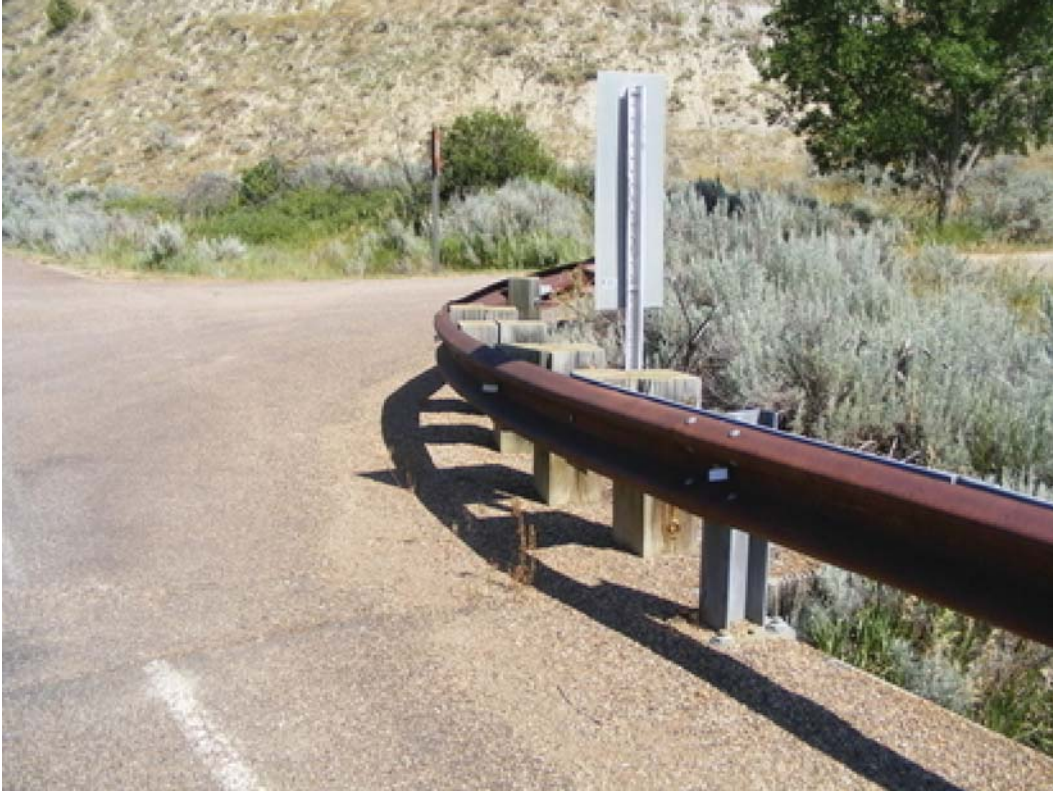
THRO_0011_28.172_L_1.JPG

Barrier ID:	THRO-0011-28.172-L				
Route Name:	SCENIC LOOP				
Inspection Date:	11/08/2010	Barrier Rating:	17.80		
Barrier Description					
Type:	W-BEAM STRONG POST	Barrier Function:	TRAFFIC		
Barrier Material:	WEATHERING STEEL/CORTEN	Post Material:	WOOD		
Blockout Type:	WOOD	Length (ft.):	27		
Speed Limit (MPH):	25	Placement with Respect to Road:	OUTSIDE OF CURVE		
Hazard Behind Barrier:	MEDIUM				
Barrier Crashworthiness					
Appropriate Test Level:	TL-1	Barrier Test Level:	TL-3	Is Barrier Crashworthy?:	YES
Beg. End Trtmt Type:	NONE	Is Beg. End Trtmt Crashworthy?:	N/A	Approach Transition Type:	RIGID W-BEAM - W-BEAM
Ending End Trtmt Type:	W-BEAM BCT	Ending End Trtmt Crashworthy?:	NO		
Average Measurements					
Design Height (In.):	27	Width (In.):	0.0	Post Spacing (In.):	37.0
Height (In.):	26.7	Lateral Offset (In.):	110.6	Road Grade (%):	0.50
Physical Condition					
Barrier	Alignment and Height:	End treatment and transition only.

Breaking and Cracking:	End treatment and transition only.			
	Missing Elements:	End treatment and transition only.			
	Corrosion and Weathering:	End treatment and transition only.			
End Treatments	Alignment and Height:	Alignment acceptable. 17-ft was 1 to 3-in below the 27-in design height.			
	Breaking and Cracking:	No cracked or broken end treatment elements.			
	Missing Elements:	No missing end treatment elements.			
	Corrosion and Weathering:	Minimal corrosion/weathering of end treatment elements.

Repair Action:	REPAIR	FMSS Work Type:	DEFERRED MAINTENANCE	Repair Cost:	\$1810
Brief Workorder:	Raise 17 feet of guardrail up to 27 inch design height.				
Workorder:	Adjust Guardrail at \$10- per -Lin. Ft. for 17-ft = \$170. Raise 17-ft of guardrail up to 27 inch design height. Low Speed Traffic Control at \$1475- per -Day for 1 Day(s) = \$1475.

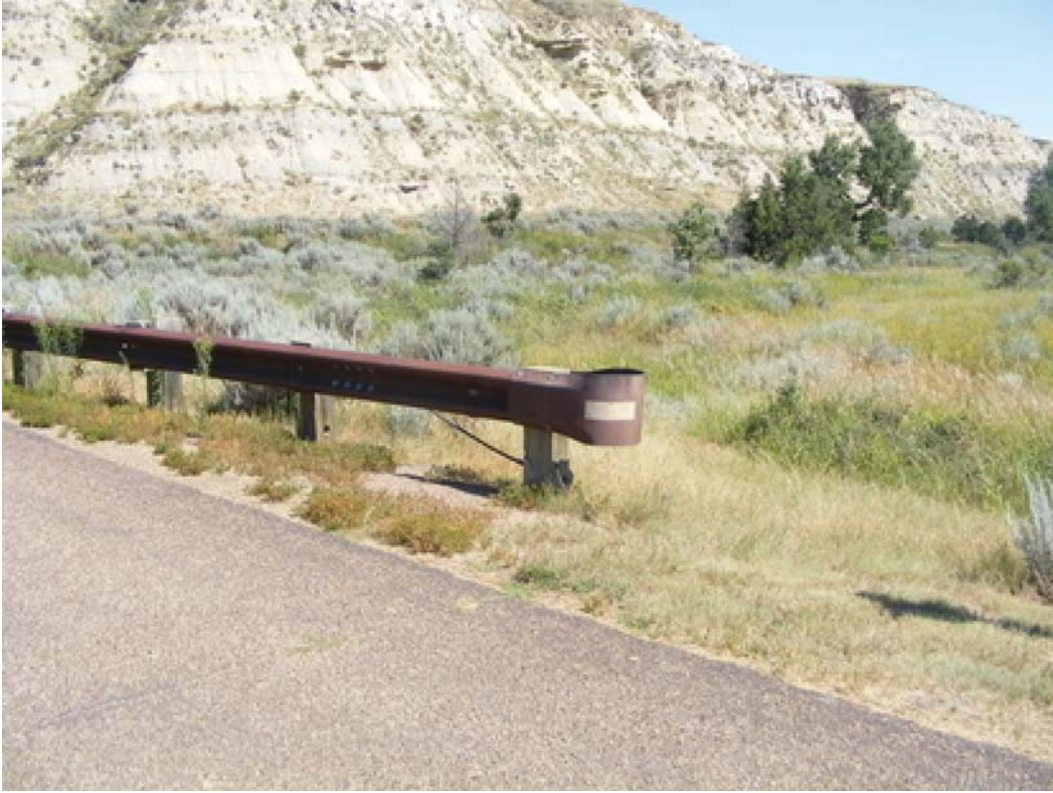
THRO_0011_28.187_L_1.JPG

Barrier ID:	THRO-0011-28.187-L				
Route Name:	SCENIC LOOP				
Inspection Date:	11/08/2010	Barrier Rating:	17.80		
Barrier Description					
Type:	W-BEAM STRONG POST	Barrier Function:	TRAFFIC		
Barrier Material:	WEATHERING STEEL/CORTEN	Post Material:	WOOD		
Blockout Type:	WOOD	Length (ft.):	88		
Speed Limit (MPH):	25	Placement with Respect to Road:	OUTSIDE OF CURVE		
Hazard Behind Barrier:	MEDIUM				
Barrier Crashworthiness					
Appropriate Test Level:	TL-1	Barrier Test Level:	TL-3	Is Barrier Crashworthy?:	YES
Beg. End Trtmt Type:	W-BEAM BCT	Is Beg. End Trtmt Crashworthy?:	NO	Approach Transition Type:	RIGID W-BEAM - W-BEAM
Ending End Trtmt Type:	NONE	Ending End Trtmt Crashworthy?:	N/A		
Average Measurements					
Design Height (In.):	27	Width (In.):	0.0	Post Spacing (In.):	75.0
Height (In.):	27.7	Lateral Offset (In.):	70.3	Road Grade (%):	0.20
Physical Condition					
Barrier	Alignment and Height:	Alignment acceptable. Height within 1-in of 27-in design height.

Breaking and Cracking:	No cracked or broken barrier elements.			
	Missing Elements:	No missing barrier elements.			
	Corrosion and Weathering:	Minimal corrosion/weathering of barrier elements.			
End Treatments	Alignment and Height:	Alignment acceptable. Height within 1-in of 27-in design height.			
	Breaking and Cracking:	No cracked or broken end treatment elements.			
	Missing Elements:	No missing end treatment elements.			
	Corrosion and Weathering:	Minimal corrosion/weathering of end treatment elements.

Barrier ID:	THRO-0011-28.187-L				
Route Name:	SCENIC LOOP				
Inspection Date:	11/08/2010	Barrier Rating:		17.80	
Repair Recommendations					
Repair Action:	NO ACTION	FMSS Work Type:	N/A	Repair Cost:	\$0
Brief Workorder:	N/A				
Workorder:

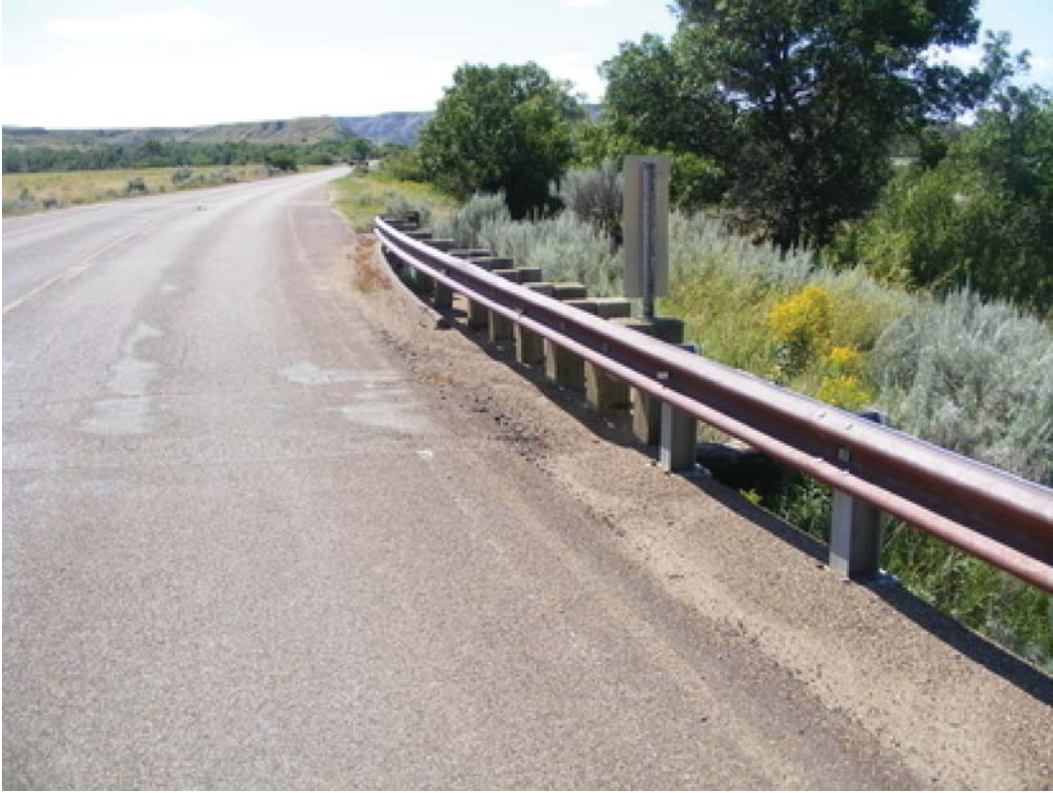
THRO_0011_28.190_R_1.JPG

Barrier ID:	THRO-0011-28.190-R				
Route Name:	SCENIC LOOP				
Inspection Date:	11/08/2010	Barrier Rating:	12.10		
Barrier Description					
Type:	W-BEAM STRONG POST	Barrier Function:	TRAFFIC		
Barrier Material:	WEATHERING STEEL/CORTEN	Post Material:	WOOD		
Blockout Type:	WOOD	Length (ft.):	68		
Speed Limit (MPH):	25	Placement with Respect to Road:	TANGENT		
Hazard Behind Barrier:	MEDIUM				
Barrier Crashworthiness					
Appropriate Test Level:	TL-1	Barrier Test Level:	TL-3	Is Barrier Crashworthy?:	YES
Beg. End Trtmt Type:	NONE	Is Beg. End Trtmt Crashworthy?:	N/A	Approach Transition Type:	RIGID W-BEAM - W-BEAM
Ending End Trtmt Type:	W-BEAM BCT	Ending End Trtmt Crashworthy?:	NO		
Average Measurements					
Design Height (In.):	27	Width (In.):	0.0	Post Spacing (In.):	74.5
Height (In.):	29.6	Lateral Offset (In.):	39.2	Road Grade (%):	0.40
Physical Condition					
Barrier	Alignment and Height:	Alignment acceptable. Height was 2 to 3-in above the 27-in design height.

Breaking and Cracking:	No breaking or cracking of barrier.			
	Missing Elements:	No missing barrier elements.			
	Corrosion and Weathering:	No weathering of the barrier.			
End Treatments	Alignment and Height:	Alignment acceptable. Height was 2 to 3-in above the 27-in design height.			
	Breaking and Cracking:	No cracked or broken end treatment elements.			
	Missing Elements:	No missing end treatment elements.			
	Corrosion and Weathering:	No major weathering of the end treatments.

Barrier ID:	THRO-0011-28.190-R				
Route Name:	SCENIC LOOP				
Inspection Date:	11/08/2010	Barrier Rating:		12.10	
Repair Recommendations					
Repair Action:	NO ACTION	FMSS Work Type:	N/A	Repair Cost:	\$0
Brief Workorder:	N/A				
Workorder:

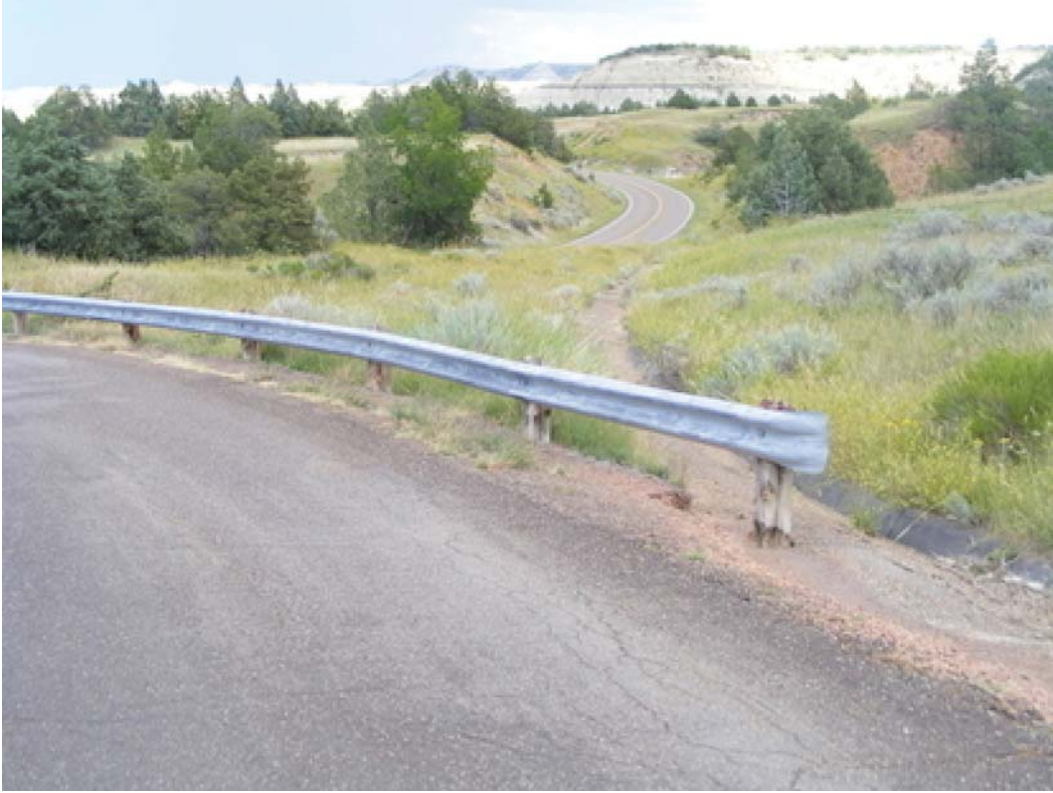
THRO_0204_0.005_L_1.JPG

Barrier ID:	THRO-0204-0.005-L				
Route Name:	BUCK HILL SPUR				
Inspection Date:	09/08/2010	Barrier Rating:	26.60		
Barrier Description					
Type:	W-BEAM WEAK POST	Barrier Function:	TRAFFIC		
Barrier Material:	GALVANIZED STEEL	Post Material:	WOOD		
Blockout Type:	N/A	Length (ft.):	90		
Speed Limit (MPH):	20	Placement with Respect to Road:	OUTSIDE OF CURVE		
Hazard Behind Barrier:	MEDIUM				
Barrier Crashworthiness					
Appropriate Test Level:	TL-1	Barrier Test Level:	TL-2	Is Barrier Crashworthy?:	YES
Beg. End Trtmt Type:	NONE	Is Beg. End Trtmt Crashworthy?:	N/A	Approach Transition Type:	NONE
Ending End Trtmt Type:	NONE	Ending End Trtmt Crashworthy?:	N/A		
Average Measurements					
Design Height (In.):	27	Width (In.):	0.0	Post Spacing (In.):	150.3
Height (In.):	25.0	Lateral Offset (In.):	55.2	Road Grade (%):	4.90
Physical Condition					
Barrier	Alignment and Height:	Alignment acceptable. Entire barrier was 2-in below the 27-in design height.

Breaking and Cracking:	Minor cracking of the barrier posts. One cracked post.			
	Missing Elements:	No missing barrier elements.			
	Corrosion and Weathering:	Some minor weathering of the barrier.			
End Treatments	Alignment and Height:				
	Breaking and Cracking:				
	Missing Elements:				
	Corrosion and Weathering:

Repair Action:	REPAIR	FMSS Work Type:	DEFERRED MAINTENANCE	Repair Cost:	\$2722
Brief Workorder:	Raise 90 feet of barrier up to 27 inch design height.				
Workorder:	Replace Post at \$100- per -Each for 1 Post(s) = \$100. Replace end post. Adjust Guardrail at \$10- per -Lin. Ft. for 90-ft = \$900. Raise 90-ft of barrier up to 27-in design height. Low Speed Traffic Control at \$1475- per -Day for 1 Day(s) = \$1475.

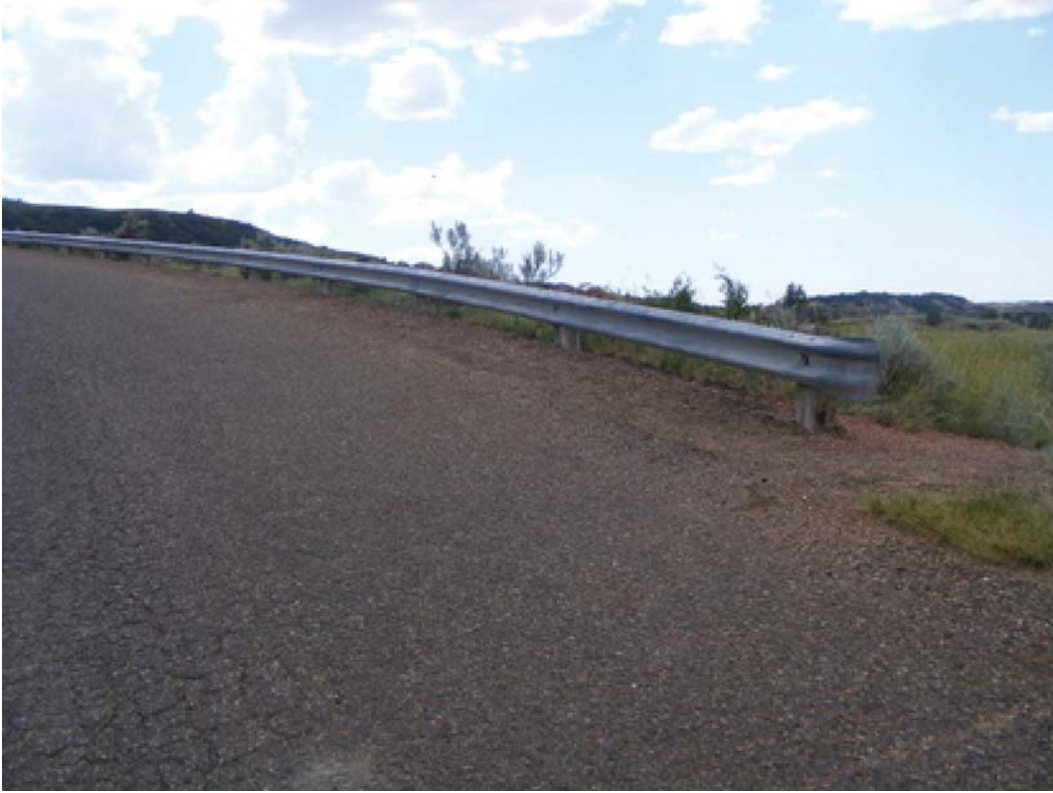
THRO_0204_0.042_R_1.JPG

Barrier ID:	THRO-0204-0.042-R				
Route Name:	BUCK HILL SPUR				
Inspection Date:	09/08/2010	Barrier Rating:	46.50		
Barrier Description					
Type:	W-BEAM WEAK POST	Barrier Function:	TRAFFIC		
Barrier Material:	GALVANIZED STEEL	Post Material:	WOOD		
Blockout Type:	N/A	Length (ft.):	540		
Speed Limit (MPH):	20	Placement with Respect to Road:	OUTSIDE OF CURVE		
Hazard Behind Barrier:	MEDIUM				
Barrier Crashworthiness					
Appropriate Test Level:	TL-1	Barrier Test Level:	TL-2	Is Barrier Crashworthy?:	YES
Beg. End Trtmt Type:	NONE	Is Beg. End Trtmt Crashworthy?:	N/A	Approach Transition Type:	NONE
Ending End Trtmt Type:	NONE	Ending End Trtmt Crashworthy?:	N/A		
Average Measurements					
Design Height (In.):	27	Width (In.):	0.0	Post Spacing (In.):	150.3
Height (In.):	21.0	Lateral Offset (In.):	53.2	Road Grade (%):	8.30
Physical Condition					
Barrier	Alignment and Height:	Alignment acceptable. Entire barrier was 6-in below the 27-in design height.

Breaking and Cracking:	No cracked or broken barrier elements.			
	Missing Elements:	No missing barrier elements.			
	Corrosion and Weathering:	Some minor weathering of the barrier.			
End Treatments	Alignment and Height:				
	Breaking and Cracking:				
	Missing Elements:				
	Corrosion and Weathering:

Repair Action:	REPAIR	FMSS Work Type:	DEFERRED MAINTENANCE	Repair Cost:	\$9185
Brief Workorder:	Raise 540 feet of barrier up to 27-in design height.				
Workorder:	Adjust Guardrail at \$10- per -Lin. Ft. for 540-ft = \$5400. Raise 540-ft of barrier up to 27-in design height. Low Speed Traffic Control at \$1475- per -Day for 2 Day(s) = \$2950.
