GIP Report

**NPS Guardwall/Rail Inventory Program
Theodore Roosevelt National Park**

**Federal Lands Highway
Road Inventory Program**

**Data Collection Date: August 2010
Report Date: November 2015**

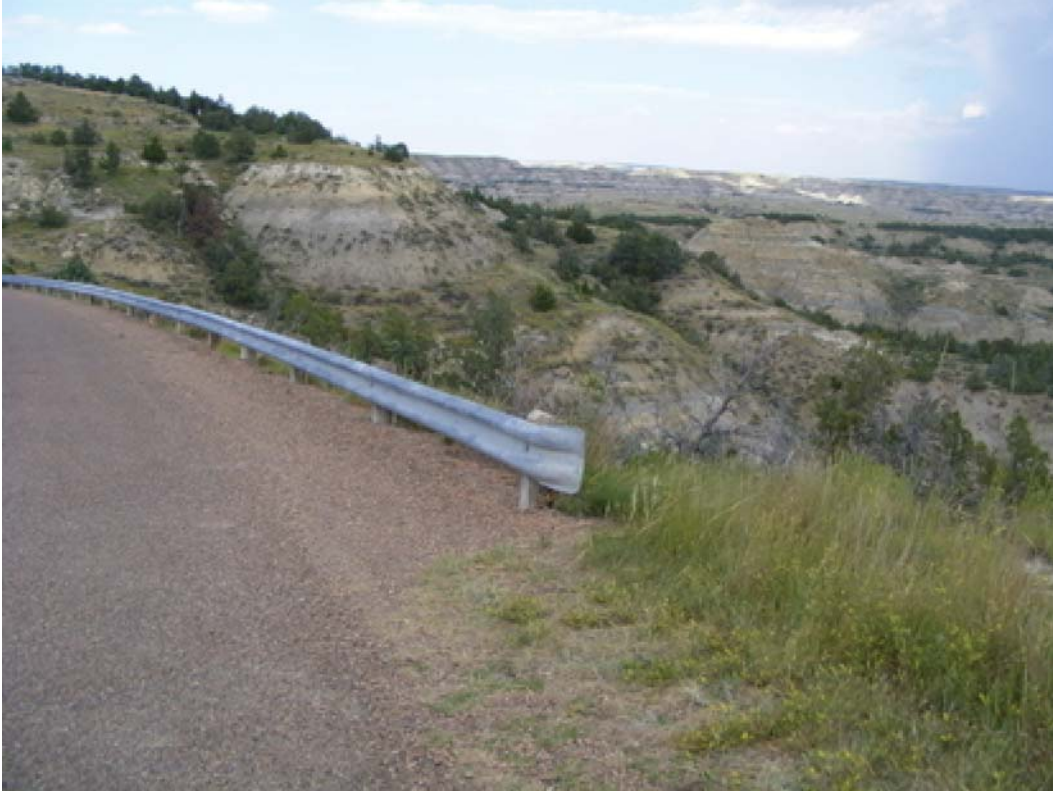
THRO_0204_0.493_L_1.JPG

Barrier ID:	THRO-0204-0.493-L				
Route Name:	BUCK HILL SPUR				
Inspection Date:	09/08/2010	Barrier Rating:	50.90		
Barrier Description					
Type:	W-BEAM WEAK POST	Barrier Function:	TRAFFIC		
Barrier Material:	GALVANIZED STEEL	Post Material:	WOOD		
Blockout Type:	N/A	Length (ft.):	351		
Speed Limit (MPH):	20	Placement with Respect to Road:	OUTSIDE OF CURVE		
Hazard Behind Barrier:	MEDIUM				
Barrier Crashworthiness					
Appropriate Test Level:	TL-1	Barrier Test Level:	TL-2	Is Barrier Crashworthy?:	YES
Beg. End Trtmt Type:	NONE	Is Beg. End Trtmt Crashworthy?:	N/A	Approach Transition Type:	NONE
Ending End Trtmt Type:	NONE	Ending End Trtmt Crashworthy?:	N/A		
Average Measurements					
Design Height (In.):	27	Width (In.):	0.0	Post Spacing (In.):	151.0
Height (In.):	22.6	Lateral Offset (In.):	59.0	Road Grade (%):	9.10
Physical Condition					
Barrier	Alignment and Height:	Alignment acceptable. Entire barrier was 4 to 5- in below the 27-in deisgn height.

Breaking and Cracking:	No cracked or broken barrier elements.			
	Missing Elements:	No missing barrier elements.			
	Corrosion and Weathering:	Some minor weathering of the barrier.			
End Treatments	Alignment and Height:				
	Breaking and Cracking:				
	Missing Elements:				
	Corrosion and Weathering:

Repair Action:	REPAIR	FMSS Work Type:	DEFERRED MAINTENANCE	Repair Cost:	\$7106
Brief Workorder:	Raise 351 feet of barrier up to 27-in design height.				
Workorder:	Adjust Guardrail at \$10- per -Lin. Ft. for 351-ft = \$3510. Raise 351-ft of barrier up to 27-in design height. Low Speed Traffic Control at \$1475- per -Day for 2 Day(s) = \$2950.

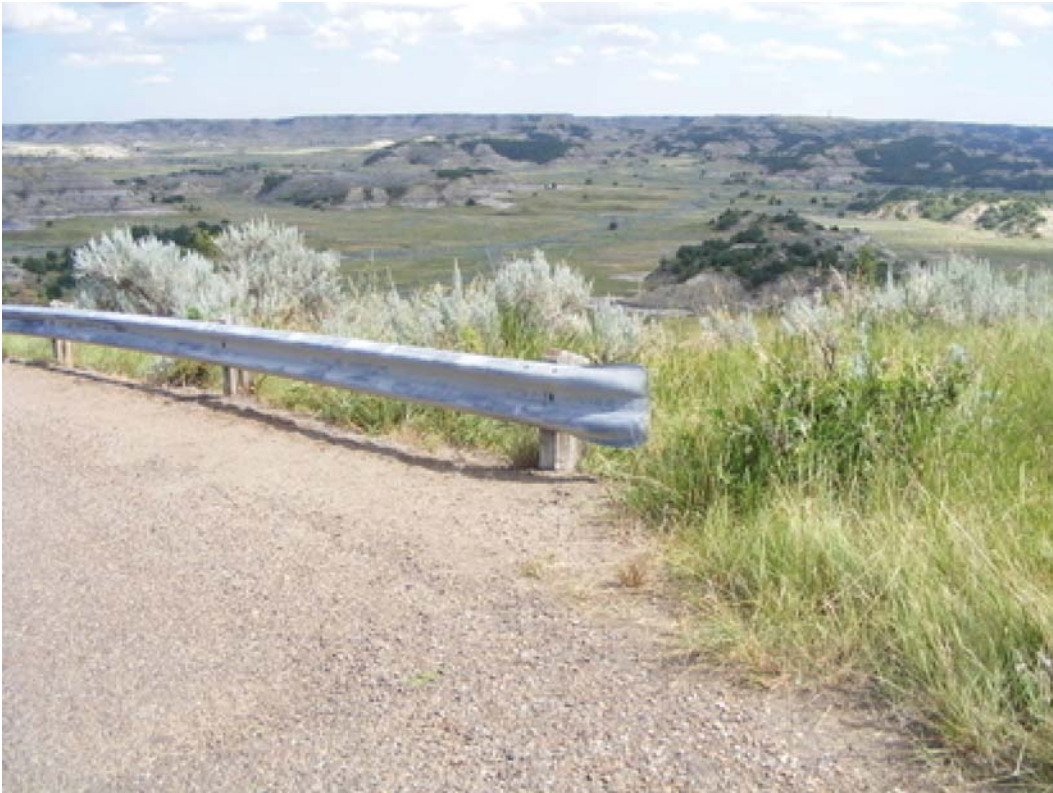
THRO_0204_0.584_L_1.JPG

Barrier ID:	THRO-0204-0.584-L				
Route Name:	BUCK HILL SPUR				
Inspection Date:	09/08/2010	Barrier Rating:	47.20		
Barrier Description					
Type:	W-BEAM WEAK POST	Barrier Function:	TRAFFIC		
Barrier Material:	GALVANIZED STEEL	Post Material:	WOOD		
Blockout Type:	N/A	Length (ft.):	82		
Speed Limit (MPH):	20	Placement with Respect to Road:	OUTSIDE OF CURVE		
Hazard Behind Barrier:	EXTREME				
Barrier Crashworthiness					
Appropriate Test Level:	TL-1	Barrier Test Level:	TL-2	Is Barrier Crashworthy?:	YES
Beg. End Trtmt Type:	NONE	Is Beg. End Trtmt Crashworthy?:	N/A	Approach Transition Type:	NONE
Ending End Trtmt Type:	NONE	Ending End Trtmt Crashworthy?:	N/A		
Average Measurements					
Design Height (In.):	27	Width (In.):	0.0	Post Spacing (In.):	150.0
Height (In.):	22.2	Lateral Offset (In.):	56.0	Road Grade (%):	8.50
Physical Condition					
Barrier	Alignment and Height:	Alignment acceptable. Entire barrier was 4 to 5- in below the 27-in deisgn height.

Breaking and Cracking:	Moderate cracking of wood posts (< 1/4 in). No broken barrier elements.			
	Missing Elements:	No missing barrier elements.			
	Corrosion and Weathering:	No corrosion of galvanized barrier rails. Moderate weathering of wood posts. No erosion around barrier posts.			
End Treatments	Alignment and Height:				
	Breaking and Cracking:				
	Missing Elements:				
	Corrosion and Weathering:

Repair Action:	REPAIR	FMSS Work Type:	DEFERRED MAINTENANCE	Repair Cost:	\$2524
Brief Workorder:	Raise 82 feet of guardrail to 27 inch design height.				
Workorder:	Adjust Guardrail at \$10- per -Lin. Ft. for 82-ft = \$820. Raise 82-ft of guardrail up to 27 inch design height. Low Speed Traffic Control at \$1475- per -Day for 1 Day(s) = \$1475.

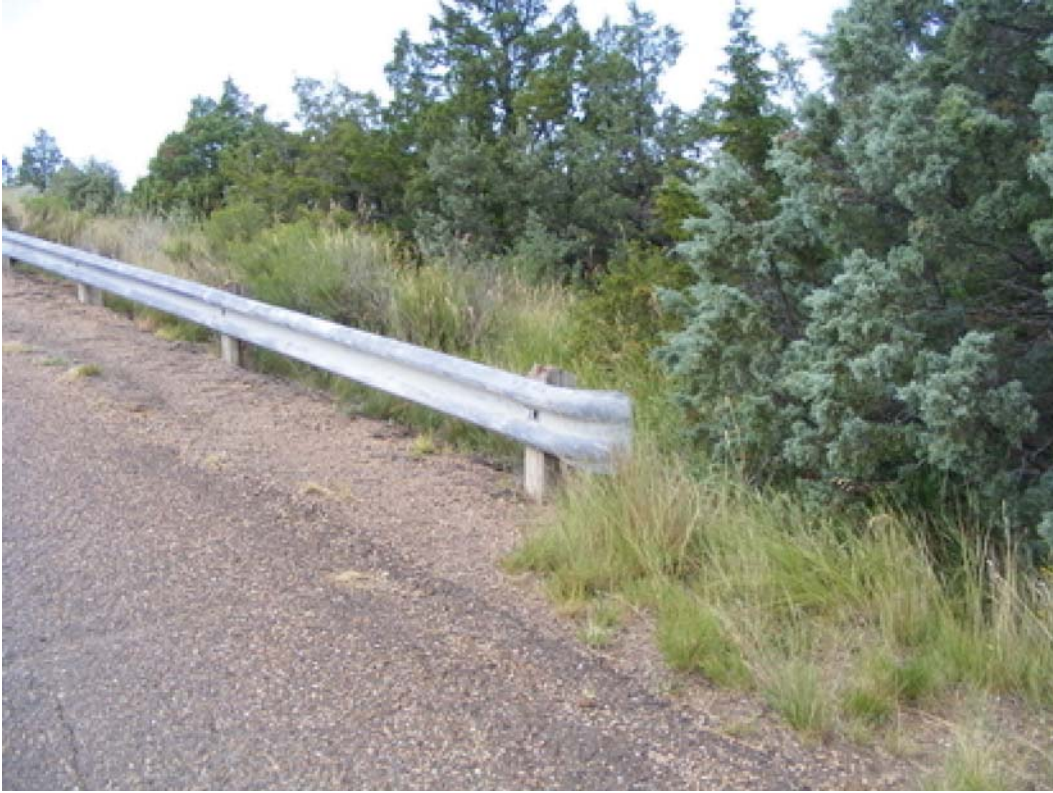
THRO_0204_0.614_R_1.JPG

Barrier ID:	THRO-0204-0.614-R				
Route Name:	BUCK HILL SPUR				
Inspection Date:	09/08/2010	Barrier Rating:	46.50		
Barrier Description					
Type:	W-BEAM WEAK POST	Barrier Function:	TRAFFIC		
Barrier Material:	GALVANIZED STEEL	Post Material:	WOOD		
Blockout Type:	N/A	Length (ft.):	626		
Speed Limit (MPH):	20	Placement with Respect to Road:	BOTH INSIDE AND OUTSIDE		
Hazard Behind Barrier:	MEDIUM				
Barrier Crashworthiness					
Appropriate Test Level:	TL-1	Barrier Test Level:	TL-2	Is Barrier Crashworthy?:	YES
Beg. End Trtmt Type:	NONE	Is Beg. End Trtmt Crashworthy?:	N/A	Approach Transition Type:	NONE
Ending End Trtmt Type:	NONE	Ending End Trtmt Crashworthy?:	N/A		
Average Measurements					
Design Height (In.):	27	Width (In.):	0.0	Post Spacing (In.):	150.1
Height (In.):	22.0	Lateral Offset (In.):	59.5	Road Grade (%):	8.00
Physical Condition					
Barrier	Alignment and Height:	Alignment acceptable. 521-ft was 3 to 7-in below the 27-in design height and 105-ft was 1 to 3-in below.
